Report No. UT-19.19

## U.S. HIGHWAY 89 KANAB- PAUNSAUGUNT WILDLIFE CROSSING AND EXISTING STRUCTURES RESEARCH

Utah Department of Transportation  
Research & Innovation Division

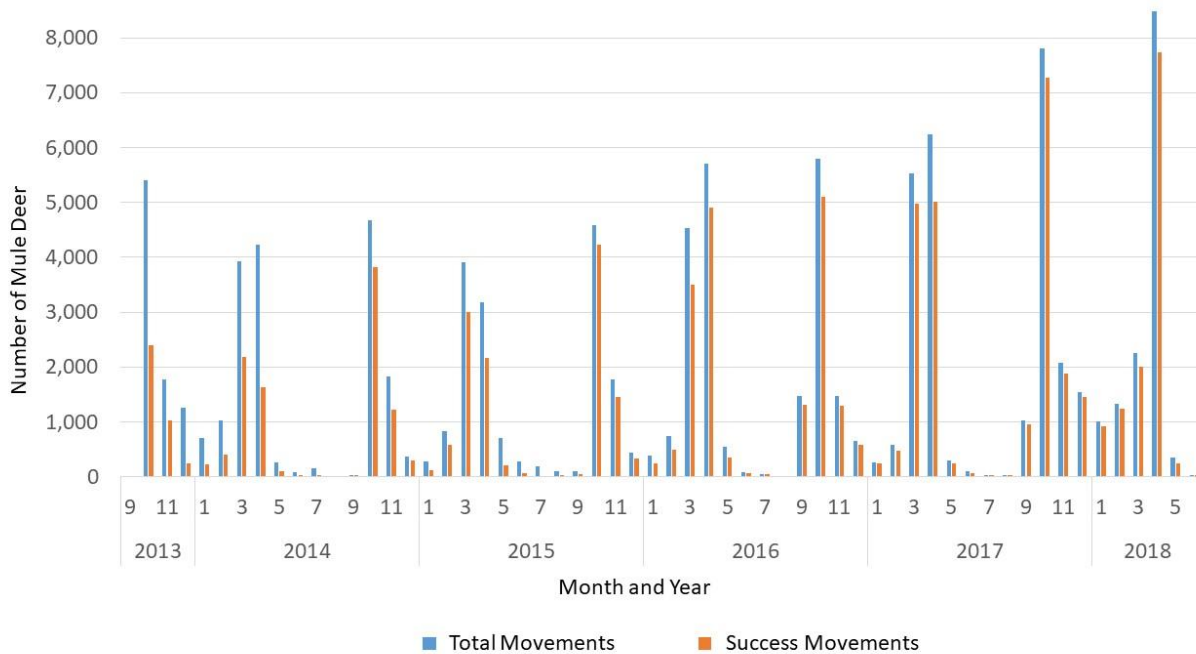
Figure 3 presents monthly mule deer Total Movements and Success Movements combined for all seven structures from September 23, 2013 through June 7, 2018. Monthly-peak Total Movements and Success Movements occurred each October during fall migrations and each March and April during spring migrations. Total Movements and Success Movements were greater during spring migrations than during fall migrations, particularly in 2016, 2017, and 2018.

**Figure 3. Monthly Mule Deer Total Movements and Success Movements Combined for All Seven Wildlife Crossing Structures from September 23, 2013 through June 7, 2018.**

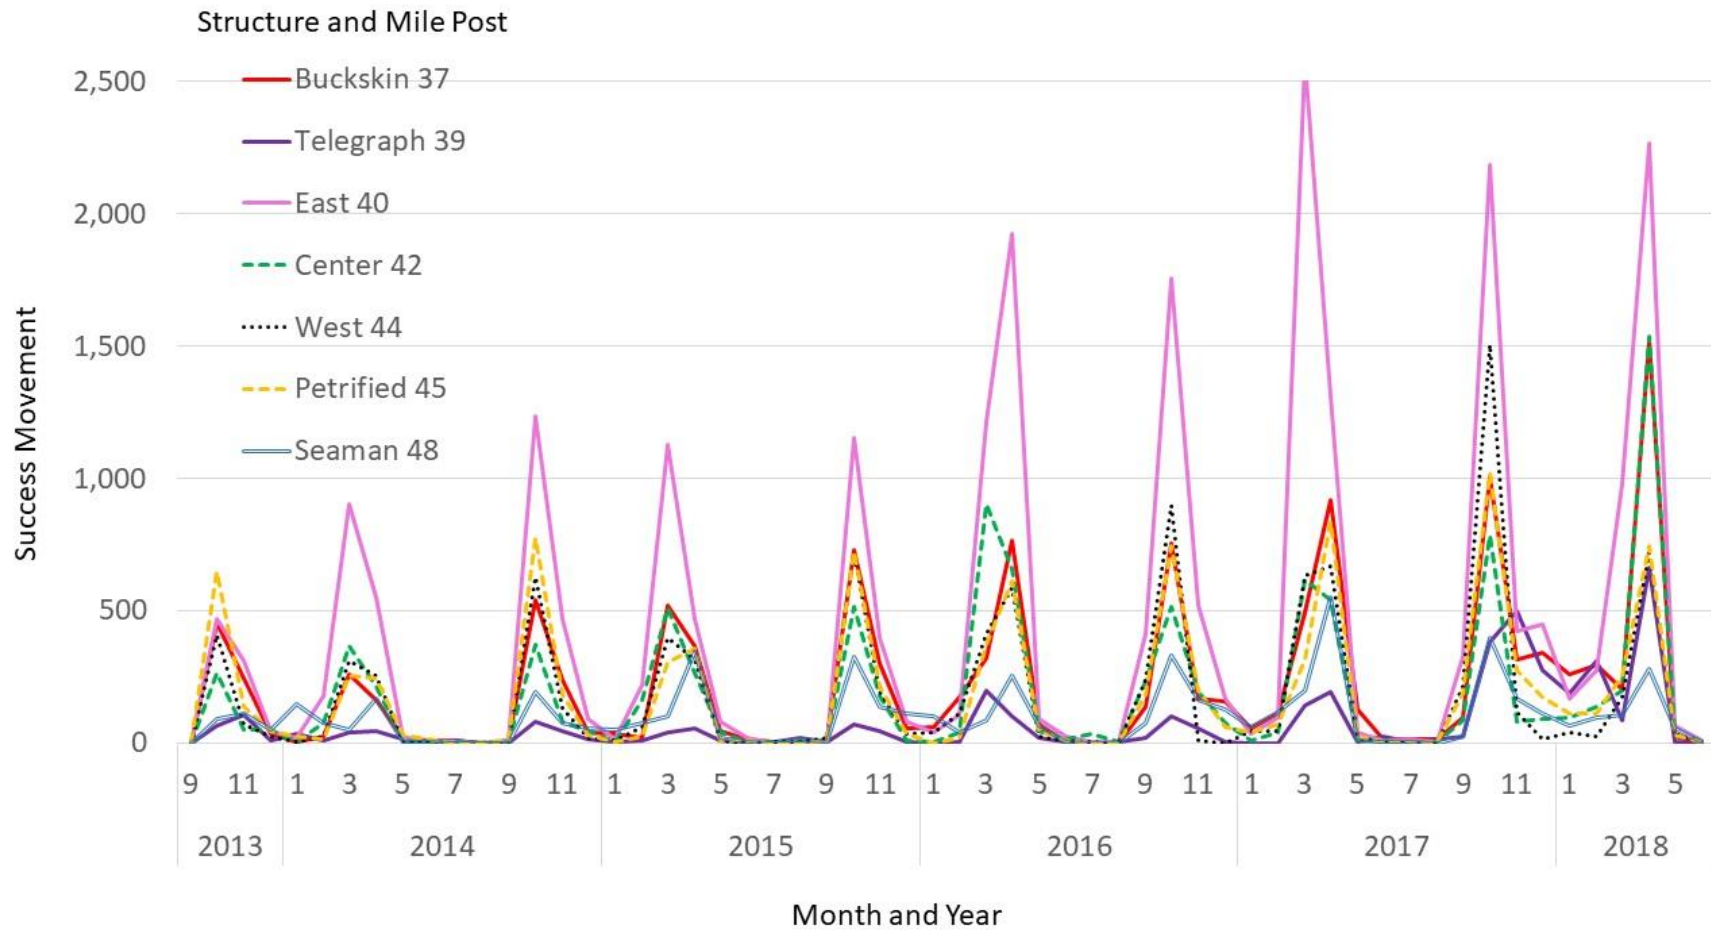
**Figure 5. Superimposed Monthly Mule Deer Success Movements at Each of the Seven Structures on US 89 from September 23, 2013 through June 7, 2018.**

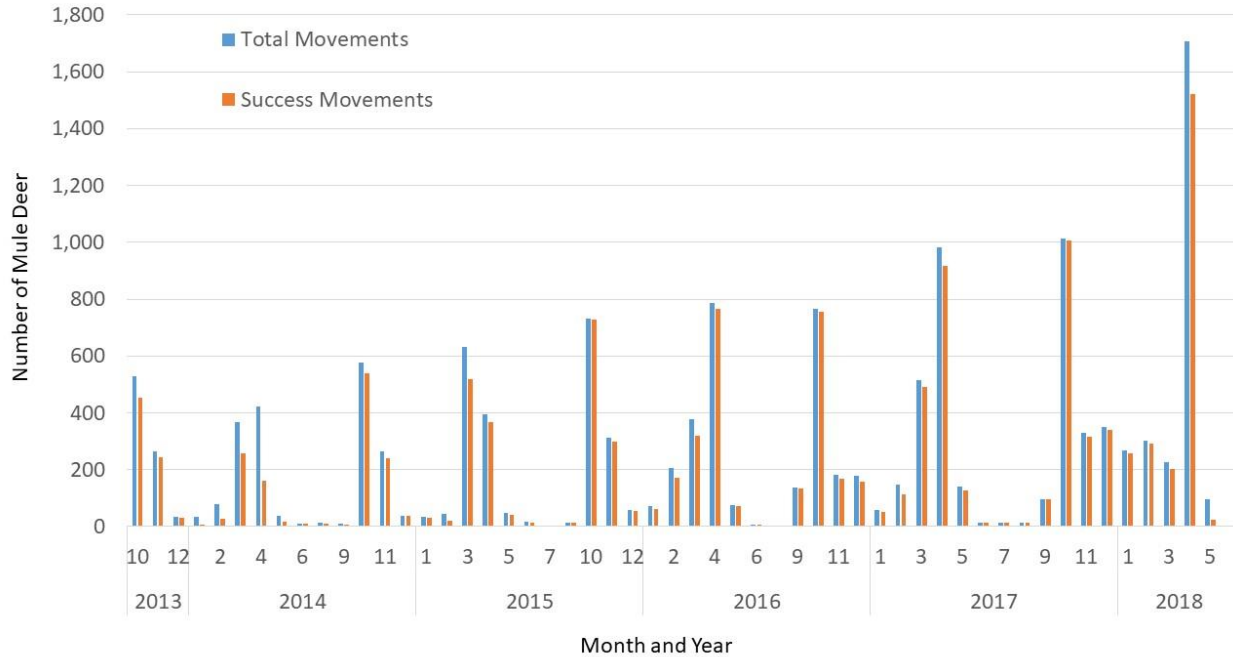
**Figure 8. Monthly Mule Deer Total Movements and Success Movements at the Buckskin Structure from September 23, 2013 through June 7, 2018.**

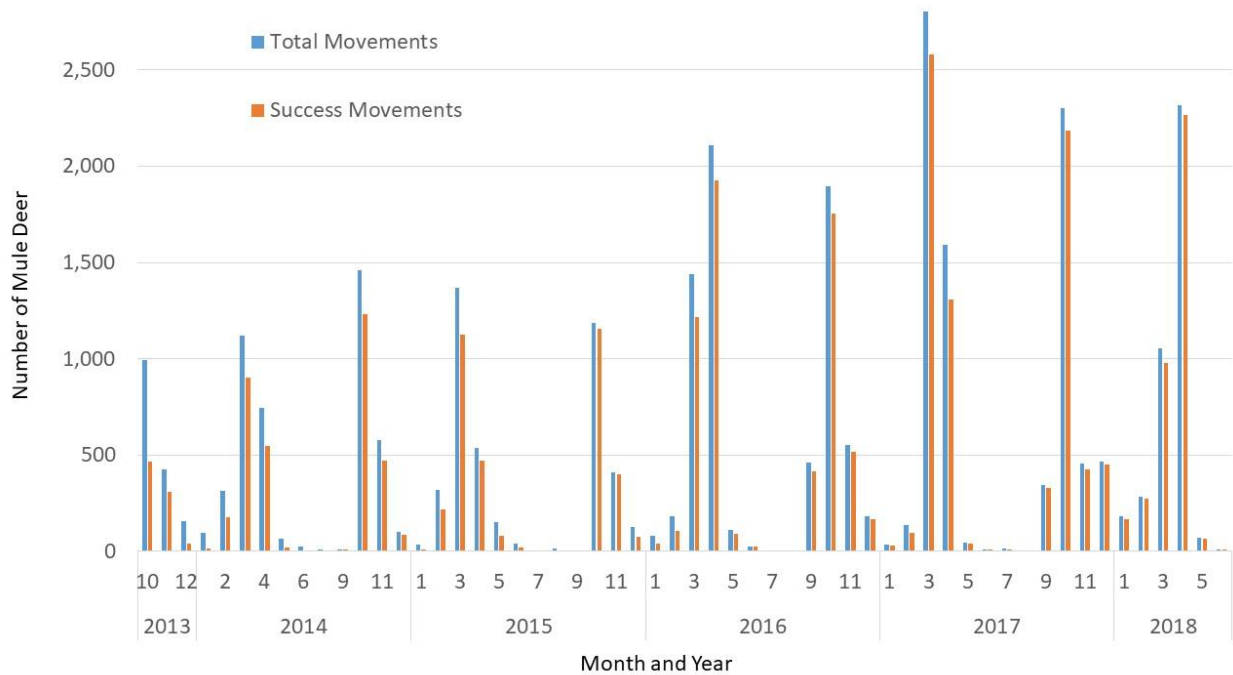
**Figure 12. Monthly Mule Deer Total Movements and Success Movements at the East New Structure from September 23, 2013 through June 7, 2018.**

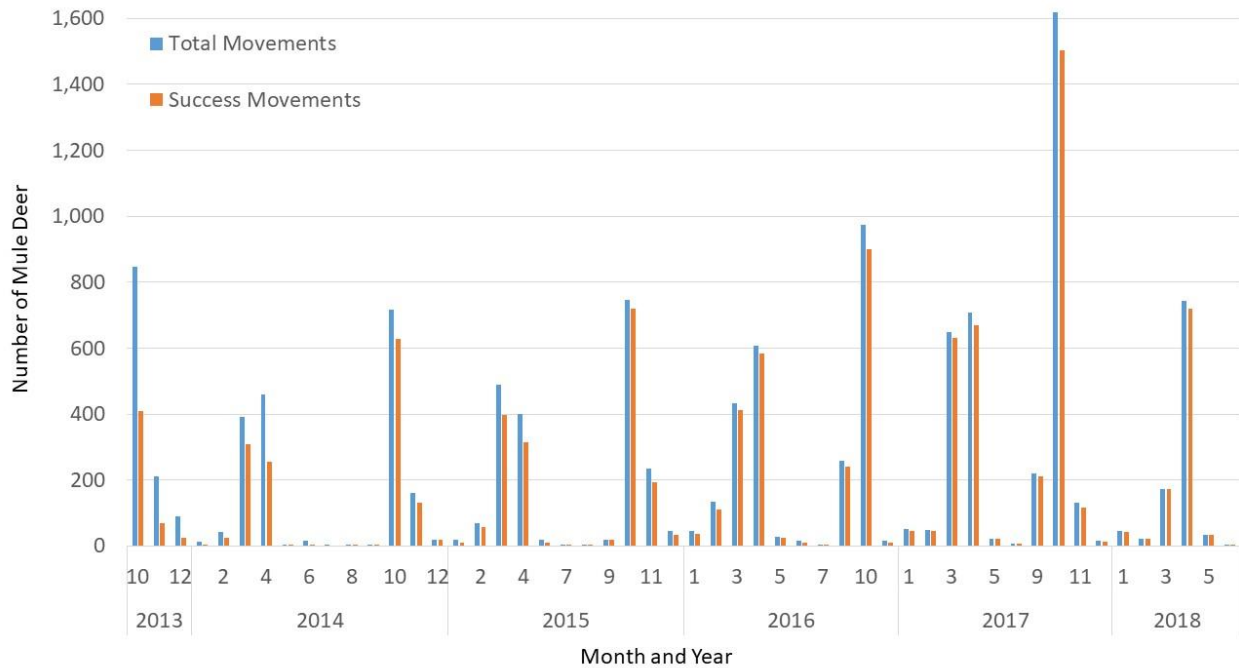
**Figure 16. Monthly Mule Deer Total Movements and Success Movements at the West New Structure from September 23, 2013 through June 7, 2018.**

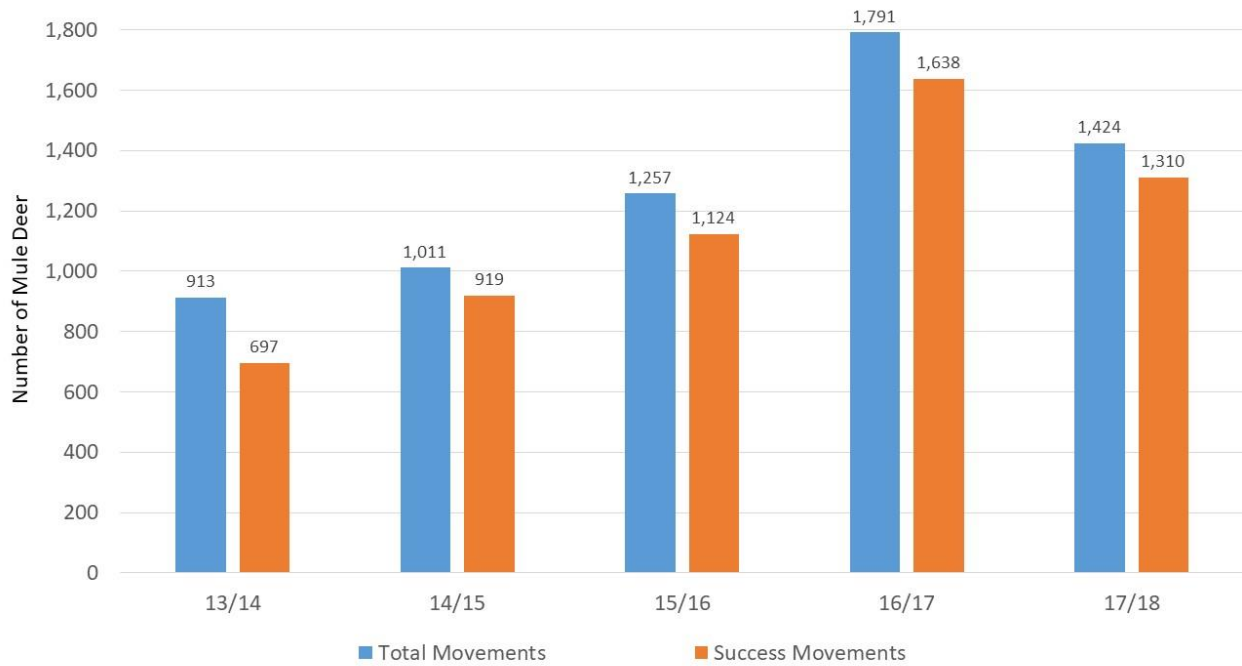
Figure 19 presents annual mule deer Total Movements and Success Movements at the Seaman structure from September 23, 2013 through June 7, 2018. Total Movements and Success Movements steadily increased through 2015/16, greatly increased in 2016/17, and decreased in 2017/18. Figure 20 presents monthly mule deer Total Movements and Success Movements at the Seaman structure from September 23, 2013 through June 7, 2018. Monthly movements generally increased during the study through 2016/17, and decreased in 2017/18. Movements during spring migrations were higher in April than in March. For paired columns in both figures, the ratio of Success Movements (orange, right) to Total Movements (blue, left) is equal to Success Rate. The closer the values of the paired columns, the higher the Success Rate. Annual Success Rate increased after 2013/14, and then remained stable with a slight decrease in 2015/16. The annual Success Rate increased from 76 percent in 2013/14 to 92 percent in 2017/18. Camera operation rates were 100 percent in 2018, 100 percent in 2017, and 83 percent in 2016 (2015, 2014, and 2013 camera operation rates were not calculated).

**Figure 19. Annual Mule Deer Total Movements and Success Movements at the Seaman Structure from September 23, 2013 through June 7, 2018.**

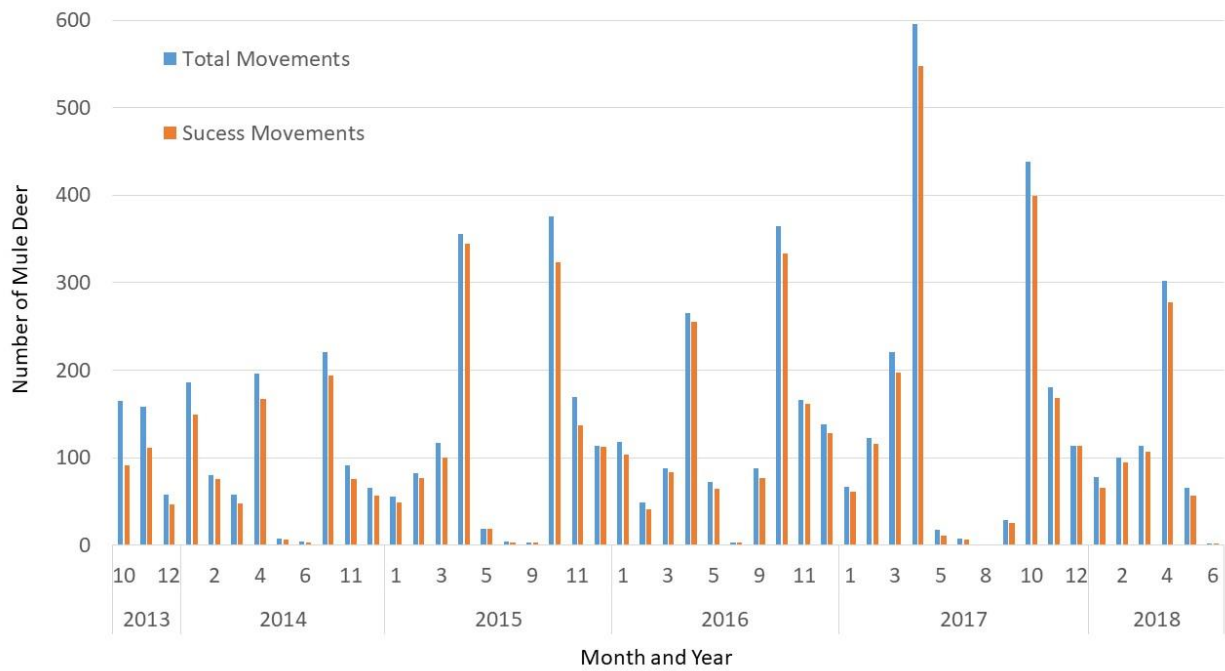
**Figure 20. Monthly Mule Deer Total Movements and Success Movements at the Seaman Structure from September 23, 2013 through June 7, 2018.**

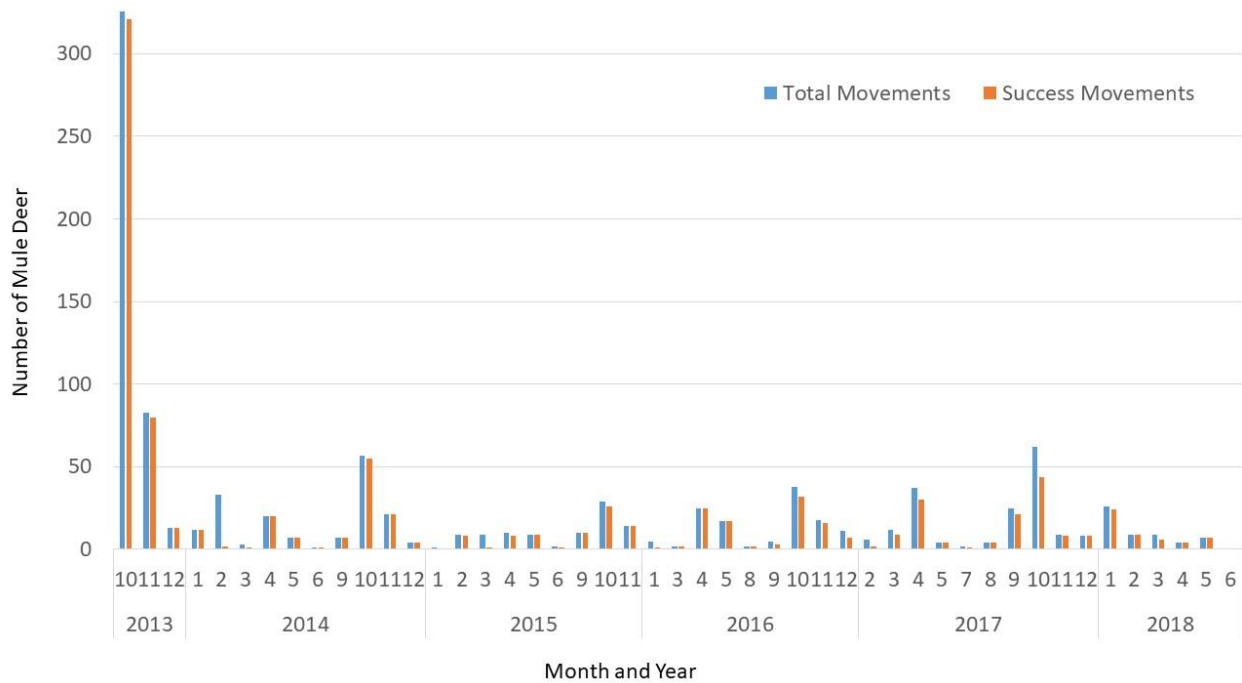
**Figure 24. Monthly Mule Deer Total Movements and Success Movements at the West Fence End from September 23, 2013 through June 7, 2018.**

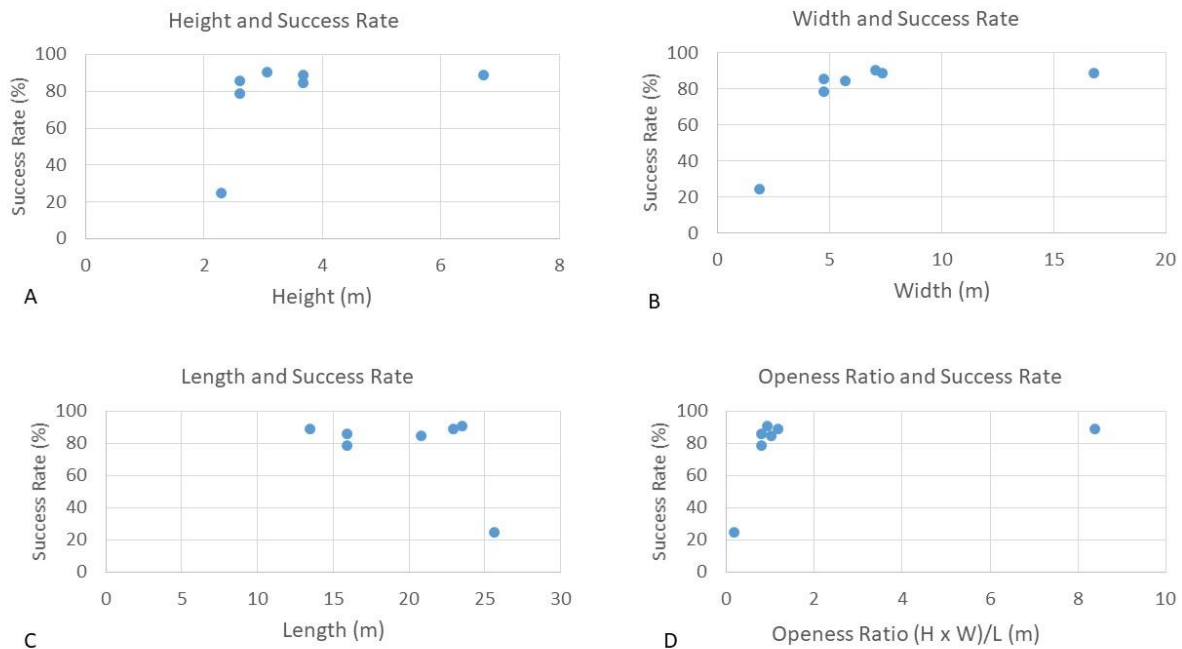
**Figure 25. Scatter Plots of Mule Deer Success Rates Against: (A) Structure Height; (B) Structure Width; (C) Structure Length; and (D) Openness Ratio.**

<b>Structure Name and Mile Post (MP)</b>	<b>Dimensions of Structure Height x Width x Length in Feet</b>	<b>Openness Ratio in Feet (ft) and in Meters (m)</b>	<b>Success Rate (%)</b>
Buckskin, MP 37	30 x 50 x 44	27.5 (ft) 8.38 (m)	89
Telegraph, MP 39.5	7.5 x 6 x 84	0.53 (ft) 0.16 (m)	25
East New, MP 40.5	8.5 x 15.6 x 52	2.53(ft) 0.77 (m)	86
Center New, MP 42.5	8.5 x 15.6 x 52	2.53 (ft) 0.77 (m)	79
West New, MP 44	12 x 18.6 x 68	3.28 (ft) 1.00 (m)	85
Petrified, MP 45.5	12 x 23 x 77	2.99 (ft) 0.91 (m)	91
Seaman, MP 48.2	12 x 24 x 75	3.84 (ft) 1.17 (m)	89

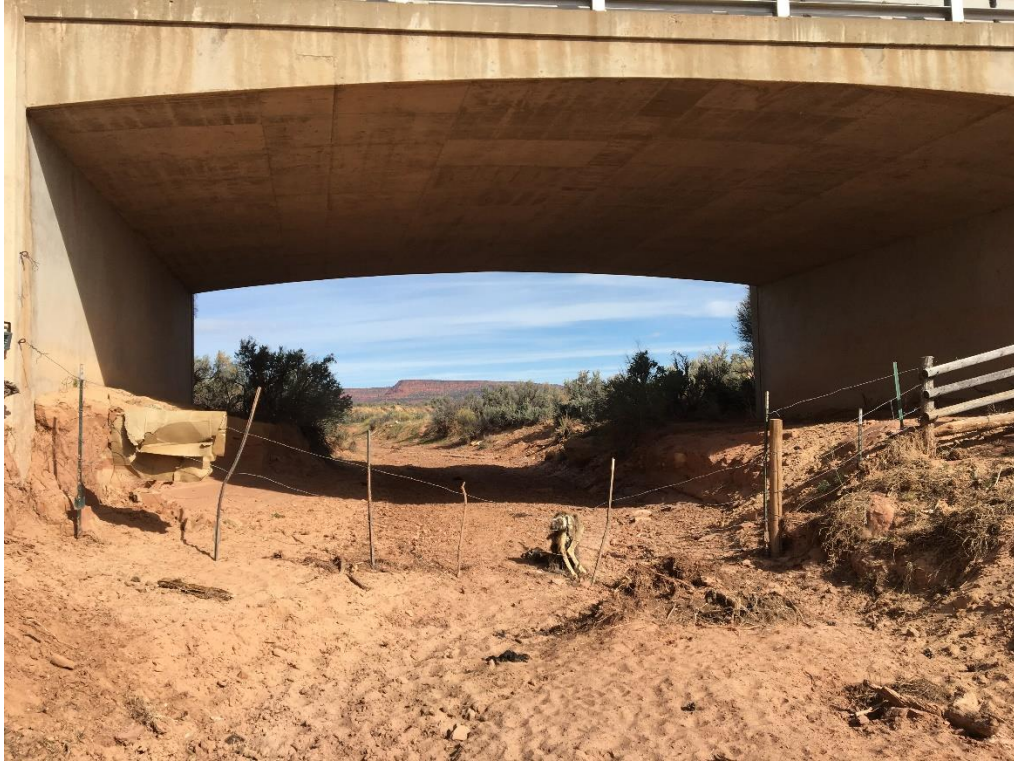
**Figure 27. Wire Fence for Domestic Cattle Attached to the South End of the Buckskin Structure in 2018 with Mule Deer Carcass Tangled In Barbed Wire.**

On multiple occasions during the study, cameras recorded BLM grazing allotment holders placing fences or gates across the Buckskin, Telegraph, and Petrified structures to manage their cattle. Cameras also recorded occasions when the fences were removed. It is important to note that the cameras may not have recorded all fence placement and removal situations. While in place, the fences temporarily deterred mule deer use of the structures and caused short-term reductions in Success Rates. These situations were occasionally rectified with adaptive management. Wildlife-friendly fence (Harrington and Conover 2006) constructed in appropriate locations away from structures will increase Success Movements through the structures, increase Success Rates, and will help prevent animals from becoming entangled in

fences. The authors recommend that UDWR and BLM work together to build a better fence solution at the Buckskin Bridge. The following list provides a timeline for each structure:

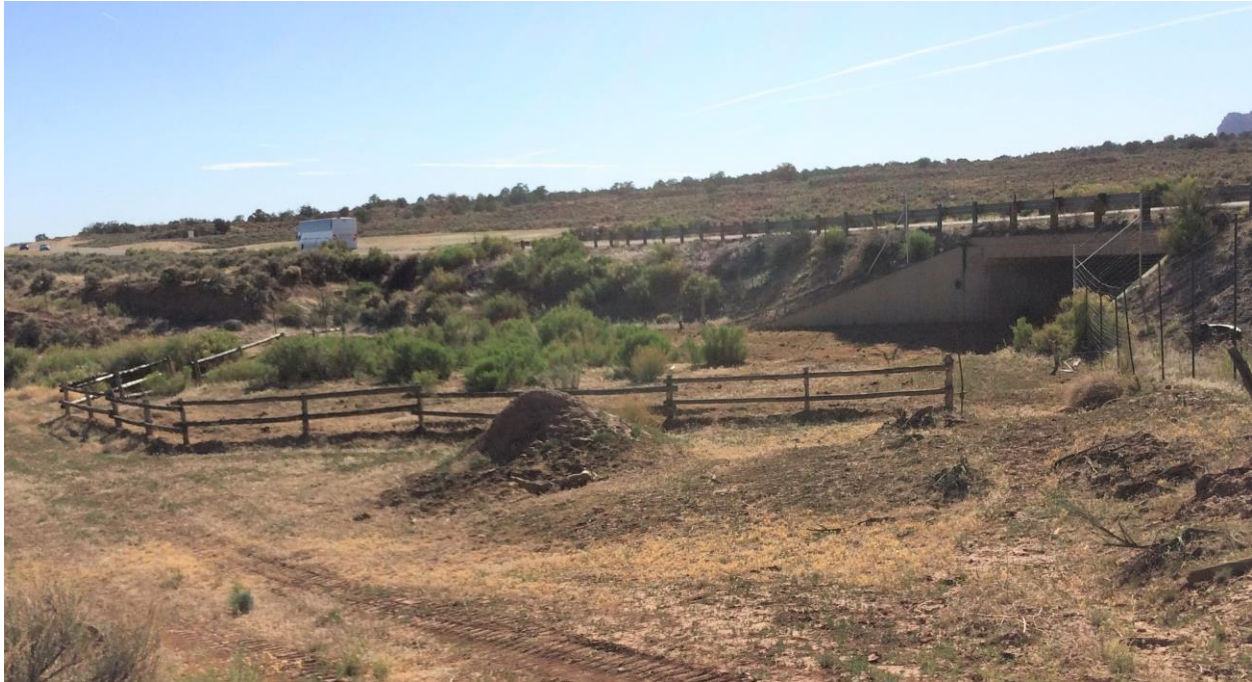
**Figure 28. Wildlife Friendly Fence Installed by UDWR Wildlife Biologists on South Side of Petrified Culvert.**

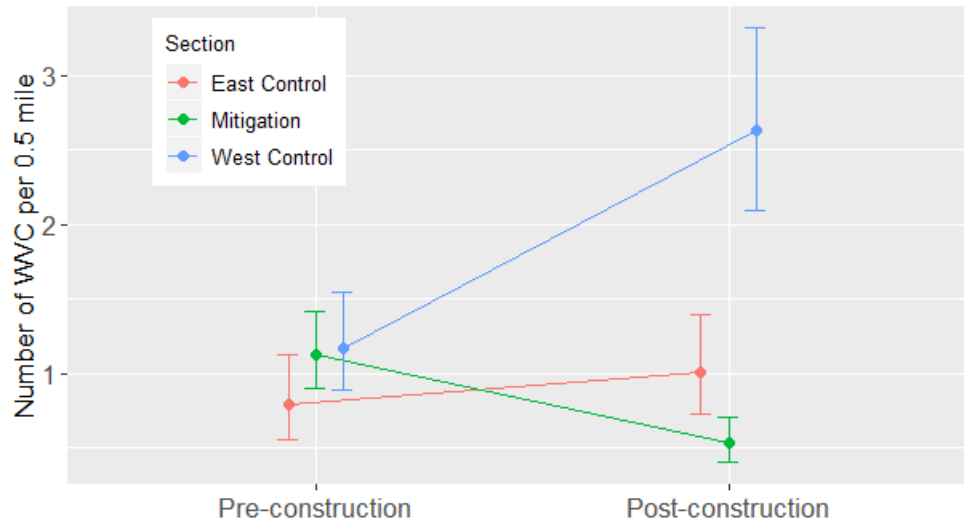
**Figure 29. WVC Crashes per 0.5 Mile (0.80 kilometers) During Pre-Construction and Post-Construction at the East Control Section, Mitigation Section, and West Control Section.**

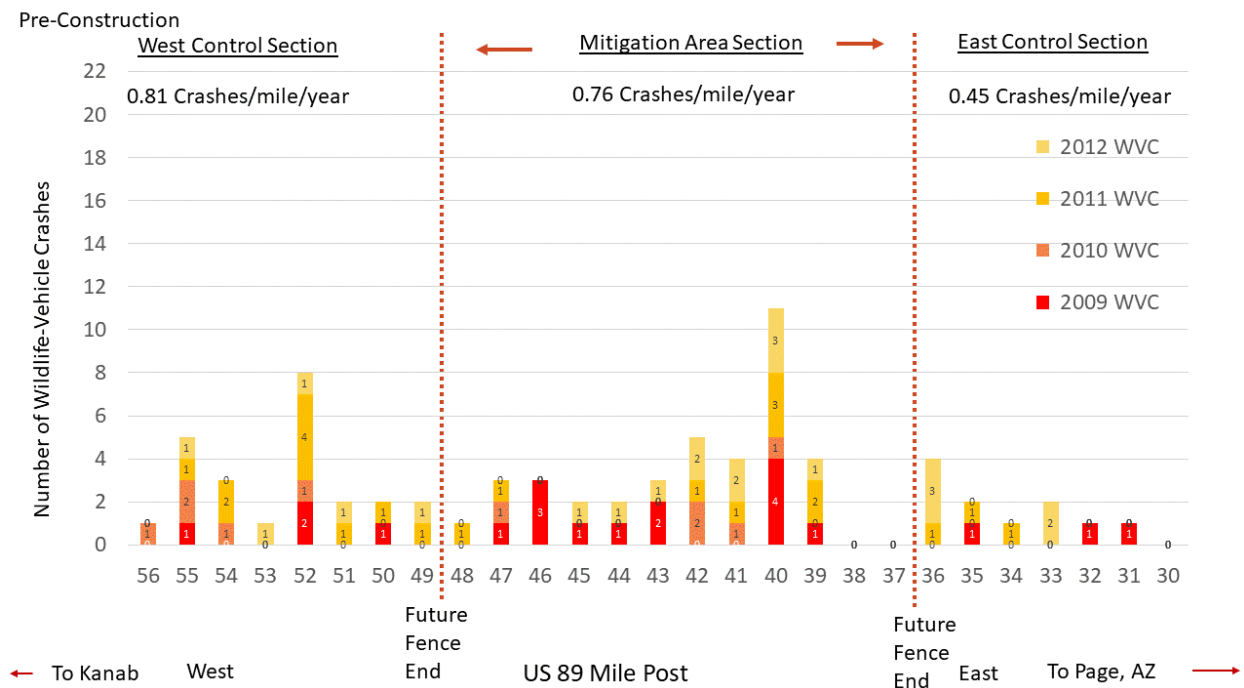
**Figure 30. Utah Department of Transportation WVC Crash Data Pre-Construction, US 89 MP 30-56, 2009 -2012.**

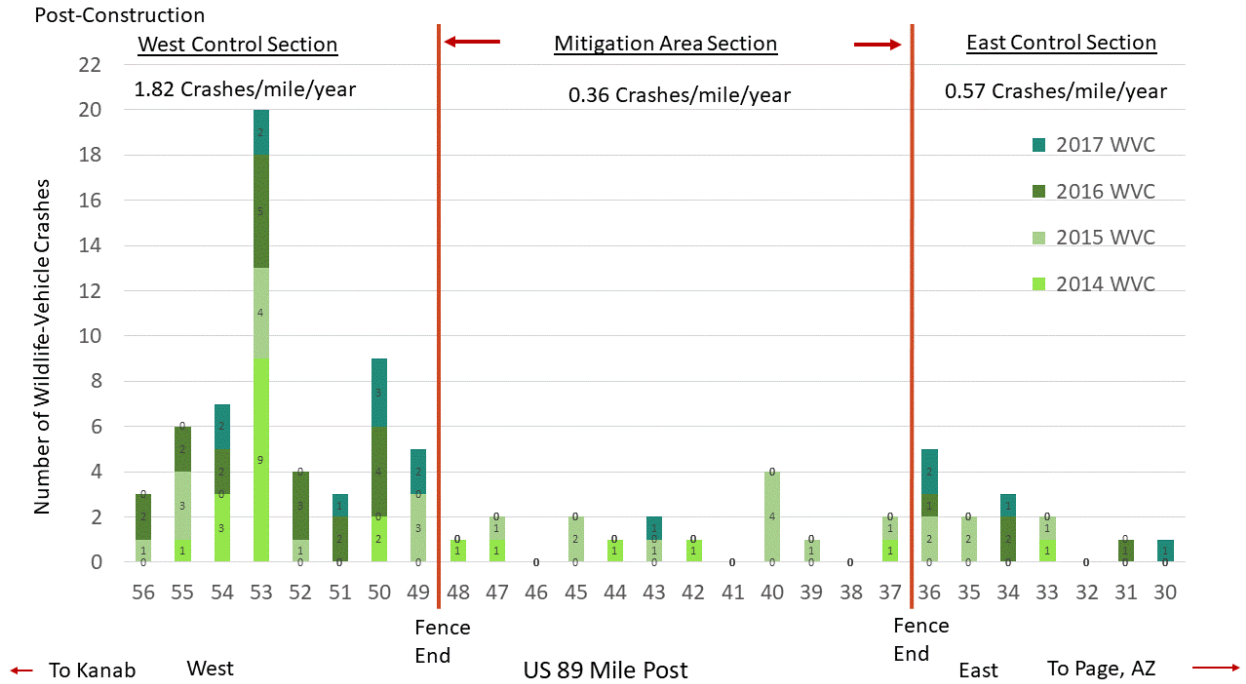
**Figure 31. Utah Department of Transportation WVC Crash Data Post-Construction, US 89 MP 30-56, 2014-2017.**

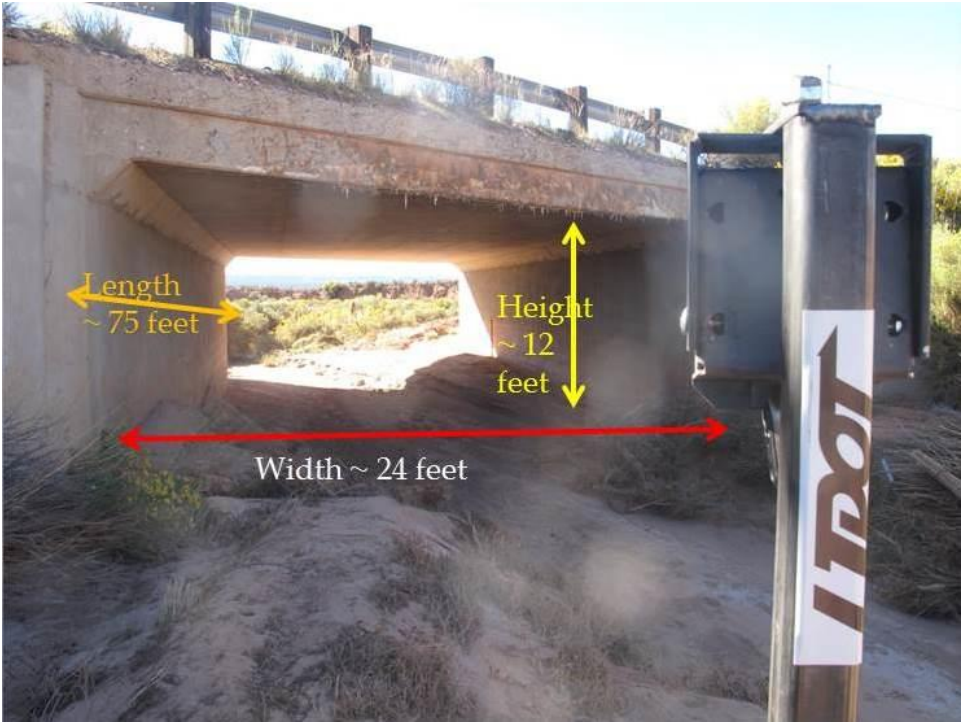
US 89 MP 48.2 Seaman Wash Existing Concrete Box Culvert.

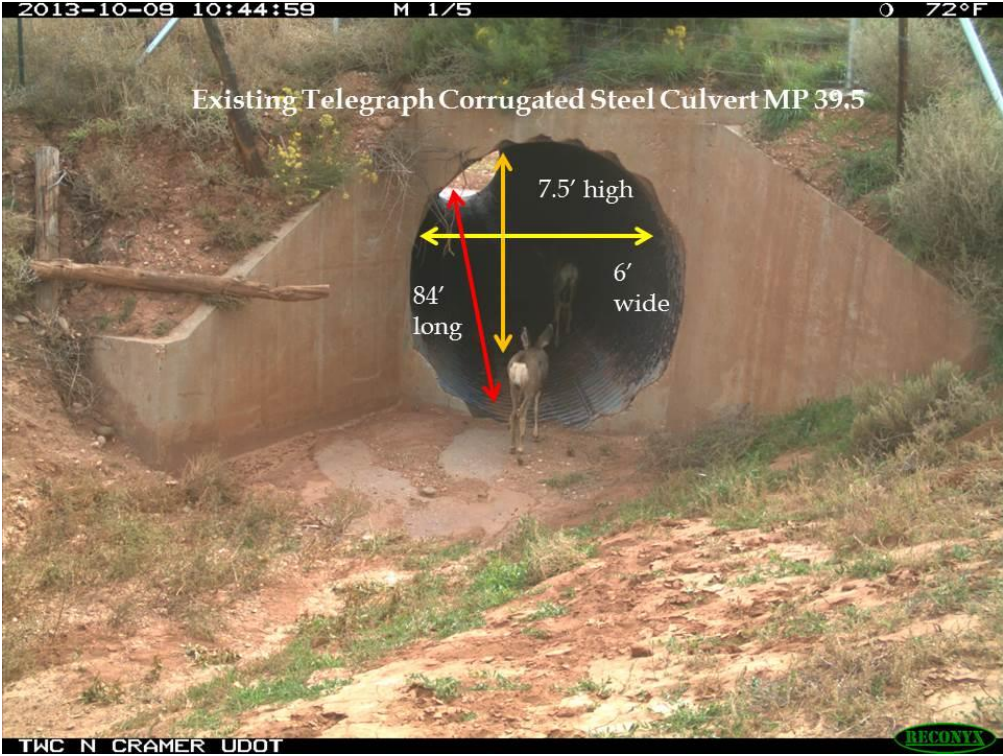
US 89 MP 39.5 Telegraph Wash Existing Corrugated Steel Culvert.

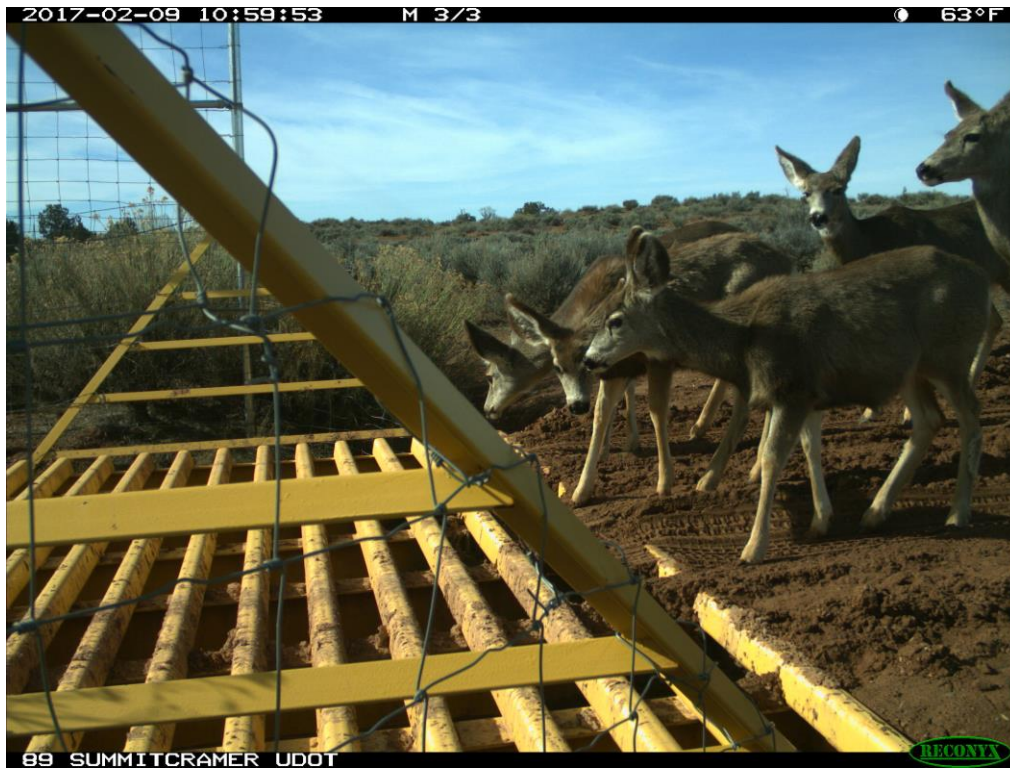
Mule Deer Approached Then Repelled From Double Cattle Guard at the Summit.
