RP 262

Concrete Performance in Aggressive Salt and Deicing Environments

RESEARCH REPORT

IDAHO TRANSPORTATION DEPARTMENT

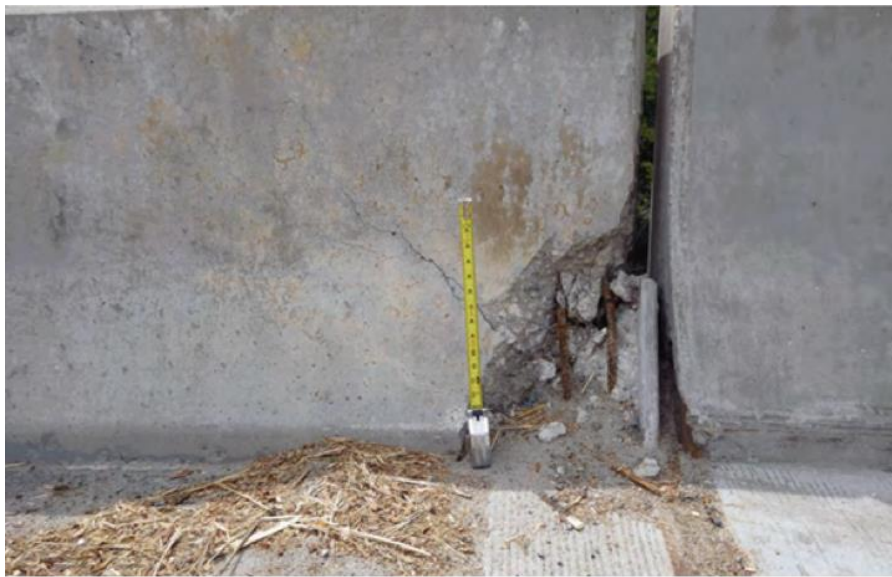
Figure 4. Concrete Spalling in a Concrete Rail (District 1)

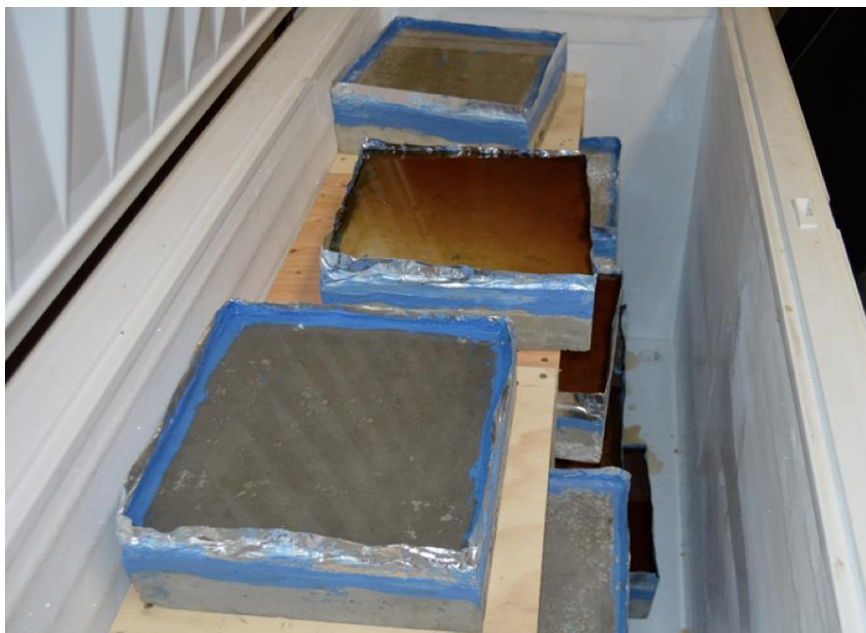
Figure 8. Slabs Exposed to Freezing Environment During Deicing Scaling Test

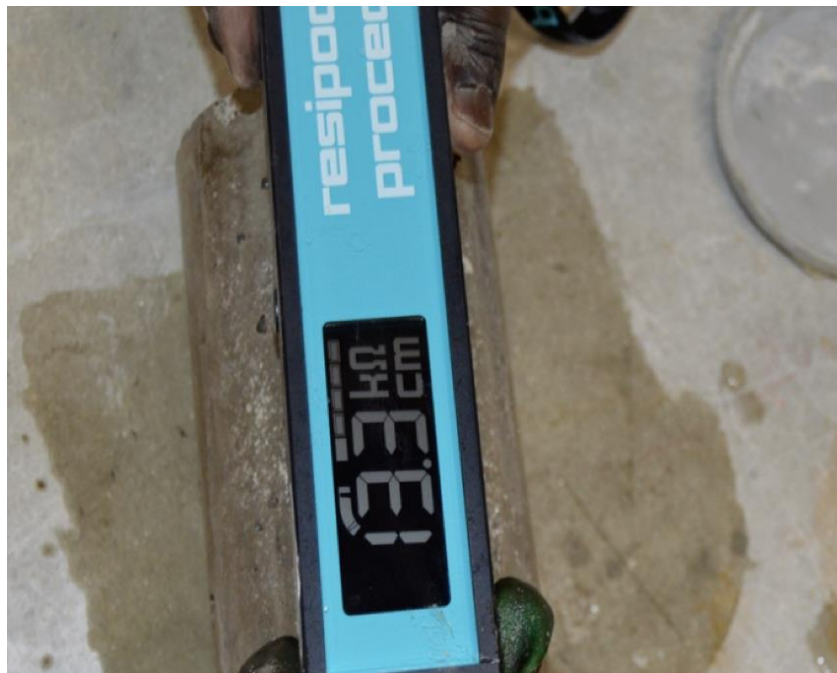
Figure 9. Surface Resistivity Testing

and 270 degrees, and two readings per quadrant were taken in the order of the marked angles to ensure consistency and no significant differences between the operator or the equipment. The surface resistivity measures the degree to which the concrete sample resists the flow of an electrical current. While the solid material in concrete has a relatively high resistivity, the pores are usually partially or fully saturated with a concentrated alkaline solution that has a relatively low resistivity. Thus, the flow of electrical current through the pore solution, gives an indirect measure of the quality of the microstructure of the concrete. The specimens were tested using the Wenner four-electrode test, which consists of four equally spaced, co-linear electrodes placed in contact with a concrete cylinder specimen. The testing procedure involves passing alternating current to the outermost electrodes and measuring the voltage between the middle two electrodes to calculate its resistance. The specimen resistivity was then calculated using the resistance, length between the electrodes, dimensions of the cylinder specimen and necessary correction factor. The surface resistivity meter is shown in Figure. 9.

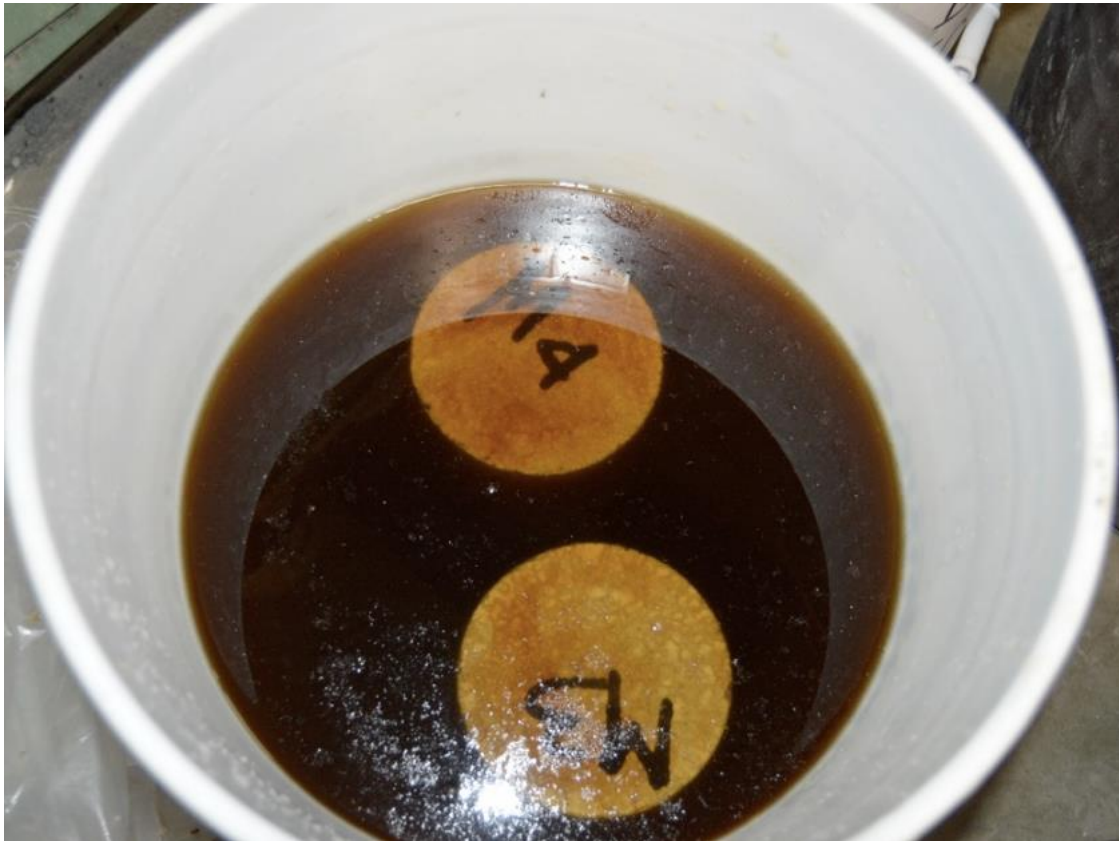
Figure 10. Concrete Specimens under Continuous Soaking

This test aims to study the deterioration of concrete microstructure after 90 days of continuous submerging in deicing chemical solutions. The cylindrical specimens were soaked (Figure 10) in salt solutions obtained from Districts 1, 2, 3, 5, and 6. The cylinders were 455 days (1 year and 3 months) age before soaking because they were from RP 253 project. After 90 days, the specimens were tested under uniaxial compression to investigate the loss in strength (ASTM C39). Two reference cylinder specimens were moist cured in the humidity chamber for 90 days and tested under uniaxial compression on the same day of testing the soaked specimens.

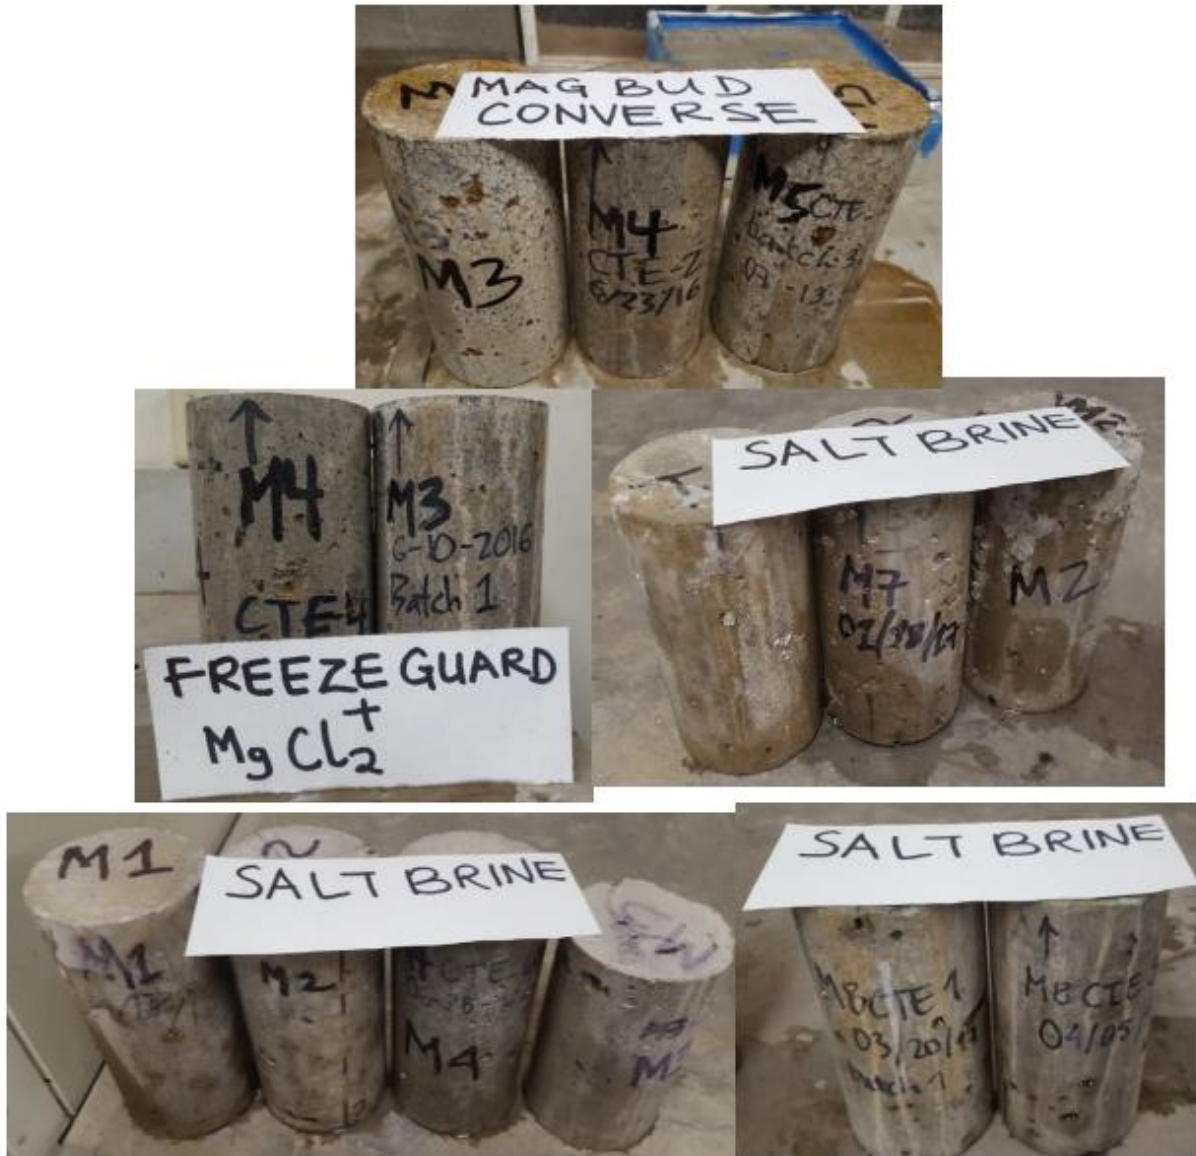
Figure 12. Concrete Specimens after 90 Days Continuous Soaking in Deicing Salt

As previously described, all the specimens were soaked continuously for 90-days in deicing chemicals at a temperature of 5°C (41°F) to promote the formation of Oxychloride compounds. As shown in Figure 12, the specimens soaked in mag-bud converse, and freeze guard plus magnesium chloride (M3, M4, and M5) displayed heavy deterioration of ASR with concrete spalling and severe cracks extended to the whole surface of the specimens with major signs of spalling, while those soaked in salt brine had mild to moderate deterioration except M2 where it showed major concrete spalling. The ASR cracked pattern observed on the concrete cylinders can be confirmed by petrographic analysis, which forms part of the suggested tests to be conducted in the future.

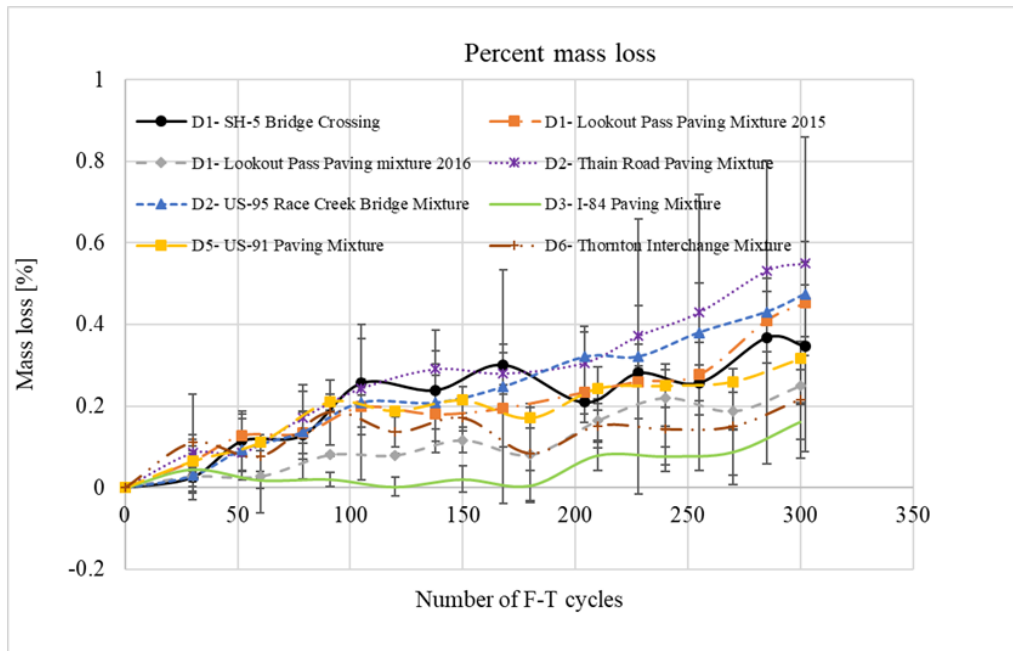
Figure 13. Specimens Mass Loss under F-T Cycle Tests

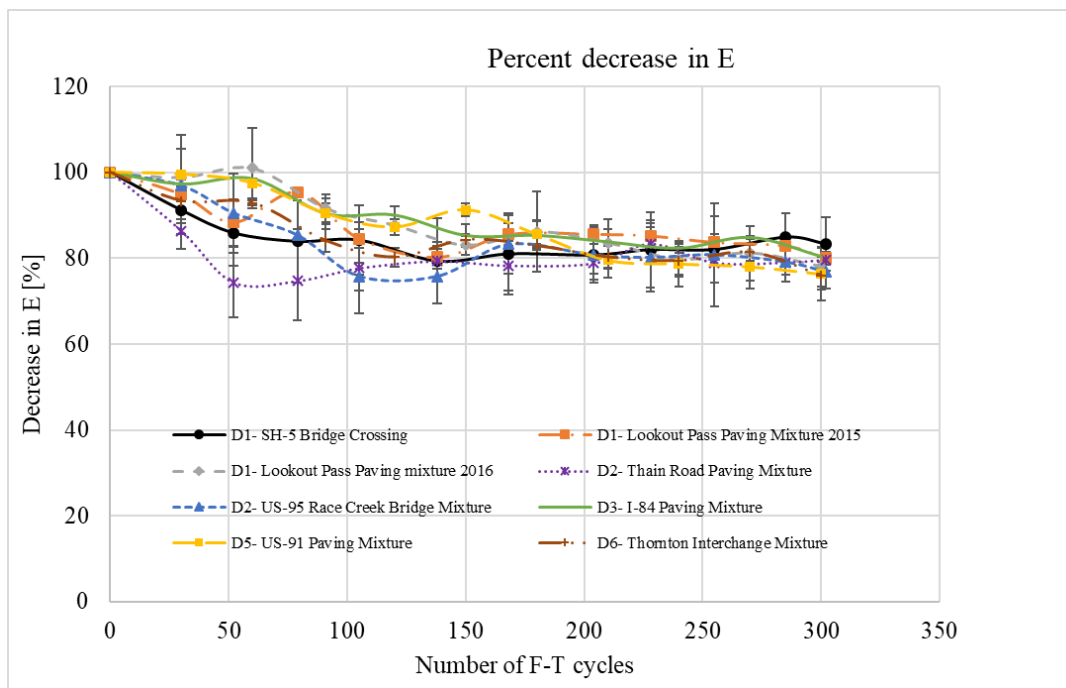
Figure 14. Variation in Elastic Modulus in F-T Cycle Test

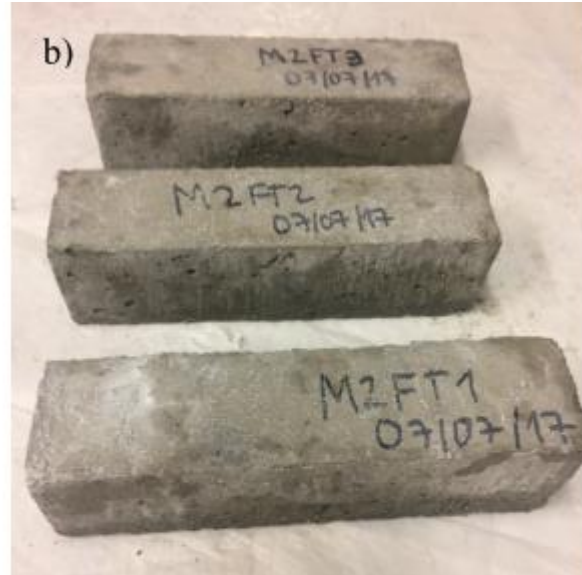
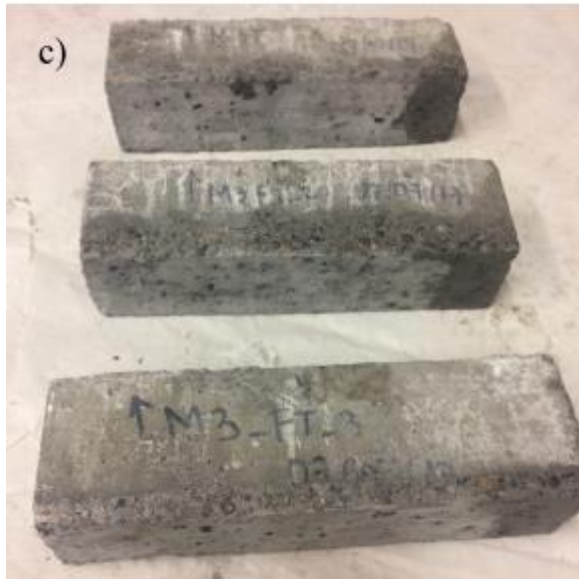
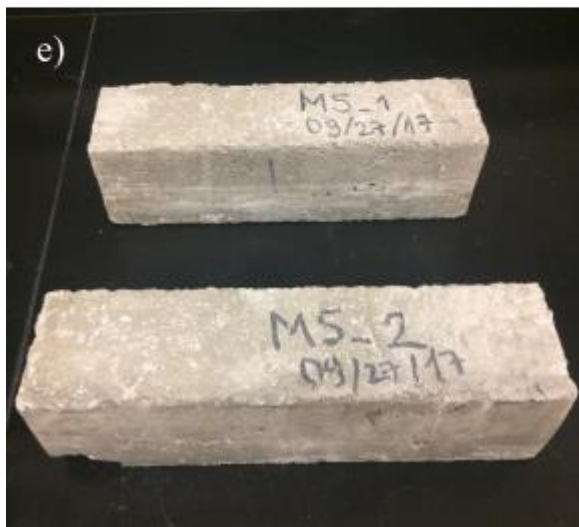
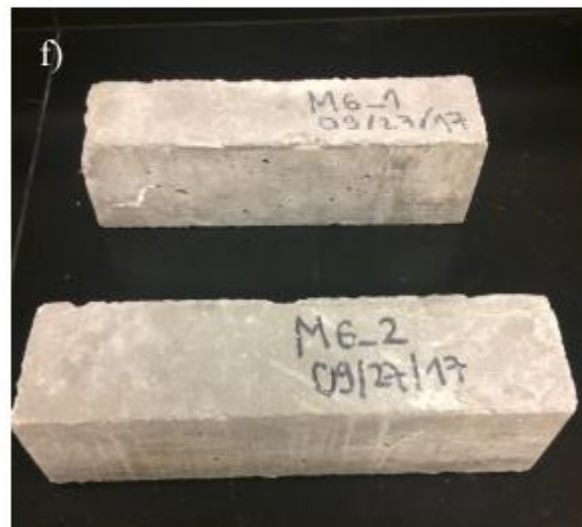
Figure 15. 300 F-T Cycles Results: a) M1, b) M2, c) M3, d) M4, e) M5, f) M6, g) M7, h) M8

Excluding mixtures M3 and M4 [see Figure 15 (c) and (d)], Figure 15 shows that the tested specimens after the entire F-T test exhibited some calcium leaching on the surface due to the prolonged contact with the water, minor damage on the surface, and overall good structural integrity, consistent with a satisfactory F-T performance elaborated above.

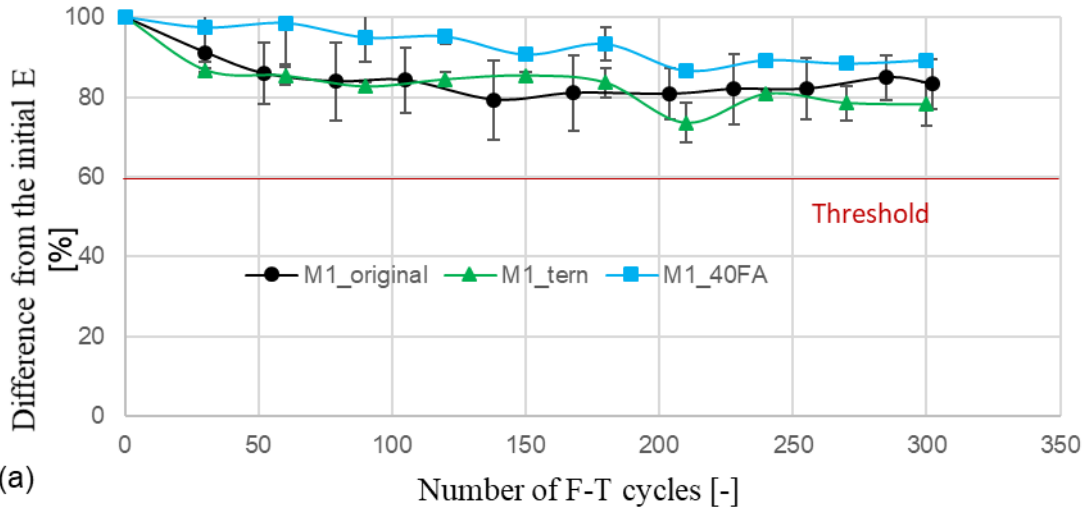
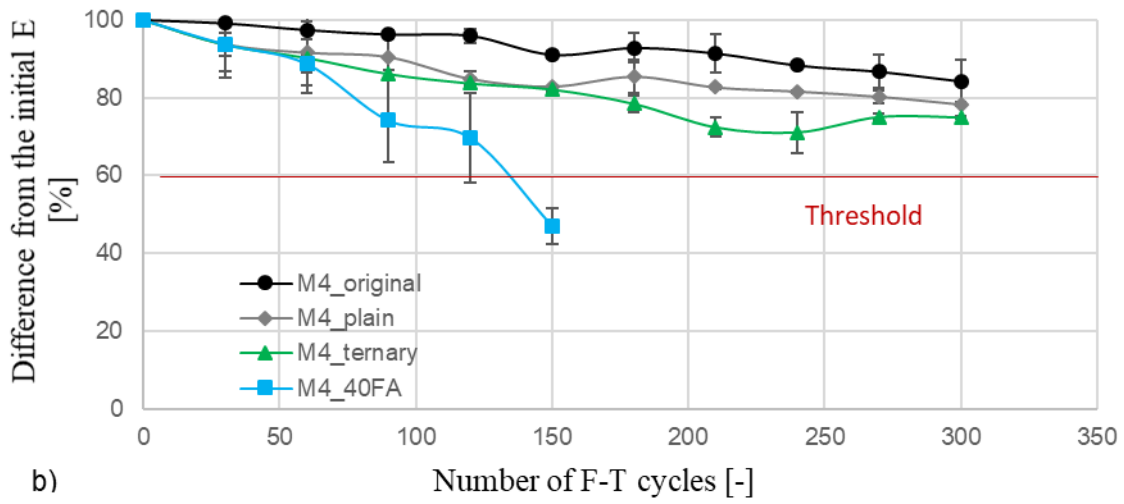
Figure 18. Variation in Elastic Modulus in F-T Test for Specimens of a) M1, b) M4, and c) M8

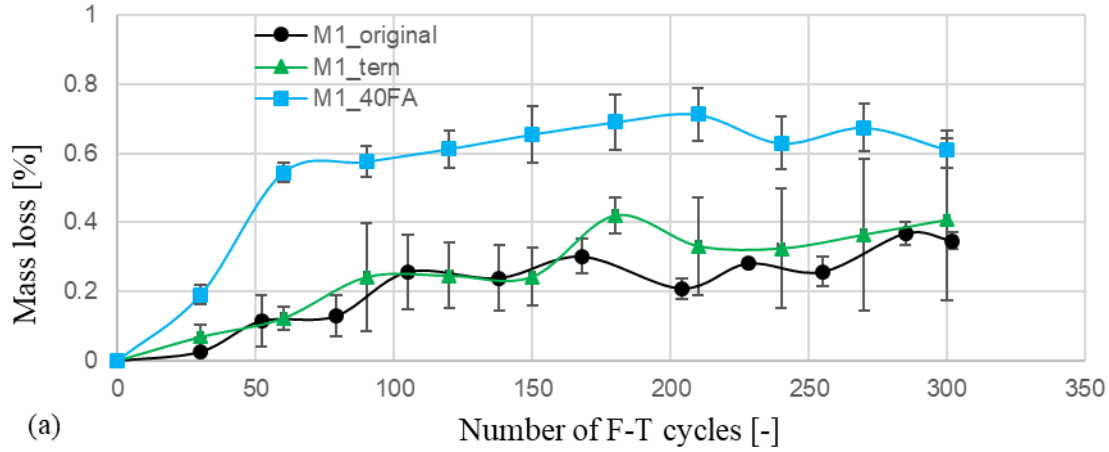
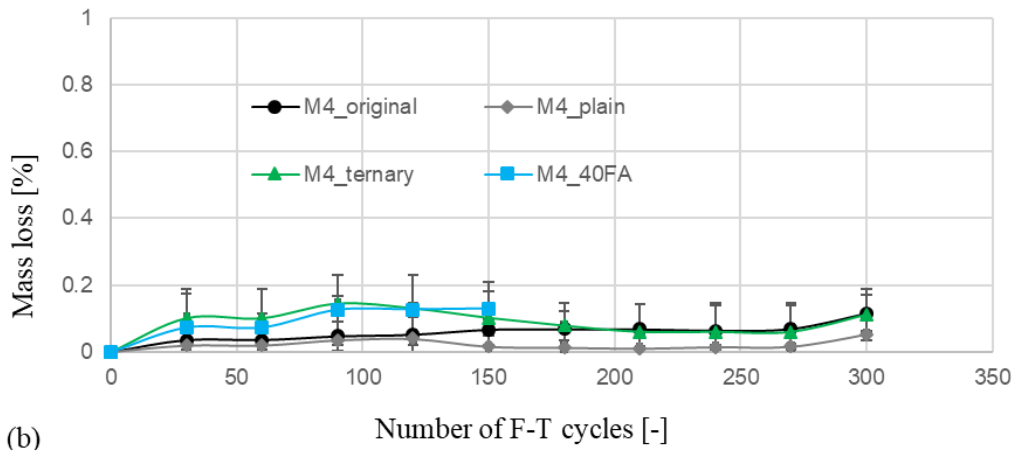
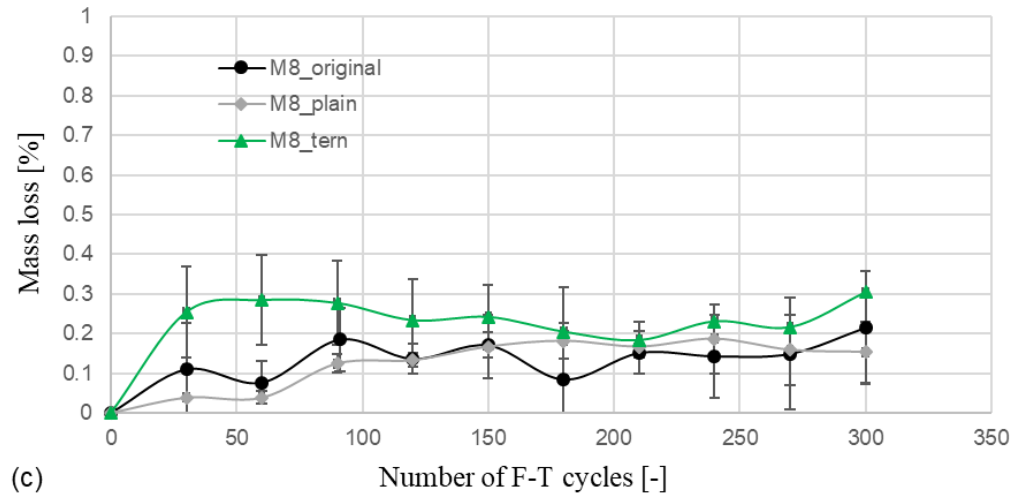
Figure 19. Mass Loss in F-T Tests for Specimens Cast from a) M1, b) M4, and c) M8

Mass loss was taken after each 30-cycle prior to E testing. As evident in Figure 19, all tested mixtures presented mass losses below 1.0 percent after 300 cycles. The mixture with the highest mass loss was the M1 replicate with 40 percent fly ash. The same mixture also retained approximately 90 percent of E after 300 F-T cycles. The mix M4_40, which did not meet the 60-percent E requirement, shows a relatively low mass loss (less than 0.2 percent after 150 cycles). These results indicate that mass loss alone may not be a good predictor of degradation of mechanical properties on F-T test.

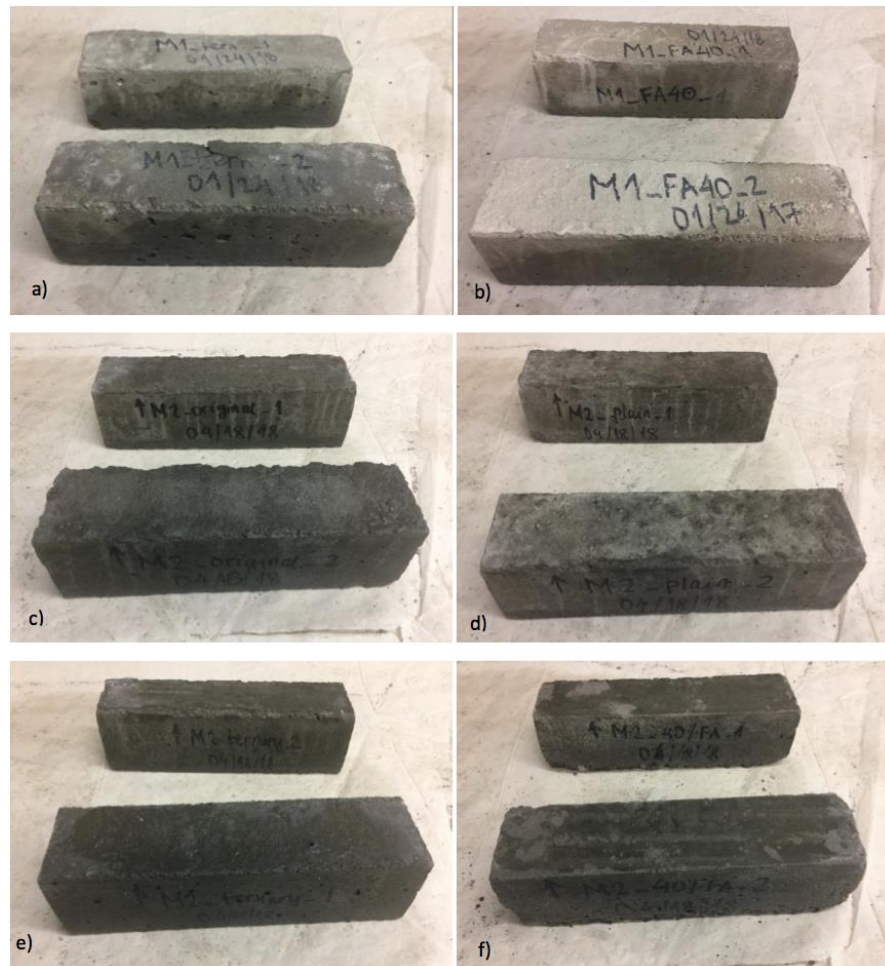
Figure 20. Results of F-T Cycles a) M1_ternary b) M1_FA40 c) M4_original d) M4_plain e) M4_ternary f) M4_FA40 g) M8_plain h) M8_ternary

Figure 20 shows the tested specimens after 300 F-T cycles for the replicates of M1, M4, and M8, respectively. As seen in the figures, besides small scaling at the surface, specimens generally exhibited

satisfactory structural integrity. Specimens from mixture M4_FA40 are captured after 150 cycles; similarly, no apparent visual damage can be identified for these specimens.

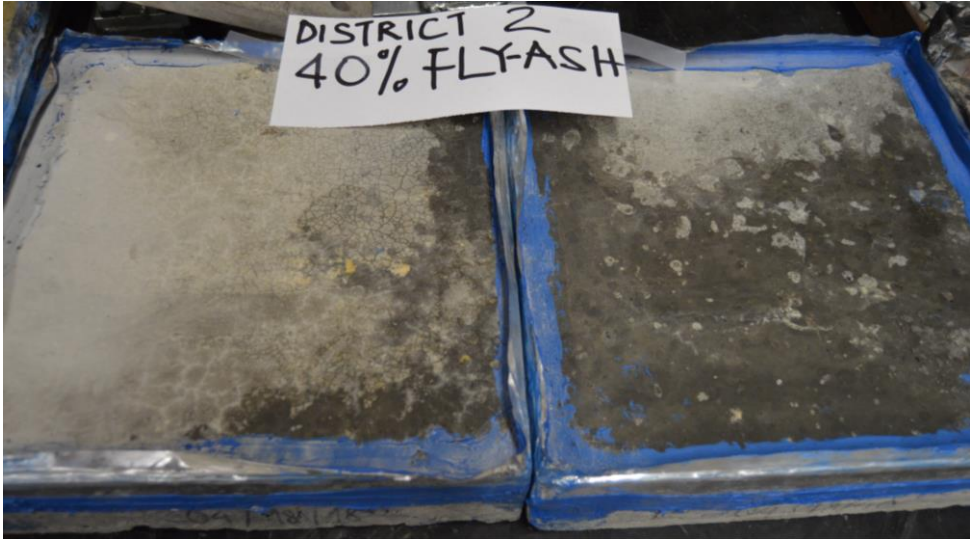
Figure 23. Specimens Tested for Deicing Scaling (District 2)

District 1 and 6. Severe scaling (visual rating of 5) was observed as shown in Figure 21 and 22. A 35-40 percent cement replacement with fly ash was reported to reduce Calcium-Oxychloride (CAOXY) formation which resulted in no scaling⁽⁵⁰⁾ (Suraneni, et al. 2016). However, other authors⁽⁵¹⁻⁵⁴⁾ reported that increasing fly ash content in concrete with water-to-cementitious ratio above 0.4 will increase scaling damage in concrete. on the contrary, very slight scaling was observed in the specimens with 40 percent fly ash for district 2 as shown in Figure 23, while the ternary mixture showed no scaling (Figure 24).

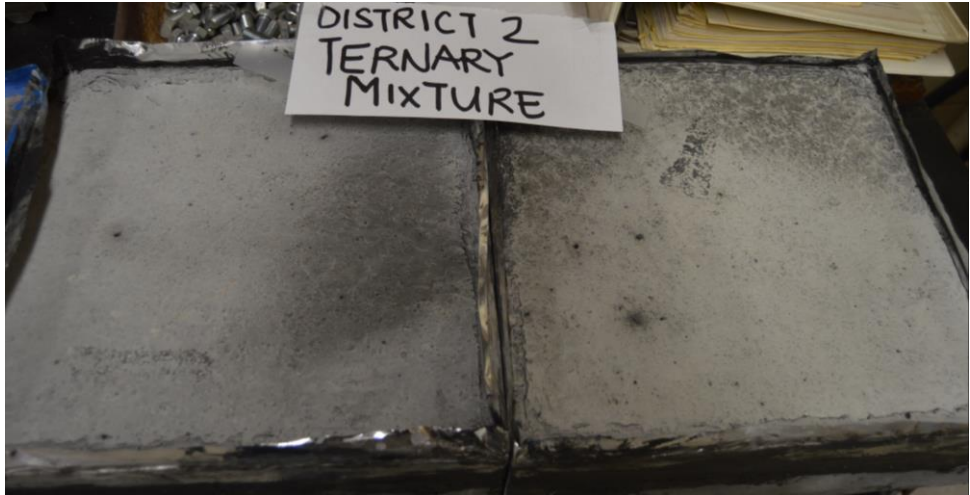
Figure 24. Specimens Tested for Deicing Scaling (District 2)

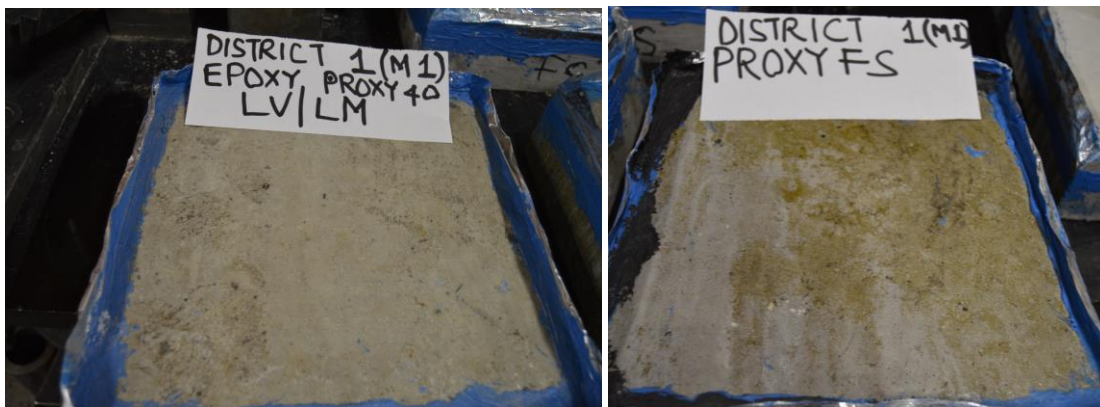
Figure 26. Epoxy coated Specimens Tested for Deicing Scaling (District 1)

The original structural mixtures specimens when coated with epoxy sealers showed no scaling as shown in Figures 25 and 26 and summarized in Table 12. Therefore, it is important to state that bridges and concrete pavement made with current ITD concrete mixtures can be protected from deicing scaling by applying epoxy sealers, if the cost is economical.
