**FHWA-WY-02/02F**

**EVALUATION OF HIGH TENSILE ELECTRIC  
FENCE DESIGNS ON BIG GAME MOVEMENTS  
AND LIVESTOCK CONTAINMENT**

Wyoming Cooperative Fish and Wildlife Research Unit  
University of Wyoming  
Laramie, Wyoming 82071-3166

May, 2002

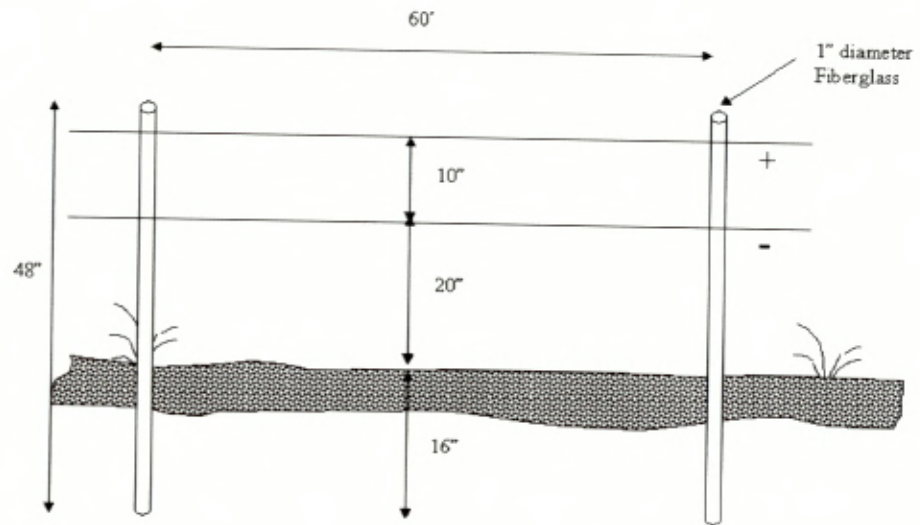
1) 2-Wire

**Figure 2.** Electric fence design detail. All fences use  $\frac{3}{4}$ " - 1" diameter solid fiberglass line posts. Wire is 12.5 gauge, Class III galvanized with a maximum tensile strength of 170,000 PSI and maximum breaking strength of 1308 lbs. Wires are connected to line posts and stays using metal clips.

Three different fence designs were tested (Figure 2). These designs were selected because they were relatively common in Wyoming and conversations with ranchers and wildlife biologists indicated that these designs held the most promise of allowing wildlife to cross, but still contain cattle and bison. The 2 and 3-wire fence designs are similar to design specifications for 3-wire cross-cattle fence and 2-wire cross-cattle fence (Gallagher™, San Antonio, TX). Three-wire post spacing and the use of stays varied between locations and terrain. We did not separate out these variations for analysis because the overall fence flexibility remained relatively constant. The 4-wire fence primarily used to contain bison did not follow Gallagher design specifications, but most were made with Gallagher products. When we constructed fences to test under pressured conditions with cattle, Gallagher products and designs were used to maintain consistency.

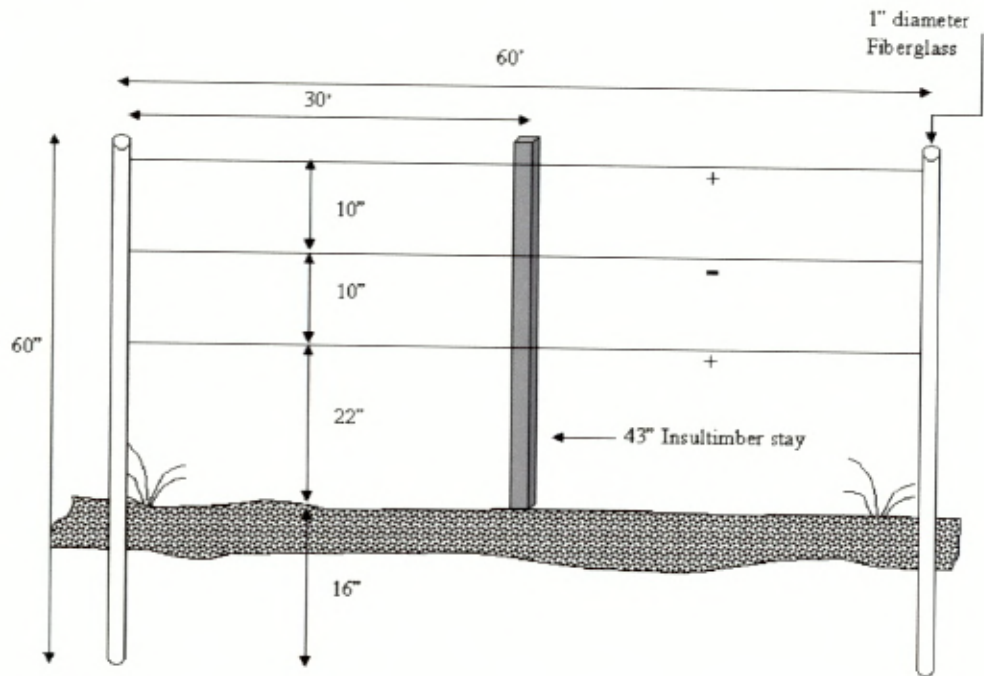
**3-Wire Type B**

**Figure 2.** Electric fence design detail cont.

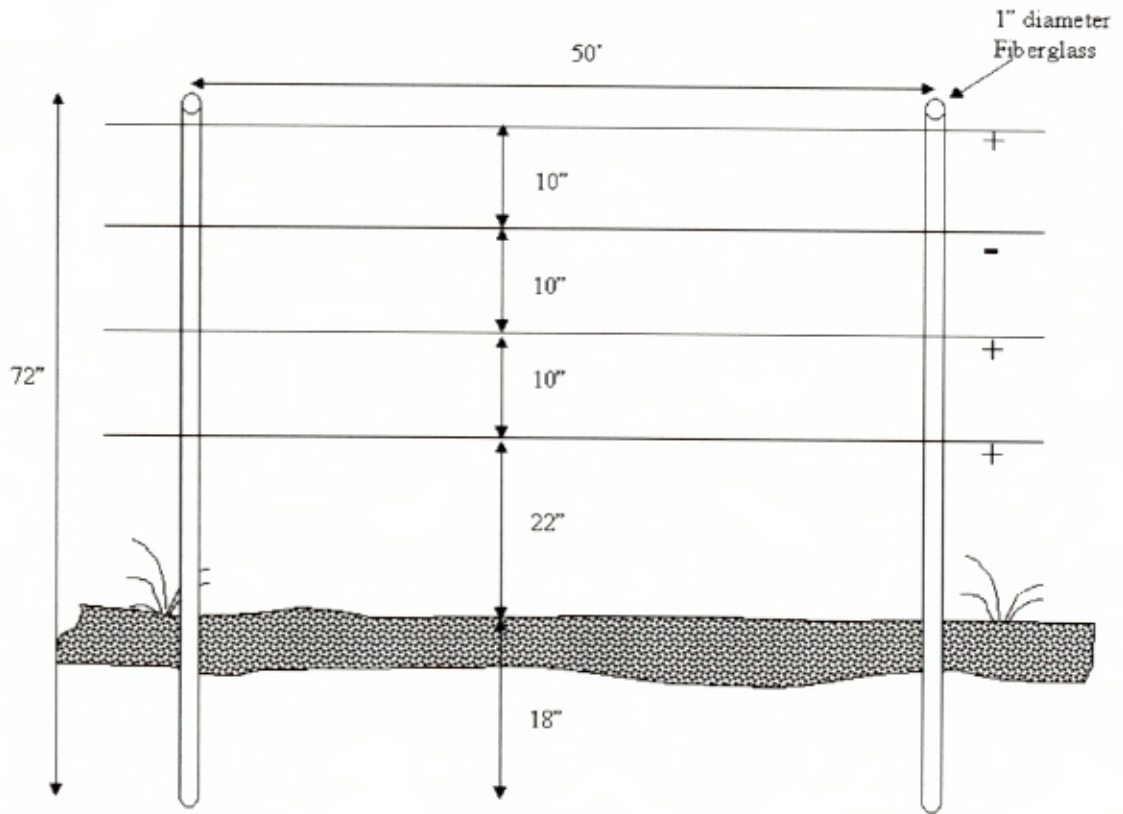
3) 4-Wire

**Figure 2.** Electric fence design detail cont.

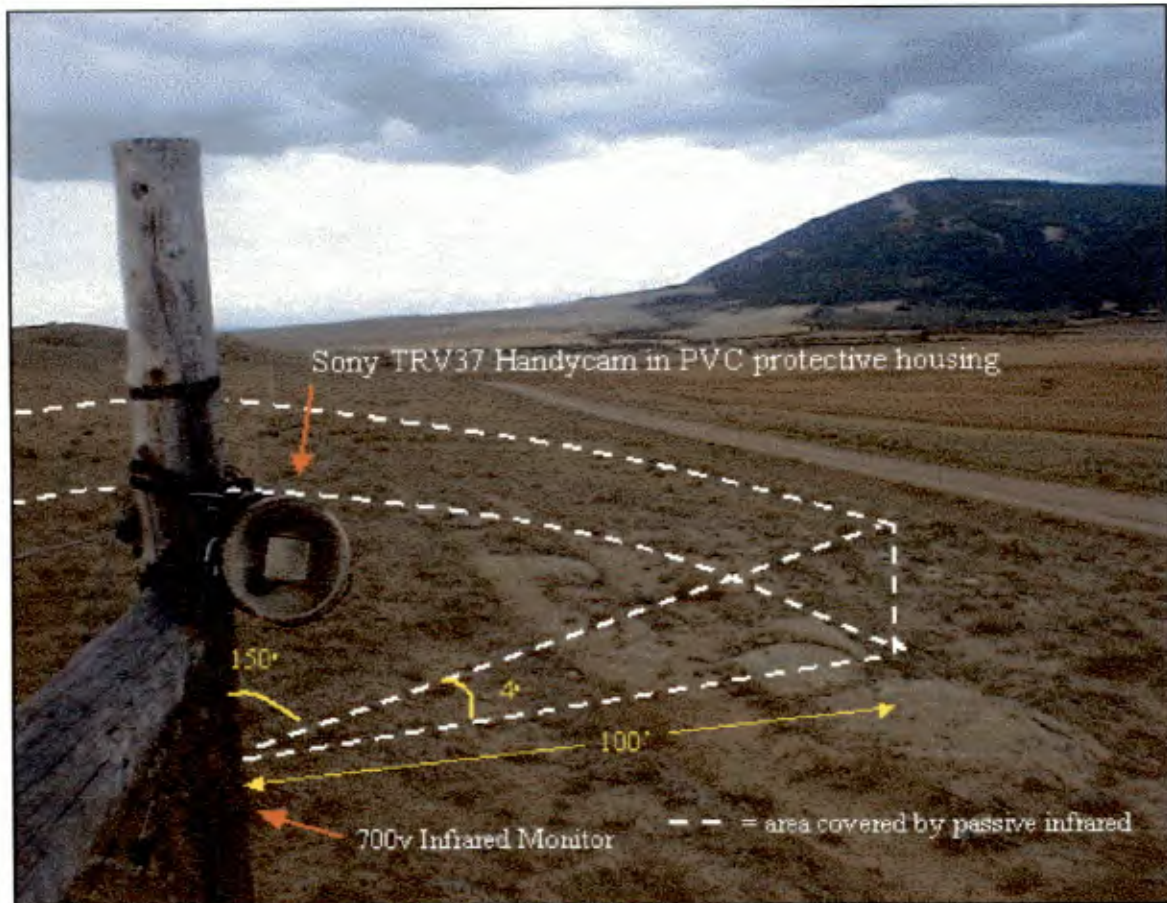
**Figure 3.** Typical video/passive infrared monitoring system setup. The area within the dashed white lines indicates TM700v monitor coverage.

We used 10 battery-powered video cameras (Sony, New York, NY) in combination with 10 Trailmaster® 700v passive infrared game monitors (Goodson and Associates, Lenexa, KS) to record wildlife and livestock reactions to electric fences.

The monitor was strapped to either a wood brace post within the fence line, a nearby tree, or a post that we set. The least sensitive setting (P=5 and pt=2.5) was used to minimize false activations. The video camera, which was protected by a 6-inch polyvinyl chloride (PVC) pipe housing, was strapped to the post or tree just above the infrared monitor. In theory, the camera was to be activated when heat and movement were detected within the coverage area (Figure 3). Although these systems were adequate for collecting our data, and were activated by the monitors when target species were present, many false hits caused by wind-blown grass, debris, and wind-caused movement of the fence wires were recorded. On average we collected approximately 5 minutes of target footage for every 2 hours of videotape. Cameras were checked and film and batteries were replaced approximately every 14 days.

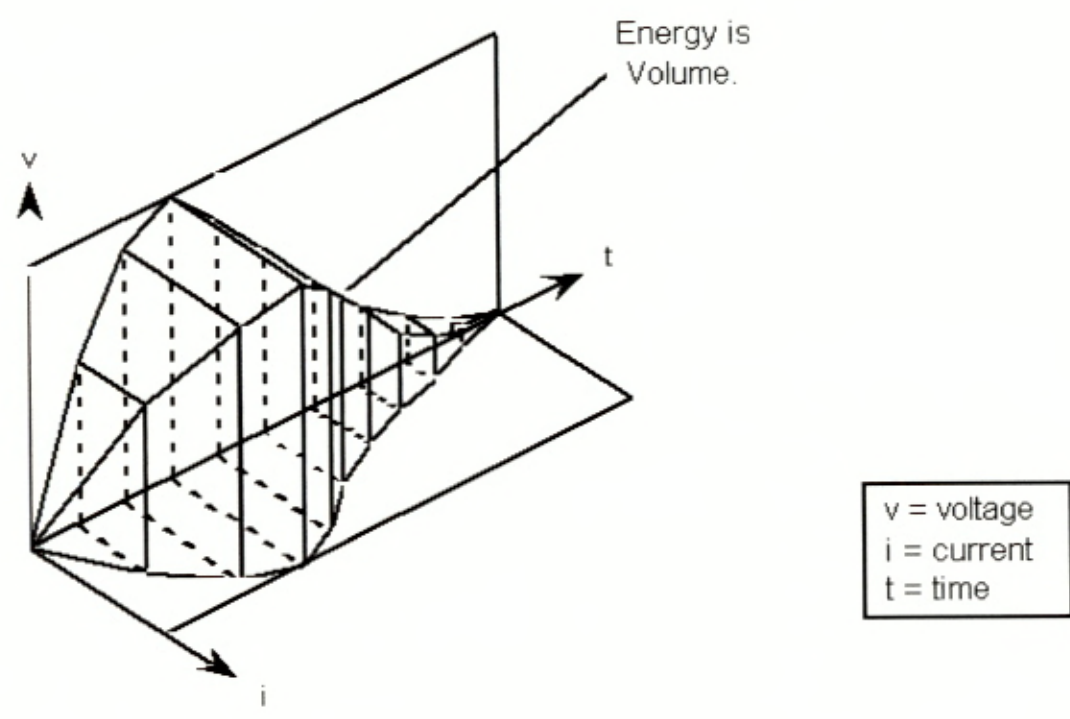
Figure 4. Shock energy released by the energizer is indicated by volume of the electrical pulse.  $v$ =volts,  $i$ =current, and  $t$ =pulse length or time.

A voltmeter is an effective tool for determining if a fence is maintaining desired voltage and for identifying shorts. However, a voltage measurement alone is not adequate for measuring the shock energy available on a fence or for comparing shock energy between different fences. To determine the shock energy or Joules available at any point on a particular fence, you need to know not only voltage, but also current, pulse shape, and pulse length (Figure 4). In essence, the higher the voltage, the higher the current, and the longer they both exist, then the greater the energy (Hancock 1995). The best tool available to measure the shock energy of an electric fence is a Joule meter. Joule meters allow the operator to estimate the resistance in the system and program the meter accordingly. We used a standard resistance of a mature cow, 500 ohms, for all Joule meter readings because this was the only resistance setting available on the meter that was close to the body size of our test subjects. In order to compare wildlife and livestock reactions between fences we needed to have a measure of the pain potential of any particular fence and a Joule meter was the best tool available. We measured the Joule output of every fence at each camera location every time we checked the cameras (approximately every 14 days).

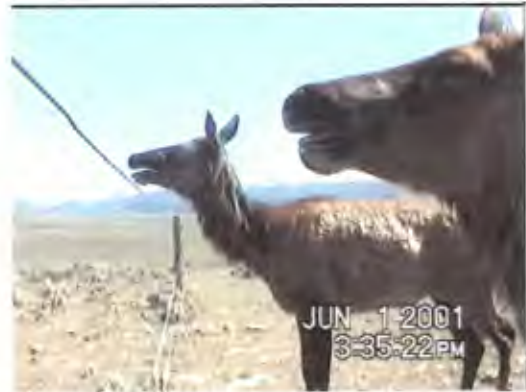
Elk looking for a location to cross a 52" 4-wire electric fence

Both the 2-wire and 3-wire fences are relatively easy for elk to traverse and the animals are less stressed when interacting with these fences. The 4-wire fences that we monitored have a relatively high aversion rate and elk are sometimes injured (we often found hair and skin where the animals had crossed and recorded 3 animals that flipped 180 degrees and landed on their backs when tripped up by the top wire) when attempting to cross. All of our data and observations suggest that elk experience elevated stress levels when faced with traversing a 52" 4-wire fence.

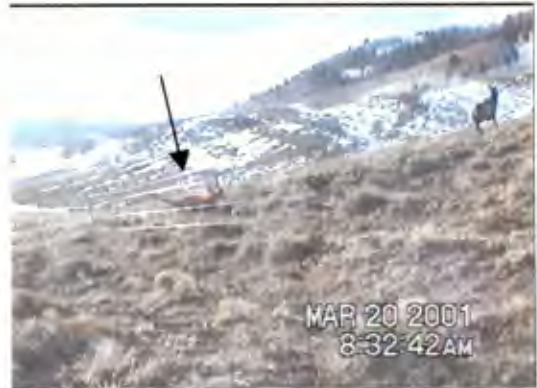
Elk on her back after getting tripped up by the top wire of a 52" electric fence

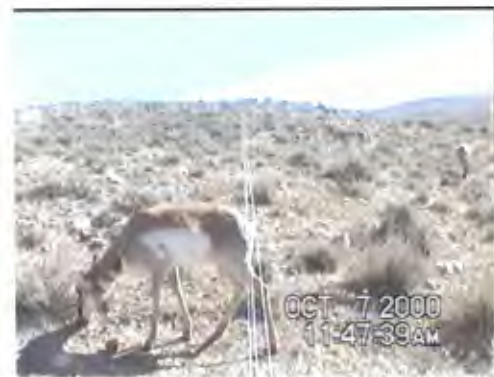
Pronghorn doe feeding on shrub while in direct contact with hot wire

No pronghorn were shocked by the electric fences. Electrical shock does not appear to be an important factor influencing the reaction of pronghorn to electric fences. The insulating quality of pronghorn guard hairs, combined with dry soils allow the animals to contact the hot wires and feel little or no pain. As with elk and deer, pronghorn would be more susceptible to being shocked if they touch a hot wire with their nose or ears or were standing in wet soils.

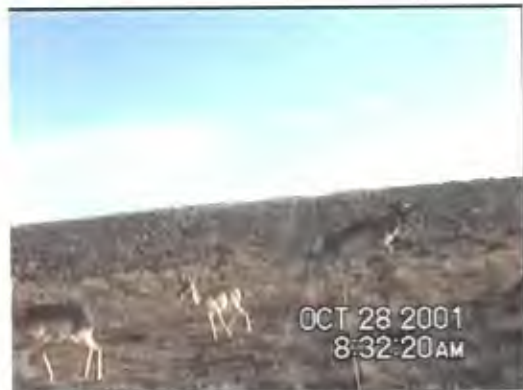
Pronghorn jumping 2-wire fence.

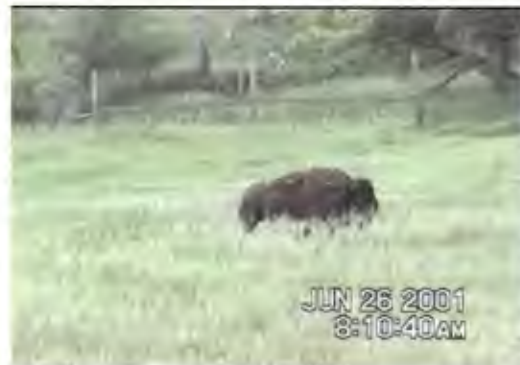
Bison cow looking for an escape route while running beside a newly constructed 3-wire electric fence.

The second fence was built at the Sybille Wildlife Research Unit. There we only had 3 animals to work with, but they were a good test for our 3-wire fence because they were extremely dependent on one another and had never been exposed to an electric fence. We built a 1-acre enclosure and separated the cows from a mature bull. The 2 cows, realizing they were separated from the bull, immediately tested the fence and were shocked. They then began running up and down the fence line looking for an escape. The bull pushed against the fence and was shocked twice before backing off. Although he stayed near and would occasionally walk the fence line, he did not physically test the fence again. The cows continued their travel of the fence line throughout the 7-day test and wore an obvious 5-inch deep path along the interior of the fence. Although we were only able to test the 3-wire fence under pressured conditions for a relatively small number of animals, these observations strongly support that 3-wire fence is effective at containing bison. The higher top wire on a 4-wire fence is not needed to contain bison if they are trained to electric fence and are managed properly. From our own experience working with bison, as well as knowledge gained from discussing fencing options with bison

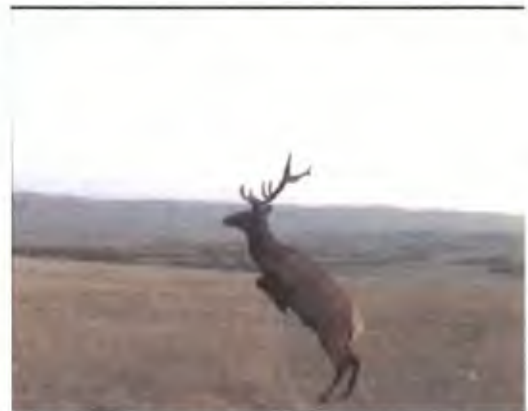
Bull elk jumping 3-wire fence
