**FHWA-WY-01/03F**

## **EVALUATION OF THE FLASH (FLASHING LIGHT ANIMAL SENSING HOST) SYSTEM IN NUGGET CANYON, WYOMING**

**Wyoming Cooperative Fish and Wildlife Research Unit  
University of Wyoming  
Laramie, WY 82071**

**July, 2001**

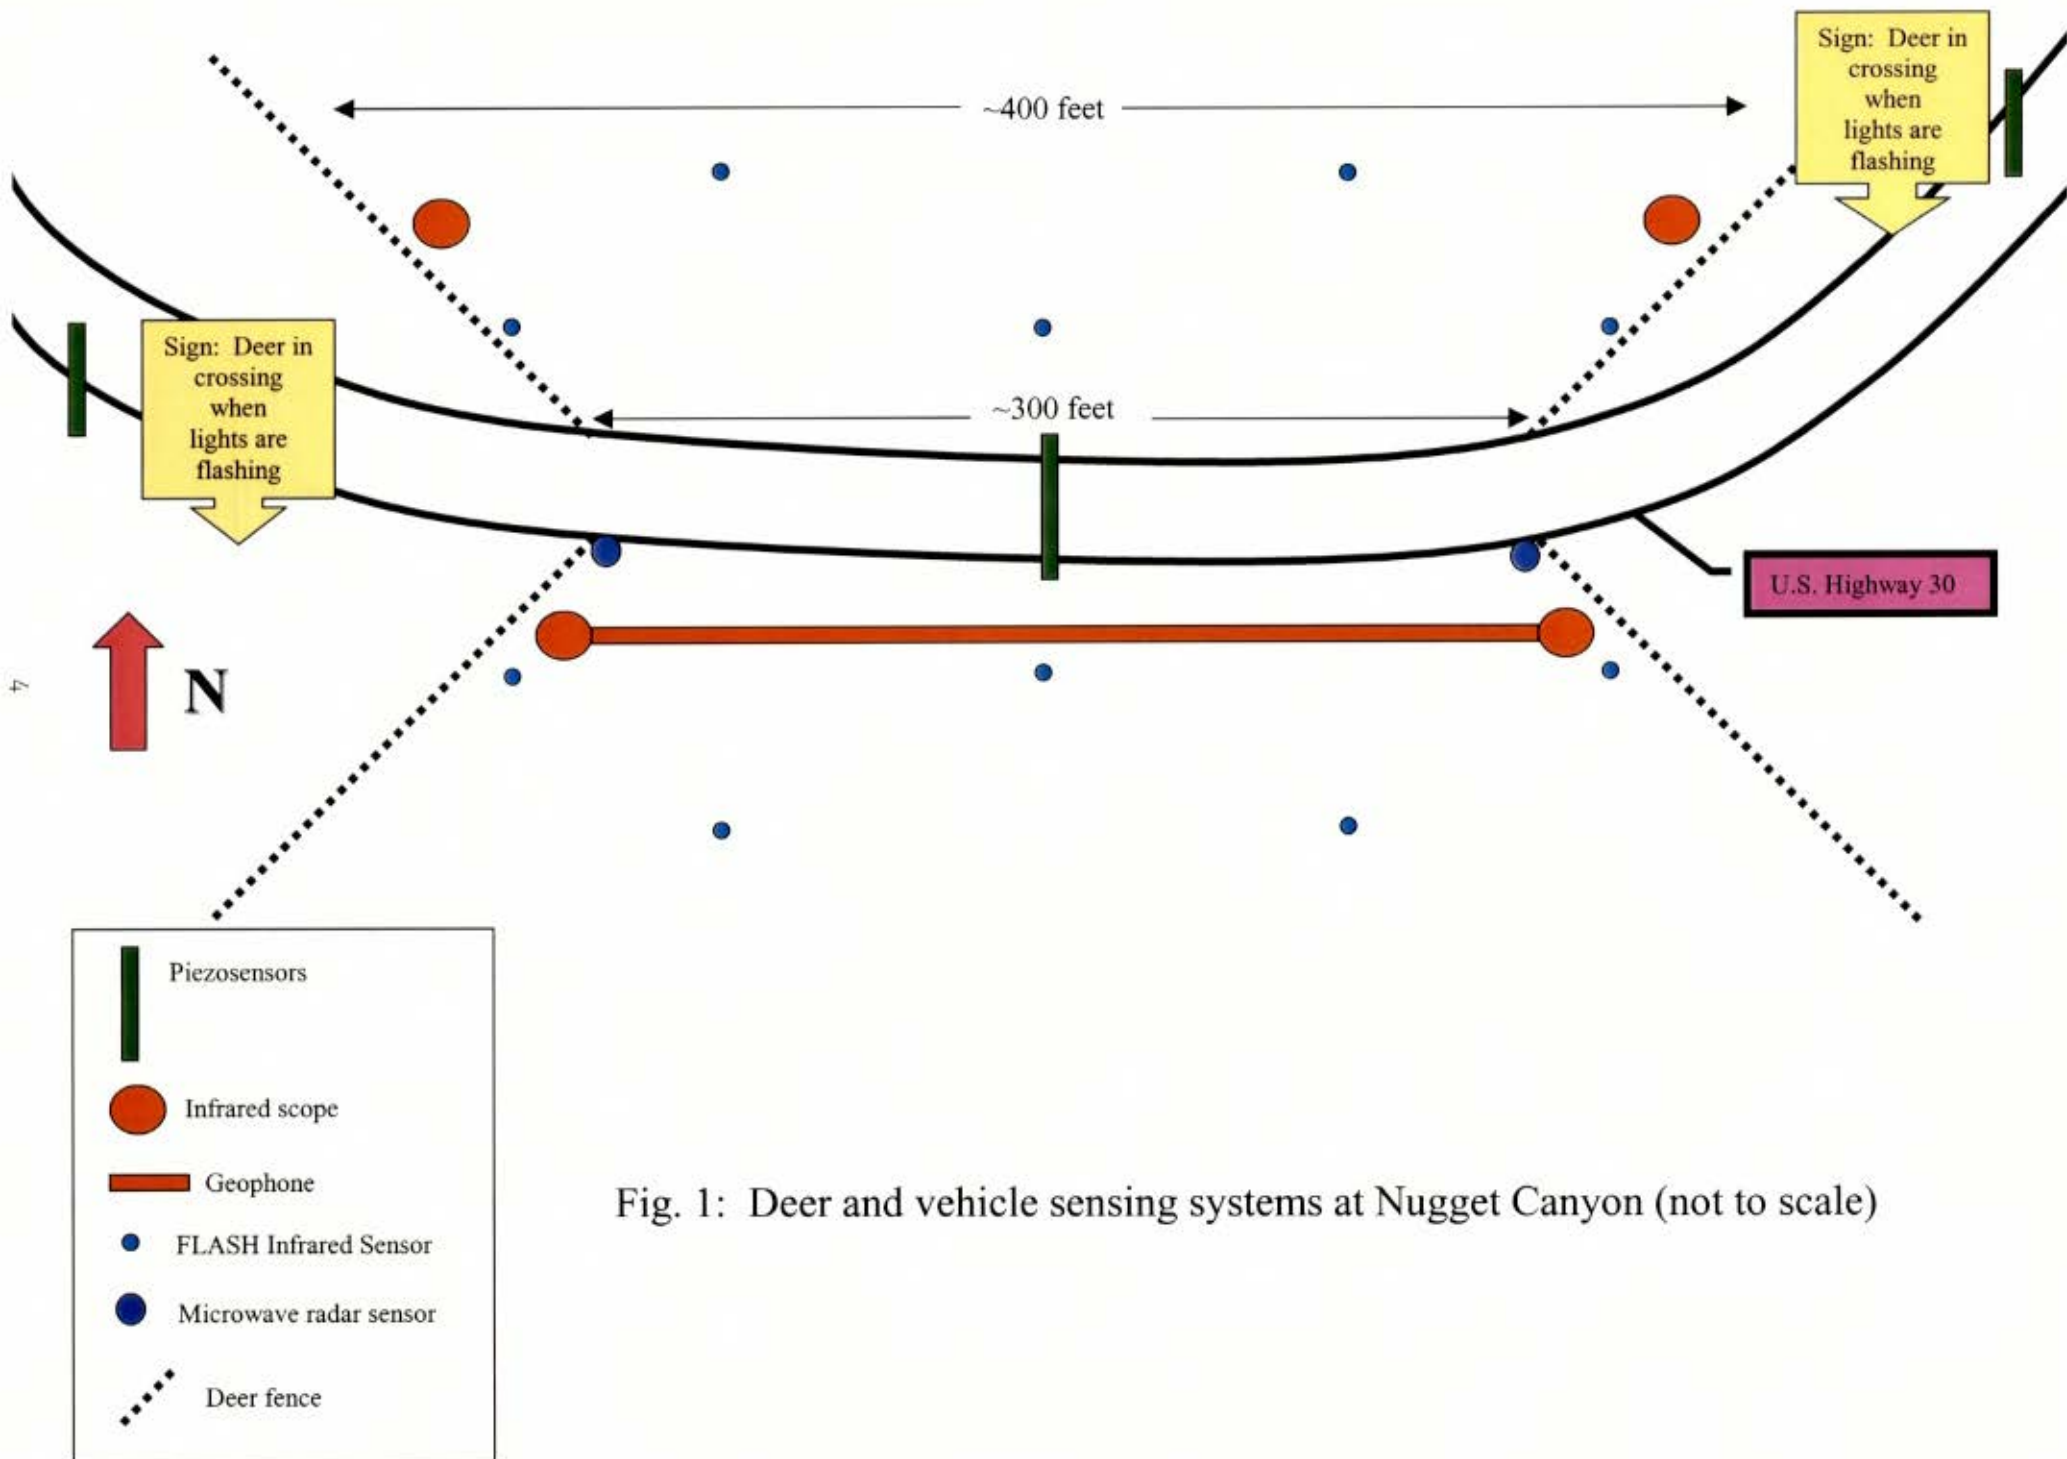
Fig. 1: Deer and vehicle sensing systems at Nugget Canyon (not to scale)

A geophone unit which detects ground vibrations caused by animals crossing at the south side of the site, paired with infrared scopes at the north and south sides of the site, acts as a back-up system for gathering data on deer crossings. A second backup system, consisting of microwave sensors flanking the south side of the site, was installed but is seldom used due to its tendency to register hits from passing trucks and other non-deer stimuli. The number of detections by all three deer systems were recorded by a counter.

Data consisting of speed, classification, and size of vehicles travelling along US 30 are collected by sensors located at points east and west of the crossing, as well as at the crossing itself. The east and west sensors gathered data on vehicles before the warning sign was encountered by motorists. These data as well as data collected by the deer detection systems were stored in a counter and downloaded remotely via modem into a database that allowed manipulation and analysis of the data.

The FLASH system and accompanying data collection systems have been installed in the deer crossing in Nugget Canyon at milepost 30. Technical specifications for all systems mentioned in the description below are included in the report prepared by Wyoming Department of Transportation engineers Bill Gribble and Matt Johnson, attached to this report as Appendix A. Three different systems are in place for detecting deer presence in the crossing (Fig. 1). The system of primary interest in this study, the FLASH system designed by Victoria Gooch and maintained and installed by George Twitchell of the Mid-American Manufacturing Technology Center (MAMTC) consists of infrared sensors that detect the body heat of animals. These sensors transmit a signal to a receiving unit, which activates a sign with flashing lights to warn motorists. The signs are located to the east and west of the crossing, approximately 300 m (984 ft) from the crossing. The signs can be flipped back and forth to display one of two messages: "Attention: Migratory Deer Crossing" or "Deer on Road when Lights are Flashing."

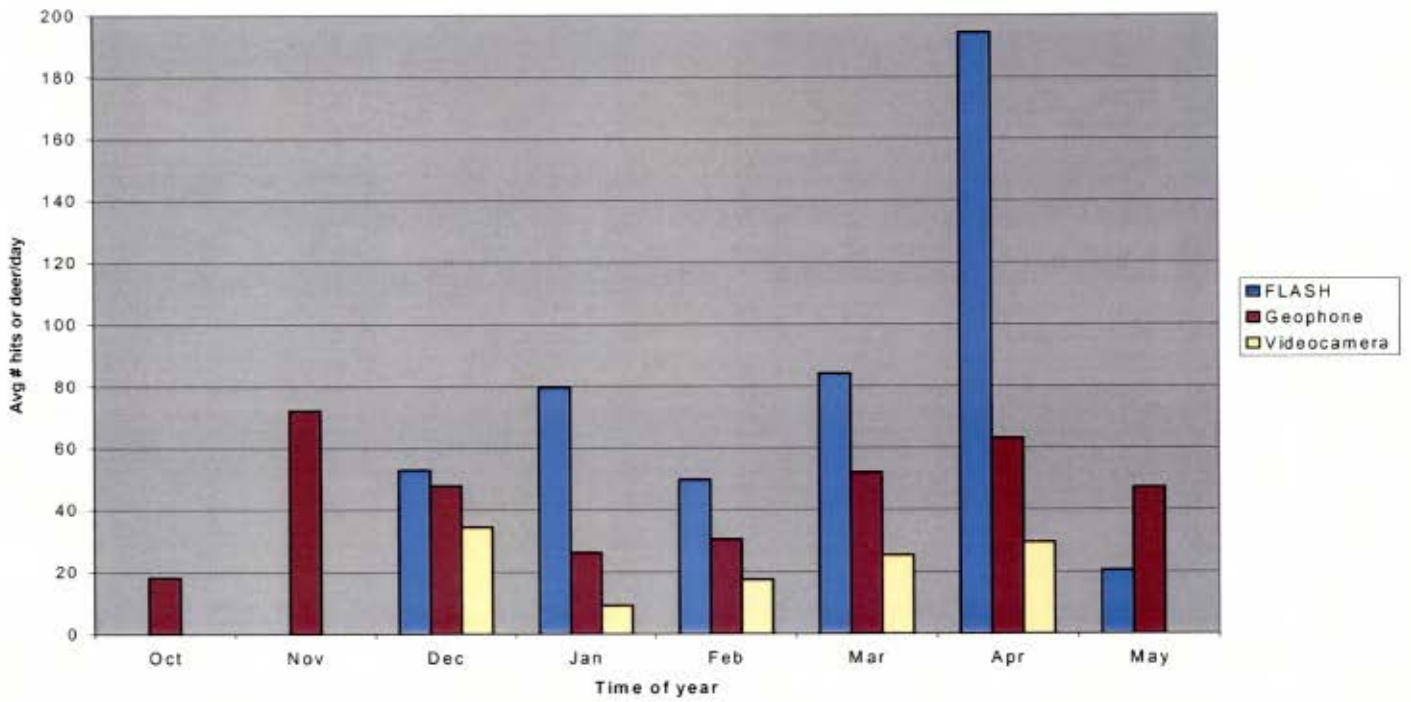
Figure 2: Average daily deer activity by month for three deer detection systems

The geophone and the videocamera showed similar trends in deer activity during the time that the videocamera system was operating (Figure 2). This could be due to the fact that the geophone system was used to activate the videocamera system. However, because the geophone system was found to be extremely reliable in detecting deer it is safe to assume that the similarity in trends is reflective of a real relationship between number of hits registered by the geophone and number of deer recorded by the videocamera. Because of the fact that the geophone can register multiple hits for a single deer moving back and forth through the crossing, the average number of hits per day registered by the geophone is higher than the average number of deer per day recorded by the videocamera. However, because of its reliability and the fact that it closely relates to the videocamera data, the geophone is valuable in assessing trends in deer movement.

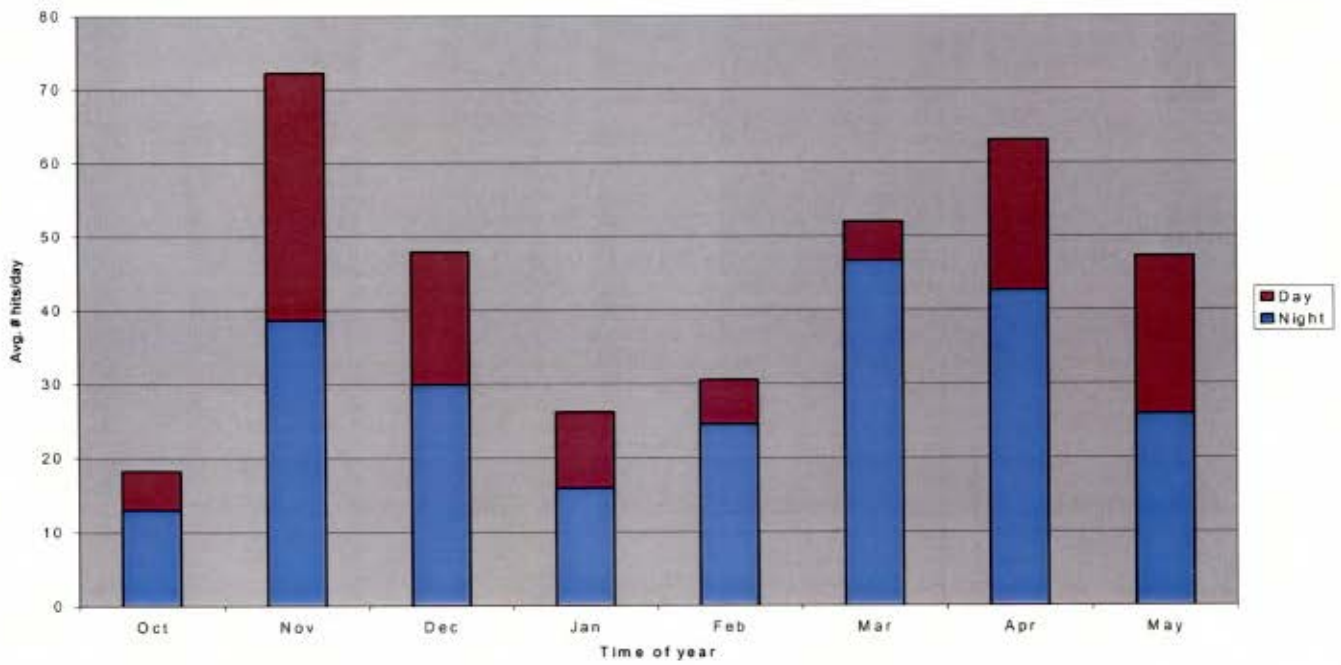
Figure 3: Night/Day Deer Activity Measured by the Geophone

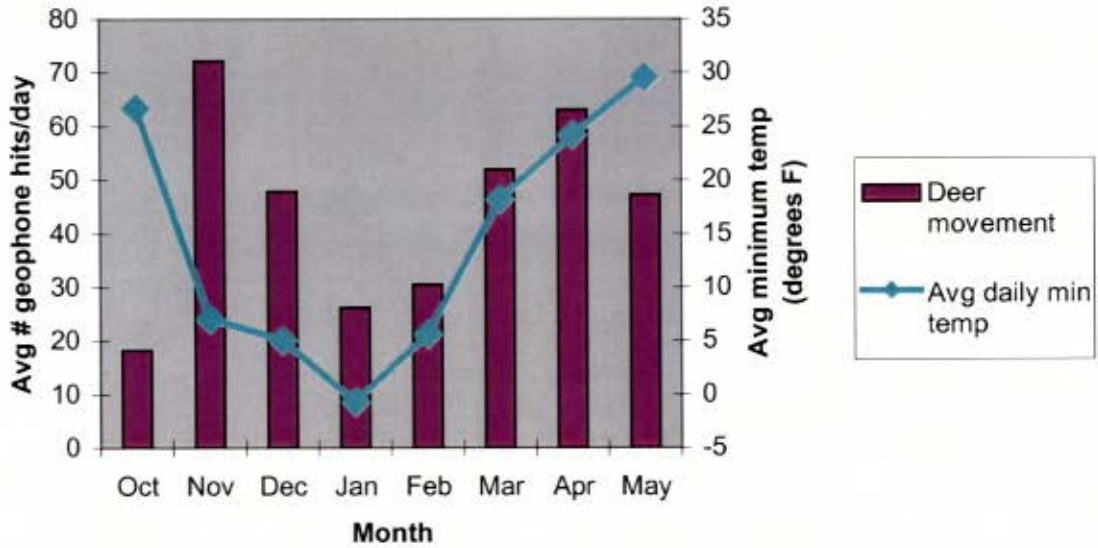
**Fig. 4: Deer movement and average daily minimum temperature by month**

Average daily maximum and minimum temperatures and average precipitation are graphed against deer movement as indicated by geophone data in figures 4, 5, and 6 respectively. Peaks in deer movement in the fall and the spring were both preceded by steep changes in average daily minimum temperatures and, to a lesser extent, average daily maximum temperatures. No pattern was evident with average daily precipitation, but it should be noted that precipitation data was missing for many days out of each of the months, and consequently major precipitation events may have been missed. Also, deer movement may be more dependent on short-term, intense episodes of snow or rainfall, rather than the overall precipitation occurring during a particular time of year.

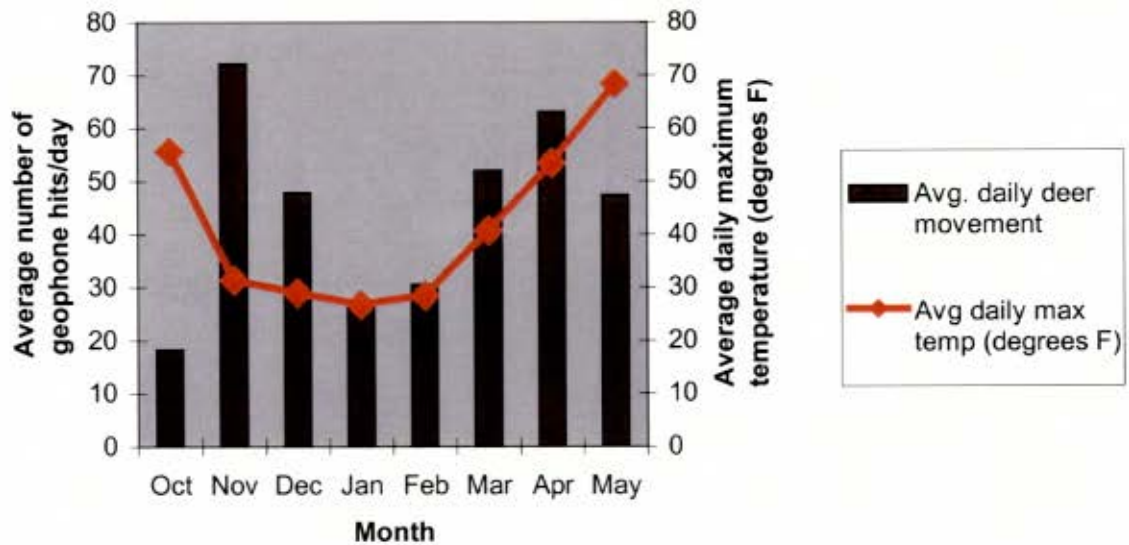
**Fig. 5: Deer movement and average daily maximum temperature by month**

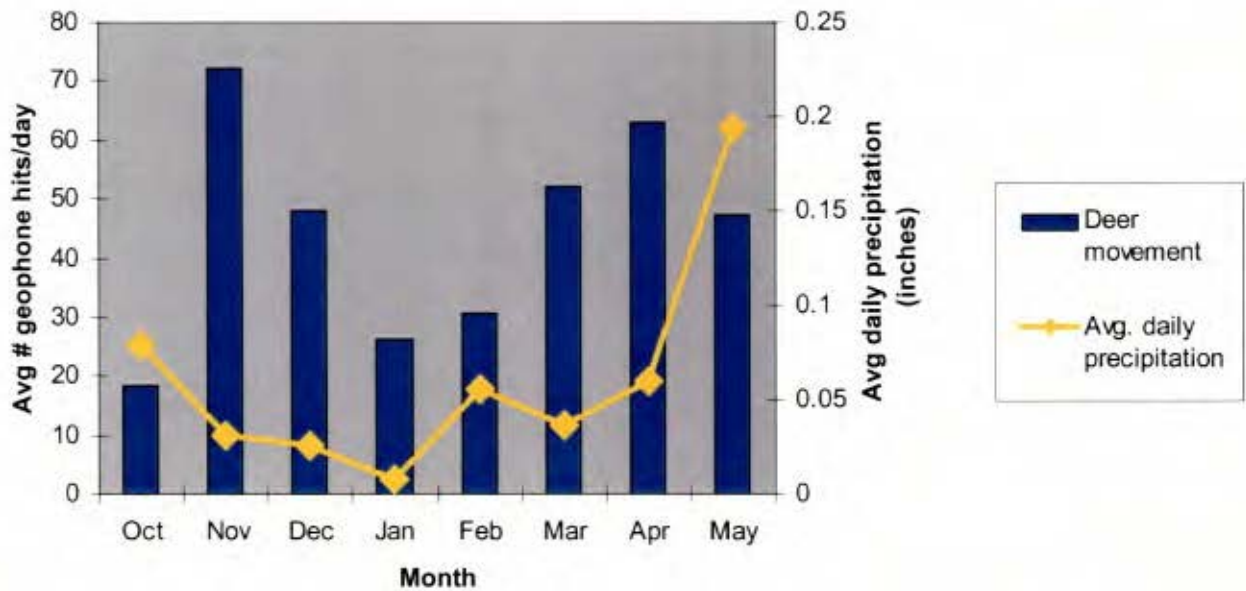
**Fig. 6: Deer movement and average daily precipitation by month**

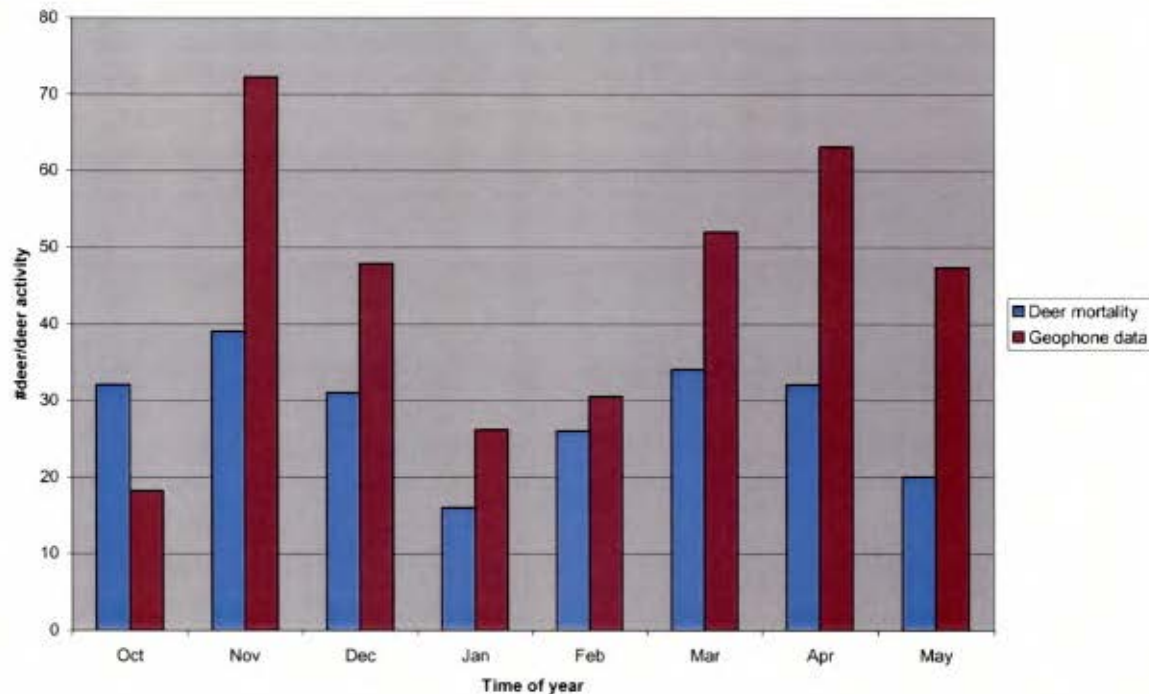
Figure 7: Comparison of deer mortality and deer activity at Nugget Canyon

Seasonal variation in vehicle-caused deer mortality closely tracked deer movement (Fig. 7), with the highest number of deer killed per month occurring in November, March, and April during the peak migration times. Adult females were killed more frequently than any other age/sex class (Fig. 8), with 122 killed over the course of the season. Fifty-eight yearling females were killed, followed by 42 adult males and 8 yearling males. A higher proportion of adult males were killed in December, late in the fall migration period, and in February, early in the spring migration period, tentatively indicating that males of this herd may be spending less time on the winter range than females.

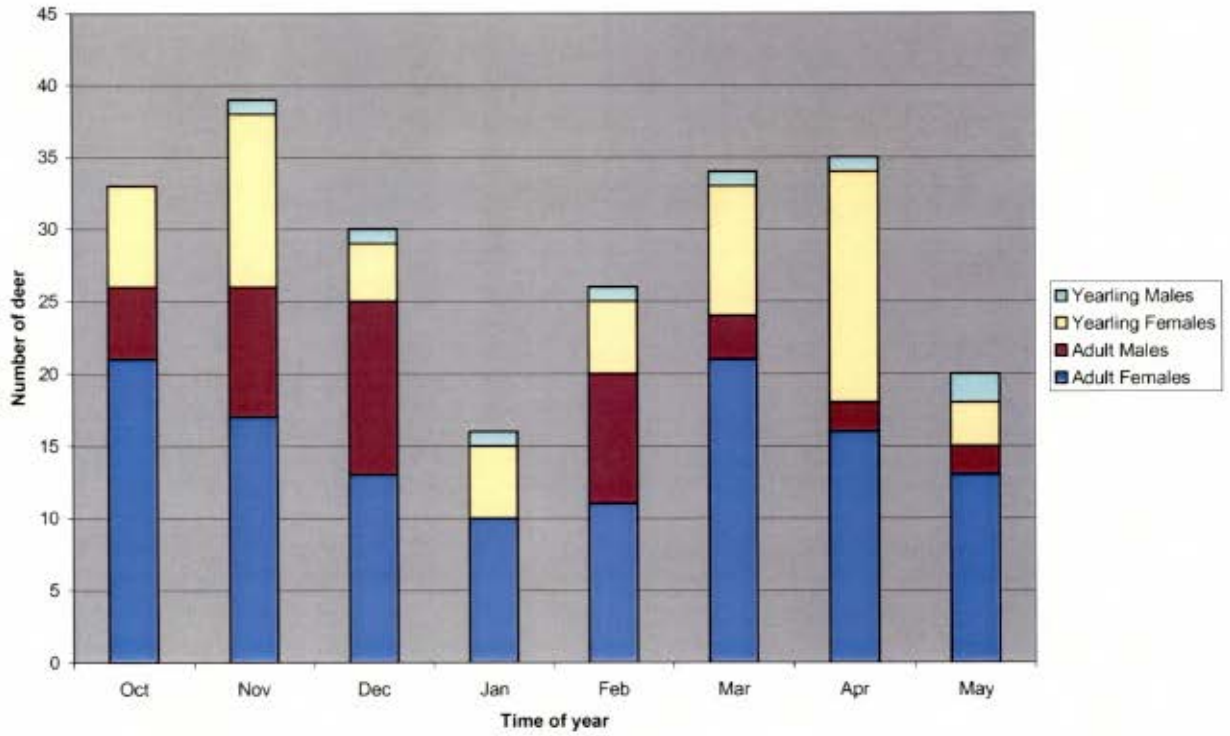
Figure 8: Vehicle-caused deer mortality in Nugget Canyon by sex and age

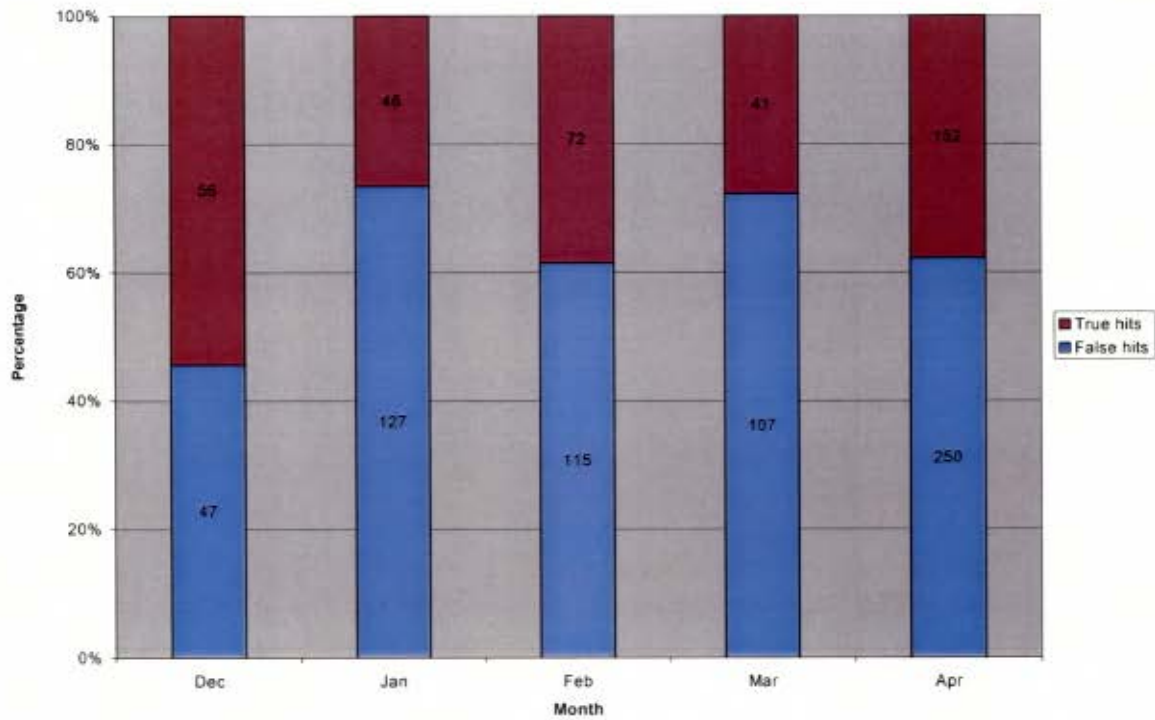
Fig. 9: Percentage of false hits on the FLASH system by month

During 30 hours of observation, neither the FLASH nor the geophone system registered false hits. Additionally, all deer that passed through the crossing during the observation periods were picked up by both systems. Incidental observations of deer crossings outside the observation periods were also confirmed by hits on both systems when these were checked after the fact. No evidence of false hits or failure to detect deer was ever found for the geophone system; it appeared to work perfectly throughout the study period. No evidence was found of the FLASH system failing to detect deer moving through the crossing. However, the FLASH system started registering numerous false hits starting in January due to birds feeding on carrion in the crossing, frost, and snow thrown by passing snowplows. Observations of birds in the crossing in the absence of deer were later confirmed to have registered hits on the FLASH system, but not on the geophone system. In April, a faulty transmitter caused the FLASH system to start registering false hits in response to tractor-trailers. Figure 9 shows percentage of false hits on the FLASH system by month from December until May.

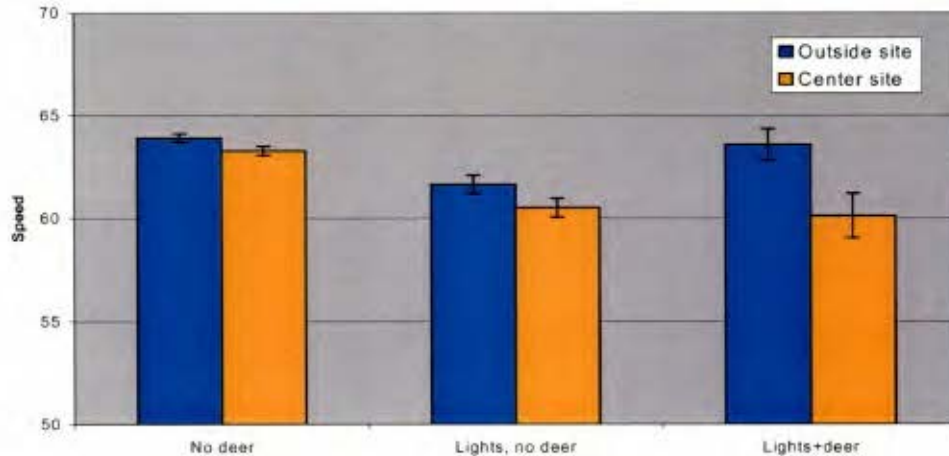
**Figure 10: Vehicle speed reduction in response to the FLASH warning system**

The warning lights associated with the FLASH system are set to be activated for two minutes after a hit is registered. Consequently, motorists may travel through the crossing while the lights are still on but after the deer have crossed the road. To the motorist, it may appear that the system is not functioning properly even when a deer was actually detected. This may explain why only a minor speed reduction was seen in response to genuine hits on the FLASH system.

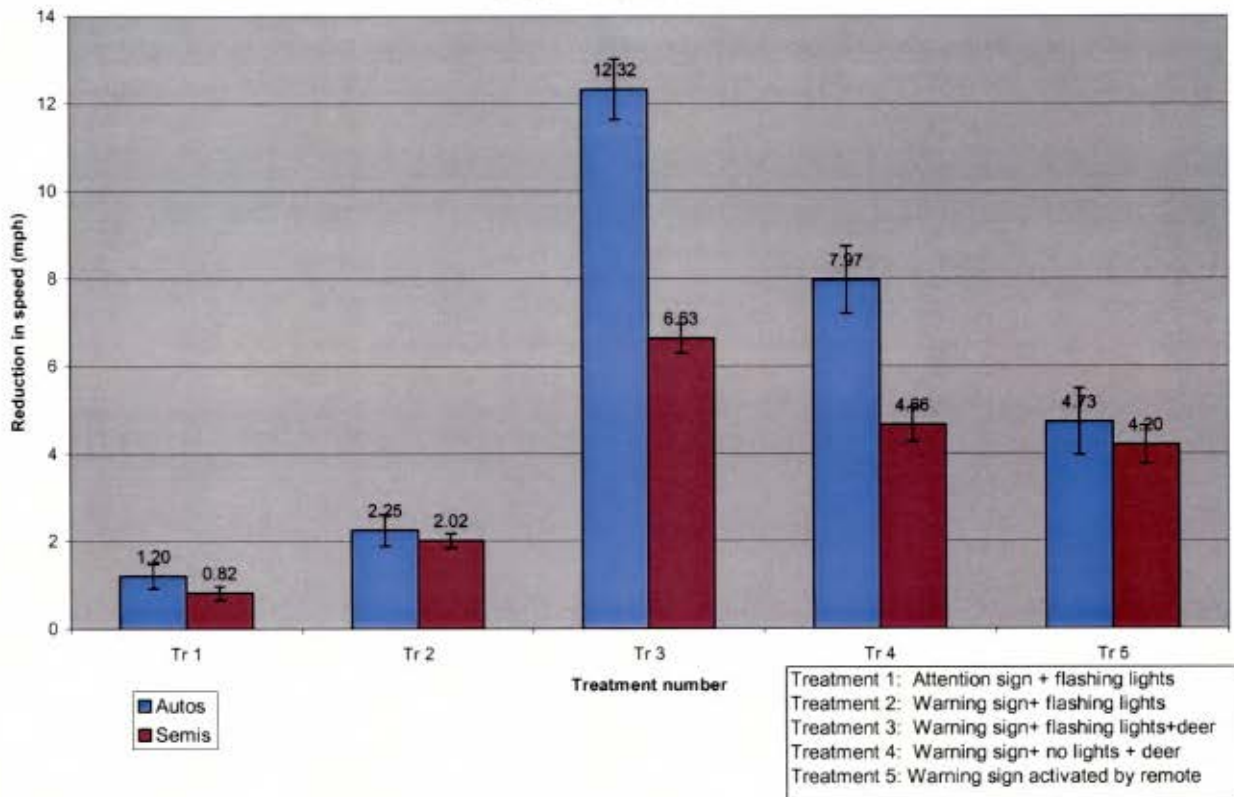
**Figure 11: Change in speed of automobiles and tractor trailers in response to five different experimental treatments.**

indicate that the lights play a trivial role in causing motorists to slow in comparison with the presence of deer in the crossing. When data are broken down into speed reduction categories, treatments 3 and 4, with deer present, had the highest proportion of vehicles slowing down by 10 mph or more for both automobiles (Fig. 12) and tractor trailers (Fig. 13). Only a small percentage (9.6% for passenger vehicles and 6.8% for tractor-trailers) of the vehicles slowed down by more than ten mph in response to the warning lights without the deer. These data, combined with the data gathered when the FLASH system was running continuously during non-treatment periods, demonstrate that the FLASH warning system by itself does not cause motorists to reduce their speed enough to prevent deer-vehicle collisions along U.S. Highway 30 in Nugget Canyon.

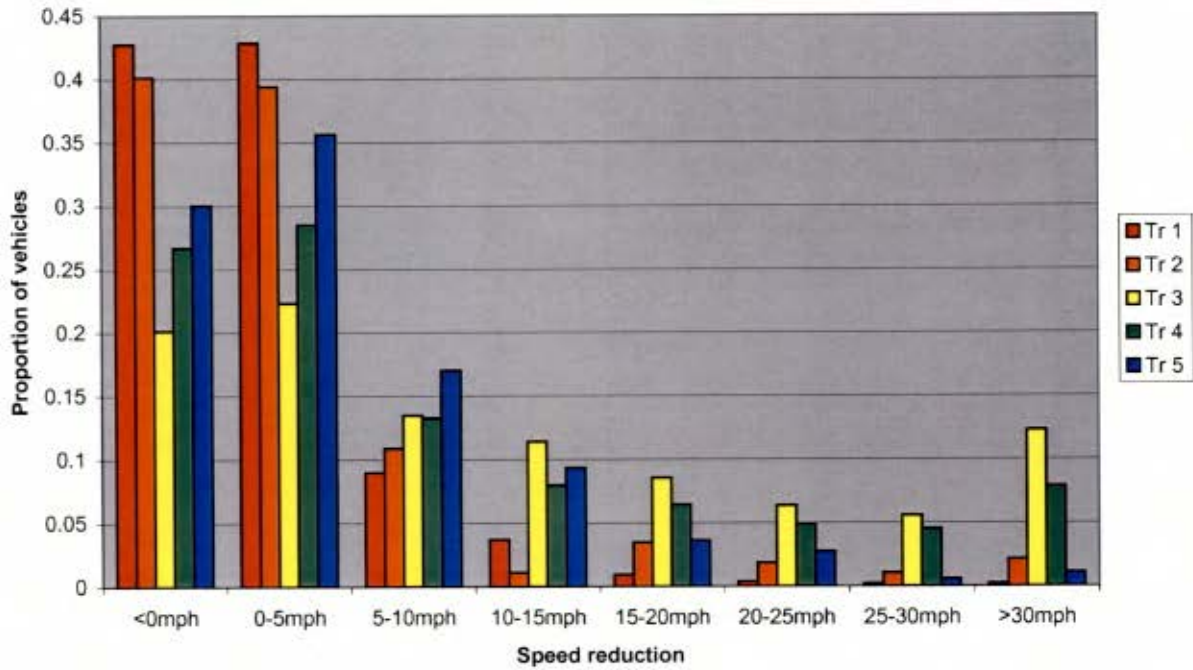
Figure 12: Passenger vehicle categorical speed reductions in response to five experimental treatments

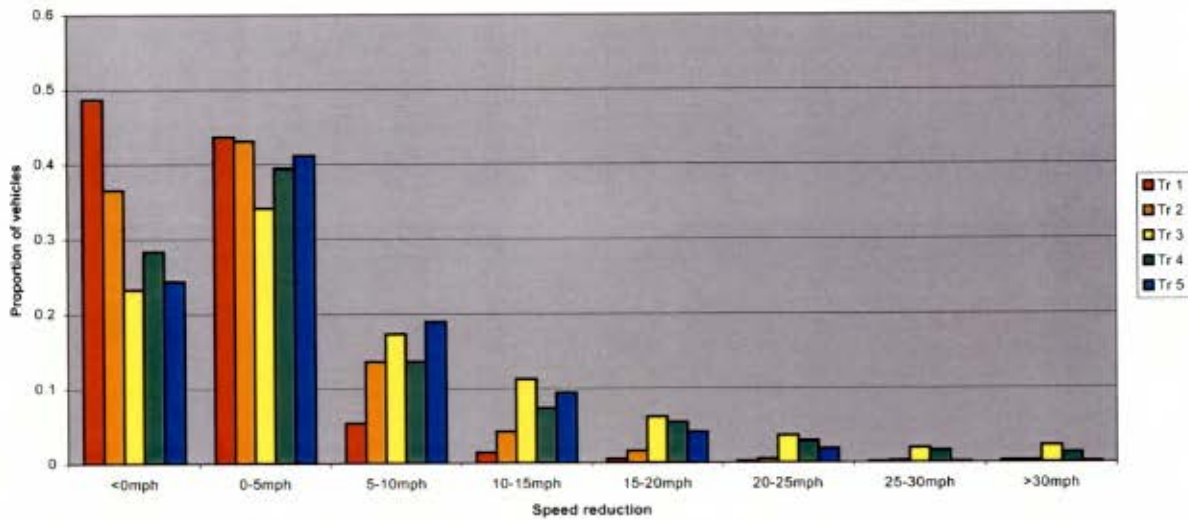
Figure 13: Tractor trailer categorical speed reductions in response to five experimental treatments

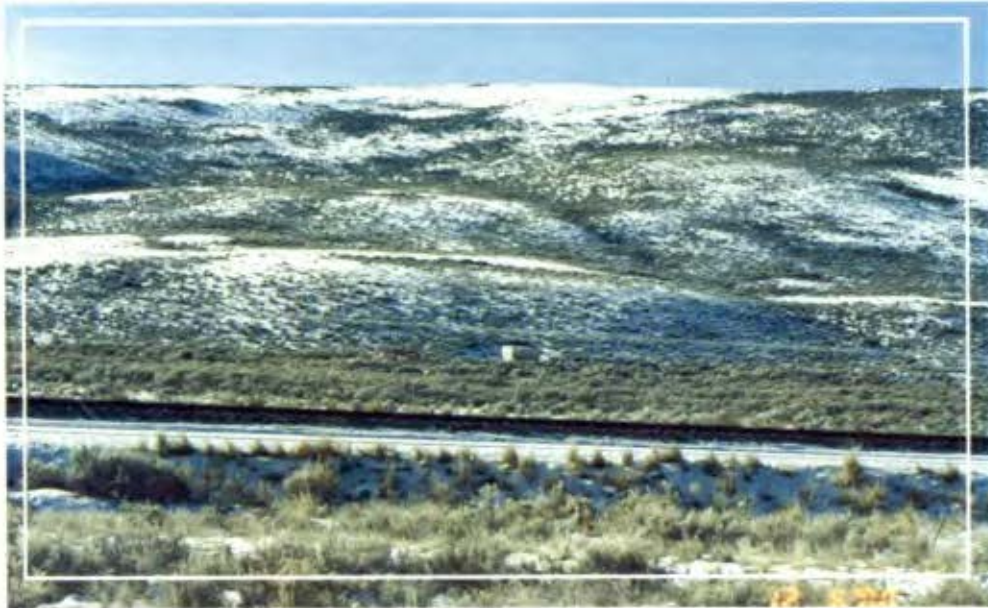
*Real time remote monitoring of site operation was done from the trailer parked approximately one-fourth mile south of the crossing zone. Visual observation of deer in the crossing zone was compared to the recording of sensor hits on a second traffic counter at the center site. A low power radio linked the computer at the site to a laptop computer in the University of Wyoming's trailer.*

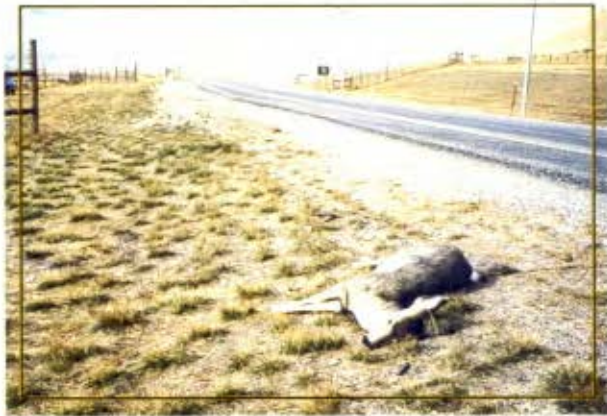
*A deer just outside the boundary fence of the crossing zone in an area leading to the one-way jump over point. Deer continue to be hit at the crossing and their carcasses attract a large number of scavenger birds who often set off the deer detectors. Maintenance crews regularly patrol and haul away the carcasses.*

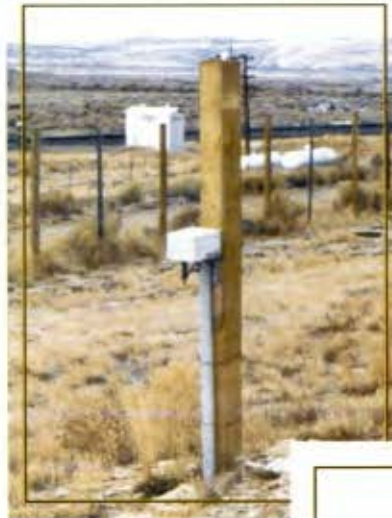
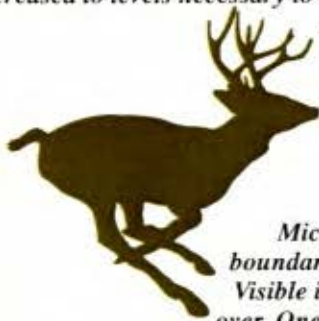
*One of two microwave radar transmitters on the south side of the crossing zone. A number of locations and modes of operation were tried, but the result was always intermittent, wild counts. The units were designed to count motor vehicles and became unstable when sensitivity was increased to levels necessary to consistently detect deer.*

*Microwave radar mounted just outside the boundary fence pointed into the crossing zone. Visible in the background is the one-way jump over. One is located on each side of the crossing zone and on both sides of the highway. Most deer walked or trotted straight through the crossing, but occasionally they would drift or be driven by traffic to one side or another on the highway. These sites channeled the deer off the highway where they would use the jump area where the dirt was sloped toward the fence in the corner.*

The radar had to be set to high sensitivity levels in order to consistently detect deer, which then made it susceptible to false hits caused by blowing grasses, fences flexing back and forth in the wind, snowfall, birds flying through the zone and possibly other sources. The contractor supplied FLASH system seemed to be suffering from the effects of bright sunlight at different times of the day. This seemed to cause false hits when the sun would first rise or when the sun would emerge from behind clouds, particularly in the afternoon. Eventually, it seemed, the sensors would become saturated in continuous bright sunshine and then not detect deer even when they walked very close to the sensors. (See the F.L.A.S.H. schematic on page 34 and the Microwave schematic on page 35.)

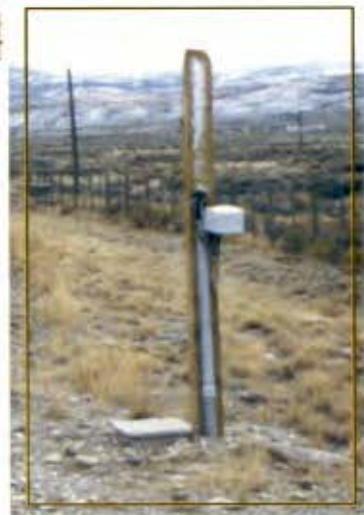
*The ground sensors for the Geophone System were installed in a shallow trench in a string just over 300 feet long. Sensor spacing was approximately 32 feet. While the initial installation detected deer well, it also detected trains and the occasional passing truck. The addition of infrared scopes cured the problem. Scopes alone were used on the north side of the road.*

Throughout this period, the Geophone system continued to perform extremely well. This system had started with string of 10 sensors buried in a line across the south side of the crossing. When the system picked up occasional false hits caused by passing trains and truck traffic, it was modified with the addition of two infrared scopes which were set on each end of the opening, pointed toward the center. The system required a "hit" to be detected by both the ground sensor and a scope to be considered valid. It was this system that worked so well throughout the Winter and Spring. In March of 2000, in order to assess the feasibility of expanding the Geophone system at minimal cost to both sides of US 30 at the deer crossing, the Geophone system was re-programmed to only require a hit on the infrared scopes for a valid detection. This test proved successful. Several trips were made to the site following the change, and monitoring of site activity showed that the scopes alone detected deer extremely well and did not produce false hits. (See the Geophone schematic on page 36.)

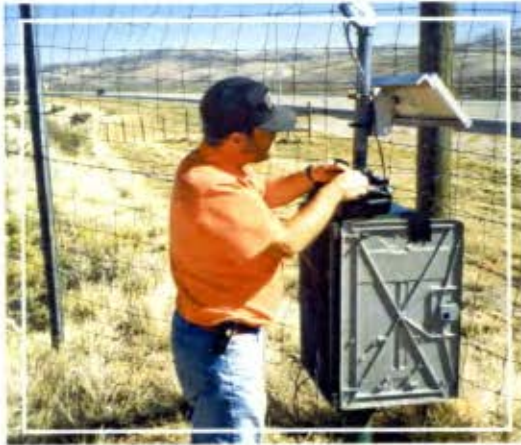
*Matt Johnson installs the controller and transmitter for the Geophone scopes on the north side of the crossing zone.*

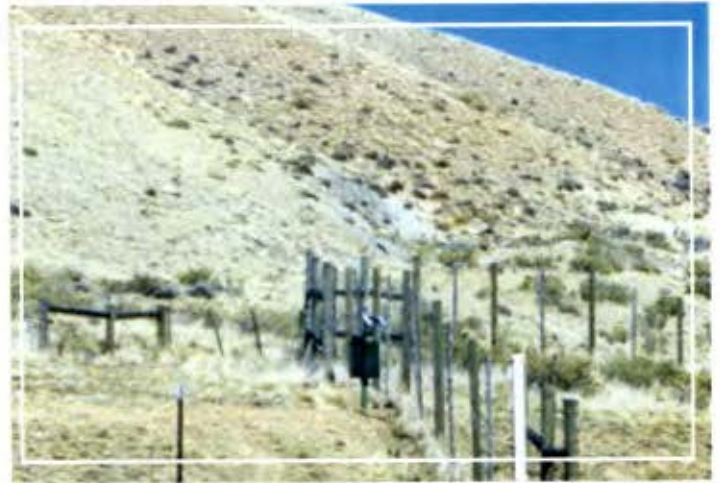
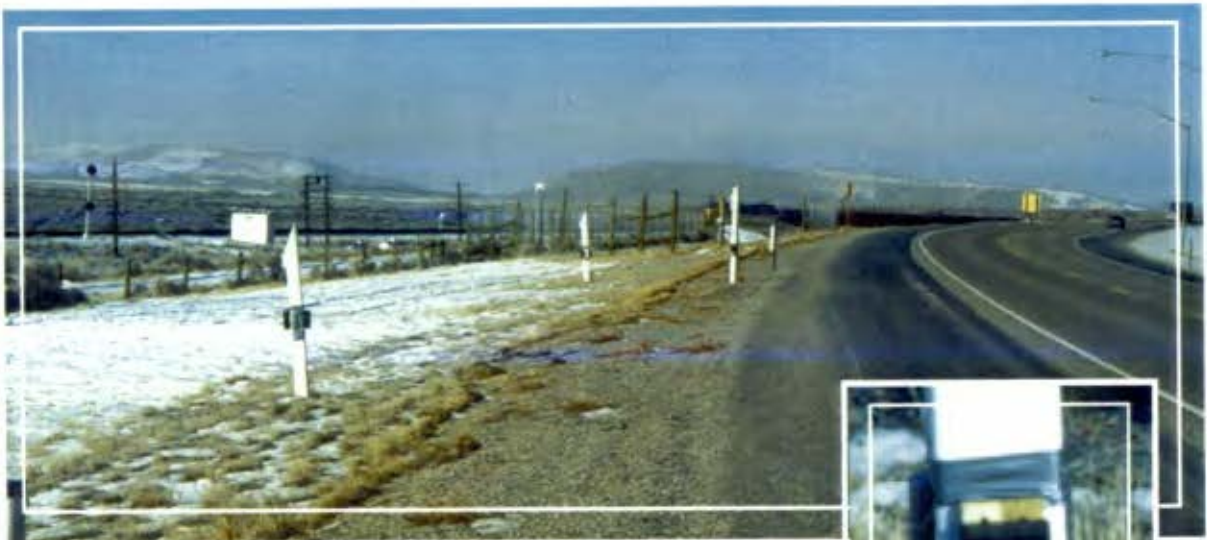
*East boundary fence on north side of crossing zone. A F.L.A.S.H. sensor and a Geophone scope are shone mounted on the boundary fence. The cabinet housing for the Geophone transmitter is located further up the slope to allow un-broken transmission over the truck traffic.*

*South side of crossing zone looking west. Some of the revised F.L.A.S.H. System sensors are shown in center, while some of the overhead lighting is visible on the right. A train and a truck approach from the west. Trains, heavy truck traffic and the curved road created problems in setting and tuning the Deer Detectors. None of the conditions were present at the initial testing done at the Sybille Canyon Research Center.*

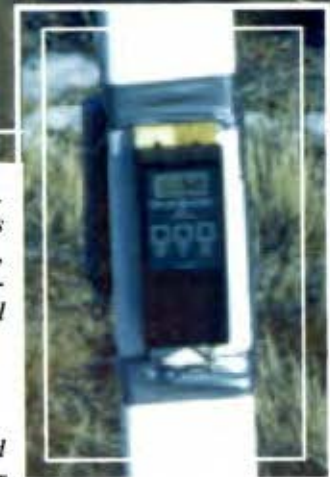
*Close up of active infrared sensor for the revised F.L.A.S.H System. The modification changed their system into a "break the beam" technology.*

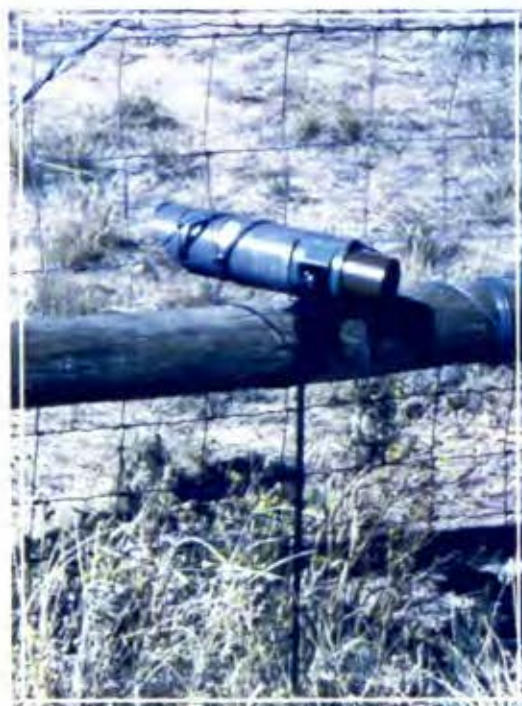
*Geophone scope installed on the north side of the Highway. Shrouds of plastic PVC pipe were made and installed by Counter Shop Personnel early in the testing of the original scopes. Factory sun shades proved inadequate, leading to an eventual saturation condition which resulted in "under-detection". The pvc shrouds cured the problem and did not reduce coverage area.*

The installation of the scopes on the north side of the road proved more difficult than the south had. Tuning and aiming of the scopes was more difficult because the north location is on the inside of a curve, and the heat signatures from passing trucks was causing occasional false hits, even when they were quite some distance away from the crossing zone. We began detecting deer behind the right-of-way fence when the scopes were aimed at too great an angle from the highway, and the goal, of course, was to only detect them in the right-of-way when they were a hazard to traffic. The deer often did mill around for quite awhile behind the fence before entering the crossing zone, and many times would not enter the crossing point for hours, alternately approaching and then fleeing the opening. During the time the effort to place and tune the scopes was going on, a problem surfaced with the low power transmitter.

In an effort to increase battery life, the transmitter was designed with a power save feature that would put the unit in a "sleep mode" after a period of time with no hits. Our unit would not "wake up" and transmit valid hits after several hours of no activity. A similar problem had developed during the previous year when the scopes were added to the Geophone system on the south side of the road. In that case the new controller had been at fault. Working with the manufacturer, Eagle Telonics, several remedies were tested, but the problem persisted. In late September they sent a replacement transmitter. By October 12, 2000 the Geophone installation was fully proofed and functional on both sides of U.S. 30. The

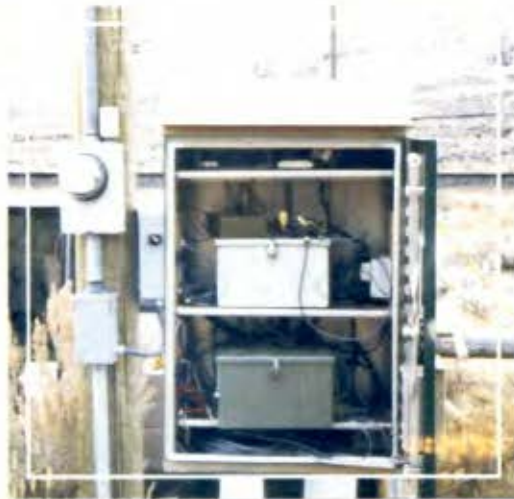
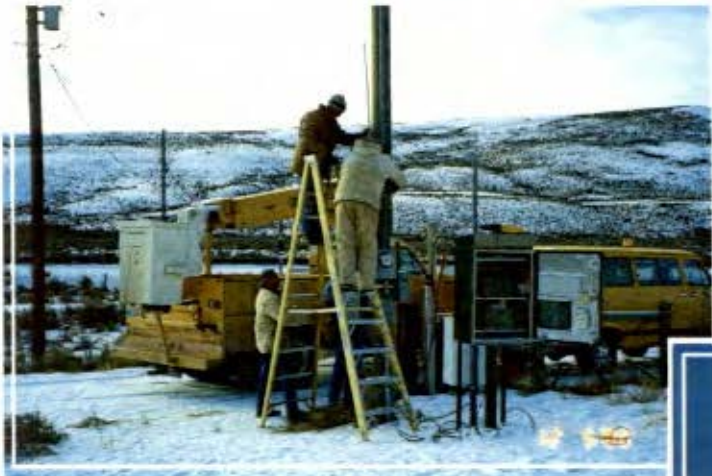
*Main Control Cabinet. On the top shelf are the A-B switch, Cell Phone brick and Modem. The middle shelf contains the Geophone Controller and the Phoenix Traffic Counter/Classifier. The bottom shelf holds the second Phoenix Counter/Classifier used to record the time of each Deer Detector activation. The power supply for the radar is under the bottom shelf. A remote data link was added later.*

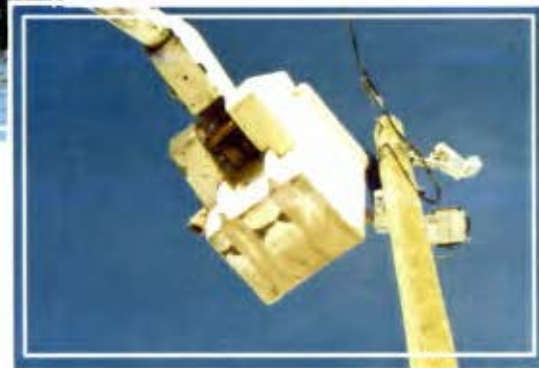
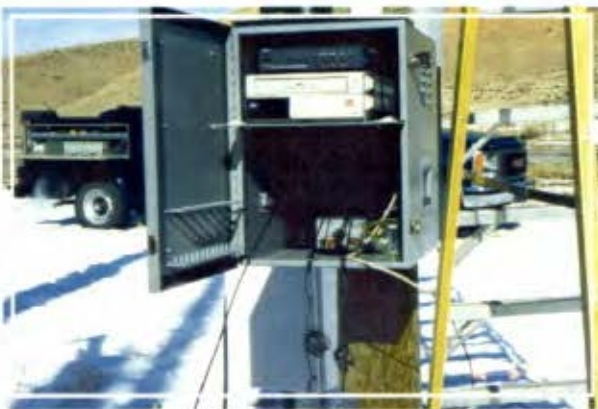
*Personnel from the Counter Shop and District 3 Traffic work with a District 3 bucket truck to mount the low-light cameras on the power pole. The cooperation of District 3 Traffic personnel was essential to the project. In addition to providing the auger and bucket trucks, they upgraded the power service at the center site, changed motorist warning signs and modified controller to allow the F.L.A.S.H. System to turn on warning lights.*

*Video Controller and special VCR for the ATD Video System. Recordings can be made from one, two or all 4 cameras in a split screen format. John Reed, the Cokeville maintenance crew foreman often chnged the 8-hour tapes. John provided a tally of the number of deer killed in the crossing zone, kept the zone mowed, and raised and lowered the right-of-way fence in response to deer migration and livestock grazing patterns.*

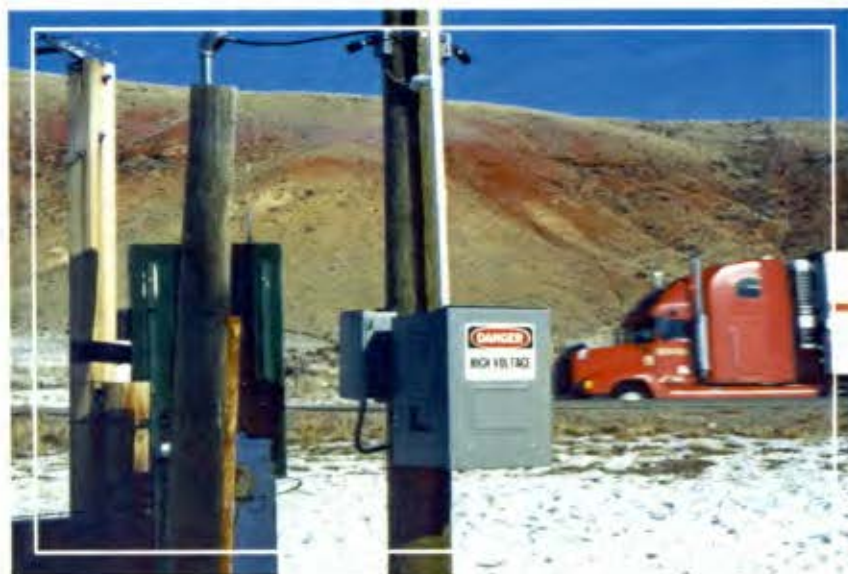
*The grey cabinet houses the Controller and VCR for the Video System. The two infrared cameras are seen mounted to the pole above the cabinet. These small cameras feature wide-angle lenses which allow coverage from the highway to the right-of-way fence. They were*

*aimed to avoid wash-out from the overhead lighting on the north side of the highway and the headlights of passing traffic. The cameras are mounted 10 feet above ground level. The Directional antenna used for remote monitoring of site operation is mounted on a pole to the left.*
