**FHWA-WY-01/03F**

## **EVALUATION OF THE FLASH (FLASHING LIGHT ANIMAL SENSING HOST) SYSTEM IN NUGGET CANYON, WYOMING**

**Wyoming Cooperative Fish and Wildlife Research Unit  
University of Wyoming  
Laramie, WY 82071**

**July, 2001**

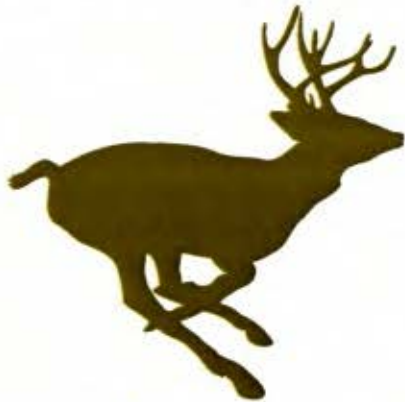
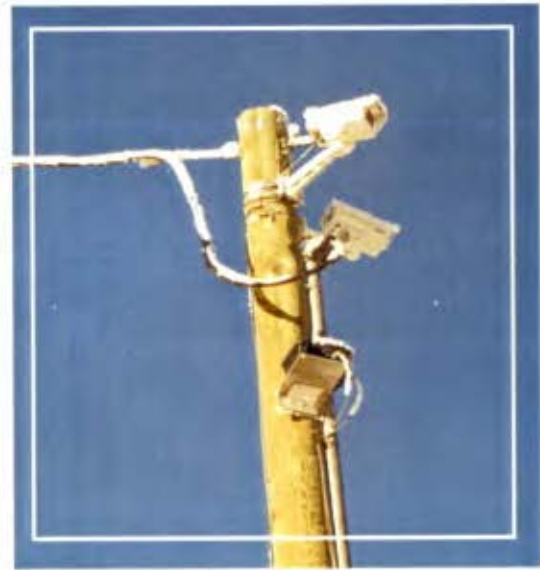
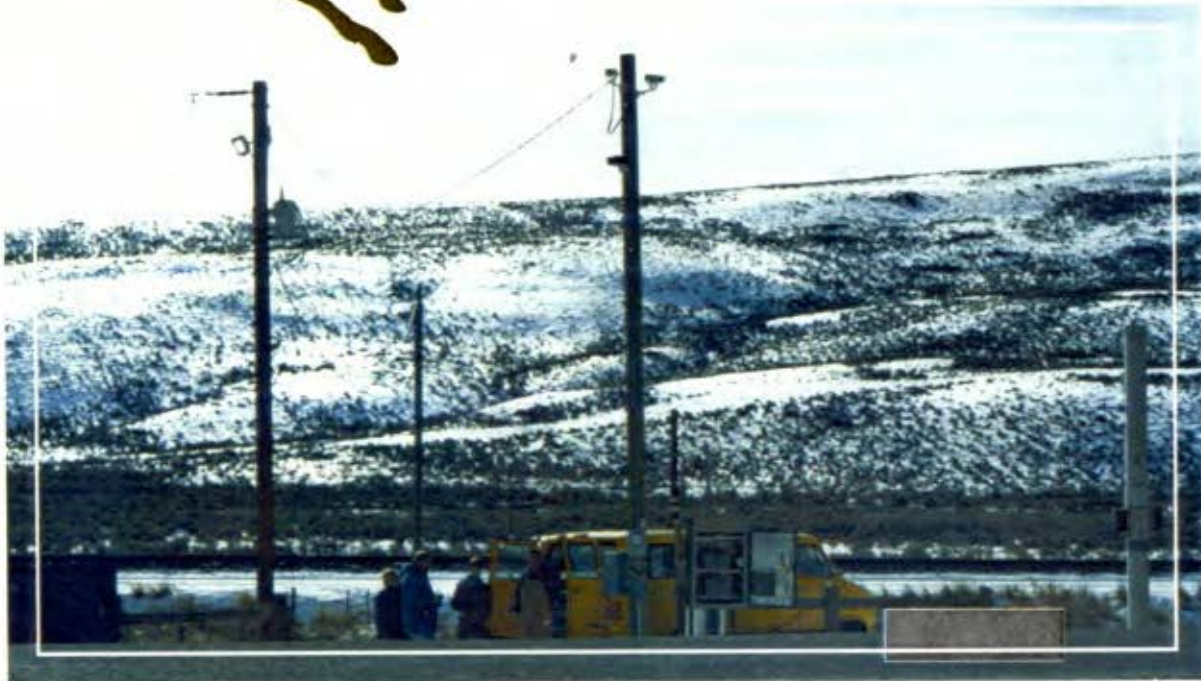
*Conditions at Nugget Canyon can be harsh, and this was a new application for most of the equipment. As shown in a picture to the right, a thick coat of frost covers the low-light camera housings and Geophone receiver on a bitter December morning. Despite the cold temperatures and heavy frost on the antennas, all systems continued to operate normally.*

*Looking south from the highway toward the control cabinet area. The low-light cameras are mounted in housings near the top of the power pole at approximately 26 feet above ground level; the Geophone receiver is just below these at approximately 22 feet. The video system had to be able to see over passing trucks into the north side of the crossing zone. The Geophone system utilized a low powered line-of-sight transmitter which required the high mounting to avoid broken transmissions from the north side zone to the controller in the south zone.*
