South Dakota
Department of Transportation
Office of Research

Evaluation of Thermal Imaging Equipment

Study SD2007-05
Final Report

March 2011

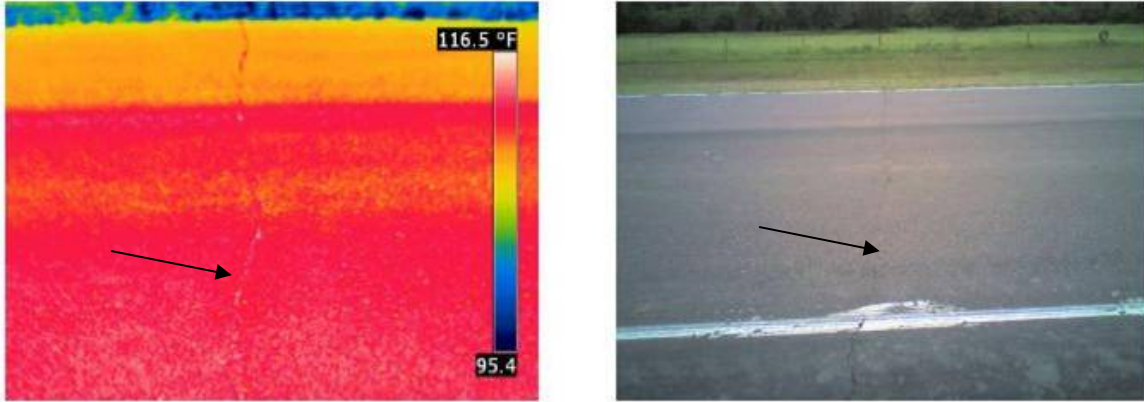
Thermal imaging was investigated to see if cracks in asphalt pavement were able to be seen either before or after cracks appeared on the surface. Small cracks (<5mm) were typically hard to see with the naked eye, but also were difficult to see with the camera. As seen in Figure 5, due to the narrow width of the crack it was challenging to distinguish the location of the crack due to a very small temperature differential of typically <1°F. Large cracks in asphalt are readily seen with the thermal camera as seen in Figure 6. In this image, a temperature differential of as much as 13°F warmer occurs inside large cracks compared to the asphalt surface. Typically, it was seen that a wide crack (>5mm) would vary by as much as 5°F or more, where a small crack (<5mm) may only vary by 1°F or less. No cracks or voids were able to be found without visible surface cracks. It could be possible to see voids or bottom-up cracks, but due to the hand-held nature of the camera, only small areas of pavement were investigated and neither of these were identified during the investigation.

Figure 5: Asphalt crack detection photos taken on SD38 east of Mitchell, SD.

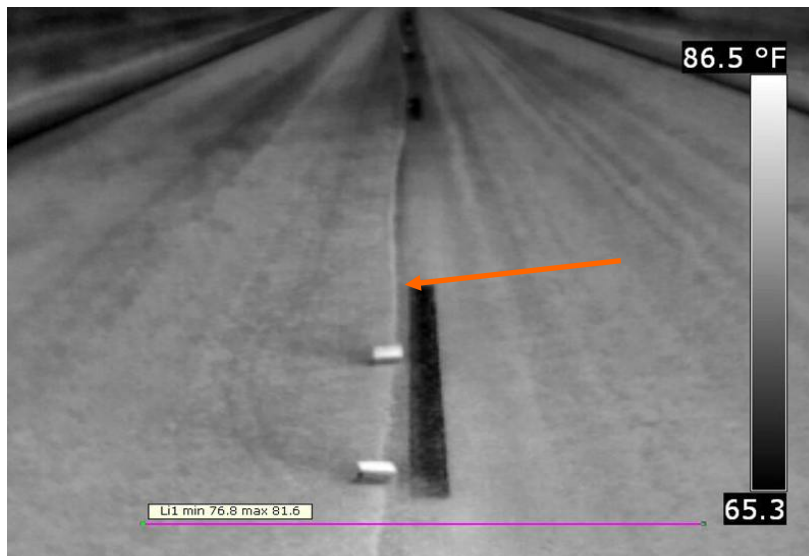
Asphalt centerline joints were investigated to determine if voids or other joint deficiencies were detectable with thermal imaging. Joints in the center mainline on asphalt roads were usually visible under the ideal conditions. Ideal conditions consist of a newer pavement with no chip seal having been applied and sufficient solar loading has occurred; a temperature gradient was then noticeable at the joint. As seen in Figure 7 and Figure 8, there was no exposed aggregate from oil loss and a good cover of oil still existed that provided a well exposed joint and did show a temperature differential of a few degrees highlighting joint geometry. However, on older pavements with chip seals or exposed aggregate due to oil loss it was typically harder to discern the precise location of joints in images.

Figure 7: Asphalt centerline joint on SD1804 north of Pierre, SD.

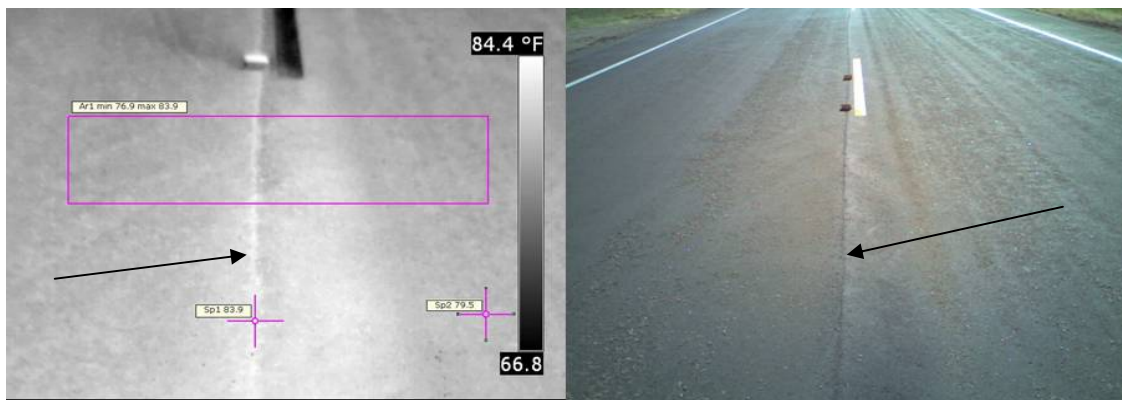
It may be possible to see voids from the pavement surface by seeing temperature differentials, but during this project no voids were discovered and it is unknown if voids did exist where images were taken. Due to the hand-held nature of the camera only small areas are surveyed which leads to the possibility that voids may exist, but missed due to not finding them without some indication on the surface of the pavement.

Figure 8: Asphalt centerline joint on SD1804 north of Pierre, SD.

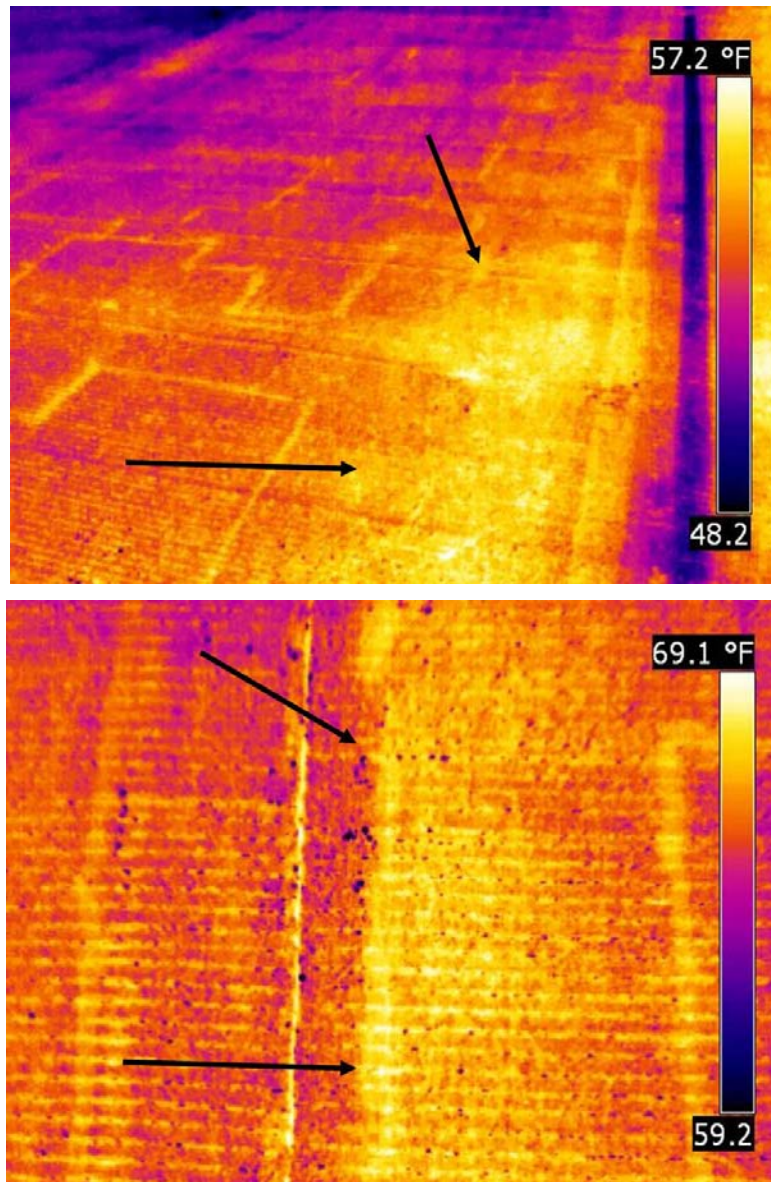
The bridge selected for investigation was chosen due to a previous inspection by traditional methods (chain drag) conducted by SDDOT where known delaminations were marked on the deck with marking paint. The marked areas known to have delaminations showed temperature differentials with warmer temperatures around 1~2.5°F higher, as seen in Figure 9 (top); where bright yellow is warmer and dark purple is cooler. The top image is showing an overview of the northbound lane of the deck which clearly shows the painted lines from the traditional testing and a warm spot inside the painted lines. In the top picture of Figure 9 there is a temperature differential of about 1~1.5°F higher within the marked delaminations. The bottom photo is a close-up image of the bridge deck where it is easy to see the warmer (yellow) areas; the transverse tining is also visible in this image.

Figure 9: Thermal images of bridge deck delamination on SD1804 west of Gettysburg, SD. Overview of northbound lane (top) & close up at centerline between slabs (bottom).

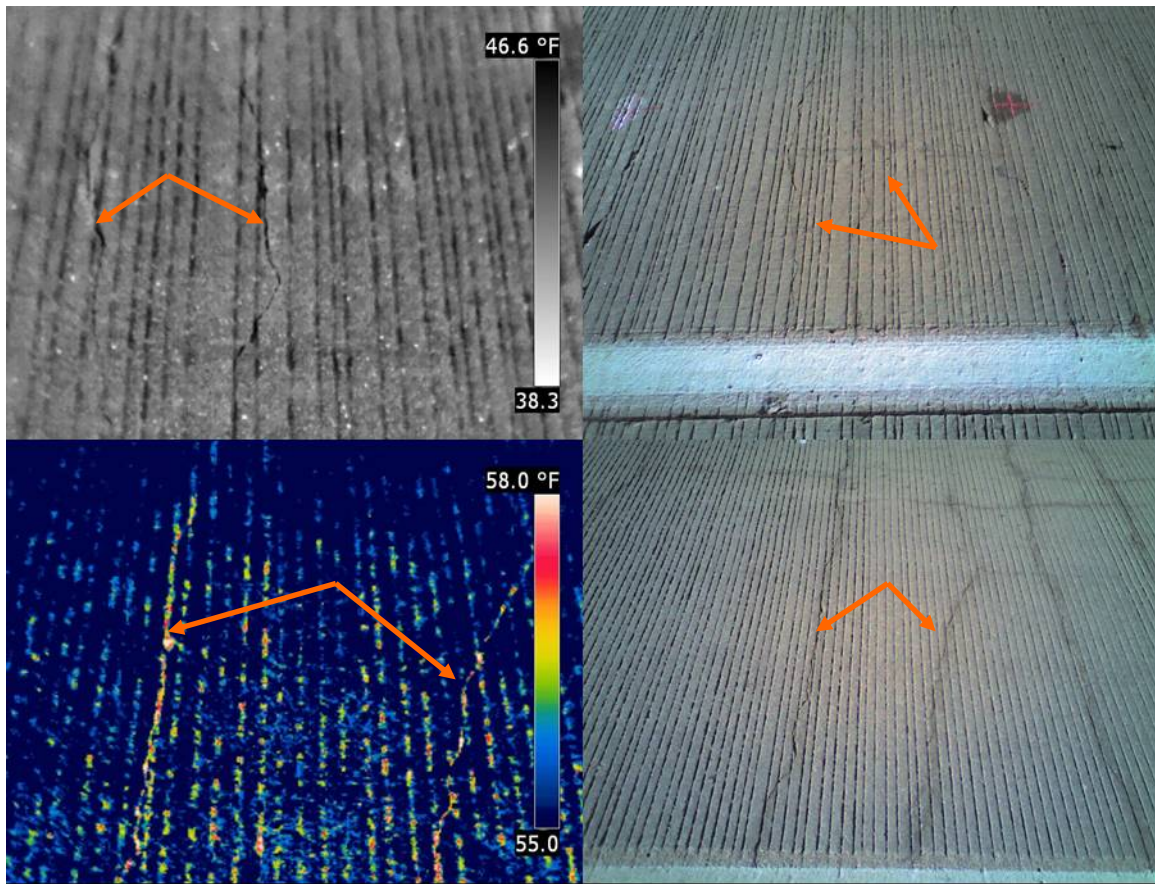
Figure 12: Concrete crack detection photos taken on I-90 east of Sioux Falls, SD.

investigation to determine the location of known voids or very small cracks and correlating the images with traditional investigation would need to be completed to draw a firm conclusion.

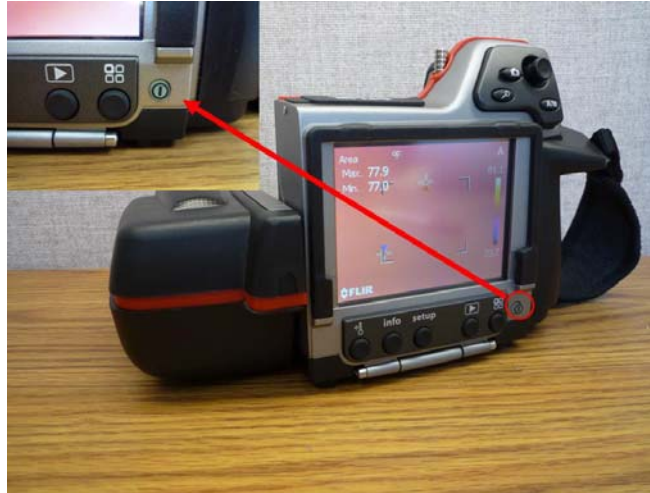
1. Locate the power button; the bottom right corner below the screen is a small button with an “I” on it, press until the camera powers on. Let off power button once camera begins to start. Camera will boot up for ~15 seconds before the camera is ready to take images. It is recommended to allow the camera to equilibrate for five minutes.

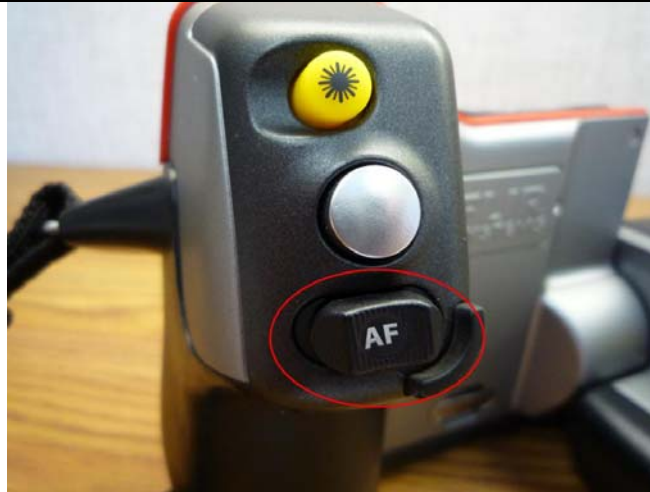
2. To take an image, aim the camera and push the auto-focus button once to allow the camera to focus (sliding button on front right of camera with “AF” on it). Also, adjust manually if needed with this same button by pushing right or left.

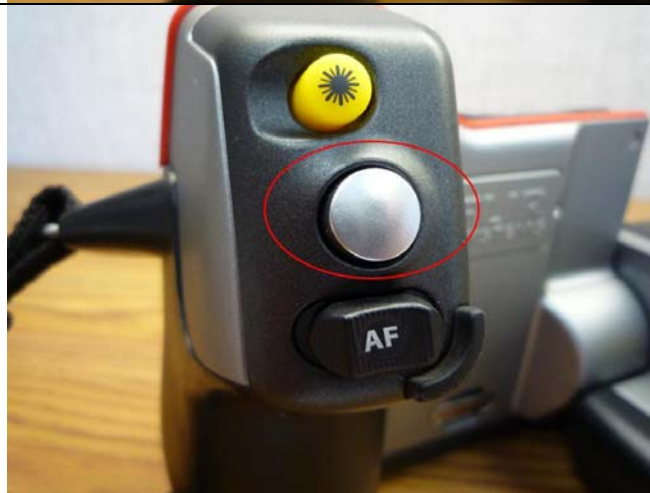
3. When the desired object appears focused, press the silver button on the right front to capture an image. By pressing the button quickly (1 sec.) it will capture and save an image or by holding the button down for longer (>1 sec.) it will ask you if you want to save or delete the image

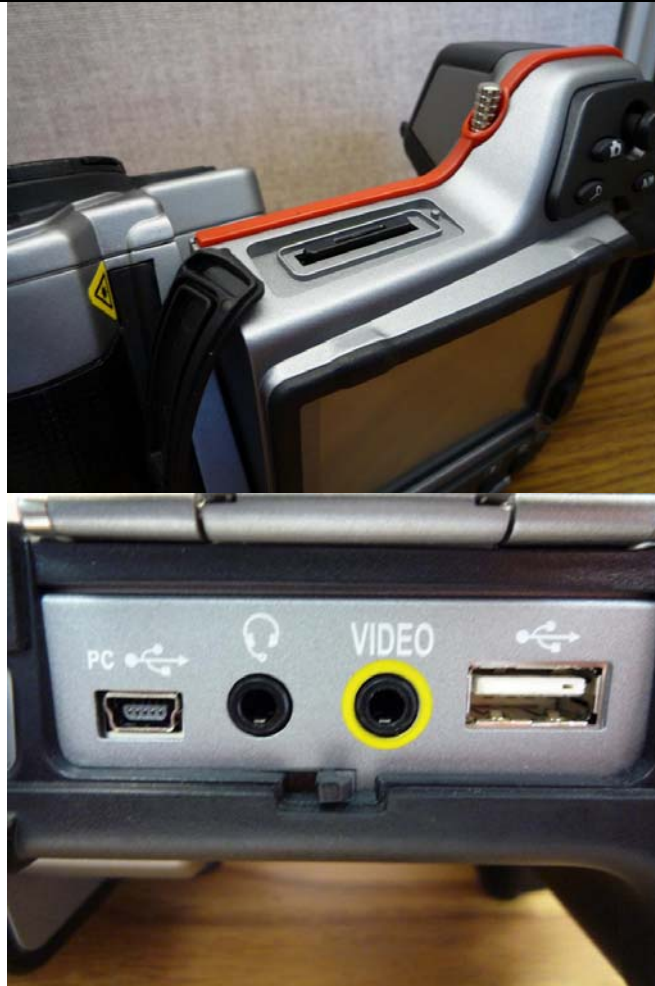
4. To download saved images, attach the accompanying USB cable to a computer and the micro USB port on the camera or use a USB flash drive to transfer. Another option is to remove the SD card from the top of the camera and connect to a computer with a SD card reader. Once connected to the computer, copy the images directly from the storage device or, if FLIR software is installed, use the software to download the images.

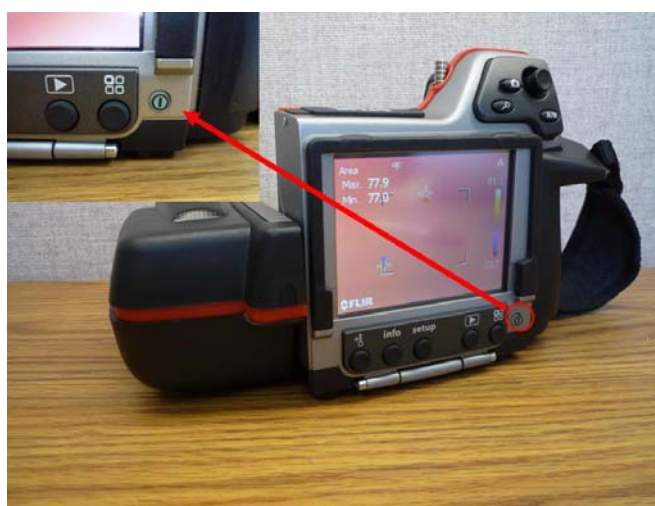
5. To turn off the camera, simply hold the power button down until the camera shuts off. If the power button is pressed quickly the camera will go into sleep mode and does not fully shut off and will drain the batteries. It should be noted that all data, once stored, will not be lost if the batteries are allowed to die.

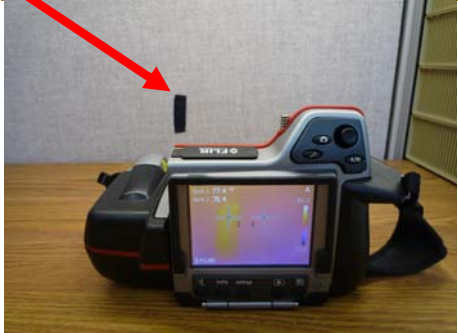
<p>2. Place a piece of black electrical tape on the object wanting to be imaged and allow it to equilibrate to the same temperature as the object.</p> <p><i>Note: Ideally the tape and object should be heated above ambient air temperature for the best results.</i></p>

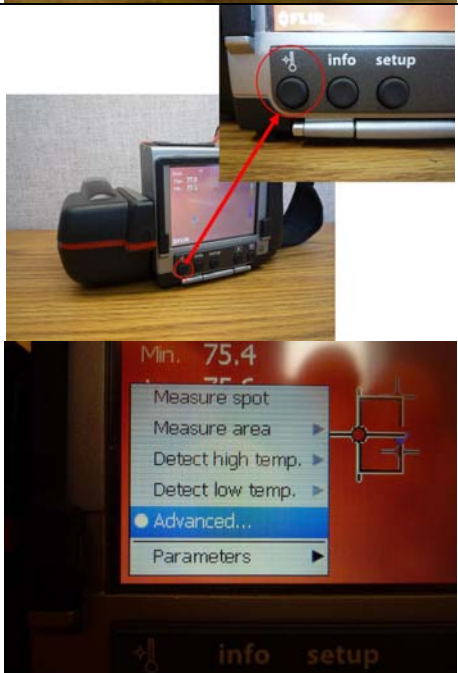
<p>3. Two “spot” measurements need to be added to the screen. First select the “measure” button and select “advanced”.</p>

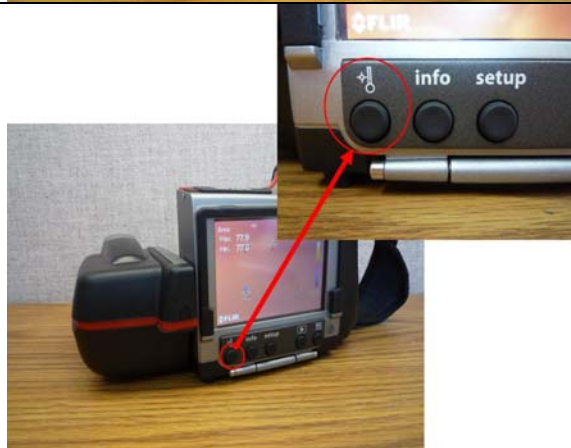
2. An “area” measurement needs to be set up. Click on the “measure” button.

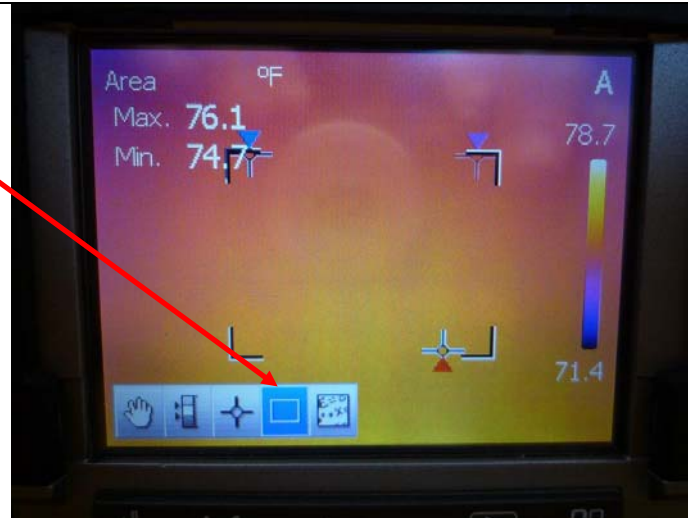
4. Once all measurements are removed, select the “add area” tool: the fourth icon from the left. This will add an area measurement to the screen.

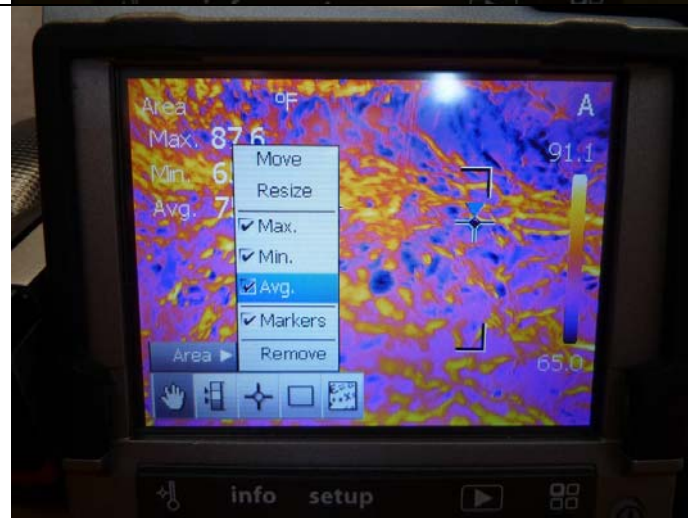
5. The area can be re-sized by selecting the first icon on the left again. The average temperature will need to be shown and can be selected in this same menu. Select the “measure” button to exit the menu once the area is resized and the average temperature is displayed.

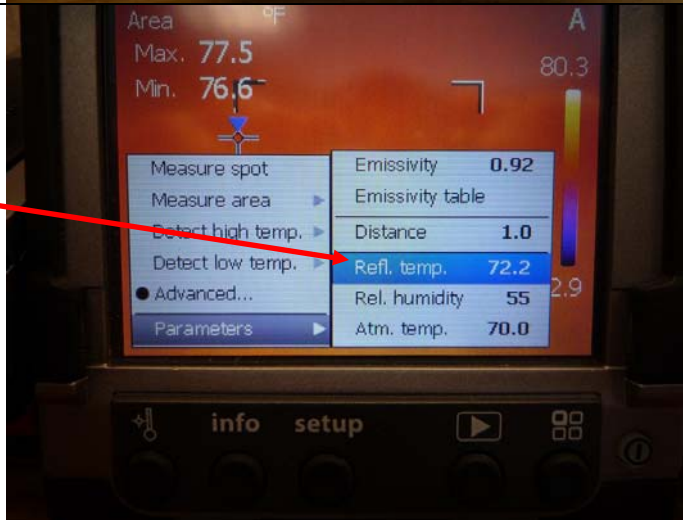
10. Now the RAT can be set within the camera. Select the “measure” button and then “parameters”. Navigate to “Refl. temp.” and select with the toggle.
