Gravel Surfacing Guidelines for South Dakota

Study SD2009-08

Final Report

November 2017

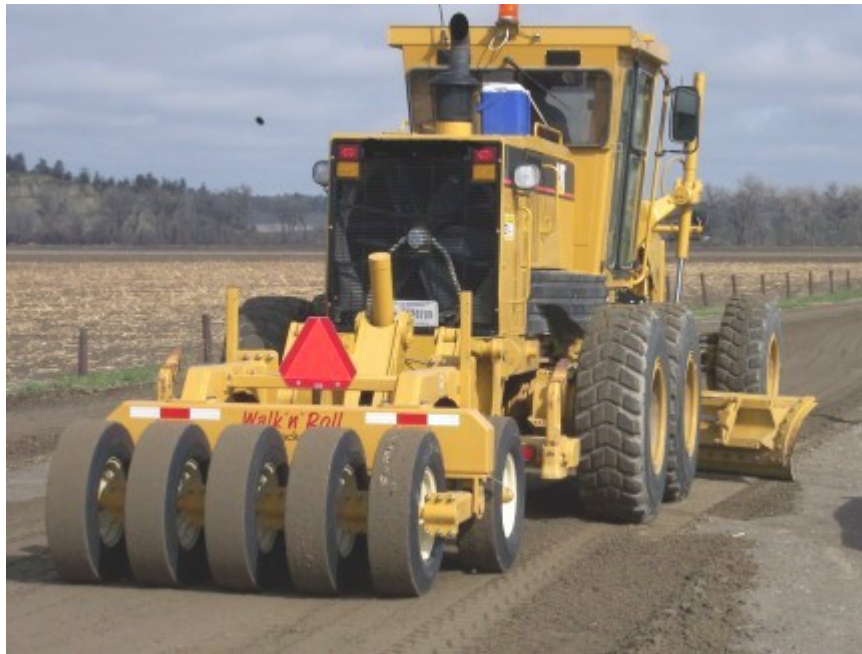
Figure 3: Walk and roller packer attached to a grader
(image from <http://www.walknrollpackers.com/>)

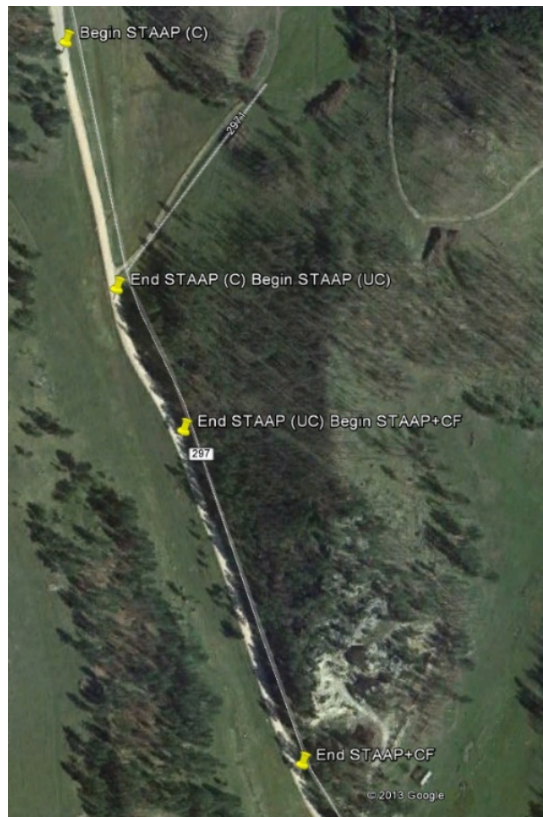
Figure 5: Layout of two STAAP and STAAP plus crusher fines sections (Google Earth images).

Figures 5 and 6 provide aerial views of the Custer County site. As can be seen, there is some slight horizontal curvature along each section of roadway, primarily in the STAAP-uncompacted and Bear Mountain-compacted test sections.

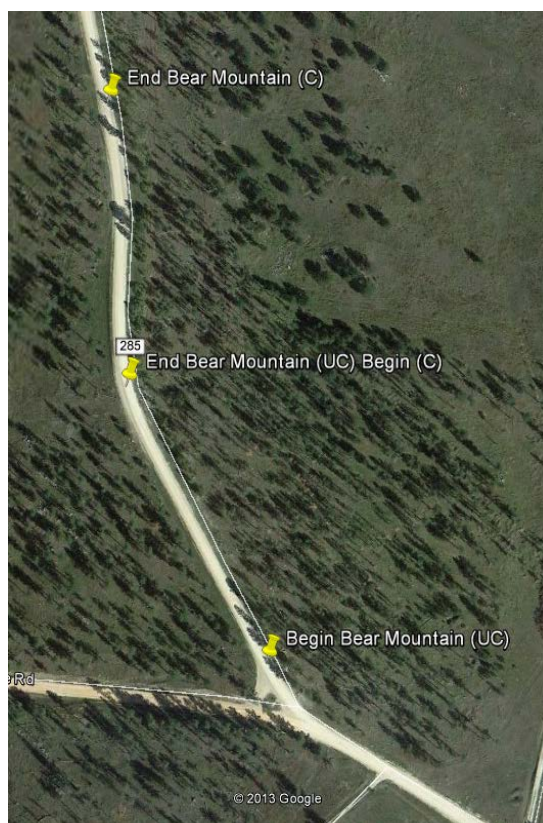
Figure 6: Layout of two Bear Mountain test sections (Google Earth images).

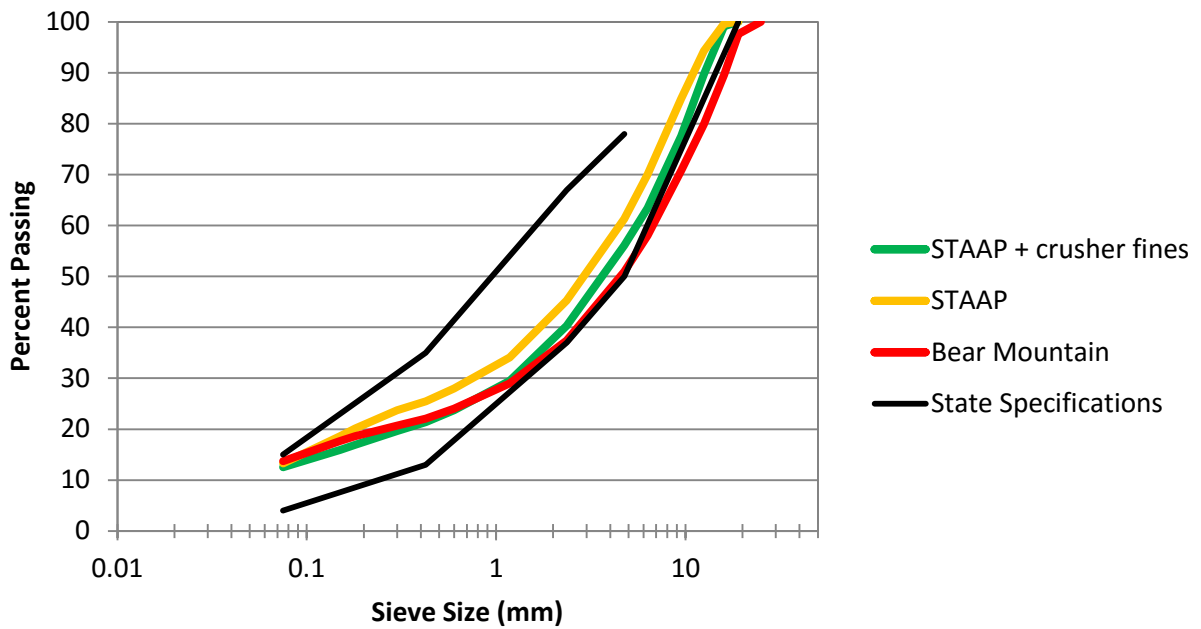
Figure 7: Custer County gravel gradation curves.

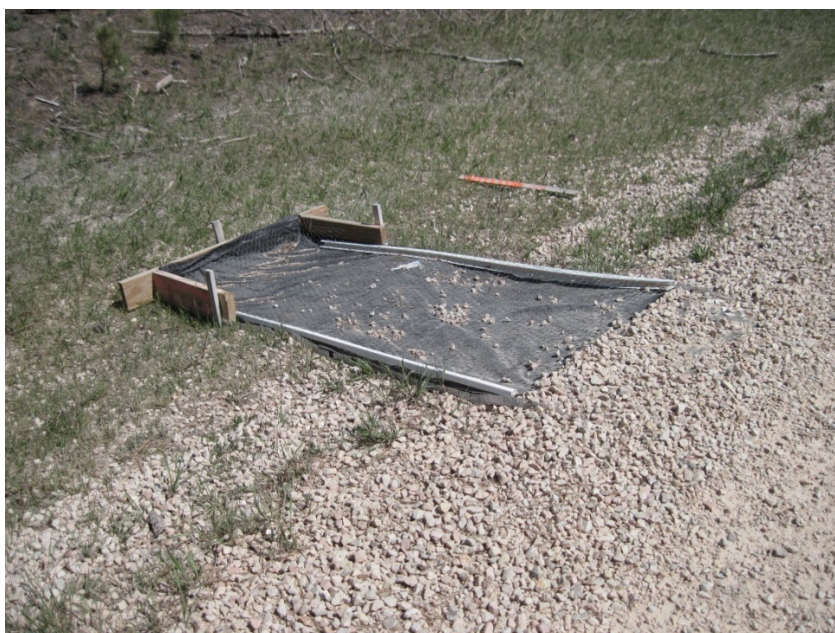
Figure 10: Cast-off collection box located in Custer County.

For calculations, it was assumed that the amount collected in each box was representative of the whole section. Also, the first foot of sample in the collection apron was discarded at each inspection, since this material would be reincorporated into a typical road during routine maintenance.

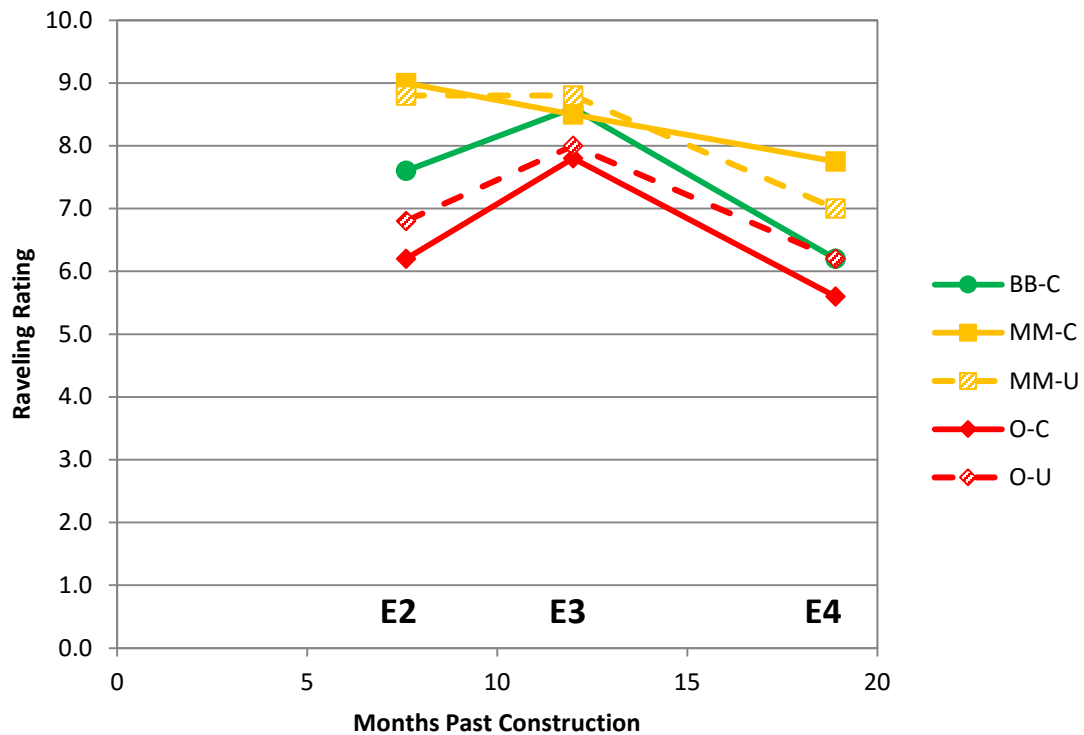
- Based on the range in ratings at E2 and assuming that the initial raveling ratings were near 10 after construction, then there must have been a drop in raveling ratings for all of the sections during the first eight months after construction. Some maintenance was performed at four and five months after construction; however, there is no data to determine its effect.
- Based on the ratings of the compacted and uncompact sections at E2, there is no indication that compaction had any effect on raveling.
- The curves indicate that the two Martinmas (standard) sections performed the best in terms of raveling, while the two Oakley (substandard) sections performed the worst. The performance of the Bone Bright (above-standard) section appears to be better than the Oakley sections, but worse than the Martinmas sections.

Figure 13: Raveling ratings over time for the Hand County test sections.

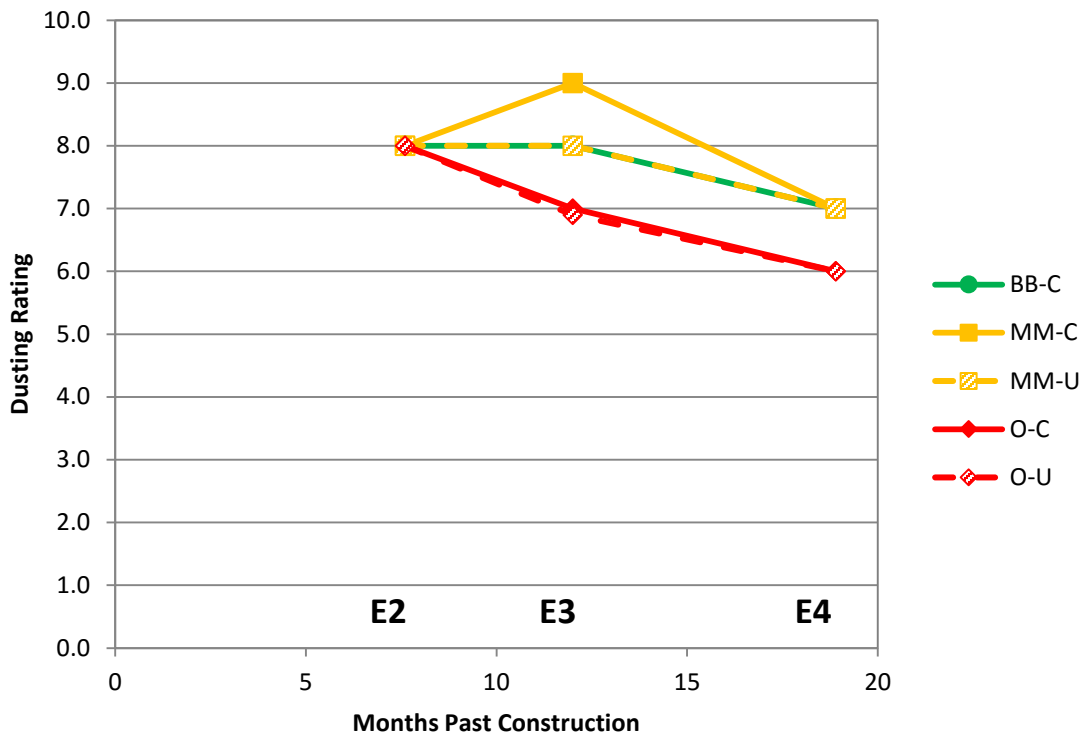
- The dusting rating curves indicate that the two Martinmas (standard) sections and the Bone Bright (above-standard) section performed about the same. In fact, the performance of the Martinmas-uncompacted section was identical to that of the Bone Bright-compacted section. The performance of the two Oakley (substandard) test sections was identical and both performed worse than the two Martinmas sections and the Bone Bright section.

Figure 15: Dusting ratings over time for the Hand County test sections.

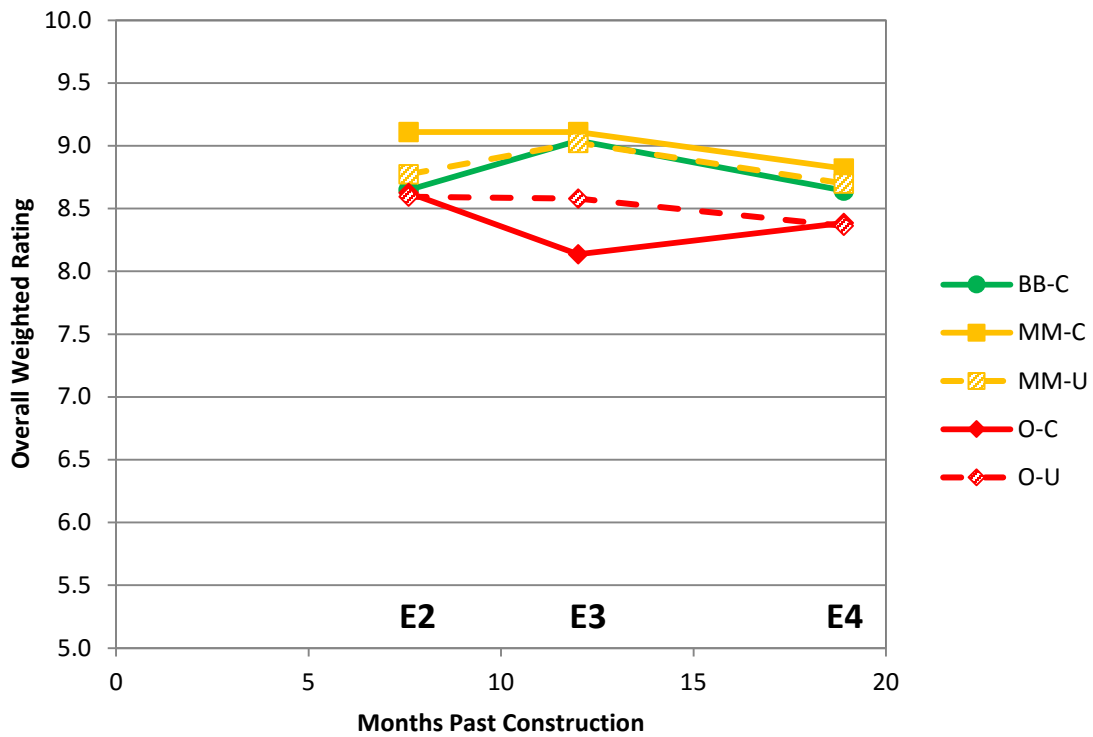
- The graph indicates that the Bone Bright (above-standard) and both Martinmas (standard) sections performed about the same overall. The graph also indicates that the two Oakley (substandard) sections performed about the same; however, their performance was worse than the Martinmas and Bone Bright sections, especially after the E2 survey period.

Figure 16: Overall weighted ratings over time for the Hand County test sections.

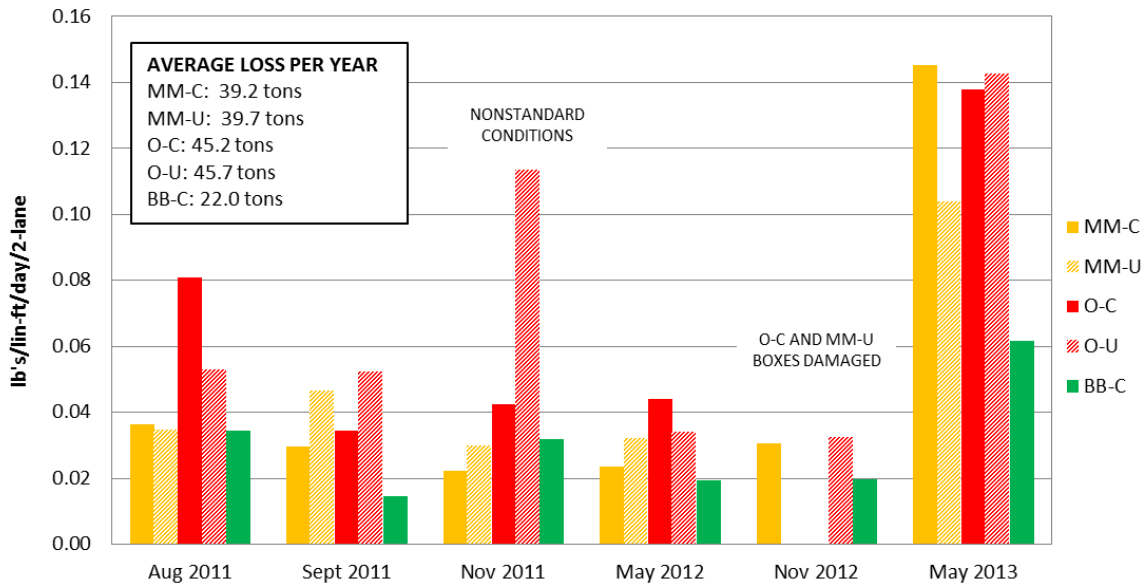
The summary results from the gravel loss measurement are presented in figure 17. The most significant observation from these results is that the Bone Bright-compacted (above-standard) test section experienced the lowest rate of gravel loss (22 tons per year), while the Martinmas-compacted (standard) and Martinmas-uncompacted sections experienced a higher gravel loss of about 39 tons per year. At about 45 tons per year, the Oakley-compacted (substandard) and Oakley-uncompacted test sections exhibited the highest gravel loss.

Figure 17: Gravel loss rates for Hand County test sections.

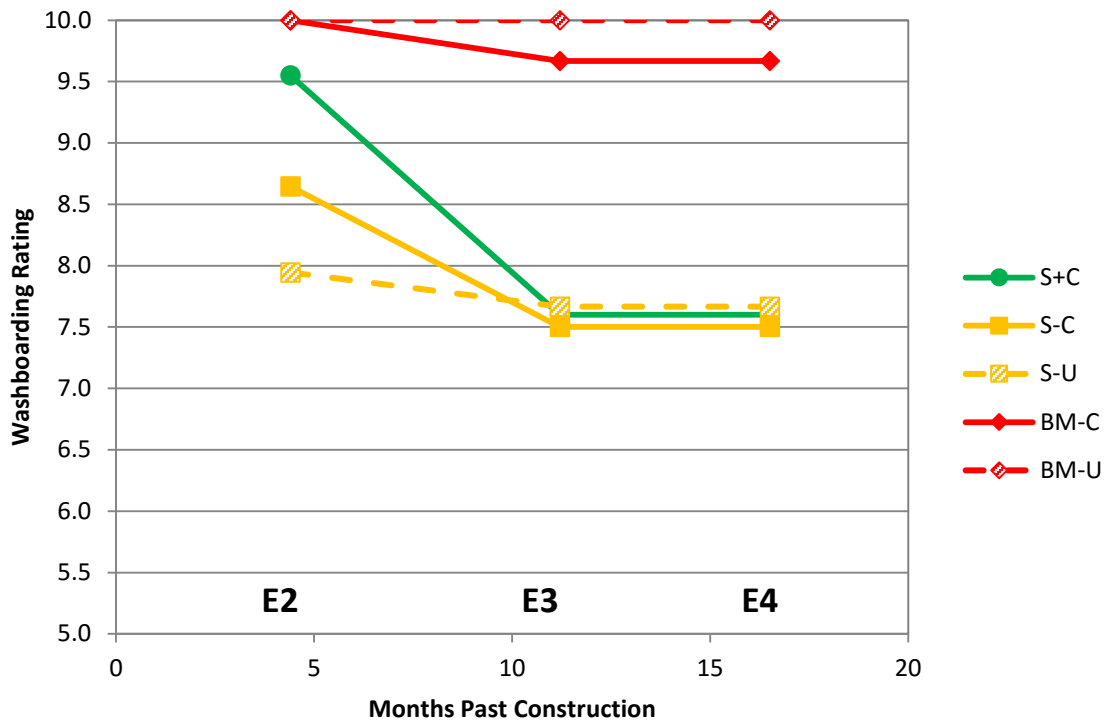
- The difference in washboard ratings between the STAAP (standard)-compact and STAAP-uncompact sections at E2 suggest that compaction did have an effect on performance during the first four months after construction.

Figure 18: Washboard ratings over time for the Custer County test sections.

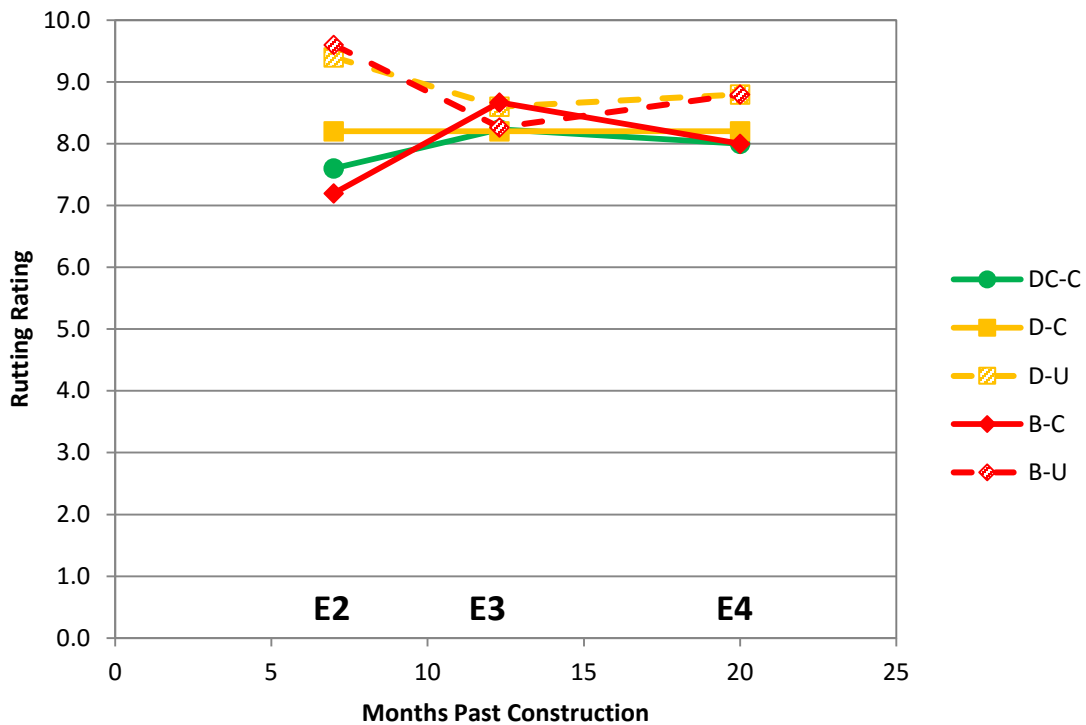
- Based upon the rutting ratings at E2, the uncompacted test sections performed better than the compacted sections. After E2, there is no apparent difference in performance.

Figure 26: Rutting ratings over time for the Brookings County test sections.

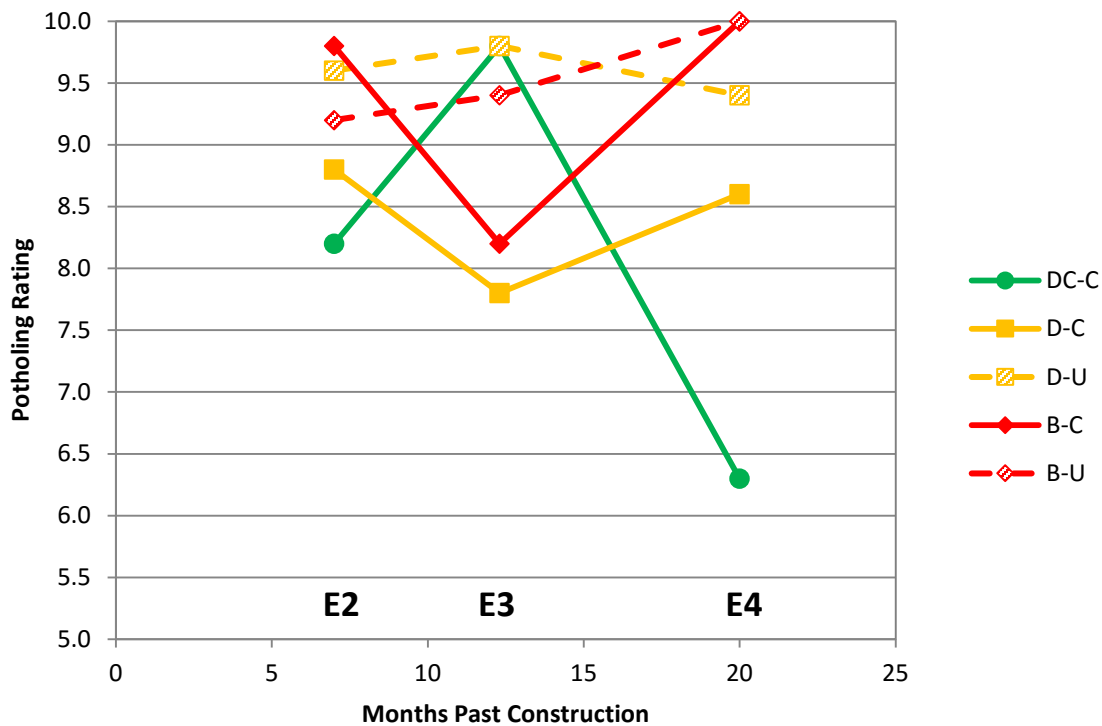
- The Bowes (substandard)-compacted section generally performed reasonably well in terms of potholing; however, its performance was likely affected by all the maintenance it received to address washboarding.
- The Dupraz (standard)-uncompacted and Bowes (substandard)-uncompacted test sections performed the best in terms of pothole ratings. However, it is important to note that all the maintenance that Bowes-uncompacted section received to address washboarding (as compared to the Dupraz-uncompacted section) likely improved its pothole performance.
- In this instance, the data show that the uncompacted test sections performed much better than the compacted test sections.

Figure 28: Potholing ratings over time for the Brookings County test sections.

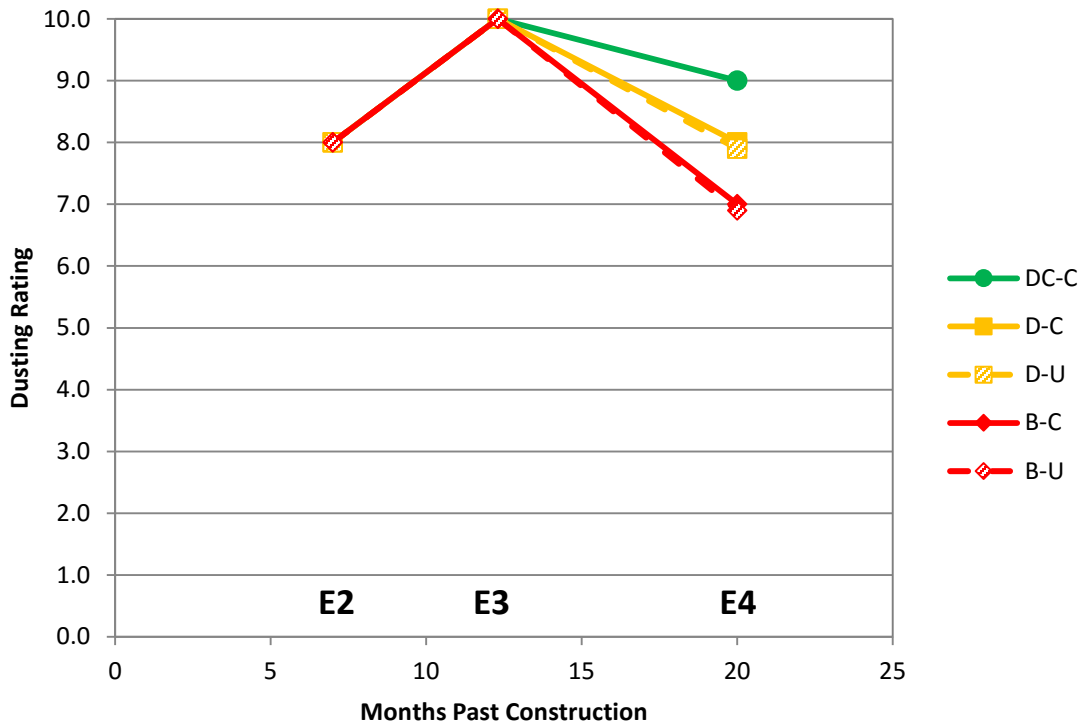
- Since the dusting rating at the time of construction was not determined, there is no basis to indicate how much the gravel deteriorated between the time of construction and E2. The Bowes-compacted section received considerably more maintenance than the other two sections over the course of the project; however, it is not possible to determine how much this maintenance might have affected the dusting ratings.
- Because there was no difference in the performance between the compacted and uncompacted test sections in terms of dusting rating, there is no evidence to indicate whether compaction during construction had an effect on the dusting rating.

Figure 29: Dusting ratings over time for the Brookings County test sections.

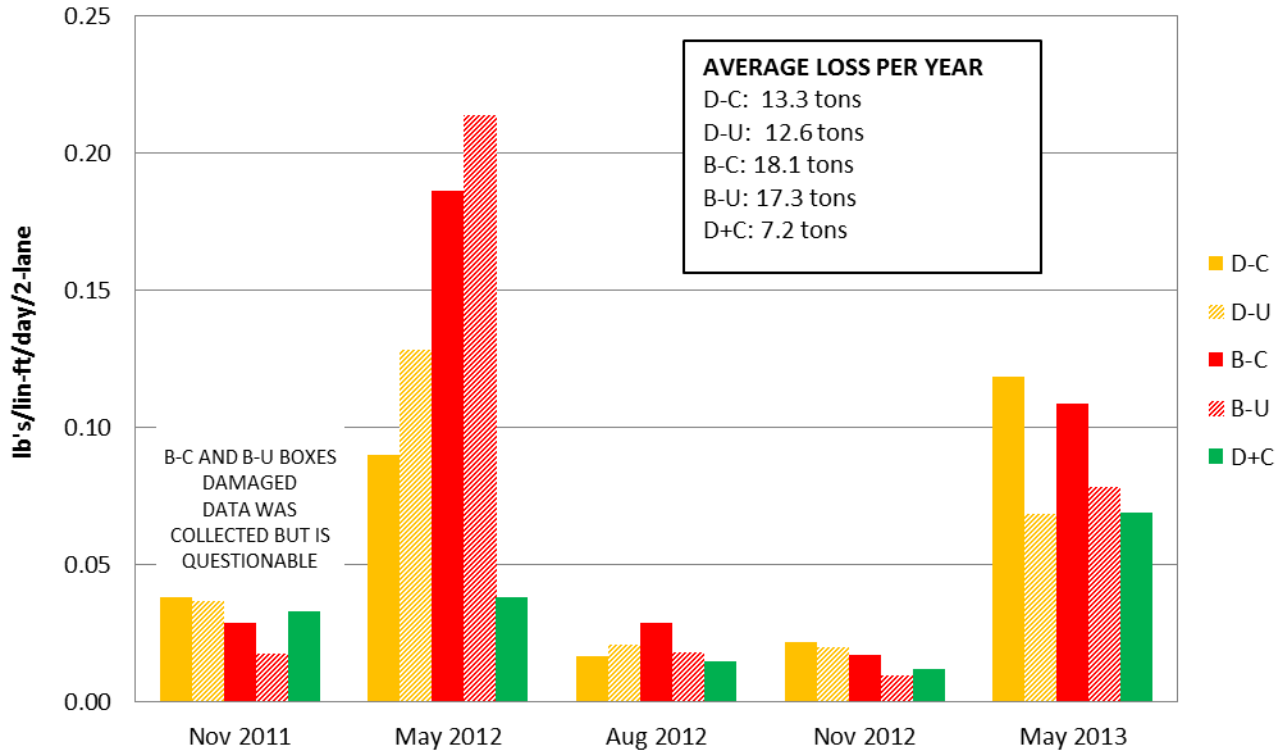
The summary results from the gravel loss measurements are presented in figure 31. The primary finding from these results is that the Dupraz plus clay-compacted test sections experienced the least rate of gravel loss at 7.2 tons per year. The Dupraz-uncompacted and Dupraz-compacted sections experienced a higher gravel loss of 12.6 and 13.3 tons per year, respectively. Lastly, the Bowes-uncompacted and Bowes-compacted test sections exhibited the highest gravel loss at respective rates of 17.3 and 18.1 tons per year.

Figure 31: Gravel loss rates for each test section in Brookings County over the testing period.
