## Assessment of Highway Deicing Impacts to Roadside Pines in the Black Hills

Study SD2006-01-F  
Final Report

Plant Science Department  
South Dakota State University  
Brookings, SD, 57007

March 2018

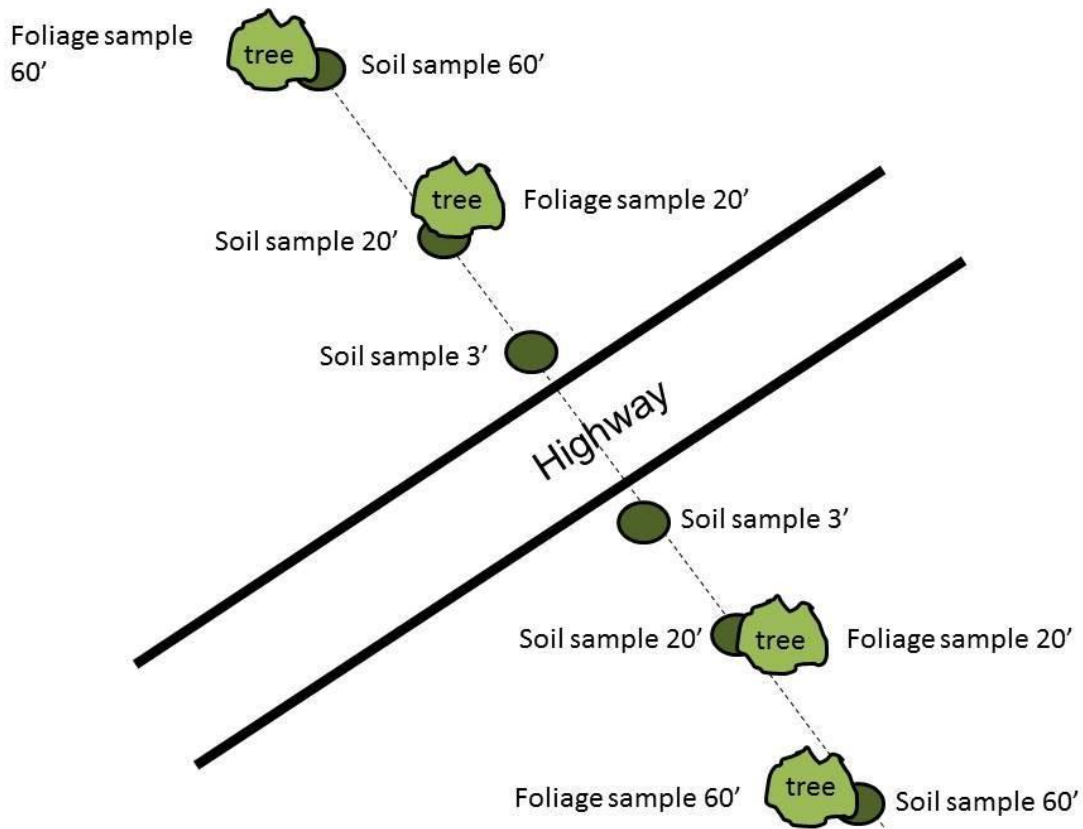
Figure 4-2. Plan for collection of foliage and soil samples at each location at a site.

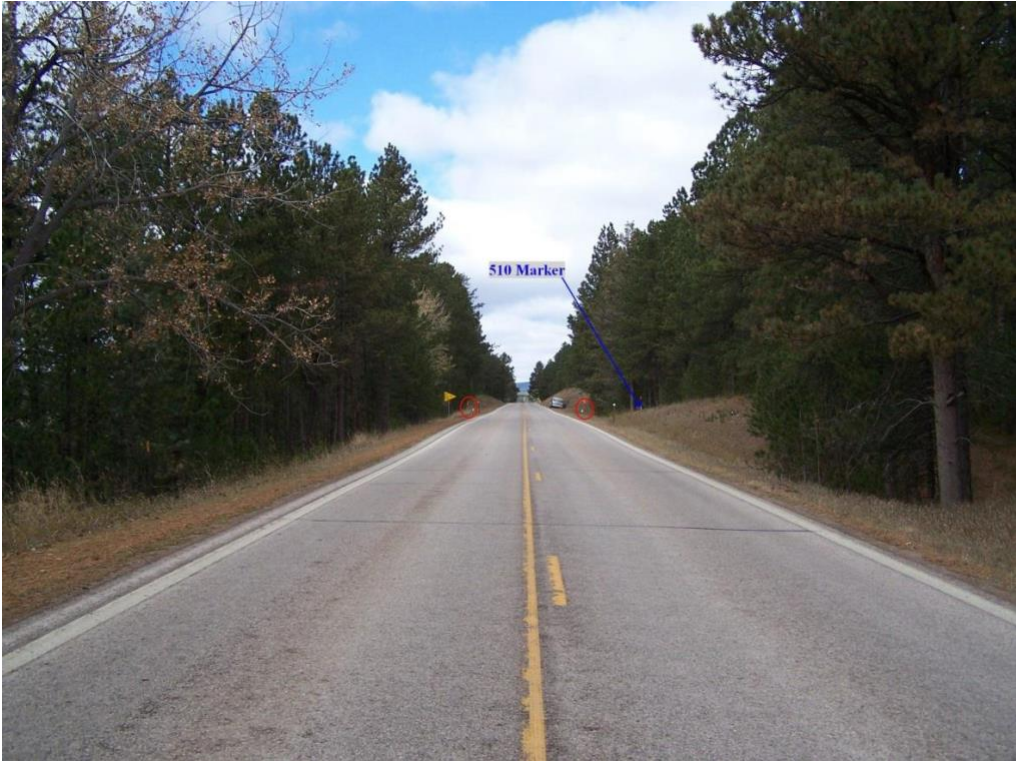
Figure 5-4. Symptomatic location, Box Elder site.

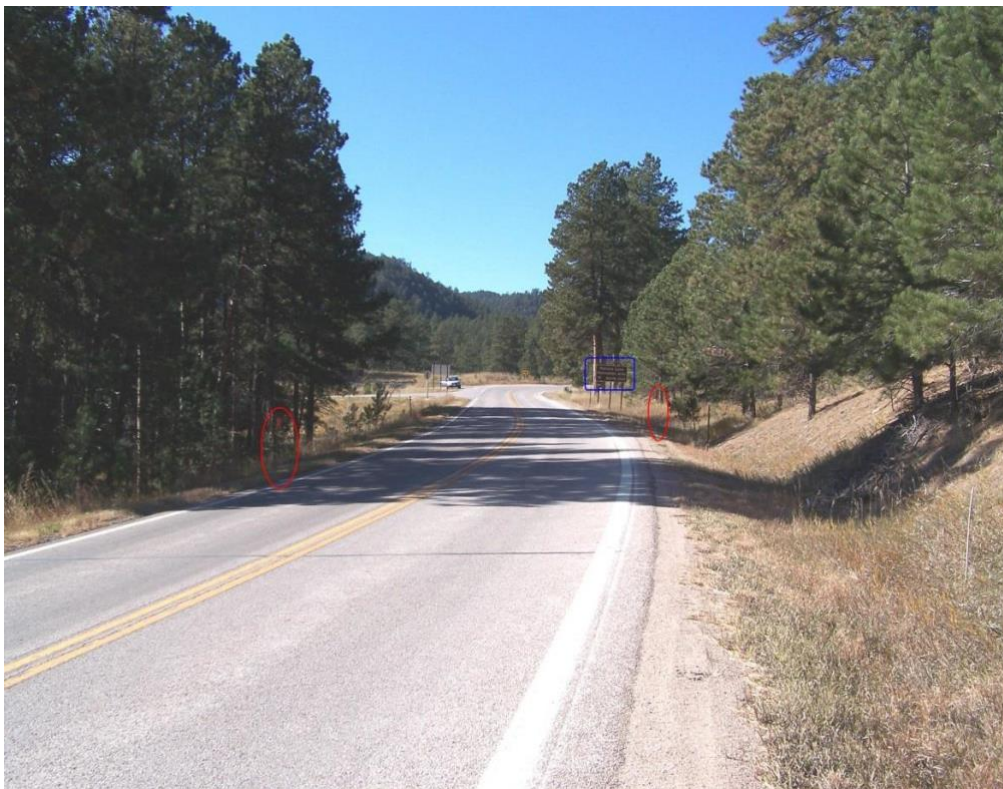
**Figure 5-7. Symptomatic location, Pactola site.**

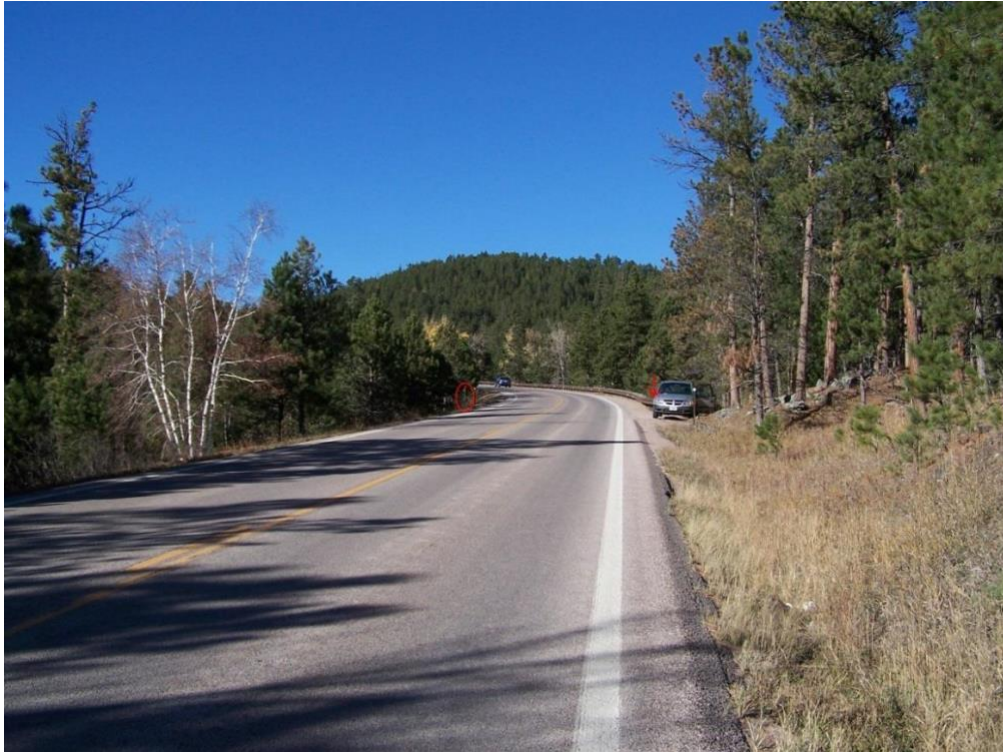
Figure 5-10. Symptomatic location, Sheridan site.

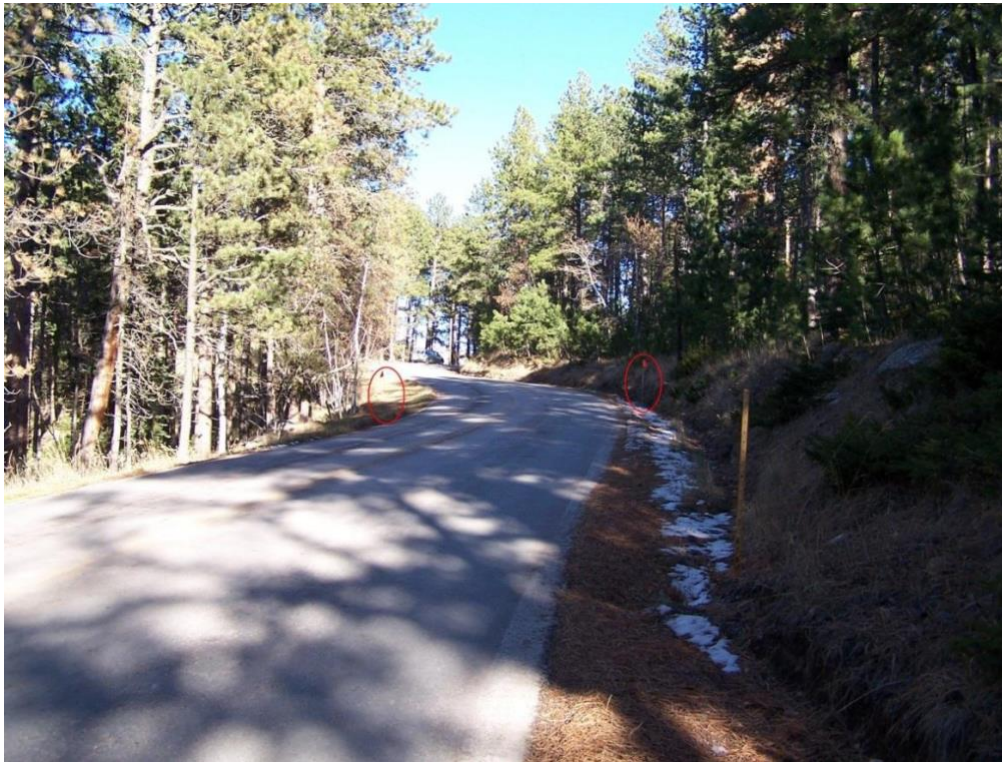
Figure 5-13. Symptomatic location, Sylvan site.

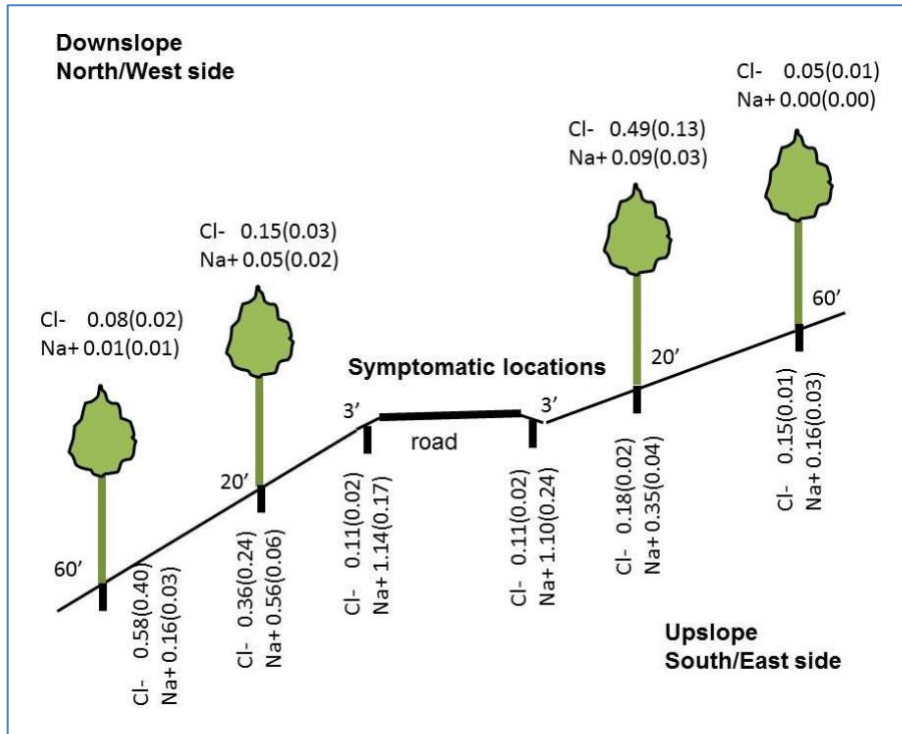
Chloride, the deicing salt ion most associated with plant injury, also showed a change with distance. However, the amounts increased with distance only on the downslope side of the road (Figure 5-6 and 5-7). This is due to the mobility of the anion and in these channery soils the ion moves quickly with water flow. The trend in chloride was the opposite for canopies where the trees on the upslope had the highest concentration of chloride. The most likely source for the increased concentration of chloride in the foliage of pines at 20 feet from the pavement edge is chloride carried by aerial spray to the canopy rather than carried into the soil but run off and then absorbed into the tree. Low precipitation results in more chloride drying on the pavement as dust and later being carried into the canopies and deposited on the foliage where it remains to be absorbed rather than washed off during a storm.

The amount of deicing salts in soils generally decreases with distance from the road and soil depth. The rate of decrease is dependent upon the permeability of the soil and the chemical components of the deicing salt. Channery soils generally have moderate permeability with water moving at a rate of 0.6 to 2.0 inches per hour so highly mobile ions such as chloride are leached from the upper soil horizons (Adam, 2011). Chloride is considered to have the highest mobility followed by sodium with both of these ions being much more mobile than magnesium (Hudson, 1995).

Figure 5-14. Mean (SE) foliage concentration and soil amounts (6-12 inch depth) for locations with ponderosa pines presenting symptoms of deicing salt injury.

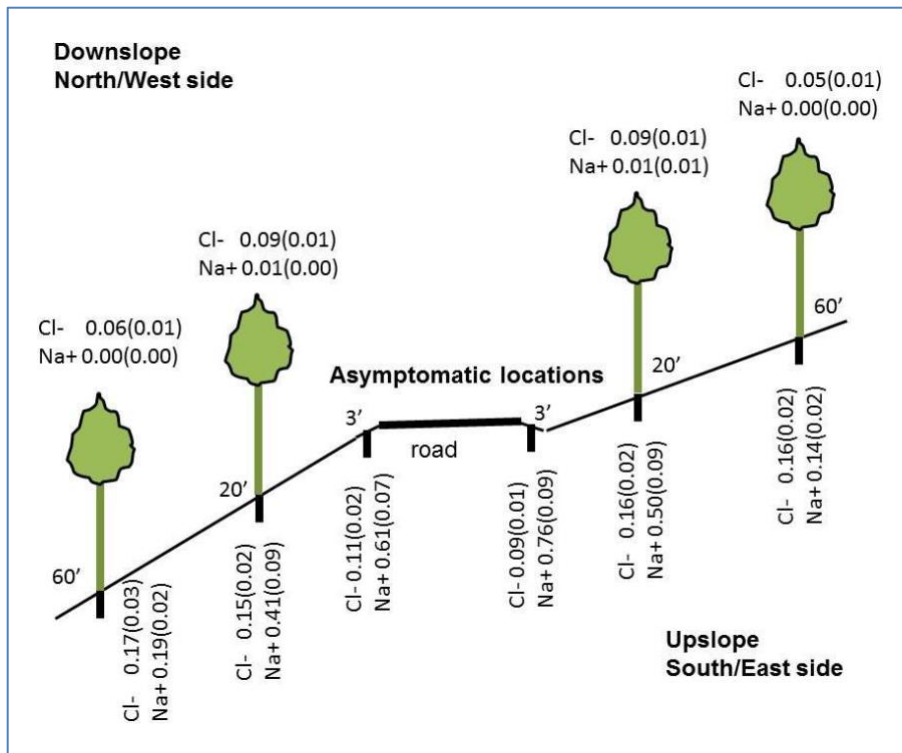
Figure 5-15. Mean (SE) foliage concentration and soil amounts (6-12 inch depth) for locations with ponderosa pines not presenting symptoms of deicing salt injury.

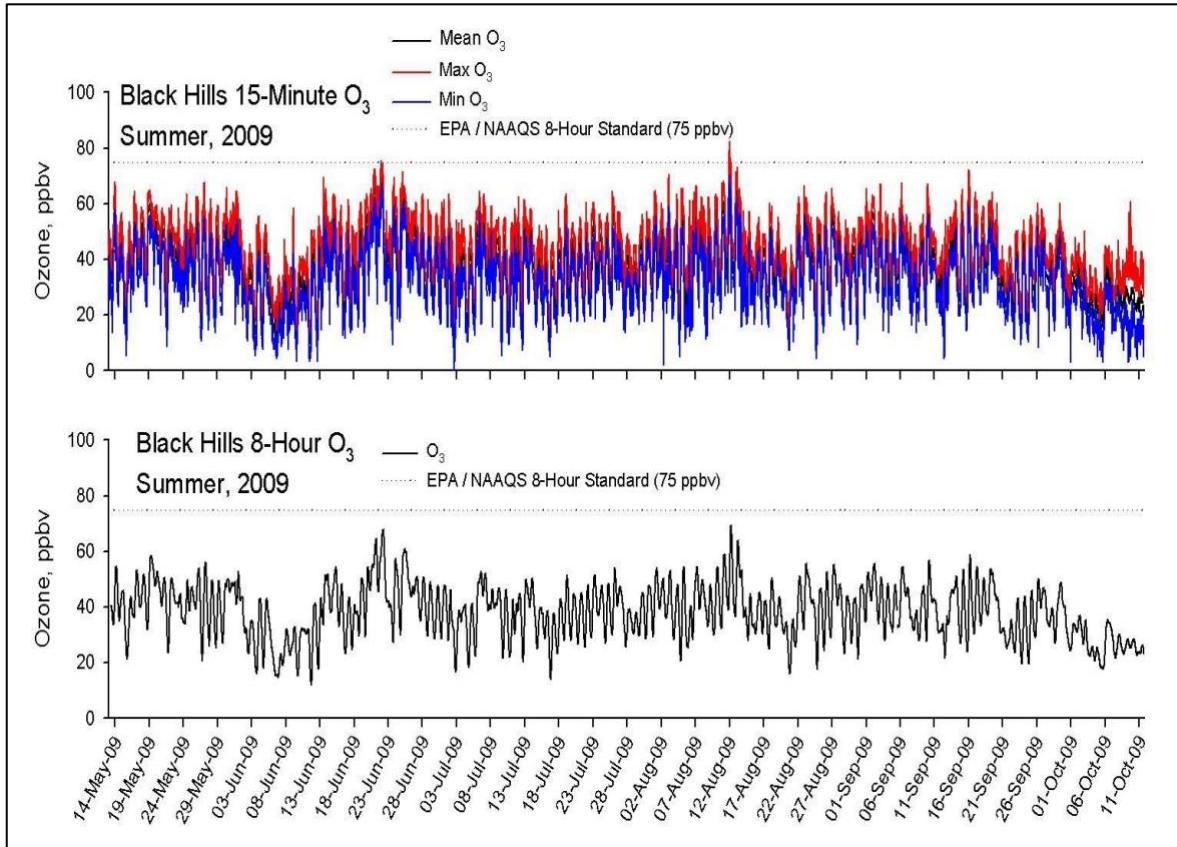
Ozone appeared to be higher during the first exposure period in mid-May 2009 than during any other time during that growing season. The passive data did not indicate any higher values during the Sturgis Motorcycle Rally. Passive samplers record continuous loading and cumulative exposure and thus were unable to determine whether high NO<sub>3</sub> values found from the passive filter analyses are from a large number of low O<sub>3</sub> events or a few high-value O<sub>3</sub> episodic events during this exposure period. Data from the continuous monitor indicates that the U.S. National Ambient Air Quality Standard (NAAQS) for O<sub>3</sub> prior to 2008 (Primary Standard of 84 ppb per 8-hour average) and 2008-2009 NAAQS (Primary Standard of 75 ppb per 8-hour average) (US EPA, 2008) were likely not exceeded at the Pactola Reservoir monitoring site (Figure 5-17).

**Figure 5-17. Continuous data from the Pactola ozone active monitoring site in 2009.**
