South Dakota
Department of Transportation
Office of Research

Impact, Cause, and Remedies for Excessive Cracking in CRC Pavement

Study SD2004-07
Final Report

May 2009

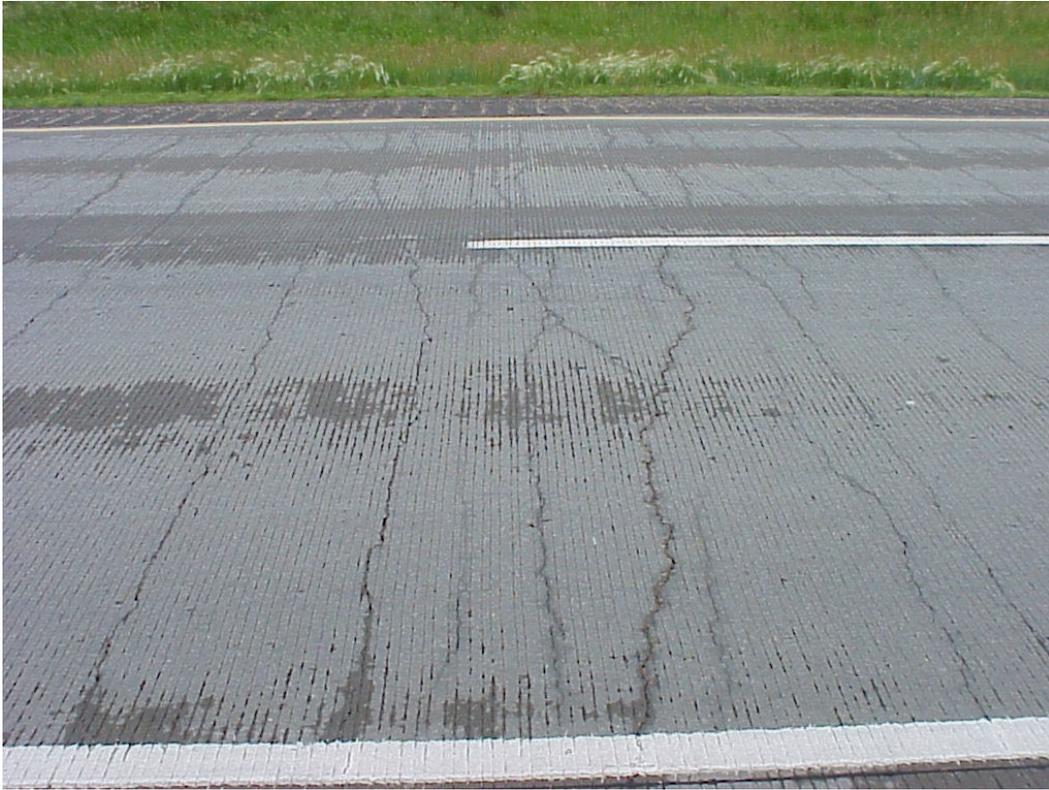
Figure 1: Network and Y-Cracks on CRCP

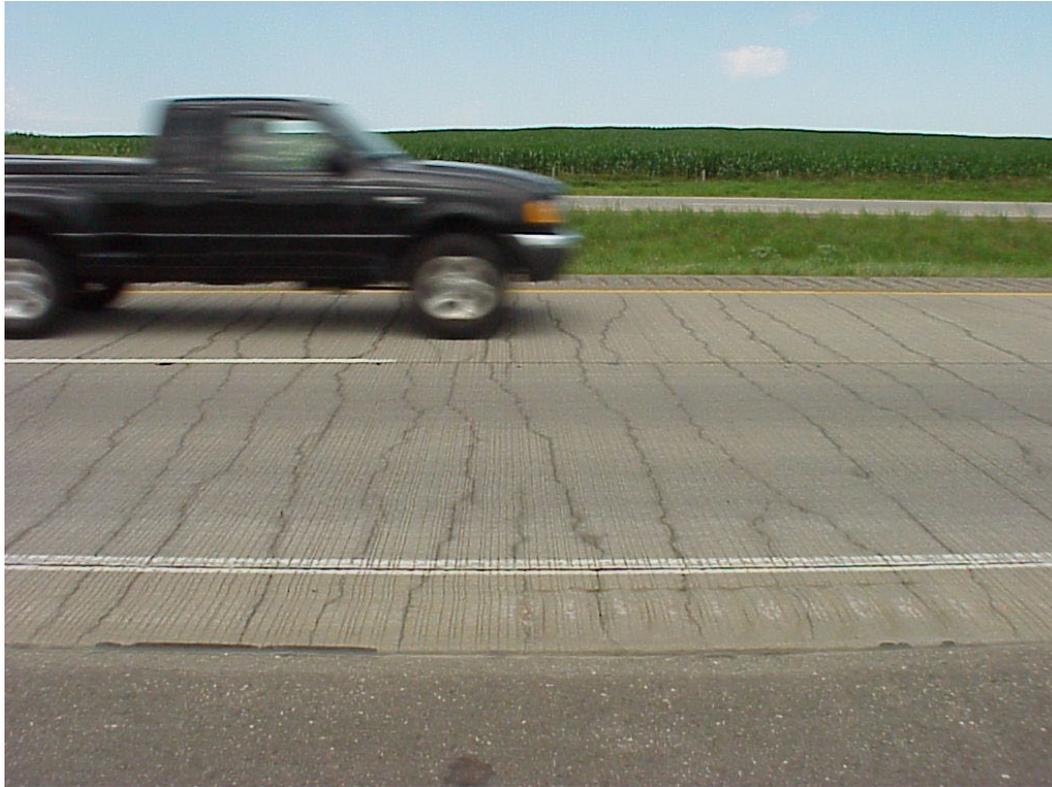
Figure 2: Typical Cluster Cracking on CRCP

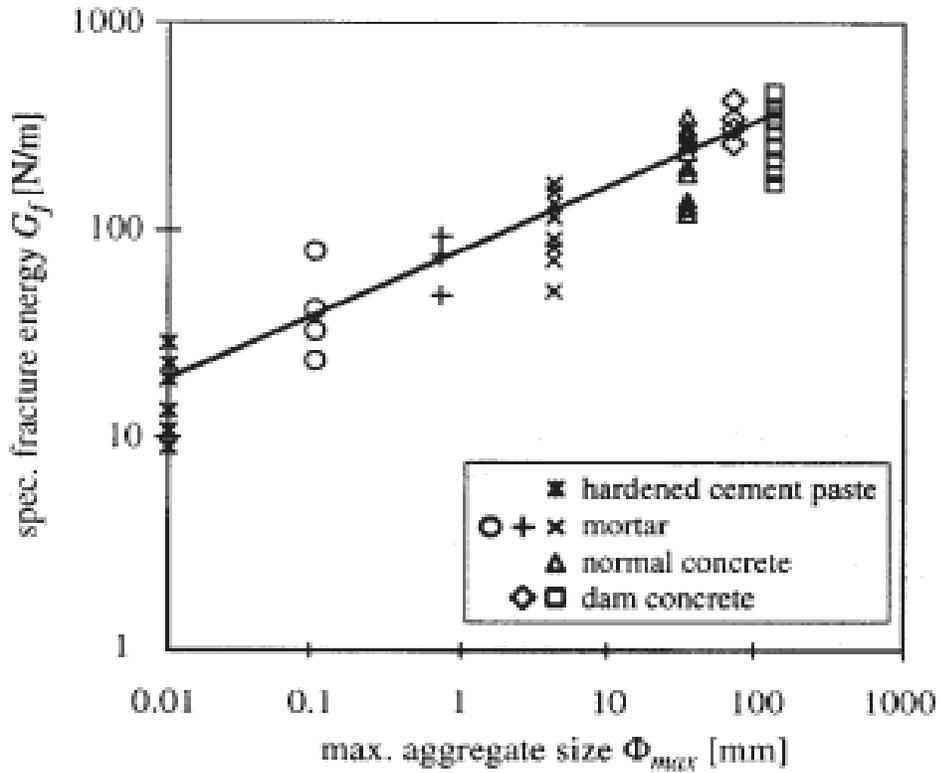
Figure 4: Specific Fracture Energy of Cement-Based Materials versus Maximum Aggregate Size

One of the primary differences noted between the concrete used in the older CRCP pavements constructed in South Dakota and the newer ones built since 1995 was the reduction in aggregate top size from 1½” nominal maximum size to 1”. Larger aggregate size results in an exponential increase in the energy required to cause fracture and, as such, can have a marked effect on cracking, especially early-aged cracking, in CRCP (11). Figure 4 illustrates the relationship for specific fracture energy versus aggregate size and shows a 20% increase in fracture energy in going from 1” to 1½”.

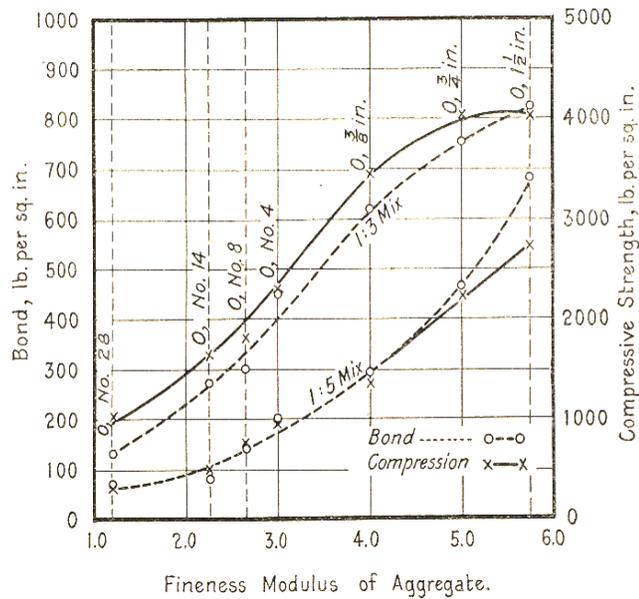
Figure 5: Effect of coarse aggregate size on bond and compressive strength

Another primary affect of aggregate size on reinforced concrete systems was demonstrated by Abrams in his seminal work on portland cement concrete (12). Figure 5 clearly demonstrates the effect that increasing coarse aggregate size has on bond strength development and compressive strength. Presumably, utilizing the largest top size coarse aggregate that still provides adequate workability, placement and consolidation would be of benefit in CRCP pavements

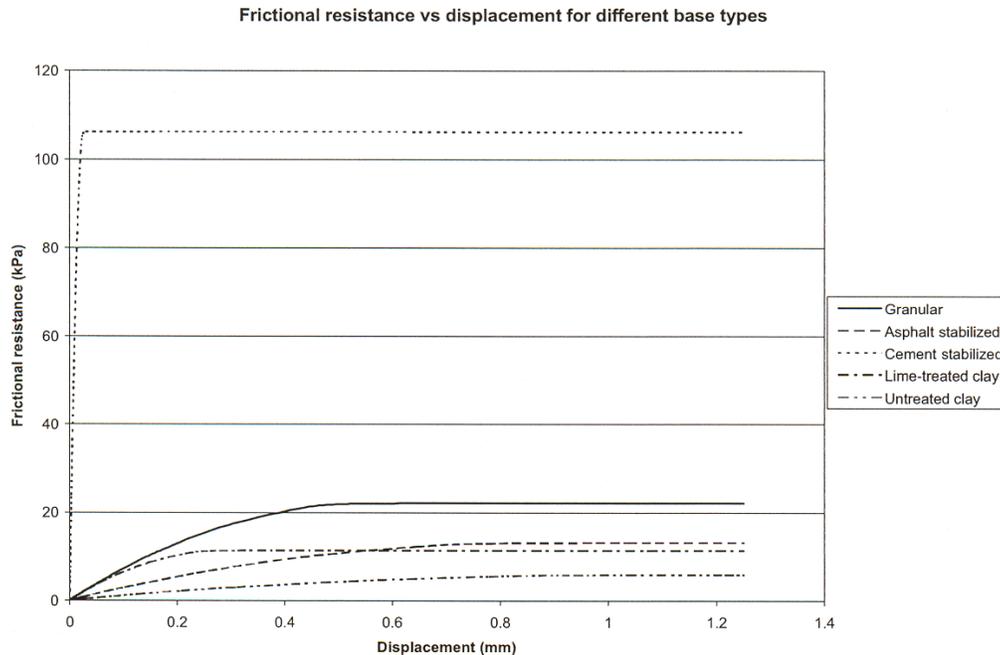
Figure 6: Typical Friction Resistance Relationships

cracking response from the individual LTPP sections could all be analyzed as a single dataset with no significant differences in cracking due to the base type for each section. Figure 6 (14) illustrates the significantly different frictional resistance response from various base types, especially cement stabilized ones where the adhesion between the base and portland cement concrete is so strong that large compressive forces build up, resulting in tensile stresses when the base acts to resist movement by the slab during expansion or contraction. The other base types yield at much lower levels of stress.

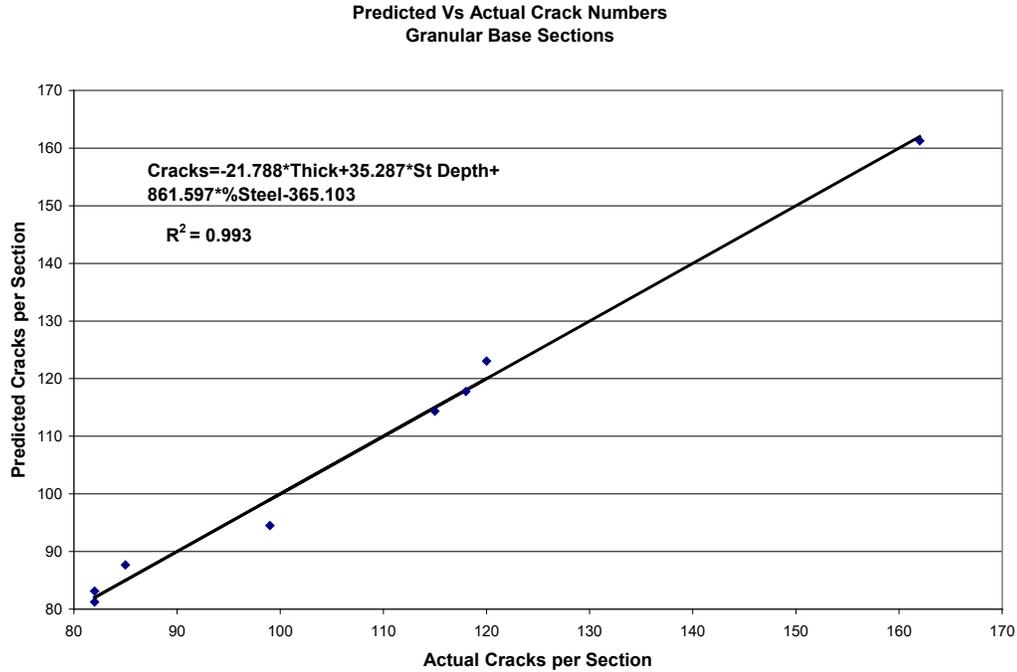
Figure 7: Granular Sections Model

implying that the majority of the cracking in CRCP with unbonded granular bases occurs at early ages. All coefficients and p values in parenthesis were forced into each model to see how close to significance they came but are not considered as part of the models.

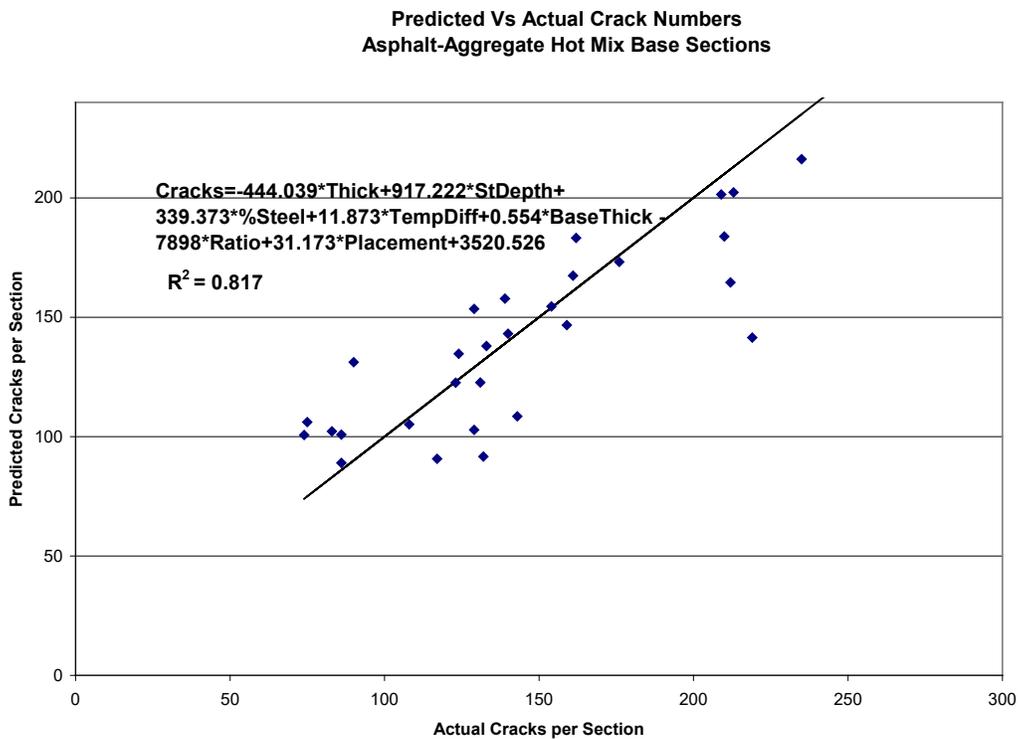
Figure 8: ACM Sections Model

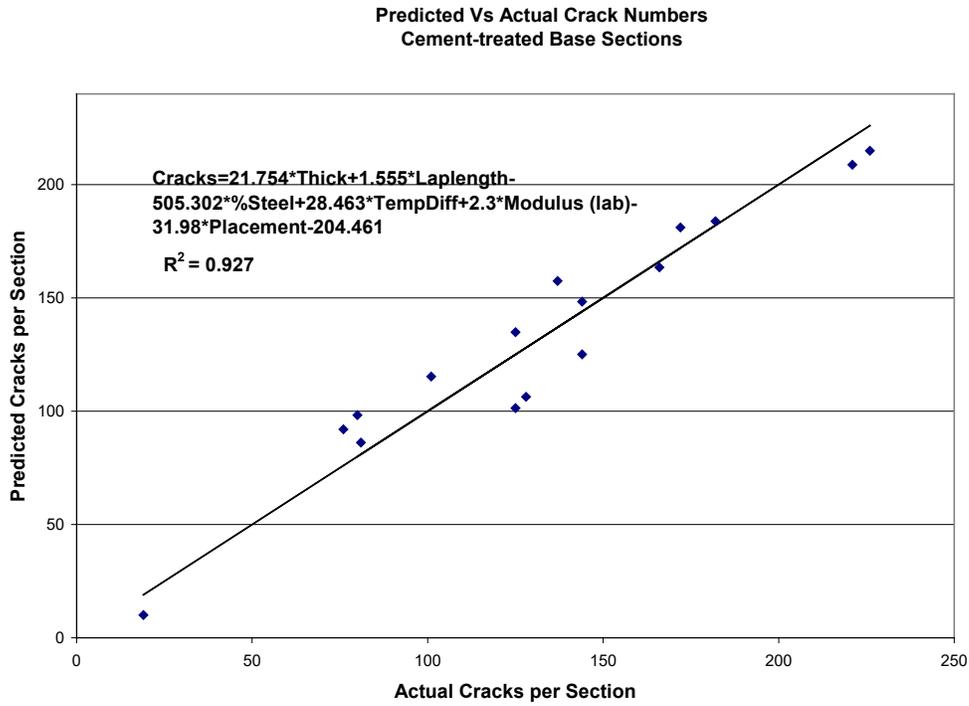
Figure 10: CAM Sections Model

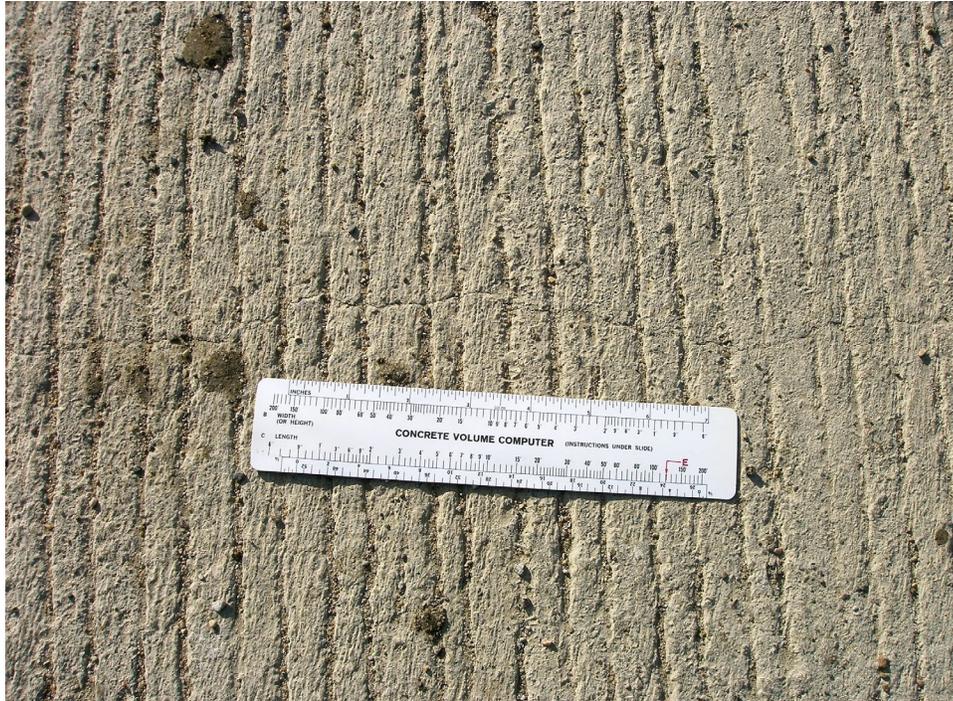
Figure 11: Early Cracking on I-29 Madison Street in Sioux Falls

Construction of CRCP projects in Rapid City and Sioux Falls was monitored and measurements of crack evolution and distribution were made on a routine basis. Strain gauges were also installed to monitor early age stress. Lapping locations were mapped out along 1000' feet sections in each project to determine, as crack development proceeded, whether the lapping detail being used was contributing to cracking, possibly due to stress concentration. No direct influence of lapping on crack development was apparent. Alarmingly, the I-90 eastbound CRCP project, near Deadwood Avenue in Rapid City, exhibited small areas of spalling within three weeks of construction. The Sioux Falls project (I-29 at Madison Street) was instrumented with steel and concrete strain gauges as well as temperature probes to look directly at strain development with time during early ages. Unfortunately, a software glitch prevented the collection of any data during the critical early stages of strain development. The Sioux Falls project was also constructed using a concrete mixture with a larger maximum aggregate size (1½") than other projects built since 1995 but similar to the aggregate top size used in the older CRC. This mix was also formulated with an optimized gradation that minimizes cement content while providing uniform, workable concrete. Larger aggregate results in greater fracture resistance, bond strength and aggregate interlock in the concrete and the I-29 project provided invaluable information on how much of a contribution to poor performance the reduced maximum aggregate size has made. This project did not exhibit visible cracking one week after construction and 3 weeks after paving had cracks averaging 20' apart which were extremely tight as illustrated in Figure 11 indicating that the change in aggregate size does appear to have had a beneficial effect. Crack development over the winter months did not alter this improvement in cracking pattern.

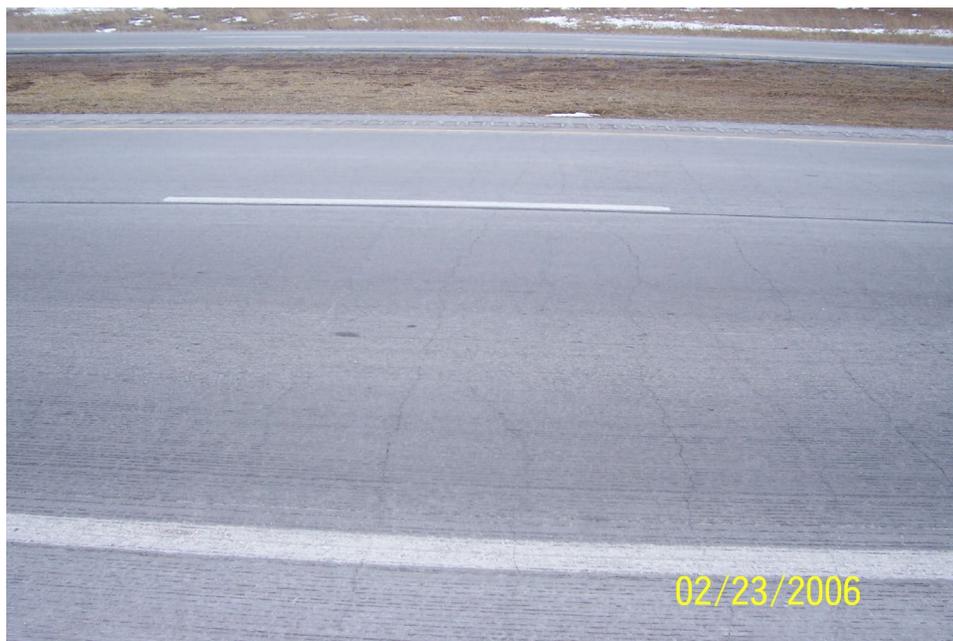
Figure 12: Early Cracking on I-90 Deadwood Avenue in Rapid City

The westbound I-90 project near Deadwood Avenue in Rapid City was constructed beginning in the spring of 2005. The only differences between the WB and EB sections were the increase in aggregate size and a reduction in cement content due to the optimized gradation used. Again, there was a substantial improvement in the cracking pattern generated compared to the eastbound lanes. Though the cracks were much tighter, however, they still exhibited a tendency toward clustering and excess wandering.

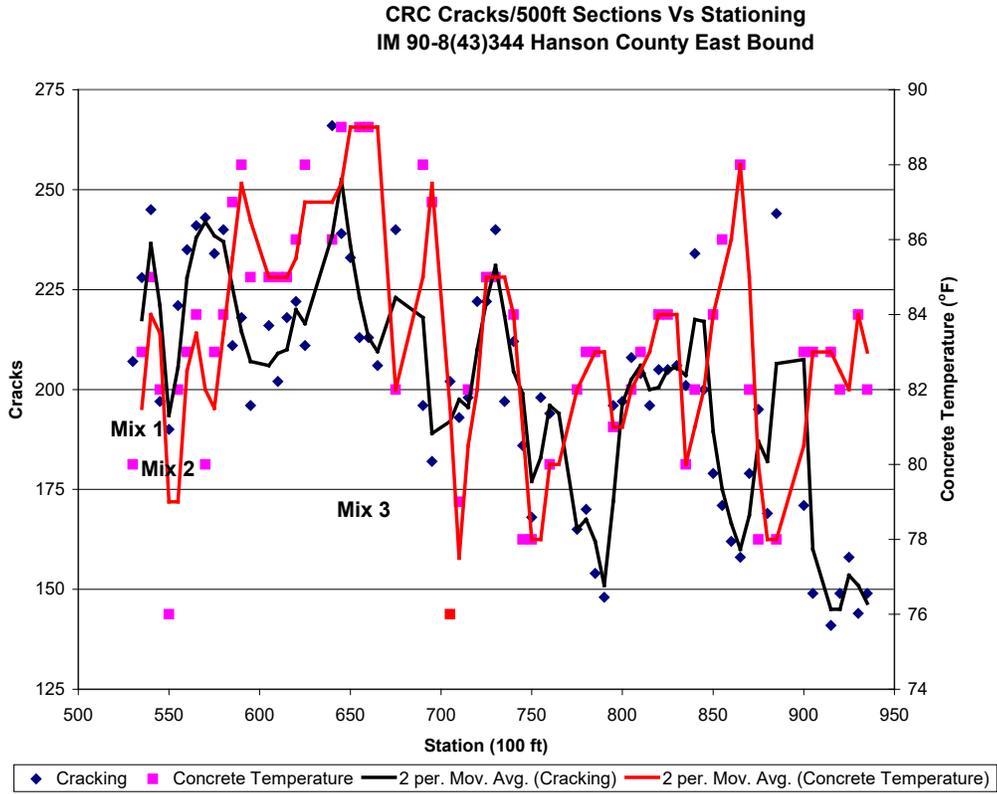
Figure 13: CRCP Cracking and Concrete Temperature versus Stationing

A plot of cracking for each 500' section versus stationing (Figure 13) gives an idea of the range in cracking manifested over the course of mainline construction. The variable plotted on the right hand axis is concrete temperature, the independent variable with the strongest correlation, not surprisingly, to cracking. Two marked trends are immediately apparent from the graph besides the general correspondence with concrete temperature. The first is the substantial reduction in the level of cracking when the concrete mixture is changed from Mix 2 (¾") to Mix 3 (1½") at relatively similar concrete temperatures. The second, somewhat more surprising trend is the minimal cracking which occurred during the final day of paving at the east end of the project. Notably, this pavement section was on the east side of a small bridge and displayed one very striking visual difference compared to all the other sections surveyed. This was the only pavement section with curing compound residue still visible along the shoulders almost a year after paving was completed.

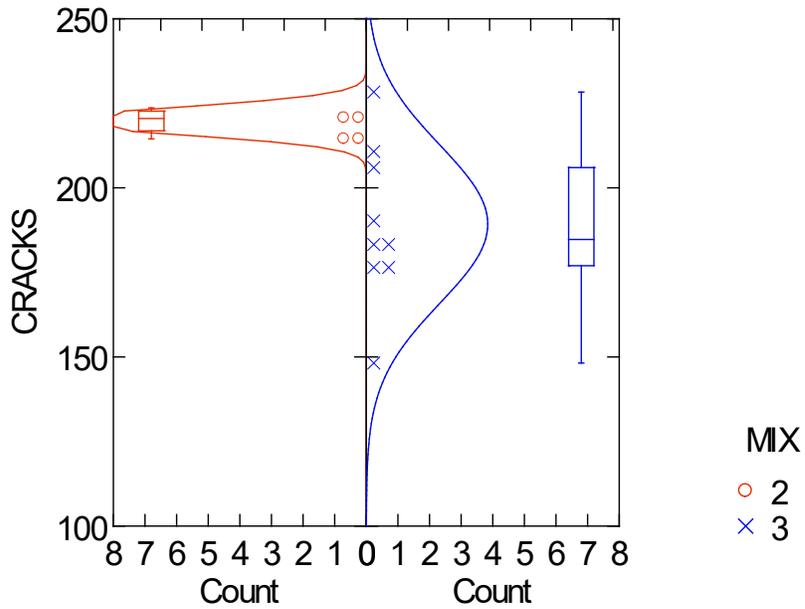
Figure 14: Normal Distribution Curves for Mix 2 and Mix 3 Cracking

Figure 14 represents a normal distribution comparison of cracking between Mix 2 and Mix 3, generated as a result of a two sample t test of the sample means where the null hypothesis was that the cracking in the Mix 2 sections was equal to that in the Mix 3 sections. The null hypothesis was rejected ($p = 0.0042$) with the means equal to 219.8 for Mix 2 and 189.3 for Mix 3. The standard deviations for the two types were significantly different with Mix 2 exhibiting almost no variability (S.D. = 3.96) whereas Mix 3 had almost eight times the range (S.D. = 23.36). Because concrete temperature was identified as a prime factor in determining the level of cracking, the possibility that this difference in the means was actually due to the Mix 2 concrete temperatures being higher had to be tested. The results are shown in Figure 15 and show that there was no significant difference in concrete temperatures for the two mixes.

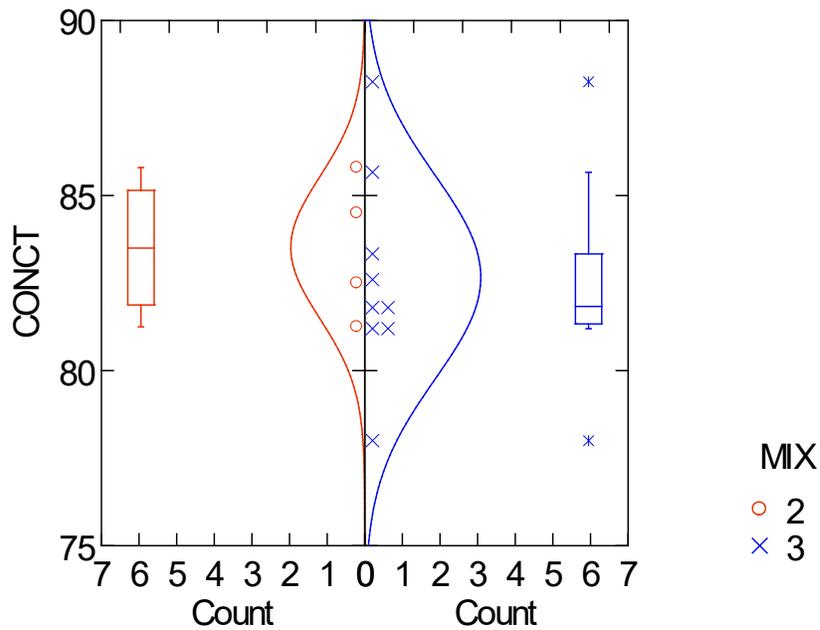
Figure 15: Comparison of Concrete Temperatures for Mix 2 and Mix 3

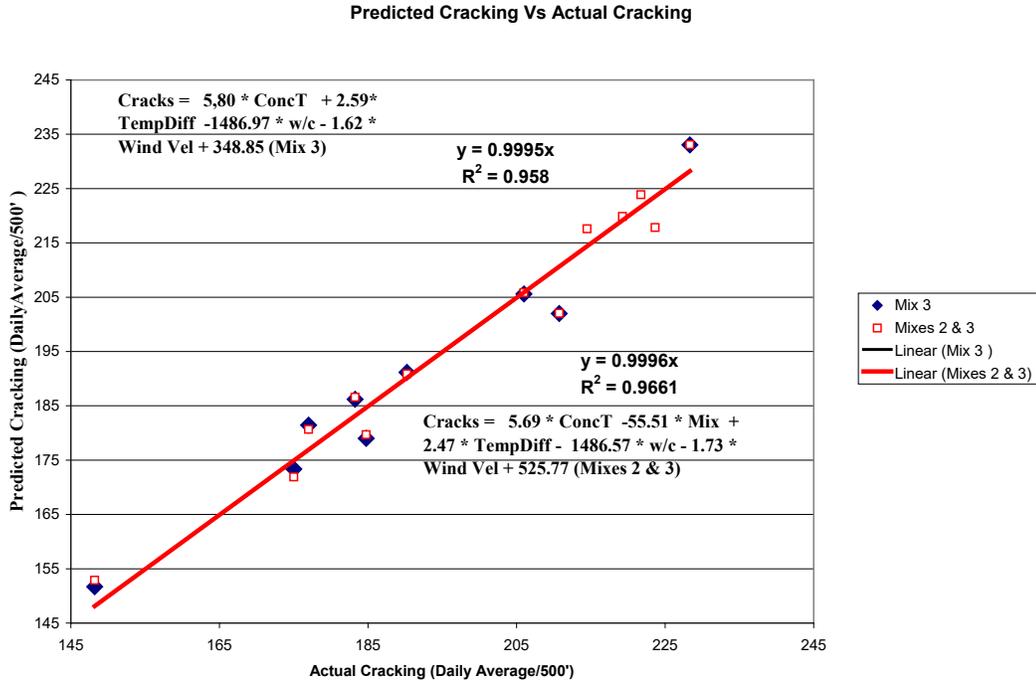
Figure 16: Comparison of Cracking Models

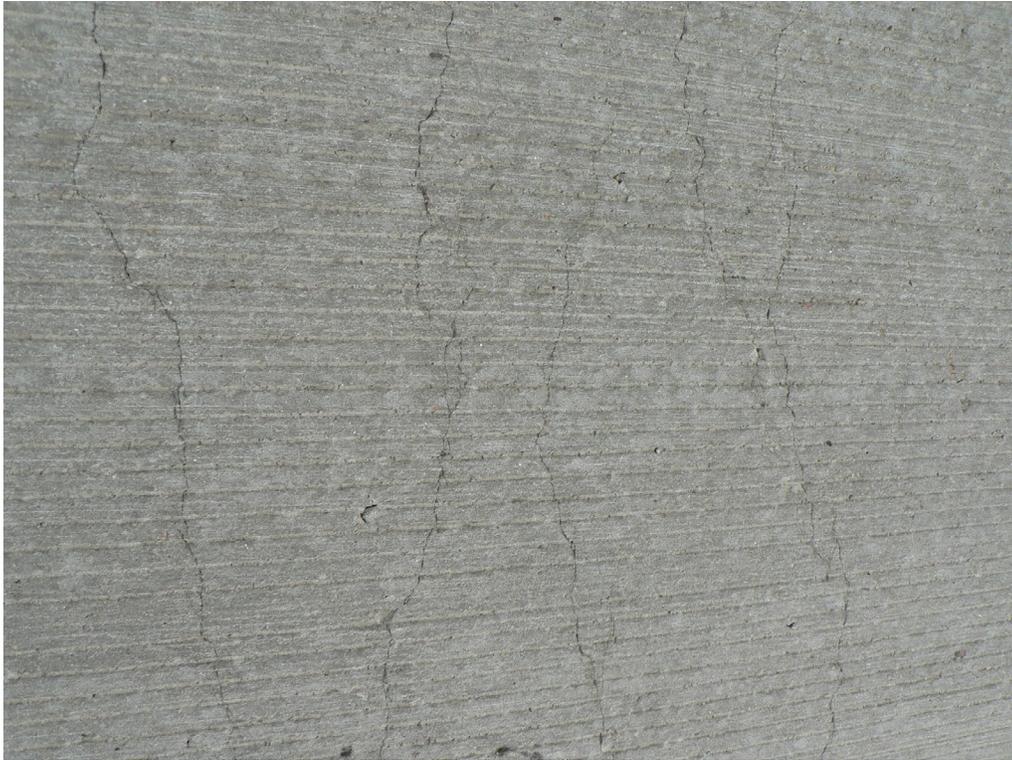
Figure 17: Cracking in Mix 2

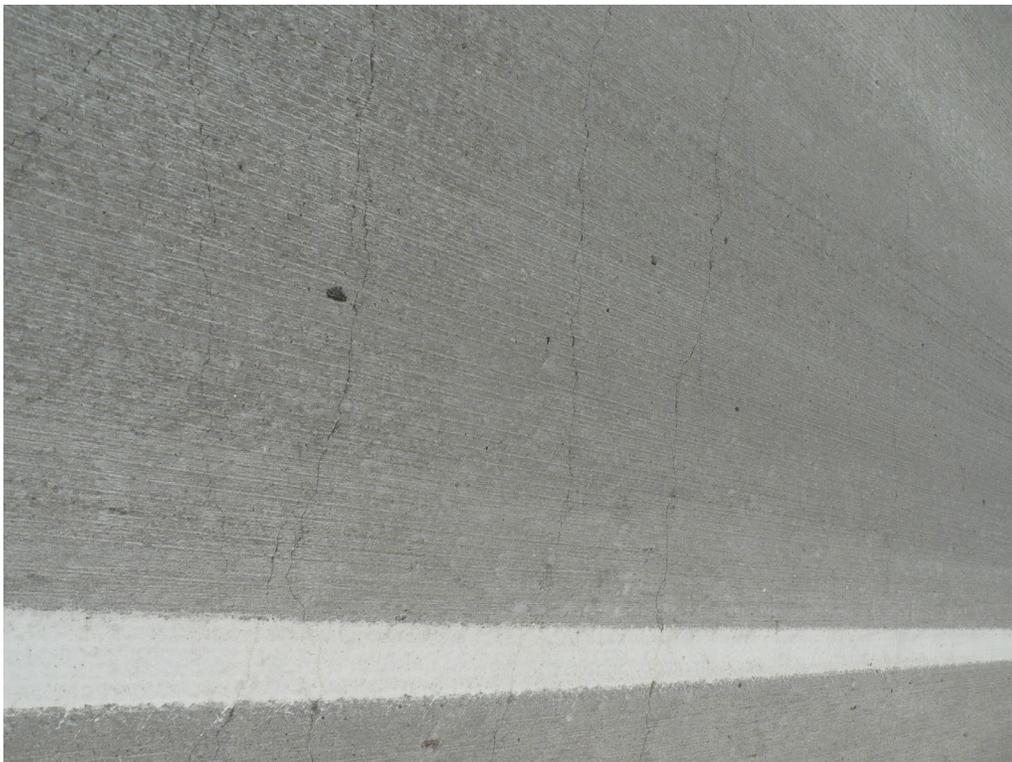
Figure 18: Cracking in Mix 3

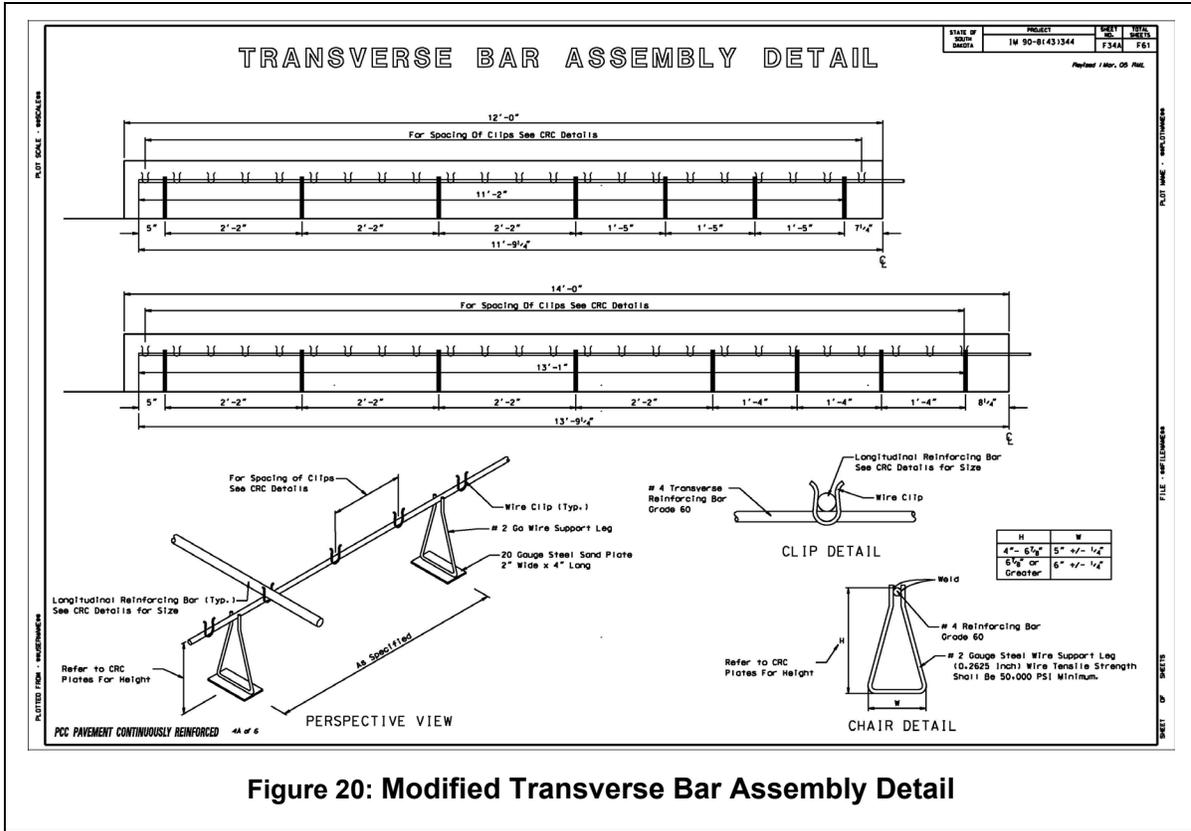
Figure 20: Modified Transverse Bar Assembly Detail

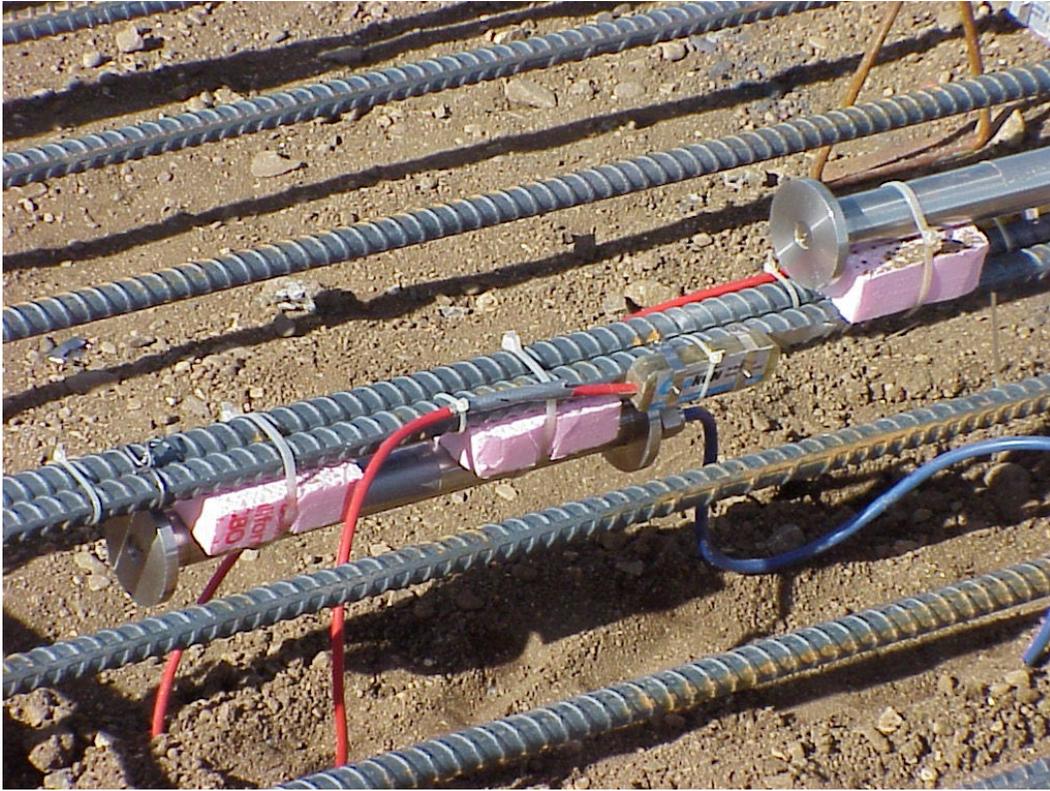
Figure 21: Embedded Strain Gauge Layout I-29 Tea Interchange

Strain gauges were installed in the southbound lane of I-29 near the Tea intersection north of the bridge on project IM 29-2(52)72 in the control section with optimized 1 1/2" coarse aggregate concrete mixture but incorporating 0.7% steel at 3 1/2" nominal depth. The purpose of this installation was to observe the early age strain behavior of the steel and concrete, measure any differences in strain across a lap section and attempt to confirm that early age stresses are of sufficient magnitude to initiate uncontrolled cracking before the concrete has reached adequate strength levels to effectively resist the stresses. Figure 21 shows the installation of embedded strain gauges (Geokon 4210 Concrete Embedment Strain Gauges) in the CRCP before paving. In all, 14 vibrating wire strain gages were installed—twelve weldable and two embedded—including four on each side of a lap, top, bottom and sides, two at the lap and two on the transverse steel. Figure 22 shows the early strain histories for a few of the gauges, primarily highlighting the response differences between the gauges installed on the steel and those embedded in the concrete.

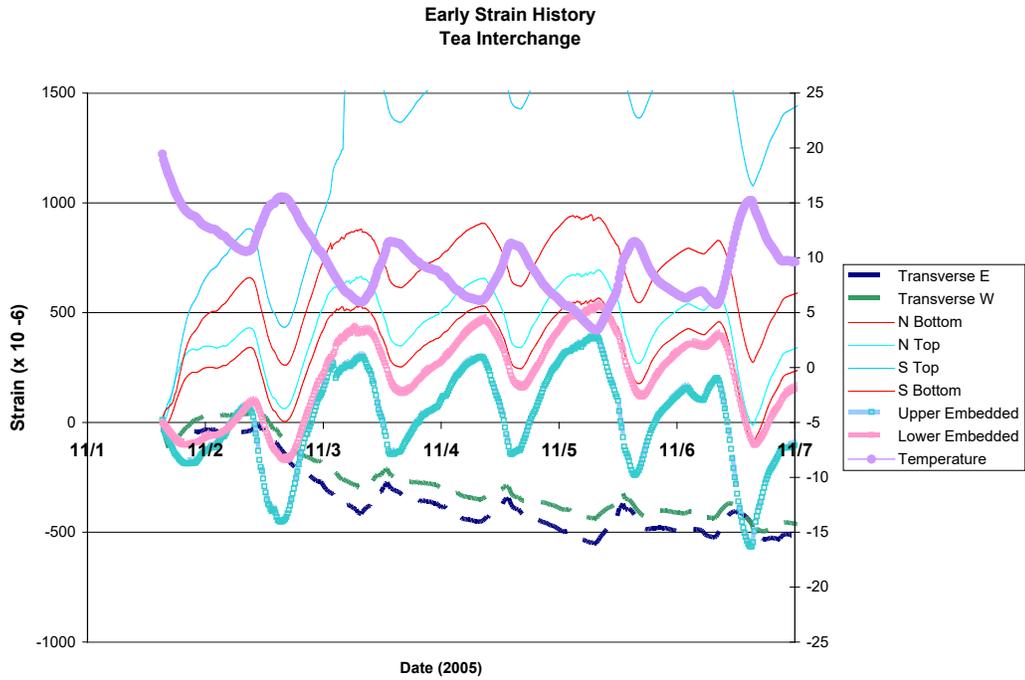
Figure 22: Early Strain Histories I-29 Tea Interchange

The transverse steel shows the expected response, being perpendicular to the direction of concrete movement resulting in cracking. The transverse strains also cycle with temperature, as expected. The embedded concrete gauges, on the other hand, go into tension almost immediately and achieve high levels of total strain, especially above the steel, during the first day. The magnitude of these strains is sufficient to explain the uncontrolled cracking, wide cracks and spalling which is occurring. This is consistent with the factors affecting crack width in CRCP where cracks which occurred during the first three days were typically wider than cracks formed at later ages (16), especially considering the quartzite coarse aggregate used which also contributes to wider cracks. For comparison purposes, Figure 23 was taken from Nam, et al. (17) and shows the early strain development in a CRCP pavement in Texas. The researchers were able to separate the stress dependent strain (elastic and creep strain) from the stress independent strain (thermal and shrinkage strain), as shown in the figure, but the total strain progression is directly comparable and totally different than that obtained at the I-29 Tea Interchange. The significant early tensile strain in the concrete is consistent with the early cracking being more like tearing and further supports the lack of restraint from the granular base and its effects on accelerating early cracking.

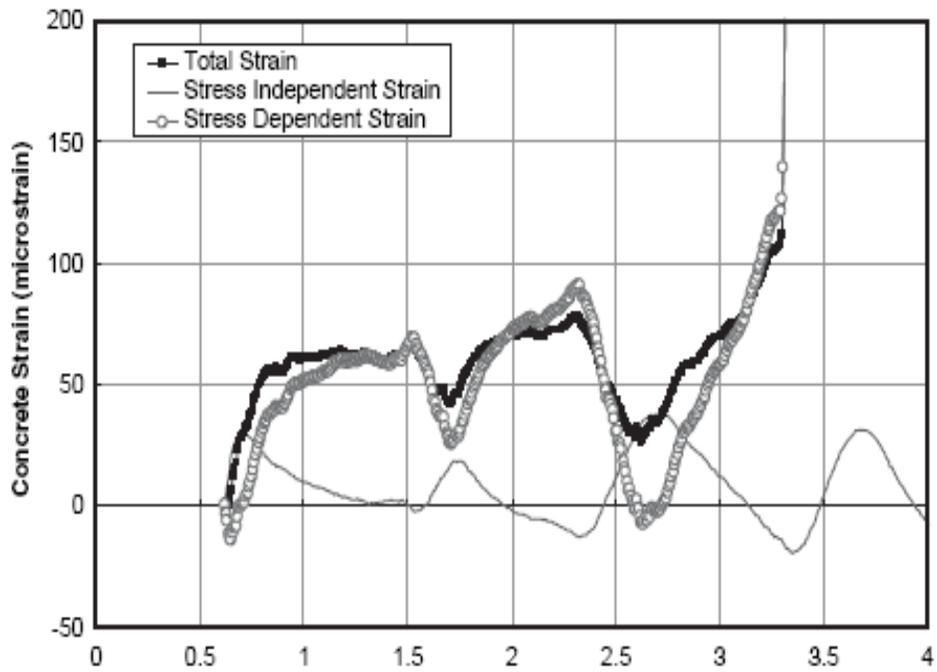
Figure 23: Concrete Strain Variation (after Nam, et. al. 2006)

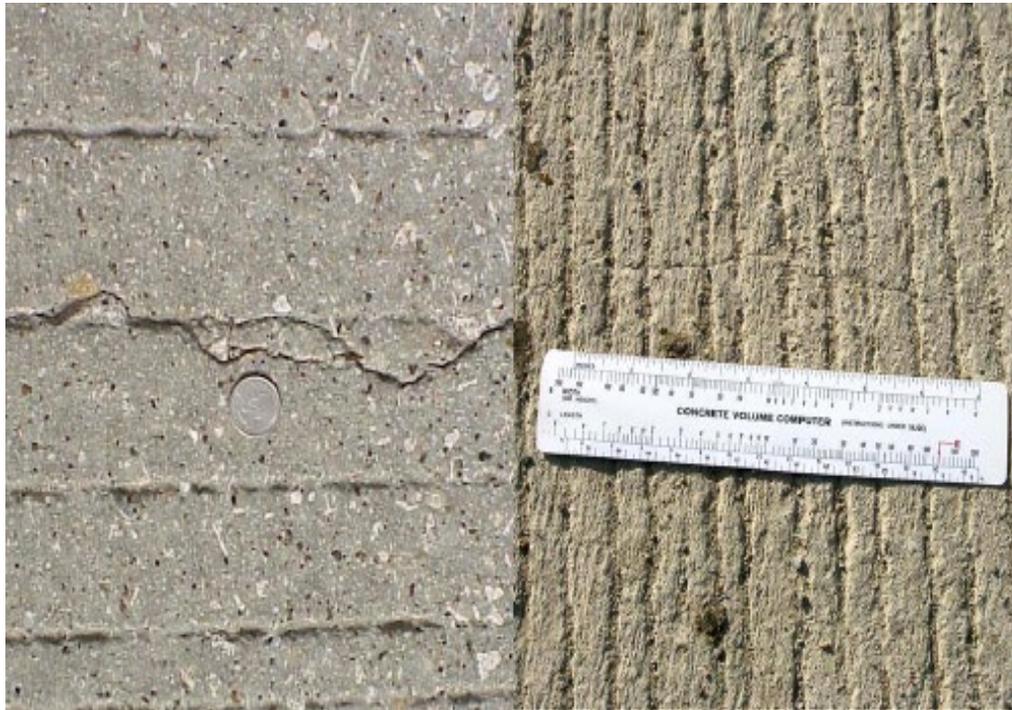
Figure 25: Crack Comparison Between I-90 ¾" Limestone (left) and I-29 1½" Quartzite (right)

An example of these conditions is the newly constructed stretch of I-90 eastbound near Exit 55 in Rapid City, SD, which consists of an 11.5" CRCP pavement. Crack mapping was begun soon after construction began and Table 9 below details the results up until the end of October 2004. The progression of spalling

and Y-cracking on this project so soon after construction is somewhat alarming, especially considering the coarse aggregate used is limestone which has a low coefficient of thermal expansion and should minimize any thermal contributions to early age stresses. All of these cracks are also extremely wide as the left image in Figure 25 shows and the spalls appear to be due to initial stresses exacerbated under traffic. This pavement had a nominal longitudinal reinforcing depth of 4" due to its thicker section. The image on the right in Figure 25, on the other hand, is from I-29 Madison Street and shows a much tighter crack even though the pavement thickness was 12" and the nominal steel depth was 4" with #7 longitudinal reinforcement. Since greater steel depth contributes to an increase in transverse cracking as does increasing steel content, based on the granular model above, one change in current design requirements which could be beneficial with no extra cost involved would be to require a nominal steel depth of 3¾" for all new CRCP no matter its depth. Reducing the size of the steel to #5 for all CRCP may also be beneficial as this will also increase crack spacing, if this can be done without reducing the cross sectional area too greatly.

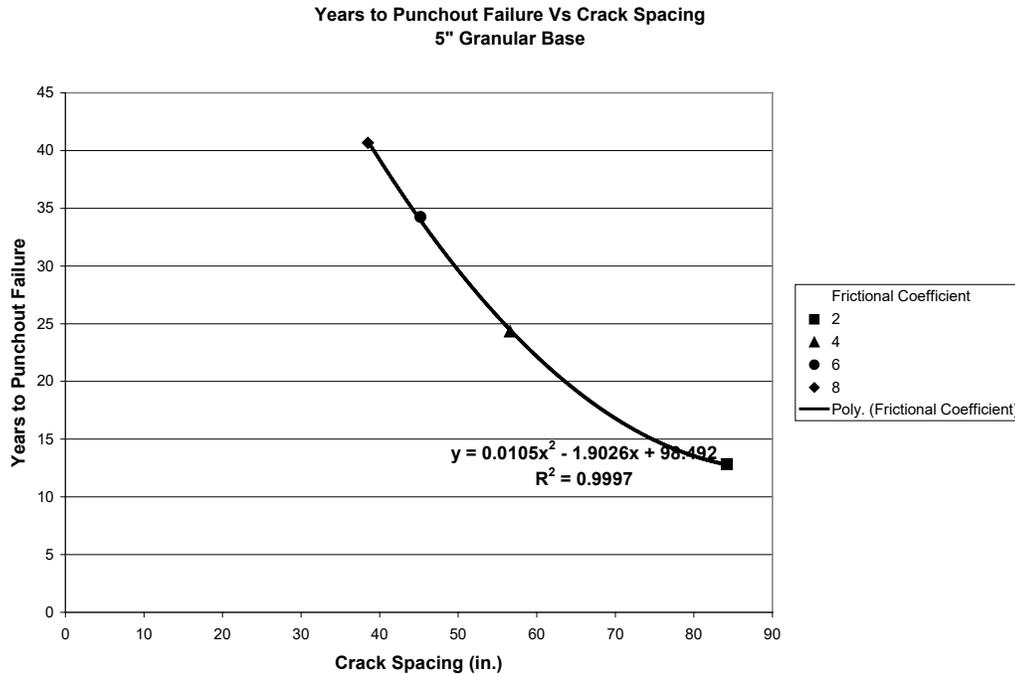
Figure 27: Years to Punchout Failure versus Crack Spacing

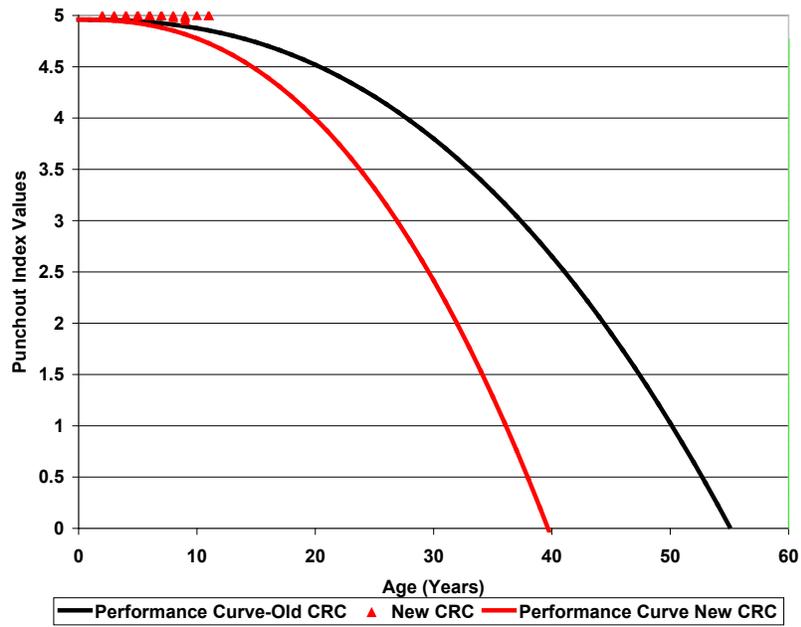
Figure 28: New CRCP Performance Curve Punchouts

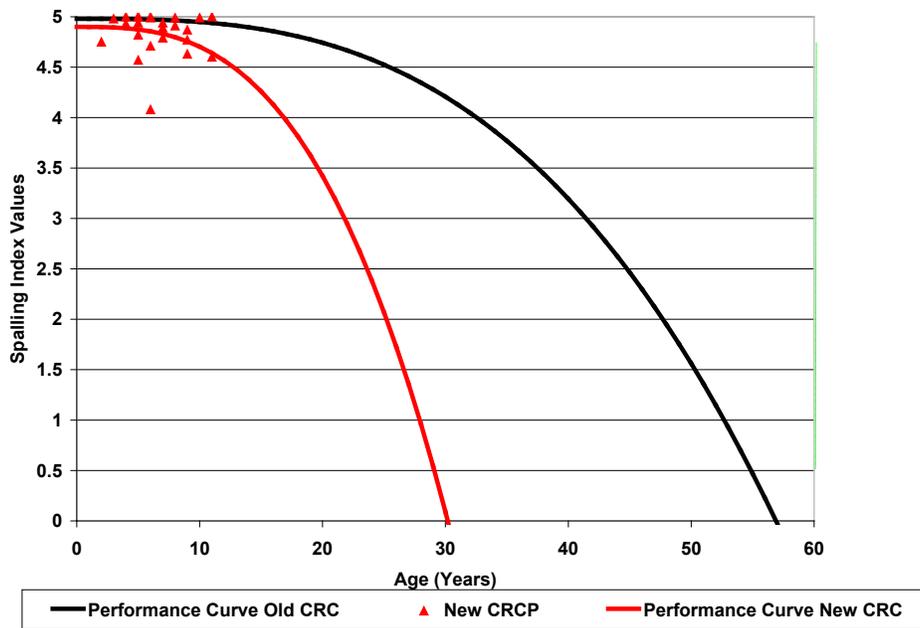
Figure 29: New CRCP Performance Curve Spalling

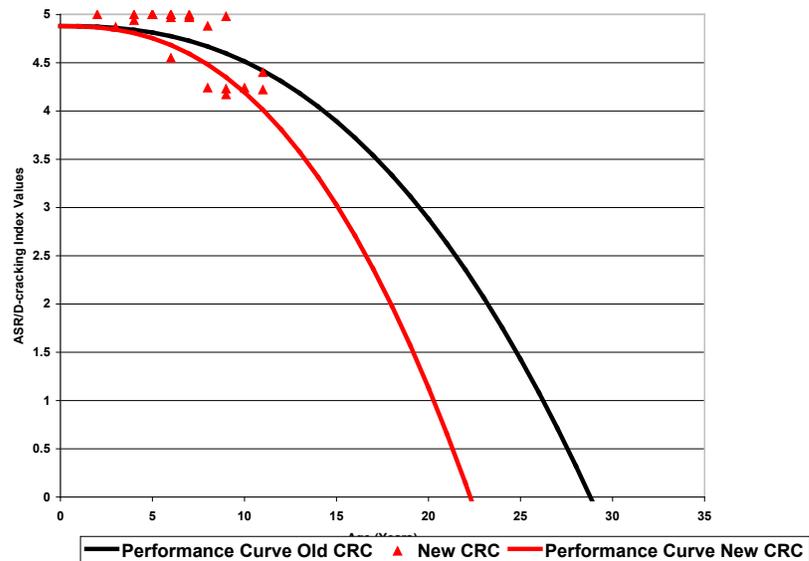
Figure 30: New CRCP Performance Curve ASR/D-Cracking

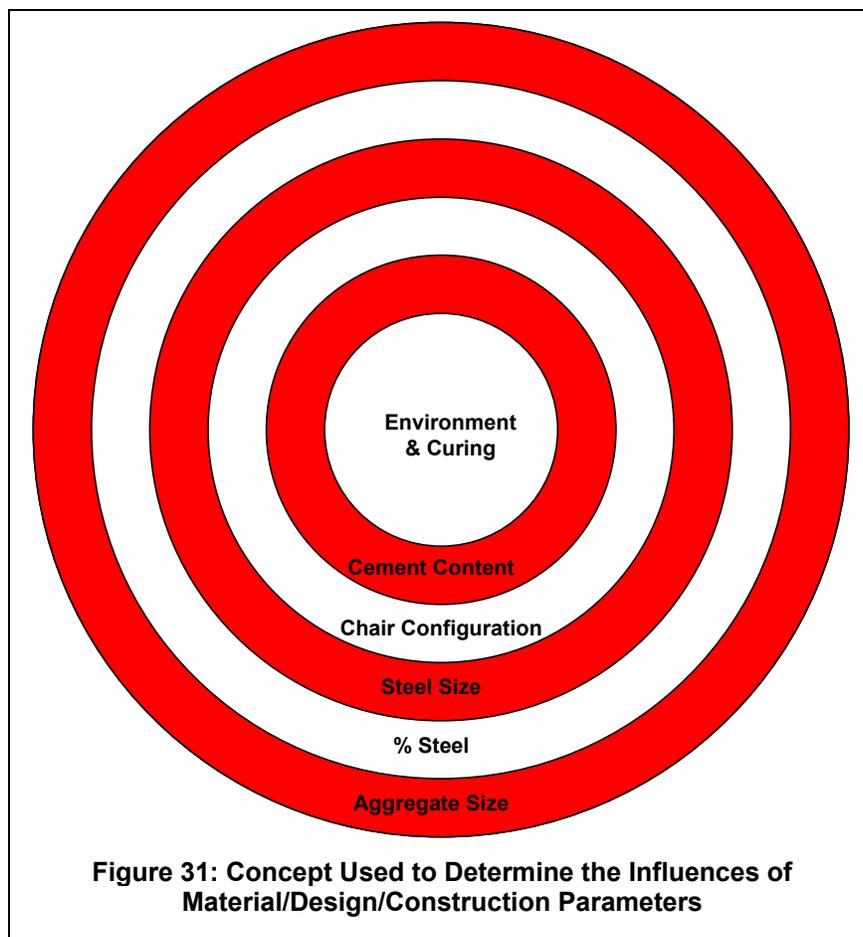
Figure 31 illustrates the approach used and, it must be emphasized, the results are directly applicable for CRCP constructed using South Dakota’s design and materials. For instance, the reduction in steel content from a high of 0.85% to an across the board 0.6% was not a major issue as the older CRCP performed well at this same level of steel content and achieved its expected design life. Traffic levels on South Dakota’s interstate are not excessive and are almost two orders of magnitude less than some of the CRCP pavements in other states. Higher steel contents could be used with granular bases but would require a significant increase in cement content and provisions for curing to achieve satisfactory cracking patterns.
