# Damage Detection and Damage Localization in Bridges with Low-Density Instrumentations Using the Wave-Method: Application to a Shake-Table Tested Bridge

Report 22-37

<b>14. Sponsoring Agency Code</b>	
<b>15. Supplemental Notes</b>			
<b>16. Abstract</b> <p>This study presents a major development to the wave method, a methodology used for structural identification and monitoring. The research team tested the method for use in structural damage detection and damage localization in bridges, the latter being a challenging task. The main goal was to assess capability of the improved method by applying it to a shake-table-tested prototype bridge with sparse instrumentation. The bridge was a 4-span reinforced concrete structure comprising two columns at each bent (6 columns total) and a flat slab. It was tested to failure using seven biaxial excitations at its base. Availability of a robust and verified method, which can work with sparse recording stations, can be valuable for detecting damage in bridges soon after an earthquake. The proposed method in this study includes estimating the shear (<math>c_s</math>) and the longitudinal (<math>c_L</math>) wave velocities by fitting an equiv

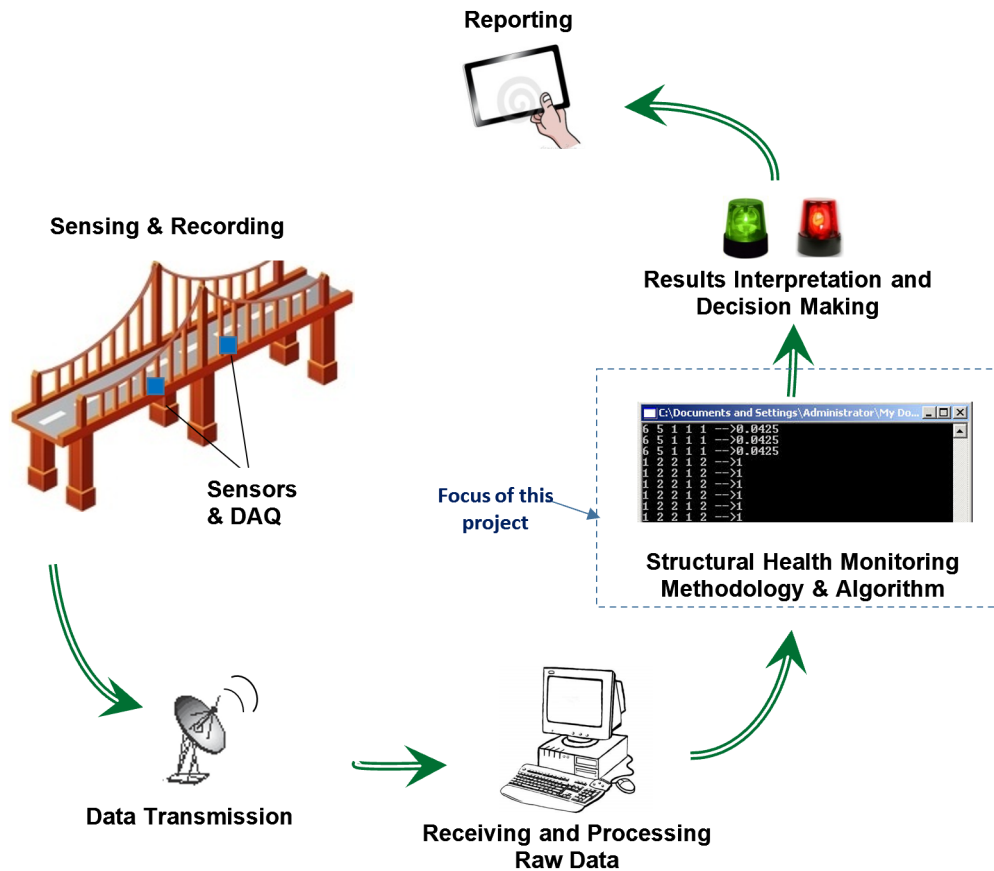
Figure 1.1. Main Elements of Structural Health Monitoring (SHM) for Bridges

Figure 1.1 shows the main elements of a structural health monitoring (SHM) system, which consists of an array of sensors and data acquisition, data processing, and decision-making tools. This study aims to develop an algorithm that converts the recorded response from a low-density recording sensor array (e.g., horizontal acceleration of bridge deck from a few widely spaced accelerometers) to useful information on the extent of damage to a bridge's piers and the location of the most severe damage.

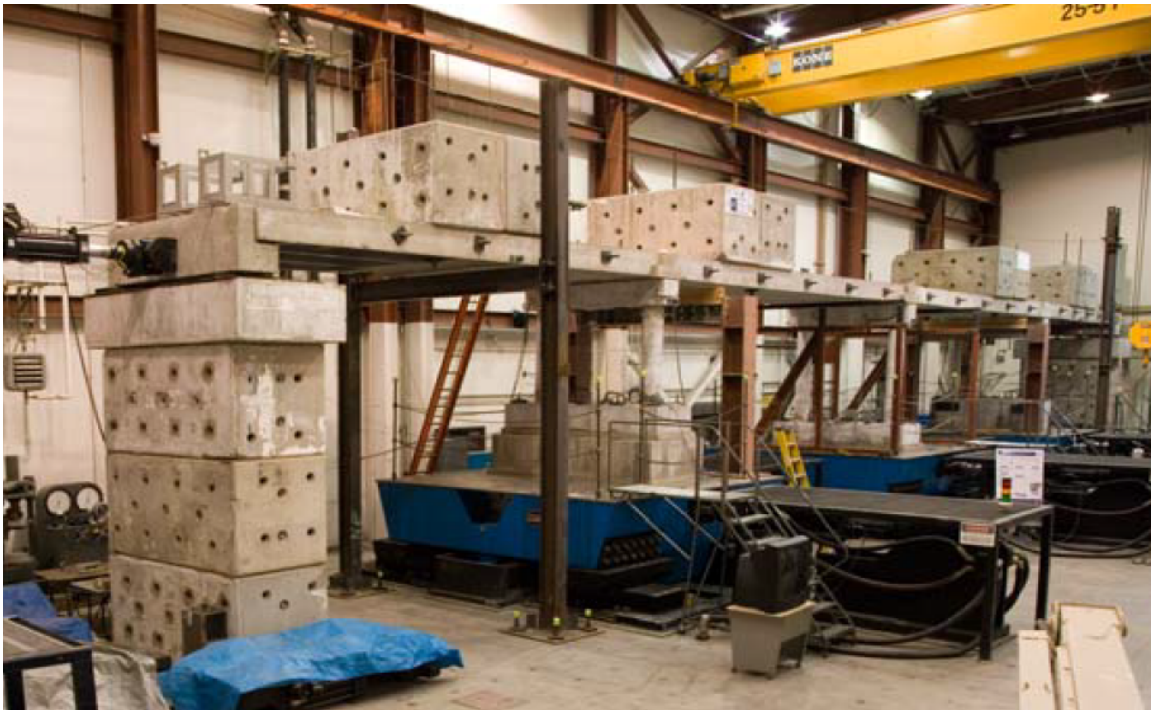
Figure 1.2. The 4-Span Prototype Reinforced Concrete Bridge

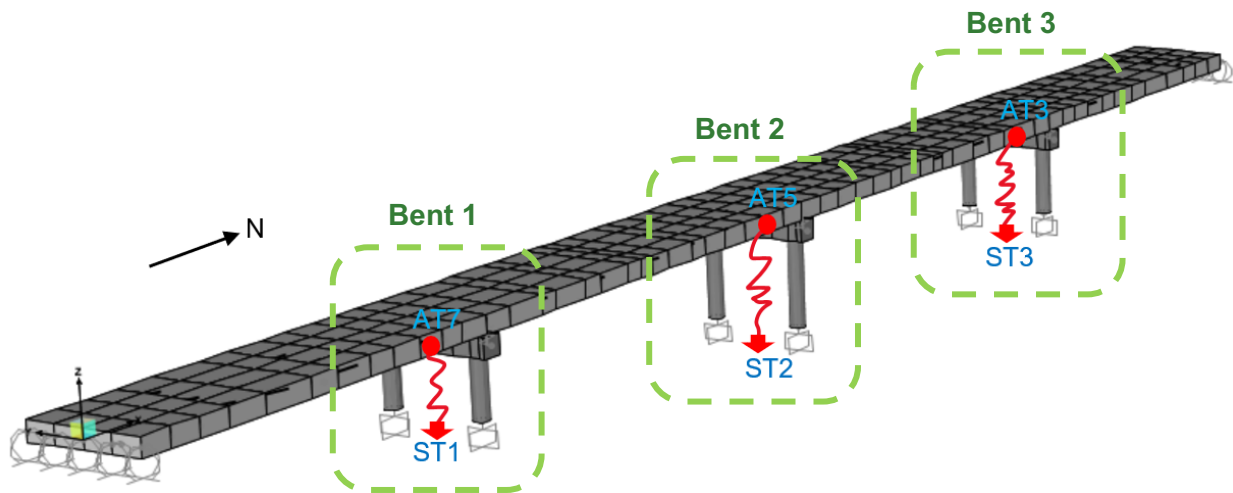
Figure 2.1. A Rendering of the Case-Study Bridge and its Three Segments (i.e., Bents) Used for Damage Identification

In this project, the bridge is divided into three segments, each encompassing a pair of columns (i.e., one bent) as shown in Figure 2.1. We consider each segment of the bridge a *waveguide* through which seismic waves propagate from the shake table to the bridge deck. Each bent (i.e., waveguide), separately, is modeled as a uniform elastic Timoshenko beam (TB), which accounts for both shear and bending deformation in the columns. The TB is characterized by its height ( $H$ ), length ( $L$ ), and width ( $W$ );  $L$  and  $W$  are further used to calculate the layer's rotary inertia ( $I$ ), shear modulus ( $G$ ), and Young's modulus ( $E$ ).  $E$  and  $G$  are related to *longitudinal* ( $c_L$ ) and *shear* ( $c_S$ ) wave velocities; the properties of the beam's material are given as  $c_L = \sqrt{E/\rho}$  and  $c_S = \sqrt{G/\rho}$ . Figure 2.2 shows details of the uniform TB model used in this study. The model transfer functions (TFs) and impulse response functions (IRFs) at the deck level and the shake-table level were computed using the propagator matrix approach, as described in Ebrahimiyan and Todorovska (2014). Furthermore, the observed TFs and IRFs were computed from the recorded acceleration response at the bridge.

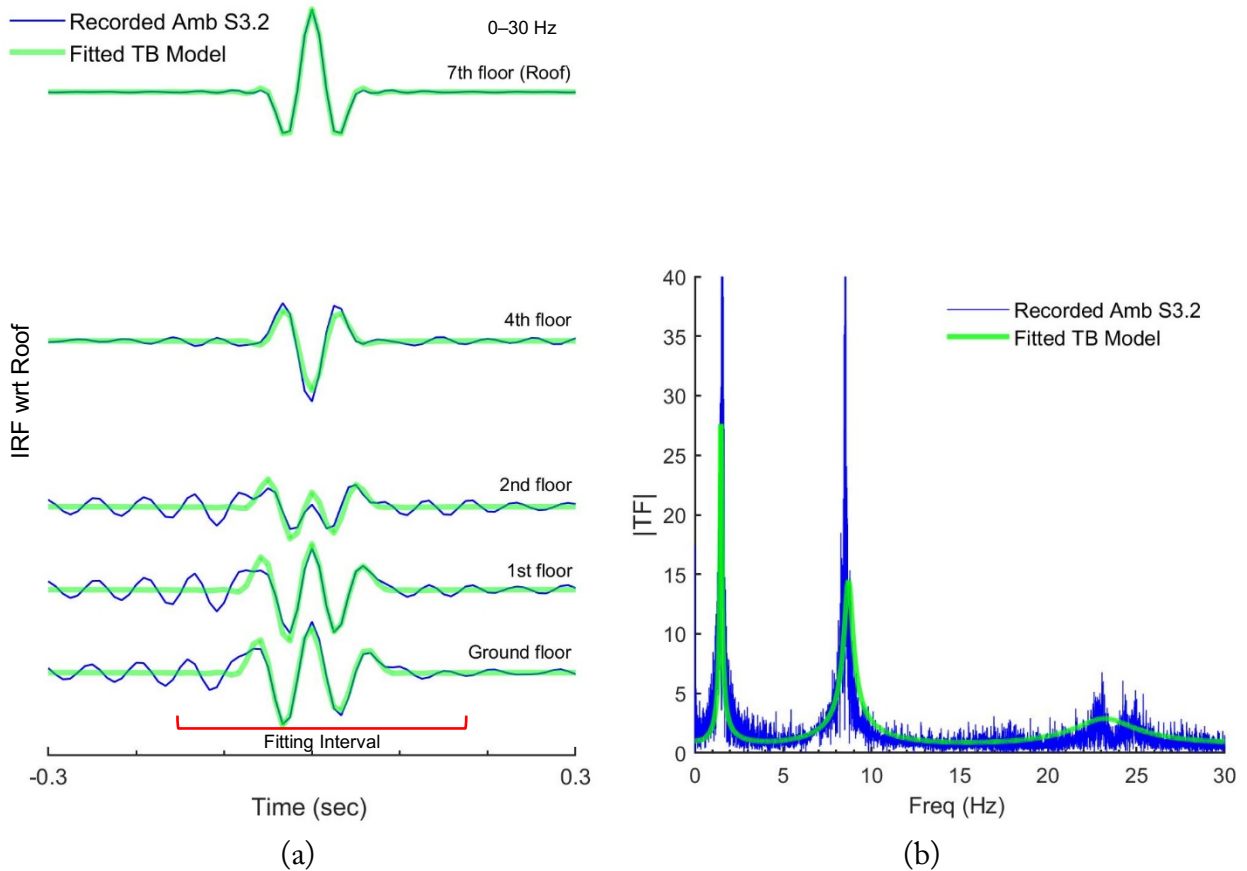
Figure 2.3 (a) Impulse Response Function for Recorded Ambient Vibration Data (Damage State S3.2) and Its Best Fitted Layered TB Model, and (b) Their Corresponding Transfer Function

The *waveform inversion algorithm* (Rahmani and Todorovska, 2013) fits the model IRFs into the observed ones in the least-square sense. Figure 2.3 illustrates the fitted IRFs and the consequent TFs' agreement for a seven-story building that was modeled by a 4-layer TB (Rahmani et al, 2021). The IRFs are low-pass filtered before fitting, and a careful choice of the cut-off frequency,  $f_{\max}$ , is very important because the cut-off frequency affects the width of the source pulse (at the roof) and consequently the shape of the causal and acausal propagating pulses in the IRFs. Also, it determines the number of modes included in our calculation. We chose to use  $f_{\max}=10$  Hz, such that the passband includes two transverse modes of vibration and at least one longitudinal and one torsional mode. Given our one-layer TB model, the fit is performed at one level only (the receiving station) since the IRFs are identical at the source, as shown in Figure 2.3 (i.e., at the source, the pulse is an inverse Fourier transform of a low-pass filtered boxcar function).

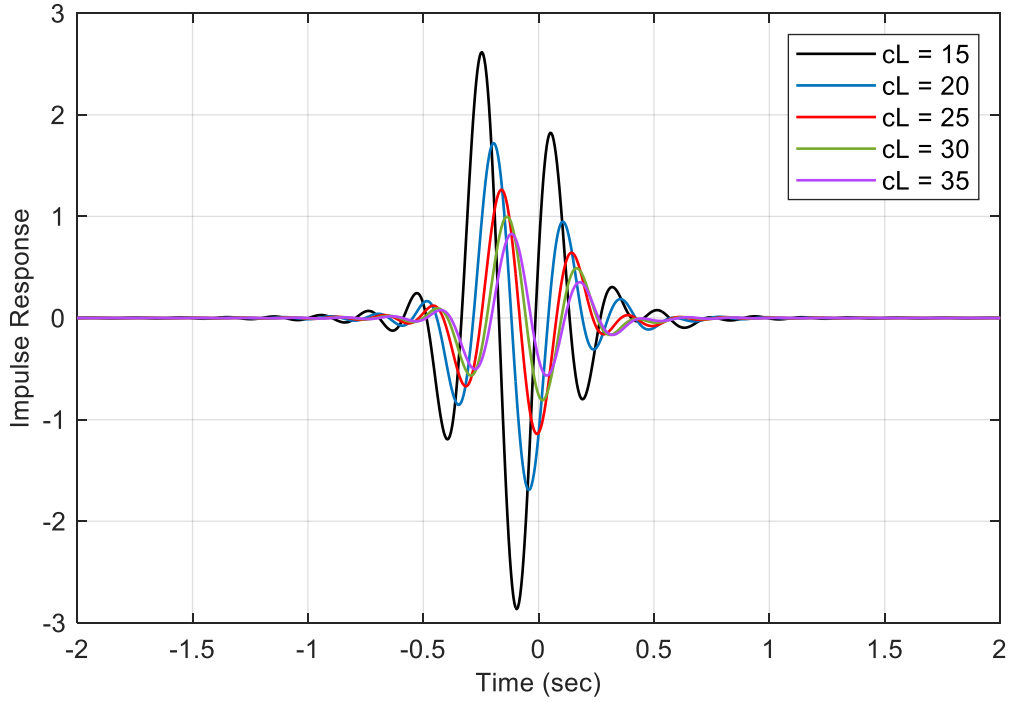
Figure 2.4. IRF Plots of a TB Model with 5% Damping,  $R = 0.2$  and Varying  $c_L$

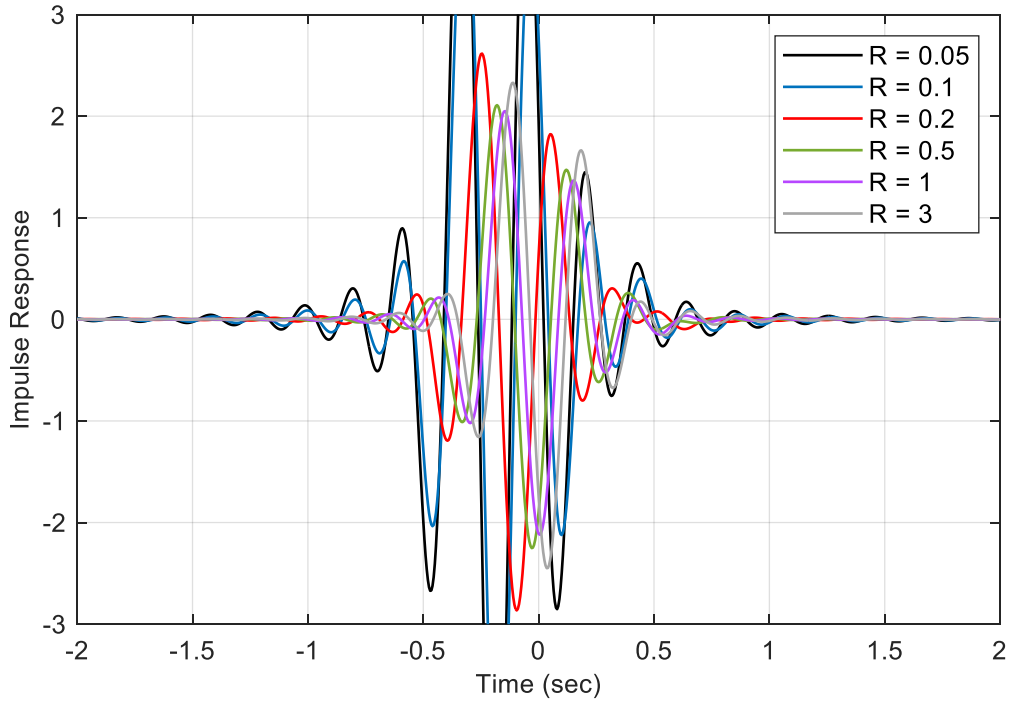
Figure 2.7. IRF Plots of a TB Model with 5% Damping,  $c_L = 15$  and Varying  $R$

Figures 2.7 to 2.9 show IRF plots for 0.05 sec damping, a constant  $cL$ , and varying  $R$ -values. Similarly, the IRF plots shift to the positive time direction when the  $R$  value increases and the amplitude of IRF plots decreases. When the  $R$ -value is smaller than one (i.e., shear deformation is pronounced), these changes are larger. Figure 2.10 shows the pattern of pulse shifts in IRFs for various  $cL$  and  $R$ -values and for both damping values. In comparison, 0.05 sec damping has shown less pulse shifts in the IRF plots relative to 0.01 sec damping. Comparing results for 0.01 sec and 0.05 sec damping reveals that the pulse amplitudes of IRFs are larger for the 0.05 sec damping. When  $R$  and  $c_L$  are constant, a higher damping value (0.05 sec) causes a larger shift in the pulses compared with the lower (0.01 sec) damping. Our waveform inversion, utilizing a nonlinear least-square algorithm, aims to find the optimal values for these three unknowns such that the IRFs of the TB model fits best the IRFs calculated from the observed response.

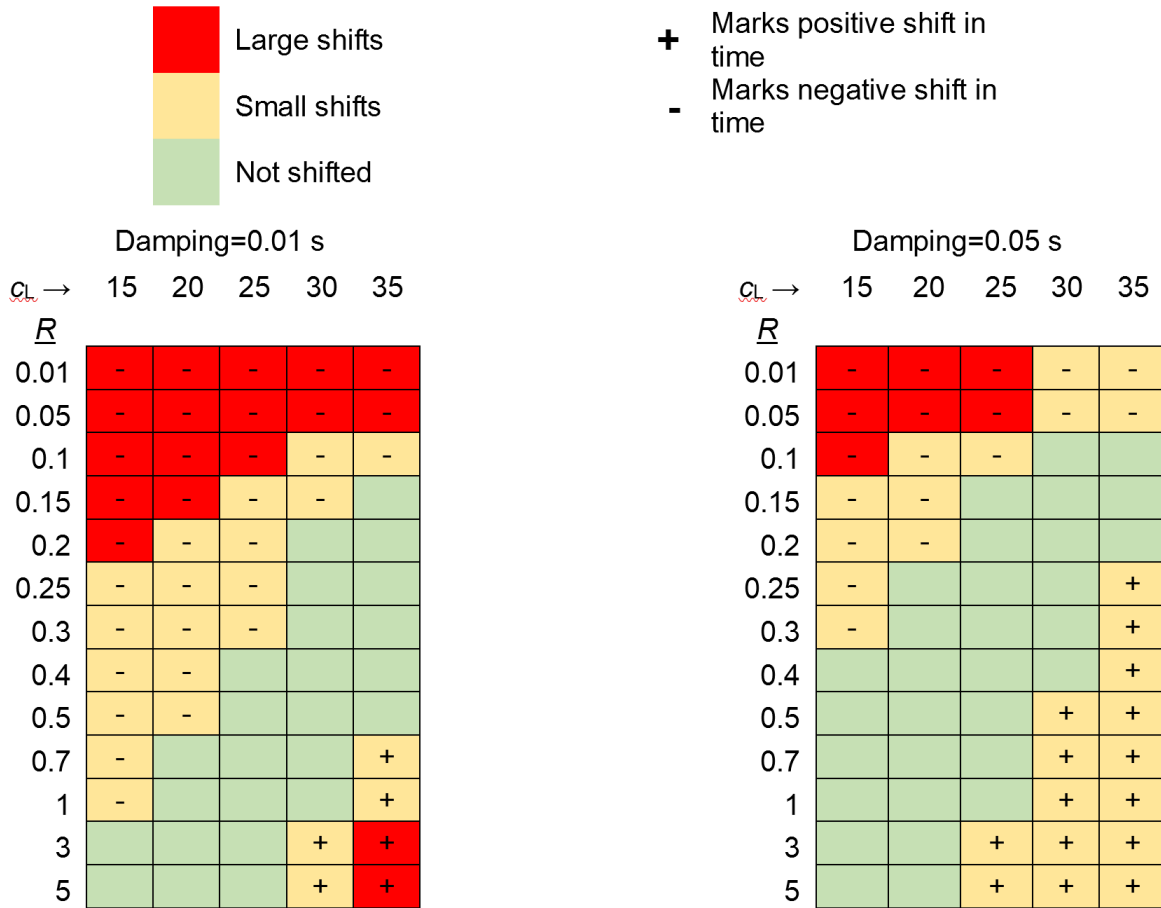
Figure 2.10 The Magnitude of Shift in the Main Pulses of the Impulse Response Functions for Various TB Model's  $c_L$  and  $R$ -values

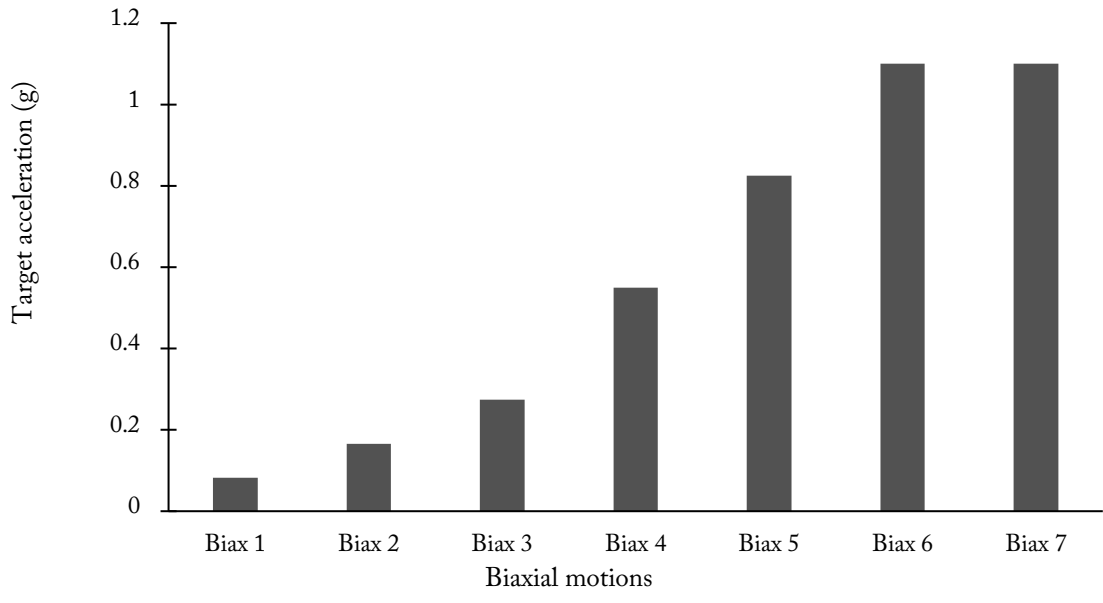
Figure 2.13. Average Target Acceleration at the Shake Tables During Actual Bridge Test

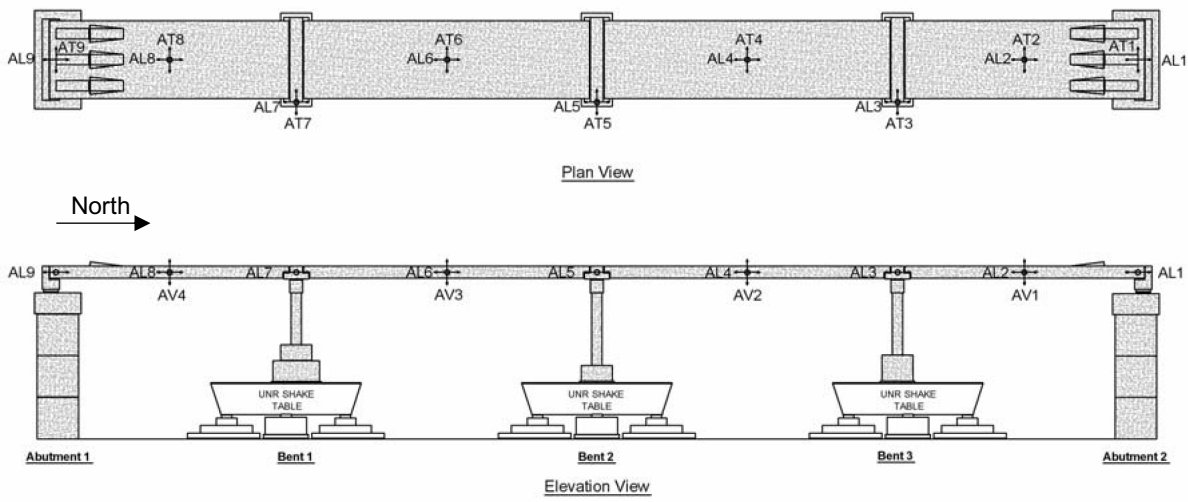
Figure 2.14. Locations of Accelerometers

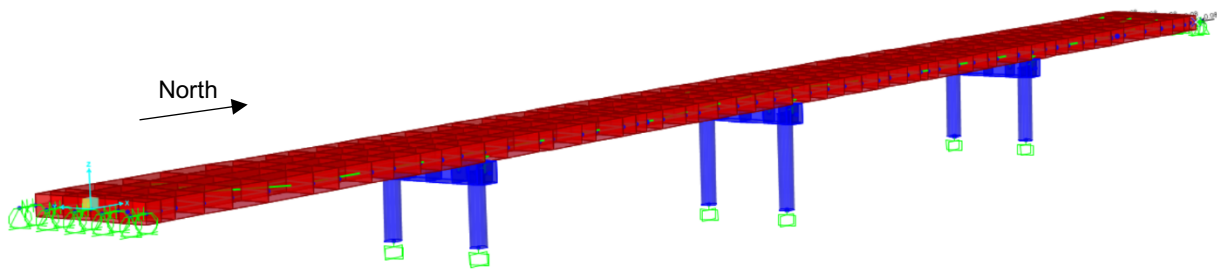
Figure 3.1. Bridge FEM 3D View from SAP2000, Concrete Deadload Blocks Not Shown

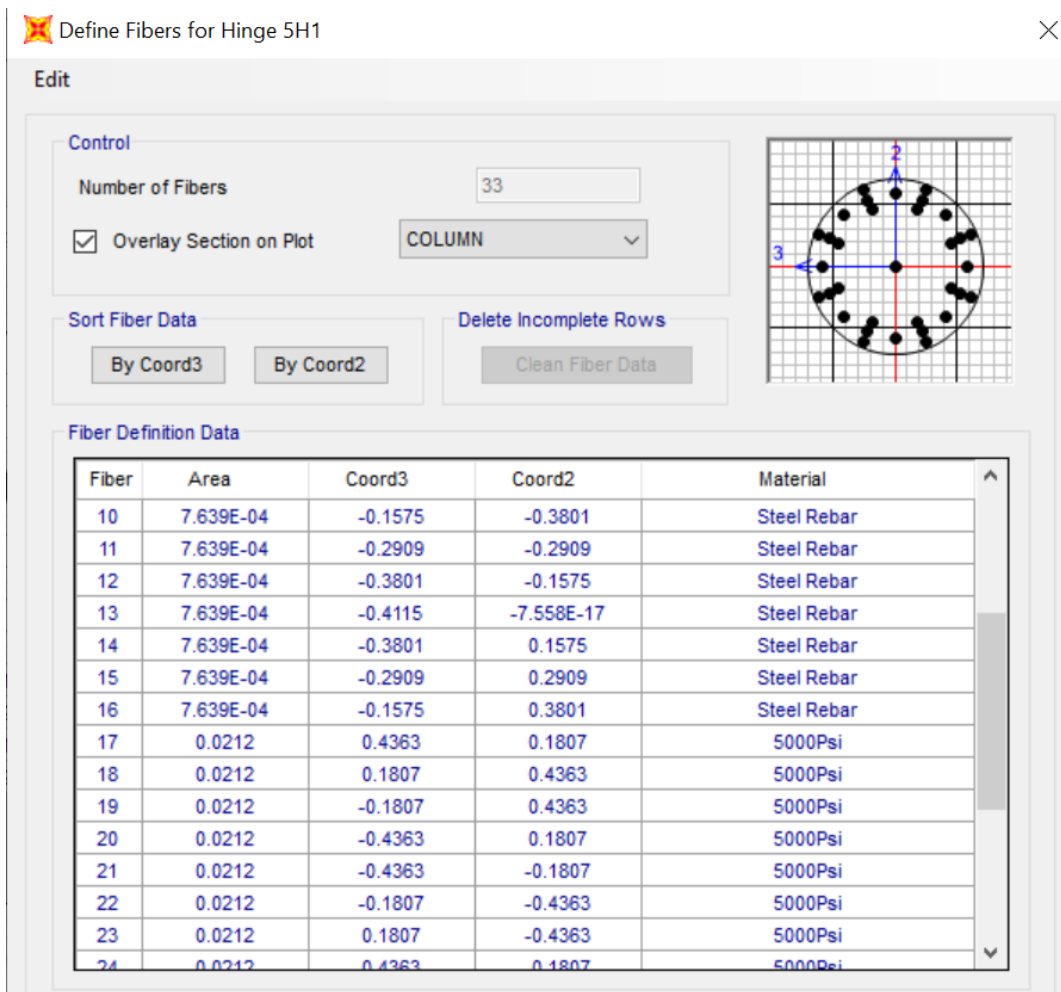
Figure 3.9. Nonlinear Hinge at the Bottom of a Column in Bent 1

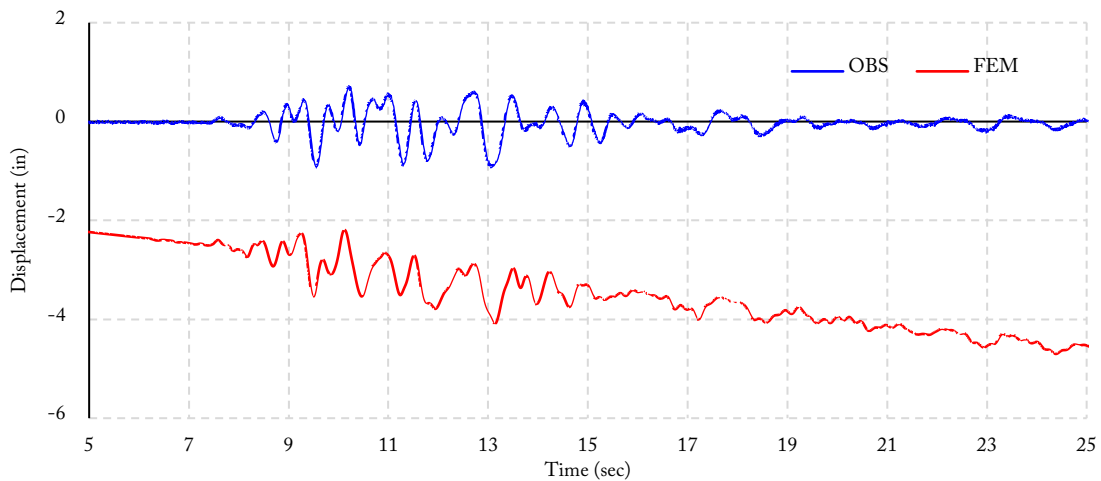
Figure 3.13. Displacement Agreement for Biaxial 3, Channel DT3, With Raw FEM Data

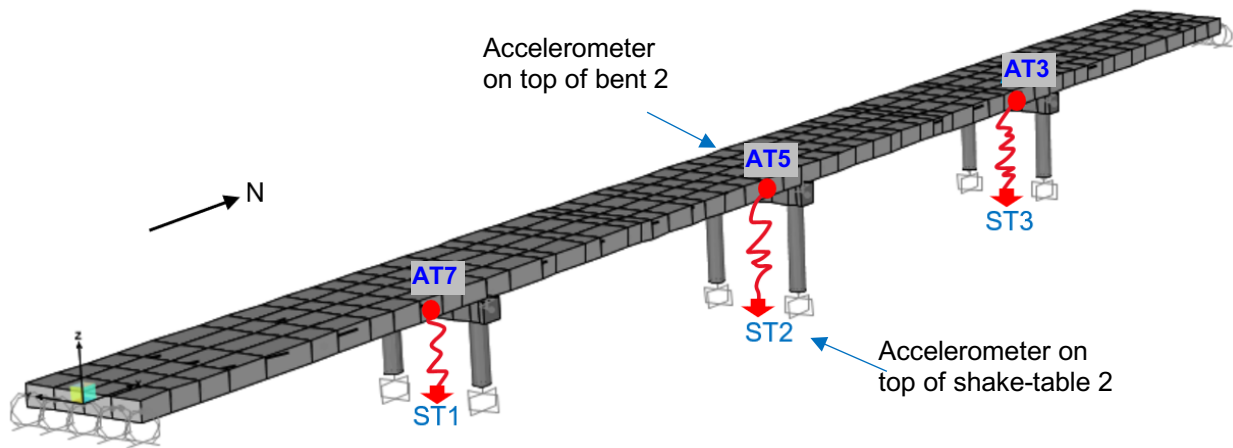
Figure 4.1. Wave Passage 1 (WP1) Through the Columns at each Bent. This was used here.

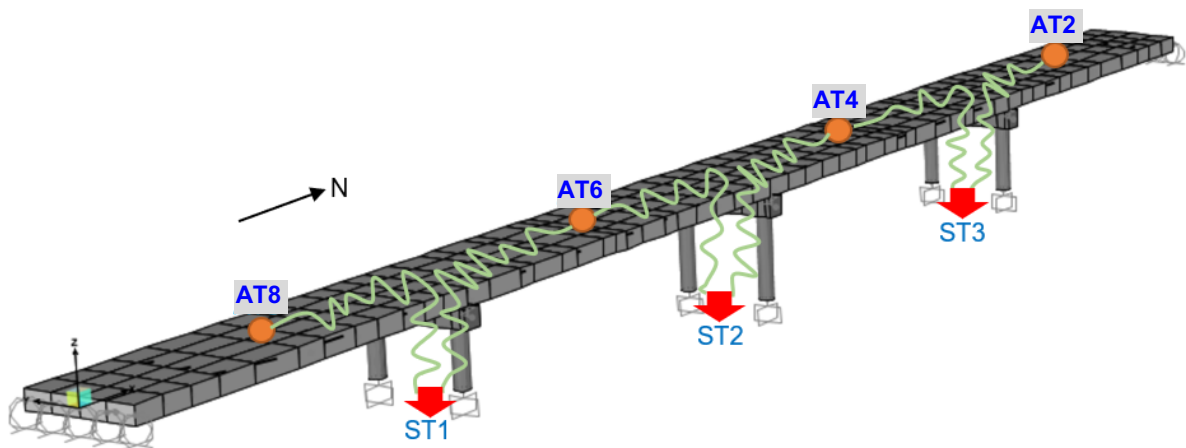
Figure 4.2. The Wave Passage 2 (WP2) Illustration

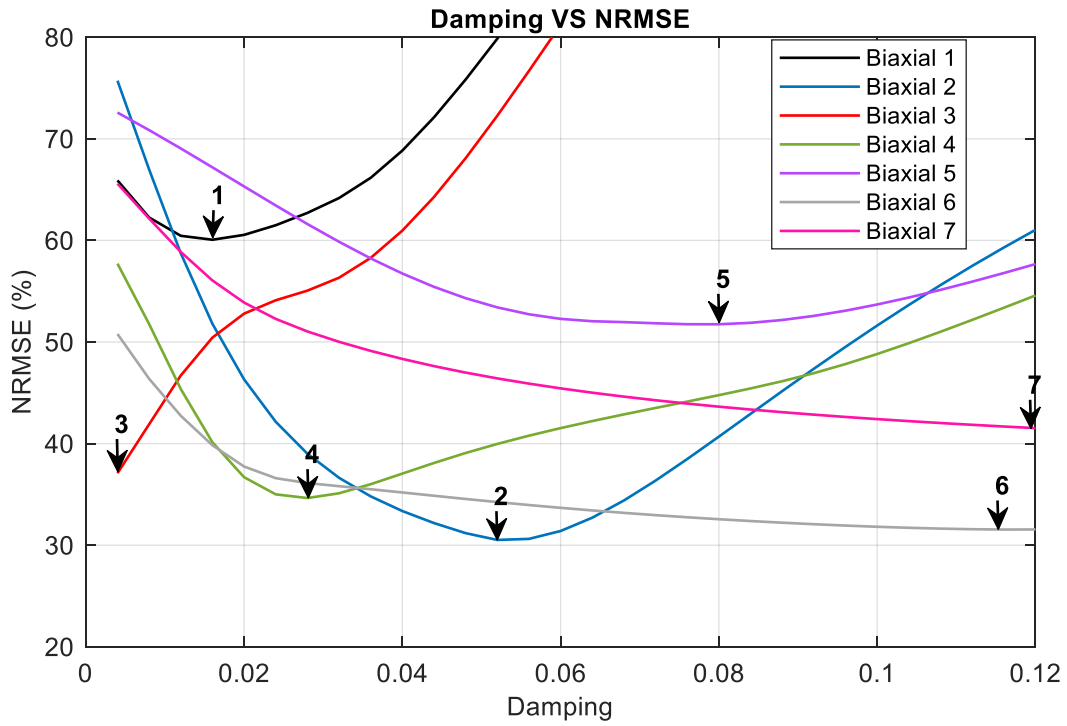
Figure 4.3. Damping vs. NRMSE for the Seven Biaxial Motions at the Bent 3 (Pair AT3-ST3) for Actual Tested Bridge

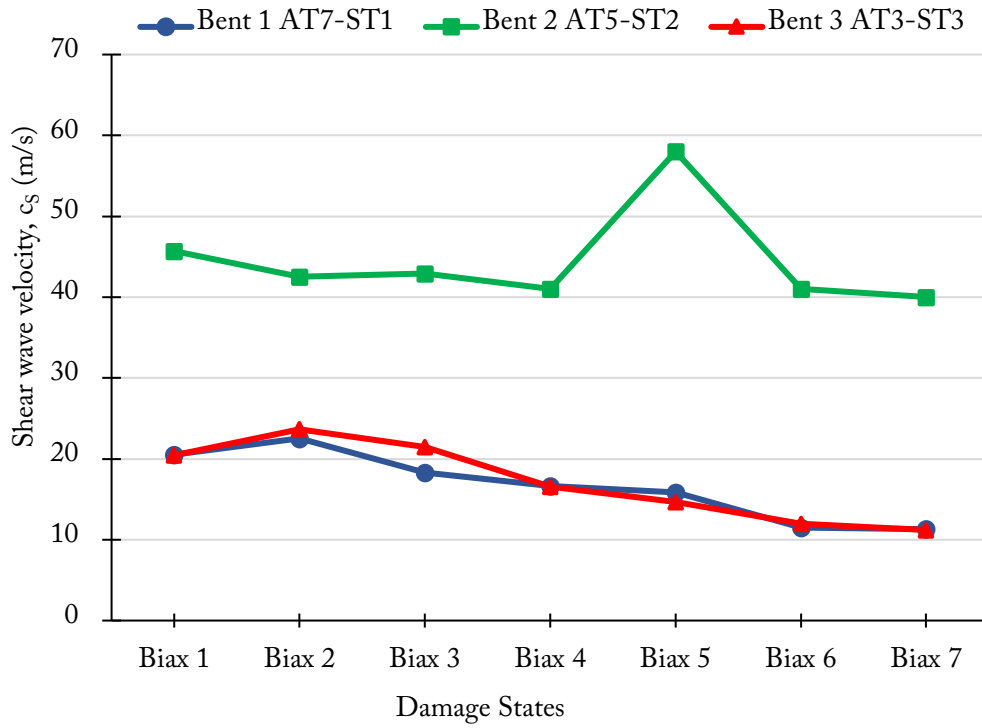
Figure 4.13. Shear Wave Velocity,  $c_s$ , for Wave Passage 1 for Actual Tested Bridge

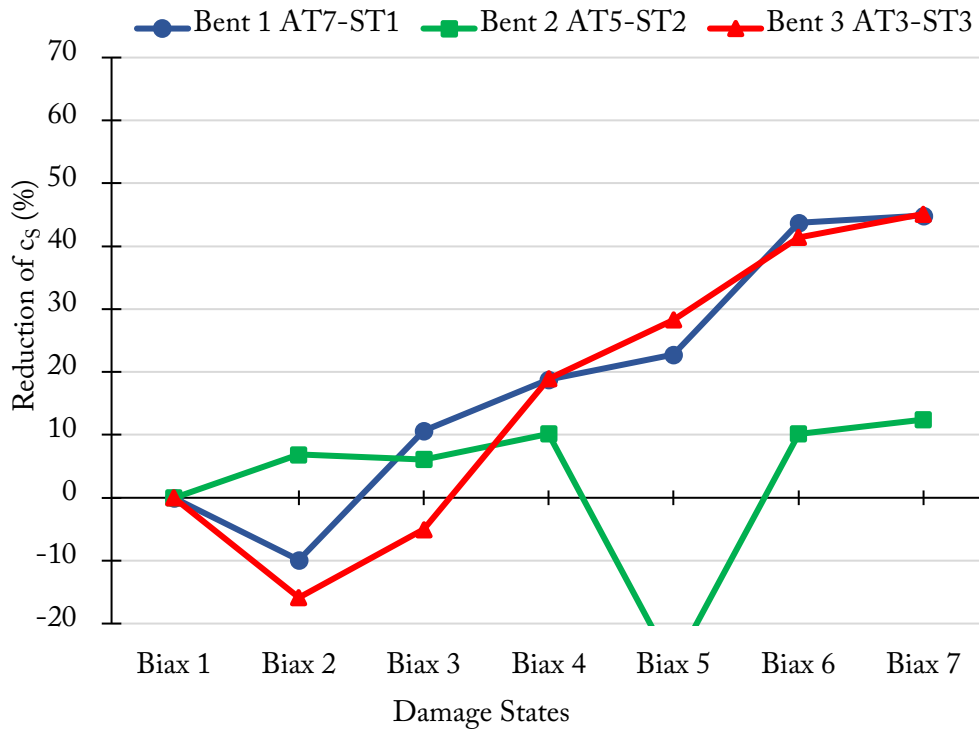
Figure 4.14. Percentage of Reduction in Shear Wave Velocity,  $c_s$ , for Actual Bridge

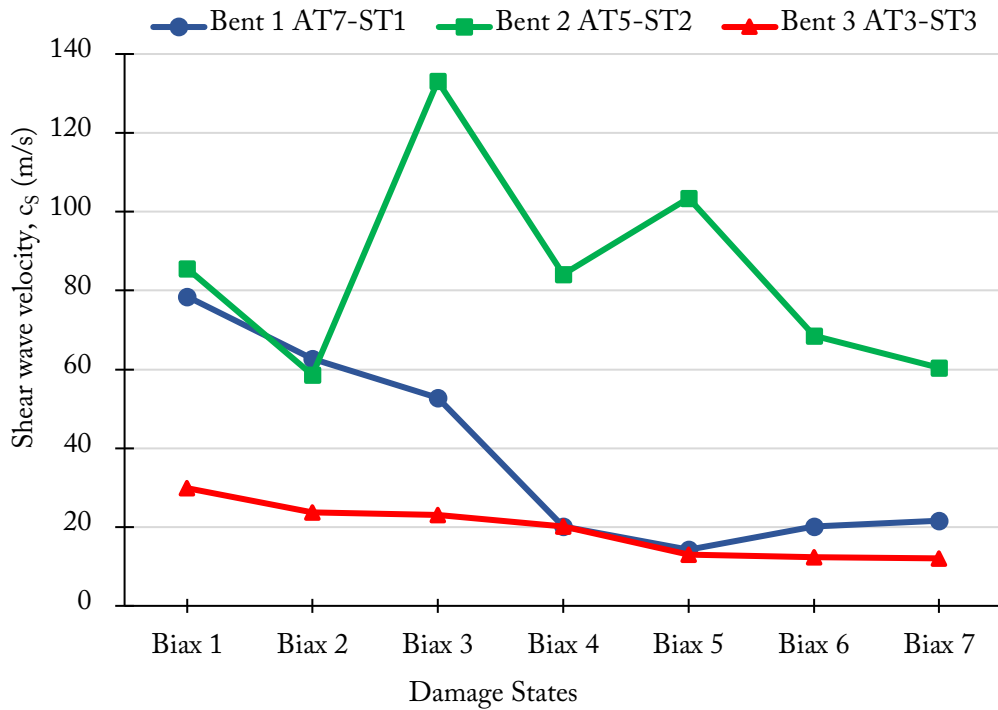
Figure 4.26. Shear Wave Velocity,  $c_s$ , from FEM Response

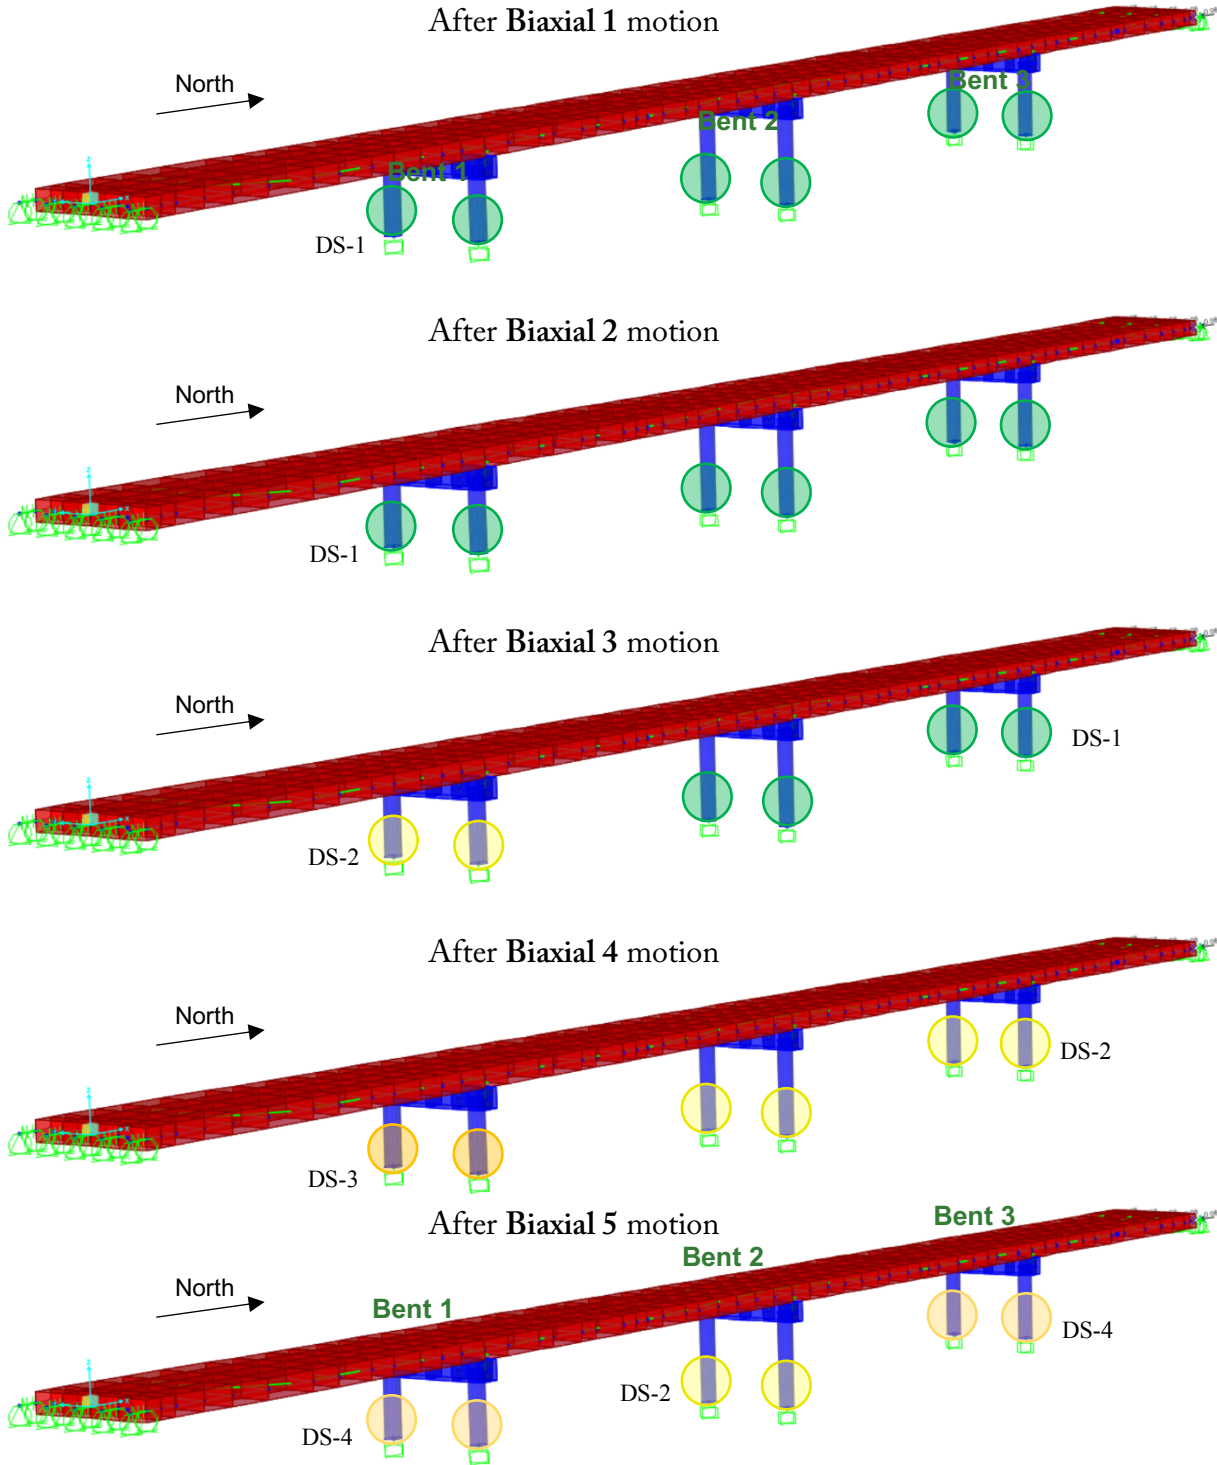
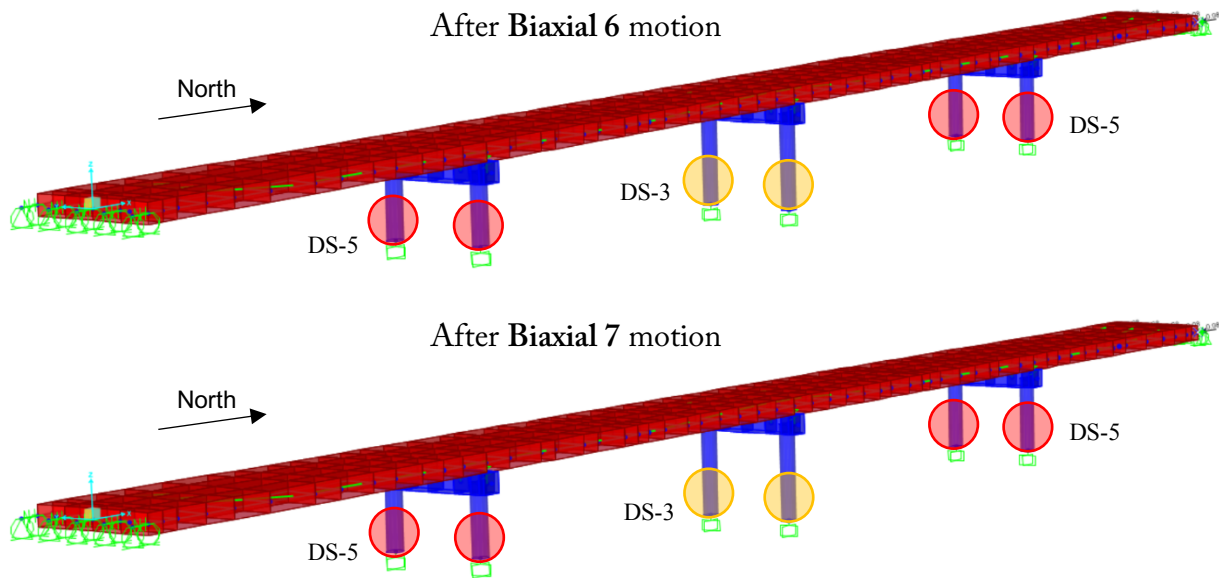
- DS-1: Minor flexural cracks
- DS-4: Visible lateral and longitudinal bars
- DS-2: First spalling and shear cracks
- DS-5: Imminent failure
- DS-3: Extensive cracks and spalling

Figure 4.30. Damage States Observed at the Three Bents of the Bridge After Each Biaxial Motions According to On-Site Damage Inspection Report by Nelson et al. (2007). The 3D Rendering as Schematic

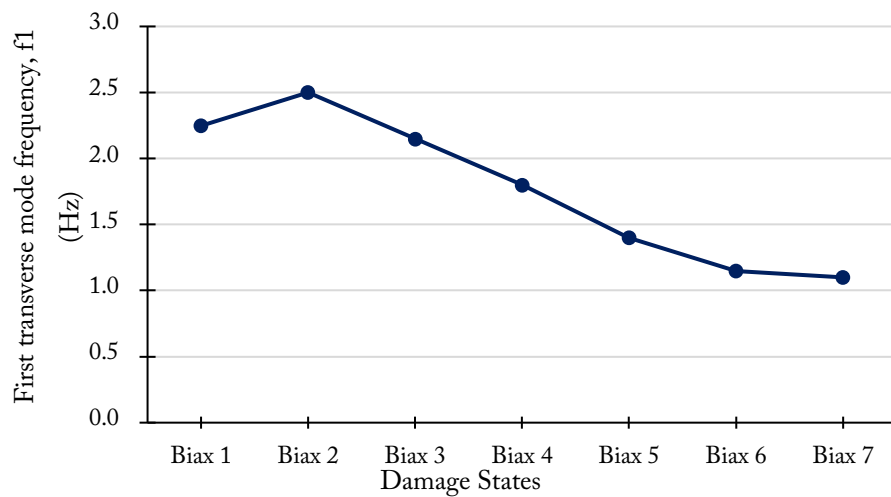
Figure 4.32. First Transverse Mode Frequency  $f_1$  from Actual Tested Bridge

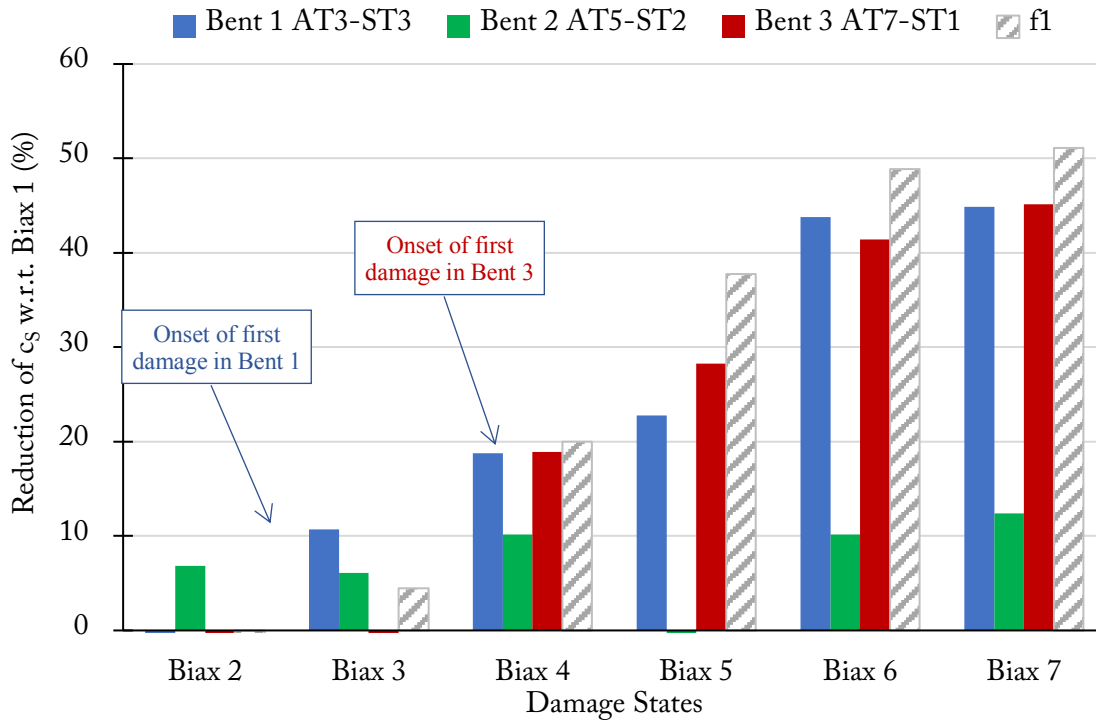
Note: First Transverse Mode's Apparent Frequency is Shown for Comparison

Figure 4.33. Reduction of  $c_s$  Three Bents of Actual Bridge

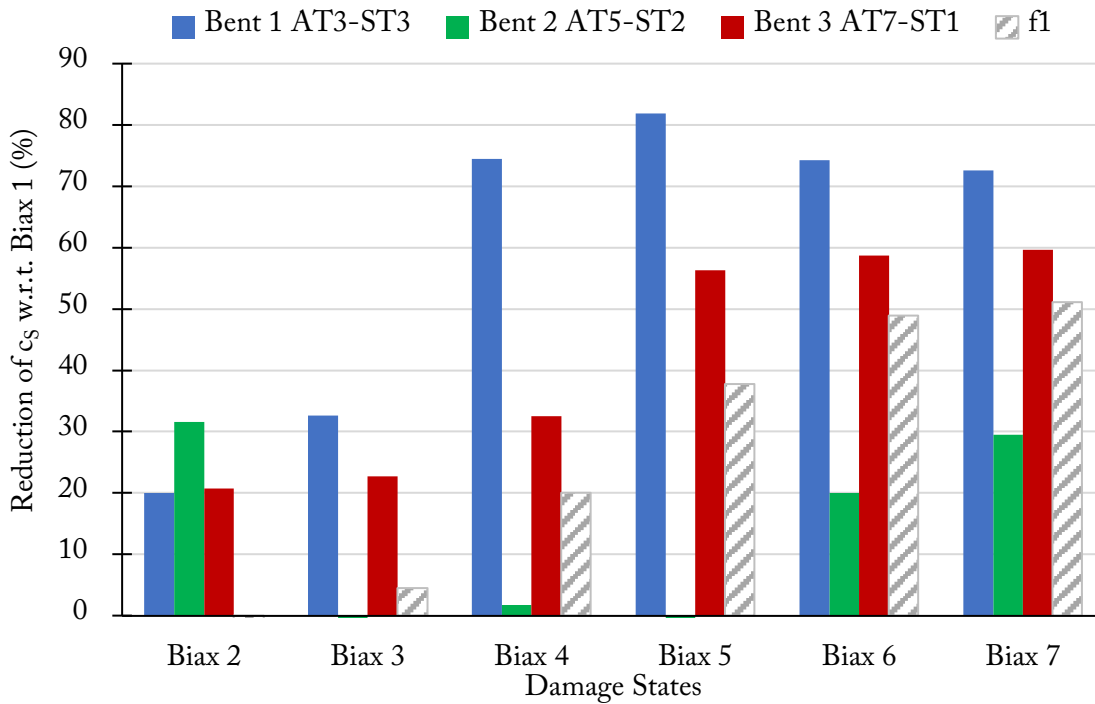
Figure 4.35. Reduction of  $c_s$  for Three Bents for FEM Response

2. Results for bents 1 and 3 are consistent with the hinge formation sequence in the FEM. Bent 1 was damaged first, followed by bent 3 from biaxials 3 to 7. At biaxial 4, the reduction in  $c_s$  for bent 1 is very large relative to bent 3. Investigating the hinge hysteresis results shows a reasonable correlation between the nonlinearity in the columns and the observed reduction in  $c_s$ .

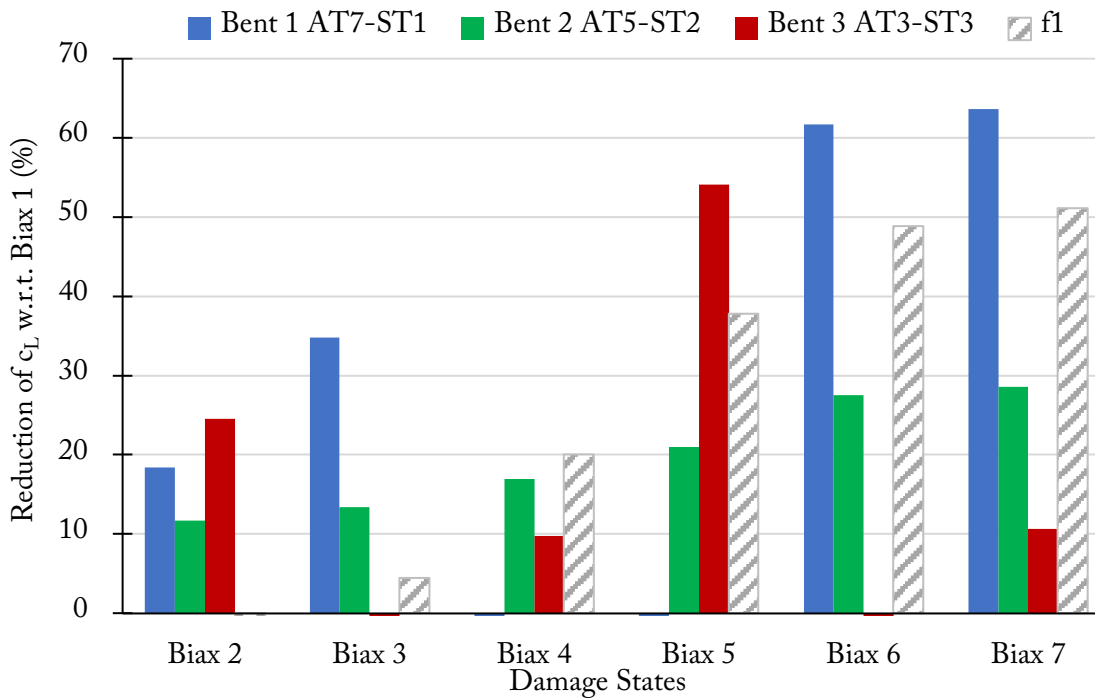
Figure 4.36 Reduction of  $c_L$  for Three Bents for FEM Response
