DOT/FAA/TCTN-22/27

An Analysis of State of Charge in Lithium-ion Batteries

Technical Note

| 16. Abstract In February 2022, a package containing 140 lithium-ion pouch cells caught fire on a conveyor belt in a sort facility of an all-cargo airline. One of the packages in the shipment was sent to the Federal Aviation Administration's (FAA) William J. Hughes Technical Center for hazard evaluation. Specialized cell analysis equipment was used to determine the state of charge (SOC) of the cells in the package. The measurements revealed that the cells were approximately at a 70% SOC, exceeding the maximum allowable shipping limit of a 30% SOC for the transport of cells and batteries classified as "UN3480, Lithium-ion batteries (including lithium-ion polymer batteries)". It was hypothesized that the fire in this incident started when the terminals of two cells packaged together made contact, causing the cells to short circuit, overheat, and enter thermal runaway. Testing was conducted to validate this hypothesis and to evaluate the fire risk of these cells at various SOCs. Key findings include: <ul style="list-style-type: none"> • The cells tested at a higher SOC present a much higher f

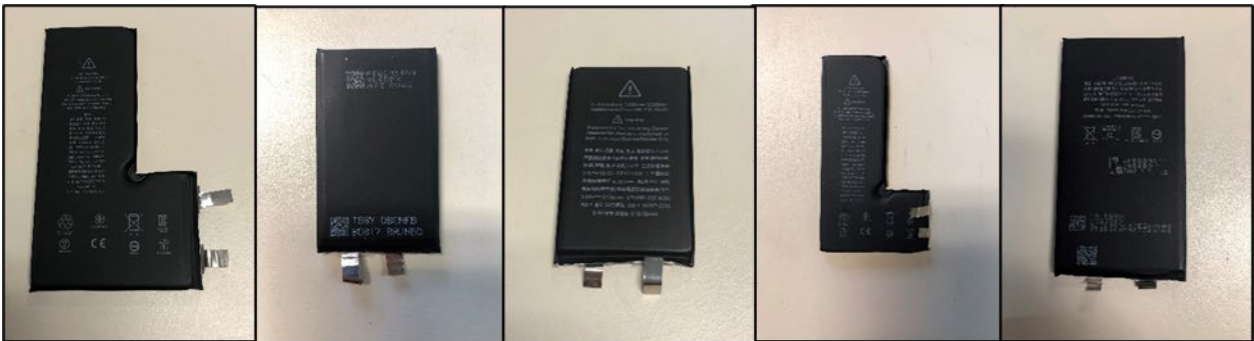
Figure 1. Battery Cells from left to right; 3.79V, 3.80V Cell #1, 3.80V Cell #2, 3.83 L-Shaped, 3.83 Square

A total of 140 pouch cells of five different types; 3.79V, 3.80V Cell #1, 3.80V Cell #2, 3.83V L-Shape, and 3.83V Square were shipped to the Federal Aviation Administration’s (FAA) William J. Hughes Technical Center. Figure 1 shows pictures of each cell. The cells were used for replacements of various iPhone models including the iPhone 11 Max, iPhone XS Max, iPhone 11 Pro and iPhone 12 Pro ®. Due to the lack of information found during internet research, it was determined that the cells were not from the original equipment manufacturer (OEM).

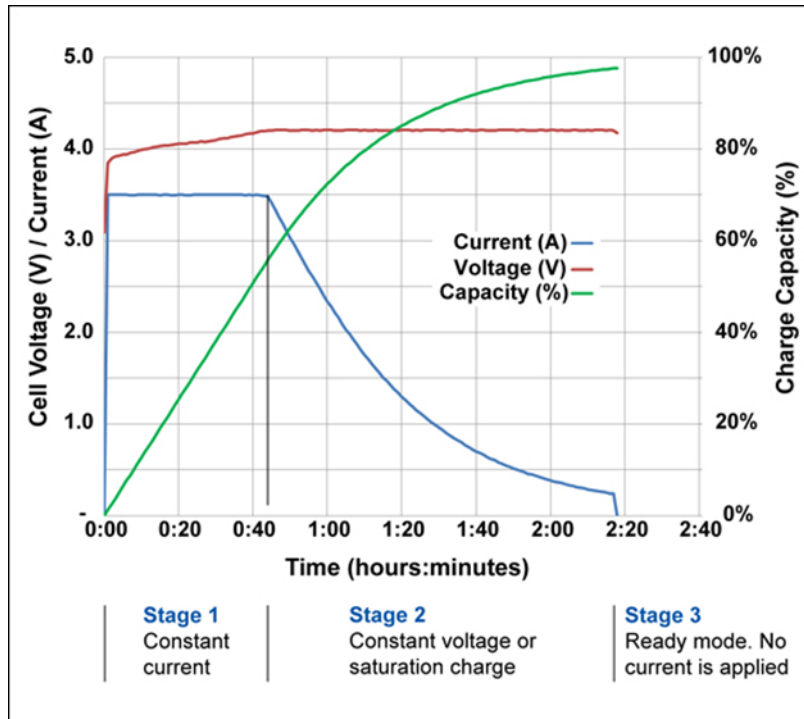
Figure 3. CC-CV Charging Method

A sample size of twenty cells were evaluated, in which four batteries of each type (3.79V, 3.80V Cell #1, 3.80V Cell #2, 3.83 Square, and 3.83 L-Shape) were charged using a Constant Current – Constant Voltage (CC-CV) charging method. In this method, constant current (CC) was used to charge the cell until the voltage reached the maximum charging voltage value, then the charging process shifted to constant voltage (CV) charging. In CV, the cell was charged at the maximum charging voltage value and the current decreased until it reached the minimum current termination value. A CC-CV charging method is standard for lithium-ion cells/batteries. An example of this charging method is shown in Figure 3 (Buchmann, 2017).

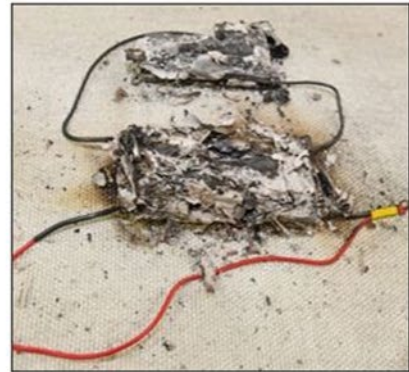
Figure 7. Peak reaction and post-test damages of each cell stack

The 30% cell stack released very little smoke and minimal damage was present in the post test analysis. Only the 3.80V cells showed signs of some damage presenting as slight swelling in the cells. It is common for damaged lithium-ion pouch cells to swell if damaged or overheated.

There were no visible signs of damage to the 3.79V cell. No signs of flame or burn damage were present in this 30% SOC stack. Since only the 3.80V cells showed signs of damage and the 3.79V cells did not, this suggests that the heat was not able to propagate to the top cardboard container.

The 70% SOC stack went into thermal runaway and released a significant amount of smoke and gas. Additionally, there was a small amount of flame present within the interior of the packaging. There were signs of thermal propagation, as all cells within the stack experienced thermal runaway at different times during testing. Charring and burn damage were observed in both the cells and surrounding packaging during the post-test analysis.

The 100% SOC stack experienced thermal runaway and a significant amount of smoke, gas and flames were released. As the 3.79V cell underwent thermal runaway, the surrounding gas ignited and large flames were released. There was clear evidence of thermal propagation and the packaging and cells for all containers were completely destroyed.

Images of the peak reaction for each stack and the damages for each SOC stack is shown in Figure 7.

High SOC cells were more likely to have more violent reactions in the event of thermal runaway. The 70% and 100% SOC stacks consistently produced both flame and smoke, whereas the 30% SOC stack released very little smoke and no flame. Furthermore, cells charged to a higher percent were more likely to propagate to nearby cells. Burn damages were present for all cells and cardboard packages for the 70% and 100% stacks, but only the 3.80V cells showed any signs of damage in the 30% stack. This was consistent with previous FAA testing (Webster, et al., 2016).

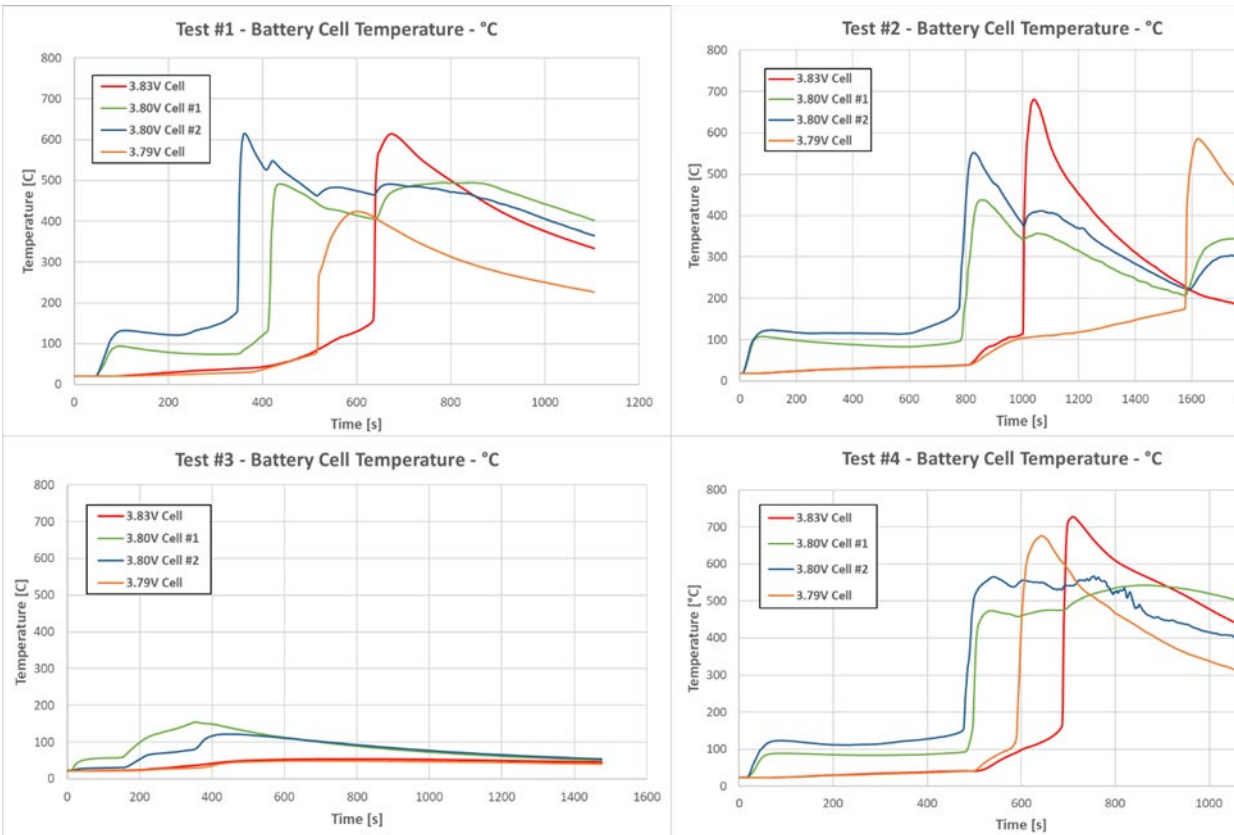
Figure 8. Cell Temperatures

The ability of the cells to reach thermal runaway was inconsistent between tests. In three of the four tests, all cells underwent thermal runaway and reached temperatures ranging from 400 to 700°C. The 3.79V and 3.83V cells, which had the highest capacities, had the highest overall temperature peaks. Figure 8 shows the temperatures of all cells throughout testing. The sudden increase in temperature indicates that a cell has reached thermal runaway.

It was observed that the as-delivered 70% SOC cells experienced some temperature propagation between cardboard containers. Furthermore, it was evident during testing that the cell within the top container had reached thermal runaway shortly after the bottom cells went into thermal runaway. This suggests that the batteries were at a high enough SOC in the initial package fire incident that the temperature from one thermal runaway cell had enough energy to propagate to other cells within the container.

The time needed for cells to reach thermal runaway was inconsistent throughout repeated testing. Throughout all four tests, the time from test to the initial thermal runaway event varied between six minutes to thirteen minutes. Once the initial cell achieved thermal runaway, however, the temperature was able to propagate to surrounding cells and cause them to enter thermal runaway within a few minutes.

In Test #1, the first cell was able to reach thermal runaway within the six minutes of testing and the temperature was able to propagate to all other cells in the stack within a five-minute period.

In Test #2, the first cell did not achieve thermal runaway until almost thirteen minutes into testing during which both 3.80V cells experienced thermal runaway. The temperature was able to propagate to both the top and bottom container, but it took an additional thirteen minutes for the 3.79V Cell to reach thermal runaway. This was a much longer time period compared to other tests, as it typically took less than five minutes for the temperature to propagate.

In Test #3, none of the cells experienced any thermal runaway events. Approximately five minutes into the test, 3.80V Cell 1 reached a max temperature of 150°C, but no other cells exceeded this temperature. No flame and very little smoke were visible for this particular test. A post-test analysis showed no signs of burn damage to the cells or surrounding container, however

both 3.80V cells were bloated which indicated that the internal components of the cells were damaged from high temperatures experienced during testing.

A thermal runaway event occurred in all cells for three of the four 70% SOC stack tests conducted. In those three tests, all cells underwent thermal runaway and reached temperatures ranging from 400 to 700°C. Cells at 70% SOC produced enough heat to propagate to other cells within the container. The results of this testing indicates that it is likely the original fire started and spread when two of the 3.80V cell terminals made contact.
