Federal Railroad
Administration

RR 22-25 | September 2022

FEASIBILITY OF SPECIAL TRACKWORK INSPECTION USING ULTRASONICS

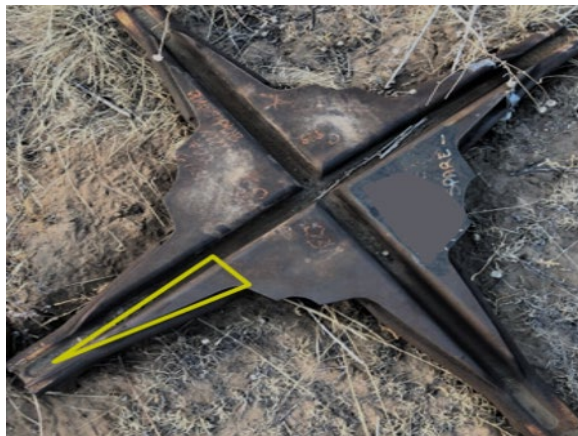
Figure 2. Crossing diamond, yellow triangular wedge shape shows the cut made

Figure 2 shows a spare new AMS crossing diamond casting TCI used for this study.

A small piece was cut out to generate a wedge-shaped sample from this casting. Several through-holes were then drilled into this wedge-shaped test sample for the ultrasonic NDE study. Also, a small piece of the sample was cut out and analyzed for the microstructural analysis and micro-hardness measurement. Figure 3 shows the engineering drawing of the crossing diamond wedge sample with drilled through-holes of different diameters drilled at different depths from the surface of the sample.

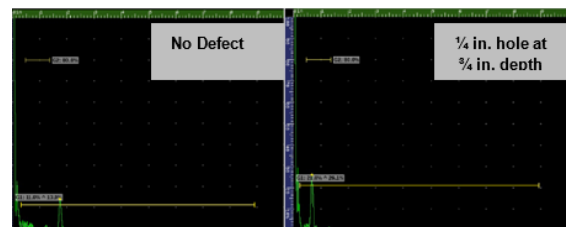
Figure 7. 2.25 MHz UT results in crossing diamond sample

Reflectors were large enough to produce a detectable signal echo. Signals were clear for the holes in the wider sections. In the narrow section (tip of the diamond sample), the footprint of the currently used transducer could influence the results; however, some echoes were visible. Next, a 2.25-MHz test was conducted, with Figure 7 showing the results. The ultrasonic signal response on the 0.75-inch (19 mm) depth through-hole was about 26 percent and the signal echo was detectable. The low-frequency UT findings demonstrated that utilizing low-frequency UT NDE methods could be useful for characterizing internal flaws in crossing diamond samples that have coarse grain structures
