# Magnetic Flux Leakage Device for Evaluation of Prestressed Concrete Box Bridges

Final Report VTRC 20-R14

**FINAL REPORT**  
**MAGNETIC FLUX LEAKAGE DEVICE FOR EVALUATION OF PRESTRESSED  
CONCRETE BOX BRIDGES**

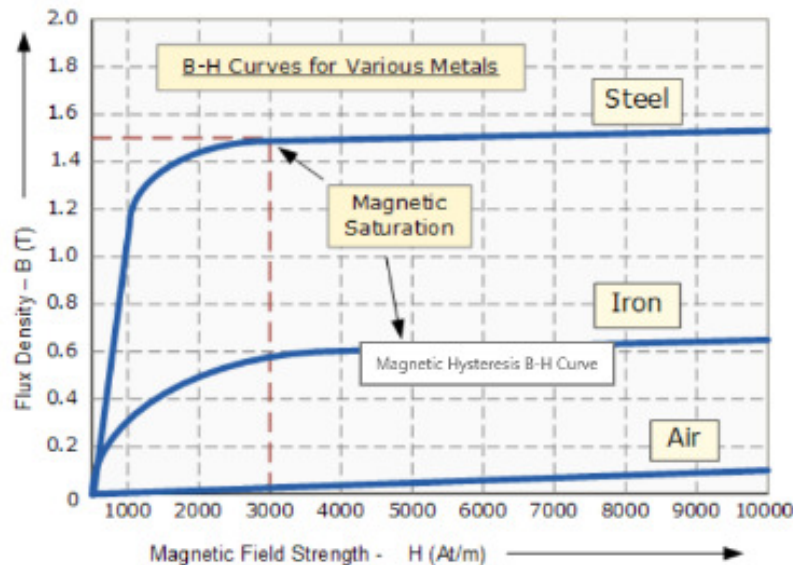
Figure 1. Characteristic Magnetization Curves. B= flux density; H = magnetic field strength.

Ferromagnetic materials, such as steel, exhibit a highly nonlinear relationship between the strength of the magnetizing force and the corresponding flux density. The relationship between magnetizing force, measured in units of ampere-turns, and magnetic flux density, measured in teslas (T), is somewhat analogous to the stress-strain curve relationship familiar to most civil engineers. Some typical magnetic field strength flux density curves for different materials are shown in Figure 1.

Magnetic saturation, where there is no further increase in flux density with an increase in magnetic field strength, is clearly observed for steel. The key to a successful MFL application is to saturate the magnetic material. With saturation, significant leakage of flux will occur if metal is lost. Steel becomes saturated in a magnetic field with a flux density of approximately 1.4 T. It is assumed that prestressing strand has the magnetization hysteresis properties of very low carbon steel.

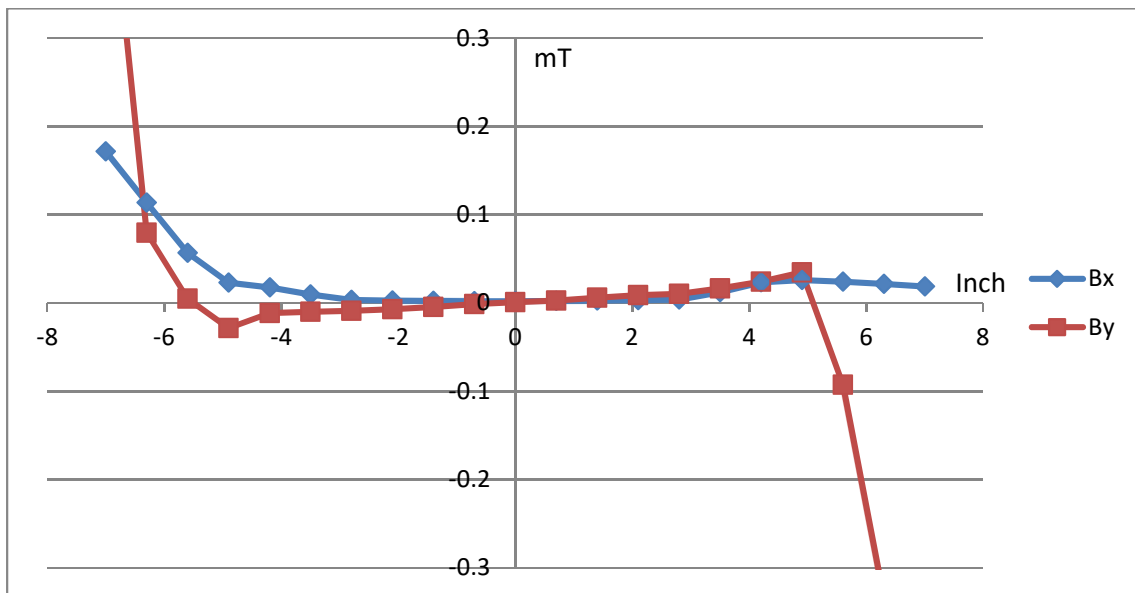
Figure 3. Longitudinal and Transverse Flux Density (mT) Along Length (in) of Intact Strand

The magnetic flux density in both the x and y directions will be measured close to the surface of the concrete by an array of Hall effect sensors. These sensors are quite sensitive and able to provide an analog voltage proportional to the magnitude and polarity of these fluxes. The  $B_x$  (the flux density aligned in the direction of the strand) and the  $B_y$  (the flux density perpendicular to the strand) will be measured. The variation in the values of these fluxes from the 2D simulation for an intact strand is shown in the y-axis in Figure 3, along the length of the strand represented by the x-axis, where the two magnets were placed 12 in apart, equidistant from the origin.

Many simulations were performed using ANSYS 19.0 finite element software by ANSYS, Inc. Simulations were performed for different magnets with various strengths and for different damage scenarios. The responses in the magnetic flux for different degrees of damage in the prestressing strands are shown in Figures 15 through 17. The MFL that occurs between the strand and the magnets will be captured using Hall effect sensors, as initially shown as simplified plots in Figures 3, 5, and 7.

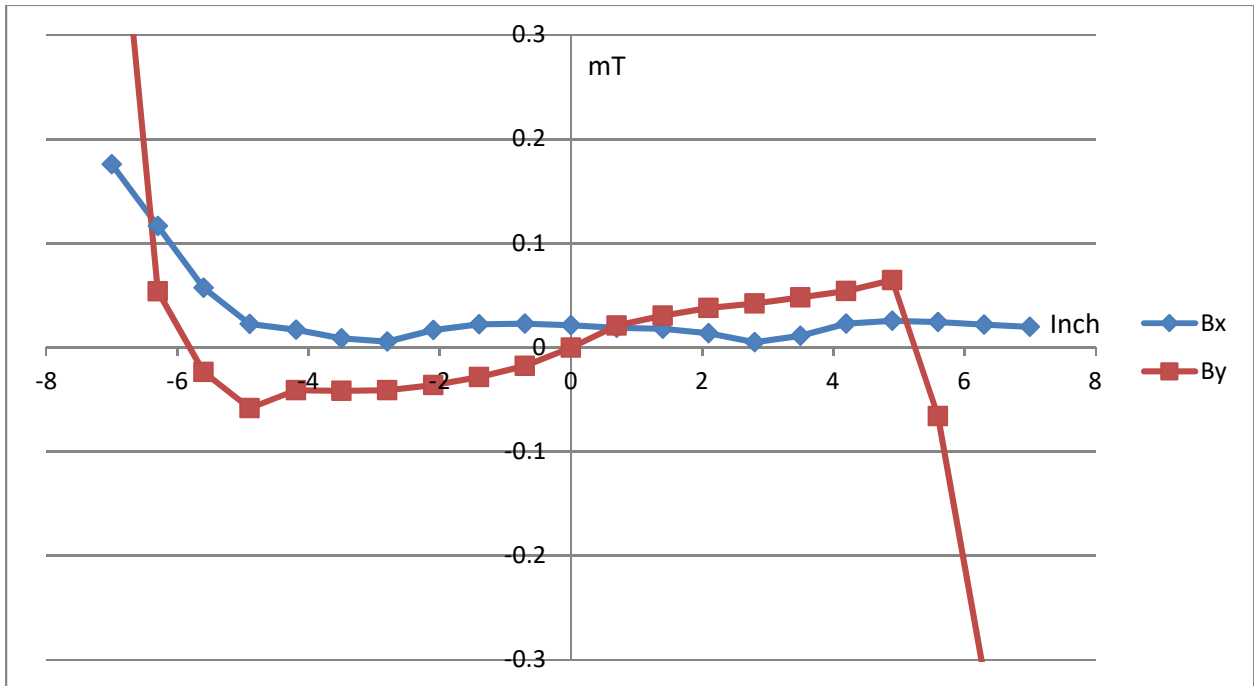
Figure 5. Longitudinal and Transverse Flux Density (mT) Along Length (in) of Broken Strand

For a broken strand, there is very significant flux leakage, as shown in Figure 4. Similar to Figure 3, the flux values for a broken strand, which would be measured by the Hall effect sensors, are shown in Figure 5.

There is a characteristic increase in the magnitude of the flux in the y direction with a much lower change in the x direction. The location where the polarity of  $B_y$  changes is related to the relative location of the break with respect to the sensor array.

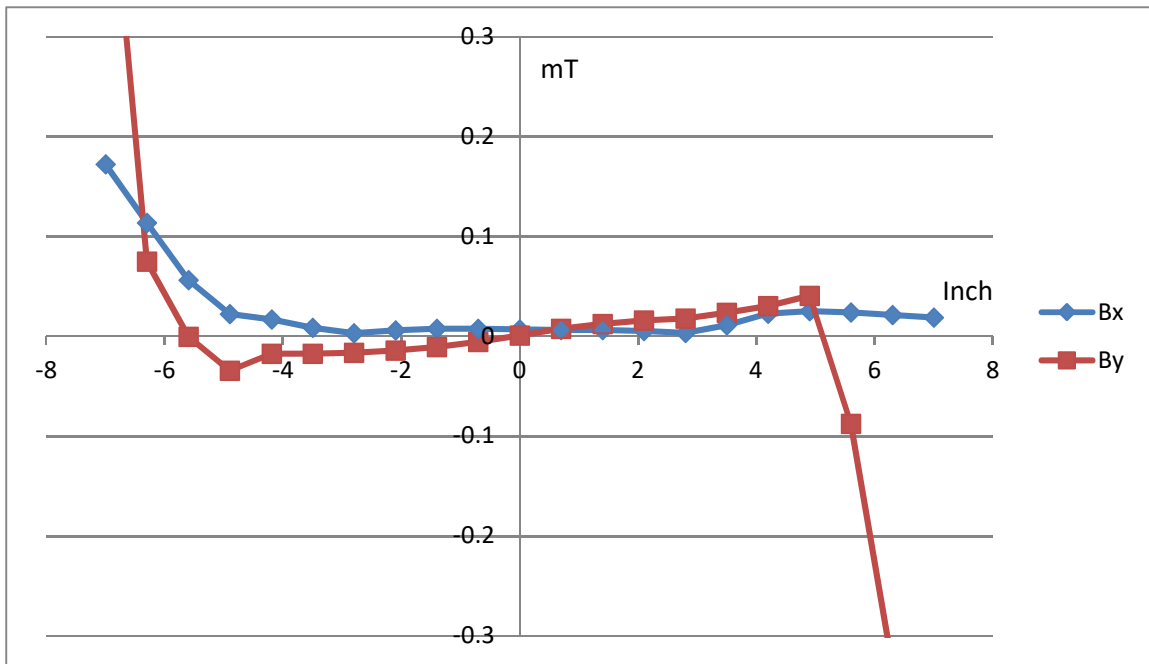
Figure 7. Longitudinal and Transverse Flux Densities (mT) Along Length (in) for 40% Section Loss

A strand with some loss of section but not yet broken will present indications that are intermediate between the two extremes described. A simulation was performed for a strand with a 40% section loss. The results are shown in Figures 6 and 7.

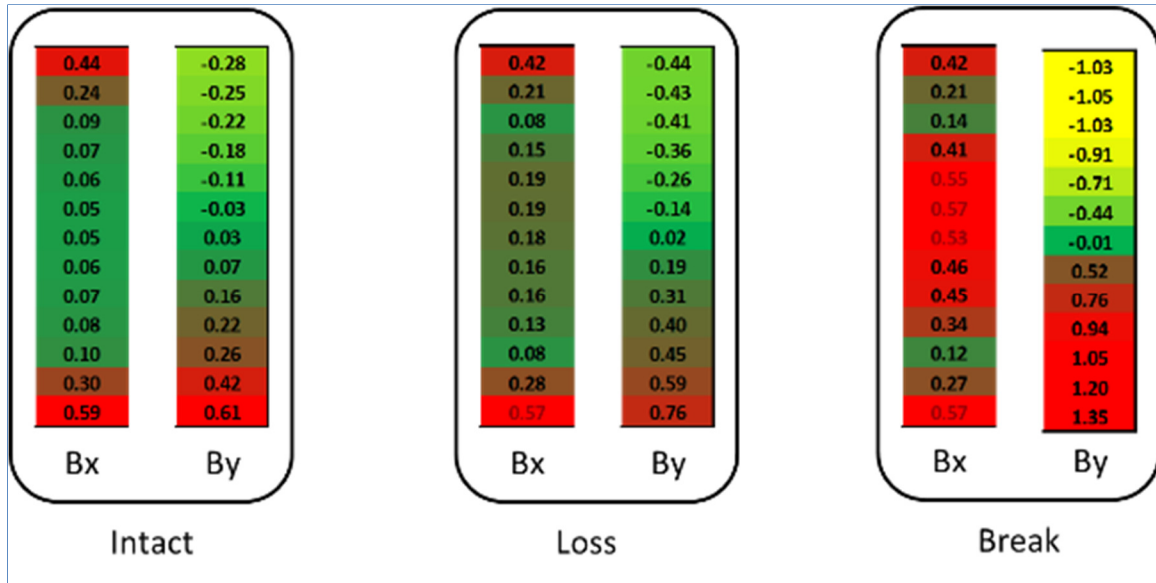
Figure 8. Conceptual Test Indication of Magnetic Flux Densities (mT)

It would be advantageous for a MFL device to have a self-containing, user-friendly interface, which would eliminate the need for a computer during routine inspections. By coupling the individual Hall effect sensor modules with a color-coded bar display, a characteristic pattern could be presented when the MFL device is positioned directly over a broken strand. This would require further design, but the concept is illustrated in Figure 8.

Such a display would provide an indication to the inspector, which would be very easy to interpret. The device would also have the capability of interfacing with a laptop computer for more accurate and quantitative scanning to follow up on such indications.

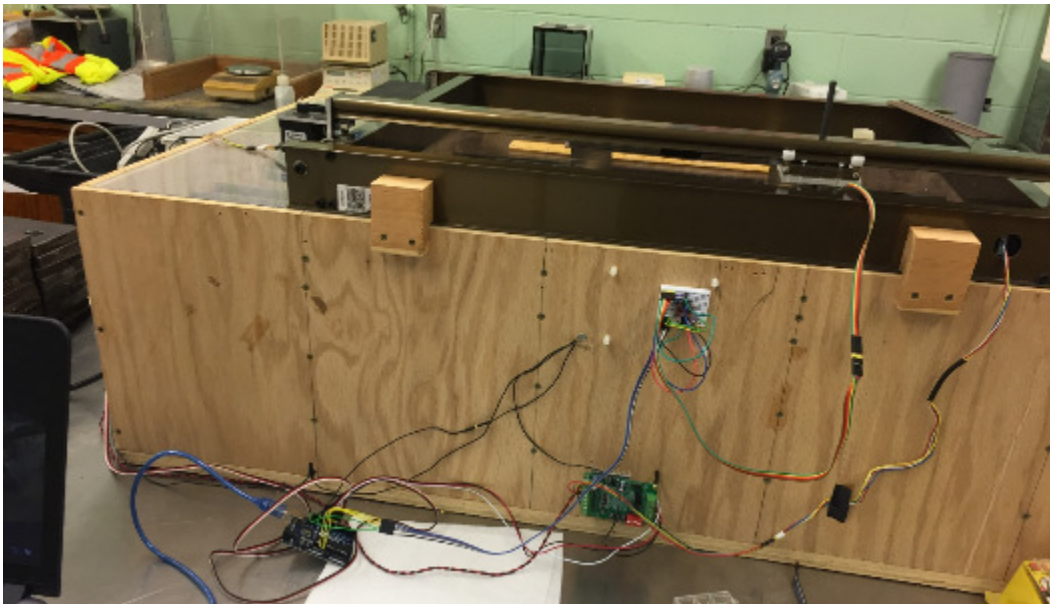
Figure 9. Magnetic Flux Leakage Inspection System Test Fixture

A test fixture was designed and implemented to simulate a typical prestressed box beam. The test fixture consisted of a plywood box 2 ft wide, 4 ft long, and 1 ft deep. A layer of ½-in-diameter prestressing strands, spaced at 2 in, was placed so that the distance from the top of the fixture to the top of the strands was 2 in. The strands could be removed and adjusted in the fixture. One of the strands was intentionally damaged in such a way as to allow replicate damage scenarios ranging from an intact strand to a strand with six fully broken wires.

In addition to this mockup of a box beam, an x-y scanner was designed and fabricated, which enabled programmable 2D movement of a magnetic field sensor, using a 2D x-y plotter purchased for this purpose. In addition, a power supply, stepper motor controllers, and a microcontroller were purchased and integrated into a complete scanning system.

Images of the test fixture are provided in Figures 9 and 10.

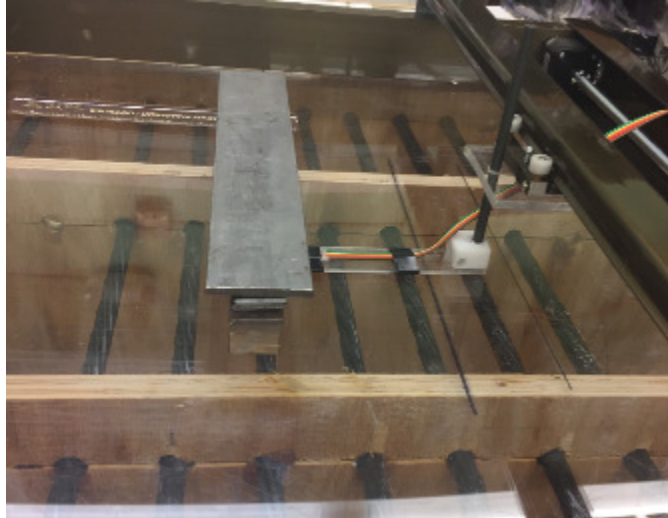
**Figure 10. Magnetic Sensor and Magnets**

A magnetic field sensor was also integrated into the test fixture. Several magnetic sensors were evaluated, and the TLV493D 3-axis magnetic field sensor was selected for this test fixture. This sensor provided the ability to measure the three components of the magnetic field with high precision and accuracy.

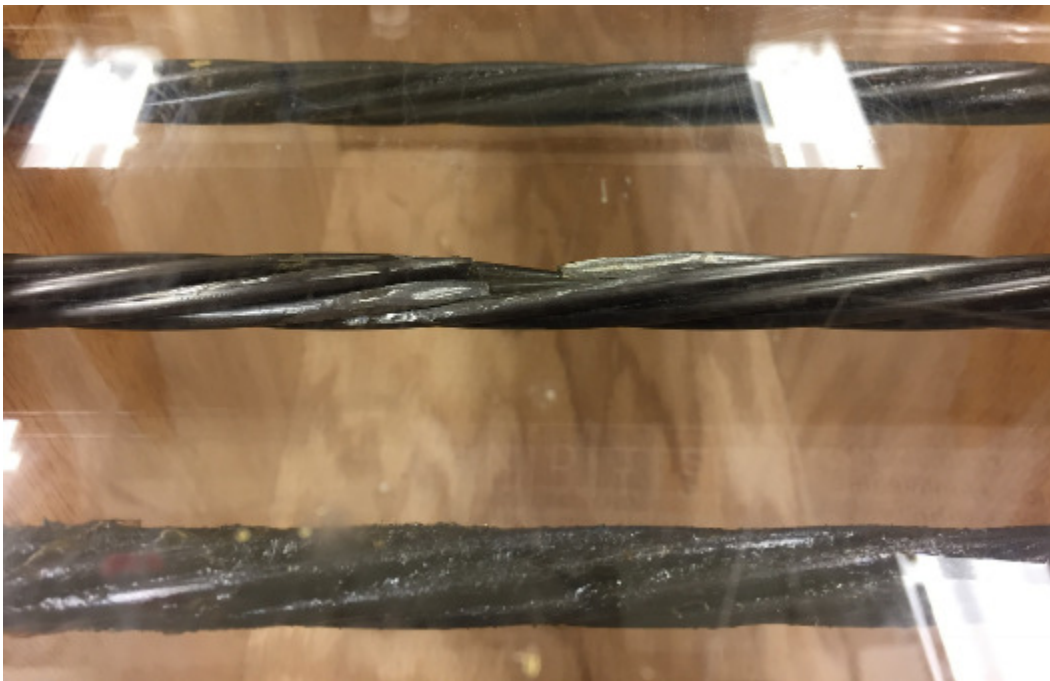
**Figure 11. Strand With Gradual Section Loss**

The tests performed with the test fixture measured the three-dimensional (3D) magnetic field at a resolution of approximately 0.1 in. Measurements were performed for seven damage scenarios. The scenarios ranged from intact strand to strand with six fully broken wires. The helical nature of the wires in a typical seven-wire strand enabled the same strand to be used to produce all seven of the damage scenarios. An image of strand with two broken wires is provided in Figure 11. The tapered ends of the damaged wires are intentional. Previous studies have used sharply cut wires, and this abrupt change in metal cross section induces large flux variations. Observation of damaged strands from decommissioned bridges showed that a more gradual loss of metal, because of corrosion, is more typical.

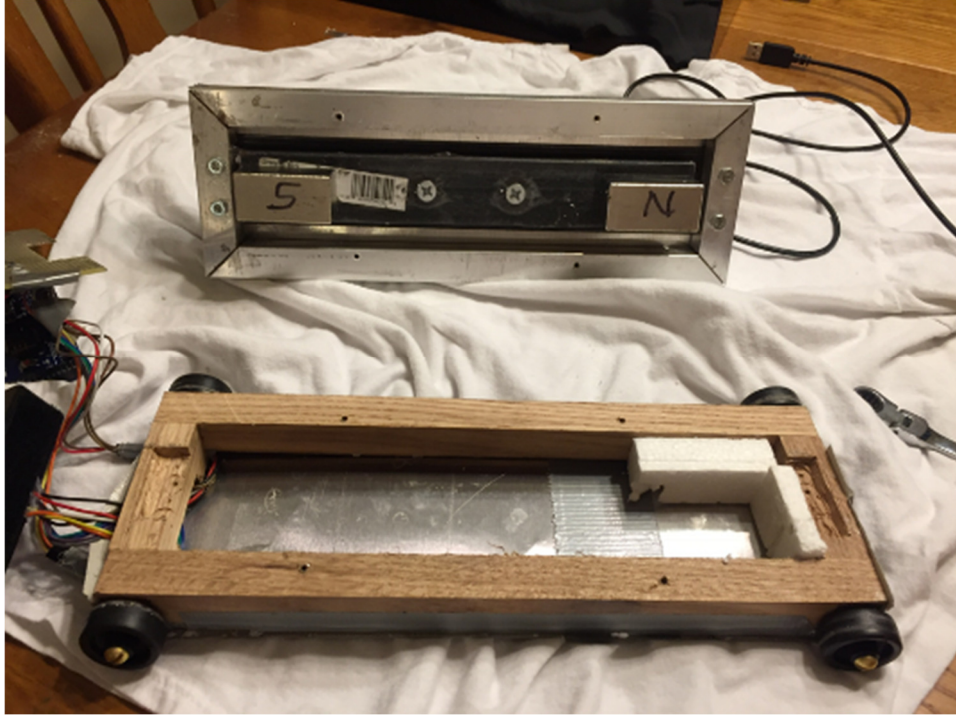
**Figure 12. Disassembled MFLIS Prototype Device. MFLIS = magnetic flux leakage inspection system.**

The prototype was built with two high-strength magnets mounted on a steel pole piece, a series of Hall effect sensors, a microcontroller module, and multicolor LED lights. The pole piece also served as a suitable support for the handle and a place to attach the housing. The housing was fabricated from non-magnetic materials (wood and aluminum). The magnets were positioned with about 6 in between the inside faces. The electronics consisted of a microcontroller module, a Hall effect sensor array module, and a multicolor LED array unit.

The prototype was fabricated in an upper and lower unit. The upper unit provides the main structural support and contains the magnets, the pole piece, a handle, and Velcro supports for the multicolor LED array. The lower unit consists of a wooden frame and the electronics. The electronics include the microcontroller module, the Hall effect sensor array module, and the multicolor LED indicator array. The unit is shown in Figures 12 and 13.

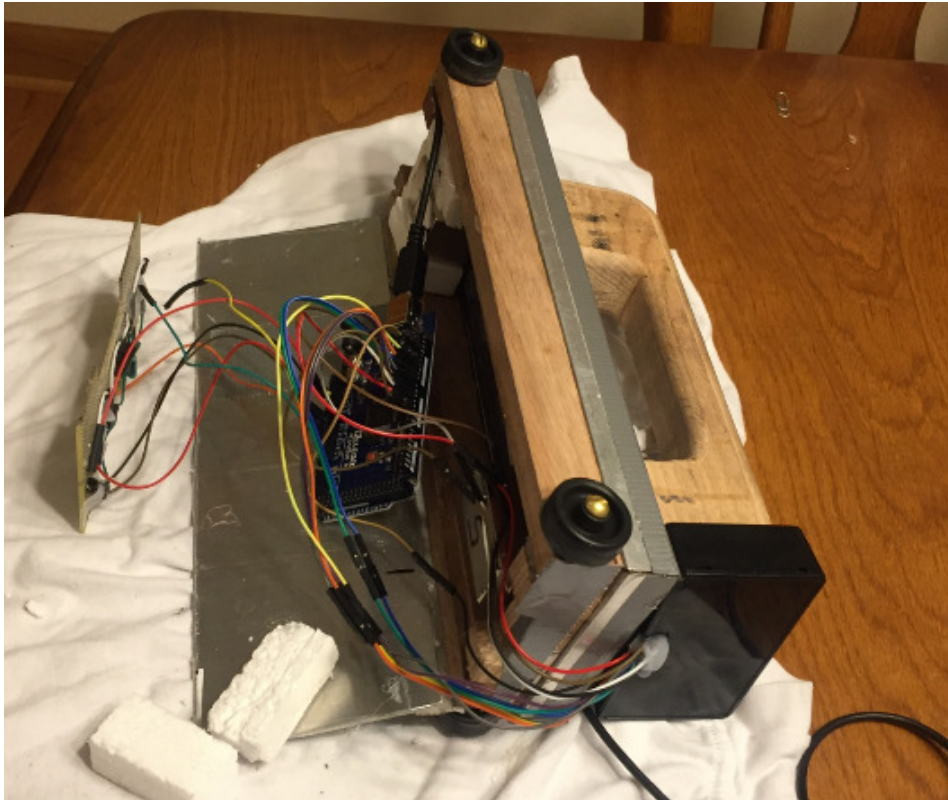
**Figure 13. Assembled MFLIS Device Before Bottom Cover Is Closed. MFLIS = magnetic flux leakage inspection system.**

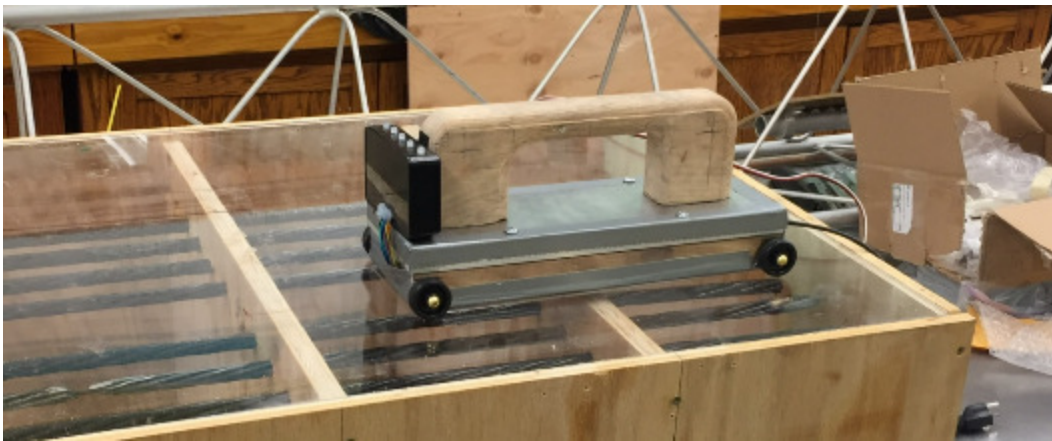
Figure 14. Prototype Tested on Mockup

The prototype was moved over intact and damaged strands to record the results, as shown in Figure 14.

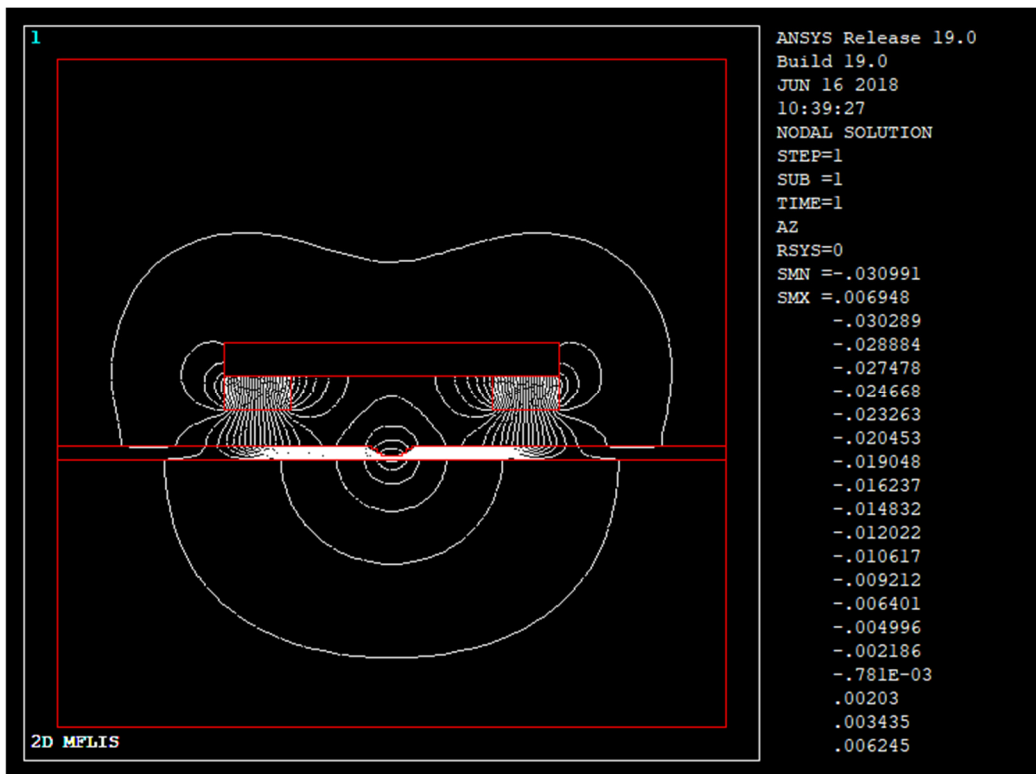
Figure 16. Flux Density With 75% Damage

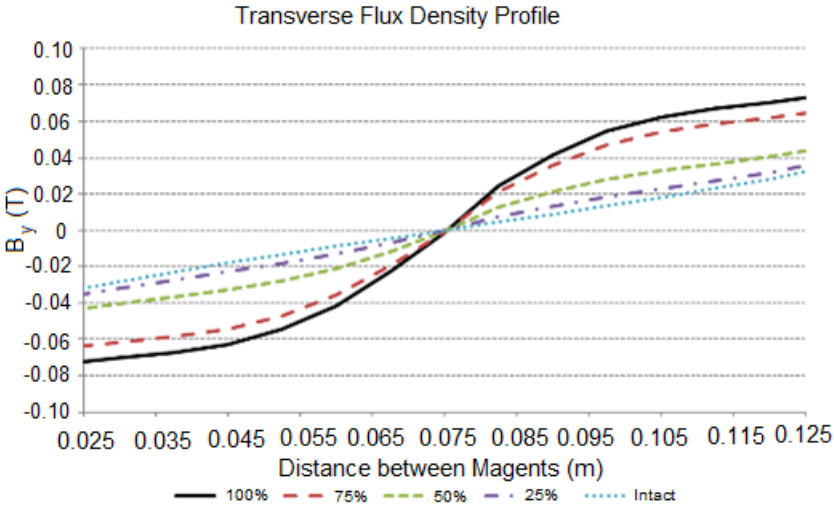
Figure 18. Flux Density Profile Between Magnet Faces for Percentages of Section Losses

It was observed that the flux leakage varied along the interval between the interior faces of the magnets. The transverse flux density in this interval was plotted for all of the different damage scenarios, and the results are shown in Figure 18.

The simulations indicated that there was a significant difference between the flux density profiles between the magnet faces. The differences in flux density values were also within the range of values that can reliably be measured with the available sensors. The results also suggest that the slope of the flux density profile near the center of the device might be a useful damage indicator.

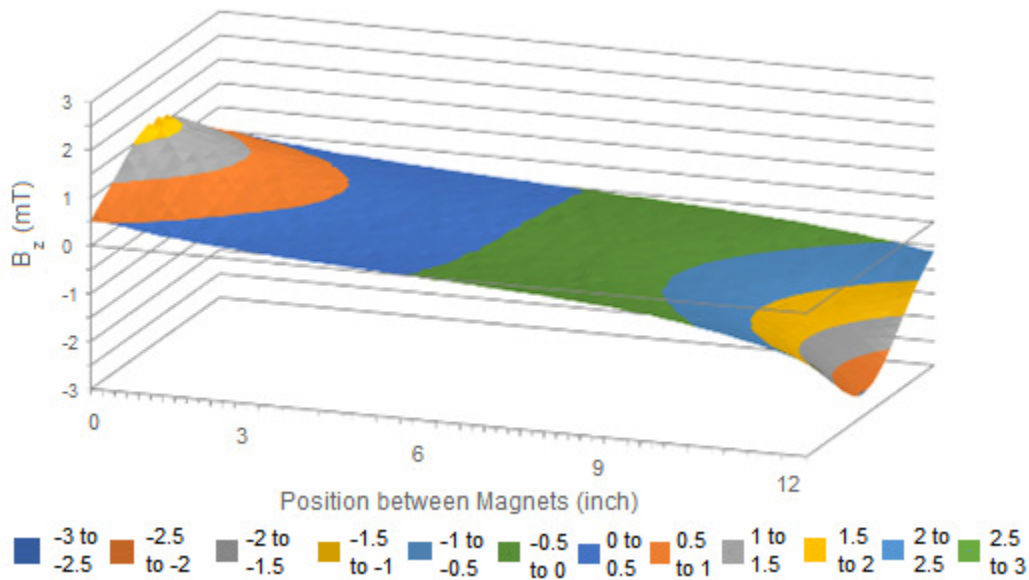
Figure 19. 3D Flux Density Field for Intact Strand

The laboratory test results provide measured 3D flux density field values for different damage scenarios. The sensor used provided flux density values in three mutually perpendicular directions. It was originally hypothesized that the additional data from all three axes would help detect damage by revealing previously unknown patterns in the flux density values in the presence of damage. However, it was found that the additional data did not reveal any useful patterns and that the transverse flux density profile was adequate to characterize the changes in flux density associated with damage. It was also noted that the profile of the transverse flux density had a maximum value between the magnets aligned with the maximum flux gradient. This is illustrated in Figure 19 for intact strand and in Figure 20 for a strand with six broken wires. The x-axis represents the distance between the two magnets.

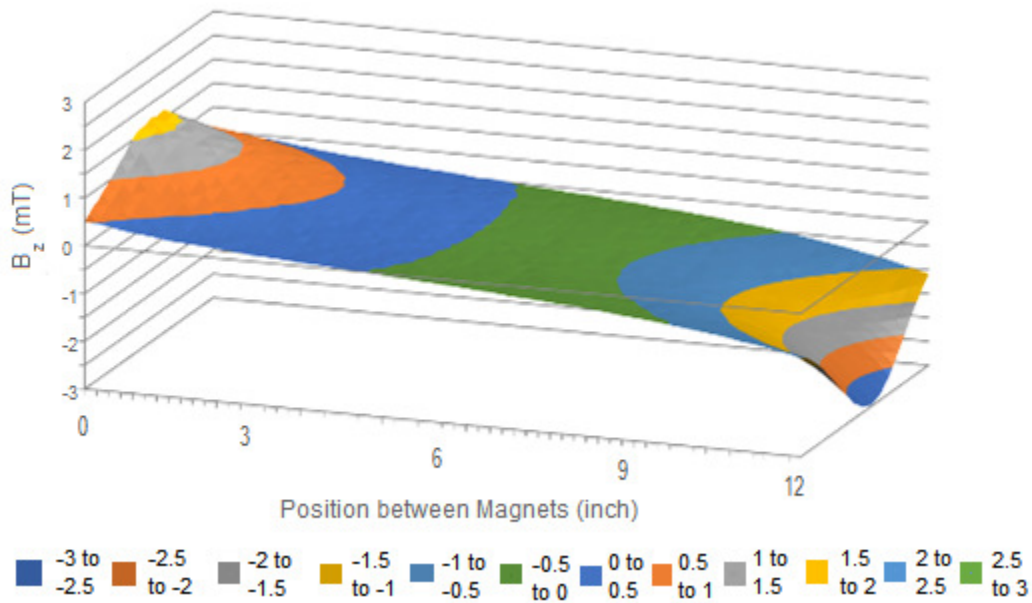
Figure 20. 3D Flux Density Field for Strand With Six Broken Wires

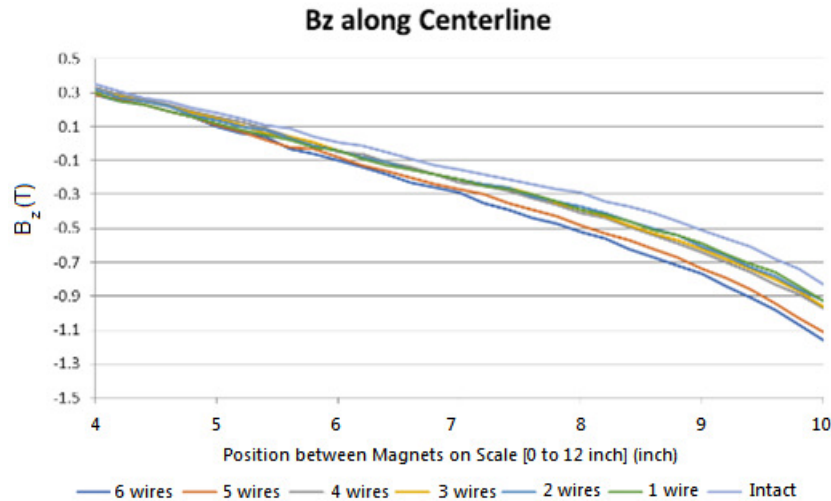
Figure 21. Profile of Measured Maximum Transverse Flux Density for Different Damage Scenarios

The maximum flux density profile for the different damage scenarios were determined, as shown in Figure 21. Only the negative segment of the curves are plotted in order to help show the differences between the curves. There is a slight offset along the x-axis in the curves because of slight differences in the initial position and the location of the damaged portion of the strand. The different tests required manual placement of the strand, and slight differences in the relative position of the damaged portion of the strand relative to the center of the test magnets are expected.

The maximum measured difference in flux density between an intact strand and a strand with six broken wires at position 50 was 0.28 mT. This was less than predicted by the finite element simulation, but it is still measurable with the Hall effect sensors used in the device.

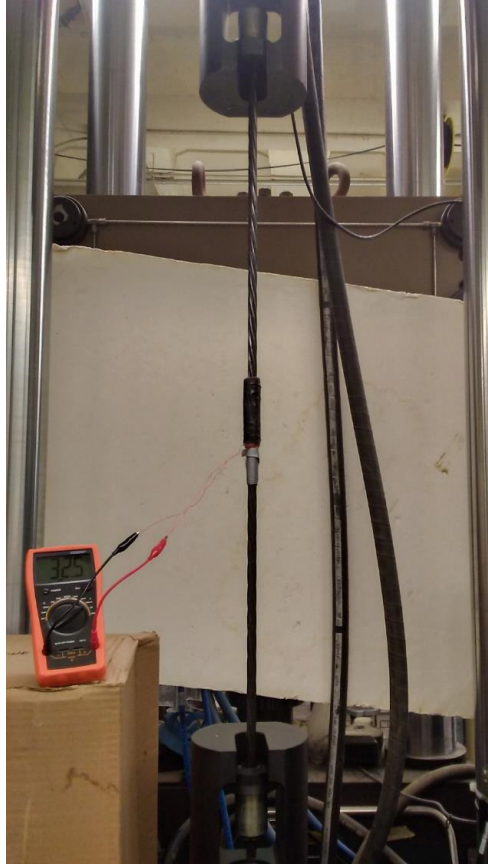
**Figure 22. Tensile Loading and Magnetic Permeability Measurement**

Magnetic properties of materials reduce with the presence of mechanical stress. The prestressed strands carry enormous mechanical stresses and thus will have different magnetic properties compared to unstressed strands. This will affect the results of MFL testing. Thus, a laboratory test of the effect of mechanical stress on the magnetic permeability of the strands was conducted, as shown in Figure 22.

A solenoid was placed around the strand during load testing to measure the inductance in the coil. Equation 1 shows the relationship between inductance in the solenoid coil and the magnetic permeability of the strand.

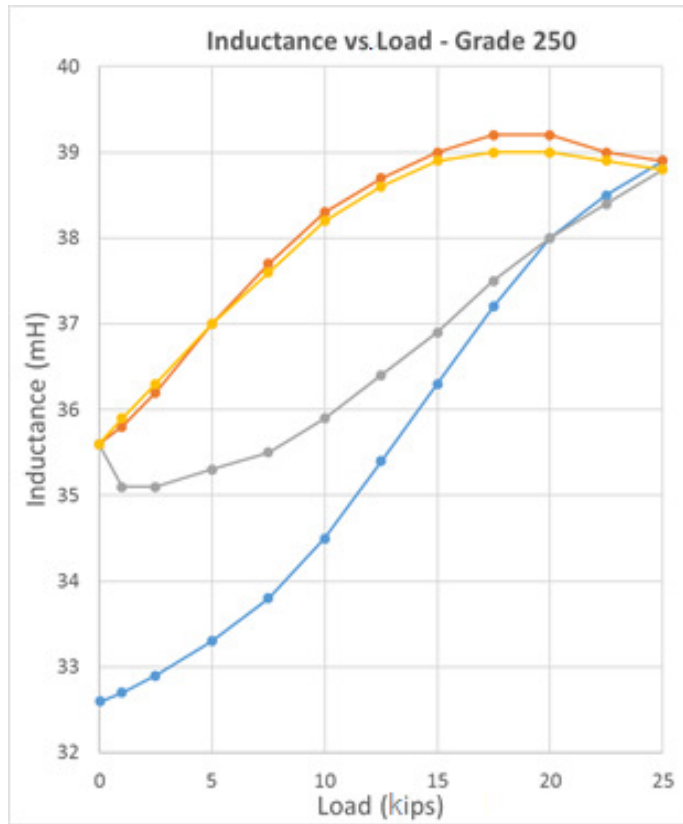
Figure 23. Stress and Magnetic Permeability of Grade 250 Strand

A Grade 250 strand and a Grade 270 strand were tested in this manner. The results are shown in Figures 23 and 24, respectively. The inductance started around 32.5 mH for both strands. When the strands were loaded gradually, the inductance increased, but with different magnitudes for the two strands, as indicated by the blue line. However, the shapes of the hysteresis loops were the same for both strands.

When loads reached 70% of the guaranteed ultimate tensile strength, the strands were gradually unloaded until there were no loads. It was observed that the inductance had permanently changed to a higher value, as shown by the difference between the starting point of the blue line on the left and the gray line. This is because of the change in the molecular structure of the strands caused by mechanical loading. When the strands were loaded and unloaded again, the inductance reached the same maximum value and came back to the same higher-low values. This shows that once loaded, the magnetic permeability can entirely change. This indicates that the magnetic flux readings should be taken in relative terms for better interpretation.

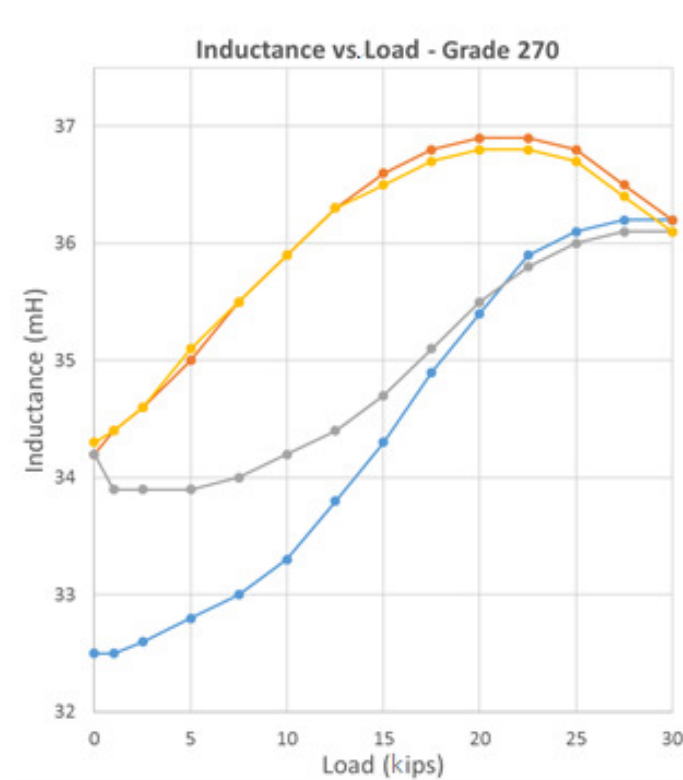
Figure 24. Stress and Magnetic Permeability of Grade 270 Strand

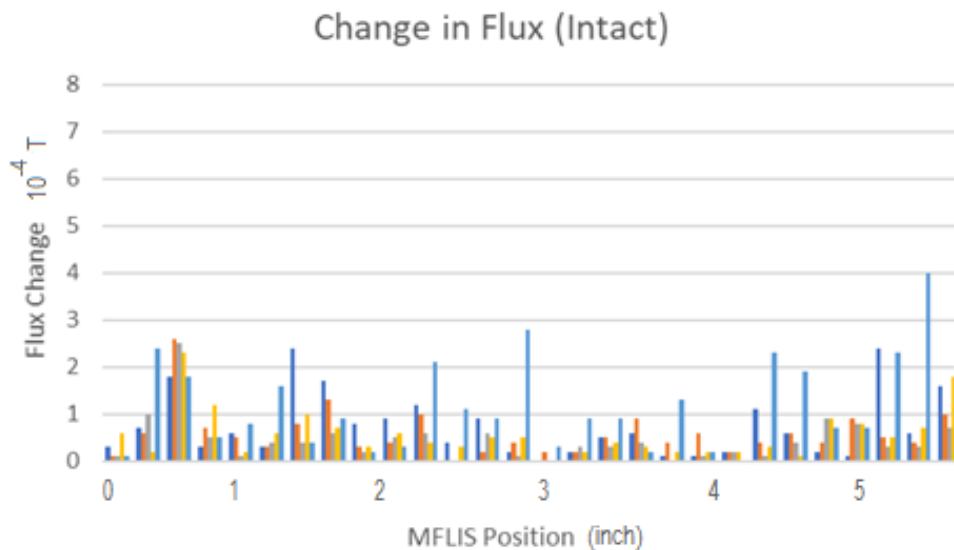
Figure 25. Localized Flux Change for Intact Strand. MFLIS = magnetic flux leakage inspection system.

The prototype device was used to scan the strands in the laboratory mockup. Damaged and intact strands were tested. The prototype was connected to a laptop computer, the measurements from the Hall effect sensors were recorded, and any indications on the multicolor LEDs were observed. The flux values varied along the strand, even for the intact strand. This was unexpected, although it could be explained by residual stress in the strand because of uncoiling, for example. The researchers decided to use the localized change in the flux relative device position as a damage indicator. Gradual changes in flux because of gradual permeability changes were eliminated, but flux changes because of localized corrosion damage were retained. This is illustrated in Figures 25 and 26. The plots show lines of five different colors indicating the five Hall effect sensors as the device was moved across the length of the strand. Since the overall response at the Hall effect sensors was of interest and any specific reading from a Hall effect sensor was not useful for this technique, the colors were chosen arbitrarily.

It can be noted that localized flux changes have much lower values for intact strand relative to damaged strand. It was possible to locate the damaged portion of the strand by observing when the localized flux change exceeded a threshold value. A threshold of  $5 \times 10^{-4}$  T was selected for the change in flux as the severe damage threshold value based on these laboratory tests.

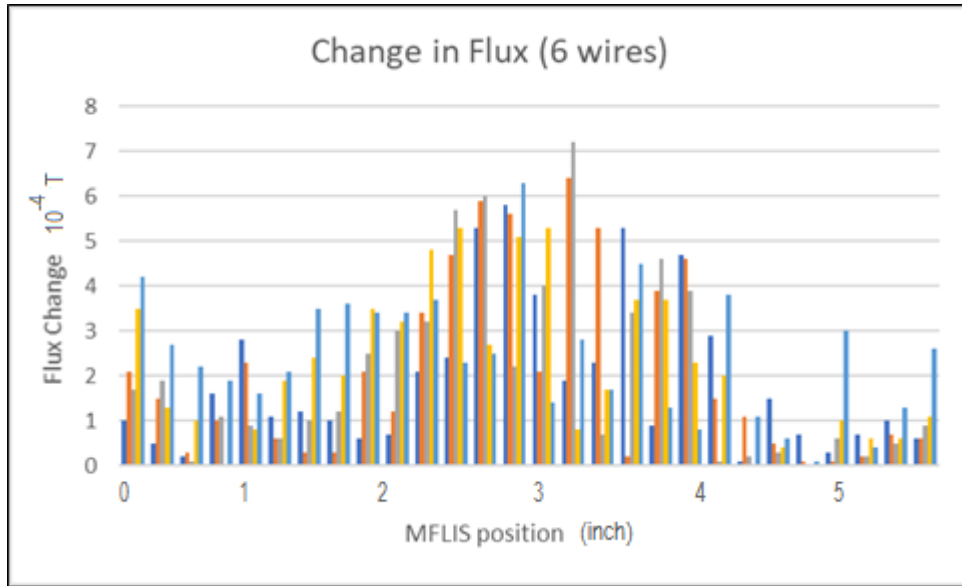
**Figure 26. Localized Flux Change for a Strand With Six Broken Wires. MFLIS = magnetic flux leakage inspection system.**

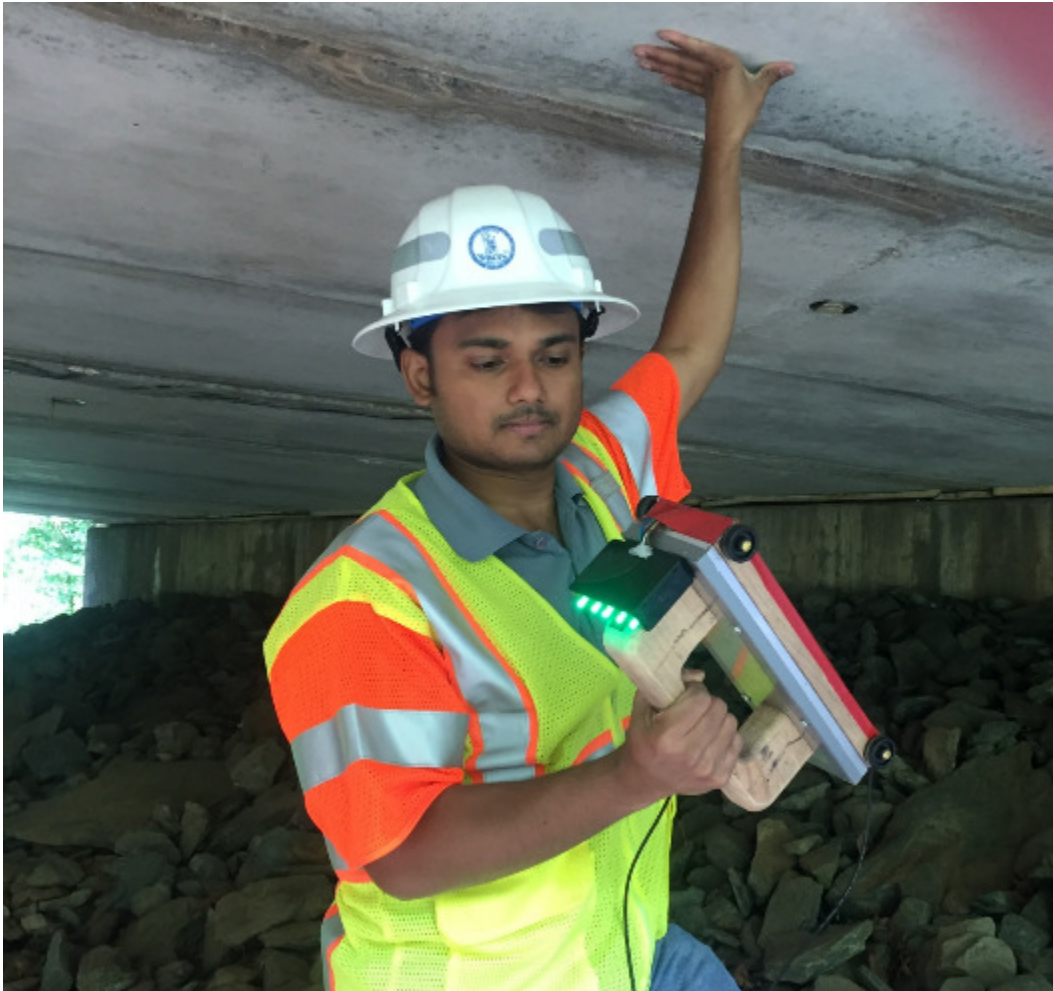
**Figure 27. MFLIS Device Being Used by Inspector. MFLIS = magnetic flux leakage inspection system.**

Testing consisted of applying the device to different box beams with apparent delaminations and solid sections and observing the results. The device is shown in the hand of an inspector in Figure 27. The green indications of the LED should be noted. The device was then used to scan the underside of a box beam as shown in Figures 28 and 29.

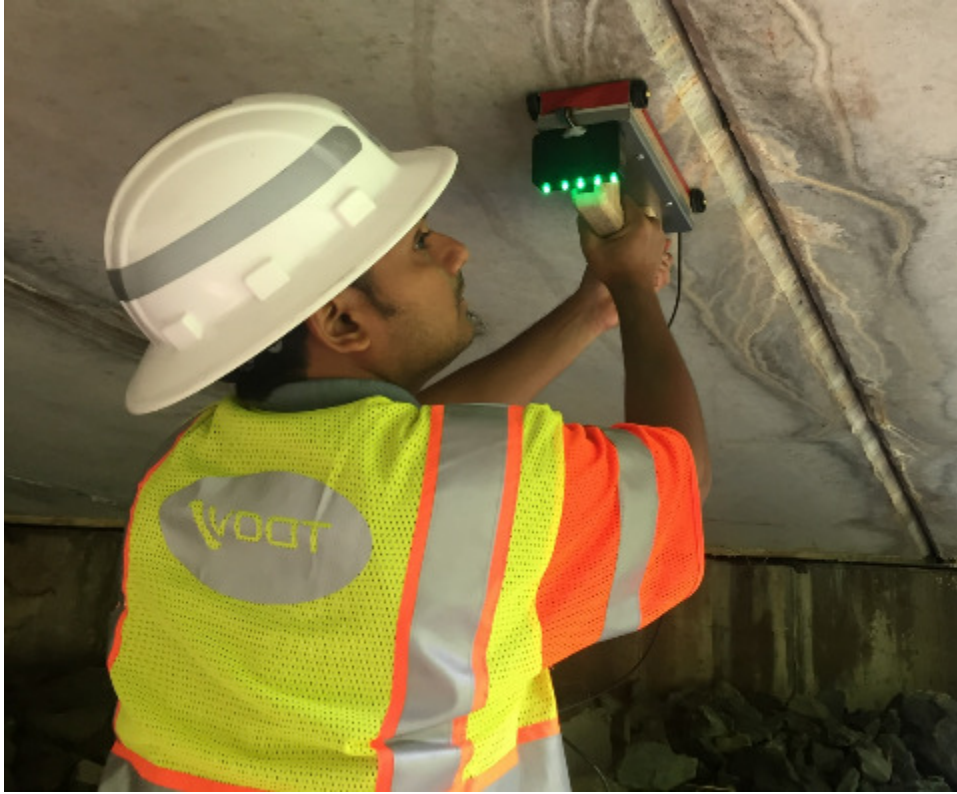
**Figure 28. MFLIS Device Scanning Underside of Box Beam. MFLIS = magnetic flux leakage inspection system.**

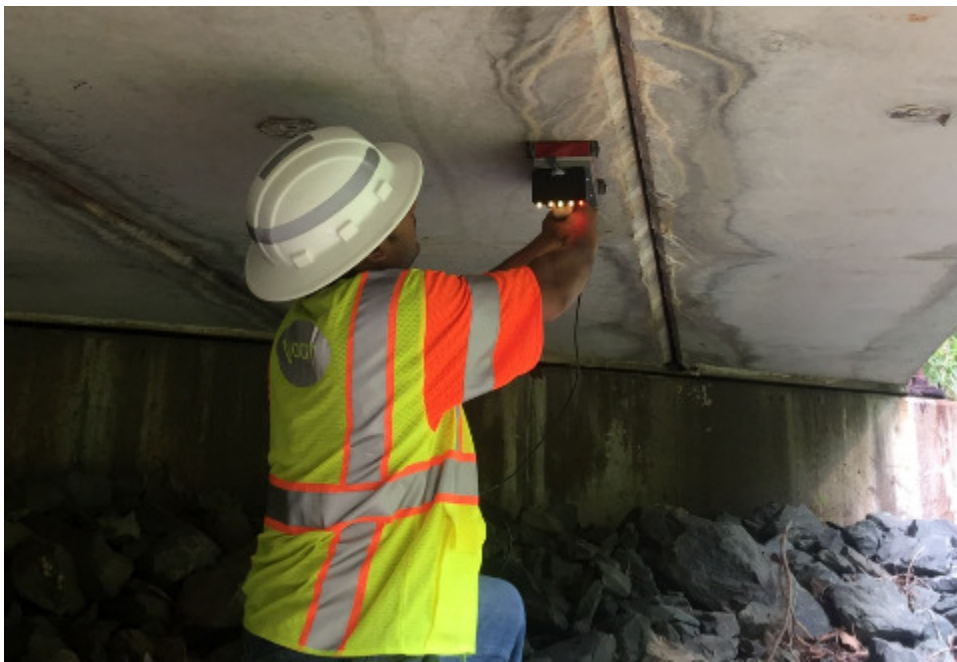
**Figure 29. MFLIS Device Showing Change in Flux. MFLIS = magnetic flux leakage inspection system.**
