1. REPORT NUMBER FHWA/CA17-2557	2. GOVERNMENT ACCESSION NUMBER	3. RECIPIENTS CATALOG NUMBER	
4. TITLE AND SUBTITLE COMPLIANCE CRASH TESTING OF THE CA ST-70SM SIDE MOUNTED BRIDGE RAIL		5. REPORT DATE February 2017

6. PERFORMING ORGANIZATION ROADSIDE SAFETY RESEARCH GROUP	
7. AUTHOR(S) VUE HER, CHRISTOPHER CALDWELL, JOHN JEWELL, ROBERT MELINE		8. PERFORMING ORGANIZATION REPORT NO. FHWA/ CA17-2557

COMPLIANCE CRASH TESTING OF THE CA ST-70SM SIDE MOUNTED BRIDGE RAIL

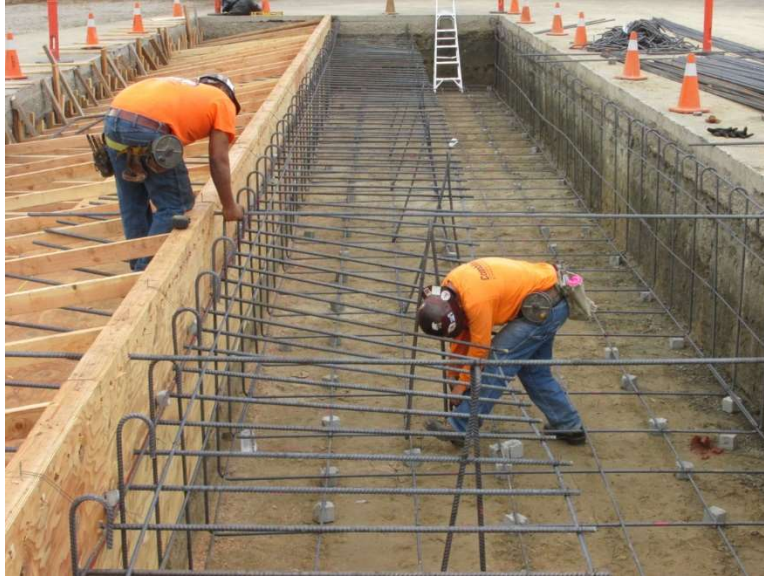
Figure 2-4. Anchor Block Rebar

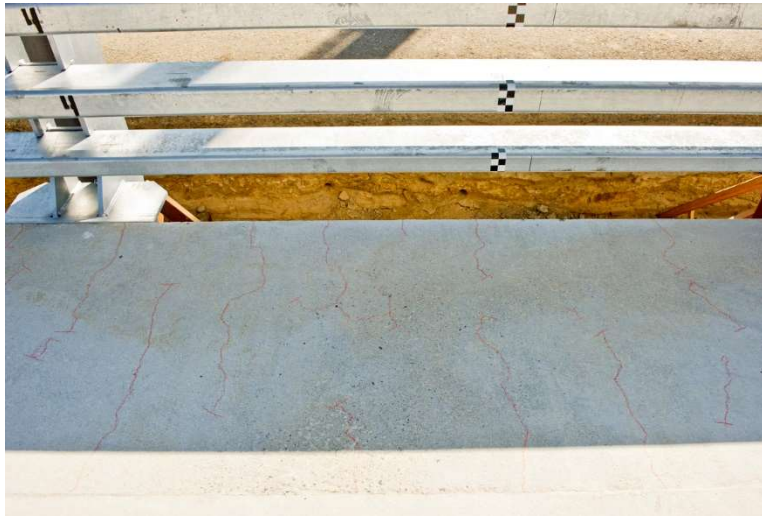
Figure 3-1. Point of Impact 66 inches (1.7 m) Upstream of Post 4

The point of impact was 66 inches (1.7 m) upstream from the center of post 4. There was minimal damage to the barrier. The vehicle bumper first made contact at the impact point upstream of rail post 4 (see Figure 3-2). The red contact marks on the bridge rail were from the front right tire. The green contact marks on the bridge rail were from the rear right tire. Based on video analysis and markings on the barrier, the vehicle stayed in contact with the bridge rail for 14 feet (4.3 m). The vehicle did not snag or pocket. The three upper disc spring sets on post 4 went into plastic deformation during impact, thus requiring replacement for future testing. String potentiometers (pots) were mounted on posts 3, 4, and 5 to measure deflection. Both dynamic and static displacements were measured from the rear middle of the top rail. See Table 3-2 for maximum dynamic and static displacements. Strain gages were installed on the all anchor rods for posts 3, 4, and 5 to indicate stress levels during testing. See *FHWA/CA17-2557 Supplement* report for strain gage and string pot results. (*Strain gage and string pot measurements are not within the scope of ISO 17025 A2LA Accreditation of the RSRG Lab*)

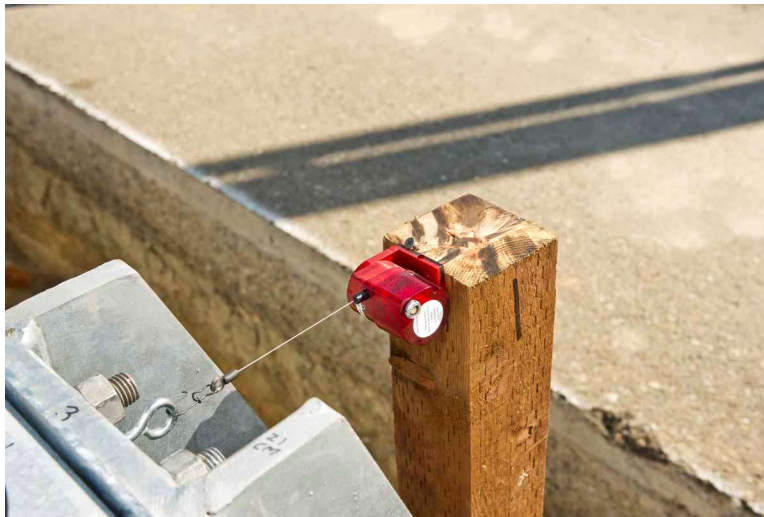
Figure 3-8. String Pot Installed on Upper Post

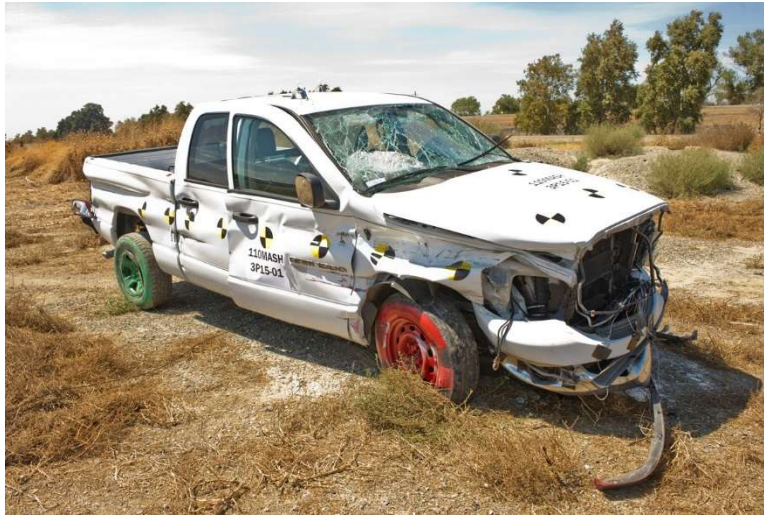
Figure 3-9. 110MASH3P15-01 Dodge Ram 1500 Damage (Side)

The front right corner of the test vehicle sustained most of the damage from the impact with the side mounted bridge rail. The bumper, headlight, hood, doors, and front and rear fenders were severely damaged. The right front tire ruptured upon impact with the bridge rail. Both airbags deployed in the vehicle. The right front and rear doors were wedged in and still attached but could not be opened. The impact with the bridge rail left indentations along the pickup truck's side relative to where it was in contact with the rails during impact. The windshield cracked but did not separate or enter the occupant compartment. The maximum amount of passenger compartment deformation was 1.2 inches (31 mm), which occurred at the roof of the vehicle. The maximum amount of deformation for the floorboard and dashboard were 0.7 inches (18 mm) and 0.7 inches (18 mm), respectively. These values are below the

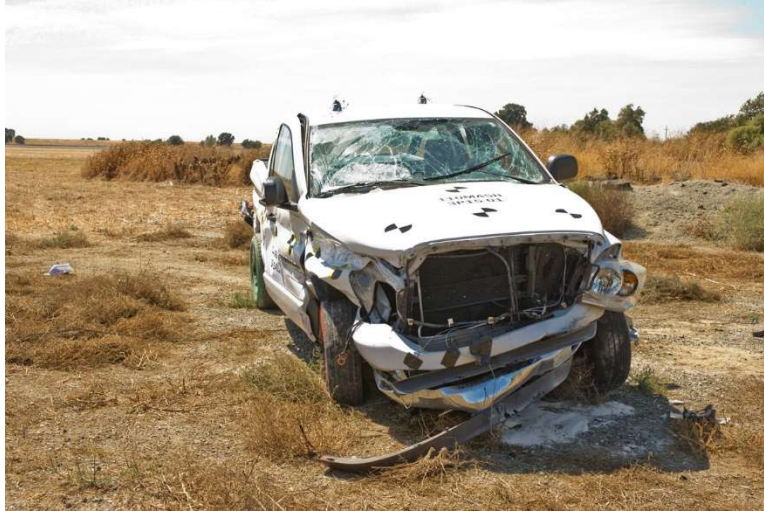
Figure 3-11. 110MASH3P15-01 Dodge Ram 1500 Damage (Front)

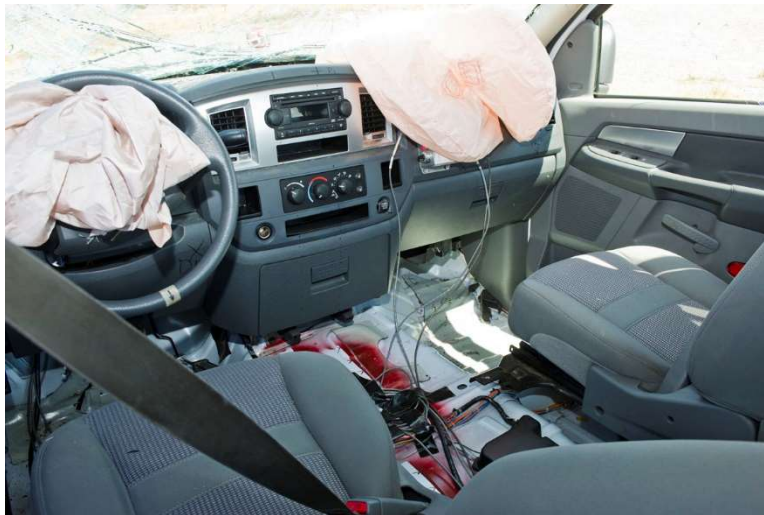
Figure 3-12. 110MASH3P15-01 Dodge Ram 1500 Airbags Deploy

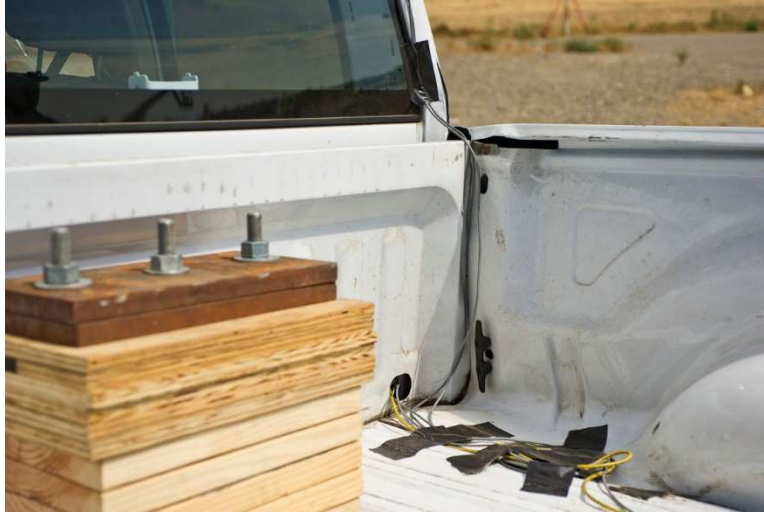
Figure 3-13. 110MASH3P15-01 Dodge Ram 1500 Damage (Truck Bed)

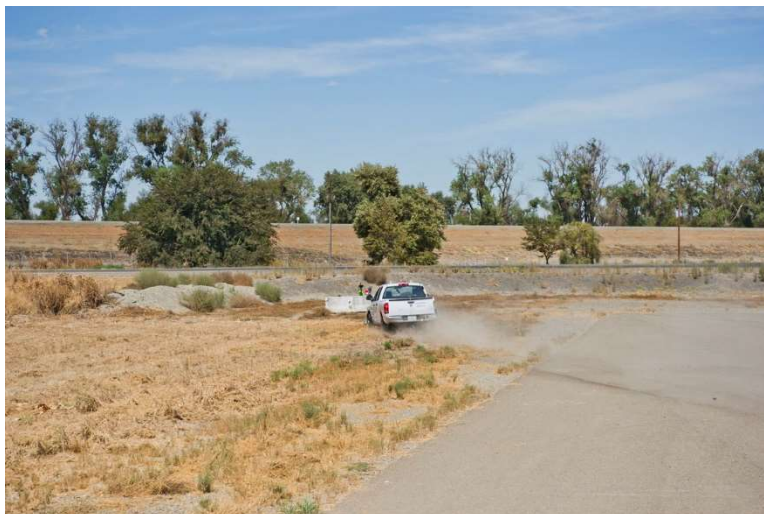
Figure 3-14. Trajectory Towards K-Rail

The vehicle sustained damage from a secondary impact with a construction barrier (k-rail) that was set about 270 feet (82 m) downstream of the target impact point to protect a high-speed video camera. The vehicle remote braking system was applied several vehicle lengths after leaving the bridge rail but the brake did not stop the vehicle before it hit the K-Rail. The impact with the K-Rail occurred on the front left (drivers side) of the vehicle causing the bumper to fold under with the vehicle coming to rest on the K-Rail. Even though the left side of the vehicle was damaged during the secondary impact, it did not cause difficulty analyzing the damage from the primary impact with the bridge rail. The interior deformations were still within acceptable limits.

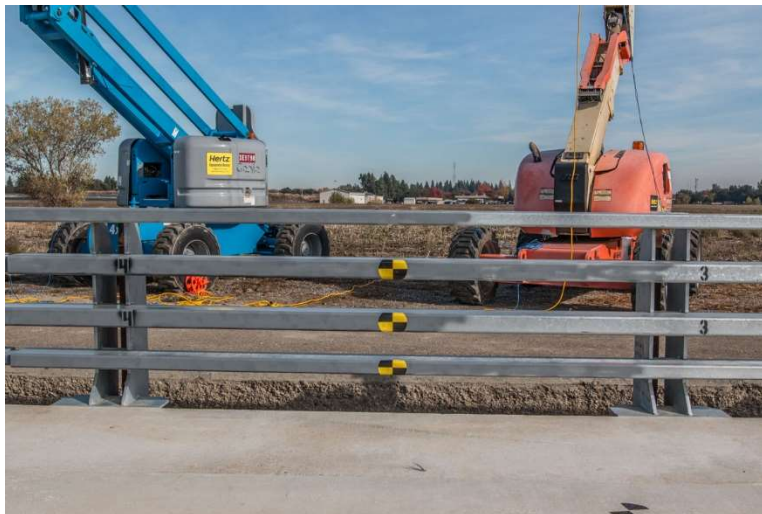
Figure 3-17. Target Point of Impact 66 inches (1.7 m) Upstream of Post 4

The point of impact was 66 inches (1.7 m) upstream from the center of post 4. There was no damage to the barrier. The vehicle bumper first made contact at the impact point upstream of rail post 4 (see Figure 3-18). The red contact marks on the bridge rail were from the front right tire. The green contact marks on the bridge rail were from the rear right tire. The vehicle stayed in contact with the bridge rail for 10.6 feet (3.2 m). The vehicle did not snag or pocket. There were no permanent deflections on the disc springs. String pots were mounted on posts 3, 4, and 5 to measure deflection. Both dynamic and static displacements were measured from the rear middle of the top rail. See Table 3-3 for maximum dynamic and static displacements. Strain gages were installed on the all anchor rods for posts 3, 4, and 5. See *FHWA/ CA17-2557 Supplement* for strain gage and string pot results. (*Strain gage and string pot measurements are not within the scope of ISO 17025 A2LA Accreditation of the RSRG Lab*)

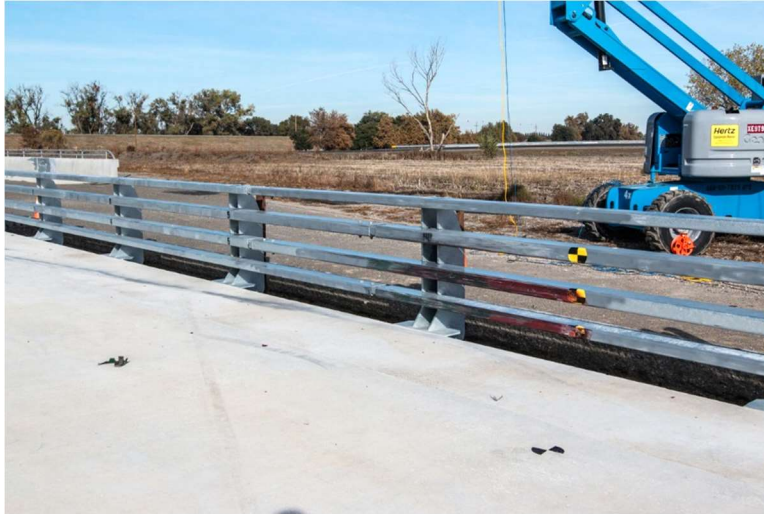
Figure 3-18. Vehicle Impact Tire Marks (Red – Front Right Tire, Green – Rear Right Tire)

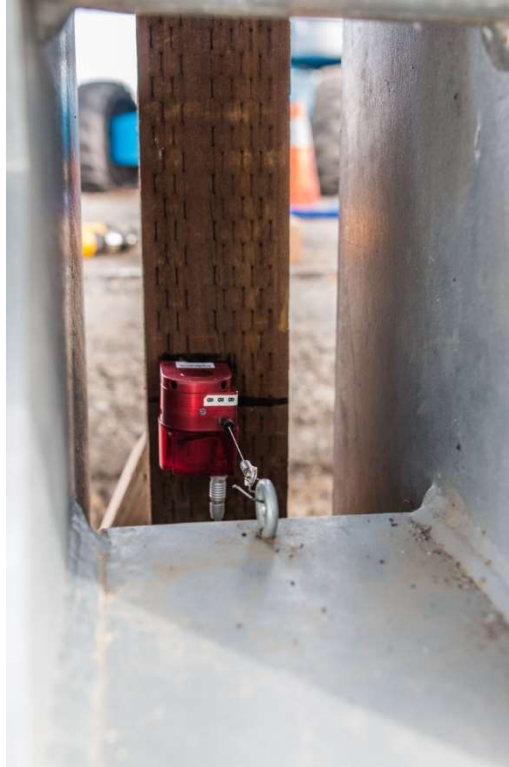
Figure 3-24. String Pot Installed on Base of Post

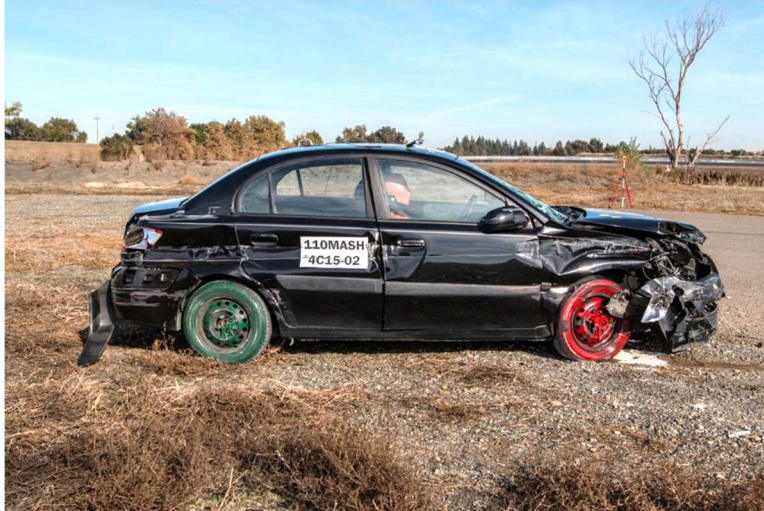
Figure 3-25. 110MASH4C15-02 Kia Rio Damage (Side)

The front right corner and passenger side of the test vehicle sustained most of the damage from the impact with the side mounted bridge rail. The whole passenger side of the vehicle made contact with the side mounted bridge rail. The passenger headlight was completely torn off the vehicle. The bumper, hood, doors, and front and rear fenders were severely damaged. The airbags did not deploy because the vehicle was towed and the vehicle's battery had been removed. The right front and rear doors were damaged and could not be opened. The impact with the bridge rail left depressions along the vehicle's side relative to where it contacted the rails during impact. The windshield cracked but did not separate or enter the occupant compartment. The maximum amount of passenger compartment deformation was 2.0 inches (52 mm), which occurred at the floorboard. The maximum amount of deformation for the roof and dashboard are 0.4 inches (10 mm) and 0.3 inches (8 mm), respectively. These values are below the maximum MASH 2009 limits. See Appendix 8.2.6 for complete interior deformation measurements for test 110MASH4C15-02.

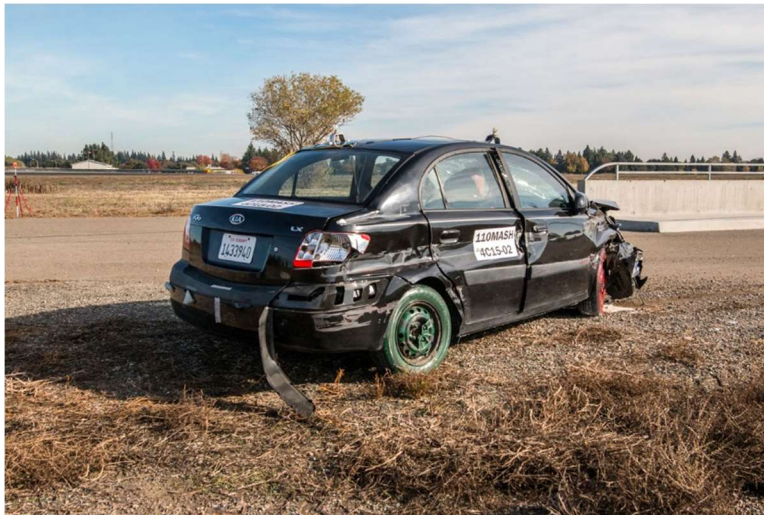
Figure 3-26. 110MASH4CP15-02 Kia Rio Damage (Rear)

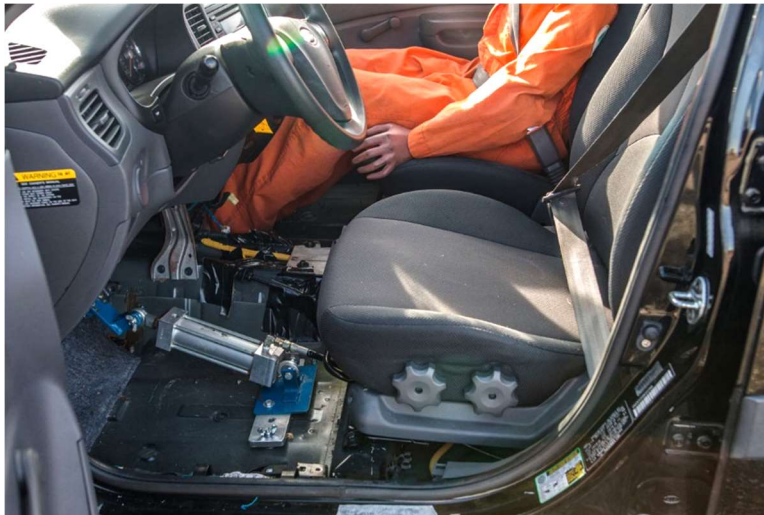
Figure 3-28. 110MASH4C15-02 Kia Rio Interior Post Test

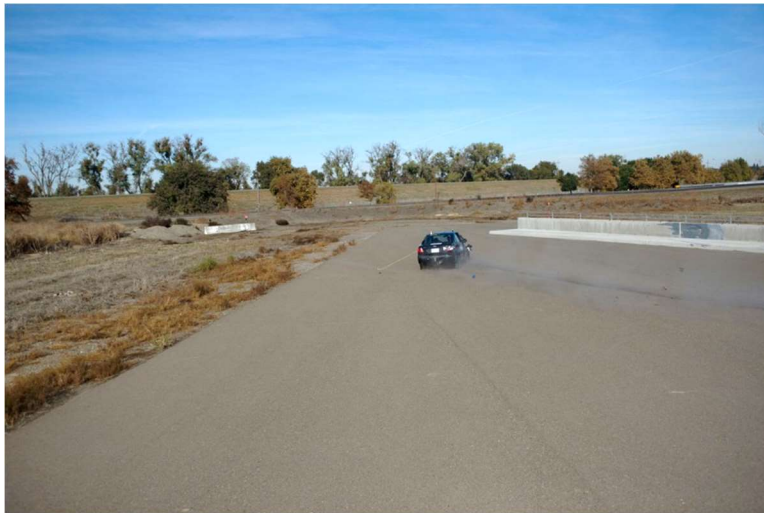
Figure 3-30. Trajectory After Impact

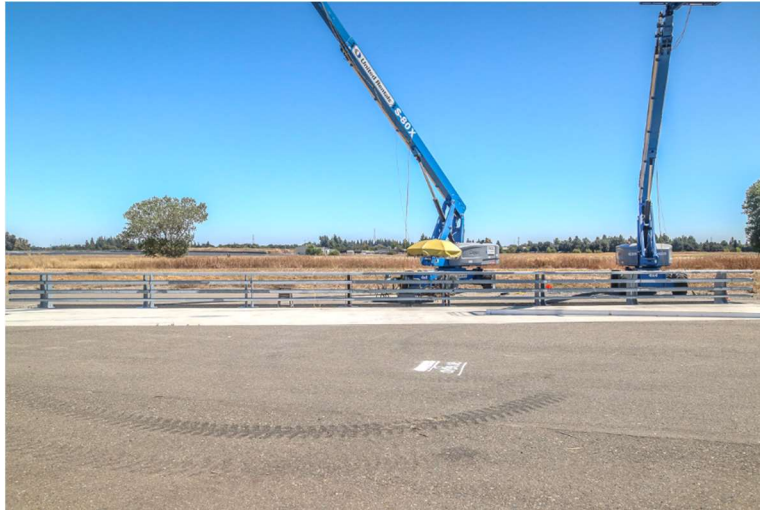
Figure 3-33. Point of Impact 60 inches (1.5 m) Upstream of Post 3

The target point of impact for test 110MASH4S16-03 was determined from Table 2-7 of MASH 2009, which was 60 inches (1.5 m) upstream from the center of post 3. This point would apply maximum loading to post 3. The vehicle impacted the barrier at 56.3 mph (90.6 kph) at an angle of 15.8°. The impact severity was 171.9 kip-ft (233.1 kJ).

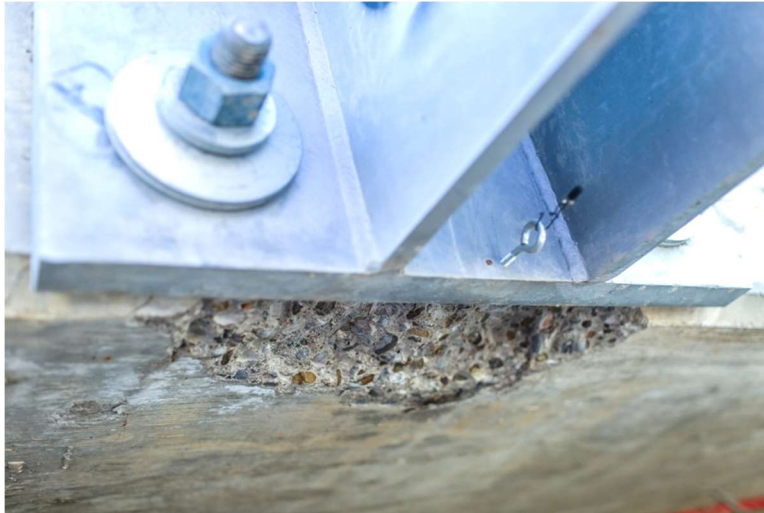
Figure 3-34. 110MASH4S16-03 Post 3 Concrete Spalling

Most of the damage to the barrier was on the rails. The studs from the front right tire gouged the two inner rails and left longitudinal dents between posts 2 and 4. The nuts for the three upper disc springs from posts 2 and 3 were loose after contact, which meant that those upper disc spring sets went into plastic deformation. A piece of concrete spalled right below post 3.

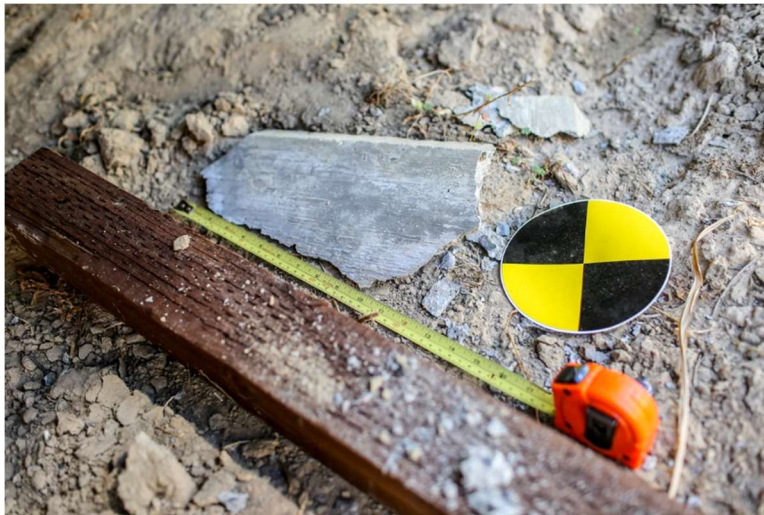
Figure 3-35. 110MASH4S16-03 Approximate Size of Spalled Concrete from Post 3

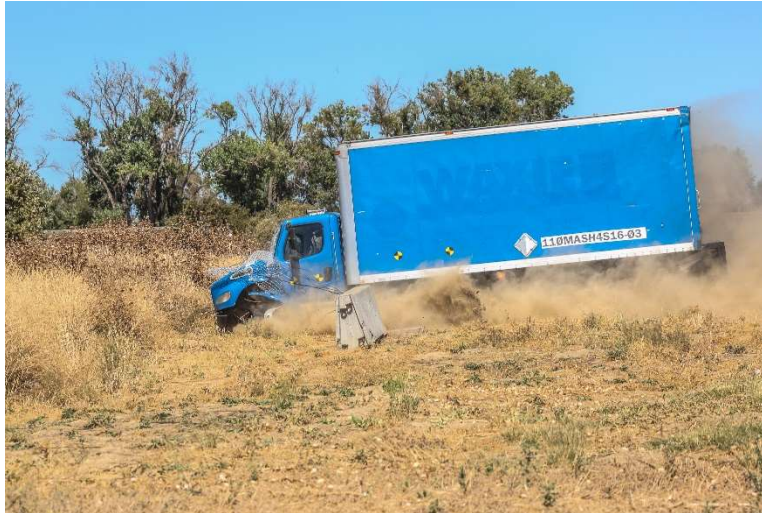
Figure 3-40. 110MASH4S16-03 Impact with Fence

The 10000S test vehicle sustained damage from a secondary impact with a fence that was installed downstream of the vehicles presumed exit path. The fence was placed there to help slow the test vehicle down. Even though the fence caused some damage during the secondary impact, it did not cause difficulty analyzing the damage from the primary impact with the bridge rail.

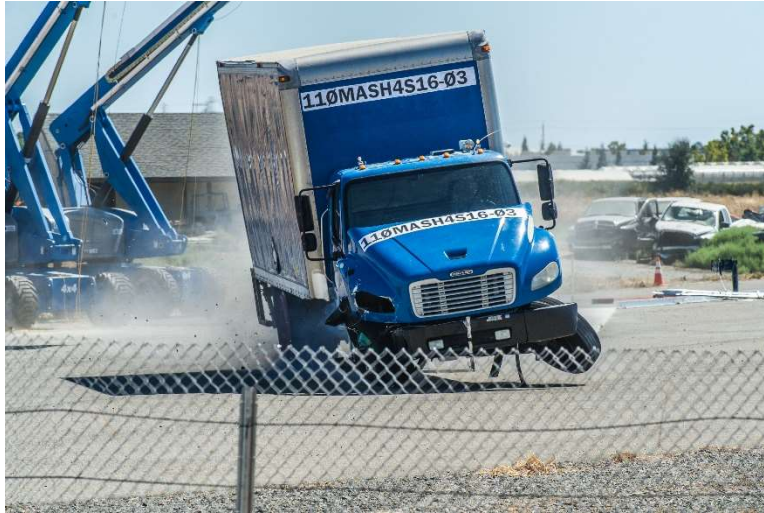
Figure 3-41. 110MASH4S16-03 Upstream View

The front right fender and right side of test vehicle sustained most of the damage from the impact with the side mounted bridge rail. Still camera images and high-speed videos showed the test vehicle's hood release broke and the hood partially opened. The front right wheel detached and folded under the vehicle. The front axle was also broken during impact. It disconnected from the vehicle with the exception of the hydraulic steering lines, which dragged the axle underneath the front of the vehicle. The front right headlight broke and right side of the bumper folded into the engine compartment. The right fuel tank was also damaged from contact with the barrier. The right passenger door was damaged but it was able to be opened.

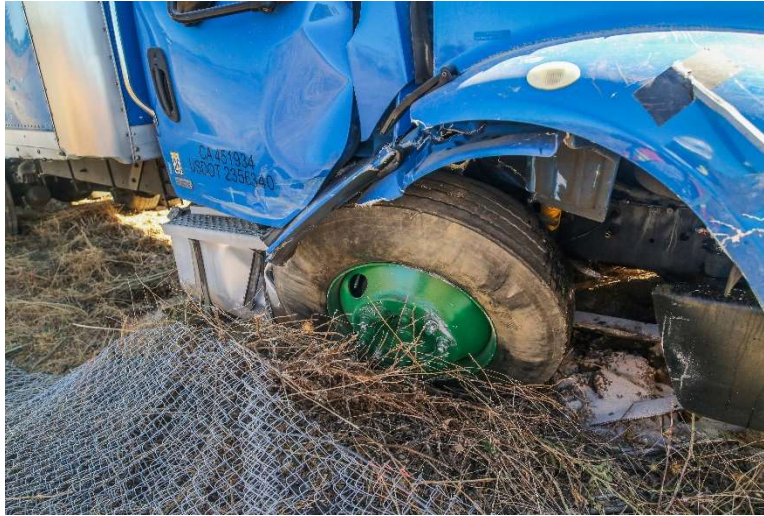
Figure 3-43. 110MASH4S16-03 Front Right Tire

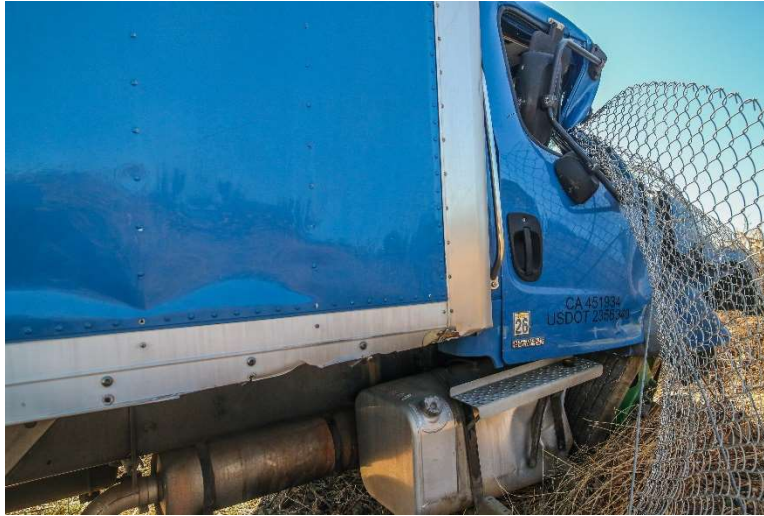
Figure 3-45. 110MASH4S16-03 Fuel Tank and Right A-Pillar Damage

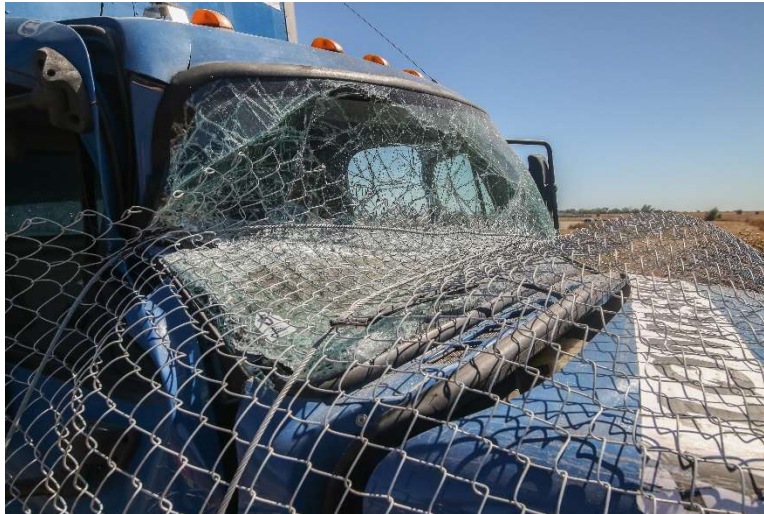
Figure 3-46. 110MASH4S16-03 Fence into Windshield

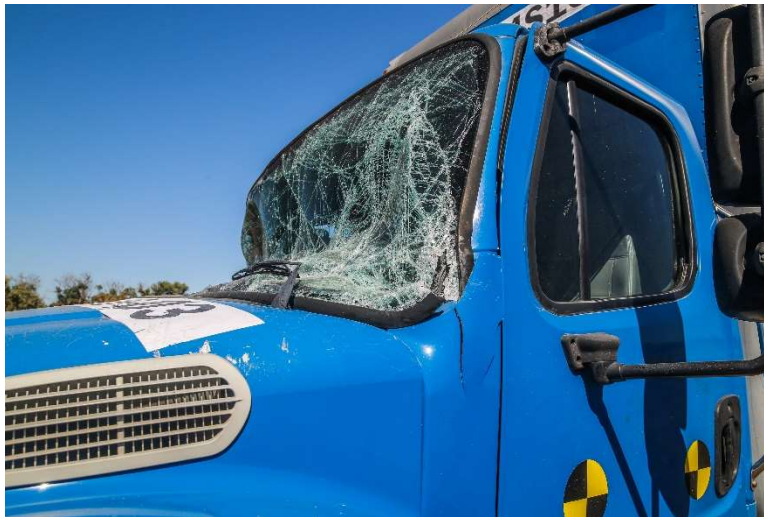
Figure 3-48. 110MASH4S16-03 Windshield Damage

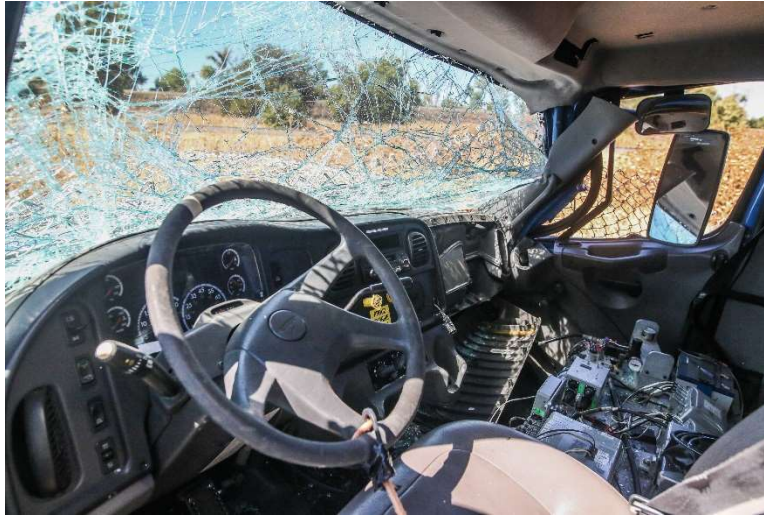
Figure 3-49. 110MASH4S16-03 Cab View Damage

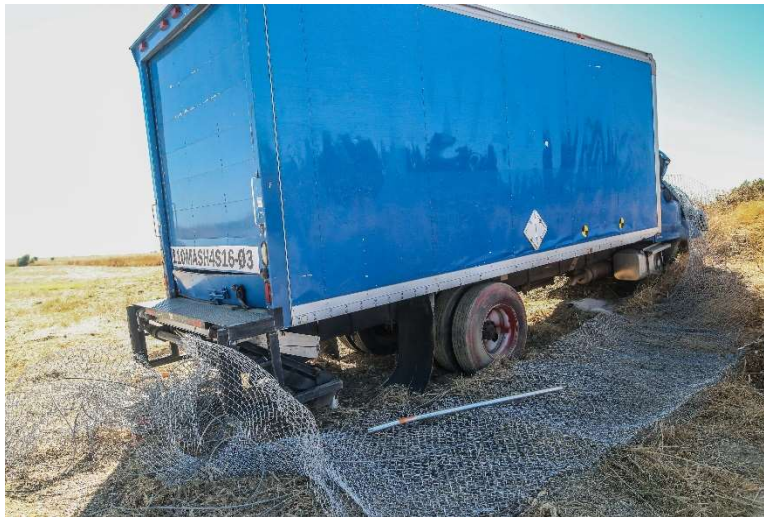
Figure 3-50. 110MASH4S16-03 Rear View

The box did not disconnect from the frame. The ballasts did shift a few inches toward the impact side but did not disconnect. The box also had a permanent lean towards the impact side after impact.

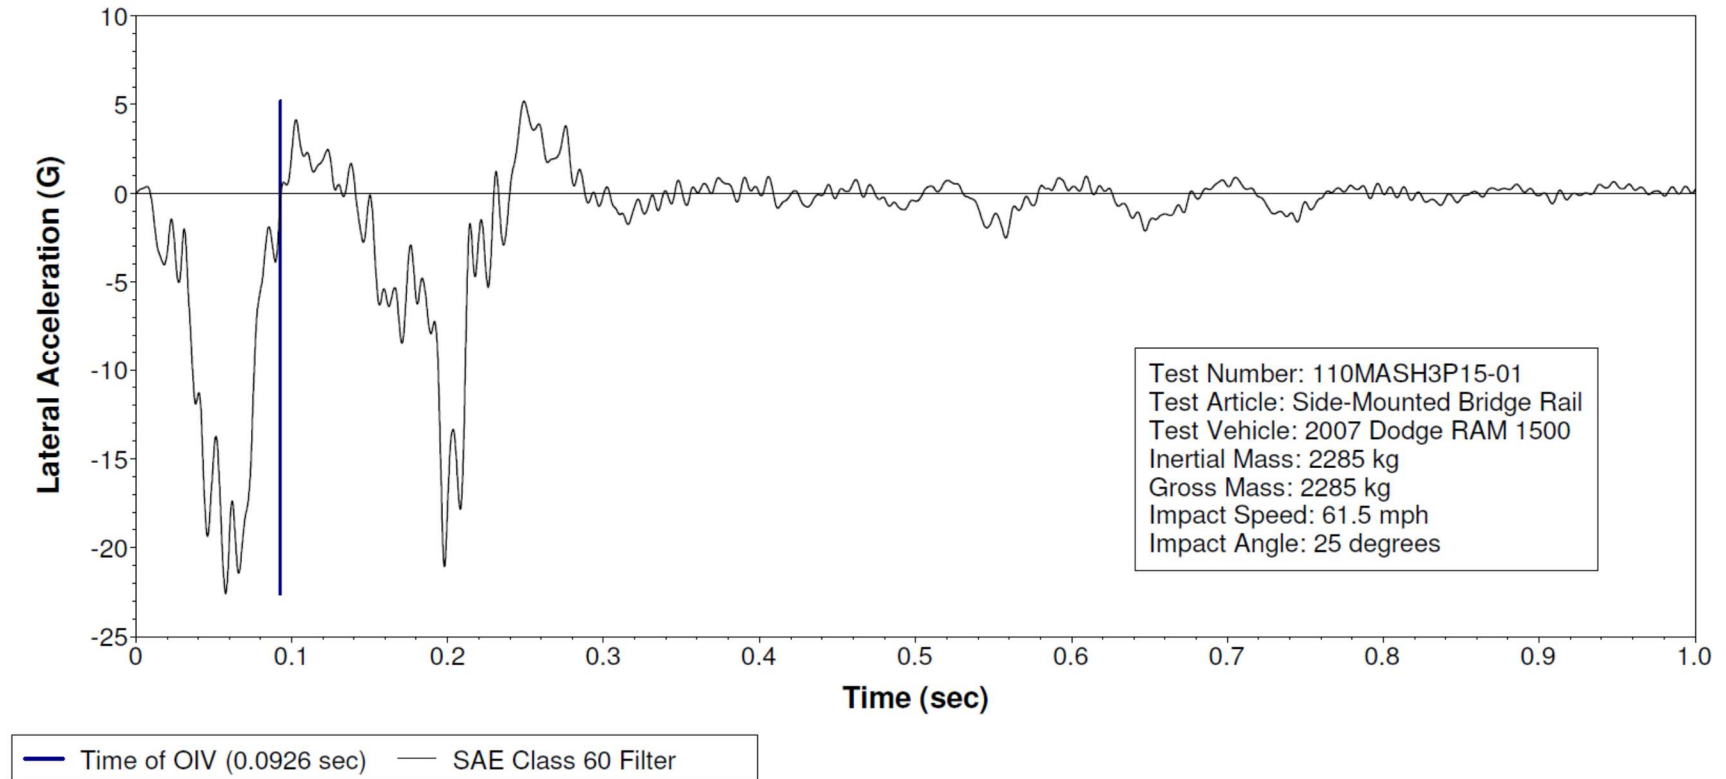
Figure 8-11. 110MASH3P15-01 Y (Lateral) Acceleration at CG vs Time

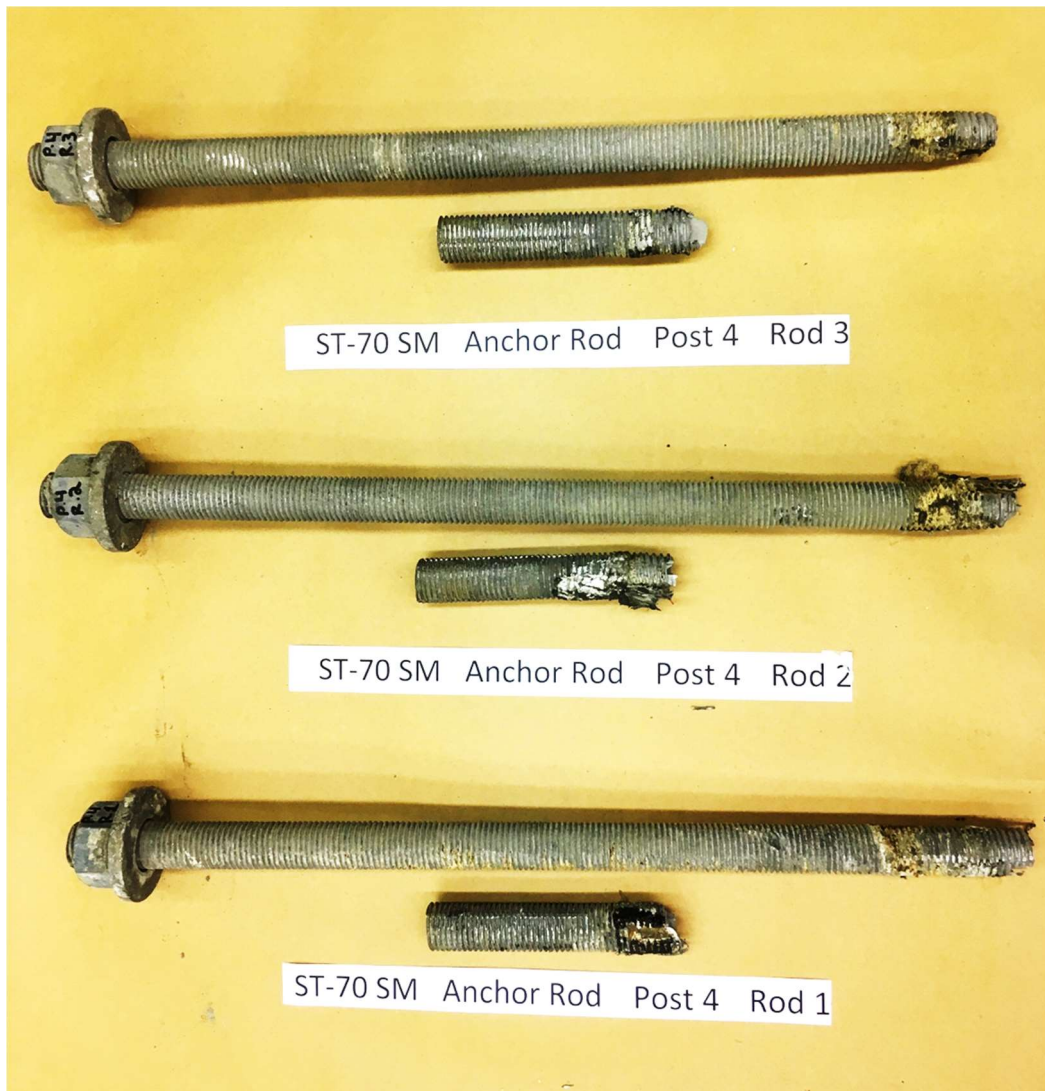
Figure 9-12. Post 4, Anchor Rods 1, 2, & 3
