# Use of Ultra-High-Performance Fiber-Reinforced Concrete (UHP-FRC) for Fast and Sustainable Repair of Pavements

Project No. 17STUTA03

Lead University: University of Texas at Arlington

Final Report

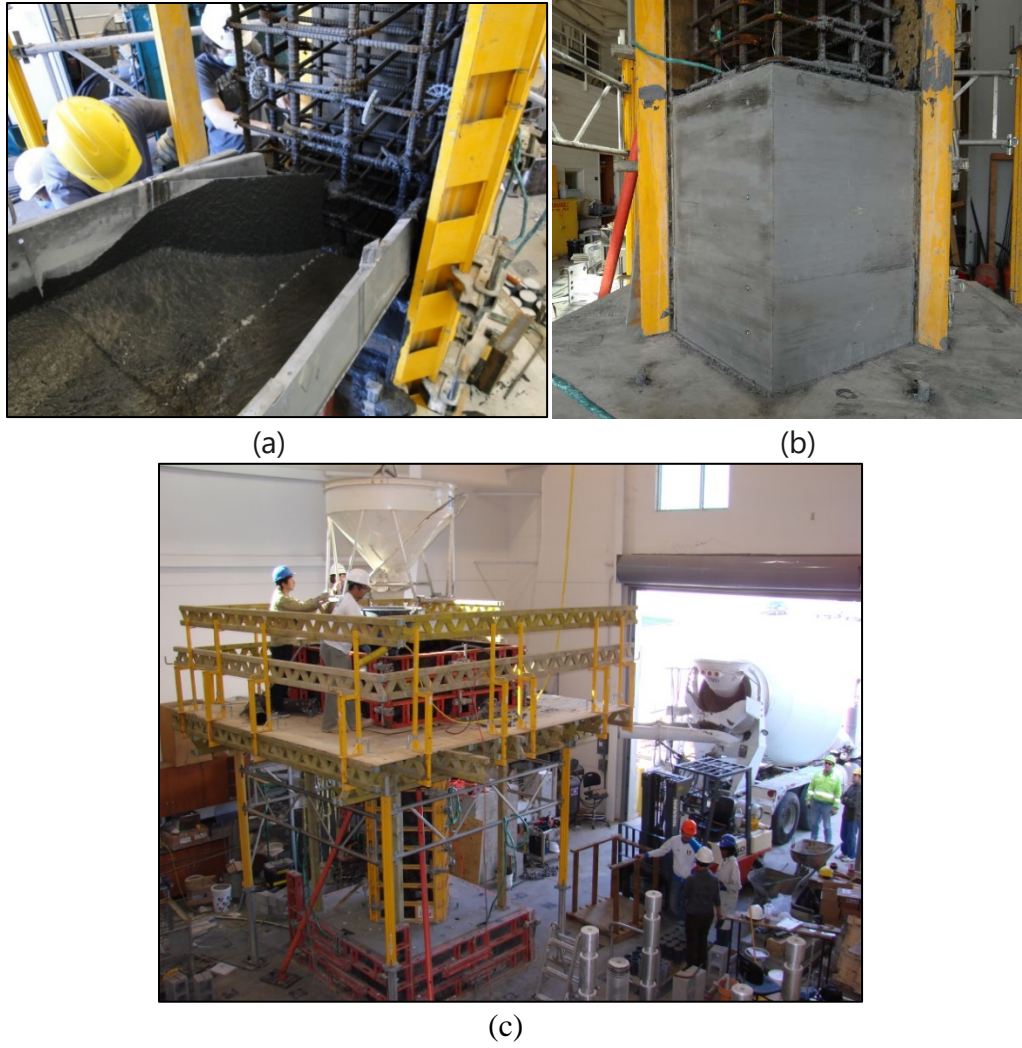
Figure 6. UHP-FRC (a) pouring, (b) completed section, and (c) final casting.

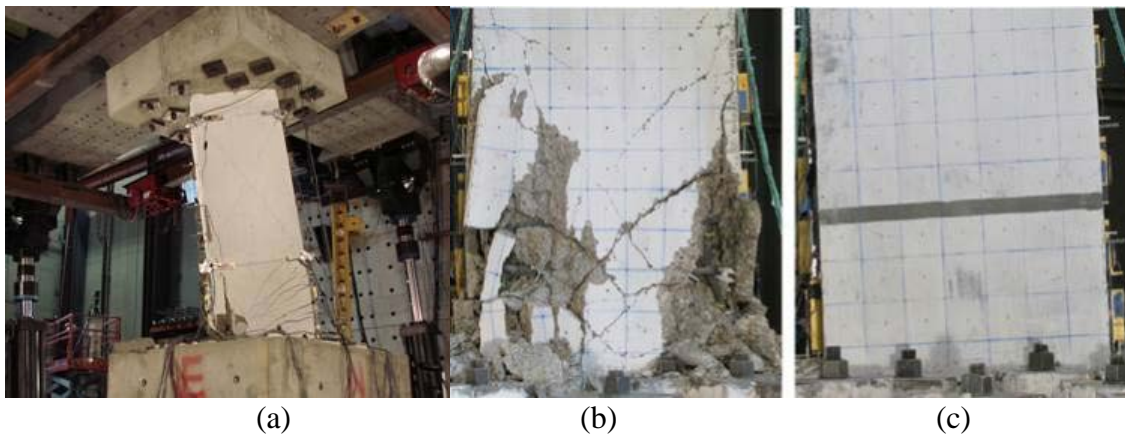
Figure 7. Experimental testing at NSF MAST laboratory (a) Test setup, (b) conventional reinforced concrete column, and (c) UHP-FRC concrete column.

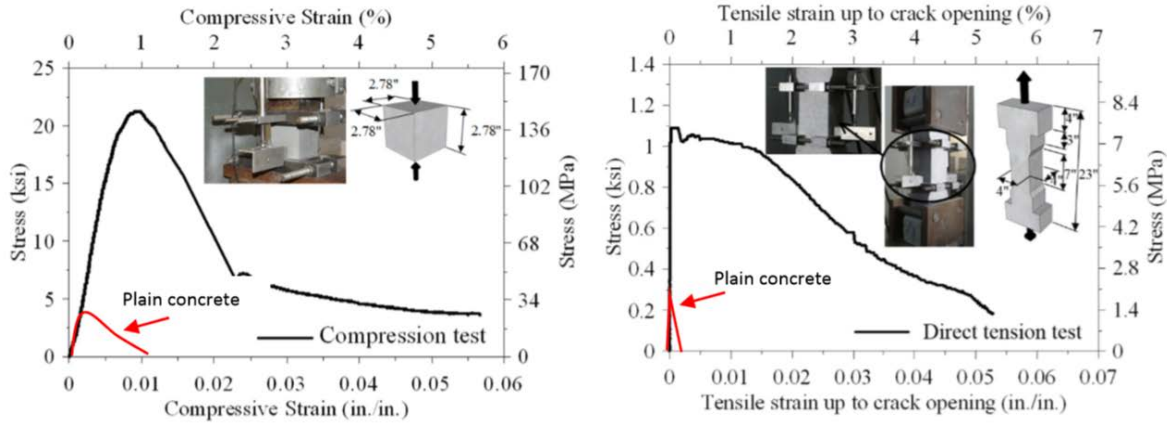
Figure 9. Typical compressive stress-strain of UHP-FRC/plain concrete (left); and direct tension test response for UHP-FRC/plain concrete (right) (17).

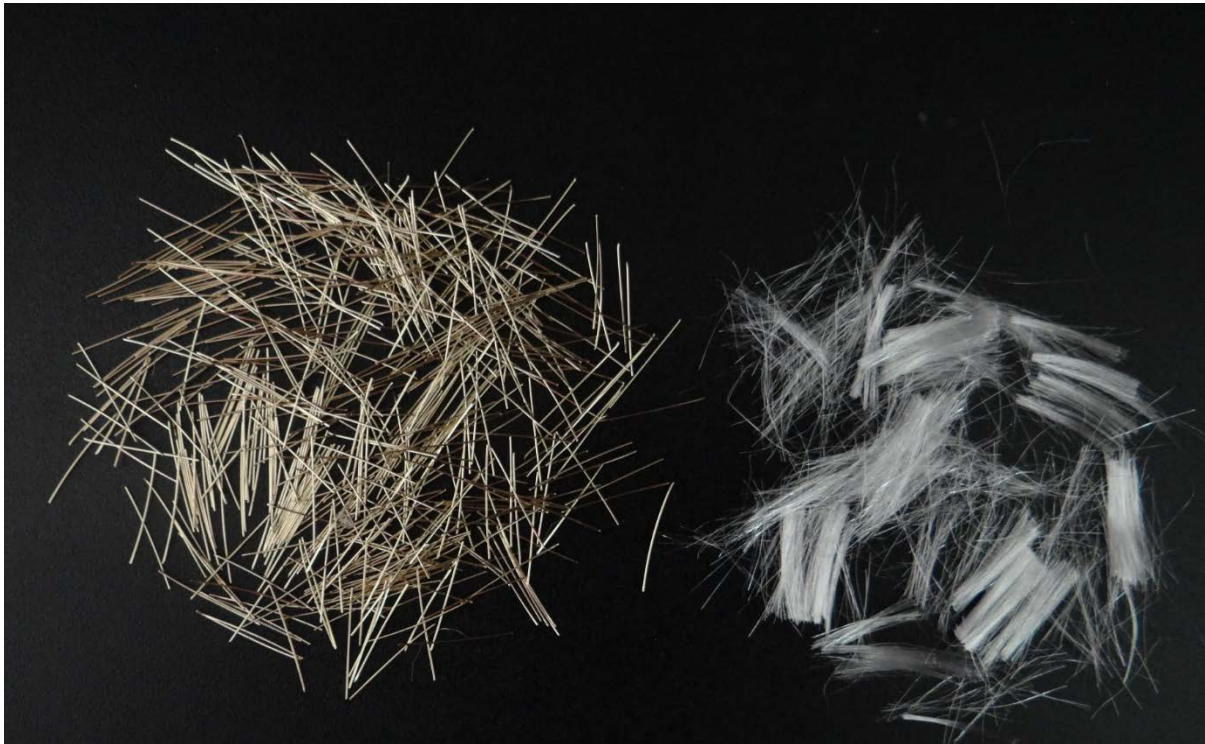
Figure 12. Micro steel fiber (left) and ultra-high molecular weight polyethylene fiber (right).

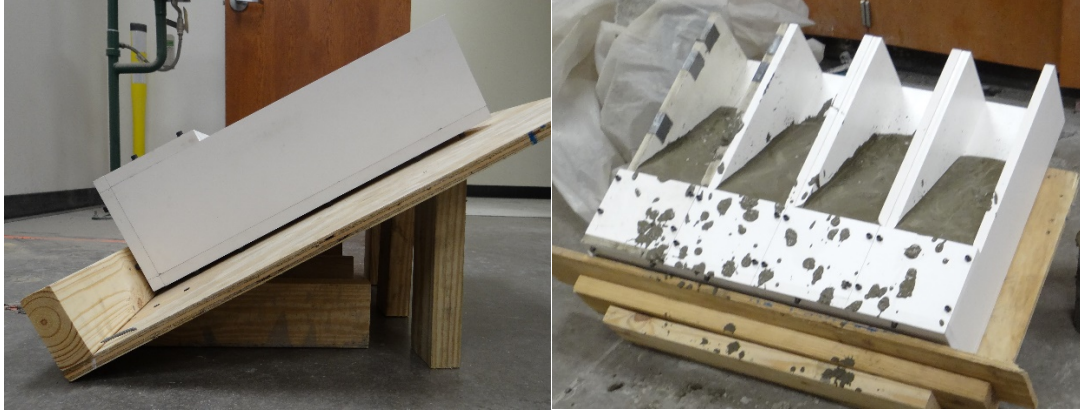
**Figure 14. Mold placement and casting for bottom half of slant shear specimen.**

1. A wood support (Figure 14) was prepared to provide an incline casting surface at an angle of 30°. The mold was placed on the support with its back face resting on the inclined support as shown below. Then, the bottom half of the mold was cast, covered by plastic sheeting and cured at normal room temperature for a minimum of six days.

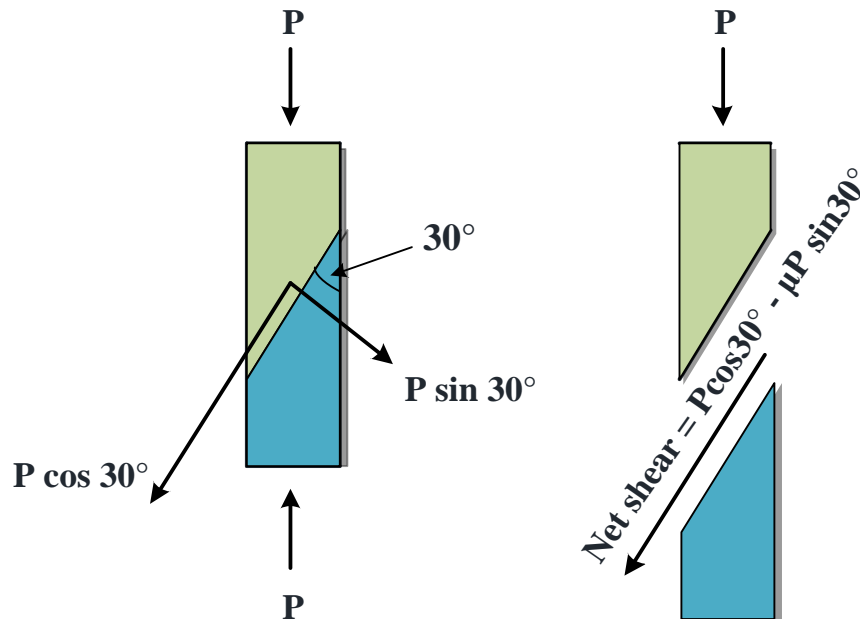
Figure 21. Forces transfer in a slant shear test specimen.

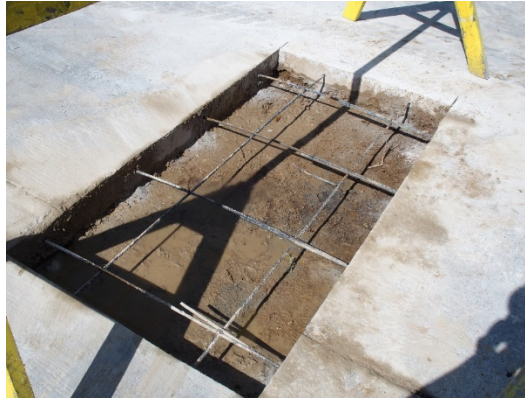
Figure 22. Conventional concrete repair.

The punch test for conventional concrete was designed on the basis of the actual repair practices used in the field (Figure 22).

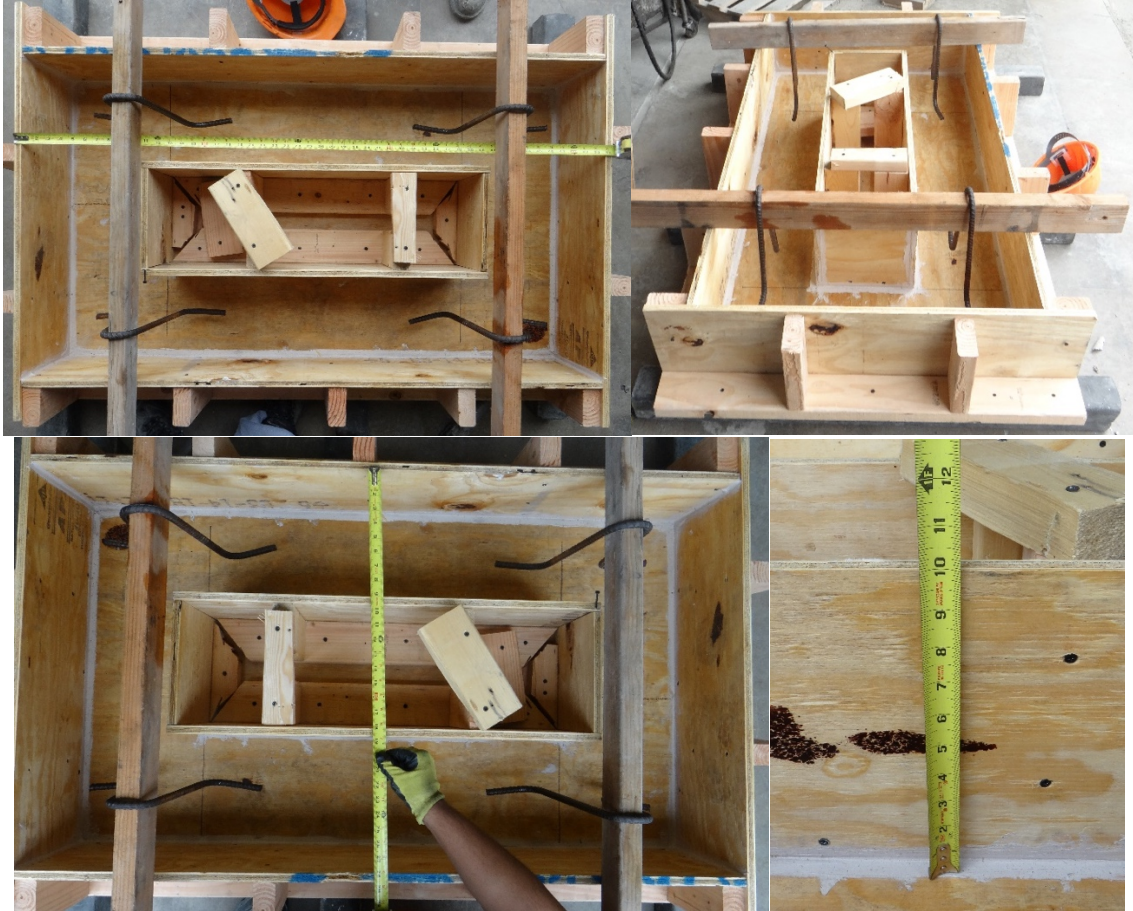
**Figure 27. Formwork for the outer hollow slab.**

The preparation of formwork, mixing, and casting of the outer hollow slab is presented below from Figures 27 to 28. The concrete surface after the removal of the specimen from the formwork is shown in Figure 29.

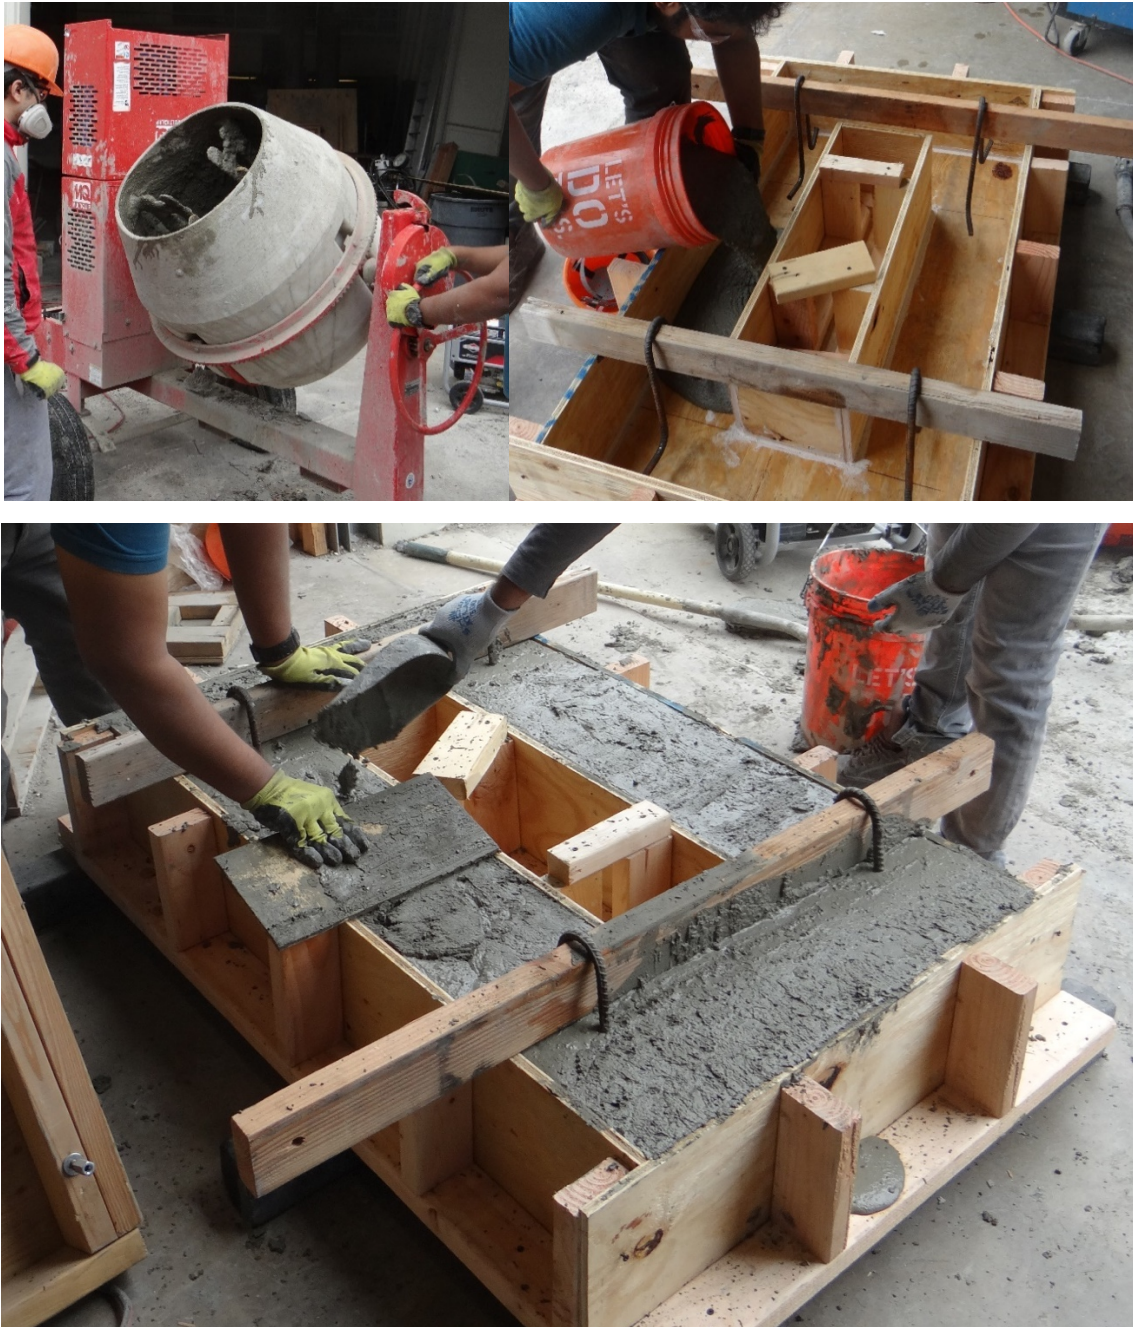
**Figure 28.** In-lab concrete mixing is shown in top photo and casting for the outer hollow slab is shown in the bottom photo.

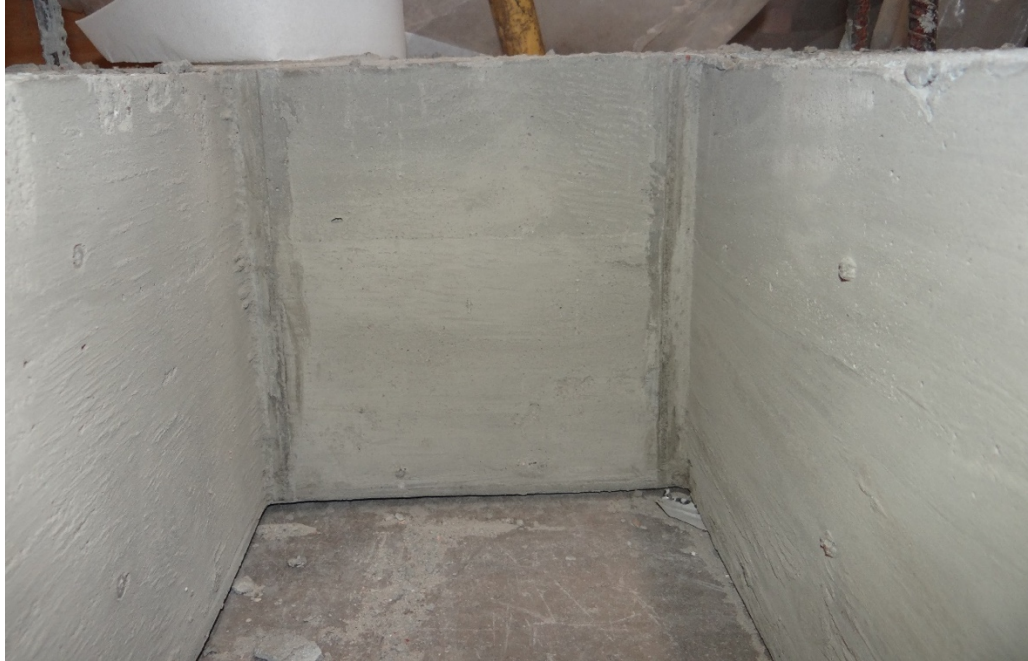
Figure 29. Concrete surface roughness (cast in contact with wood formwork).

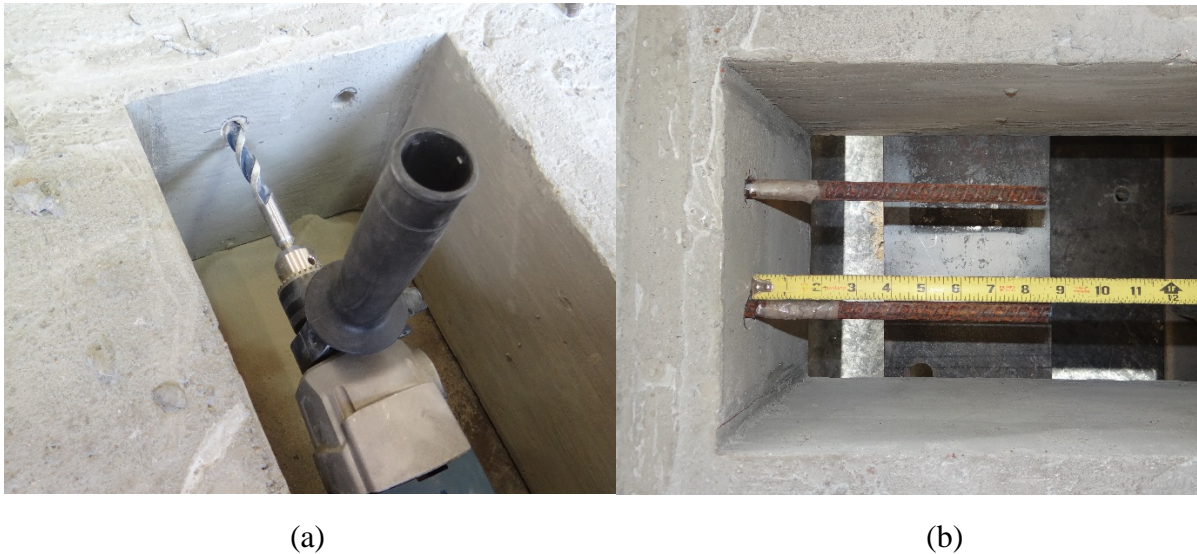
Figure 30. (a) Drilling in the outer hollow slab for rebar placement and (b) rebar length inside the newly repaired concrete.

1. Holes 8.5 inches deep (shown in Figure 30) were drilled in the outer hollow slab at a depth of 2 inches from the top surface. Then the hole was blown out twice, brushed out twice, and blown out twice again. Epoxy was then put in the hole and a rebar was inserted with a slight twisting motion. Figure 31 shows the specimen after the insertion of rebar.

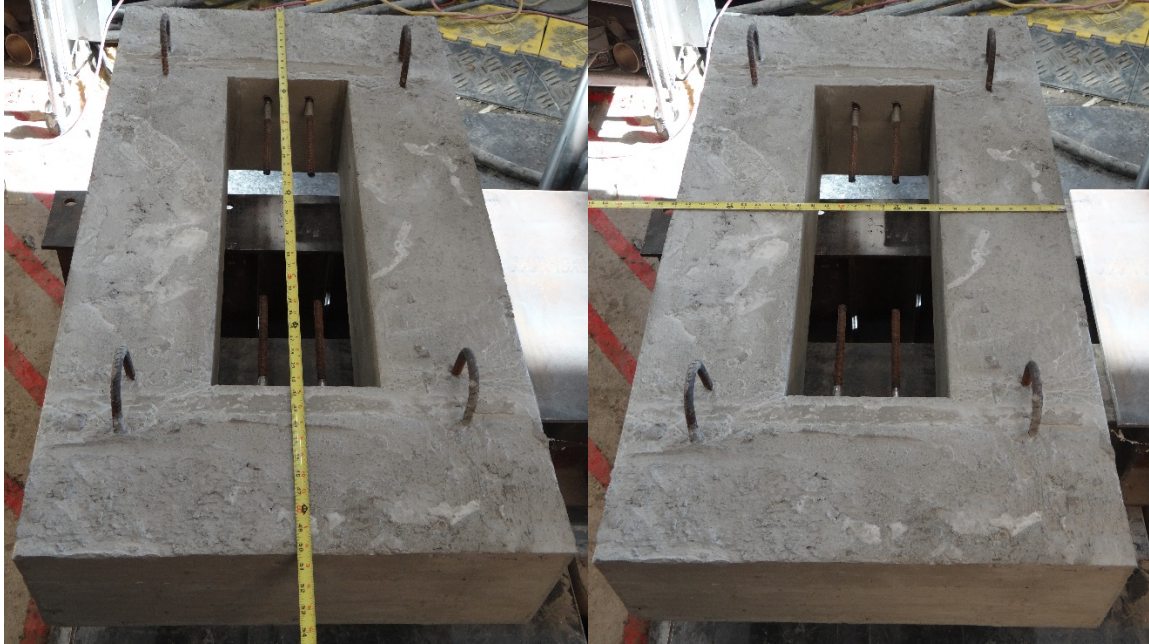
**Figure 31. Outer hollow slab showing embedded rebar location.**

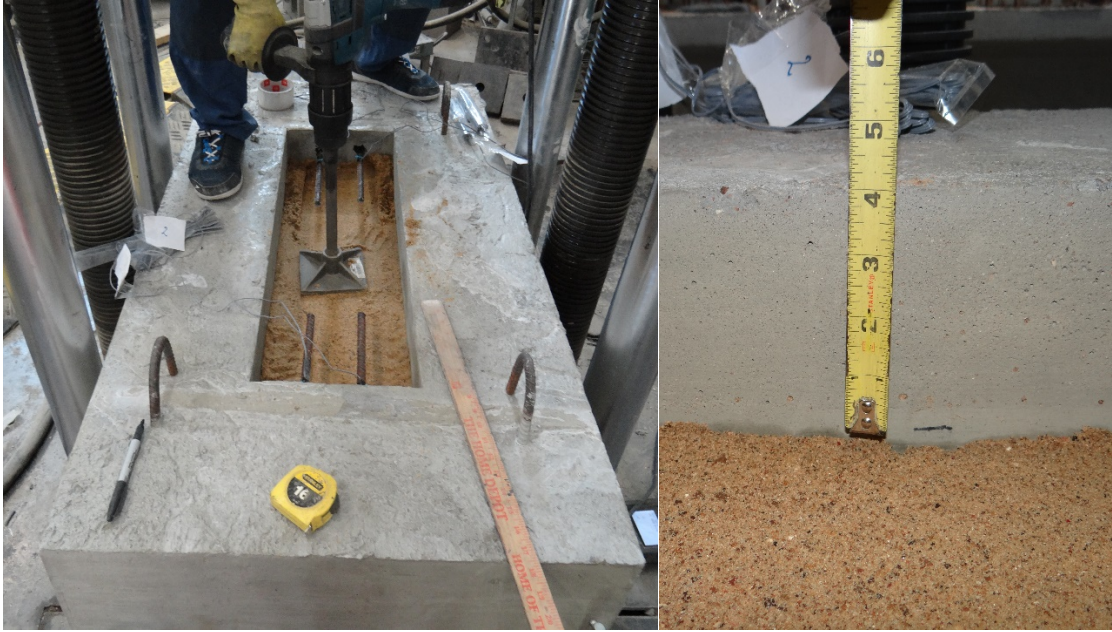
**Figure 33. Placing and compacting the sand in the hollow portion of the slab to provide a firm support for casting 4 inches of cast-in-place PC.**

3. The outer hollow slab with the rebar installed with the strain gauge was setup on the compression machine on a steel support.
4. The hollow portion was filled with 6 inches of sand and slightly compacted to provide a firm base for casting 4 inches of cast-in-place plain concrete as shown in Figure 33.

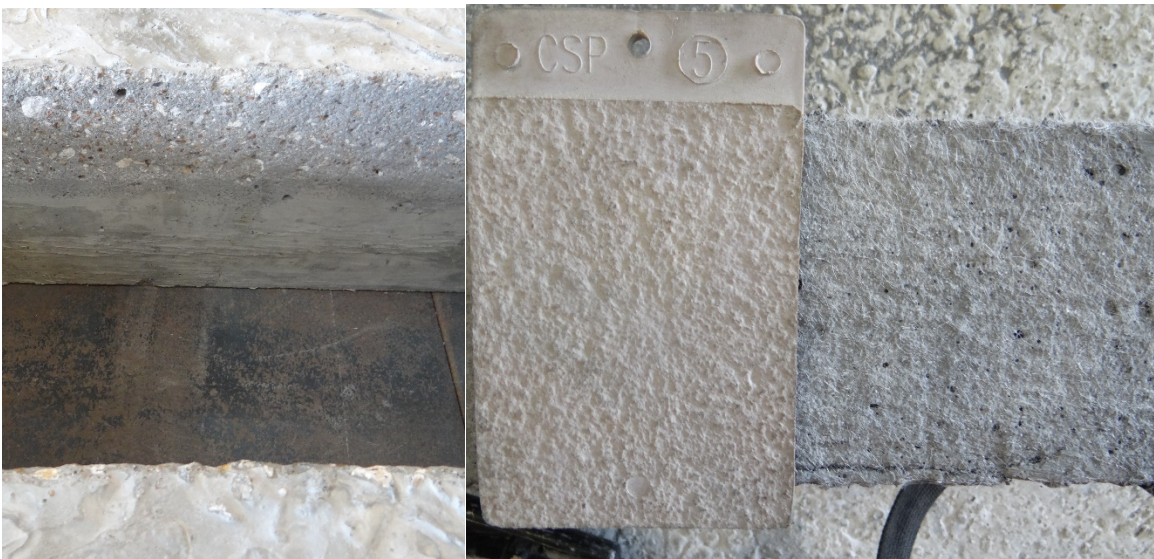
**Figure 36. Roughened surface of inner wall of the outer hollow slab with a depth of 4 inches with a roughness level of CSP 5.**

2. Then, the inner surface of the hollow slab was roughened to a depth of 4 inches from the top. A pneumatic needle scaler was used to get a CSP 5 roughness level (Figure 36).

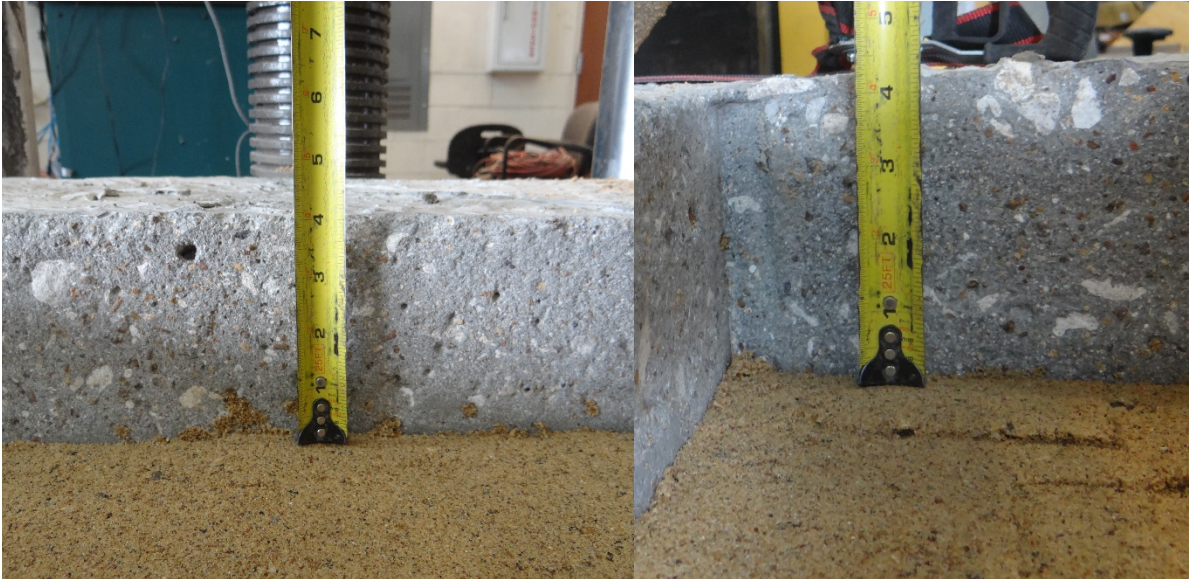
**Figure 37. The 4-inch casting surface level obtained after placement and compaction of sand in the hollow portion.**

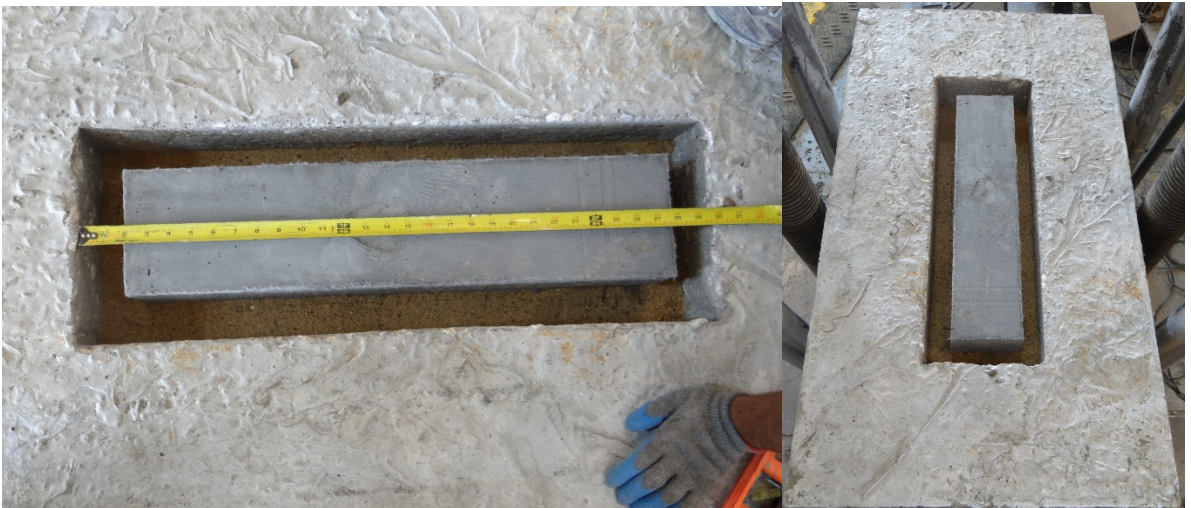
**Figure 38. Placement of precast UHP-FRC panel into hollow portion of outer hollow slab.**

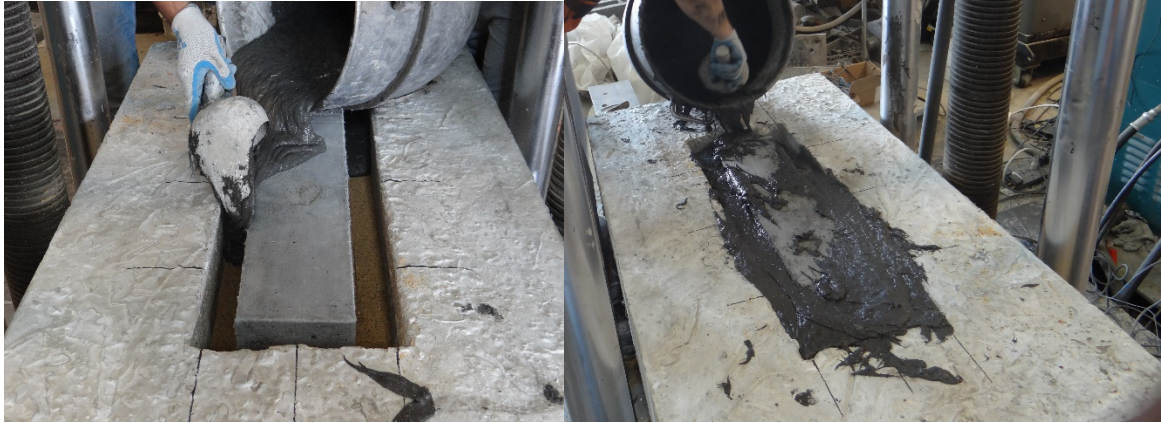
**Figure 39. Cast in place UHP-FRC between the precast UHP-FRC slab and outer hollow slab.**

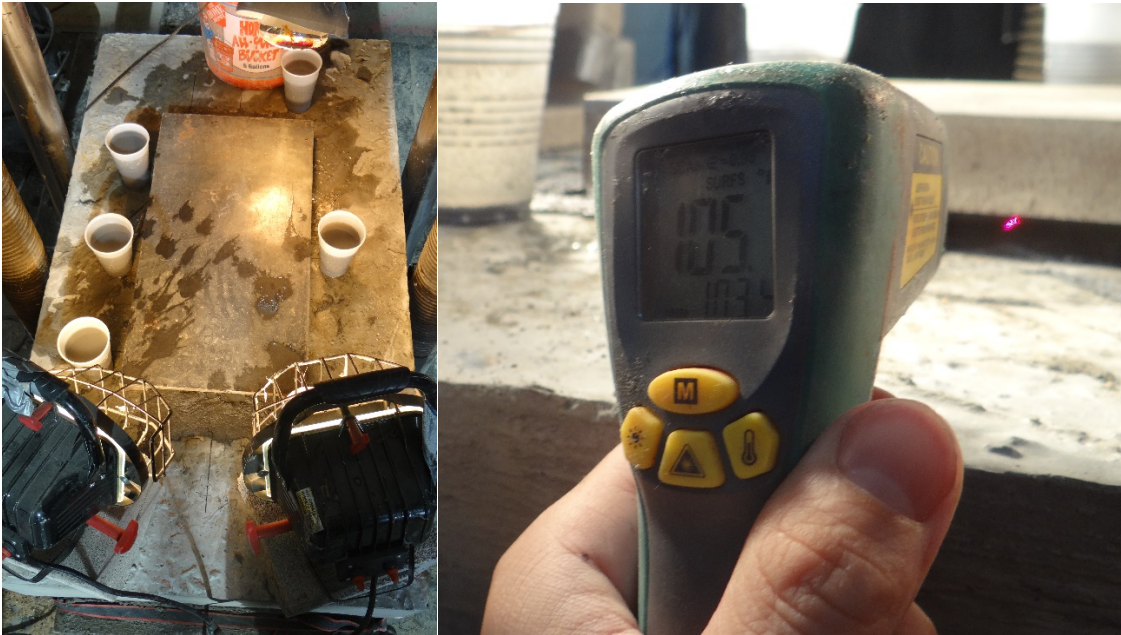
**Figure 40. The cast-in-place UHP-FRC repair joint heated to an average temperature of 100 °F using a combination of heaters.**

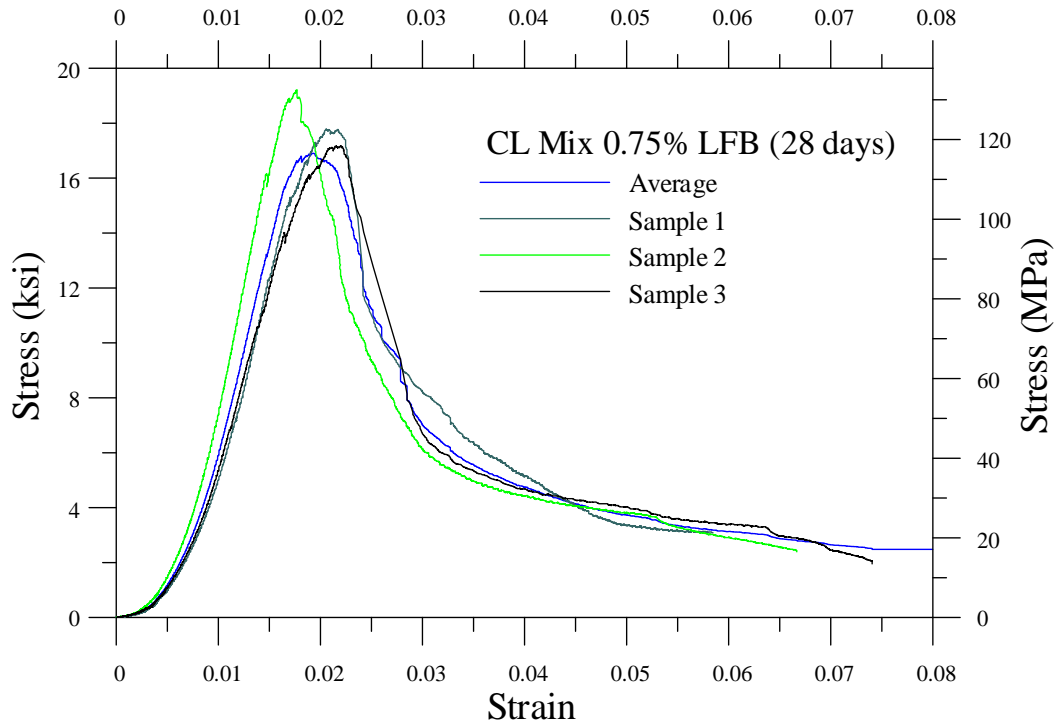
Figure 42. Stress vs. strain (Trial Mix 1: CL mix 0.75% LFB for 28 days).

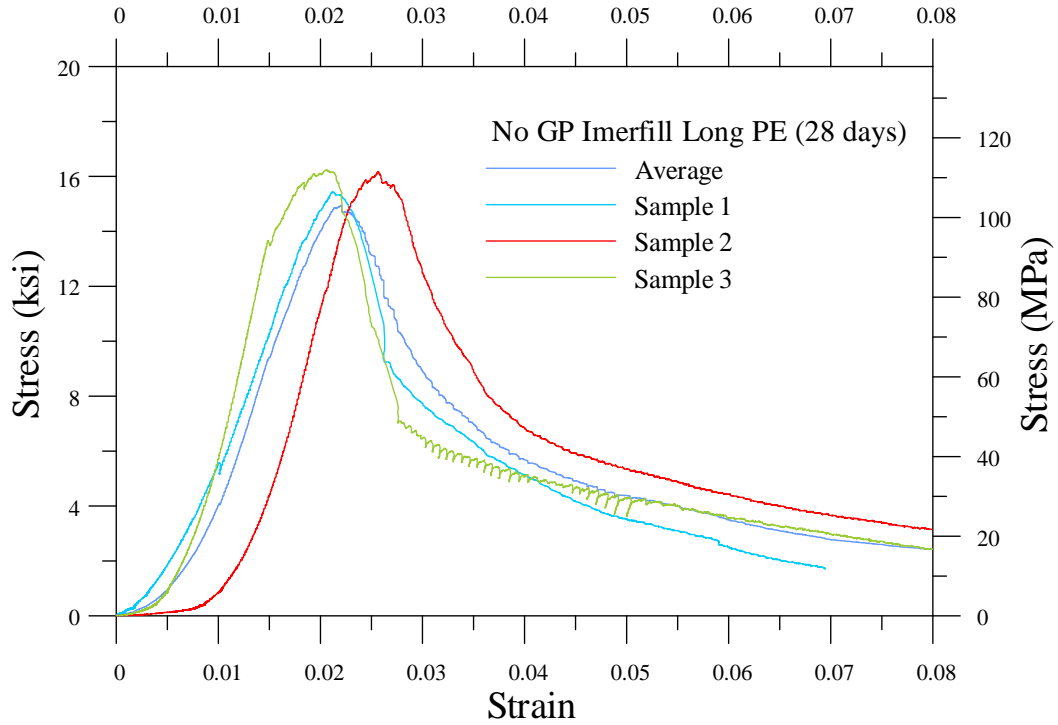
Figure 43. Stress vs. strain (Trial Mix 2: No GP, Imerfill, long PE for 28 days).

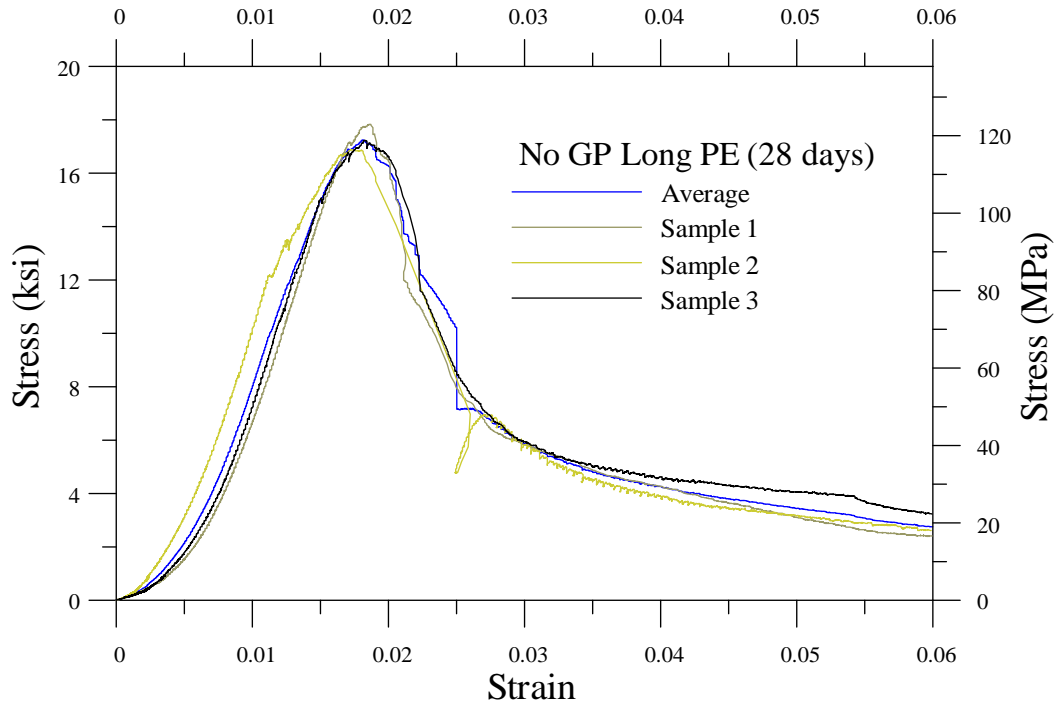
**Figure 44. Stress vs. strain (Trial Mix 3: No GP, long PE for 28 days).**

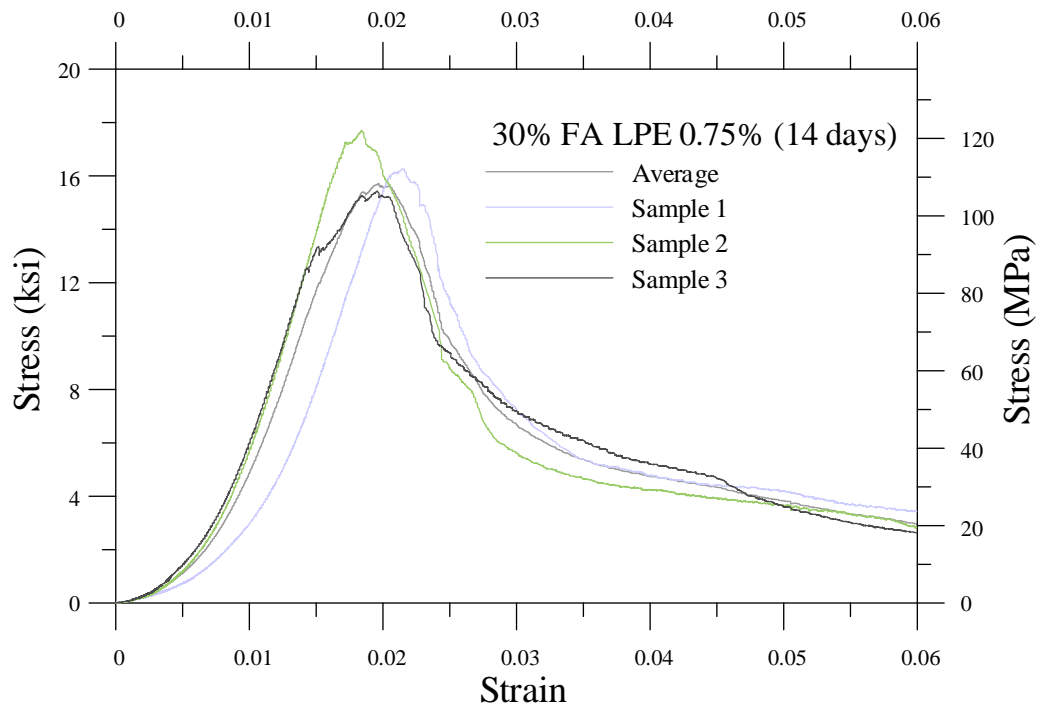
**Figure 45. Stress vs. strain (Trial Mix 4: 30% FA, long PE 0.75% for 14 days).**

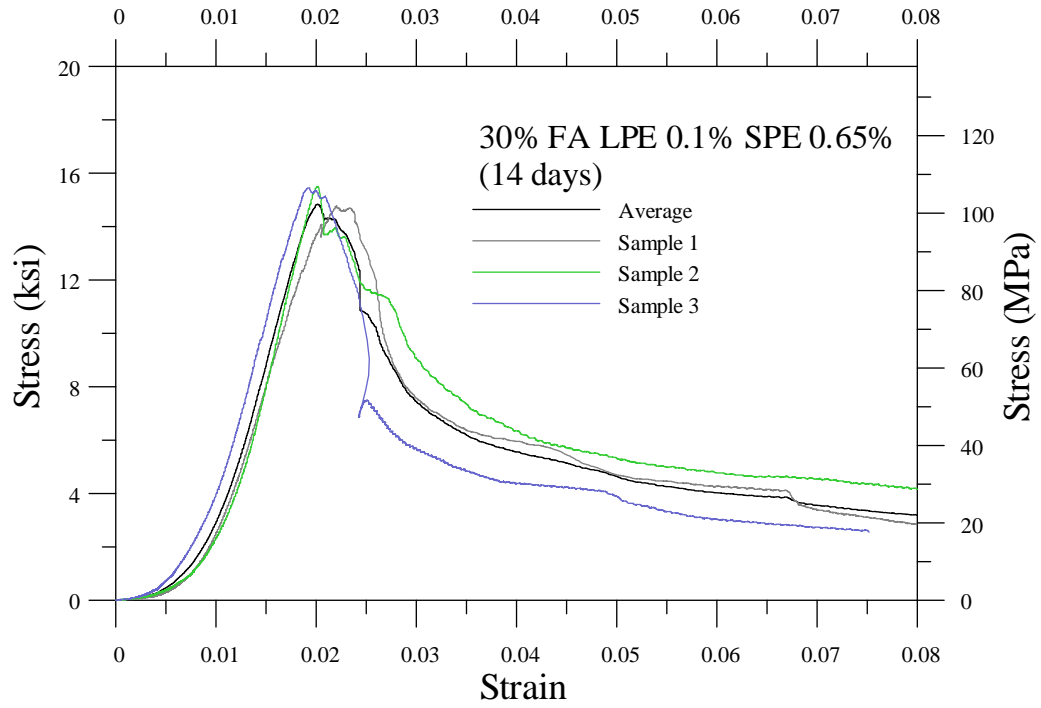
Figure 46. Stress vs. strain (Trial Mix 5: 30% FA, long PE 0.1%, short PE 0.65% for 14 days).

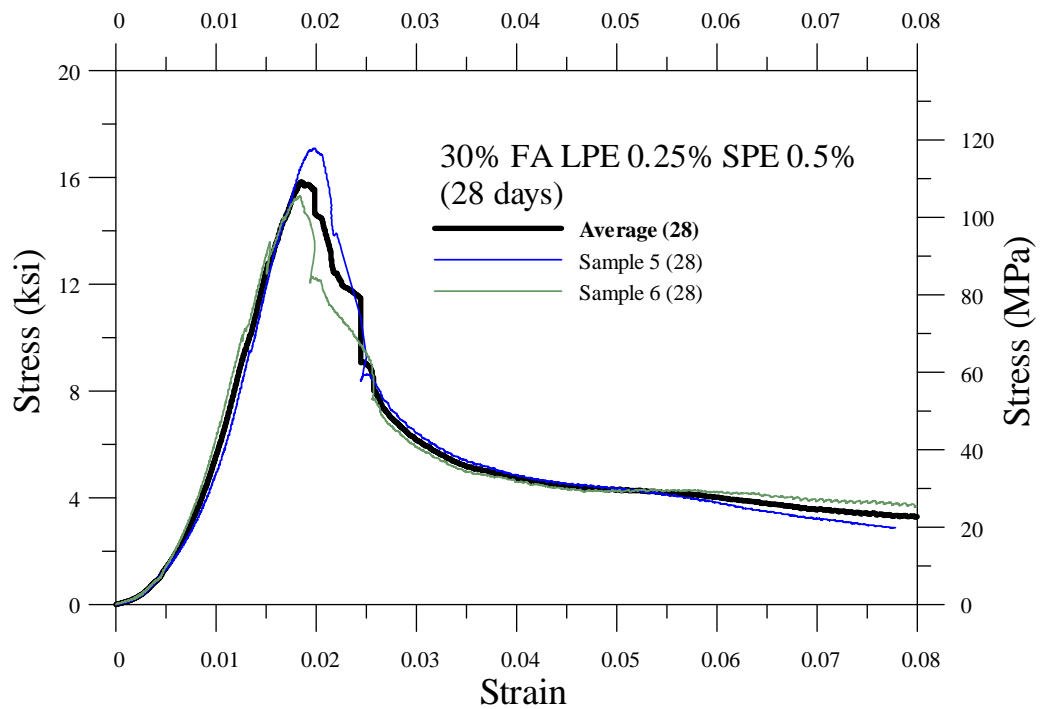
Figure 49. Stress vs. strain (Trial Mix 8: 30% FA long PE 0.25% short PE 0.5% for 28 days).

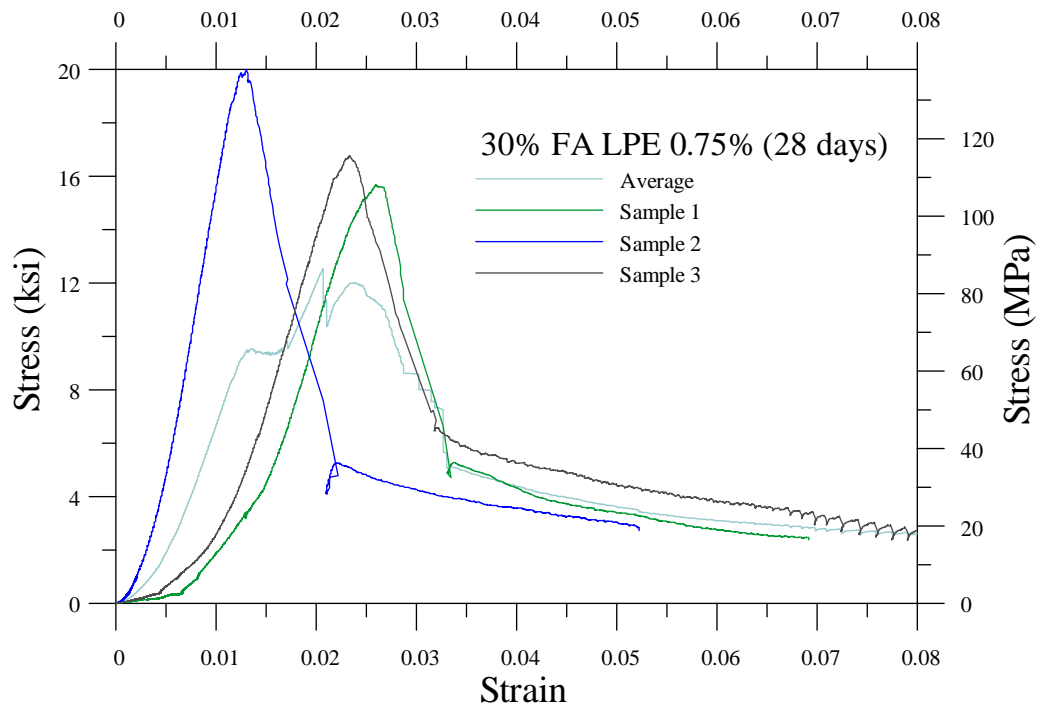
Figure 51. Stress vs. strain (Trial Mix 10: 30% FA long PE 0.75% for 28 days).

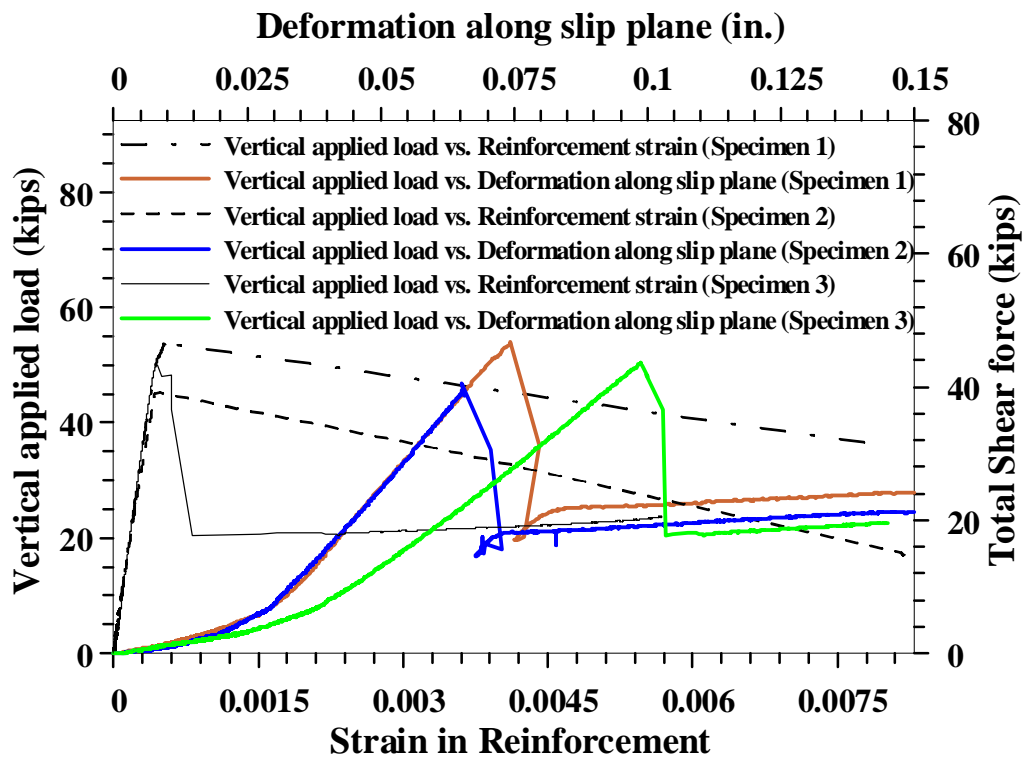
Figure 54. Vertical applied load vs. strain in reinforcement and vertical applied load vs. deformation along the slip plane for SST test specimen with a smooth surface and rebar.

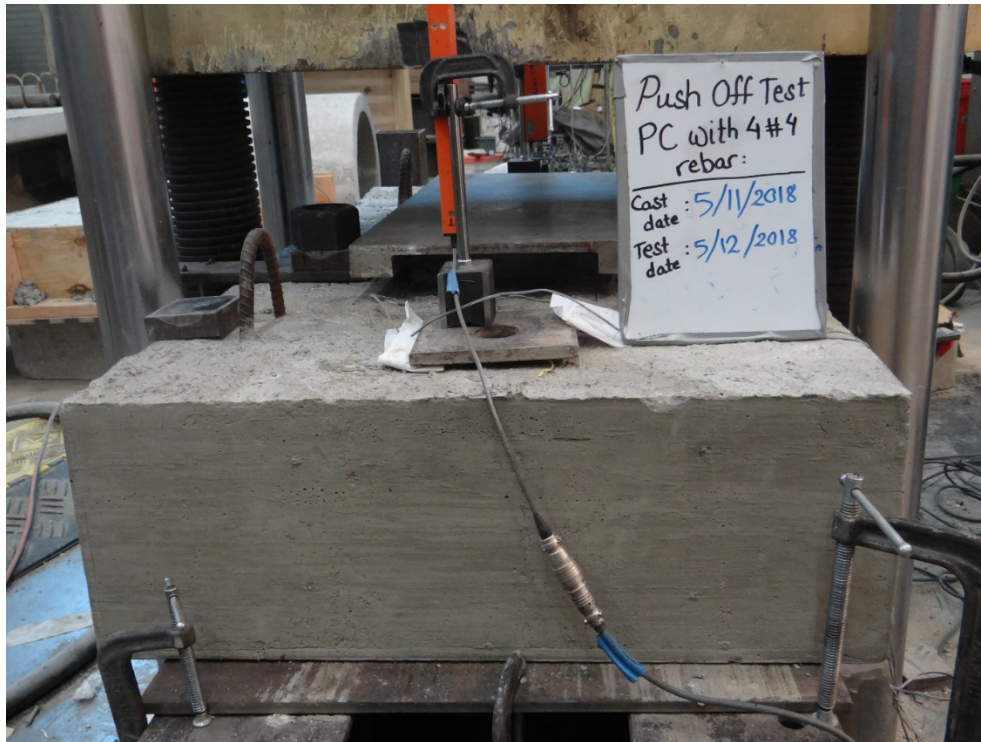
**Figure 58. Punch test setup for PC specimen with dowel bars.**

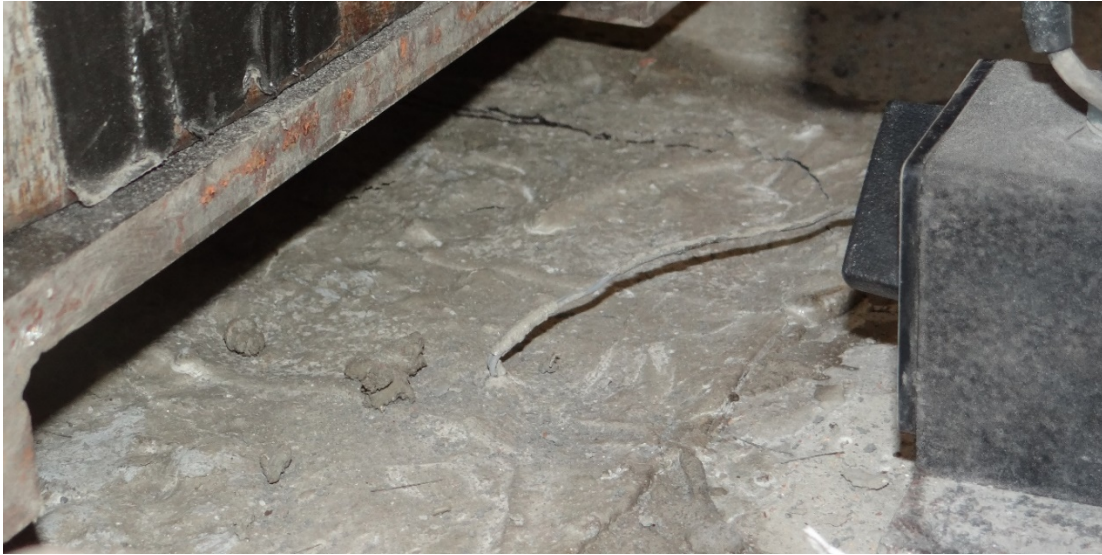
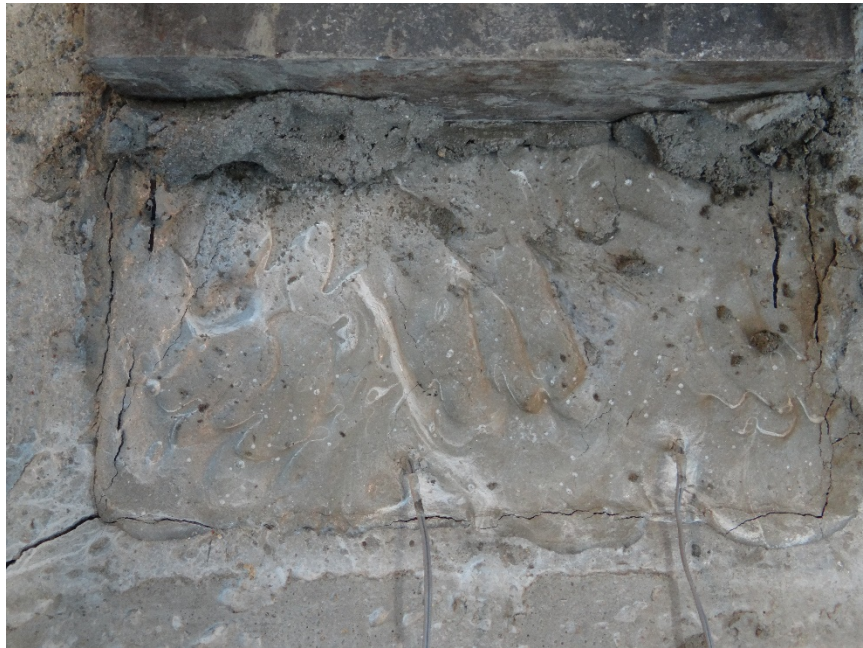
**Figure 59. Cracks observed at the interface between repair cast in place PC and the old concrete (outer hollow slab) post peak.**

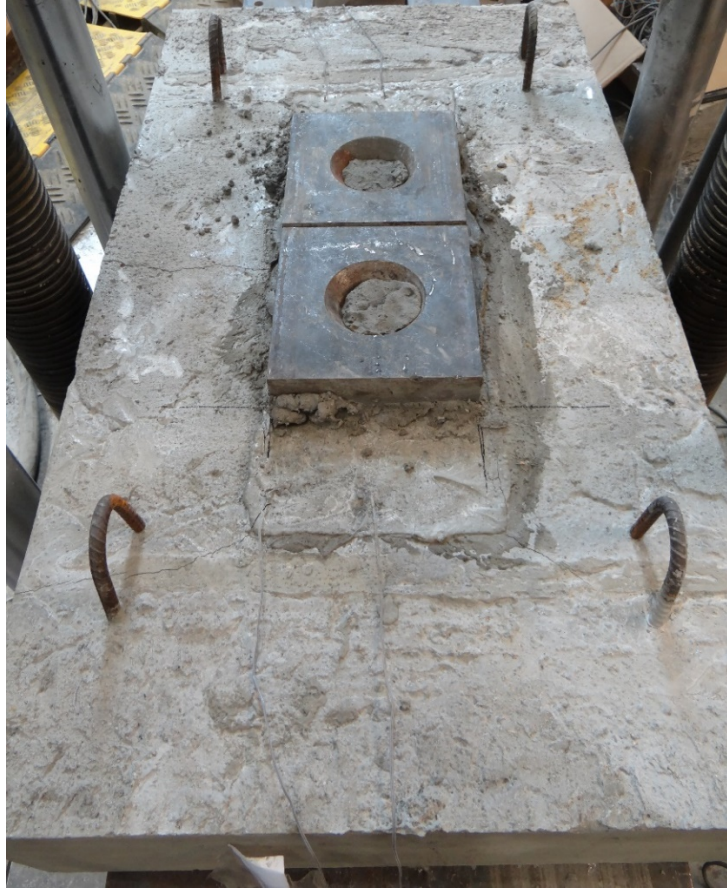
**Figure 60. Cracks seen in the outer slab initiating from the interface with the loading plates.**
