# Use of Ultra-High-Performance Fiber-Reinforced Concrete (UHP-FRC) for Fast and Sustainable Repair of Pavements

Project No. 17STUTA03

Lead University: University of Texas at Arlington

Final Report

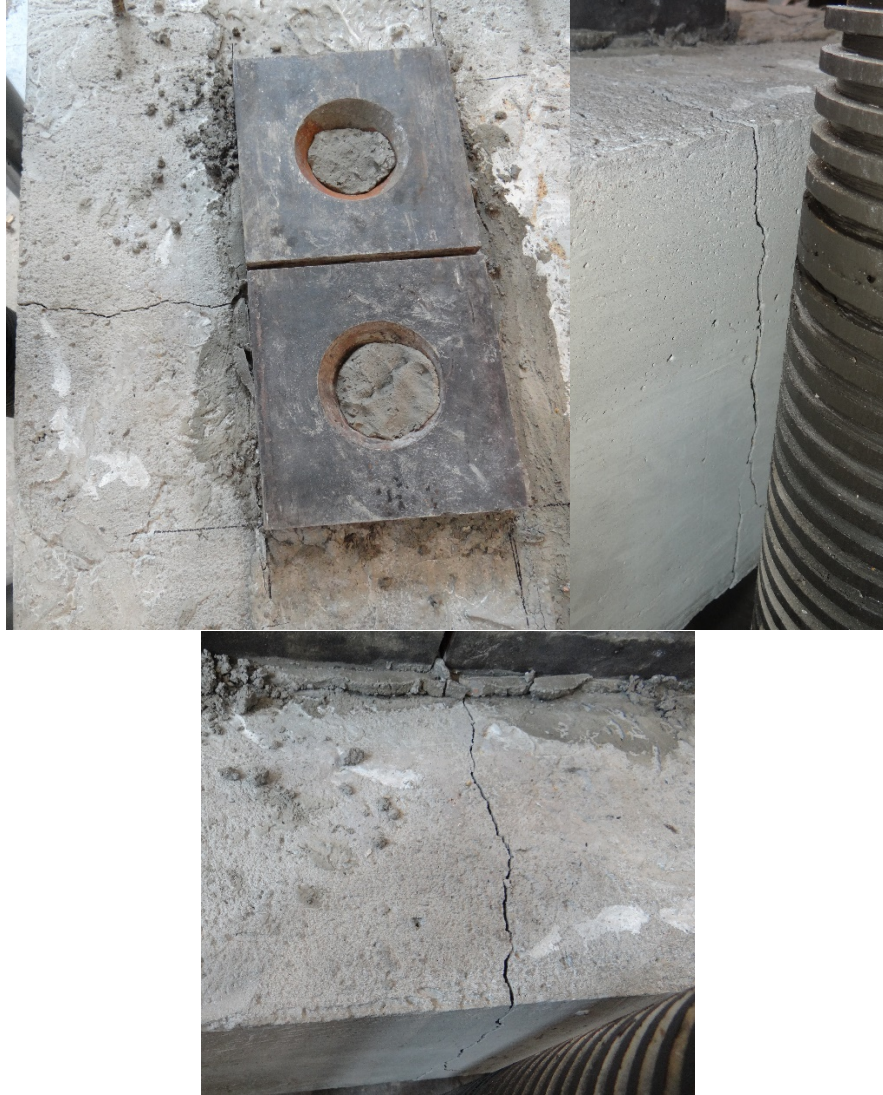
**Figure 61. Cracks seen at mid-span of the longer dimension extending throughout the depth of the slab.**

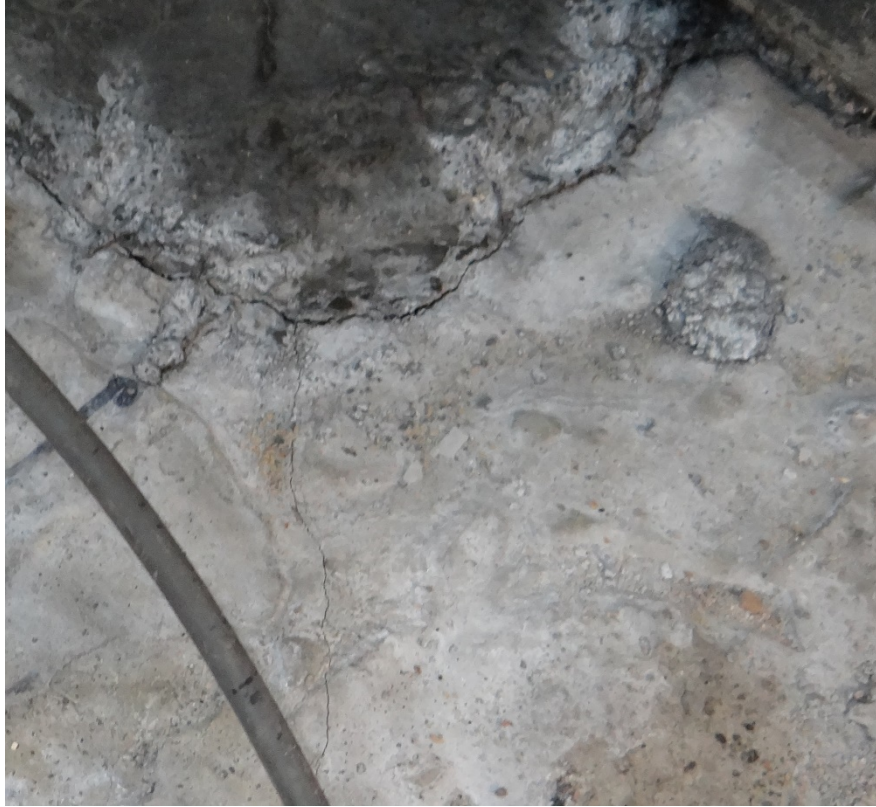
**Figure 65. Interface cracks observed in the UHP-FRC punch test specimen after peak.**

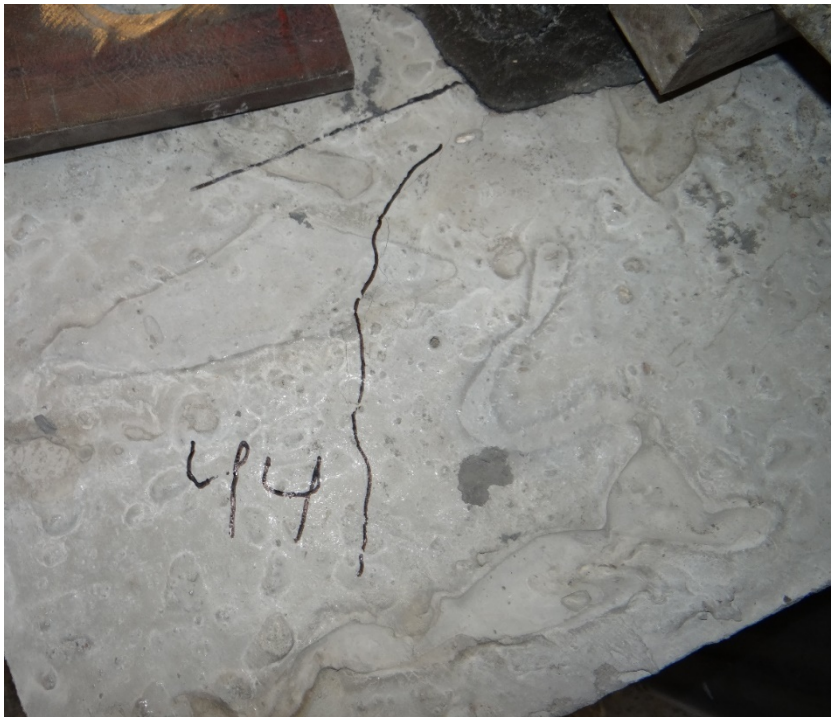
**Figure 66. Initiation of cracks from the corner of the repair joint at 44 kips of the post peak vertical load.**

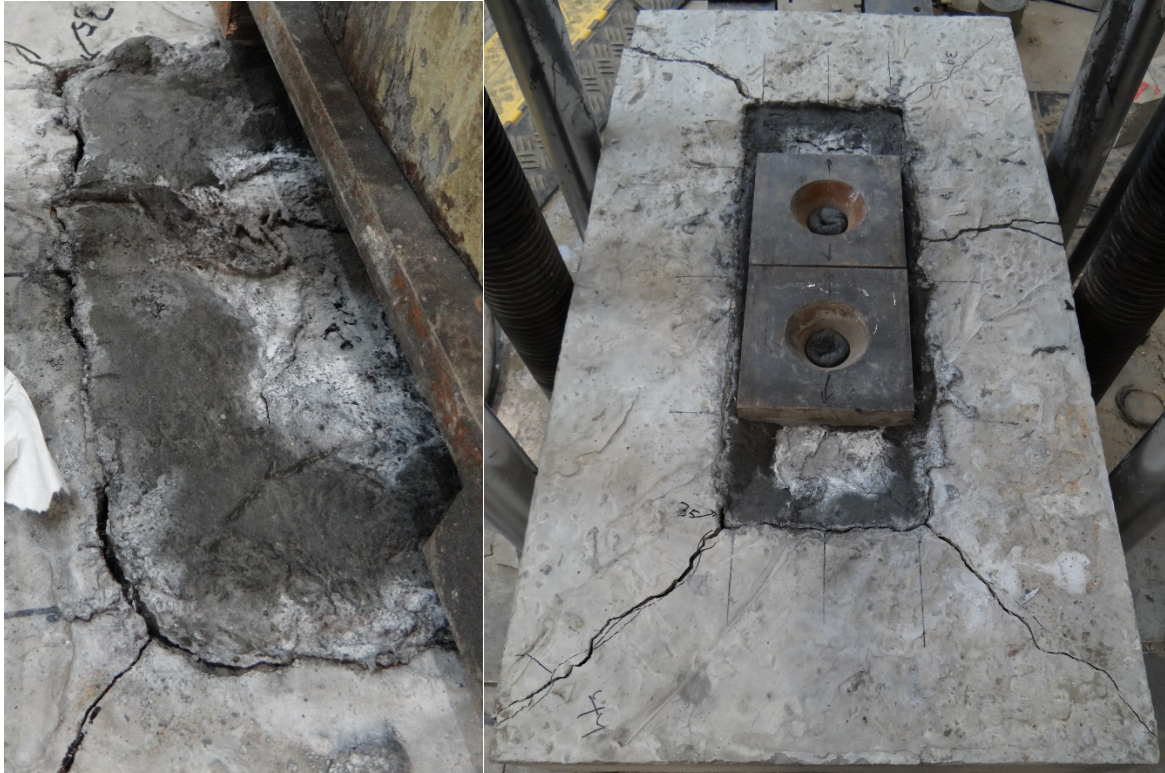
**Figure 67. Interface crack caused due to vertical slip and cracks observed on the outer support slab.**

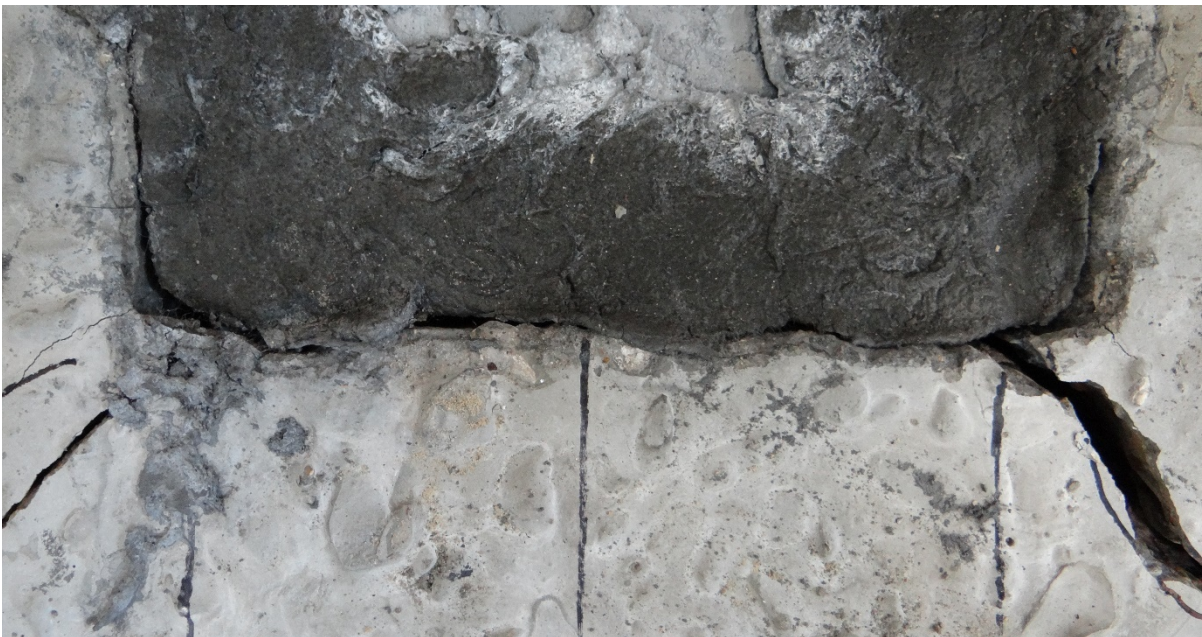
**Figure 68. Vertical deformation of the central repair slab and cracks propagating from the corner of the repair slab into the supporting outer slab.**

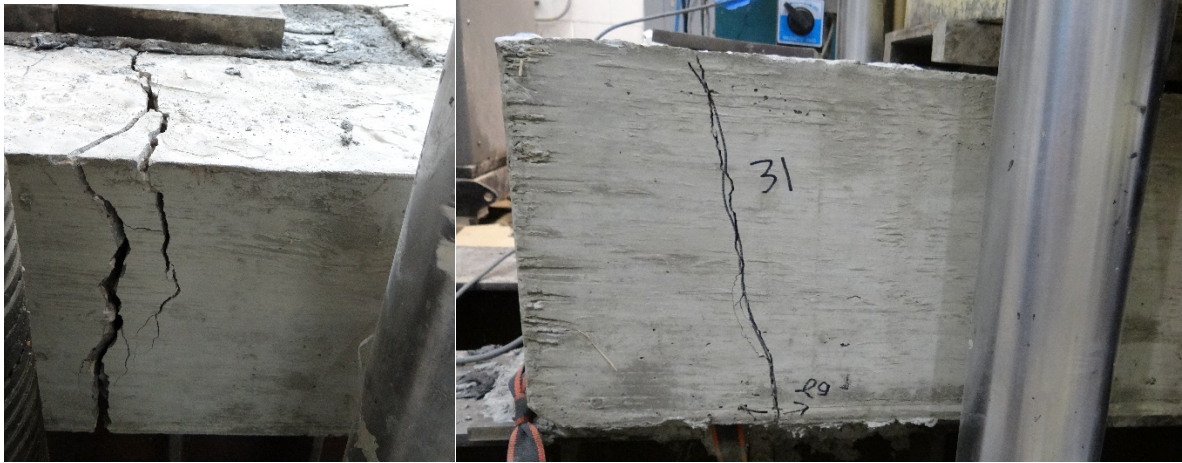
Figure 69. Cracks at the mid-span and the edge of the support outer slab.

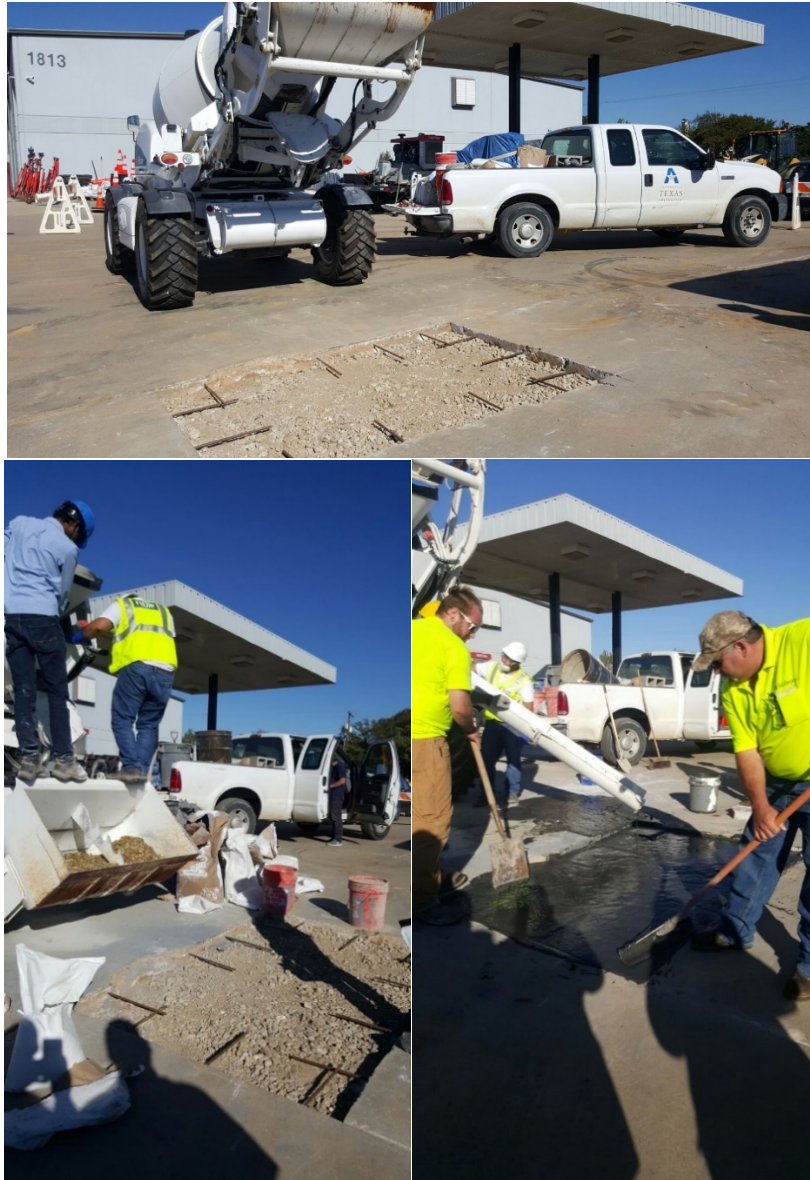
Figure 71. Field installation in the City of Bedford, TX.
