Evaluating the Accuracy and Use of Drilled Shaft Integrity Testing Methods in Illinois

Research Report No. FHWA-ICT-22-014

ICT PROJECT R27-188

Illinois Center for Transportation
October 2022

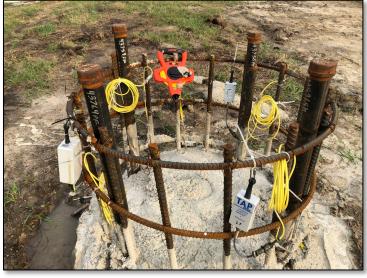
Figure 5. Photo. Photographs showing (a) 3.5 ft diameter rebar cage with 4 CSL access tubes and 4 TIP thermal wires installed before placement in shaft and (b) installed rebar cage after concrete pouring and connection of TIP readout boxes.

Figure 5(a) shows the 3.5 ft diameter rebar cage with 4 CSL access tubes and 4 TIP thermal wires already installed before placement in the drilled shaft. Figure 5(b) shows the 3.5 ft diameter rebar cage with 4 CSL access tubes and 4 TIP thermal wires after concrete pouring.

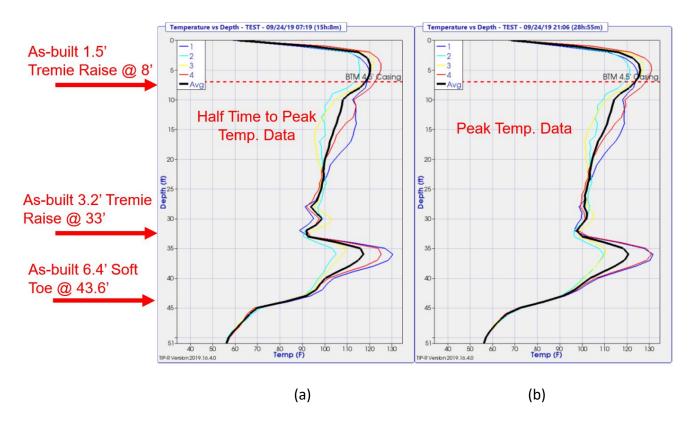
The measured profiles indicate a reduction in temperature in all thermal wires starting at a depth of 7 ft. This depth corresponds to the first planned defect, which is a 1.5 ft high tremie pipe raise at a depth of 8 ft. This temperature reduction is probably due to changing the diameter of the drilled shaft from the cased diameter of 4.5 ft to the uncased diameter of 4 ft and the tremie raise at 8 ft. This conclusion is based on the temperature reduction not being an abrupt reduction at one specific location but the reduction starting at 7 ft and continuing to reduce gradually with depth. However, there is a sharp temperature reduction in wires #1 and #4 at a depth of 10 ft at one-half the time to peak temperature and peak temperatures data figures, and therefore, the detection of the 1.5 ft tremie raise at 8 ft is inconclusive. The 4 in. offset of the rebar cage from 2 to 12 ft can be observed in one-half the time to peak temperature (see Figure 7[a]) to peak (see Figure 7[b]) data. For example, wire #4 shows a temperature higher than wire #1 up to a depth of 12 ft, after which wire #1 shows a higher temperature than wire #4.

Figure 7. Graph. Temperature versus depth profiles for four thermal wires in test shaft #1: (a) at one-half time to peak temperature and (b) at peak temperature, with red arrows showing the location of installed defects.

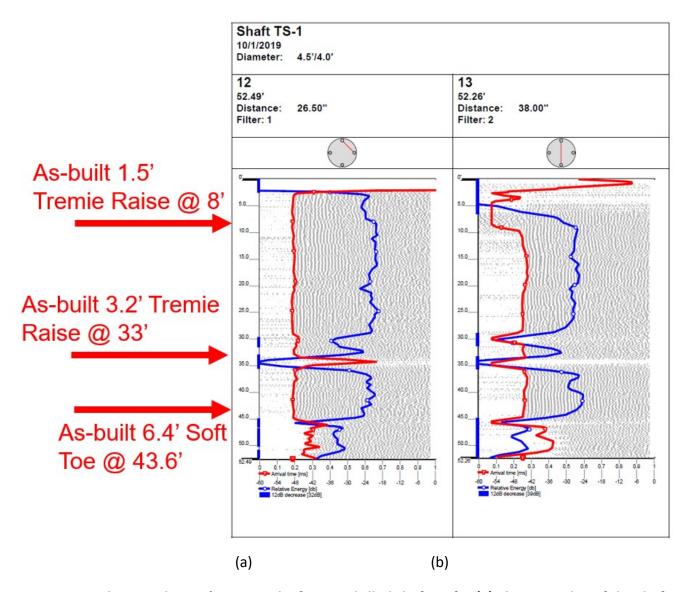
Figure 8. Graph. Consultant B's CSL results for test drilled shaft #1 for (a) along an edge of the shaft (profile 1–2) and (b) across the shaft (profile 1–3), with red arrows showing defect locations.

Figure 8 show the CSL results for test drilled shaft #1 with the defect locations indicated with red arrows to facilitate interpretation of the test results.

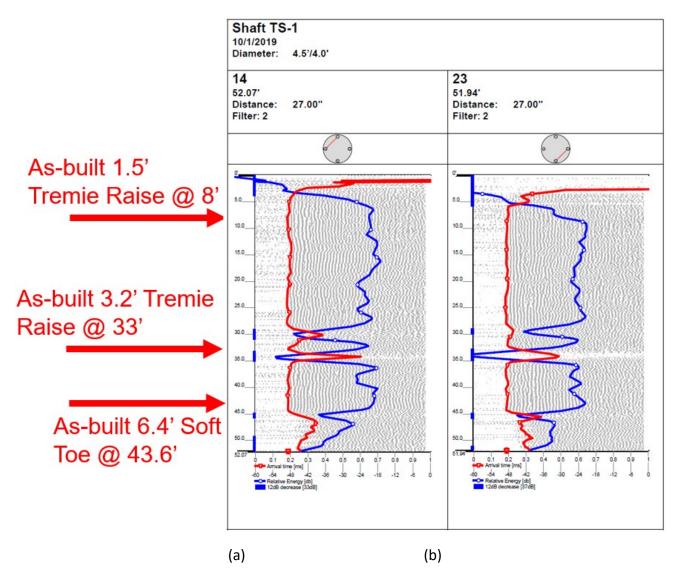
Figure 9. Graph. Consultant B's CSL results for test drilled shaft #1 along edges of the shaft: (a) profile 1–4 and (b) profile 2–3, with red arrows showing defect locations.

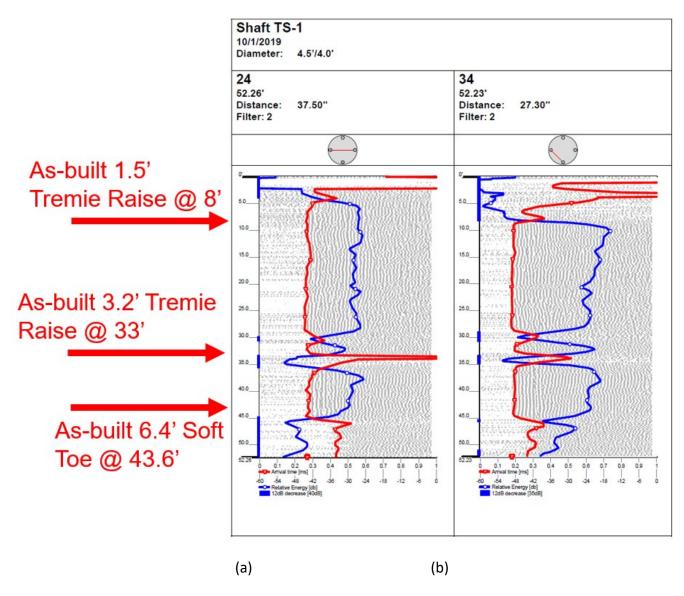
Figure 10. Graph. Consultant B's CSL results for test drilled shaft #1 for (a) across the shaft (profile 2-4) and (b) along the edge of the shaft (profile 3-4), with red arrows showing defect locations.

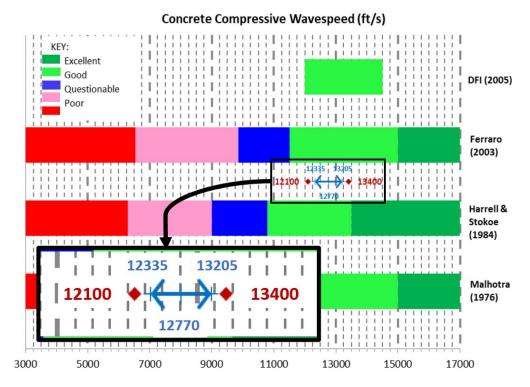
Figure 11. Chart. Calculated concrete wave speed comparisons.

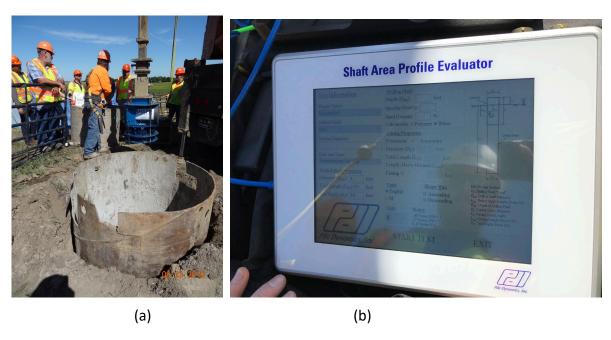
Figure 12. Photo. Photograph showing (a) SHAPE (see blue device) attached to a Kelly bar before descending test drilled shaft #1 and (b) SHAPE software showing while testing.

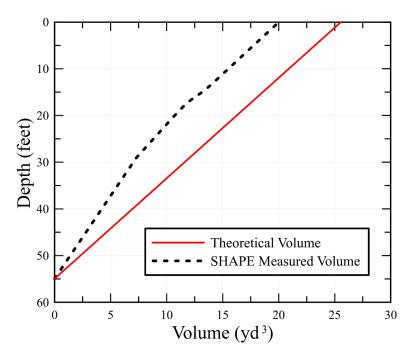
Figure 13. Graph. SHAPE data used to estimate shaft volume with depth for comparison with the theoretical value of test shaft #1.

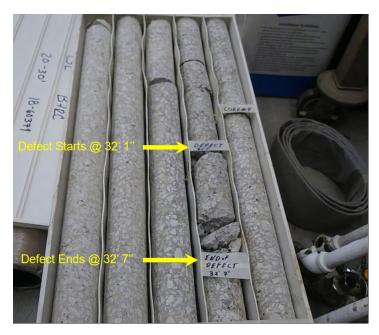
Figure 16. Photo. Cores obtained from coring test drilled shaft #1 showing the start and end of the observed defect between 32 ft 1 in. and 32 ft 7 in. depth.

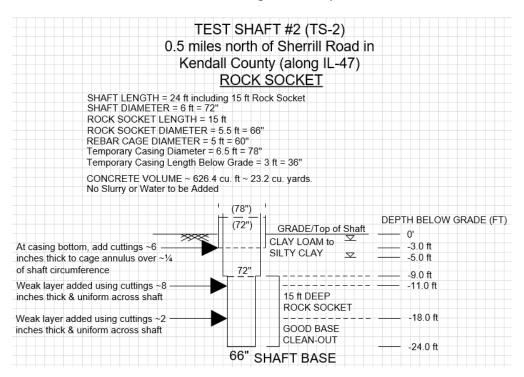
Figure 17. Illustration. Initial design of test drilled shaft #2 located 0.5 miles north of Sherrill Road in Kendall County, Illinois (along IL-47).

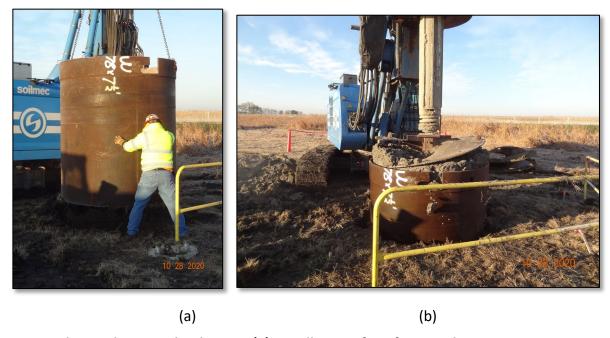
Figure 19. Photo. Photographs showing (a) installation of 6.5 ft outer diameter temporary casing and (b) start of excavation after placing the temporary casing in the shaft.

Figure 19(a) shows installation of the 6.5 ft outer diameter temporary casing, and Figure 19(b) shows the start of excavation after placement of the temporary casing. Figure 20(a) shows the 5 ft diameter rebar cage with 6 CSL access tubes and 12 TIP thermal wires already installed before placement in the drilled shaft. Figure 20(b) shows the 5 ft diameter rebar cage with six CSL tubes and 12 TIP thermal wires after concrete pouring.

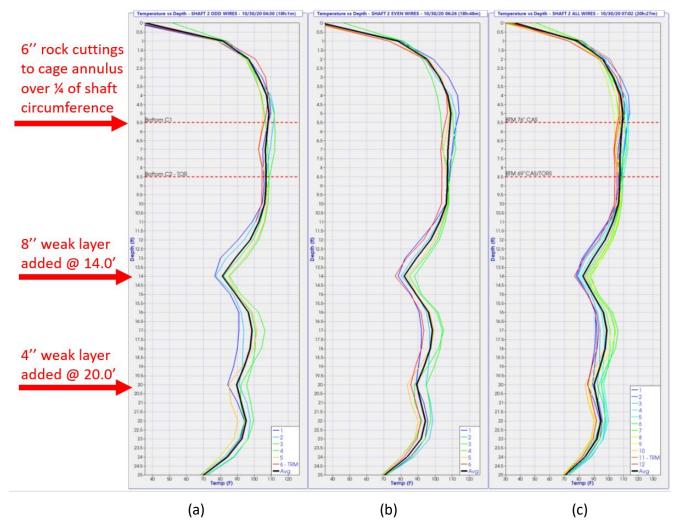
Figure 22. Graph. Temperature versus depth profile in test drilled shaft #2 with red arrows indicating the location of the defects for (a) six odd wires at 18 hours and 1 minute, (b) six even wires at 18 hours and 48 minutes, and (c) all 12 thermal wires installed in test shaft #2 at 20 hours and 27 minutes after concrete placement.

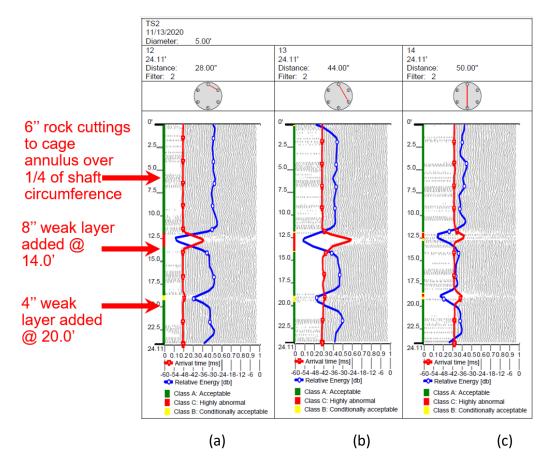
Figure 23. Graph. Consultant B's CSL results for test shaft #2 for (a) along an edge of the shaft (profile 1–2), (b) across the shaft (profile 1–3), and (c) across the middle of the shaft (profile 1–3), with red arrows showing installed defect locations.

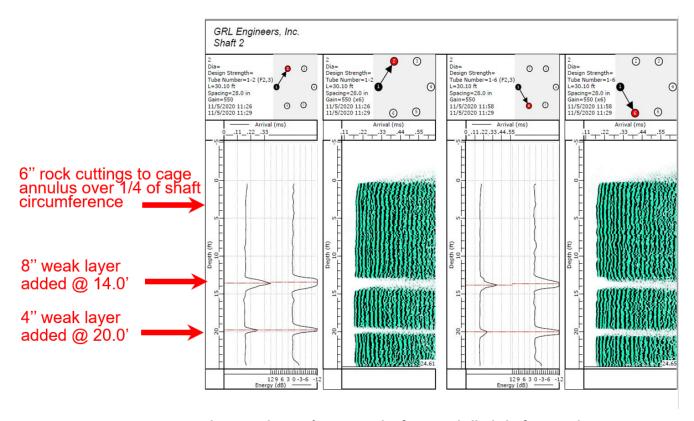
Figure 24. Graph. Consultant A's CSL results for test drilled shaft #2 with defect locations for profile 1–2 on the left and profile 1–6 on the right.

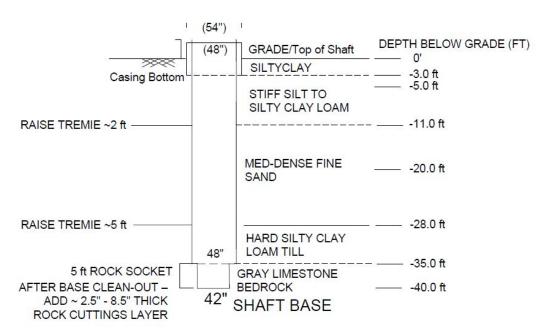
Figure 26. Illustration. Initial design of test drilled shaft #3 located 0.3 miles north of Nelson Road in Grundy County, Illinois, along IL-47.

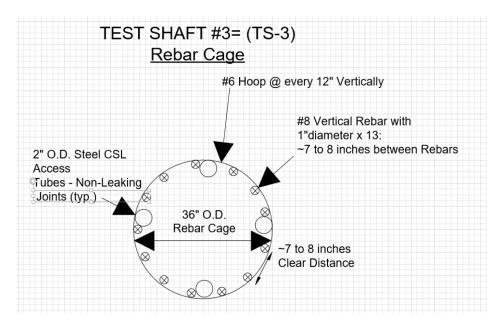
Figure 27. Illustration. Initial design cross section of test drilled shaft #3 with reinforcement detail.

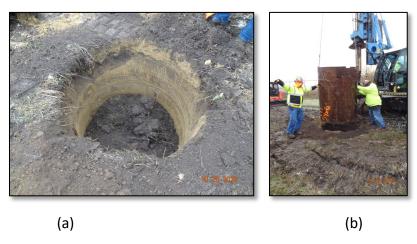
Figure 28. Photo. Photographs showing (a) start of excavation for test drilled shaft #3 and (b) installation of 4.5 ft diameter temporary casing.

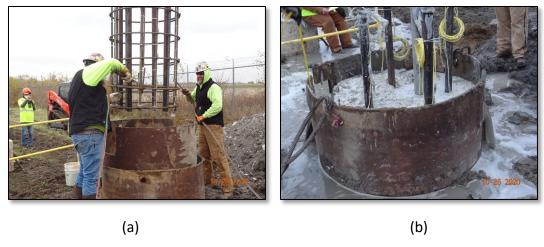
Figure 30. Photo. Photographs showing (a) suspended 3 ft diameter rebar cage with four CSL tubes and eight TIP thermal wires and (b) test drilled shaft #3 after concrete pouring.

Figure 28(a) shows the installation of 4.5 ft outer diameter temporary casing, and Figure 28(b) shows the start of excavation for test drilled shaft #3. Figure 29 shows the 3 ft diameter rebar cage with four CSL access tubes and eight TIP thermal wires already installed or attached to the cage. Figure 30(a) shows the rebar cage before placement in the drilled shaft. Figure 30(b) shows the 3 ft diameter rebar cage with four CSL access tubes and eight TIP thermal wires after concrete pouring. Figure 31 shows the as-built diagram for test drilled shaft #3, which includes the pre-planned defects.

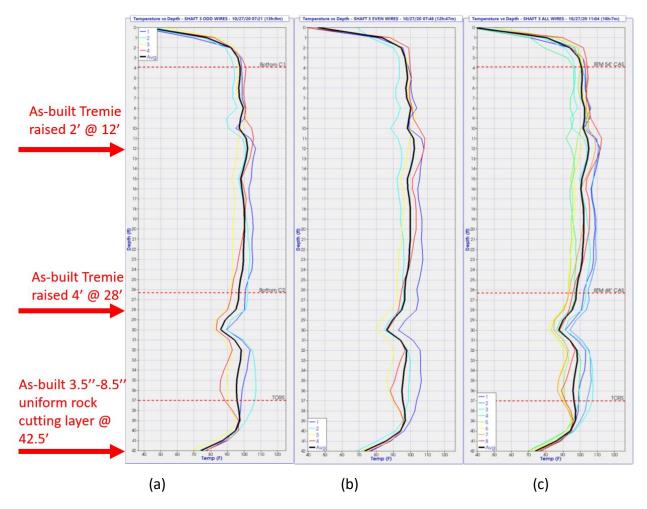
Figure 32. Graph. Temperature versus depth profile in test drilled shaft #3 for (a) the four odd wires at 13 hours and 9 minutes, (b) the four even wires at 12 hours and 47 minutes, and (c) all eight thermal wires at 16 hours and 7 minutes after concrete placement with red arrows showing defect locations.

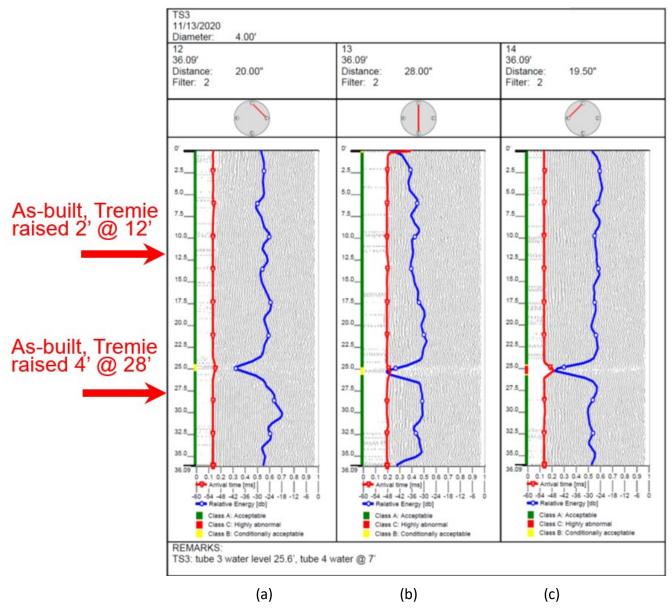
Figure 33. Graph. Consultant B's CSL results for test drilled shaft #3 for (a) along an edge of the shaft (profile 1–2), (b) across the shaft (profile 1–3), and (c) along an edge of the shaft (profile 1–4), with red arrows showing defect locations.

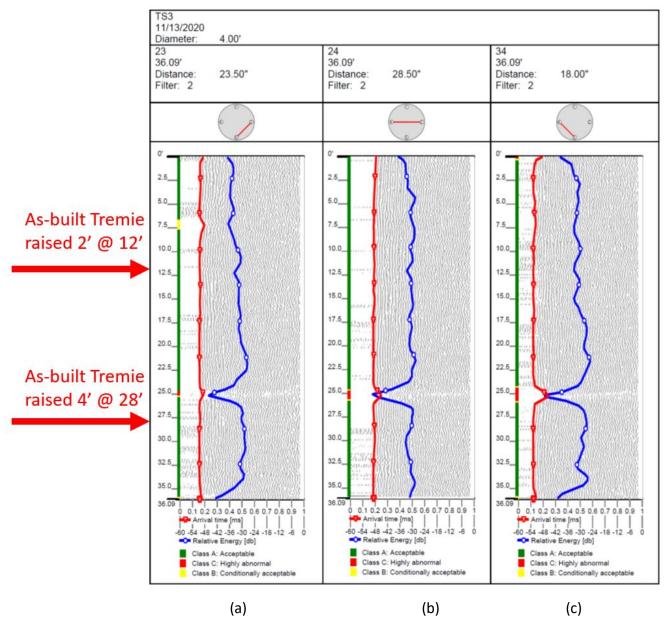
Figure 34. Graph. Consultant B's CSL results for shaft #3 for (a) along an edge of the shaft (profile 2–3), (b) across the shaft (profile 2–4), and (c) along an edge of the shaft (profile 3–4), with red arrows showing defect locations.

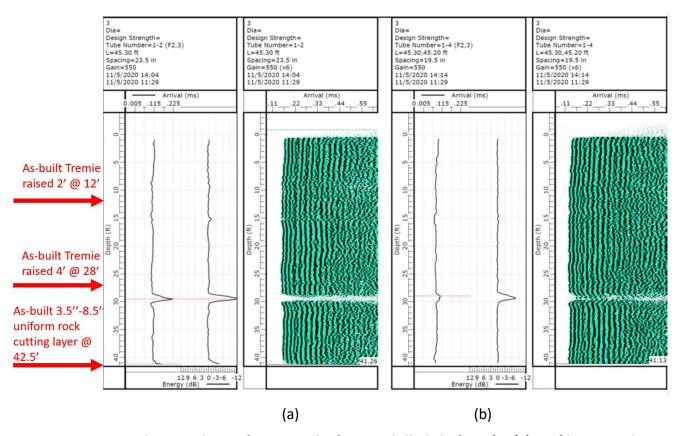
Figure 35. Graph. Consultant A's CSL results for test drilled shaft #3 for (a) profile 1–2 and (b) profile 1–4, with red arrows showing defect locations.

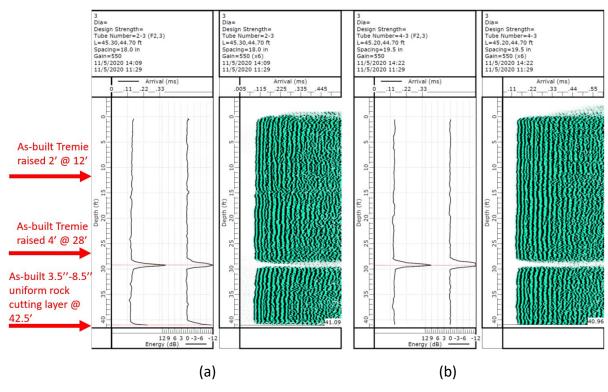
Figure 36. Graph. Consultant A's CSL results for test drilled shaft #3 for (a) profile 2-3 and (b) profile 4-3, with red arrows showing defect locations.

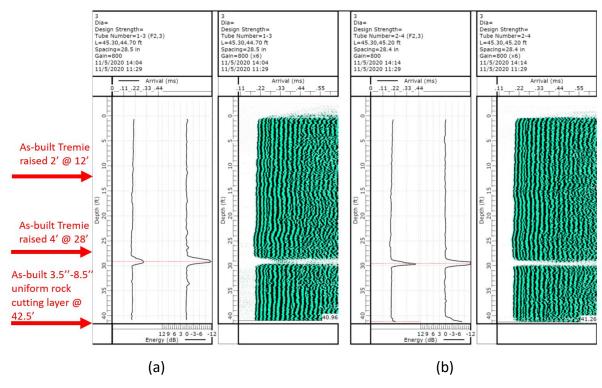
Figure 37. Graph. Consultant A's CSL results for test drilled shaft #3 for (a) profile 1-3 and (b) profile 2-4, with red arrows showing defect locations.

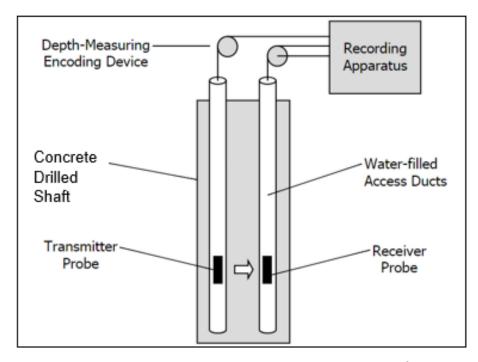
Figure 40. Illustration. Diagram of basic CSL testing arrangement (ASTM D6760).

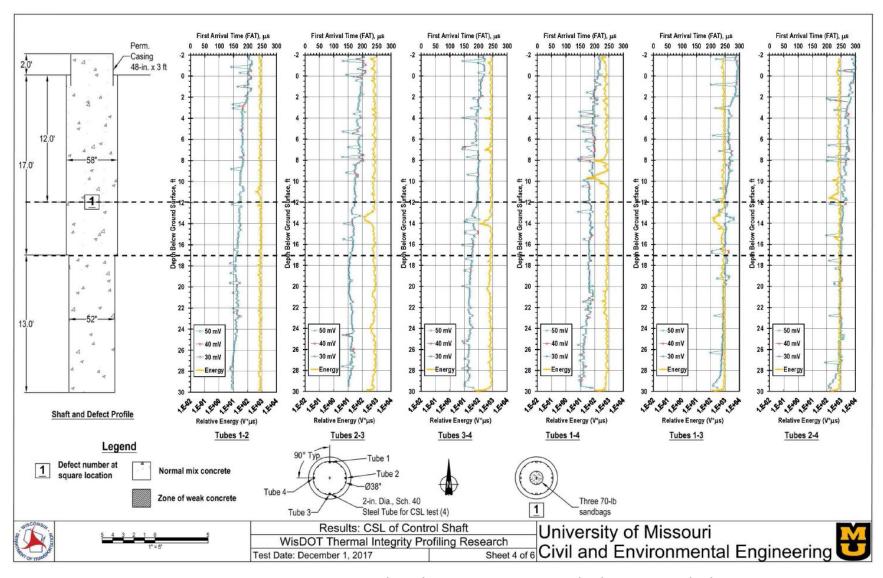
Figure 41. Graph. Graph from Boeckmann and Loehr (2018) showing arrival times (ms) and energy (dB) profiles for different access duct pairings with depth (ft) for a fifty-eight (58) inch (1.5 m) diameter test drilled shaft with a thirty (30) foot (9.2 m) tip depth with no planned defects.

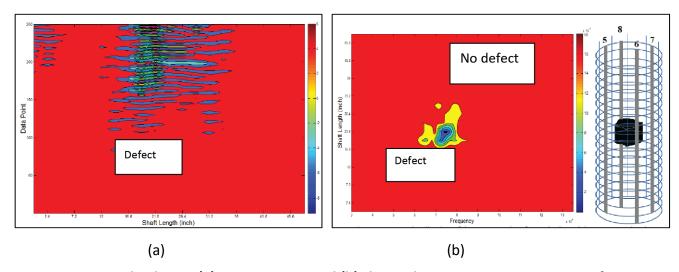
Figure 42. Graph. Shows: (a) Time Domain and (b) shows the Frequency-Domain Data from CSL testing of a drilled shaft [image from (Hajali and Abishdid, 2014)].

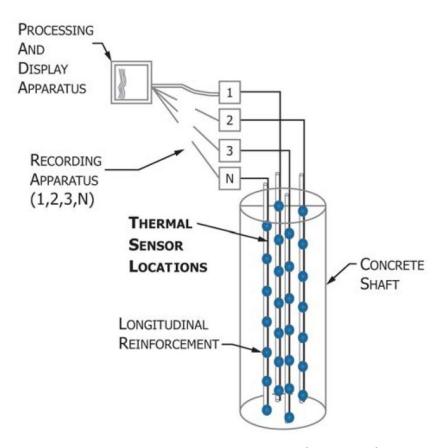
Figure 44. Illustration. Schematic diagram of the TIP testing (Method B) arrangement, including thermal wires, thermal access ports (TAPS), computer, and remote data transmitter (ASTM D7949).

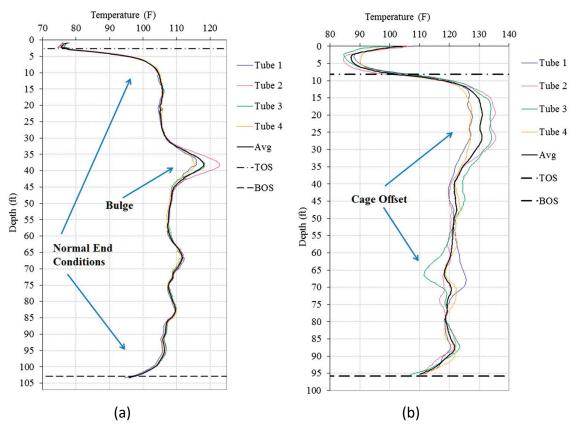
Figure 46. Graph. Temperature distribution and dissipation due to concrete hydration in two non-idealized drilled shafts (images from Johnson, 2016) (Johnson, 2016).

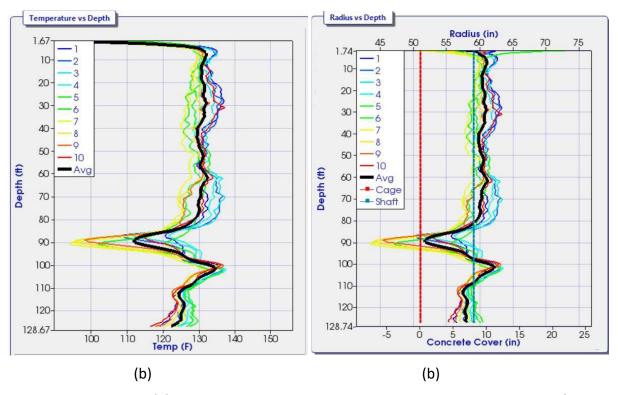
Figure 47. Graph. Shows: (a) ten different temperature profiles with an average profile (black line) and (b) shows the estimated shaft radius and concrete cover based on the measured temperature profiles (images from Piscsalko et al., 2016 (Piscsalko et al., 2016).

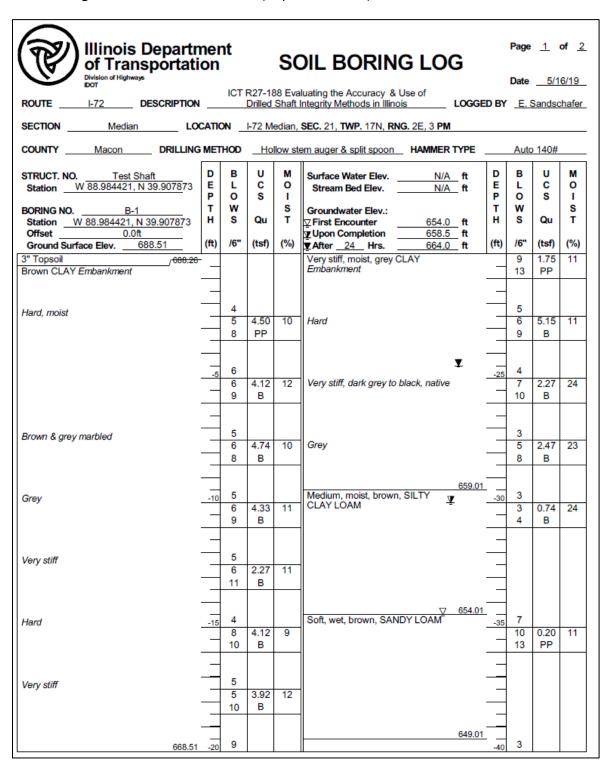
Figure 51. Illustration. Soil Boring log #1 of test drilled shaft #1.

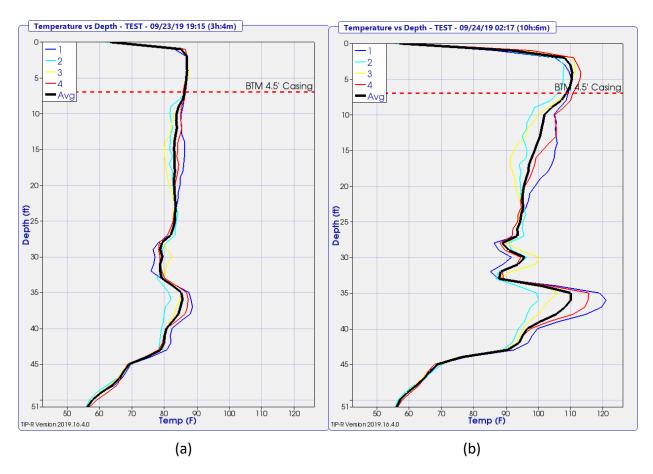
Figure 55. Graph. Temperature versus depth profile for the 4 wires in test drilled shaft #1: (a) at 3h 4m, and (b) at 10h 6m after concrete placement.

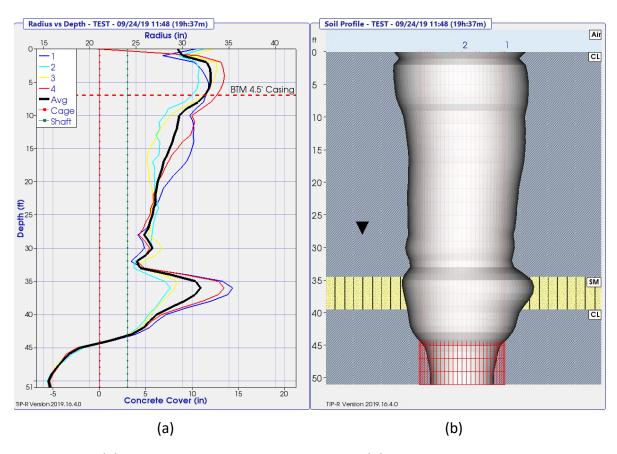
Figure 58. Graph. (a) radius versus depth and Illustration. (b) 3D rendering with rebar cage and soil type for the 4 wires in test drilled shaft #1.

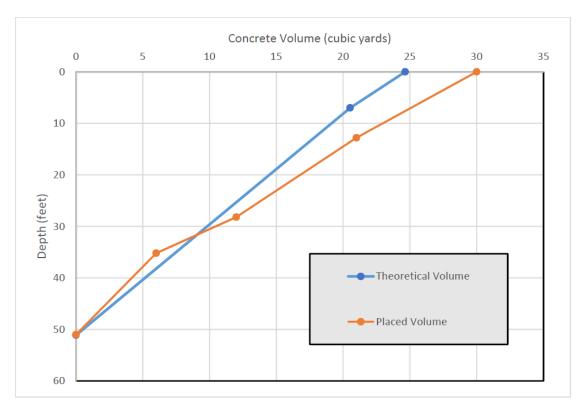
Figure 59. Graph. Theoretical vs. Placed Concrete Volume in test drilled shaft #1.

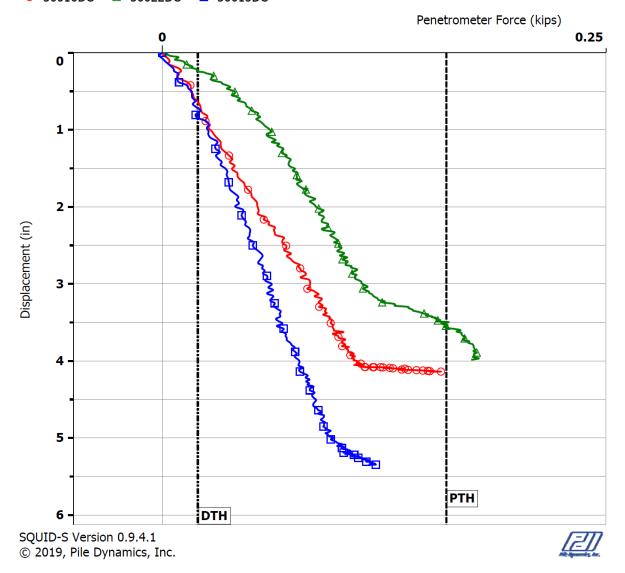
Figure 71. Graph. SQUID results for test drilled shaft #1 with defects' locations (run number 1).

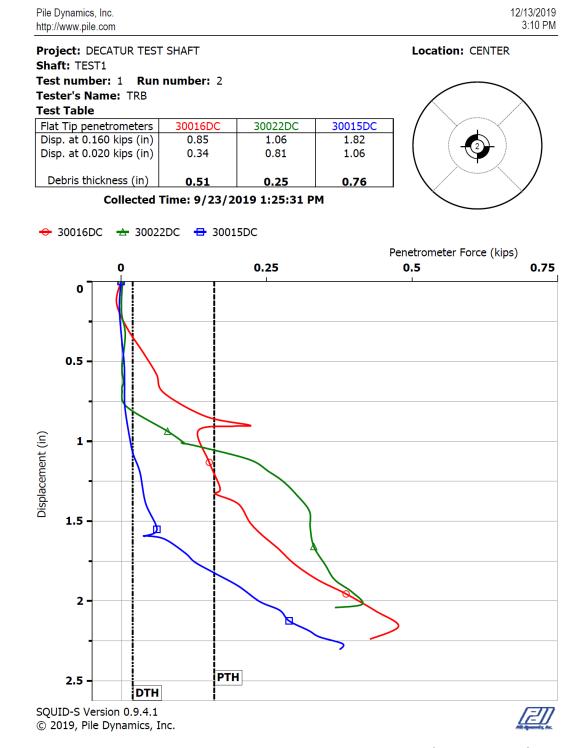
Figure 72. Graph. SQUID results for test drilled shaft #1 (run number 2).

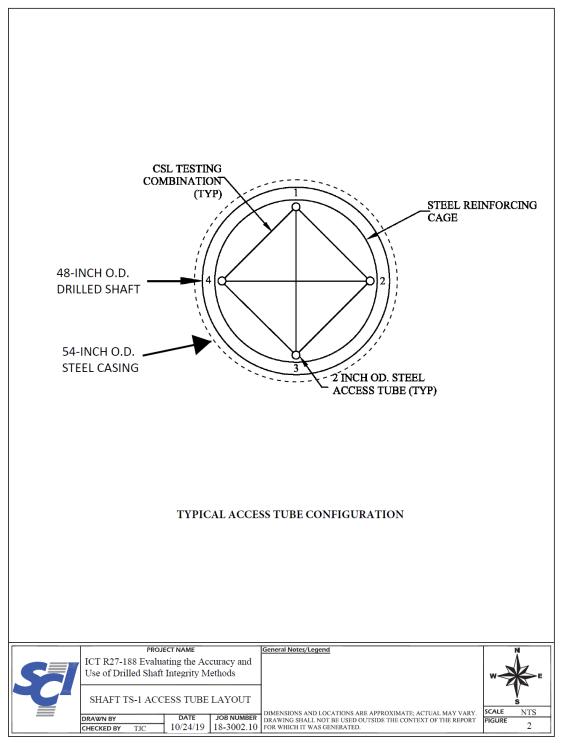
Figure 74. Illustration. Consultant B's CSL access tube configuration for test drilled shaft #1.

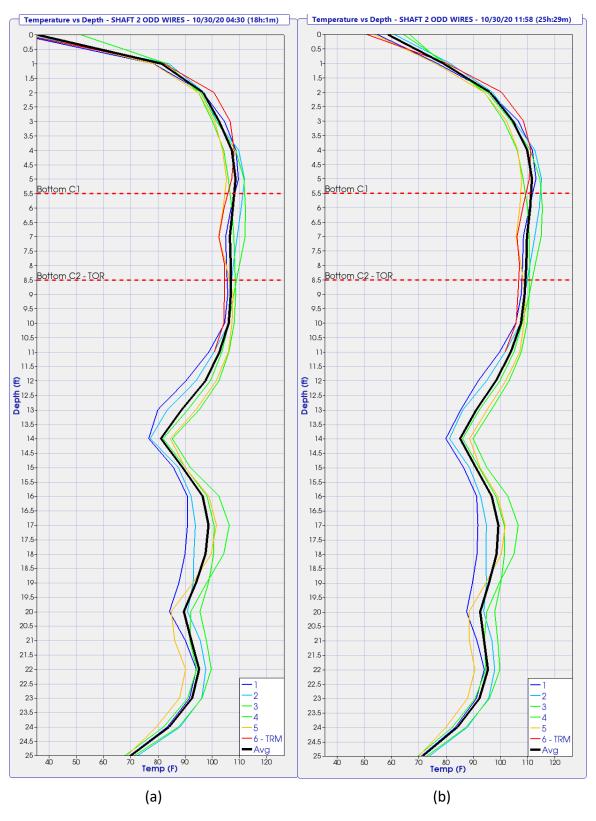
Figure 89. Graph. Temperature versus depth profile for the 6 odd wires in test drilled shaft #2: (a) at 18h 1m, and (b) at 25h 29m after concrete placement.

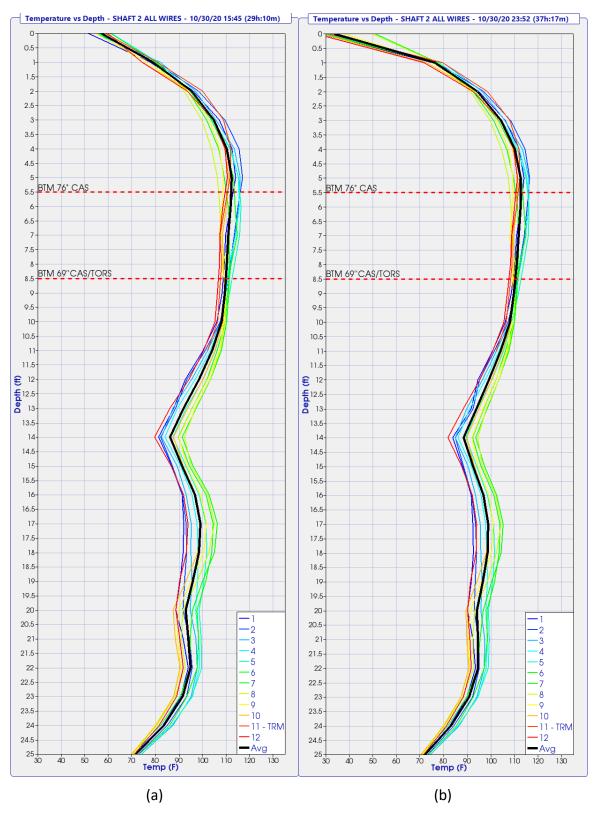
Figure 98. Graph. Temperature versus depth profile for all the 12 wires in test drilled shaft #2: (a) at 29h 10m, and (b) at 37h 17m (peak) after concrete placement.

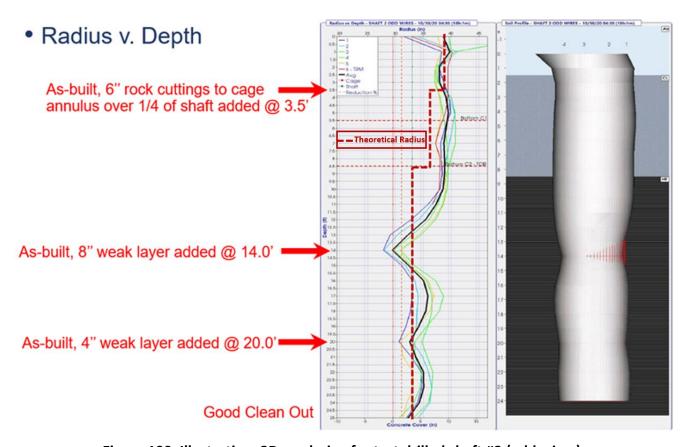
Figure 100. Illustration. 3D rendering for test drilled shaft #2 (odd wires).

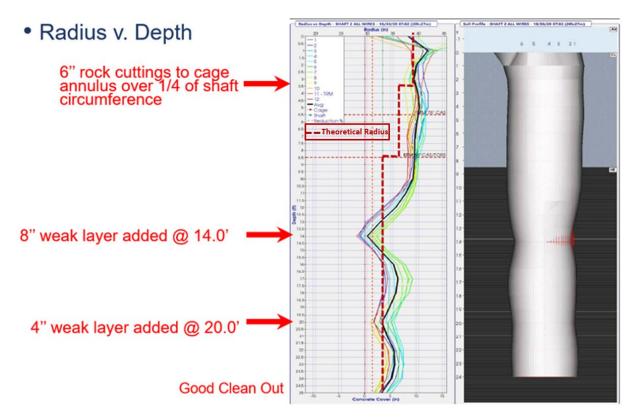
Figure 102. Illustration. 3D rendering for test drilled shaft #2 (all wires).

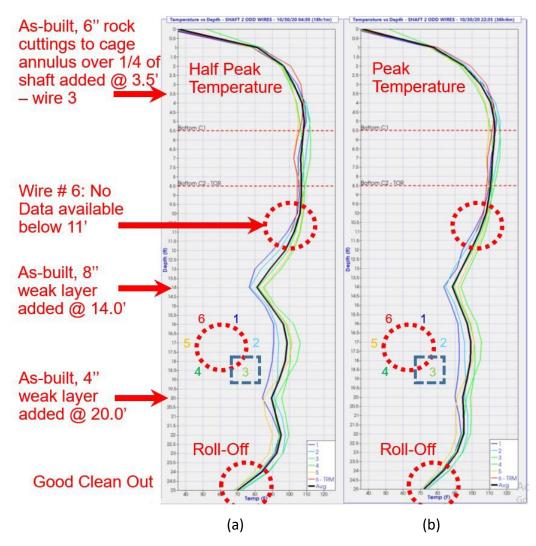
Figure 103. Graph. Temperature versus depth profiles for six odd wires in shaft #2: (a) at one-half time to peak temperature and (b) at peak temperature with red added arrows showing the location of installed defects.

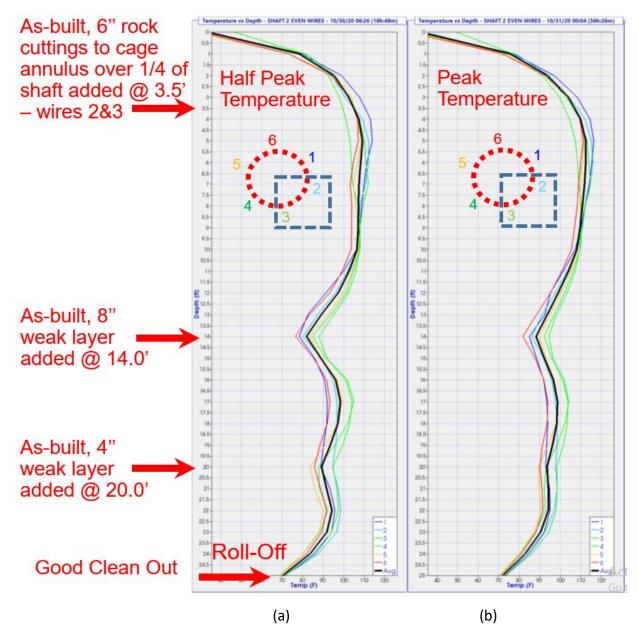
Figure 104. Graph. Temperature versus depth profile for the six even wires in test drilled shaft #2:

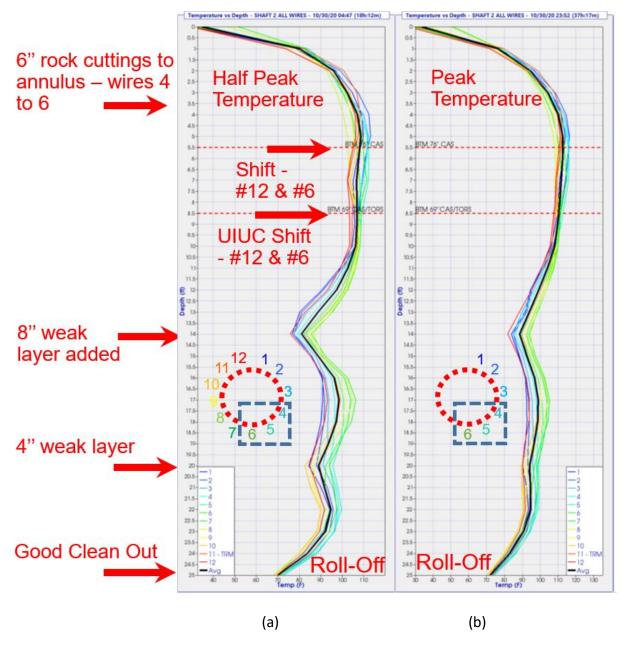
Figure 105. Graph. Temperature versus depth profile for all the twelve wires in test drilled shaft #2: (a) at one-half time to peak temperature and (b) at peak temperature with red added arrows showing the location of installed defects.

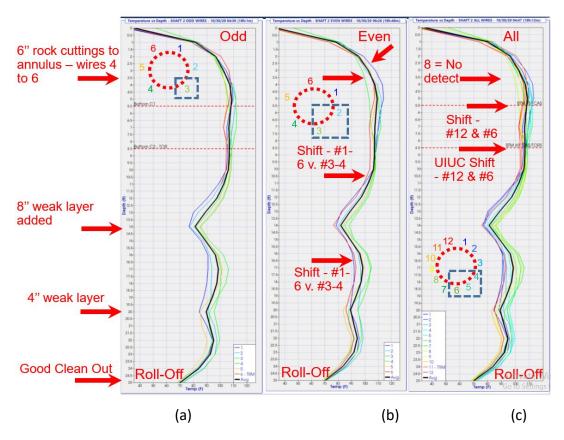
Figure 106. Graph. One-half time to peak temperature profiles for test drilled shaft #2 for: (a) odd wires, (b) even wires, and (c) all wires.

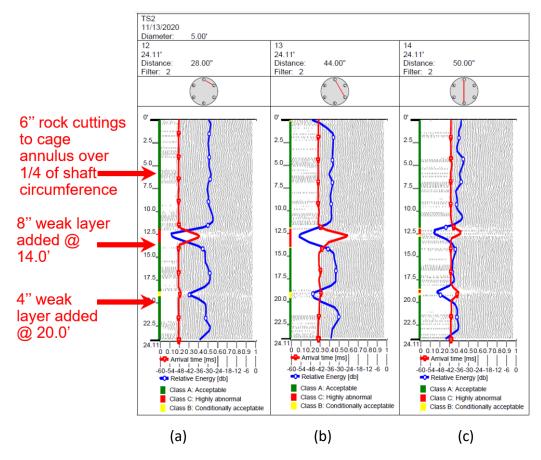
Figure 107. Graph. Consultant B's CSL results for test drilled shaft #2 for: (a) profile 1-2, (b) profile 1-3, and (c) profile 1-4 with red arrows showing the location of installed defects.

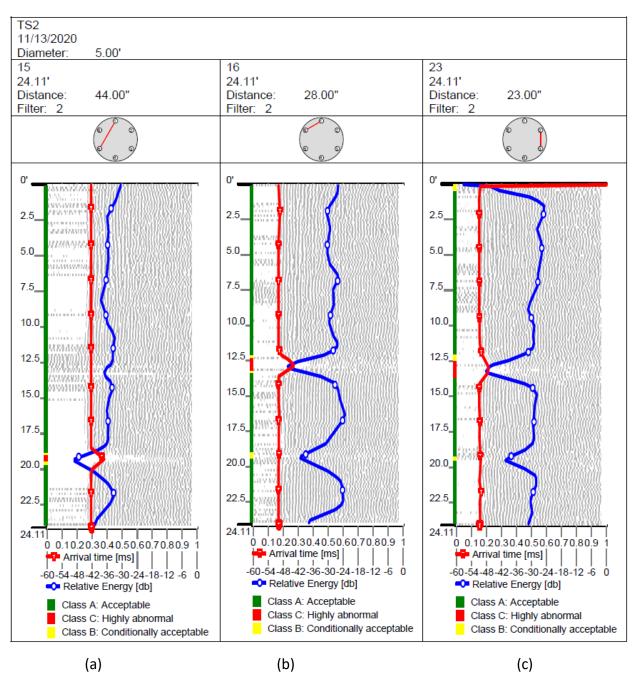
Figure 108. Graph. Consultant B CSL results for test drilled shaft #2 for: (a) profile 1-5, (b) profile 1-6, and (c) profile 2-3.

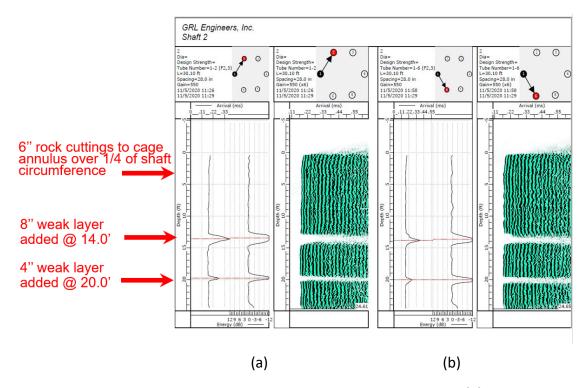
Figure 112. Graph. Consultant A's CSL results for test drilled shaft #2 for: (a) profile 1-2 and (b) profile 1-6 with red arrows showing the location of installed defects.

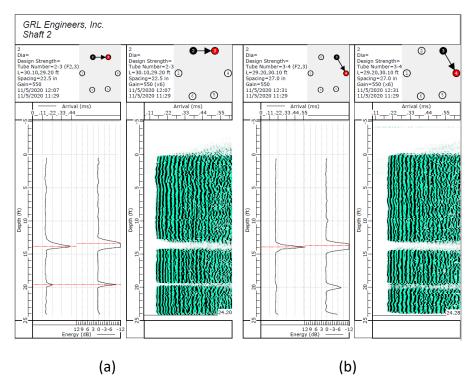
Figure 113. Graph. Consultant A's CSL results for test drilled shaft #2 for: (a) profile 2-3 and (b) profile 3-4.

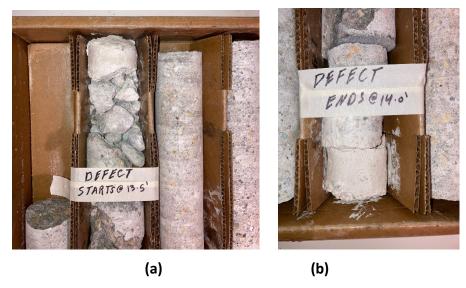
Figure 121. Photo. Close-up photographs of: (a) start of defect at 13.5 ft and (b) end of defect at 14.0 ft in test drilled shaft #2.

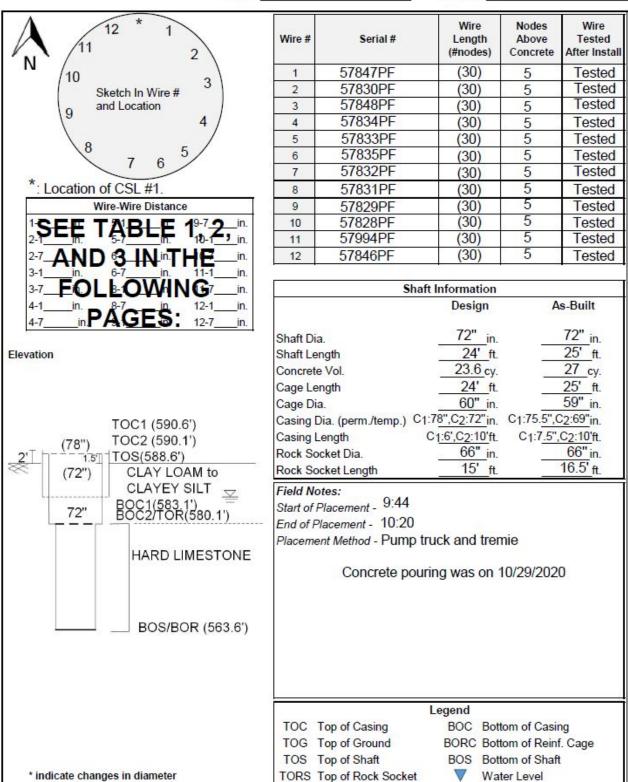
Figure 122. Illustration. TIP installation log for test drilled shaft #2.

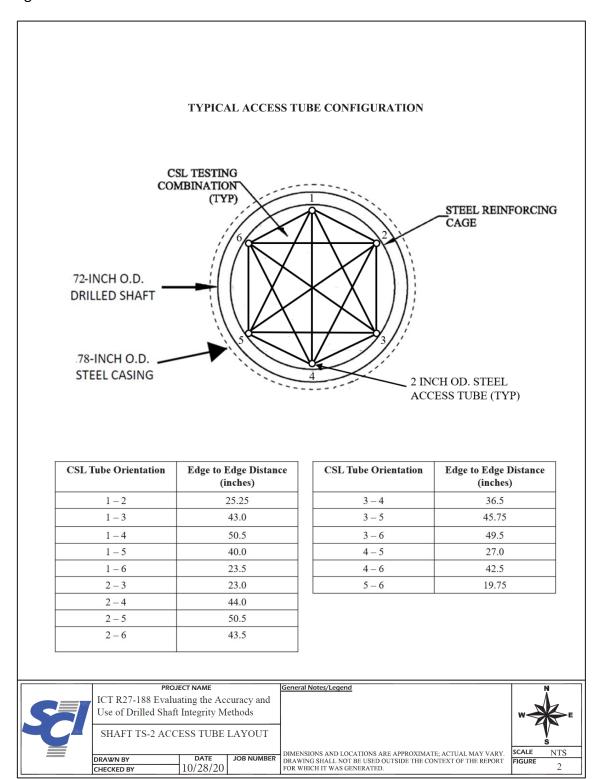
Figure 123. Illustration. CSL access tube configuration for test drilled shaft #2.

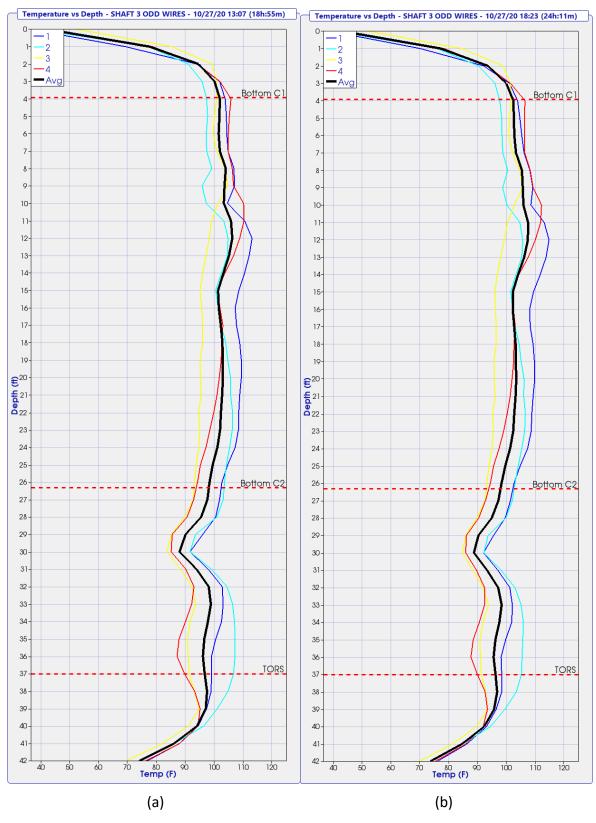
Figure 139. Graph. Temperature versus depth profile for the 4 odd wires in test drilled shaft #3: (a) at 18h 55m, and (b) at 24h 11m (peak) after concrete placement.

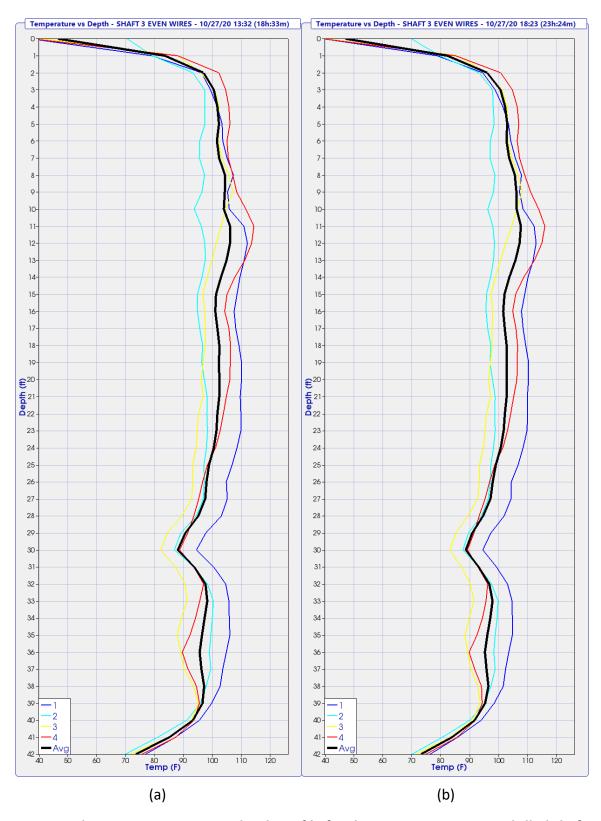
Figure 142. Graph. Temperature versus depth profile for the 4 even wires in test drilled shaft #3: (a) at 18h 33m, and (b) at 23h 24m (peak) after concrete placement.

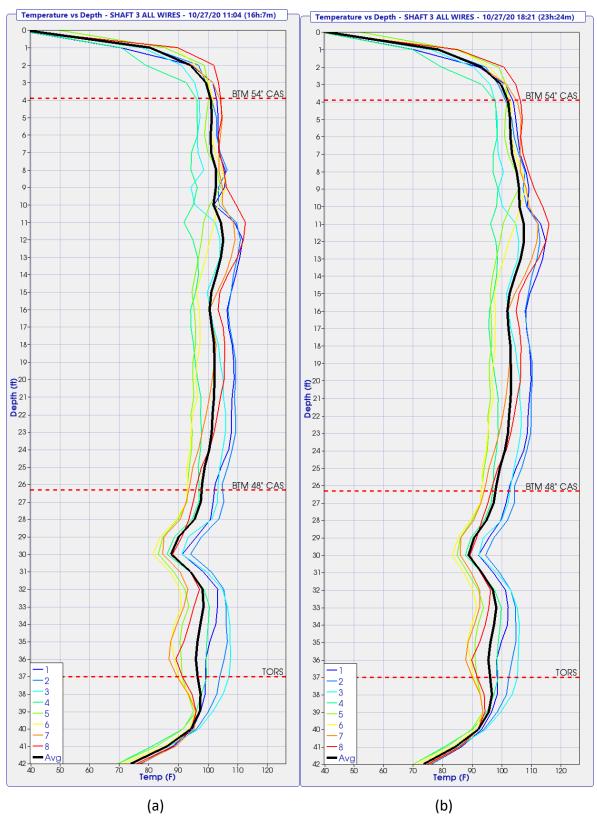
Figure 145. Graph. Temperature versus depth profile for all the 8 wires in test drilled shaft #3: (a) at 16h 7m, and (b) at 23h 24m (peak) after concrete placement.

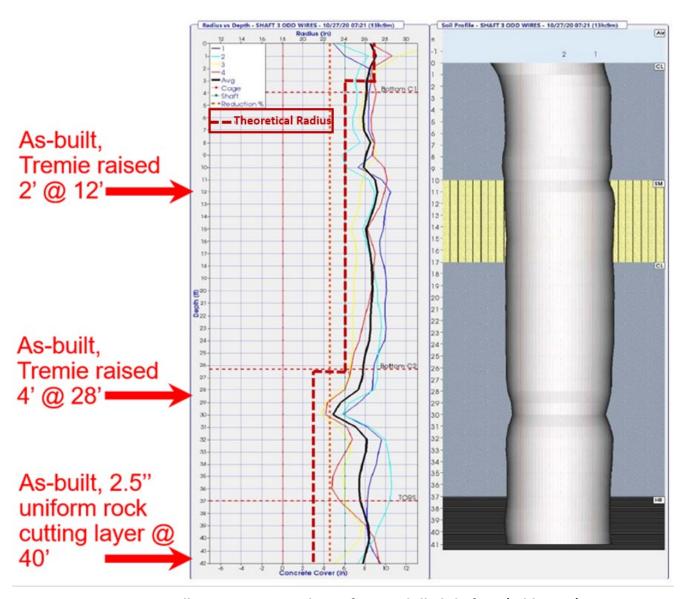
Figure 147. Illustration. 3D rendering for test drilled shaft #3 (odd wires).

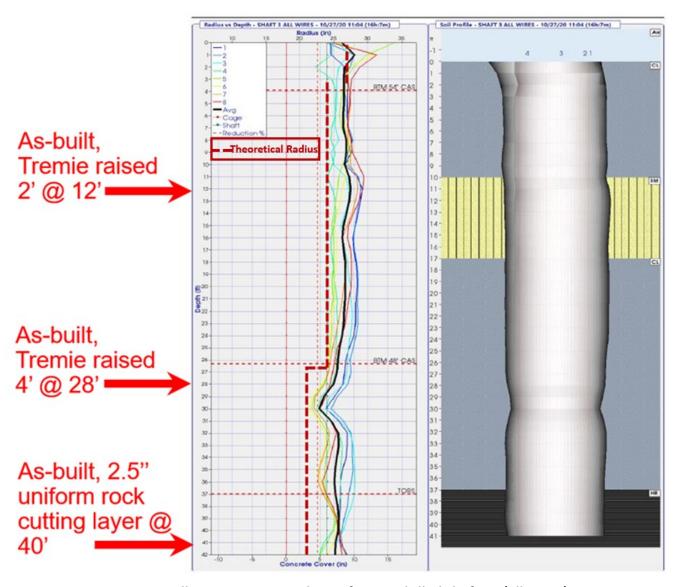
Figure 149. Illustration. 3D rendering for test drilled shaft #3 (all wires).

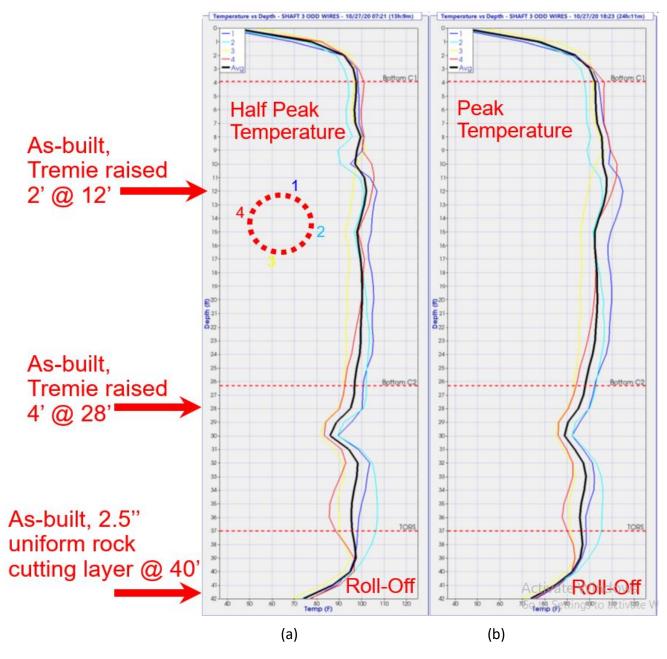
Figure 150. Graph. Temperature versus depth profile for the 4 odd wires in test drilled shaft #3: (a) at one-half the time to peak temperature, and (b) at peak with red arrows showing the location of installed defects.

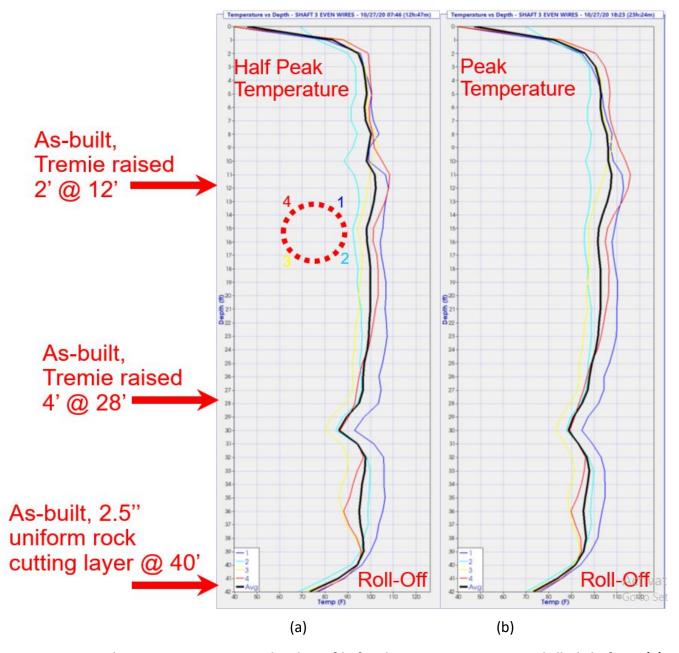
Figure 151. Graph. Temperature versus depth profile for the 4 even wires in test drilled shaft #3; (a) at one-half the time to peak temperature, and (b) at peak temperature with red arrows showing the location of installed defects.

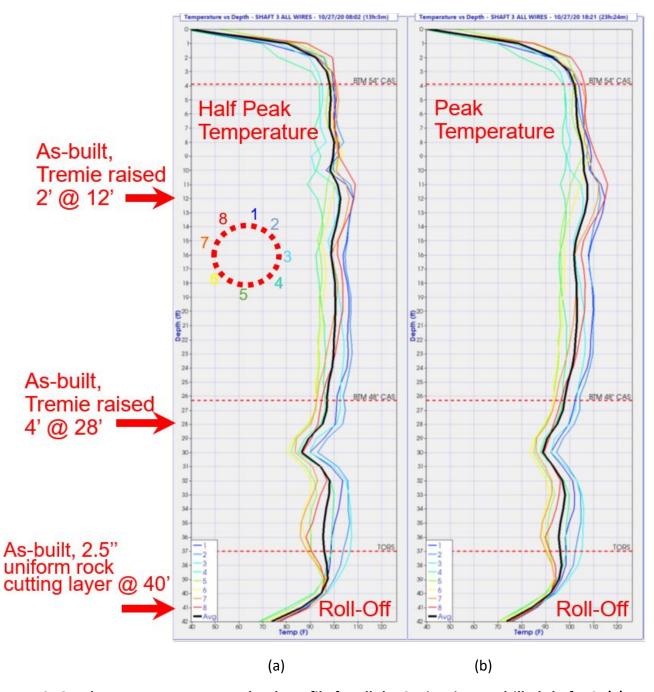
Figure 152. Graph. Temperature versus depth profile for all the 8 wires in test drilled shaft #3; (a) at one-half the time to peak temperature, and (b) at peak temperature with red arrows showing the location of installed defects.

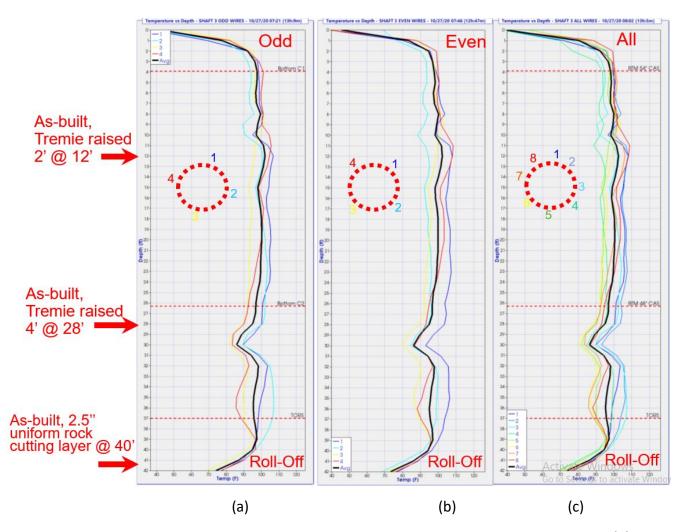
Figure 153. Graph. One-half time to peak temperature profiles for test drilled shaft #3 for: (a) odd wires, (b) even wires, and (c) all wires.

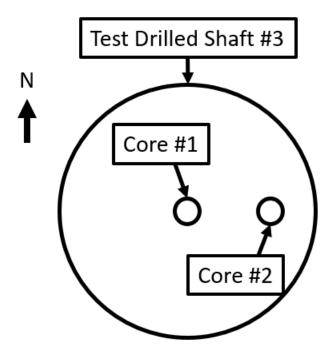
Figure 154. Sketch. Sketch showing the first core (core #1) and the second core (core #2) locations in test drilled shaft #3.
