Evaluating the Accuracy and Use of Drilled Shaft Integrity Testing Methods in Illinois

Research Report No. FHWA-ICT-22-014

ICT PROJECT R27-188

Illinois Center for Transportation
October 2022

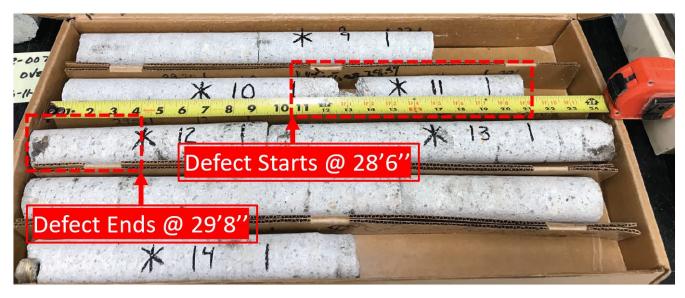
Figure 155. Photo. Photograph showing the start of defect at 28 ft 6 in. depth and end of defect at 29 ft 8 in. depth from core #1 of test drilled shaft #3.

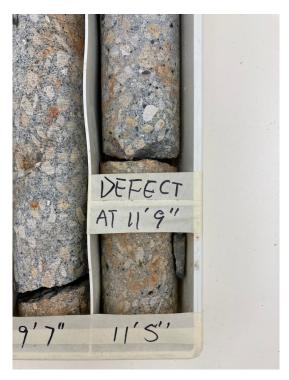
Figure 156. Photo. Photograph showing a core obtained from core #2 of test drilled shaft #3 showing a joint at a depth of 11 ft 9 in.

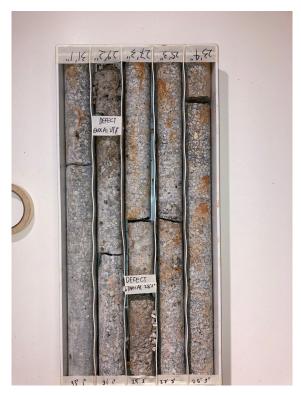
Figure 157. Photo. Photograph showing a core obtained from core #2 of test drilled shaft #3 showing the start and end of an observed defect between depths of 28 ft 7 in. and 29 ft 7 in.

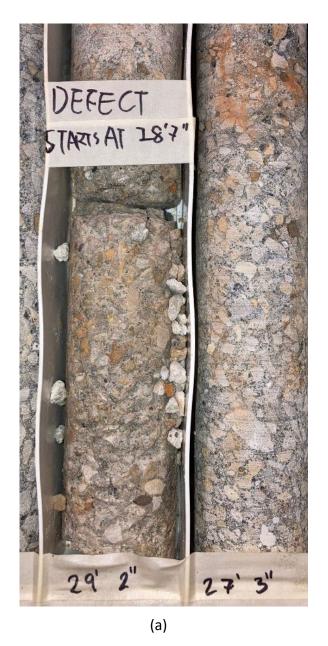
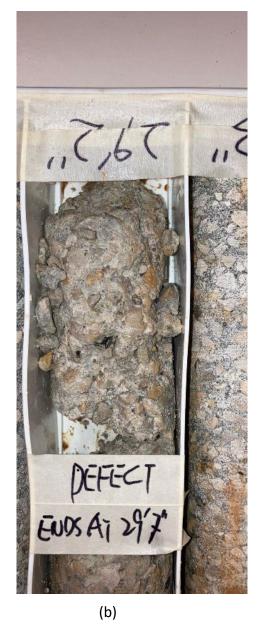
Figure 158. Photo. Close-up photographs showing: (a) start of defect at 28 ft 7 in. and (b) end of defect at 29 ft 7 in. from core #2 of test drilled shaft #3.

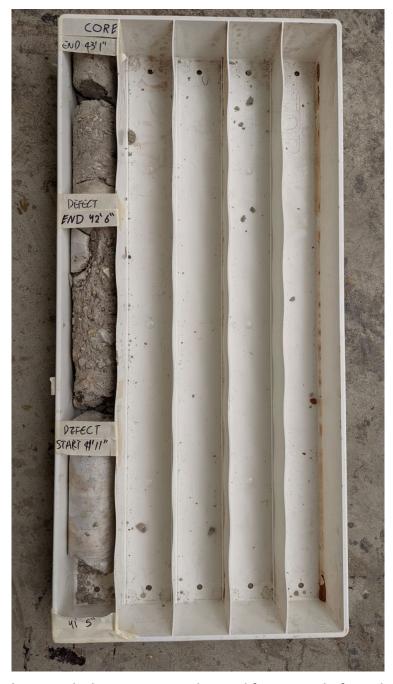
Figure 159. Photo. Photograph showing a core obtained from test shaft #3 showing the start and end of observed defect between a depth of 41 ft 11 in. and 42 ft 6 in from core #2 of test drilled shaft #3.

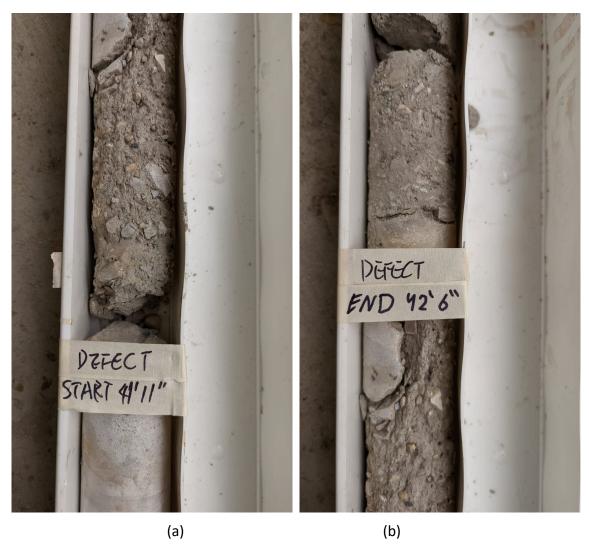
Figure 160. Photo. A close-up photograph showing the: (a) start of defect at 41 ft 11 in. depth and (b) end of defect at 42 ft 6 in. depth from core #2 of test drilled shaft #3.

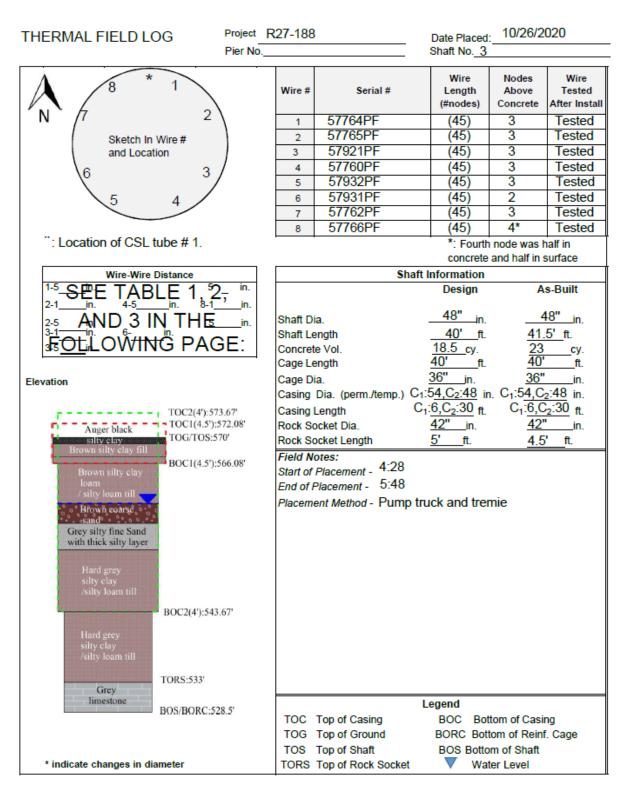
Figure 161. Illustration. TIP installation log for test drilled shaft #3.
