Evaluation of Partial Depth Pavement Repairs on Routes Heavily Traveled by Amish Horse and Buggies-Phase 2

State Job Number 135526

March 2020

Final Report

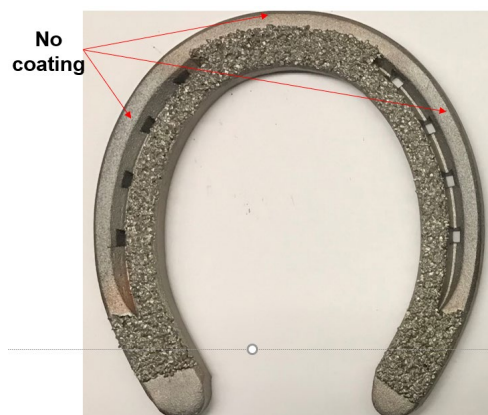
Figure 1. The Selected tungsten carbide coating design for horseshoes

Another coating method that was explored was developed by Tunco Manufacturing. This method applies the tungsten carbide through furnace heating. Different horseshoes were obtained by the Amish farrier identified by the Amish steering committee. The shoes were coated with two different grades (grade #16 and #36). The coated shoes were used on the Amish farrier horses. Initial evaluation showed that horseshoes with #16 grade had good traction but moderate wearing. In addition, horseshoes with #36 grade had moderate traction but better wearing resistance. Therefore, a coating grade of #24 was used. In addition, the Amish farrier also suggested that leaving the edge lines uncoated to give the horse some flexibility (Figure 1). Two Amish farriers evaluated this design and found it to provide the adequate traction during the summer and fall season. In addition, the coating was good after more than 120 miles of travel. Therefore, this alternative was selected for further evaluation.

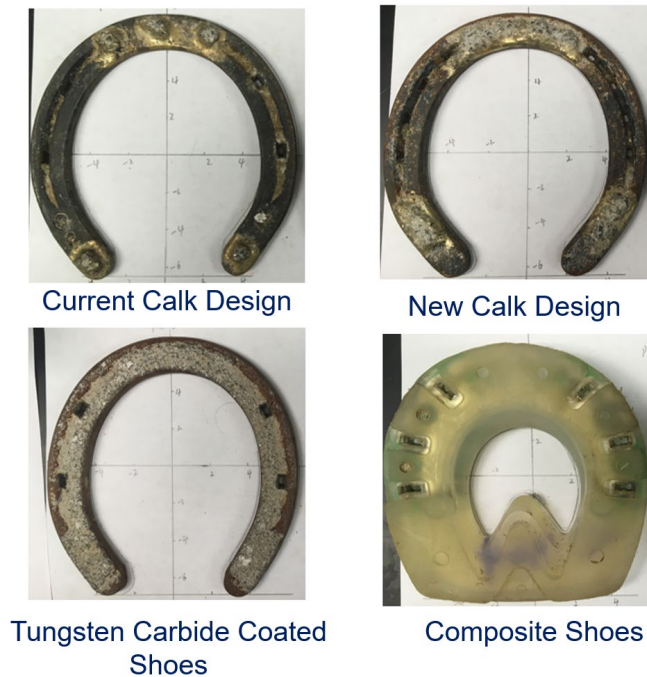
1. Three horseshoes with high profile Drilltec (tungsten carbide) calk design that the Amish community commonly used.

2. A horseshoe with a new calk design consisting of low profile Drilltec (tungsten carbide) calks that was identified by the designated Amish farriers as an alternative to reduce damage on roads.
3. A horseshoe coated with the selected tungsten carbide coating design.
4. Composite horseshoe

Figure 2. Horseshoes identified in this study

The research team quantified the reduction in horseshoes damage to local roads due to using the alternative shoes. To achieve that, experiments were conducted on different horseshoes alternatives shown in Figure 2, which included:

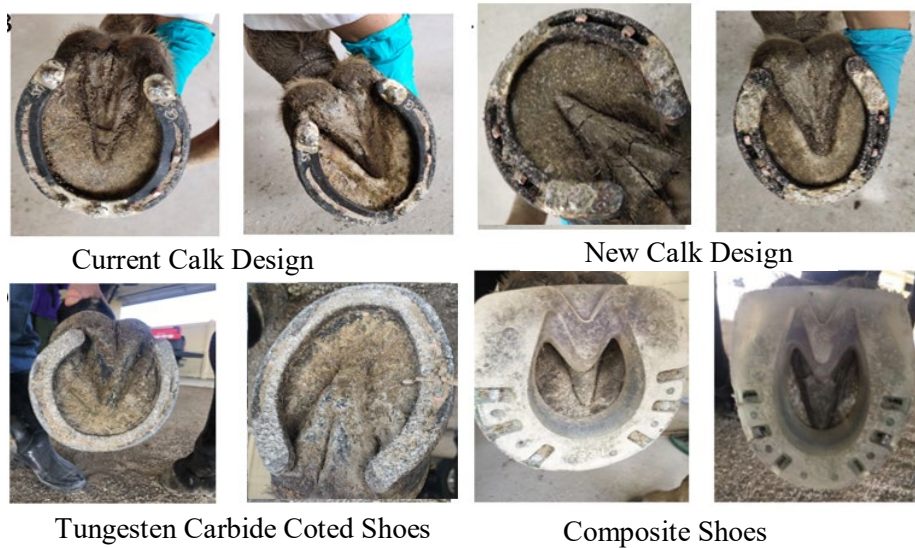
Figure 3. Pictures of different horseshoes tested in on fore (left) and hind (right) hoof

all performed. A licensed farrier performed all hoof preparation and shoe application. Prior to the application of the first set of shoes, gait data was collected with no shoes three days after hoof preparation. Horses were maintained in stall confinement for the duration of the study. As noted above, shoes were applied in random order. Shoes were sized and shaped for each hoof of all horses (Figure 3). Two nails were used on each side of shoe for stabilization and to avoid unnecessary hoof damage. Force platform data collection was performed no less than 24 hours after shoe application. After the force platform data collection, shoes were replaced with the next set. No shoes were worn for more than 30 hours.

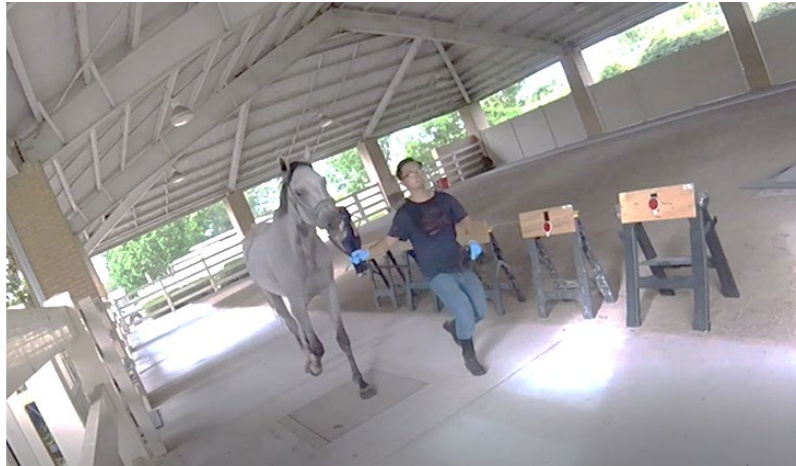
Figure 4. Pictures of horses and handler taken during gait experiment

The kinetic gait data collection process is standard in the laboratory and has been described previously (Mirza et al. 2016; Taguchi et al. 2018). A 900 × 900 mm force platform embedded in the center of a 40 m concrete runway (Advanced Mechanical Technology, Inc., Watertown, MA) was used to collect ground reaction force data (Figure 4). The force platform surface is the same color and the texture as the runway. Horses were conditioned to the force platform and experienced handlers trotted them for all trials. A trial was considered successful if a forelimb contacted the force platform followed by contact of the ipsilateral hind limb at a velocity of 2.00-3.80 m/s and an acceleration of -0.9 to 0.9 m/s². Data logging was triggered by a force of 50 N. Trials were rejected if the hoof was not straight on the force platform, was not completely on the force platform or was within 5 cm of the force platform edge. A series of five retroflected photocell sensors (Mek 92-PAD, Doslyn Clark Controls, Inc.) were used to determine the velocity and acceleration for each trial. A minimum of five successful trials were recorded for each side. All trials were recorded at a rate of 1,000 Hz and processed with commercially available software (Acquire V7.3, Sharon Software).

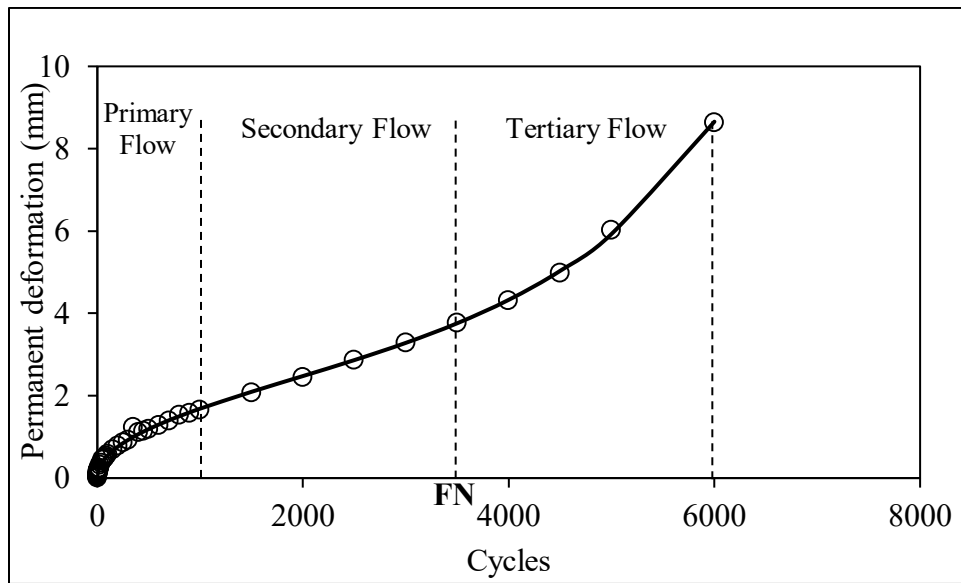
Figure A.2 Permanent deformation curve from the flow number test

The flow number was determined as the cycle number corresponding to the start of the tertiary flow stage. It was determined by fitting the permanent deformation curve to Francken’s model, as previously described. The results of this test are shown in Figure A.3. The flow number indicates

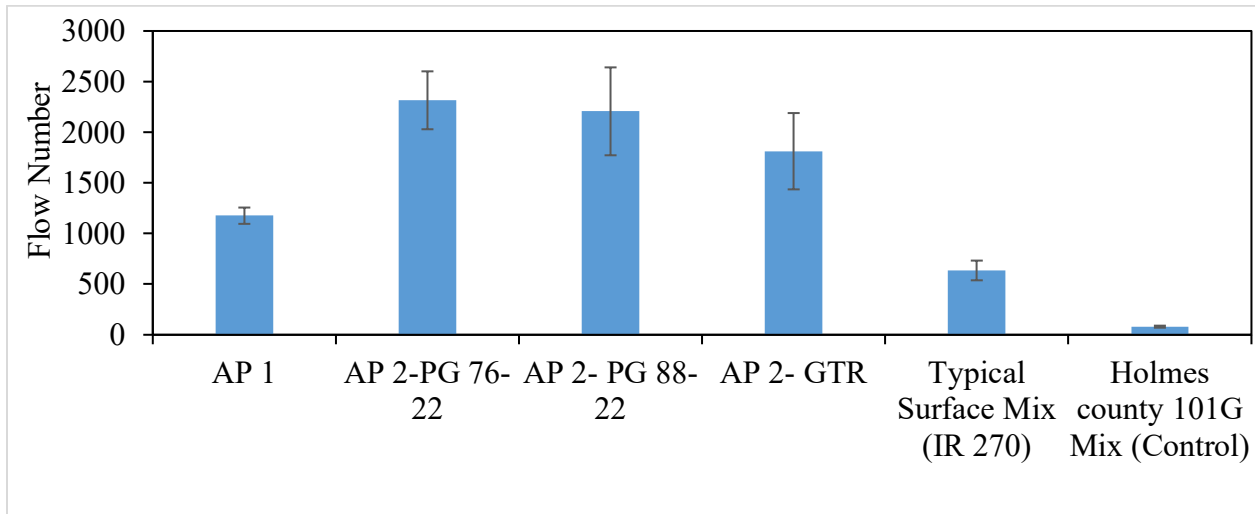
the rutting resistance of each mix. The higher the flow number, the higher resistance the mix can provide. Based on these results, mixes AP2-76, AP2-88, and AP2-GTR had the best performance in terms of rutting resistance. However, AP2-76 have shown the highest variability of the flow number value among these mixes. The flow number for AP2-76 is significantly higher than that for AP1-76, indicating that the modification of aggregate gradation was effective in improving the rutting resistance. Between AP2-76 and AP2-88 that had the same aggregate structure, there is no significant difference in the flow number, indicating similar binder contribution towards permanent deformation resistance. The control mix has the smallest flow number, indicating poor resistance to rutting as compared to the other mixes. The average flow number for the control mix is 80, which means it reached the tertiary flow stage more than 20 times faster than AP2 mixes.

Figure A.3 Flow number of different mixes

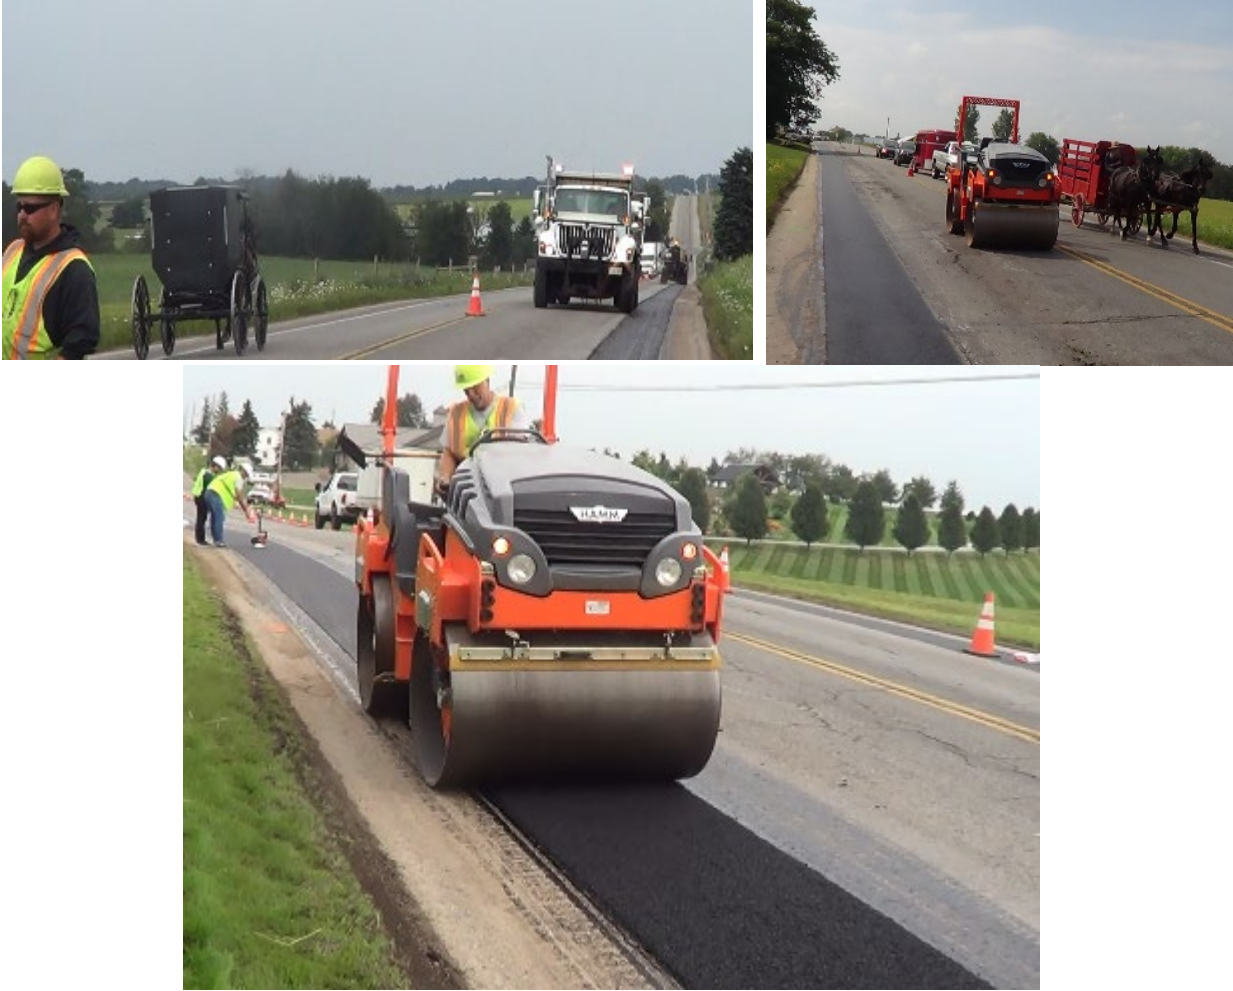
Figure A.3 Pictures taken during construction of test sections on SR 241

The best performing mixes designed in the laboratory part of this study were selected for further evaluation in the field. The field evaluation involved constructing several test sections in August 2017 as part of a partial depth repair project on State Route (SR) 241. The test sections included the airport mixtures that had an aggregate structure designed based on Bailey’s method and polymer modified binder. Three different polymer modified binders were used meeting PG 70-22M, PG 76-22M, and PG 88-22 M. In addition, a mixture typically used in partial-depth repairs in ODOT Holmes County was used as the control mix. The control mix had a polymer modified binder PG 70-22M, and aggregate gradation meeting that of ODOT item 441. Figures A.2 shows the layout and location of the test section constructed on SR 241. The research team monitored the placement and compaction of the test sections. This included measuring the mat temperature and recording the density at core locations. Field density was measured using a PQI 380 asphalt density gauge. Photos were collected and videos of the test sections were recorded during and after construction. Figure A.3 presents some of the photos taken.

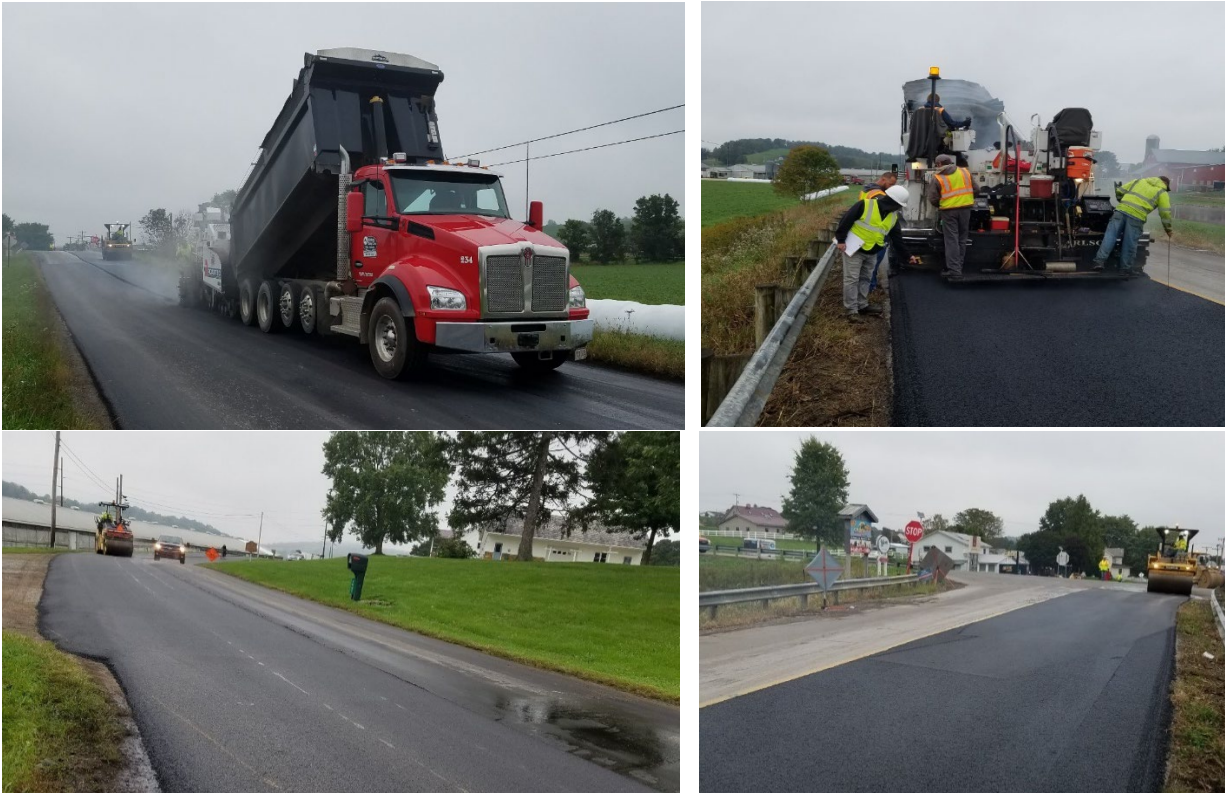
Figure A.4 Pictures taken during construction of test sections on CR 114

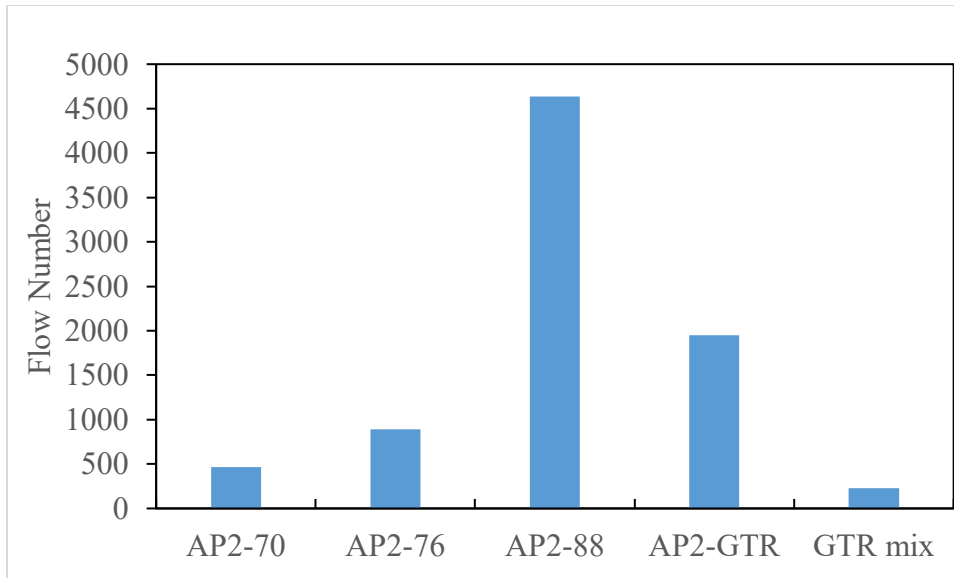
The flow number values for mixtures obtained during construction of test section on SR 241 and CR 114 are shown in Figure A.5. The test was performed at 54°C. Specimens were conditioned at testing temperature for three hours in the environmental chamber prior to the start of the test. The flow numbers for field-produced mixtures were higher than the lab-produced mixtures. This difference may be attributed to the short-term aging that field-produced mixtures encountered. The difference in aggregate gradation and asphalt content between the lab-produced and plant-produced mixes might also affected the flow number. It can be observed that AP2-88 field mix has the highest flow number. This indicate that it has the highest resistance to rutting. Among the other mixes, AP2-GTR1 was the best performing mix and its flow number was significantly higher. As expected, GTR-Mix had the lowest flow number and, and thus the lowest resistance to rutting. This is attributed to the excessive amounts of natural sand that reduces internal friction which is necessary for shear strength development. However, there is no significant difference between the flow numbers of AP2-70 and GTR-Mix.

According to AASHTO TP79, an HMA mix is required to have a flow number higher than 740 for a traffic level of 30 million EASALs or higher. Therefore, only mixes AP2-88, AP2-GTR, and AP2-76 exceeded this requirement for heavy traffic.

Figure A.5 Flow number test results for mixes included in Phase 2

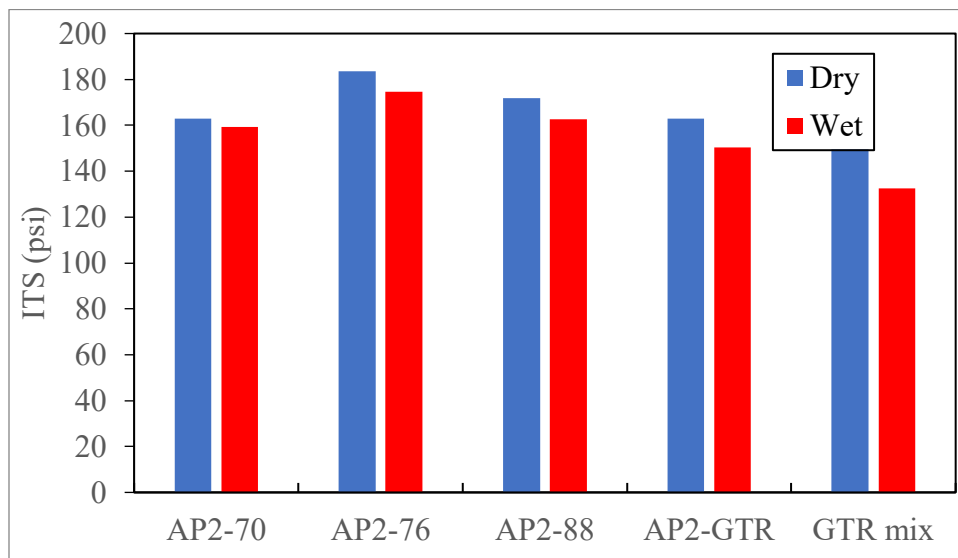
The average ITS for dry and wet conditioned samples are presented in Figures A.6. Based on the ITS test results, AP2-76 and AP2-88 provided the highest ITS values. They are both ranked the best in terms of ITS values. Also, mixes AP2-GTR and AP2-70 provided similar ITS values and their results were not significantly different. GTR mix provided the smallest strength among all mixtures included in field part of this study. TSR values are shown from Figure A.7. It is noted that all mixes exceeded the TSR limit set by ODOT at 80%, which indicates adequate resistance to freezing and thawing and thus, good durability. It is worth noting that AP2-88 provided the highest TSR value, which means that freezing and thawing of the specimens did not reduce the ITS significantly.

Figure A.6 Average ITS values for field mixes

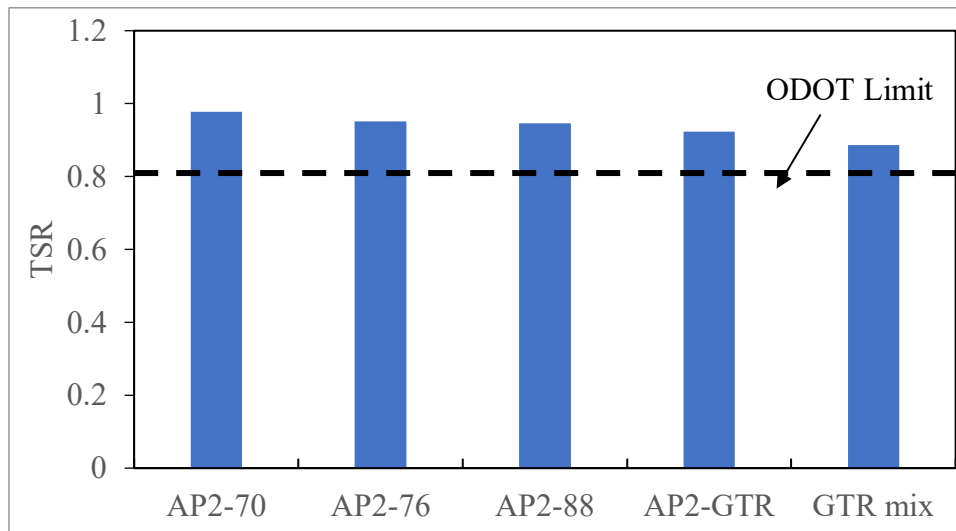
Figure A.7 TSR values for field mixes

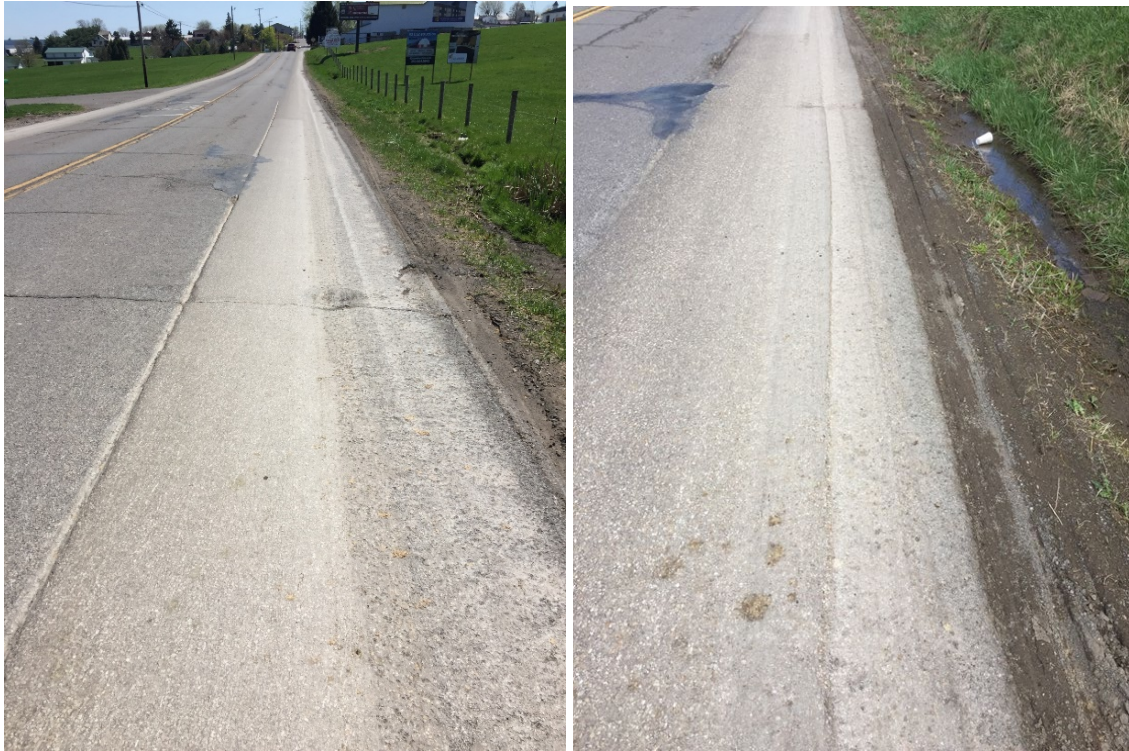
Figure A.8 Pictures of sections with control mix after 20 months of construction

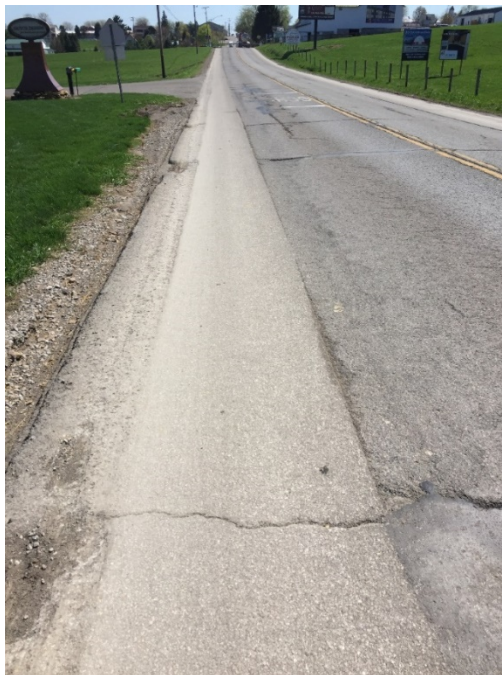
Figure A.9 Pictures of section with AP2-70 mix after 20 months of construction

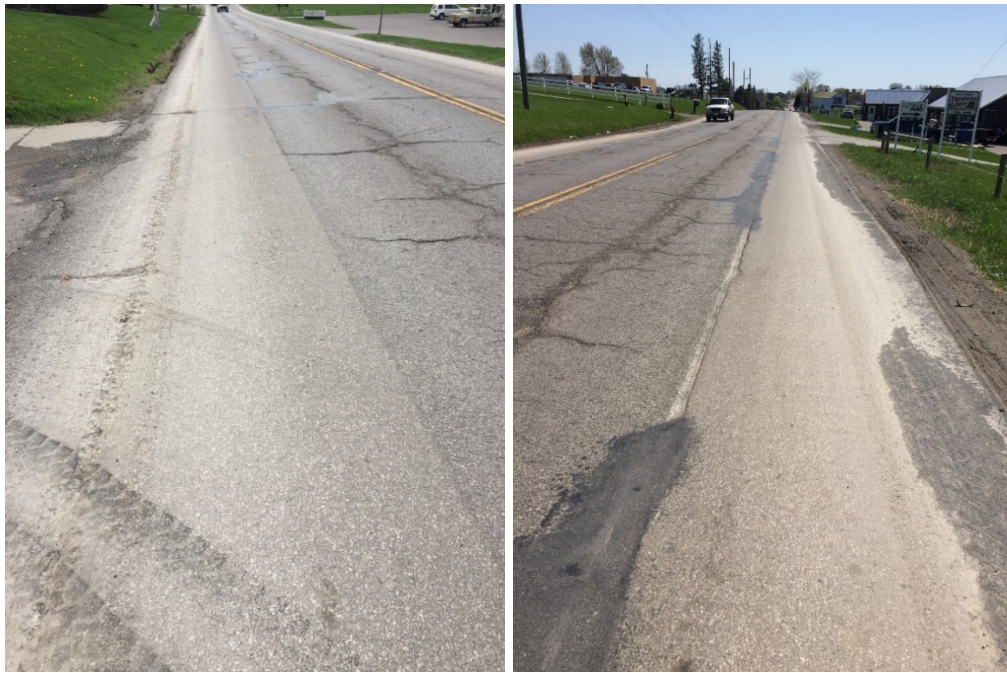
As shown in Figure A.10, these sections had no significant damage. The joint along the interface with at the old pavement is relatively in good condition in one section but had some deterioration on the old pavement side in the other section. In general, there was minimal rutting in these sections. In addition, there was low severity deterioration of surface aggregate. However, some aggregate particles were crushed but were not detached. A few transverse cracks propagated from adjacent old pavement.

Figure A.10 Pictures of sections with AP2-76 mix after 20 months of construction

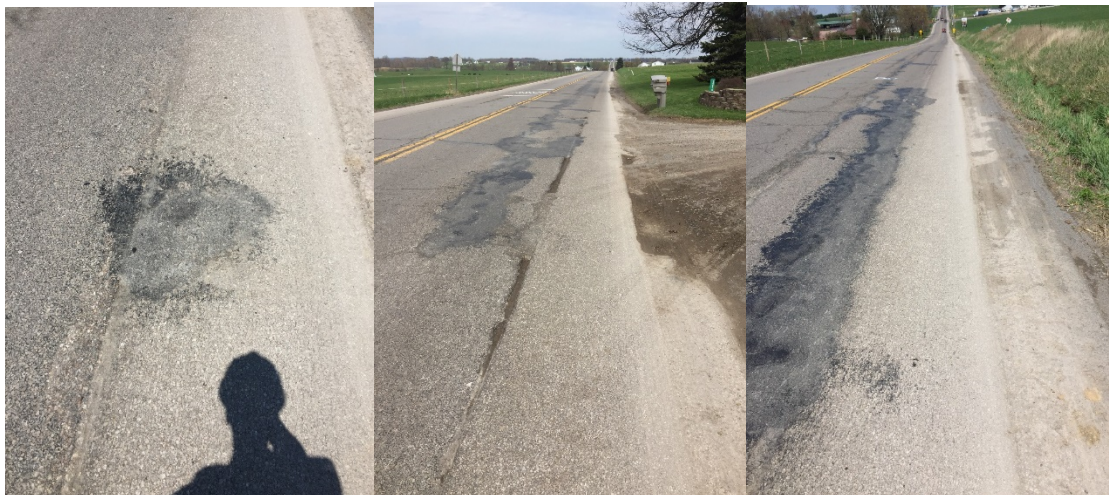
These test sections did not have any rutting or noticeable deterioration. However, there was some deterioration in adjacent old pavement along the joint between the Amish buggy test sections and adjacent old pavement. This may be attributed to the significant damage in the adjacent pavement as shown in Figure A.11. In addition, not sealing the joints after construction of test section might have contributed to that. Some few transverse cracks propagated from the old adjacent pavement to the test section.

Figure A.11 Pictures of sections with AP2-88 mix after 20 months of construction

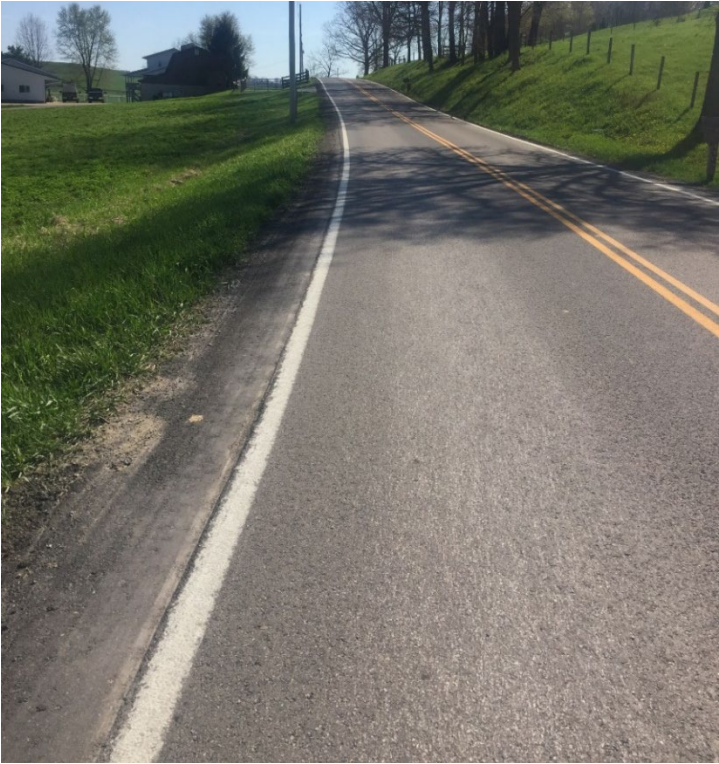
Figure A.12 Pictures of AP2-GTR test sections after 7 months of construction

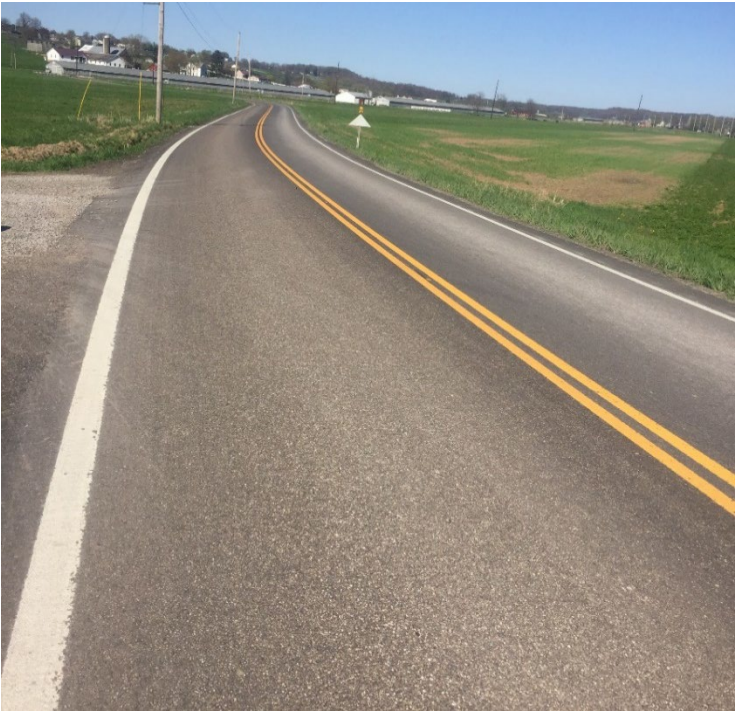
Figure A.13 Pictures of GTR-Mix test sections after 7 months of construction

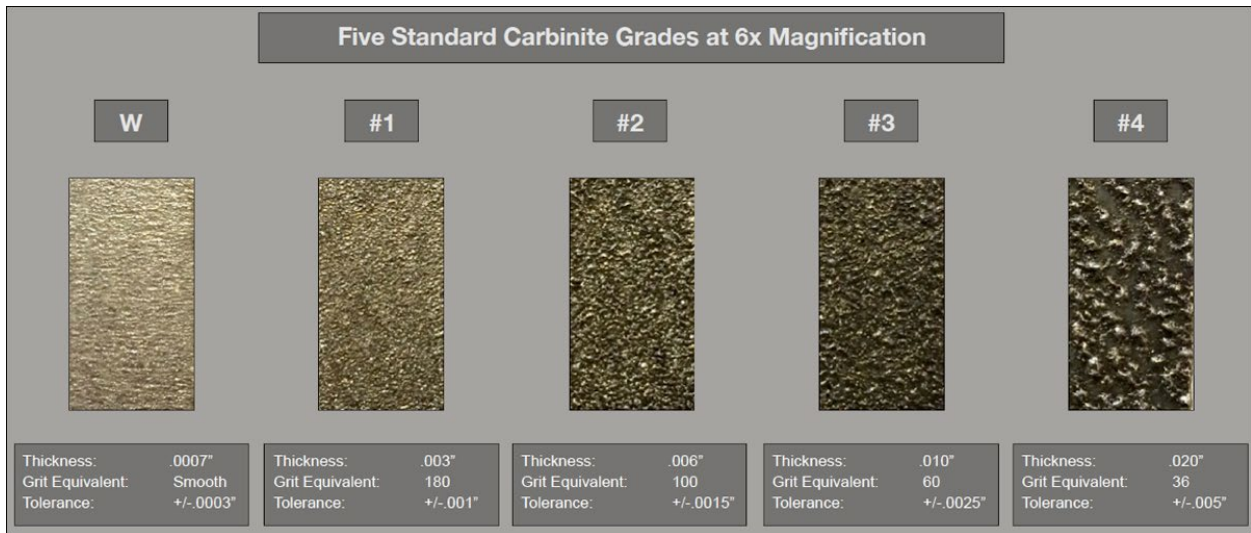
Figure B.1 Carbinite grades

As the main function of the calks is to provide adequate traction, the research team worked on identifying different coating methods and materials that can provide the needed traction while not causing damage to the roads. The first coating material and method identified was Carbinite. Carbinite is a metallurgically bonded textured coating that can be applied to a wide variety of industrial applications in order to increase friction, reduce wear, and improve performance. It consists tungsten/carbide alloy and is applied to metals using a process called Electro Spark Deposition (ESD), which yields a true metallurgical bond. This high bond strength far surpasses any spray-on coating currently available. Carbinite has been used as an alternative to spray, thermal, or diamond coatings in many applications including oil and gas tools such as static gripping jaws. There are different carbinite grades as shown in Figure B.1. Different horseshoes were obtained by one of the Amish farriers identified by the Amish steering committee. The shoes were coated with two different grades (grade #1 and #4). The coated shoes were used on the Amish farrier horses. The farriers indicated that while the #4 grade provided adequate traction for the horses, it wears off in less than 60 miles. Therefore, this coating method was not further evaluated.

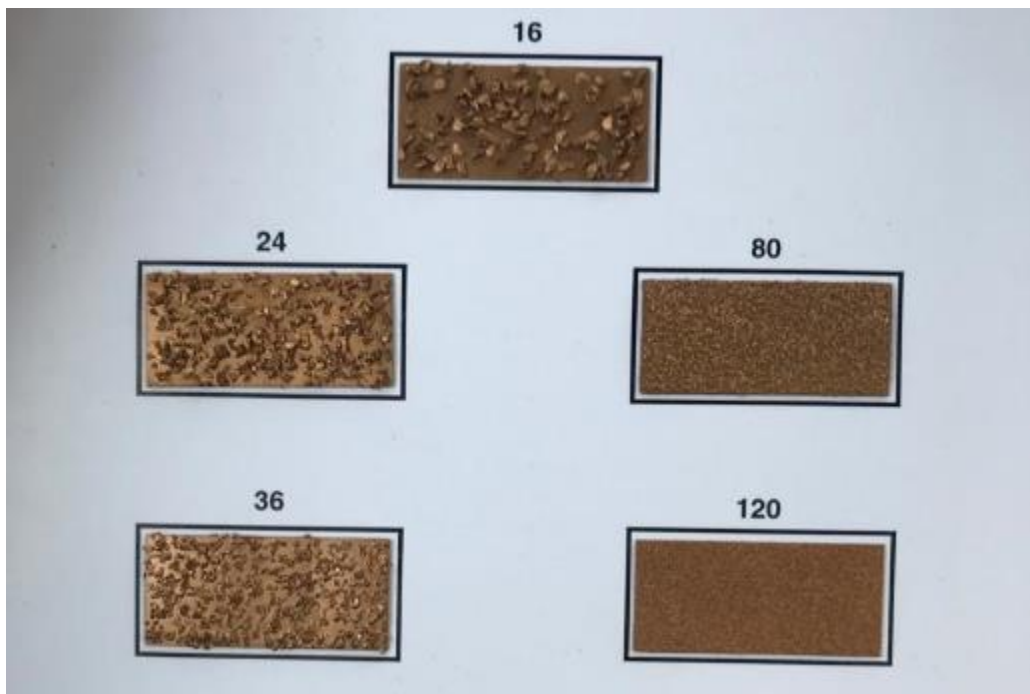
Another coating method that was explored was developed by Tunco Manufacturing. This method applies the tungsten carbide through furnace heating. As shown in Figure B.2, there are different coating grading that depends on the particles size and distribution. Standard Horseshoes were obtained by the Amish farrier identified by the Amish steering committee. The shoes were coated with two different grades (grade #16 and #36). The coated shoes were used on the Amish farrier's horses. Initial evaluation showed that horseshoes with #16 grade had good traction but moderate wearing. In addition, horseshoes with #36 grade had moderate traction but better wearing resistance. Therefore, a coating grade of #24 was selected for further evaluation. In addition, the Amish farrier also suggested that leaving the edge lines uncoated (Figure B.3) to give the horse some flexibility. Two Amish farriers evaluated this design and found it to provide the adequate traction during the summer and fall seasons. In addition, the coating was good after more than 120 miles of travel. Therefore, this alternative was selected for further evaluation.

Figure B.2 Different grades of tungsten carbide coating

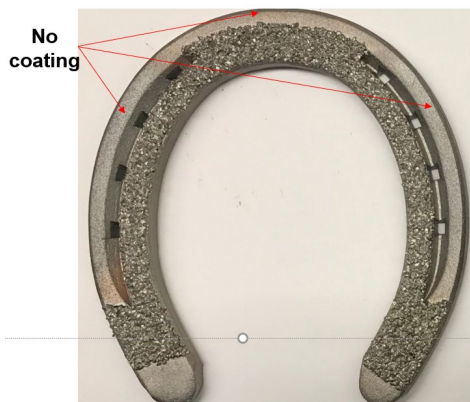
Figure B.3 The selected tungsten carbide coating design for horseshoes

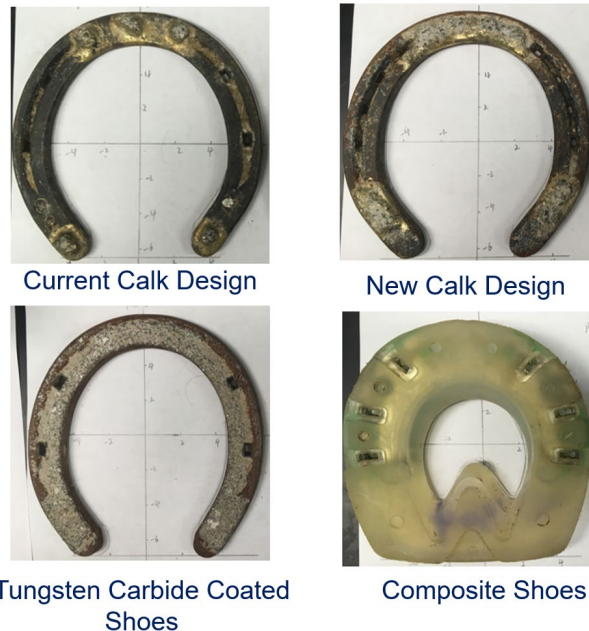
1. Three horseshoes with high profile Drilltec (tungsten carbide) calk design that the Amish community commonly used.
2. A horseshoe with a new calk design consisting of low profile Drilltec (tungsten carbide) calks that was identified by the designated Amish farriers as an alternative to reduce damage on roads.
3. A horseshoe coated with the selected tungsten carbide coating design.
4. Composite horseshoe

Figure B.4 Horseshoes considered in this study

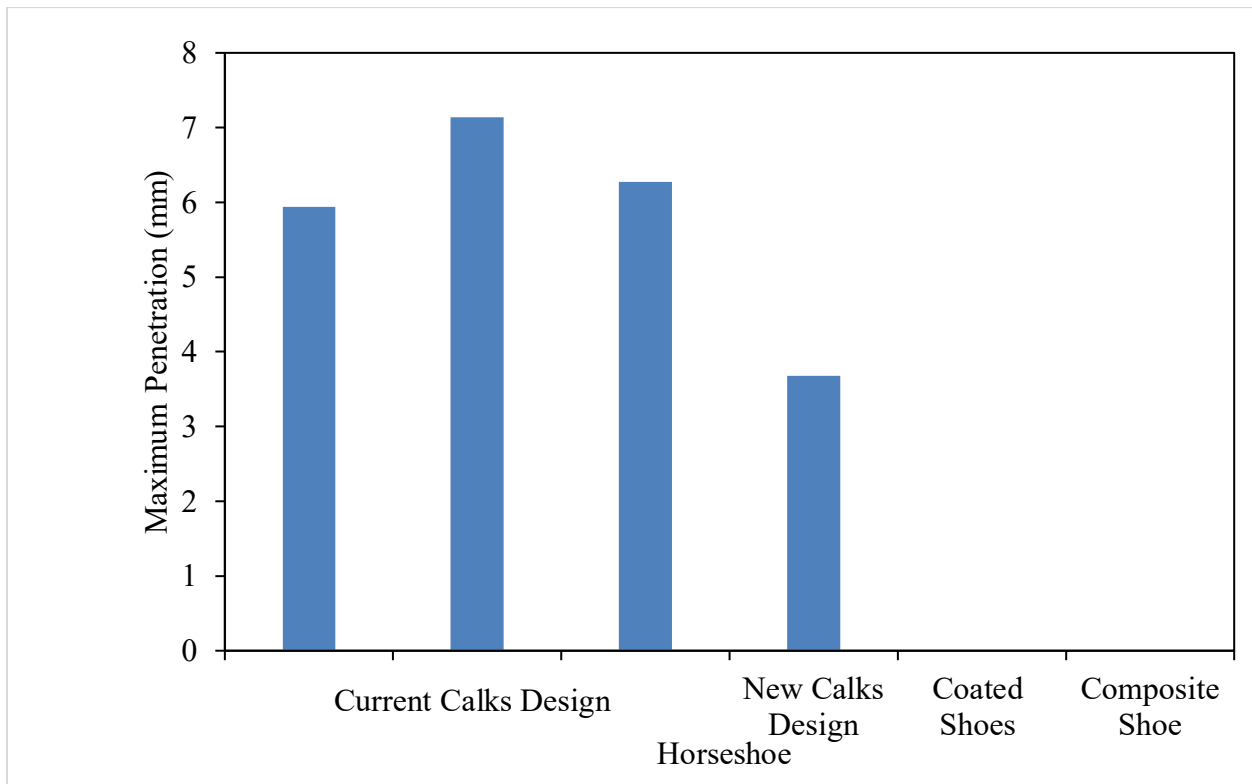
Figure B.5 Maximum penetration obtained for different horseshoes

The conducted experiments involved attaching a horseshoe to a 6 inch Marshall hammer that was modified for this purpose. A sample of an asphalt mix typically used on state routes and local roads were obtained. At least 50 blows of the hammer with attached horseshoes were applied to compacted asphalt mixture sample to evaluate the damage of the different horseshoes. This was used to quantify the reduction of damage to asphalt mixes with the alternative horseshoes.

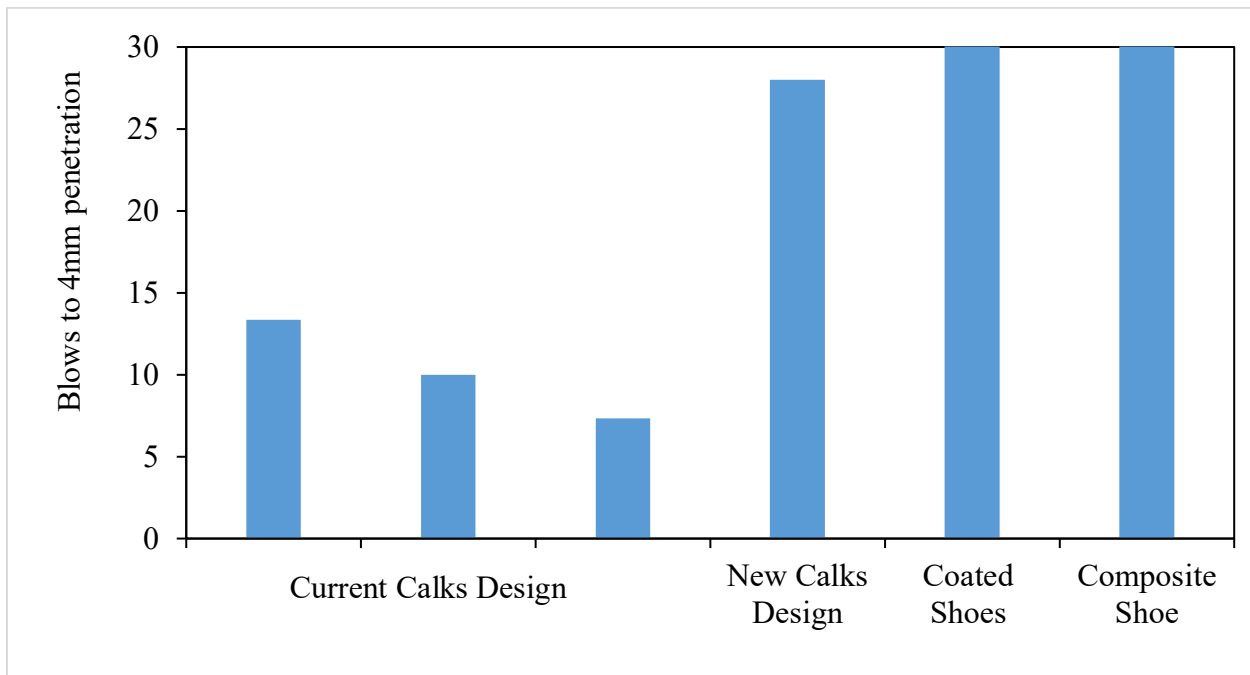
Figure B.6 Maximum penetration obtained for different horseshoes

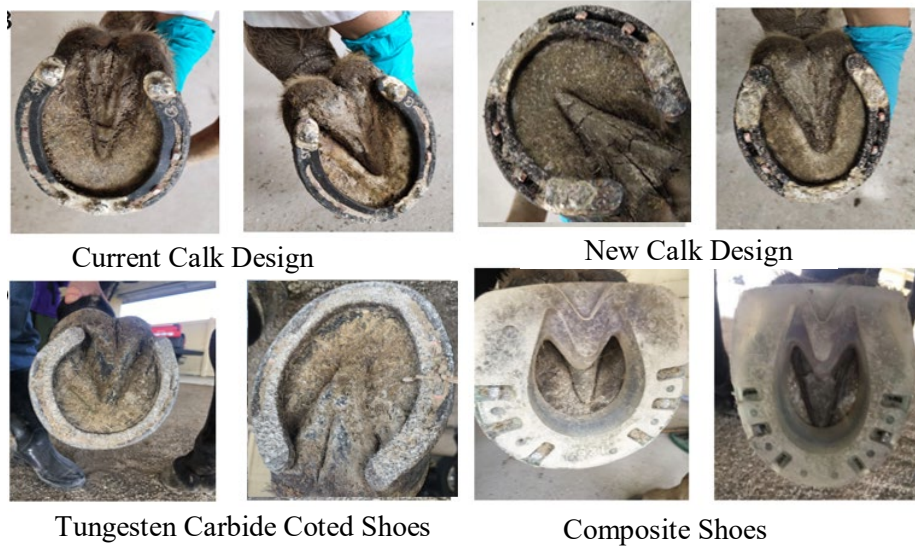
Figure B.7 Pictures of different horseshoes tested in on fore (left) and hind (right) hoof

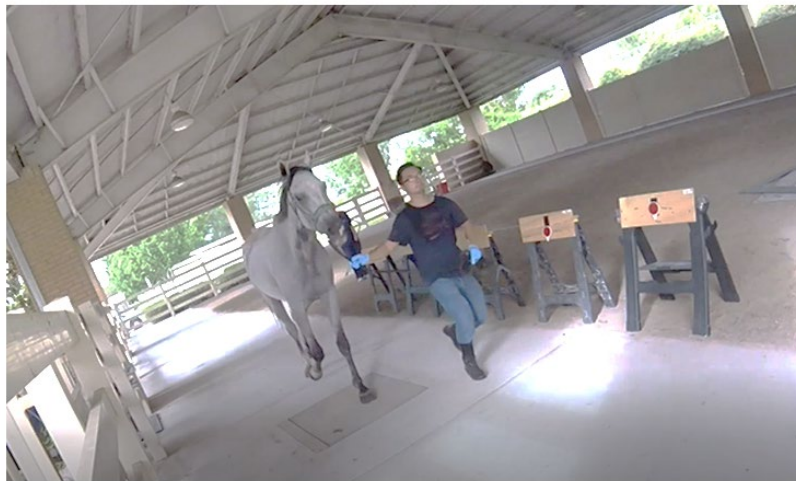
Figure B.8 Pictures of horses and handler taken during gait experiment

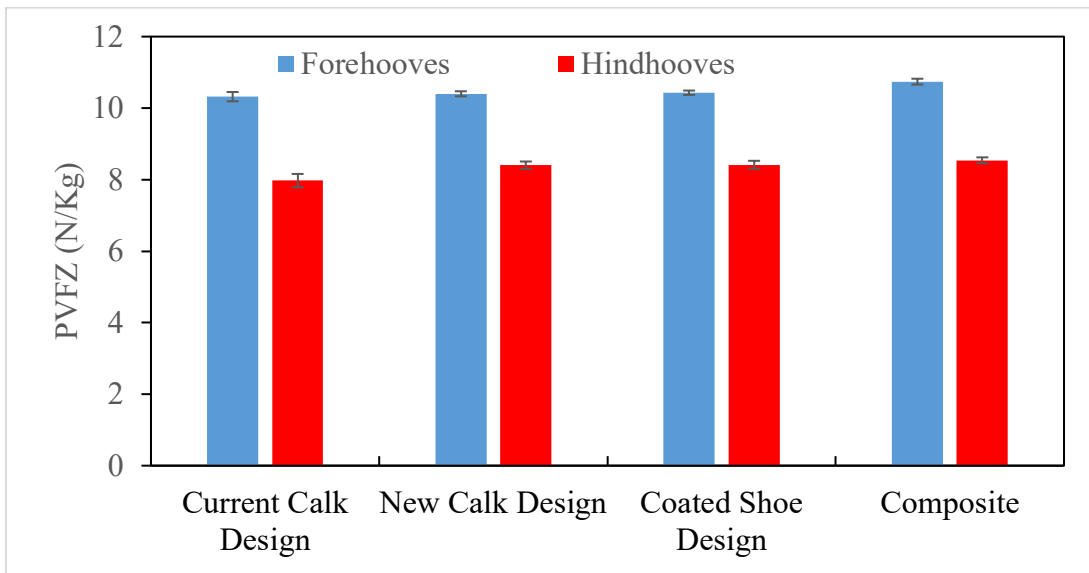
Figure B.9 Peak vertical force (PVF_Z) obtained for the horseshoe alternatives

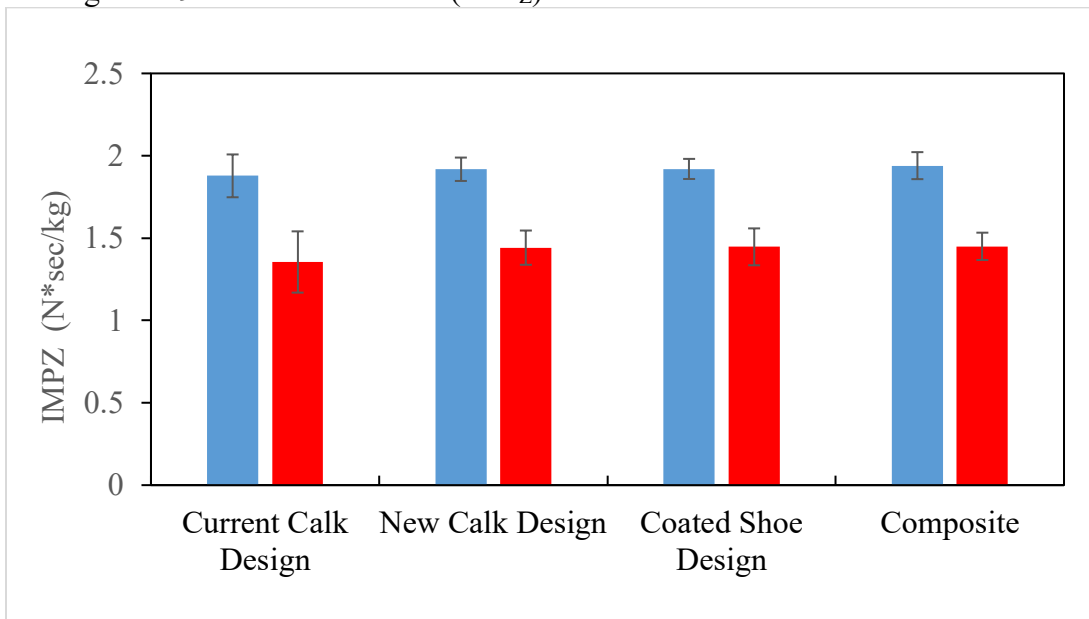
Figure B.10 Vertical impulse (IMP_Z) obtained for the horseshoe alternatives

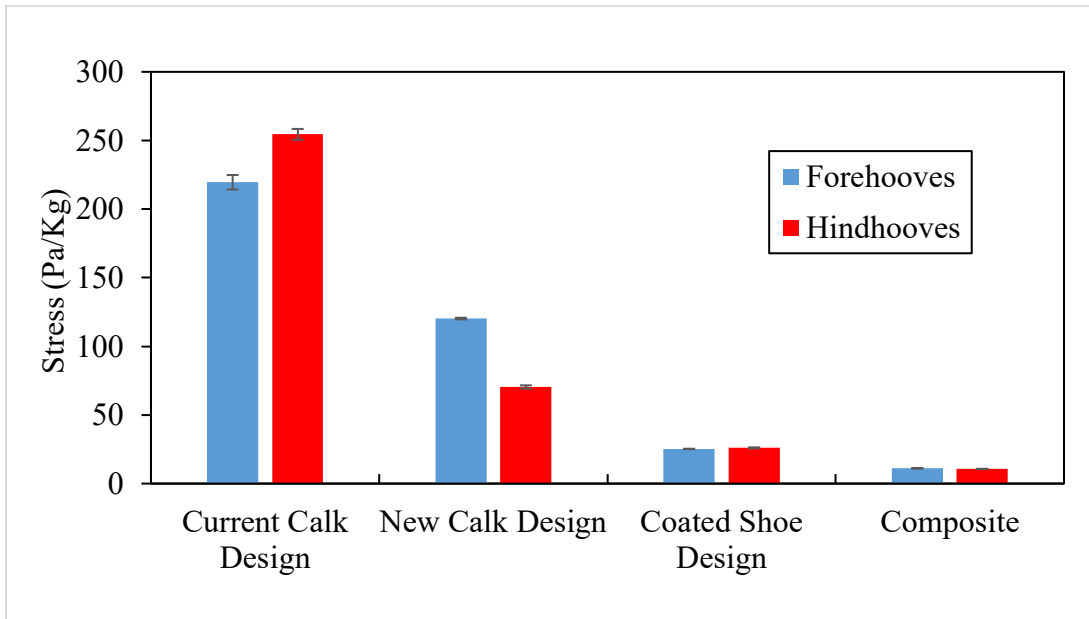
Figure B.11 Vertical stress obtained for the horseshoe alternatives

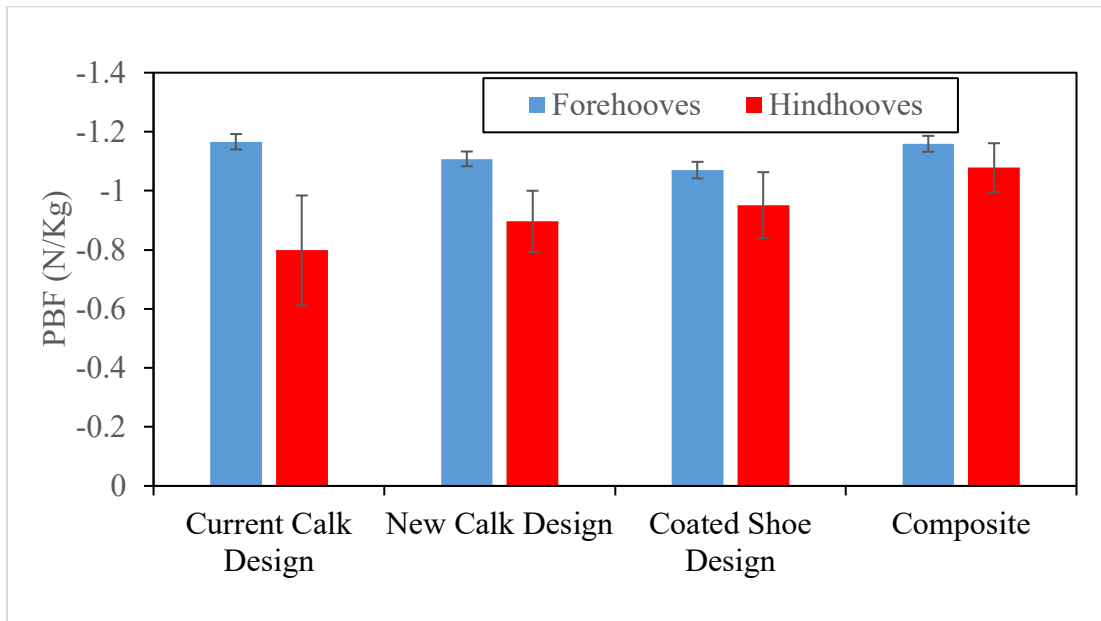
Figure B.12 Peak braking force (PBF) obtained for different horseshoe alternatives

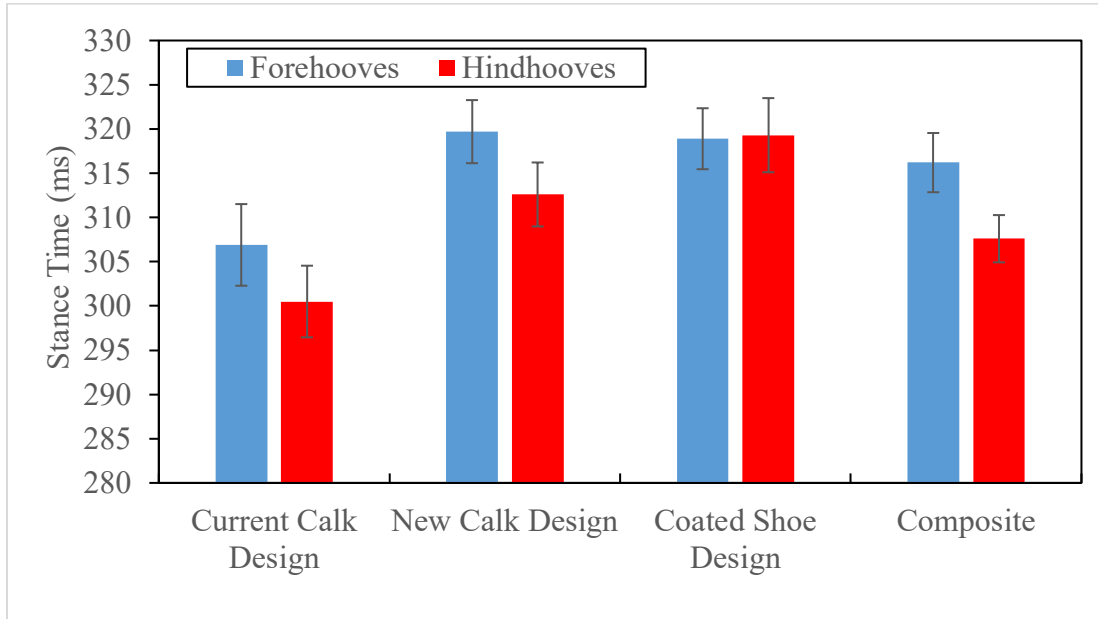
Figure B.13 presents the stance time obtained in experiments. Stance time for the horseshoes with the current calks design were much lower than the alternative horses considered in this study. This might indicate that the horses were more comfortable with the alternative shoes than those with the current calks design.

Figure B.13 Stance time obtained for different horseshoes alternatives
