Evaluation of Partial Depth Pavement Repairs on Routes Heavily Traveled by Amish Horse and Buggies-Phase 2

State Job Number 135526

March 2020

Final Report

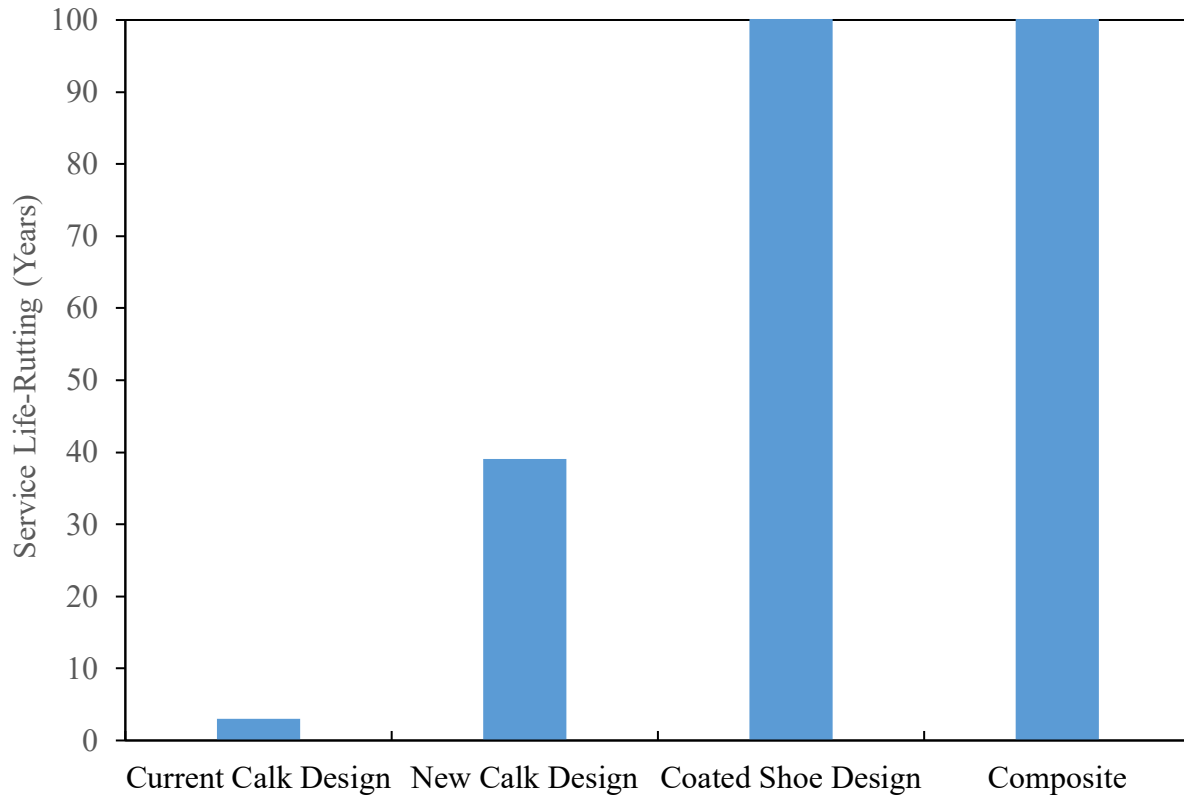
Figure B.14 presents the computed service life of roads with heavy Amish buggy traffic when using different horseshoe alternatives. It is noticed that using horseshoes with current calk design will result in less than 3 years of road service life. In addition, the use of horseshoes with the new calk design, horseshoes with coated with tungsten carbide, or composite horseshoes will increase the service life to at least 39 years, which suggests that the roads will not fail of rutting developed from these horse traffic. It is worth noting that the previous laboratory experiment showed that horseshoes with coated with tungsten carbide and composite horseshoes did not cause any abrasion wear to mixtures; however, the new calk design reduced the abrasion wear but did not eliminate it. Therefore, horseshoes with new calk design will increase the service life by about 90%. In addition, the use of horseshoes coated with tungsten carbide or composite horseshoes will result in the increasing the service life of roads to similar with heavy Amish buggy traffic to be similar to those without any Amish buggy traffic.

Figure B.14 Computed service life of roads when using different horseshoes alternatives

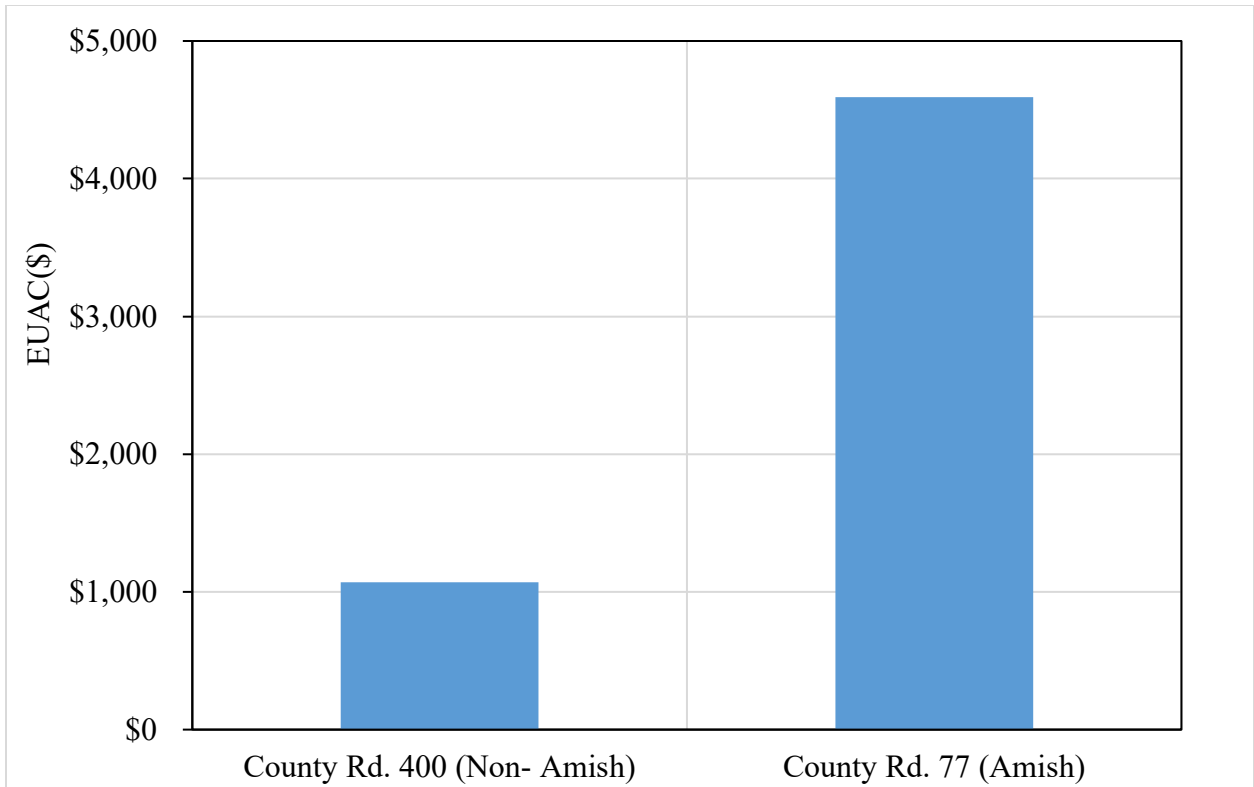
Figure C.1 EUAC for Amish buggy routes and routes without Amish buggy traffic in Holmes County

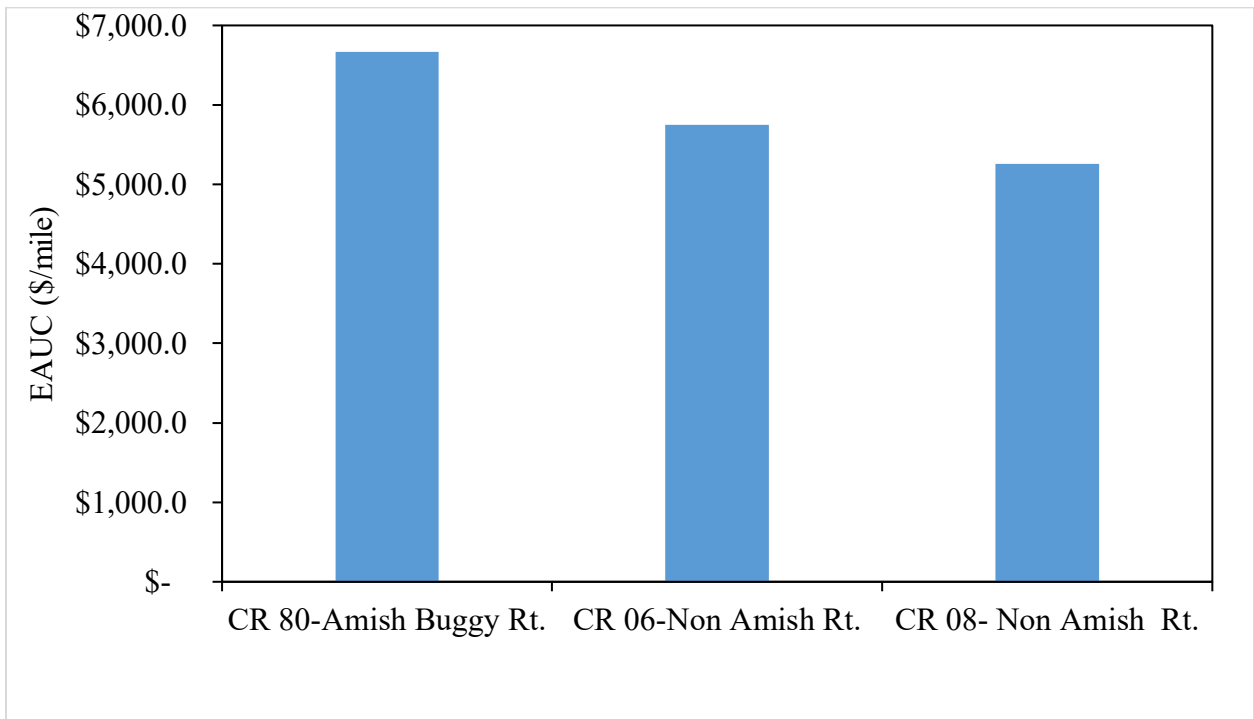
Figure C.2 EUAC for Amish buggy routes and routes without Amish buggy traffic in Wayne County

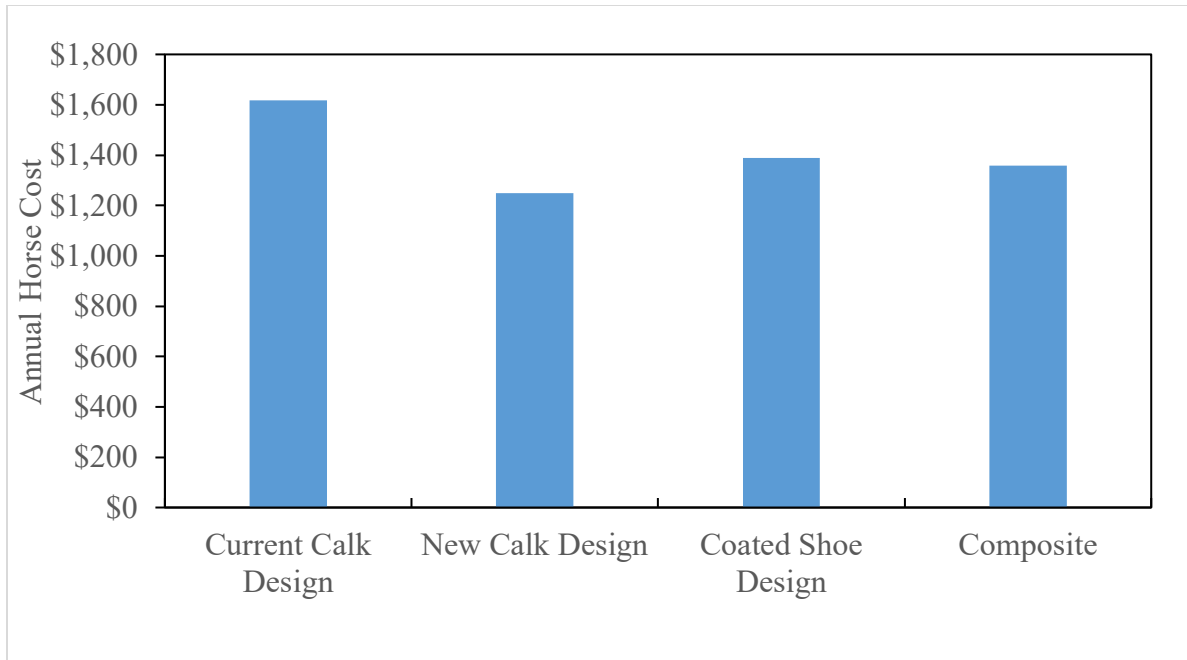
Figure C.3 presents the computed equivalent uniform annual horse cost when using different horseshoes considered in this study. It is noted that using horseshoes with new calk design can result in reducing the annual horse costs by at least 20%. Furthermore, the use of horseshoes coated with tungsten carbide or composite shoes will result in reducing the annual horse cost by about 15%.

Figure C.3 Annual cost of horses when using different shoes

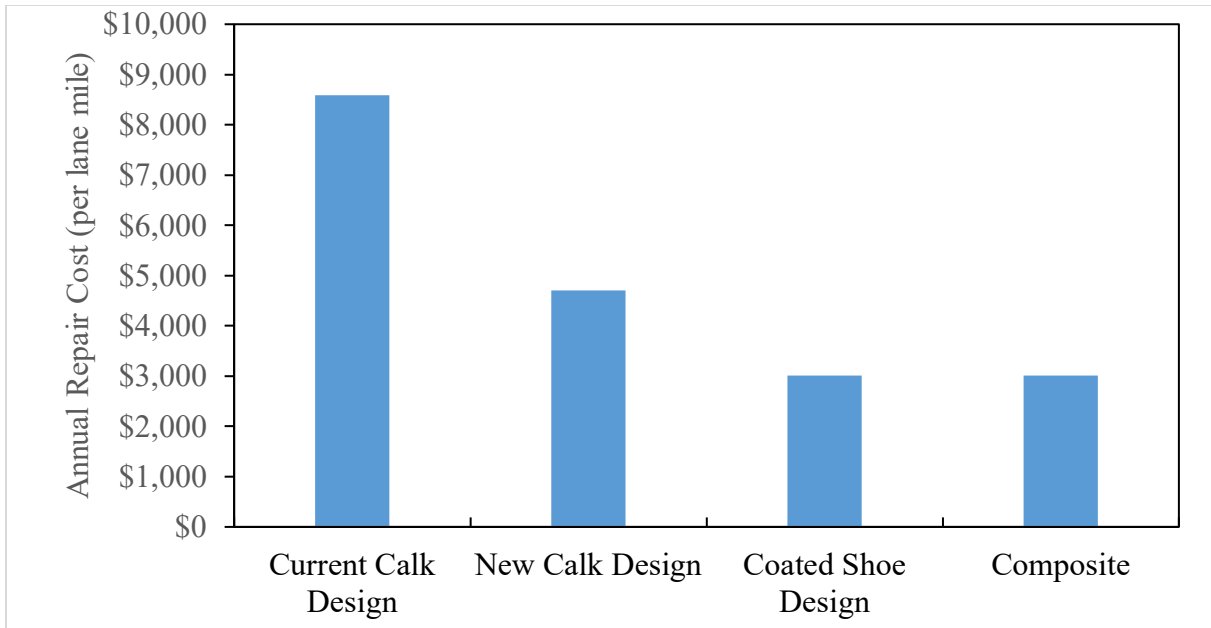
Figure C.4 EUAC for Amish buggy routes when using different horseshoes

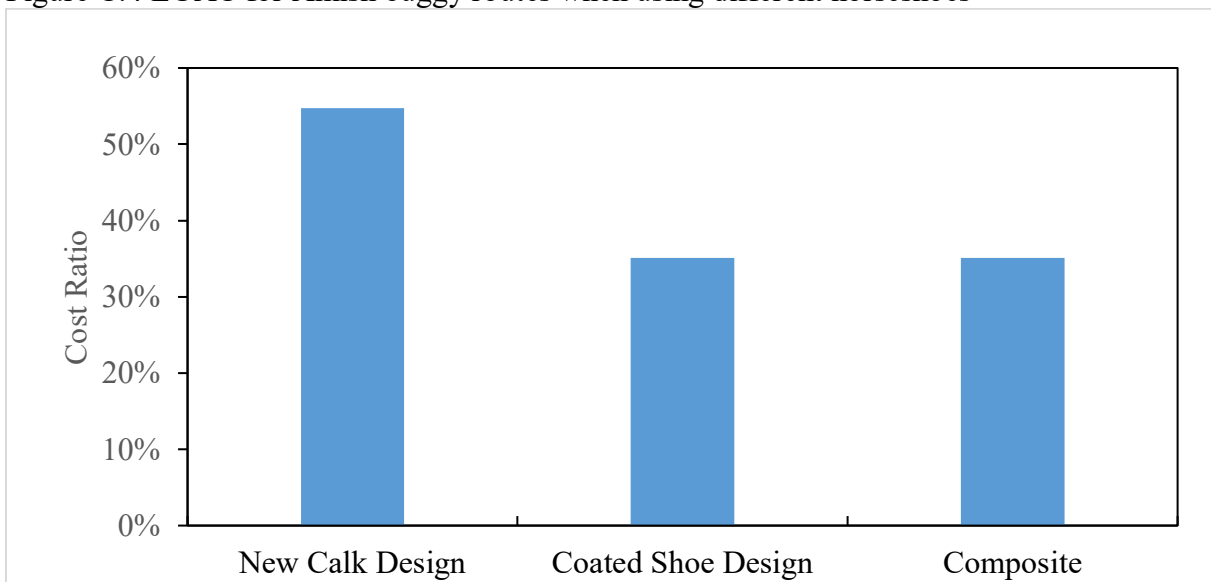
$$\text{Cost Ratio} = \frac{\text{EUAC}_{\text{new horseshoe}}}{\text{EUAC}_{\text{current horeshoe}}} \quad (\text{C.2})$$

Figure C.5 Cost Ratio for Amish buggy routes when using different horseshoes
