Re-tightening the Large Anchor Bolts of Support Structures for Signs and Luminaires

August 2018

Research Project
Final Report 2018-27

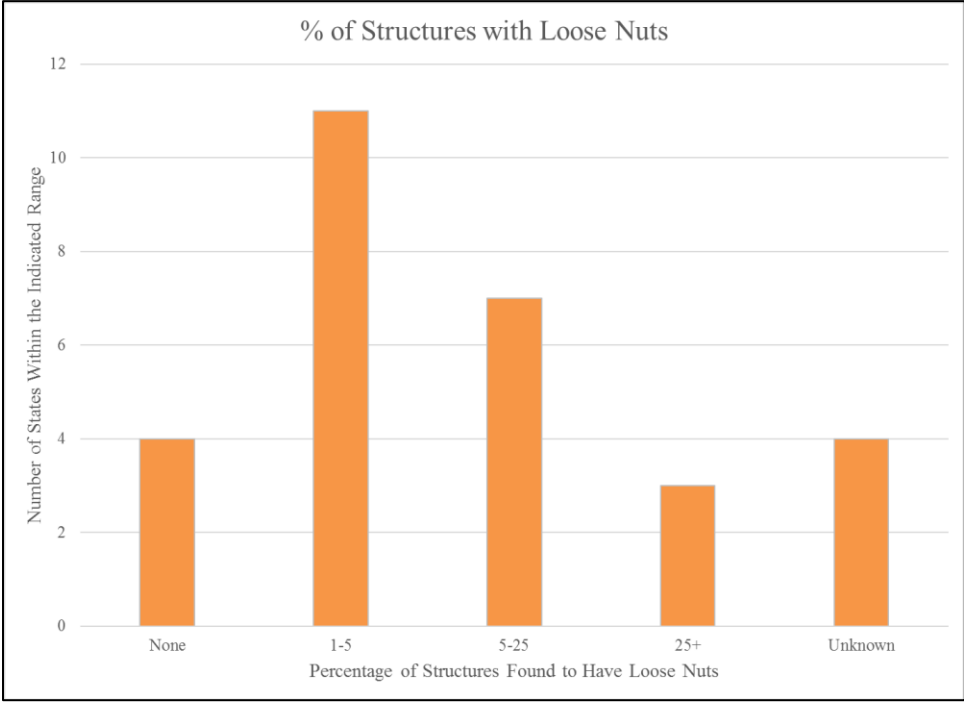
Figure 3-5 - Percentage of Structures with Loose Nuts Per State Survey

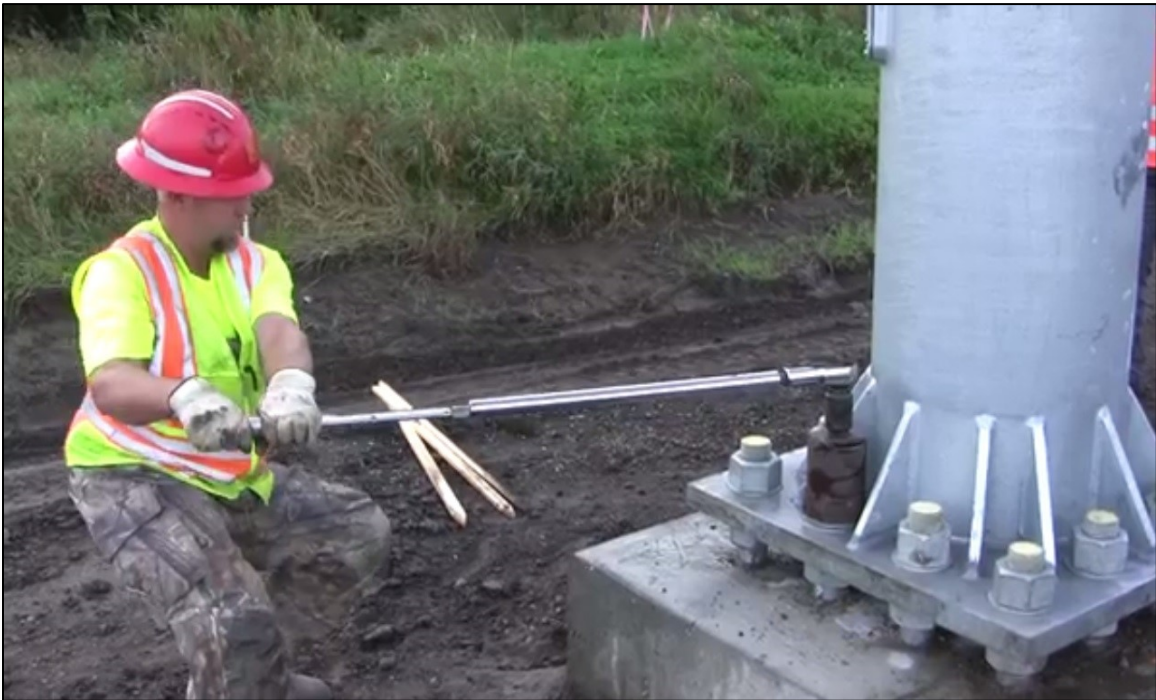
Figure 3-11 - Top Nut Tightening with Calibrated Wrench in Minnesota

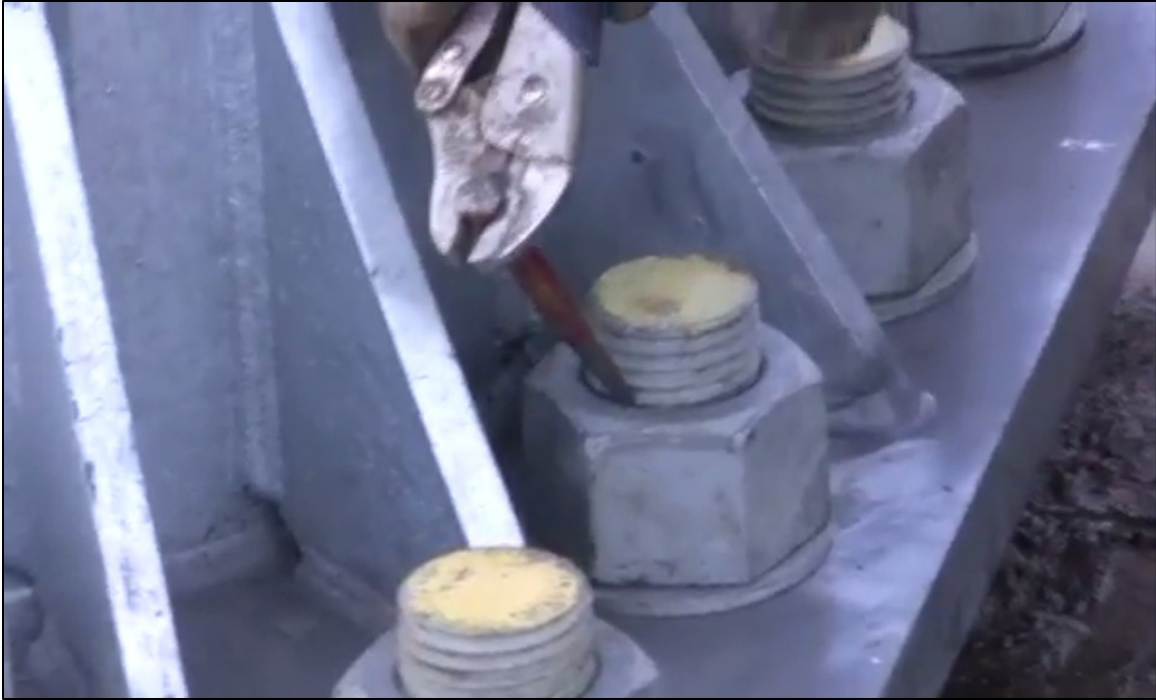
Figure 3-12 - Puncturing of Threads after Tightening

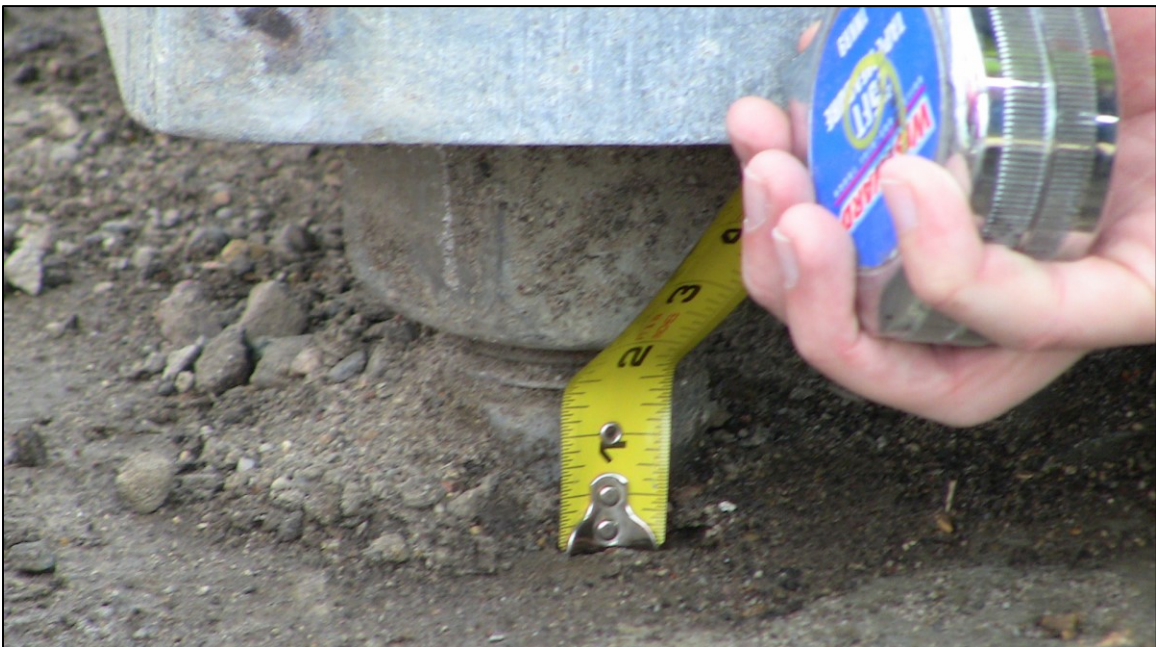
Figure 3-13 - Distance from Foundation to Bottom Leveling Nut

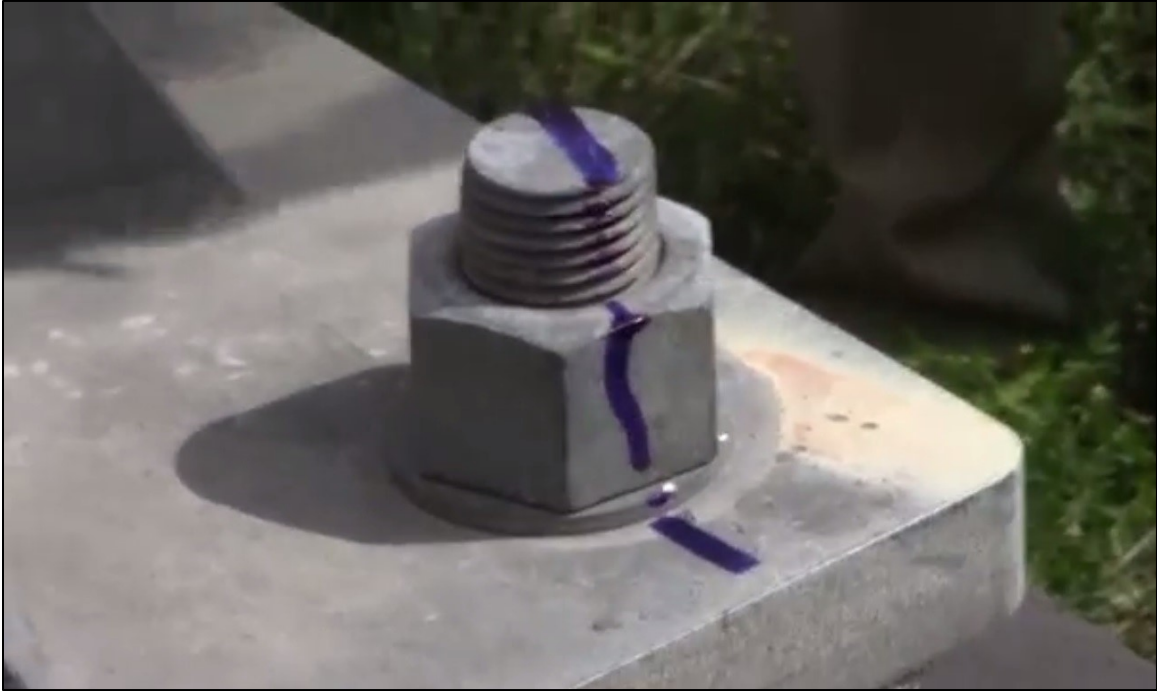
Figure 3-16 - Reference Marks Used During Maintenance

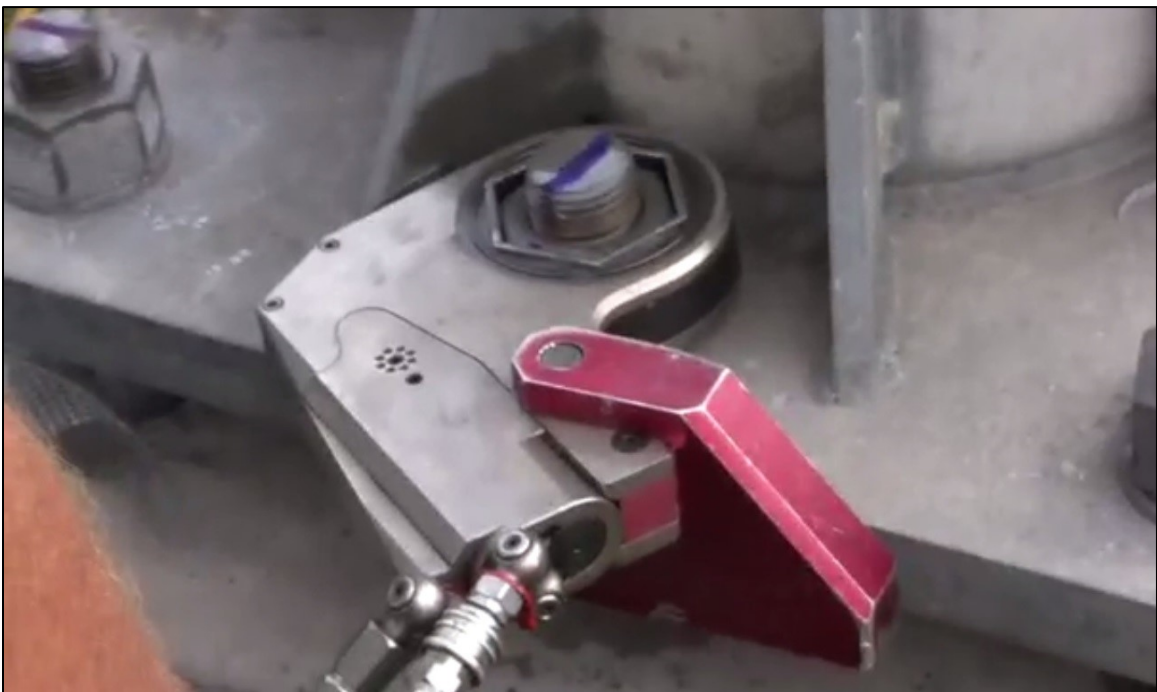
Figure 3-17 - Hydraulic Wrench Used for Maintenance Retightening

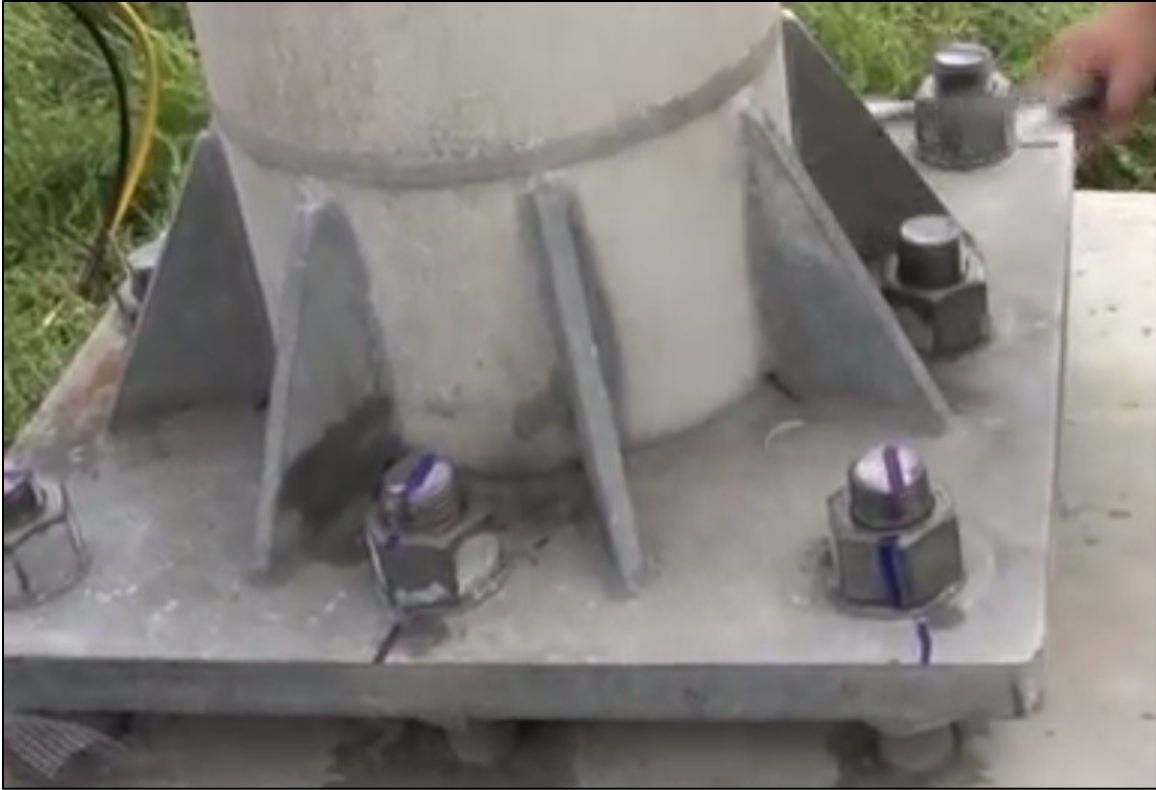
Figure 3-18 - After Maintenance Retightening

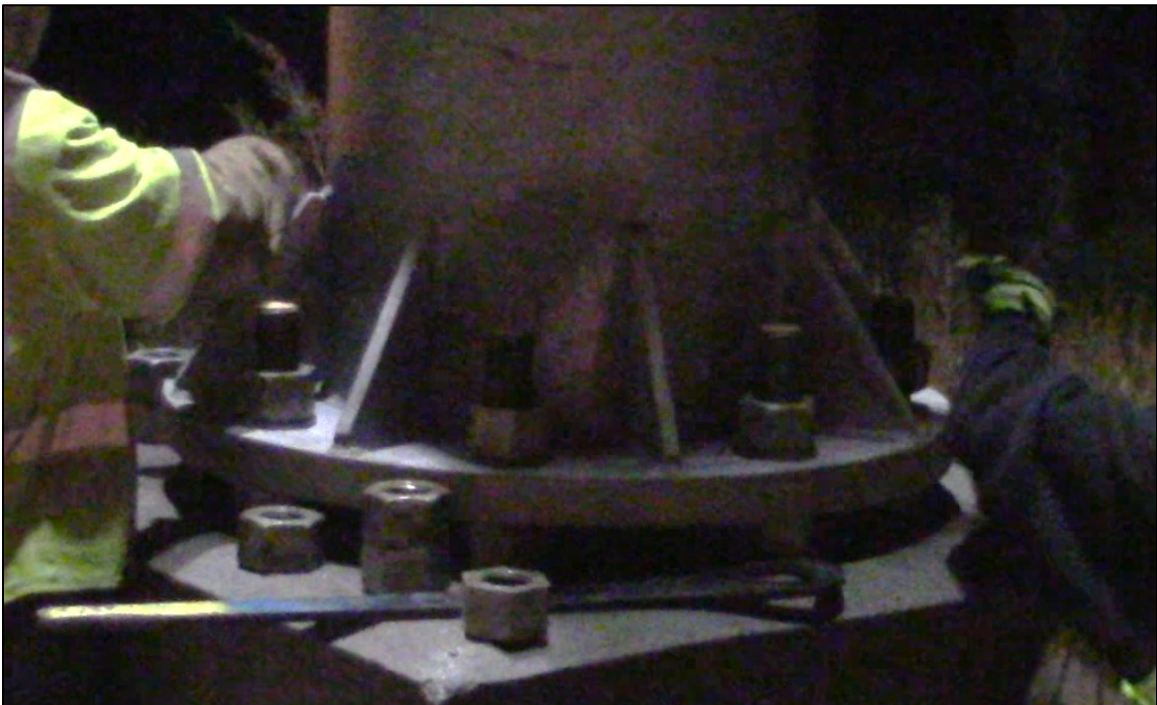
Figure 3-23 - Hand Tightening of Bolts

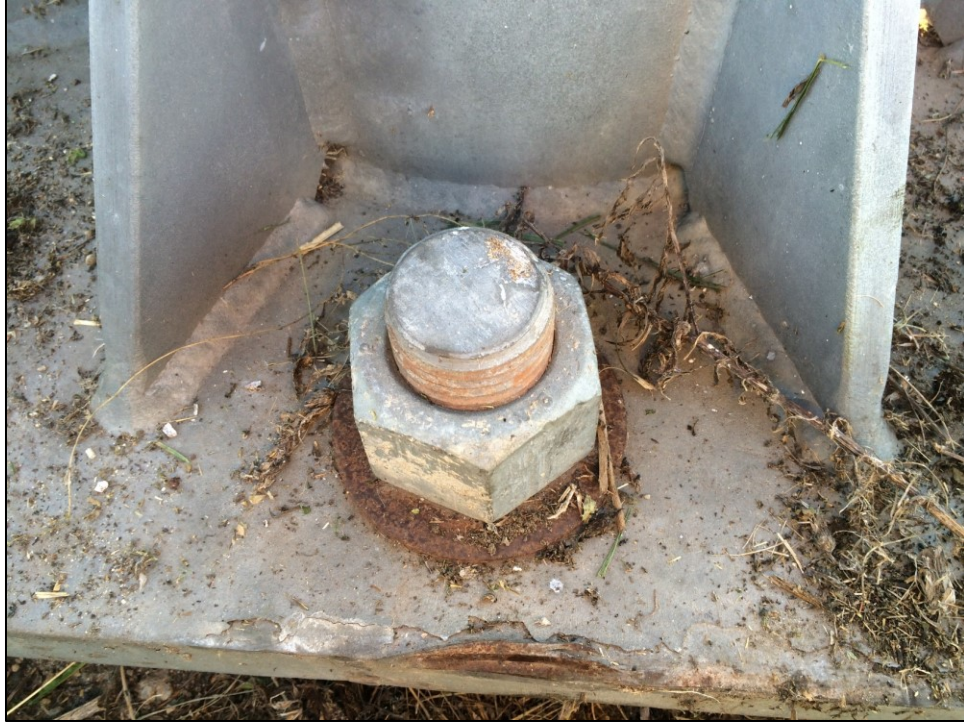
Figure 3-28 - Rusted Washers Found in District 6

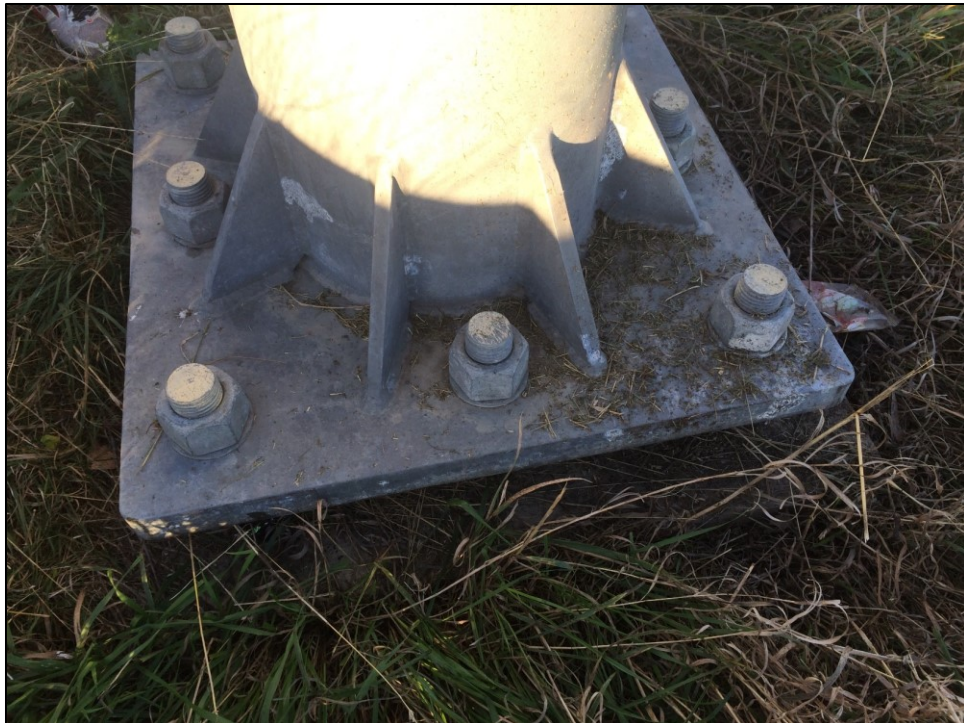
Figure 3-29 - Undersized Washers Found in District 6

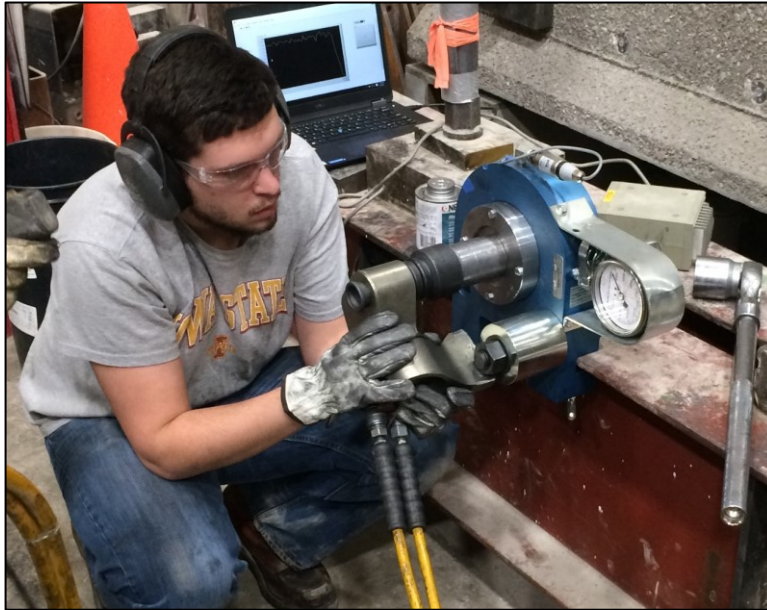
Figure 4-1 - Hydraulic Wrench Tightening

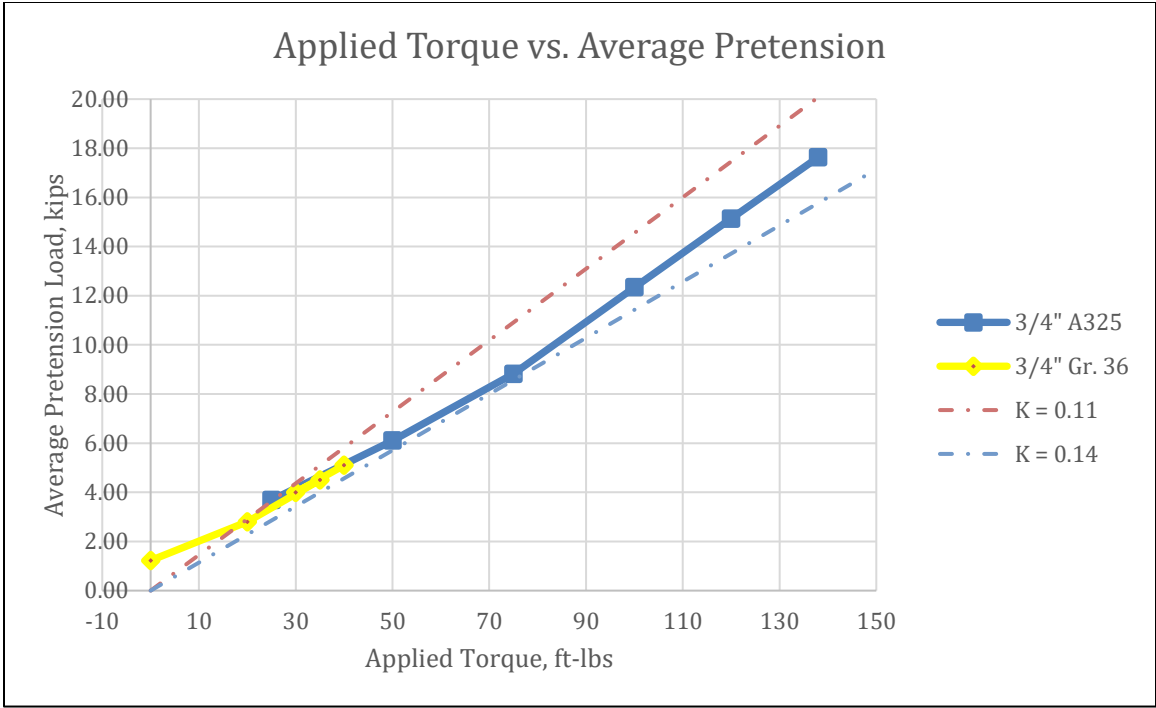
Figure 4-8 – 0.75" Bolts Torque vs. Tension

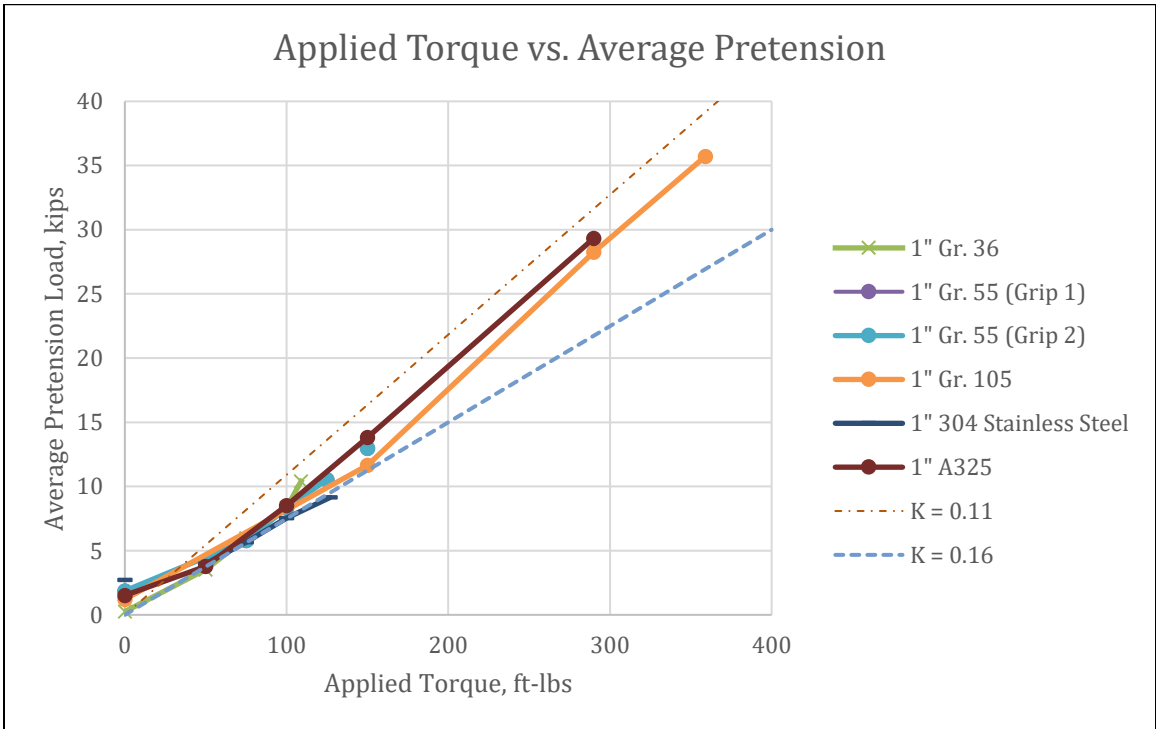
Figure 4-9 - 1" Torque vs. Tension

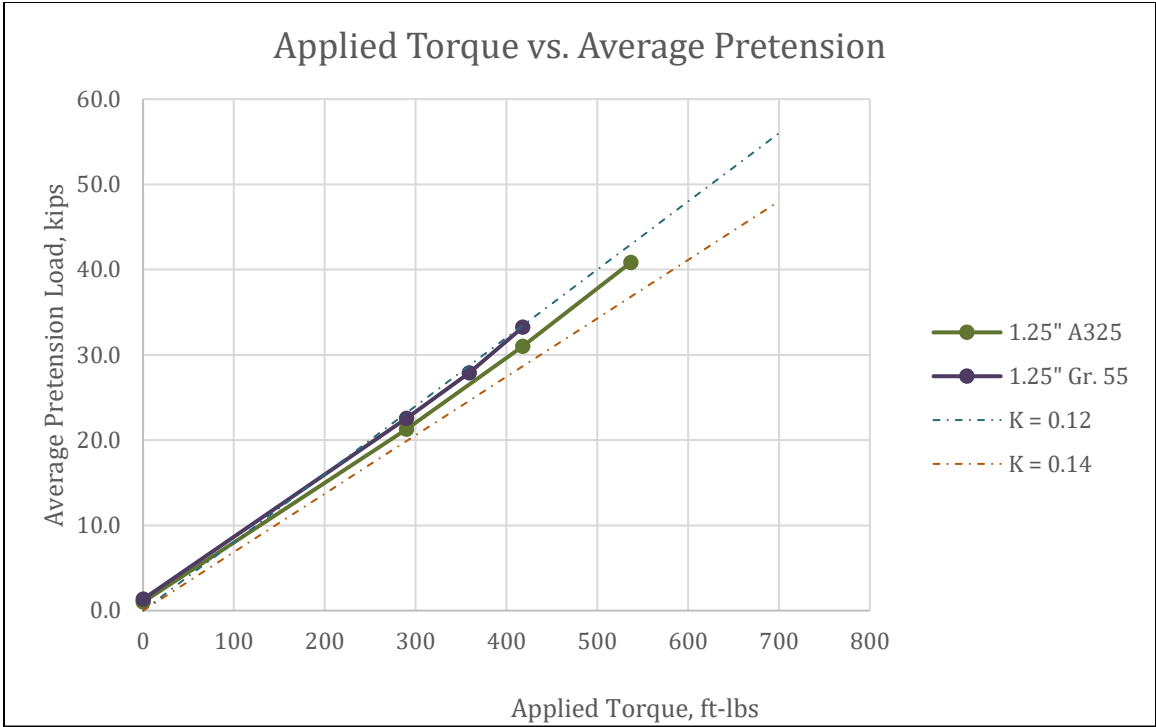
Figure 4-10 – 1.25" Torque vs. Tension

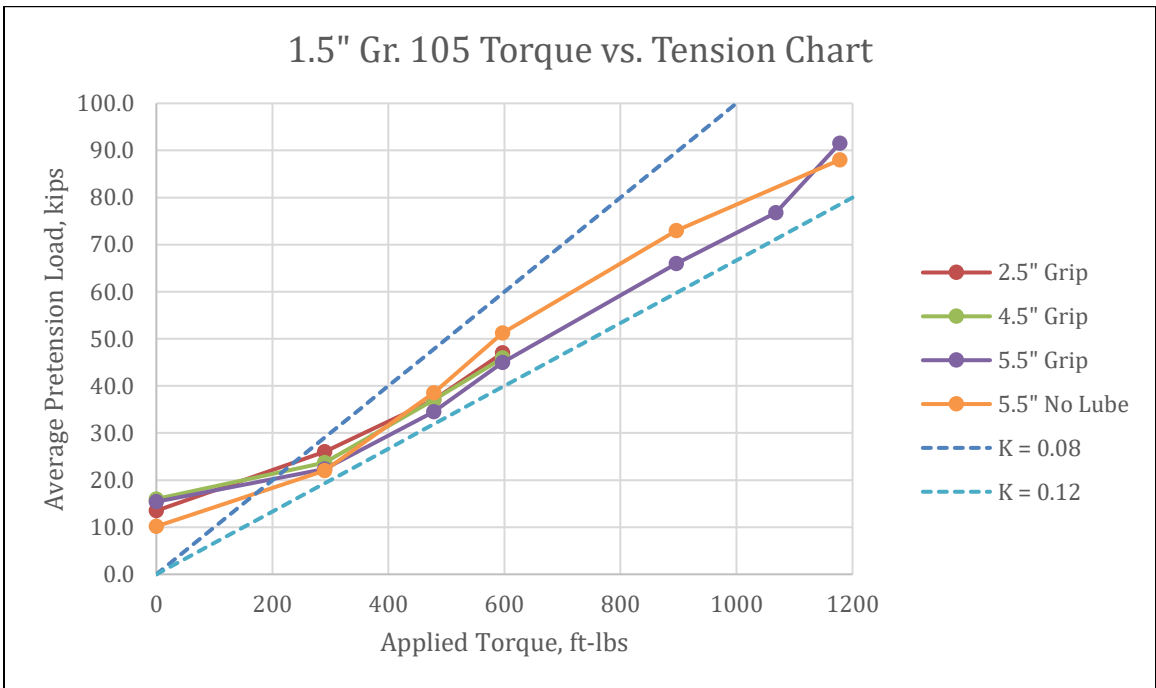
Figure 4-11 – 1.5" Torque vs. Tension

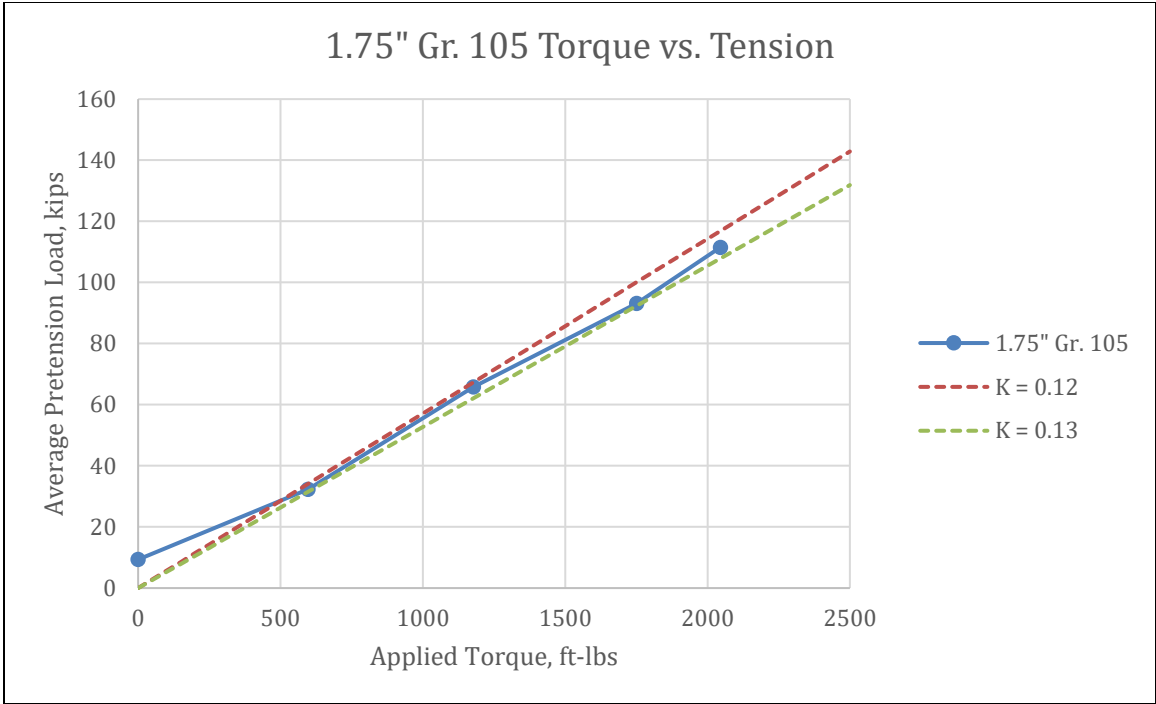
Figure 4-12 – 1.75" Torque vs. Tension

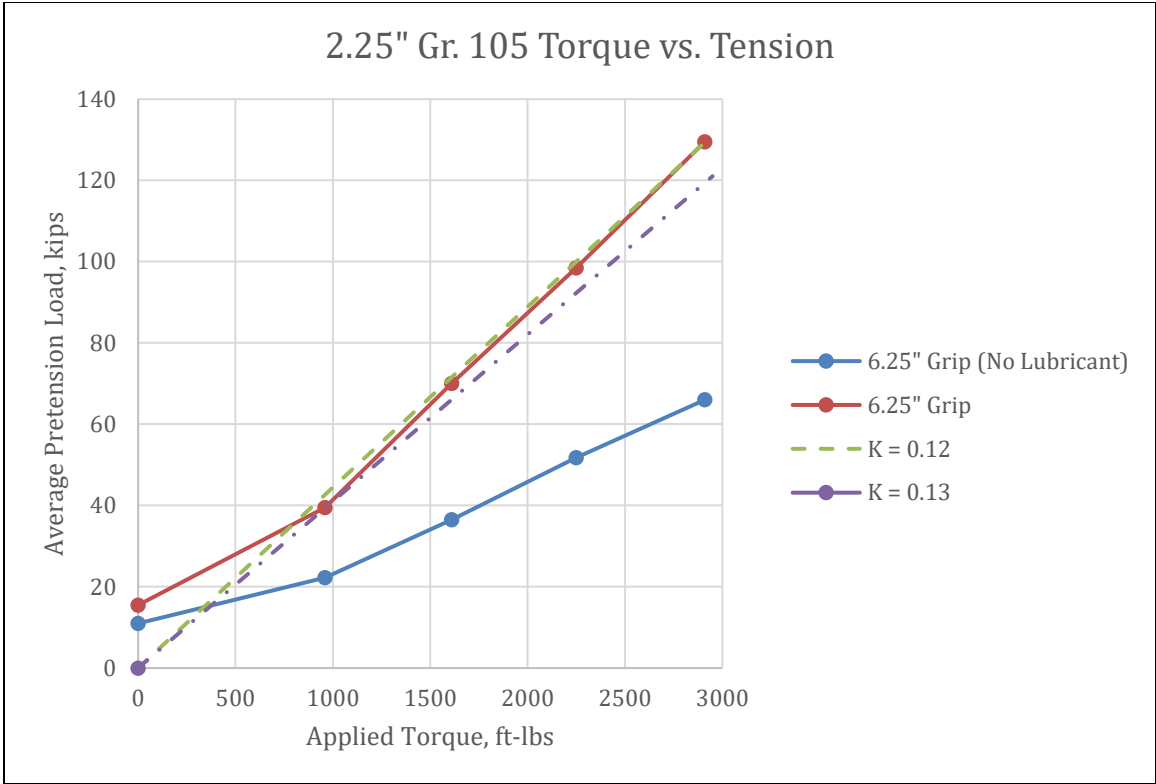
Figure 4-14 – 2.25" Torque vs. Tension

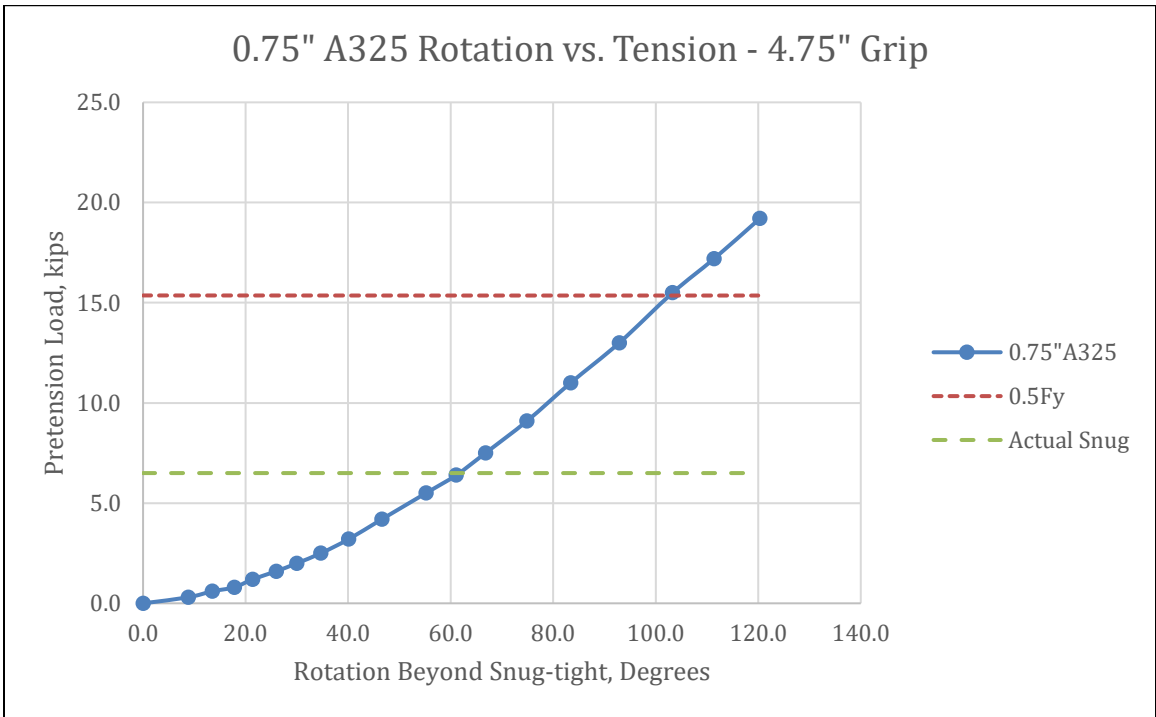
Figure 4-15 - Pre-Snug & Rotation Beyond Snug Curve

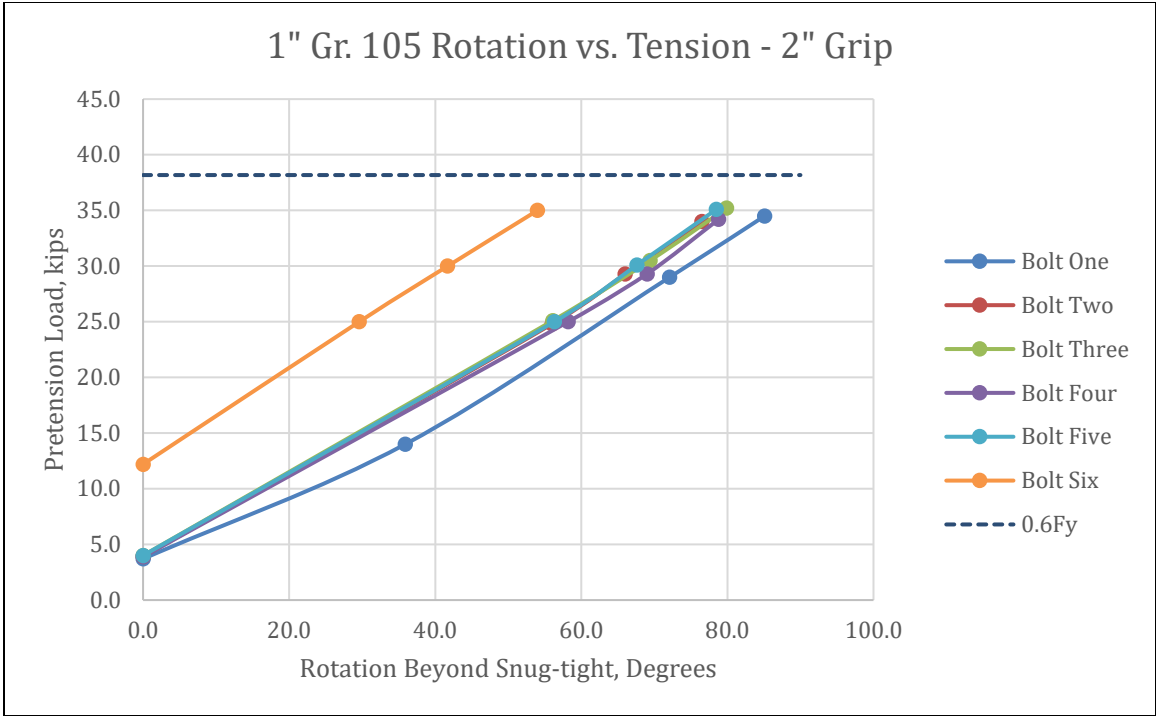
Figure 4-18 - 1" Gr. 105 Rotation vs. Tension

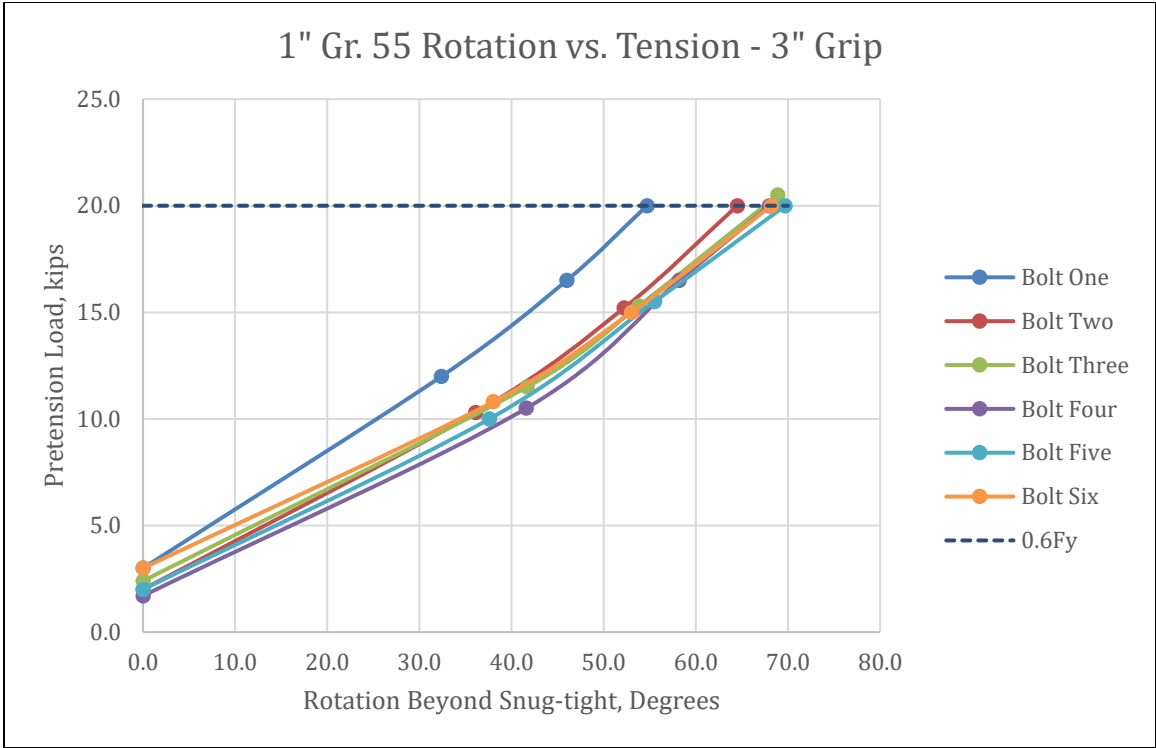
Figure 4-20 - 1" Gr. 55 with 3" Grip Rotation vs. Tension

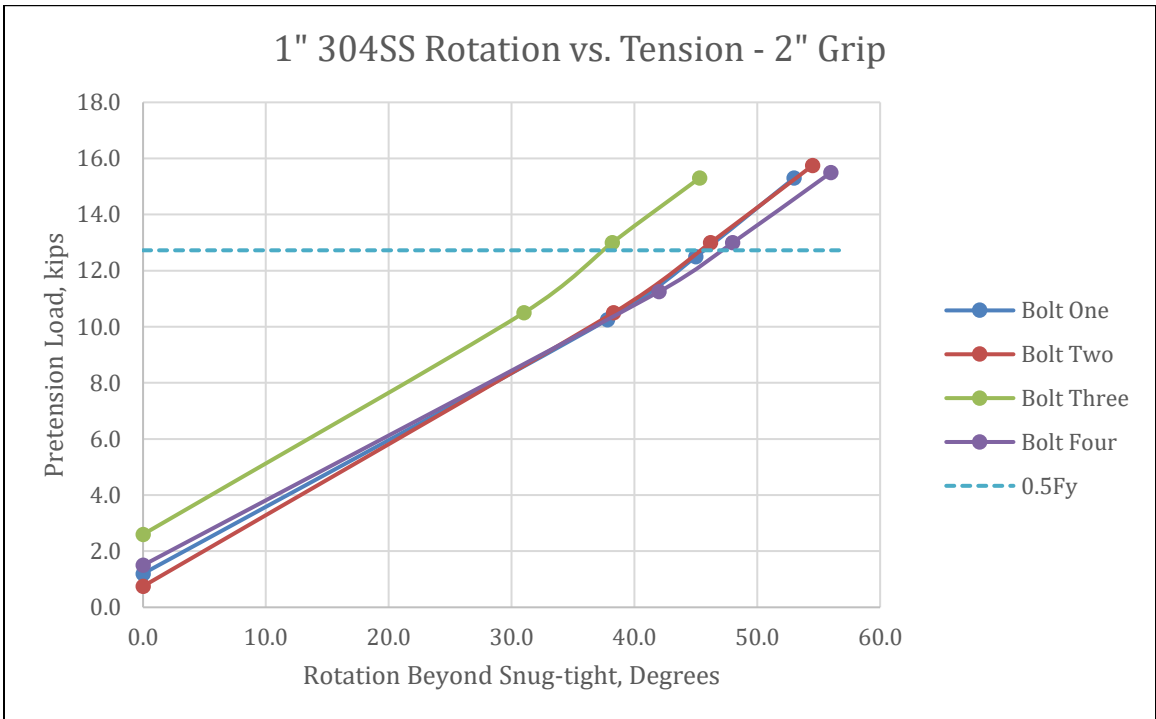
Figure 4-21 - 1" 304 Stainless Steel Rotation vs. Tension

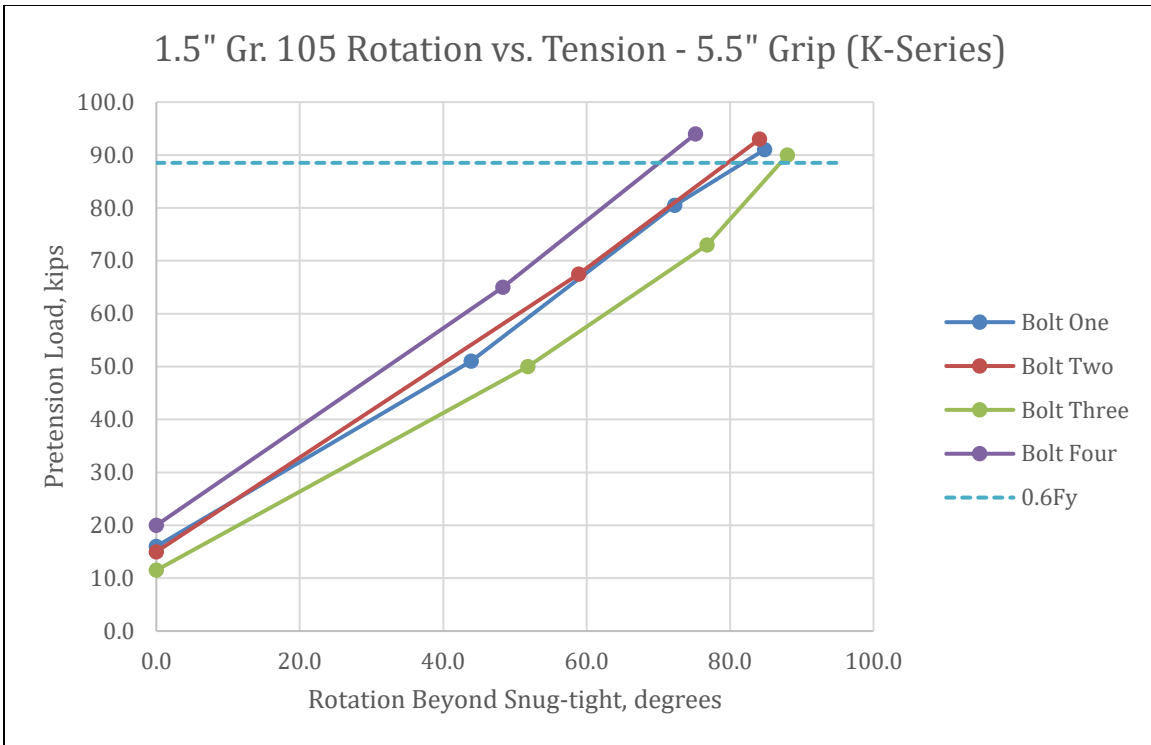
Figure 4-28 - 1.5" Gr. 105 with 5.5" Grip (K-Series) Rotation vs. Tension

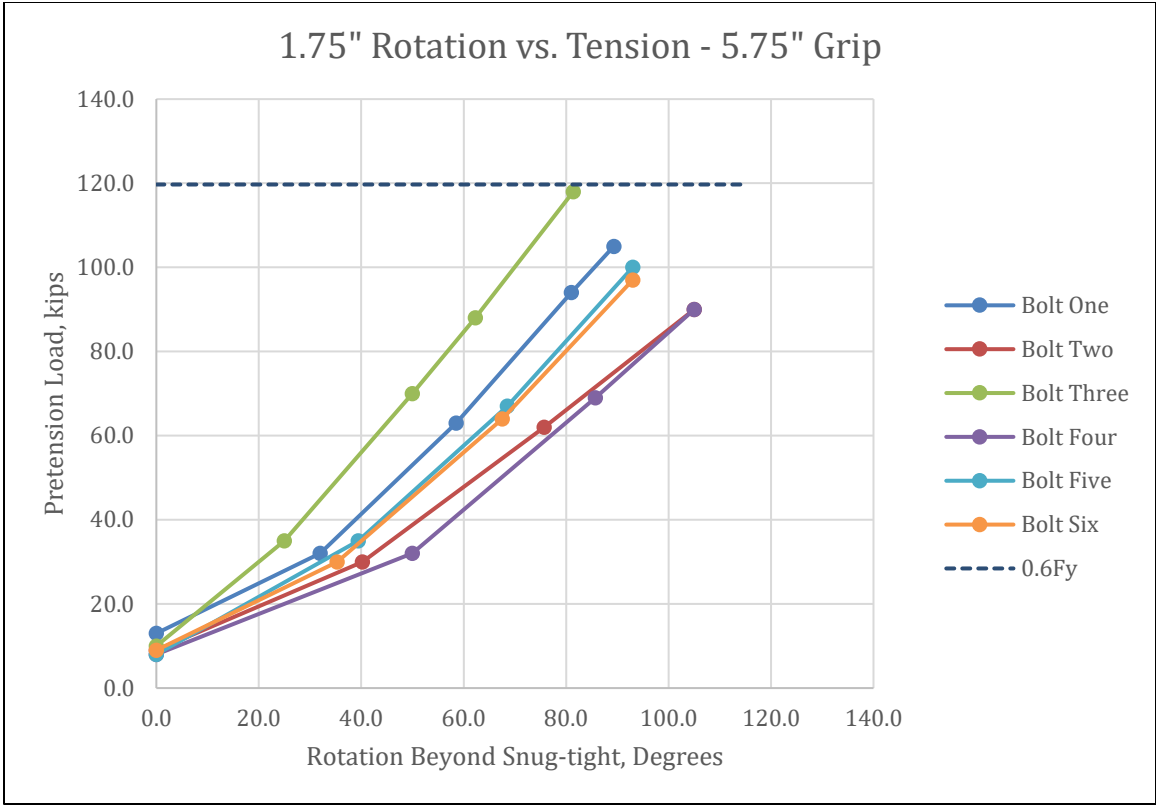
Figure 4-30 - 1.75" Gr. 105 Rotation vs. Tension

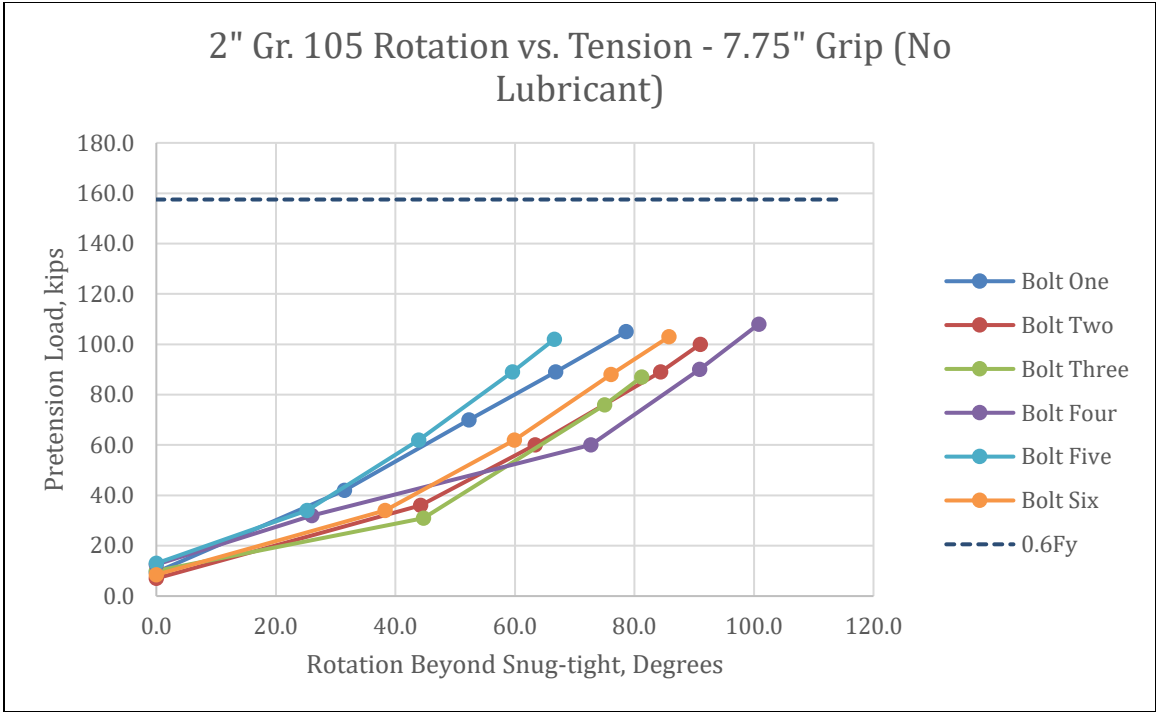
Figure 4-32 - 2" Gr. 105 with 7.75" Grip (No Lubricant) Rotation vs. Tension

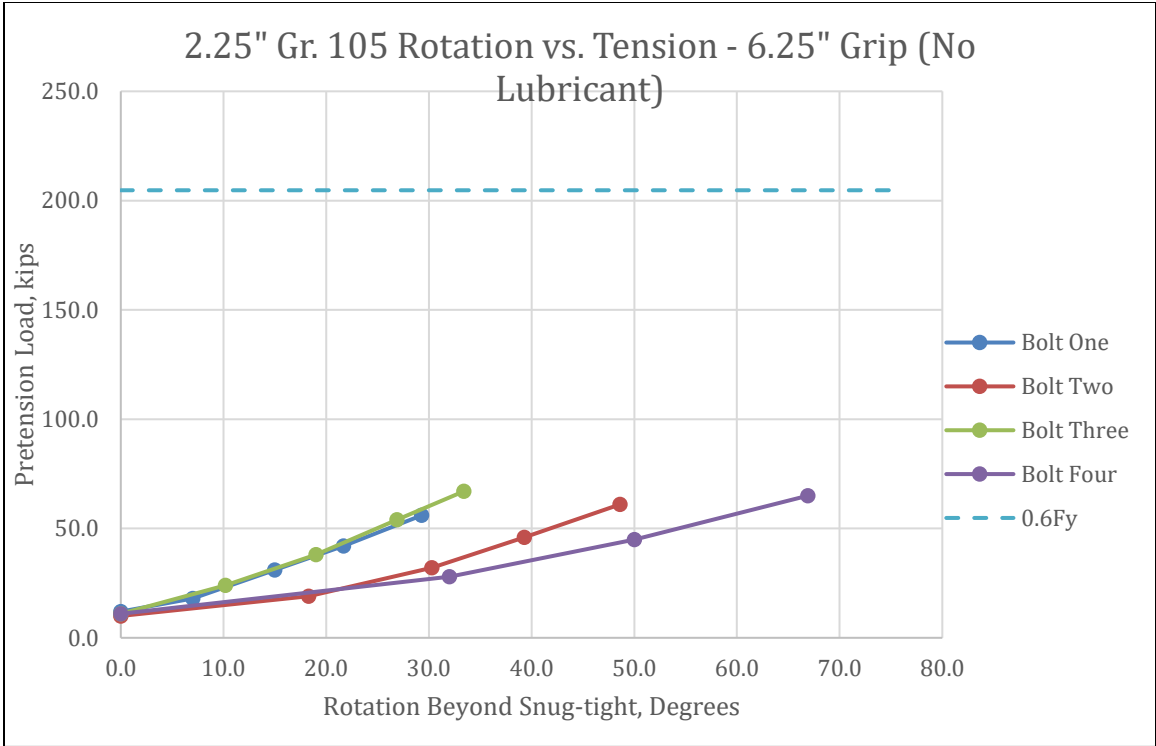
Figure 4-34 - 2.25" Gr. 105 Rotation vs. Tension (No Lubricant)

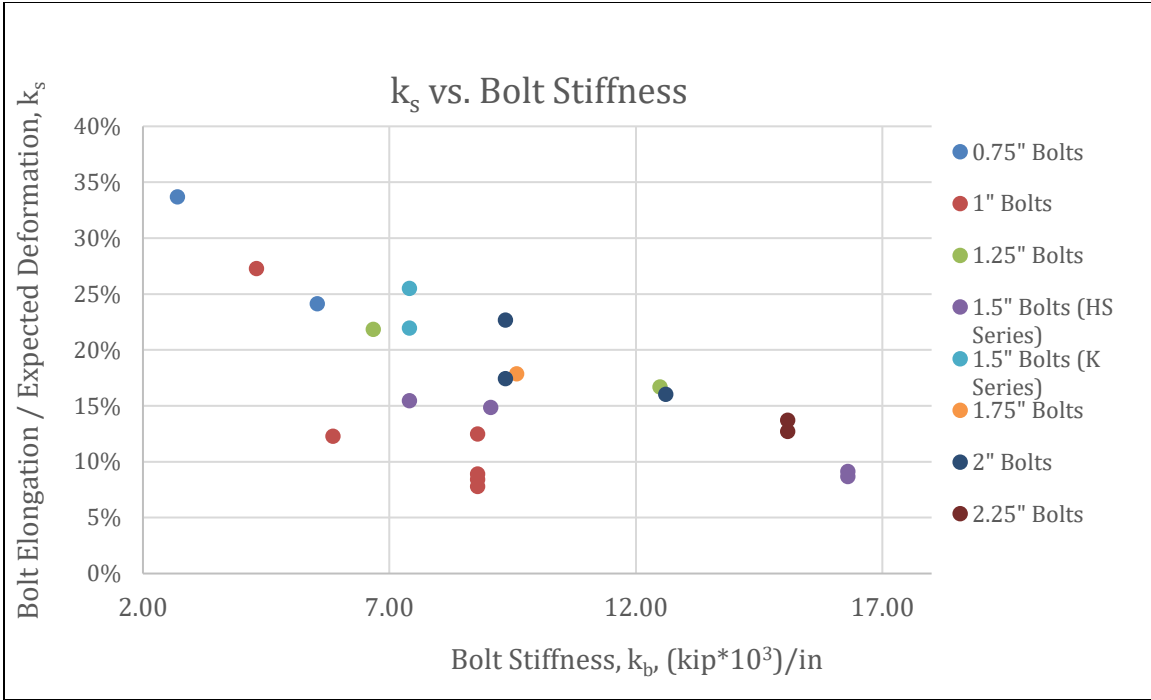
Figure 4-36 - Bolt Stiffness vs. k_s

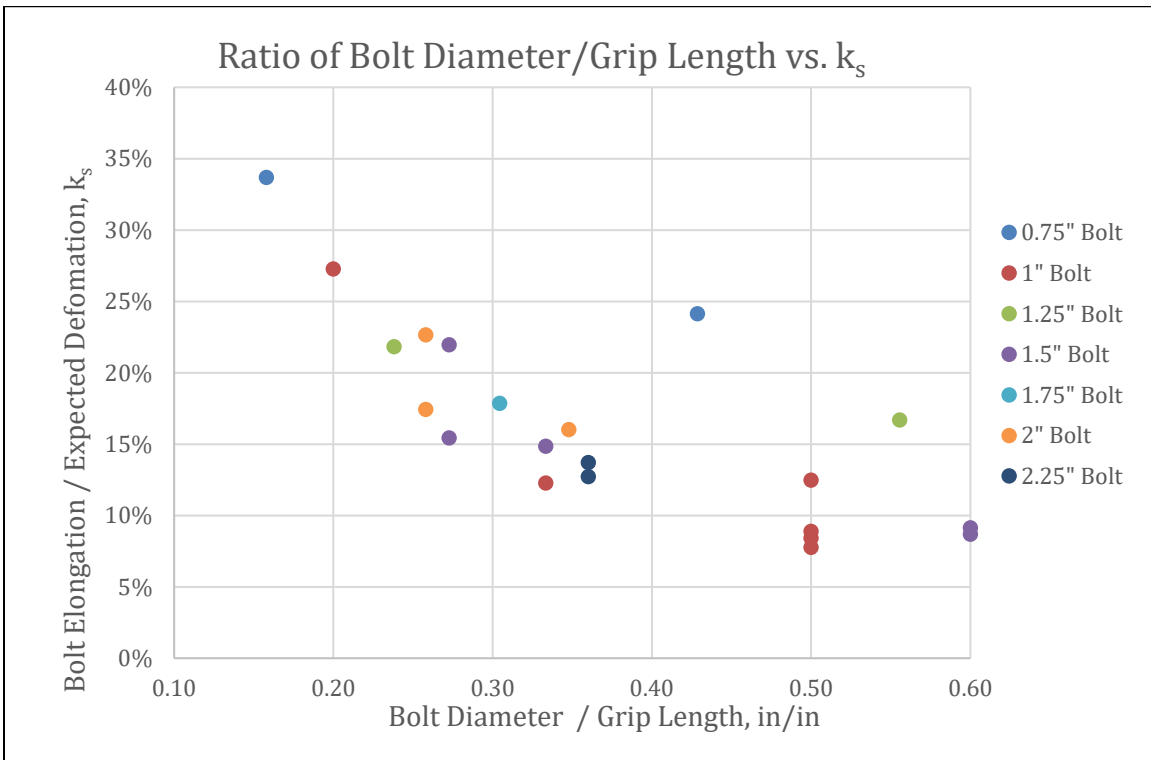
Figure 4-37 - Bolt Diameter / Grip Length vs. k_s

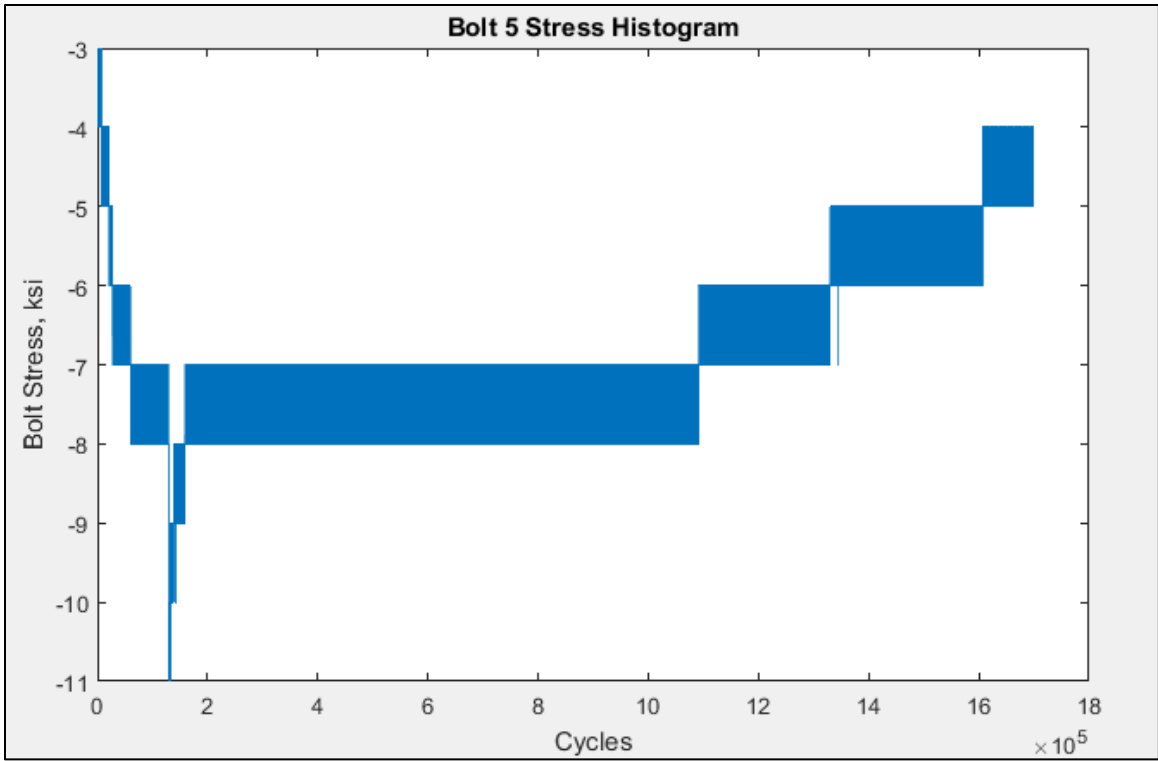
Figure 5-16 - Bolt 5 Stress Histogram
