Re-tightening the Large Anchor Bolts of Support Structures for Signs and Luminaires

August 2018

Research Project
Final Report 2018-27

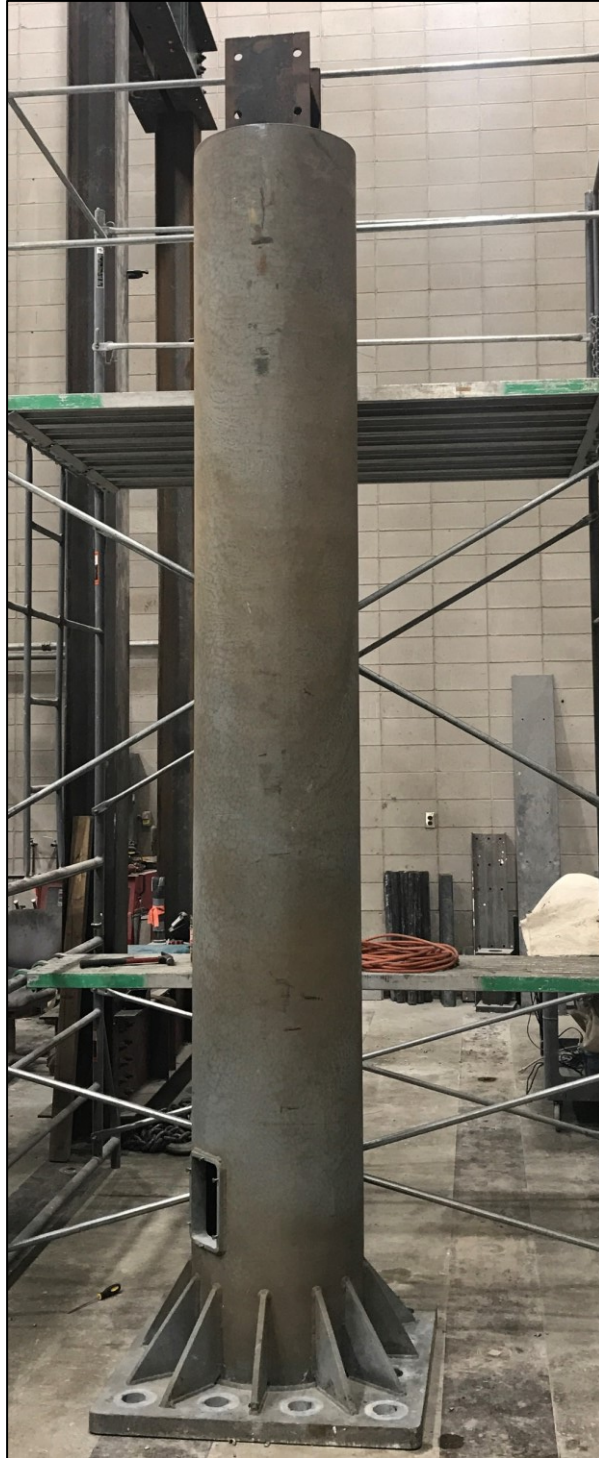
Figure 5-33 - H-Pile Placed Inside Sign Post

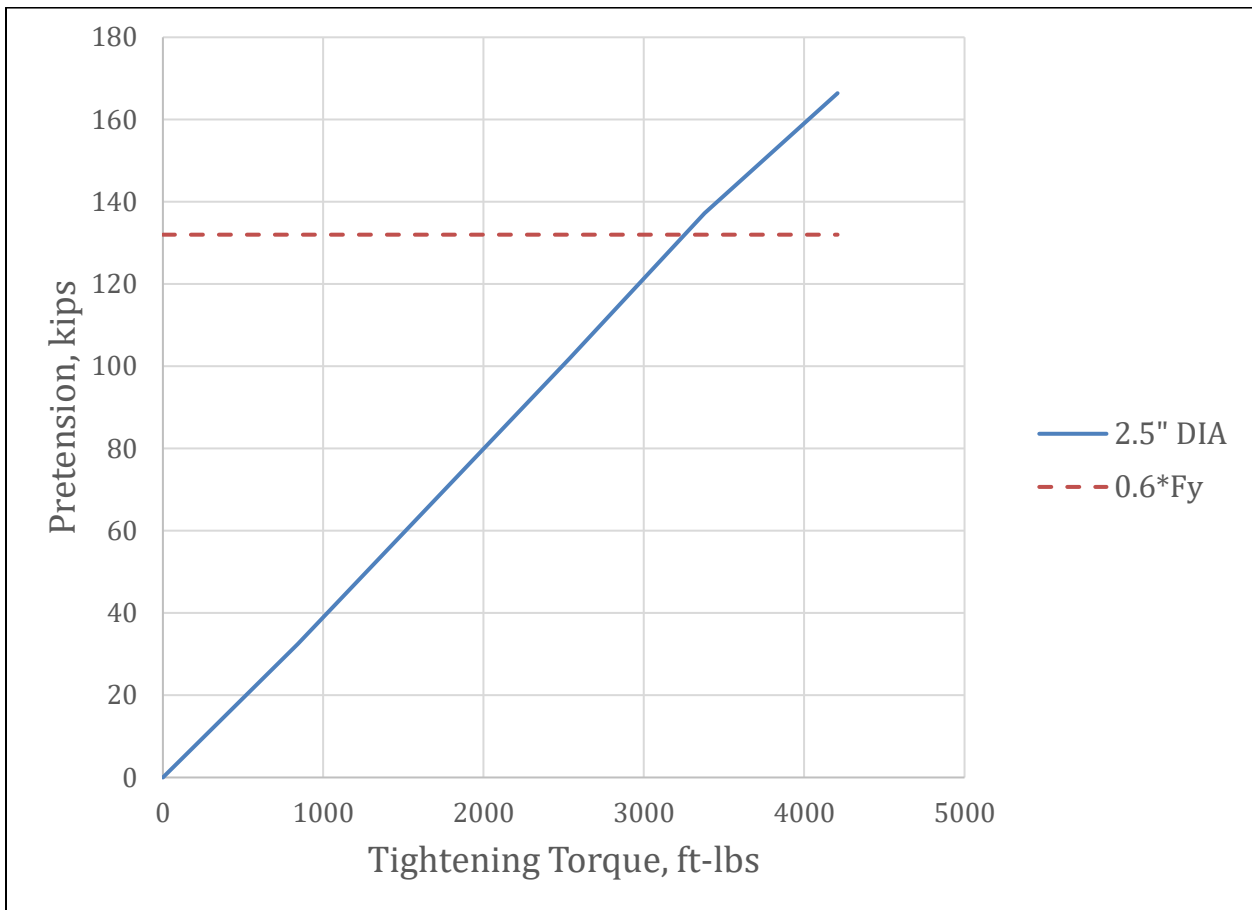
Figure 5-38 - Torque vs. Tension for 2-1/2" Diameter Bolts

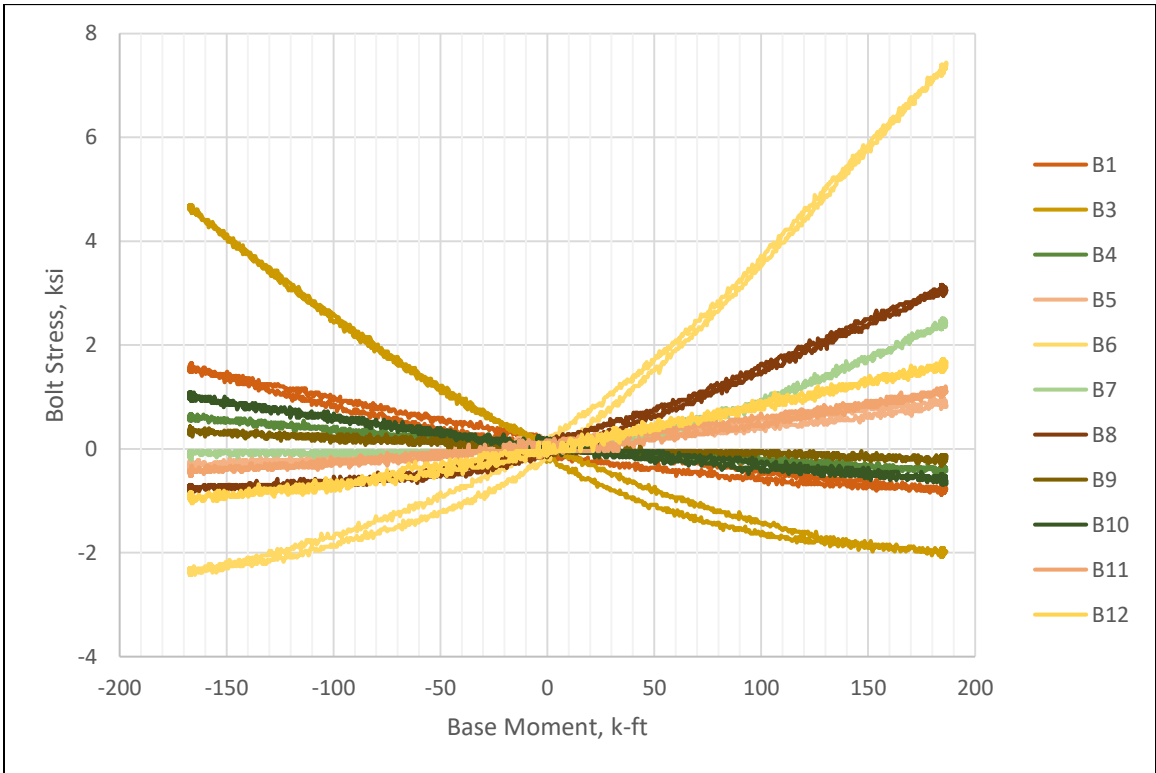
Figure 5-42 - Base Moment vs. Bolt Stress

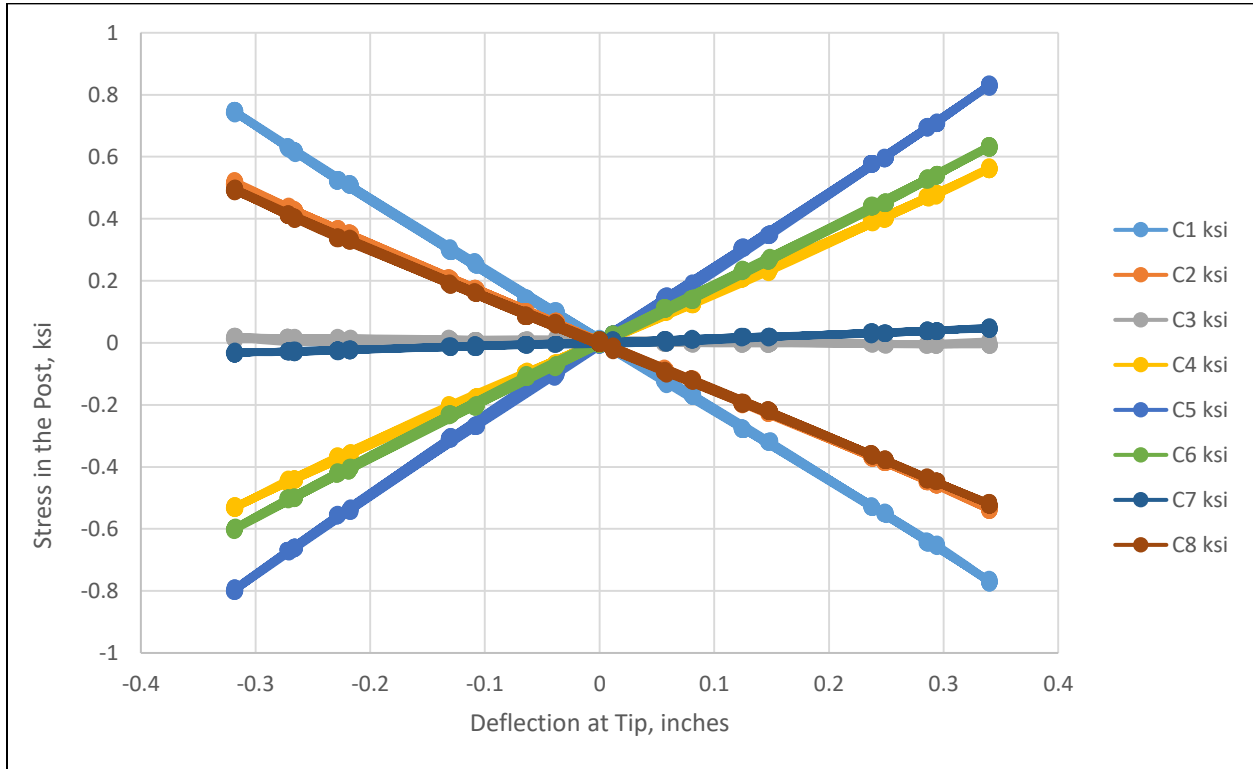
Figure 5-46 - Post Stress vs. Deflection

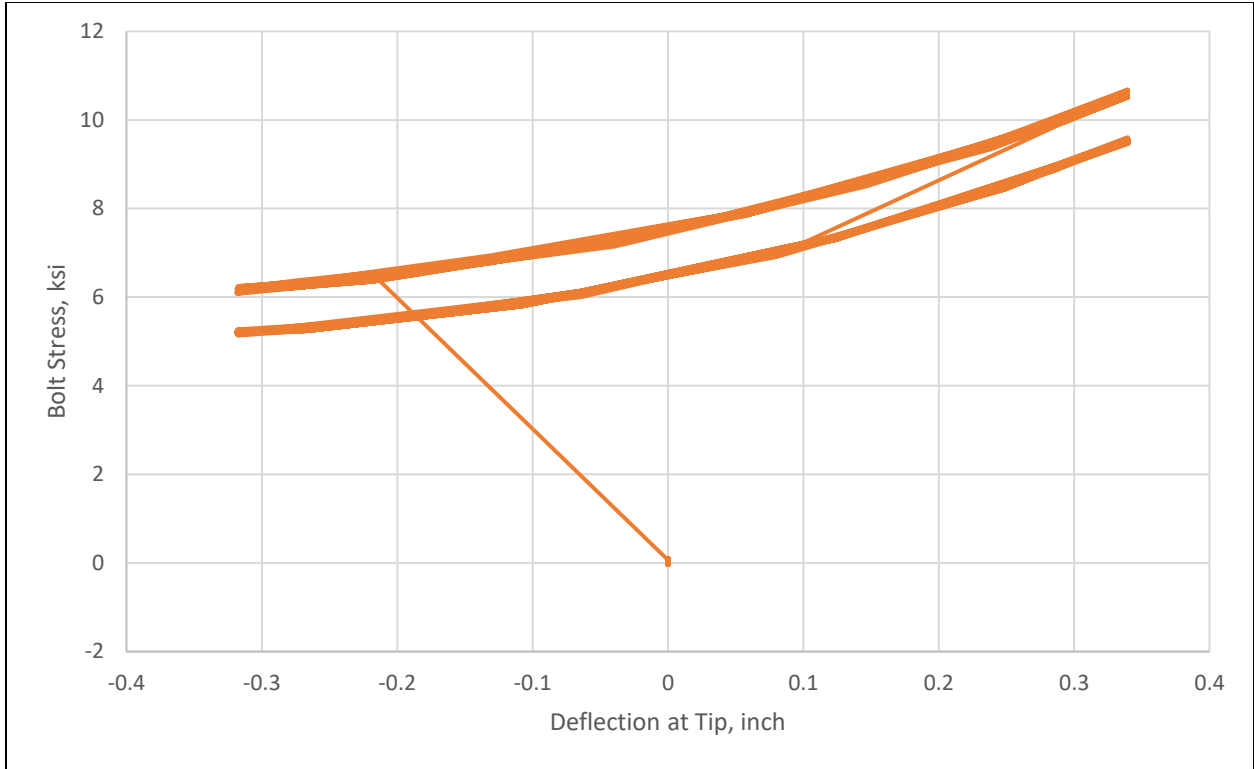
Figure 5-49 - Bolt 3 Stress vs. Deflection

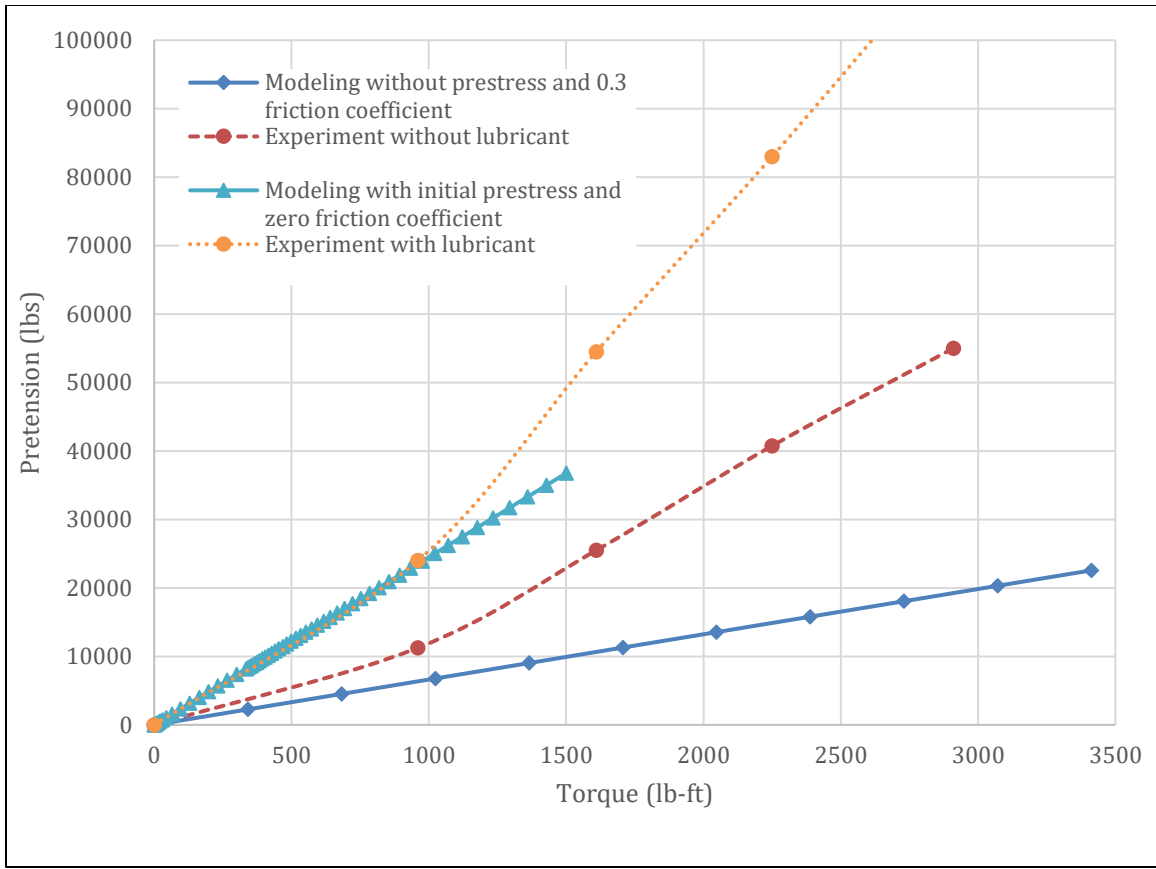
Figure 6-8 - Comparison of Experiment and Modeling

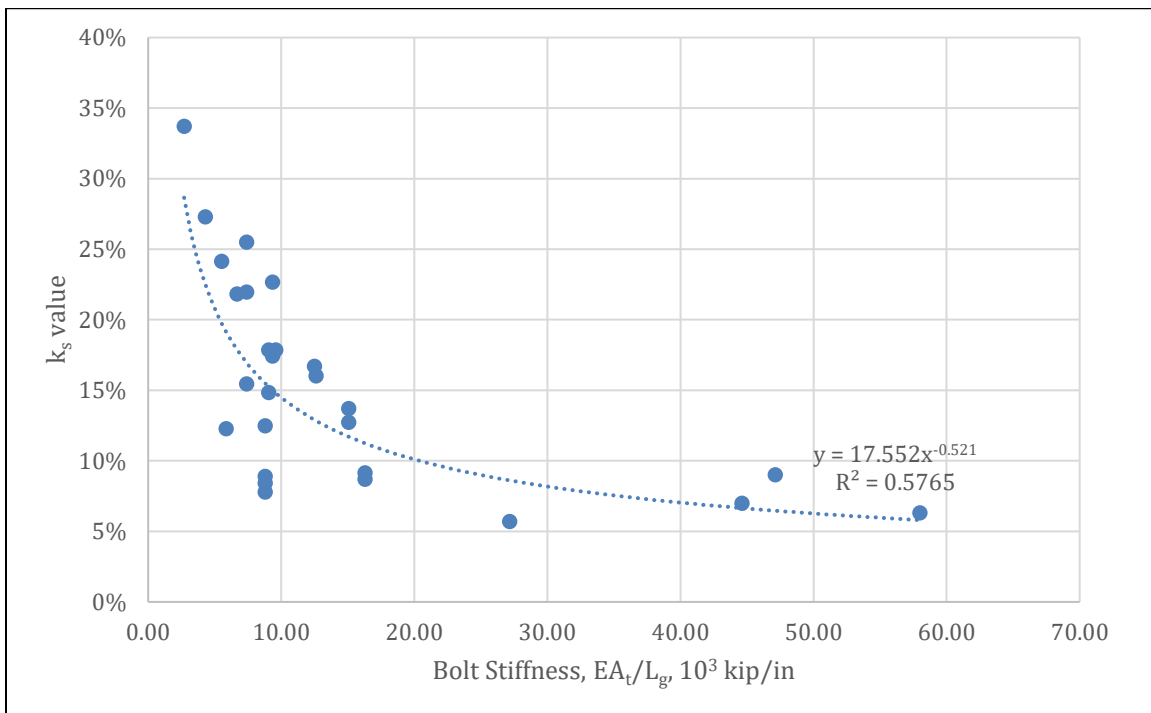
Figure 7-1 - k_s Value vs. Bolt Stiffness

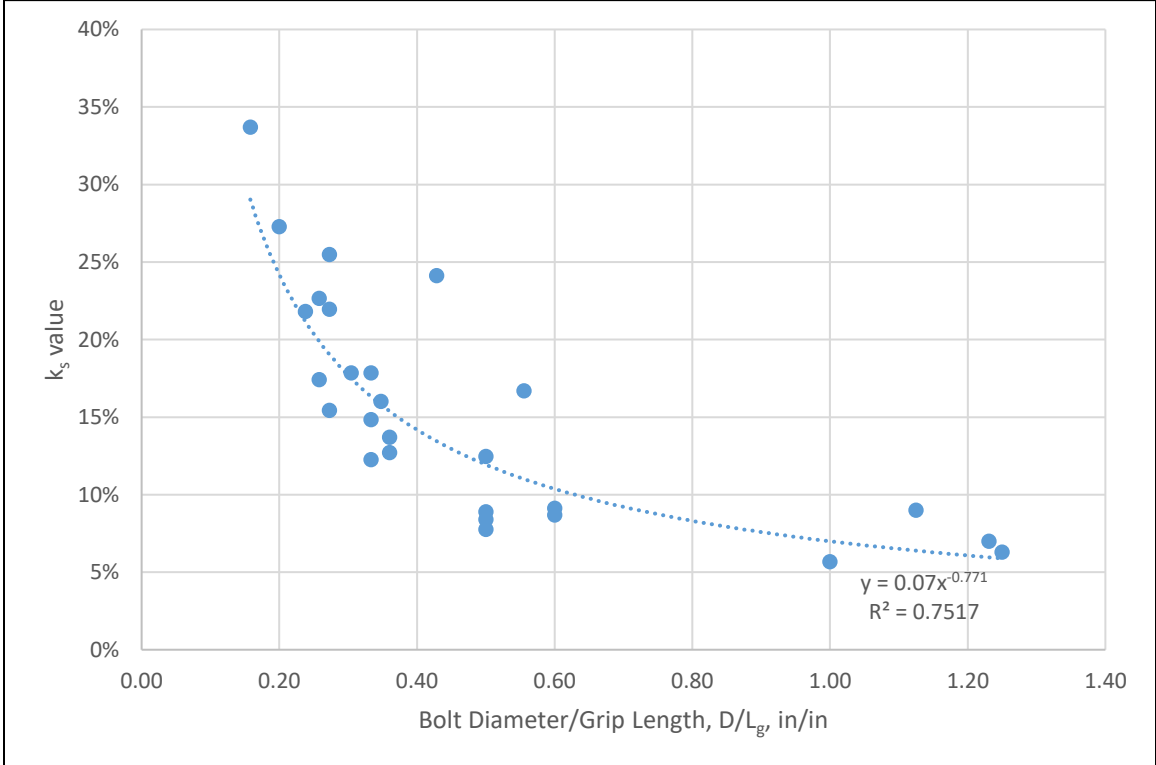
Figure 7-3 - k_s Values vs. Ratio of Bolt Diameter to Grip Length

Figure 7-3 compares the ratio of bolt diameter to grip length and design k_s values. This is synonymous for bolt stiffness, but does not take into account the smaller area due to the threads. The demonstrated fit was better than that of Figure 7-1, and calculating D/L can be cleaner than a bolt stiffness is thousands of kips/in.
