Improving the Quality of Bridge Inspections Using Unmanned Aircraft Systems (UAS)

Barritt Lovelace, Principal Investigator
Collins Engineers, Inc.

July 2018

Research Project
Final Report 2018-26

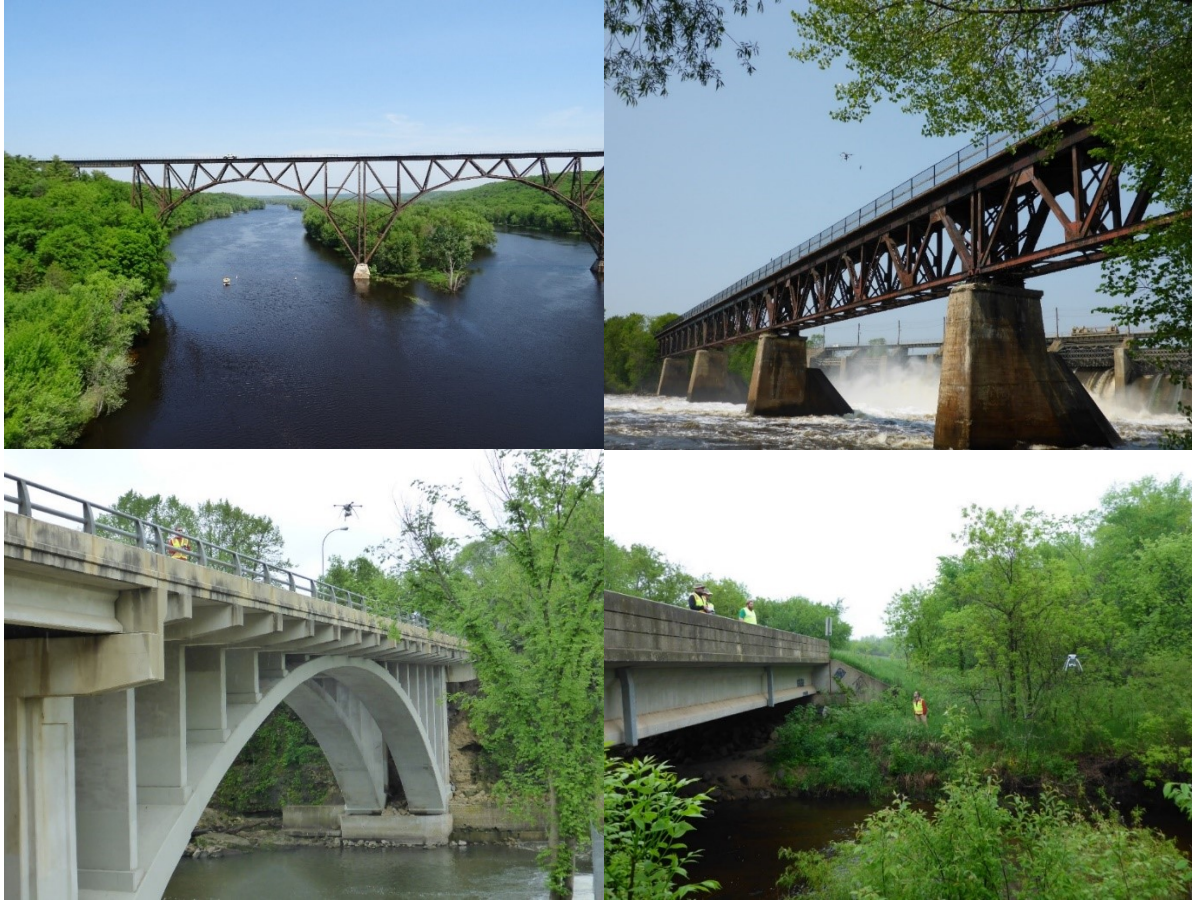
Figure 1.1 Overall Photographs of Four Bridges Selected for Phase I UAS Inspection.

Investigators identified four bridges in Minnesota that represented a variety of bridge types and sizes: an 80-foot local bridge in Chisago County, a medium-sized concrete arch bridge in Oronoco, a large steel truss bridge in Morrison County, and a 2,682-foot long railroad bridge near Stillwater that rises 185 feet above the St. Croix River.

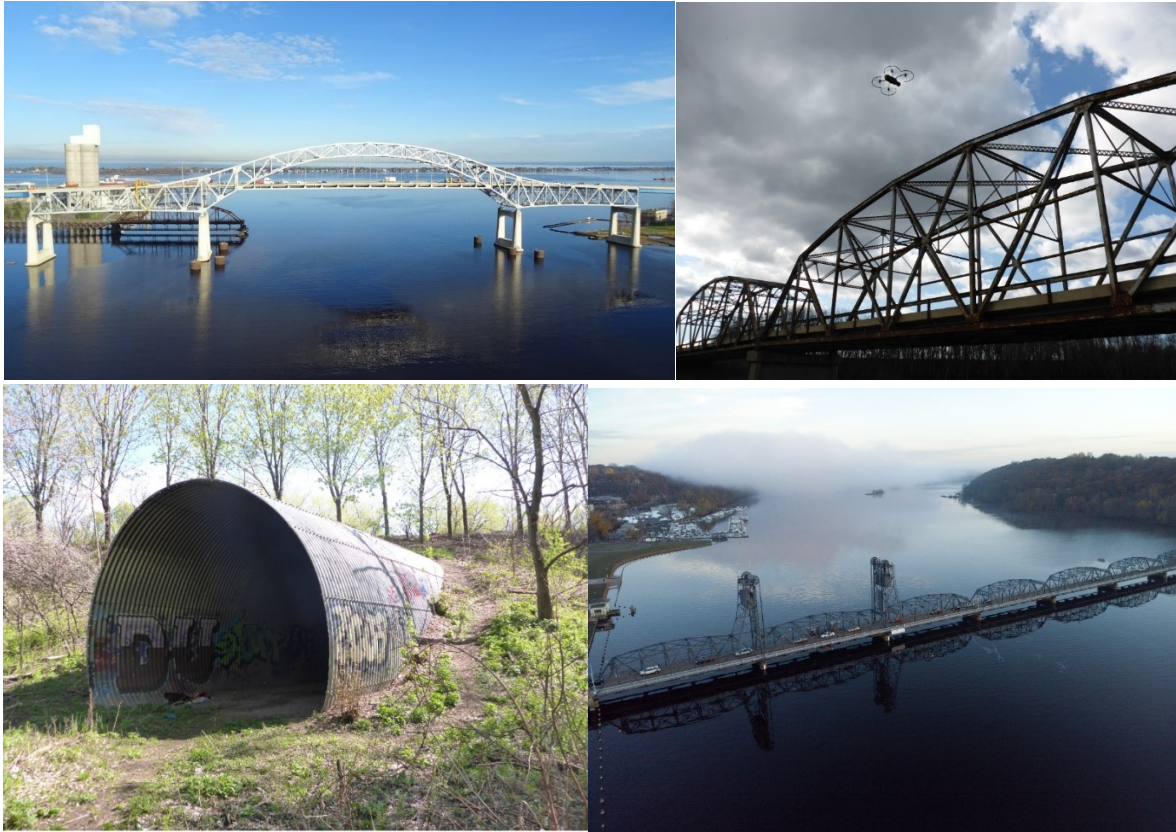
Figure 1.2 Overall Photographs of Four Bridges Selected for Phase II UAS Inspection.

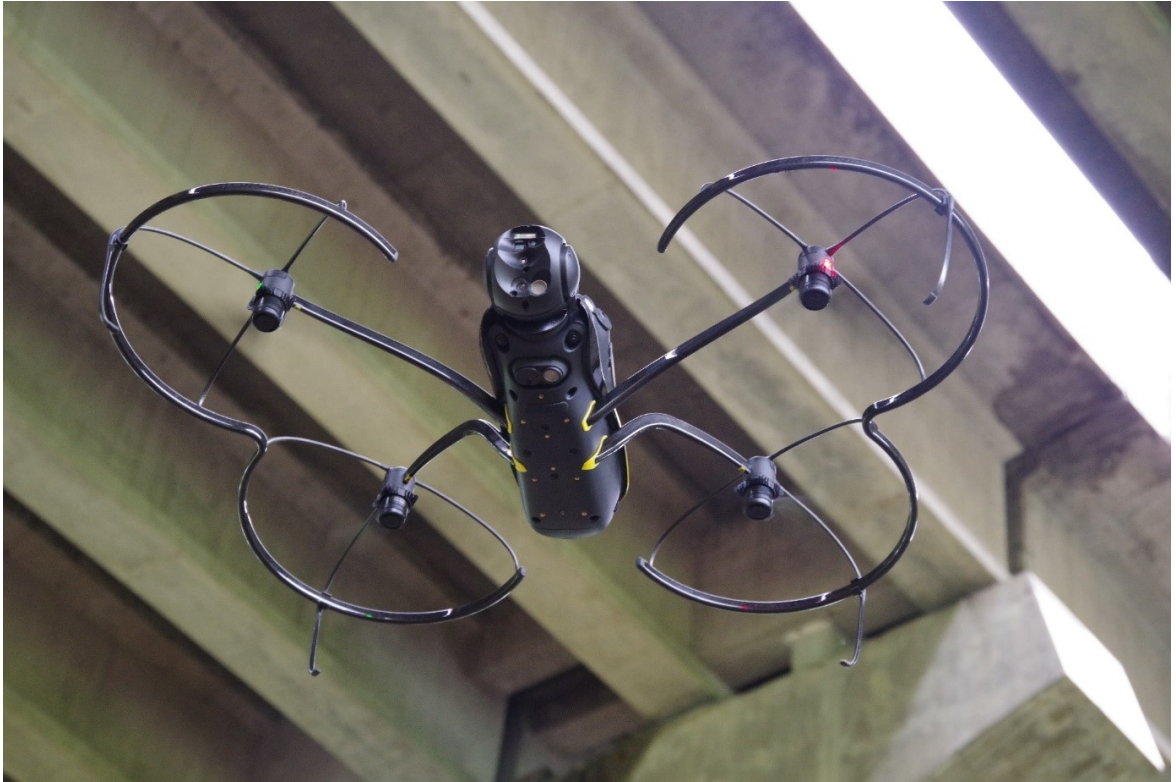
Figure 3.2 Image of the senseFly albris UAS.

This UAS was used in Phase II and selected again for Phase III given the overwhelming positive results. There have been a few changes to the albris hardware or software since the Phase II study, although the cost has decreased significantly since then. The UAS is approximately 22in by 32in by 7in and weighs 3.96lbs. This allows for easy handling and transportation. The batteries typically provide up to 20 minutes of flight time when operating under safe manufacturer guidelines. Flight hardware restrictions include wind speeds greater than 22 mph, range over 2.8mi away, or speeds in excess of 26mph.

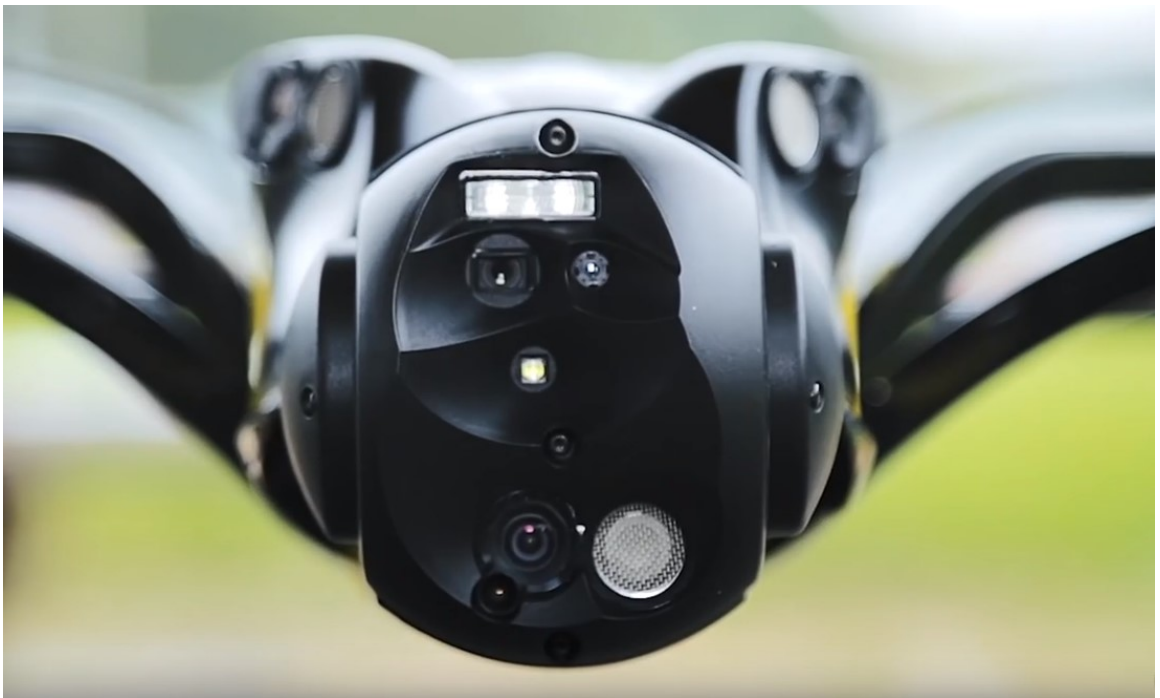
Figure 3.3 Image of the Sensor Payload On-Board senseFly albris UAS.

The albris imaging payload consists of a TripleView head containing a high-definition video camera, a 38 Mega-Pixel (MP) still camera, and an infrared camera. The 38MP camera is the primary data acquisition tool. With pre-programmed or interactive flights, the albris can take still images at regular intervals which can then be processed by software to produce high-resolution images and models. The absolute horizontal/vertical accuracy of the UAS is reported at 3ft to 16ft without using ground control points and down to 0.04 in when using ground control points.

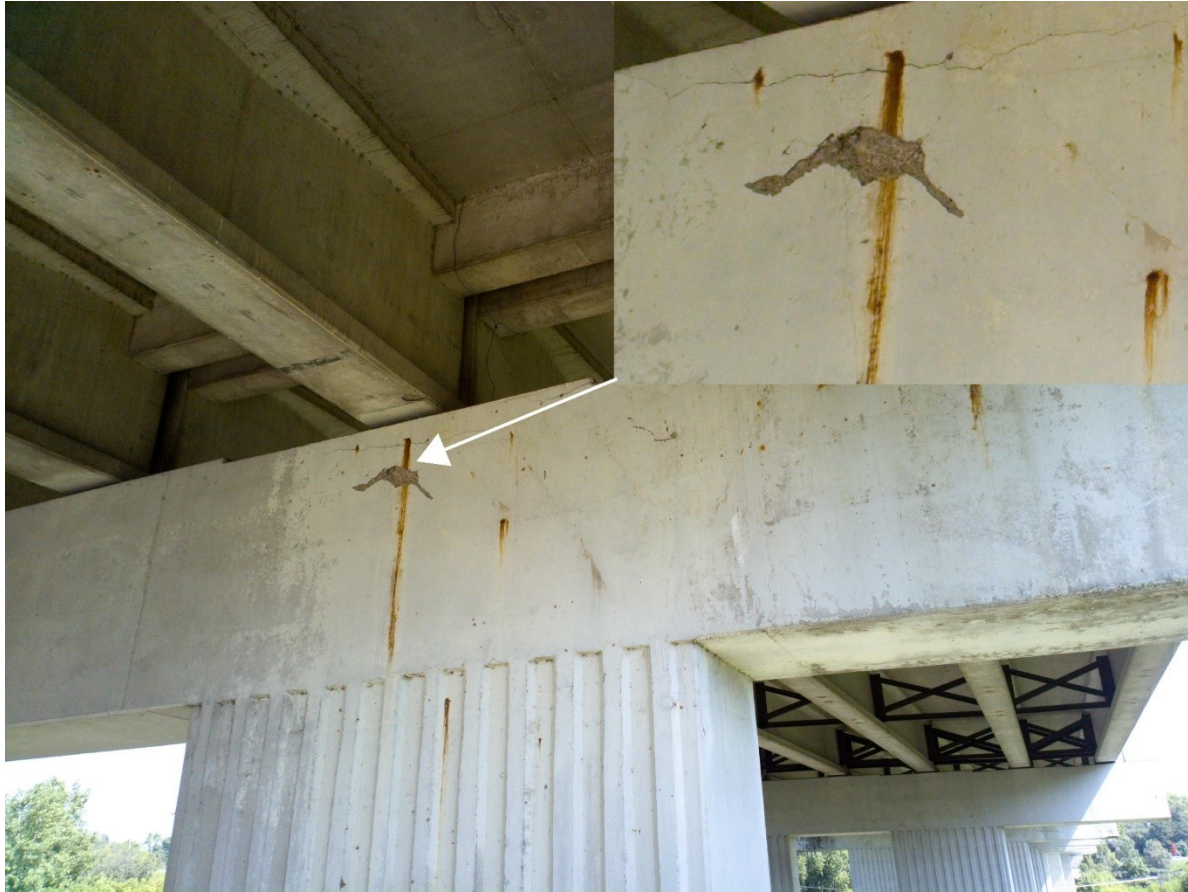
Figure 3.4 Example of albris High-Resolution Image Capability.

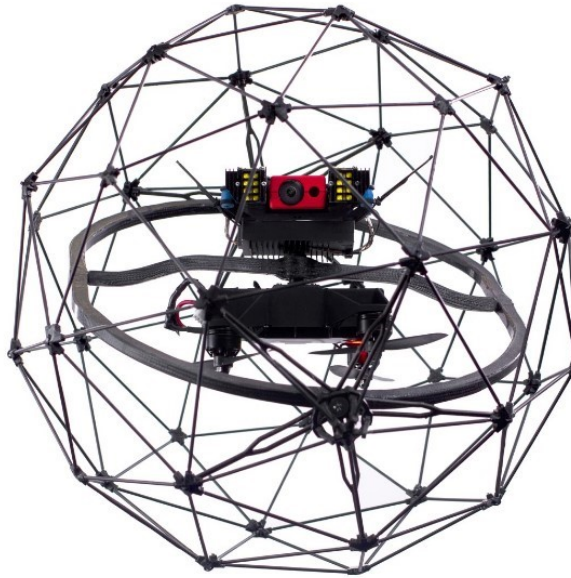
Figure 3.6 Image of the Flyability Elios UAS.

The collision-tolerant UAS was selected for use in the inspection of 17 bridges. At several of these bridges, the collision-tolerant UAS was used in conjunction with the larger mapping and photogrammetry UAS. The operation of the Elios was performed by a FAA licensed remote pilot and followed FAA regulations. Set up and operation of the Elios was very simple, taking about 5 minutes. All flights were done interactively, meaning the pilot was under control of the UAS throughout the mission because the Elios is not capable of preprogrammed flight paths. The pilot navigated the UAS using a live video stream through a proprietary application on a tablet mounted on the remote control.

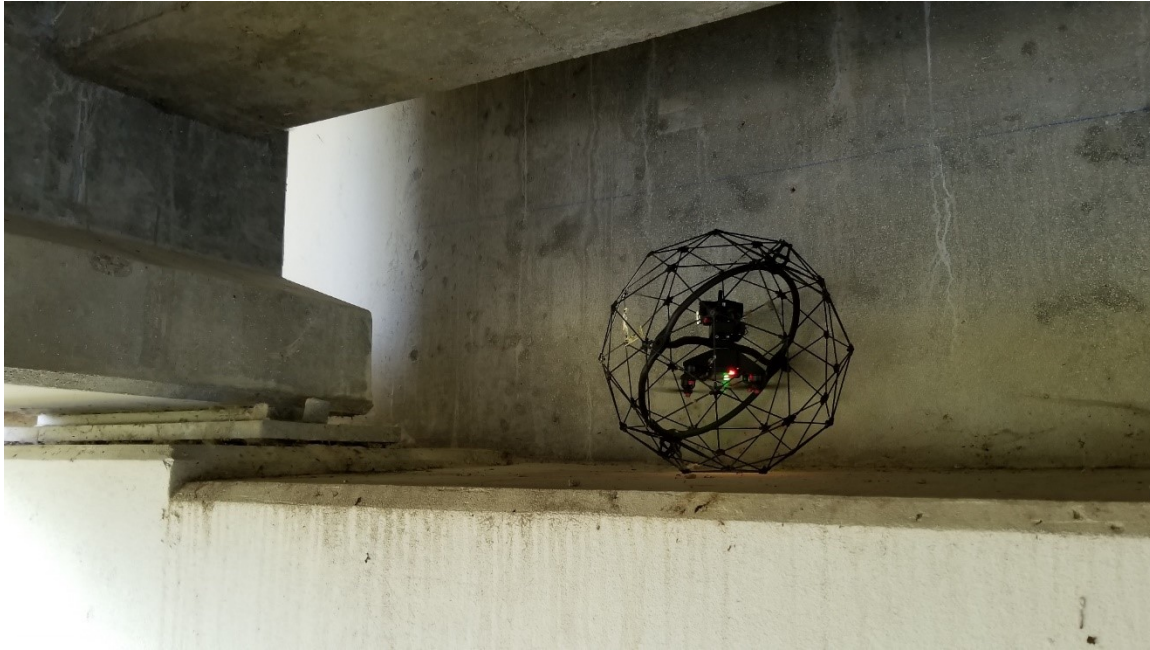
Figure 3.7 Photograph of the Elios UAS Rolling on Top of an Abutment Bearing Seat.

- Easily piloted: UAS was easily operated by a pilot due to the ability to hit objects without fear of damage
- Ability to roll: The protective frame can serve as a rolling device to better control the UAS, save battery life, and maintain a fixed distance from the face of an object. It was ideal for inspecting wide flange beams and concrete deck soffits by rolling the UAS along the top side of the bottom flanges.

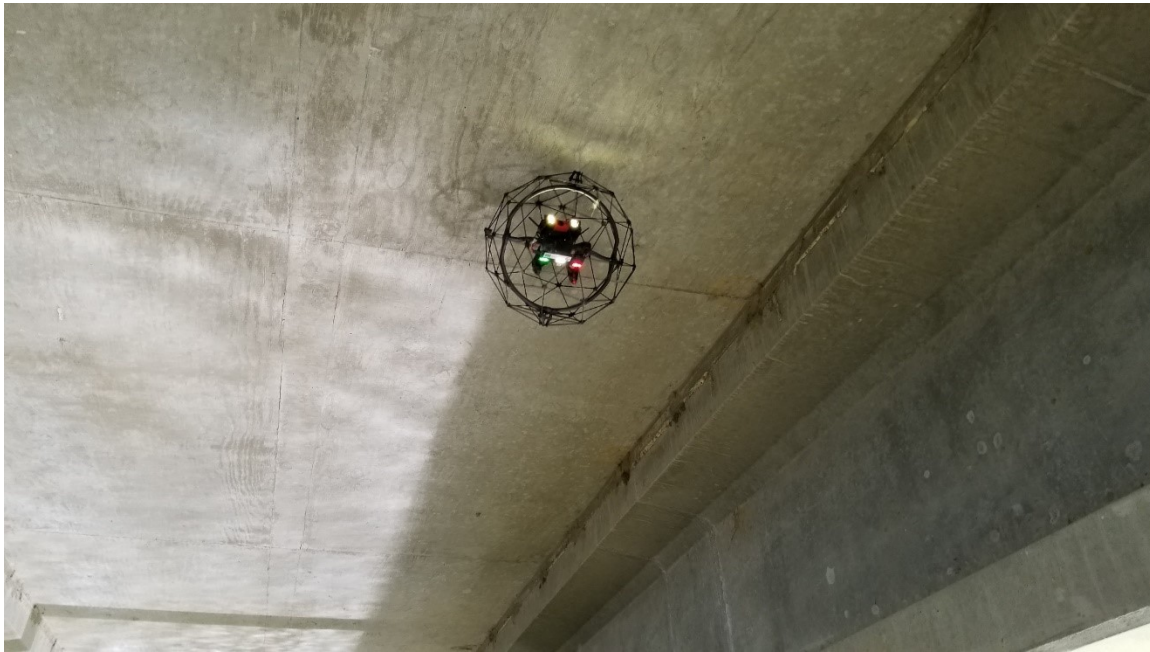
Figure 3.8 Photograph of the Elios UAS Rolling along a Concrete Deck Soffit.

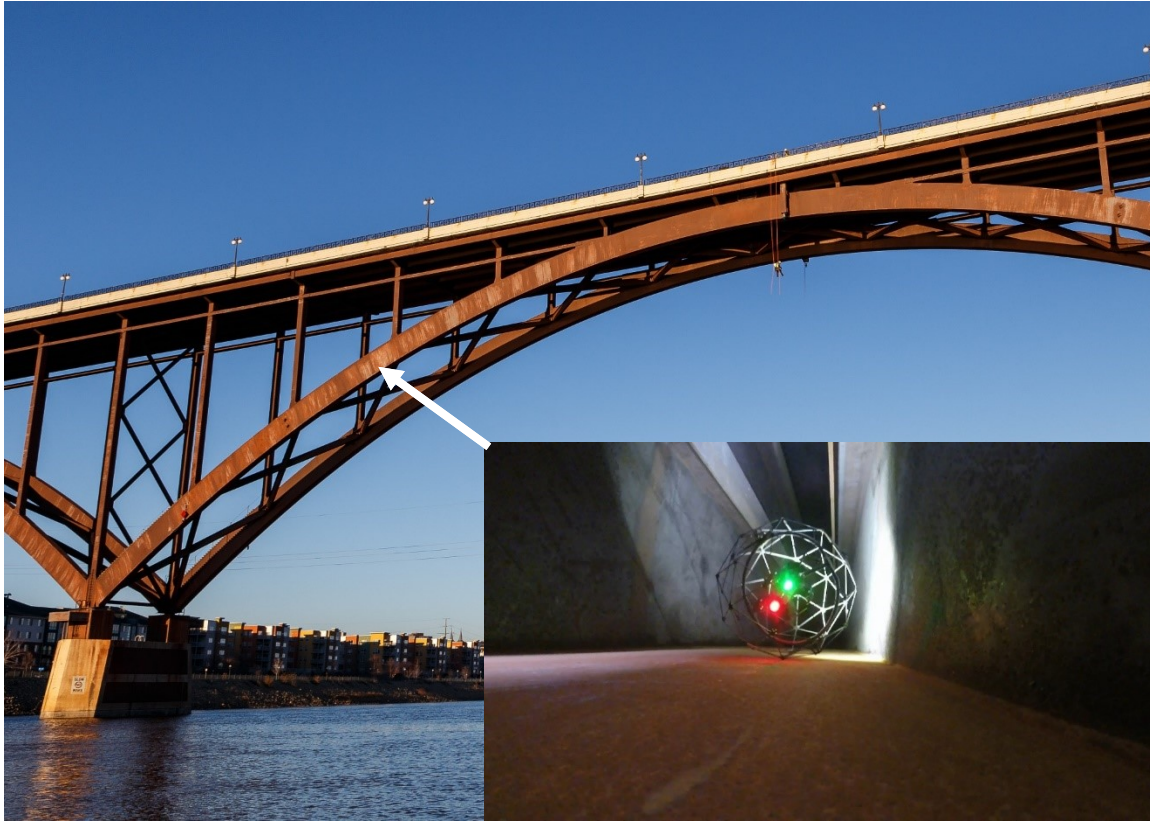
Figure 3.9 Photograph of the Elios UAS Rolling Inside a Steel Box Beam

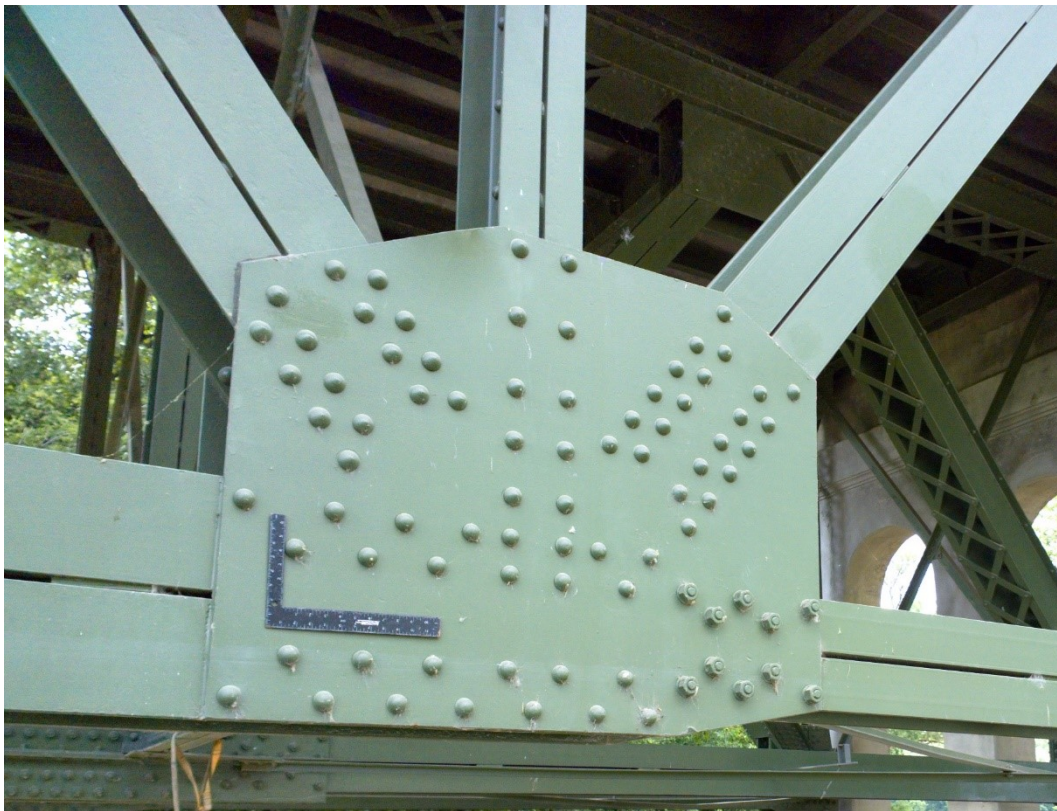
There is much focus on the image quality and the ability to detect deficiencies by viewing images taken with a drone. It is very difficult to quantify a minimum resolution or minimum camera parameters because the conditions encountered during an inspection differ widely. Image sensors and processing software have become sophisticated and it is difficult to rely on camera specifications alone. Our research has shown that the focus should be on the inspector's qualifications and their ability to determine on a case by case basis if the image quality is enough to determine with certainty the structural condition of the bridge element that is being inspected. In many cases, suspect deficiencies or areas should be followed up with a hands-on inspection. This is especially true when an inspector feels the need to use tools such as a hammer for sounding. For routine bridge inspections, there is no examination of an inspector's visual acuity, and this is not used as a metric for measuring the quality of bridge inspections. The exception is for NDT Certified inspectors to typically have their eyesight examined annually.

Figure 4.1 High Resolution UAS Image

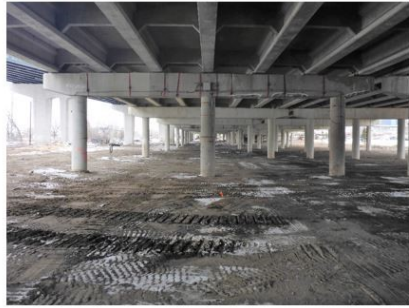
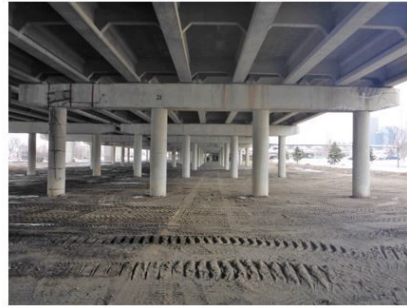
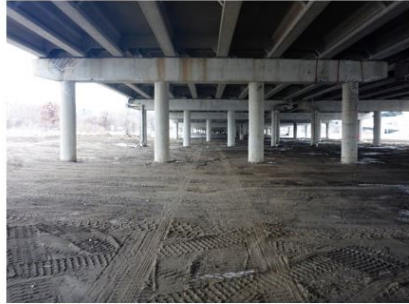
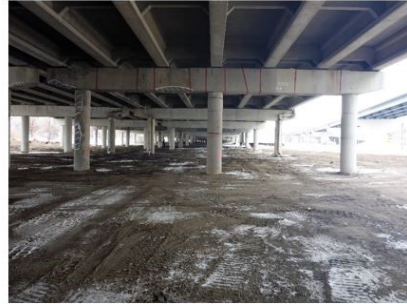
P1300083 – Pier 37WB, looking east

P1300096 – Pier 37EB, looking east

P1300097 – Pier 37EB, looking west

P1300082 – Pier 37WB, looking west

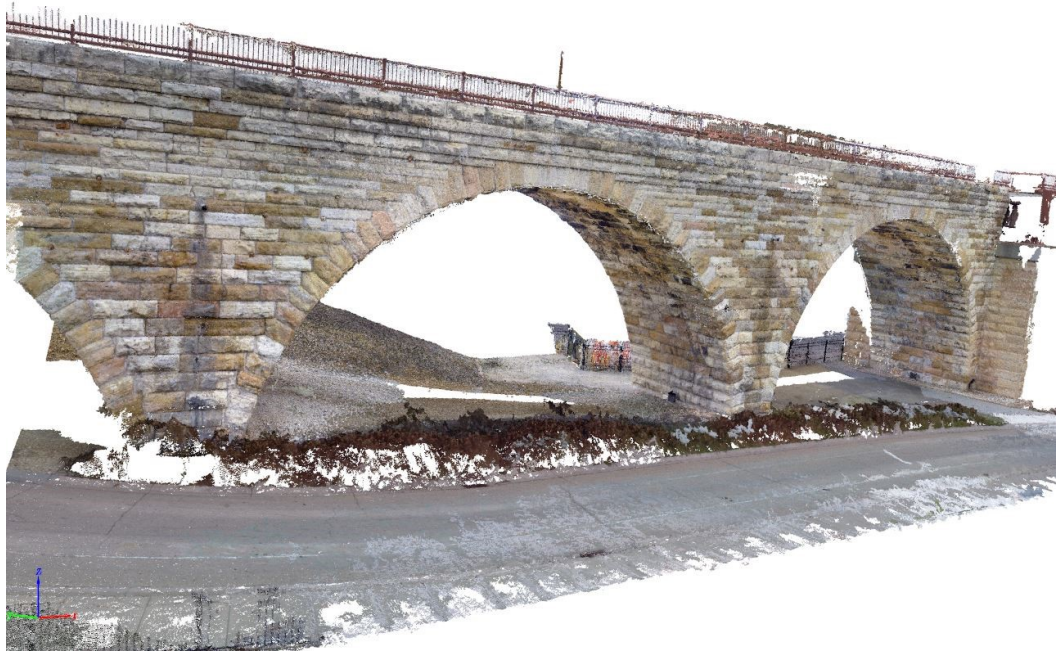
Figure 4.4 Pix4D 3D Point Cloud

Reality modeling is the process of creating 3D photorealistic models from both drone and terrestrial images. The models generated are comprised of highly precise georeferenced point clouds and triangular meshes. The models can be used to measure deficiencies and can be annotated with inspection notes. Once a model is generated, the photos are located and referenced to the model. When the user clicks anywhere on the bridge model, the corresponding images of that area or bridge element are displayed. Therefore, the inspector no longer needs to create a photo log of the inspection, which can save a great deal of time during report generation. Traditional inspection photo logs are cumbersome, and time consuming to create and navigate. The reality model 3D photo log is easier to navigate and reference. It also creates a record of the bridge condition at a point in time so that as the bridge ages, deterioration rates can be observed.

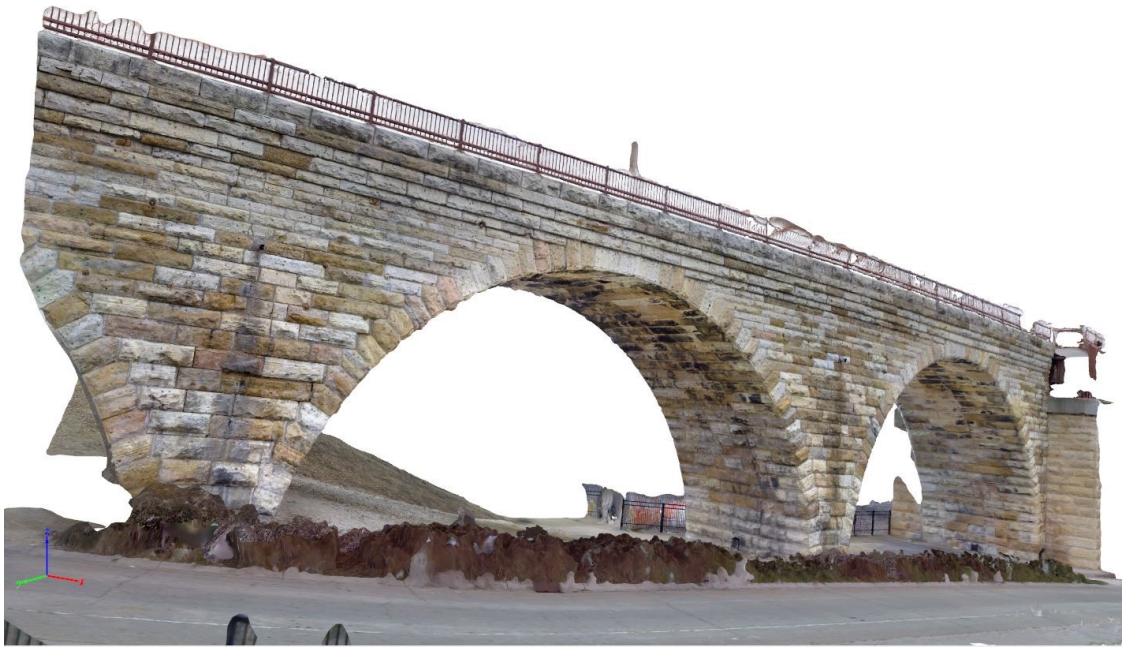
Figure 4.5 Pix4D 3D Triangular Mesh

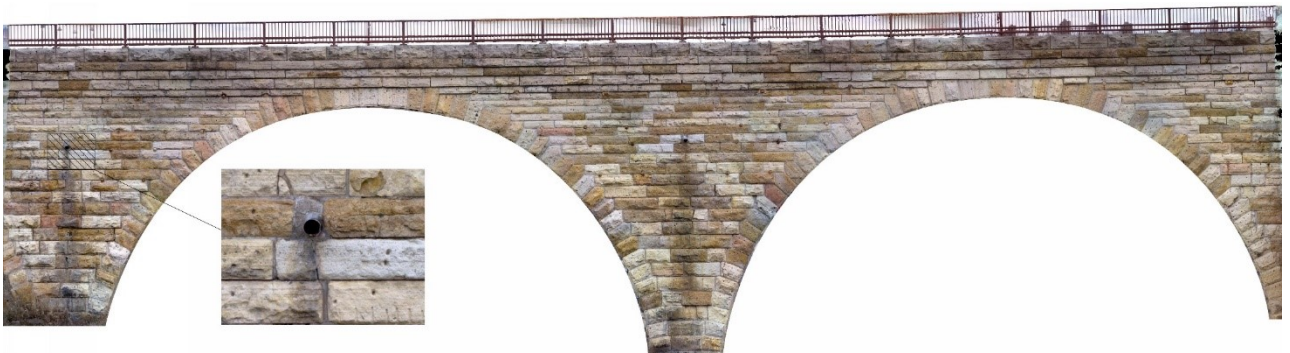
Figure 4.7 Pix4D Bridge Facade Orthoplane

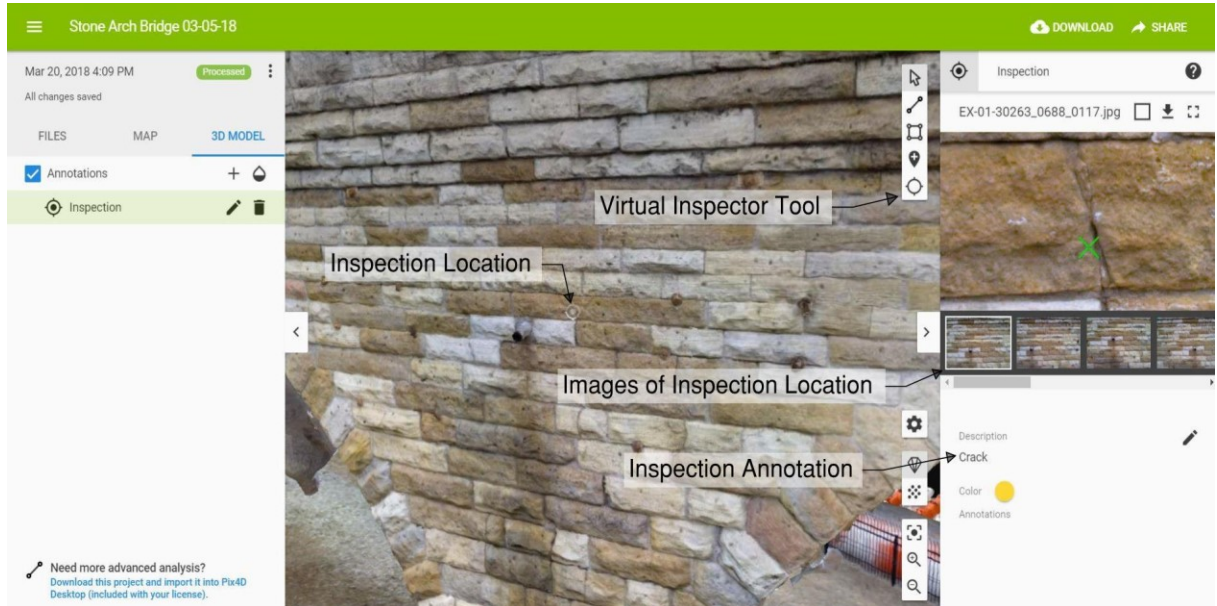
Figure 4.8 Cloud Virtual Inspector

be difficult to share with bridge owners and decision makers, especially via email and ftp sites where firewalls may exist. The solution lies in the ability to share inspection results on cloud based platforms. Using the cloud interface, a bridge engineer or owner can view the inspection data in 3D models without having to download and store large amounts of data.

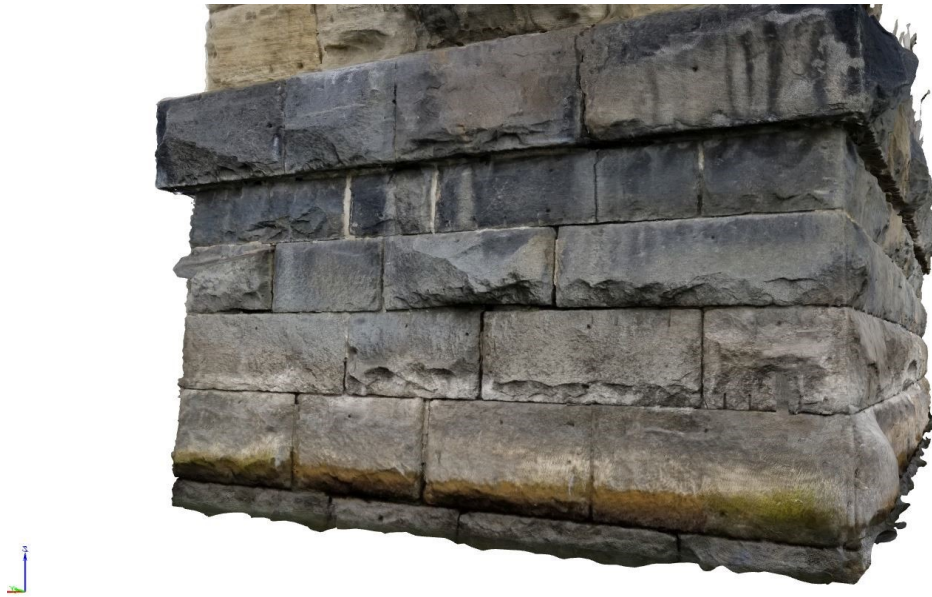
In several cases, terrestrial photographs alone were used to obtain high-resolution photographs and 3D models for post-inspection reviewing. The final results were positive and illustrated that the concept of photogrammetry in bridge inspection is a method which includes but is not limited to UASs. An example of the 3rd Avenue Bridge Pier Inspection can be found [here](#).

Figure 4.9 3D Model of Bridge Pier Created from Terrestrial Photos

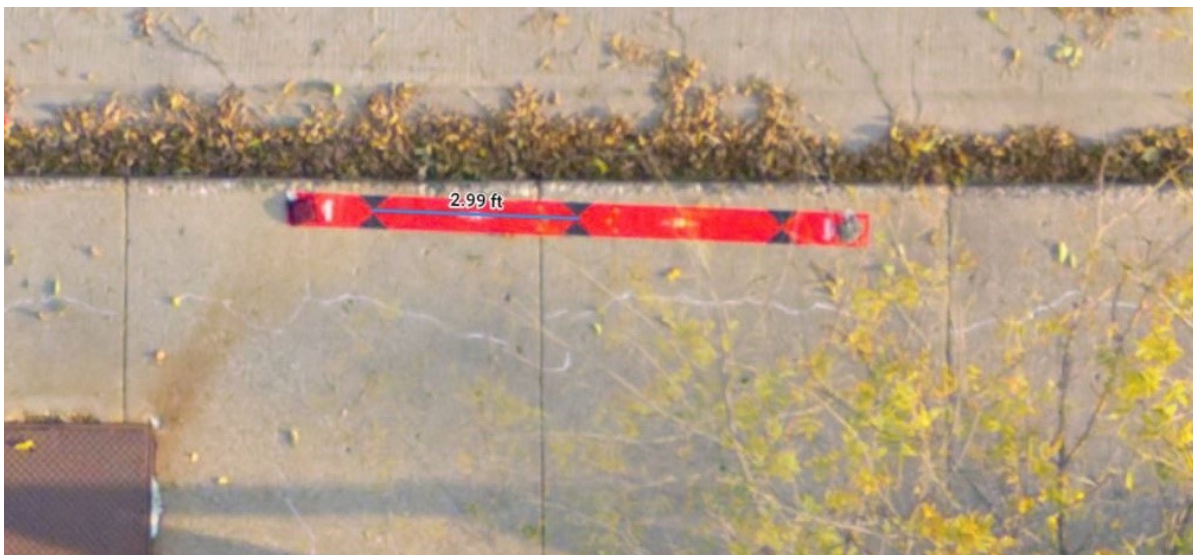
Another important input when creating bridge inspection deliverables are scales and/or ground control points (GCPs). The ability to accurately measure defects in the models is important. Generally, models created without these inputs can have an accurate scale within about an inch. However, to ensure accuracy, a scale can be placed before images are collected and can be used to check the accuracy or to manually scale the model.

Figure 4.10 Scale Used During Image Collection

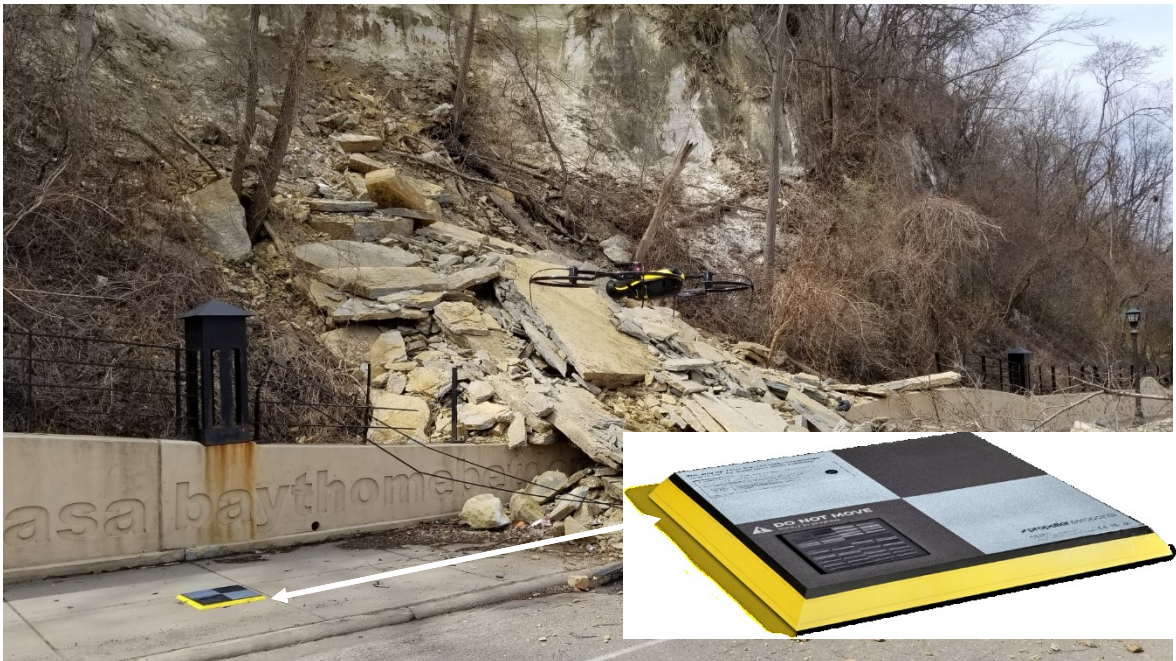
Recently introduced to the market, are drone specific aerial targets that record their own position using GPS, which is processed and corrected to ensure survey grade accuracy. Our team used the [Propeller Aeropoints](#) with very good success. These targets allows the documentation each defect, deficiency and condition in their exact global coordinates. The ability to locate defects accurately enables engineers to track things such as crack locations and lengths.

Figure 4.11 AeroPoint Automated Ground Control Point Figure

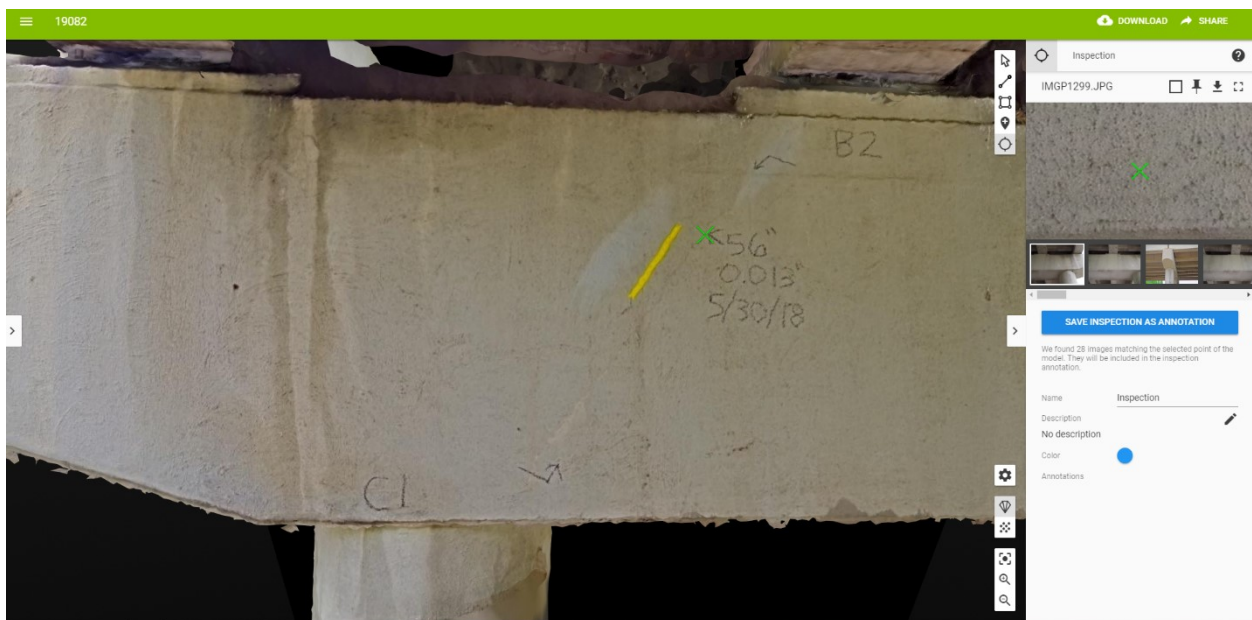
The first workflow includes performing the inspection first before collecting imagery data. Typically, the inspection results are annotated directly on the structure itself and the resulting 3D model can then be used to measure and quantify defects such as concrete delaminations. The most common application of this workflow would be a deck condition survey where the deck is chain dragged and concrete delaminations and cracking are marked or outlined. The deck is then flown by drone to obtain the imagery used to create a photo-realistic orthomosaic map and 3D model of the entire deck. Cost savings and safety improvements are introduced in the reduction of time spent measuring deficiencies in the field as they can be measured in the office. Performing the measurements in the office has also proven to be more accurate as it can be difficult to measure deficiencies in the field that are comprised of complex geometry. With more accurate measurements, owners can better compare inspection results over different inspection cycles and improve the ability to determine deterioration rates.

Figure 4.12 Pier Inspection

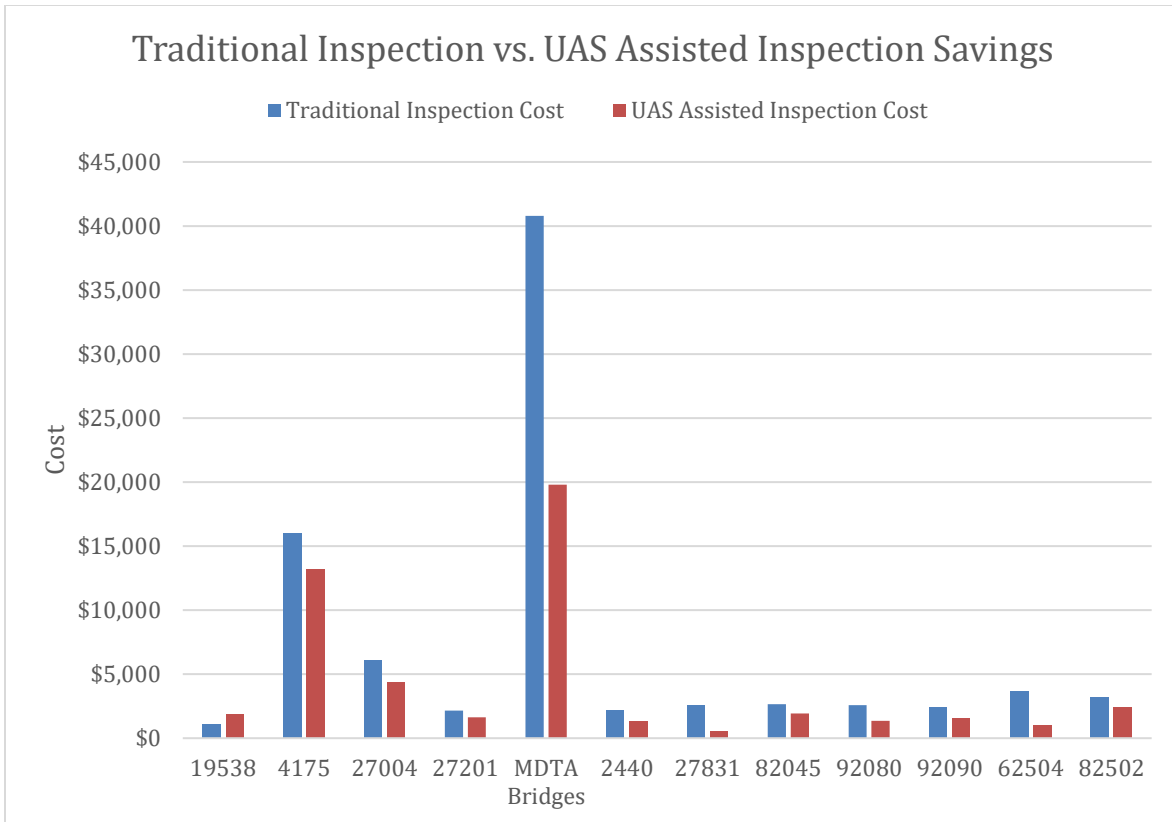
Figure 5.1 Traditional Inspection vs. UAS Assisted Inspection Savings

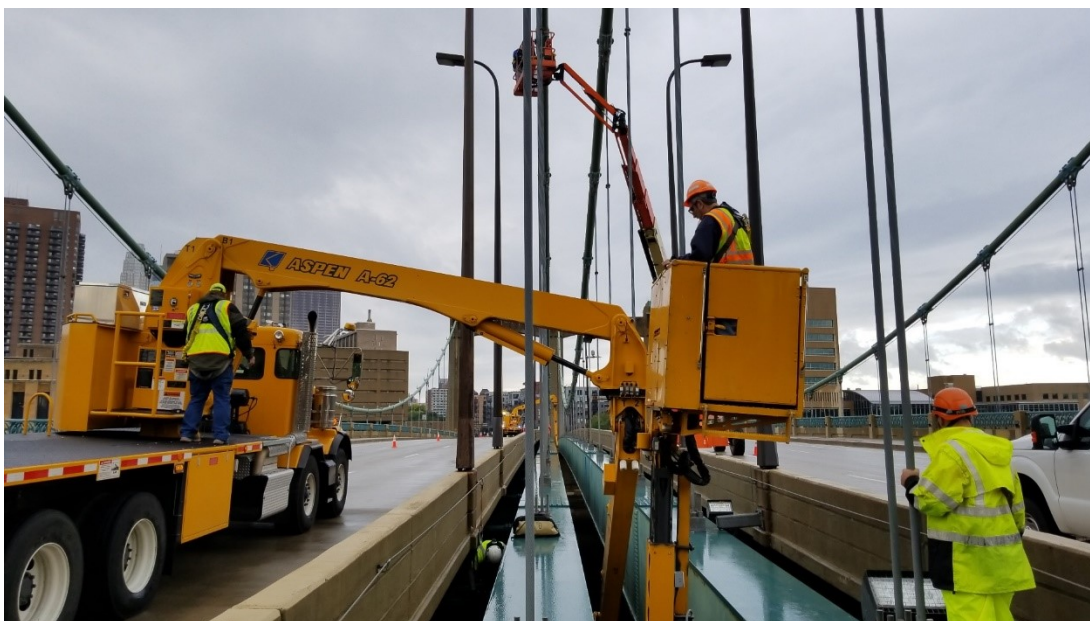
There are no statistics specifically associated with bridge inspections but accidents and fatalities resulting from bridges inspections are not uncommon. There is some risk associated with the use of bridge inspection equipment and working at heights, but the largest risk factor is associated with working near traffic and in shoulder and lane closures. Drones can be utilized during bridge inspections to reduce or eliminate the need for traffic control and the need for inspection personnel to work near traffic. Bridge owners should consider the use of drones when the risks to the public and inspectors can be reduced while considering the inspection quality and condition of the bridge. For low risk bridges the use of drones should be considered even when reduced inspection quality is expected if there is a significant improvement in overall safety. While traditional access methods will continue to be needed the use of drones for bridge inspections are underutilized by bridge owners.

Figure 6.1 Pier Typical Bridge Inspection Work Zone with Traffic Control

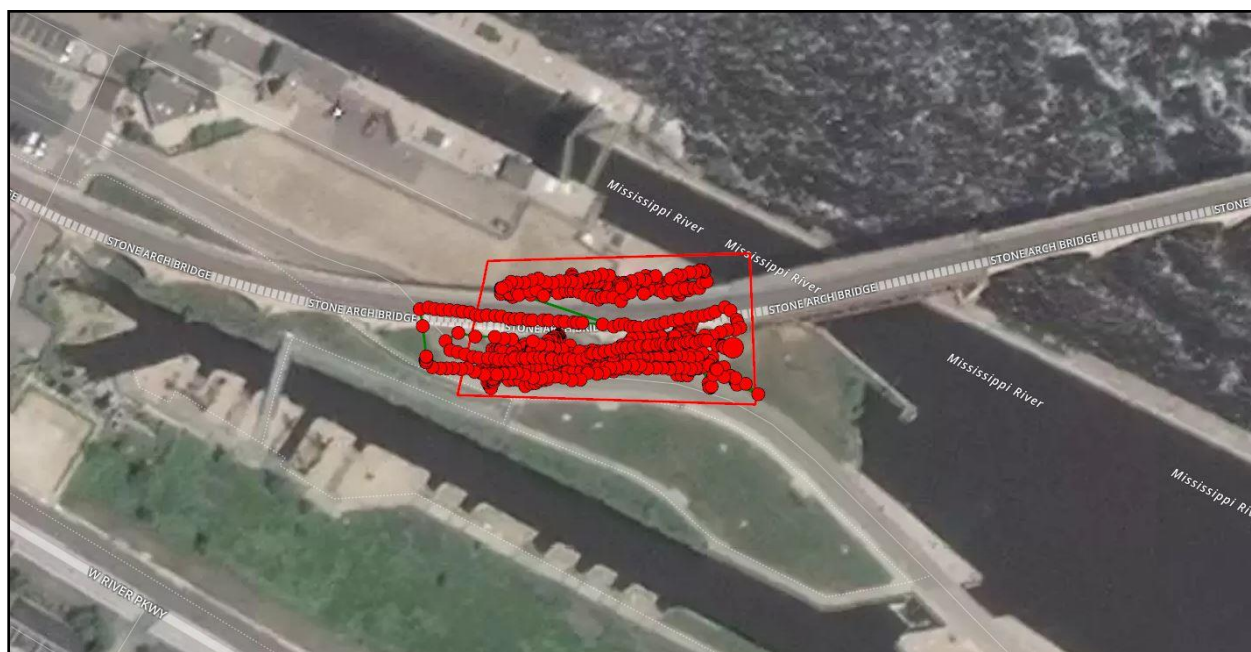
A Mapping & Photogrammetry mission using the Albris was identified for this bridge to explore the potential of UAS photography to map bituminous deck surface defects. The target goal of the mission was to gather information in the form of photographs in a quick, efficient process which could later be used to map the deck and have a post-inspection tool to aid in report writing and historical documentation. Additionally, the ease of use in an urban environment was displayed. The mission consisted of a pre-planned flight path that imaged the top of deck. The north and south fascias were mapped using the distance lock and cruise control features to ensure adequate image overlap. The underside of the arches were flown manually. The UAS collected over 720 high-resolution still images of the bridge fascia and top side. All images were geo-tagged with GPS coordinates. Refer to Images 6 and 7 for views of the Flight and Mapping Mission.

Image 6: View of Mission Flight Map (Preplanned and Interactive).

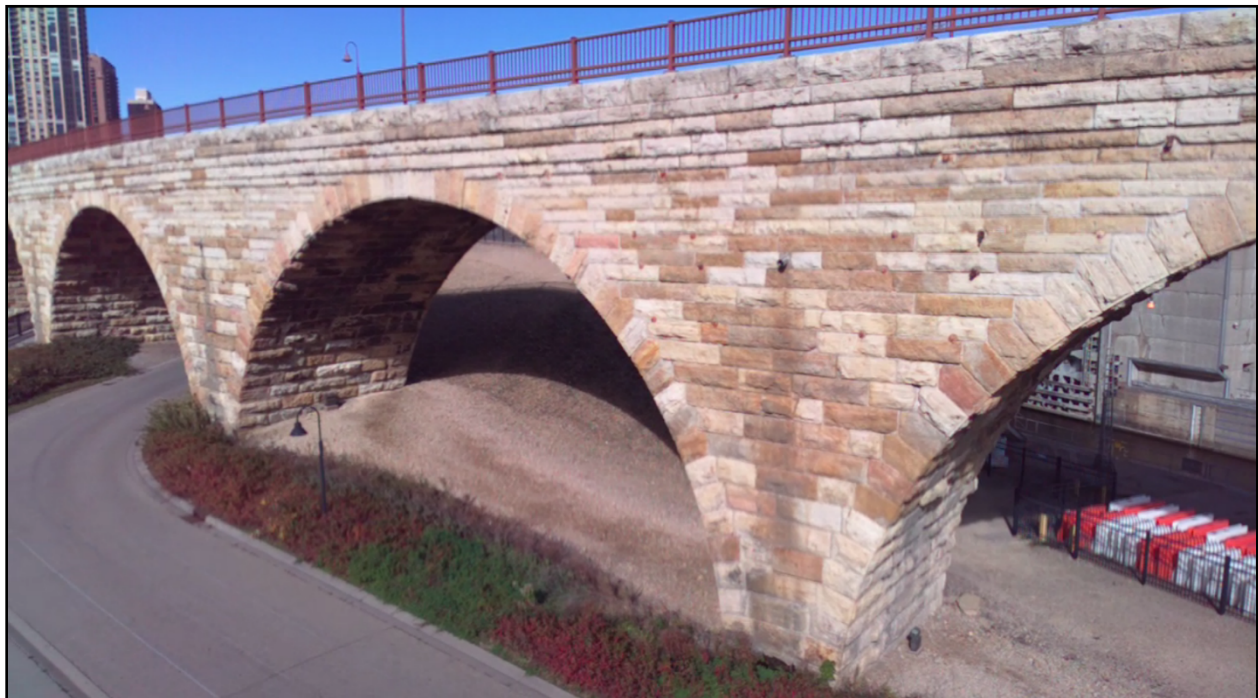
Image 8: View Flight Camera During Inspection. [\(Click Image to play video\)](#).

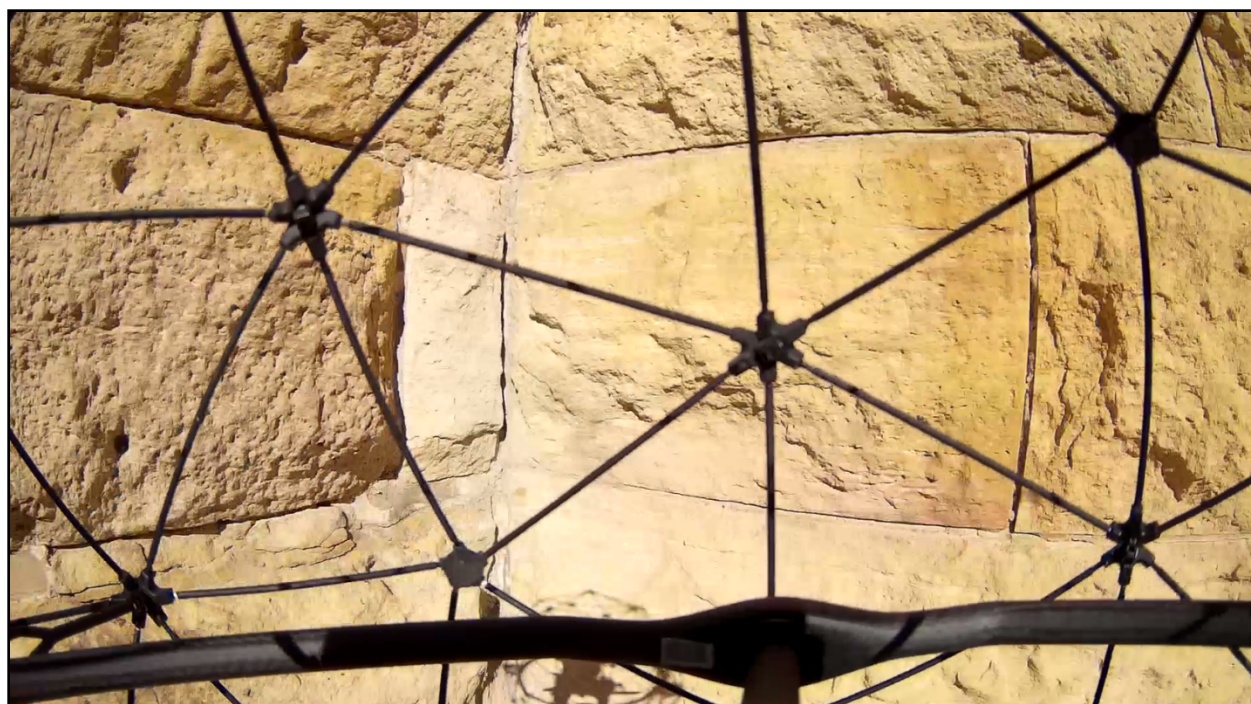
A High Definition Video Mission was conducted of limited access areas using the Elios UAS. The target goal of this mission was to determine the quality and applicability of using a Collision-Tolerant UAS to capture images and assess the condition of bridge elements which are typically not tactically accessible or easily viewed during the scope of a routine inspection. The site also tested the UASs quality of flight in open-air environments. The mission consisted of an interactive flight using only pilot controls. During a typical routine inspection, the masonry of the fascia at an elevation high above the ground level would have been difficult to access. The use of the Elios UAS focuses on these hard to access locations. An inspector can then review the video footage to look for defects or findings. Refer to Image 9 for a view of the Elios UAS in a difficult to access location.

Image 9: Image Clipped from Elios Inspection Video ([Click Image to play video](#)).

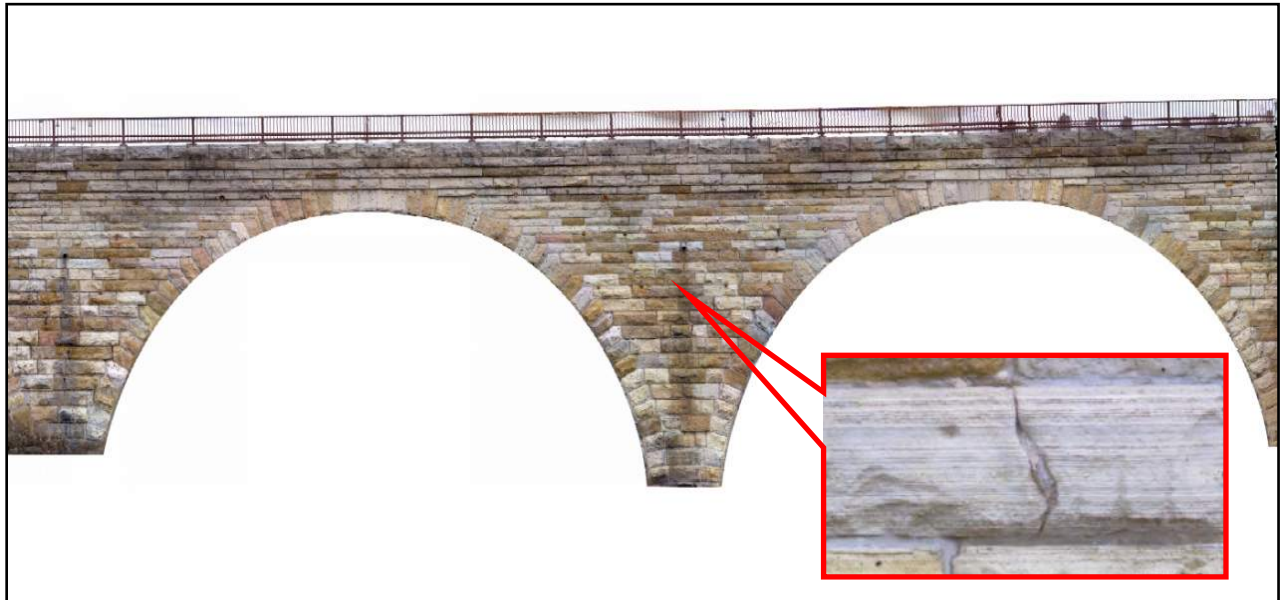
An Orthomosaic image of the bridge fascia was created in the Pix4D software to use as an inspection tool. The target goal for this process was to produce an easily viewable, high resolution image of a large area that could be used by an inspector to carry out a detailed inspection, area measurements, condition assessment, or historical documentation. An Orthomosaic image is a single image file which is created from many individual images captured during the Mapping and Photogrammetry Mission. The final product of an Orthomosaic image is an image file that can be used to measure true distances. For this bridge, an Orthomosaic image was made of the vertical fascia of Spans 14 and 15 of the stone masonry arch. An inspector then reviewed a single file and can measure true distances and areas for a final product. Refer to Image 10 and 11 for a view of Orthomosaic Detail.

Image 10: View of the Level of Detail in a Single High-Resolution Image. [\(Click Image to Access Video\)](#)
