Improving the Quality of Bridge Inspections Using Unmanned Aircraft Systems (UAS)

Barritt Lovelace, Principal Investigator
Collins Engineers, Inc.

July 2018

Research Project
Final Report 2018-26

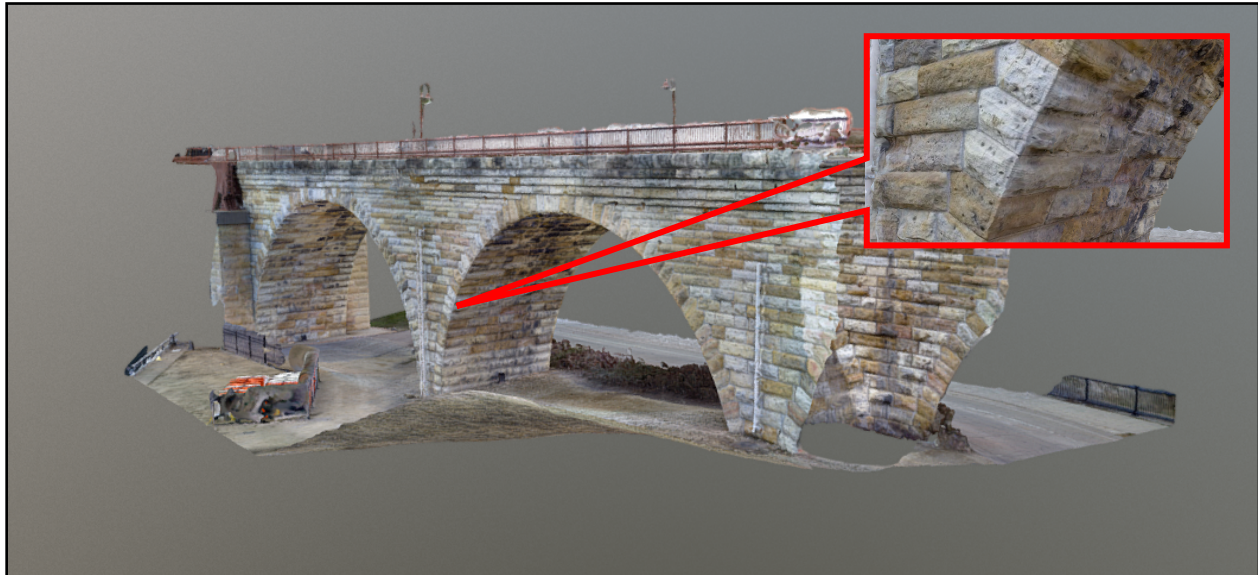
Image 12: View of the 3D model in SketchFab. [\(Click Image to access 3D Model\)](#)

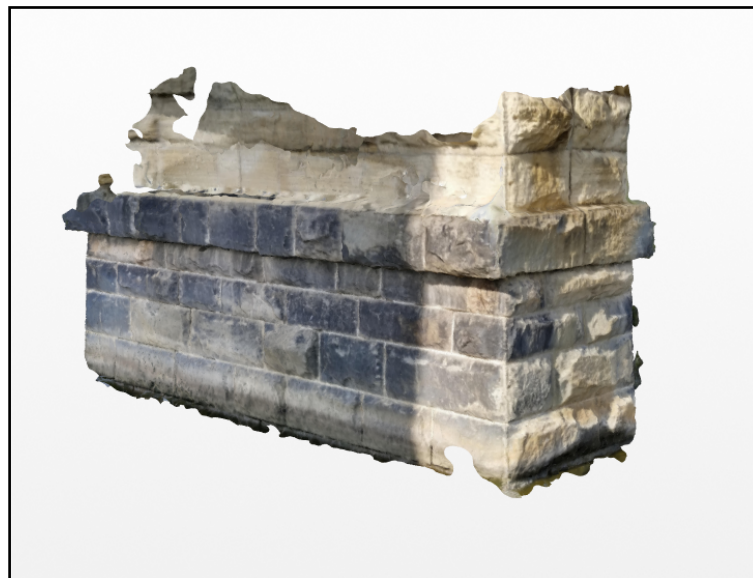
The example results of the Pier 4 and Pier 9 terrestrial Imaging yielded a total of 58 and 80 usable images, respectively, for each pier. These images were processed with the Pix4D software to provide the inspector with a 3D model and high-resolution photograph log. Refer to Images 13 and 14 below for views of Pier 4 and 9, respectively.

Image 13: View of the 3D model of Pier 4 in Pix4D.
[\(Click Image to access 3D Model\)](#)

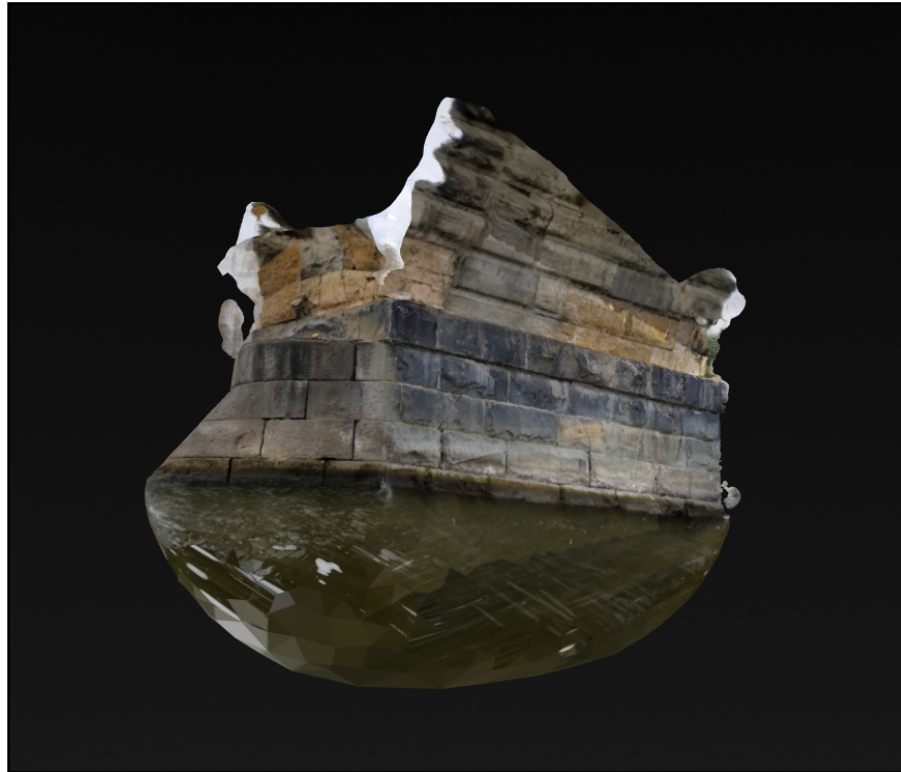
Image 14: View of the 3D model of Pier 9 in Pix4D. [\(Click Image to access 3D Model\)](#)

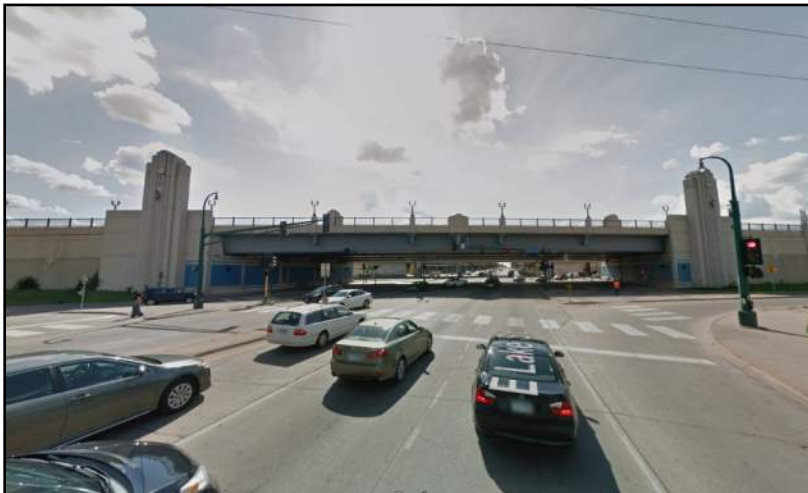
Bridge Number 27201 spans approximately 505 feet over Lake St. and carries two northbound and two southbound lanes of Trunk Highway 55 (Hiawatha Ave.). The bridge deck is approximately 110 feet wide and consists of cast in place concrete with a concrete overlay wearing surface. The bridge superstructure consists of three spans of four continuous closed steel box girders. The substructure consists of reinforced concrete abutments and pier walls all founded on piles. The longitudinal axis of the bridge is orientated approximately north to south. Refer to Images 2 and 3 for overall views of the bridge.

Image 2: Overall View of Bridge.

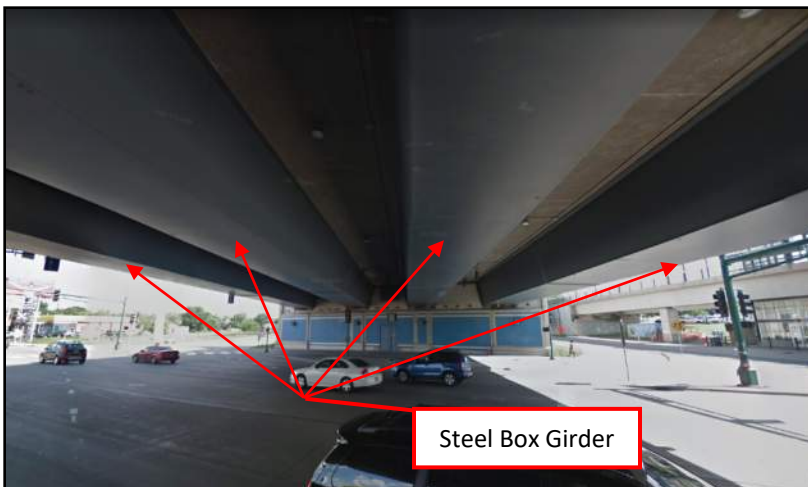
Image 3: Overall View of Bridge Underside.

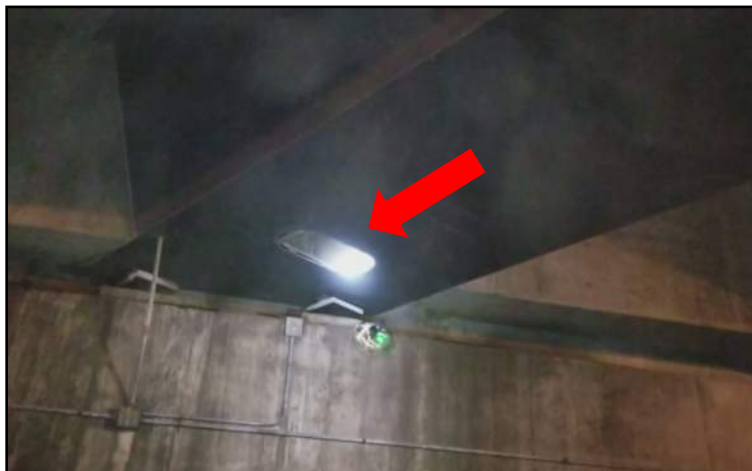
Image 6: View of Box Girder Entrance Hatch.

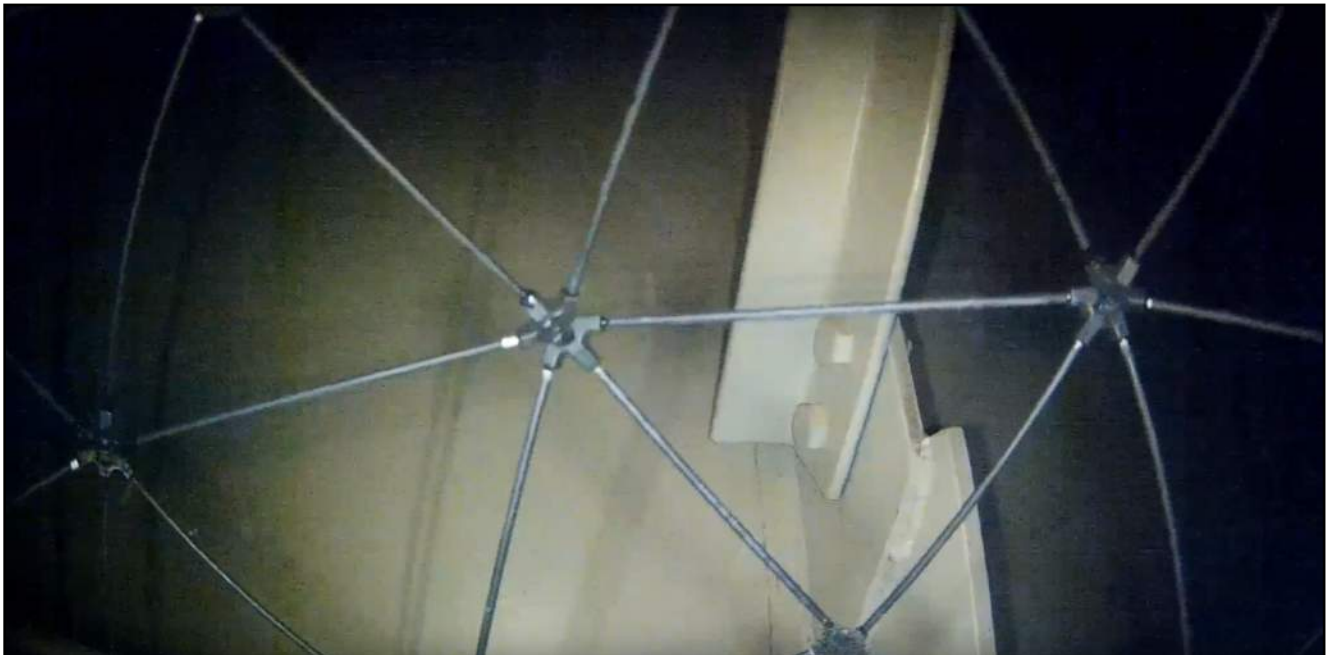
The lead pilot/inspector flew the mission in interactive mode. The live video stream was viewed throughout the inspection to provide both navigational awareness and view areas of inspection interest. A total of seven flights were conducted through one girder line at Span 1. Each flight was progressively more thorough and inspected a longer stretch of girder. The UAS was flown from grade, up through the box hatches and longitudinally down the boxes. The UAS was navigated using a combination of rolling the protective frame along box walls, floor and ceiling and free flying through the girders. The UAS used an on-board LED light for navigation light, however often had to refer to a light shining through the hatch for global orientation. The UAS was also flown outside the box girders also to inspect the concrete deck soffit within Span 1.

Image 7: Image Clipped from Elios Inspection Video ([Click Image to play video](#)).

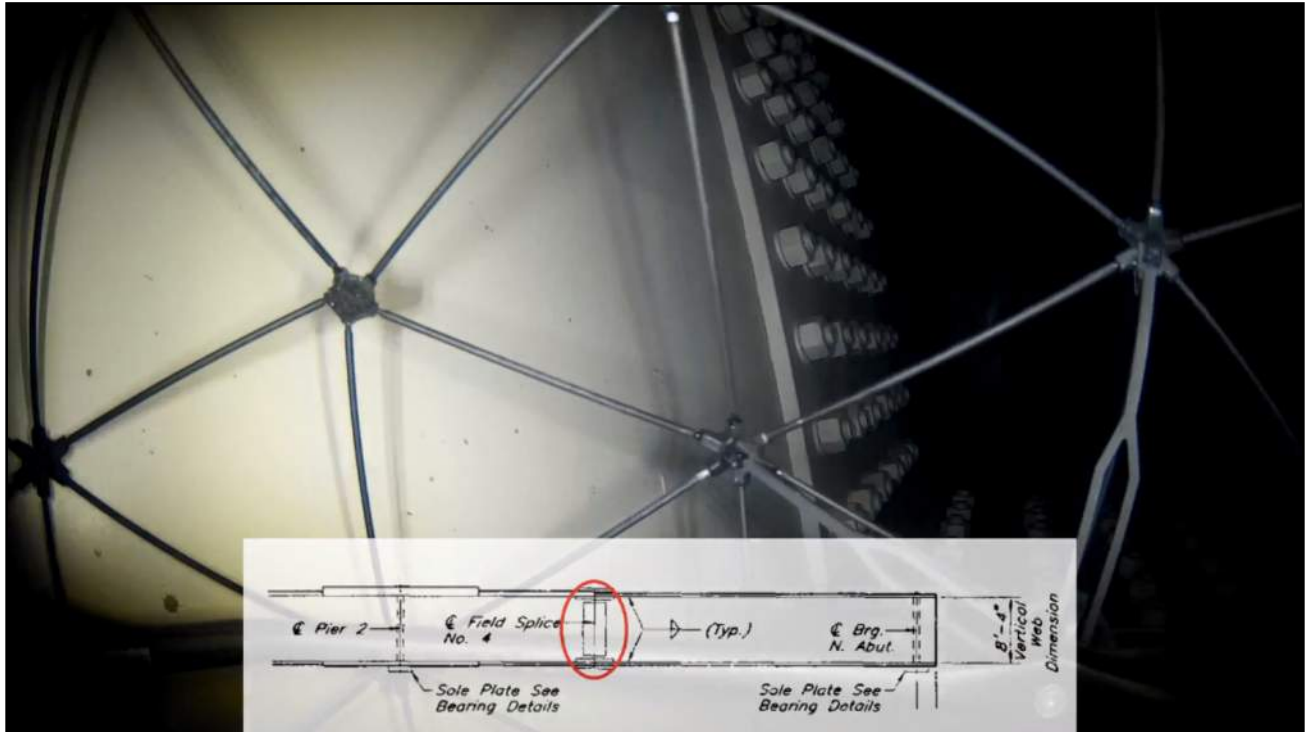
Video from the High Definition Video Mission using the Elios was viewed by an inspector after returning from the flight mission. The video could be observed in any software capable of playing .MP4 files. Additionally, the manufacturer of Elios, Flyability, has created an inspection software where the UASs flight log can be opened with the video file to show inspector UAS attributes such as heading, altitude, and temperature. The inspector can then maneuver their way through the video to obtain still images of defects or notable findings.

Image 8: Image Clipped from Elios Inspection Video. Inspection of Splice Assembly.

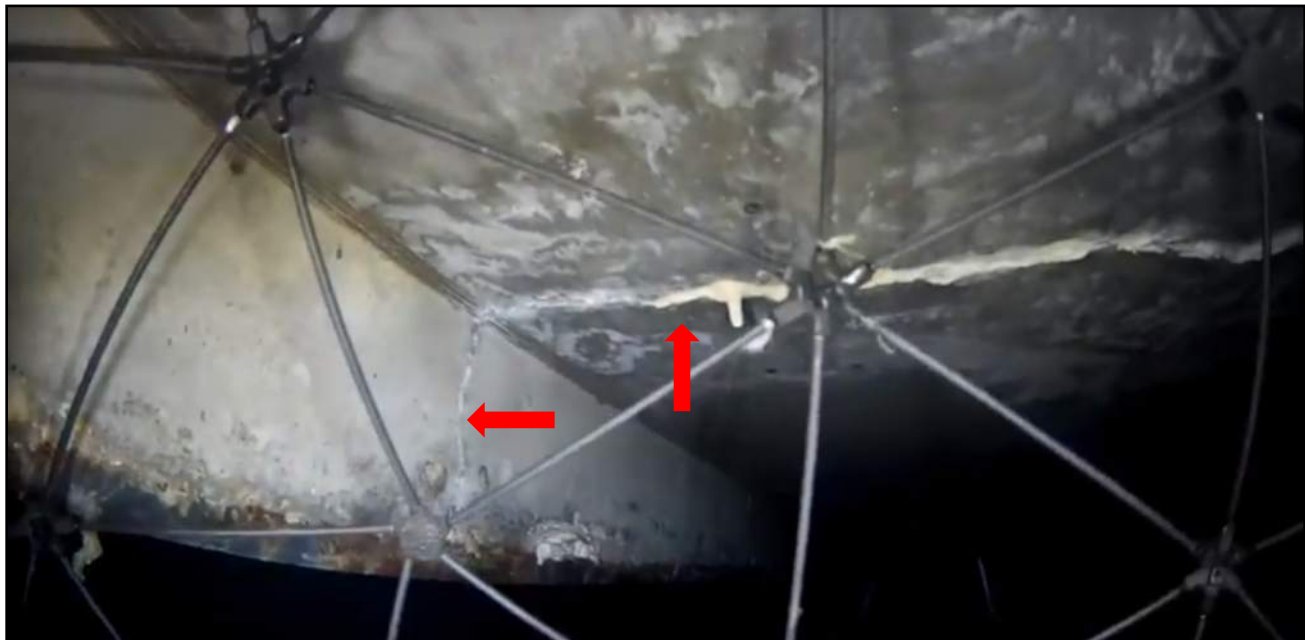
Image 9: Image Clipped from Elios Inspection Video. Inspection of Deck Soffit, note efflorescence and cracking.

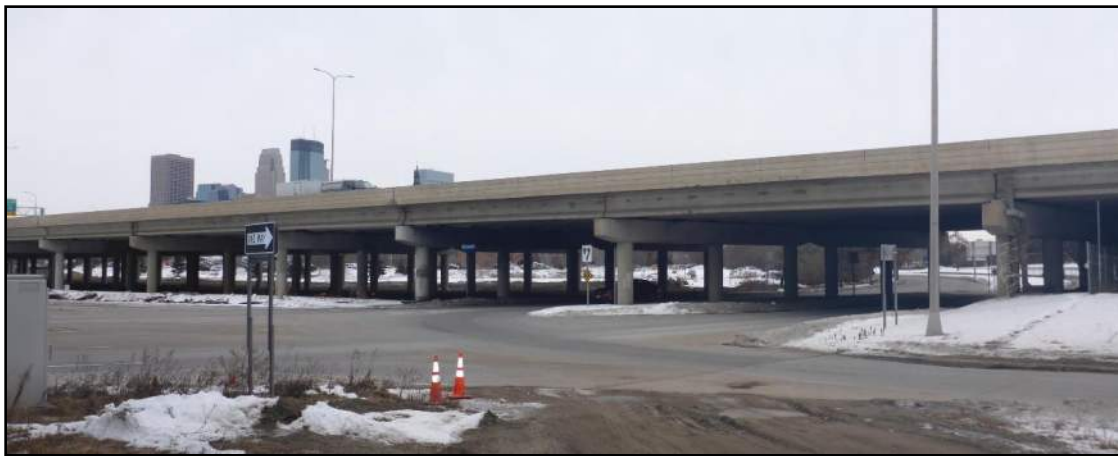
Bridge Number 27831 spans approximately 2740 feet over Dunwoody Boulevard and carries three eastbound and three westbound lane of I 394. The bridge deck varies in width but is approximately 100 feet wide and consists of a cast-in-place concrete with a concrete wearing surface. The bridge superstructure consists of 50 prestress concrete beam spans. The substructure consists of 2 reinforced concrete abutments, 29 driven steel pile bents and 20 concrete pile bents founded on concrete footings on piles. The longitudinal axis of the bridge is orientated approximately northeast to southwest. Refer to Images 2 and 3 for overall views of the bridge.

Image 2: Overall View of Bridge North Elevation.

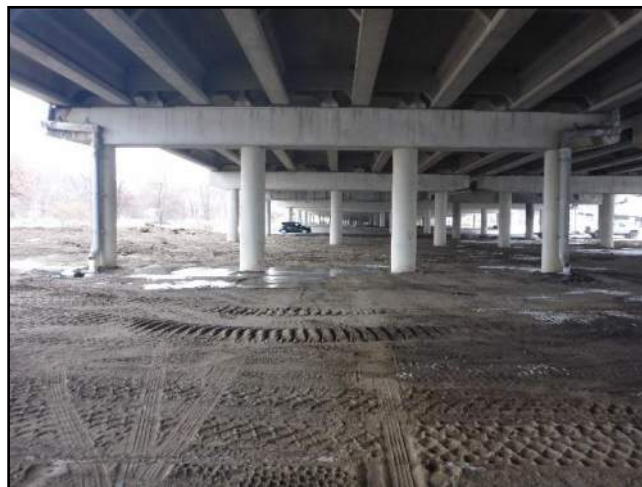
Image 3: Overall Elevation View of Typical Concrete Pile Bent.

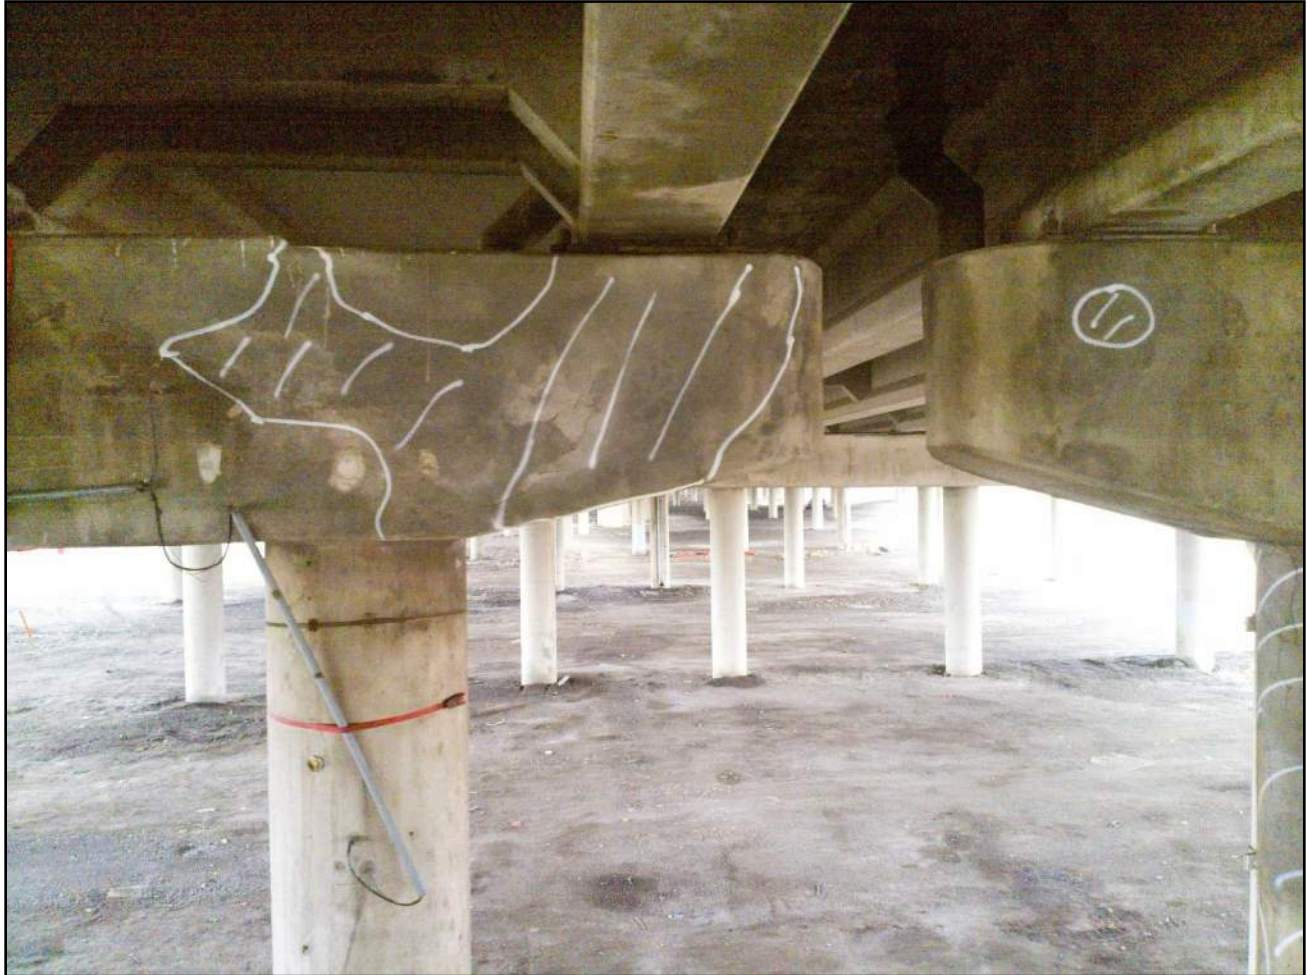
Image 8: View of the Image from the Albris UAS.

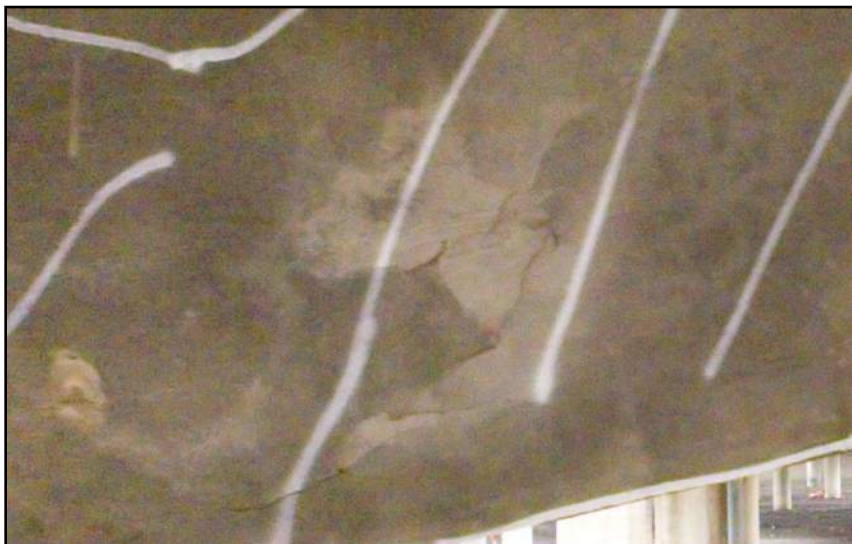
Image 9: View of the Image Quality from the Albris UAS.

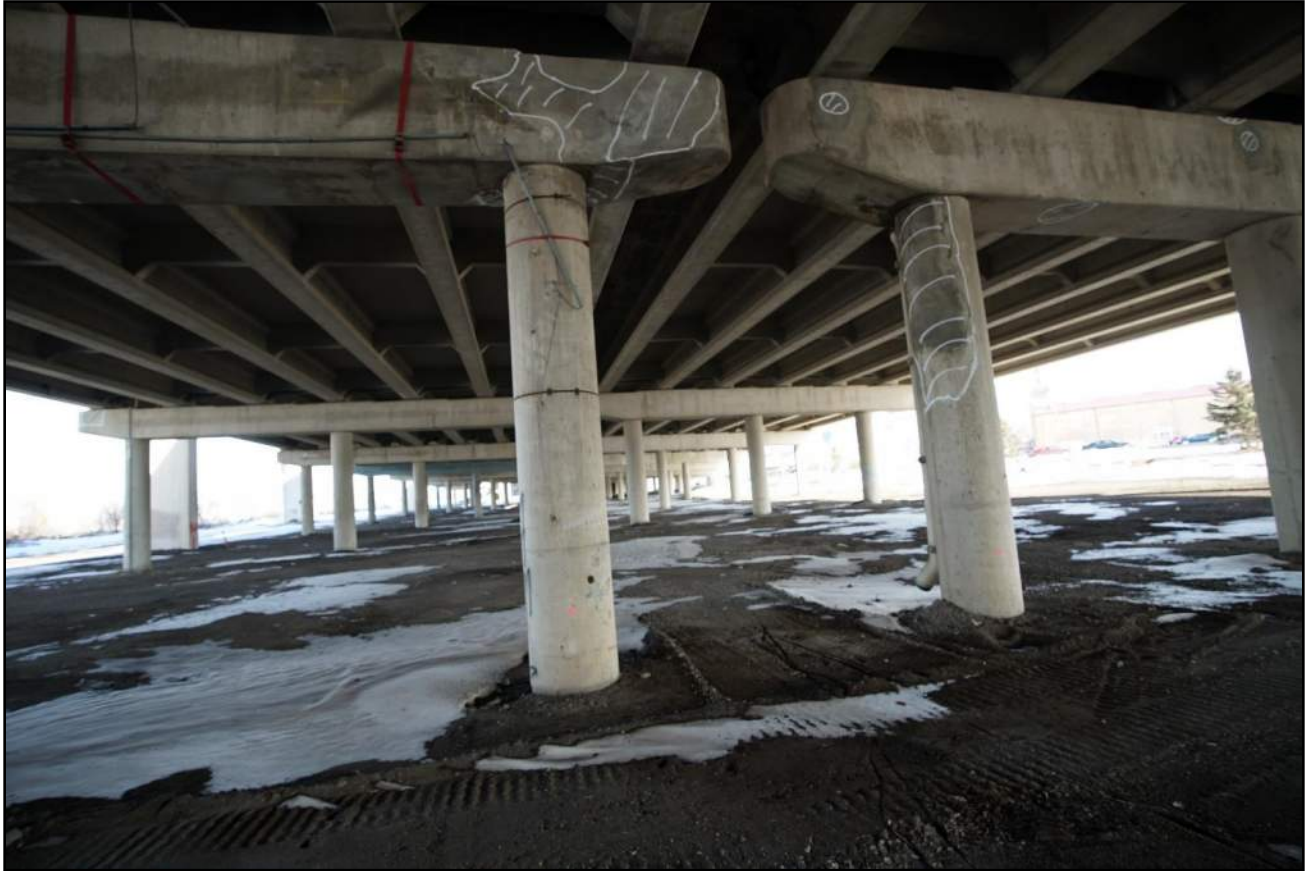
Image 10: View of the Image from the Sony Alpha A7R II.

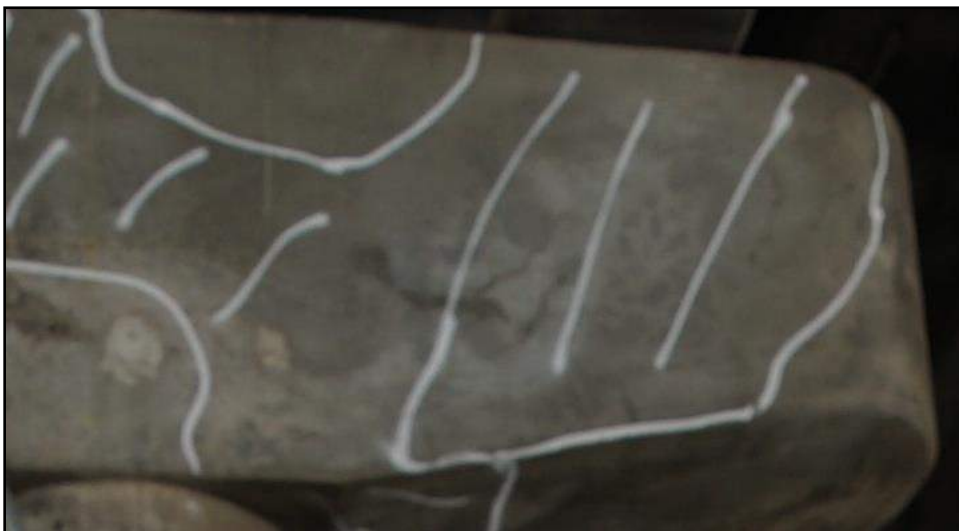
Image 11: View of the Image Quality from the Sony Alpha A7R II.

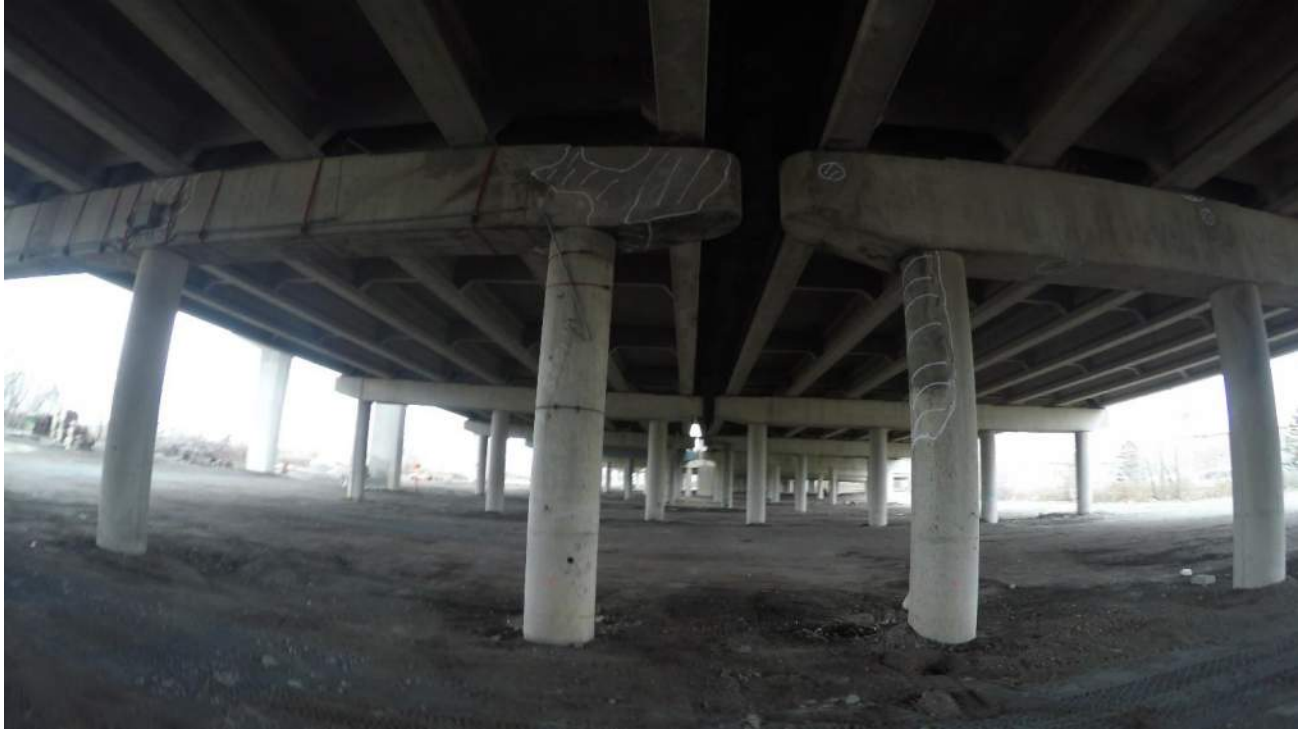
Image 12: View of the Image of the GoPro Hero 5 Video.

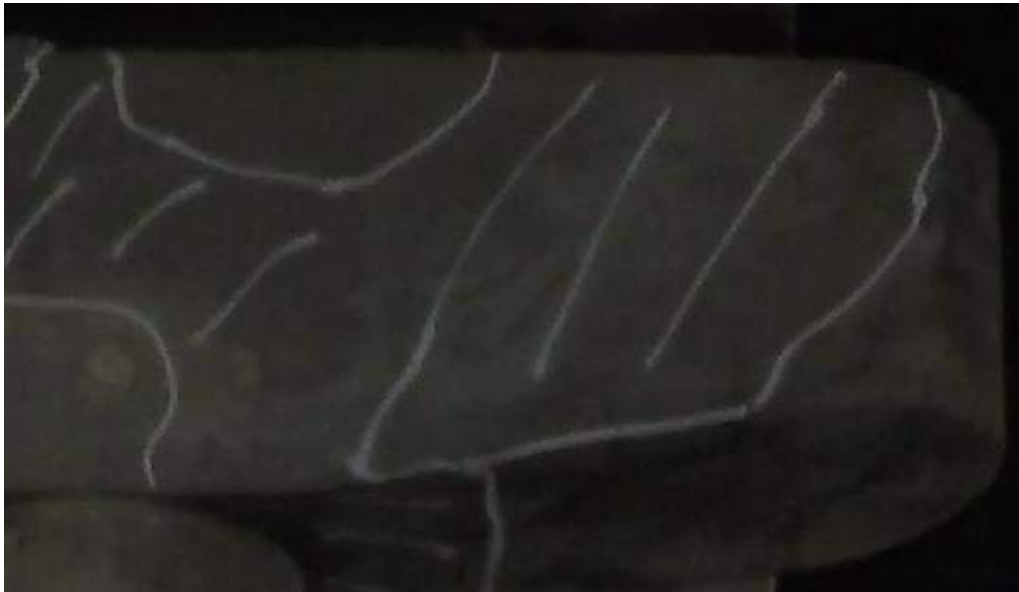
Image 13: View of the Image Quality of the GoPro Hero 5 Video.

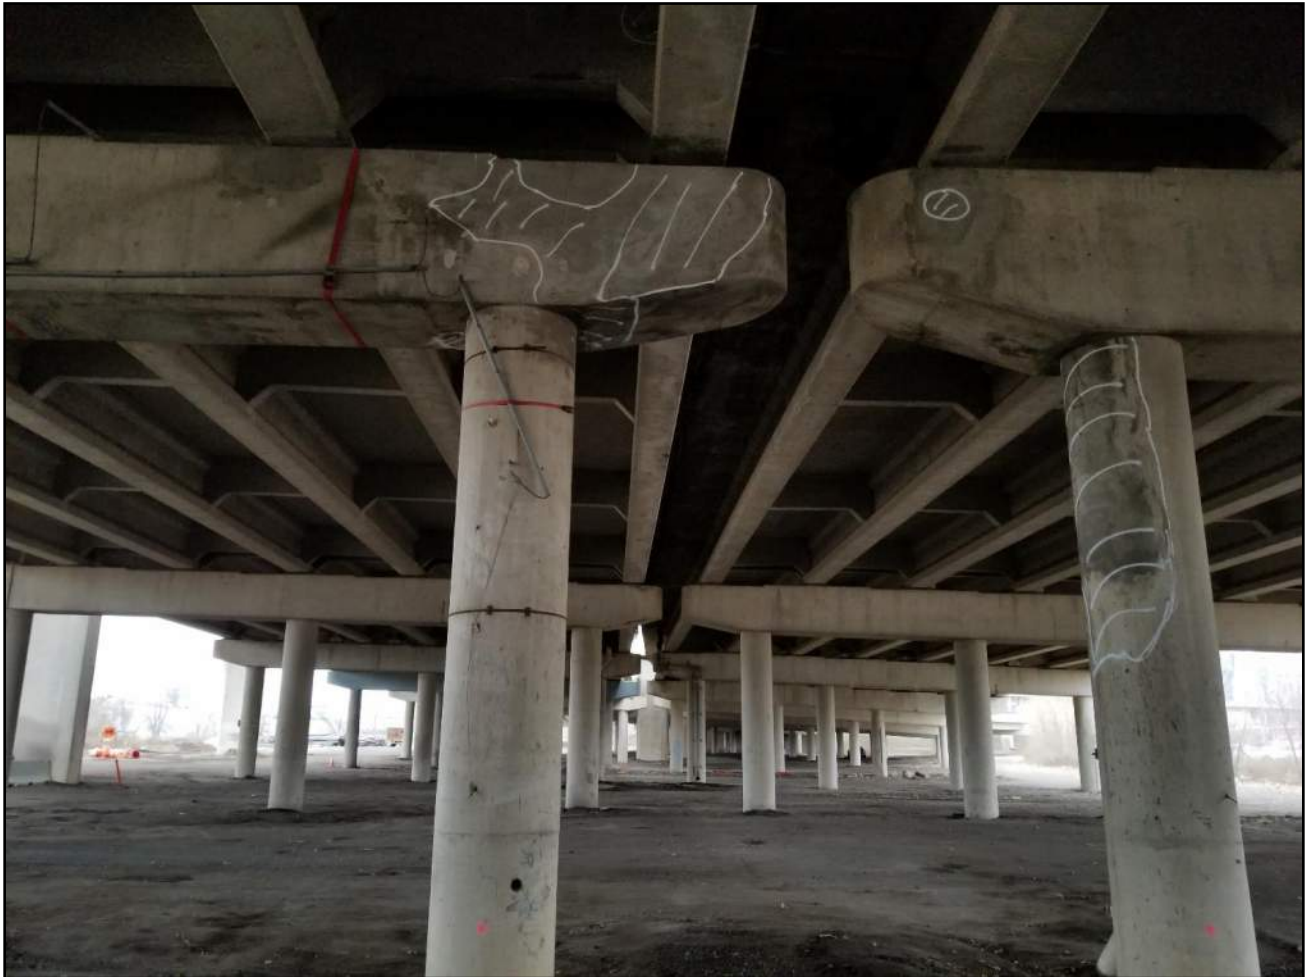
Image 14: View of the Image from the Samsung Galaxy S8 Phone Camera.

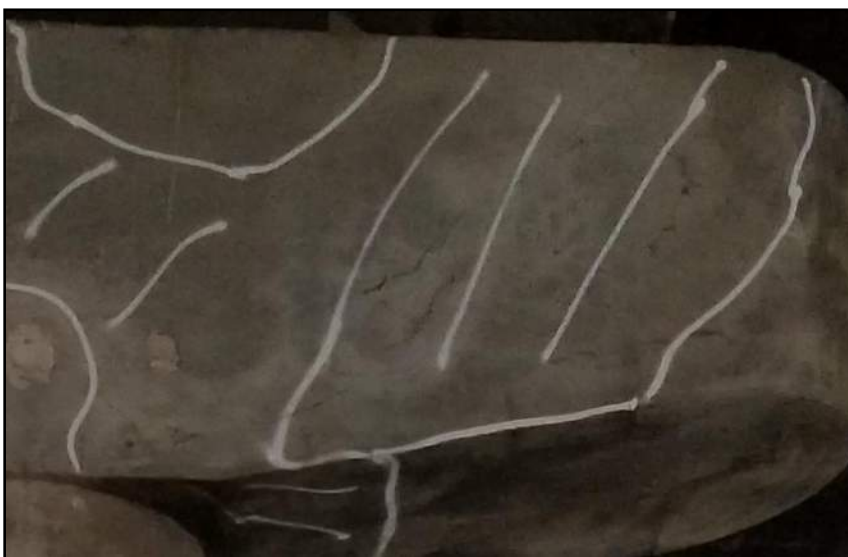
Image 15: View of the Image Quality of the Samsung Galaxy S8 Phone Camera.

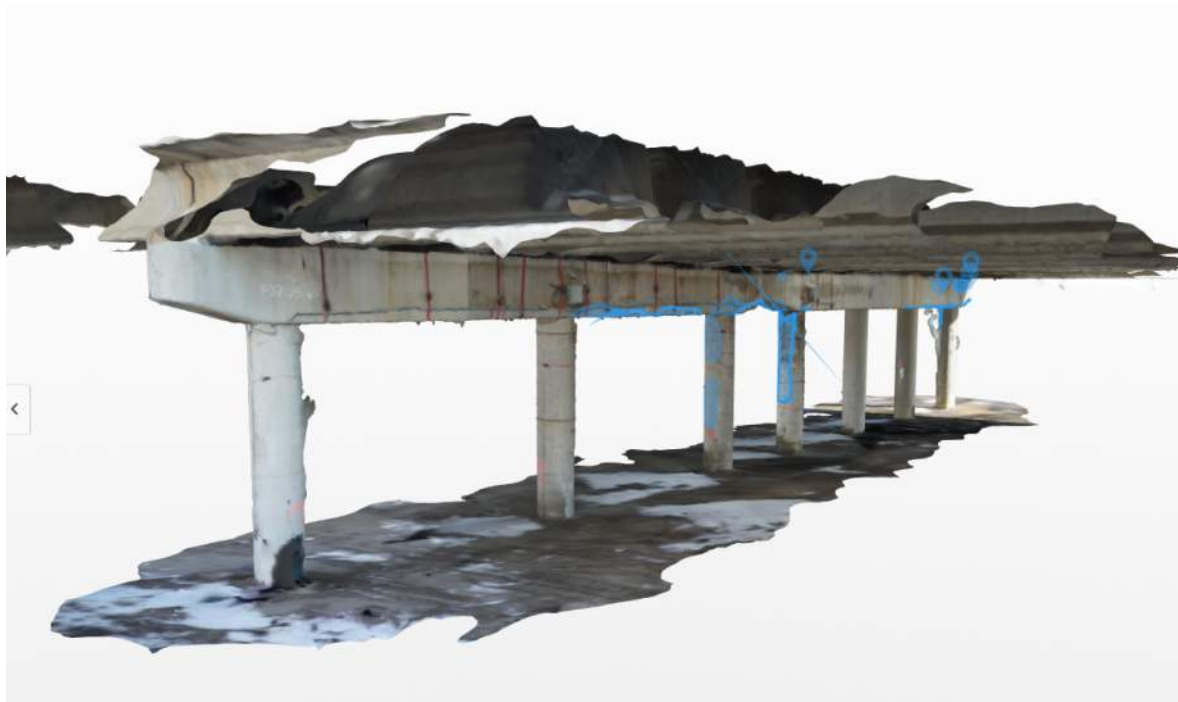
An inspector was able to use the Pix4D program to navigate the 3D model and select areas of interest. The software provides the inspector with all still images containing the selected area of interest which can then be viewed in high resolution. Additionally, the inspector can place annotations or measurements areas in the model for design plans, further detailed inspection or construction documents. Refer to Image 17 for a view of the Inspector Tool providing a Photograph Log from a selected area of the 3D model.

Image 16: View of the Sony Alpha A7R II 3D Model with Annotations. [\(Click Image to Access 3D Model\)](#)

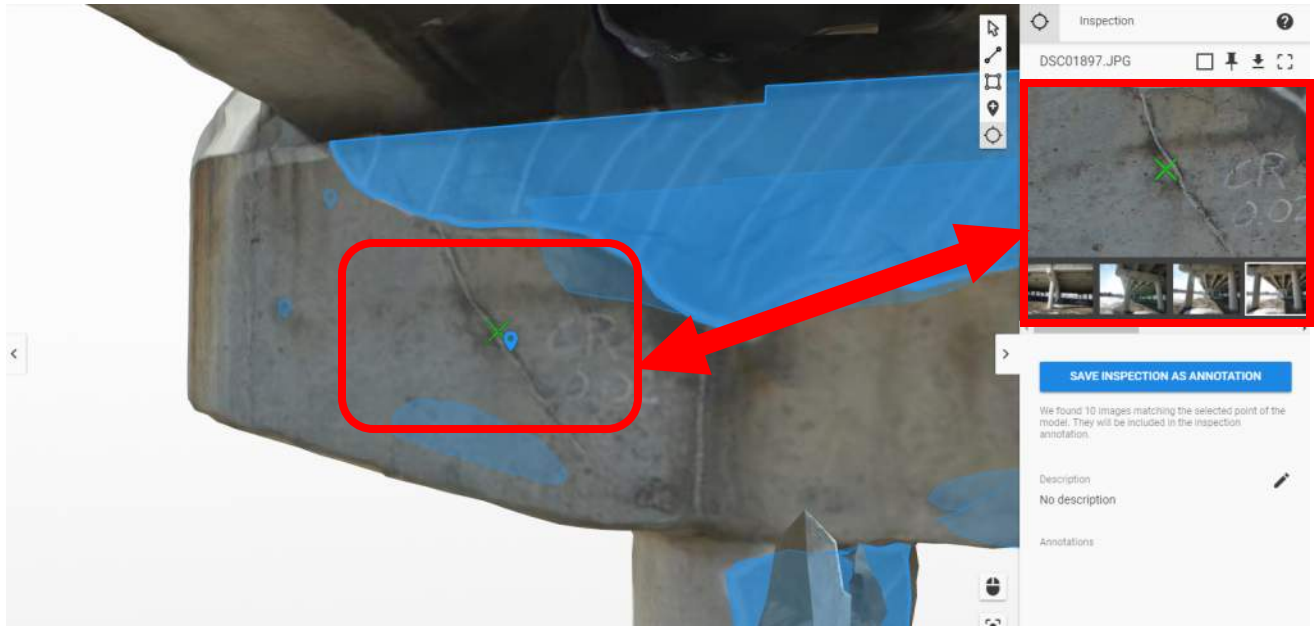
Image 17: View of a Crack Viewed from the Inspector Tool from the Sony Alpha A7R II 3D Model.

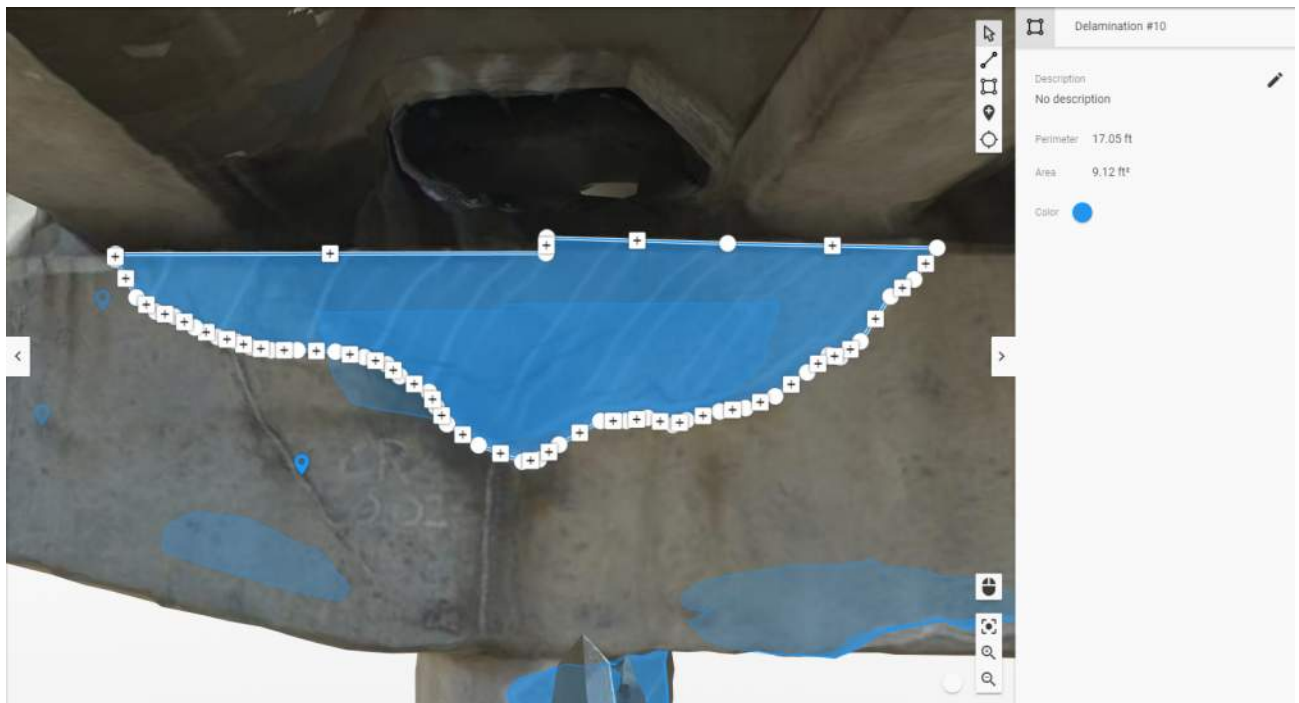
Image 18: View of a Spall Measurement and Annotation from the Sony Alpha A7R II 3D Model. Note Spall Area and Perimeter are Provided.

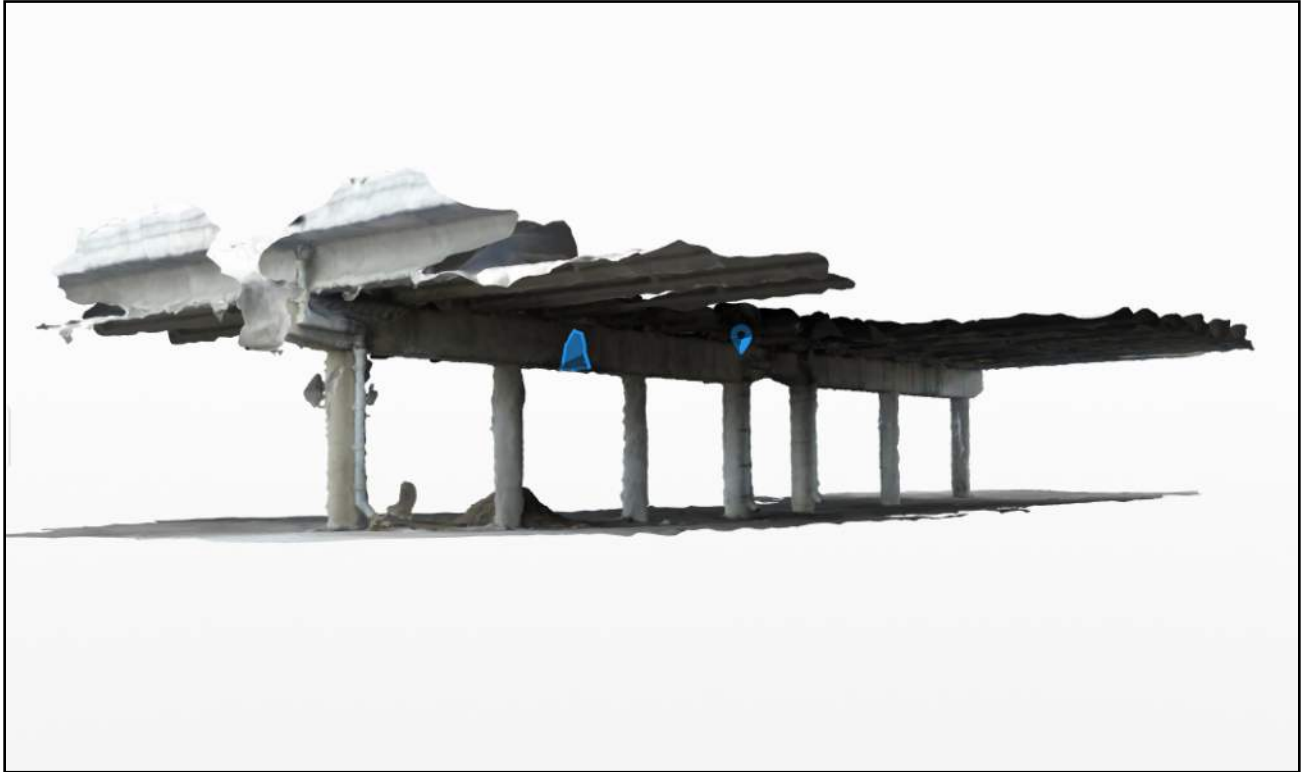
Image 19: View of the 3D Model Created from the GoPro Images. [\(Click Image to access Model\)](#)

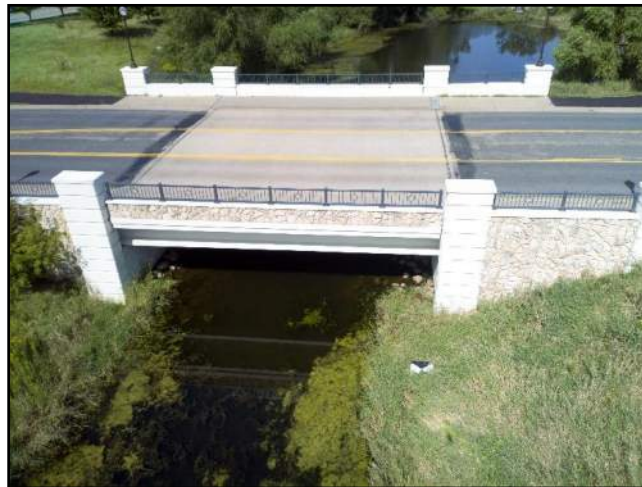
Bridge Number 19538 spans approximately 45.0 feet over the North Branch of the South Creek and carries one east bound and one west bound lane of Heritage Drive. The bridge deck is approximately 62.5 feet wide and consists of cast in place concrete with epoxy coated reinforcing steel. The bridge superstructure consists of six precast prestressed concrete beams bearing on steel and elastomeric bearings. The bridge substructure consists of a concrete abutment and footing bearing on piles. The longitudinal axis of the bridge is orientated approximately northeast to southwest. Refer to Images 2 and 3 for overall views of the bridge.

Image 2: Overall View of Bridge Topside.

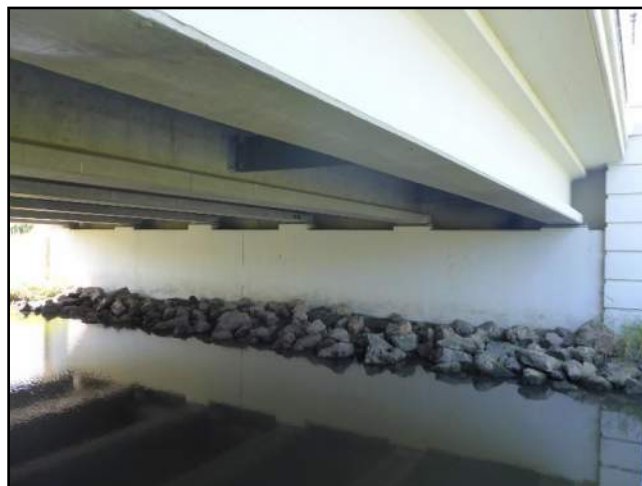
Image 3: Overall View of Bridge Underside.

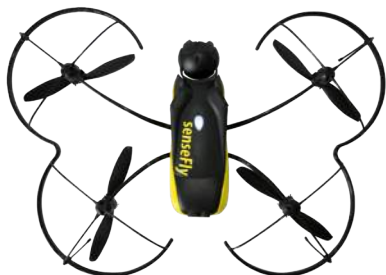
A two-person crew, consisting of a professional engineer-pilot and a field engineer, conducted the UAS inspection. The pilot was certified as a FAA Remote Pilot. The inspection was conducted using two different registered UAS's; an Inspection and Mapping UAS and an Collision-Tolerant UAS. The aerial mapping UAS was a SenseFly Albris quadcopter equipped with a TripleView head consisting of a HD video camera, a 38MP still camera, and an infrared camera. Additionally, the Albris contains five acoustic sensors, GPS location, and navigation camera technology which aid both 3D preplanned and interactive flight missions. The Collision-Tolerant UAS was a Flyability Elios quadcopter equipped with a full HD camera, Infrared camera, and on-board lighting system. Additionally, the Elios has a protective frame surrounding the UAS body allowing for access to tight locations and up-close imaging. Refer to Image 4 for a view of the SenseFly Albris and Image 5 for a view of the Flyability Elios.

Image 4: View of SenseFly Albris.

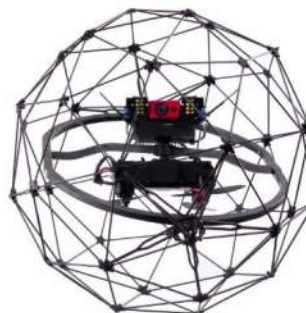
Image 5: View of Flyability Elios.

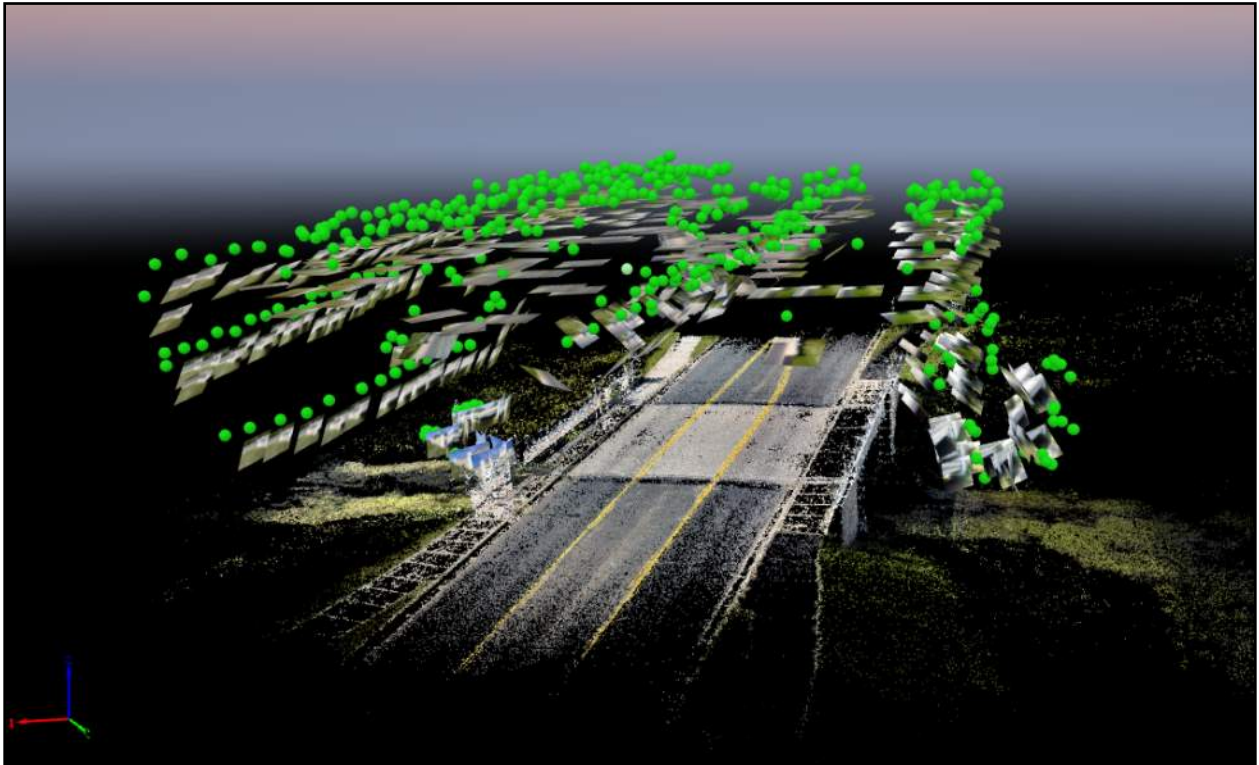
Image 7: View of Camera Position (Green Dot) at Locations of Photographing.

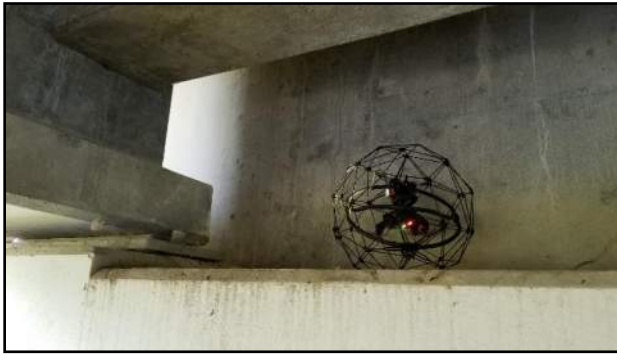
A High Definition Video Mission was conducted of limited access areas using the Elios UAS. The target goal of this mission was to determine the quality and applicability of using a Collision-Tolerant UAS to capture images and assess the condition of bridge elements which are typically not easily visually or tactically accessible during the scope of a routine inspection. The mission consisted of an interactive flight using only manual pilot controls. During a typical routine inspection, the deck soffit, beam faces, and bearings would have been difficult to access. The use of the Elios UAS focuses on these hard or impossible to access locations. An inspector can then review the video footage to look for defects or findings. Refer to Images 8 and 9 for views of the Elios UAS in a difficult to access locations.

Image 8: View of Elios Inspecting a Hard to Reach Bearing.

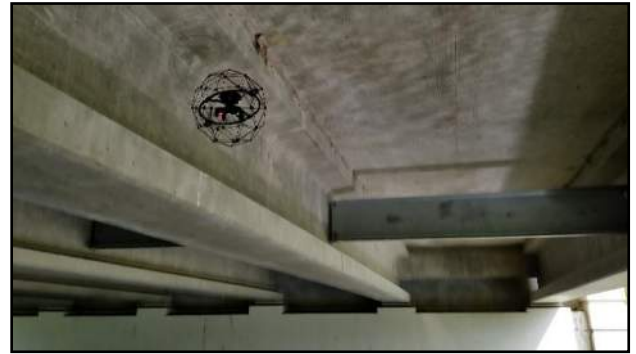
Image 9: View of Elios Inspecting a Hard to Reach Face of a Concrete Beam.

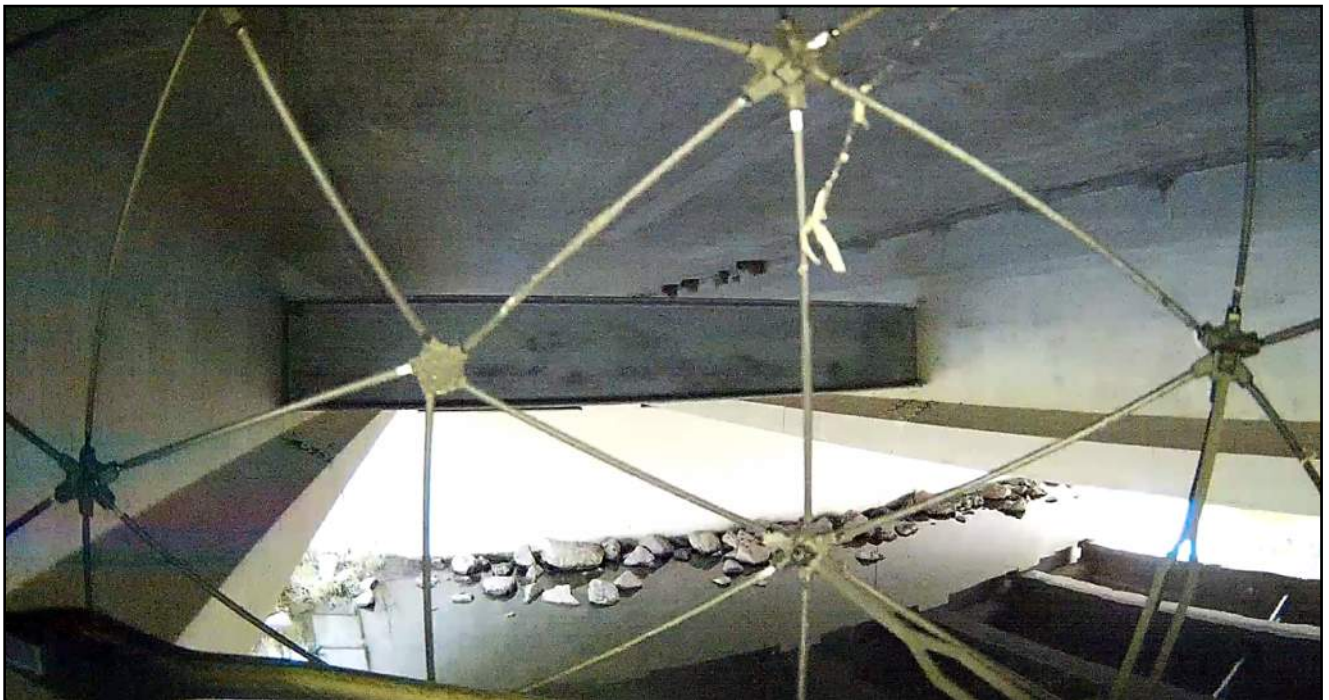
Image 10: Image Clipped from Elios Inspection Video ([Click Image to play video](#)).
