Improving the Quality of Bridge Inspections Using Unmanned Aircraft Systems (UAS)

Barritt Lovelace, Principal Investigator
Collins Engineers, Inc.

July 2018

Research Project
Final Report 2018-26

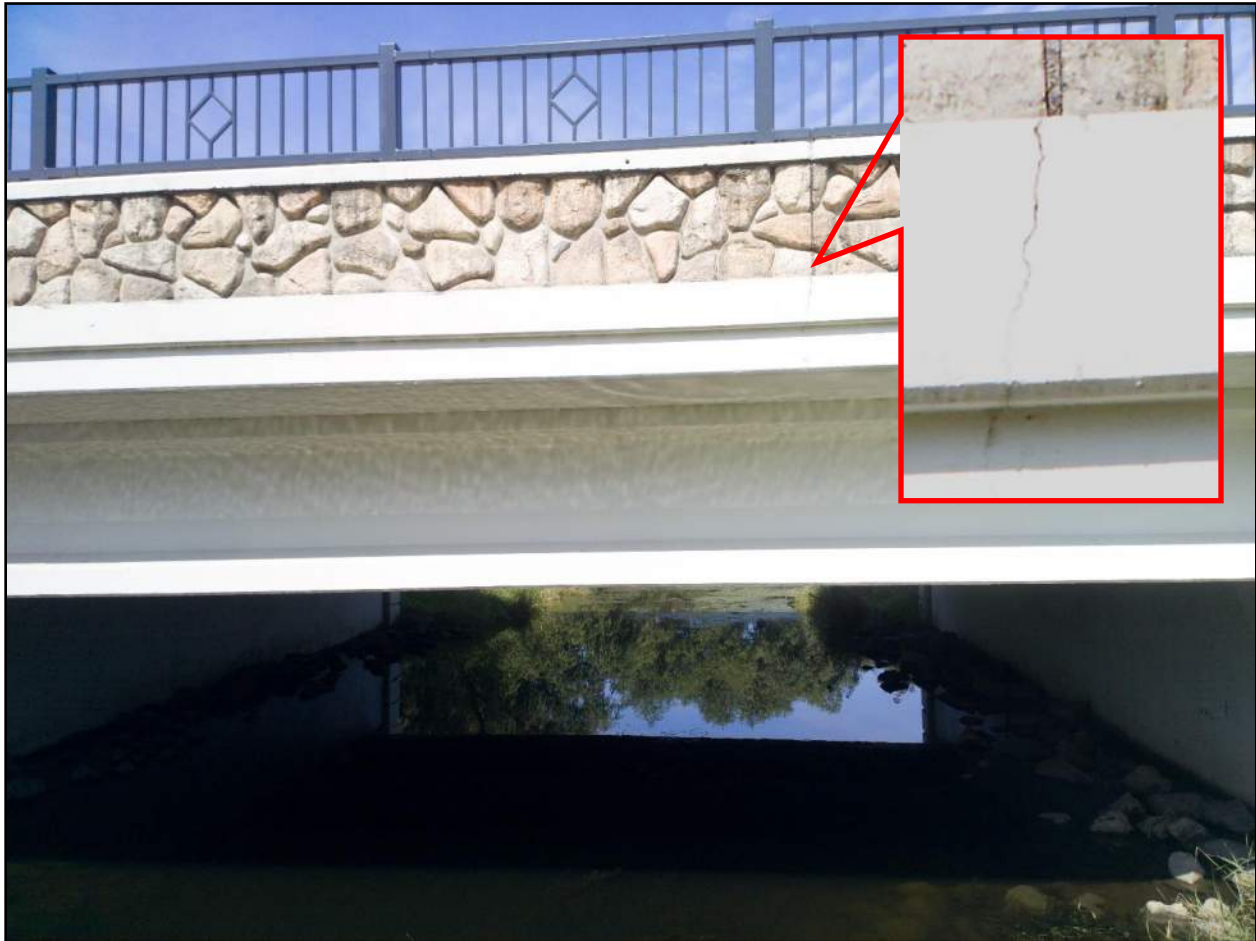
Image 12: View of the Level of Detail in a Single High-Resolution Image.

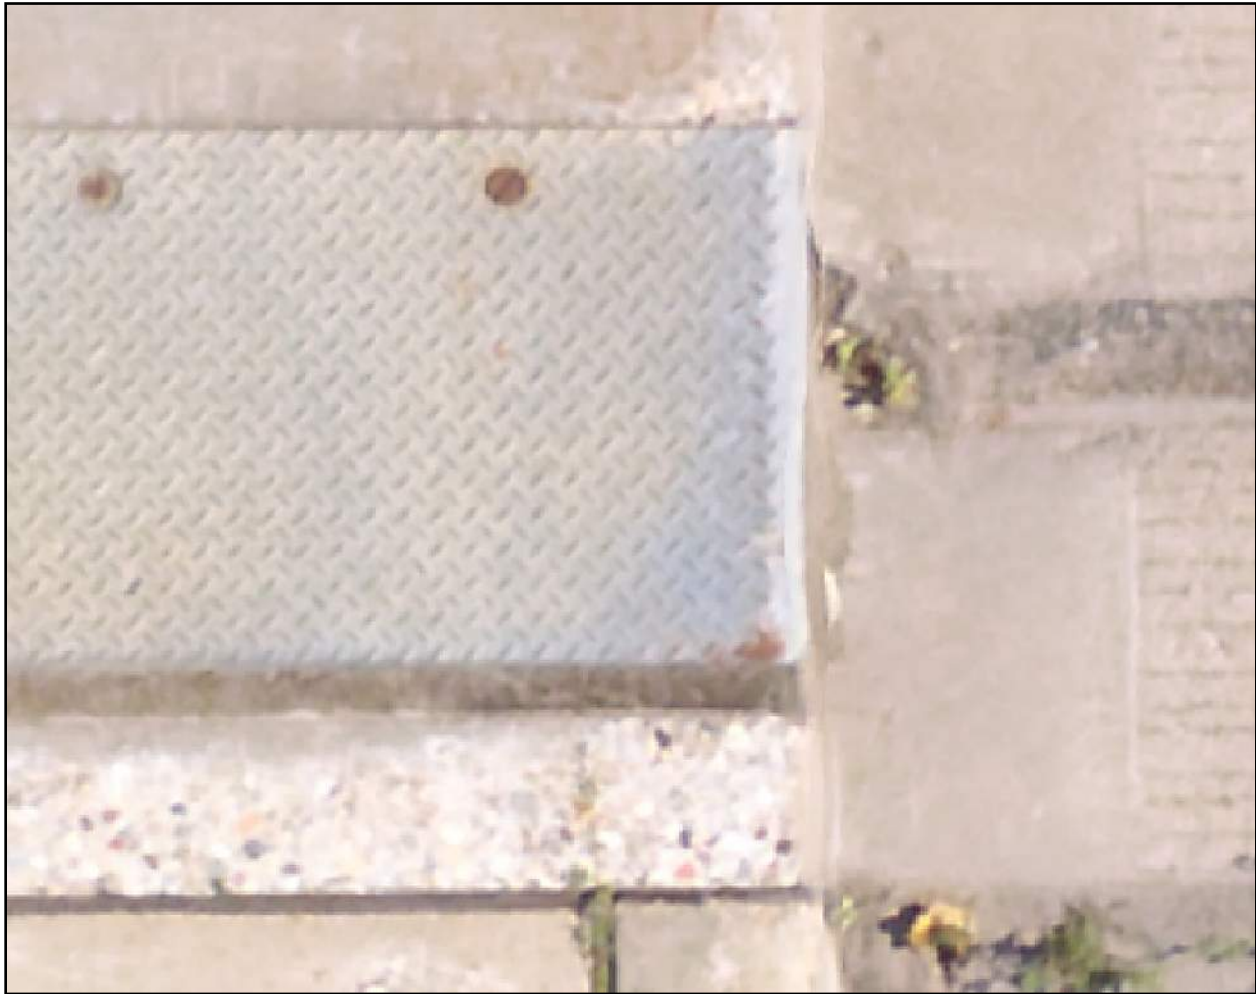
A Orthomosaic image was created to use as an inspection tool and to document the condition of the bridge deck at the time of inspection. The target goal for this process was to produce an easily viewable, high resolution image of a large area that could be used by an inspector to carry out a detailed inspection, area measurements, condition assessment, or historical documentation. An Orthomosaic image is a single image file which is created from many individual images captured during the Mapping and Photogrammetry Mission. The final product is an image file that can be used to measure true distances. For this bridge, an Orthomosaic image was made of the concrete deck topside. An inspector then reviews a single file and can measure true distances and areas for a final product. Refer to Image 11 for a view of Orthomosaic Detail.

Image 14: View of level of Detail of the Orthomosaic Image.

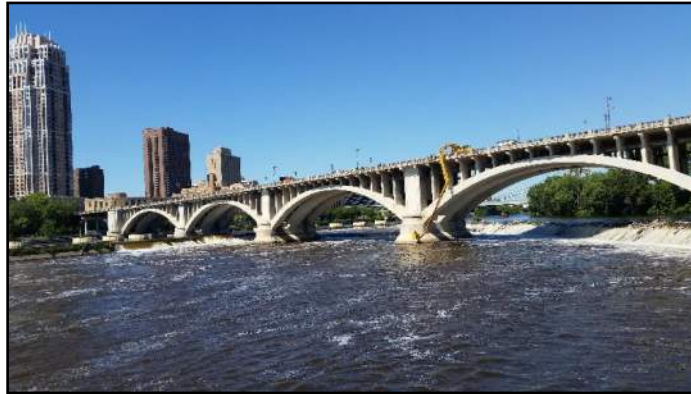
Bridge Number 2440 spans approximately 1,887 feet over the Mississippi River and carries two north bound and two south bound lanes of Trunk Highway 65 (3rd Ave). The bridge deck is approximately 81.6 feet wide and consists of cast in place concrete with a low slump concrete wearing surface. The bridge superstructure consists of 11 concrete open spandrel arch spans. The bridge substructure consists of concrete abutment walls on steel piles and concrete piers founded on bedrock. The longitudinal axis of the bridge is orientated approximately northeast to southwest. Refer to Images 2 and 3 for overall views of the bridge.

Image 2: Overall View of Bridge Topside.

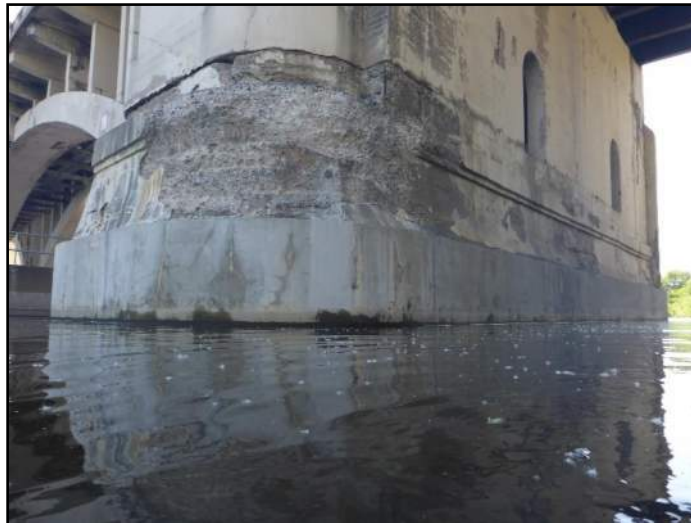
Image 3: Overall View of Bridge Pier.

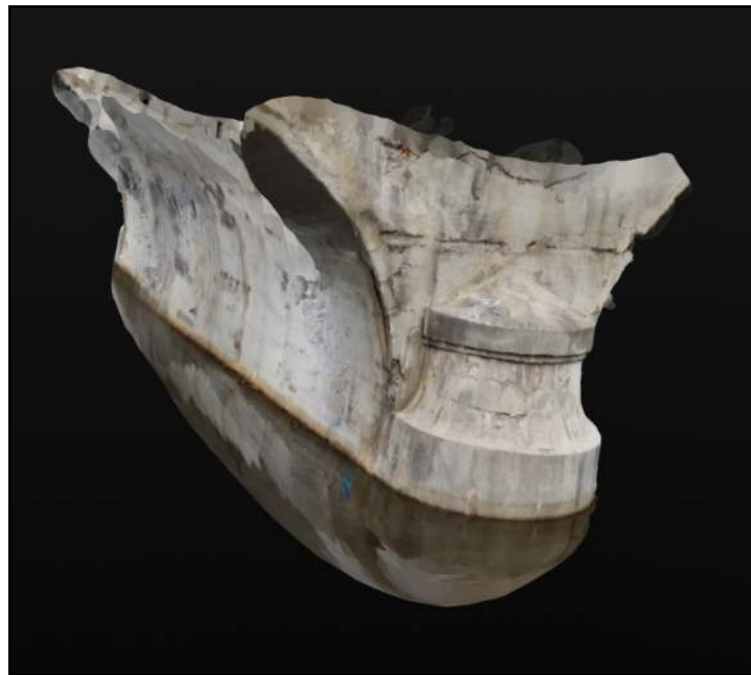
A 3D Model with a high-resolution photo log was processed for bridge which can be seen in Image 5 below. The target goal for this process was to determine the ease of use and applicability of having a 3D photolog to assist an inspector during post-processing, report writing, and future inspection. All photographs taken during the Photogrammetry Mission were processed in the Pix4D software. The software processes all photographs to form a 3D point cloud for digital viewing. The point cloud was then processed by the same software to generate a 3D mesh of the bridge. Refer to Images 6 and 7 for a comparison between the real-life picture and the 3D model in Pix4D. An inspector was then able to navigate the 3D model and select areas of interest. The software provides the inspector with all still images containing the selected area of interest which can then be viewed in high-resolution. Additionally, the inspector can place annotations within the file for future reference or for clarification when sharing the file. Refer to Image 7 for a view of the Inspector Tool providing a Photograph Log from a selected area of the 3D model.

Image 5: View of the 3D Model of Pier 7 in Pix4D ([Click Image to access 3D Model and Inspection Photolog](#))

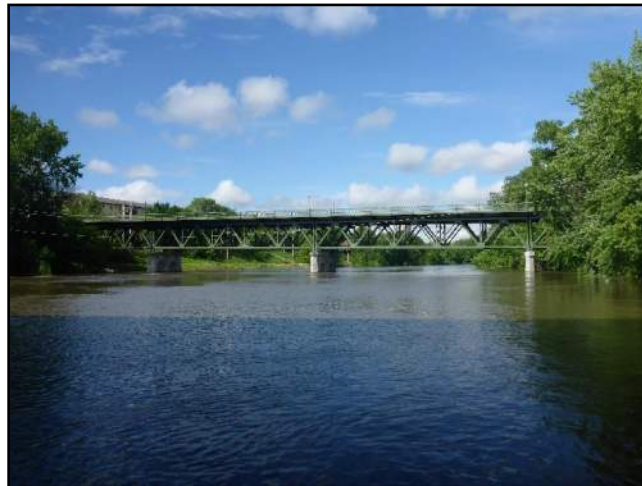
Bridge Number 4175 spans approximately 635 feet over the Minnesota River and carries a Pedestrian Walkway. The bridge deck is approximately 42 feet wide and consists of cast in place concrete with no wearing surface. The bridge superstructure consists of 4 steel deck truss spans with steel floor beams and stringers and 4 cast-in-place concrete deck grid spans. The substructure consists of reinforced concrete abutments, pier walls and column bents all founded on piles. The longitudinal axis of the bridge is orientated approximately north to south. Refer to Images 2 and 3 for overall views of the bridge.

Image 2: Overall View of the Bridge fascia.

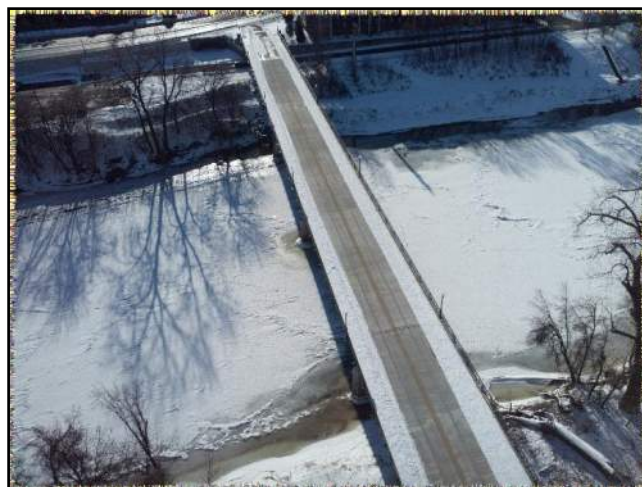
Image 3: Overall View of Bridge Topside.

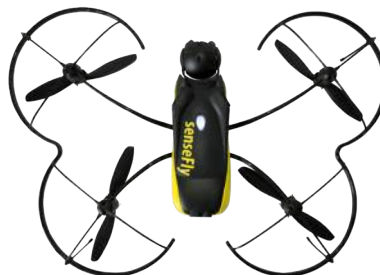
A two-person crew, consisting of a professional engineer-pilot and a field engineer, conducted the UAS inspection. The pilot was certified as a FAA Remote Pilot. The inspection was conducted using two different registered UAS's; an Inspection and Mapping UAS and an Collision-Tolerant UAS. The aerial mapping UAS was a SenseFly Albris quadcopter equipped with a TripleView head consisting of a HD video camera, a 38MP still camera, and an infrared camera. Additionally, the Albris contains five acoustic sensors, GPS location, and navigation camera technology which aids both 3D preplanned and interactive flight missions. The Collision-Tolerant UAS was a Flyability Elios quadcopter equipped with a full HD camera, Infrared camera, and on-board lighting system. Additionally, the Elios has a protective frame surrounding the UAS body allowing for access to tight locations and up-close imaging. Refer to Image 4 for a view of the SenseFly Albris and Image 5 for a view of the Flyability Elios.

Image 4: View of SenseFly Albris.

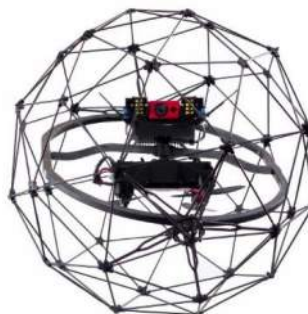
Image 5: View of Flyability Elios.

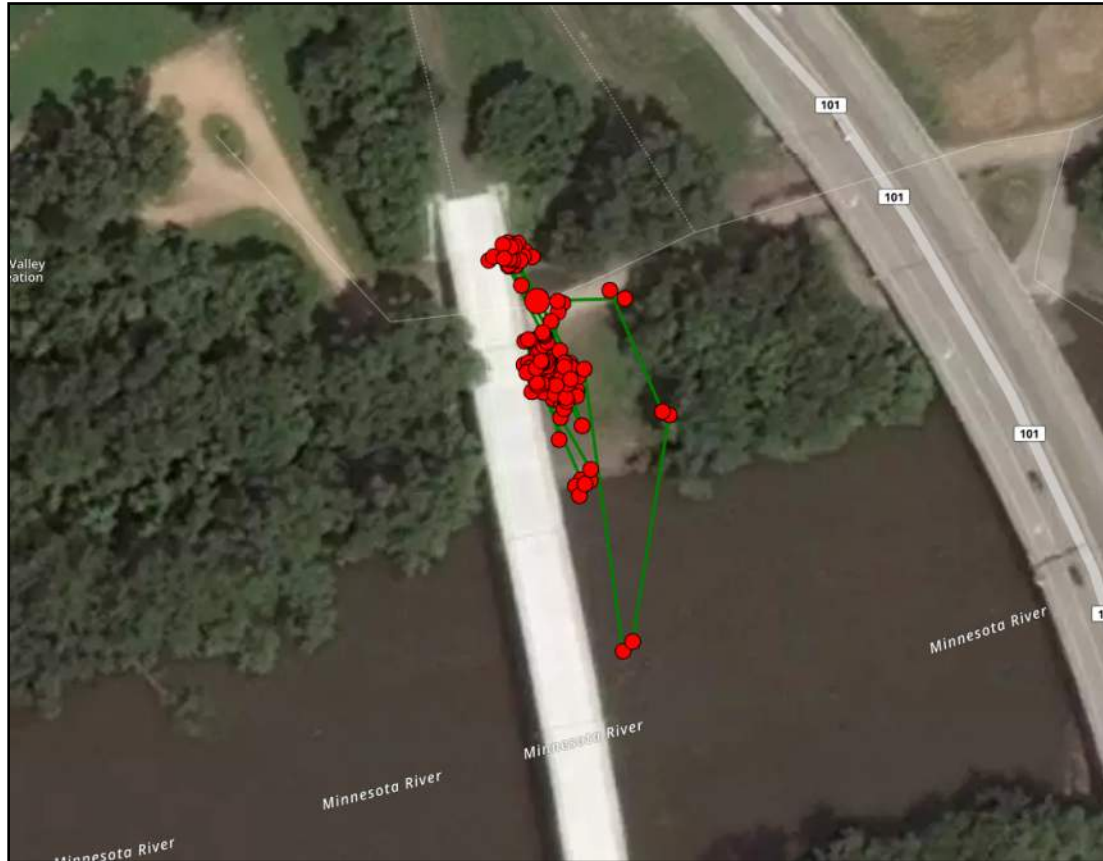
A Mapping & Photogrammetry mission using the Albris was identified for this bridge to explore the potential of UAS photography to map concrete deck surface defects. The target goal of the mission was to gather information in the form of photographs in a quick, efficient process which could later be used to map the concrete deck and have a post-inspection tool to aid in report writing and historical documentation. The mission consisted of a pre-planned flight path. The UAS collected over 110 high-resolution still images of the bridge top side. All images were geo-tagged with GPS coordinates. Refer to Image 6 for a view of the Flight and Mapping Mission.

Image 6: View of Mission Flight Map (Both Mapping & Photogrammetry Mission and Gusset Plate Model Mission).

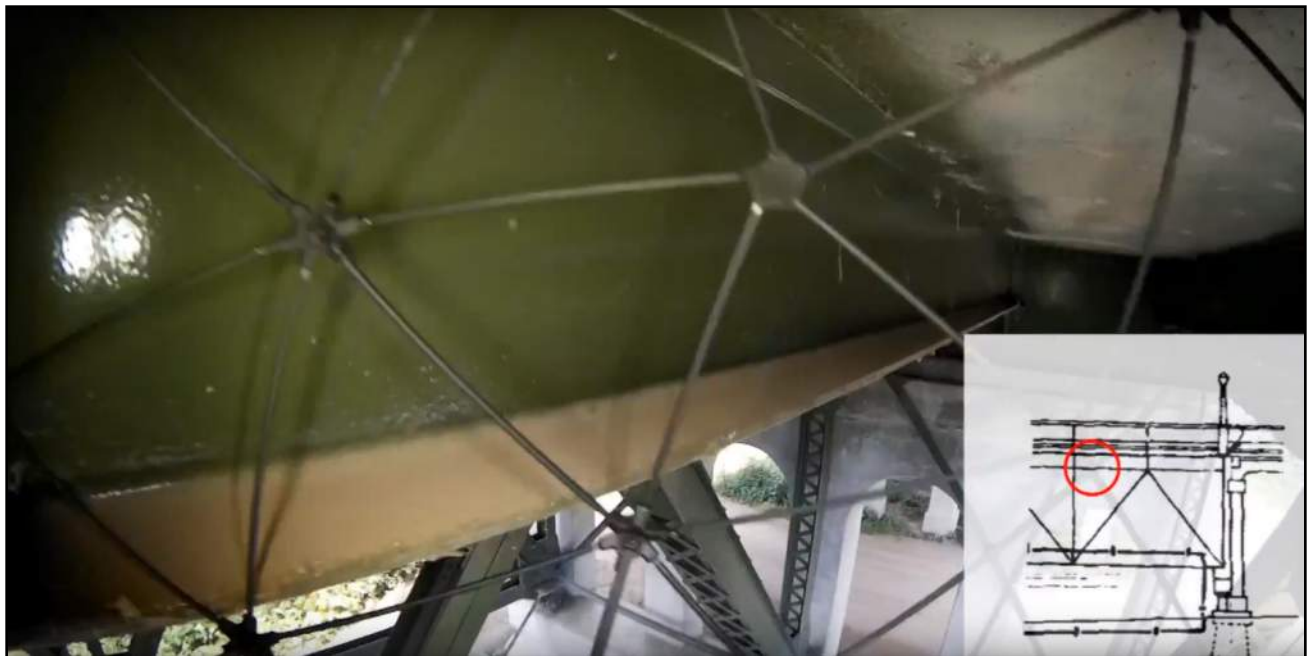
A High Definition Video Mission was conducted of limited access areas using the Elios UAS. The target goal of this mission was to determine the quality and applicability of using a Collision-Tolerant UAS to capture images and assess the condition of bridge elements which are typically difficult to access in a close-up view during the scope of a routine inspection. The mission consisted of an interactive flight using only pilot controls. During a typical routine inspection, the deck soffit, beam faces, and bearings would have been difficult to access. The use of the Elios UAS focuses on these hard to view locations. An inspector can then review the video footage to look for defects or findings. Refer to Images 8 for a view of the Elios UAS in a difficult to access locations.

Image 8: Image Clipped from Elion Inspection Video. [\(Click Image to play video\).](#)

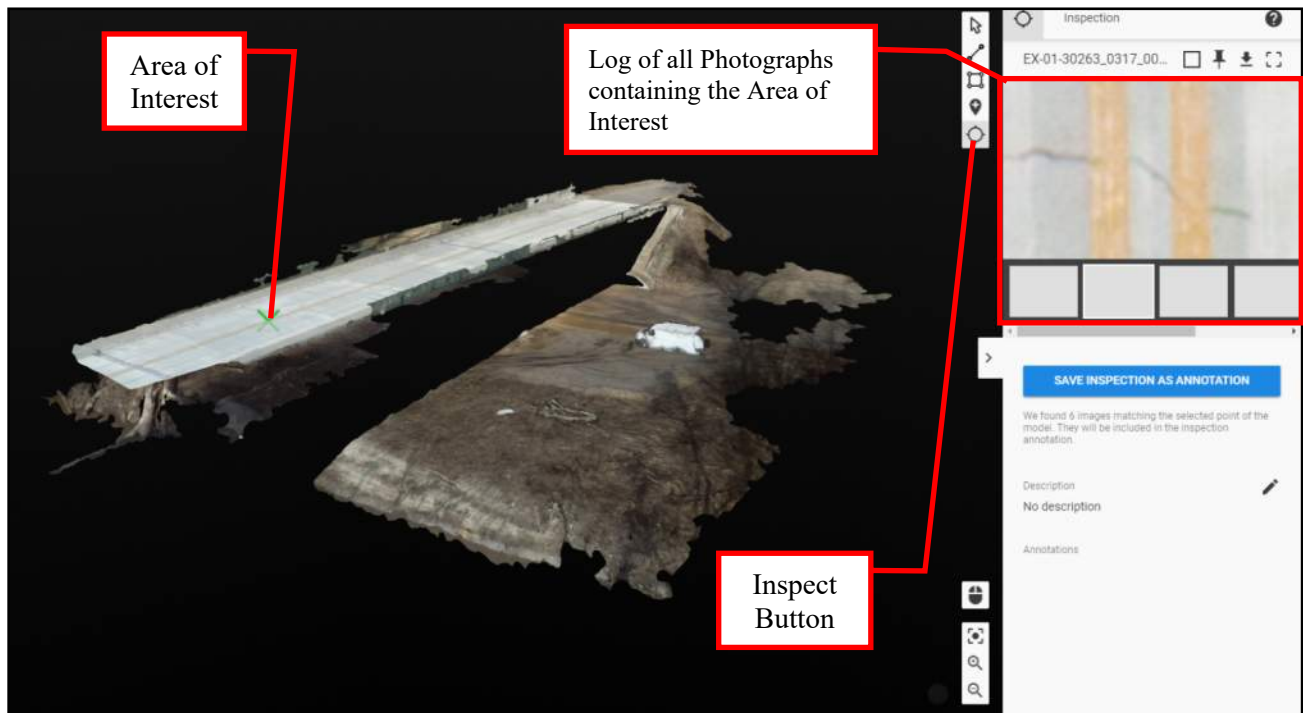
generate a 3D mesh of the bridge. An inspector was then able to navigate the 3D model and select areas of interest. The software provides the inspector with all still images containing the selected area of interest which can then be viewed in high resolution. Additionally, the inspector can place annotations within the file for future reference or for clarification when sharing the file. Refer to Image 9 for a view of the Inspector Tool providing a Photograph Log from a selected area of the 3D model.

Image 9: View of the Inspector Tool providing a Photograph Log from a selected area of the 3D model.
(Click Image to access 3D Model and Inspection Photolog – Click on the Inspect Button)

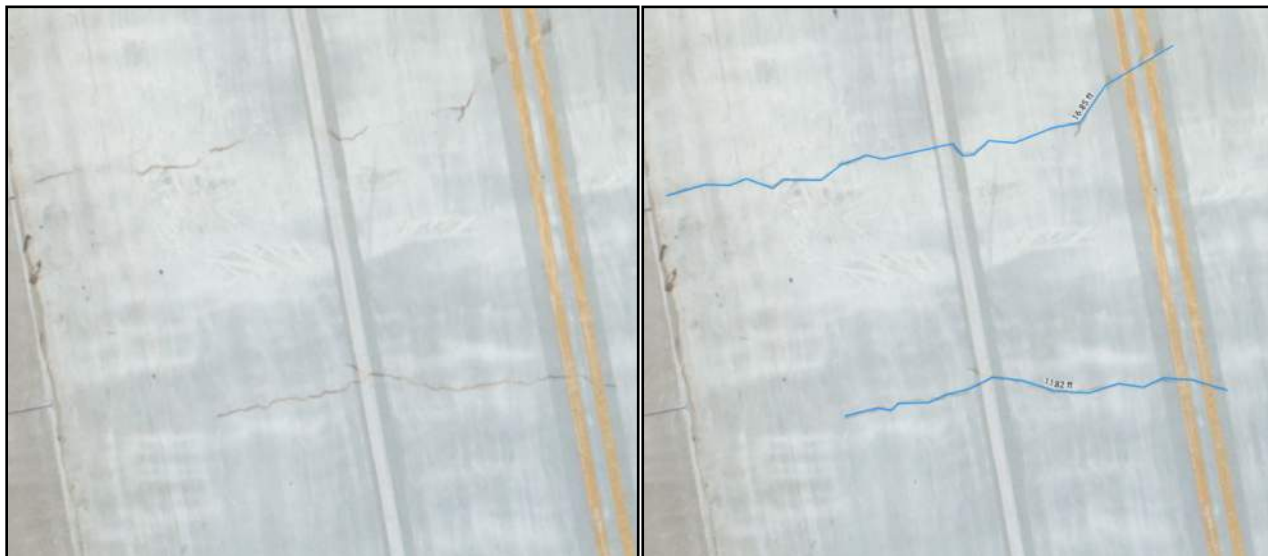
Image 11: View of the Orthomosaic Detail and Measuring Ability in the Pix4D software.

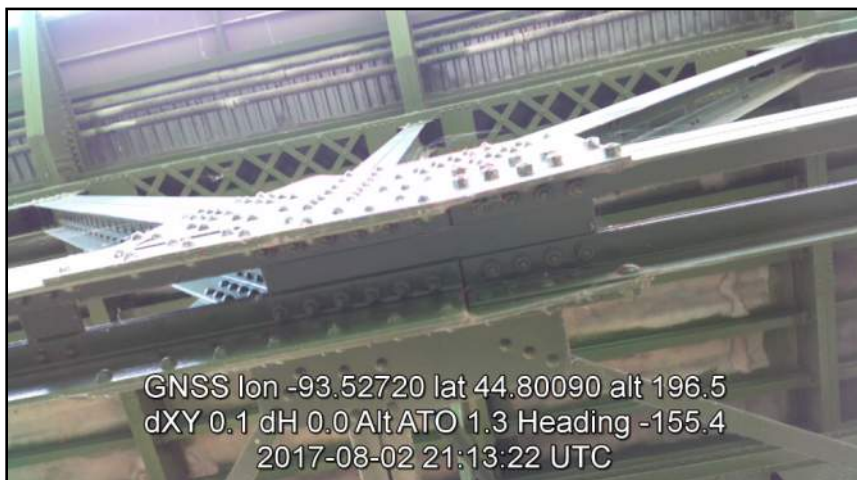
During the Albris UASs flight Mission, a video of the gusset plate was also taken to explore the potential for video inspection using the albris. Refer to Image 14 for the Albris UAS video of the gusset plate.

Image 14: View of snapshot of Albris Video of the Gusset Plate. [\(Click Image to Access Video\)](#)

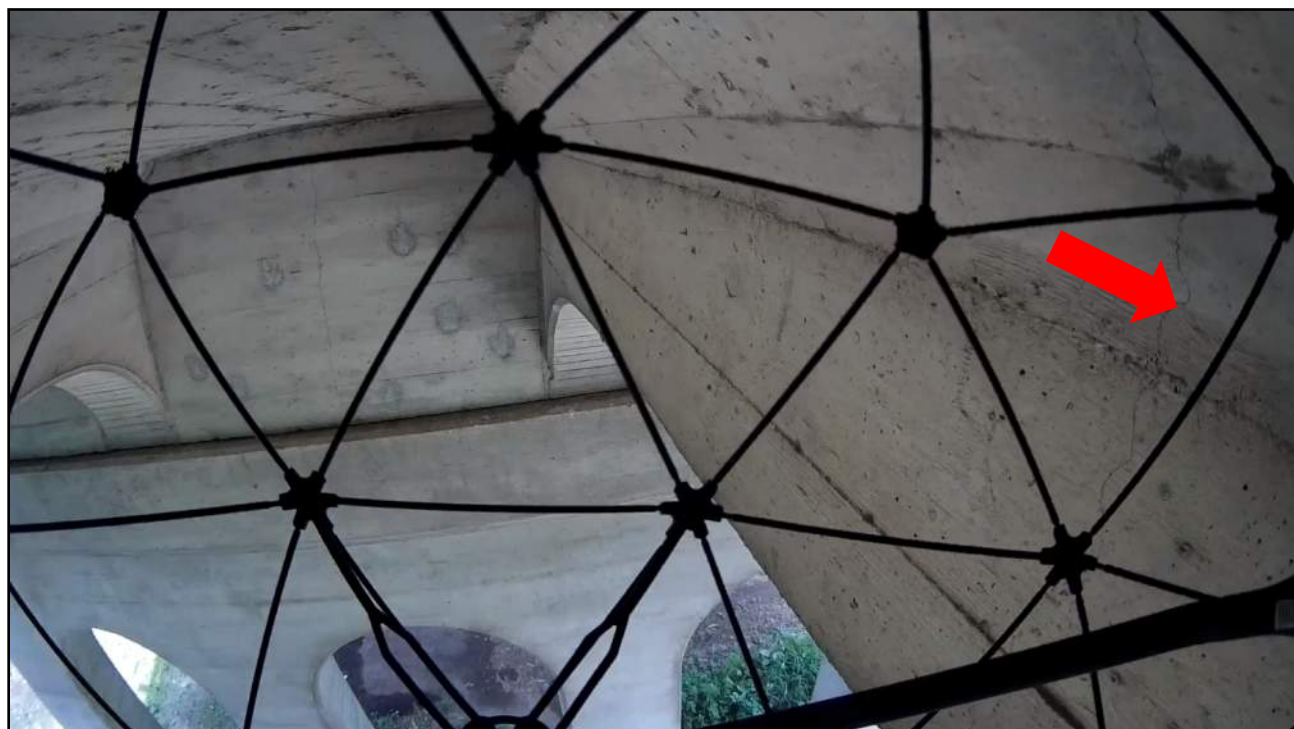
Video from the High Definition Video Mission using the Elios was viewed by an inspector after returning from the flight mission. The video could be observed in any software capable of playing .MP4 files. Additionally, the manufacturer of the Elios, Flyability, have created an inspection software where the UAS flight log can be opened with the video file to show inspector UAS attributes such as heading, altitude, and temperature. The inspector can then maneuver their way through the video to obtain still images of defects or notable findings. Refer to Image 15 below for a view of the Elios inspecting cracking defects on the bridge.

Image 15: View of a Still Image Taken from the Video Playback Showing a Crack in the Concrete. [\(Click Image to Access Video\)](#)

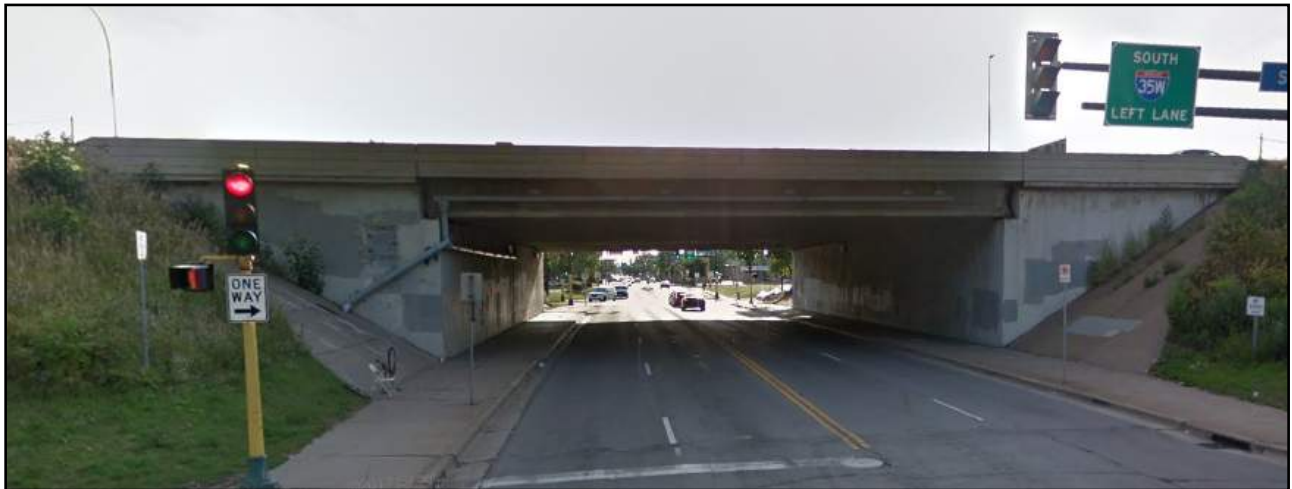
Bridge Number 62504 spans approximately 128.6 feet over E 31st St. and carries four north bound and four south bound lanes of I 35W. The bridge deck is approximately 141.3 feet wide and consists of cast in place concrete with a low slump concrete wearing surface. The bridge superstructure consists of sixteen precast concrete beams and the bridge substructure consists of concrete abutments bearing on piles. The longitudinal axis of the bridge is orientated approximately north to south. Refer to Images 2 and 3 for overall views of the bridge.

Image 2: Overall View of Bridge.

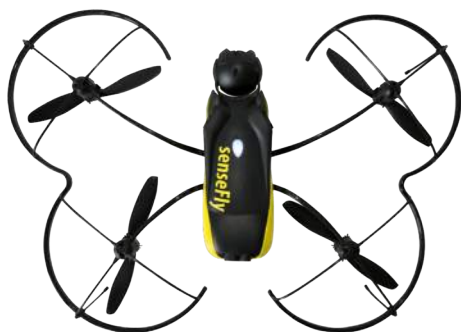
A one-person crew, consisting of a professional engineer-pilot, conducted the UAS inspection. The pilot was certified as a FAA Remote Pilot, and conducted the inspection using an Inspection and Mapping UAS. The aerial mapping UAS was a SenseFly Albris quadcopter equipped with a TripleView head consisting of a HD video camera, a 38MP still camera, and an infrared camera. Additionally, the Albris contains five acoustic sensors, GPS location, and photo-identification stabilization technology which aid both 3D preplanned and interactive flight missions. Refer to Image 4 for a view of the SenseFly Albris.

Image 4: View of SenseFly Albris.

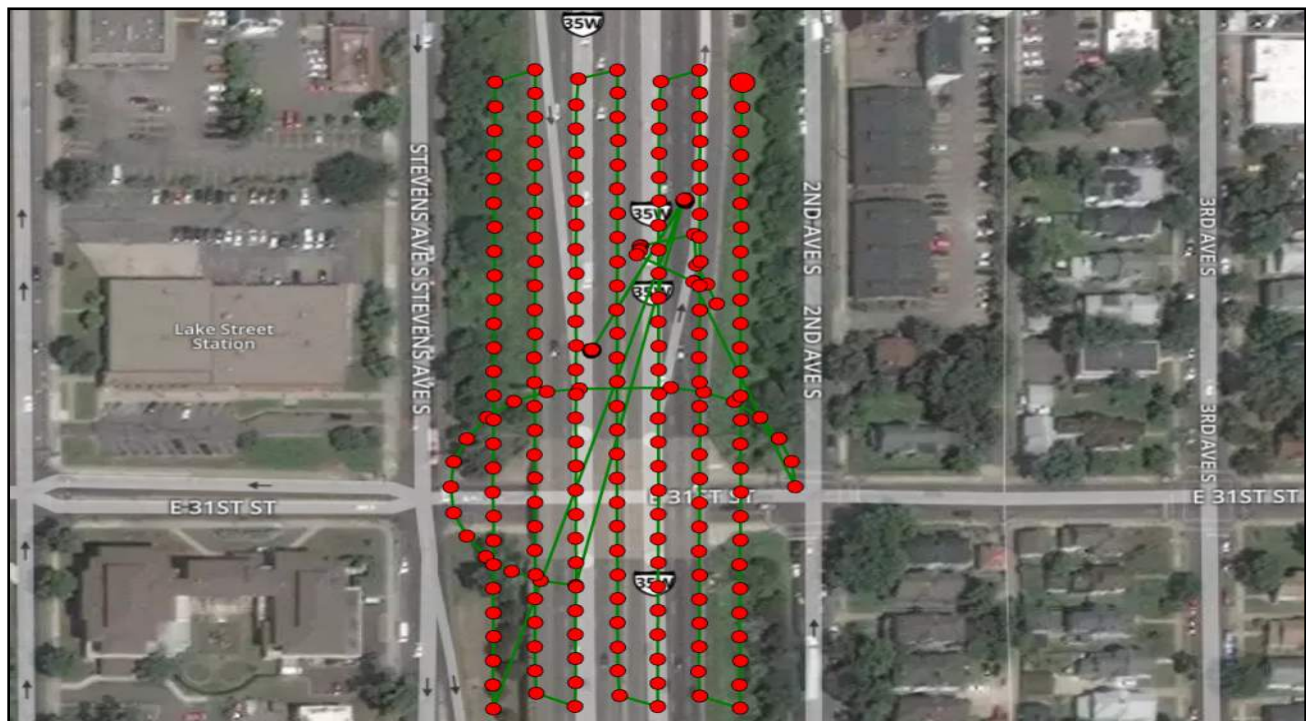
A Mapping & Photogrammetry mission using the Albris was identified for this bridge to explore the potential of UAS photography to map deck surface defects. The target goal of the mission was to gather information in the form of photographs in a quick, efficient process which could later be used to map the deck and have a post-inspection tool to aid in report writing and historical documentation. Additionally, the ease of use in an urban environment was displayed. The mission consisted of a pre-planned flight path that imaged the top of deck and both north and south fascia. The UAS collected over 156 high-resolution still images of the bridge fascia and top side. All images were geo-tagged with GPS coordinates. Refer to Images 5 and 6 for views of the corridor Flight and Mapping Mission. Additional missions were flown to determine the ability of the drone to map deck defects from different altitudes or different ground sampling distances.

Image 5: View of Mission Flight Map (Preplanned and Interactive).

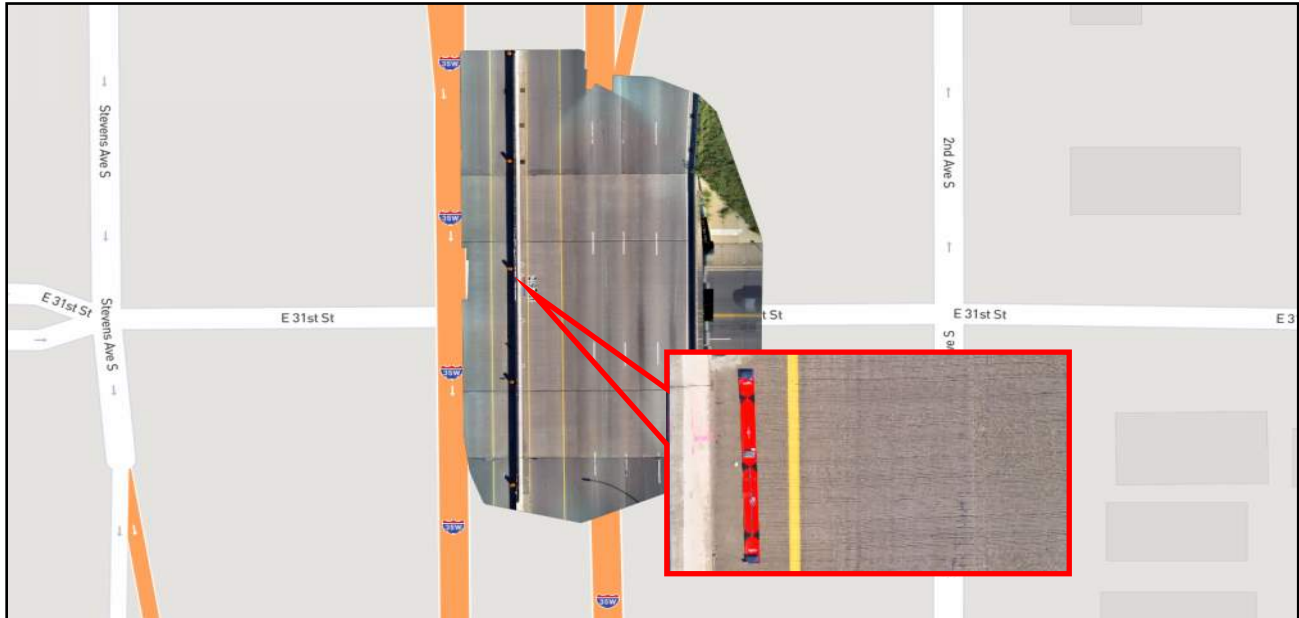
Image 7: View of the Level of Detail in a Single High-Resolution Image.

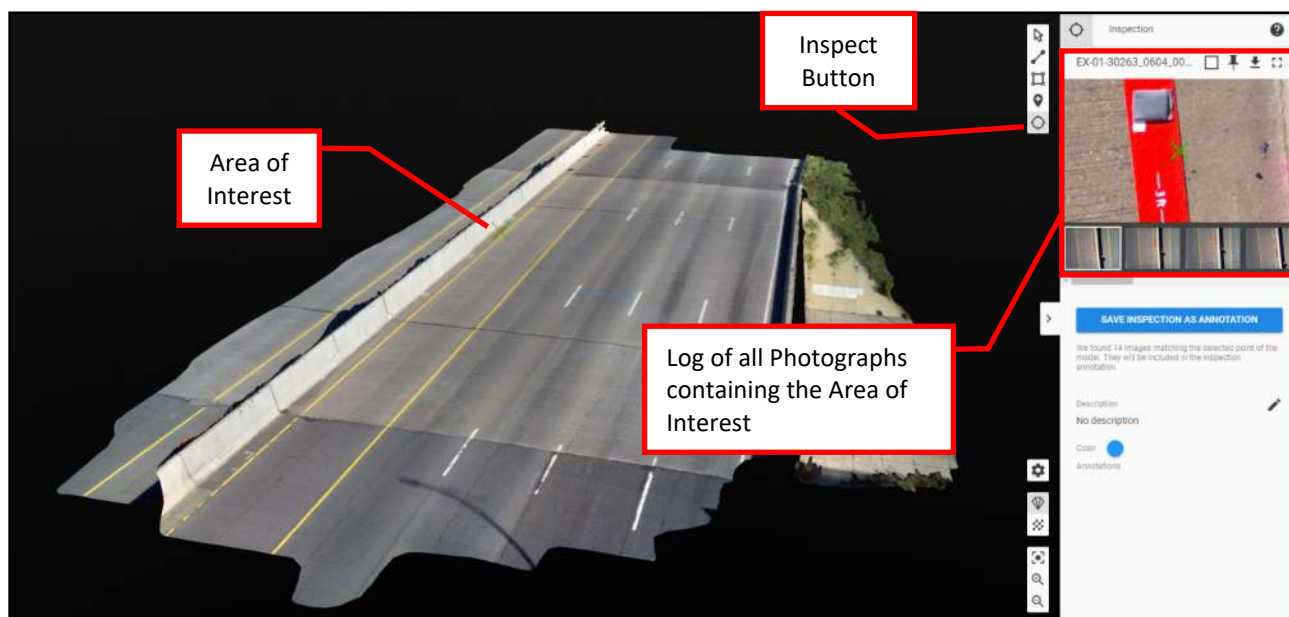
An inspector was able to use the Pix4D program to navigate the 3D model and select areas of interest. The software provides the inspector with all still images containing the selected area of interest which can then be viewed in high resolution. Additionally, the inspector can place annotations within the file for future reference or for clarification when sharing the file. Refer to Image 9 for a view of the Inspector Tool providing a Photograph Log from a selected area of the 3D model.

Image 9: View of the Inspector Tool providing a Photograph Log from a selected area of the 3D model.

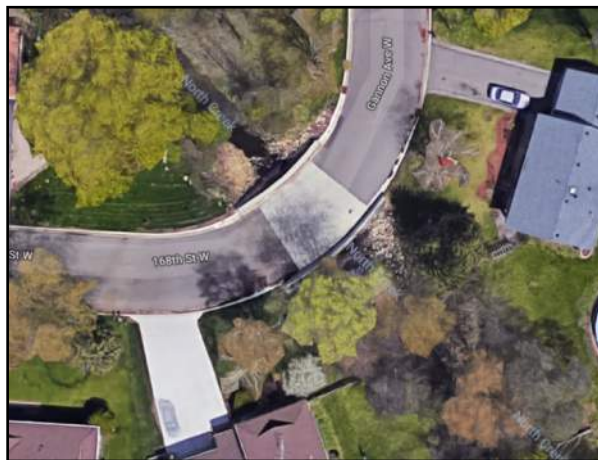
Image 2: Overall View of Bridge.

Bridge Number 19565 spans approximately 30 feet over North Creek and carries one east bound and one west bound lane of 168th St. West. The bridge deck is approximately 35.2 feet wide and consists of cast in place concrete with no wearing surface. The bridge superstructure consists of a curved reinforced concrete slab span. The longitudinal axis of the bridge is orientated approximately southwest to northeast. Refer to Images 2 for an overall view of the bridge.

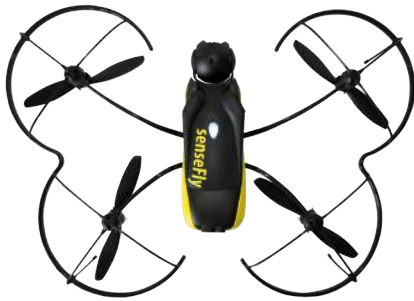
Image 4: View of SenseFly Albris

A one-person crew, consisting of a professional engineer-pilot, conducted the UAS inspection. The pilot was certified as a FAA Remote Pilot, and conducted the inspection using an Inspection and Mapping UAS. The aerial mapping UAS was a SenseFly Albris quadcopter equipped with a TripleView head consisting of a HD video camera, a 38MP still camera, and an infrared camera. Additionally, the Albris contains five acoustic sensors, GPS location, and image flow stabilization technology which aid both 3D preplanned and interactive flight missions. Refer to Image 4 for a view of the SenseFly Albris.

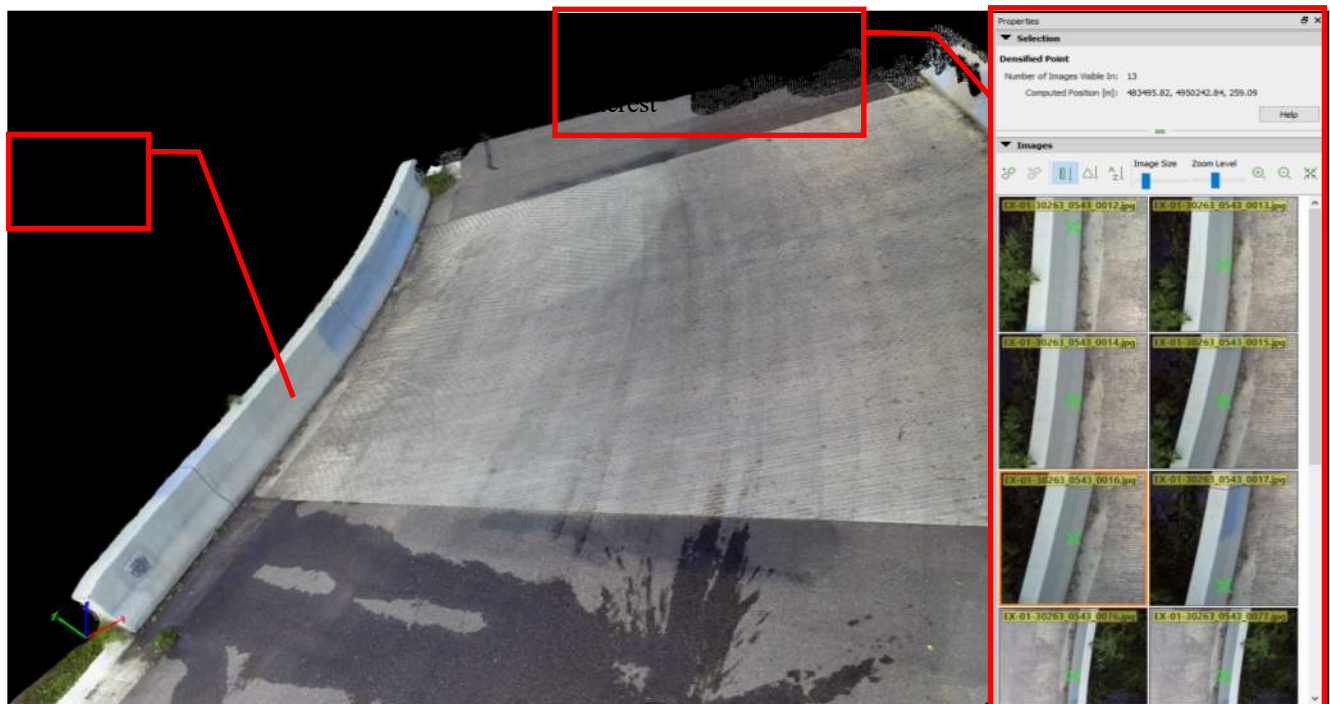
A 3D Model with a high-resolution photog log was processed for bridge. The target goal for this process was to determine the ease of use and applicability of having a 3D photolog to assist an inspector during post-processing, report writing, and future inspection. All photographs taken during the Mapping and Photogrammetry Mission were processed in the Pix4D software. The software processes all photographs to form a 3D point cloud for digital viewing. The point cloud was then processed by the same software to generate a 3D mesh of the bridge. An inspector was then able to navigate the 3D model and select areas of interest. The software provides the inspector with all still images containing the selected area of interest which can then be viewed in high resolution. Additionally, the inspector can place annotations within the file for future reference or for clarification when sharing the file. Refer to Image 7 for a view of the Inspector Tool providing a Photograph Log from a selected area of the 3D model. Bridge 19565 has some deck cracking that was measured using the 3D model. These measurements are more accurate than field measurements and the model will allow for comparison during future inspection cycles to determine if the cracks are growing or if they are stable.

Image 7: View of the Inspector Tool providing a Photo Log from a selected area of the 3D model. Note the annotated areas for future reference or ease of sharing.

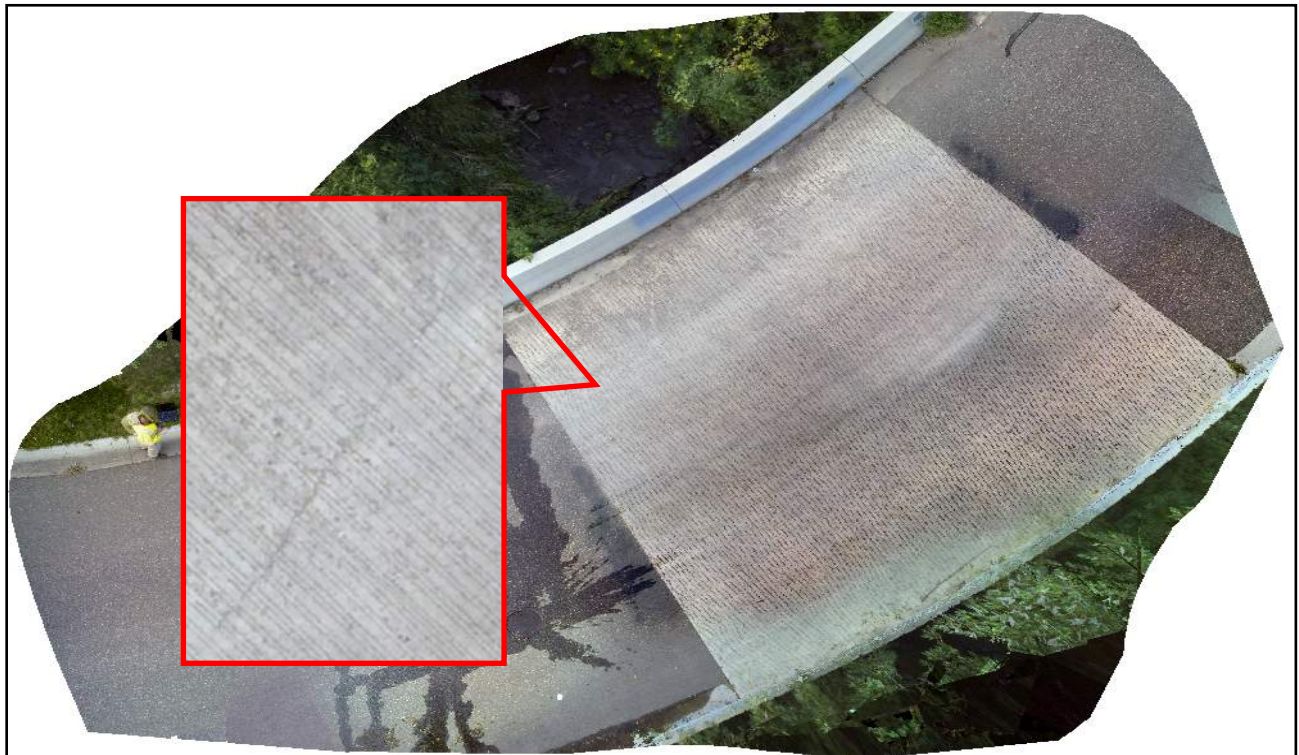
Image 8: View of the Level of Detail in an Orthomosaic Image.

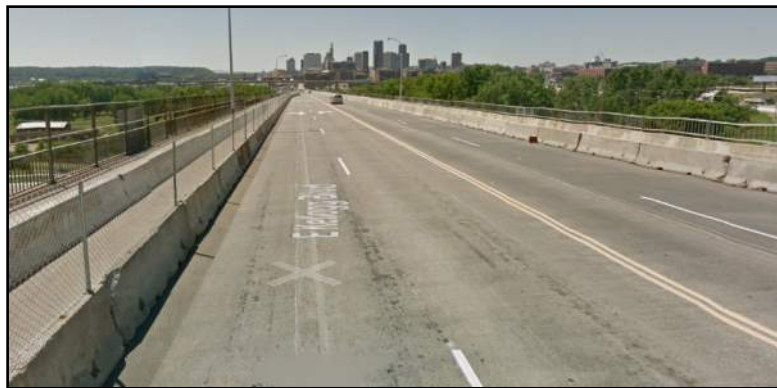
Image 2: Overall View of Bridge Topside.

Bridge Number 62080 spans approximately 1,914 feet over I-94; RR; Commercial St. and carries two westbound and two eastbound lanes of Kellogg Blvd. The bridge deck is approximately 69.3 feet wide and consists of cast in place concrete with a low slump concrete wearing surface. The bridge superstructure consists of 7 prestressed concrete girders and a cast in place concrete deck. The substructure consists of cast in place concrete abutments and pier caps on 2 rectangular columns all bearing on steel piles. The longitudinal axis of the bridge is orientated approximately northeast to southwest. Refer to Images 2 and 3 for overall views of the bridge.

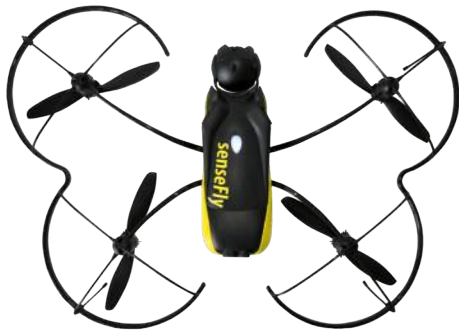
Image 4: View of SenseFly Albris.

A two-person crew, consisting of a professional engineer-pilot and inspection team leader, conducted the UAS inspection. The pilot was certified as a FAA Remote Pilot, and conducted the inspection using an Inspection and Mapping UAS. The aerial mapping UAS was a SenseFly Albris quadcopter equipped with a TripleView head consisting of a HD video camera, a 38MP still camera, and an infrared camera. Additionally, the Albris contains five acoustic sensors, GPS location, and image flow stabilization technology which aid both 3D preplanned and interactive flight missions. Refer to Image 4 for a view of the SenseFly Albris.

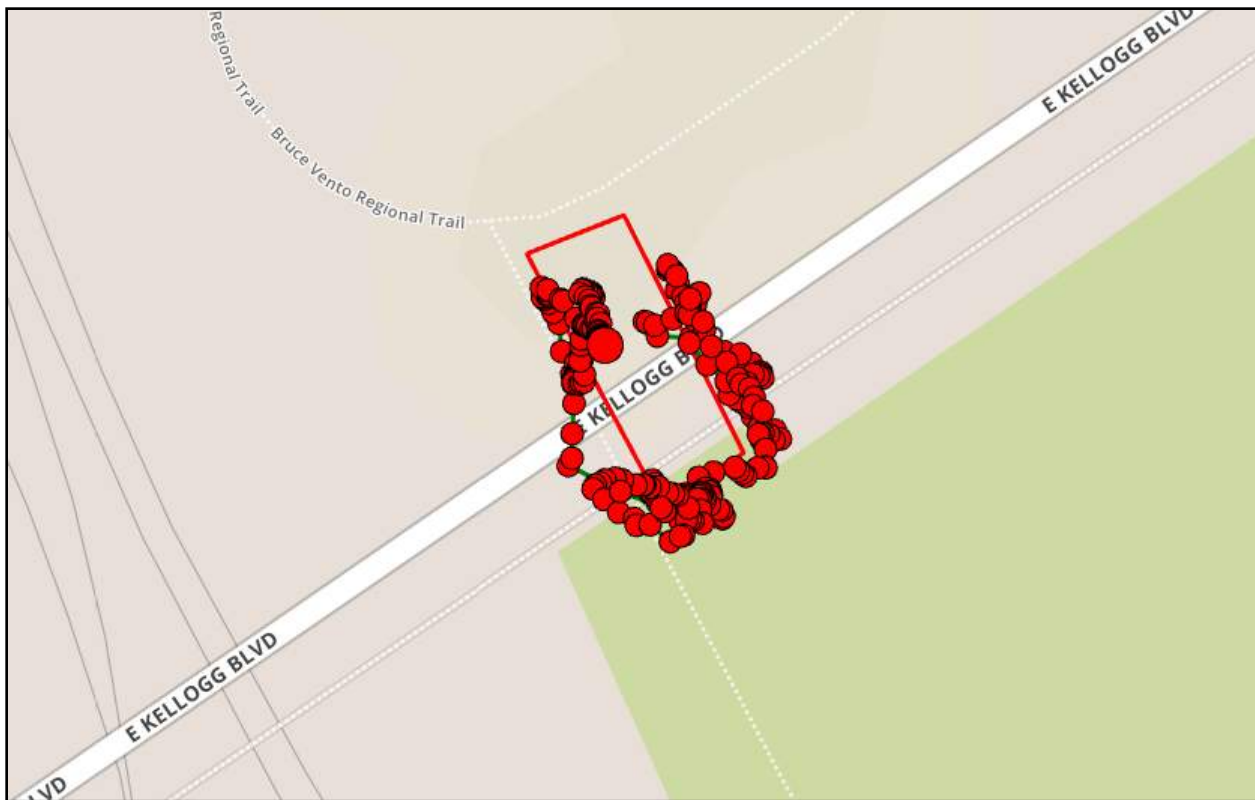
A Mapping & Photogrammetry mission using the Albris was identified for this bridge to explore the potential of UAS photography to map defects on concrete reinforced piers. The target goal of the mission was to gather information in the form of photographs in a quick, efficient process which could later be used to map the concrete deck and have a post-inspection tool to aid in report writing and historical documentation. The mission consisted of a pre-planned flight path at an elevation of approximately 50 feet or less above ground level (AGL). The UAS collected high-resolution still images of the bridge piers. All images were geo-tagged with GPS coordinates. Refer to Images 5 and 6 for views of the Flight and Mapping Mission.

Image 5: View of Mission Flight Map (Preplanned and Interactive).

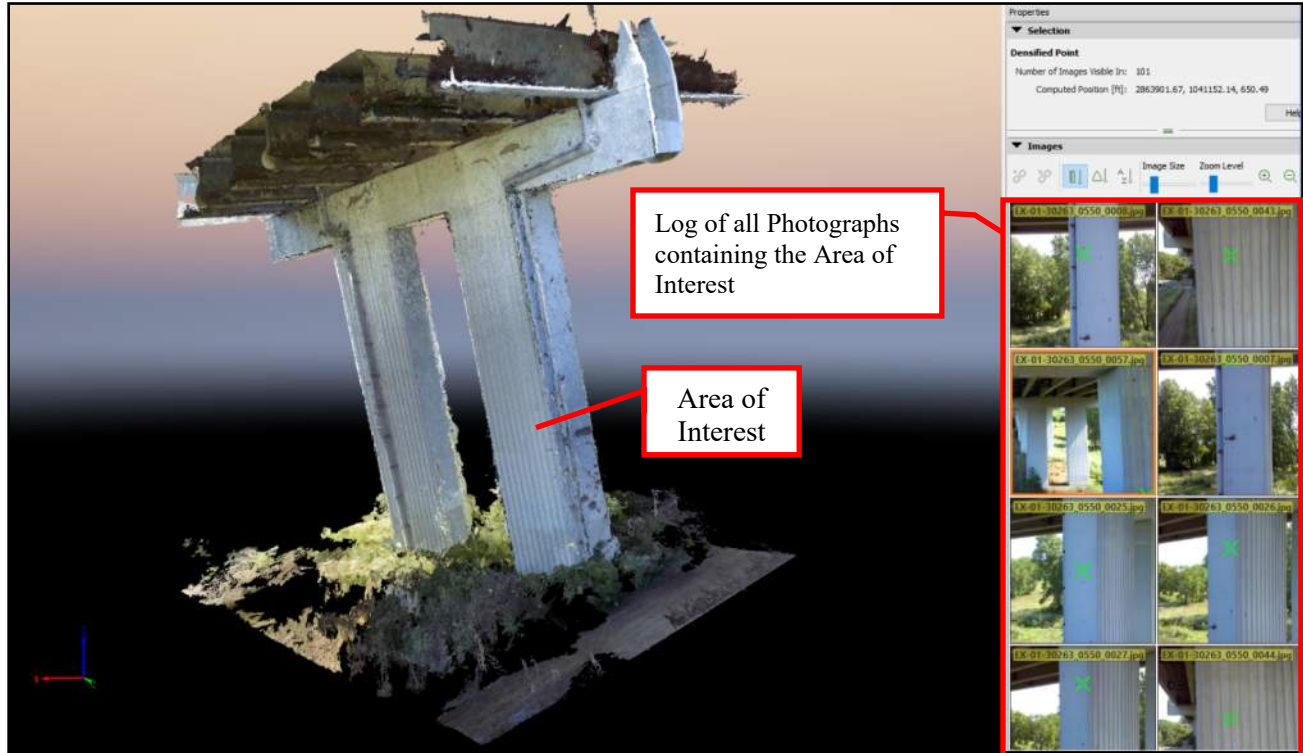
Image 7: View of the Inspector Tool providing a Photograph Log from a selected area of the 3D model. Note the annotated areas for future reference or ease of sharing.

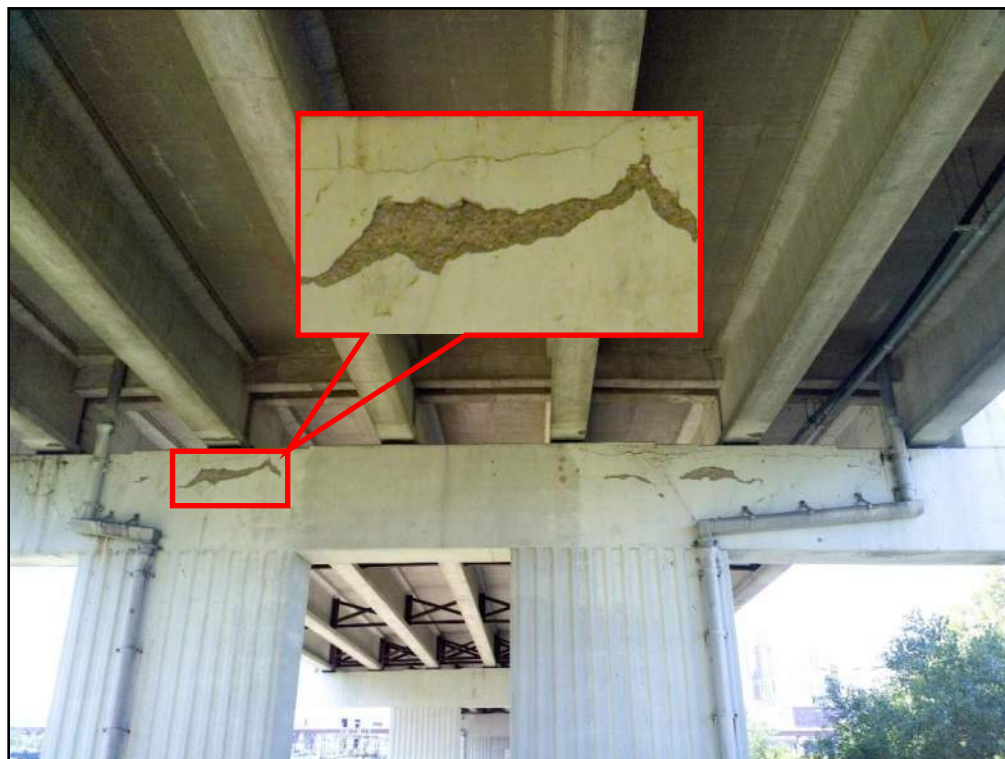
Image 8: View of the Level of Detail in a Single High-Resolution Image.
