Improving the Quality of Bridge Inspections Using Unmanned Aircraft Systems (UAS)

Barritt Lovelace, Principal Investigator
Collins Engineers, Inc.

July 2018

Research Project
Final Report 2018-26

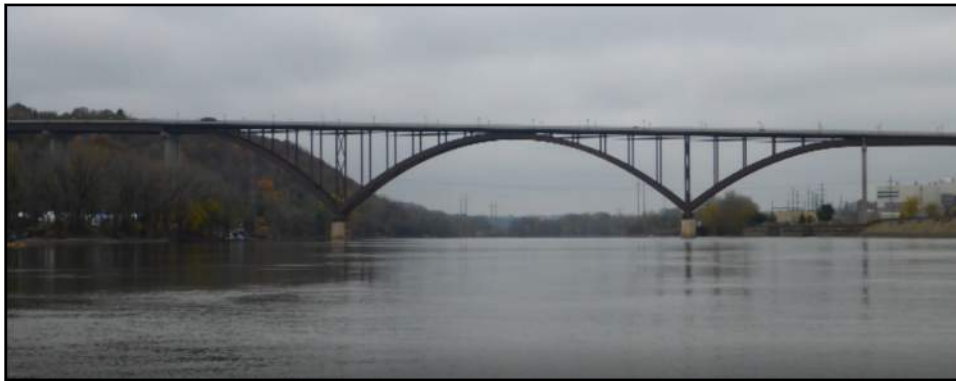
Image 2: Overall View of Bridge.

Bridge Number 62090 spans approximately 2,769 feet over the Mississippi River and carries 1 northbound and 1 southbound lane of Trunk Highway 149 (Smith Ave). The bridge deck is approximately 54 feet wide and consists of cast in place concrete with a low slump concrete wearing surface. The bridge is an 11-span continuous steel and post-tensioned, tied steel arch bridge. The substructure consists of reinforced concrete abutments and pier walls all founded on piles. The longitudinal axis of the bridge is orientated approximately northwest to southeast. Refer to Images 2 and 3 for overall views of the bridge.

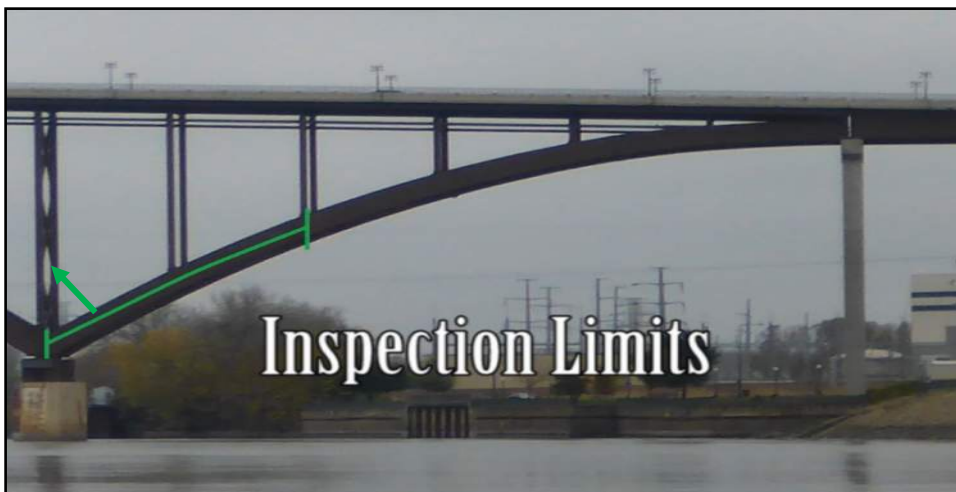
Image 3: Overall View of Bridge Underside & Inspection Limits for Steel Arch.

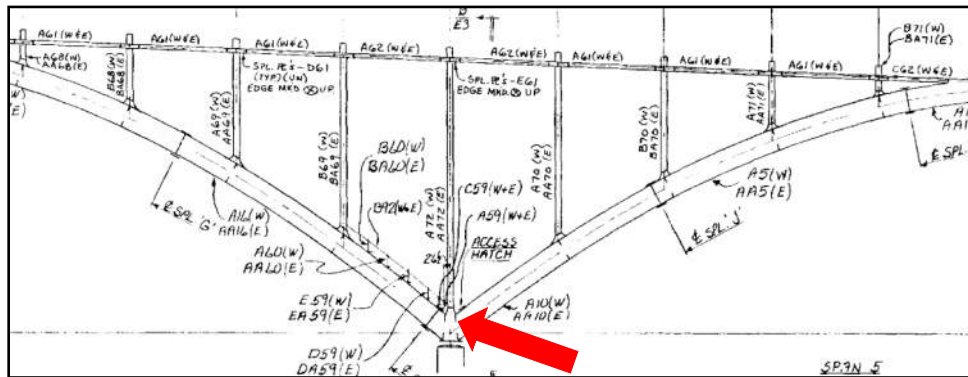
Image 5: View of Steel Arch Entrance Hatch.

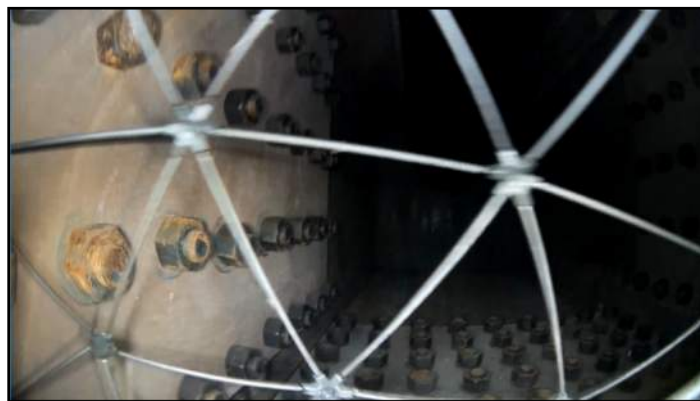
A High Definition Video Mission was conducted of limited access areas using the Elios UAS. The target goal of this mission was to determine the quality and applicability of using a Collision-Tolerant UAS to capture images and assess the condition of enclosed steel arches. These bridge elements are typically not able to be inspected efficiently by inspectors given the confined space and physical size limitations. For this Mission, the pilot accessed the inside of the arch from a hatch located near the bottom of the arch where it ties into pier number 4. Refer to Image 5 and 6 for views of the arch inspected.

Image 6: View of Elios Inspecting a Splice in the Arch.

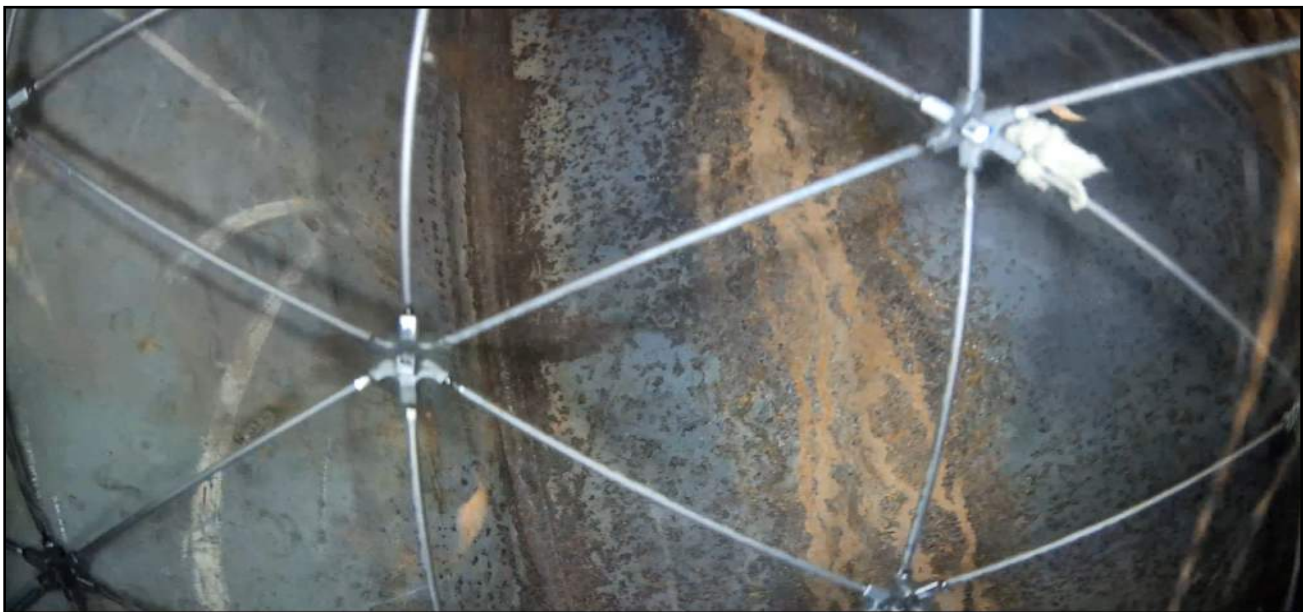
The lead pilot/inspector flew the mission in interactive live-time controlling. The live video stream was viewed throughout the inspection to provide both navigational awareness and look for areas of inspection interest. A total of seven flights were conducted through one girder line at Span 1. Each flight was progressively more thorough and inspected a longer stretch of the arch. The UAS was flown the inside at the bottom of the arches, up through the steel arch. The UAS was navigated using a combination of rolling the protective frame inside the arch walls along the floor and ceiling and free flying through the arch. The UAS used an on-board LED light for navigation to traverse its way through the arch.

Image 8: Image Clipped from Elios Inspection Video ([Click Image to play video](#)).

Video from the High Definition Video Mission using the Elios was viewed by an inspector after returning from the flight mission. The video could be observed in any software capable of playing .MP4 files. Additionally, the manufacturer of Elios, Flyability, has created an inspection software where the UASs flight log can be opened with the video file to show inspector UAS attributes such as heading, altitude, and temperature. The inspector can then maneuver their way through the video to obtain still images of defects or notable findings.

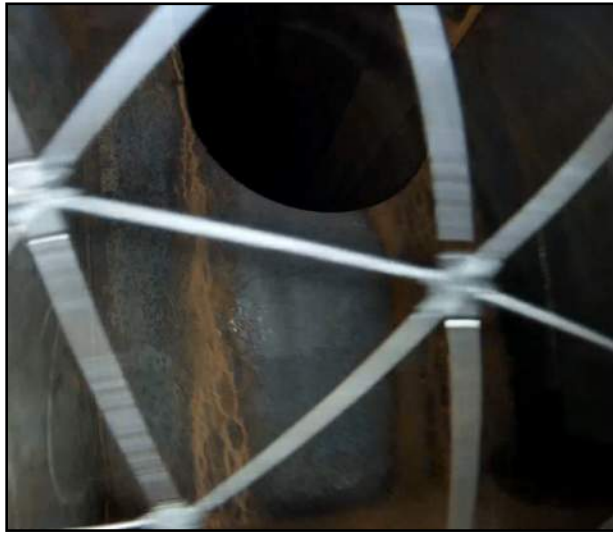
Image 9: View of Elios Inspecting an Arch Rib Section.

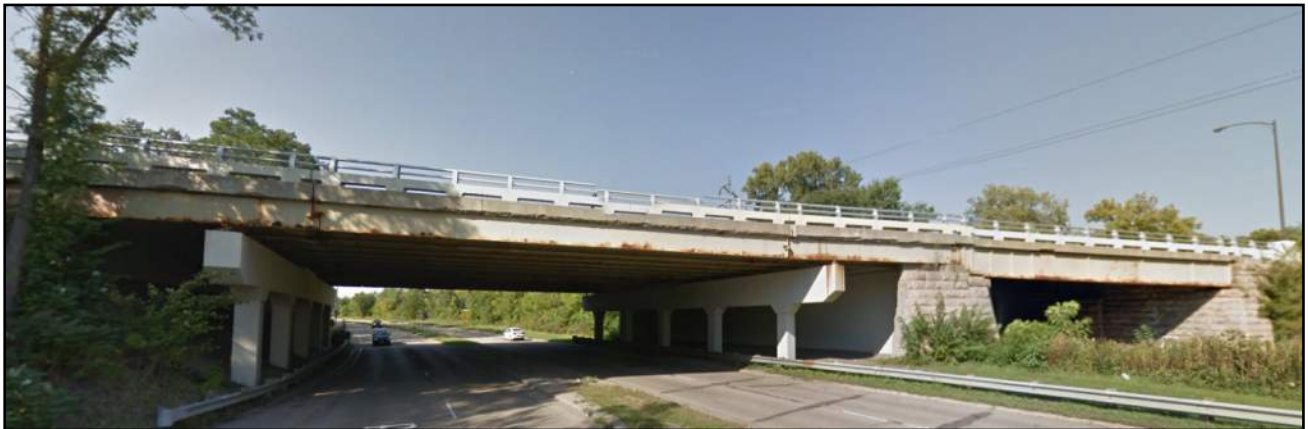
Image 2: Overall View of Bridge.

Bridge Number 62504 spans approximately 214 feet over AYD Mill Road and carries two east bound and two west bound lanes of Summit Ave. The bridge deck is approximately 101.6 feet wide and consists of cast in place concrete with a low slump concrete wearing surface. The bridge superstructure consists of sixteen continuous steel beams and the bridge substructure consists of concrete abutments and piers bearing on piles. The longitudinal axis of the bridge is orientated approximately east to west. Refer to Images 2 and 3 for overall views of the bridge.

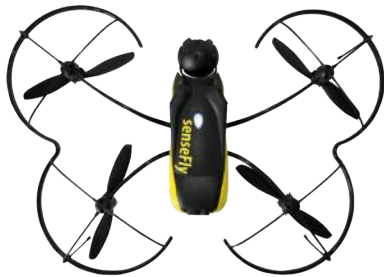
Image 4: View of SenseFly Albris.

A one-person crew, consisting of a professional engineer-pilot, conducted the UAS inspection. The pilot was certified as a FAA Remote Pilot, and conducted the inspection using an Inspection and Mapping UAS. The aerial mapping UAS was a SenseFly Albris quadcopter equipped with a TripleView head consisting of a HD video camera, a 38MP still camera, and an infrared camera. Additionally, the Albris contains five acoustic sensors, GPS location, and image flow stabilization technology which aid both 3D preplanned and interactive flight missions. Refer to Image 4 for a view of the SenseFly Albris.

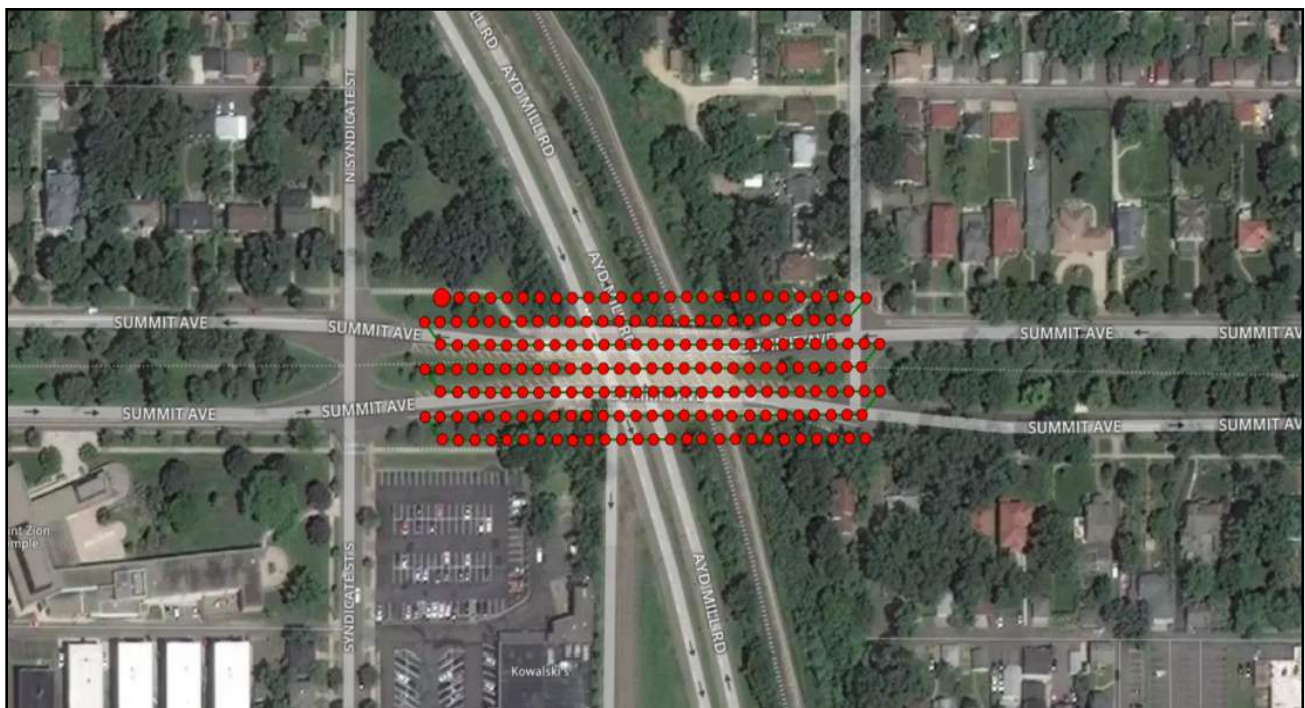
A Mapping & Photogrammetry mission using the Albris was identified for this bridge to explore the potential of UAS photography to map bituminous deck surface defects. The target goal of the mission was to gather information in the form of photographs in a quick, efficient process which could later be used to map the deck and have a post-inspection tool to aid in report writing and historical documentation. Additionally, the ease of use in an urban environment was displayed. The mission consisted of a pre-planned flight path that imaged the top of deck and both north and south fascia. The UAS collected over 192 high-resolution still images of the bridge fascia and top side. All images were geo-tagged with GPS coordinates. Refer to Images 5-7 for views of the Flight and Mapping Mission.

Image 5: View of Mission Flight Map (Preplanned and Interactive).

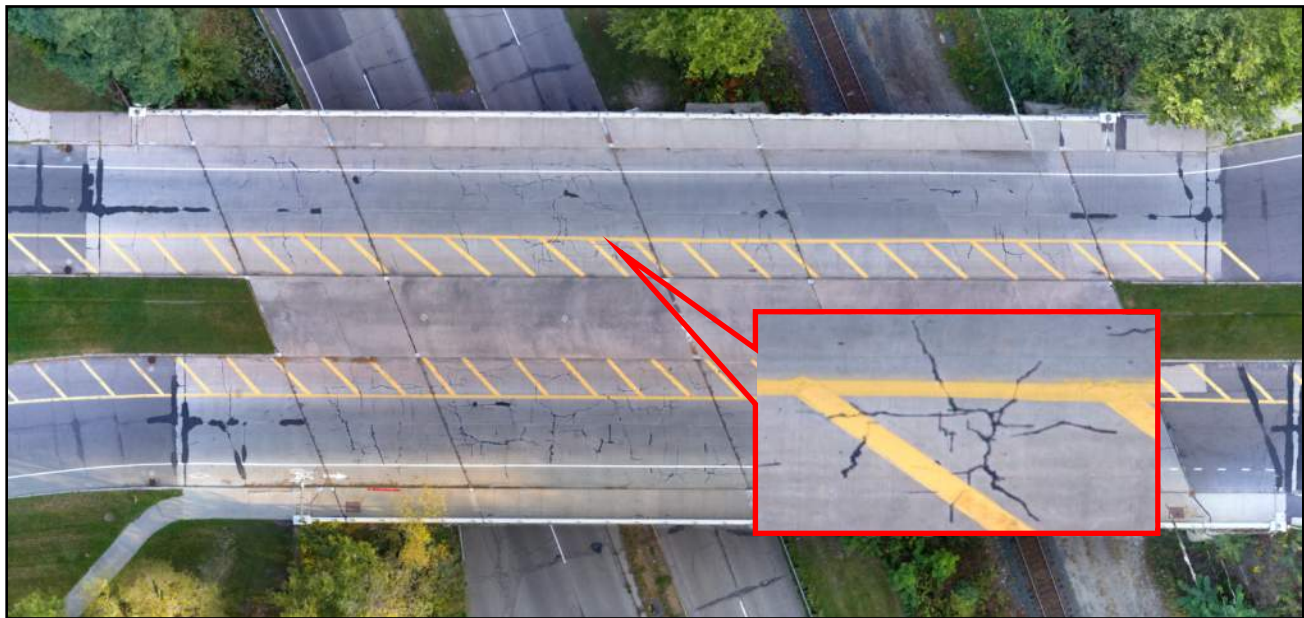
Image 8: View of the Level of Detail in a Single High-Resolution Image. [\(Click Image to Access Video\)](#)

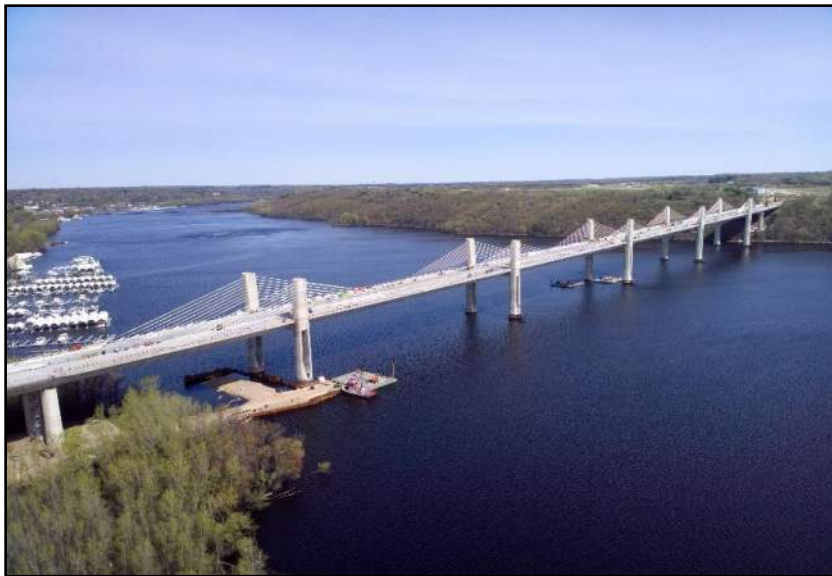
Image 2: Overall View of Bridge.

Bridge Number 82045 spans approximately 3,360 feet over the St. Croix River and carries two eastbound and two westbound lanes of Trunk Highway 36. The bridge deck is approximately 99 feet wide and is a concrete extradosed bridge. The substructure consists of reinforced concrete abutments and piers all founded on piles. The longitudinal axis of the bridge is orientated approximately northeast to southwest. Refer to Images 2 and 3 for overall views of the bridge.

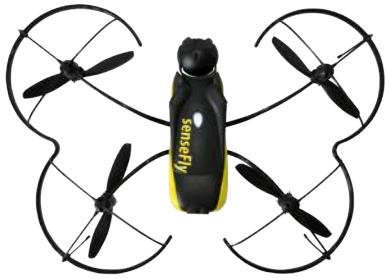
A two-person crew, consisting of a professional engineer-pilot and a field engineer, conducted the UAS inspection. The pilot was certified as a FAA Remote Pilot. The inspection was conducted using two different registered UAS's; an Inspection and Mapping UAS and an Collision-Tolerant UAS. The aerial mapping UAS was a SenseFly Albris quadcopter equipped with a TripleView head consisting of a HD video camera, a 38MP still camera, and an infrared camera. Additionally, the Albris contains five acoustic sensors, GPS location, and image flow stabilization technology which aid both 3D preplanned and interactive flight missions. The Collision-Tolerant UAS was a Flyability Elios quadcopter equipped with a full HD camera, Infrared camera, and on-board lighting system. Additionally, the Elios has a protective frame surrounding the UAS body allowing for access to tight locations and up-close imaging. Refer to Image 4 for a view of the SenseFly Albris and Image 5 for a view of the Flyability Elios.

Image 4: View of SenseFly Albris.

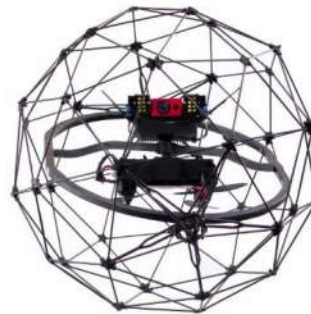
Image 5: View of Flyability Elios.

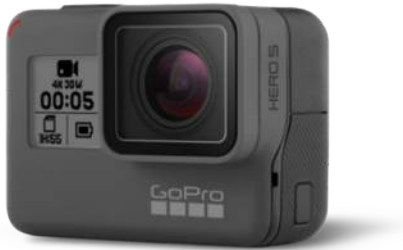
In addition to the UASs a high-resolution action camera, and a phone camera were used to capture photographs from the ground. The action camera was a GoPro Hero 5 High-Resolution Camera. The camera was equipped with a 12 Megapixel still camera and a fisheye lens. The phone camera was a Samsung Galaxy S8 with a 12MP camera and a f/1.7 lens. Refer to Image 6 for a view of the GoPro Hero 5.

Image 6: View of GoPro Hero 5.

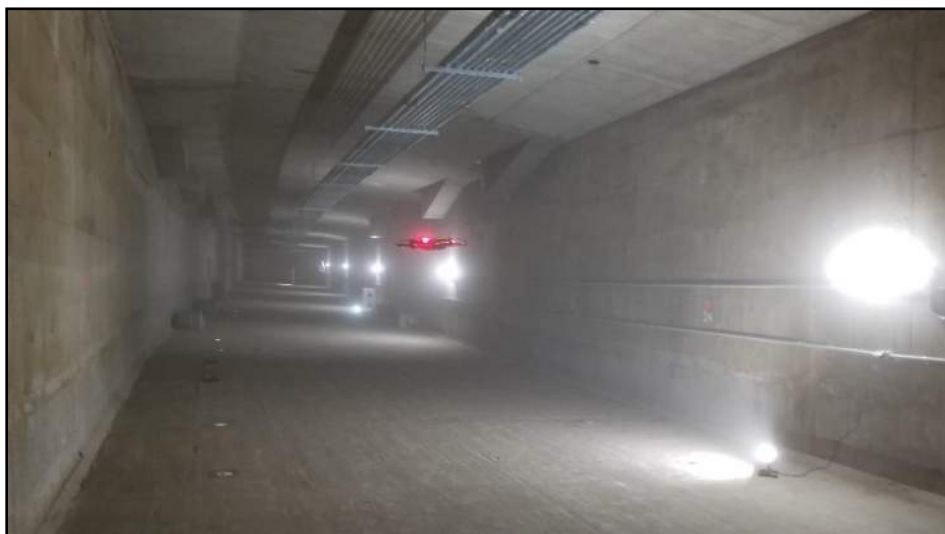
Image 8: View of Albris Gathering Detailed Photographs of Girder.

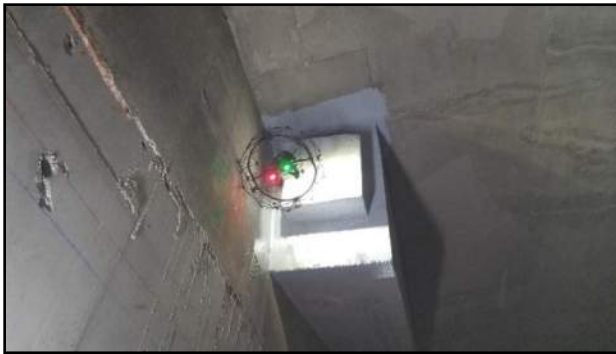
A High Definition Video Mission was conducted of limited access areas using the Elios UAS. The target goal of this mission was to determine the quality and applicability of using a Collision-Tolerant UAS to capture images and assess the condition of bridge elements which are typically not visually or tactically accessible during the scope of a routine inspection. The mission consisted of an interactive flight using only pilot controls. During a typical routine inspection, the interior of the concrete box girder and pier towers were flown. The use of the Elios UAS focuses on these difficult to access locations. An inspector can then review the video footage to look for defects or inspection findings. Refer to Images 9 and 10 for views of the Elios UAS in a difficult to access locations, and image 11 and 12 to see the full video of the Elios in action.

Image 9: View of Elios Inspecting a Hard to Reach Area.

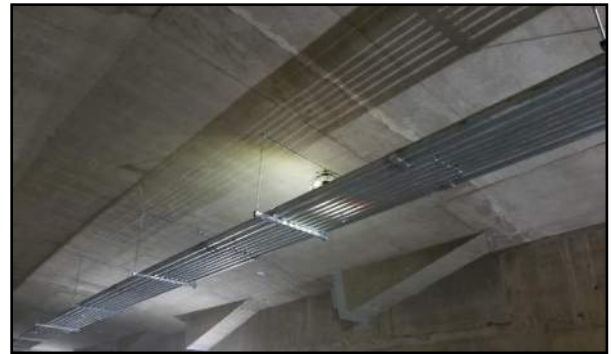
Image 10: View of Elios Inspecting a Hard to Reach Face of Girder.

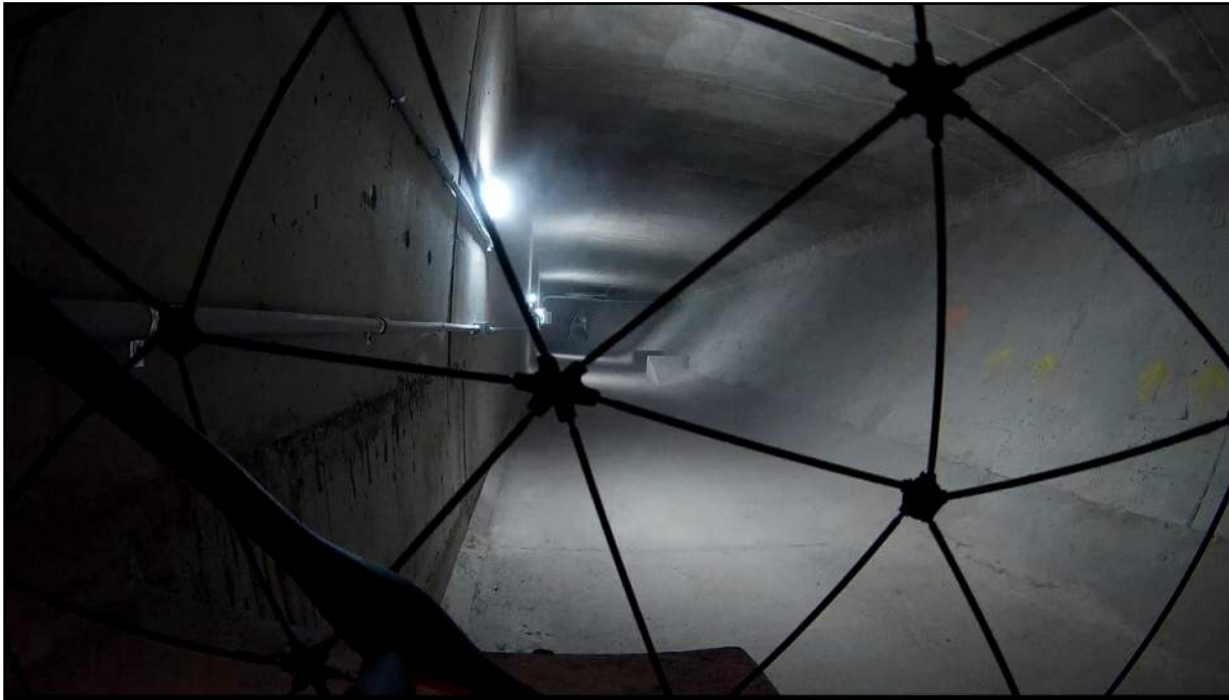
Image 11: Image Clipped from Elios Box Girder Inspection Video ([Click Image to play video](#)).

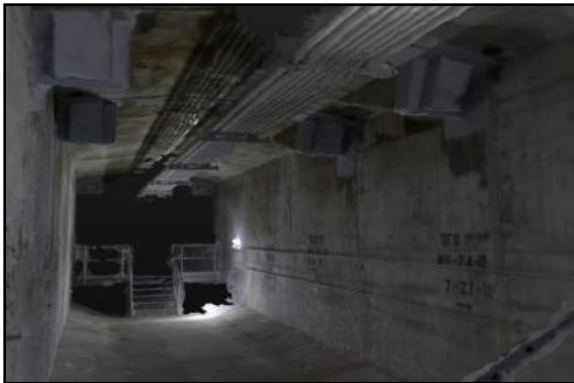
A 3D Model with a High-Resolution Photograph Log was processed for the bridge interior. The target goal for this process was to determine the ease of use and applicability of having a 3D photolog to assist an inspector during post-processing, report writing, and future inspection. All photographs taken during the Mapping and Photogrammetry Mission were processed in the Pix4D software. The software processes all photographs to form a 3D point cloud for digital viewing. The point cloud was then processed by the same software to generate a 3D mesh of the bridge. An inspector was then able to navigate the 3D model and select areas or interest. The software provides the inspector with all still images containing the selected area of interest which can then be viewed in high resolution. Additionally, the inspector can place annotations within the file for future reference or for clarification when sharing the file. Refer to Image 13 for a view of the 3D model and image 14 for an photo from the same angle.

Image 13: 3D model of the Inside of the Box Girder.
(Click Image to access 3D Model)

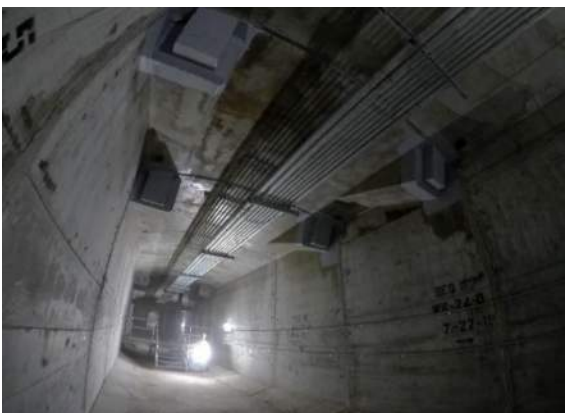
Image 14: Actual view of the Inside of the Box Girder.

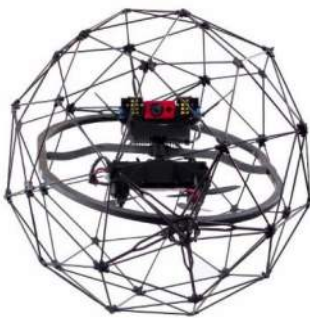
A two-person crew, consisting of a professional engineer-pilot and a field engineer, conducted the UAS inspection. The pilot was certified as a FAA Remote Pilot. The inspection was conducted using two different registered UAS's; an Inspection and Mapping UAS and an Collision-Tolerant UAS. The aerial mapping UAS was a SenseFly Albris quadcopter equipped with a TripleView head consisting of a HD video camera, a 38MP still camera, and an infrared camera. Additionally, the Albris contains five acoustic sensors, GPS location, and photo-identification stabilization technology which aid both 3D preplanned and interactive flight missions. The Collision-Tolerant UAS was a Flyability Elios quadcopter equipped with a full HD camera, Infrared camera, and on-board lighting system. Additionally, the Elios has a protective frame surrounding the UAS body allowing for access to tight locations and up-close imaging. Refer to Image 4 for a view of the SenseFly Albris and Image 5 for a view of the Flyability Elios.

Image 5: View of Flyability Elios.

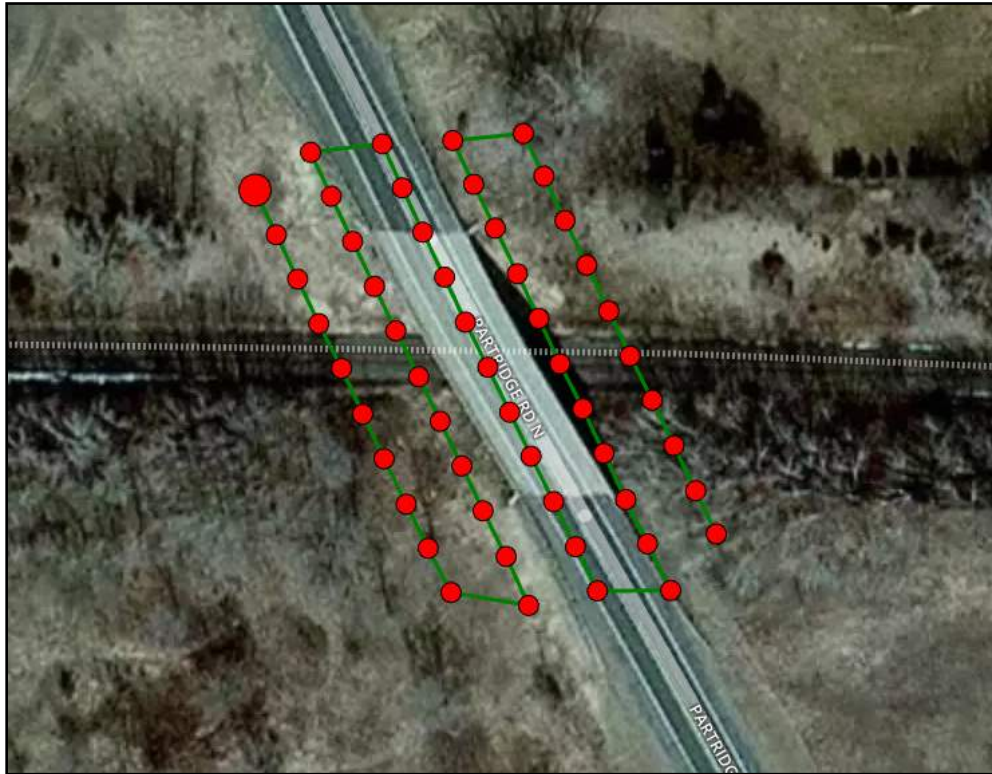
A Mapping & Photogrammetry mission using the Albris was identified for this bridge to explore the potential of UAS photography to map concrete deck surface defects. The target goal of the mission was to gather information in the form of photographs in a quick, efficient process which could later be used to map the deck and have a post-inspection tool to aid in repair plans, quantity estimation and historical documentation. Additionally, the mission was carried out in three separate sub-missions to explore the effect of quality on photograph elevation, photograph overlap, and number of photographs. The three sub-missions consisted of pre-planned flight path that imaged the top of deck from several elevations to allow for a high-resolution final product. The first sub-mission consisted of 53 high-resolution still images of the bridge topside taken from the UAS at an elevation of 105 feet above the deck surface. The second sub-mission consisted of 118 high-resolution still images of the bridge topside taken from the UAS at an elevation of approximately 50 feet above the deck surface. The third sub-mission consisted of 402 high-resolution still images of the bridge topside taken from the UAS at varying elevations ranging from 10 feet to 50 feet above the deck surface. All images were geo-tagged with GPS coordinates. Refer to Images 7 through 12 for views of the Flight and Mapping Missions.

Image 7: View of Sub-Mission 1 Flight Map.

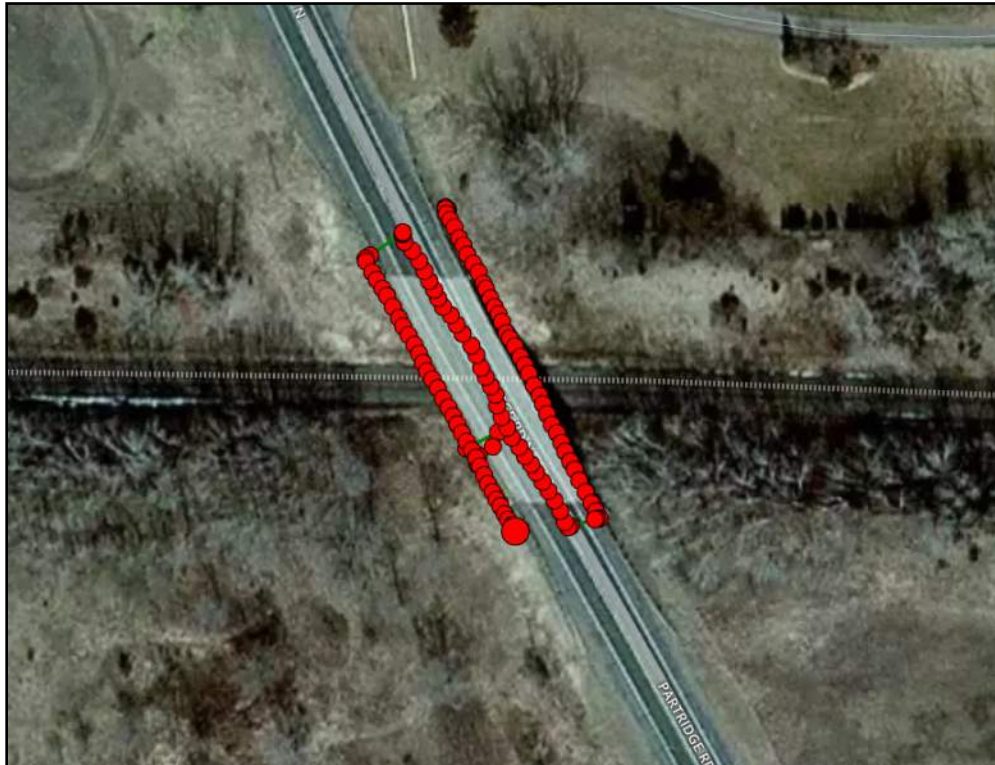
Image 9: View of Sub-Mission 2 Flight Map.

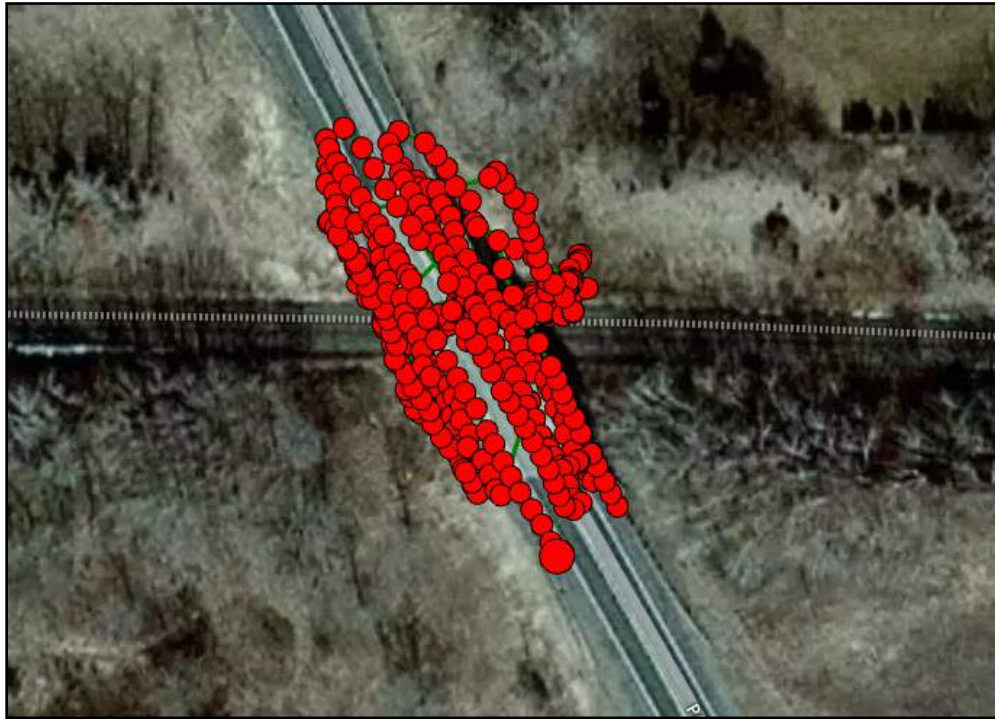
Image 11: View of Sub-Mission 3 Flight Map.

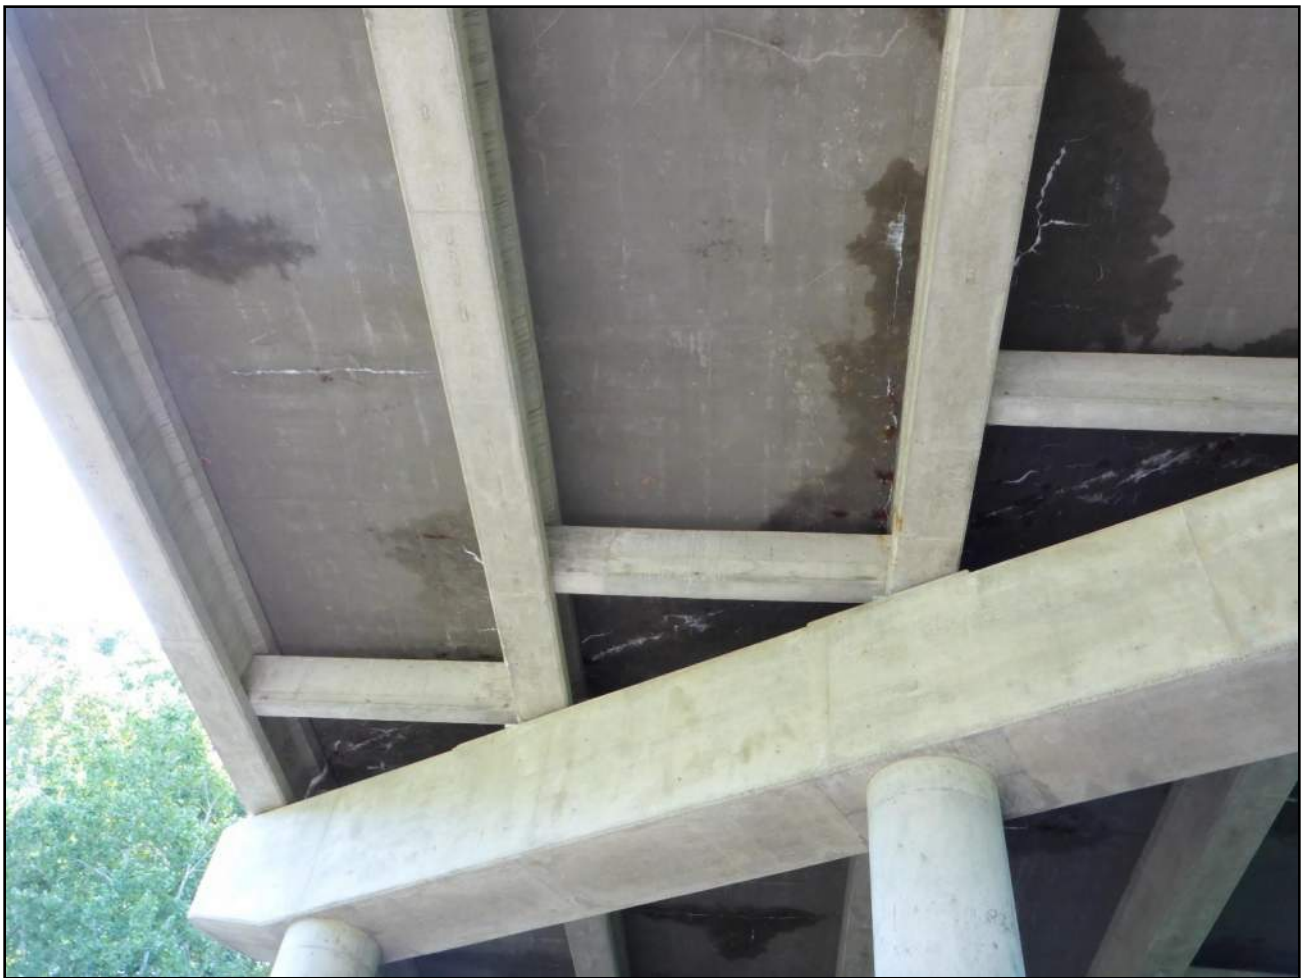
A High Definition Video Mission was conducted of limited access areas using the Elios UAS. The target goal of this mission was to determine the quality and applicability of using a Collision-Tolerant UAS to capture images and assess the condition of bridge deck underside element which is typically difficult and costly to access and not easily viewed during the scope of a special inspection. The site also tested the UASs quality of flight in open-air environments. The mission consisted of an interactive flight using only pilot controls. During a typical special inspection, the concrete deck soffit would have been difficult to access and typically require coordination of an aerial work platform. The use of the Elios UAS focuses on these hard to access locations. An inspector can then review the video footage to look for defects or findings. Refer to Image 13 and 14 for a view of different hard to access location.

Image 13: Image of Hard to Access Locations.

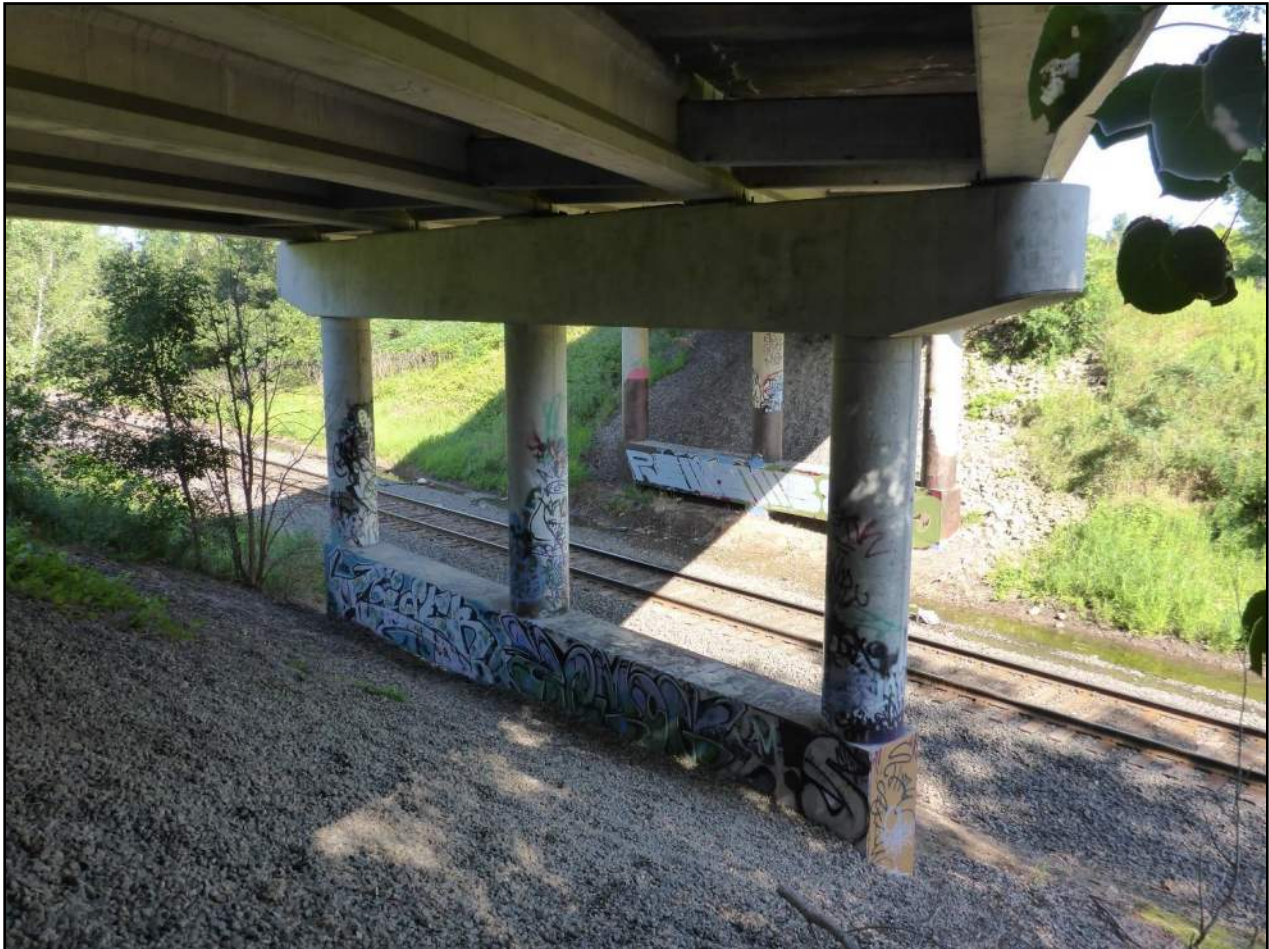
Image 14: Image of Hard to Access Locations.

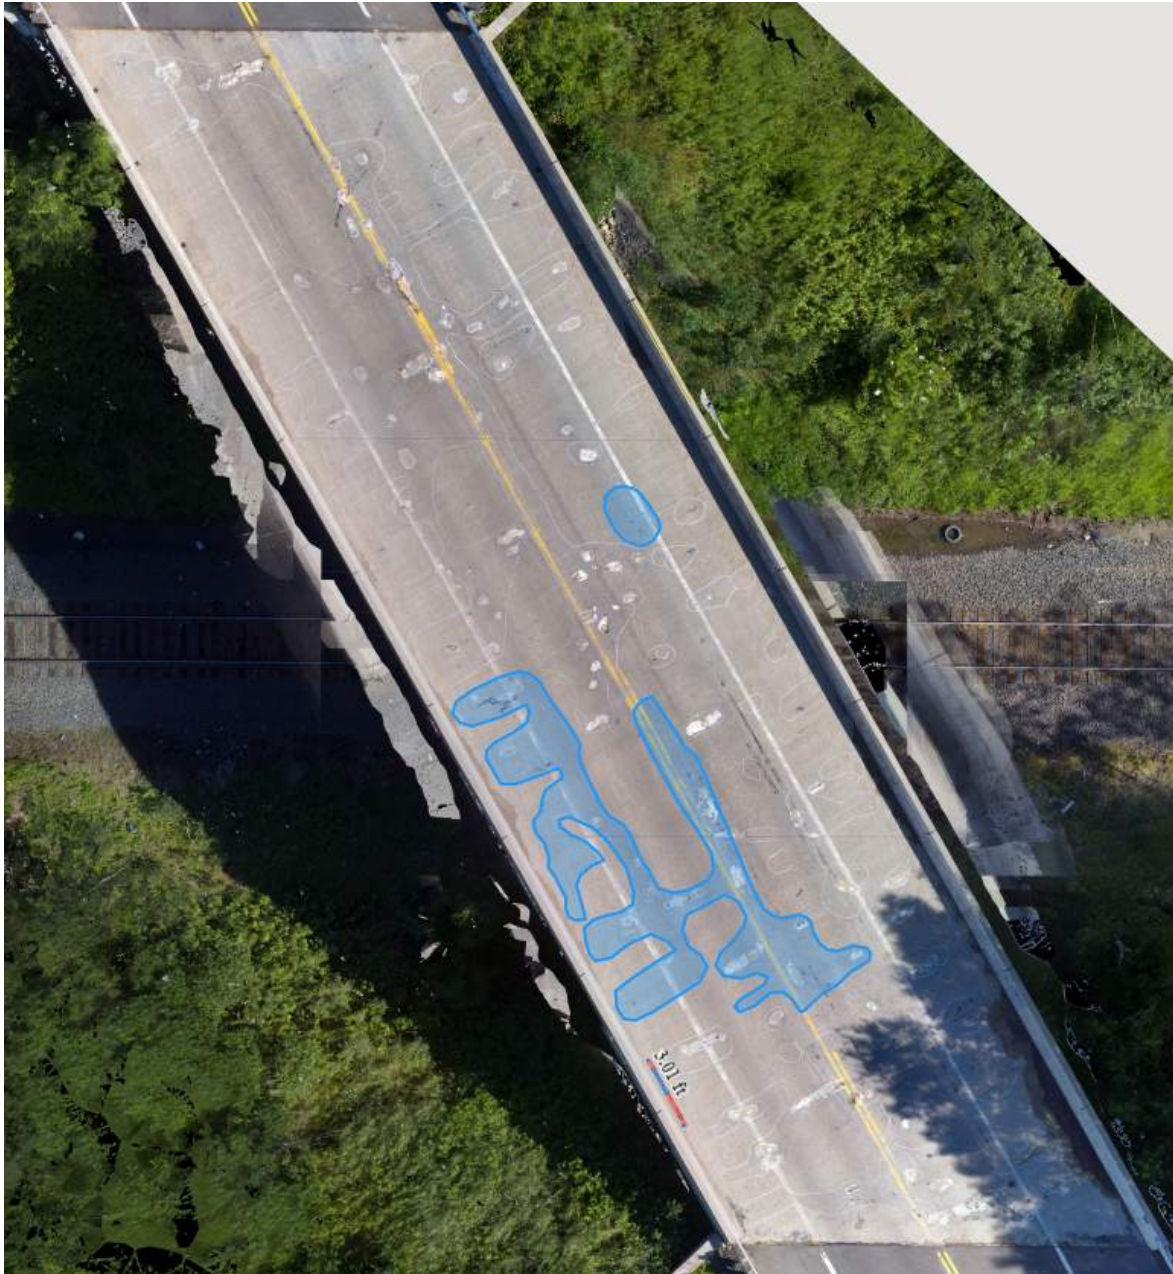
topside of the concrete deck. An inspector then reviewed the orthomosaic images and measured true distances and areas for a final product. The quality of the orthomosaic image was also compared between the three sub-missions to gain knowledge of photogrammetry techniques. Refer to Image 15 through 18 for views of Orthomosaic Detail and comparison.

Image 15: View of the Sub-Mission 3 Orthomosaic and Area measurement. [\(Click Image to Access Orthomosaic\)](#)

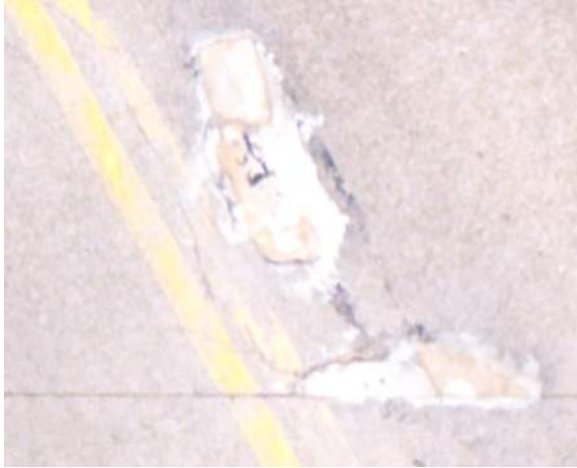
Image 16: View of the Sub-Mission 1 Orthomosaic detail.

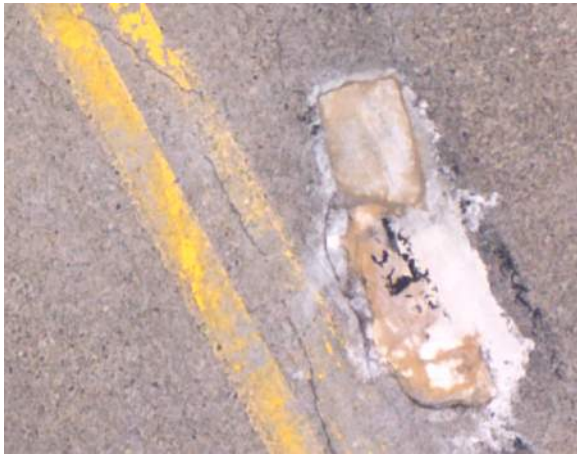
Image 17: View of the Sub-Mission 2 Orthomosaic detail.

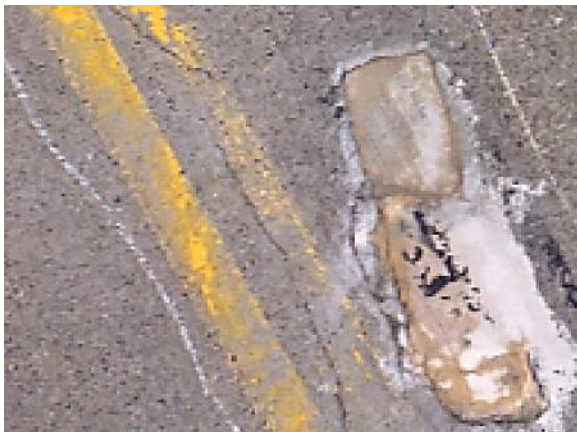
Image 18: View of the Sub-Mission 3 Orthomosaic detail.

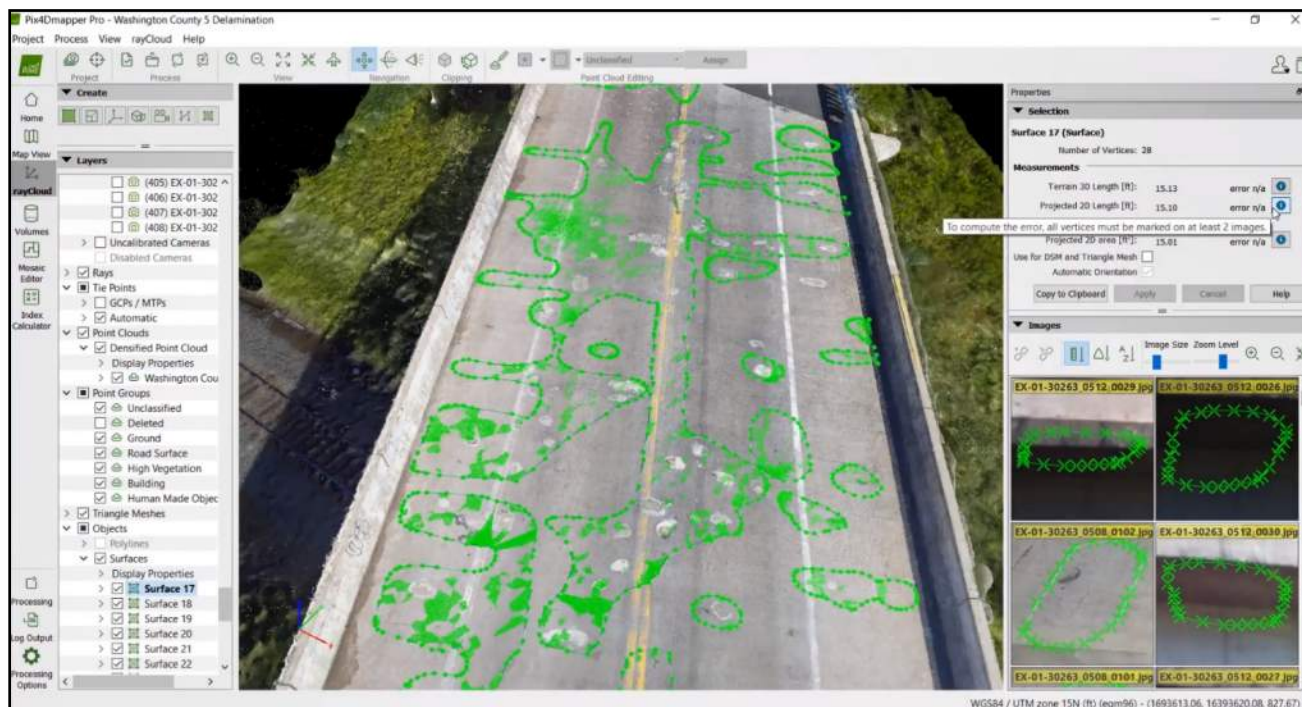
An inspector was able to use the Pix4D program to navigate the 3D model and select areas of interest. The software provides the inspector with all still images containing the selected area of interest which can then be viewed in high resolution. Additionally, the inspector can place annotations or measurements areas in the model for design plans, further detailed inspection or construction documents. Refer to Image 19 for a view of the Inspector Tool providing a Photograph Log from a selected area of the 3D model.

Image 19: View of the Model a Photograph Log from a selected area of the 3D model. [\(Click Image to access Video\)](#)

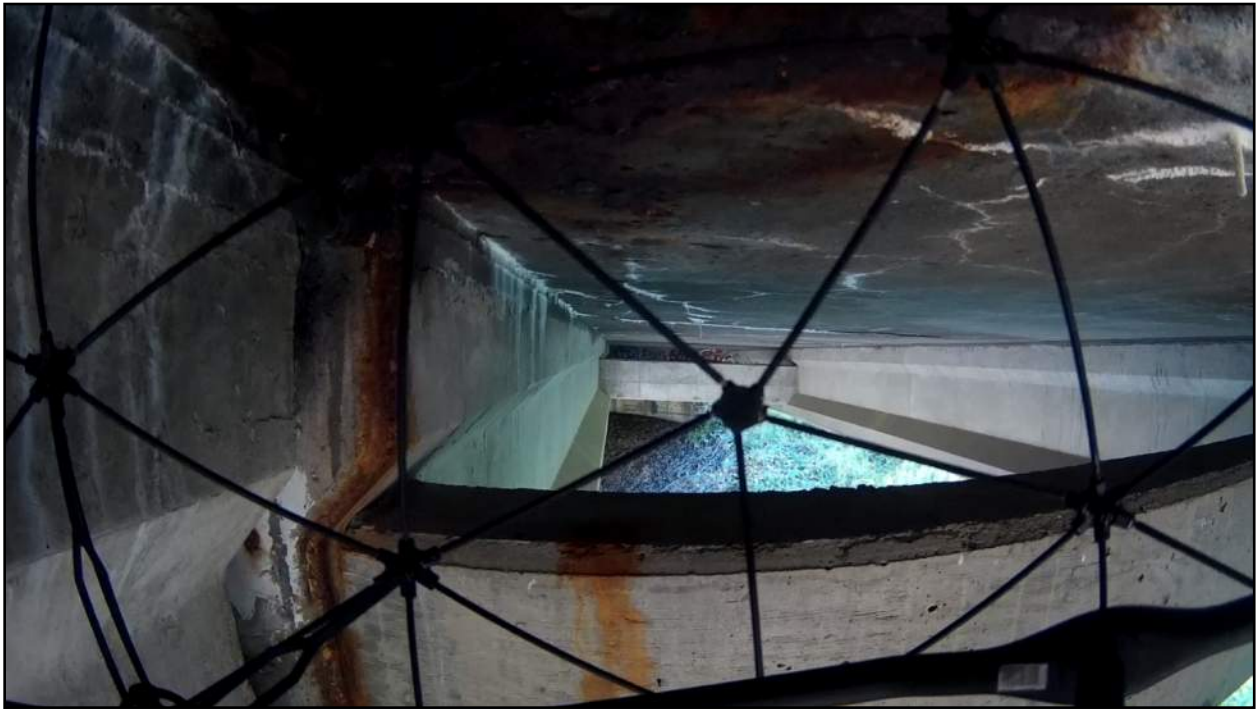
Video from the High Definition Video Mission using the Elios was viewed by an inspector after returning from the flight mission. The video could be observed in any software capable of playing .MP4 files. Additionally, the manufacturer of Elios, Flyability, has created an inspection software where the UASs flight log can be opened with the video file to show inspector UAS attributes such as heading, altitude, and temperature. The inspector can then maneuver their way through the video to obtain still images of defects or notable findings. General areas of deterioration, specific types of deterioration, and extent could all be observed through the video. These results could be used in conjunction with the topside survey to determine overall deck condition. Refer to Image 20 below to watch the Elios in action.

Image 20: View of a Screenshot from the Elios Interactive Flight Mission. [\(Click Image to access Video\)](#)

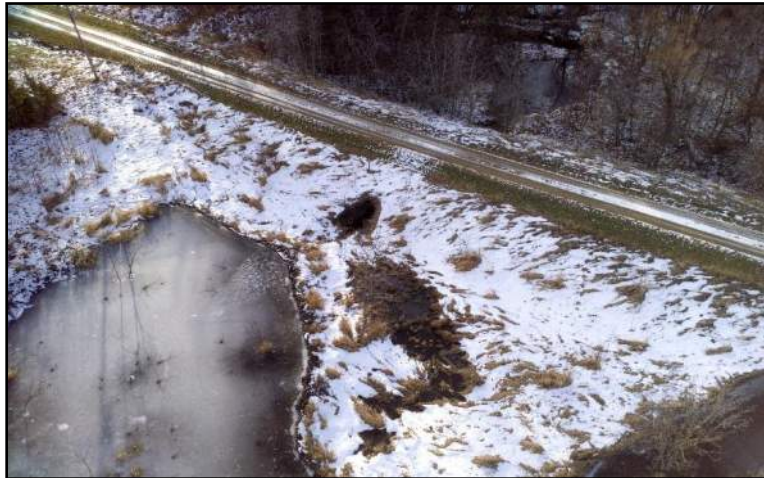
Bridge Number 97649 is a precast pipe arch that carries Meadow Creek under TWP 398 and spans 10 feet along the roadway. The 122" x 77" culvert lies 4 feet below the roadway covered by a gravel wearing surface. The longitudinal axis of the bridge is orientated approximately north to south. Refer to Images 2 and 3 for overall views of the bridge.

Image 2: Overall View of Culverts Topside.

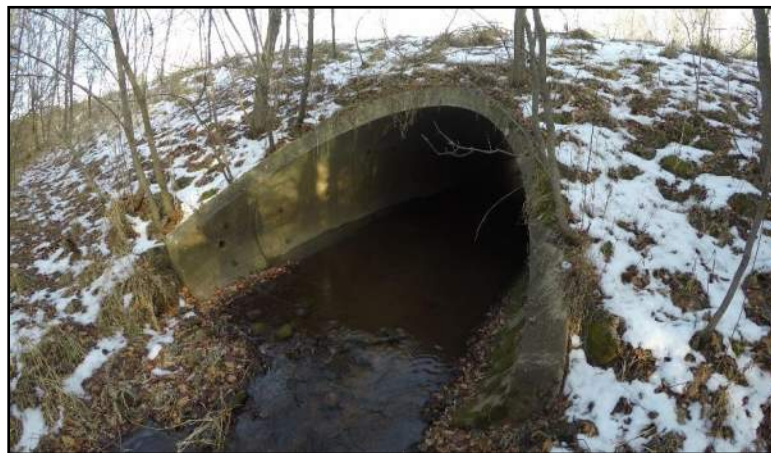
Image 3: View of Culverts East Entrance.

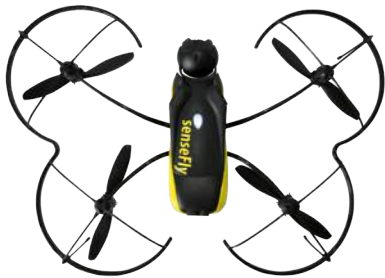
A one-person crew, consisting of a professional engineer-pilot, conducted the UAS inspection. The pilot was certified as a FAA Remote Pilot. The inspection was conducted using an aerial mapping UAS called the SenseFly Albris quadcopter which is equipped with a TripleView head consisting of a HD video camera, a 38MP still camera, and an infrared camera. Additionally, the Albris contains five acoustic sensors, GPS location, and photo-identification stabilization technology which aid both 3D preplanned and interactive flight missions. The action camera was a GoPro Hero 5 High-Resolution Camera. The camera was equipped with a 12 Megapixel still camera and a fisheye lens. Refer to Image 4 for a view of the SenseFly Albris and Image 5 for a view of the GoPro Hero 5.

Image 4: View of SenseFly Albris.

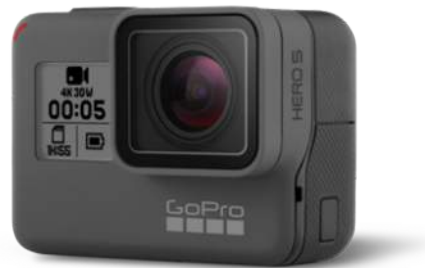
Image 5: View of GoPro Hero 5.
