Improving the Quality of Bridge Inspections Using Unmanned Aircraft Systems (UAS)

Barritt Lovelace, Principal Investigator
Collins Engineers, Inc.

July 2018

Research Project
Final Report 2018-26

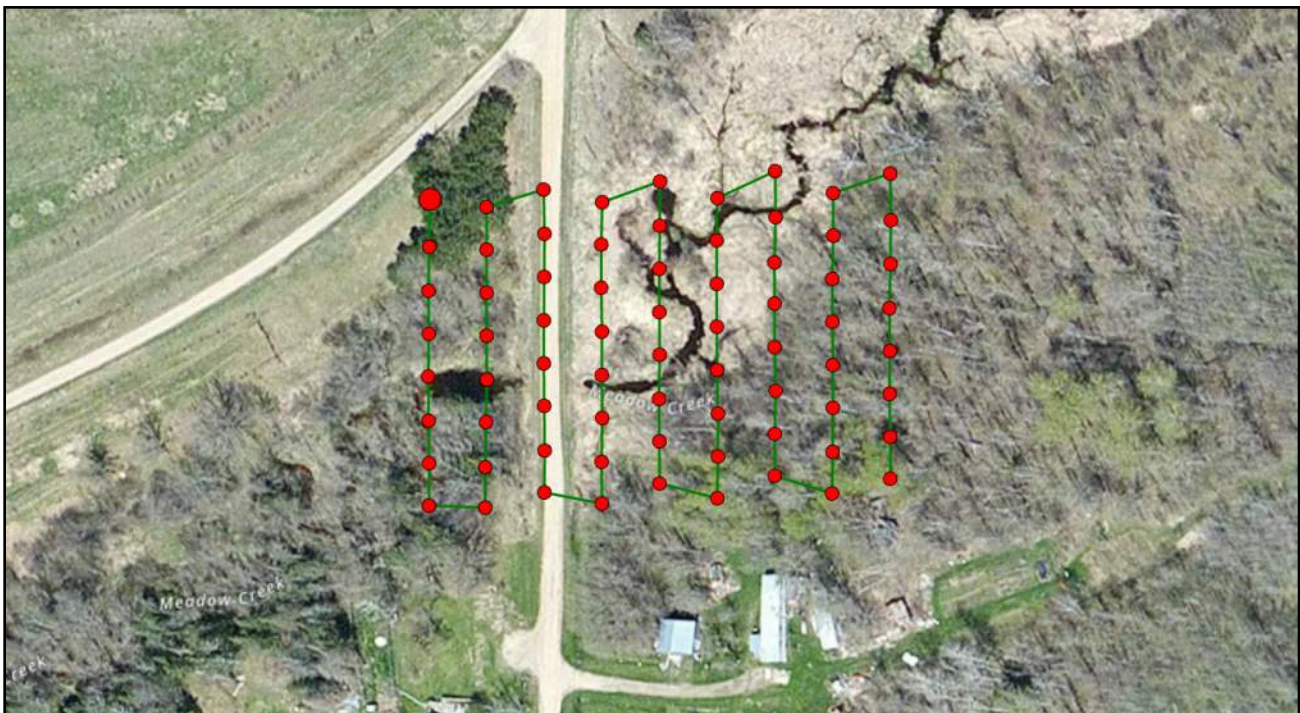
A Mapping & Photogrammetry mission using the Albris was identified for this bridge to explore the potential of UAS photography to map the culvert structure along with the surrounding water channel. The target goal of the mission was to gather information in the form of photographs in a quick, efficient process which could later be used to map the structure/channel and have a post-inspection tool to aid in report writing and historical documentation. The mission consisted of a pre-planned flight path at an elevation of approximately 180 feet above ground level (AGL). The UAS collected over 72 high-resolution still images of the bridge fascia and top side. All images were geo-tagged with GPS coordinates. Refer to Images 6 and 7 for views of the Flight and Mapping Mission.

Image 6: View of Mission Flight Map (Preplanned and Interactive).

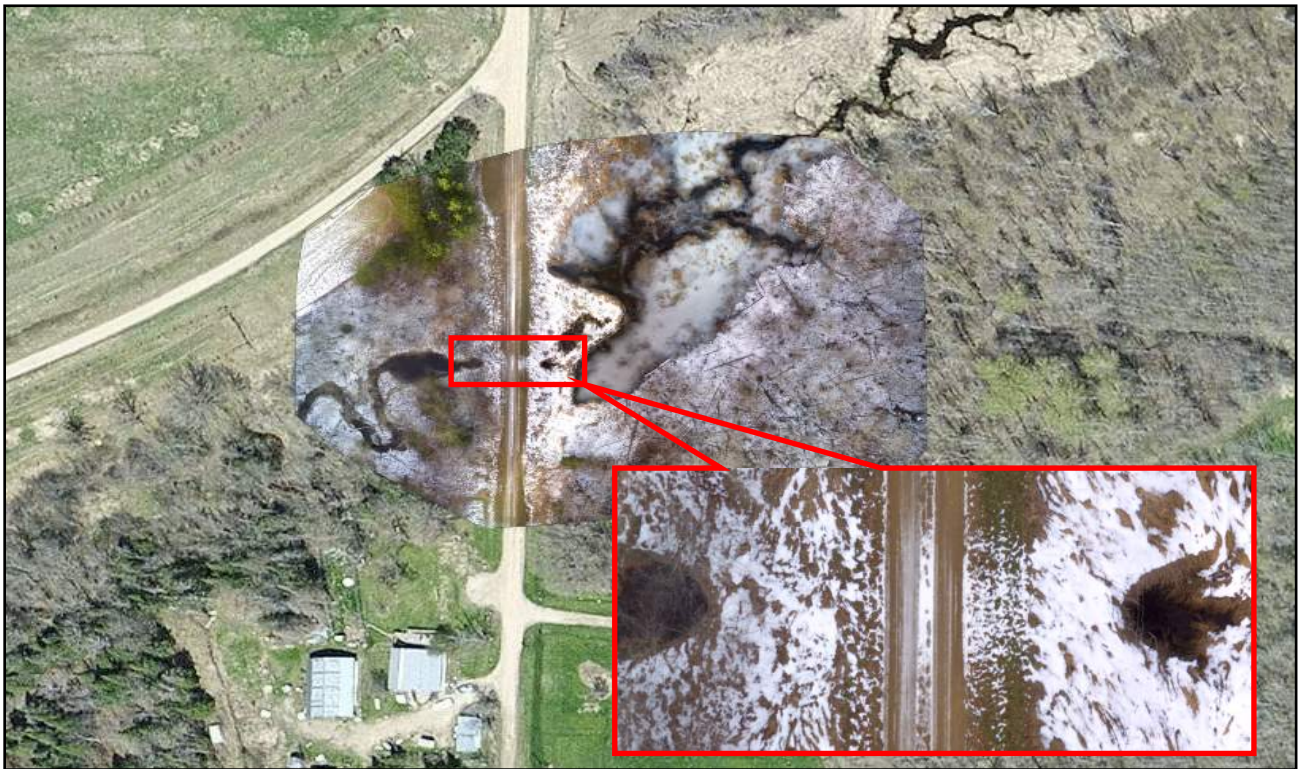
Image 10: View of the Orthomosaic Image Generated Using Pix4d Software. [\(Click Image to access Model\)](#)

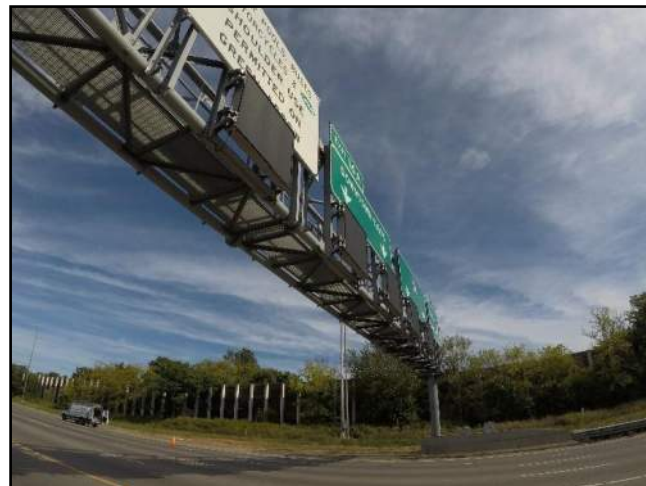
The overhead sign spans approximately 169 feet over highway I-35W. The structure is a 6 feet wide steel truss supported on two steel columns bearing on concrete foundations. The longitudinal axis of the structure is orientated approximately east to west. Refer to Images 2 and 3 for overall views of the bridge.

Image 3: Overall View of Gantry Underside.

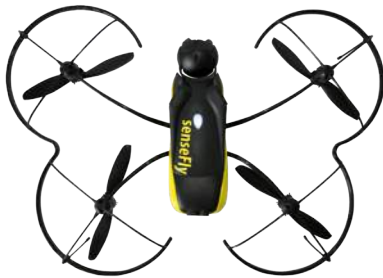
A one-person crew, consisting of a professional engineer-pilot, conducted the UAS inspection. The pilot was certified as a FAA Remote Pilot, and conducted the inspection using an Inspection and Mapping UAS. The aerial mapping UAS was a SenseFly Albris quadcopter equipped with a TripleView head consisting of a HD video camera, a 38MP still camera, and an infrared camera. Additionally, the Albris contains five acoustic sensors, GPS location, and photo-identification stabilization technology which aid both 3D preplanned and interactive flight missions. The action camera was a GoPro Hero 5 High-Resolution Camera. The camera was equipped with a 12 Megapixel still camera and a fisheye lens. Refer to Image 4 for a view of the SenseFly Albris and Image 5 for a view of the GoPro Hero 5.

Image 4: View of SenseFly Albris.

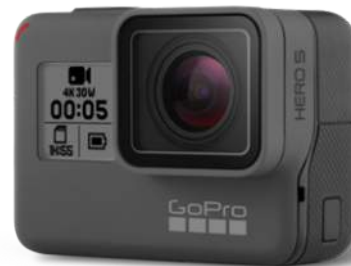
Image 5: View of GoPro Hero 5.

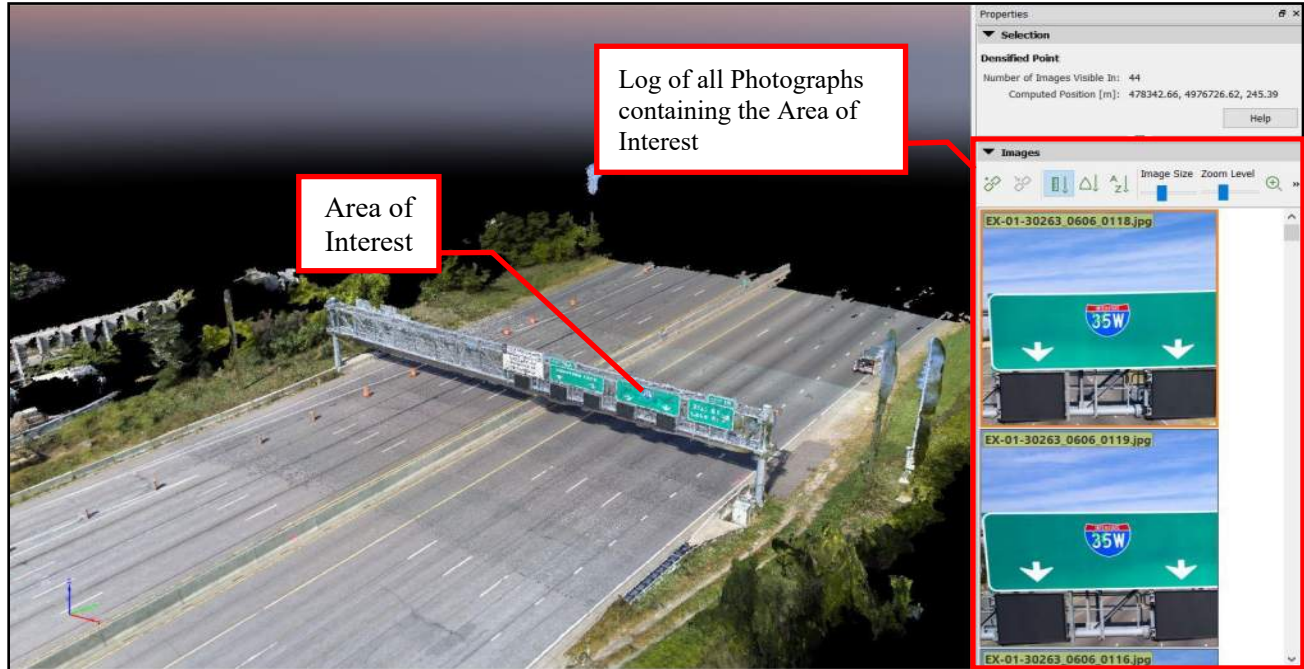
Image 8: View of the Inspector Tool providing a Photograph Log from a selected area of the 3D model. Note the annotated areas for future reference or ease of sharing.

A 3D Model with a High-Resolution Photograph Log was processed for the sign structure. The target goal for this process was to determine the ease of use and applicability of having a 3D photolog to assist an inspector during post-processing, report writing, and future inspection. All photographs taken during the Mapping and Photogrammetry Mission were processed in the Pix4D software. The software processes all photographs to form a 3D point cloud for digital viewing. The point cloud was then processed by the same software to generate a 3D mesh of the structure. An inspector was then able to navigate the 3D model and select areas of interest. The software provides the inspector with all still images containing the selected area of interest which can then be viewed in high resolution. Additionally, the inspector can place annotations within the file for future reference or for clarification when sharing the file. Refer to Image 8 for a view of the Inspector Tool providing a Photograph Log from a selected area of the 3D model, and Image 9 for a view of the detail included in the photo logs.

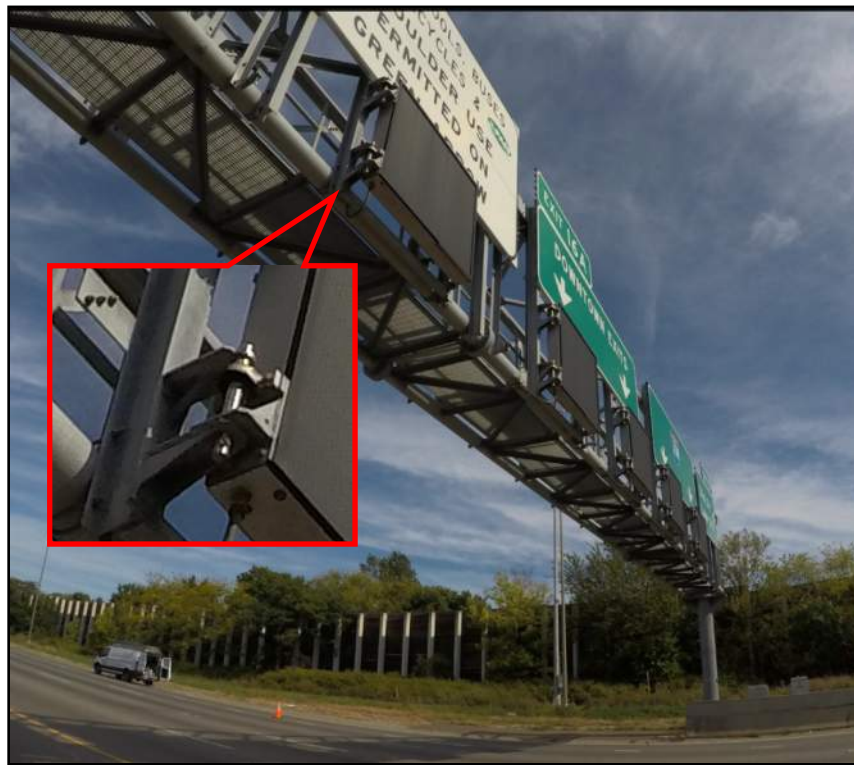
Image 9: View of the Level of Detail Taken from GoPro Hero 5.

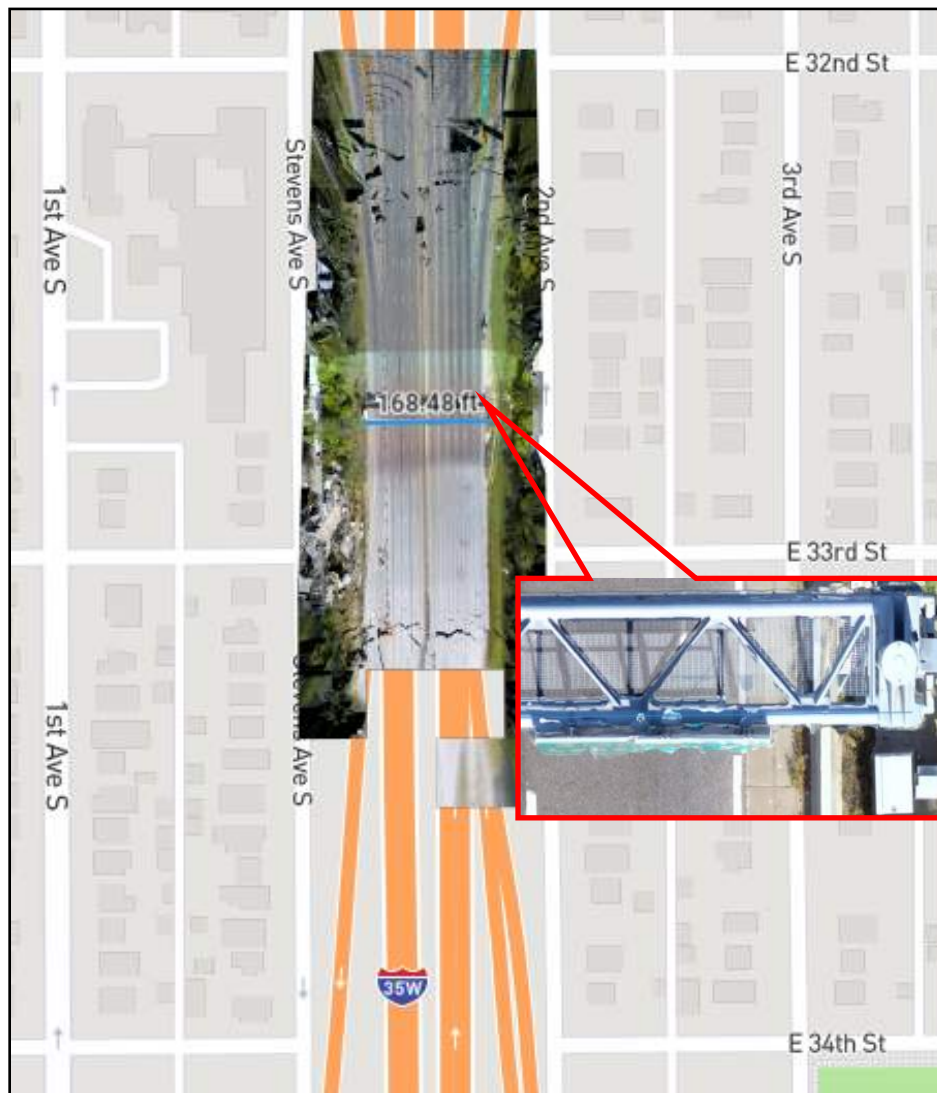
Image 10: View of Orthomosaic Image

A Orthomosaic image was created to use as an inspection tool. The target goal for this process was to produce an easily viewable, high resolution image of a large area that could be used by an inspector to carry out a detailed inspection, area measurements, condition assessment, or historical documentation. An Orthomosaic image is a single image file which is created from many individual images captured during the Mapping and Photogrammetry Mission. The final product of an Orthomosaic image is an image file that can be used to measure true distances. For this structure, an Orthomosaic image was made of the top of the gantry and surrounding area. An inspector then reviews a single file and can measure true distances and areas for a final product. Refer to Image 10 for a view of Orthomosaic Detail.

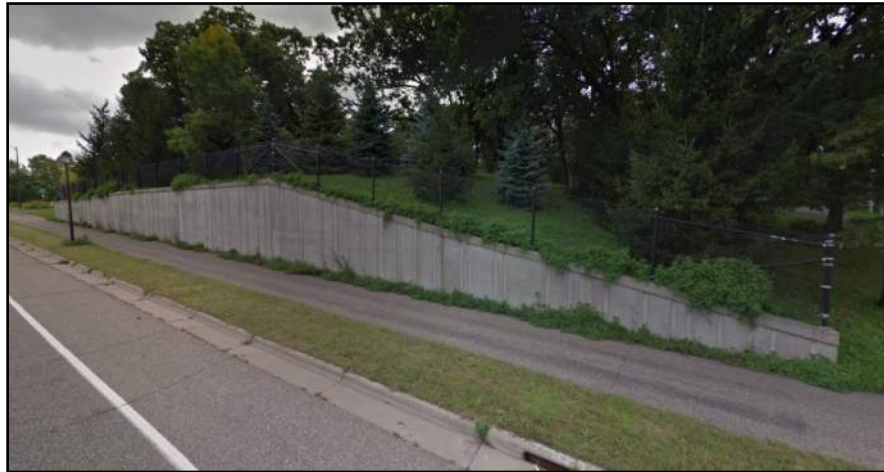
Image 3: Overall View of Lakeville Retaining Wall.

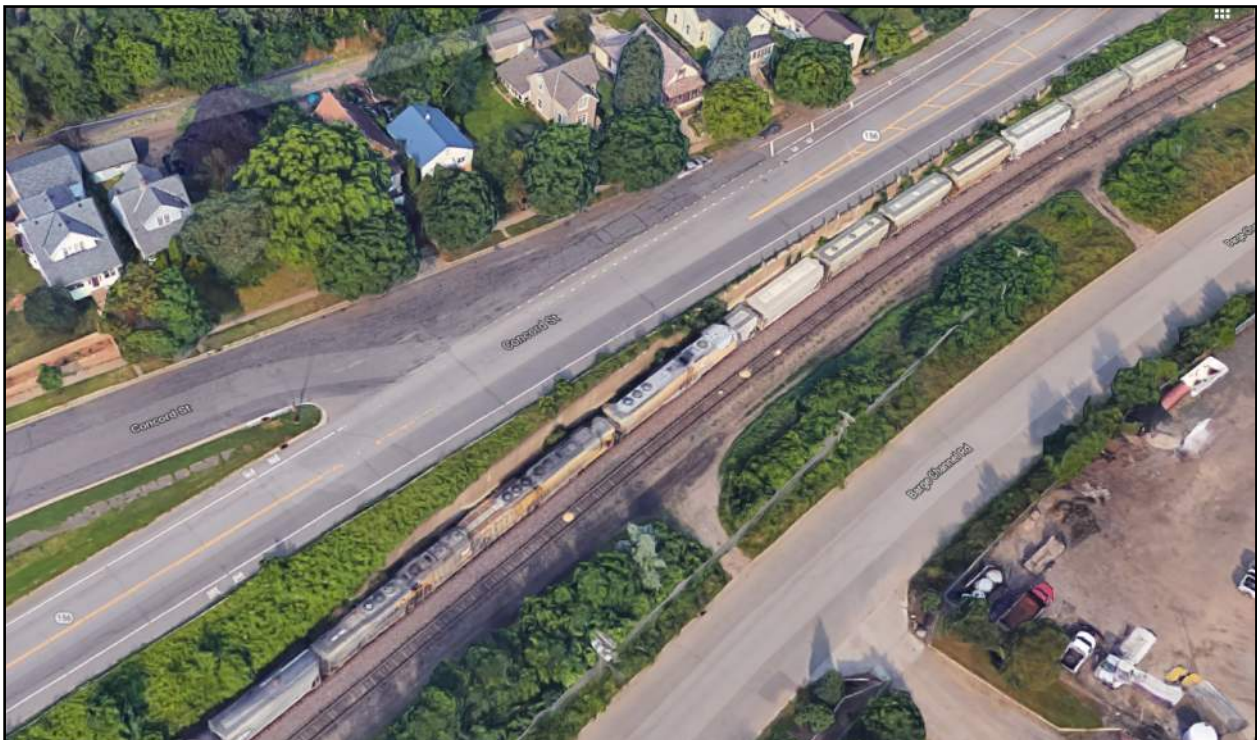
The South St. Paul Retaining Wall is located directly to the east of Concord St. and adjacent to two rail tracks approximately between Arthur Ave. and Concord St. (west frontage road). The portion of wall imaged was approximately 243 feet long and generally tapers from approximately 15 feet at the south end to 6 feet at the north end. The wall imaged was a segment of a longer retaining wall. The wall consisted of cast in place concrete wall with a concrete cap and concrete-steel wire parapet. Refer to Image 4 below for a view of the South St. Paul Retaining Wall.

Image 4: Overall View of South St. Paul Retaining Wall.

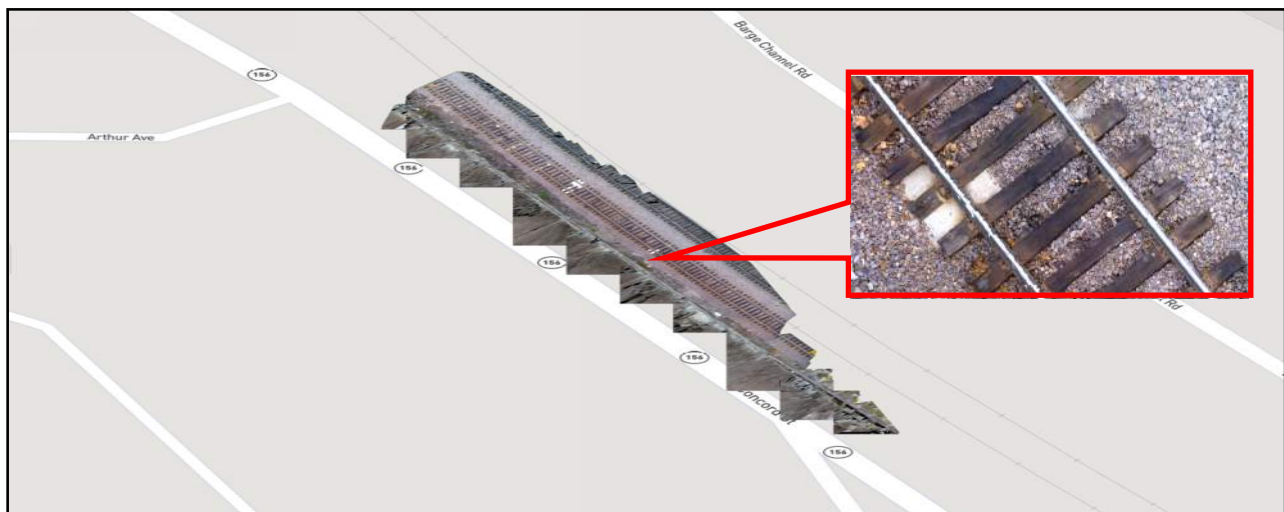
Image 8: View of the Level of Detail in a Single High-Resolution Image. [\(Click Image to View the Model\)](#)

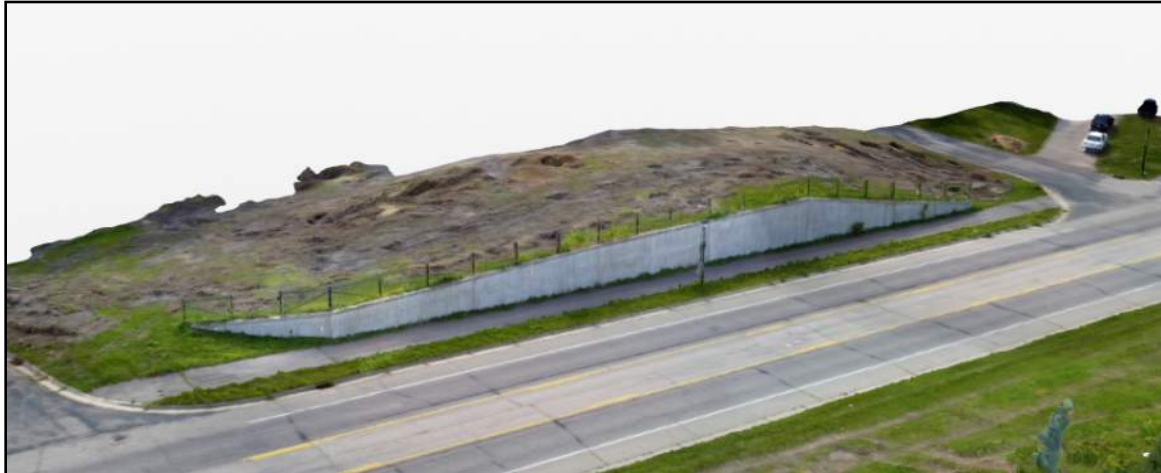
The results of the retaining wall terrestrial Imaging yielded a total of 217 and 179 usable images for the Lakeville and South St. Paul retaining walls respectively. These images were processed with the Pix4D software to provide the inspector with a 3D model and high-resolution photograph log. Refer to Images 9 and 10 below for views of Lakeville and South St. Paul retaining walls.

Image 9: View of the Lakeville 3D model in Pix4D. [\(Click Image to access 3D Model\)](#)

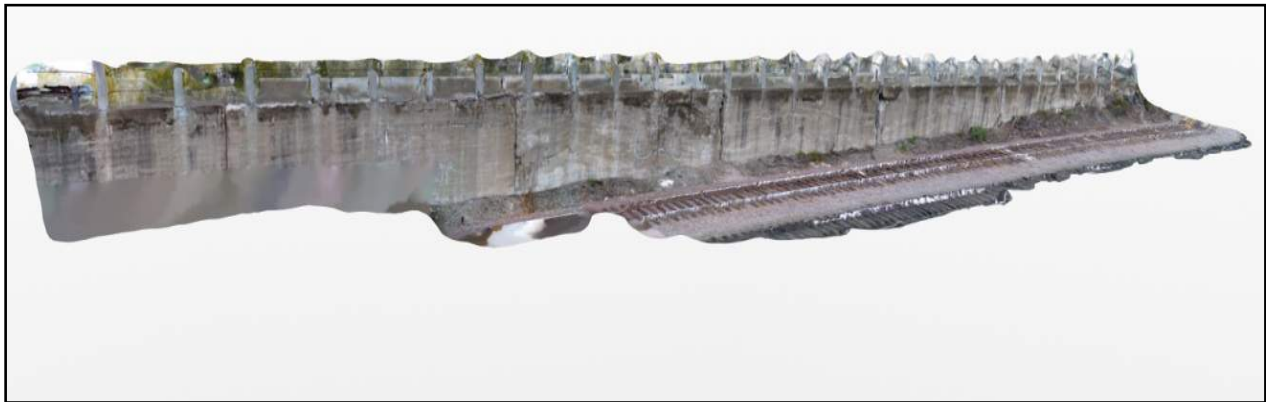
Image 10: View of the South St. Paul 3D model in Pix4D. [\(Click Image to access 3D Model\)](#)

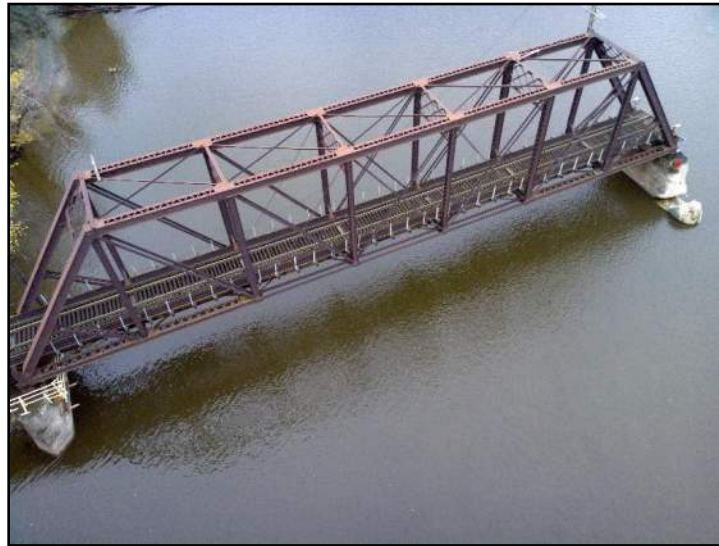
Union Pacific railroad bridge is a swing bridge that spans approximately 1275 feet over the Minnesota River and carries one track of Union Pacific railroad. The bridge deck is approximately 18 feet wide and consists of steel tracks on timber beams. The bridge superstructure consists of a steel truss span with steel floor beams and stringers. The substructure consists of reinforced concrete abutments and piers founded on piles. The longitudinal axis of the bridge is orientated approximately northeast to southwest. Refer to Images 2 and 3 for overall views of the bridge.

Image 2: Overall View of Bridge Topside.

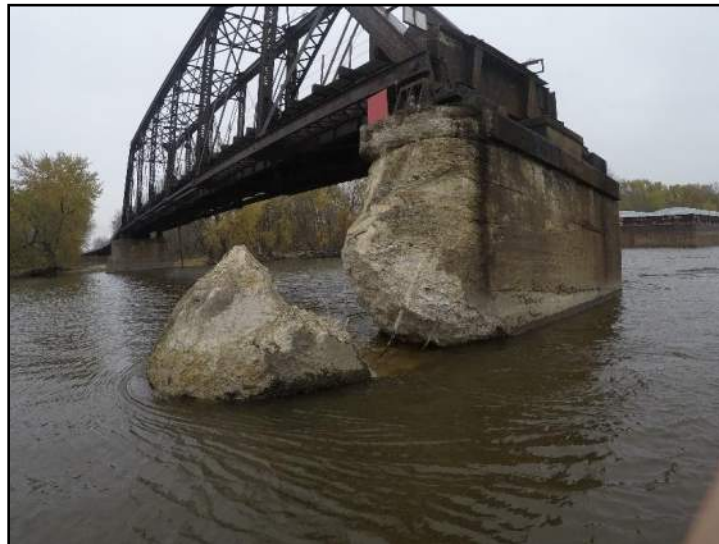
Image 3: Overall View of Bridge Underside.

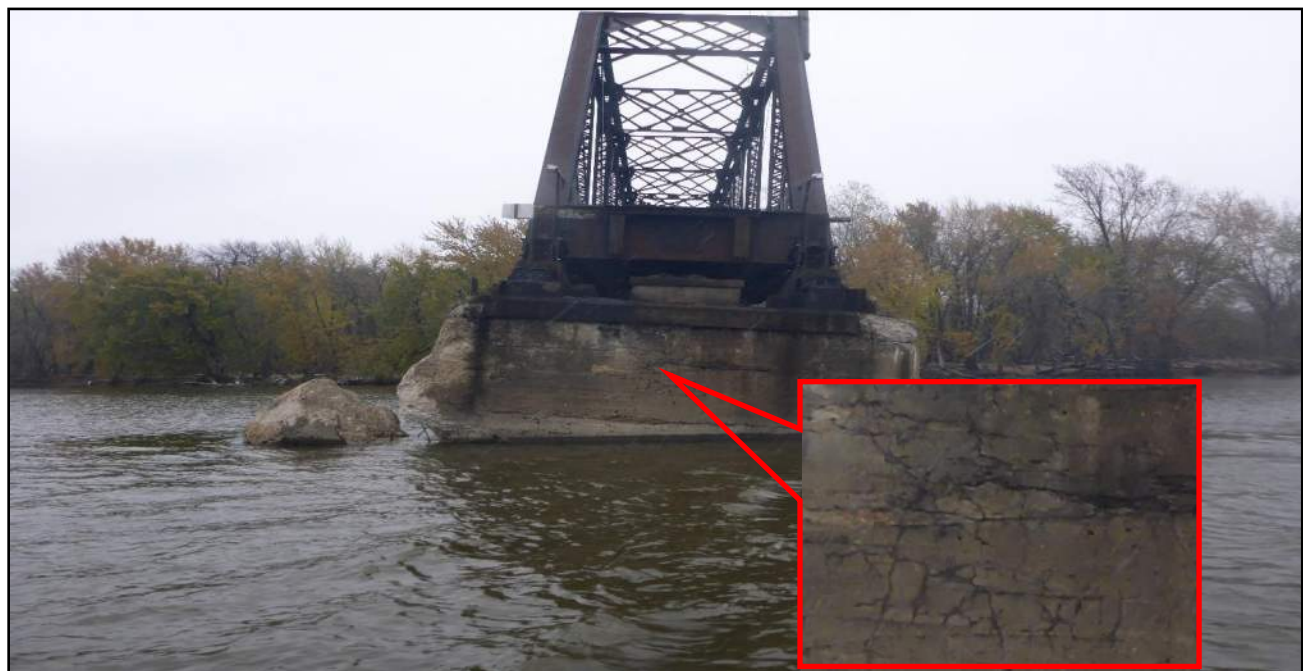
Image 9: View of the Level of Detail in a Single High-Resolution Image.

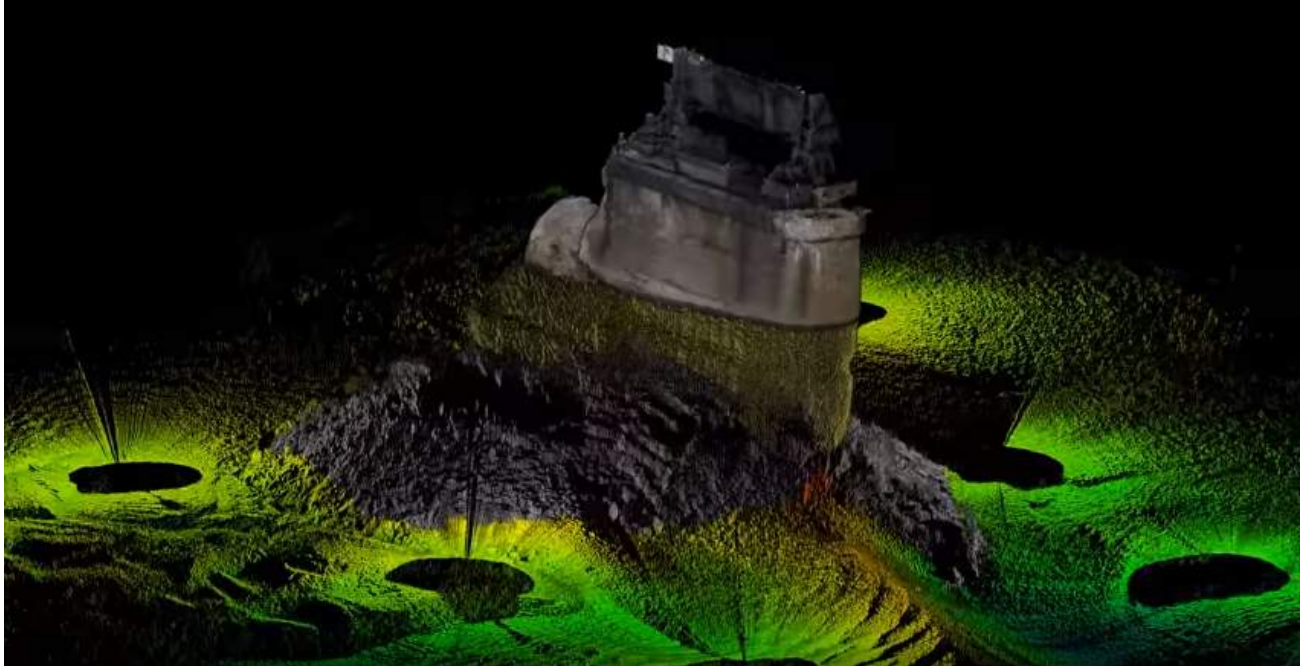
called CloudCompare to create one entire model of the structure. The resulting model demonstrates the ability to create three D model of both the above water and below water portions of the structure. But

Image 11: View of the Level of Detail in a Single High-Resolution Image. [\[Click Image for Video of 3D Model\]](#)

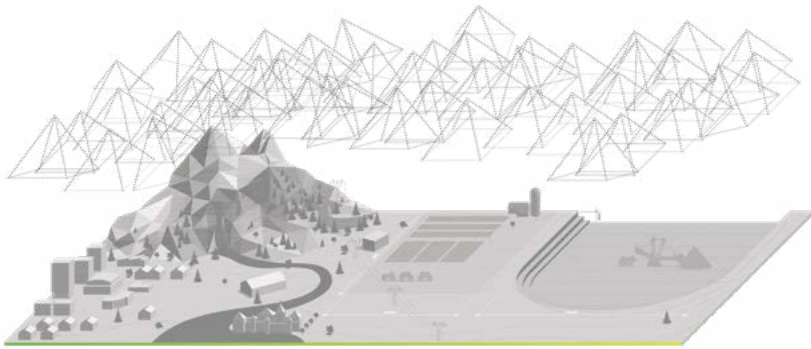
After albris lands, simply use eMotion 3's built-in Flight Data Manager to pre-process, geotag and organise its images, before starting image processing.

Then use professional image processing software to transform the drone's images into geo-referenced 2D orthomosaics, 3D building models, 3D point clouds, triangle models, digital surface models and more.

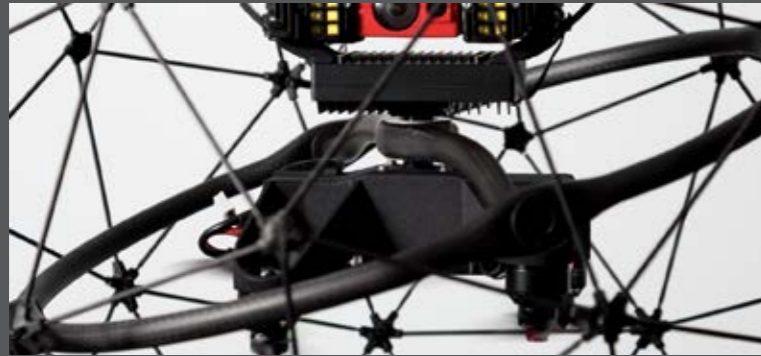
The protective frame of Elios is no ordinary one. It is decoupled on three axes from the inner frame – the drone – using a gimbal mechanism. This ingenious decoupling mechanism is what allows Elios to remain stable in the event of a collision.

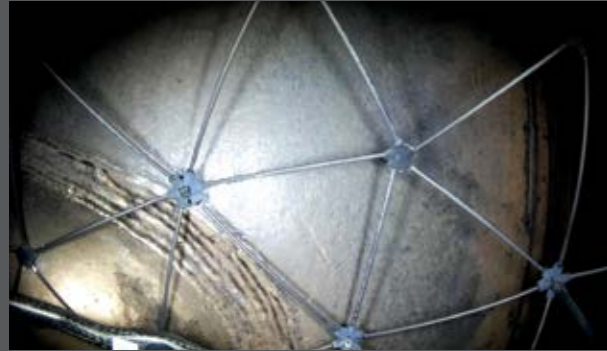
When flying in contact with a surface, Elios can gather close-up images with a sub-millimeter resolution of 0.2 mm/px.

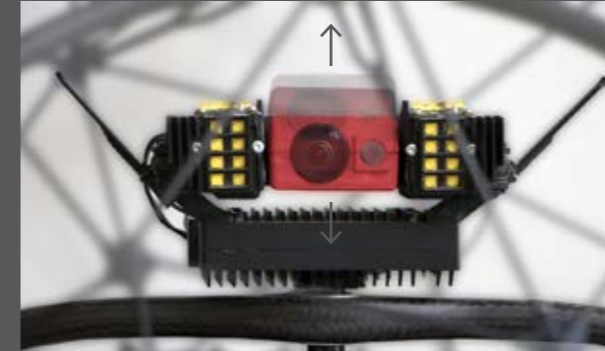
A FLEXIBLE VISION. SEE ABOVE AND BELOW.

Mounted on a rotatable head the cameras can capture images looking above and below the drone. The full HD camera offers a total field of view of 215° and a horizontal field of view of 130° while the thermal camera offers a total vertical field of view of 42° and a horizontal field of view of 56°.

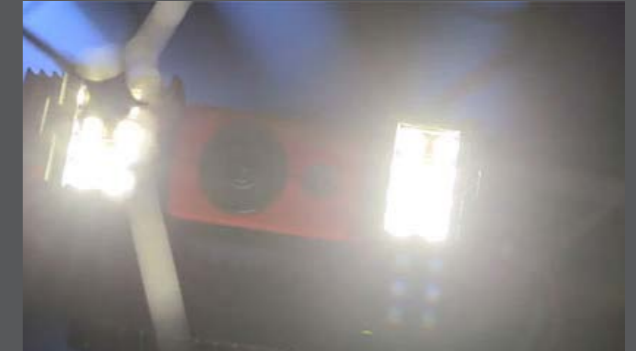
ON-BOARD LIGHTING. LET THERE BE LIGHT.

When inspecting and exploring pitch dark environments the onboard LED lighting system becomes very useful. Preventing the need for any additional external lighting, it lights up the scene in all the directions you may be looking.

The intensity of the 5 arrays of high-efficiency LEDs providing even lighting in front, top, and bottom of the robot, can be adjusted remotely using the ground station.

When changing the pitch angle of the camera head, the light beam is adapted, always providing the right lighting.

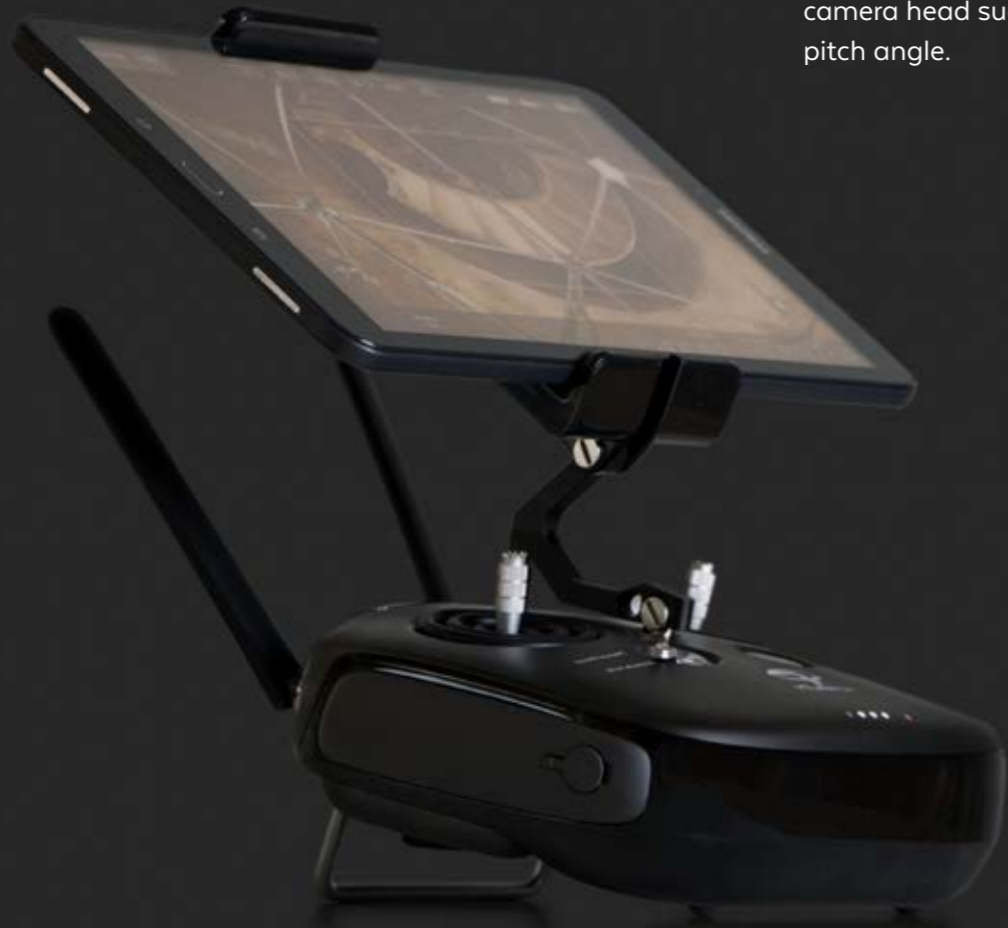
ELIOS COCKPIT. EVERYTHING UNDER CONTROL.

In addition to displaying the live SD stream received from the drone, Elios Cockpit displays live telemetry data, gives you access to a detailed status of your drone and let you adjust settings right from the application.

Elios Ground Station is composed of a remote controller, a tablet and a purpose designed ground control application providing the pilot with live telemetry data, an SD live video stream captured by Elios, and the information and controls that you need to operate it efficiently and safely. In addition to giving you full control over the navigation of the drone, the different buttons of the remote controller let you adjust, in real-time, all the settings of the camera head such as exposure, lighting and pitch angle.

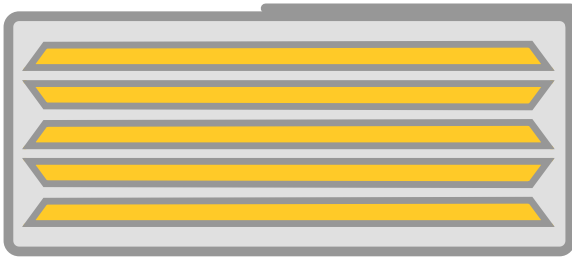
Above: Stack and store Aeropoints with their undersides together.

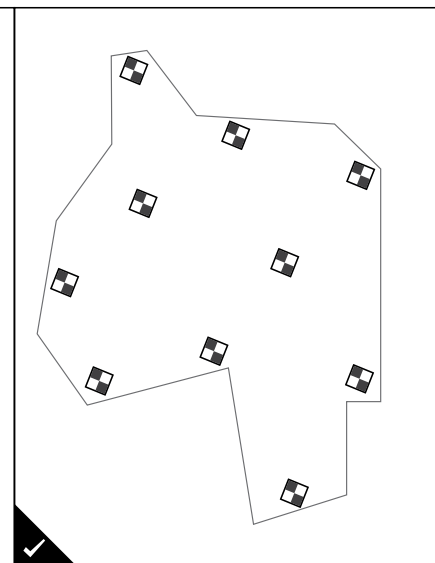
Success: AeroPoints are distributed evenly around the site perimeter, with remainder near the center.

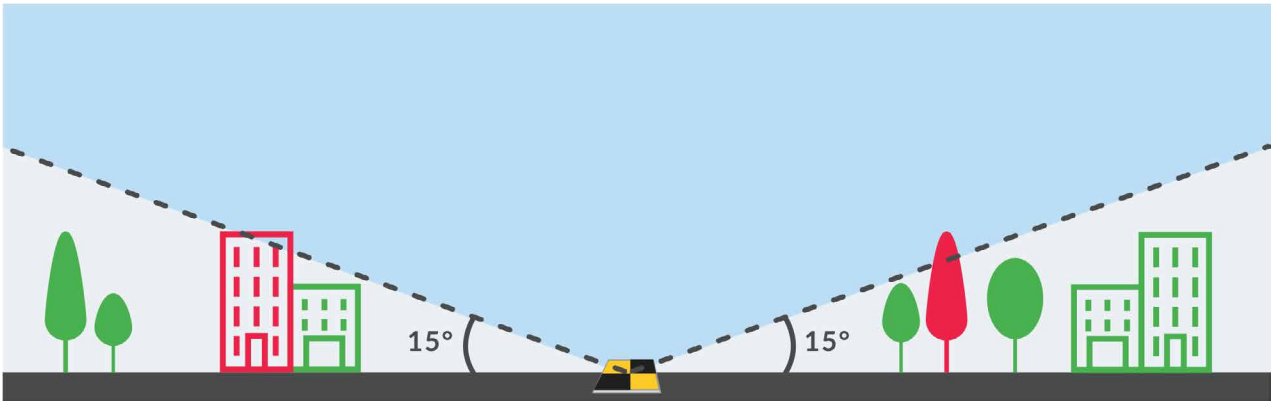
Important: AeroPoints (and/or AeroStencil marks) should have an unobstructed view of the sky in every direction above a 15° angle.

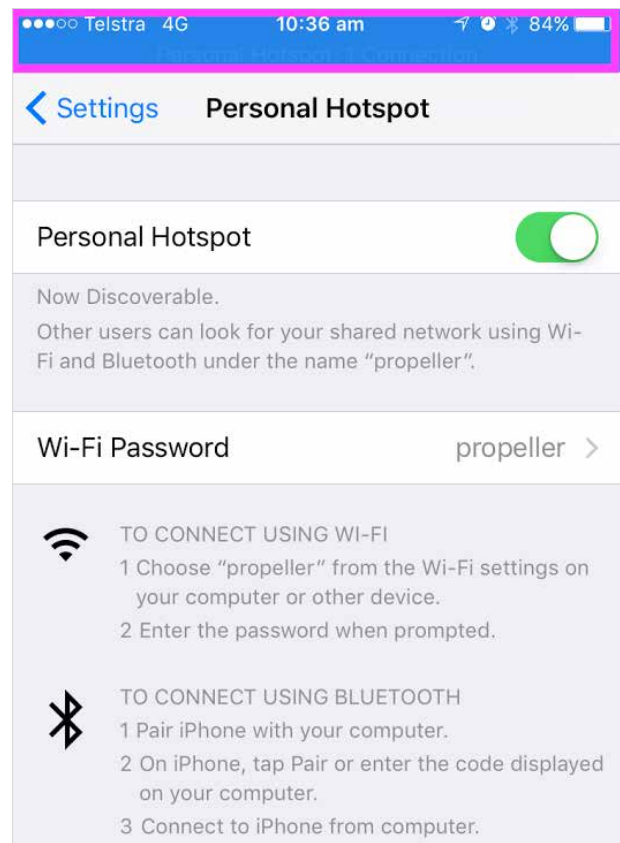
Above: A blue bar will indicate that your Personal Hotspot is active as AeroPoint data uploads.

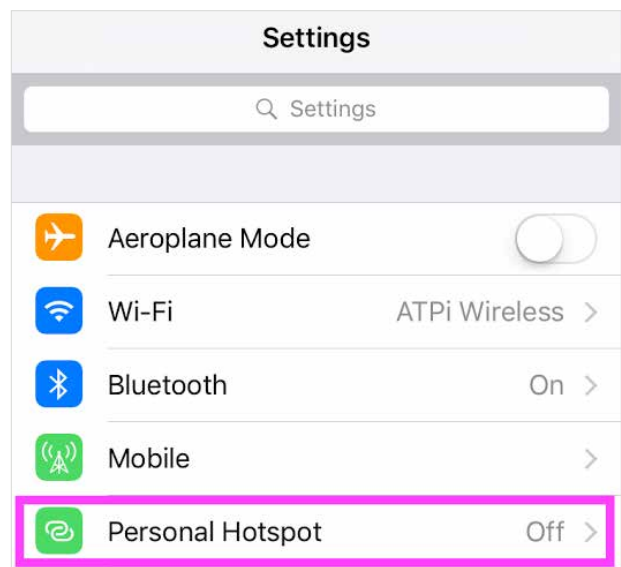
Above: Opening your hotspot settings on iOS.
