Investigating Inductive Loop Signature Technology for Statewide Vehicle Classification Counts

Chen-Fu Liao, Principal Investigator
Department of Mechanical Engineering
University of Minnesota

October 2018

Research Project
Final Report 2018-31

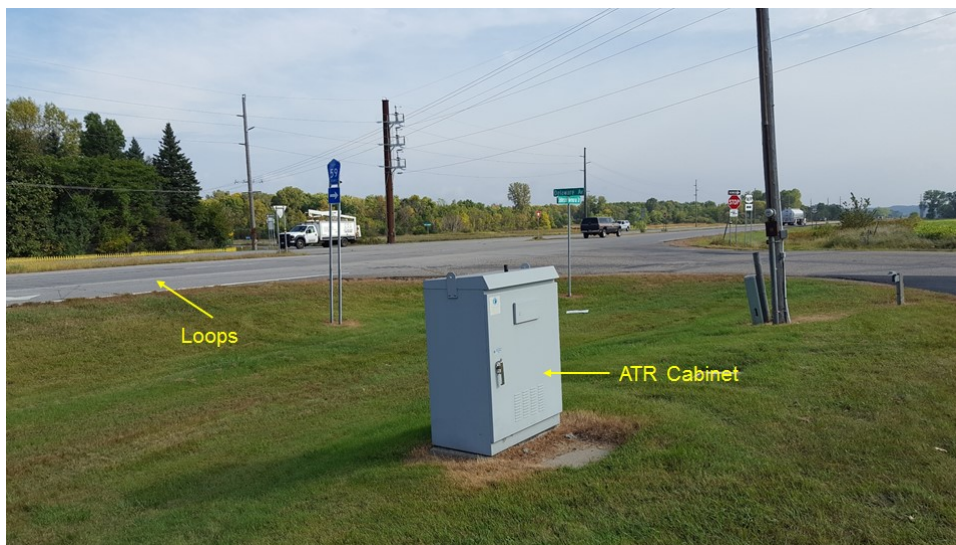
Figure 2.3 Photo of ATR353 Cabinet and Loop Detector Location.

Figure 2.2 illustrates the installation location of the inductive loop detectors and the ATR353 controller cabinet located on the SW corner of highway 169 and CSAH50. A photo of the ATR353 site is displayed in Figure 2.3.

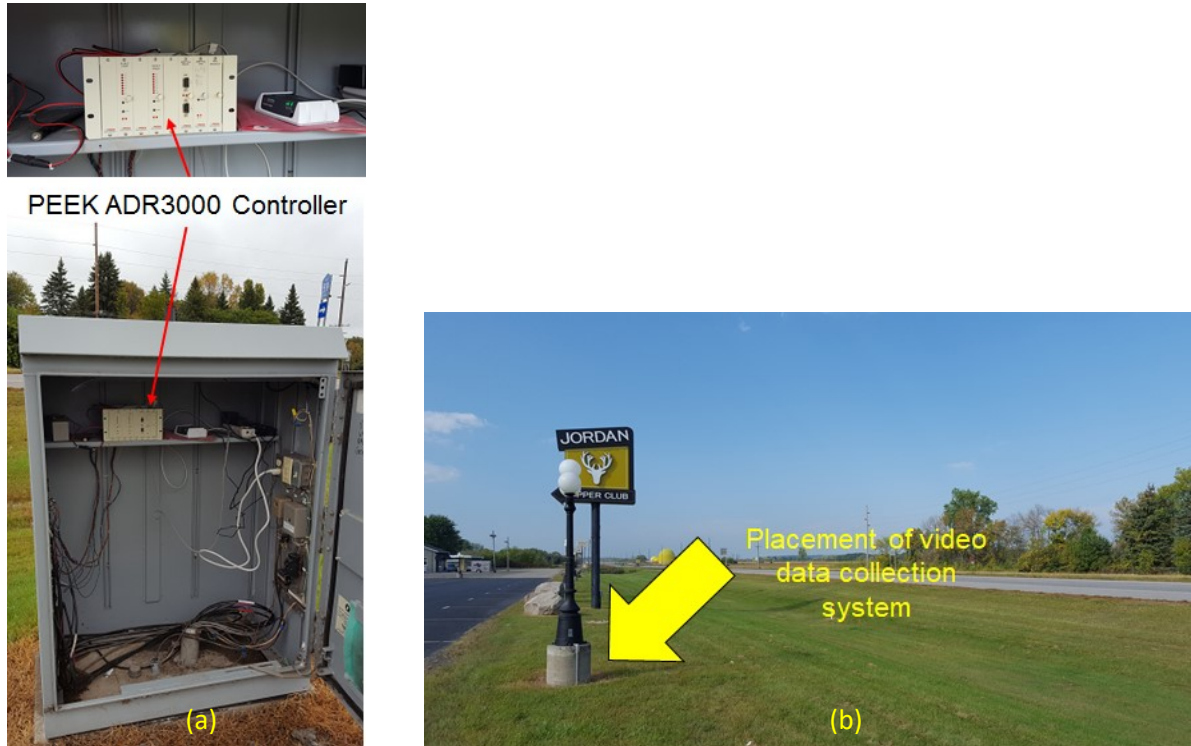
Figure 2.4 PEEK ADR3000 Controller and TIMS Deployment.

Figure 2.4(a) illustrates the PEEK ADR3000¹ controller inside the cabinet. As illustrated in Figure 2.4(b), it is suggested to place the TIMS right next to a lamp post own by the Jordan Supper Club & Tap Room restaurant near the ATR353 controller cabinet to collect ground truth vehicle classification information during our experiments.

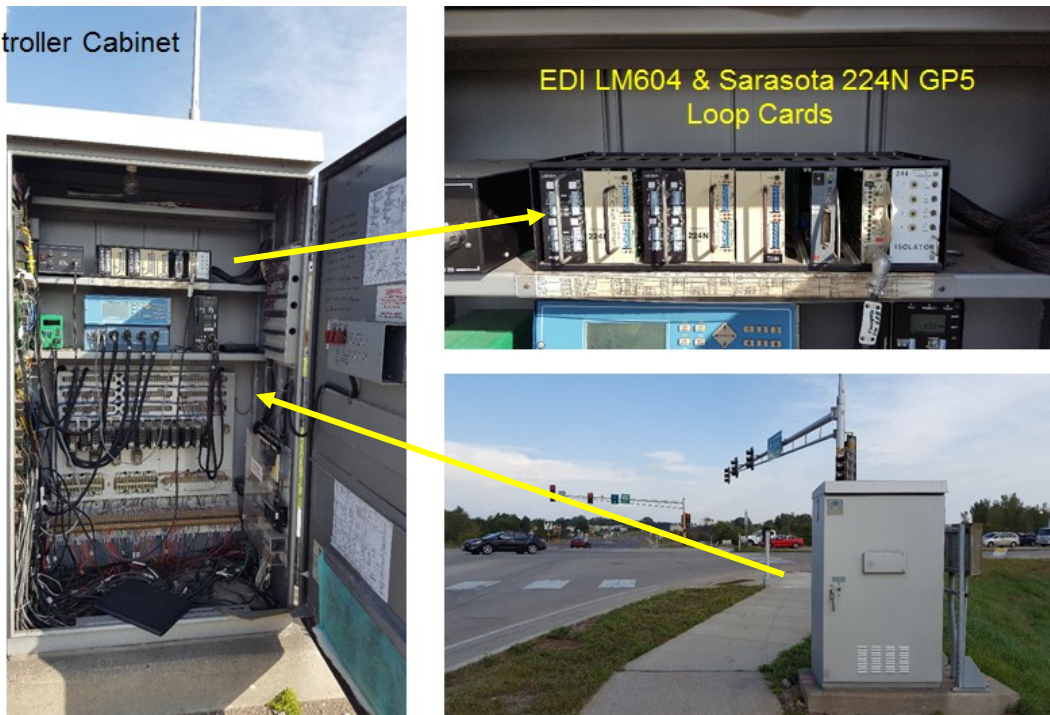
Figure 2.6 Controller Cabinet and Loop Detector Cards at TH169 & TH282 Intersection.

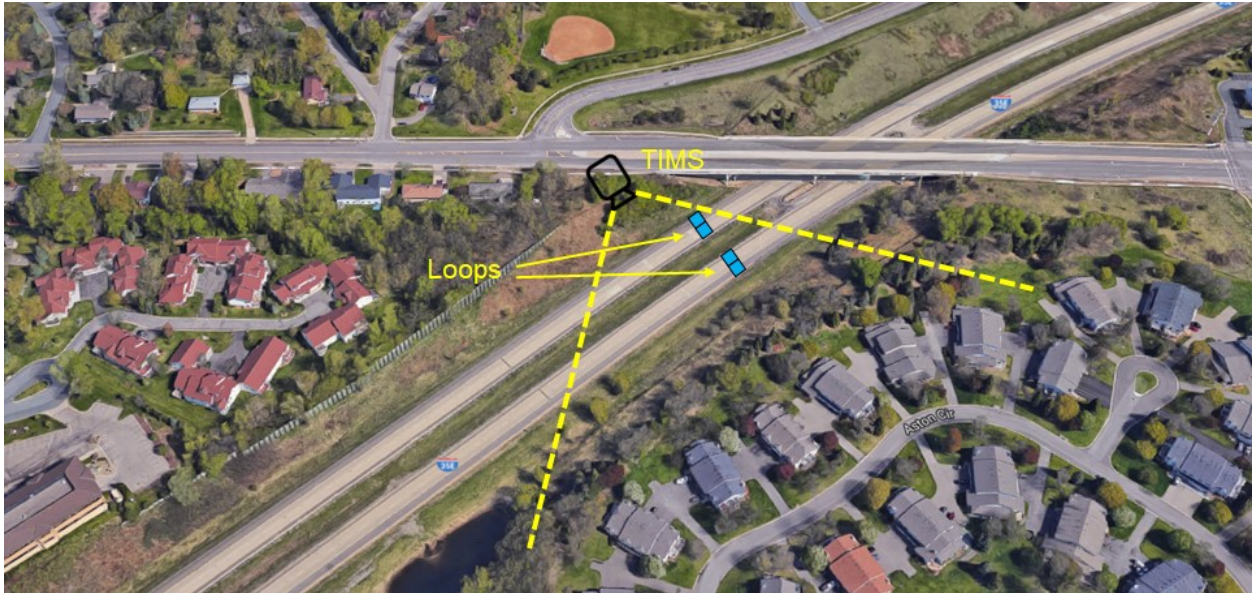
Figure 2.9 Loop Detector Locations on I-35E South of McAndrews Road.

Test site #4 is located on I-35E south of McAndrews Road in Burnsville as illustrated in Figure 2.9 & 2.10.

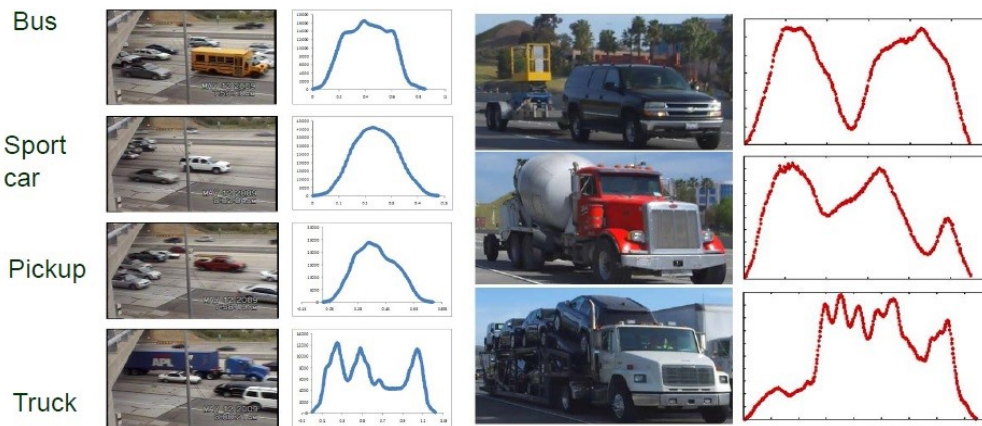
Figure 3.1 Loop Signatures for Different Type of Vehicles (Image from CLR Analytics Inc.).

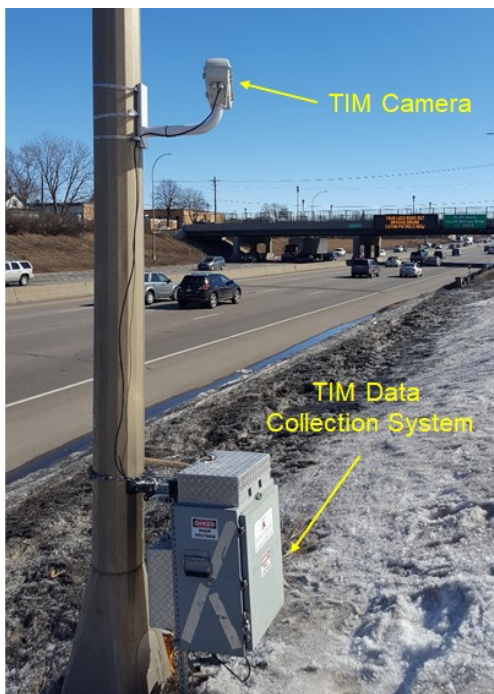
Figure 3.3 A Rapid-Deployable, Low-Cost Traffic Video Data Collection System.

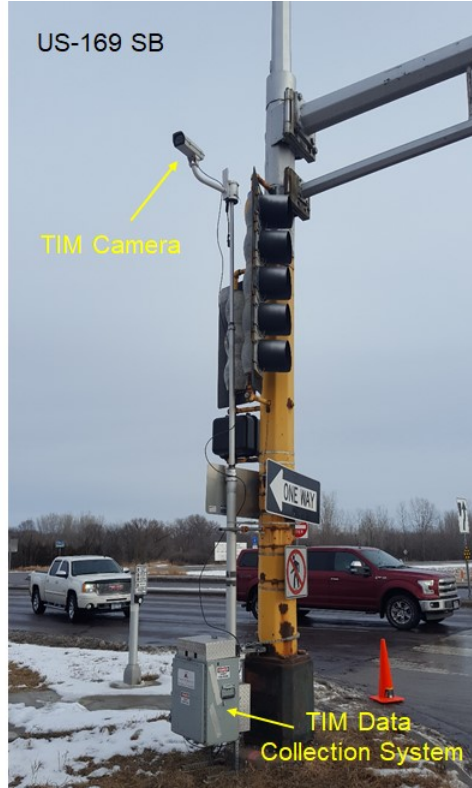
Figure 3.7 Installation of Video Data Collection System at US-169 & TH-282/Quaker Ave.

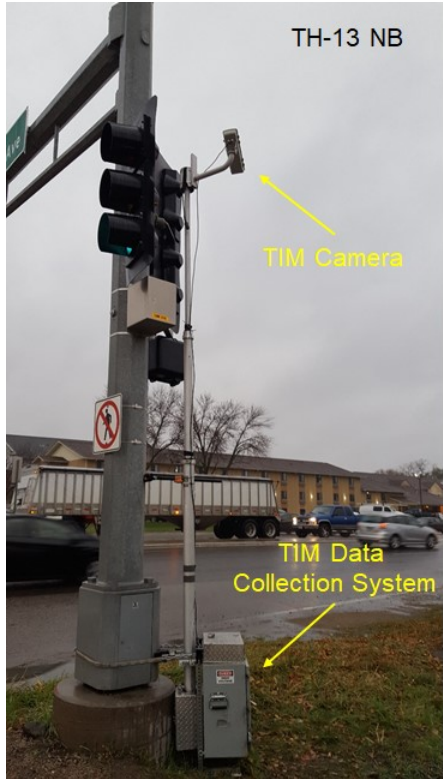
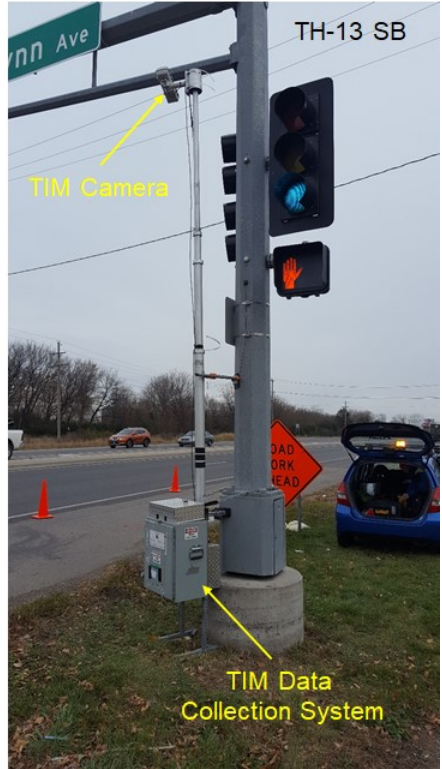
Figure 3.11 Installation of Video Data Collection System at Site #3 (TH-13 at Lynn Ave).

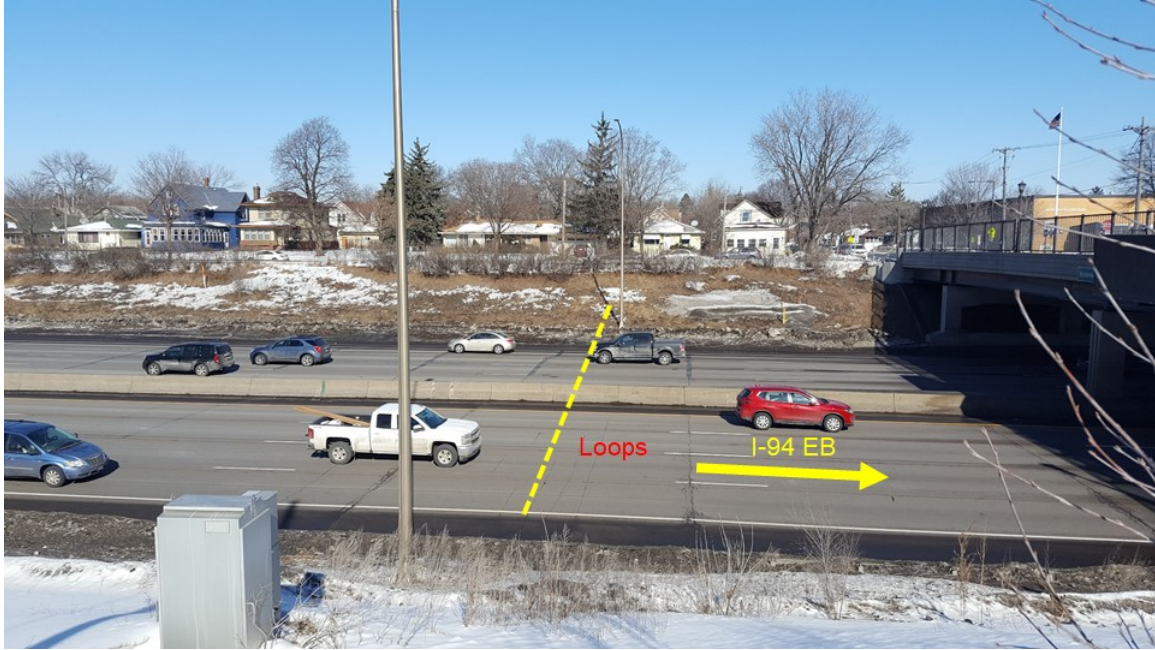
Figure 3.17 Location of Inductive Loop Sensors at Site #5 (I-94 at N Victoria St).

Four loop signature cards and a data collection gateway (SigMaster card) were installed inside the RTMC loop controller cabinet at I-94 & N Victoria St. in St. Paul MN, as illustrated in Figure 3.16. The first and second loop cards cover the 4 lanes of traffic on I-94 WB and the other two loop cards collect data from the 4 lanes of traffic in the EB direction. Location of inductive loop sensors at this site is shown in Figure 3.17.

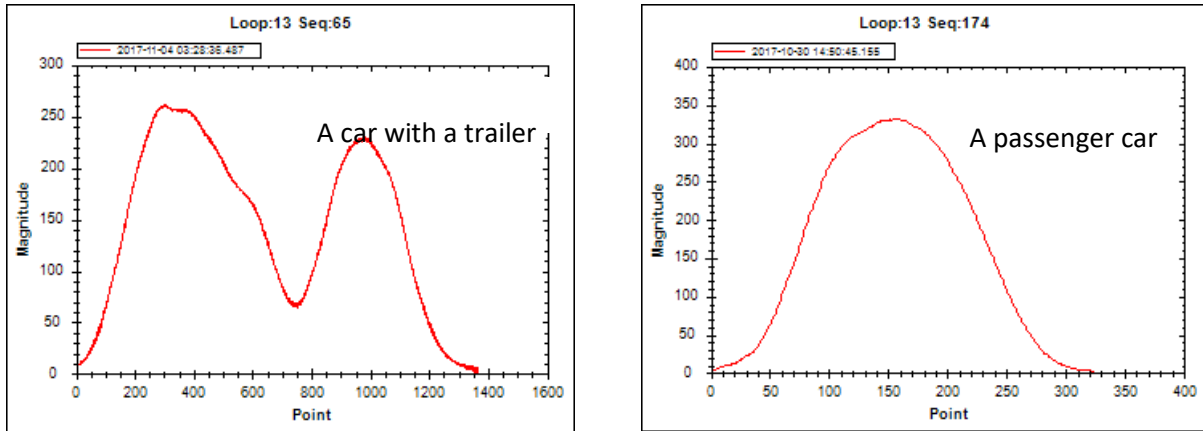
Figure 4.3 Sample Loop Signature Profiles of Two Vehicles.

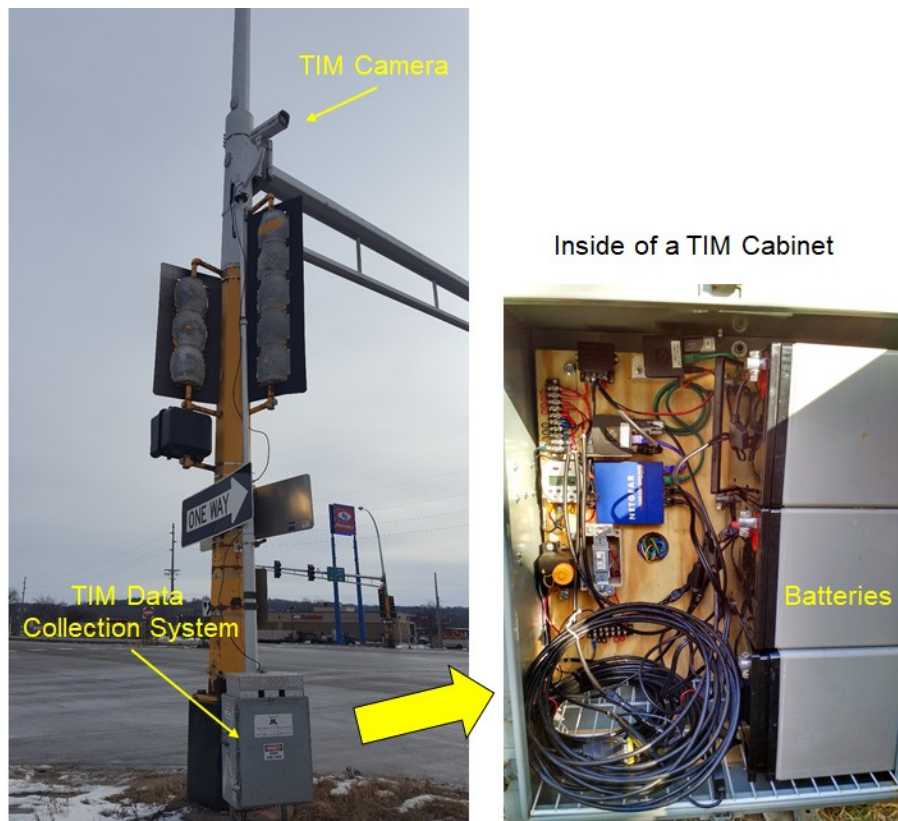
Figure 4.5 TIM Video Data Collection System Installed at Site #2

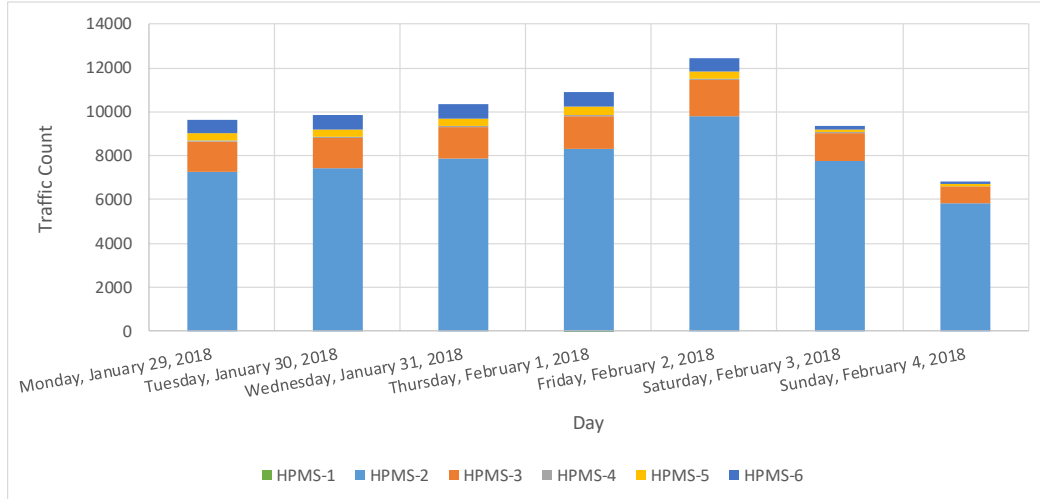
Figure 4.12 One Week of Traffic Count by HPMS Vehicle Classification at the Site #1.

Figure 4.12 shows the distribution of vehicle classification based on the Highway Performance Monitoring System (HPMS) vehicle class groups [16] at the site #1 in the NB direction using one week of loop data. Based on the loop data, class 2 or 3 vehicles averagely make up over 90% of the traffic at this location.

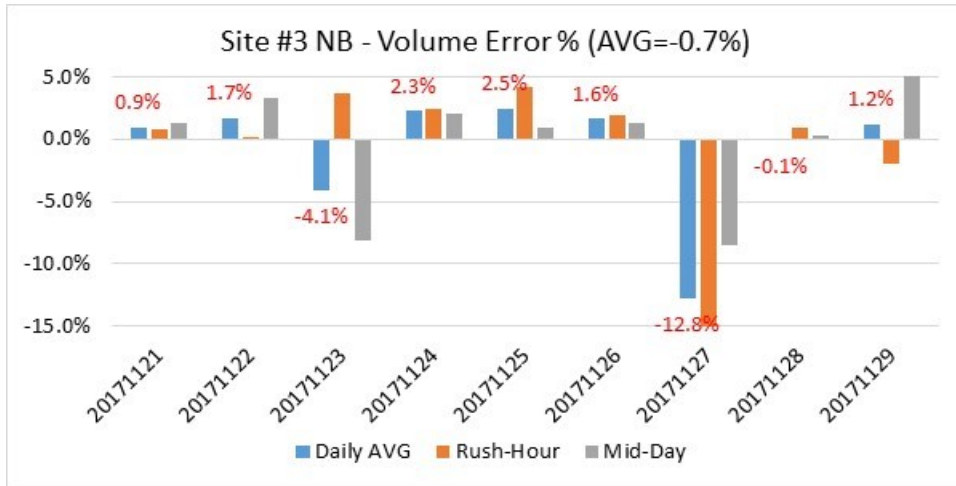
Figure 4.24 Traffic Volume Error Percentage at Site #3 NB.

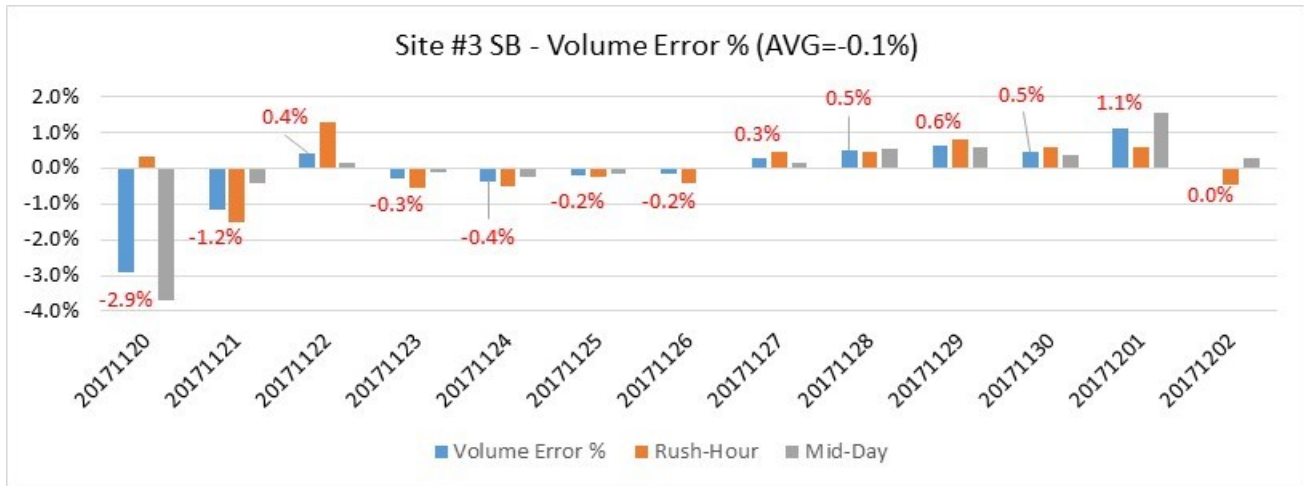
Figure 4.25 Traffic Volume Error Percentage at Site #3 SB.
