SCREW SPIKE AND SPRING WASHER HOLD-DOWN FORCE AND RESILIENCY INVESTIGATION

The Rail Transportation Engineering Center (RailTEC) at the University of Illinois (Illinois) is investigating spike failures in timber tie track to determine the root cause(s) and develop failure prevention strategies. This research is part of an ongoing investigation into spike failures sponsored by the Federal Railroad Administration (FRA) that began in 2018.

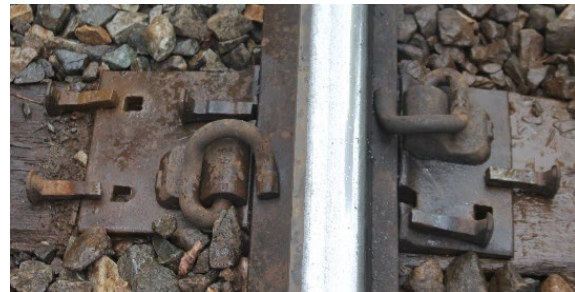
Figure 1. Broken spikes in elastic fastening system

Broken spikes are found on both sides of the tie plate, in all spiking locations, and are often found on the high rail of high degree curves with grade. The problem is most pronounced in elastic fastening systems (Figure 1), particularly when not supplemented with rail anchors (Khachaturian, Dersch, Edwards, & Trizotto, 2022).
