Report No. UT-20.24

ASSESSING CORROSION OF EXTRACTED MSE WALL REINFORCEMENT COUPONS, UTAH PHASE II STUDY

Utah Department of Transportation
Research and Innovation Division

Final Report

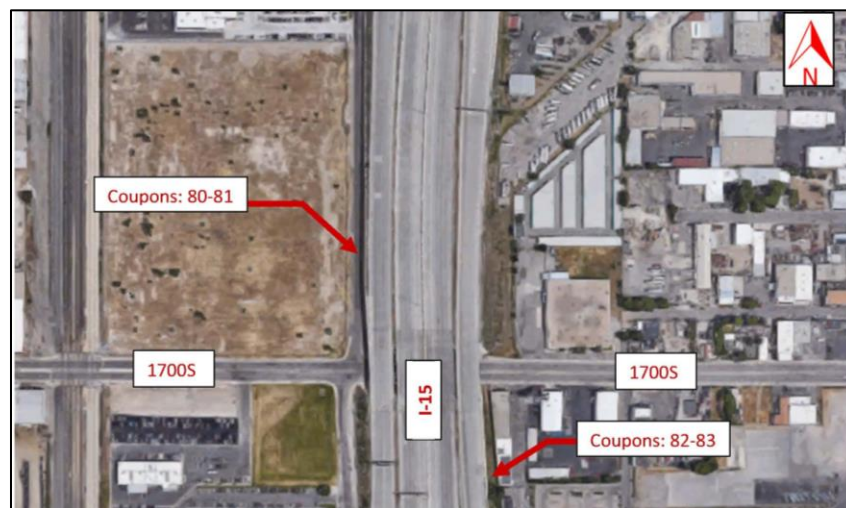
Figure 1-1: Aerial View Illustrating Basis of Coupon Nomenclature

In Figure 1-1, the nomenclature used to identify coupons in Table 1-1 through Table 1-4 and Table 3-1 is illustrated. In these tables, the column labeled “Intersection, Quadrant, and Distance from End of Wall (ft)” describes the location of coupon extraction. The intersection is the street address of the intersection closest to the wall, and in some cases is the exact location of the wall. The quadrant (typically NW, NE, SW, or SE) is an imaginary grid if the intersection was to be split in four sections. The quadrant gives a description of direction from the intersection. The distance from the end of the wall is an approximate distance, in feet, from the MSE wall panel where the coupons are extracted, to the end of the MSE wall closest to the intersection. Each wall panel is typically 10 feet long, so distances are in increments of 10. For example, Coupon 80 would be labeled “1700S and I-15, NW, (260)”.

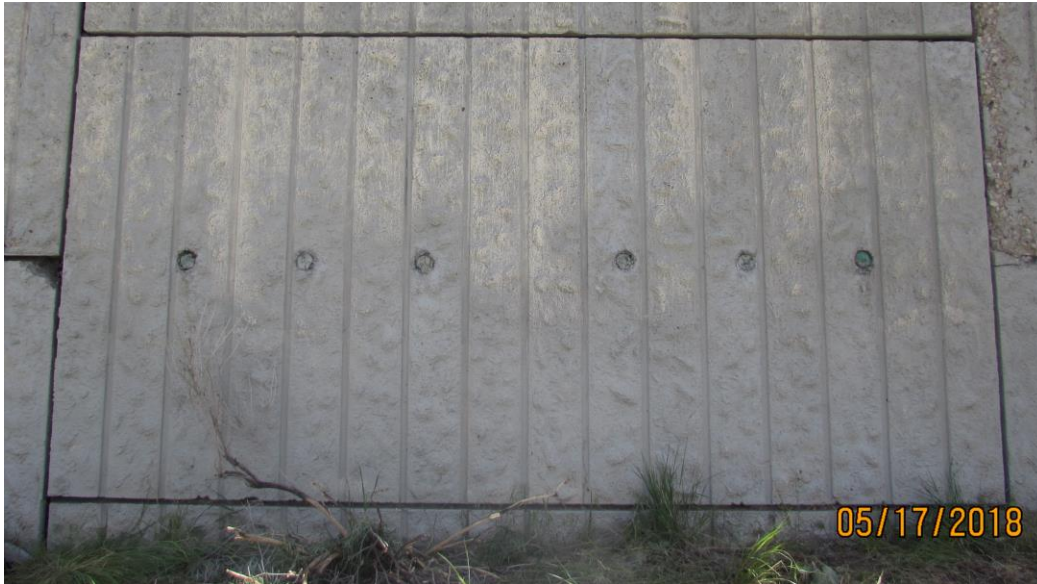
Figure 1-2: MSE Wall Panel with Coupons

Columns labeled “Position of Coupon” are a spatial representation of where the coupons to be extracted are on the wall as shown in Figure 1-2. Wall numbers underlined in Table 1-1 identify walls that are now buried and inaccessible due to the 2018-2020 I-15 expansion project.

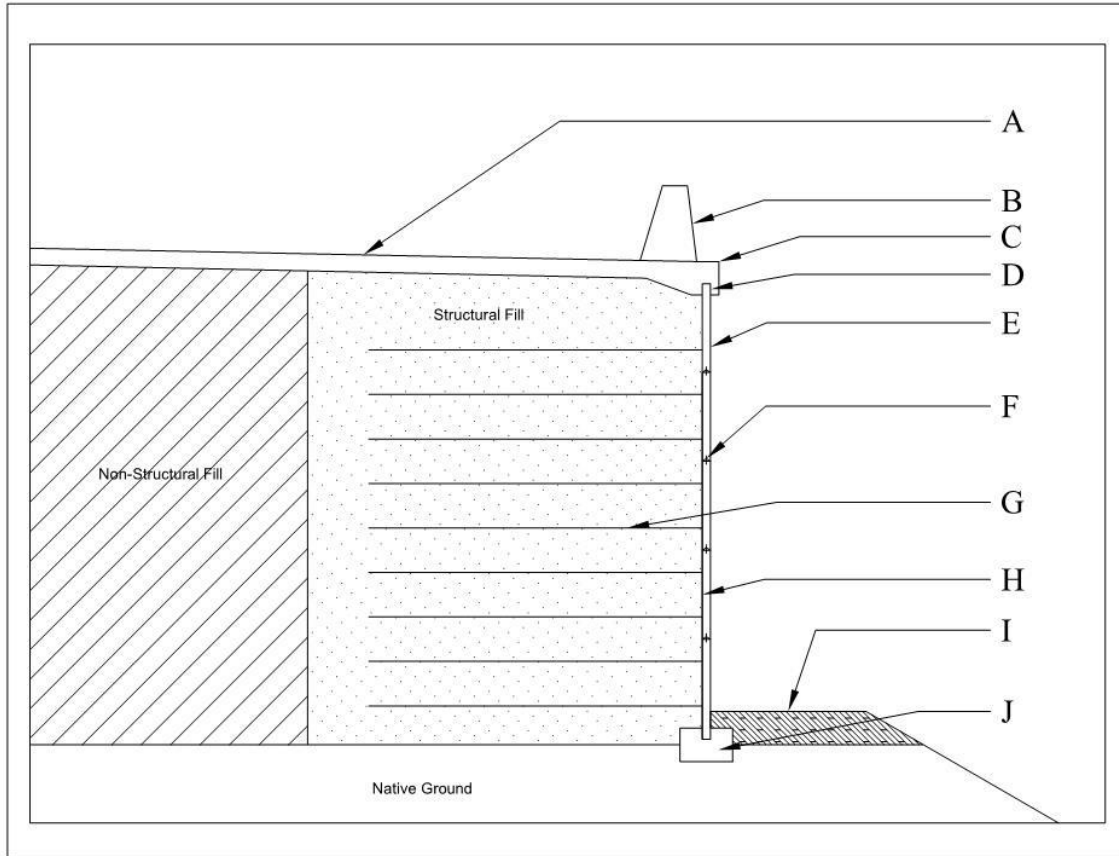
Once the specified number of layers has been placed, a concrete coping caps the wall face panels and provides an aesthetic finish to the top of the wall. Through this process of placing structural face panels, structural soil backfill and compaction, and reinforcement layering, the MSE wall becomes a composite system that can withstand lateral earth pressures, surcharge loads, seismic activity, and water infiltration. Figure 2-1 shows a typical cross-section of a one-stage MSE wall.

| A. Road Surface | F. Tongue & Groove Joint Reinforced with Steel Dowels |
| D. Bond Breaker (typ. extruded polystyrene) | I. Protective Clay Layer to Reduce Erosion at the Foundation |

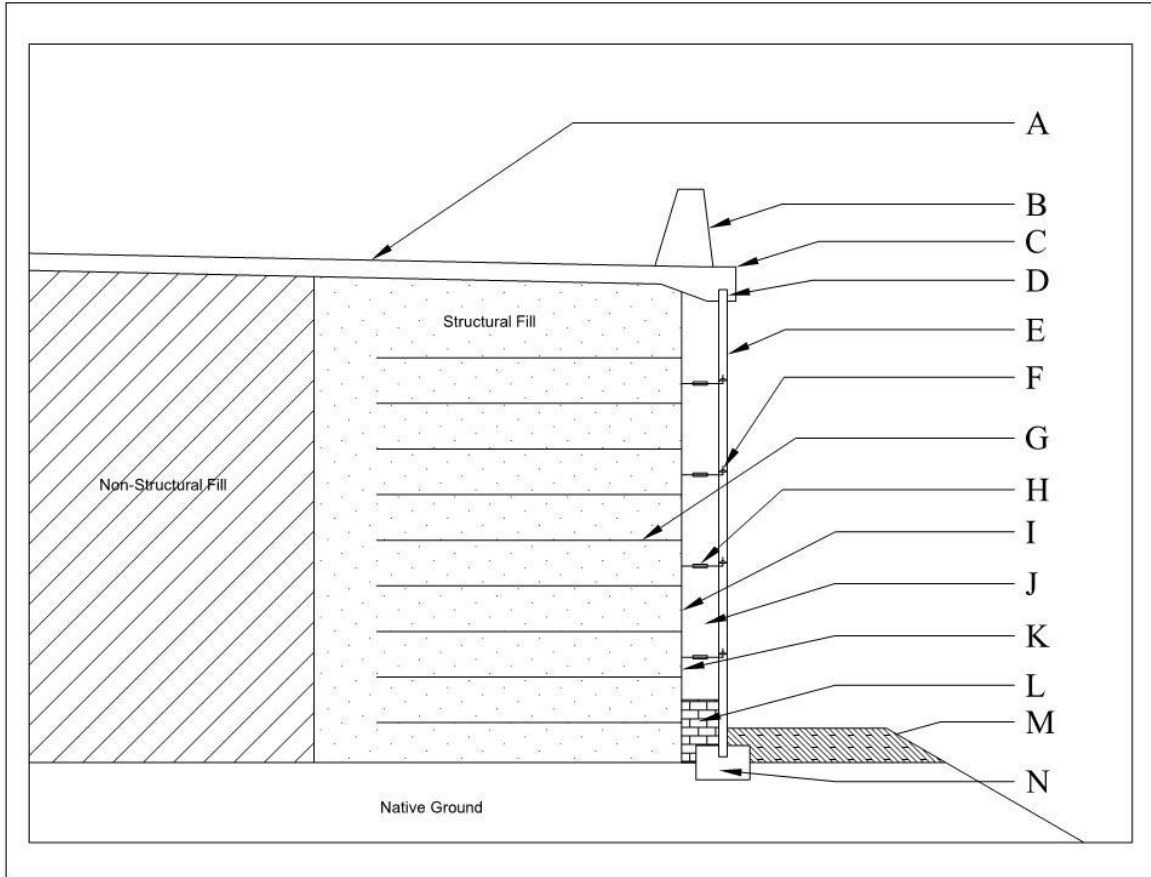
The two-stage MSE wall system is beneficial when large settlements occur. Because the concrete panels are not the system retaining the soil, when large soil settlement occurs, the concrete panels are not damaged like the panels in a one-stage wall if they were subjected to such settlement.

| A. Road Surface | I. Geo-textile for Soil Retention |
| E. Concrete Wall Panels | M. Protective Clay Layer to Reduce Erosion at the Foundation |

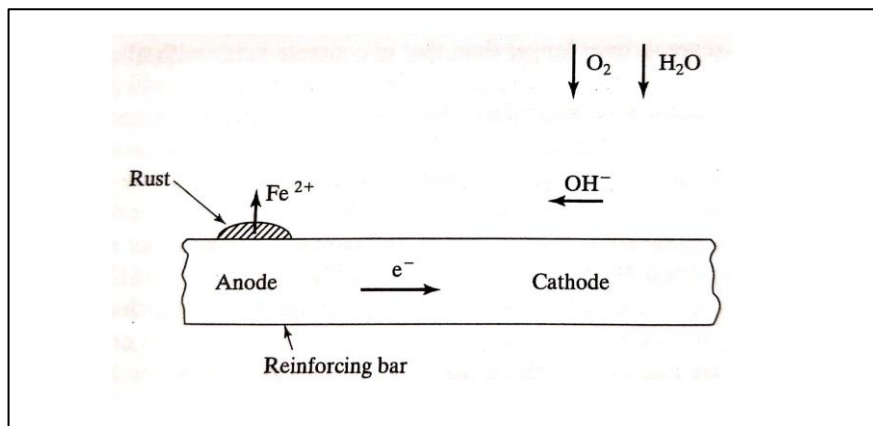
Corrosion is an electro-chemical process involving water, oxygen, and a metallic element; an electrical current is required for the reaction to occur. On a bare steel reinforcing element, iron is oxidized in an anodic reaction as depicted in Figure 2-3. The buried reinforcement in an MSE wall becomes oxidized because electrons are transferred to the oxygen or the water in the surrounding soil. The soil and its components are reduced in a cathodic reaction, acquiring the electrons that are lost by the anodic reaction. The electrical current goes from anode to cathode in the soil and from cathode to anode in the reinforcing steel. At locations where the iron becomes oxidized, iron oxides and a corrosion product (rust) are produced (Mindess, Young, and Darwin 2003).

Figure 2-3: Chemical Process of Corrosion

When the iron ions leave the steel element to form rust, voids appear in the steel element causing a reduction in the cross-sectional area. This reduction in steel material leads to a loss of load capacity (i.e., strength of the reinforcement). The reduction in reinforcement strength weakens the MSE wall. If the reduction in strength is significant, the reinforcement in the MSE wall might fail, and failure of the MSE wall system can occur. To reduce the corrosion potential of bare steel, the steel can be galvanized. The process and benefits of galvanization are discussed in the next section of this chapter.

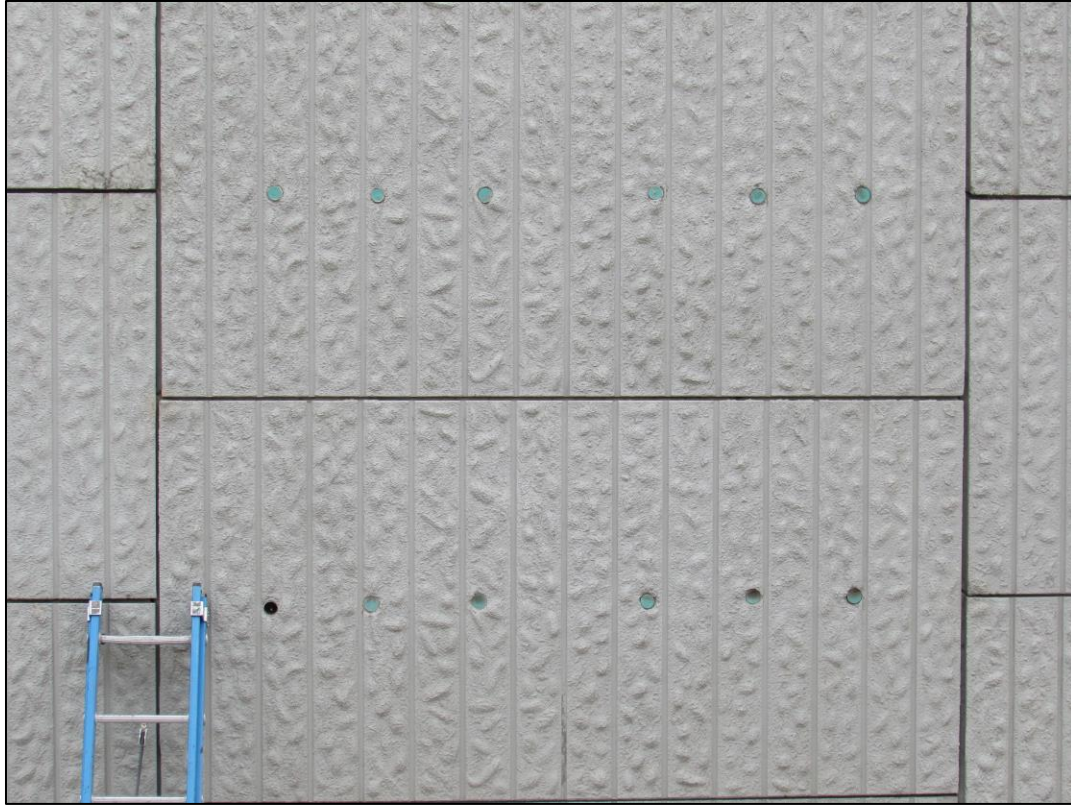
Concrete panels where the reinforcement coupons were installed had six access holes, as shown in Figure 3-1, to allow the extraction of the coupons. Depending on the number of coupons that were originally installed, MSE walls had either one, two, or three concrete panels, located one above the other, each with six access holes.

Figure 3-1: Typical MSE Wall Panels with Test Coupons

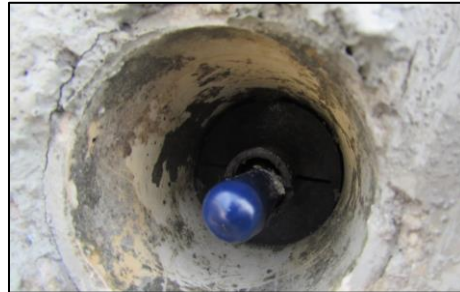
concrete panel. Water runoff, exposure to air, and potential for dislocation of the rubber outer plug increased the probability of corrosion to the end of the coupon. In order to protect the threaded end of the coupon against corrosion, most of the coupons had a silicone sleeve over the threaded portion as shown in Figure 3-2.

Figure 3-2: Outer End of Test Coupon with Protective Sleeve

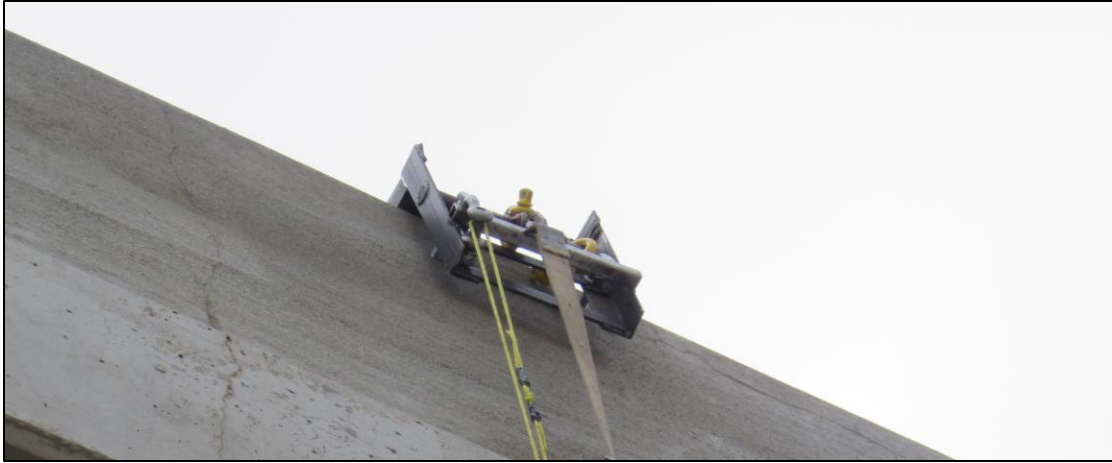
The saddle was transported to the freeway above the MSE wall and installed on the concrete barrier directly over the extraction location. The saddle was set on the barrier and bolted in place with set bolts underlain by neoprene pads to protect the concrete barrier surface. The safety harness and pulley for the jack were lowered to the extraction site below. The harness was then attached to a worker, and the jack was attached to the pulley system.

Figure 3-3: Steel Saddle Safety System

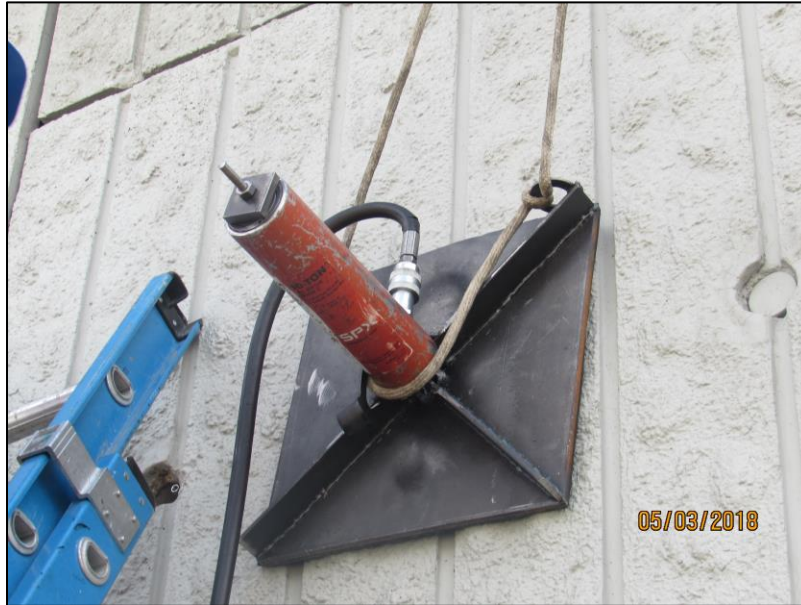
system to lift and center the jack over the extraction hole, rather than manually doing so via a ladder.

Figure 3-5: Center-Hole Hydraulic Cylinder Jack

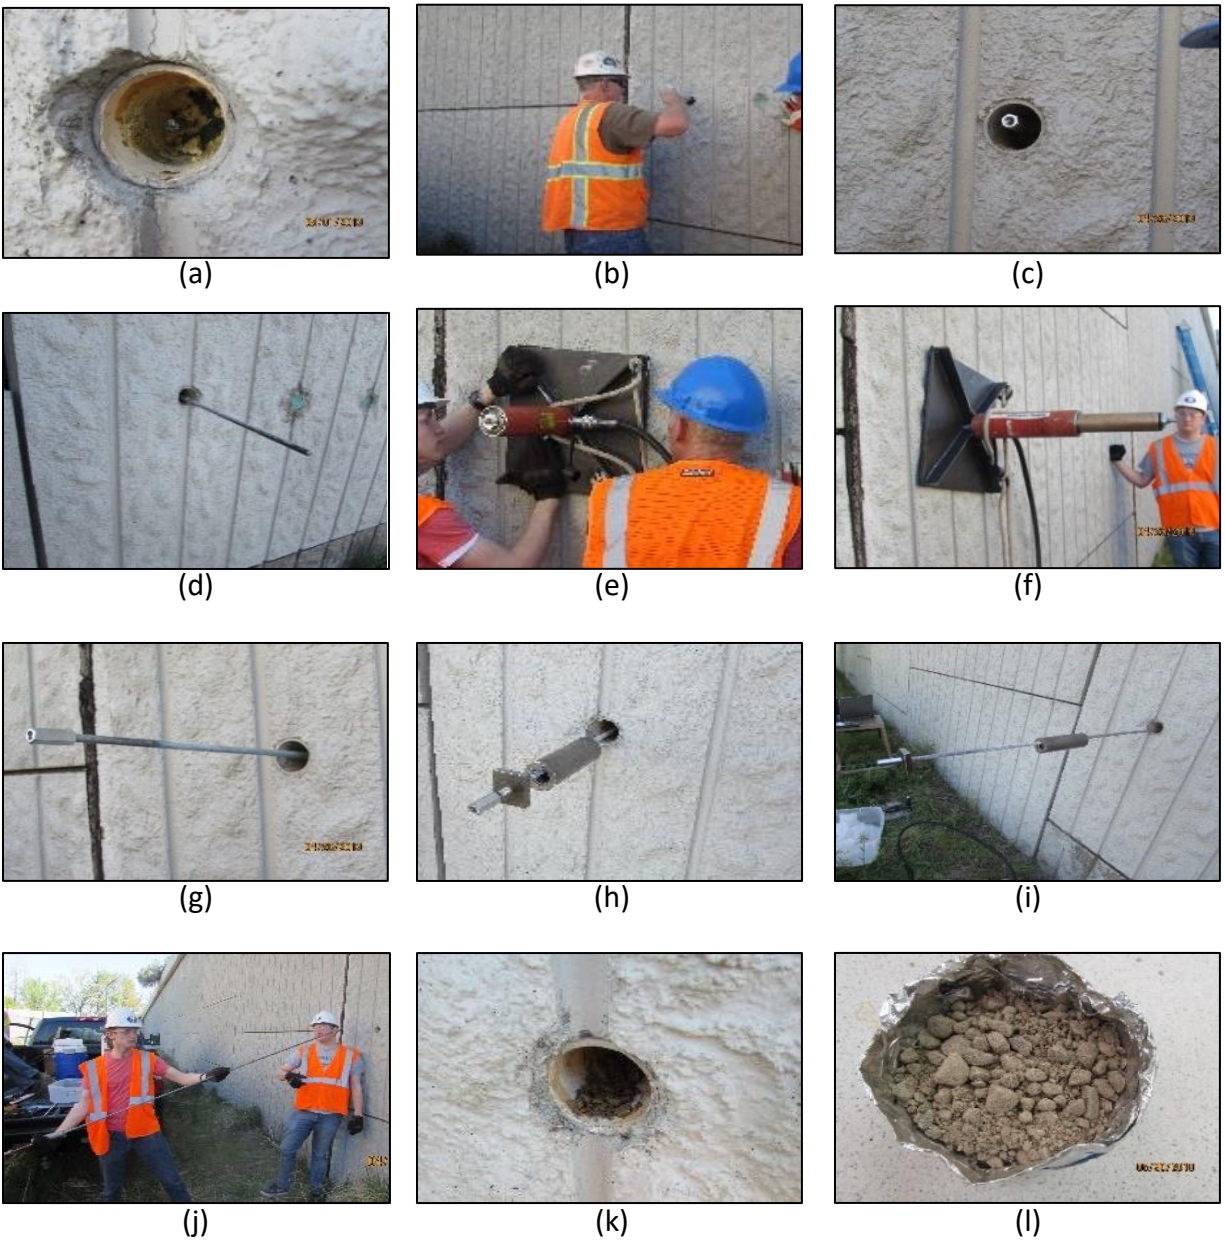
When the jack was fully retracted, the nut and washers were pushed flush with the edge of the jack and the pumping process repeated. Once the coupon was extracted approximately another 7 inches, the jack was completely removed from the wall, as shown in Figure 3-6g. After the jack was removed from the wall, a lightweight slide hammer was used to continue the coupon extraction, as shown in Figure 3-6h, i, j. Once the coupon was completely extracted, a soil sample was obtained (where possible for the one-stage walls), as shown in Figure 3-6k, l.

Figure 3-6: Extraction Procedure

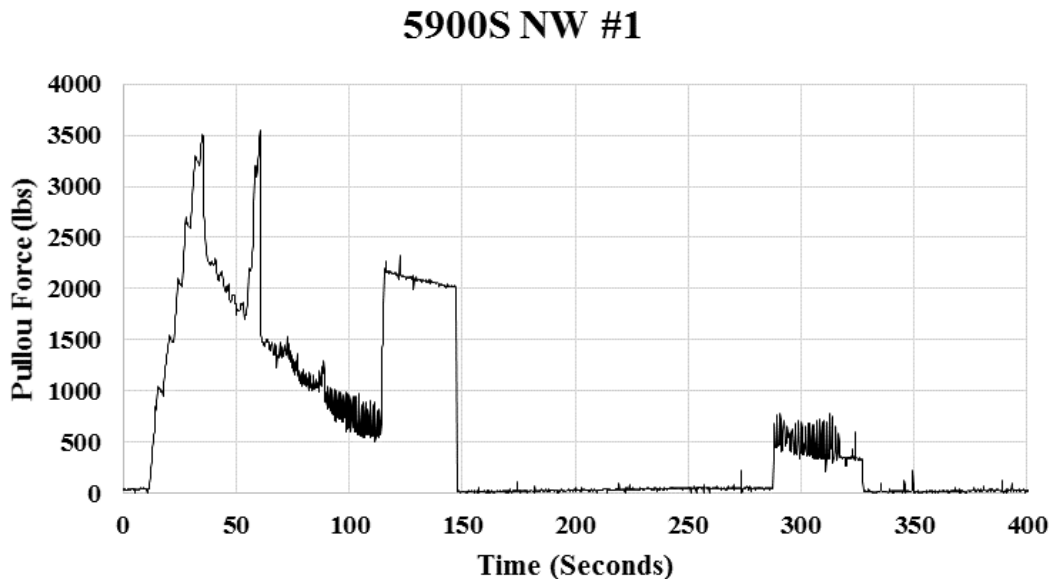
Figure 3-7 shows a typical pullout force vs time plot for a coupon. In this case, the load required to pull out the coupon was approximately 3500 lbs. The very small decreases in load observed between 0 and 3500 lbs are due to the pumping of the center-hole jack. In the plot shown, and as typical, the load dropped suddenly as the initial pull out of the coupon was observed. As extraction continued, however, the coupler sometimes was caught at the edge of the steel plate supporting the center-hole jack and, when that happened, the load would increase. In the plot shown, the load increased to approximately 3600 lbs. The coupler would eventually be freed as extraction continued and the load dropped suddenly. For the case shown, the extraction continued but the coupler was caught again at the edge of the center-hole jack, which happened sometimes, and the load would increase again. In the plot shown, the load increased to approximately 2200 lbs. As extraction continued, the coupler would slowly slide inside the cylinder of the center-hole jack and would eventually be freed again; causing the load to drop completely.

Figure 3-7: Pullout Force vs. Time for Trial Extraction

As each coupon was extracted, the load was recorded during the entire extraction. In Figure 3-7, the response of the first and most complicated extraction accomplished was presented. In Figure 4-1, a more typical load vs. time response is presented.

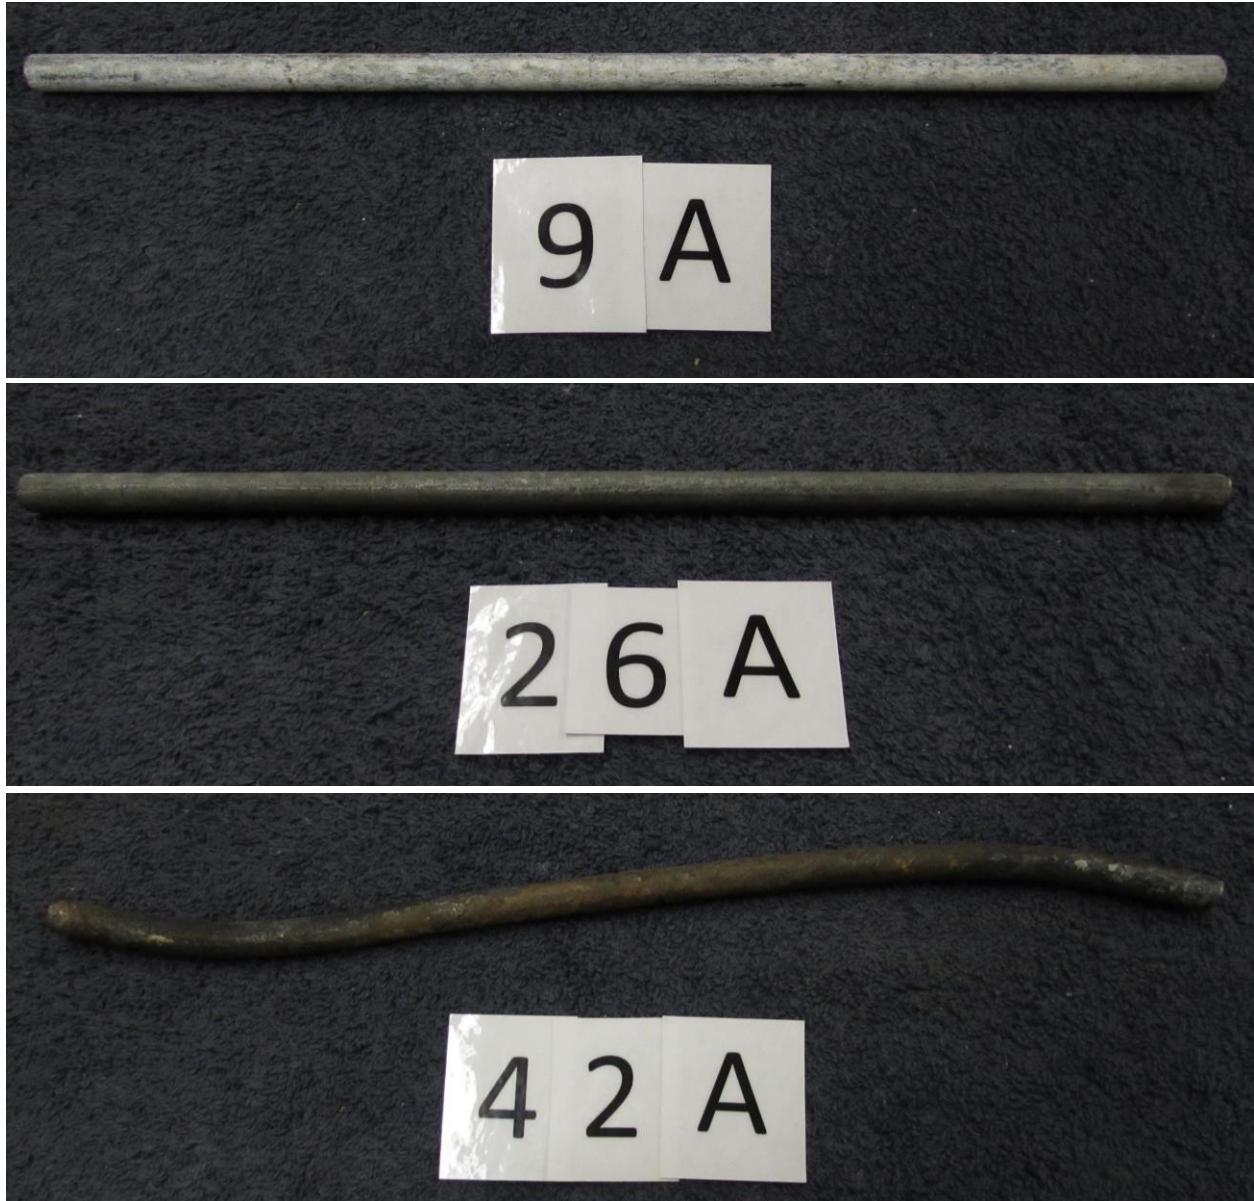
Coupons that had heavy mechanical damage were likely damaged upon installation and not caused by movement in the soil backfill. These visual observations relate to the samples tested by Gerber and Billings (2010), which showed light oxidation present on the samples. The visual difference in the eight years since the first phase of this study is a change from light oxidation to moderate oxidation. This condition of the coupons is expected, as zinc oxidation will gradually increase with time until full depletion of the zinc coating.

Figure 3-8: Typical Sample Conditions – Top (a), Middle (b), Bottom (c)

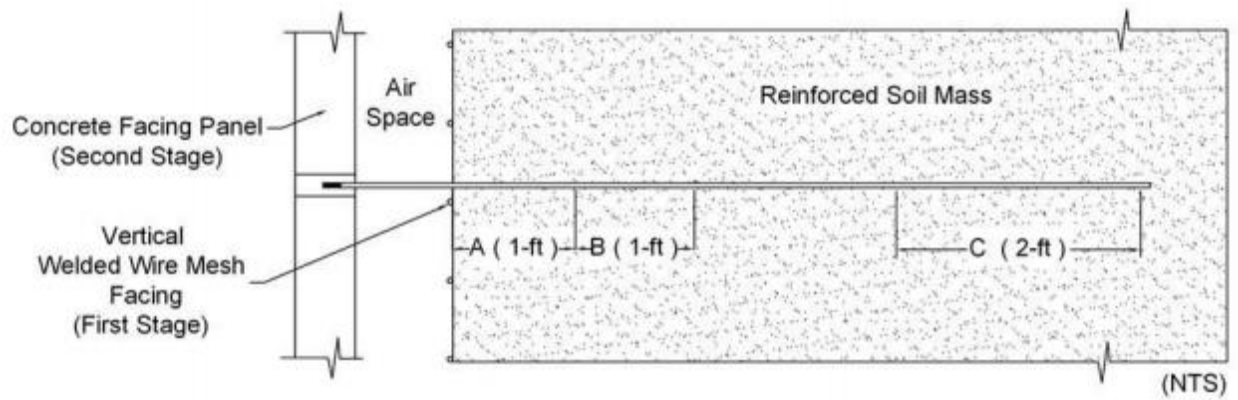
labeled sample “A”, the second 12 inches was labeled “B”. The third sample taken from each coupon was cut 24 inches from the end furthest from the concrete panel facing. This last sample was labeled “C”. The threaded portion of the coupon that was used for extraction purposes was cut off along with any coupon length that was not embedded in soil. For one-stage walls, the portion not embedded in soil was typically five inches. For two-stage walls, the portion not embedded in soil was typically about two feet. ASTM A90/A90M (ASTM 2018a) requires a minimum sample length of 12 inches for testing.

Figure 3-9: Coupon Segmentation

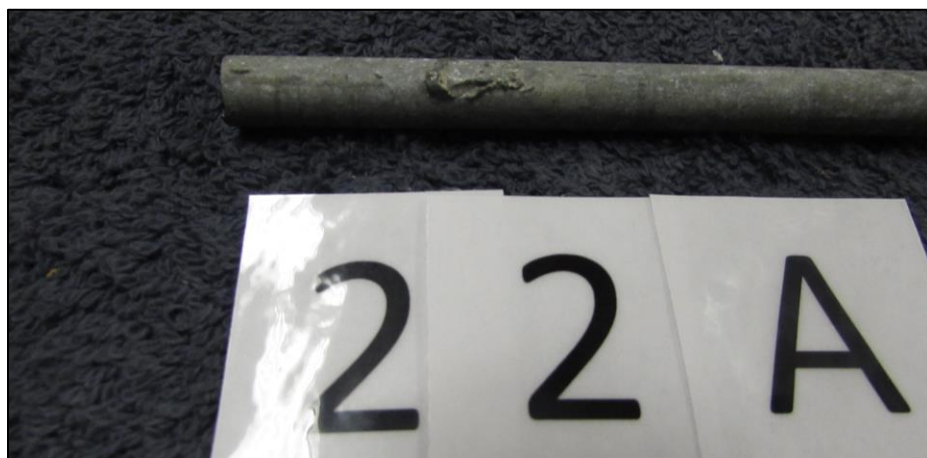
Some samples had extreme unevenness (i.e., extrusions or dripping) of the zinc galvanization. This is likely due to the hot dipping process for galvanization, which requires the sample to be dipped and then left to dry. The time it takes for the zinc to solidify could allow for some flow or dripping of the zinc coating, thus causing bumps in the coating as shown in Figure 3-10.

Figure 3-10: Zinc Coating Surface Abnormality

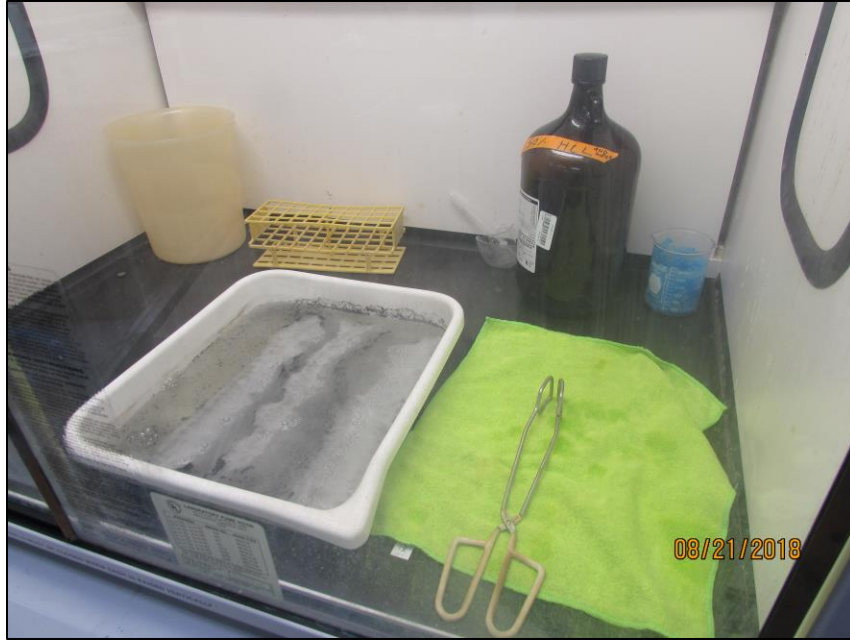
The zinc galvanization was stripped away in general accordance with ASTM A90/A90M. Due to the dangerous nature of hydrochloric acid, safety measures following the MSDS for the safe use of the chemical were followed. The acid stripping procedure was done in a ventilated fume hood, meeting OSHA safety requirements for volume of air flow. Respirator masks and gloves were worn during the procedure. Samples were placed and removed from the acid by tongs to avoid any contact with the acid. Once stripping was complete, the acid and other chemicals used in the procedure were properly and safely disposed.

Figure 3-11: Hydrochloric Acid Bath in Ventilated Fume Hood

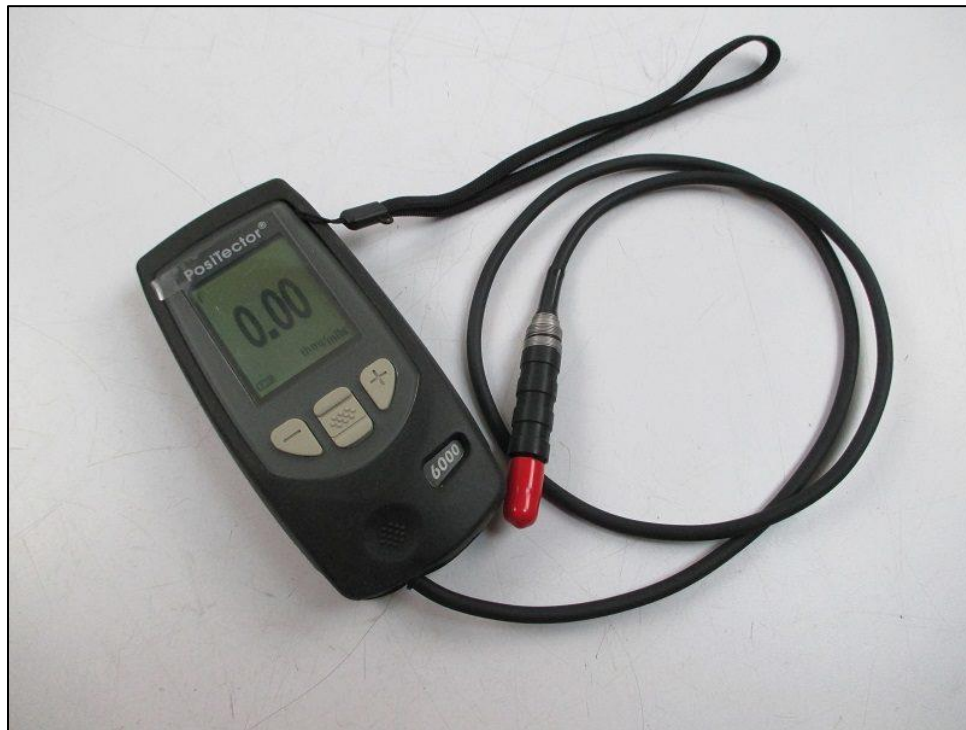
the digital measurements were taken at six locations along the sample. Two measurement locations were near one end (spaced about an inch apart), two in the middle, and two at the other end. At each of these six locations, measurements were taken at third points along the circumference of the sample for a total of 18 measurements. The 18 measurements were averaged for each sample to obtain a more accurate representation of the overall zinc coating thickness.

Figure 3-12: DeFelsko Positector 6000 device

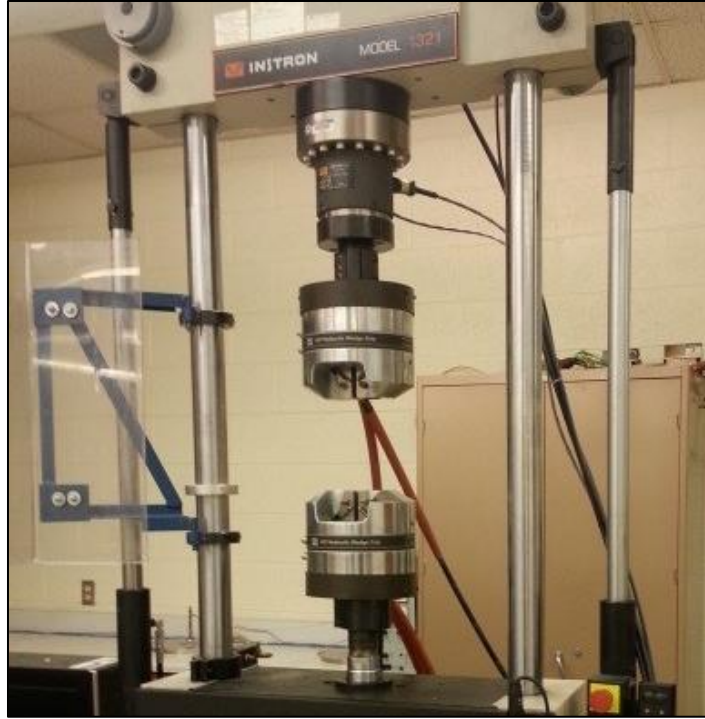
Each sample was placed vertically in the testing machine shown in Figure 3-13. The head grips at the top and bottom of the sample gripped about two inches each leaving an eight-inch potential failure area. An extensometer was attached in the middle of the eight-inch failure length. The gauge length of the extensometer was two inches. The failure did not always occur in the region recorded by the extensometer. Therefore, when necking in the sample began to occur outside the gauge length, the recorded value of strain dropped to zero. The value of stress recorded and used for comparisons was not affected by lack of strain recorded by the extensometer.

Figure 3-13: Instron Testing Machine

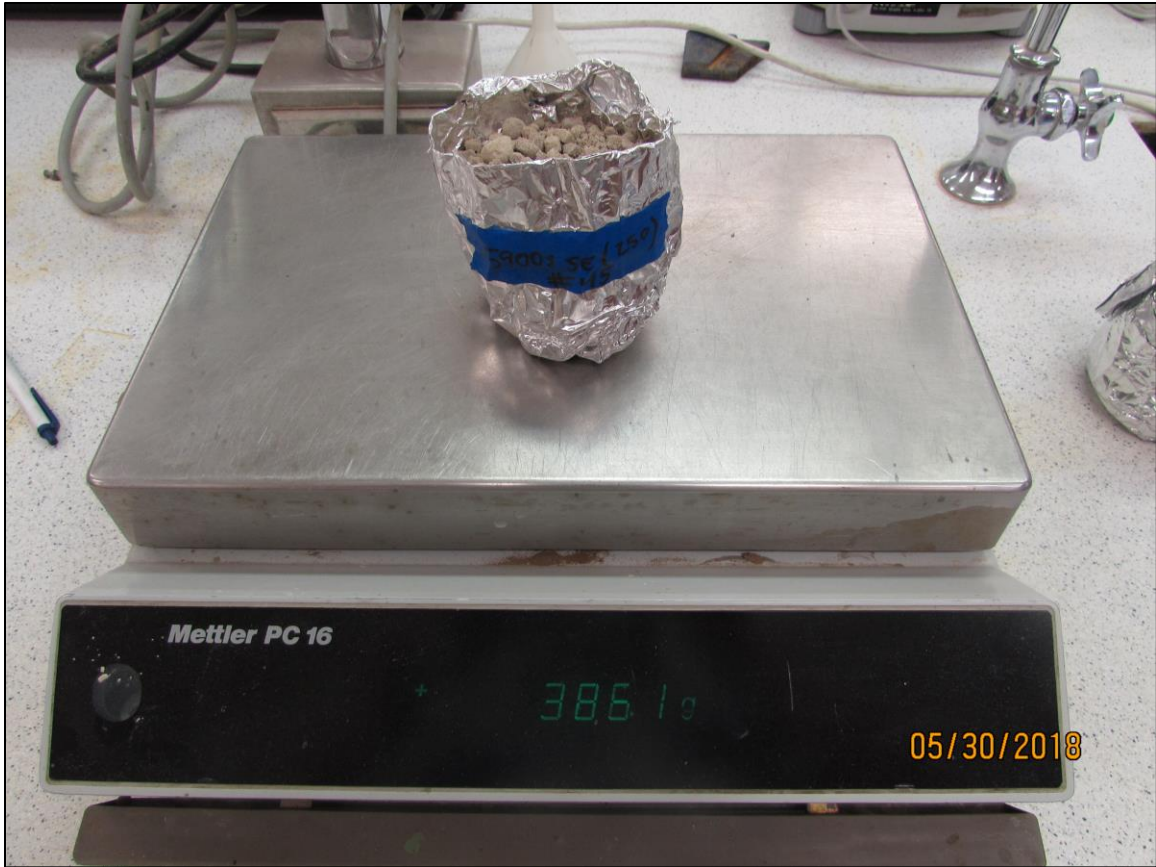
The moisture content of soil samples taken from extraction holes was determined in general accordance with ASTM D2216-10 (ASTM 2019). The soil sample was weighed in the field on a portable digital scale. An aluminum foil lid was placed over the soil sample and the container was placed in a zip-lock bag and sealed. The sealed sample was then placed in a cooler to reduce moisture loss due to evaporation. The soil samples were transported to the laboratory and the weight of the soil and container were determined, as shown in Figure 3-14, before being put in the oven at $110^{\circ}\text{C} \pm 5^{\circ}\text{C}$.

Figure 3-14: Soil Weight Determination

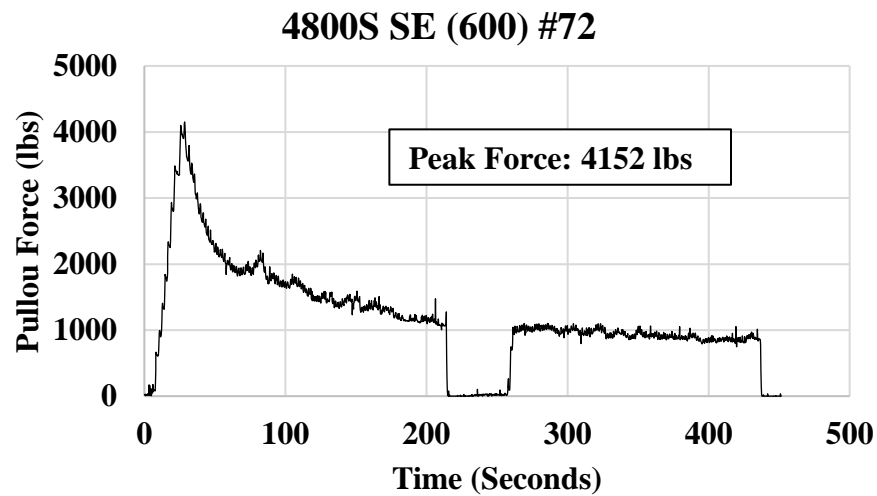
Figure 4-1: Pullout Force vs. Time for Trial Extraction

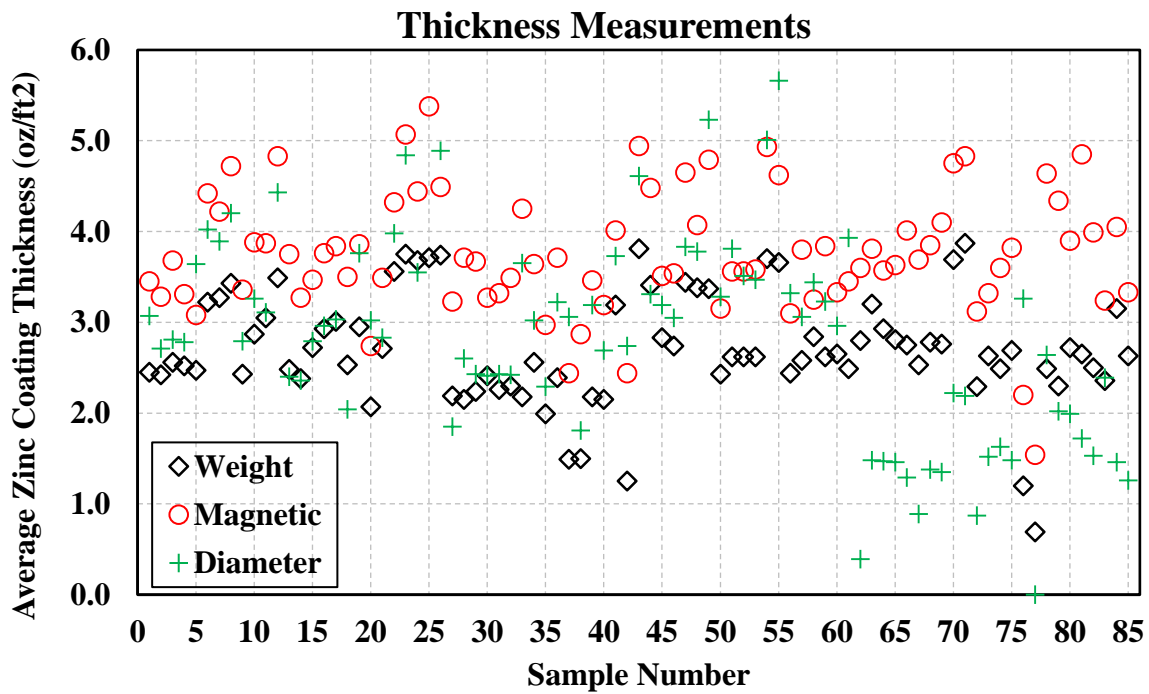
Figure 4-2 is a visual representation of the thickness measurements using all three methods. As mentioned in Section 3.3.2, the diameter difference method has the most variability. The coefficients of variation for the zinc coating thicknesses from weight, magnetic, and diameter methods are 23.7, 20.6, and 54.1% respectively.

Figure 4-2: Average Zinc Coating Thickness for All Measurement Methods

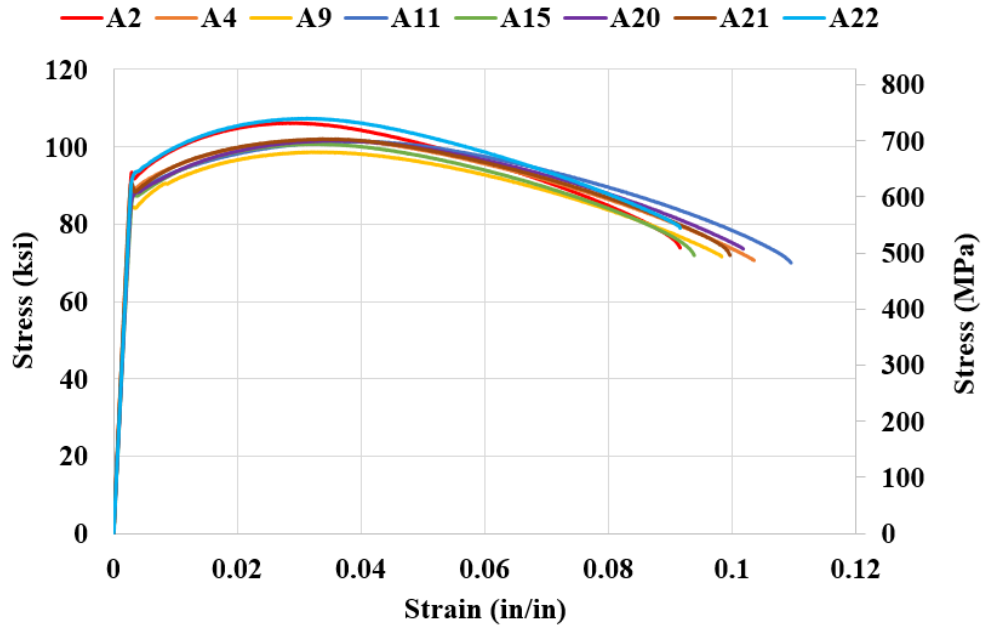
The results for Group X of the Phase I samples are shown in Figure 4-3 and summarized in Table 4-4. The results for Group Y of the Phase I samples are shown in Figure 4-4 and summarized in Table 4-5. The results from Group X and Group Y of the Phase I samples are used as a baseline comparison for the tension results of the Phase II samples.

Figure 4-3: Stress-Strain Curve for Phase I Samples Group X

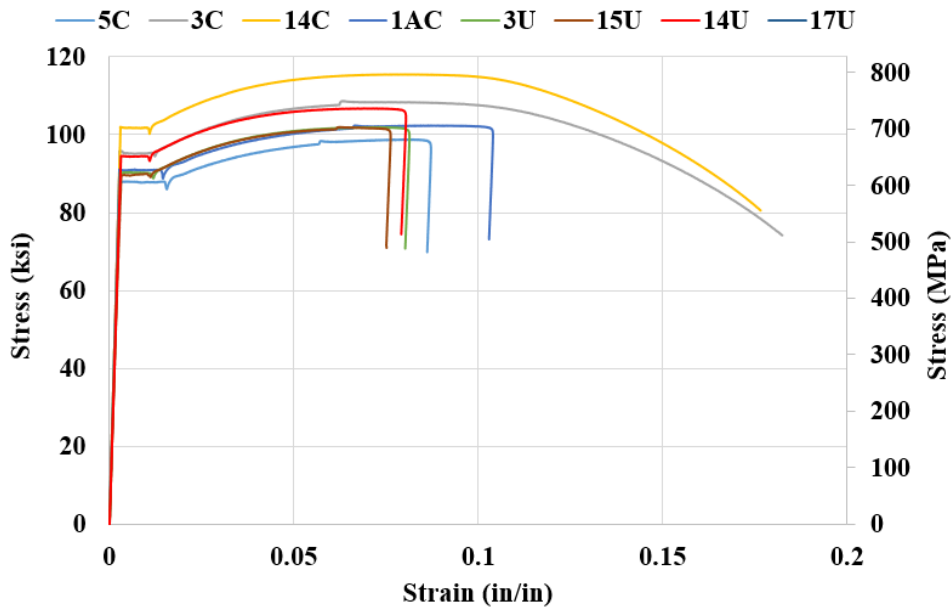
Figure 4-4: Stress-Strain Curve for Phase I Samples Group Y

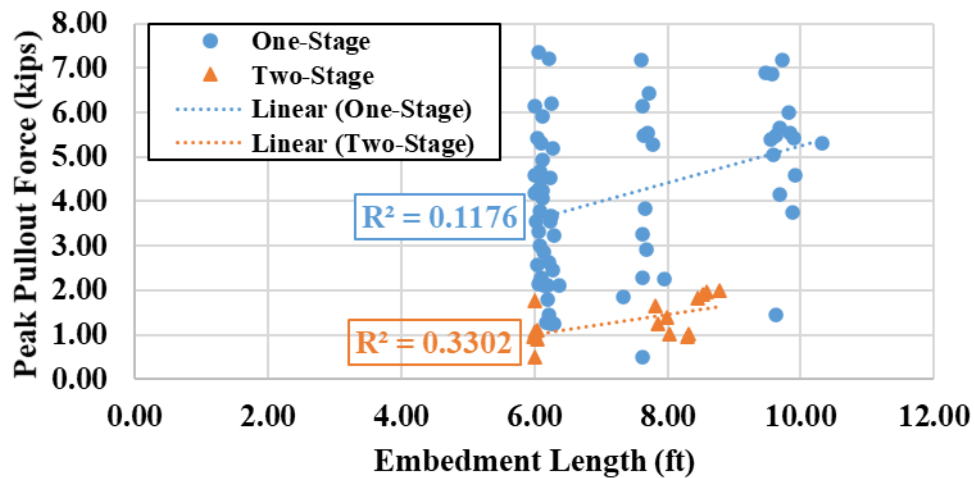
assumed to be equal to the height of soil that is applying overburden pressure on the steel coupon. It was initially assumed that the weight of the soil bearing on the embedded coupons would generate a greater frictional resistance, thus increasing the required pullout force for extraction. Figure 5-2 shows the pullout force per length of embedded coupon vs. the overburden soil height. Force per embedment length does not have a strong correlation to the height of overburden soil above the coupon. One potential explanation for this is the effect of arching of backfill above the single element of wire reinforcement together with the absence of any orthogonally welded wires. What can more readily be determined from the comparison in Figure 5-1 and Figure 5-2 is that two-stage wall coupons typically require less pullout force than coupons from one-stage walls. We suspect this is likely due to a lower relative soil density and less effective compaction effort as a result of the flexible facing behind the wall facing panel.

Figure 5-1: Peak Pullout Force vs. Embedded Length

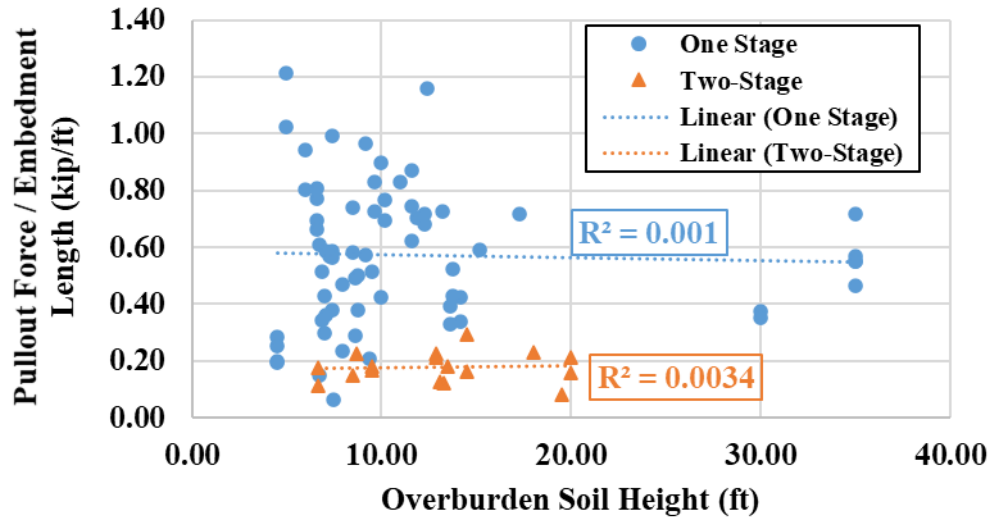
Figure 5-2: Pullout Force / Embedded Length vs. Overburden Soil Height

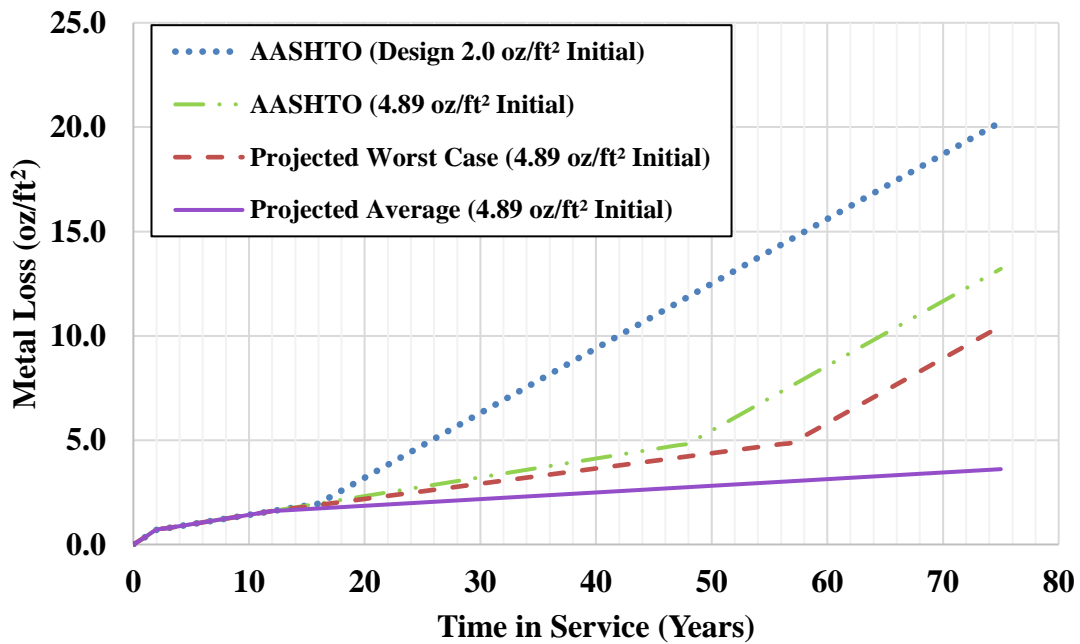
Although it is unknown exactly what the initial coating thickness was, the corrosion rate of 0.073 oz/ft²/year was used to back-calculate a theoretical initial coating thickness of 4.89 oz/ft². Figure 5-3 shows the AASHTO design corrosion rate applied to this estimated initial coating thickness of 4.89 oz/ft², which would result in depletion of the zinc coating after 49 years in service.

Figure 5-3: AASHTO Design Loss Rate and Projected Loss Rate

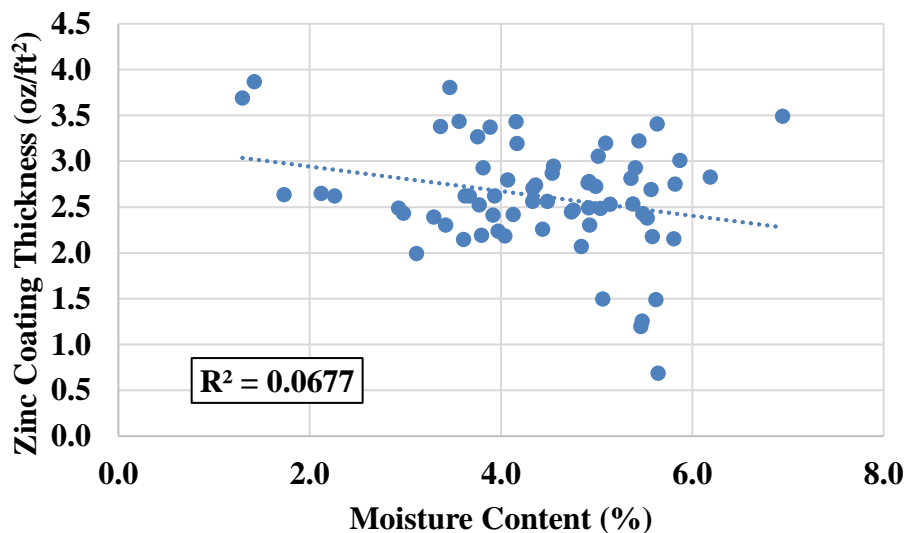
As discussed in Section 2.2.6, corrosion increases in soils with a moisture content above 25 to 40 percent. The maximum moisture content calculated for the backfill sampled in this study was 6.9%. The maximum moisture content determined herein is well below the range for a corrosive environment. The moisture contents encountered in this study are compared to the thickness of zinc coating determined at the same locations. Figure 5-4 shows the correlation of moisture content to zinc coating thickness.

Figure 5-4: Zinc Coating Thickness vs. Moisture Content

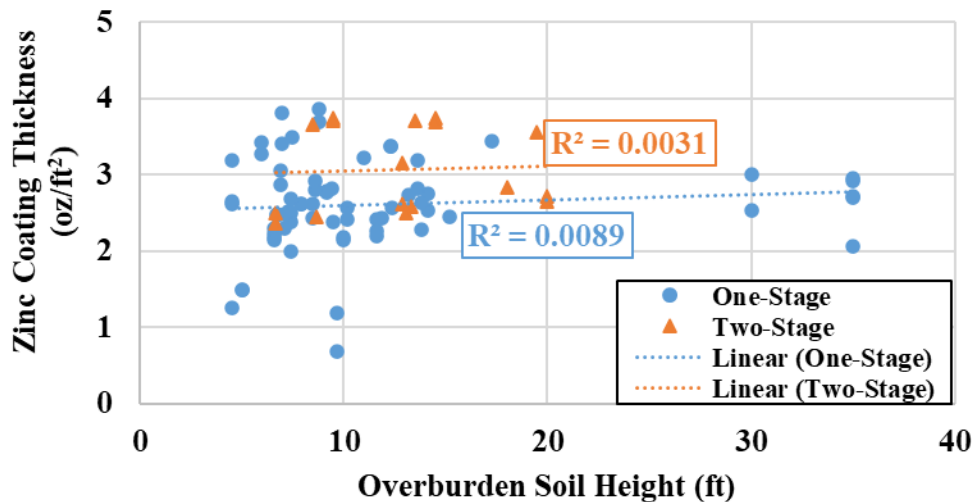
Figure 5-5 shows the zinc coating as a function of the overburden soil height for one-stage and two-stage walls. There is not a strong correlation between overburden height and the amount of zinc coating remaining on the steel coupons. From the data gathered in this study, there is not a significant effect that overburden height has on the zinc coating thickness.

Figure 5-5: Zinc Coating Thickness vs. Overburden Soil Height

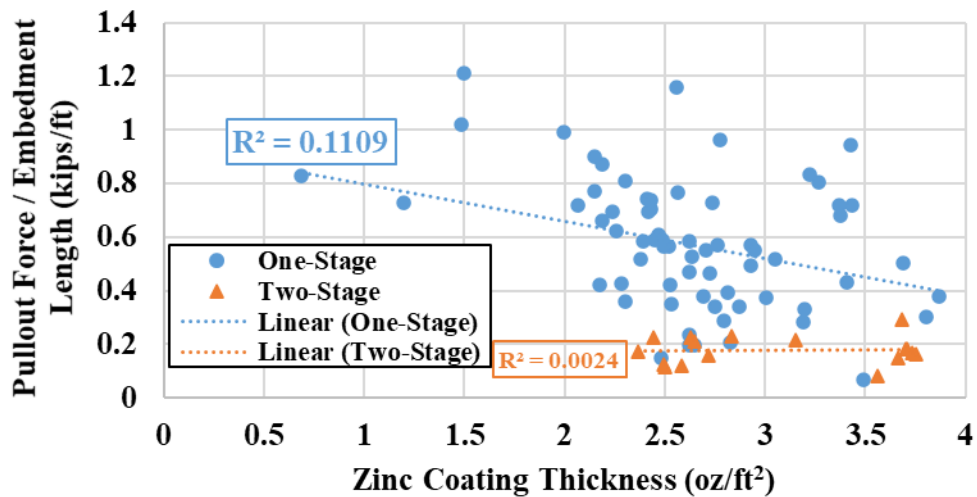
Figure 5-6 compares the pullout force / embedment length to the zinc coating thickness for both one-stage and two-stage walls. In this comparison, the pullout force / embedment length is taken as the dependent variable to determine if zinc coating thickness increases or decreases required force per length. For one-stage walls, there is a slightly negative correlation, but not strong enough to determine if the extent to which the zinc has corroded has an effect on the required pullout force. Similar results were determined by Gerber and Billings in Phase I (2010). If the zinc does not corrode uniformly, this non-uniform surface on the reinforcement might theoretically increase frictional resistance to pullout, but only if the backfill were to also deform as to be compliant with the interface surface.

Figure 5-6: Pullout Force / Embedment Length vs. Zinc Coating Thickness
