Report No. UT-20.24

ASSESSING CORROSION OF EXTRACTED MSE WALL REINFORCEMENT COUPONS, UTAH PHASE II STUDY

Utah Department of Transportation
Research and Innovation Division

Final Report

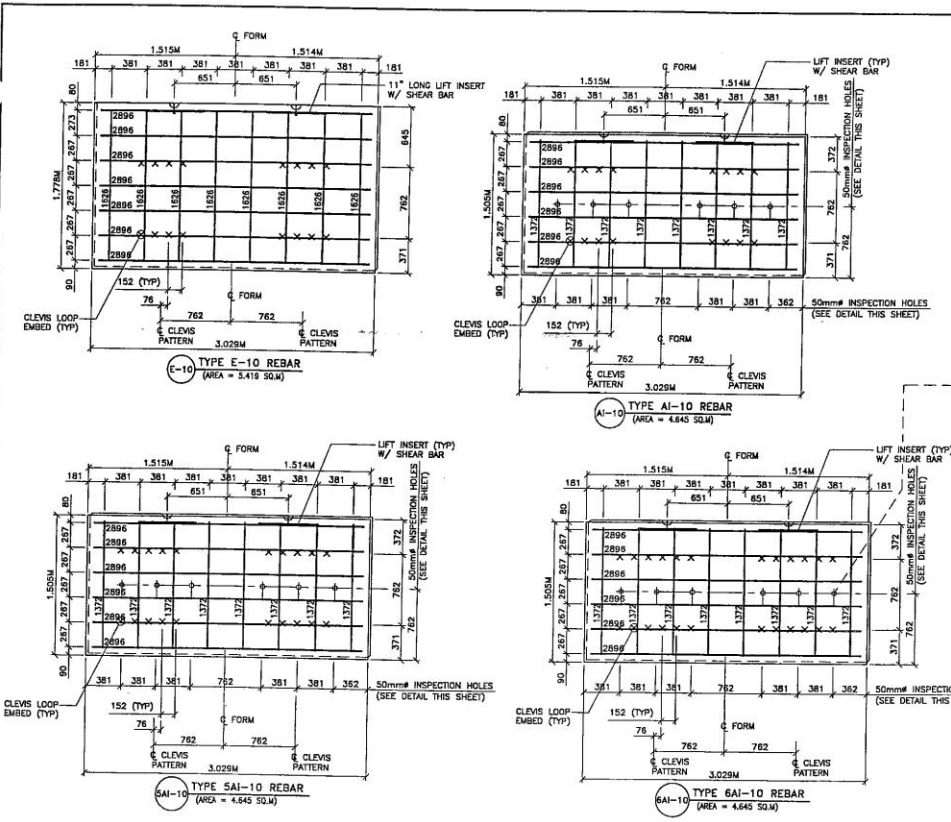
DWG. NO. CS-302
JOB NO. 233-0007
SHEET NO. STD-2

RETAINED EARTH WALLS
CORROSION STANDARD PLAN
"E" & "T" PANEL REINFORCEMENT 1.524Mx5.08M
SALT LAKE COUNTY, UTAH
UTAH DEPARTMENT OF TRANSP.

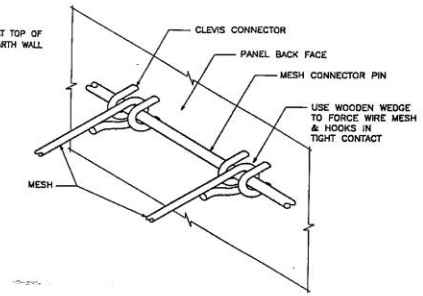
2 MESH CLEVIS CONNECTOR
VSL RETAINED EARTH IS PROTECTED UNDER U.S. PATENT 4,725,170.

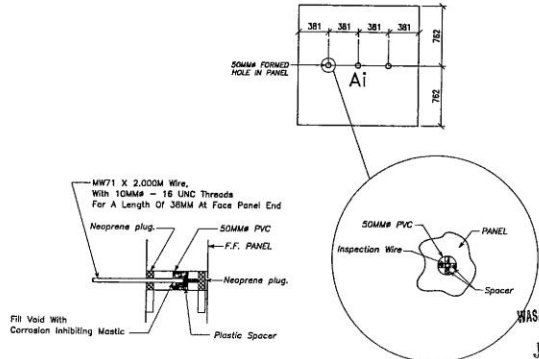
5 INSPECTION WIRE DETAIL
(PANEL FRONT FACE SHOWN)
