EVALUATION OF THE OHIO DEPARTMENT OF TRANSPORTATION'S CURRENT STORM SEWER CLEANING OPERATIONS

January 2019

Final Report

1. Report No. FHWA/OH-2019-5	2. Government Accession No.	3. Recipient's Catalog No.	
4. Title and Subtitle Evaluation of the Ohio Department of Transportation's Current Storm Sewer Cleaning Operations – Phase II		5. Report Date January 2019

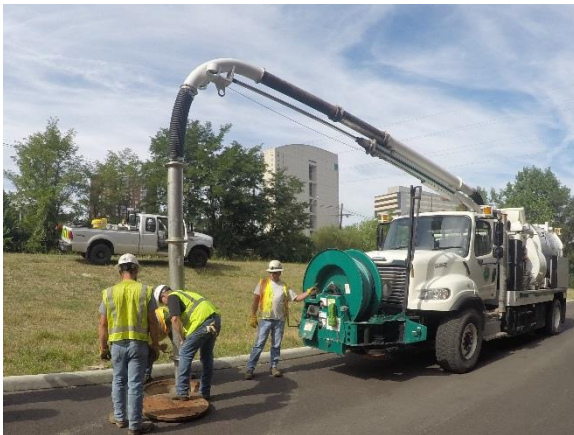
The research team began by reviewing the first phase of this project, “*Evaluation of the Ohio Department of Transportation’s Current Storm Sewer Cleaning Operations – Phase I*” (Schneider et al., 2018). The team completed a full review of ODOT’s current state of practice over a six-month timeline during Phase I. Key ODOT personnel were interviewed and the equipment was shadowed to observe operations. The team found that ODOT District 6 currently uses two VJT’s to clean storm sewers. The VJT is able to both vacuum debris from the structure and jet the lateral lines that branch from the access point. Figure 3.1 shows the current VJT systems used in District 6.

The VJT operates by combining the use of the vacuum and jetting system to remove and loosen debris that has filled the storm sewer structure. The VJT starts by vacuuming the debris/wastewater from the top of the water column if present. The operator typically would vacuum the structure until they were able to reach the bottom of the structure where they would access the lateral lines that branch off of the main structure. Next, the operator uses high pressure water jetting system to loosen any remaining debris. If there is no standing water or debris present, the operator may then start by jetting the lateral lines immediately. While the structure is being cleaned, the vacuum system remains engaged so that any water jetted may be collected and stored in the debris tank onboard the truck so that it may be disposed of at an approved facility. The two most important characteristics of the VJT are the debris and water capacity, summarized in Table 3.1.

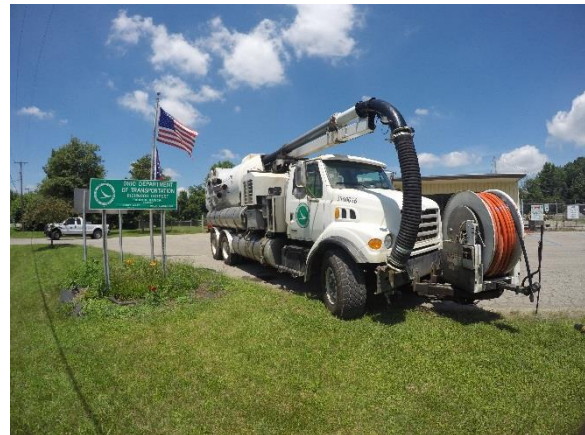
(b)

Note: Pictures taken in summer 2018 by the research team in ODOT District 6.

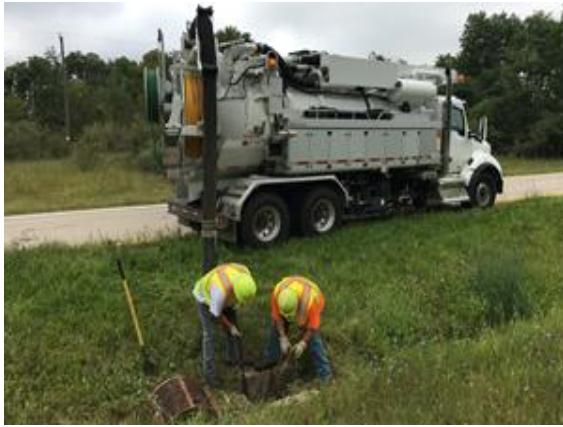
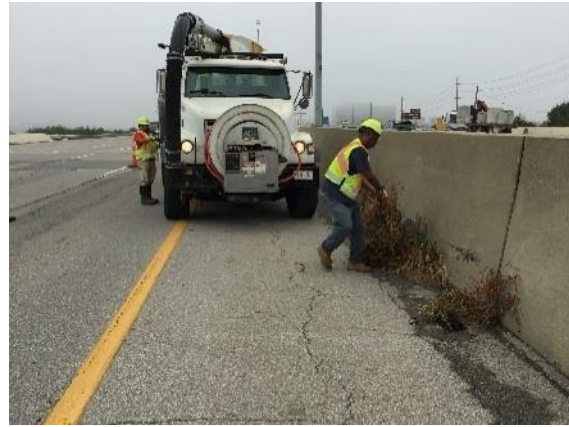
The type of setting in which the equipment was observed correlates closely to the counties in which they were tested. The majority of counties in District 6 are low density in nature, including; Fayette, Madison, Marion, Morrow, Pickaway and Union. Inversely, Delaware and Franklin Counties are more high density settings with Franklin County being the location of the city of Columbus. Examples of the different types of setting classifications may be found in Figure 4.6, as defined by the research team.

Note: Pictures taken by research team in the summer and fall of 2018.

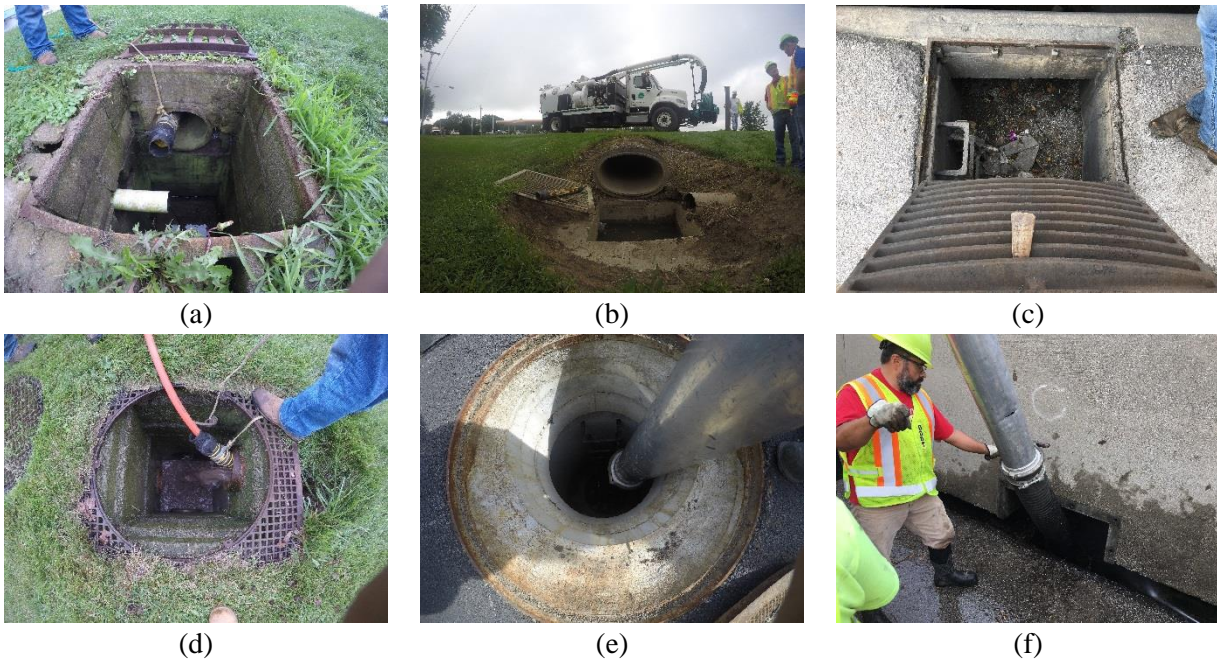
The type of structure that was cleaned during each test event was also collected. Each structure was identified as either a lateral line, catch basin, manhole vault, hydrodynamic separator or plated drain. Examples of each type of structure may be found in Figure 4.9.

Note: Pictures taken by the research team in the summer of 2018.

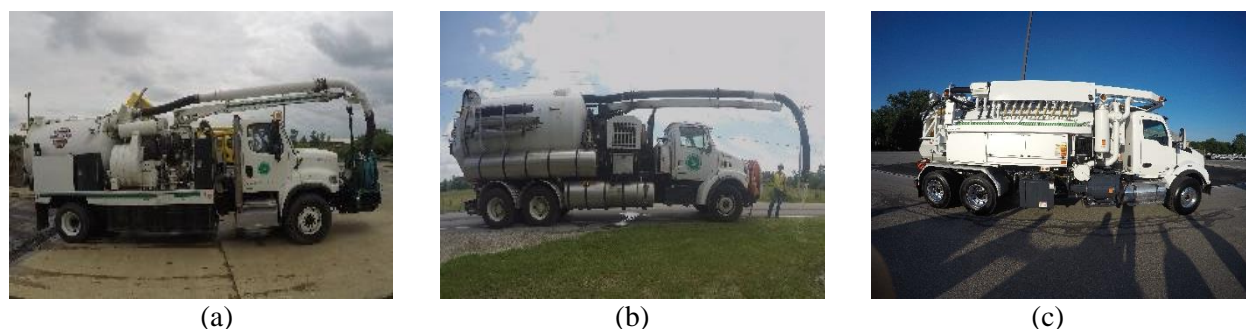
District 6 currently operates two different VJTs, a Vac-Con and Vactor 2100, that were tested. The sole Recycler option that was tested was the BUCHER RECYcler 315 that was purchased for this study. Figure 4.11 presents the three equipment options studied by the research team.

Figure 4.11: Equipment Type Classifications (a) Vac-Con VJT (b) Vactor VJT (c) BUCHER Recycler

As seen in Figure 4.11, all three pieces of equipment are similar. The largest differences, excluding the recycling system, is that the operating position is on the rear of the vehicle for the Recycler instead of at the front as in the VJT. Figure 4.12 shows the breakdown in testing for each piece of equipment.

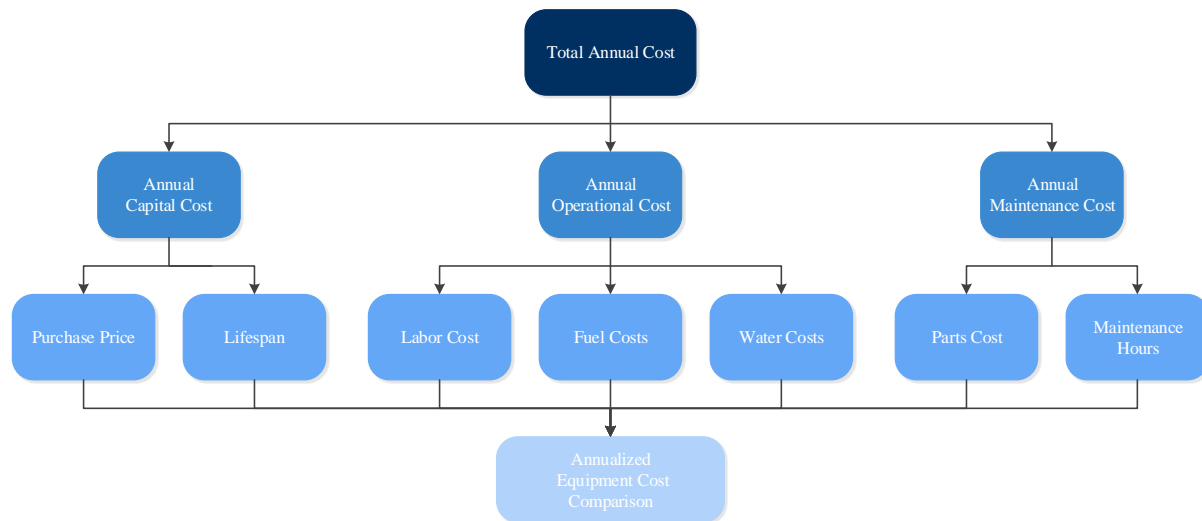
Figure 5.3: Annual Cost Matrix

Note: Figure developed in Phase I of this study “*Evaluation of the Ohio Department of Public Transportation’s Current Storm Sewer Cleaning Operations – Phase I*” (Schneider et al., 2018).

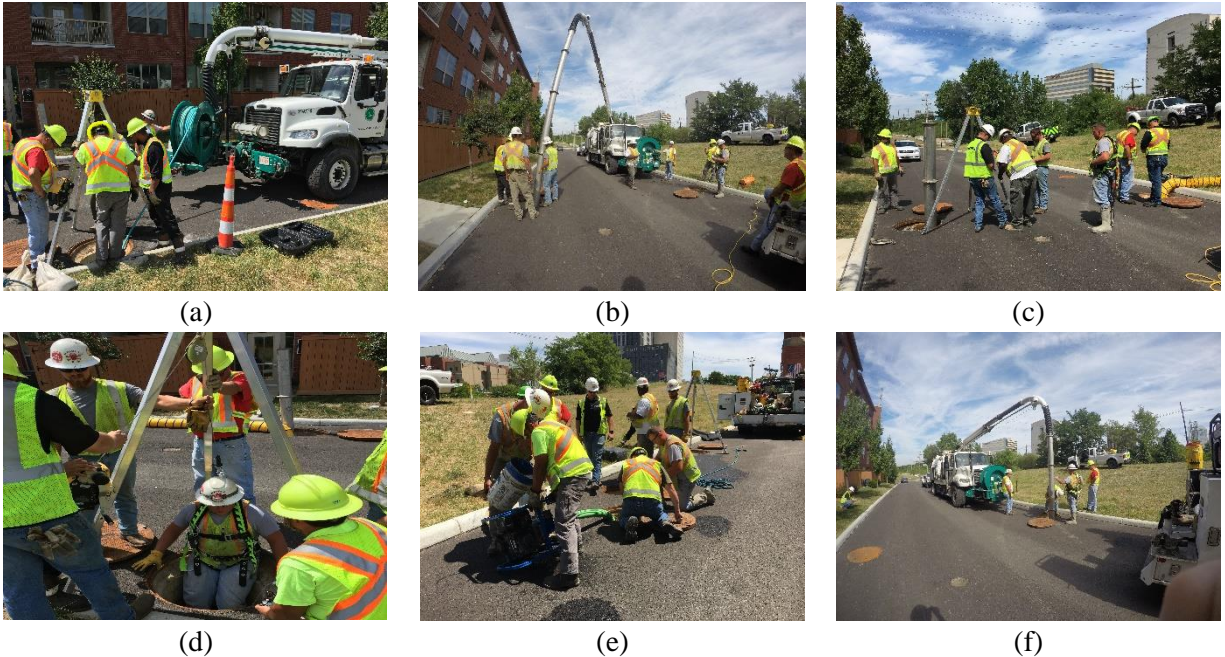
The traditional method of maintenance using the VJT involves plugging the upstream line with sandbags to stop the flow of water. The crew must then use the VJT to remove the floatables and pump the hydrodynamic separator dry so that the VJT may reach the bottom of the structure to remove the settled debris. After the structure is cleaned the crew must remove the sandbags to return the flow of water. Figure 6.4 shows the series of steps that are required to maintain the hydrodynamic separator using the traditional VJT methods.

Figure 6.4: Hydrodynamic Separator Maintenance Using Traditional VJT Methods. (a, b) VJT cleaning junction chamber so that crew member may be sent in to plug upstream line, (c) Crew waiting for junction chamber air to circulate and achieve acceptable oxygen and gas levels, (d) Crew member lowering into junction chamber to plug upstream line with sandbag, (e) Crew setting up a pump to remove standing water from hydrodynamic separator, (f) VJT cleaning the hydrodynamic separator.

As seen in Figure 6.4, the traditional method of cleaning the hydrodynamic separator involves numerous time consuming steps. In addition, it involves placing a crew member in a confined space, raising safety concerns. This type of structure promotes the greatest opportunity to improve operations using alternative maintenance methods.

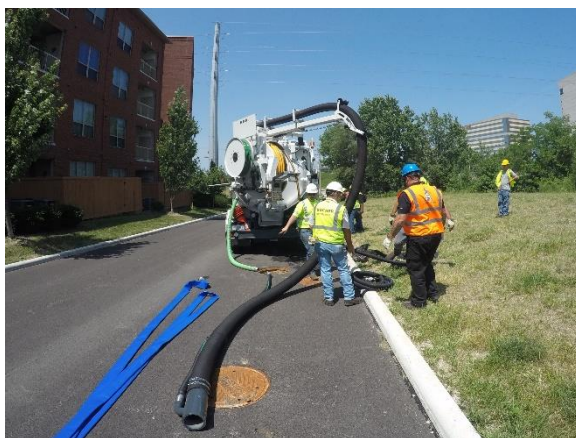
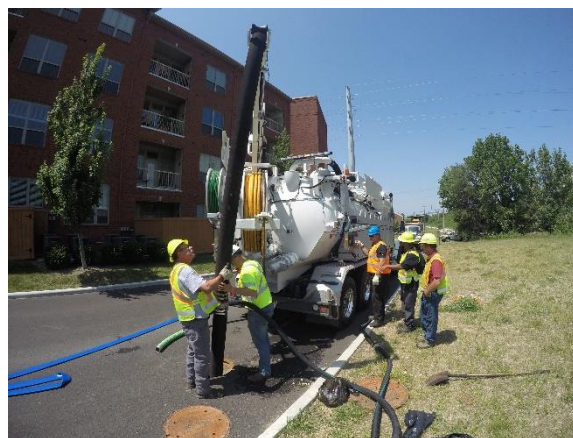
The use of alternative methods to maintain hydrodynamic separators is one of the most exciting implementations of the Recycler. The Recycler uses a positive displacement (PD) pump to produce the vacuum needed to remove debris from the structure. The PD pump, paired with a snorkel attachment and onboard air compressor, adds the ability to vacuum at the bottom of a water column. This feature allows the Recycler to clean the hydrodynamic separator without needing to first drain the structure. Figure 6.5 shows the steps involved in cleaning the hydrodynamic separator using the Recycler.

Note: Pictures taken by research team in Summer 2018.

As seen in Figure 6.5, the Recycler requires fewer steps to prepare, setup and clean the hydrodynamic separator when compared to the VJT seen in Figure 6.9. In addition, the method of cleaning the structure with the Recycler does not require anyone to enter a confined space. As a result of using the Recycler to clean the hydrodynamic separator, ODOT increases their production rate and decreases their safety concerns.

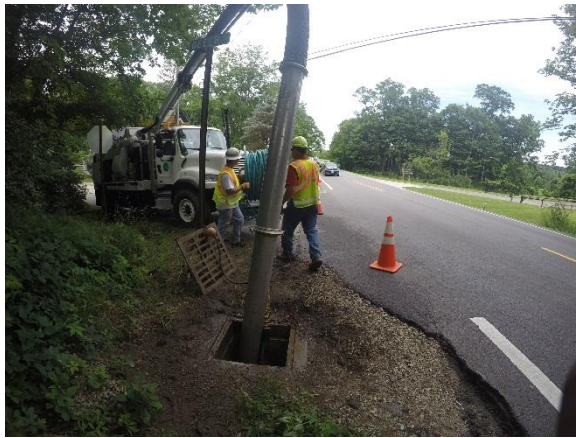
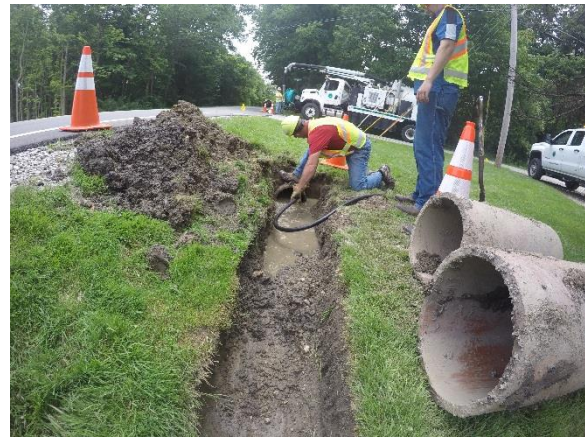
The first type of setting the team looked at were those with a low density of storm sewers. These areas typically include roads that are two lanes, carry a low traffic volume, and have unique land use factors. Low density areas in ODOT District 6 are predominately in flat regions used for agriculture. The structures in these areas are also generally far from water refilling and/or decanting locations which increases travel time to these sites. In addition, structures are typically spread across a long distance, increasing travel time between sites as well. Figure 6.7 shows an example of cleaning a structure in a low density area with the VJT.

Figure 6.7: Low Density Arterial Storm Sewer Cleaning with VJT (a) VJT cleaning catch basin in low density setting, (b) VJT cleaning underdrain in low density setting.

The storm sewer maintenance on structures in low density areas shown in Figure 6.7 typically require more time than in high density areas. In many situations, low density infrastructure is older, has been inspected less frequently, carries agricultural runoff, and may be damaged by large equipment. Figure 6.8 shows the Recycler working in a low density setting on a storm sewer damaged by agricultural equipment.

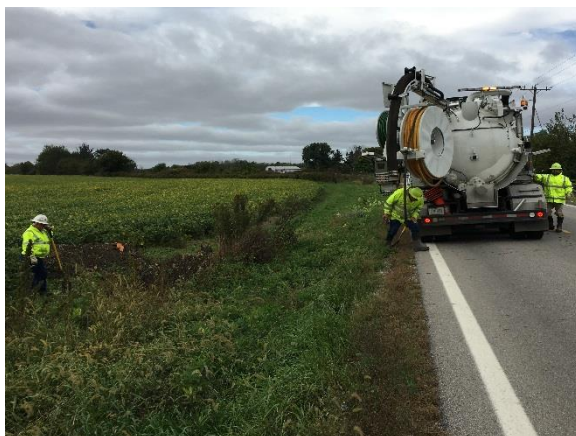
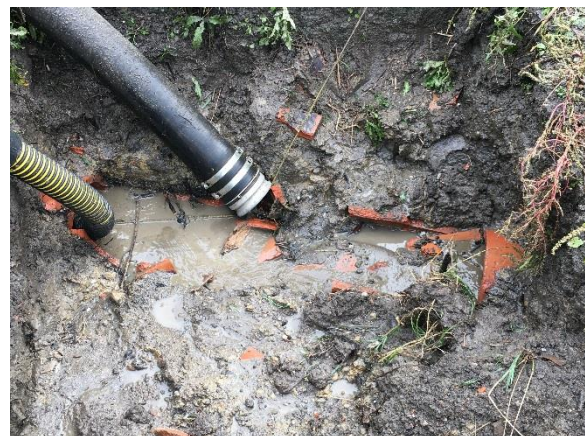
Note: Pictures taken by research team in Fall 2018.

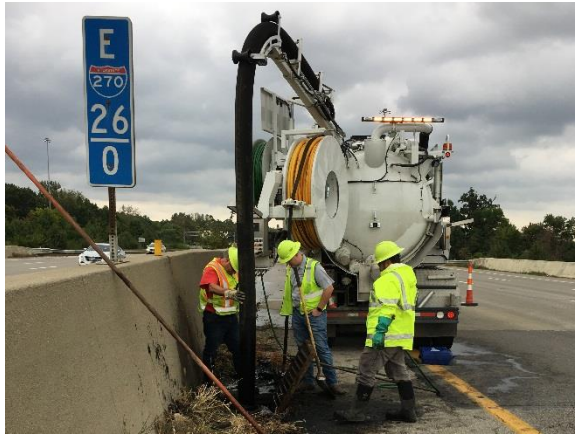
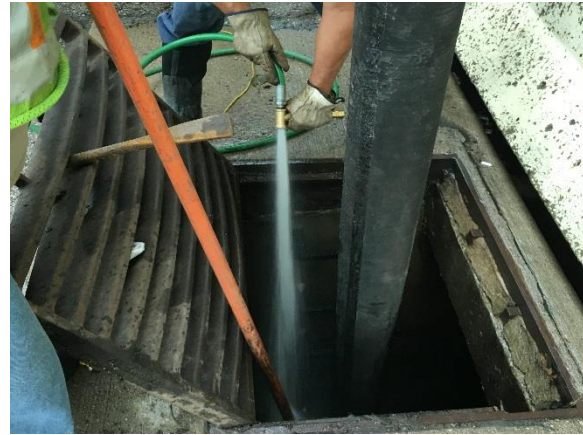
As seen in Figure 6.9, the VJT may have difficulty accessing certain types of storm sewers in some cases. For example, plated drains have narrow openings which the eight inch vacuum tube on the VJT has trouble fitting into. The operators had to hand shovel debris up to the vacuum tube from the bottom of the structure in this instance. In addition, storm sewers in high density environments are typically closer in proximity to each other and have long lateral lines to jet, leading to an increase in water usage. In addition, the time it takes to setup and breakdown the VJT before and after each cleaning leads to additional time lost. Figure 6.10 shows the Recycler operating in a high density environment.

Note: Pictures taken by research team in Fall 2018.

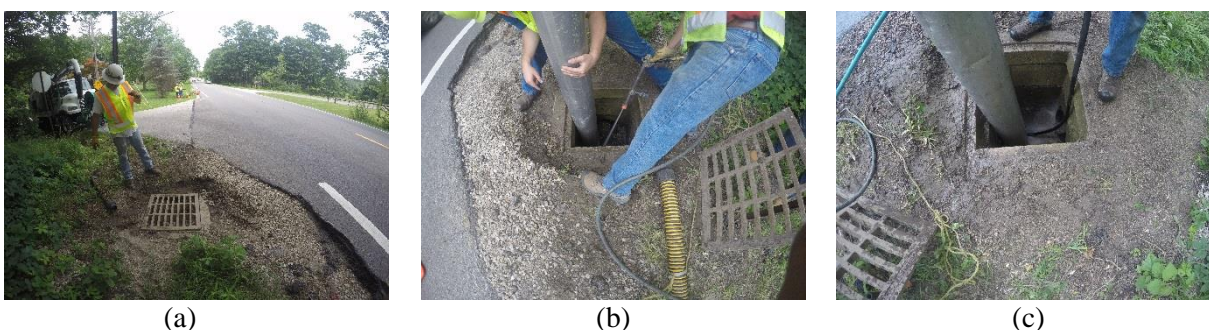
Figure B.2: VJT Operations Using Vac-Con 9CY on June 25, 2018 in Union County
(a) Structure prior to cleaning, (b) Cleaning of the structure, (c) Jetting through structure line.

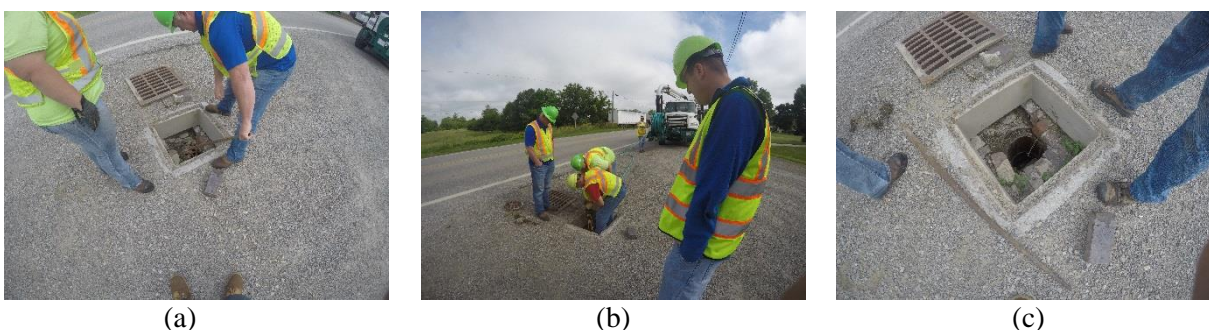
Figure B.3: VJT Operations Using Vac-Con 9CY on June 25, 2018 in Union County
(a) Structure prior to cleaning, (b) Cleaning of the structure, (c) Structure post-cleaning.

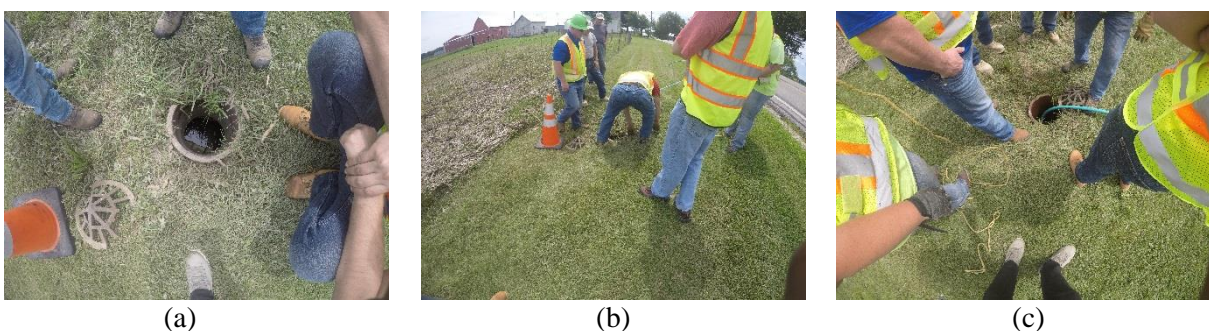
Figure B.5: VJT Operations Using Vac-Con 9CY on June 26, 2018 in Madison County
(a) Work setup, (b) Cleaning of the structure, (c) Structure post cleaning.

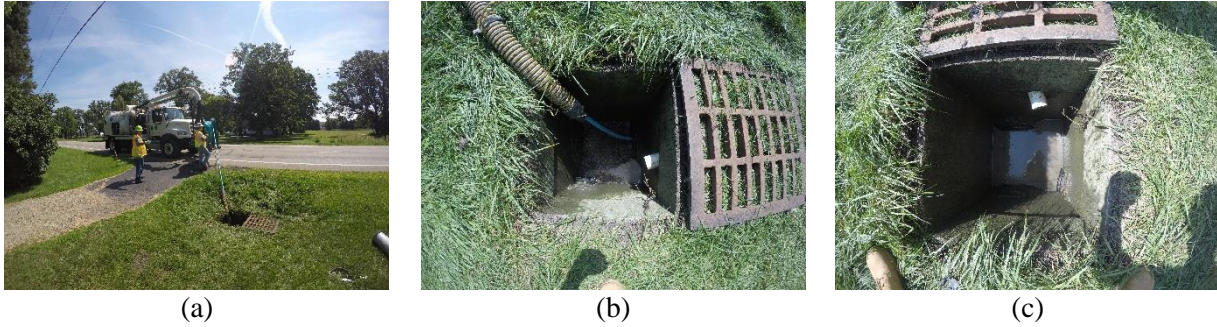
Figure B.6: VJT Operations Using Vac-Con 9CY on June 26, 2018 in Madison County
(a, b) Work setup, (c) Cleaning of the structure.

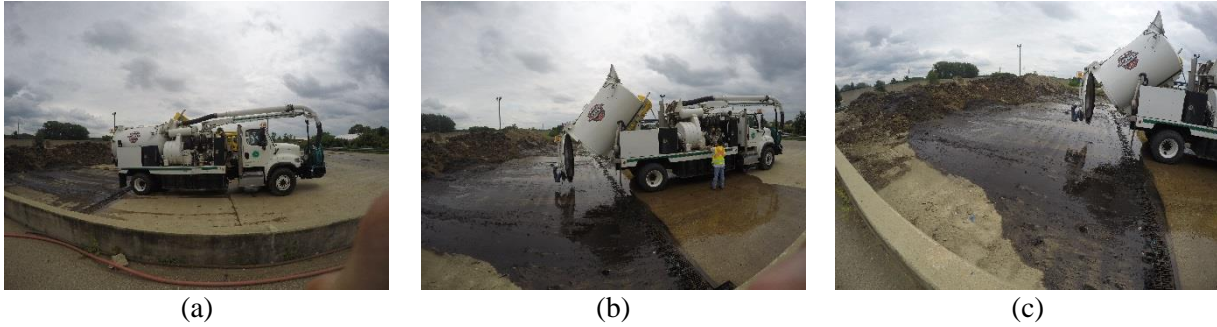
Figure B.9: VJT Operations Using Vac-Con 9CY on June 26, 2018 in Madison County
(a) Truck prior to decant, (b) Decanting at Columbus WWTP, (c) Post Decanting.

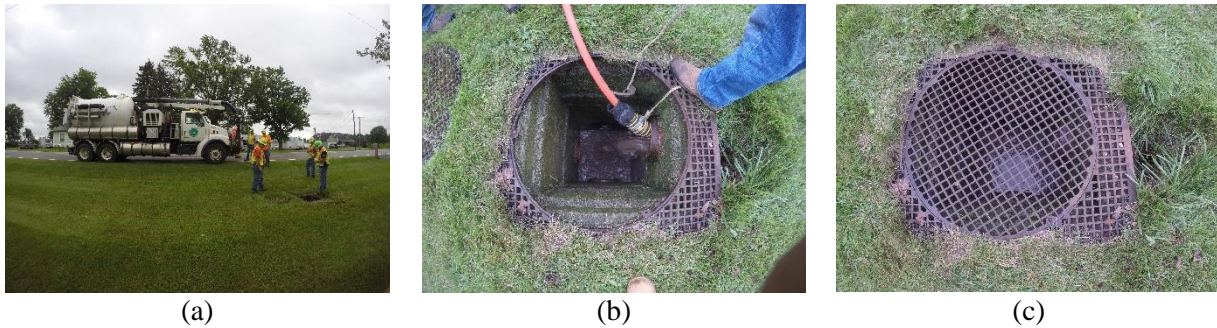
Figure B.11: VJT Operations Using Vactor 2100 on June 27, 2018 in Union County
(a) Structure prior to cleaning, (b) Structure post cleaning, (c) Searching for collapsed pipe.

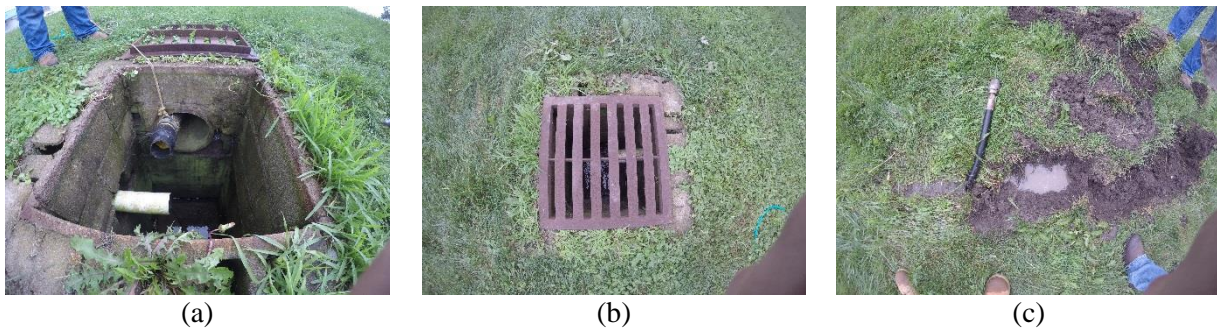
Figure B.12: VJT Operations Using Vactor 2100 on June 27, 2018 in Union County
(a) Structure prior to cleaning, (b) Cleaning of Structure, (c) Structure post cleaning.

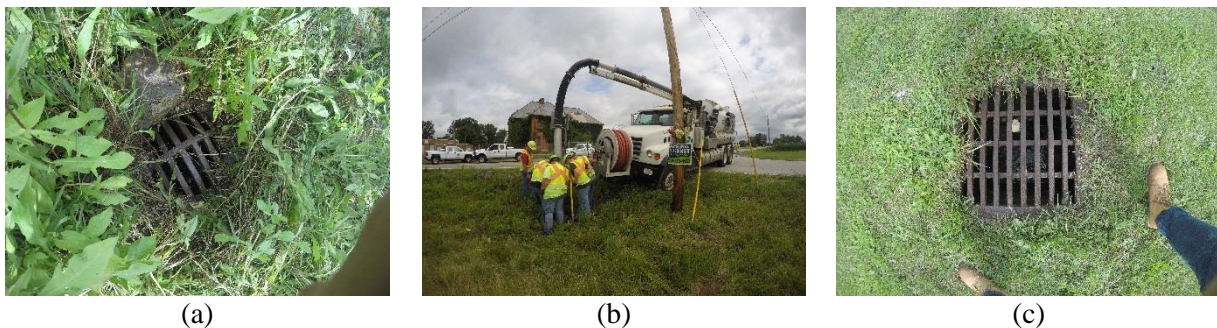
Figure B.13: VJT Operations Using Vactor 2100 on June 27, 2018 in Union County
(a) Zone setup, (b) Cleaning of the structure, (c) Zone breakdown.

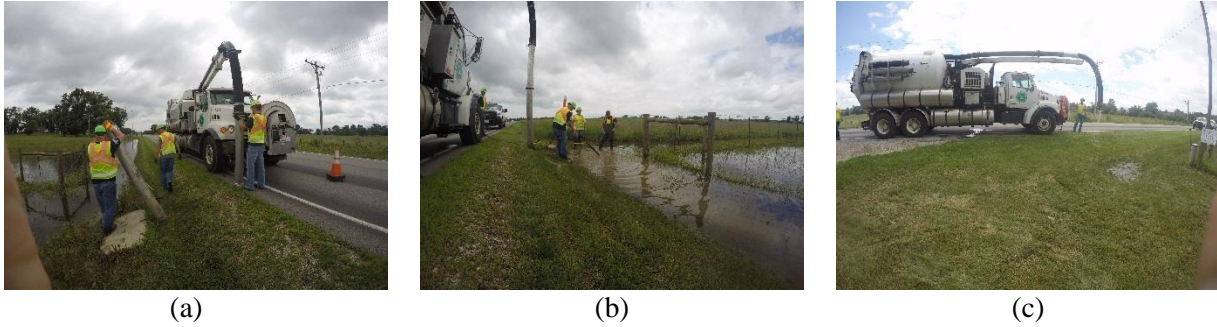
Figure B.14: VJT Operations Using Vactor 2100 on June 28, 2018 at ODOT Richwood Garage
(a, b, c) Structure during cleaning.

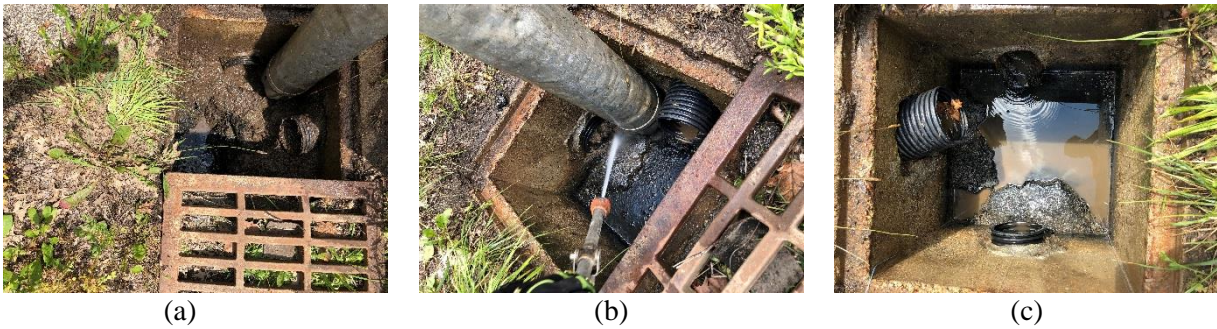
Figure B.15: VJT Operations Using Vactor 2100 on June 28, 2018 in Union County
(a) Zone prior to cleaning, (b) Inner structure prior to cleaning, (c) Cleaning of the structure.

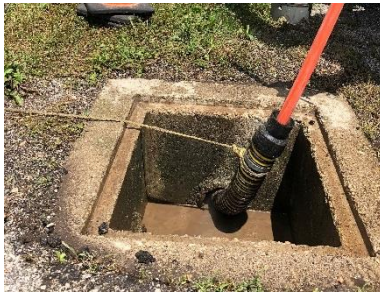
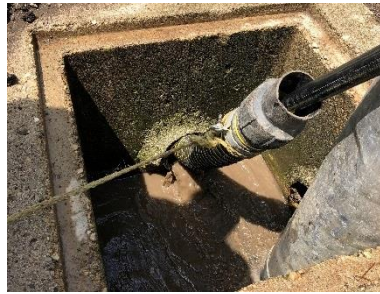
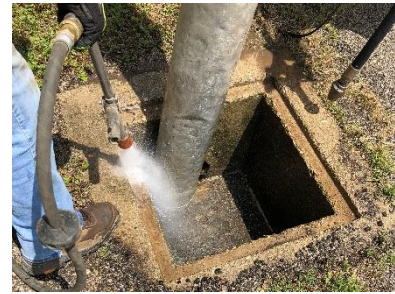
Figure B.17: VJT Operations Using Vactor 2100 on June 28, 2018 at ODOT Richwood Garage
(a) Jetting line towards adjacent structure, (b) Vacuuming and jetting (c) Vacuuming excess debris

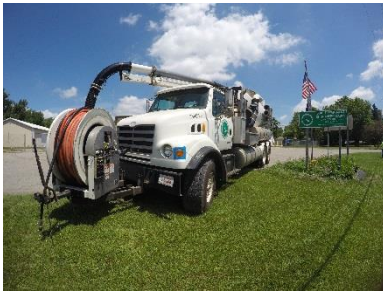
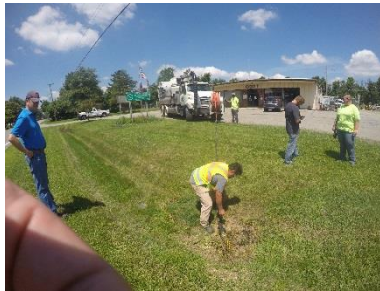
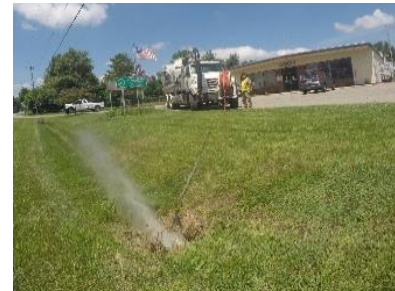
Figure B.18: VJT Operations Using Vactor 2100 on June 29, 2018 at ODOT Richwood Outpost
(a) Front-left profile of Vactor truck, (b) Preparing to run the jet, (c) Jetting through the structure.

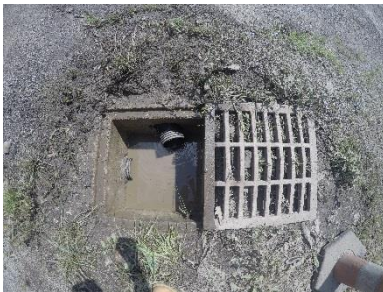
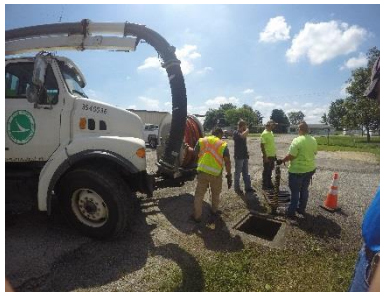
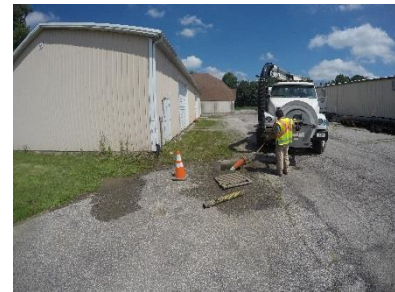
Figure B.19: VJT Operations Using Vactor 2100 on June 29, 2018 at ODOT Richwood Outpost
(a) Structure prior to cleaning, (b, c) Cleaning the structure.

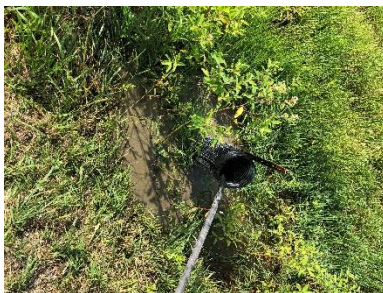
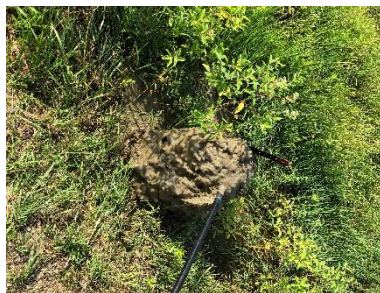
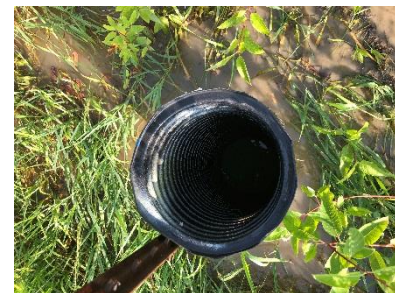
Figure B.20: VJT Operations Using Vactor 2100 on July 3, 2018 in Union County
(a, b) Jetting through the structure, (c) The structure post jetting.

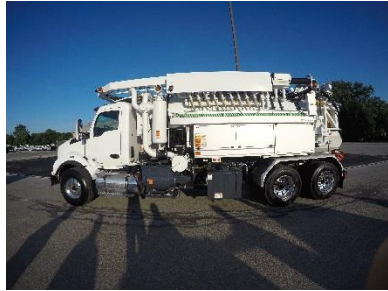
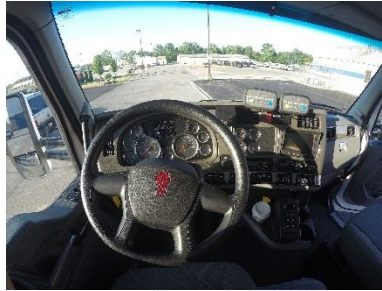
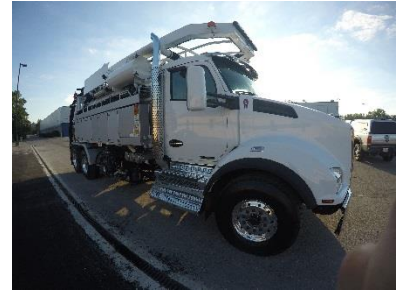
Figure B.21: BUCHER RECycler 315 Operations on July 9, 2018 at ODOT District 6 Headquarters
(a) Left profile of truck, (b) Drivers side view of cab, (c) Front-right profile of truck.

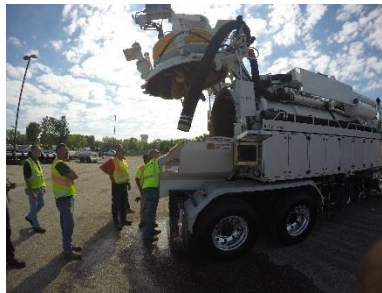
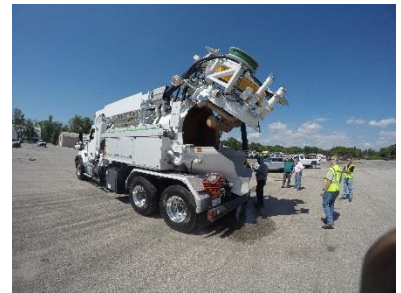
Figure B.22: BUCHER RECycler 315 Operations on July 9, 2018 at ODOT District 6 Headquarters
(a) Master control panel, (b) Bucher reps showing the main tank, (c) Back-left view of the main tank.

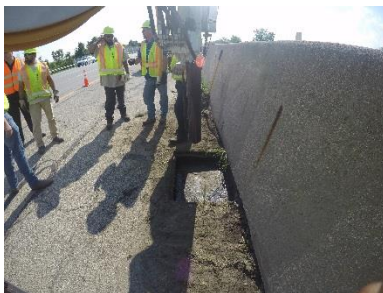
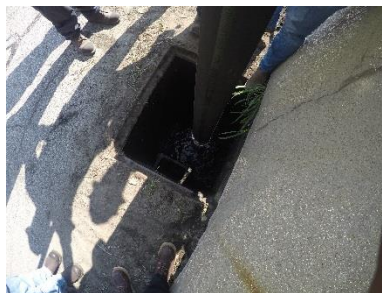
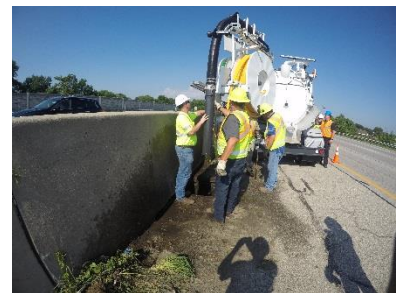
Figure B.23: BUCHER RECycler 315 Training Operations on July 10, 2018
(a) Structure prior to cleaning, (b) Structure during cleaning, (c) Vacuum and jet operating off sway arm

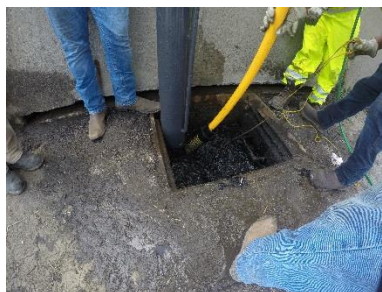
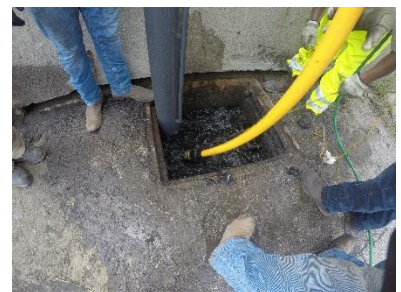
Figure B.24: BUCHER RECycler 315 Training Operations on July 10, 2018
(a) Structure during cleaning, (b, c) Simultaneous cleaning and jetting of structure.

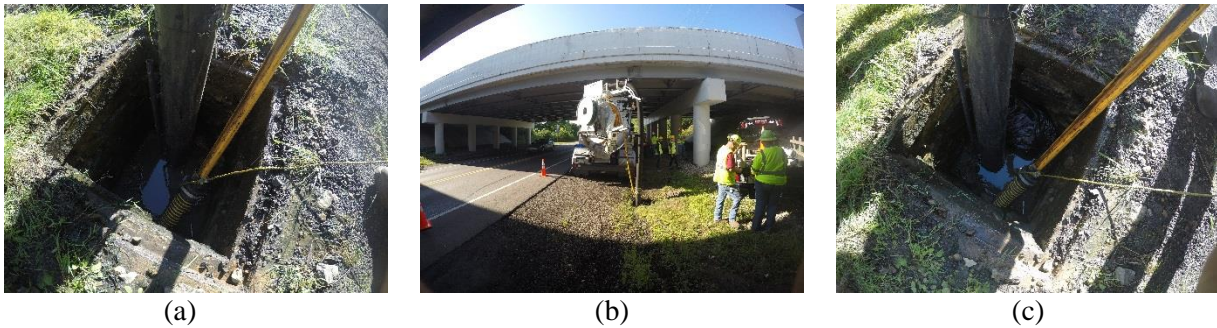
Figure B.26: BUCHER RECycler 315 Training Operations on July 11, 2018
(a) Simultaneous cleaning and jetting of structure, (b) Equipment zone, (c) Large debris within structure.

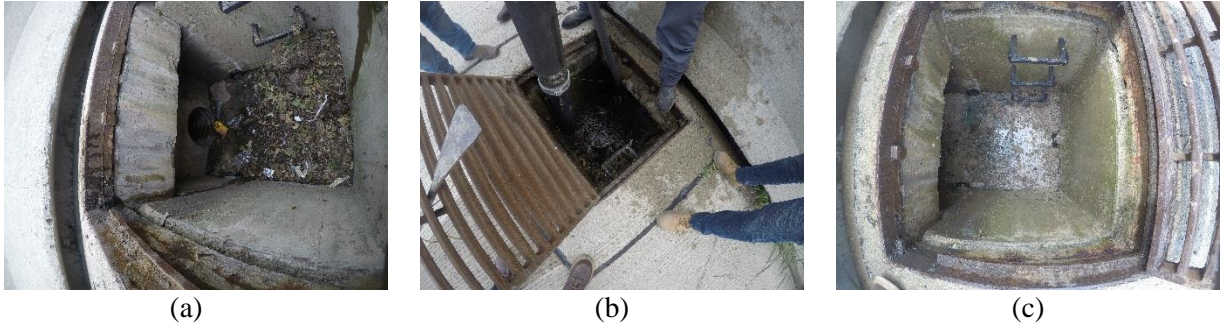
Figure B.29: BUCHER RECycler 315 Operations on July 16, 2018 in Franklin County
(a) Structure prior to cleaning, (b) Cleaning and jetting of the structure, (c) Structure post cleaning.

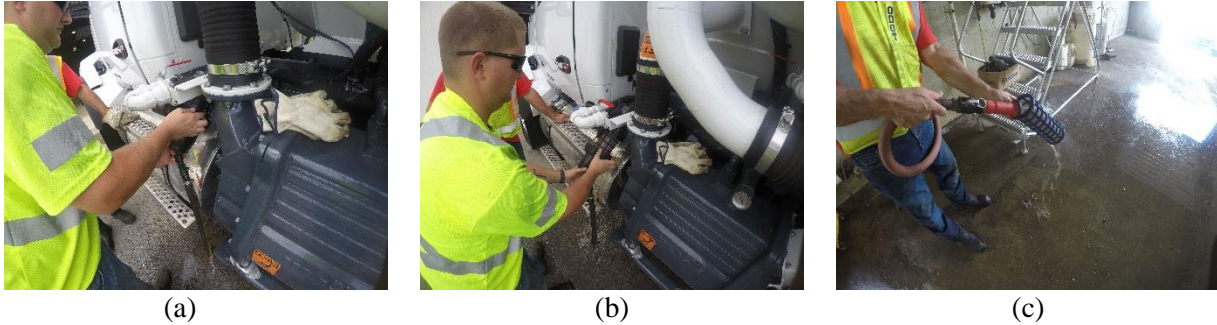
Figure B.33: BUCHER RECycler 315 Maintenance on July 16, 2018 at ODOT Westerville Outpost
(a) Draining the tube filter, (b) Releasing the filter from the enclosure, (c) Cleaning filter.

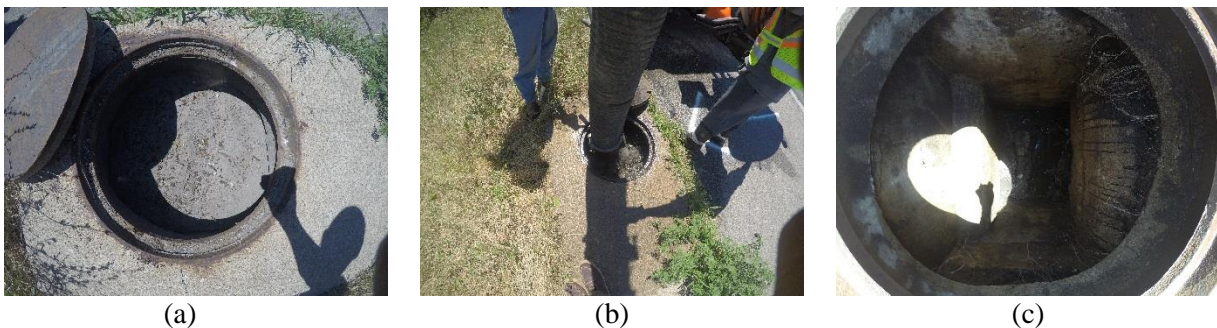
Figure B.36: VJT Operations Using Vactor 2100 on July 17, 2018 in Franklin County
(a) Structure prior to cleaning, (b) Cleaning of the structure, (c) Structure post cleaning.

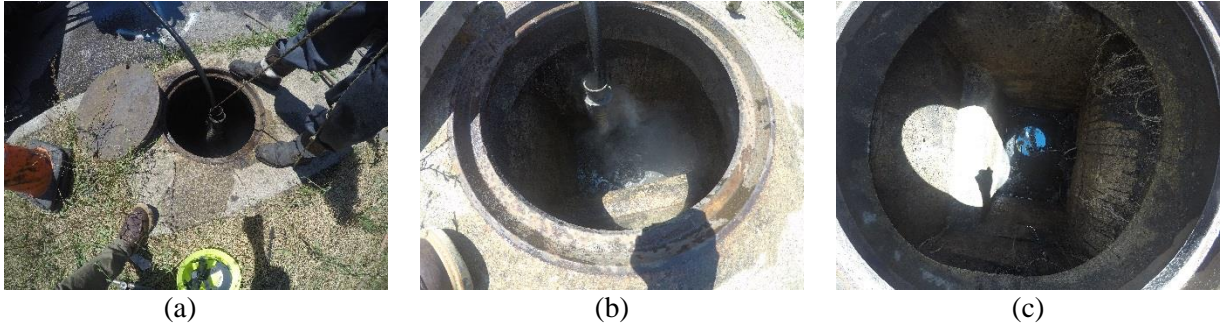
Figure B.37: VJT Operations Using Vector 2100 on July 17, 2018 in Franklin County
(a, b) Jetting the underdrain of the structure, (c) Structure cavity post jetting.

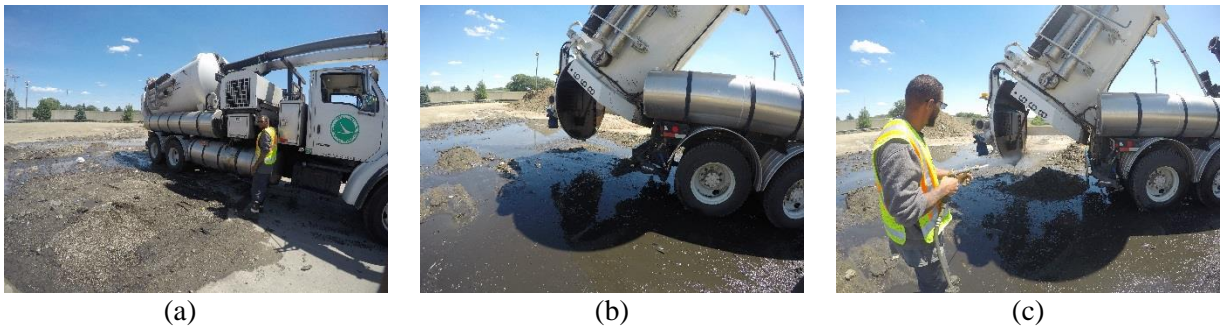
Figure B.38: VJT Operations Using Vector 2100 on July 17, 2018 at Columbus Decanting Station
(a) Preparing to dispose of waste, (b) Tank raised disposing waste, (c) Hosing to clear of excess waste.

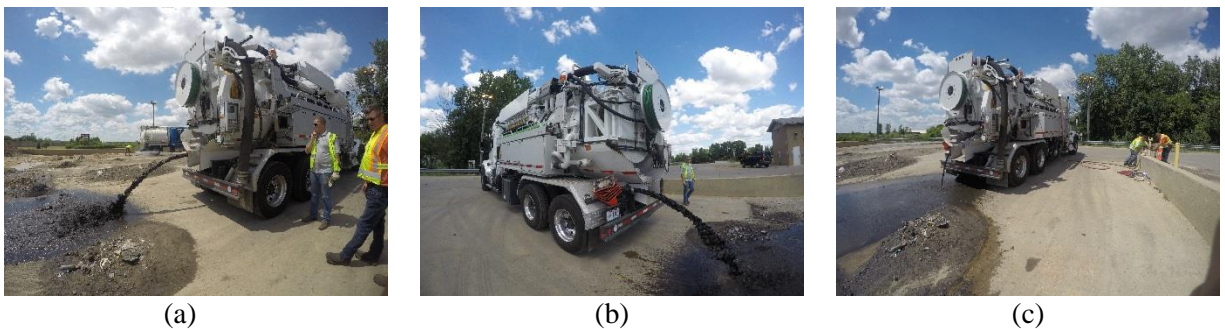
Figure B.40: BUCHER RECYcler 315 Operations on July 18, 2018 at Columbus Decanting Station
(a, b) Disposing all the liquid waste, (c) Preparing fresh water hydrant for cleaning.

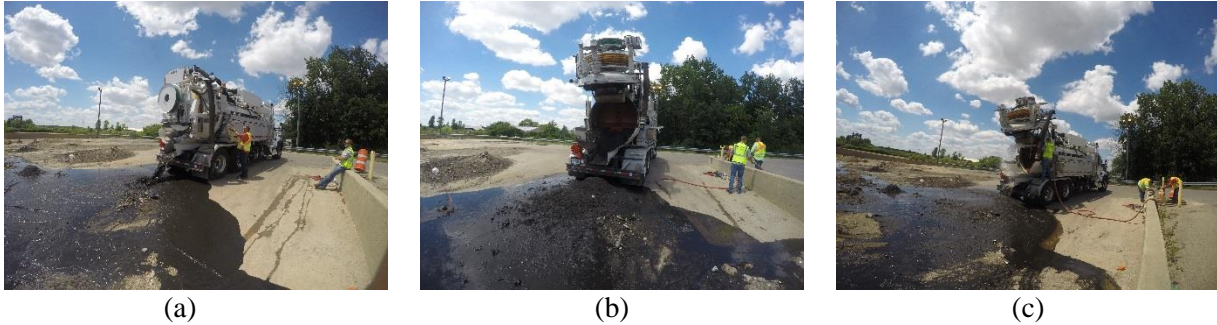
Figure B.41: BUCHER RECYcler 315 Operations on July 18, 2018 at Columbus Decanting Station
(a) Draining tank of liquid waste, (b) Rear open dumping the solid waste, (c) Rinsing of all excess waste.

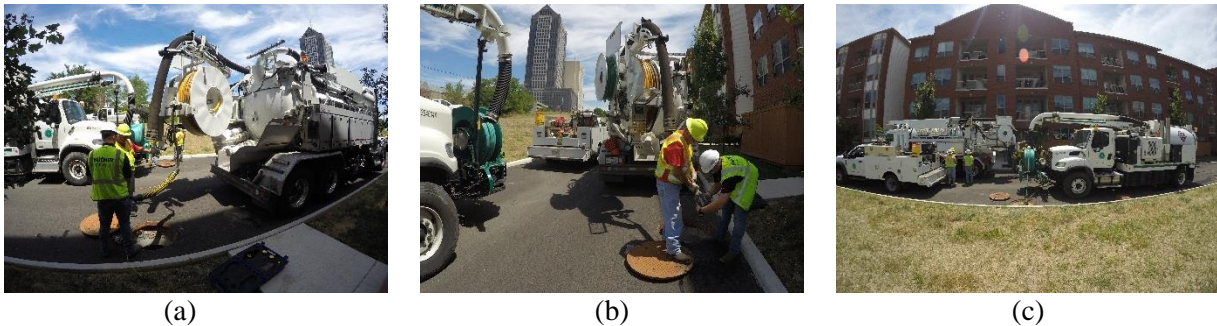
Figure B.42: BUCHER RECYcler 315 Operations on July 19, 2018 in Franklin County
(a) The RECYcler and Vac-Con preparing, (b) RECYcler running the jet, (c) Vac-Con jetting structure.

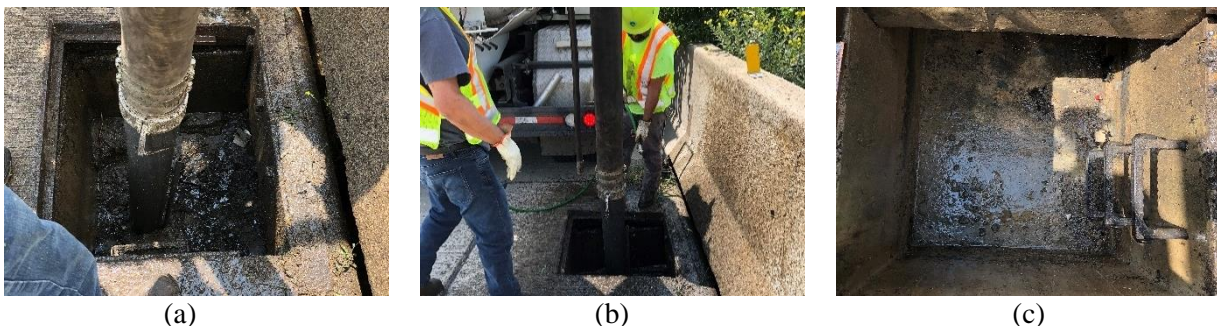
Figure B.44: BUCHER RECYcler 315 Operations on August 22, 2018 in Franklin County
(a) Cleaning the structure, (b) Operators cleaning and spraying debris with small hose, (c) Post cleaning.

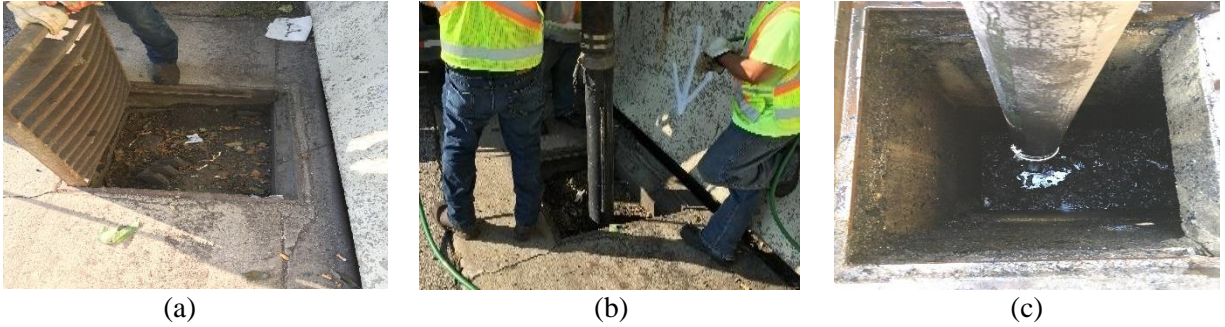
Figure B.45: BUCHER RECycler 315 Operations on August 28, 2018 in Franklin County
(a) Structure prior to cleaning, (b) Cleaning of the structure, (c) Structure post cleaning.

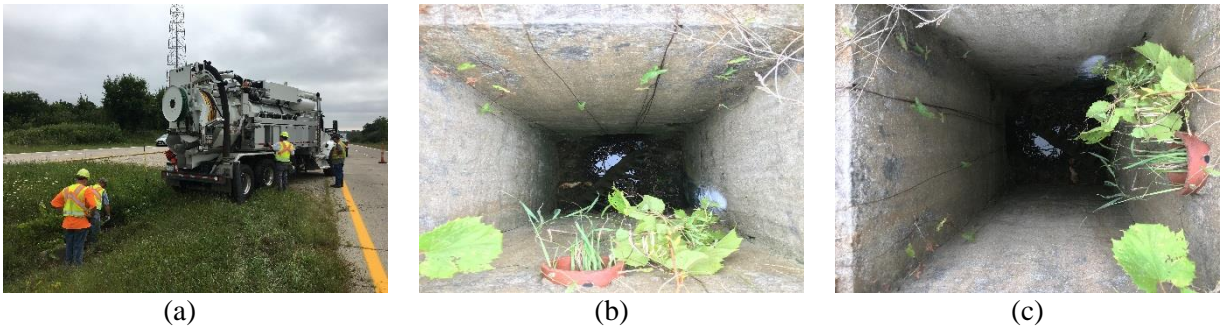
Figure B.46: BUCHER RECycler 315 Operations on August 30, 2018 in Madison County
(a) Operators setting up zone, (b) Structure pre-cleaning, (c) Structure post cleaning.

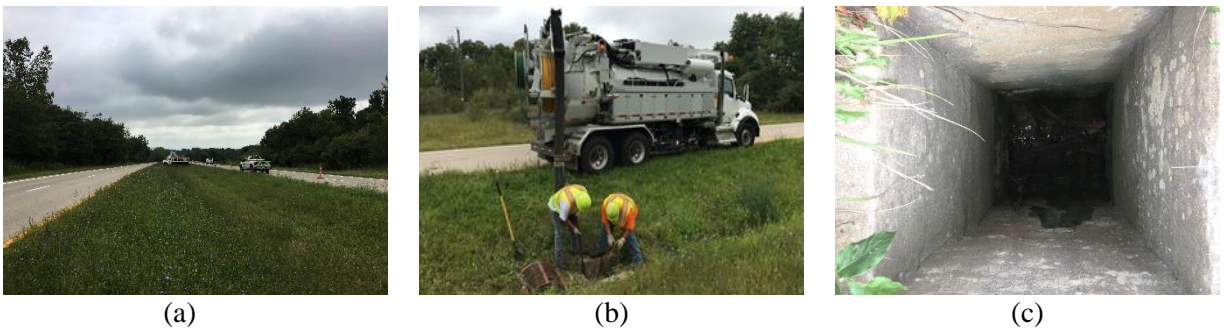
Figure B.47: BUCHER RECycler 315 Operations on August 30, 2018 in Madison County
(a) Operators setting up zone, (b) Cleaning of the structure, (c) Structure post cleaning.

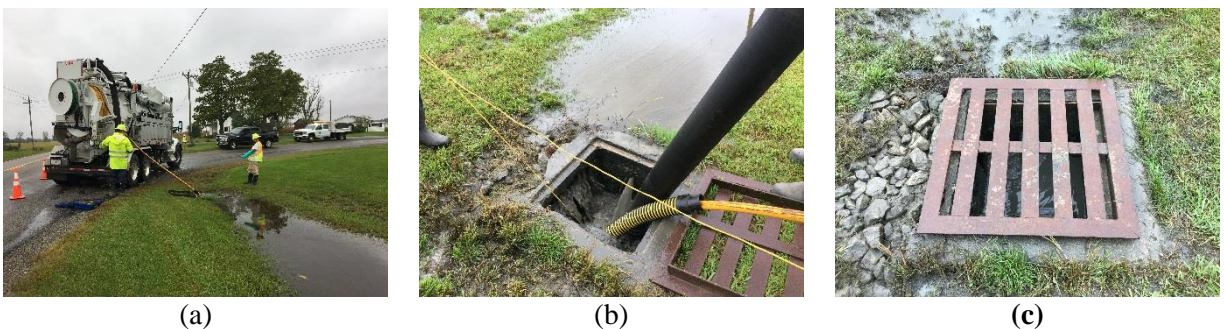
Figure B.48: **BUCHER RECycler 315 Operations** on September 25, 2018 in Union County
(a) Operators setting up zone., (b) Cleaning of the structure, (c) Structure post cleaning

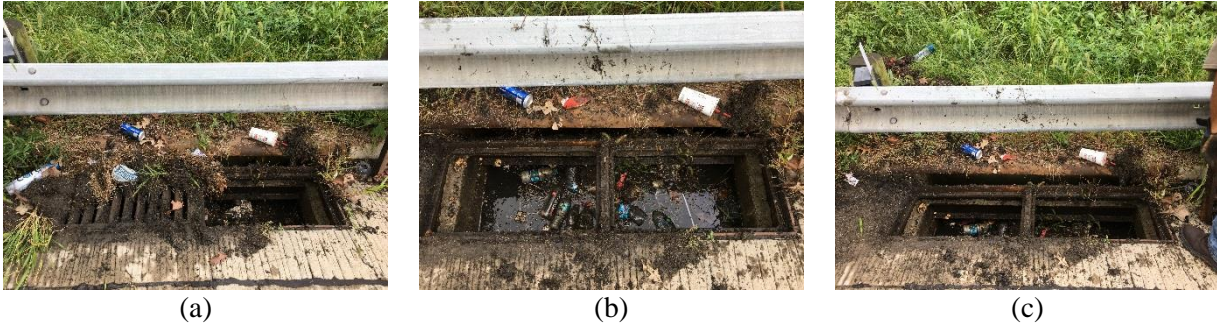
Figure B.49: BUCHER RECycler 315 Operations on September 26, 2018 in Franklin County
(a, b) Structure prior to cleaning, (c) Structure post cleaning.

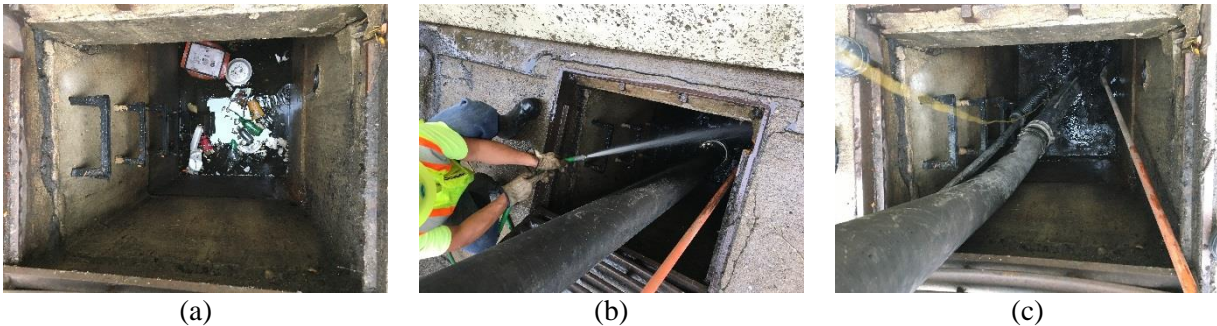
Figure B.50: BUCHER RECycler 315 Operations on September 26, 2018 in Franklin County
(a) Structure prior to cleaning, (b) Cleaning of the structure, (c) Structure post cleaning.

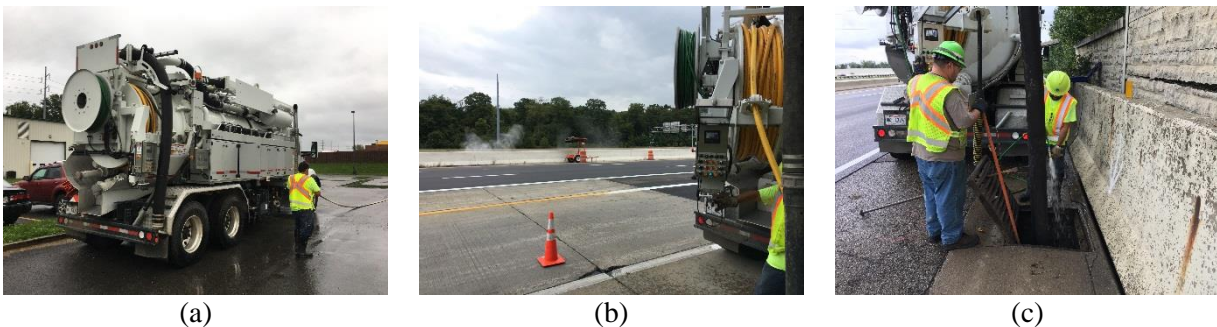
Figure B.51: BUCHER RECycler 315 Operations on September 26, 2018 in Franklin County
(a) Right profile of vehicle, (b) Rear view of vehicle with control panel, (c) Truck and operators.
