EVALUATION OF THE OHIO DEPARTMENT OF TRANSPORTATION'S CURRENT STORM SEWER CLEANING OPERATIONS

January 2019

Final Report

1. Report No. FHWA/OH-2019-5	2. Government Accession No.	3. Recipient's Catalog No.	
4. Title and Subtitle Evaluation of the Ohio Department of Transportation's Current Storm Sewer Cleaning Operations – Phase II		5. Report Date January 2019

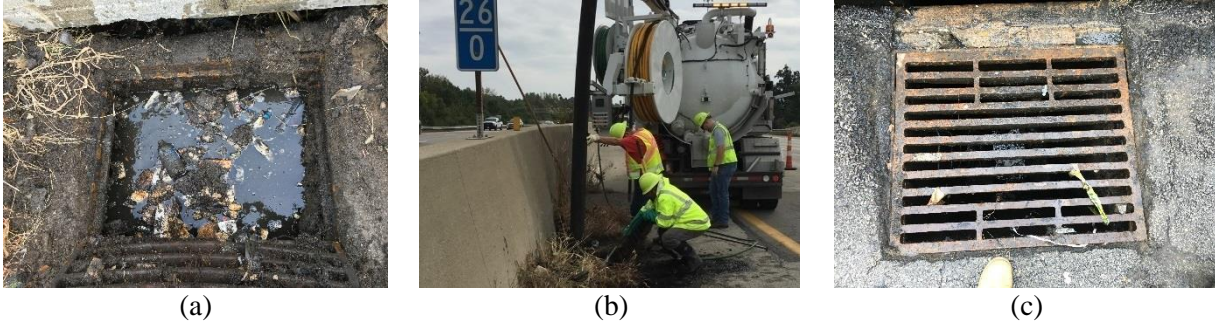
Figure B.53: BUCHER RECycler 315 Operations on October 2, 2018 in Franklin County
(a) Structure prior to cleaning, (b) operators clearing in and around catch basin, (c) post cleaning.

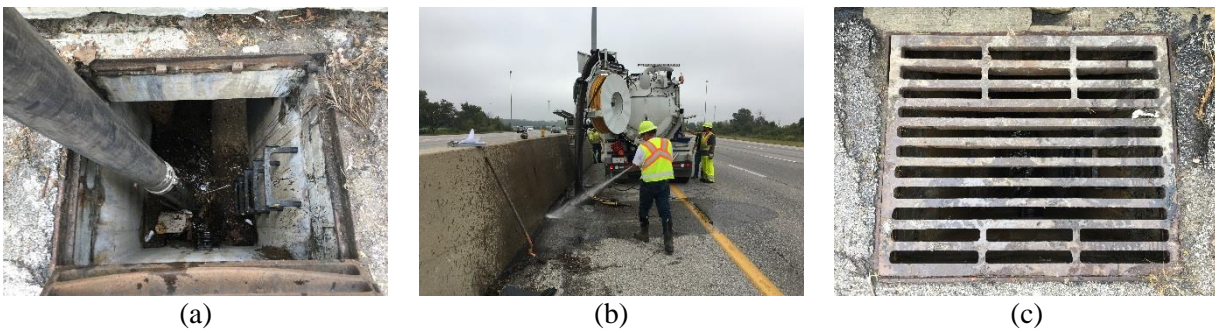
Figure B.56: BUCHER RECycler 315 Operations on October 3, 2018 in Franklin County
(a) Vacuum operating on structure, (b) Cleaning debris around cavity, (c) Structure post cleaning.

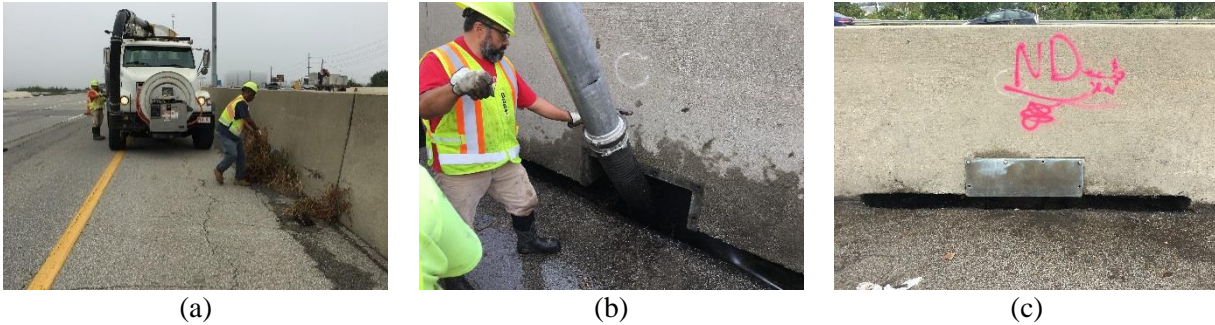
Figure B.57: Vactor 2100 Operations on October 3, 2018 in Franklin County
(a) Operators setting up zone, (b) Performing vacuum on structure, (c) Gutter after cleaning.

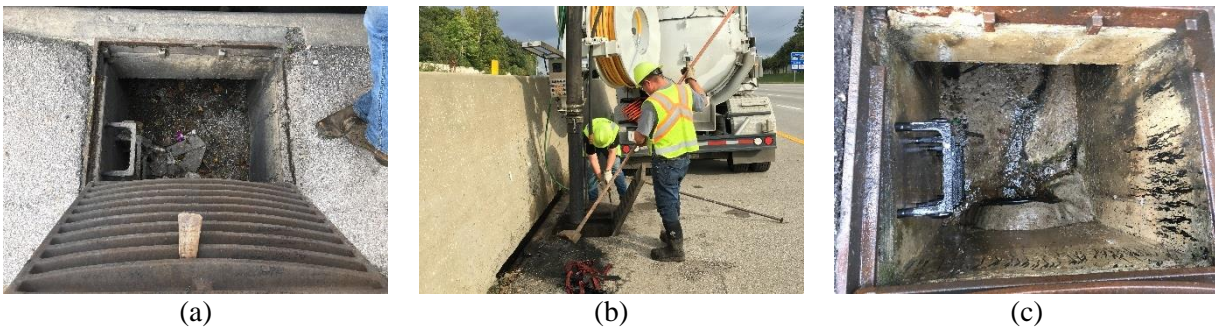
Figure B.58: BUCHER RECYcler 315 Operations on October 4, 2018 in Franklin County
(a) Structure prior to cleaning, (b) During cleaning, (c) Structure after the cleaning processes.

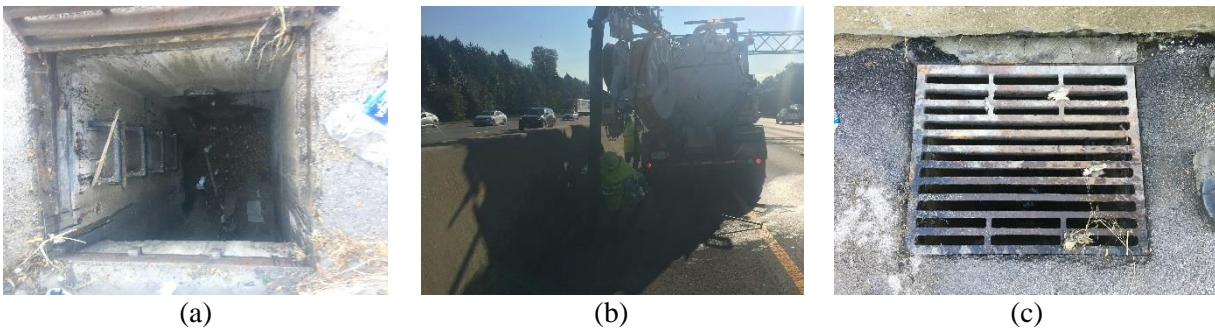
Figure B.59: BUCHER RECYcler Operations on October 9, 2018 in Franklin County
(a) Structure prior to cleaning, (b) Cleaning operations, (c) Structure after cleaning.

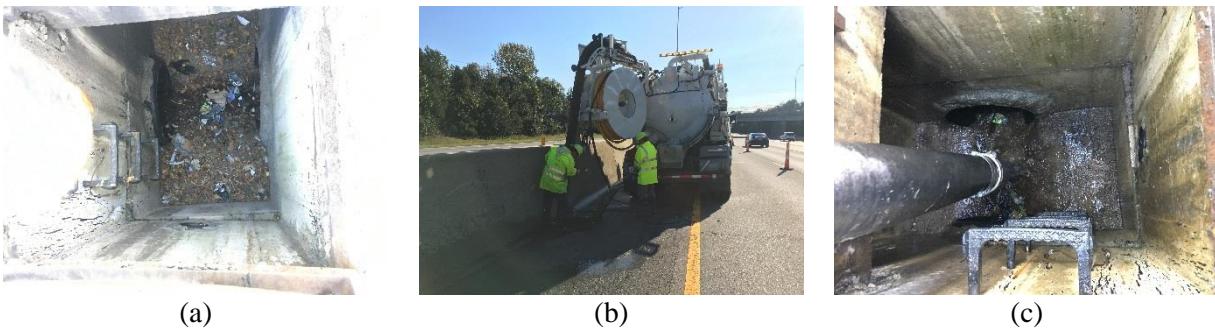
Figure B.60: BUCHER RECYcler Operations on October 9, 2018 in Franklin County
(a) Structure prior to cleaning, (b, c) During cleaning operations.

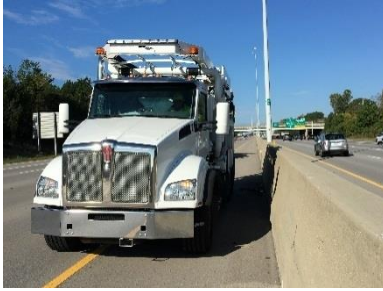
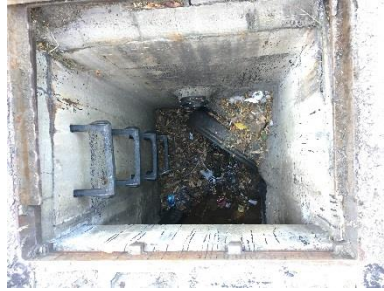
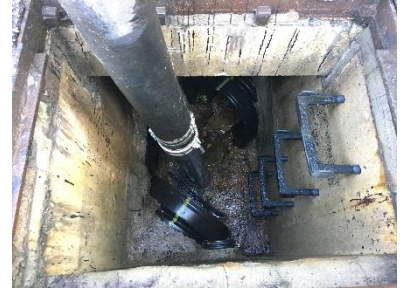
Figure B.61: BUCHER RECYCLER Operations on October 9, 2018 in Franklin County

(a) View of the truck while zone is being setup, (b) Prior to cleaning, (c) During the cleaning procedures.

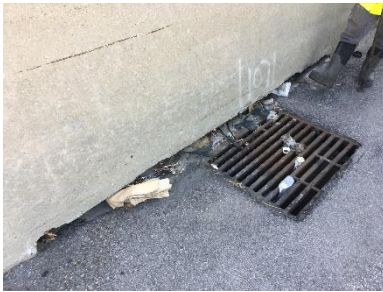
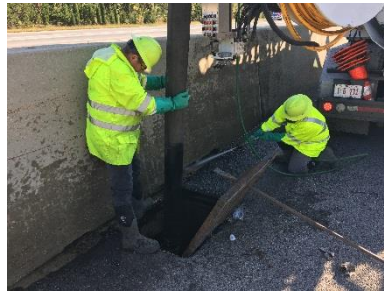
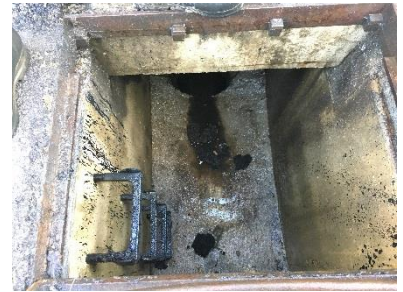
Figure B.62: BUCHER RECYCLER Operations on October 9, 2018 in Franklin County

(a) Catch basin before cleaning, (b) Operators cleaning the structure, (c) Structure post cleaning.

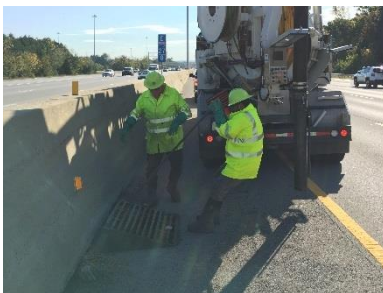
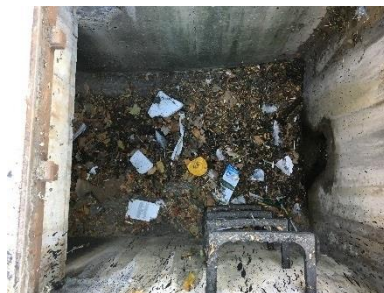
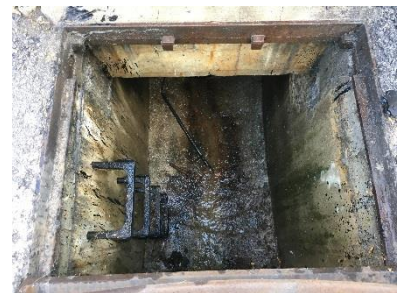
Figure B.63: BUCHER RECYCLER Operations on October 9, 2018 in Franklin County

(a) Operators preparing area, (b) Structure before the cleaning process, (c) Catch basin after cleaning.

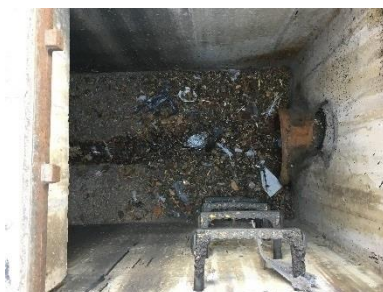
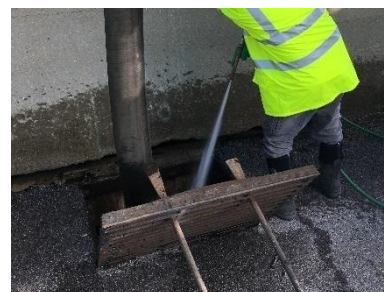
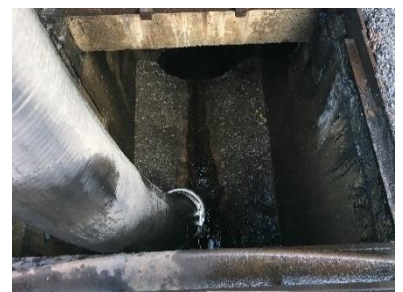
Figure B.64: BUCHER RECYCLER Operations on October 9, 2018 in Franklin County

(a) Structure prior to cleaning, (b, c) Using vacuum and jet to clean the catch basin.

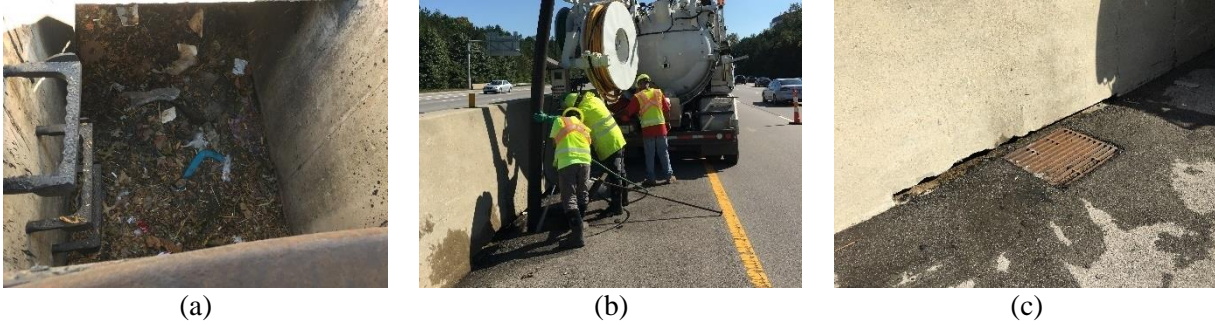
Figure B.65: BUCHER RECyler Operations on October 9, 2018 in Franklin County
(a) Structure prior to cleaning, (b, c) Operators running vacuum and jet on structure and after cleaning.

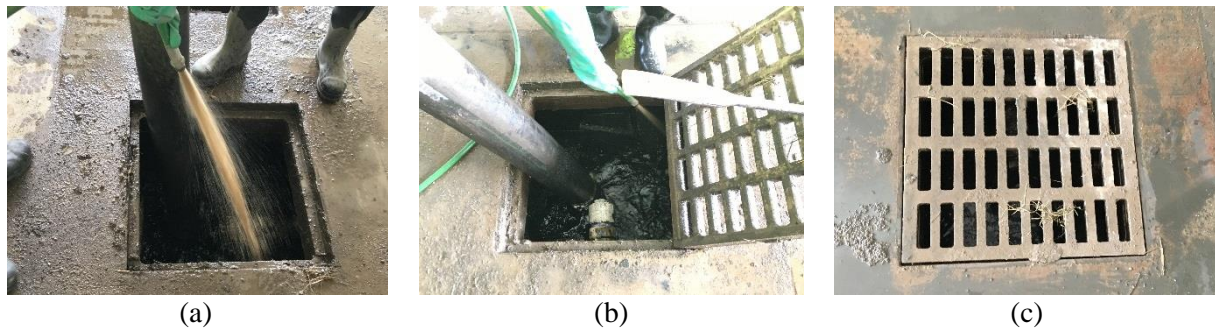
Figure B.68: BUCHER RECyler Operations on October 11, 2018 at ODOT West Jefferson Garage
(a, b) Running vacuum and small hose on the structure, (c) After cleaning the structure.
