Assessment of Maintenance Strategies for Bio-stabilization of Mudslides on Wildfire-affected Slopes

Ingrid Tomac, Ph.D., Assistant Professor, Structural Engineering
Department, University of California, San Diego
Jonathon Chavez de Rosas, MS Student, Structural Engineering
Department, University of California, San Diego

August 2022

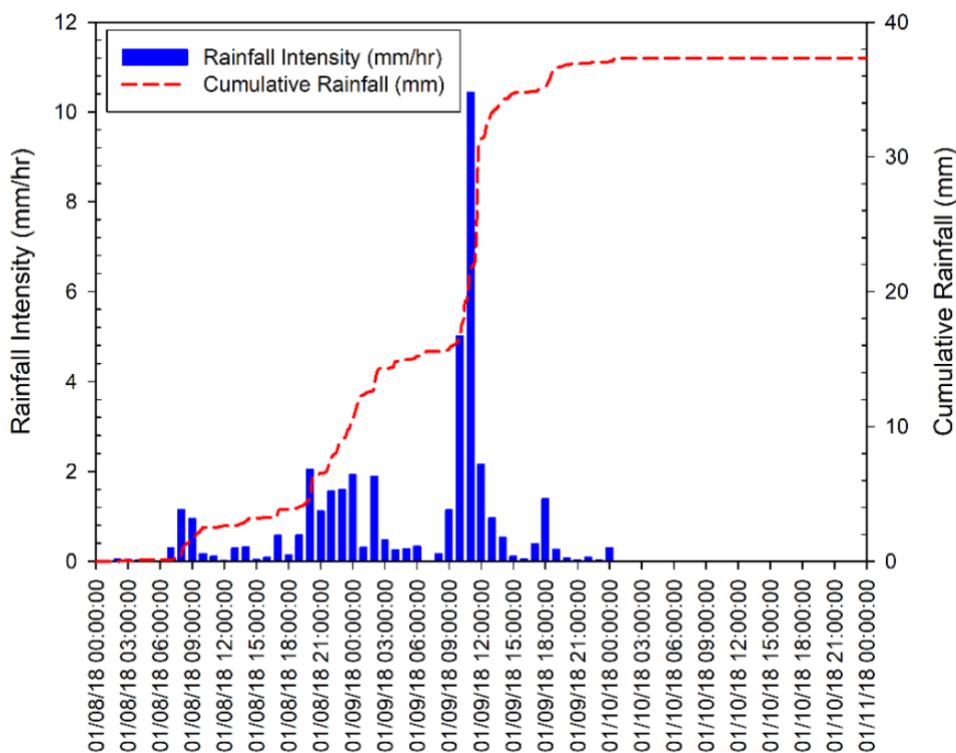
Figure 4. Time series of hourly rainfall intensity and cumulative rainfall from the January 8 to January 10 storm. All times shown are in GMT (Tiwari et al. 2020)

A case study for the 2018 Montecito, CA debris flows found that the highest average hourly rainfall intensity that triggered the debris flow around 4:30 AM PST on January 9th of that year was slightly higher than 10 mm/hr, with an instantaneous rainfall intensity of 50 mm/hr a few minutes before the debris flow occurred (Tiwari et al. 2020). It was also found that the cumulative rainfall over the three-day storm was around 37.5 mm, which can be seen in Figure 4, courtesy of the work done by Tiwari et al (2020).

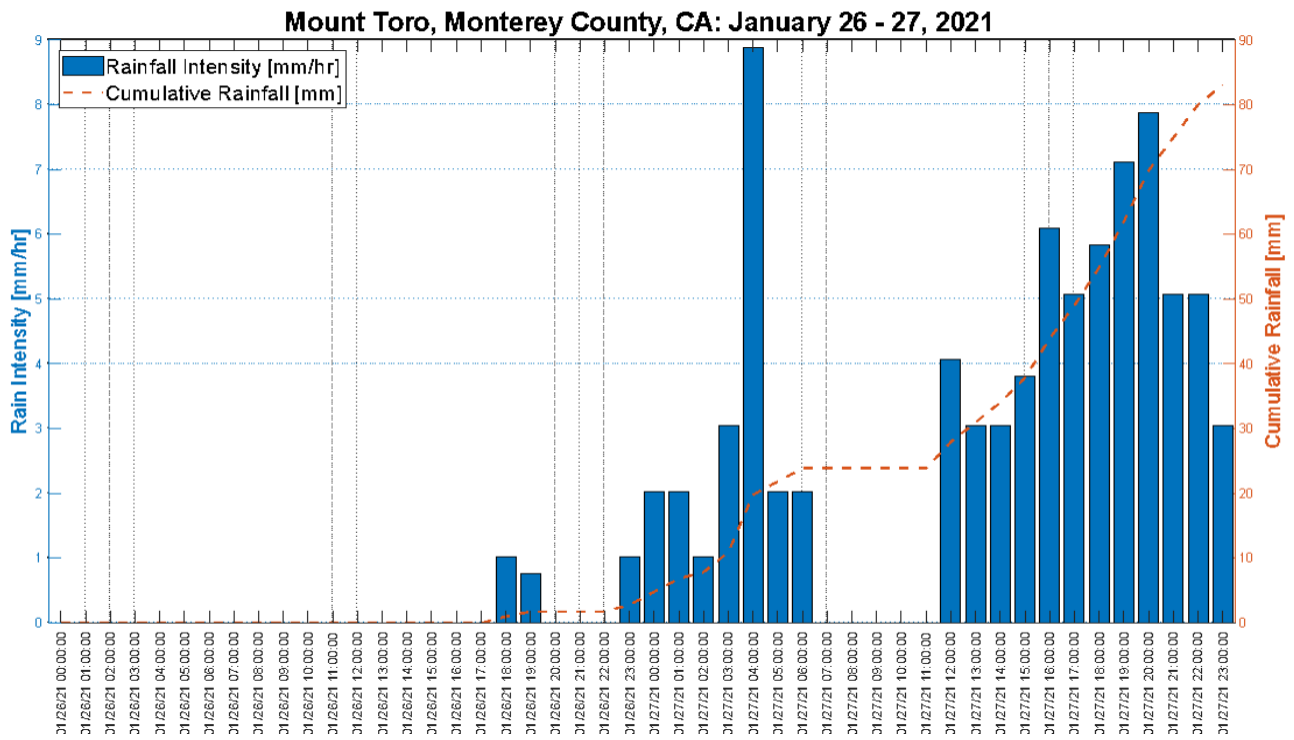
Figure 7. Time series of hourly rainfall intensity and cumulative rainfall from the January 26 to January 27 storm. All times shown in PST

Such as stated before, the data did not provide measurements for time periods shorter than an hour, but the hourly average rain intensities fall within the varying ranges for which post-wildfire mudflows have occurred. As seen in Figure 7, the maximum hourly rainfall intensity was 8.89 mm/hr at 4 AM PST on January 27, which was around the time the flow is thought to have started. The cumulative rainfall after it stopped raining was 23.9 mm, but as soon as it began to rain again, the total cumulative rainfall was found to be 83.1 mm although no more mudflows were reported during this time.

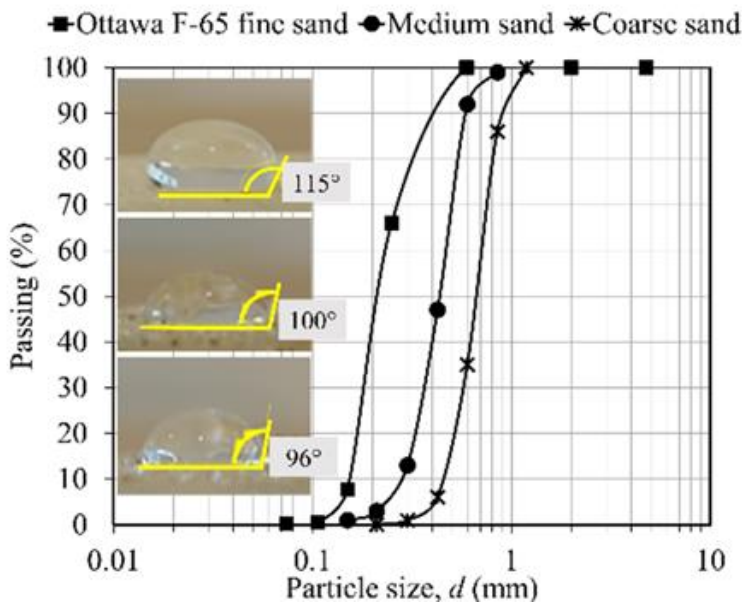
Figure 12. Granulometry of fine, medium and coarse sand, with the measured contact angles after hydrophobized

Fine, medium and coarse sand properties are shown in Table 2 and Figure 12. Severely hydrophobic sand had already been made for use in the smaller experiments, but larger quantities are made to fill the required volume of the outdoor experiments. The water drop penetration test classifies the sand as severely hydrophobic for each batch. The preparation process follows the same procedure outlined by Movasat and Tomac (2020). The preparation process for making the hydrophobic sand is to first wash the soil until it is

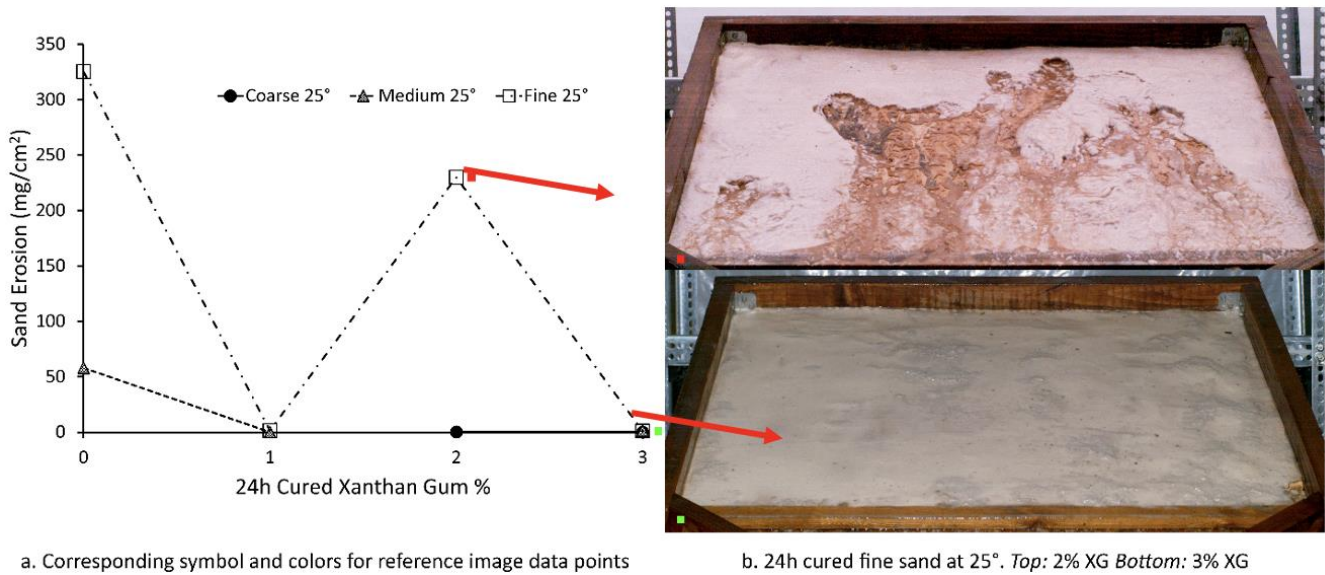
Figure 16. Sand erosion with the cured X.G.-sand mix for varying slope angles for 50 mm/hr rain intensities

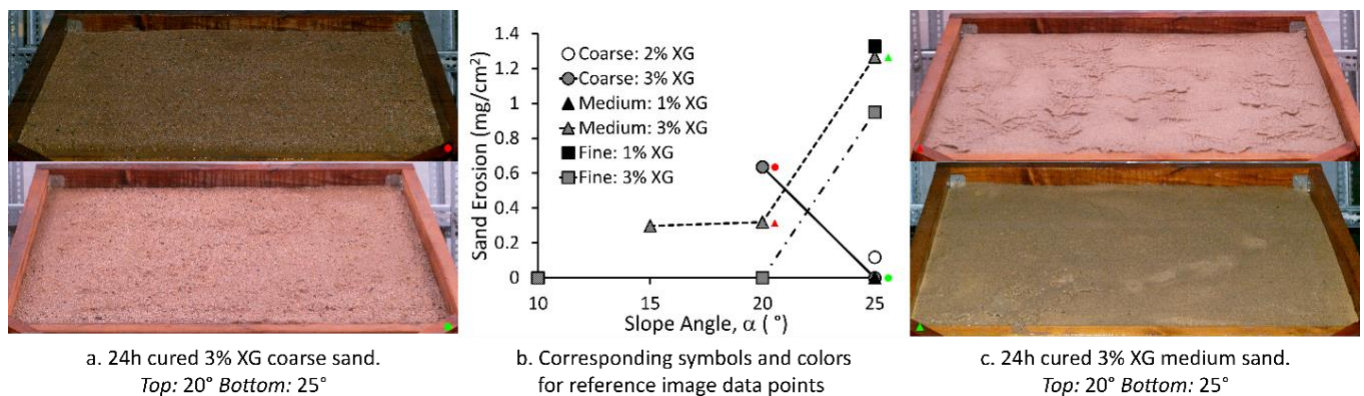
Figure 17. Sand erosion with slope angle for 24h cured XG percentages for 50 mm/hr rain intensities

also connected to the surface morphology illustrated with Figure 17b. Many sliding ridges form on the medium sand experiment with less erosion than coarse sand. The surface morphology changes at the same angle that the coarse sand experiences a shift from sliding ridges to sliding patches. Though fine sand does not develop ridges throughout most of its surface, a tiny patch erodes at the bottom right of the slope. Ridge development allows less sand runoff because sand particles that roll downhill now have a stronger cohesive force from the cured XG. However, after continued rain at high intensities, the stronger crust bonds turn from solids to goeey, and the ridges run the risk of evolving into sliding patches. Based on this, curing a sand mix with 3% XG and developing ridges decreases the amount of sand runoff but can lead to sliding patches and elevated erosion.

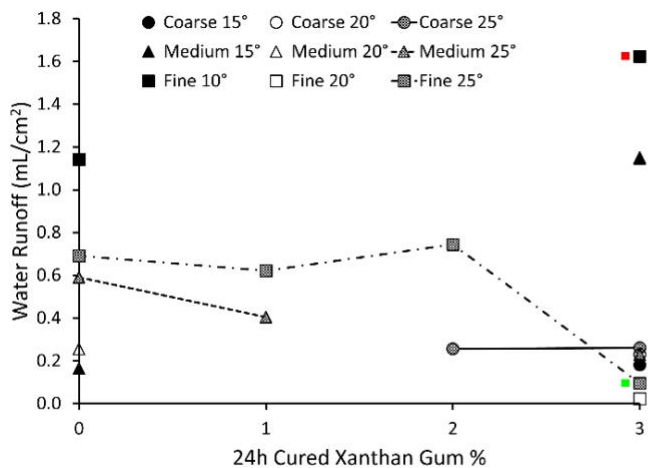
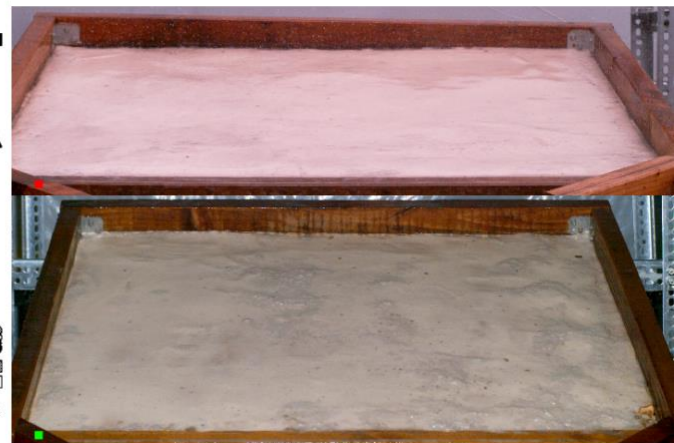
b. 24h cured 3% XG fine sand. Top: 10° Bottom: 25°

Figure 18. Water runoff with 24h cured XG percentage for varying slope angles

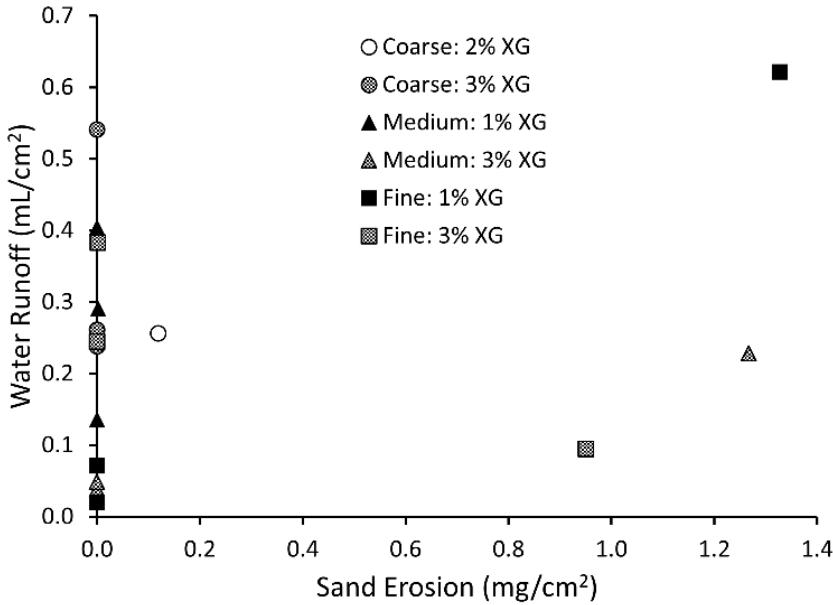
Figure 20. Water runoff with sand runoff for 24h cured XG percentages at a 25° angle

Coarse and fine sand experiments show a slight water runoff increase with an increasing slope, regardless of sand erosion. This idea is depicted in Figure 20, which when looking at a 25° slope, there were coarse, medium, and fine sand trials with cured XG percentages where there was no or little erosion and a water runoff range of 0.02 mL/cm² to 0.73 mL/cm². A majority of these no erosion data points are below 0.30 mL/cm². To conclude, although the water runoff can be high without erosion, both water and sand runoff increase exponentially once the erosion starts.

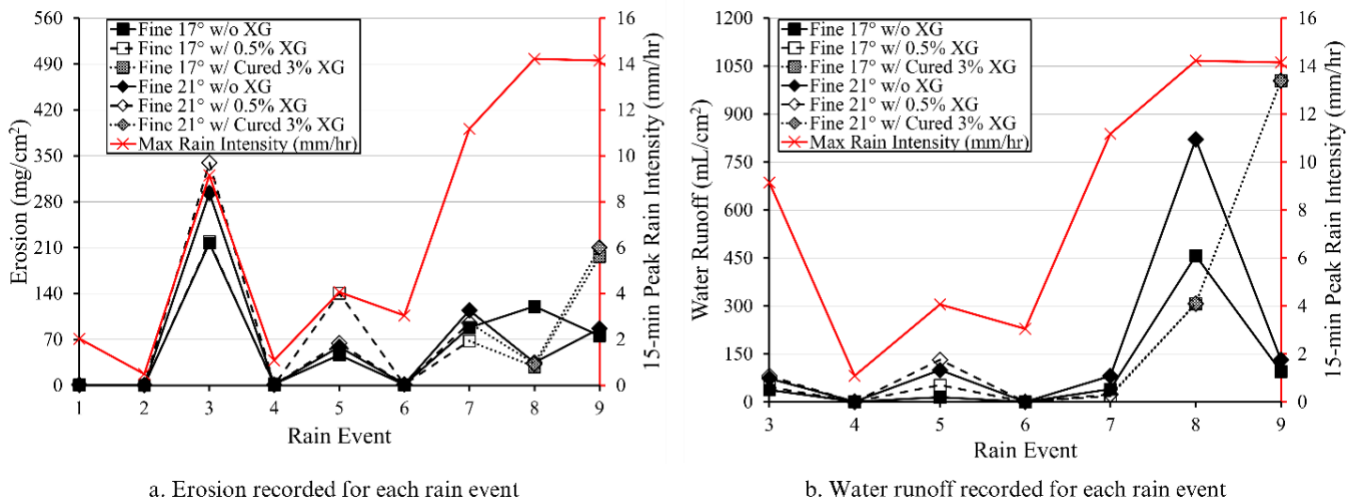
Figure 32. Fine sand erosion and water runoff with the 15-min peak rain intensities

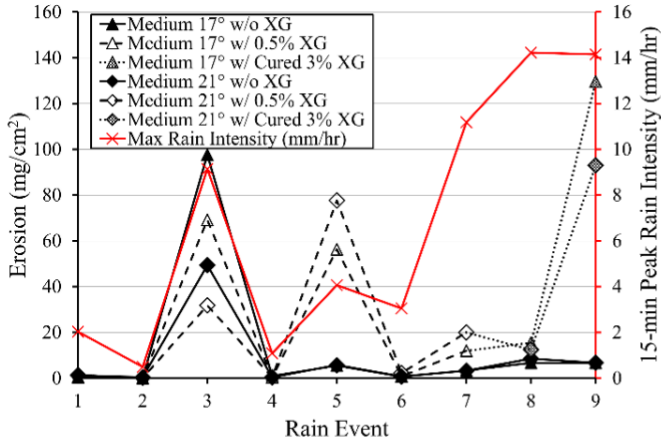
a. Erosion recorded for each rain event

b. Water runoff recorded for each rain event

For medium sand shown in Figure 33, the 0.5% XG slopes have reduced erosion during RE 3, but experience much more erosion in RE 5, with the 17° slope experiencing 10.2 times more and the 21° slope with 13.6 times more, than the untreated slopes. The same trend is seen with the water runoff. After RE 3, there was little erosion in the untreated hydrophobic slopes. The water runoff stayed consistent with an increase, decrease, and another increase from RE to RE. After applying the cured 3% XG treatment, the erosion decreased or stayed the same at a higher rain intensity than before, but it did not reduce the erosion to be less than the untreated slopes. The treated slopes then see a spiked increase in erosion during RE 9, much like the fine sand treated slopes. This is explained by the pre-formed channels from before the slopes were re-covered, with the enhanced erosion occurring along those channels. Recall Figure 30b, showing the slopes were not completely dry from RE 8 when RE 9 occurred, leading the already saturated XG-sand mix to slide down in pieces instead of a hardened crust protecting the slope before being over-wetted.

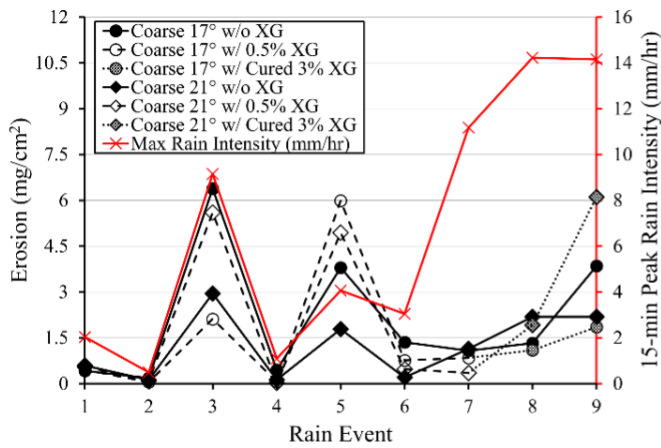
a. Erosion recorded for each rain event

b. Water runoff recorded for each rain event

Figure 34a shows that the 0.5% XG 17° initially reduced erosion during RE 3, but produced more during RE 5, much like was seen with the medium sand treated slopes. Both treated angles yielded less erosion than the untreated slopes during RE 7 and continued that trend after re-covering with cured 3% XG. Once again, there was an increase in erosion from RE 9, but not to a large extent as the largest increase was in the 21° treated slope, from 1.92 to 6.11 mg/cm². During REs 3, 5 and 9, the water runoff produced from the treated slopes were higher.

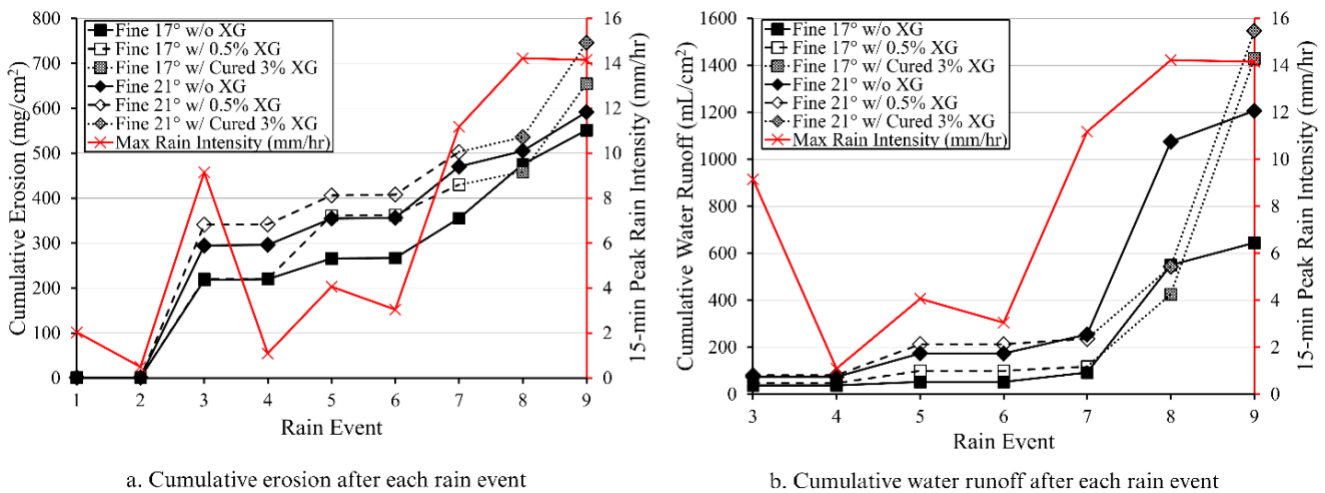
Figure 35. Fine sand cumulative erosion and water runoff with the 15-min peak rain intensities

When comparing the cumulative water runoff for each sand, once again it can be seen that the water runoff follows a similar trend from sand to sand for untreated and 0.5% XG treated slopes, with the 0.5% XG 21° slope producing more overall water runoff during REs 3 and 5 but maintain the same trend. When the XG is increased to 3%, much higher water runoff was observed. It can be noted that the water runoff slopes between REs 8 and 9 go from steeper, linear, and shallower from fine to medium and to coarse sands. This is explained through the saturation of the slopes, where most of the fine sand slope was still over-saturated from the previous RE, and the coarse sand slopes were the least over-saturated slopes, allowing the XG-sand mixture to absorb water, producing less water runoff. For the XG treated slopes, those with medium sand accumulated the most water runoff, with 3079.58 mL/cm^2 averaged between the angles, fine sand slopes less than half of the medium slopes producing 1488.10 mL/cm^2 , and the least were coarse sand slopes with 1200.11 mL/cm^2 .
