# Evaluation of Long-Term Impacts of Early Opening of Concrete Pavements

NRRA RIGID TEAM

Report No. NRRA202111

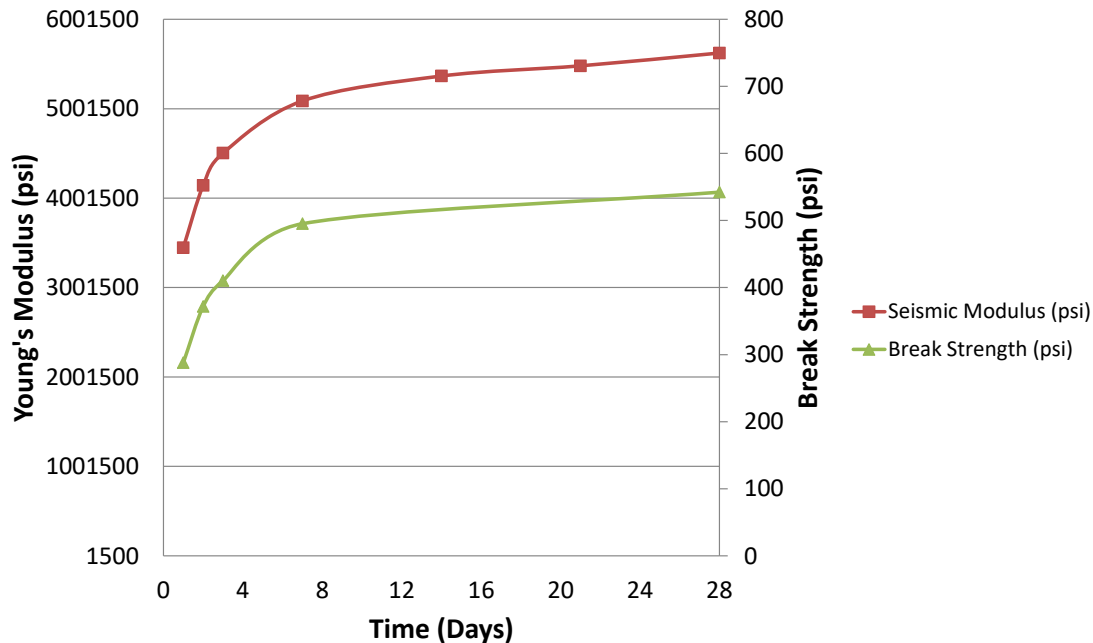
Figure 1.3 Small strain Young's modulus and strength development showed similar trends (Freeseaman et al., 2016)

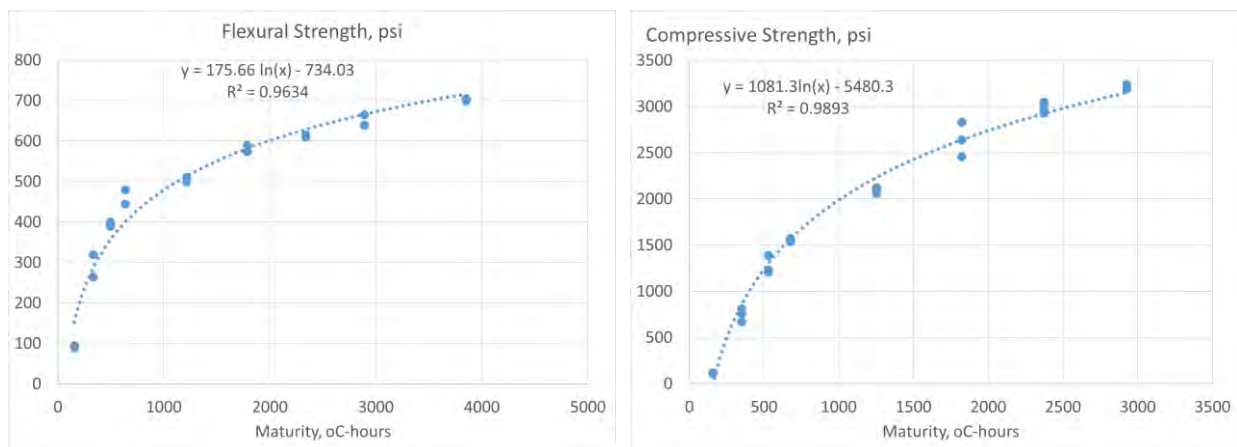
Figure 2.3 Predicted versus measured flexural (left) and compressive (right) strength gain as PCC matures

Trendlines and corresponding predictive equations are also shown in Figure 2.3.

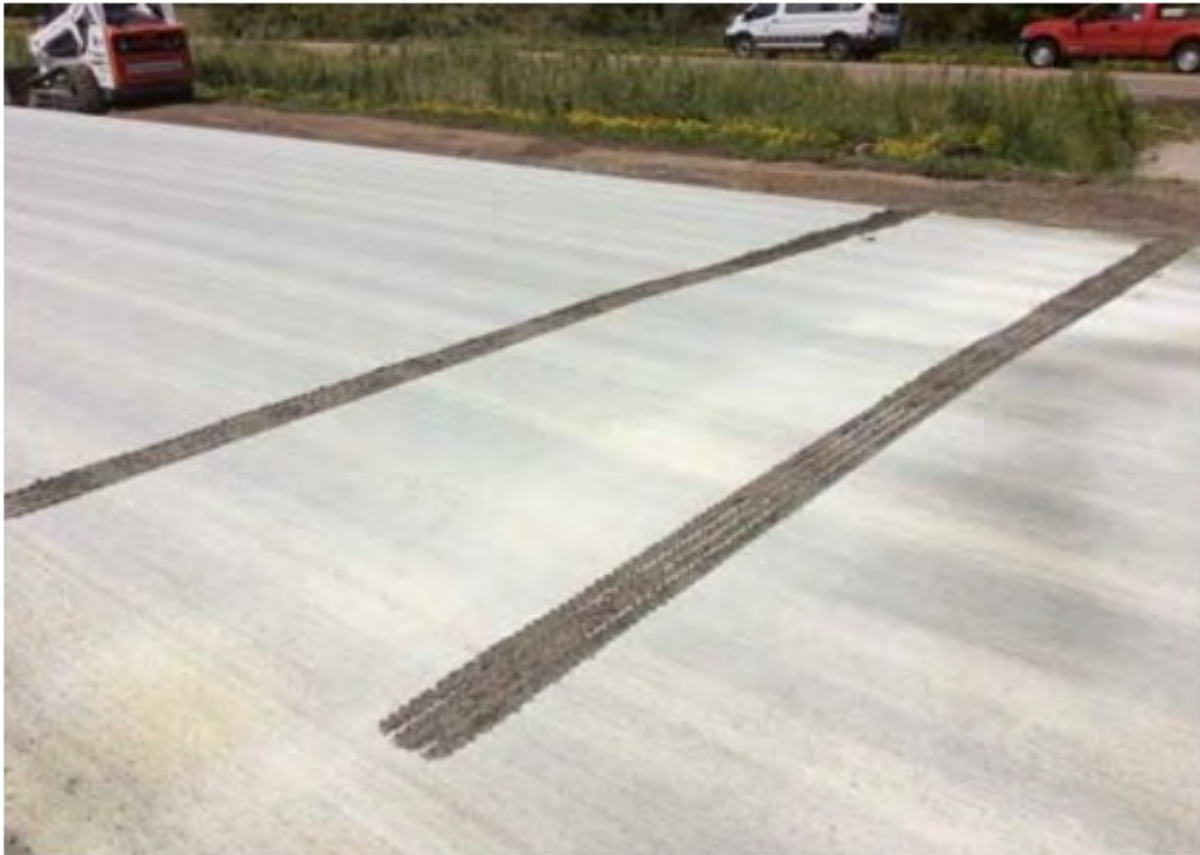
**Figure 2.5 Damage in Cell 624 due to early loading**

Cell 624 was loaded by a ¾-ton, 2-axle pickup truck traversing across the plastic pavement approximately 2 hours after paving (to induce visible damage) as shown in Figure 2.5.

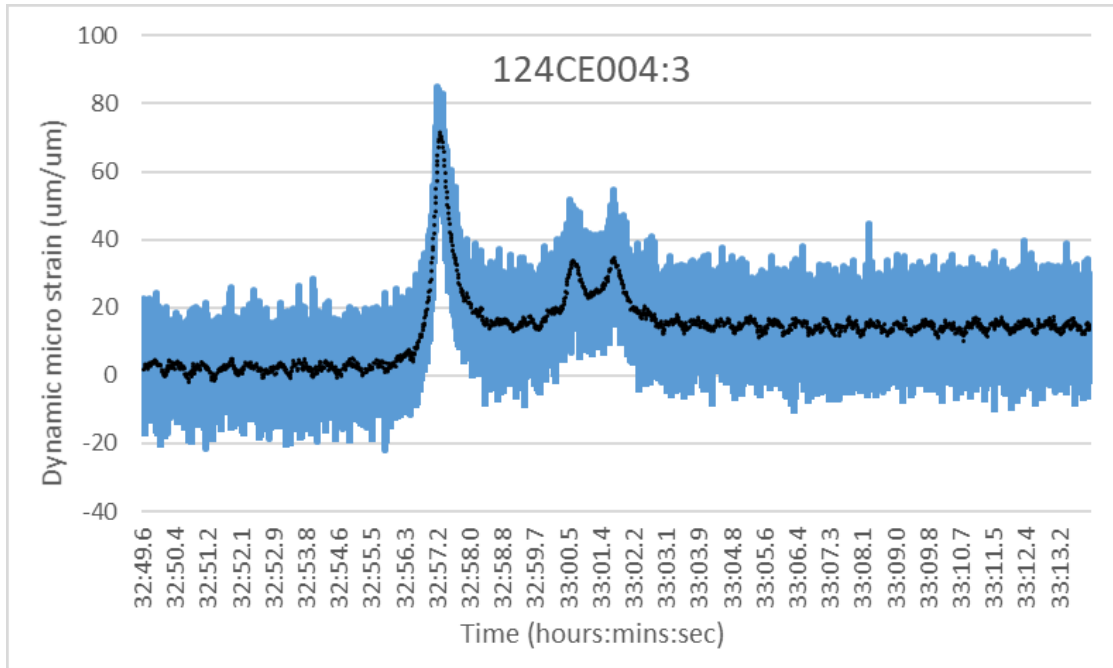
Figure 3.2 Strain time history from sensor 124CE004, loading 3 by the snow plow truck

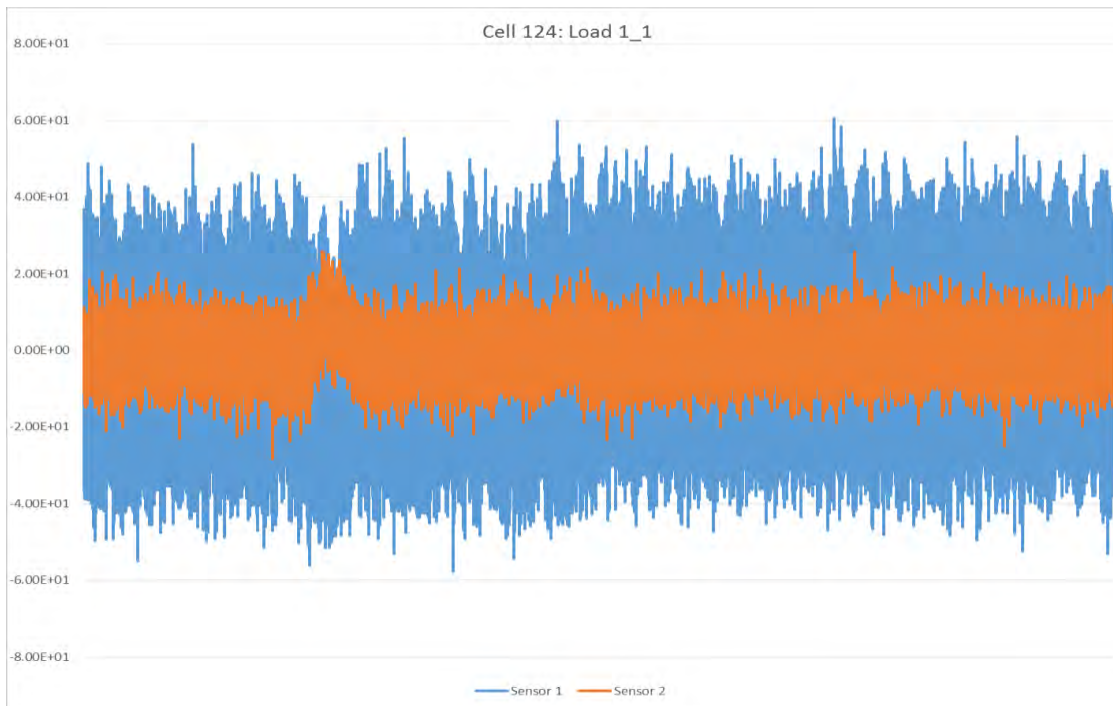
Figure 3.3 Reading from sensors 124CE001 and 124CE002, first loading by the snow plow truck

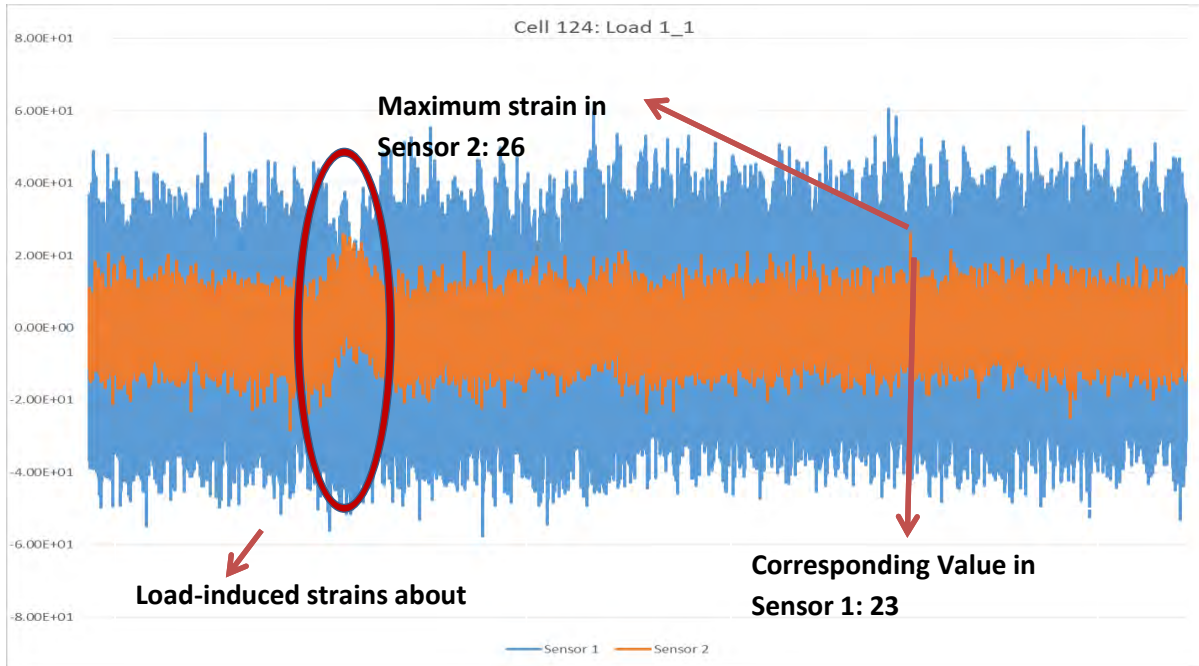
Figure 3.4 Example of data noise leading to erroneous maximum reading

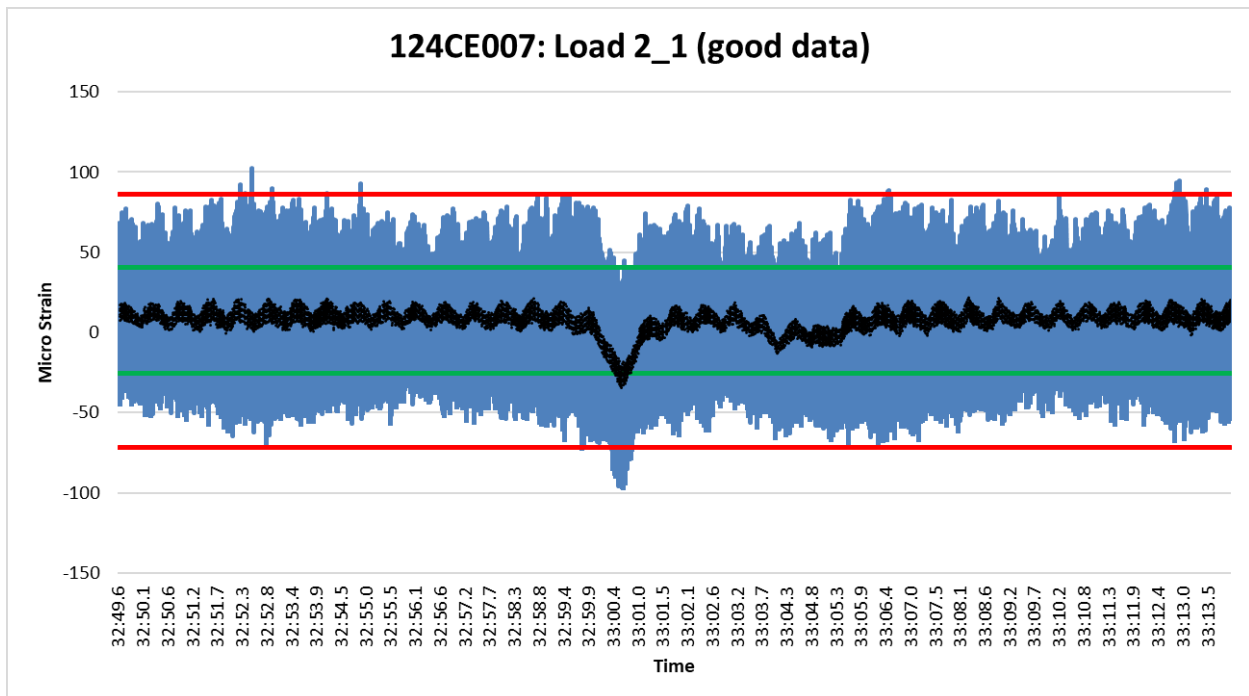
Figure 3.5 Strain time history for strain gauge 124CE007, load 2, forward pass.

Figure 3.5 shows the time history from strain gauge 124CE007 from the second loading pass. The standard deviation for this time measurement is 33.1 micro strains, which is lower than the threshold level of 80 micro strains. A distinct minimum in measured strains corresponds to the minimum in the moving average of strain measurements indicating high quality data. Figure 3.6 shows a time history from sensor 124CE001, loading 4 (back). The standard deviation for this measurement is 116 micro strains, greater than 80 micro strains. It can be observed that the measurements have no distinct peak that can be attributed to the passage of the heavy axle load. Therefore, this measurement was removed from the analysis.

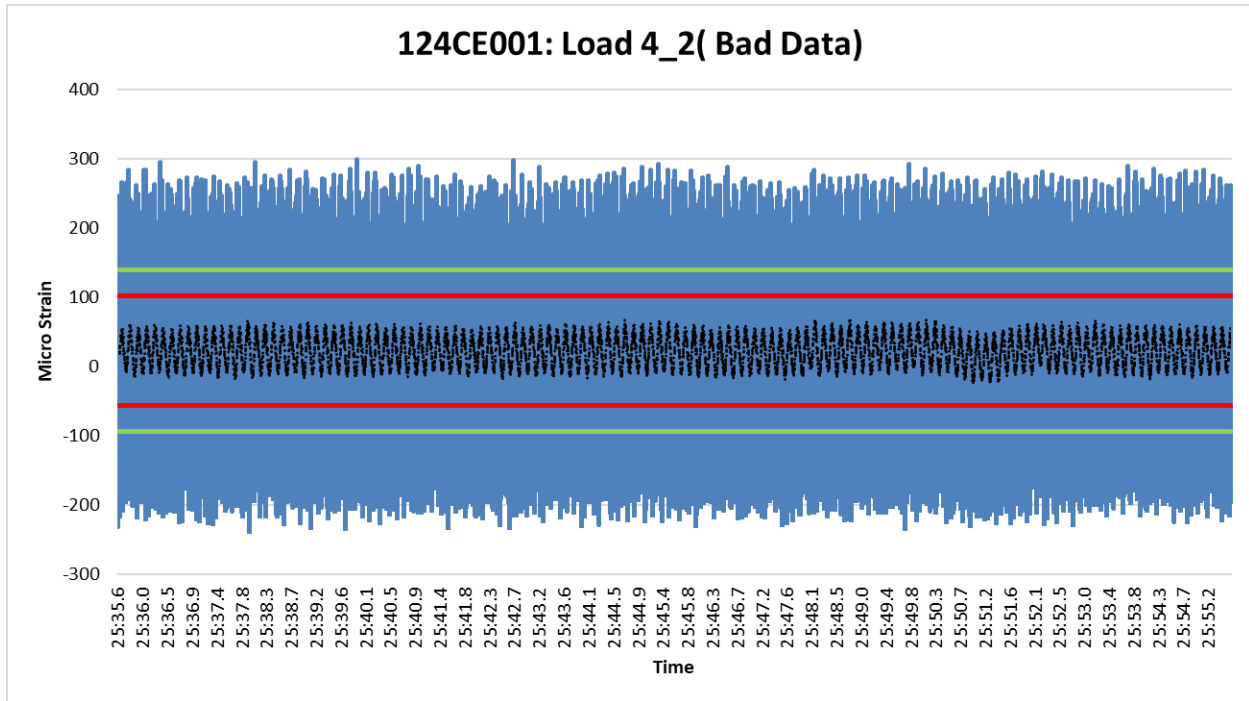
Figure 3.6 Strain time history for strain gauge 124CE001, load 5, back pass.

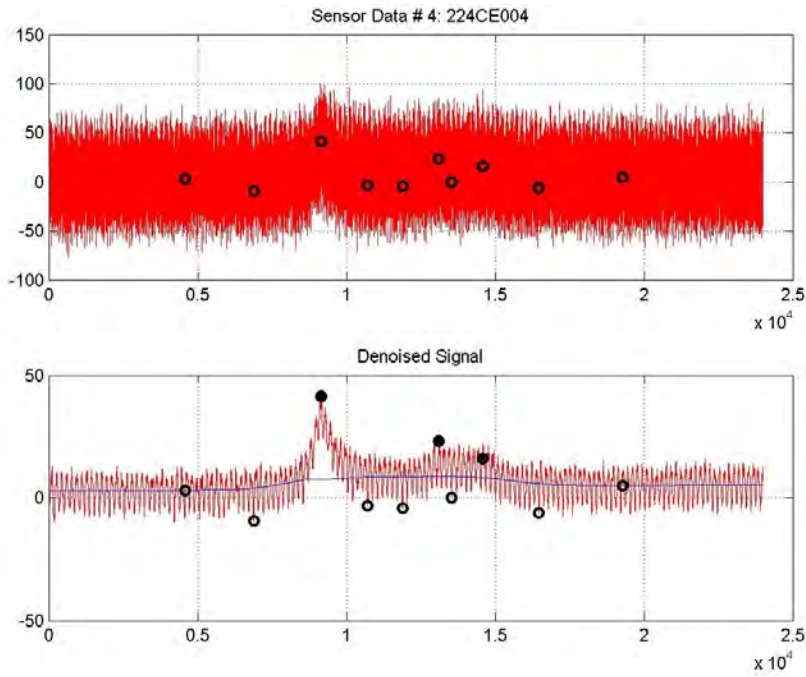
Figure 3.7 Cell 224, Run 5, Sensor 004, dynamic strain data for June 5, 2017

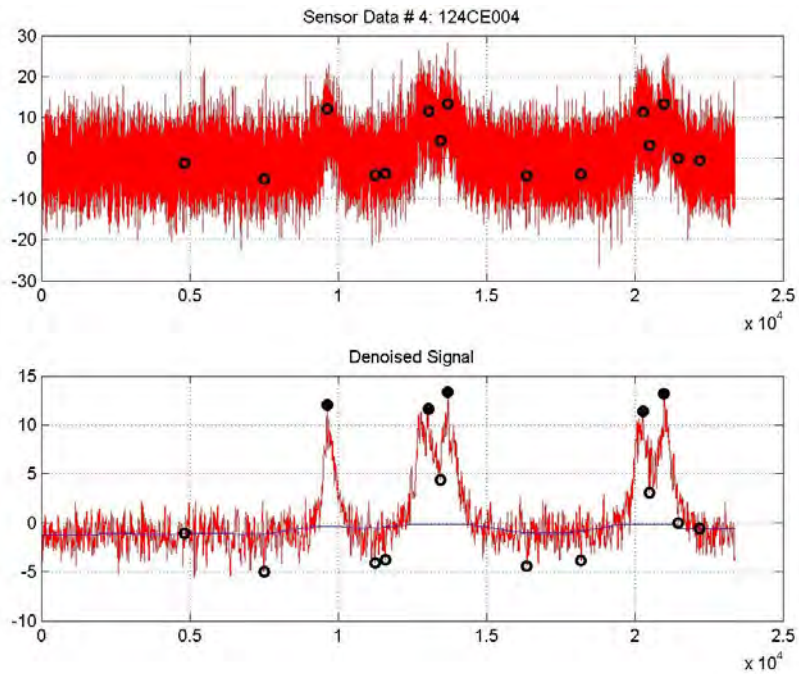
Figure 3.8 Cell 124, Run 1, Sensor 004, dynamic strain data for November 2017

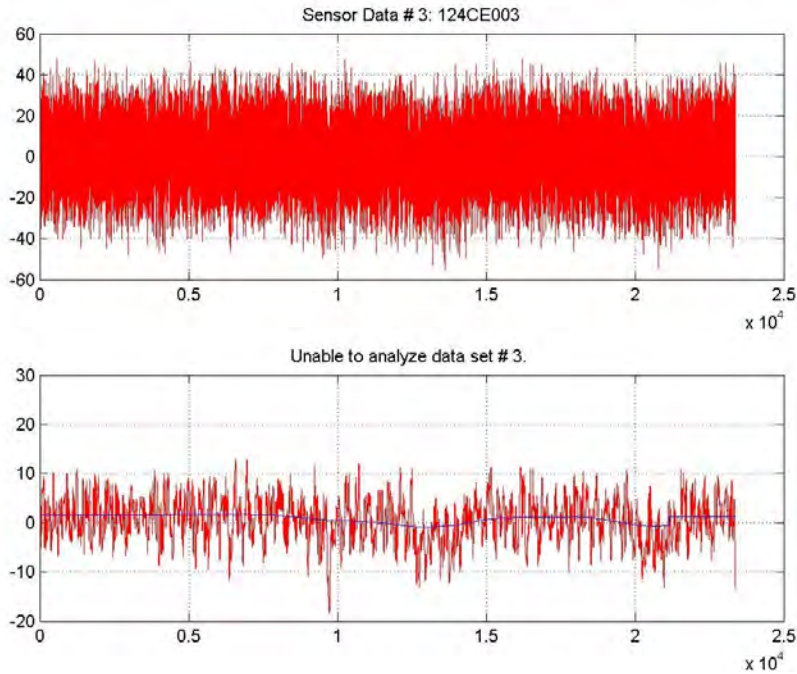
**Figure 3.9 Cell 124, Run 1, Sensor 003, dynamic strain data for November 2017**

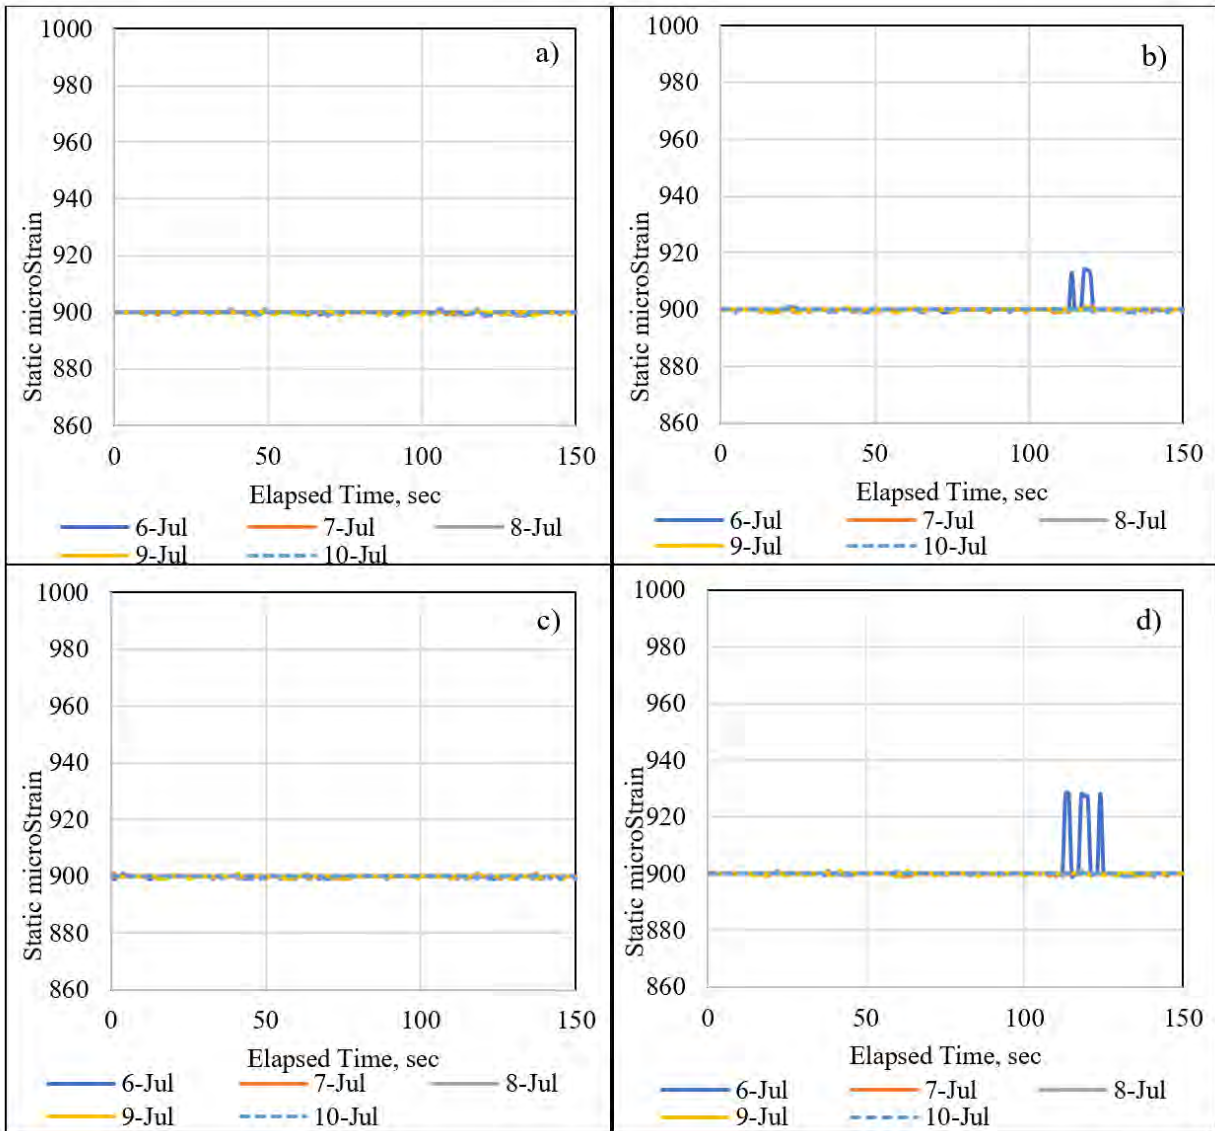
Figure 4.4 Static strain data for Cell 424 a) Sensor 001, b) Sensor 002, c) Sensor 003, and d) Sensor 004

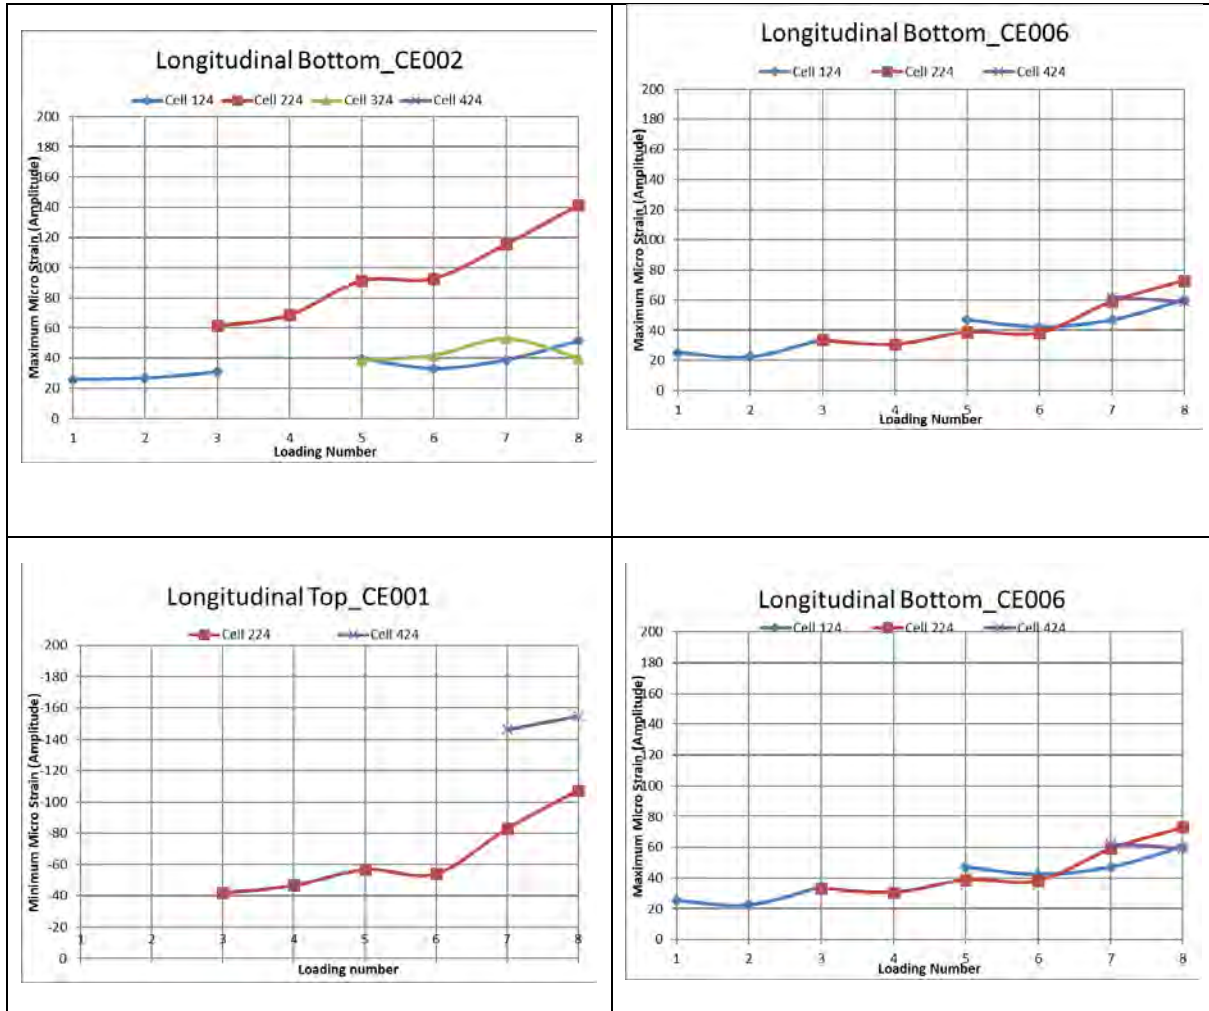
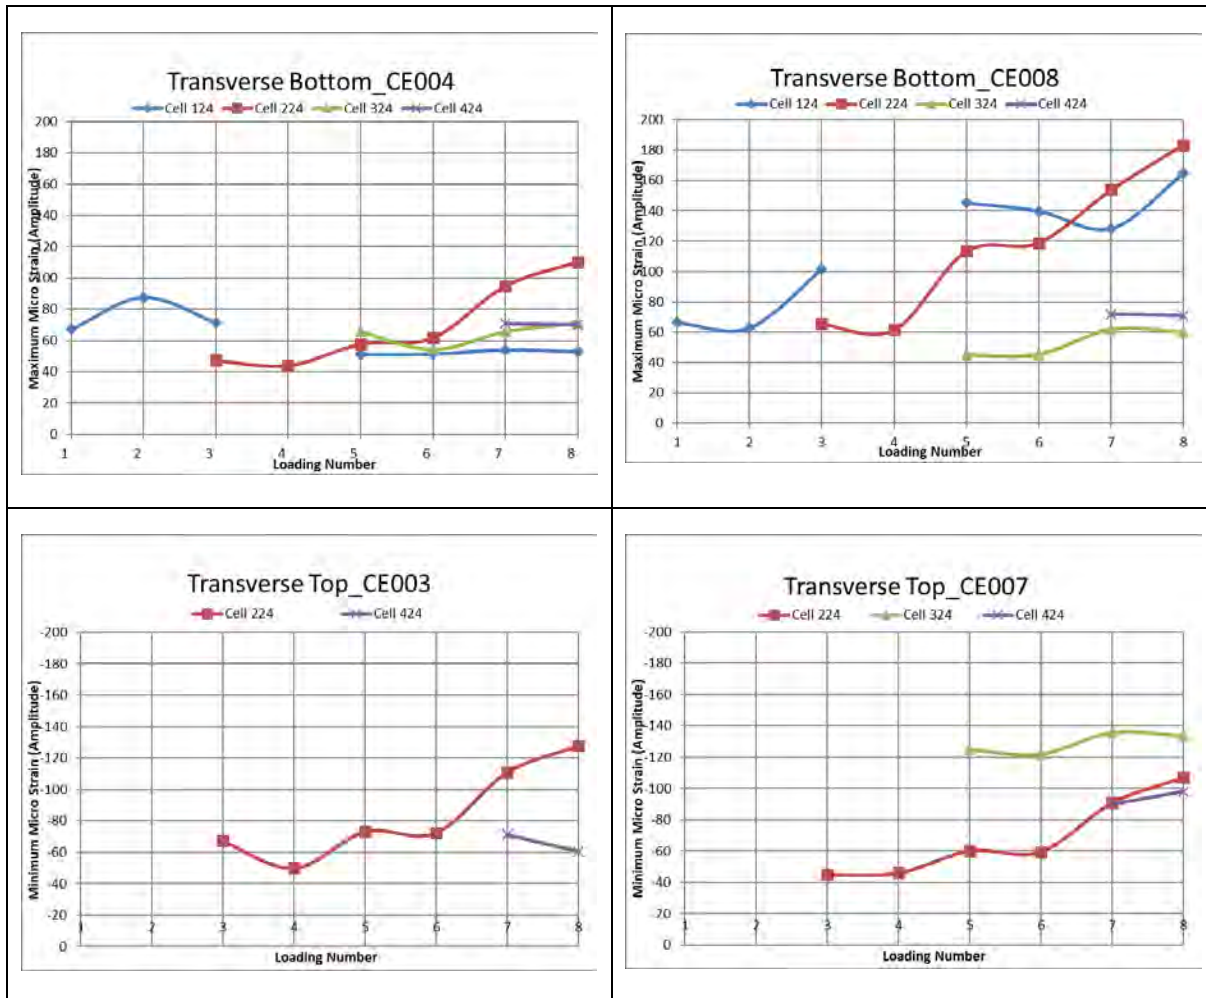
Figure 4.5 Comparison of maximum strains

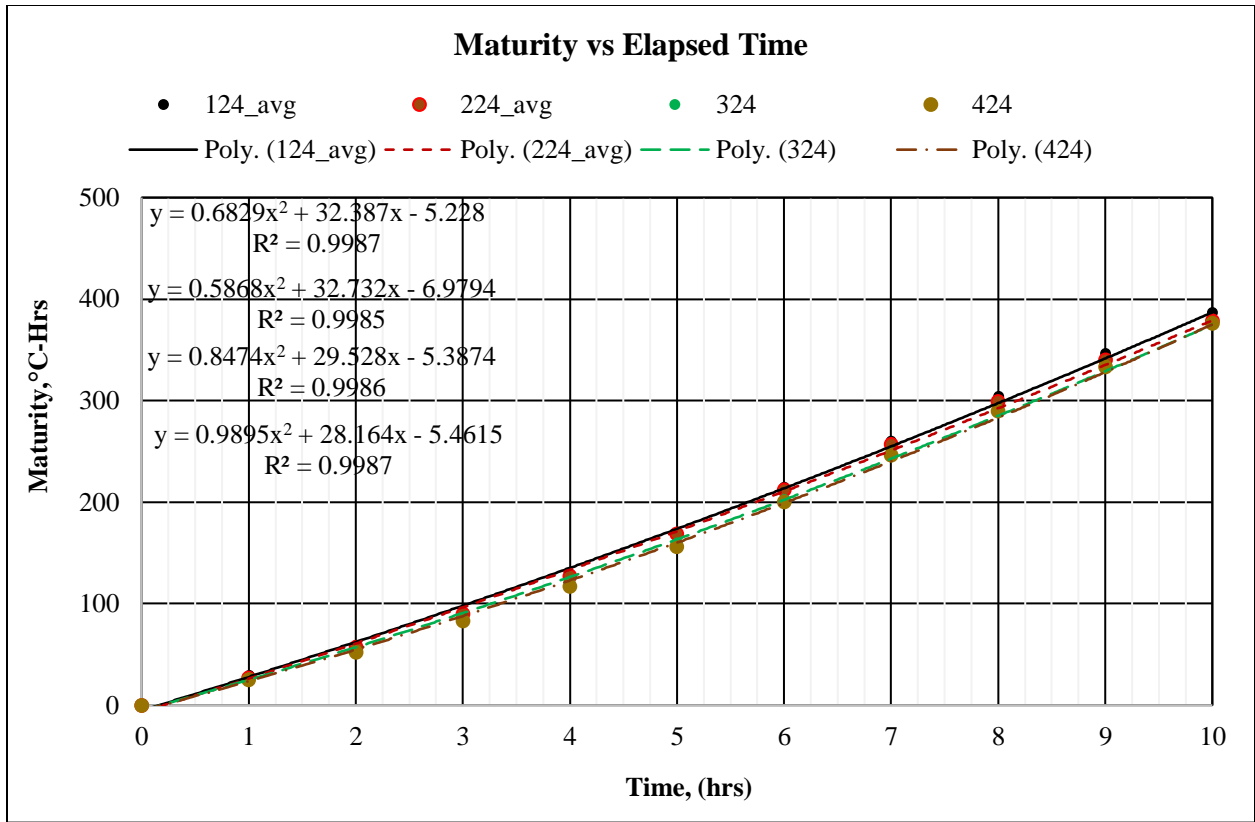
Figure 5.1 Measured concrete maturity vs time and corresponding regression equations

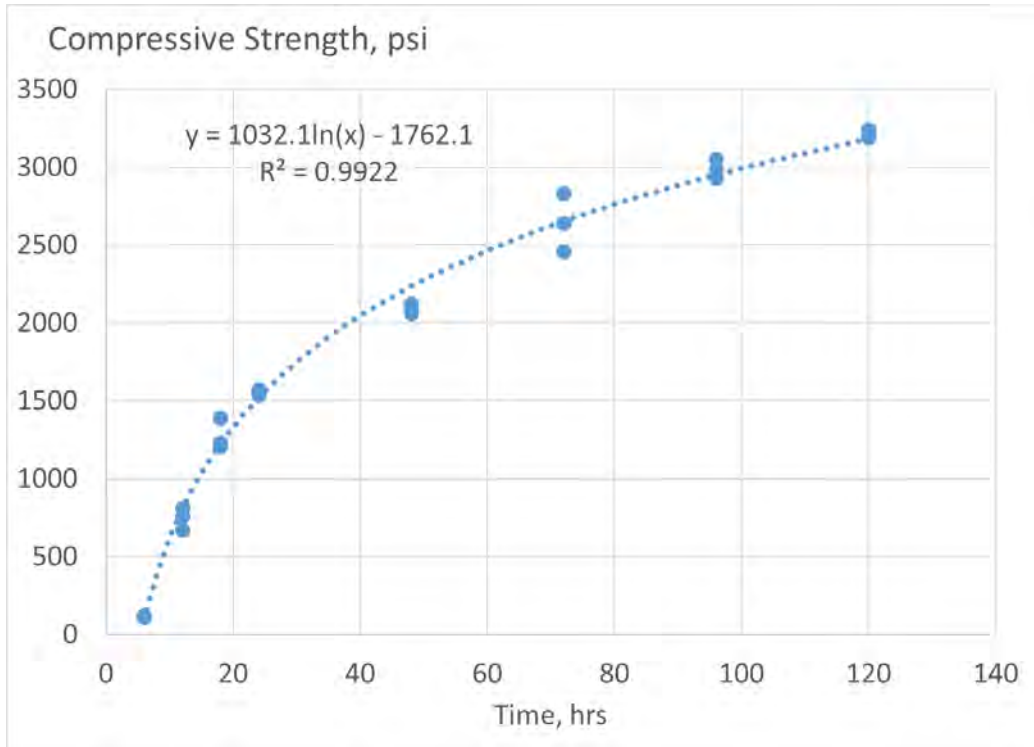
Figure 5.2 Compressive Strength at Various Ages

Analysis of maturity and strength data suggests that concrete in Cell 124 had reached compressive strength of 430 psi and flexural strength of 210 psi only after the time of 3<sup>rd</sup> loading; concrete in Cell 224 had reached flexural strength of 290 psi only at the time of the fourth loading, and Cell 424 reached tensile strength 320 psi at the time of fourth loading (Figure 5.2, Figure 5.3).

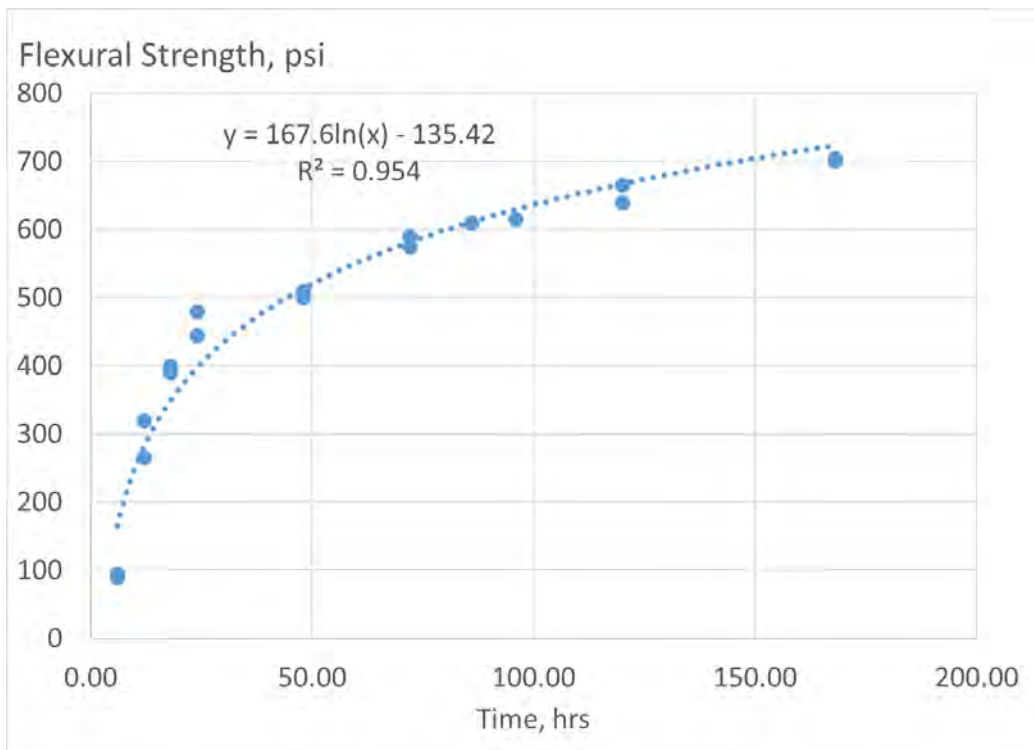
Figure 5.3 Flexural Strength at Various Ages

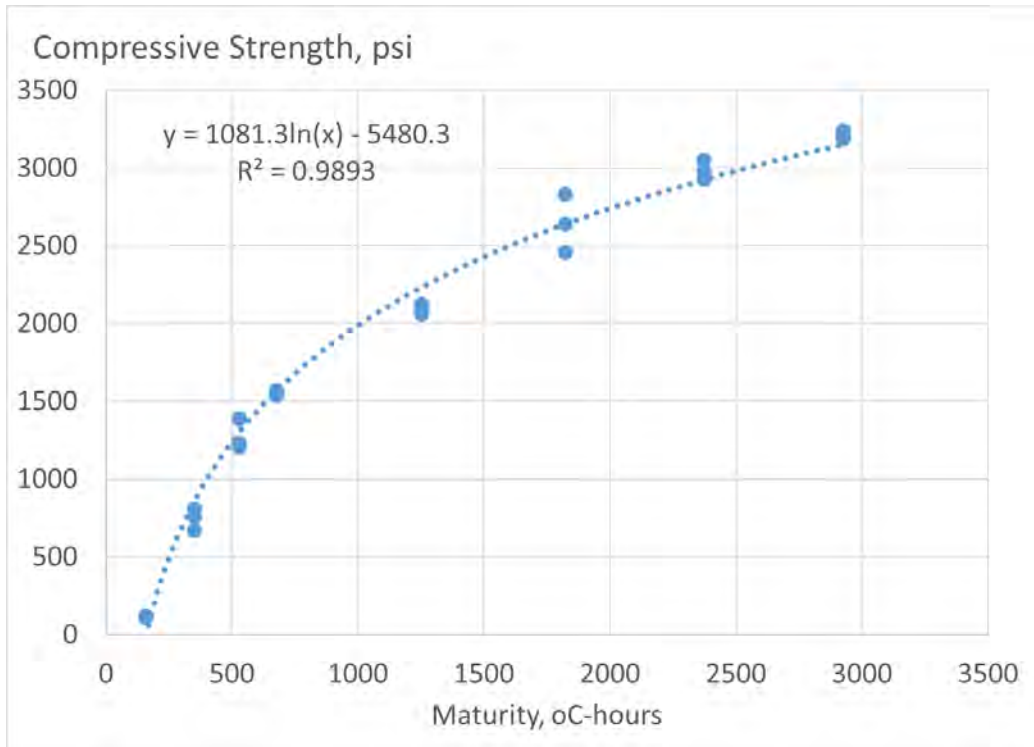
Figure 5.4 Concrete compressive strength vs maturity

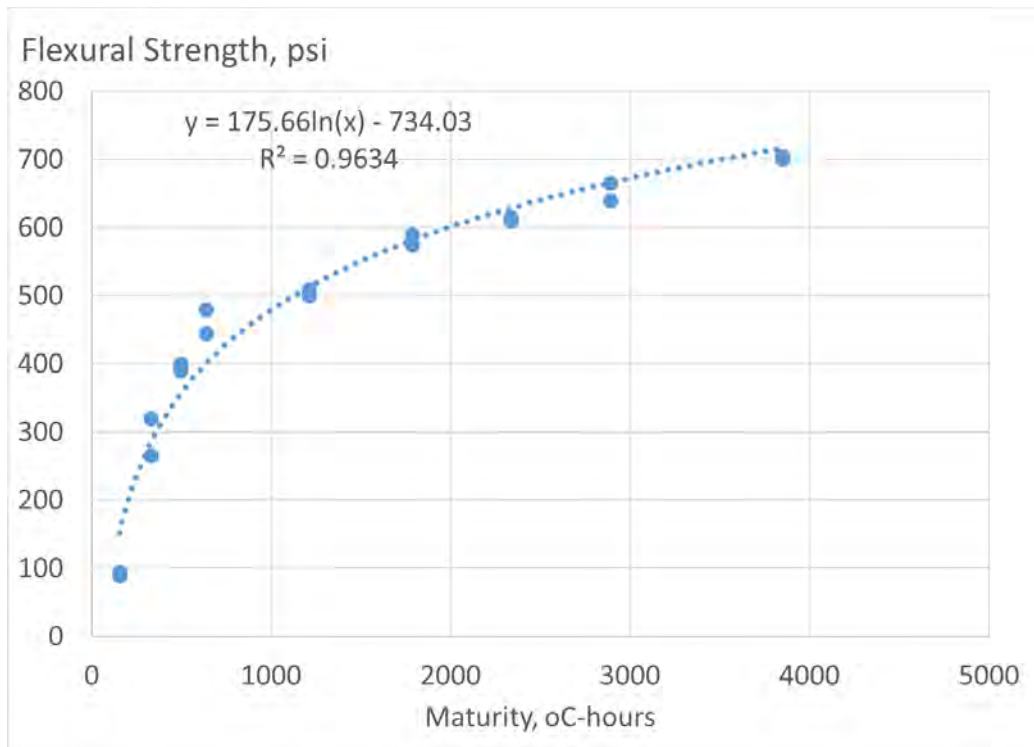
Figure 5.5 Concrete flexural strength vs maturity

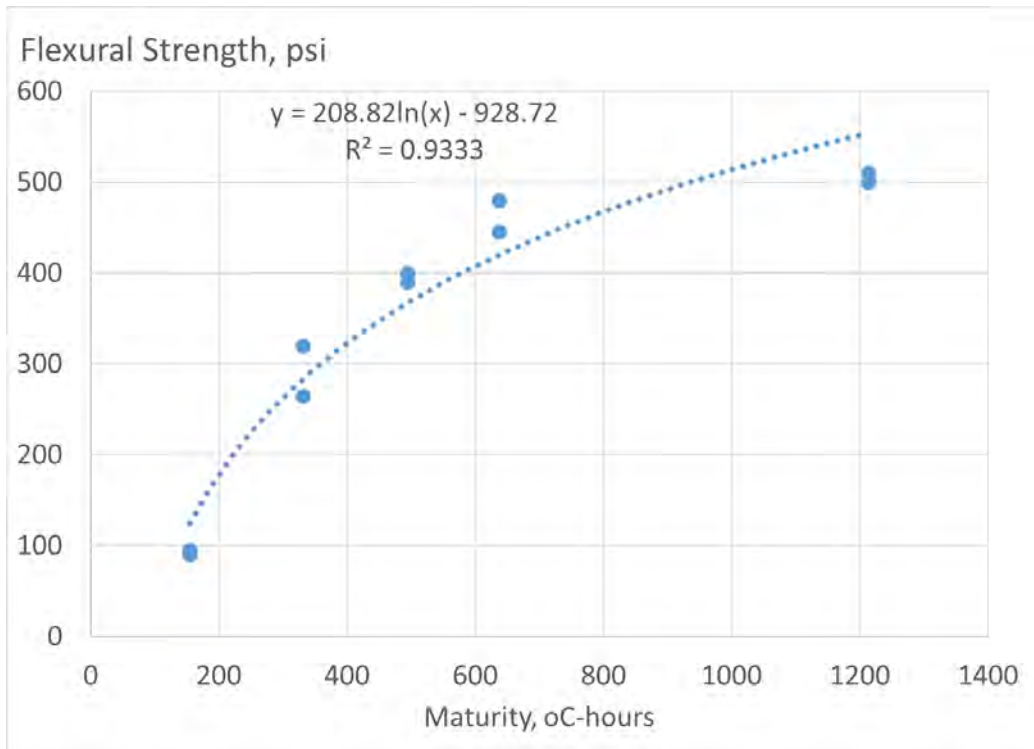
Figure 5.6 Concrete flexural strength vs maturity for low maturity levels

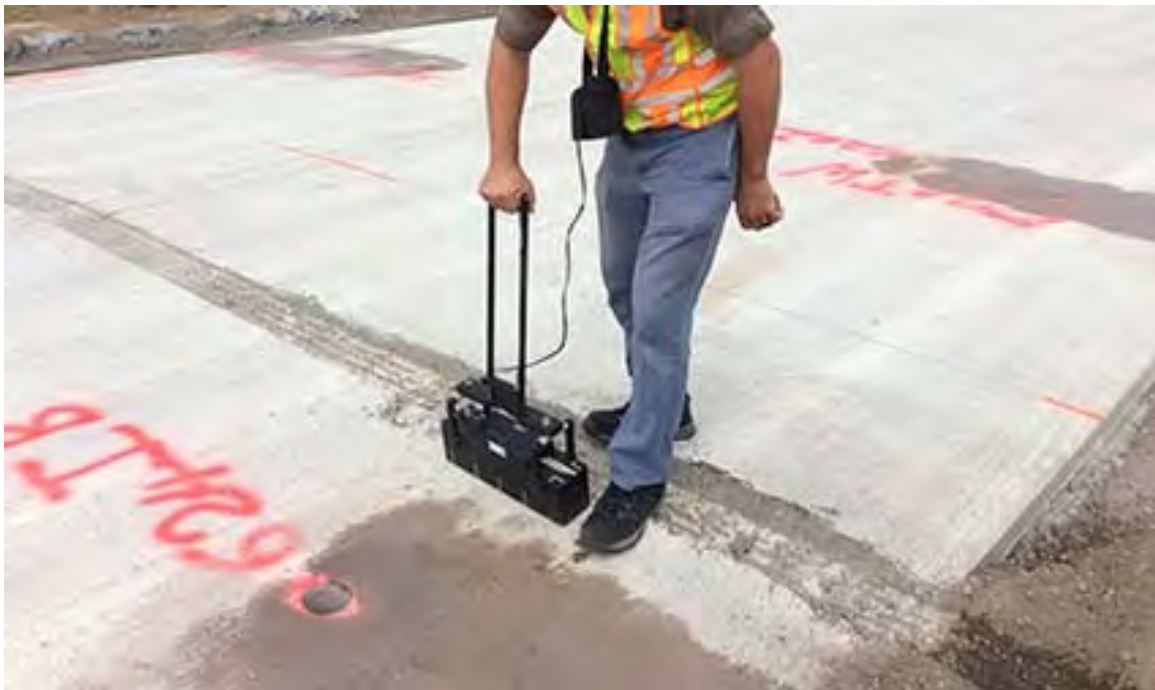
Figure 7.1 MIRA measurements

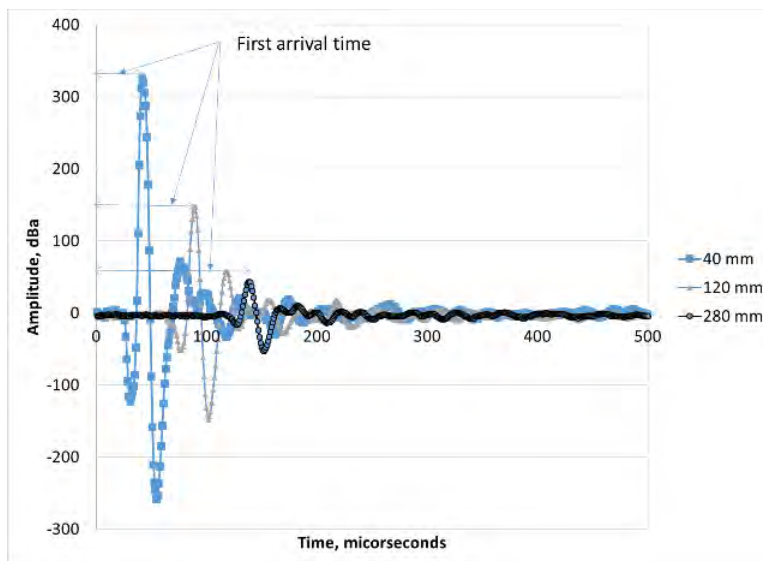
Figure 7.2 An example of MIRA signal time history for one sensor pair

Figure 7.2 shows an example of determination of arrival time for sensor pairs located 40, 120, and 280 mm apart. Then a linear regression analysis was performed between arrival times and distances between sensors for each MIRA measurement. Figure 7.3 shows an example of the plot of distance between transducer pairs and the measured signal arrival time for one of the MIRA measurements. A clear linear relationship is observed for this data set and the slope of the line,  $2.664 \text{ mm/microseconds} = 2.402 \text{ km/s}$ , is the shear wave velocity. A high  $R^2$  of 99.97% indicated that the model explains 99.97% of the change in the arrival time with the change in distance between sensors.

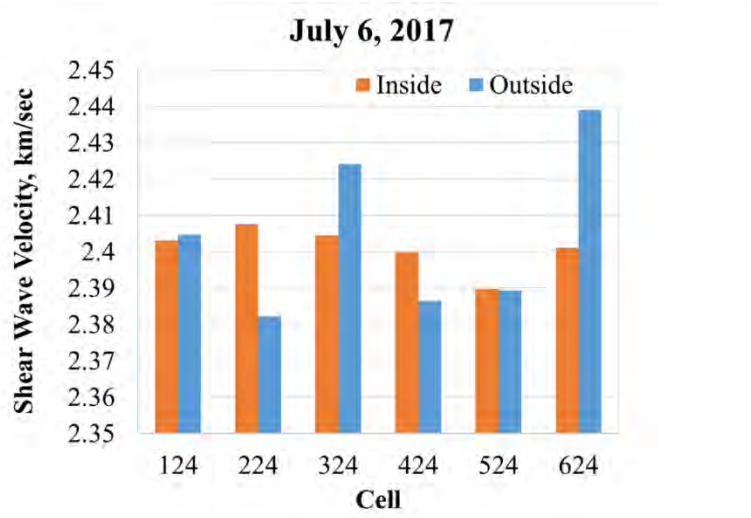
**Figure 7.4 Comparison of Mean Shear Wave Velocities for Cells 124-624**

The results of the velocity analysis for each MIRA scan are provided in Appendix C. Figure 7.4 presents the computed mean velocities for each cell from MIRA scans taken on July 6<sup>th</sup> along the width of the slabs. It can be observed that early loading of Cells 124 and 324 did not result in reduction of shear wave velocity of concrete compared to the velocity of concrete in the inside lane of control Cell 524. The mean measured velocity of concrete in the outside lane of Cell 224 was slightly lower than the velocity for the remaining slab, but this phenomenon was most likely caused by spatial variability of concrete velocities at early (less than 48 hours) age and not by 2-axle pickup truck damage.

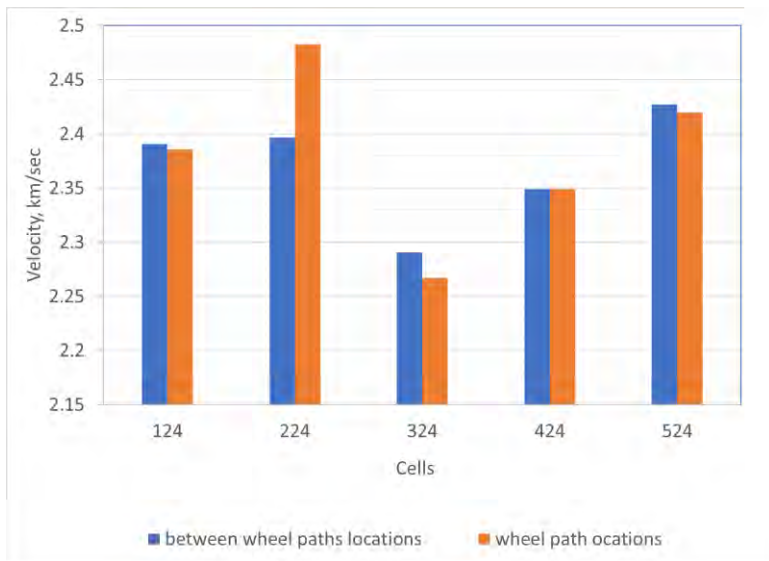
**Figure 7.5 Comparison of velocities taken in the wheel path vs between wheel path for the inside lane**

Figure 7.5 and Figure 7.6 present comparison of the average shear wave velocities taken at the wheel path and between wheel paths near core locations, for inside and outside lanes, respectively. It can be observed that for both inside and outside lanes MIRA testing in the wheel path did not result in low velocity indicating presence of significant damage.

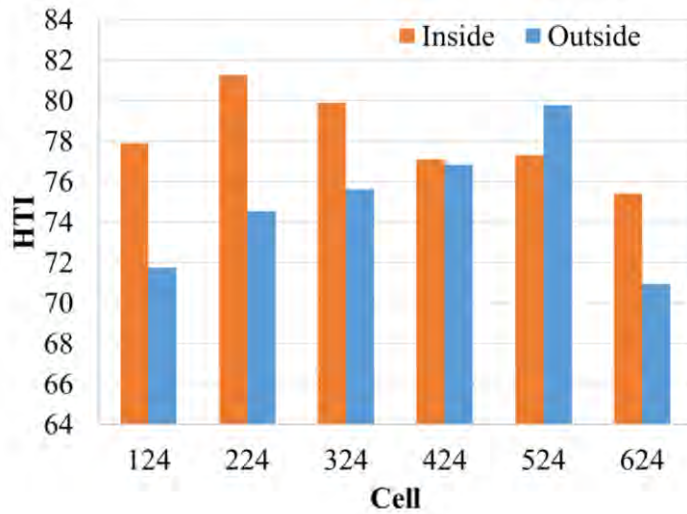
Figure 7.7 Mean HTIs for Cells 124-624 Measured on July 10, 2017

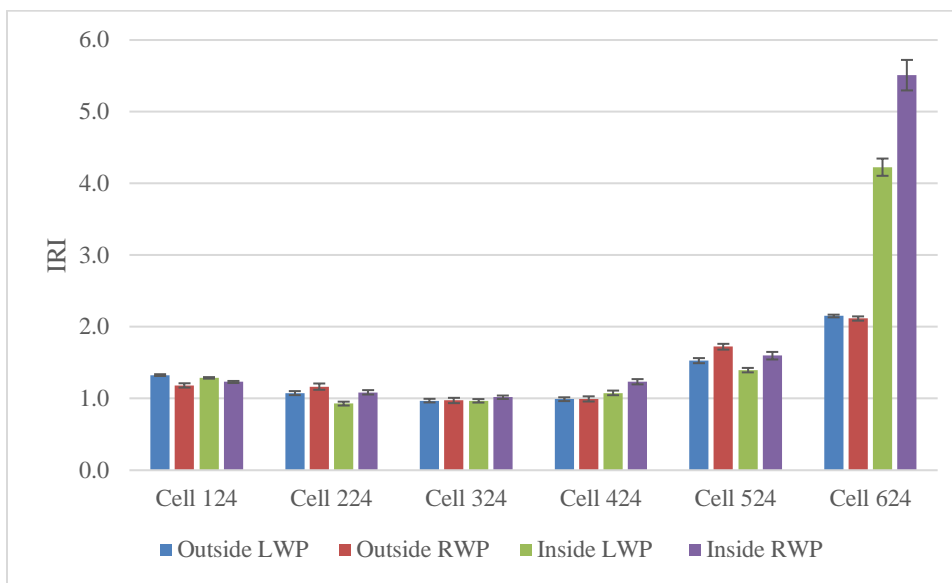
Figure 8.1 IRI for each cell

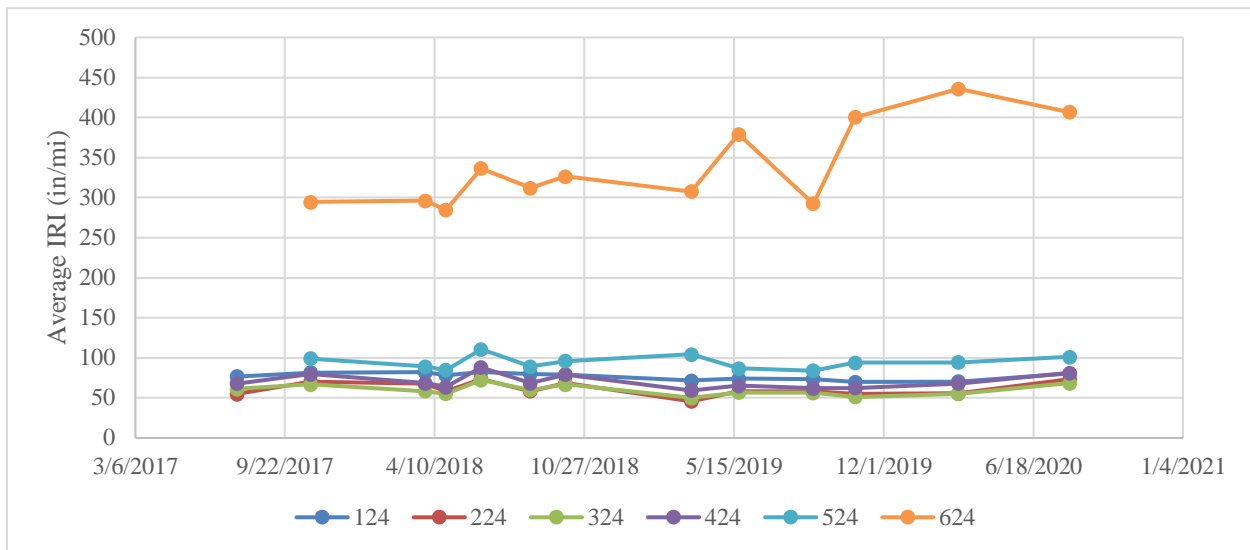
Figure 8.3 Average IRI of the inside lane

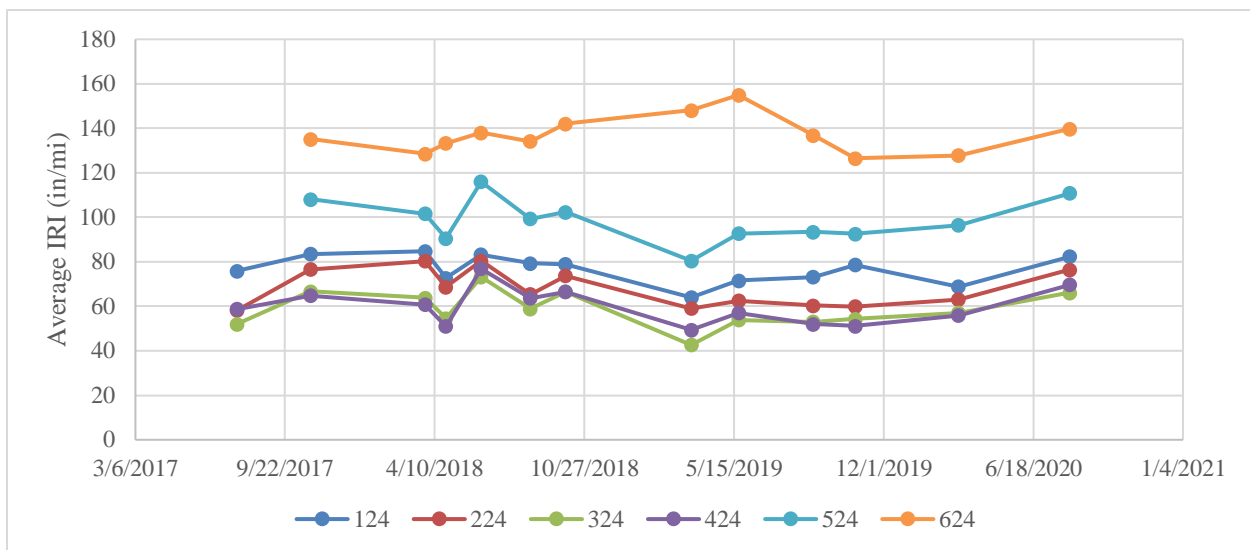
Figure 8.4 Average IRI of the outside lane

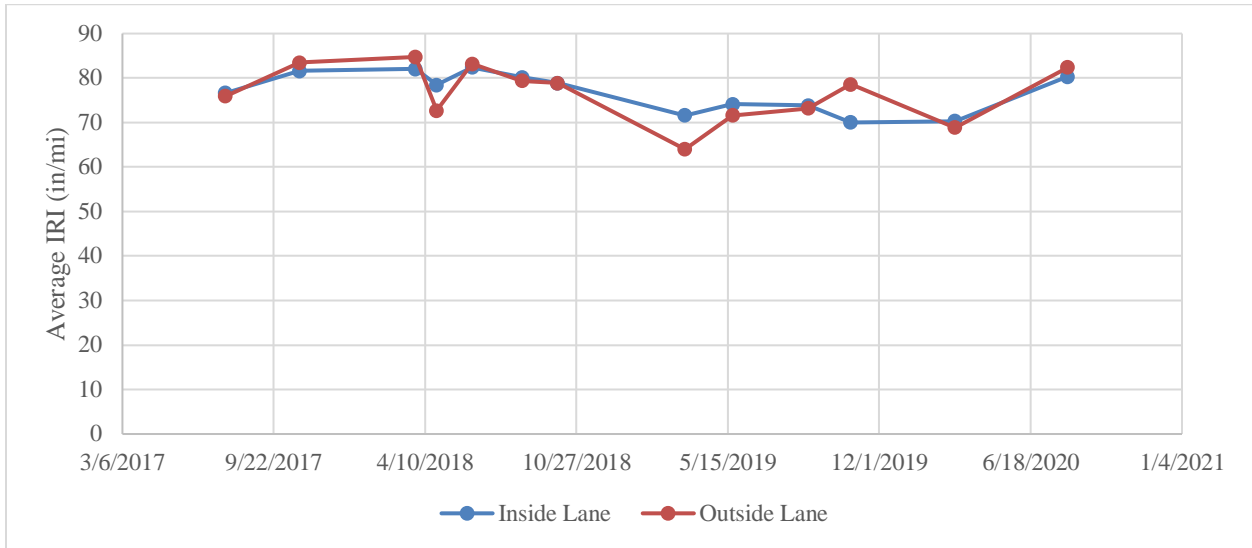
Figure 8.5 Average IRI for Cell 124
