# Evaluation of Long-Term Impacts of Early Opening of Concrete Pavements

NRRA RIGID TEAM

Report No. NRRA202111

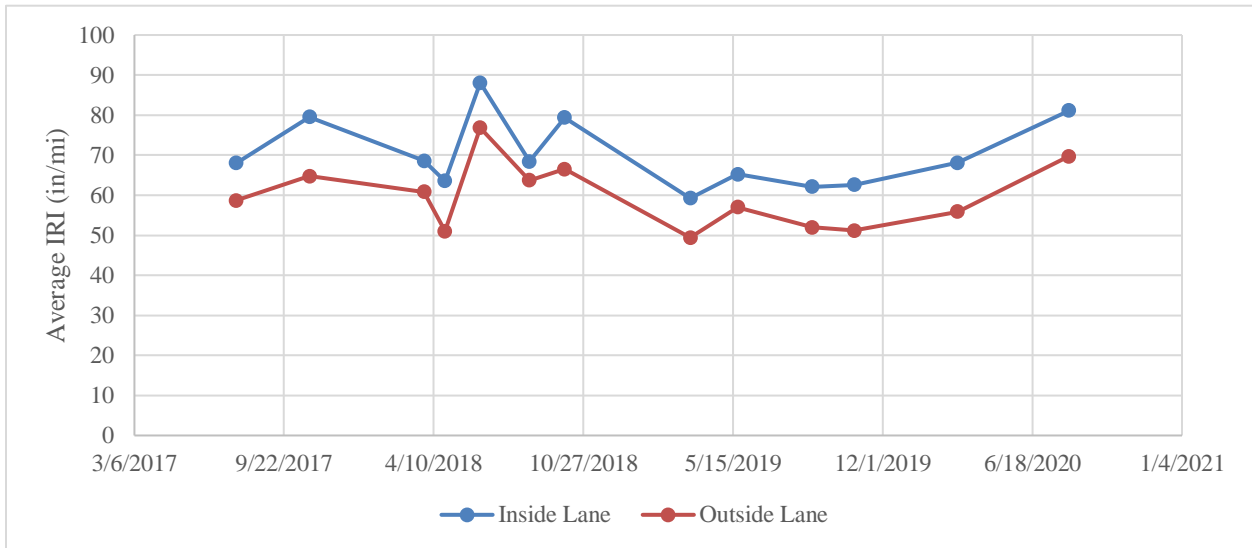
Figure 8.6 Average IRI for Cell 424

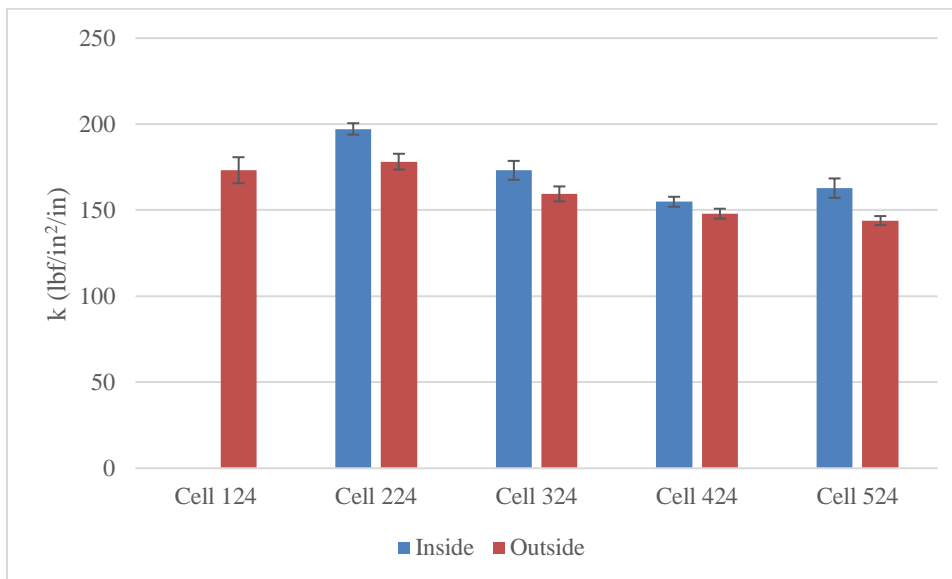
**Figure 9.2 k-values for cells**

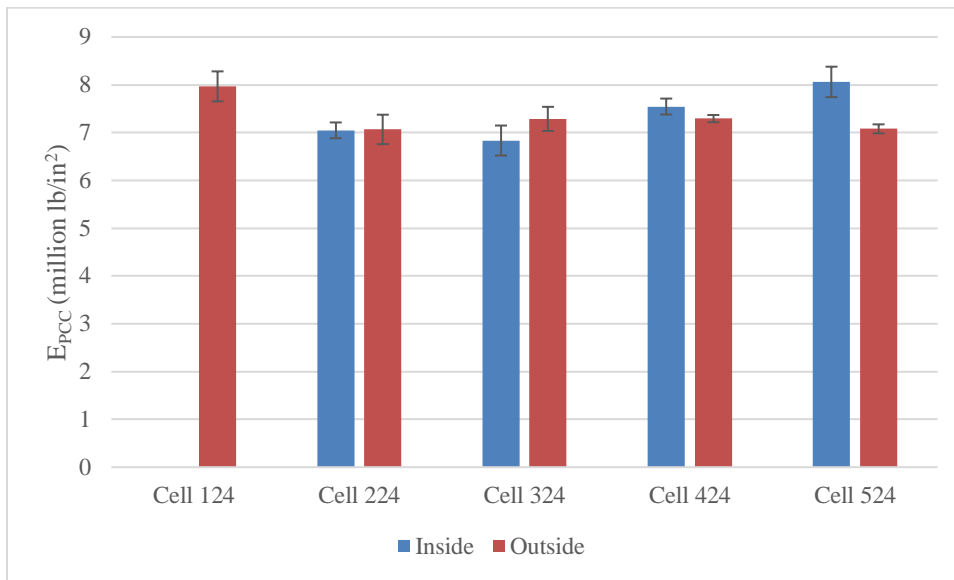
Figure 9.3 Elastic modulus for cells

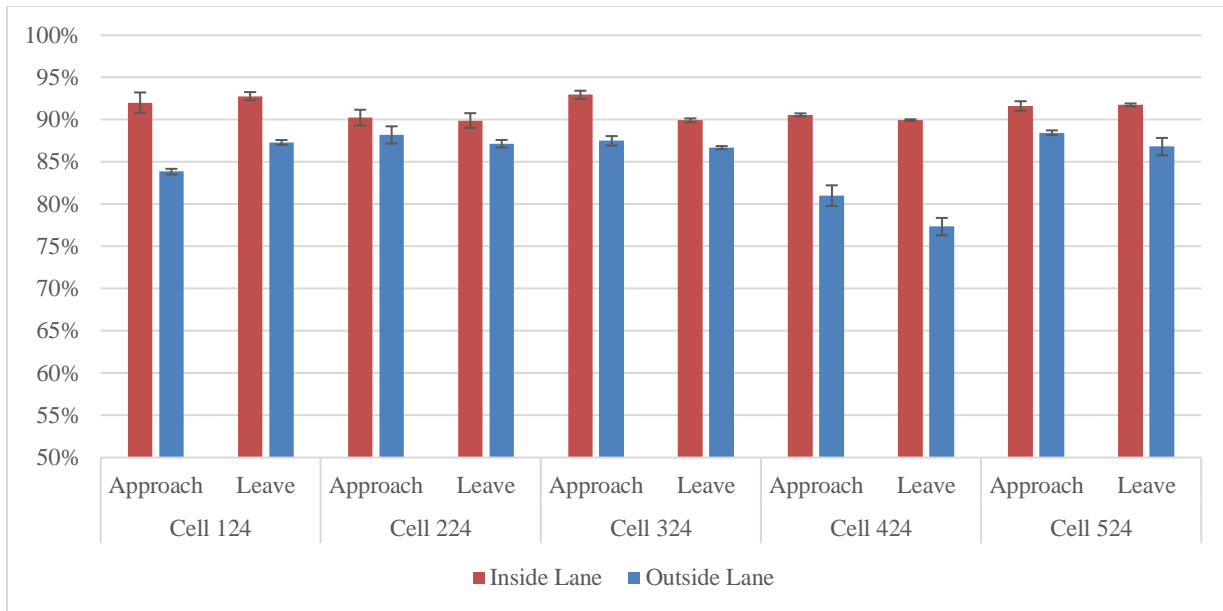
**Figure 9.5 LTE results for cells in 2017**

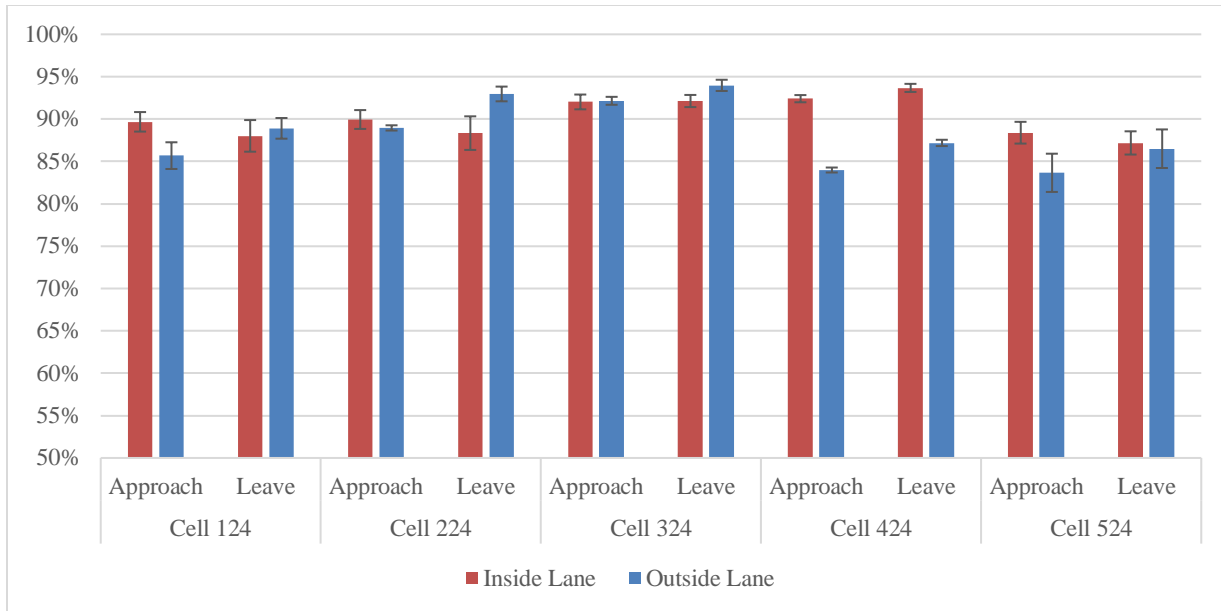
Figure 9.6 LTE results for cells in 2018

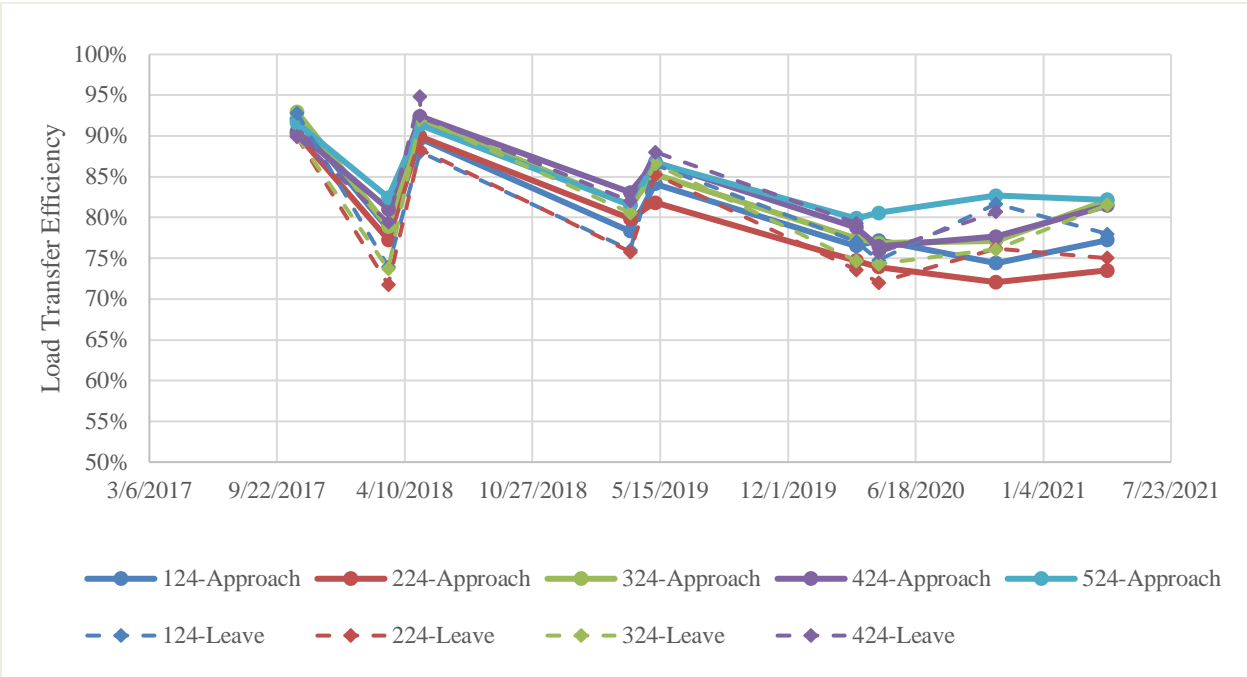
Figure 9.7 Load transfer efficiency for the inside lane

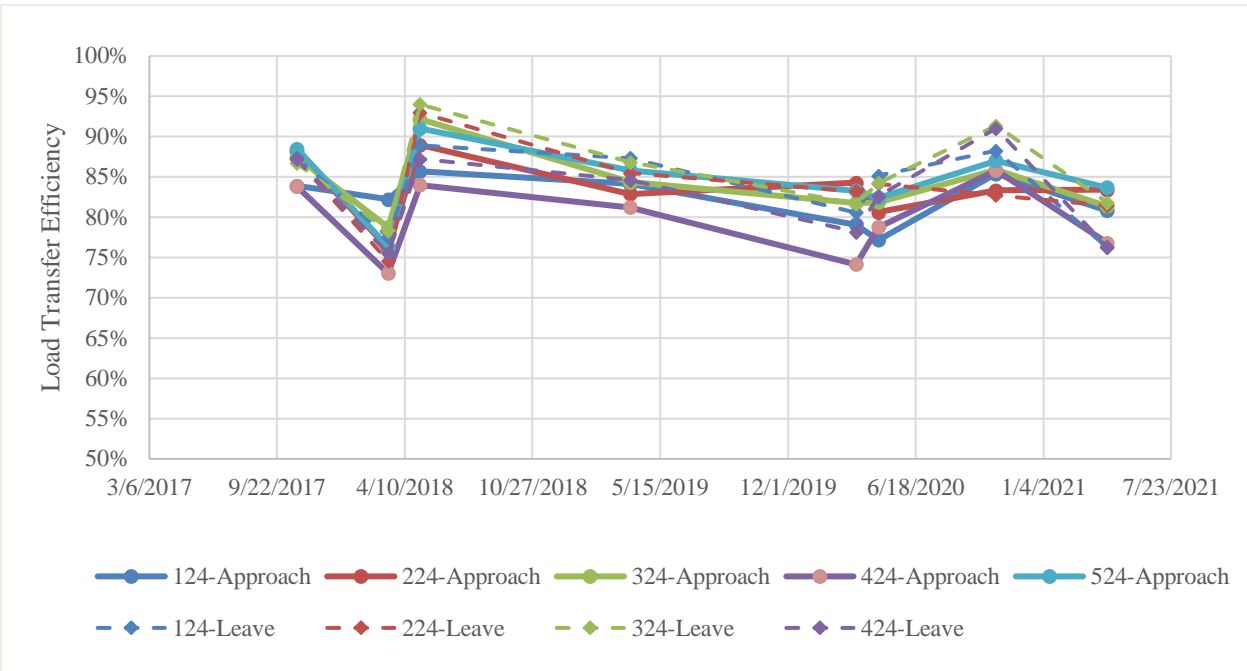
Figure 9.8 Load transfer efficiency for outside lane

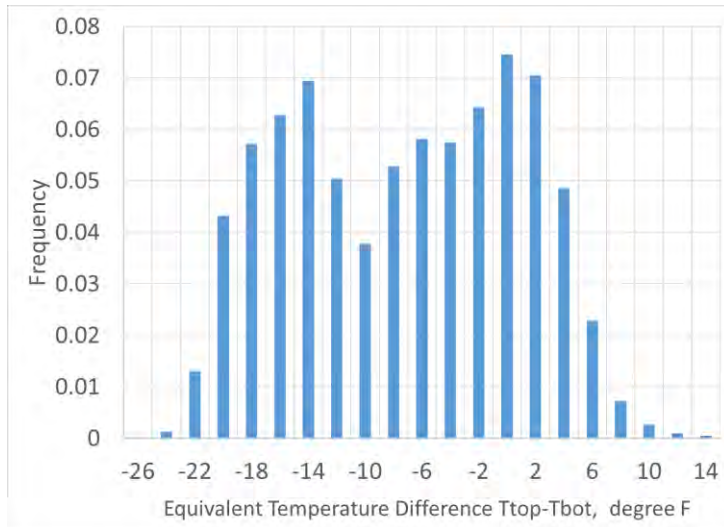
Figure 12.2 Temperature frequency analysis for July in Minnesota

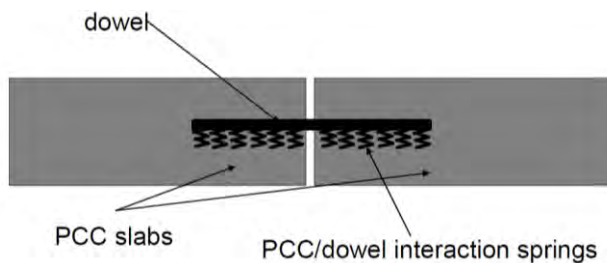
Figure 12.3 Tabatabaie and Barenberg model of doweled joints of PCC.

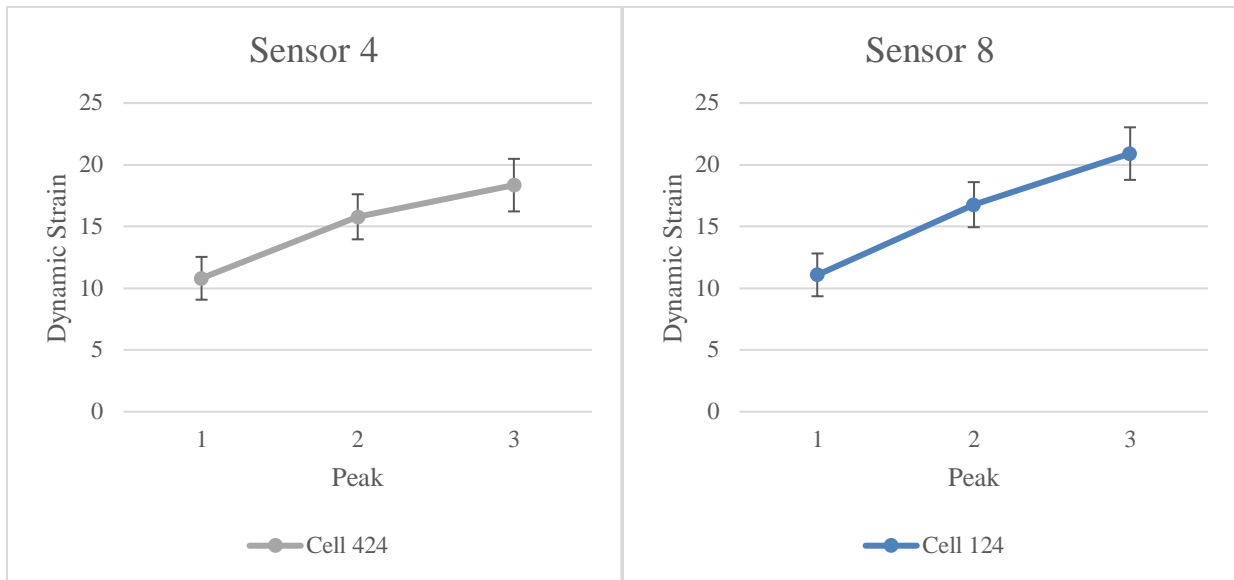
Figure D3: Long-term dynamic strain data for October 2018

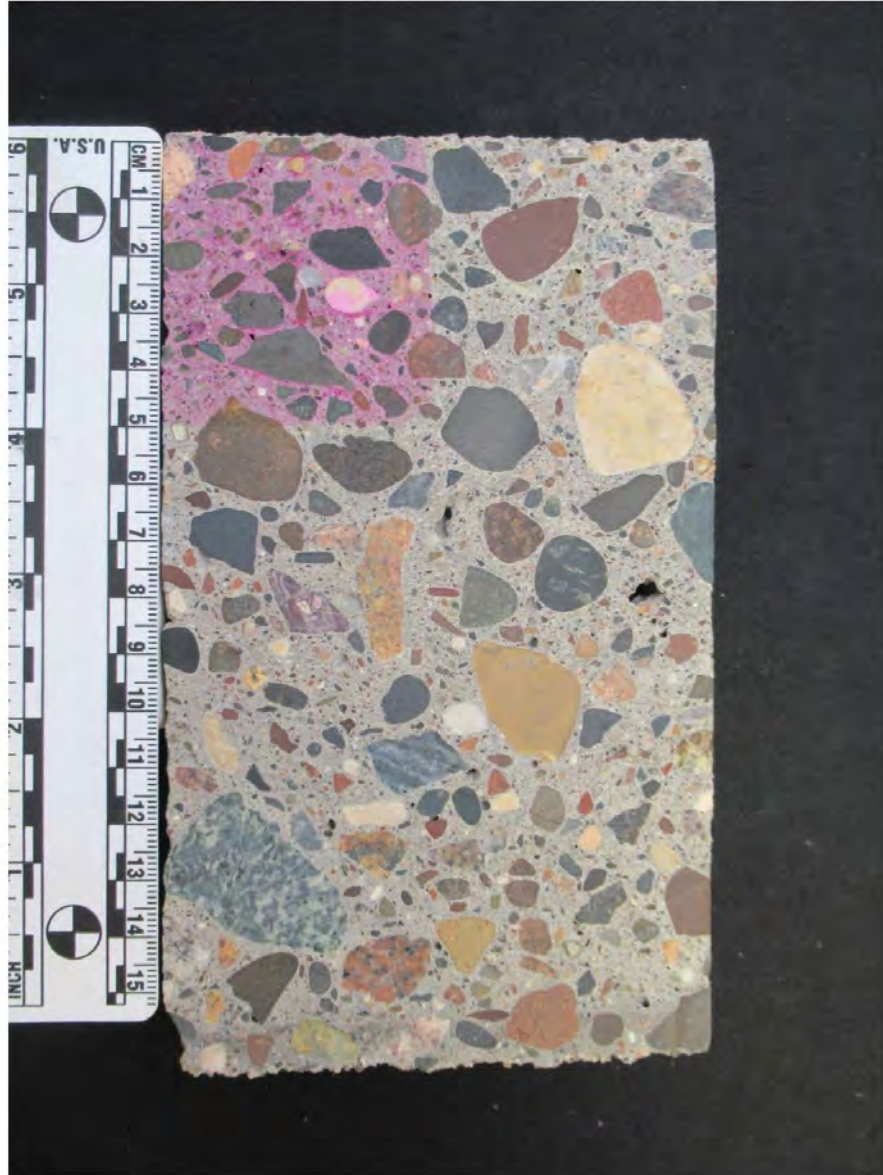
SAMPLE ID: 521 124B DESCRIPTION: A saw-cut and lapped cross section of the concrete core sample with the top surface oriented to the top of the photo. The upper left corner was treated with phenolphthalein pH indicator (pink stain).

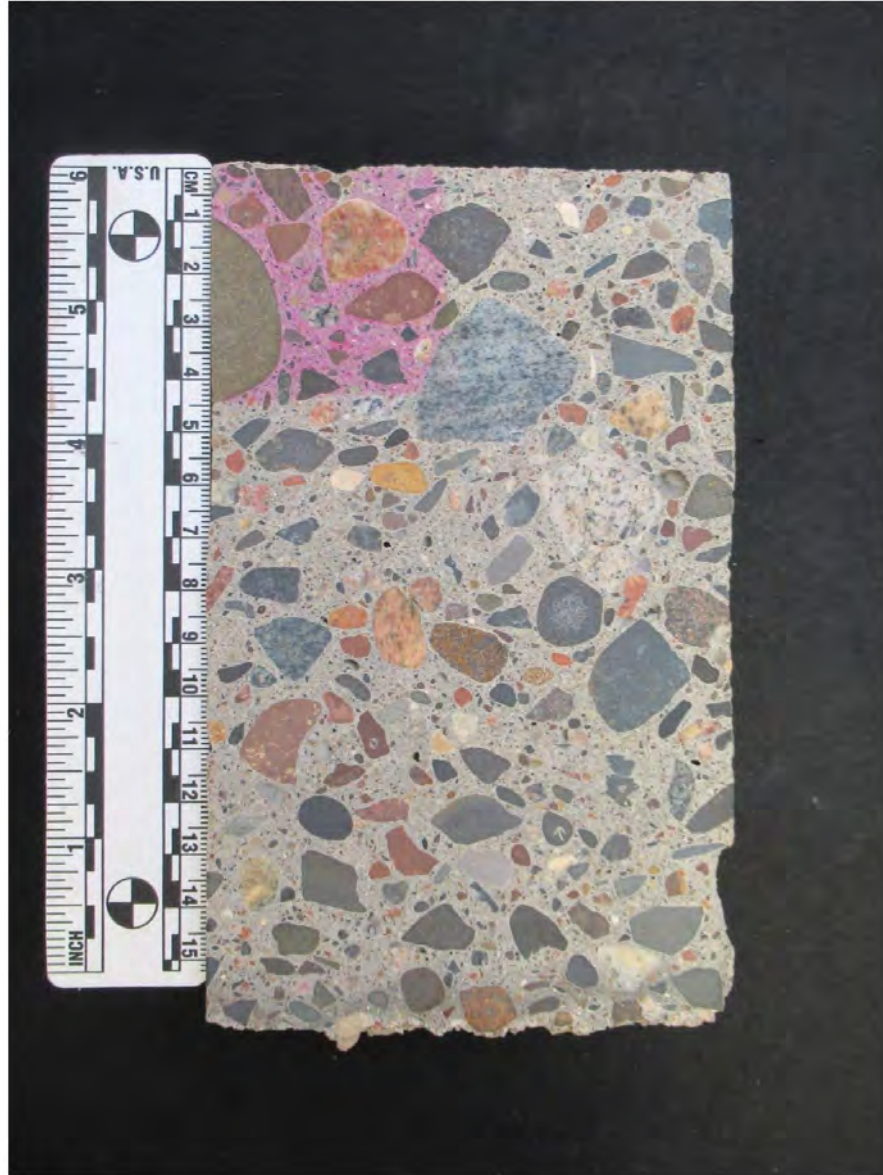
SAMPLE ID: 521 124W DESCRIPTION: A saw-cut and lapped cross section of the concrete core sample with the top surface oriented to the top of the photo. The upper left corner was treated with phenolphthalein pH indicator (pink stain).

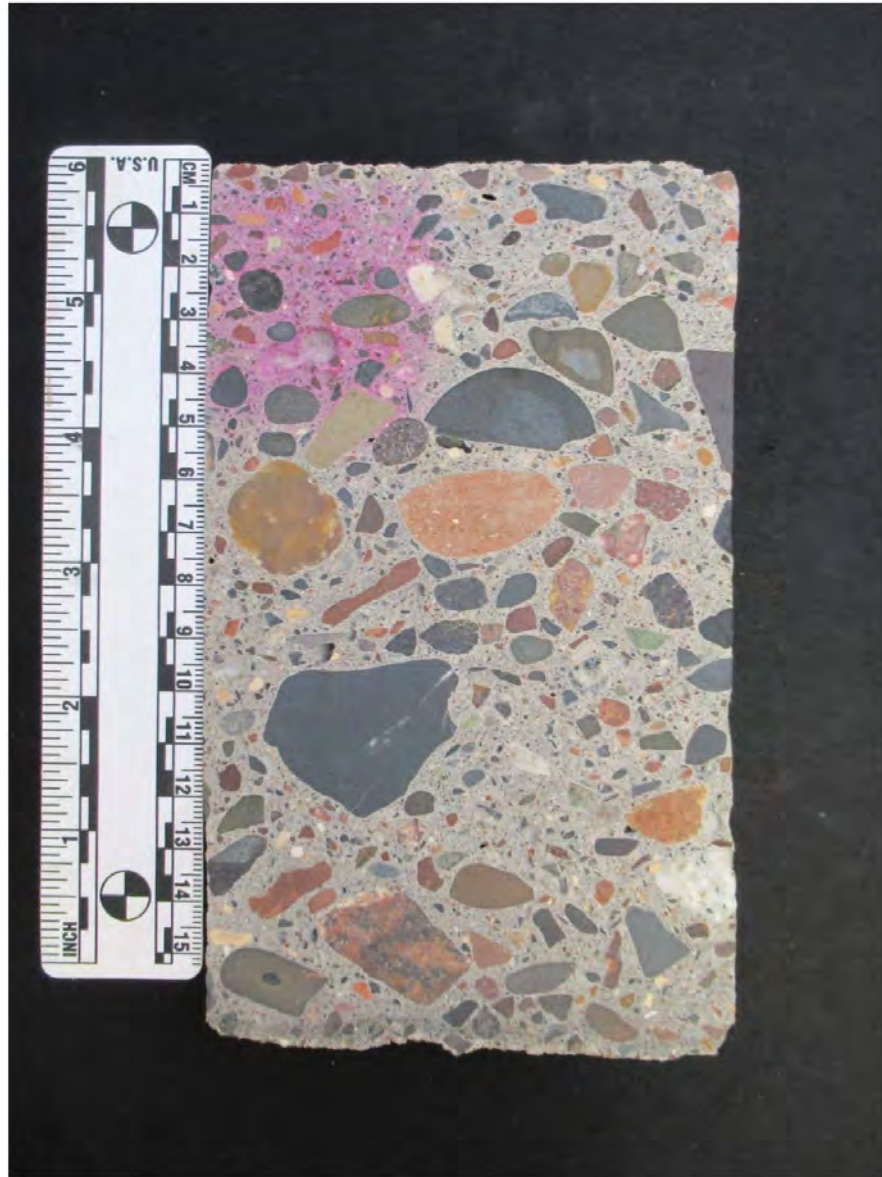
SAMPLE ID: 521 424B DESCRIPTION: A saw-cut and lapped cross section of the concrete core sample with the top surface oriented to the top of the photo. The upper left corner was treated with phenolphthalein pH indicator (pink stain).

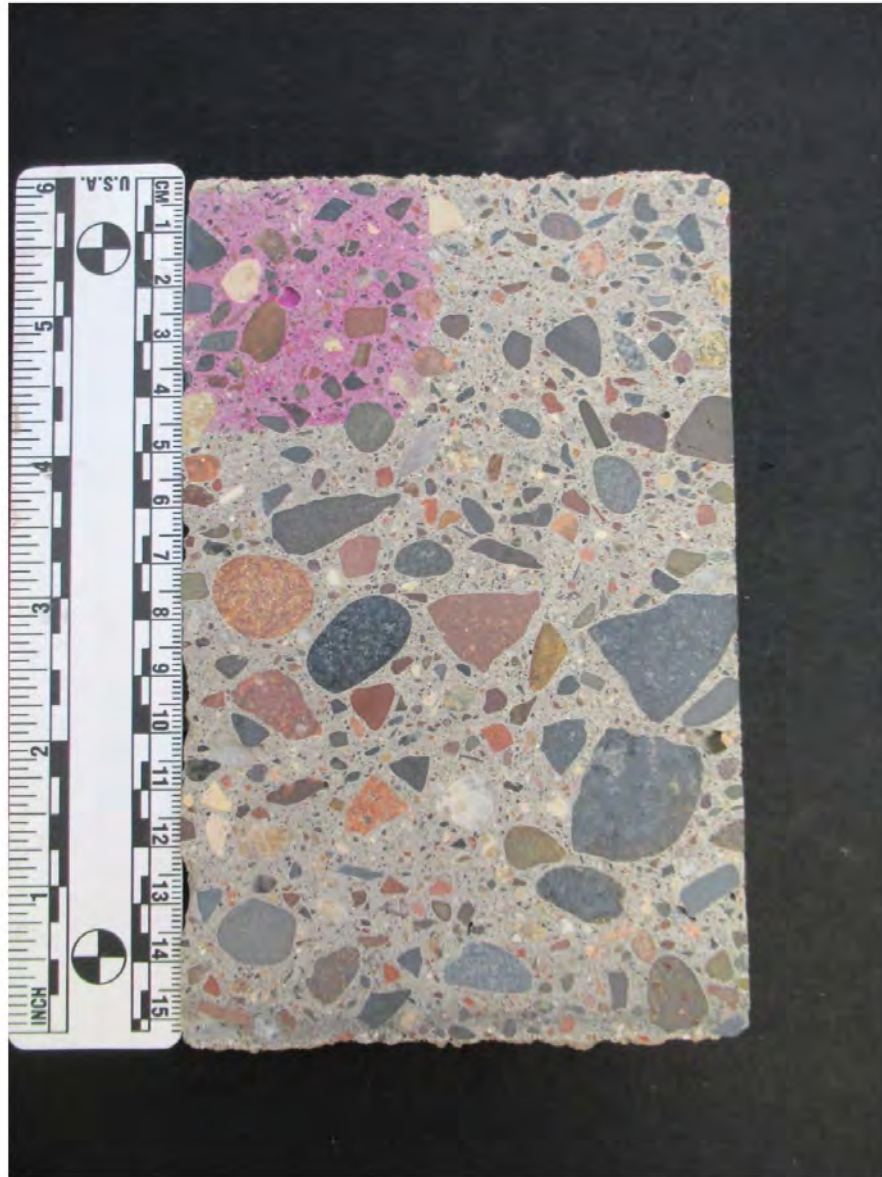
SAMPLE ID: 521 424W DESCRIPTION: A saw-cut and lapped cross section of the concrete core sample with the top surface oriented to the top of the photo. The upper left corner was treated with phenolphthalein pH indicator (pink stain).

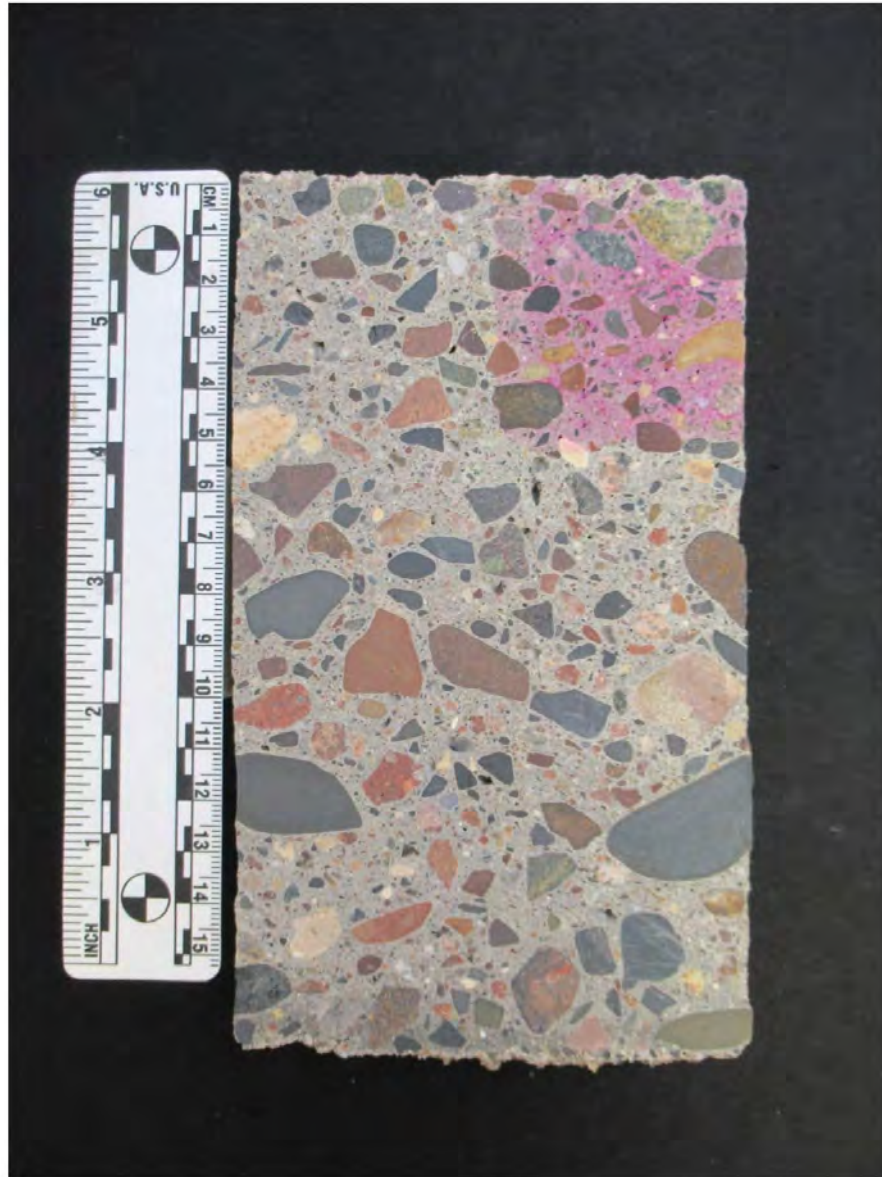
SAMPLE ID: 521 524B DESCRIPTION: A saw-cut and lapped cross section of the concrete core sample with the top surface oriented to the top of the photo. The upper right corner was treated with phenolphthalein pH indicator (pink stain).

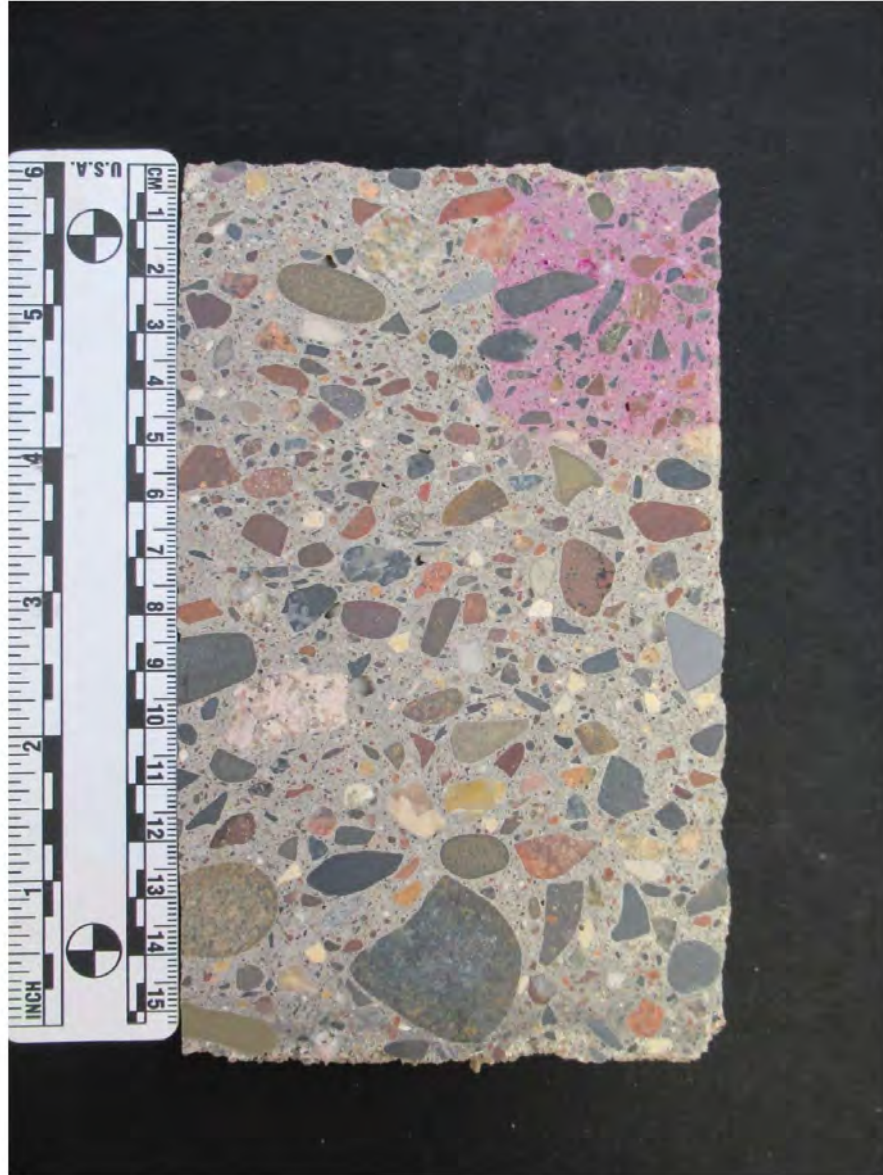
SAMPLE ID: 521 524W DESCRIPTION: A saw-cut and lapped cross section of the concrete core sample with the top surface oriented to the top of the photo. The upper right corner was treated with phenolphthalein pH indicator (pink stain).
