# Evaluation of End-of-Queue Crash Mitigation Strategies at Flagging Stations on Two-Lane Roads

Technical Report 0-6998-R1

TEXAS A&M TRANSPORTATION INSTITUTE  
COLLEGE STATION, TEXAS

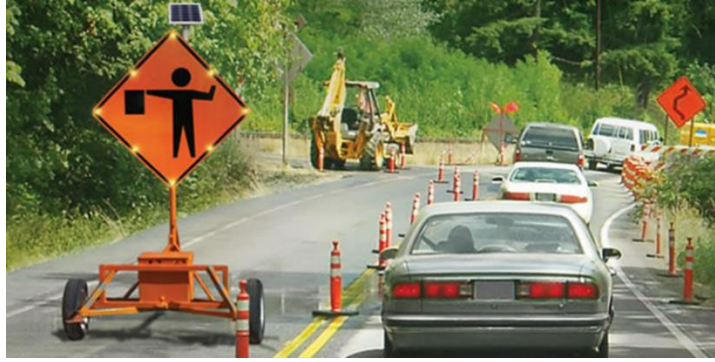
**Figure 1. Example of LED Lights Outlining a Traffic Sign to Increase Driver Attention (30).**

Some manufacturers now offer advance warning signs with light-emitting diodes (LEDs) embedded into the outline of the sign. These lights, shown in Figure 1, can be set to a steady-burn or flashing mode to attract driver attention (30). Although implemented primarily on stop signs and stop/slow paddles to date, the use of LEDs in the outline of other warning signs is also allowed (27). The effectiveness of these signs when used to prevent queue-end crashes at flagger stations would be diminished if large trucks blocked approaching motorists' view of the signs, or if the lights themselves were not bright enough to attract attention on a sunny day.

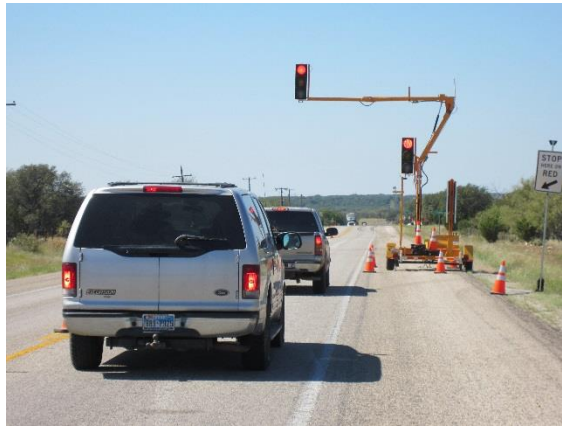
**Figure 2. Example of a PTS in Texas.**

PTSs are self-contained systems that are used to control the movement of vehicles through a one-lane section on a two-lane road (see Figure 2). While not previously identified as a tool for providing queue-end warnings, past research has found that PTSs have many advantages over the traditional flagger method, including:

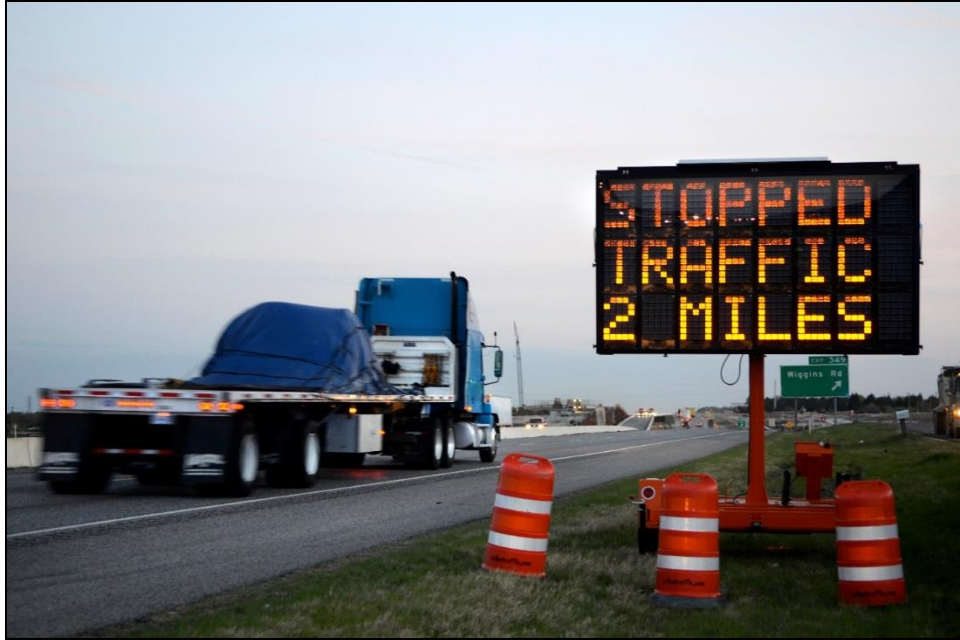
**Figure 3. Example of Work Zone ITS Queue Warning Technology (47).**

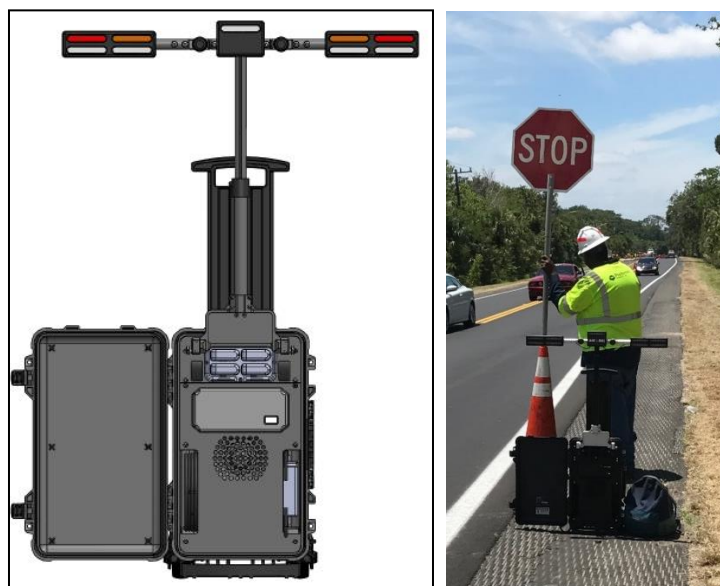
**Figure 5. Visual and Audible Warning System Under Development for Flagging Operations.**

Another example is the Advance Warning and Risk Evasion (AWARE) alarm system, which is being developed by a private-sector company. This system has been adapted for flagger stations on two-lane highways. The flagger station system, shown in Figure 5, consists of a suitcase-sized unit that unfolds and is positioned next to the flagger. Flashing lights and an audible alarm are incorporated into the unit, along with a proprietary advanced radar unit that detects approaching vehicles and tracks them relative to the flagger station. If the system detects that a vehicle is not slowing sufficiently to allow it to stop before reaching the flagger, the lights begin flashing and the alarm sounds to alert the driver in that approaching vehicle and the flagger. Although not commercially available, beta testing of the product is occurring across the country. Anecdotal comments from flaggers are that the technology has a significant benefit in attracting driver attention and reducing crash risks. In addition, the system has been successfully tested in a controlled environment (78, 79). However, no field tests of its effectiveness in real work zones have yet occurred. In addition, this technology currently only tracks approaching vehicles relative to the flagger or work vehicle and has not been adapted to produce end-of-queue alerts.

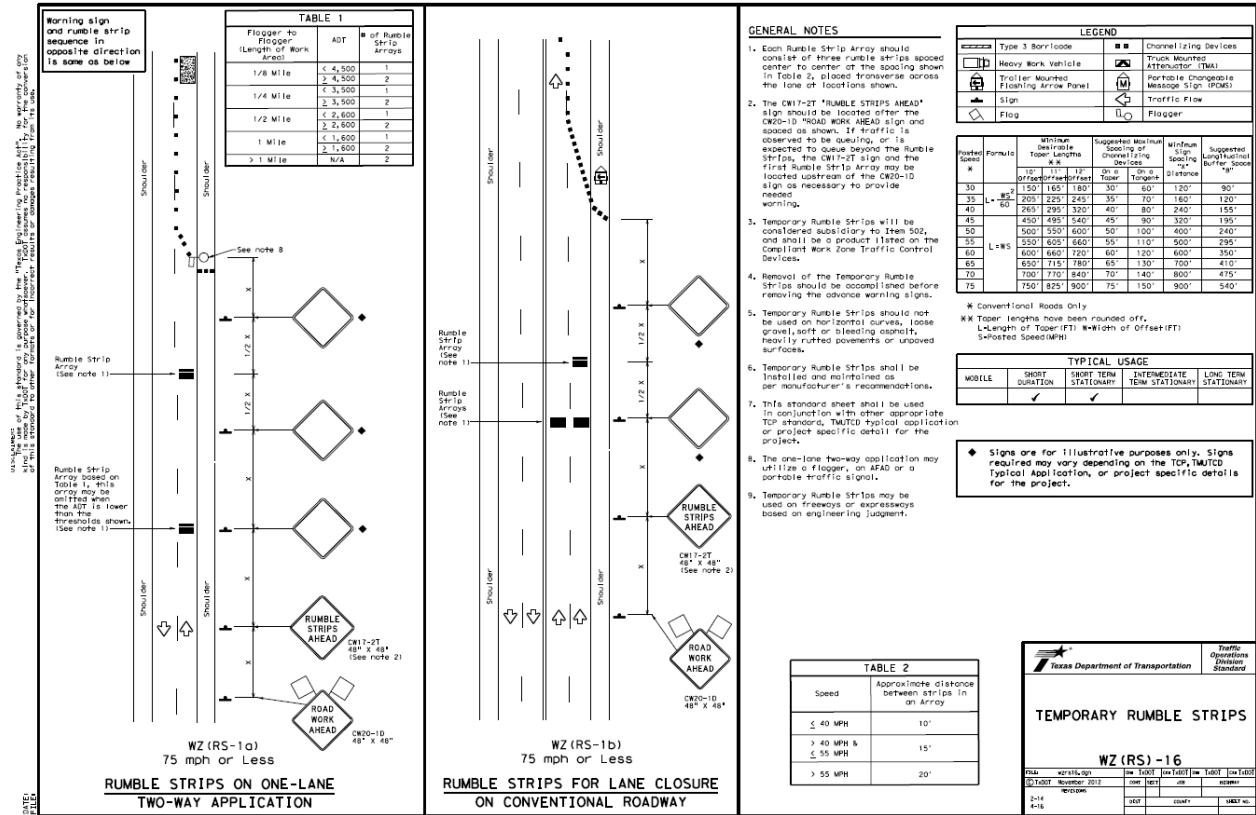
Figure 12. TxDOT WZ (RS)-16 for Temporary Rumble Strips (56).

TxDOT work zone (WZ) standard sheet (RS)-16, shown in Figure 12, specifies the use of temporary rumble strips on both one-lane two-way and lane-closure-on-conventional-roadway (multilane) applications, in conjunction with any TCP (56). These rumble strips are required unless certain conditions are present, including horizontal curves, loose gravel, soft or bleeding asphalt, heavily rutted pavements, or unpaved surfaces. As shown in TABLE 1 of Figure 12, rumble strip deployments may consist of one or two arrays, depending on the length of the work area and average daily traffic volume of the roadway.

Question 4 referred to the placement of rumble strips in the advance warning area at flagger stations in accordance with the WZ (RS)-16 standard sheet (see Figure 12). Respondents were asked if they used these rumble strips at all flagging operations and what conditions might cause them to eliminate the rumble strips from the advance warning area. Only two respondents indicated that they used rumble strips at all flagging operations without exception. One respondent, who used contracted traffic control, indicated that this decision was left to the traffic control provider. The remaining 27 respondents stated that they used rumble strips at all flagging operations except when the conditions mentioned on the standard sheet were present (i.e., horizontal curves, loose gravel, soft or bleeding asphalt, heavily rutted pavements, or unpaved surfaces). Additional field conditions warranting the elimination of rumble strips included presence of fresh seal coat, proximity of intersections, occurrence of rain, or during short-duration work. One of the 27 respondents indicated that he/she used two rumble strip arrays even when the table on the standard sheet allowed him/her to use only one.

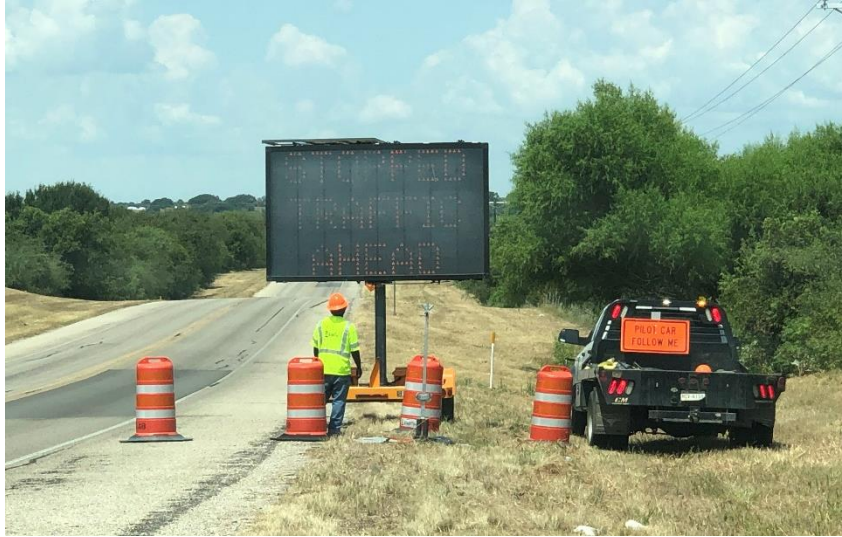
**Figure 16. PCMS Displaying STOPPED TRAFFIC AHEAD Message.**

For the PCMS treatments, the flexible roll-up BPTS sign was removed and replaced with a PCMS. The first PCMS treatment included displaying a flashing BPTS message. The second PCMS treatment included displaying a flashing STOPPED TRAFFIC AHEAD message. An example is shown in Figure 16.

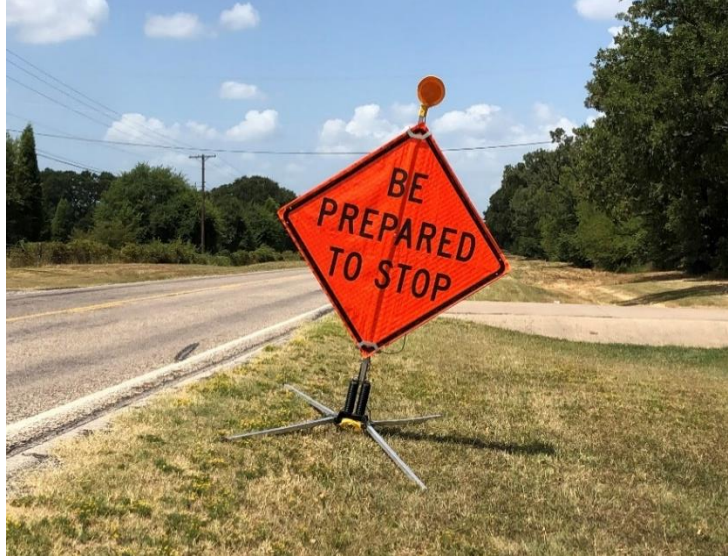
**Figure 17. Flashing Warning Light Added to BPTS Sign.**

Warning lights are readily available from many different suppliers and are typically powered by a small solar panel or by batteries contained in the plastic housing. The researchers purchased several flashing warning lights and attached them to the BPTS signs as shown in Figure 17.

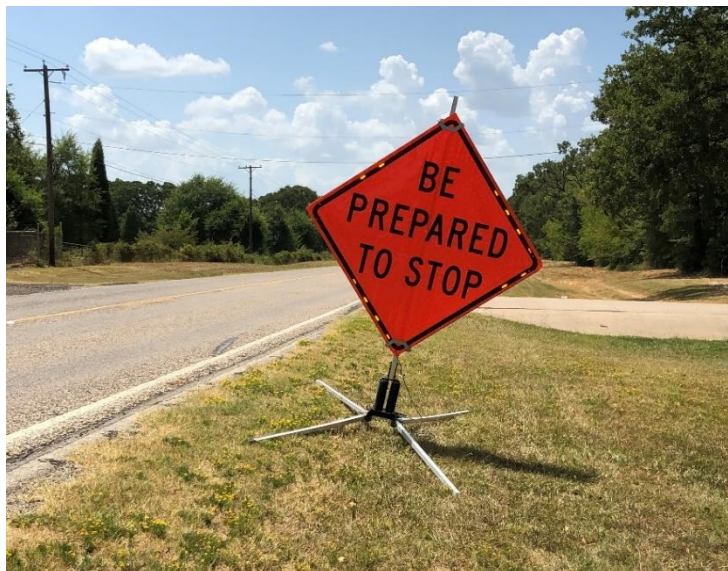
**Figure 18. LED Lights Added to the Border of a BPTS Sign.**

The researchers contacted vendors and suppliers to identify readily available flexible roll-up advance warning signs that had LED lights in the border of the sign. Unfortunately, at the time of this research, such off-the-shelf products did not exist. Therefore, researchers purchased LED lights in prefabricated strips that could be mounted on the border of the fabricated BPTS signs. A corrugated plastic substrate was added to the flexible roll-up sign in order to facilitate the addition of the LED light strips. The assembled sign is shown in Figure 18. Even on the brightest setting, the LED lights did not seem very bright (relative to the ambient sunlight conditions) when deployed in the field.

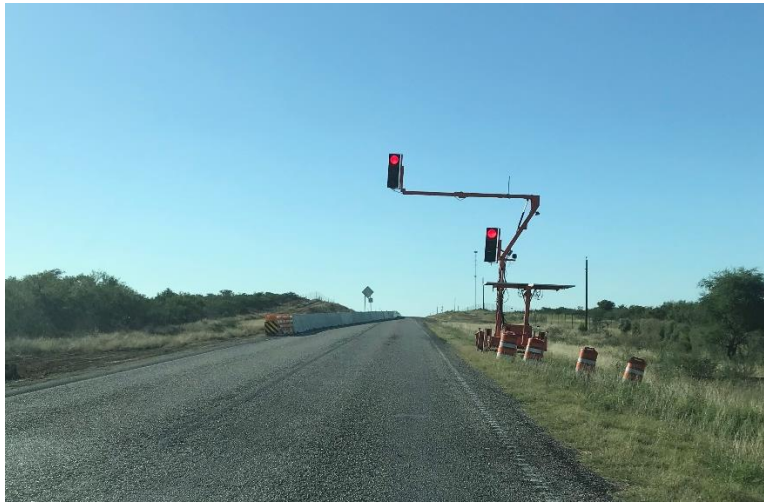
**Figure 19. PTS Deployed in TxDOT Construction Work Zone.**

TCP (2-8)-18 for One-Lane Two-Way Traffic Control with Traffic Signal (82) is typically used more frequently for long-term traffic control. Consequently, it was challenging to find TxDOT maintenance crews using PTSs as part of their daily maintenance work. Many TxDOT maintenance offices do not have PTSs in their inventory to complete TxDOT's planned maintenance work, which changes locations frequently. Thus, the researchers turned to TxDOT area engineers to identify construction jobs where PTSs were in use and where the researchers could collect data. One of the PTS deployments is shown in Figure 19.

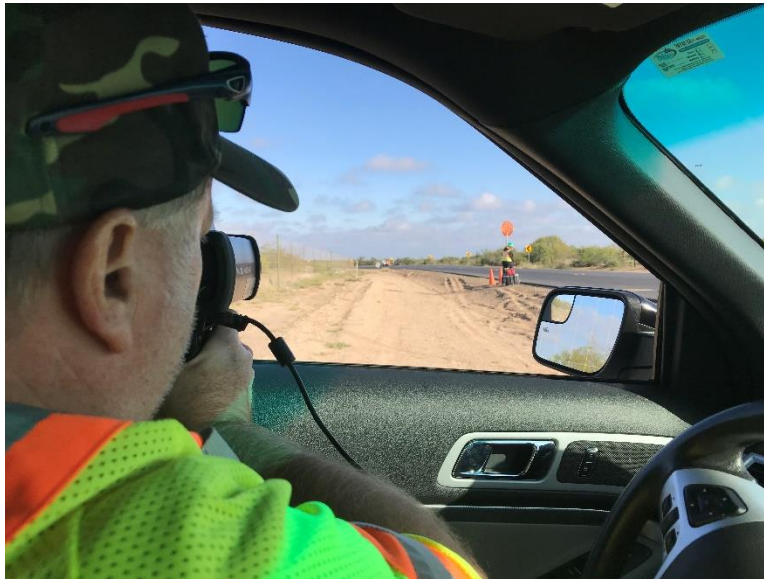
**Figure 20. LIDAR Speed Profile Data Collection.**

Once the treatment being evaluated was set up, the researchers parked their TTI fleet vehicle off the roadway in the right of way in such a manner that approaching vehicles could be seen. The position of the data collection vehicle was independently selected at each site based on field conditions (primarily roadway geometry and sight distance), and thus the location of the data collection vehicle relative to the flagger station varied by site. Light detection and ranging (LIDAR) equipment was used to capture continuous speeds and corresponding distances to create speed profiles of arriving vehicles, as shown in Figure 20.

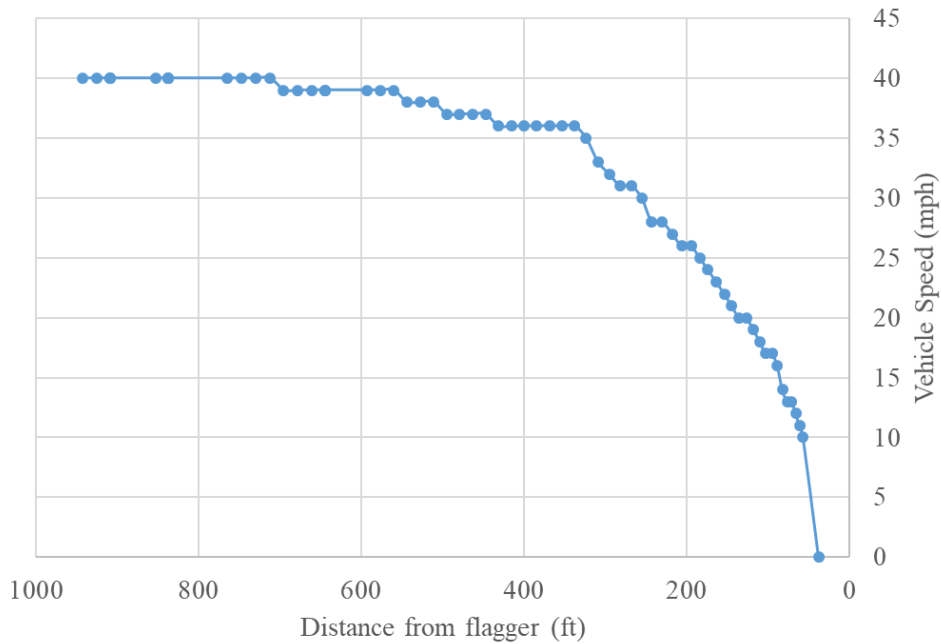
**Figure 21. Speed Profile Example.**

that drivers typically do not slow down significantly until they reach a distance of about 400 ft upstream of their ultimate stopping position (position zero). Therefore, researchers used the vehicle speeds at this distance (400 ft) as the most upstream location where speeds would be compared across treatments. Additional locations for speed comparisons were then selected at distances of 300 ft, 200 ft, and 100 ft from position zero. Depending on the deceleration profile of each vehicle, some interpolation of speeds was required for those specific measurement locations. For each position of interest, the average speed and variance were computed.

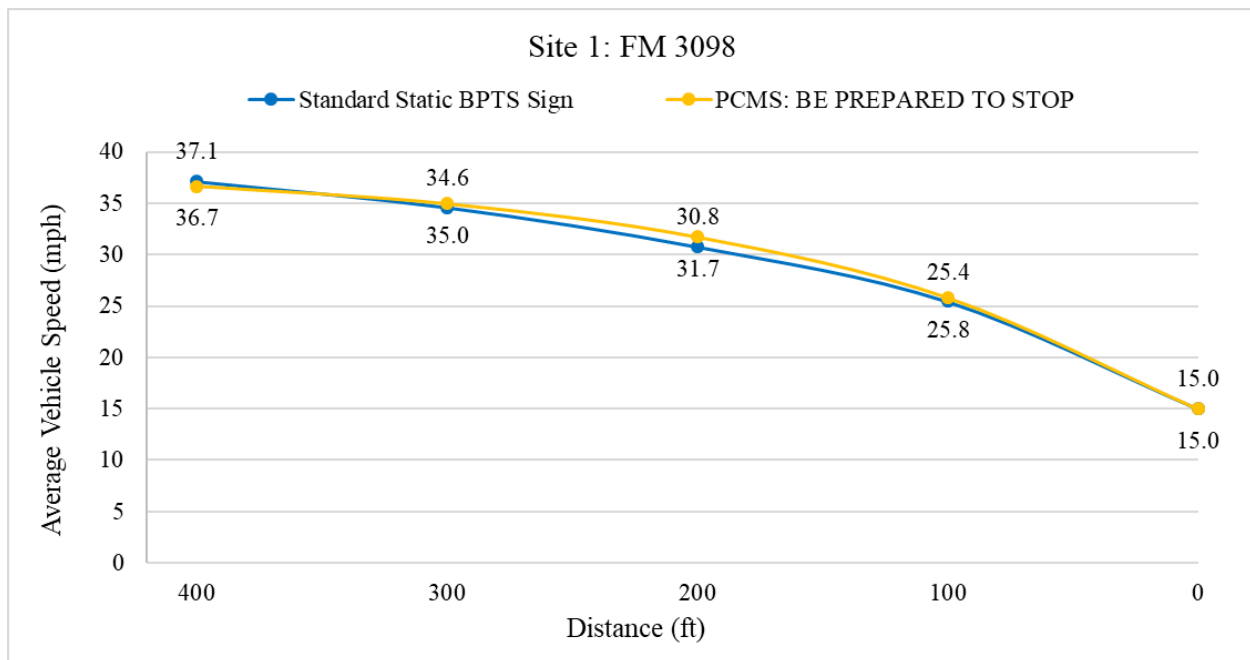
**Figure 22. Site 1 Average Vehicle Speeds for Standard Static BPTS Sign and PCMS Displaying BPTS Message.**

For sites 1, 5, and 8, the PCMS displayed a BPTS message. Figure 22 shows that practically no significant changes in average speeds were observed at site 1 (i.e., no more than a 1-mph difference is evident at any of the points of interest). Similarity, Figure 23 shows that there was no practical difference in the average speeds between the treatments at site 8. Statistical analyses also showed there were no significant differences in the treatment means at sites 1 and 8. Conversely, Figure 24 shows considerable differences in averages speeds at site 5 at 200 ft, 300 ft, and 400 ft (3.9 mph, 6.7 mph, and 4.7 mph, respectively). Statistical analysis found significant differences between the treatment means at 300 ft and suggestive evidence of differences at 200 ft and 400 ft. However, a review of the field data collection form showed that motorist behavior may have been influenced by the work operation. When the static BPTS sign was displayed, the paving operation was not visible because it was beyond a vertical curve. Later in the day, when the PCMS message was displayed, the paving operation was very close to the flagger (and visible to approaching vehicles). This likely accounted for the differences at this site.

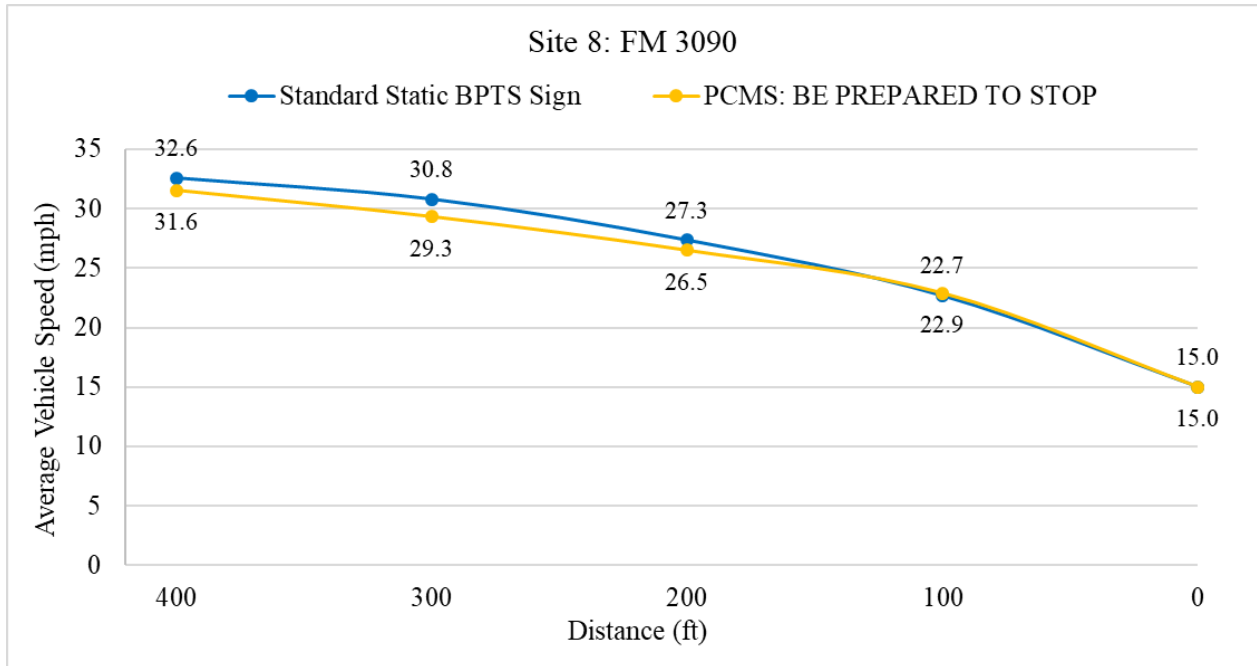
**Figure 23. Site 8 Average Vehicle Speeds for Standard Static BPTS Sign and PCMS Displaying BPTS Message.**

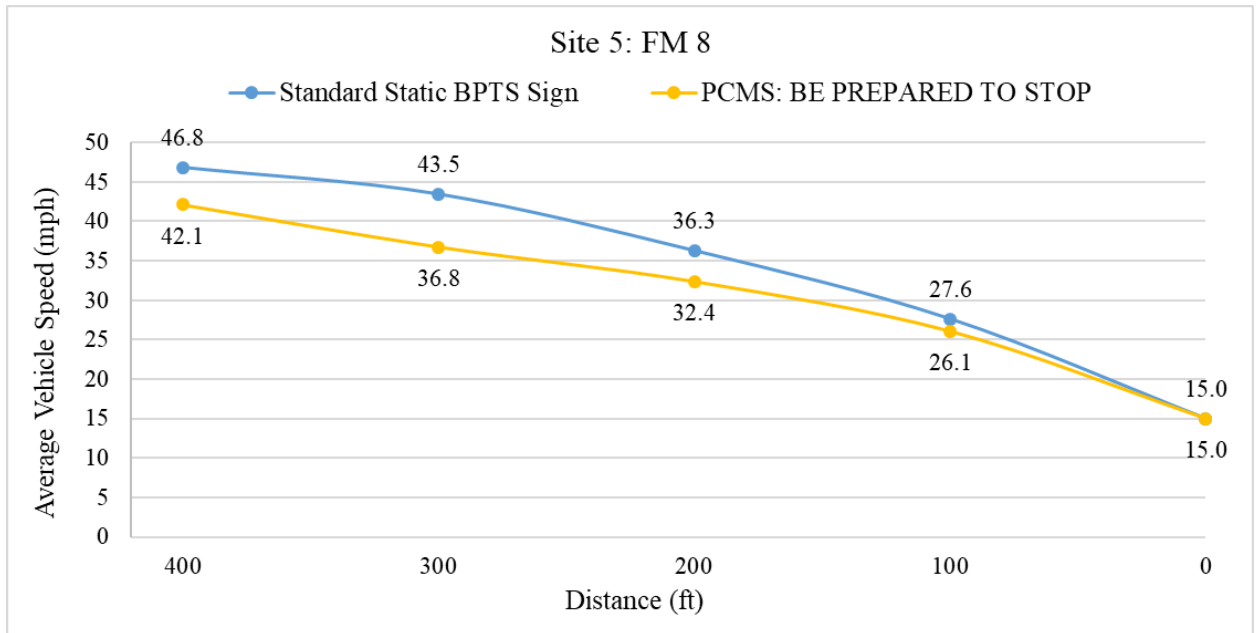
**Figure 24. Site 5 Average Vehicle Speeds for Standard Static BPTS Sign and PCMS Displaying BPTS Message.**

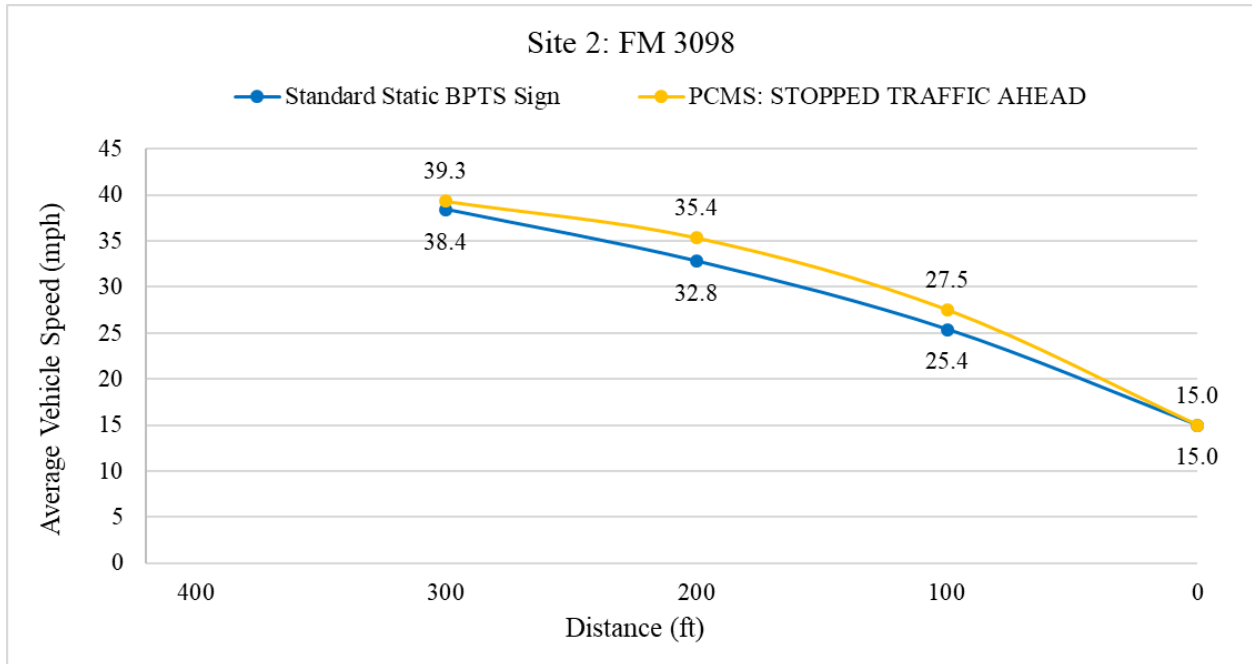
**Figure 25. Site 2 Average Vehicle Speeds for Standard Static BPTS Sign and PCMS Displaying STOPPED TRAFFIC AHEAD Message.**

For site 2, the PCMS displayed a STOPPED TRAFFIC AHEAD message. Unfortunately, due to roadway curvature, the researchers were not able to record speeds as far as 400 ft upstream of when vehicles slowed down significantly (15 mph and below). Figure 25 shows that the greatest average speed difference was 2.6 mph at 200 ft. However, this difference was not found to be statistically significant.

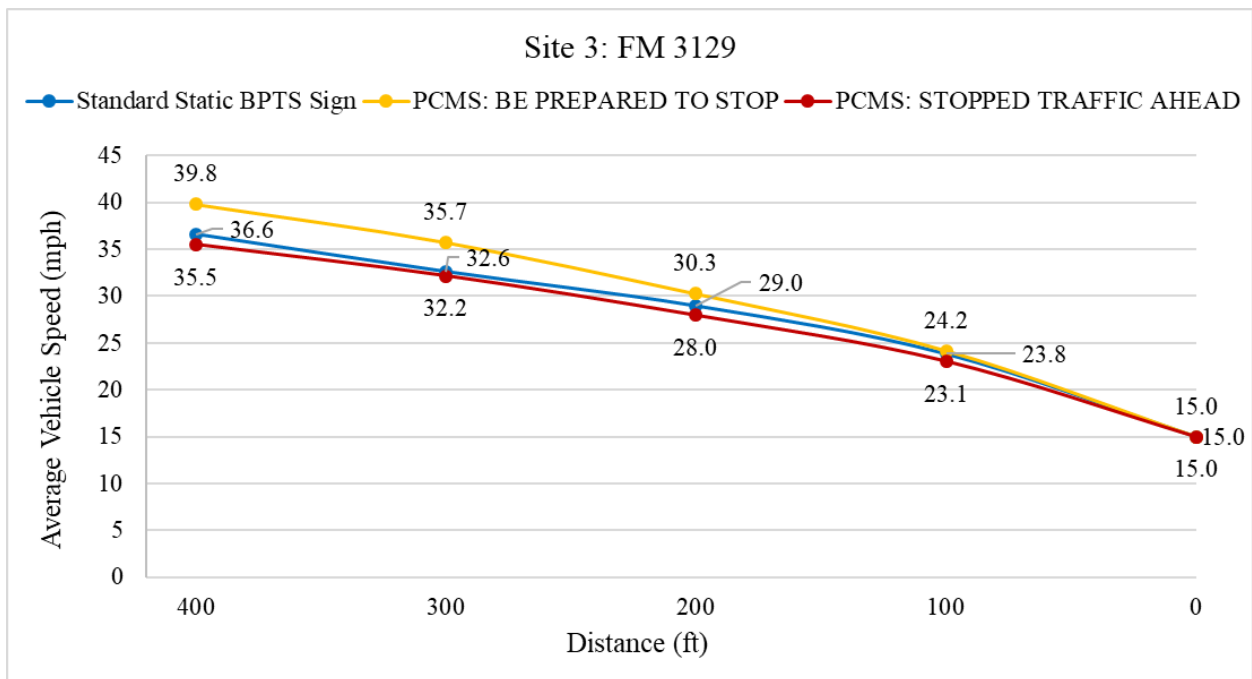
**Figure 26. Site 3 Average Vehicle Speeds for Standard Static BPTS Sign, PCMS with BPTS Message, and STOPPED TRAFFIC AHEAD Message.**

For sites 3, 4, 6, and 7, data were collected for the baseline treatment (static BPTS sign) and both PCMS treatments. The results are shown in Figure 26 through Figure 29. The one-way ANOVA tests showed no significant differences for any treatments at any of the points of interest.

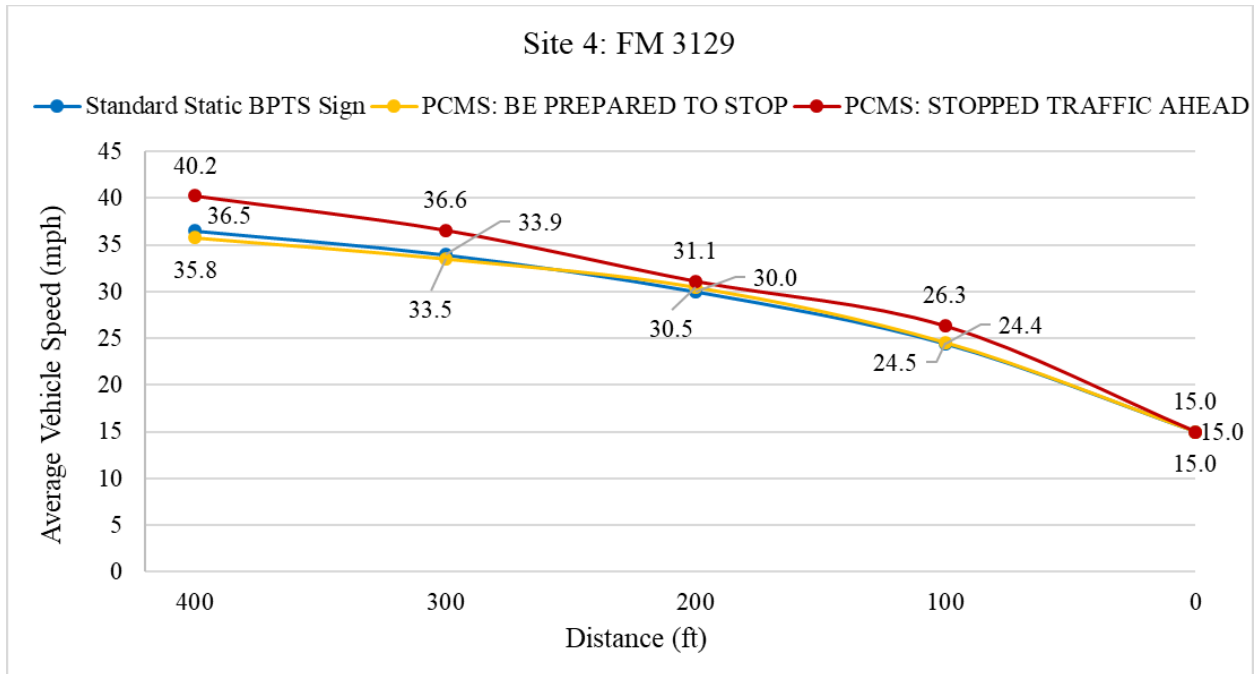
**Figure 27. Site 4 Average Vehicle Speeds for Standard Static BPTS Sign, PCMS with BPTS Message, and STOPPED TRAFFIC AHEAD Message.**

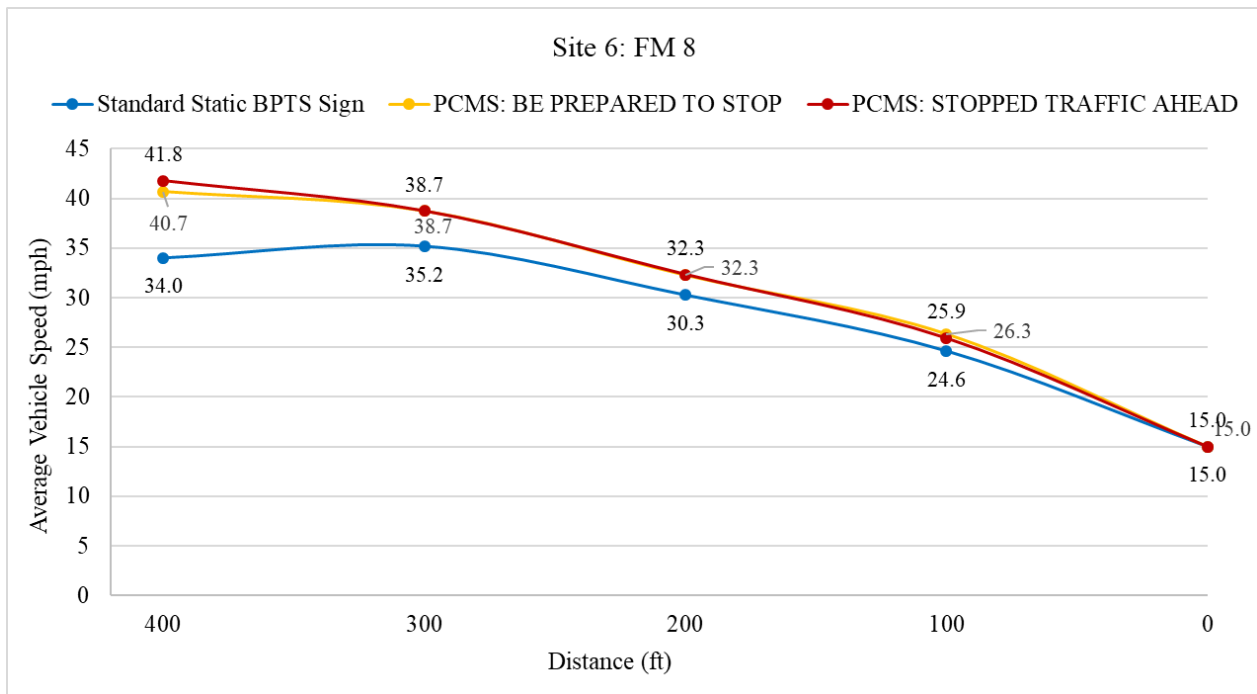
**Figure 28. Site 6 Average Vehicle Speeds for Standard Static BPTS Sign, PCMS with BPTS Message, and STOPPED TRAFFIC AHEAD Message.**

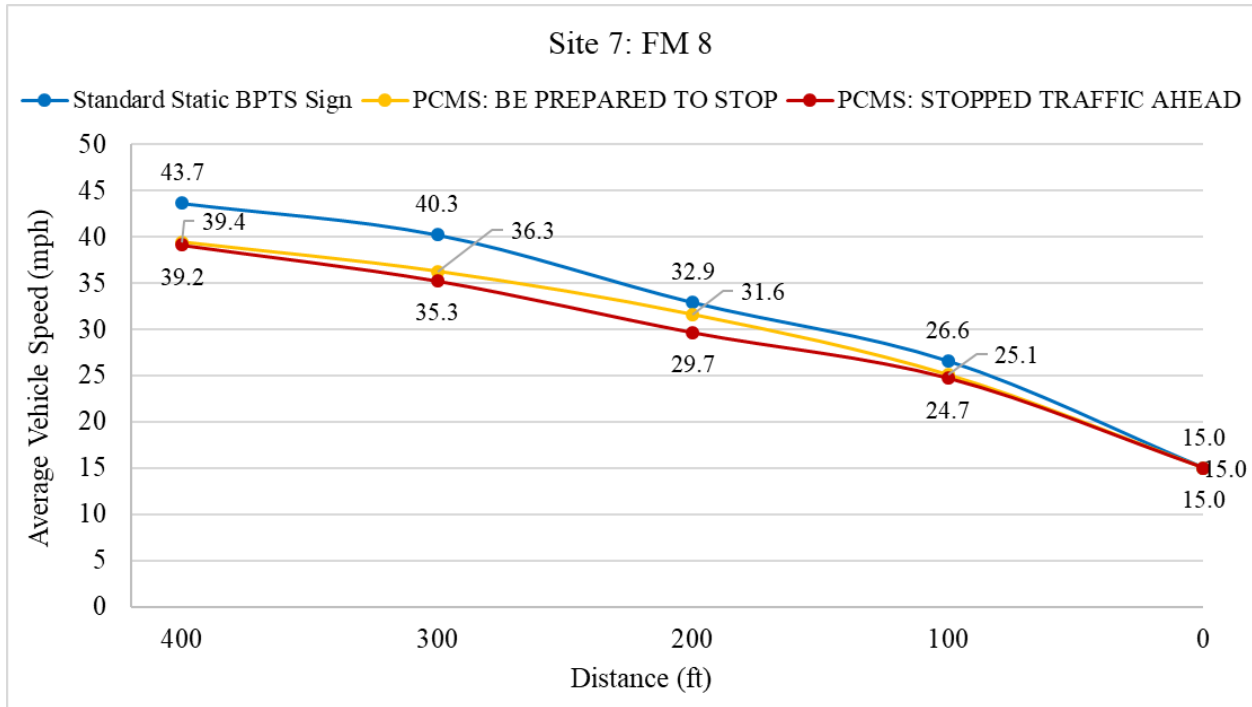
**Figure 29. Site 7 Average Vehicle Speeds for Standard Static BPTS Sign, PCMS with BPTS Message, and STOPPED TRAFFIC AHEAD Message.**

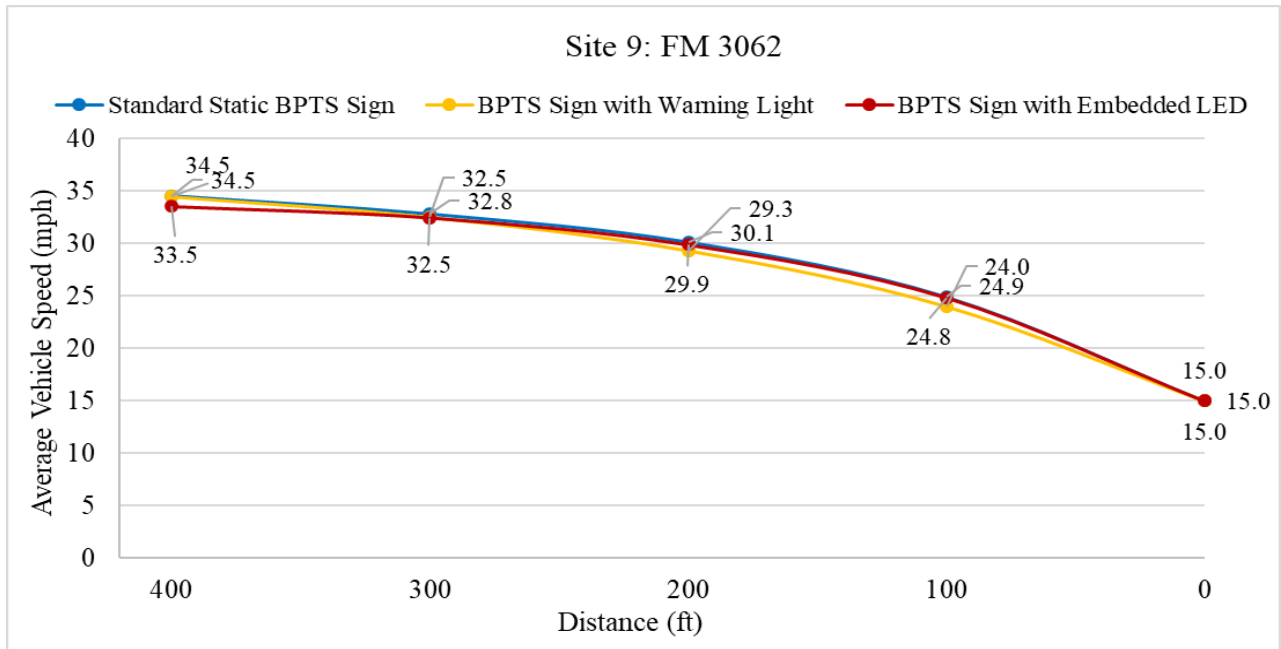
**Figure 30. Site 9 Average Vehicle Speeds for Standard Static BPTS Sign, BPTS Sign with Warning Light, and BPTS Sign with LED Lights.**

At sites 9, 10, and 12, speed profile data were collected for the baseline treatment (static BPTS sign) treatment, the BPTS sign with warning light, and the BPTS sign with LED lights (shown in Figure 30 through Figure 32). At site 13, researchers were only able to collect data for the baseline treatment and the BPTS sign with warning light (see Figure 33). For the most part, the speeds were fairly similar, within a 3-mph range. The one-way ANOVA test results showed no statistically significant differences in the treatment means. Thus, the lights on the signs appeared to have no effect. This is not surprising given that all the data were collected in daylight conditions, where these lights may have been difficult to see against the ambient lighting on a sunny day. In addition, the sign stands had flexible springs that allowed the signs to blow in the wind, potentially reducing visibility of the lights.

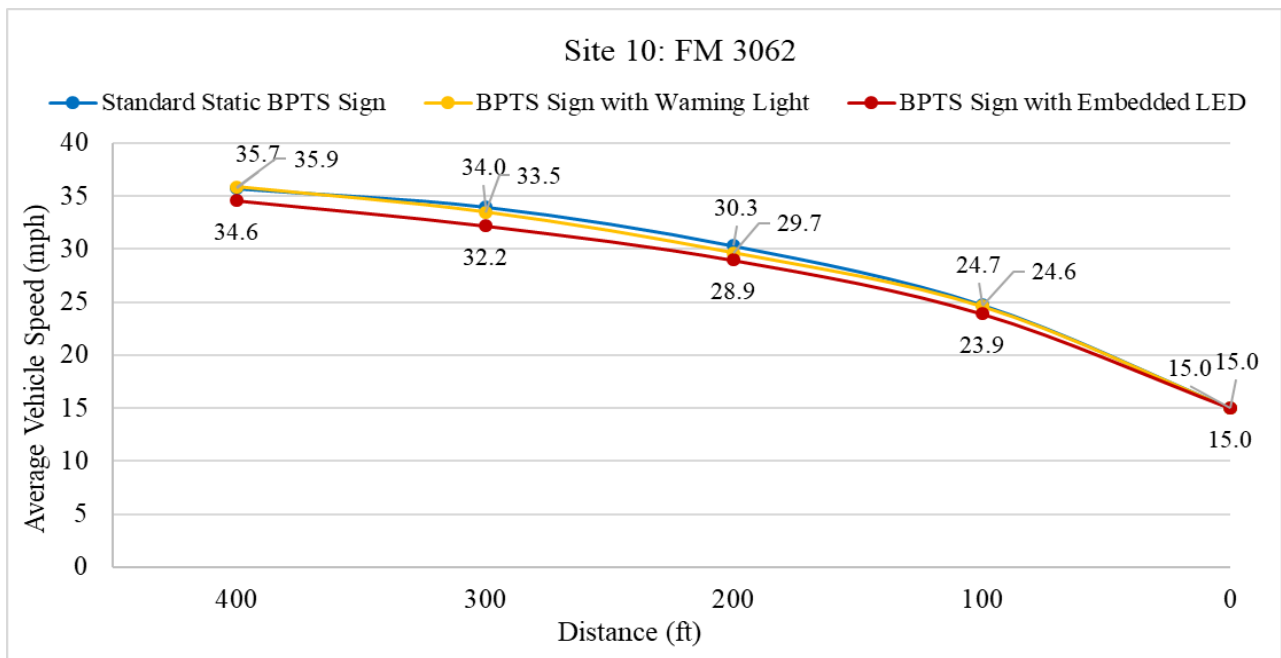
**Figure 31. Site 10 Average Vehicle Speeds for Standard Static BPTS Sign, BPTS Sign with Warning Light, and BPTS Sign with LED Lights.**

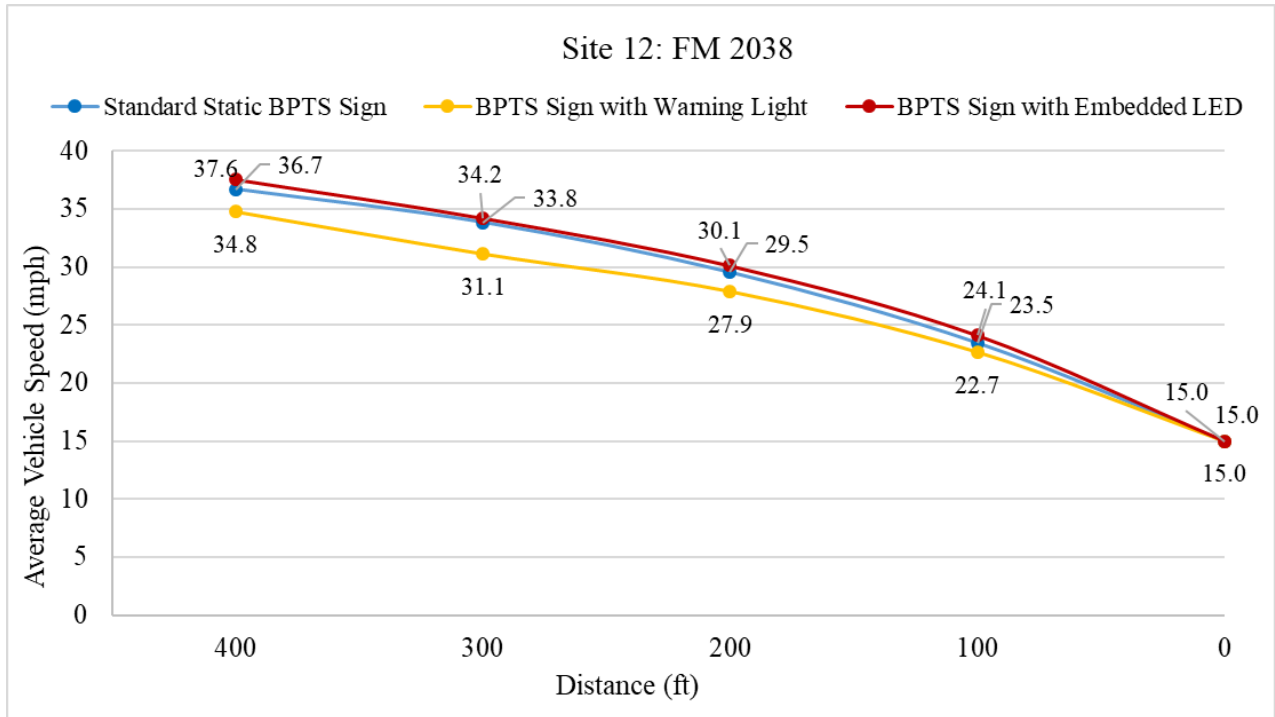
**Figure 32. Site 12 Average Vehicle Speeds for Standard Static BPTS Sign, BPTS Sign with Warning Light, and BPTS Sign with LED Lights.**

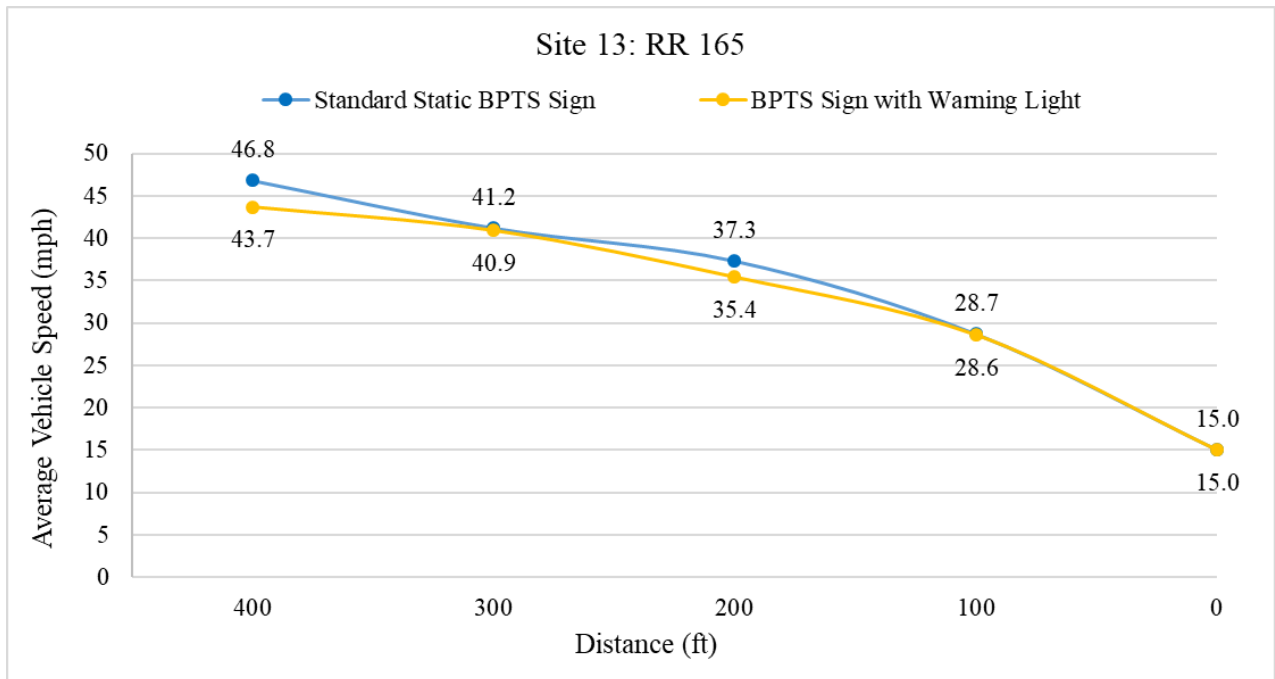
**Figure 33. Site 13 Average Vehicle Speeds for Standard Static BPTS Sign, BPTS Sign with Warning Light, and BPTS Sign with LED Lights.**

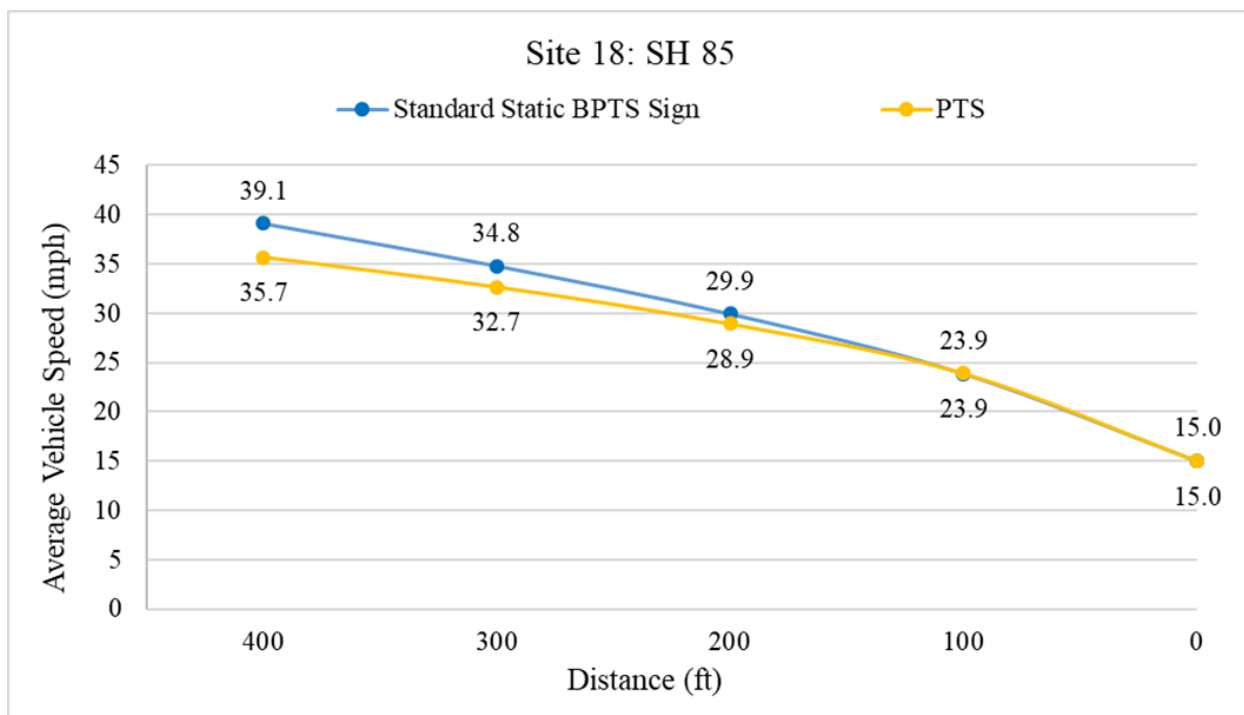
**Figure 34. Site 18 Average Vehicle Speeds for Standard Static BPTS Sign and PTS.**

For site 18, researchers obtained data for both flagging (with the baseline static BPTS sign) and PTS treatments. The average vehicle speeds are shown in Figure 34. At 400 ft, the difference in the average speeds (3.4 mph) was statistically significant. While the difference was not statistically significant at 300 ft, there was suggestive evidence of a difference. For this one site, the data show that using the PTS did create a small change in driver behavior. Researchers hypothesize that the greater visibility and attention-getting ability of the PTS resulted in drivers slowing down at a farther distance from their eventual stopping location. Unfortunately, no additional data were available.
