Report No. UT-21.19

## **EVALUATION OF COMMERCIALLY AVAILABLE CONCRETE BRIDGE DECK REPAIR MATERIALS**

Utah Department of Transportation  
Research & Innovation Division

**Final Report  
July 2021**

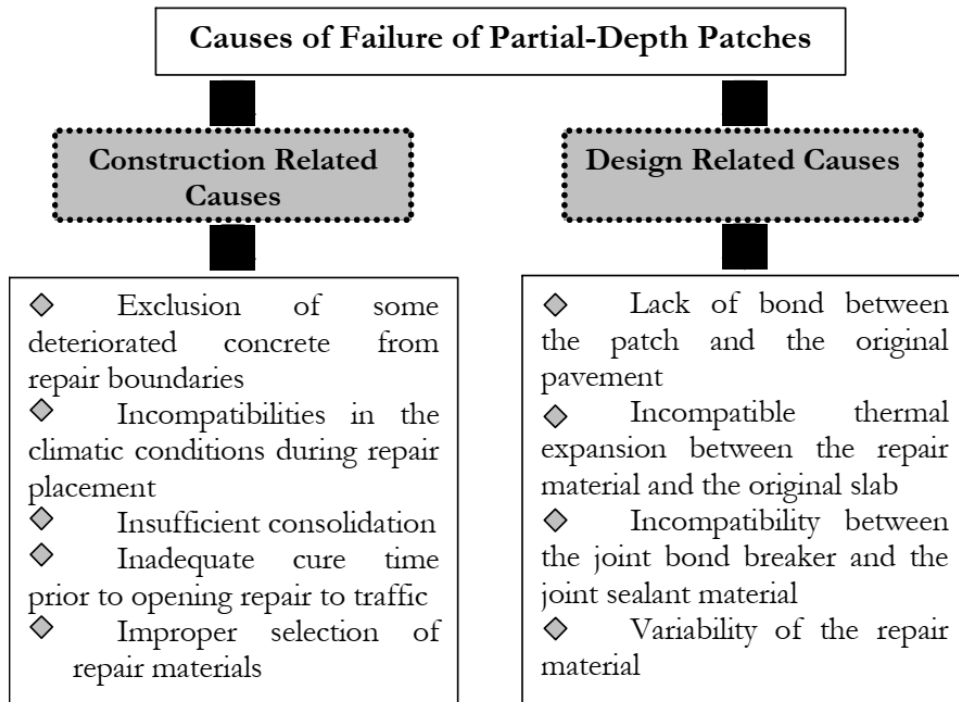
**Figure 1.1 Causes of Failure of Partial-Depth Repairs [5]**

A properly designed and placed partial-depth patch repair followed by adequate quality control can perform well, with a service life of 3-10 years or more. A poor performance is typically the result of poor design and construction, and improper quality control and condition assessment [5]. The most frequent causes of partial-depth patch failure are shown in Figure 1.1.

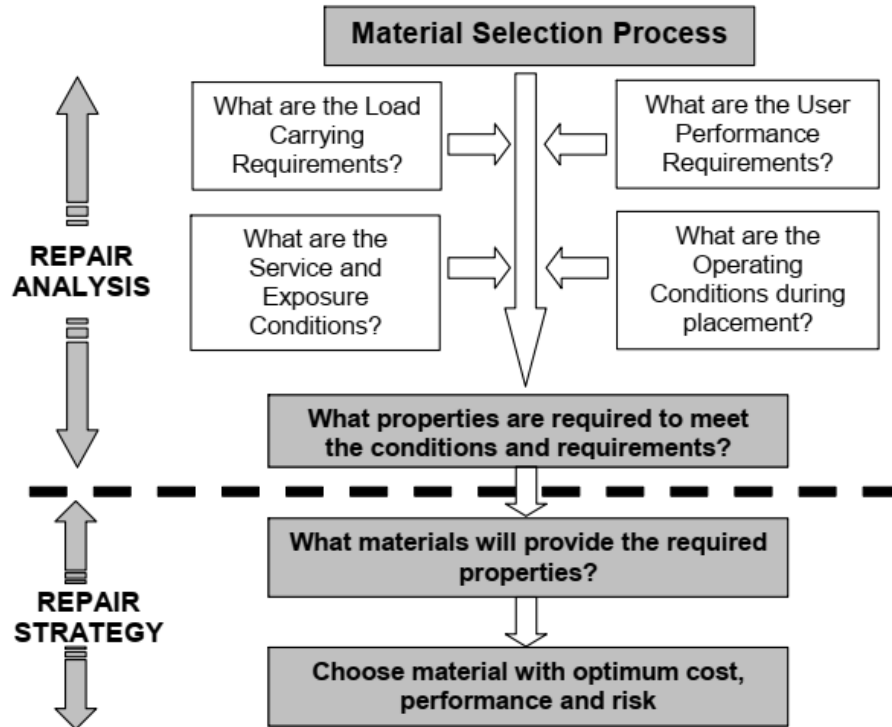
**Figure 1.2 Material Selection Process [5]**

A flowchart showing general considerations for selecting a repair material is presented in Figure 1.2.

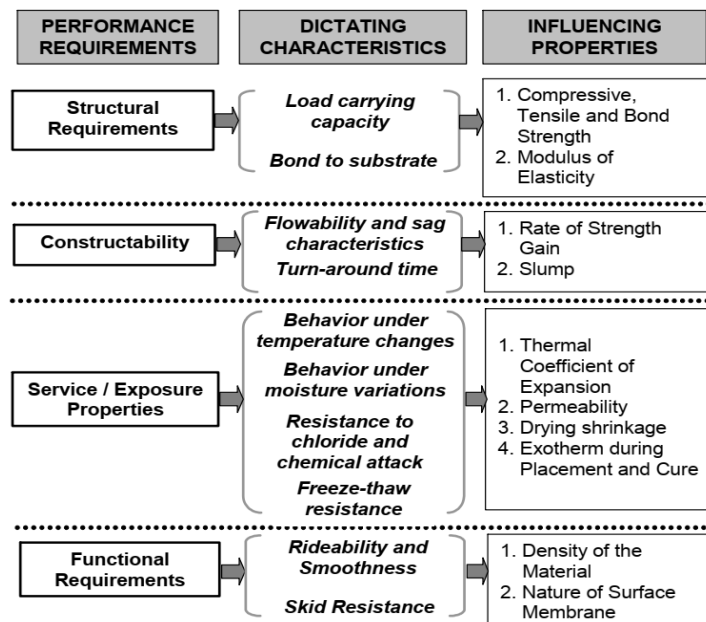
Figure 1.3 Required Performance Criteria for an Ideal Repair Material [5]

Figure 1.3 outlines general performance criteria that are required for an ideal repair material. First, the repair system should be able to satisfy the structural requirements related to the load-carrying capacity of a given element. In addition, the repair material should be able to bond well with the existing concrete, which would enable the repair system to distribute the stresses throughout the structure. Also, the repair material has to be easy to mix and place. Another

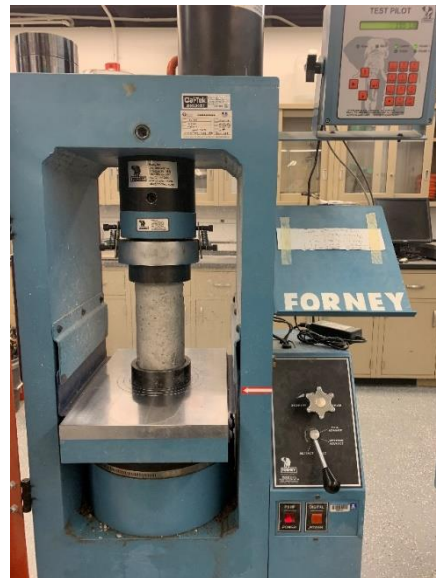
**Figure 2.2 Compressive Strength Test Setup**

All the compression test procedures are performed according to ASTM C39 [50]. Three samples at each specimen age (i.e., 4 hours, 24 hours, 7 days, and 28 days) were tested at the

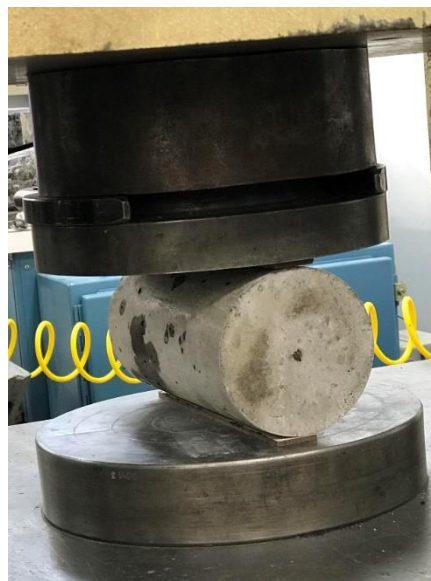
**Figure 2.3 Splitting Tensile Strength  
Test Setup**

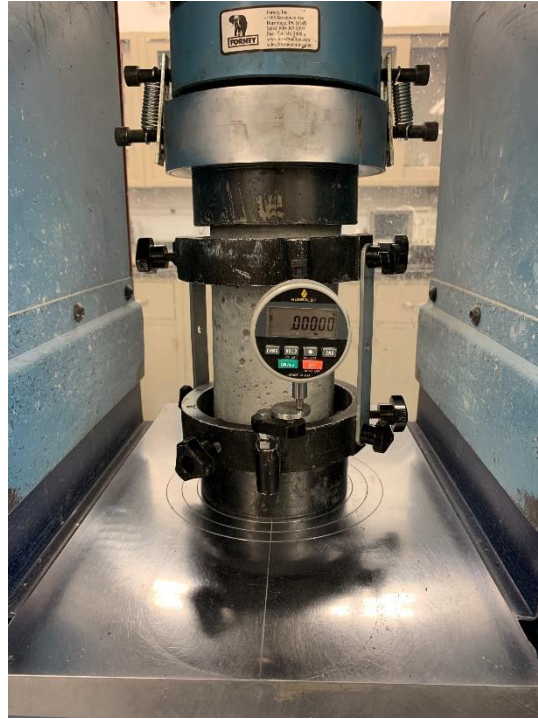
**Figure 2.4 Static Modulus of Elasticity  
Test Setup**

The static modulus of elasticity was evaluated in accordance with the specifications of ASTM C469 [53]. Three cylindrical specimens were tested for each product at each age using

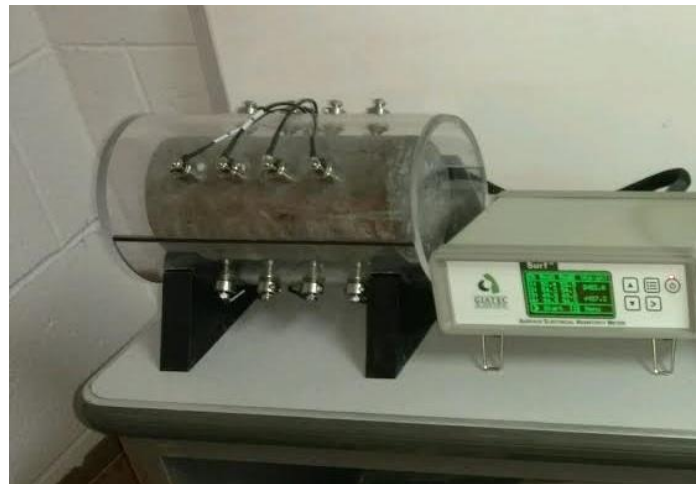
**Figure 2.5 Surface Electrical Resistivity Test Setup**

The testing apparatus, Surf by GIATEC SCIENTIFIC, is shown in Figure 2.5. Before each test, a little amount of conductive gel was applied on each probe so the probes could connect better to the surface of the cylinder. The apparatus calculates the resistivity in four perpendicular directions, averages all the measurements, and provides one resistivity value. This test was performed on each cylindrical specimen at all ages before performing the three previously described tests. Table 2.3 shows the relation of chloride penetrability classification and surface electrical resistivity at 23°C.

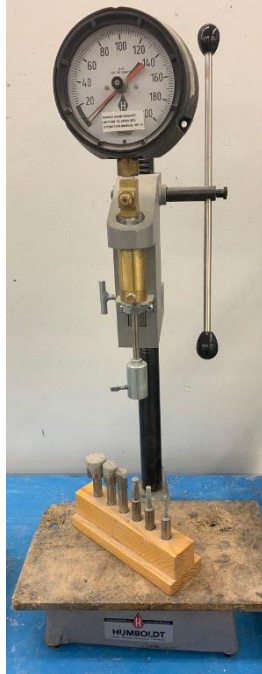
**Figure 2.6 Setting Time  
Test Apparatus**

Setting time of mortar (neat) specimens was determined by Acme penetration resistance in accordance with the specifications of ASTM C403 [56]. The Acme penetration resistance test estimates the setting times of mortar sieved from fresh concrete mixtures. Initial setting time

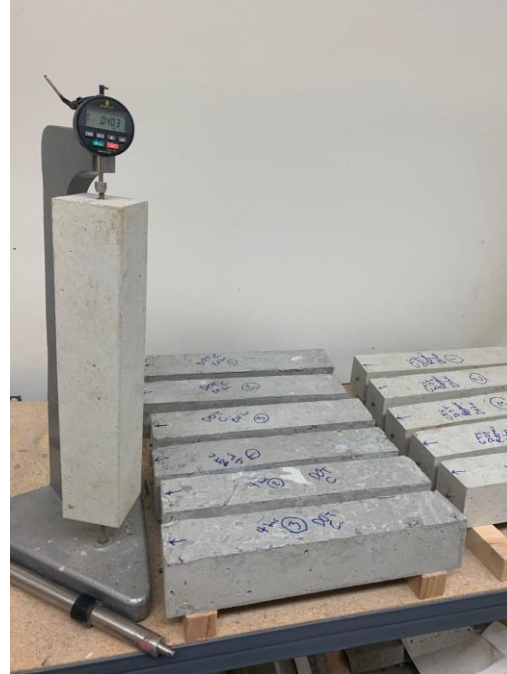
**Figure 2.7 Drying Shrinkage Test  
Specimens and the Length Comparator**

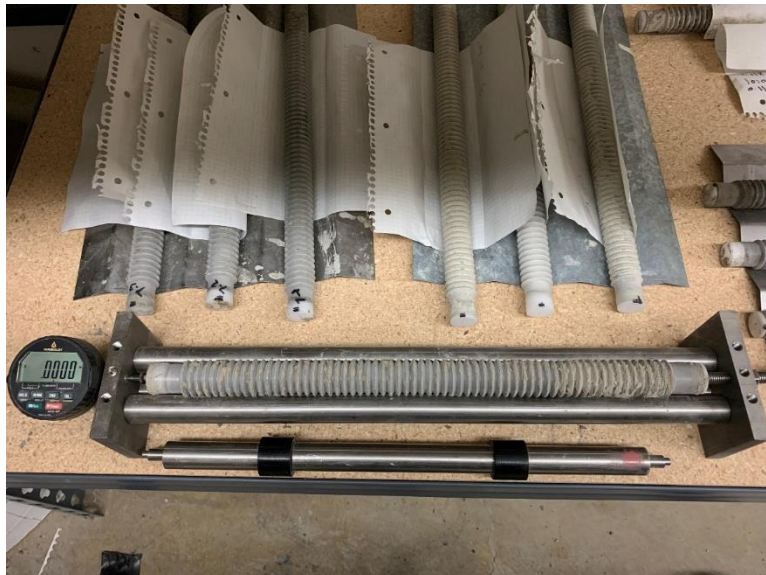
**Figure 2.8 Autogenous Shrinkage Test Specimens and Measuring Device**

It should be noted that, considering the very short working time of the materials, sieving the materials pre-extended with aggregates into mortar was not feasible. Therefore, the autogenous shrinkage test was not performed on the materials containing aggregates and fibers

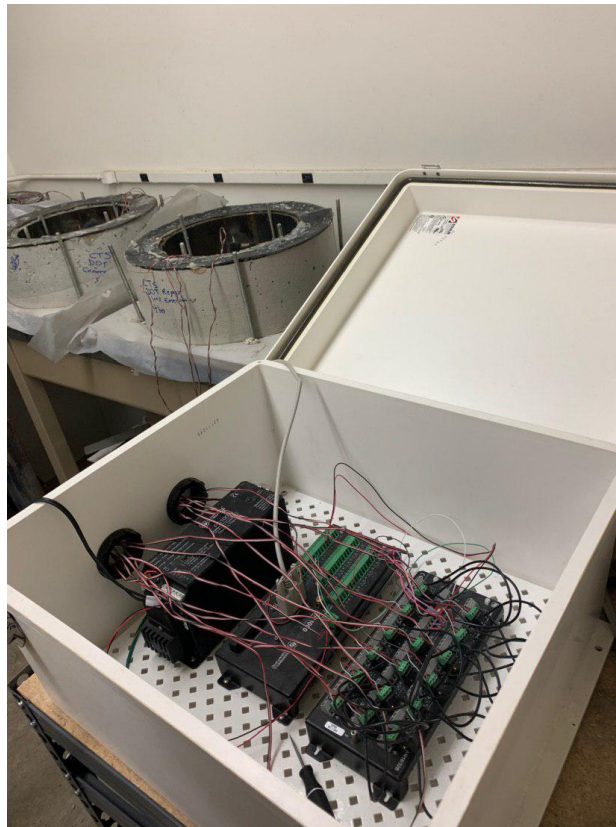
**Figure 2.9 Restrained Ring Shrinkage Test Specimens Connected to the Data Acquisition System**

The resistance to cracking due to restrained shrinkage was evaluated by the restrained ring shrinkage test, performed in accordance with the specifications of AASHTO T 334 [57]. This test determines the average time to cracking under restrained shrinkage conditions. The restrained shrinkage ring test setup is shown in Figure 2.9. The standard requires 24 hours of curing and then demolding the specimens, but since repair media were expected to perform well at early age, the test method was also modified to begin at the age of 4 hours. Therefore, two ring specimens were prepared for each material. One was demolded at 4 hours, and the other was demolded at 24 hours.

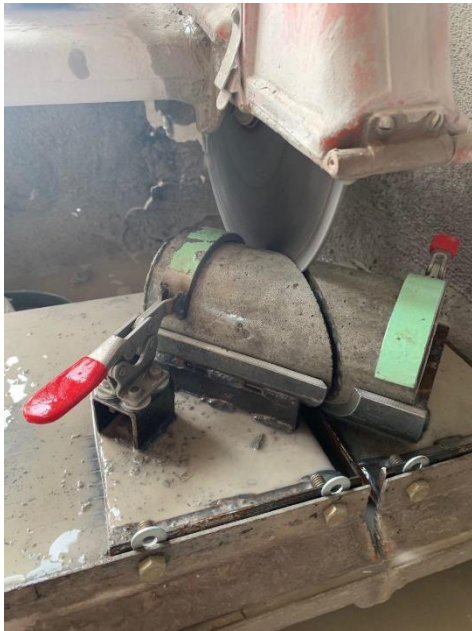
**Figure 2.10 Saw Cutting Setup for Slant Shear Test**

Substrate concrete cylindrical specimens were water cured for at least 28 days and then saw cut at a 45° angle through the long axis into two equally-sized sections, per UDOT recommendation. The saw cutting setup is displayed in Figure 2.10. Before casting, the slant surface of the substrate was pre-wet, and the fresh repair material was then poured on top of it. The composite specimen was then rodded for consolidation followed by capping and being moved to the curing room to be moist cured.

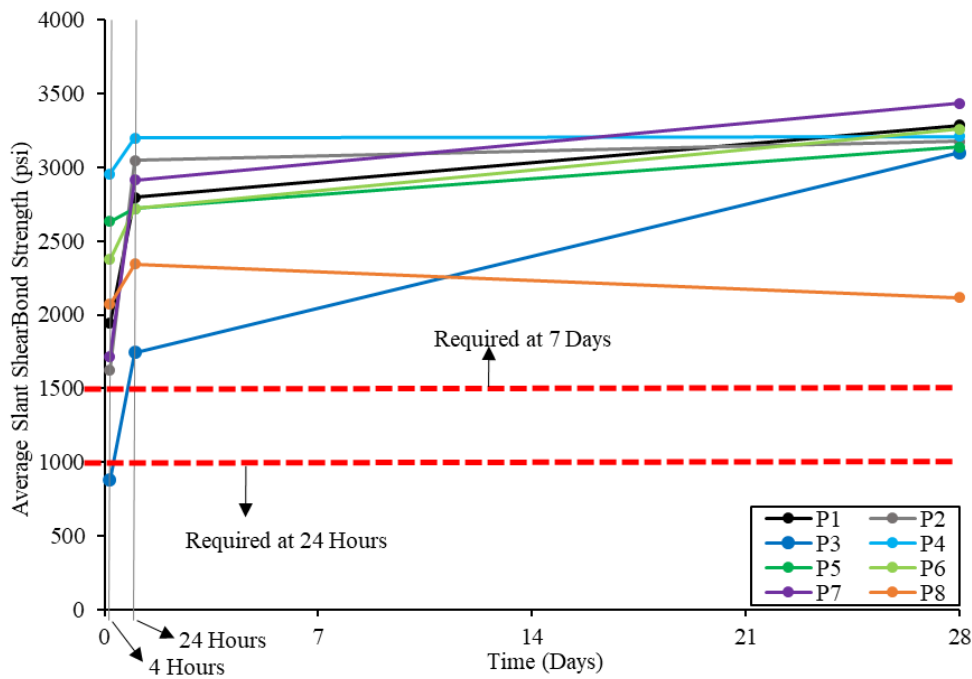
**Figure 3.7 Rate of Slant Shear Bond Strength Development for the Selected Repair Materials**

Figure 3.7 shows that all materials also satisfy the 7-days bond strength requirement of ASTM C928. Material 3, which have the lowest bond strength at 4 hours, has the most significant bond strength development among all materials. Materials 2 and 7 have the highest bond strength development from 4 to 24 hours, but material 2 does not develop much bond

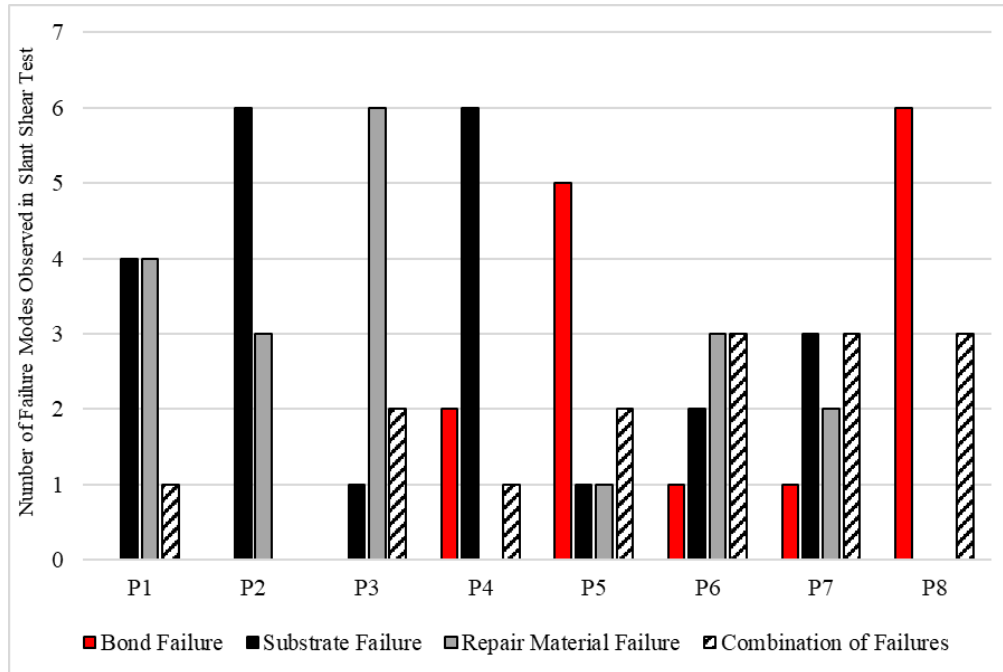
**Figure 3.9 Number of Failure Modes Observed for Each Repair Material (Slant Shear Test)**

Another observation is in failure modes in which materials show all possible failure patterns, including bond failure, repair material failure, substrate concrete failure, and a combination of the three failure modes. Figure 3.8 illustrates the typical failure modes observed in the slant shear test. The failure of the composite repair/substrate system occurring in the substrate concrete (Figure 3.8-b), repair material (Figure 3.8-c), or both (Figure 3.8-d), indicates the repair material has developed a desired bond to the substrate and the composite action of the whole system is expected to be achieved. On the other hand, if the failure plane is at the bond interface, the repair material is considered to have a poor bond to the substrate concrete and premature failure of the repair/substrate system is expected.

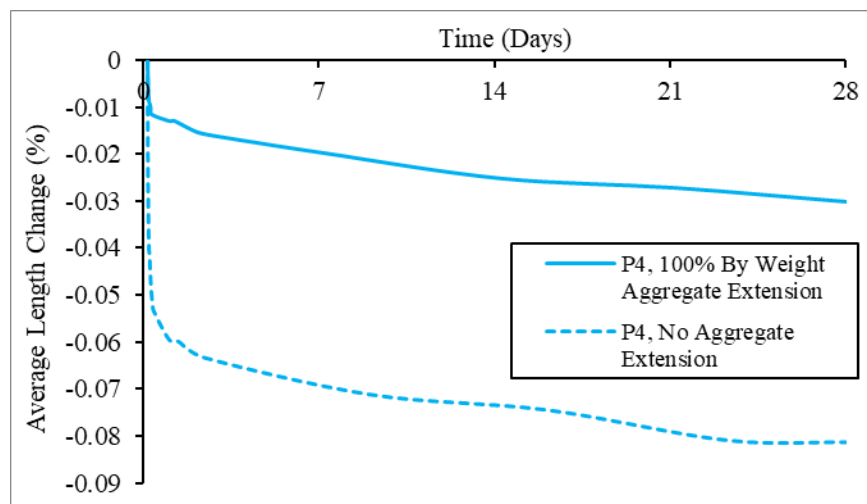
**Figure 3.12 Average Drying Shrinkage of Material 4 at Different ages, with and without Aggregate Extension**

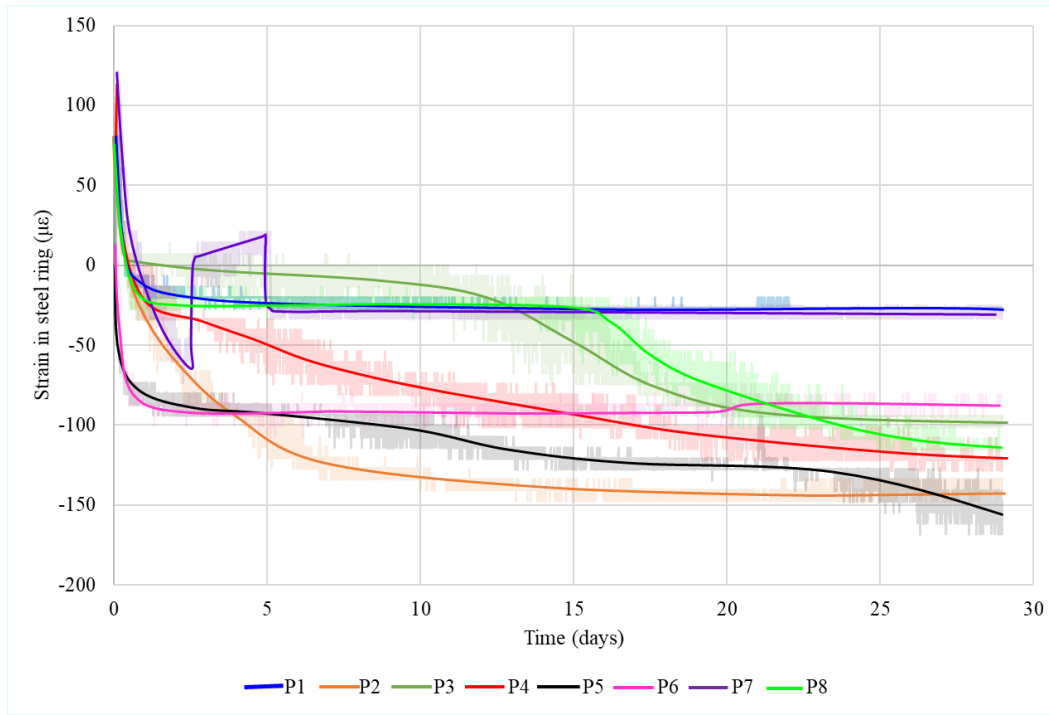
**Figure 3.13 Average Strain in Steel Ring (Outer Form Removed at 4-Hour Age)**

Only P7 cracked within 28 days, as evident from Figures 3.13 and 3.14. The specimens, demolded at 4-hour and 24-hour ages, cracked at 2.3 and 4.8 days, respectively. Each specimen developed two cracks at 180°. The average crack widths of the 4-hour specimen were  $3.72 \times 10^{-3}$

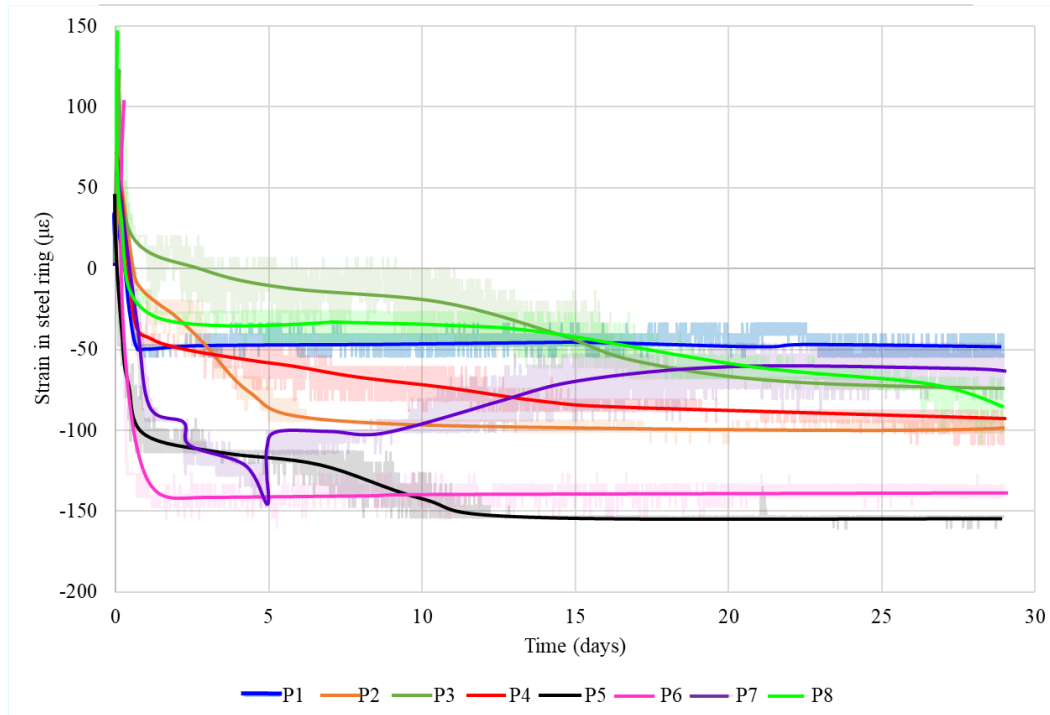
**Figure 3.14 Average Strain in Steel Ring (Outer Form Removed at 24-Hour Age)**

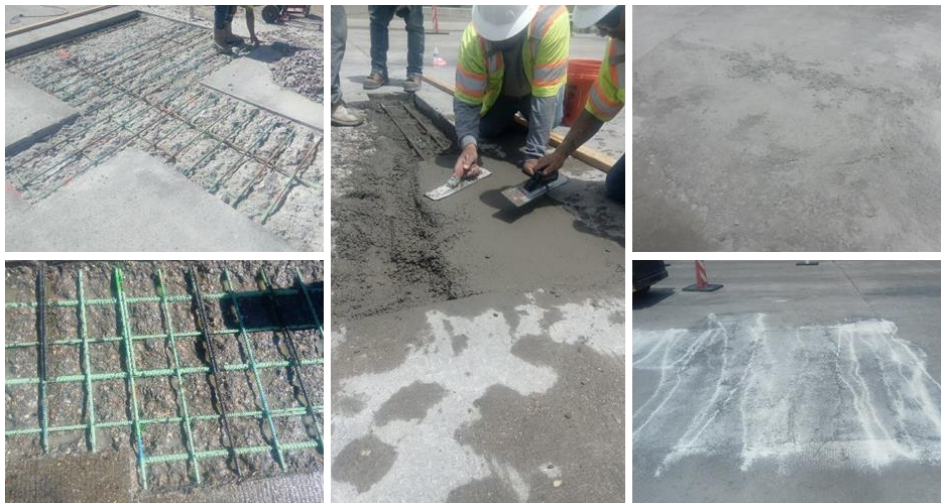
**Figure 4.1 Preparation of Substrate, Pouring, Finishing, and Application of Curing Compound (P6)**

All the products were mixed with a paddle mixer, except for P1, for which the supplier required the use of a barrel mixer. When product P1 was mixed, the ambient temperature and

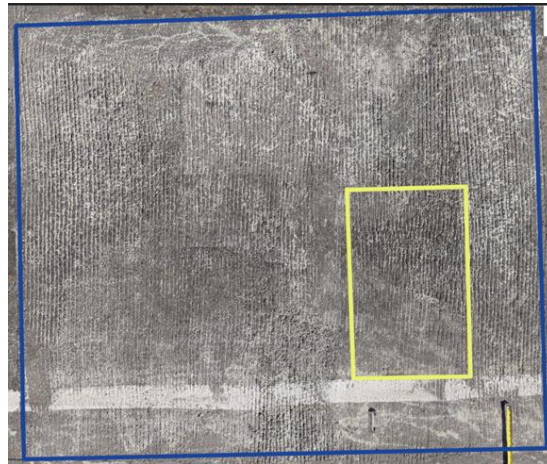
**Figure 4.6 Delamination in a Repair Patch Marked with Yellow Box (P6)**

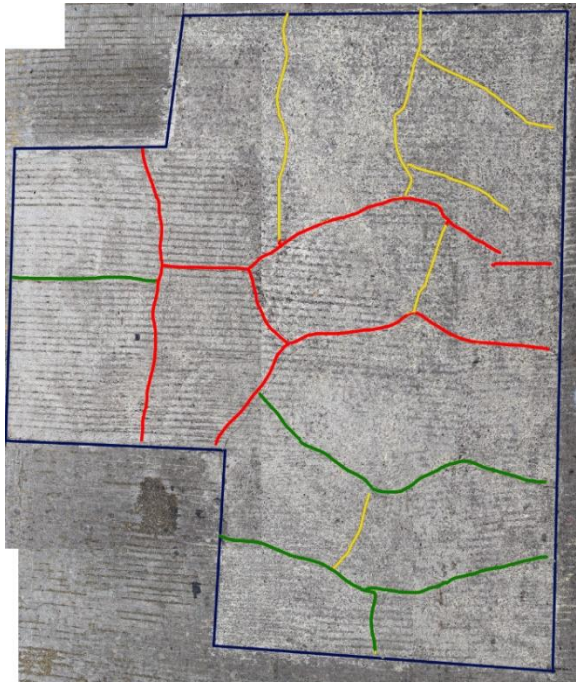
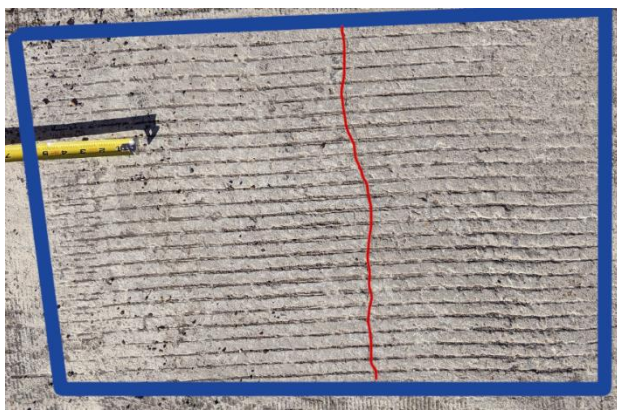
**Figure B.3 Crack Formation in Patches with P4 during First (Red), Second (Green), and Third (Yellow) Inspection**
