# Chinook Pass (National Park Highway) 1994-95, Part II

Western  
Federal Lands  
Highway  
Division

*A Glimpse into  
an Earlier Era*

Article 50  
April 2014

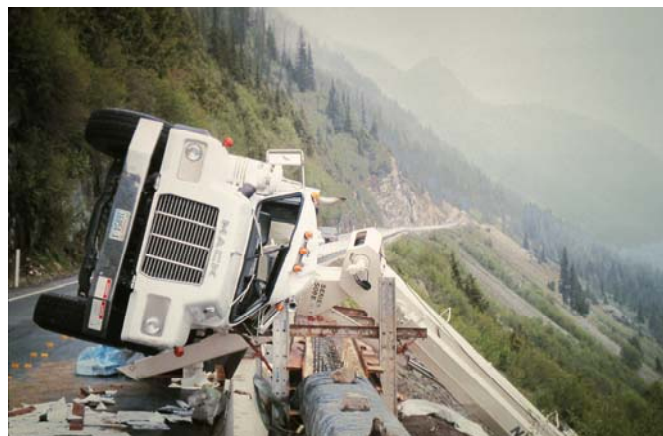
During a stormy day in the summer of 1994, a strong gust of wind catches the heavy concrete form being lifted by this boom truck, toppling the truck. A laborer is seriously injured.

The project included a lot of concrete guardwall simulating original stone walls that had been built in the 1930's by the Civilian Conservation Corps. “I drove on up there, and sure enough,” there had been an accident involving one of the cranes that had been setting forms for the

concrete work. “It was a windy, gusty day, and the winds caught the form (as) the crane was lifting (it), and swung it aside. It was like a sail. That threw the crane off balance and it toppled over.”

The crane fell on top of a laborer and crushed his legs. “The last I heard, he would probably never recover the use of his legs.”

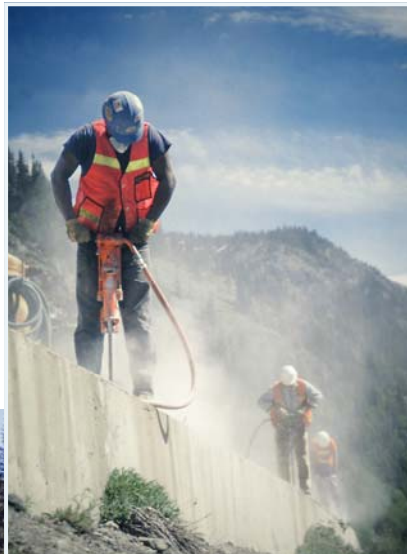
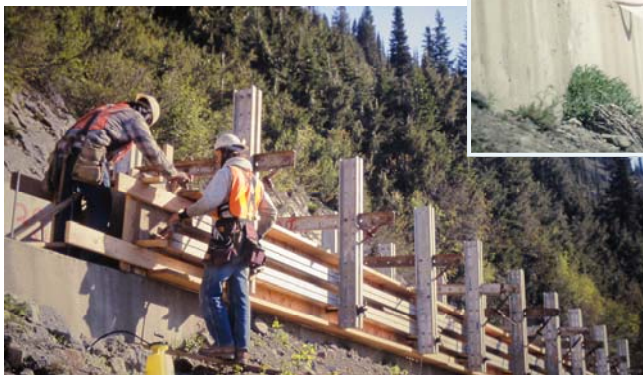
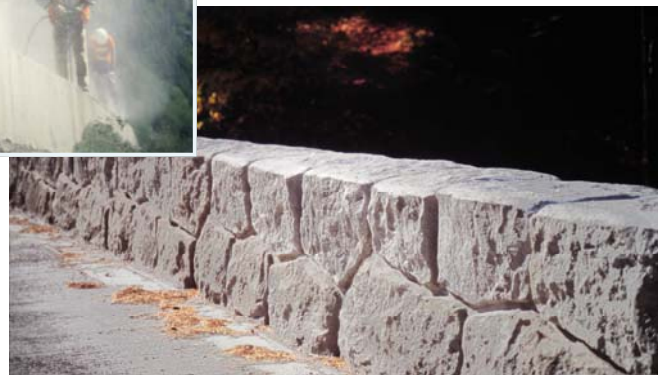
Center: Laborers drill holes in the top of existing retaining walls where vertical rebar will be epoxied into the holes. Left: Forms for the guard wall are installed on top of the retaining wall. Right: The guardwall after the forms have been removed. After final curing, the concrete will be stained to emulate the colors of stone.

“There was a big drop off below the highway,” Gary said, and protective walls were built along the edge. “These concrete guard walls ... were made to look like stone walls.”

**Jim Conquest**, who also worked on the project, described that process. “They had to make these form molds from existing stone” to replicate the

existing stone walls. “They’d make sheets of this stuff in a repeating panel in a certain length and then they’d use that as a form liner inside the concrete forms.” The concrete was

placed inside the plywood forms and “when it came out, it looked like the stone masonry design. . . .

“Then they’d color it (with a concrete stain) to match the various hues of the natural stone, Jim said, “to make it look like the stuff they were replacing.”

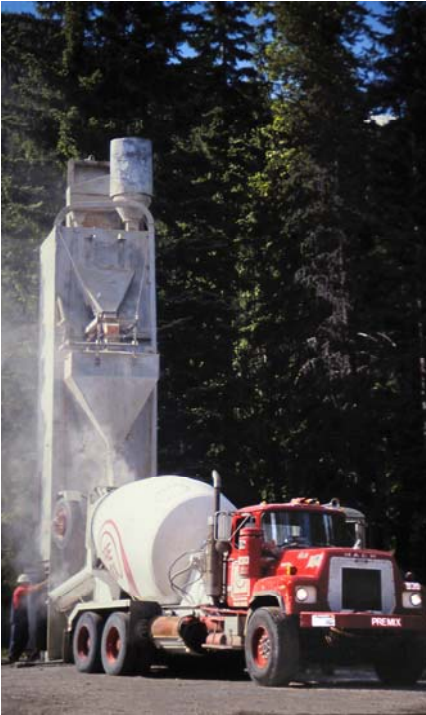
A portable batch plant erected on the project adds cement to a truck. Trucks left the supplier in Yakima loaded with sand, water, and gravel.

“Concrete that is mixed on the road this way must be used within the first 60 to 90 minutes, so getting a batch from Yakima over 90 miles of road to the project was a real problem.”

Gary said the supplier tried adding a retardant to the mixture to make it last 2 to 3 hours. “He experimented with the mix ratios by putting the mix in the trucks and having them driven around Yakima for 2-3 hours, trying to simulate the trip to the project, but they could never get the mix exactly right.”

“In the end, they put a cement silo on the project. That way they could put the sand and aggregate and water into the trucks in Yakima, send them up to the project, and add the cement at the project. By doing this, it sat in the mixer for only 15-20 minutes.”

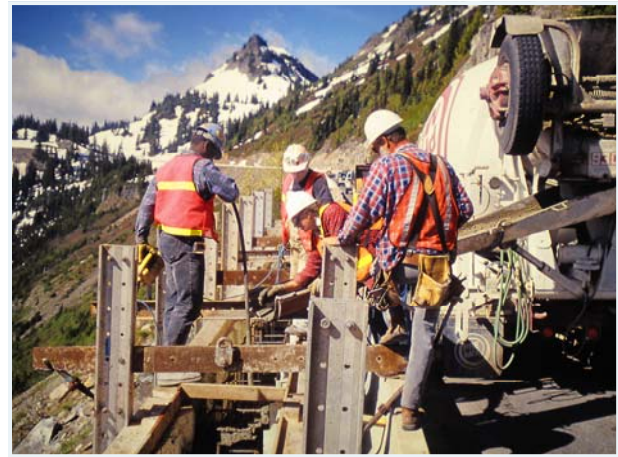
A truck delivers concrete to the guardwall forms. Sixty linear feet of forms are filled at a time.

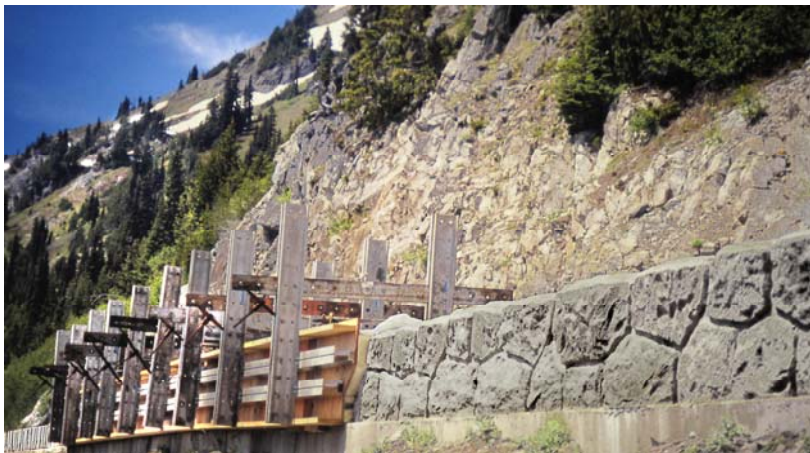
Forms remain in place at the left until the concrete achieves its initial set. At right, forms have been removed from an earlier pour. The insides of the forms are textured to give the concrete guardwall an appearance of stonework.

“Concrete needs to be kept moist for 30 days in order to cure properly,” and to keep it from cracking and spalling, Gary pointed out. “The contractor didn't do that; he didn't keep (the walls) moist enough after they were done.”

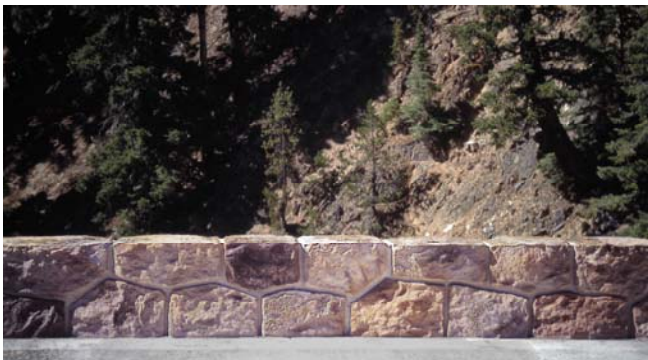
The final guardwall, after staining.

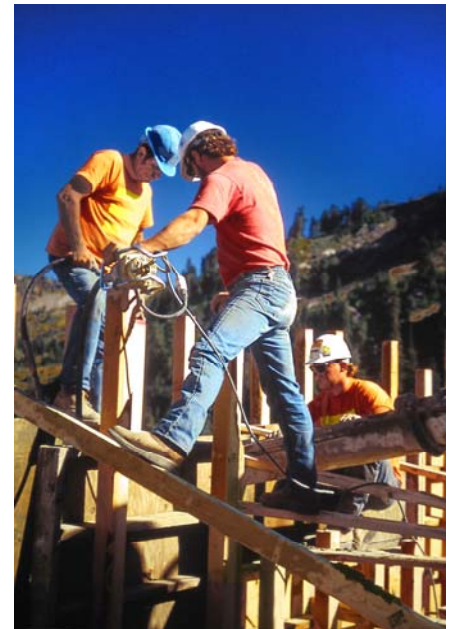
Laborers use a vibrator to consolidate the fluid concrete. This eliminates air bubbles and ensures sand and gravel are distributed evenly.
