SHEAR FRICTION CAPACITY OF CORRUGATED PIPE CONNECTION IN PRECAST FOOTINGS

(Project No.: BDV29 977-39)

Final Report

July 2022

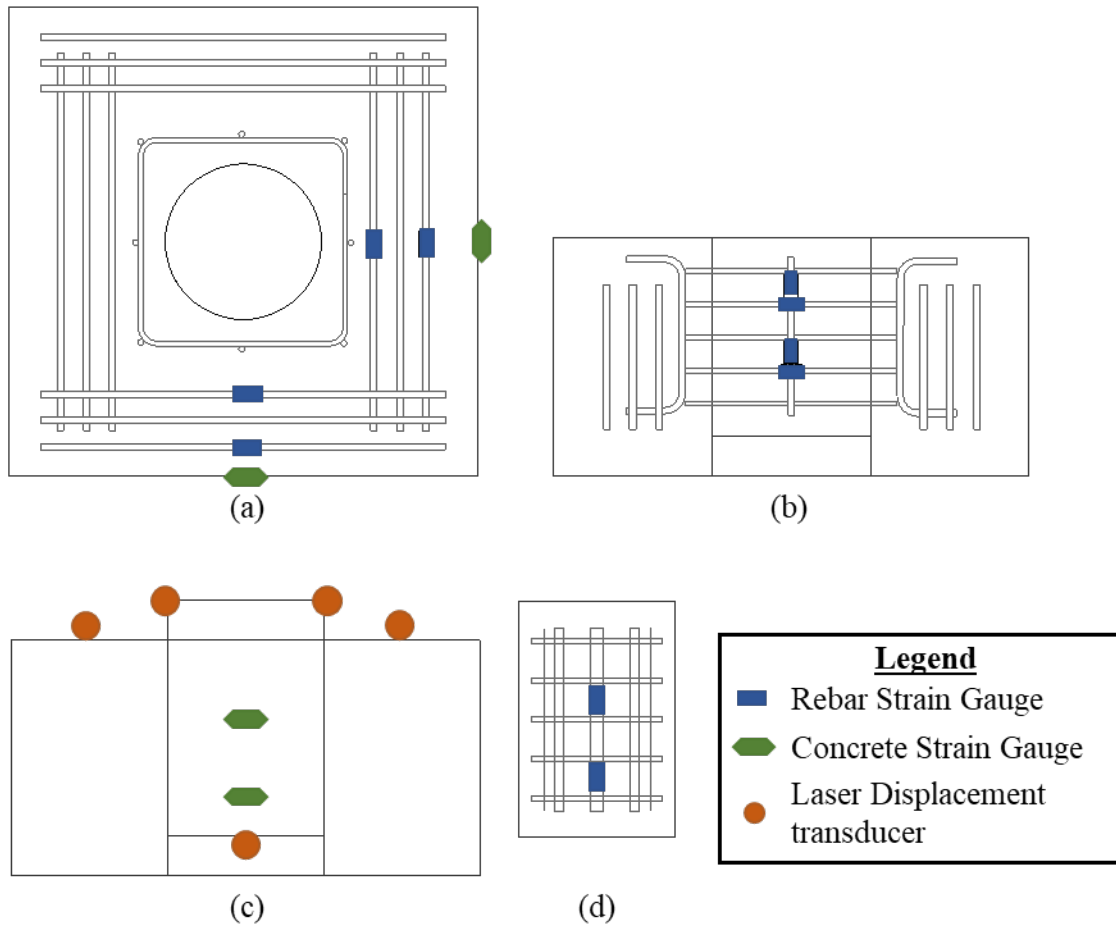
Figure 3.13: Instrumentation plan for Series II and III specimens: (a) pile-cap bottom view (b) cap-elevation, (c) plan cap, and (d) plug elevation.

specimens. Five LDTs were used in these specimens to measure displacement on the (1) opposite sides of the top of the plug, (2) opposite sides of the top of the cap, and (3) bottom of the plug.

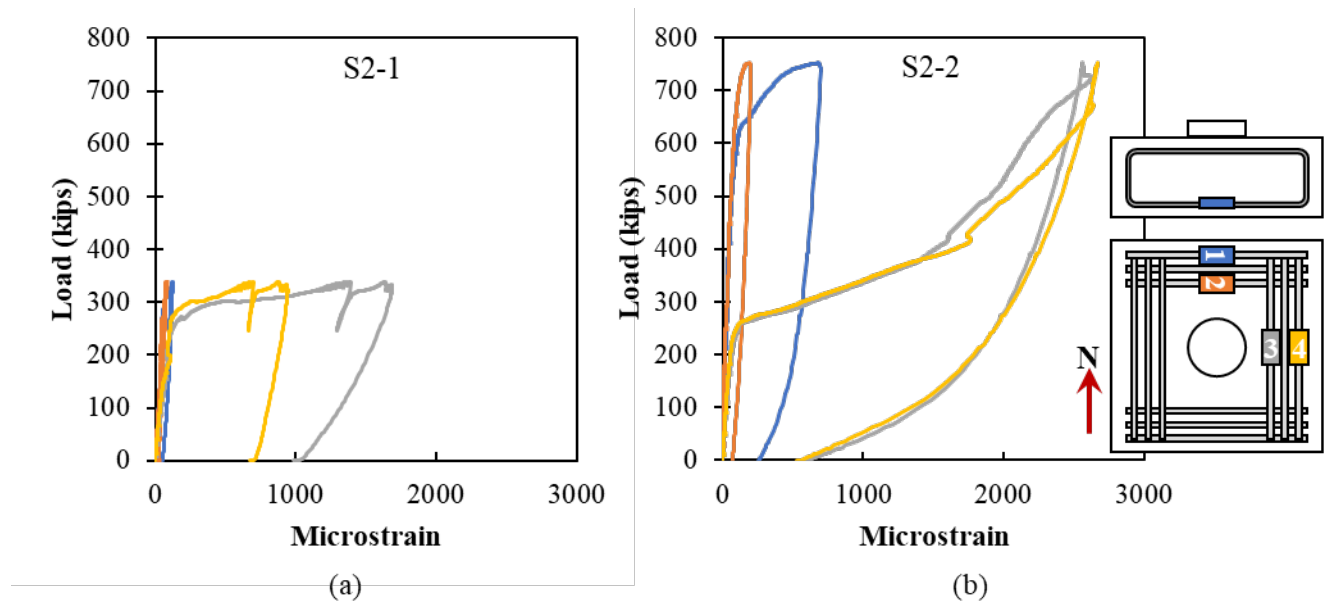
Figure 3.24: Rebar strain in longitudinal bars on bottom of specimen (a) S2-1 and (b) S2-2

The strain readings in the rebar strain gauges (RSGs) on the longitudinal steel in S2-1 and S2-2 are shown in Figure 3.24. The only difference between specimens S2-1 and S2-2 was the interface surface condition: S2-1 had a 1/16-inch roughness and S2-2 had a 1/4-inch roughness. The reinforcement in S2-1 did not begin to engage until a slightly higher load than S2-2, and the amount that the reinforcement engaged was less in S2-1 than in S2-2. The cracking in S2-1 also was later (with respect to the failure load) than S2-2. These observations are like those seen in the other rebar gauges and in other similar specimens. The 1/4-inch surface roughness led to more rebar engagement and more significant cracking than the 1/16-inch roughness. The rebar engagement in the specimens with 1/4-inch surface roughness was like that observed in the monolithically cast specimen, see Figure 3.22 (b).

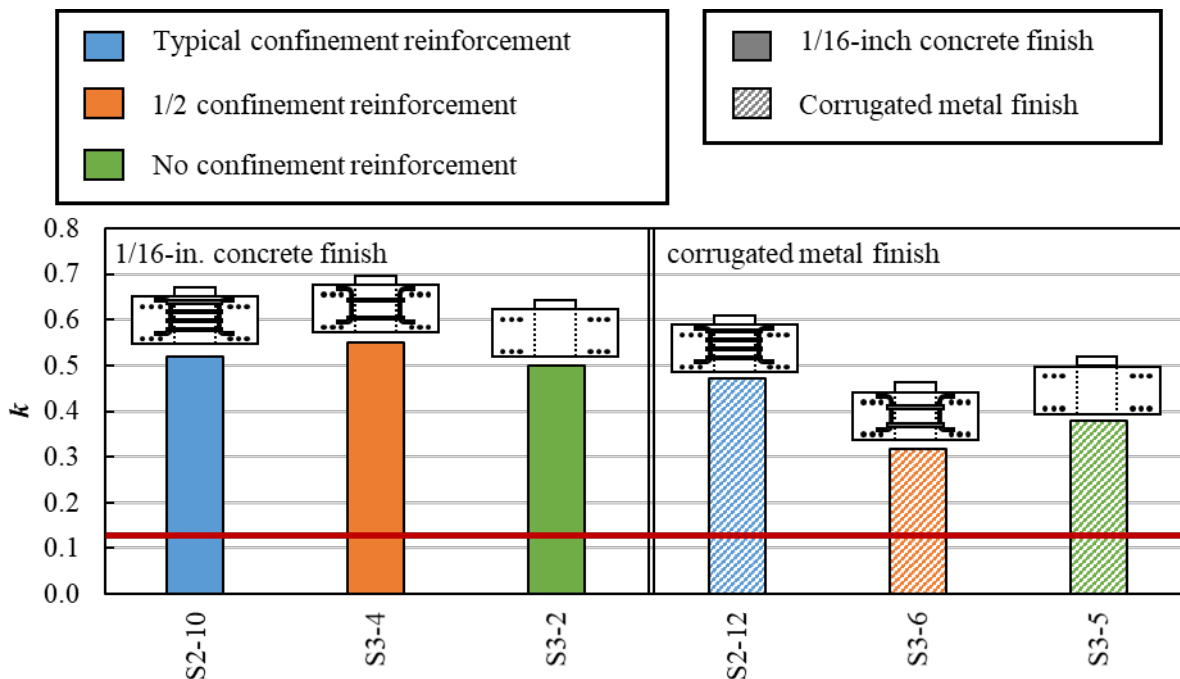
Figure 3.47: Comparison graph for specimens with varying confinement reinforcement around the pocket

The specimens with the corrugated metal pipe finish and less confinement reinforcement had between 19 percent (no confinement reinforcement) and 33 percent (half confinement reinforcement) lower strength than the specimens with corrugated metal pipe finish and full confinement reinforcement. As mentioned above, specimen S2-12 experienced rotation of the plug as the plug pushed through; compared with S3-6 and S3-7 which only experienced minor rotation of the plug.

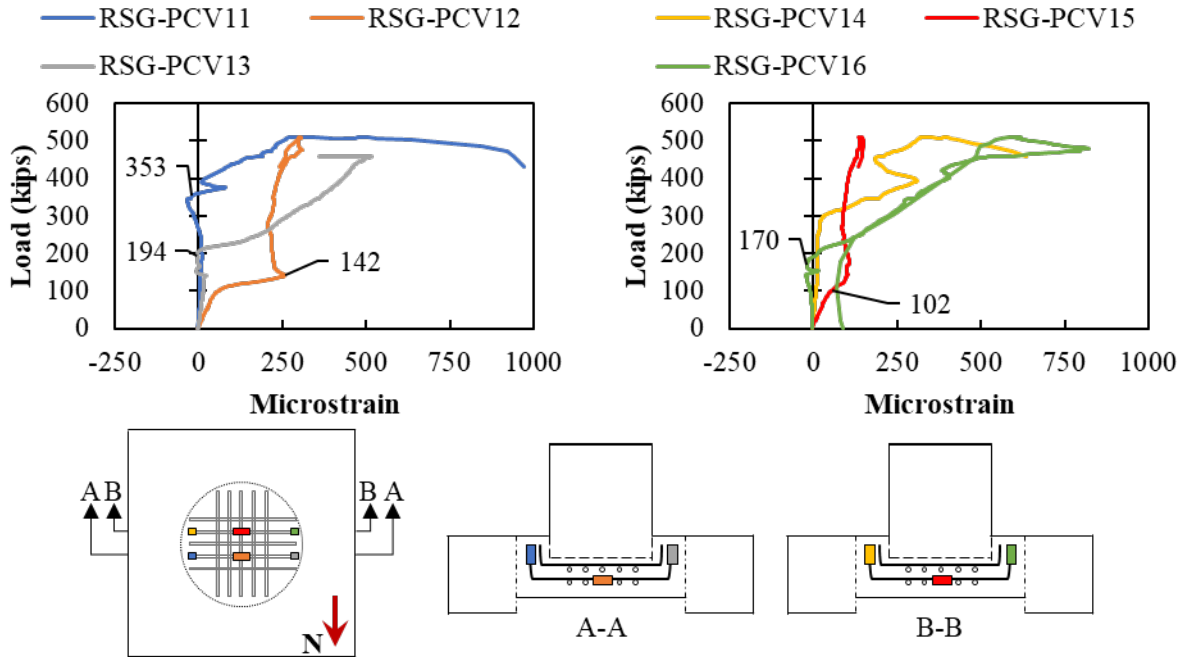
Figure 6.7: Sample load versus microstrain plots for socket reinforcement in SC-1
