# FIRE TEST OF AN UN-T75 PORTABLE TANK ON A FLAT CAR-PHASE II

The Federal Railroad Administration (FRA) contracted Southwest Research Institute (SwRI) to evaluate the fire performance of an alternative fuel storage tank using analytical methods and fire testing. The objective of this project was to expose an LNG rail storage tank to fire conditions and observe the performance of the pressure relief valve (PRV) system. The tank was filled with liquid natural gas (LNG). SwRI performed the full scale UN-T75 portable tank fire test on June 29, 2022.

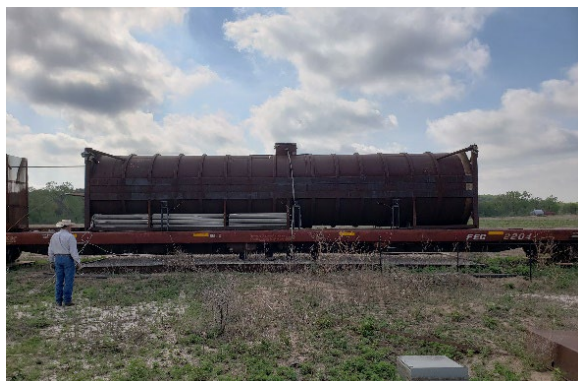
An existing International Organization for Standardization (ISO) storage tank, outfitted for LNG service, was procured from Cryogenic Vessel Alternatives, Inc. (CVA). The model number of the tank is CVA-12K-114-ISO and measures 40 ft long, 8.5 ft high and 8 ft wide. [Figure 1](#) shows the tank that was used in this experiment.

**Figure 1. UN-T75 Tank Prior to Fire Test**

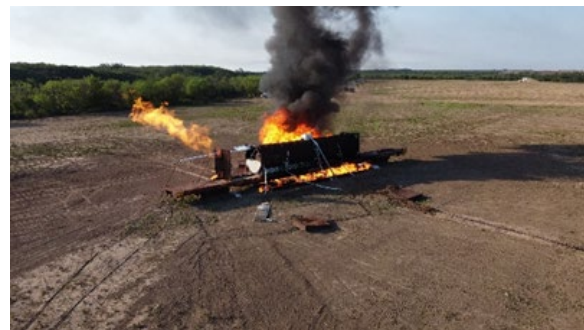
The fire test evaluated the performance of the PRV system on the tank. In addition, several types of data were collected during the experiment to understand how the fire exposure affects the internal and external heating of the tank. This information will be used in future computer modeling efforts to predict performance with different tanks and fire scenarios. [Figure 2](#) shows a photograph of the fire test in progress.

**Figure 2. Fire Test in Progress (PRV Venting)**

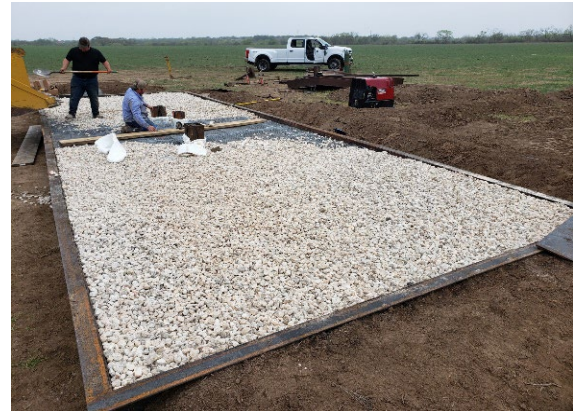
The test tank was exposed to a propane gas burner fire located directly underneath the tank and flatcar. The fire source consisted of a 40 x 13-ft (nominal footprint of ISO tank on flatcar) liquefied petroleum gas (LPG) burner. A piping array was installed in the steel burner pan. The array had eight branchlines and each branchline had 11 1/8-in. diameter holes evenly across the length.

The piping array was installed in the burner pan with the holes pointed downward, which allowed the LPG to diffuse evenly across the burner pan. LPG was introduced to the burner array at the northeast and southwest corners from a 2-in. buried pipe. An LPG supply system consisting of an 8,000-gal LPG, pump loop, and flow meter was setup approximately 900 ft away from the test area to the west. An emergency stop button allowed test personnel to safely terminate flow of

LPG to the burner by routing to the control room. Figure 3 shows the burner construction.

Figure 3. Photograph of LPG Fire Exposure Burner Construction

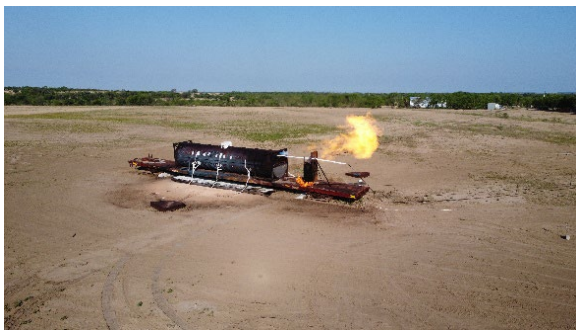
Figure 4. Test in Progress – PRV Operating (After Fire Source Burner Turned Off)

The tank safely vented its contents and did not rupture. Figure 4 shows an additional photograph from testing and Figure 5 and Figure 6 shows photographs of the post-test conditions of the tank. Figure 7 and Figure 8 show some of the selected internal and external temperature data and Figure 9 shows the internal tank pressure and level throughout data collection.

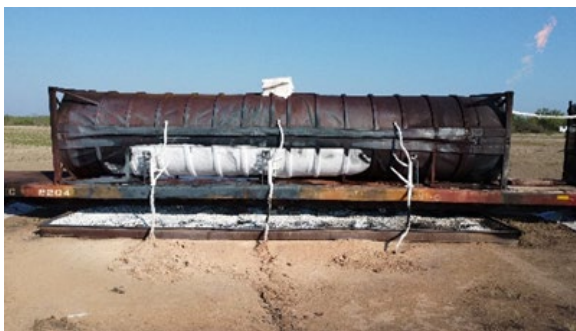
Figure 5. Post-Test Photograph of East Side of Test Tank

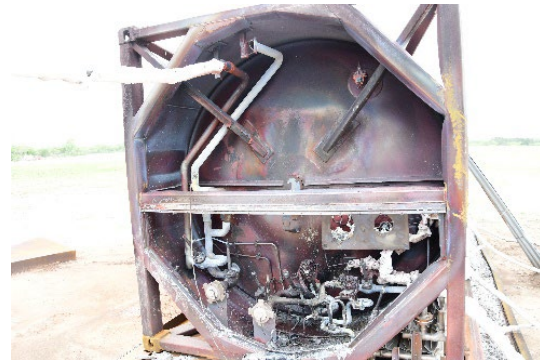
Figure 6. Post-Test Photograph of Piping Cabinet of Test Tank

1. An ISO tank, filled with LNG, was exposed to an LPG fire for approximately 56 minutes, after which time, the LNG continued to burn through the PRV and leakages in the piping cabinet for an additional 48 hours.
2. There was no catastrophic failure observed during the test.
3. Based on the internal pressure rise and vacuum pressure measurement, the vacuum likely degraded relatively quickly into the fire exposure. The pressure inside the inner tank increased to a peak of approximately 180 psig.
4. The PRV system worked properly. The pressure valves began operating at approximately 114 psig. The valves intermittently reseated, closed, and reopened before fully opening for most of the test duration.

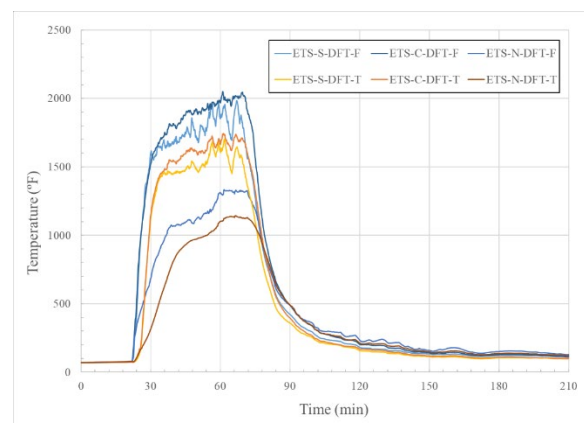
Figure 8. External Temperatures on East Side of Tank
