# UTILIZATION OF UNMANNED AERIAL VEHICLES IN ACCIDENT RECONSTRUCTION

The Volpe National Transportation Systems Center (Volpe), under the direction of the Federal Railroad Administration's (FRA) Office of Research, Development and Technology (RD&T), conducted a research study to evaluate the effectiveness of using Unmanned Aerial Vehicles (UAVs) (also known as drones) and photogrammetry software to expedite the accident reconstruction process.

In September 2021, RD&T conducted an impact test at the Transportation Technology Center (TTC) in Pueblo, CO, where a truck collided with a train. Volpe collected drone imagery of the post-crash scene in an effort to better understand what is involved in capturing the required incident data for a simulated highway-rail grade crossing environment. [Figure 1](#) shows a Volpe researcher using a drone to capture aerial imagery from the accident scene.

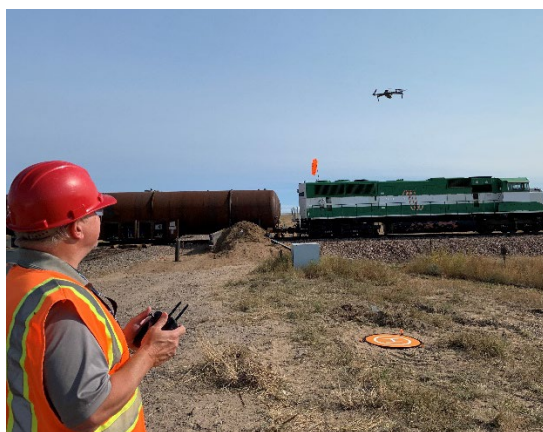
**Figure 1 - Researcher using drone to capture accident scene imagery**

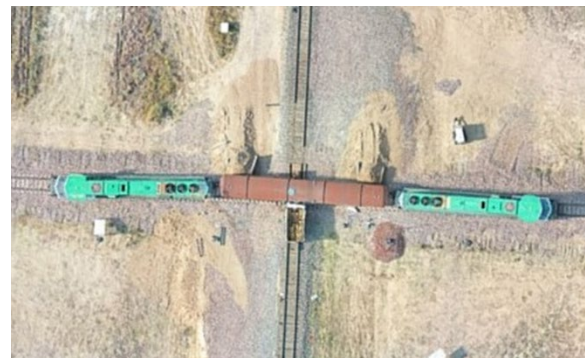
**Figure 2 - Orthomosaic of highway-rail grade crossing impact test**

Volpe processed this data and took several measurements similar to those that would be taken at an actual accident scene. [Figure 2](#)

shows an orthomosaic image produced from the data collected from this scene.

The preponderance of the highway-rail grade crossing collision test images captured at the TTC were taken autonomously by the drone from a height of 75 feet. These were used to produce a single orthomosaic image using Pix4D software. This image was then imported into a geographic information system (GIS) software package called QGIS. This is a free, open-source GIS product that enabled Volpe to take measurements that are accurate because the orthomosaic was overlaid onto the Web Mercator coordinate reference system.

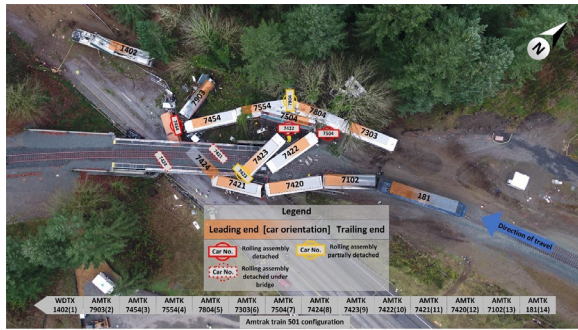
**Figure 3 – Annotated aerial view of Dupont, WA, derailment scene captured by Washington State Police helicopter (National Transportation Safety Board 2019)**

Federal investigators have often requested imagery from other sources, especially those with helicopters, to try to better establish the positions at which railcars and vehicles came to rest. [Figure 3](#) shows an image obtained by investigators of the Amtrak derailment near Dupont, WA, in 2017. State law enforcement took this photograph from a helicopter, overlaid with railcar numbers and other notes. As valuable as this image was to investigators, it is not accurate enough to be used for measurements.
