RESEARCH PROJECT CAPSULE [19-1GT]

TECHNOLOGY TRANSFER PROGRAM

Maintenance of Roadway Edge Drop-Off Utilizing Readily Available Materials

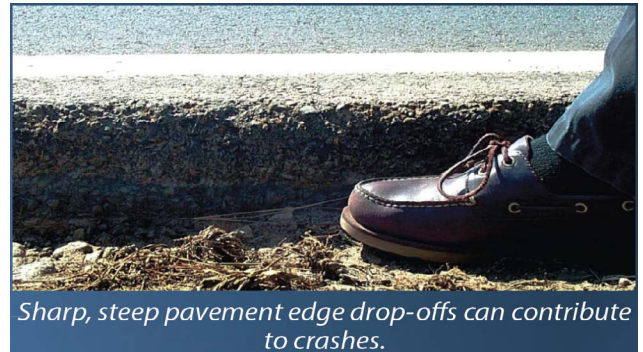
Figure 1
Extreme edge drop-off

Sharp, steep pavement edge drop-offs can contribute to crashes.

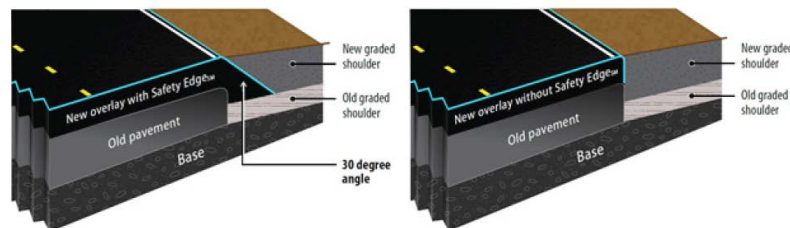
Figure 1. Graphic. SafetyEdgeSM versus conventional paved edge immediately after repaving.

(Left panel: SafetyEdgeSM immediately after paving with backfill material graded flush with paved surface. Right panel: Conventional pavement overlay without the SafetyEdgeSM with backfill material graded flush with the paved surface)

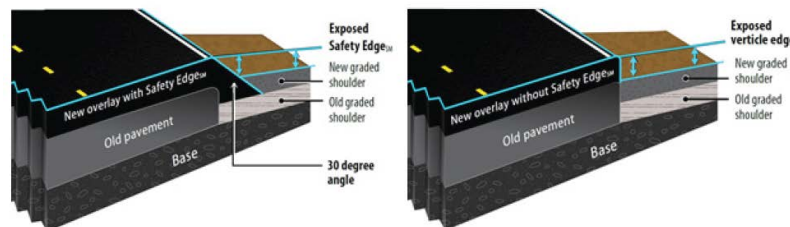
Figure 2. Graphic. SafetyEdgeSM versus conventional paved edge after backfill material settles or erodes.

(Left panel: SafetyEdgeSM is exposed to traffic after backfill material settles or erodes. Right panel: Conventional pavement overlay without the SafetyEdgeSM after backfill material settles or erodes)

SafetyEdgeSM and adjacent graded shoulder

The graded shoulder materials adjacent to overlays or existing road edges should be stable, durable, and meet the road edge; see Figure 2. Vehicles, time, and erosion wear on the shoulders, resulting in the need for maintenance operations. Cost and space issues limit the availability of asphalt paved shoulders on rural low-volume roads. The methods used to maintain these non-paved shoulders statewide varies and performance has been undocumented.
