DOT/FAA/TC-22/48

Practical Lessons Learned from Planning, Collecting, Processing, and Analyzing Small Unmanned Aircraft System Data for Airfield Pavement Inspection

December 2022

Final Report

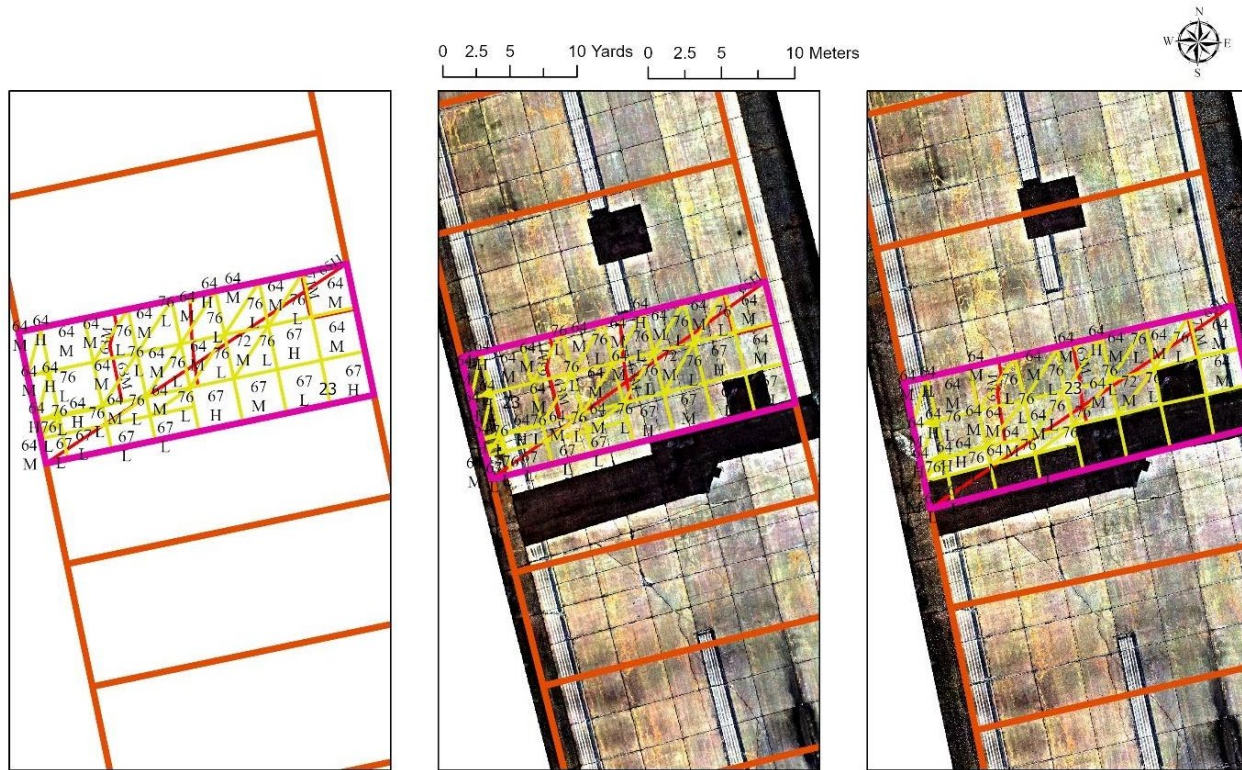
Figure 3. Manual Distress Survey Result (left); Manual Survey Results Overlaid on an RGB Data with Approximately 10-cm Position Accuracy (middle); and Well-aligned Manual Survey Results (right)

However, it is important that geospatial data “line up” relatively accurately to make data easier to compare between different data creators and over time. For example, Figure 3 shows three different views of “foot-on-ground” (FOG) (manual) surveys completed for ONZ. On the left are the inspection data as shared, without any imagery background. This is a view that an inspector would see while recording new PCI data. The middle image is a view of those data when overlaid on an orthoimage created from sUAS collected imagery with an approximately 10-cm positional accuracy. The manual inspection geospatial data range from 3.1 m to 3.8 m off the location of the sUAS imagery. The right image shows the manual inspection data once they have gone through a spatial adjustment process to align them with the sUAS imagery that has better positional accuracy. These data are significantly easier to interpret and compare between different sources of imagery.

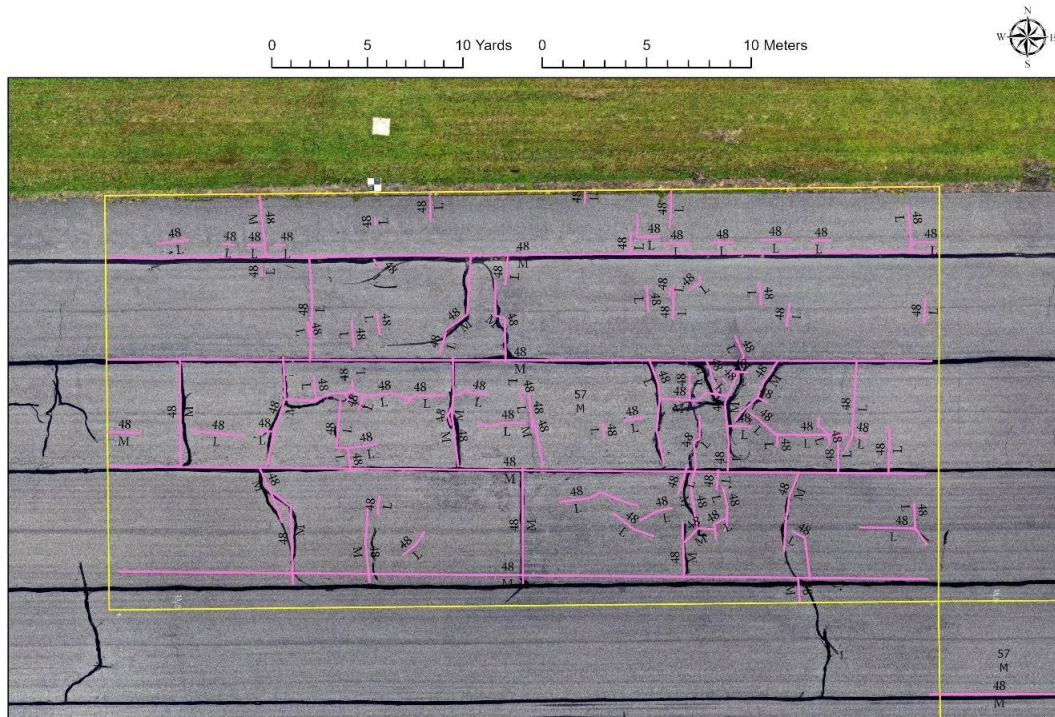
Figure 5. An Example of Recommended sUAS-assisted PCI Inspections and Geospatial Layers

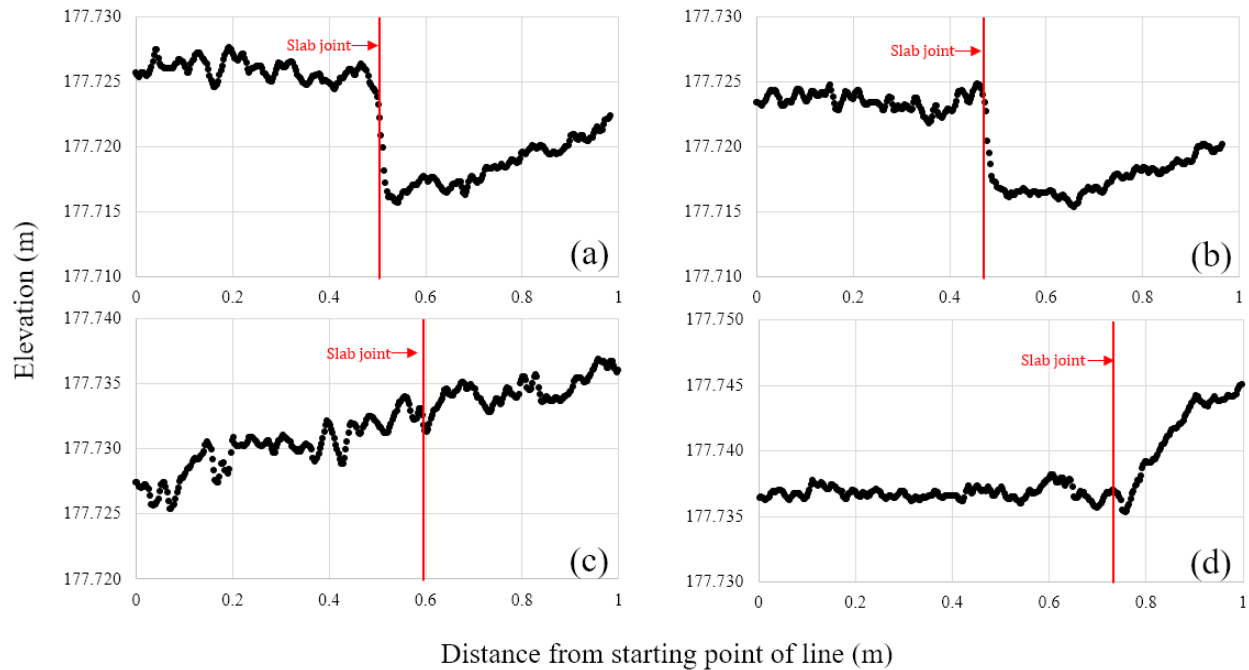
Figure 13 shows the usefulness of high-resolution DEM data in detecting and verifying a change in elevation that helps indicate the presence of a distress. The two slabs where faulting exists at their edges show height differences of approximately 10 mm (1 cm or 0.01 m), as shown in parts (a) and (b); where no faulting exists, a rapid elevation “drop” is not present, as shown in (c) and (d). With this high-resolution DEM data, it is also possible to “drape” the orthophoto imagery on top of the DEM in a 3D view using GIS software to display how elevation changes of just a few centimeters can be captured through the sUAS surveys.

Figure 13. Medium-Severity Faulting Detection in 3-mm/pix DEM; (a, b) Slab Joint with the Faulting Shows a 1-cm Elevation Drop and (c, d) Slab Joint Without Faulting with no Drop

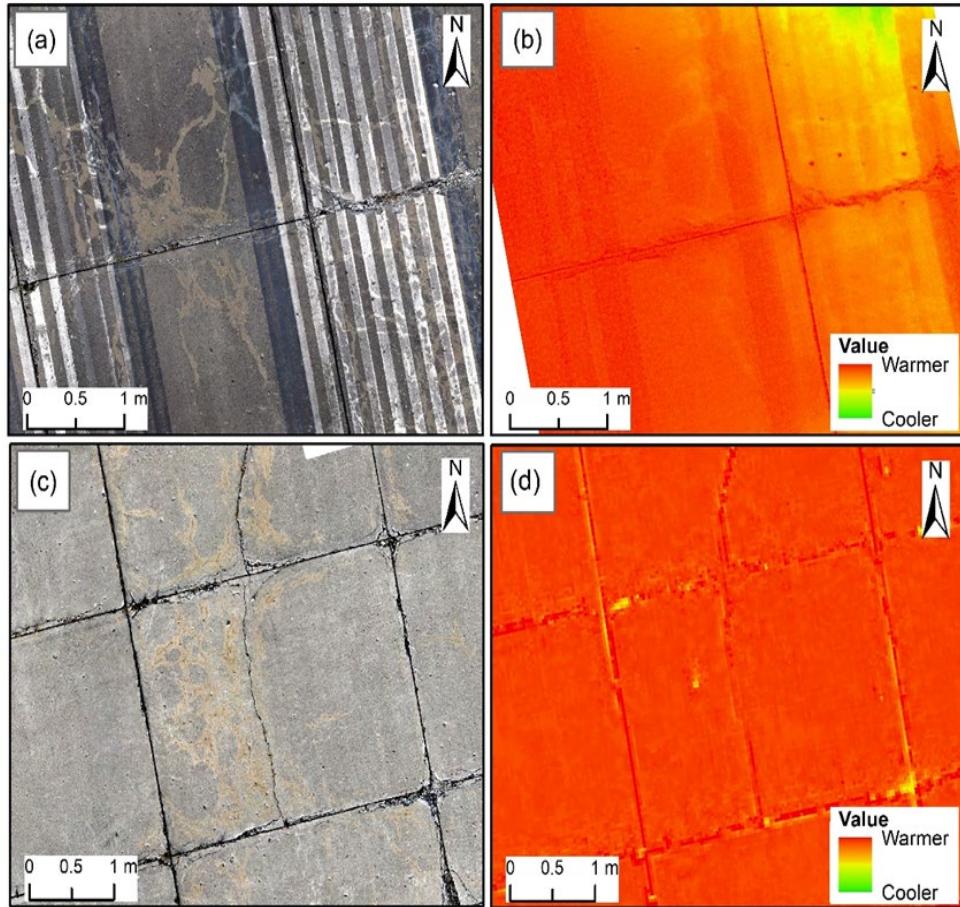
Figure 16. Longitudinal, Transverse, and Diagonal Cracks and Diagonal Cracks on PCC Pavement in Runway 17/35, Section 20 at ONZ: (a) 1.5-mm/pix Orthophoto of Sample Unit 5, (b) 8-mm/pix Stereo Thermal of Sample Unit 5, (c) 1.5-mm/pix Orthophoto of Sample Unit 23, and (d) 31-mm/pix Stereo Thermal of Sample Unit 23
