Improved Permafrost Protection Using Air Convection and Ventilated Shoulder Cooling Systems – Final Project Report

Date: November 2022

Alaska Department of Transportation and Public Facilities
Statewide Research Office
3132 Channel Drive
Juneau, AK 99801-7898

Publication Number: FHWA-AK-RD-4000(185)

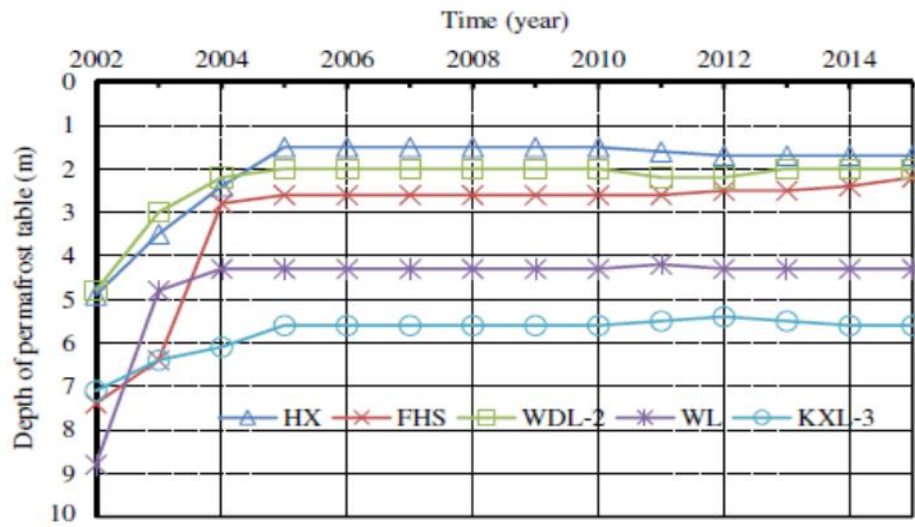
Figure 2-2 Variations in permafrost table depth over time beneath the centerline of five ACE monitoring sites (labelled HX, FHS, WDL-2, WL, and KXL-3), along the QTR. See Mu et al. [16] for details.

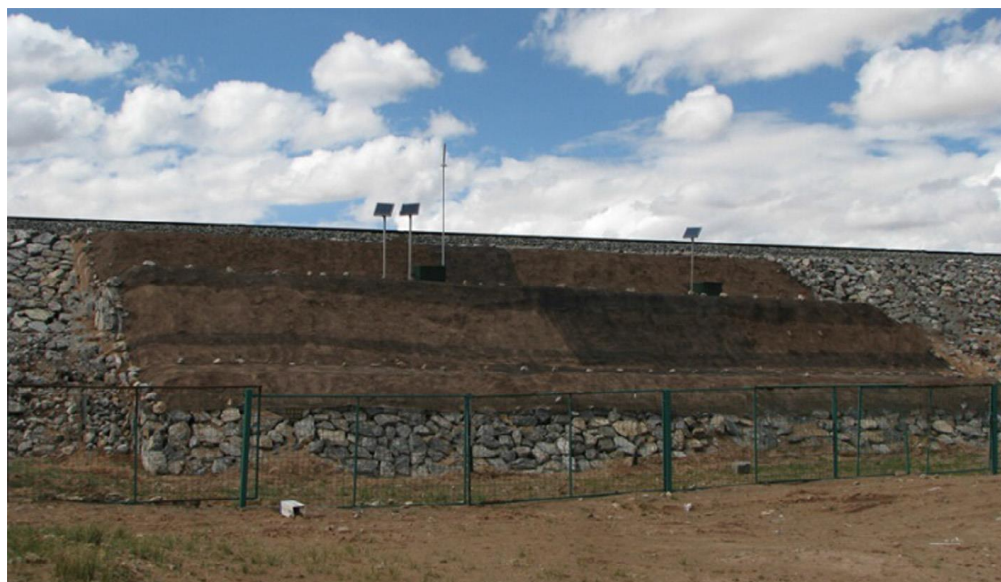
Figure 2-3 QTR test section with covered ventilated shoulder (Liu et al. [13])

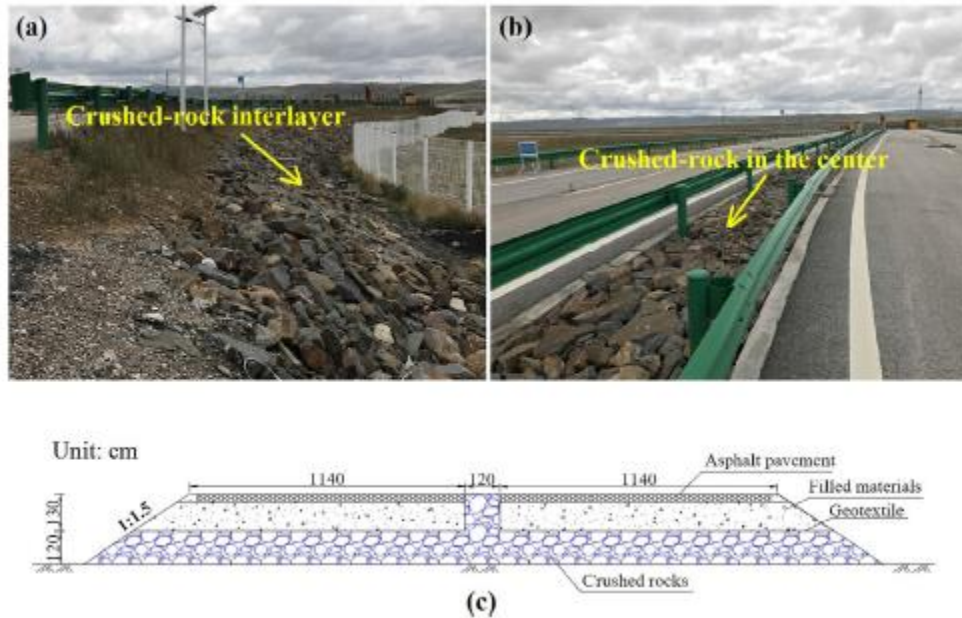
Figure 2-4 ACE layer with center vent designed for use in a wide expressway (Liu et al. [21])

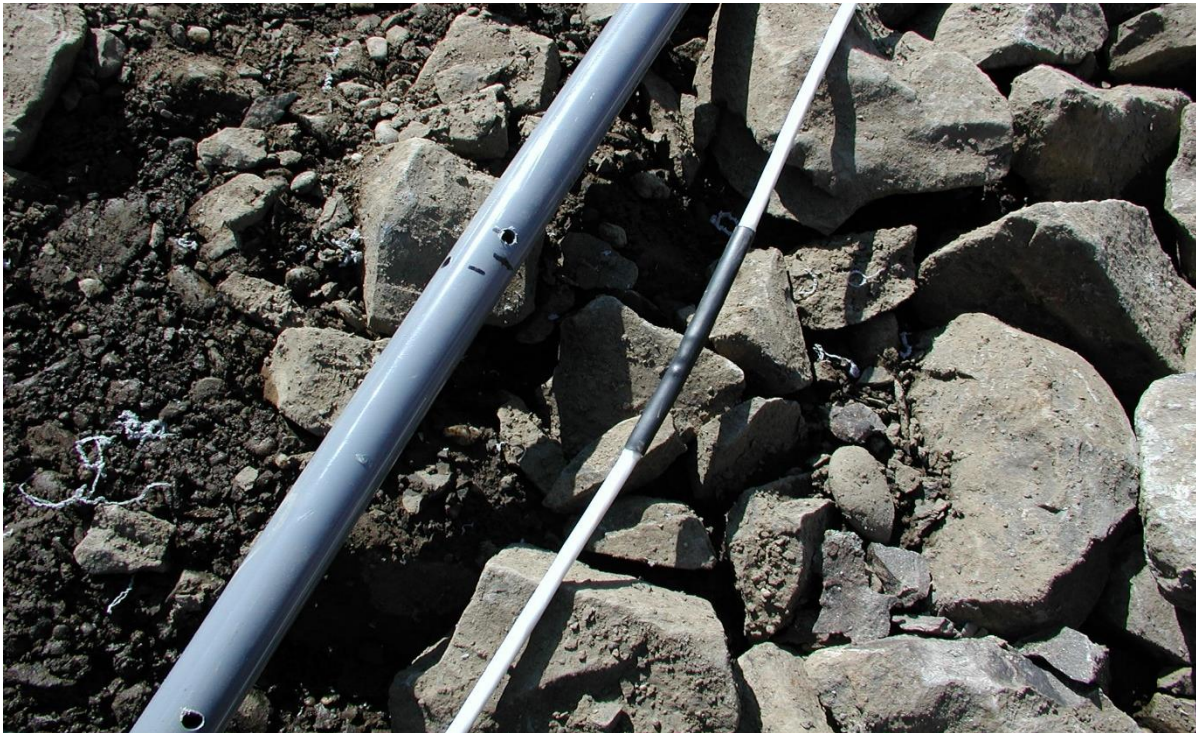
Figure 3-2 Thermistor sensor wire and vented PVC armoring tube as used in ACE areas

Figure 3-2. After drilling, the cable was pulled into the proper position within the shielding tube and silicone was injected at the intermediate points to hold the cable in place and block air motion. For the thermistor strings run vertically into the foundation soil, unshielded cables were used inside a sealed PVC casing with the annulus filled with silicon oil.

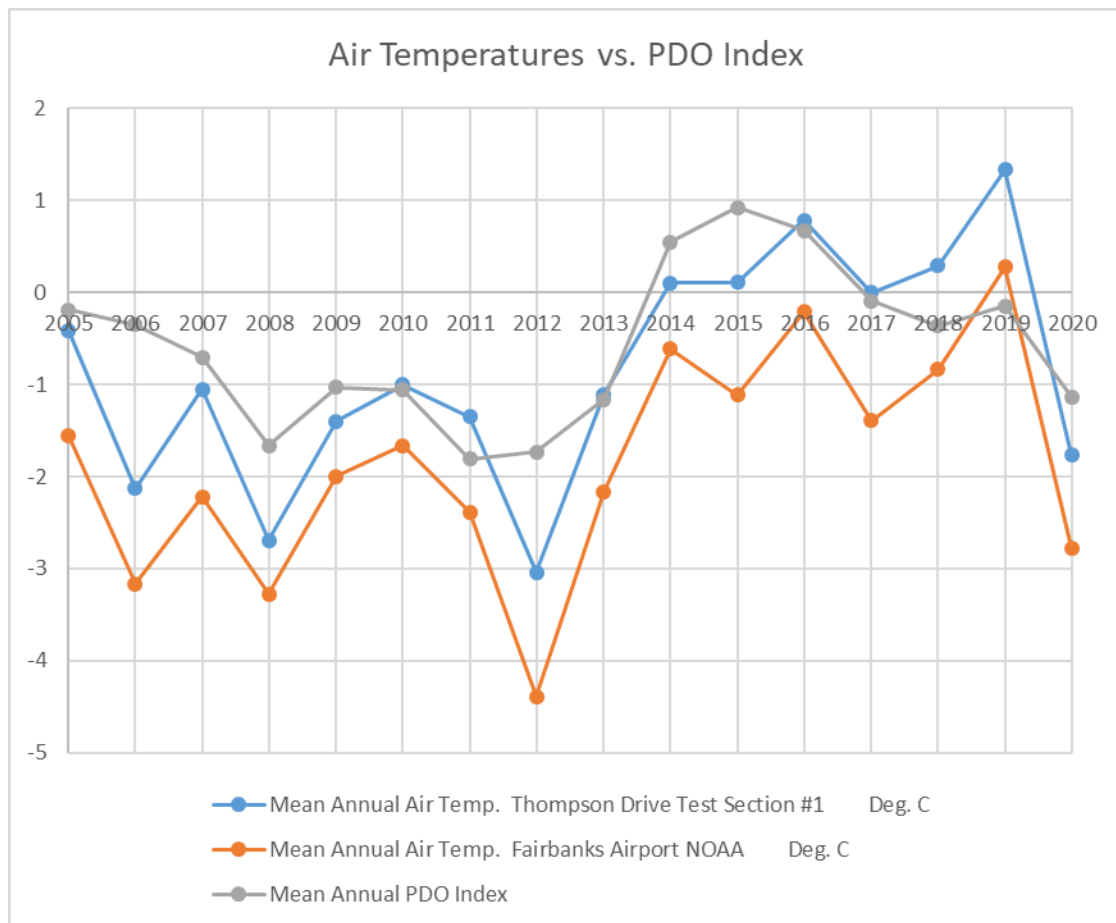
Figure 3-9 Thompson Drive and Fairbanks Airport Mean Annual Air Temperatures vs. PDO Index

during periods of relatively high PDO index values. This correlation can be seen clearly in Figure 3-9 which shows annual average values of Thompson Drive air temperature, Fairbanks airport air temperature, and PDO index. Fairbanks airport temperatures averaged -2.54°C (27.4°F) for the years 2005 through 2013, close to the long-term mean for Fairbanks air temperature. Average temperatures at Thompson Drive were generally about 1°C warmer than those reported at the airport, which is likely due to differences in elevation and the location of Thompson Drive at the base of College Hill. The years 2014 through 2019 corresponded to a period of relatively high PDO values and warm air temperatures. During those five years, air temperatures averaged -0.65°C at the airport and $+0.44^{\circ}\text{C}$ at Thompson Drive, substantially warmer than long-term average air temperatures for Fairbanks. In 2020 the PDO index dropped and air temperatures returned to values more in line with long-term average values for Fairbanks.

For the years 2006 through 2013, annual air temperatures at Thompson Drive remained relatively cold, as shown in Figure 3-9. Mean annual temperature contours for test section #1 during this time period can be found in Figures Figure A-2 through Figure A-9. As shown in these figures, every year provided additional cooling in the foundation soils beneath the test section. Temperature depressions in the vicinity of the thermosyphon evaporator increased to roughly 2°C while temperature depressions beneath the VS side-slope increased to roughly 3°C. The zone of cooling produced by the VS and that produced by the thermosyphon have merged to a certain extent and effectively cooled the entire foundation base from the centerline out to the edge of the toe. During the same time, temperatures within the VS rock layer remained similar or slightly cooler than they were during 2005, with mean annual temperatures of -5 to -6°C at the base of the shoulder layer and +1 to +2°C in the upper portions of the shoulder.

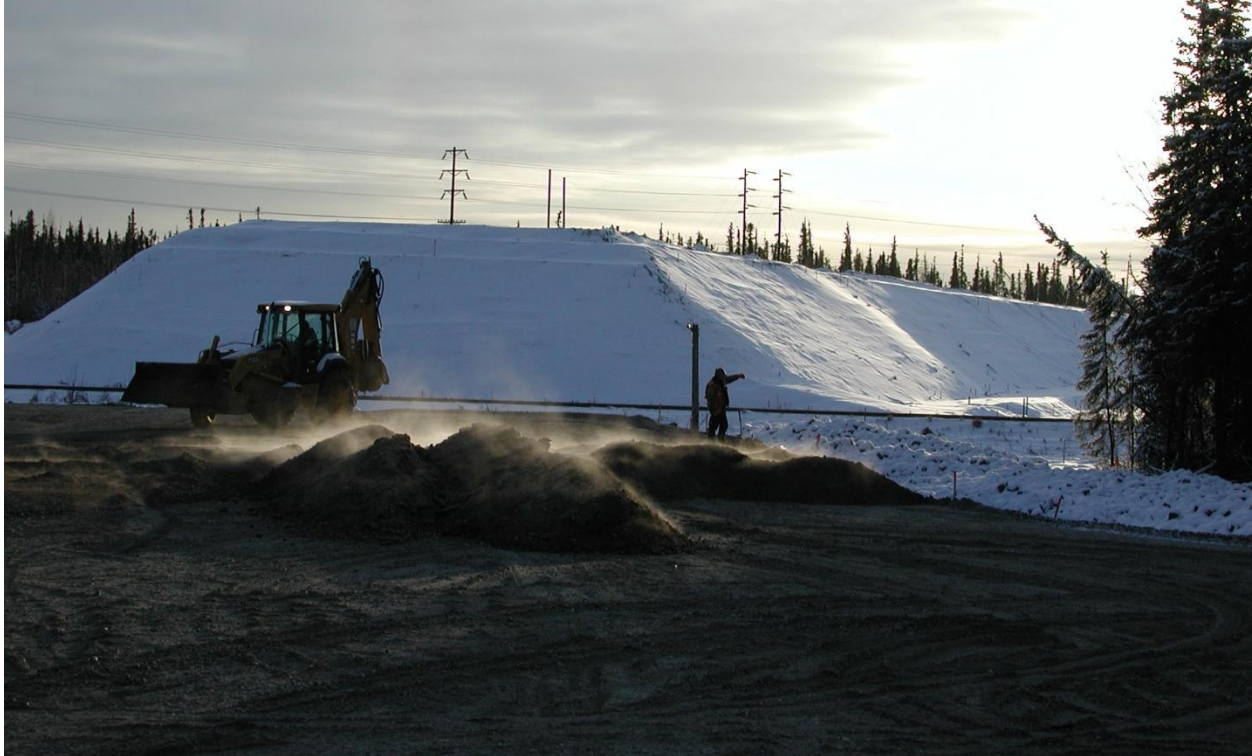
Figure 3-10 Winter Construction of Test Section #2

Beneath the ACE layer is roughly 8 m of select material, resulting in a total embankment height of about 10 m. The test section includes a thermistor array with a total of 95 sensors, 48 of which are located in a 1 m x 1 m grid spanning the right half of the ACE layer and 20 of which are located in two separate thermistor strings placed in the righthand VS structure. Thermistor locations are indicated by red dots in Figure 3-7. In an effort to reduce warming of underlying foundation soils, this section of the project was completed during winter, see Figure 3-10.

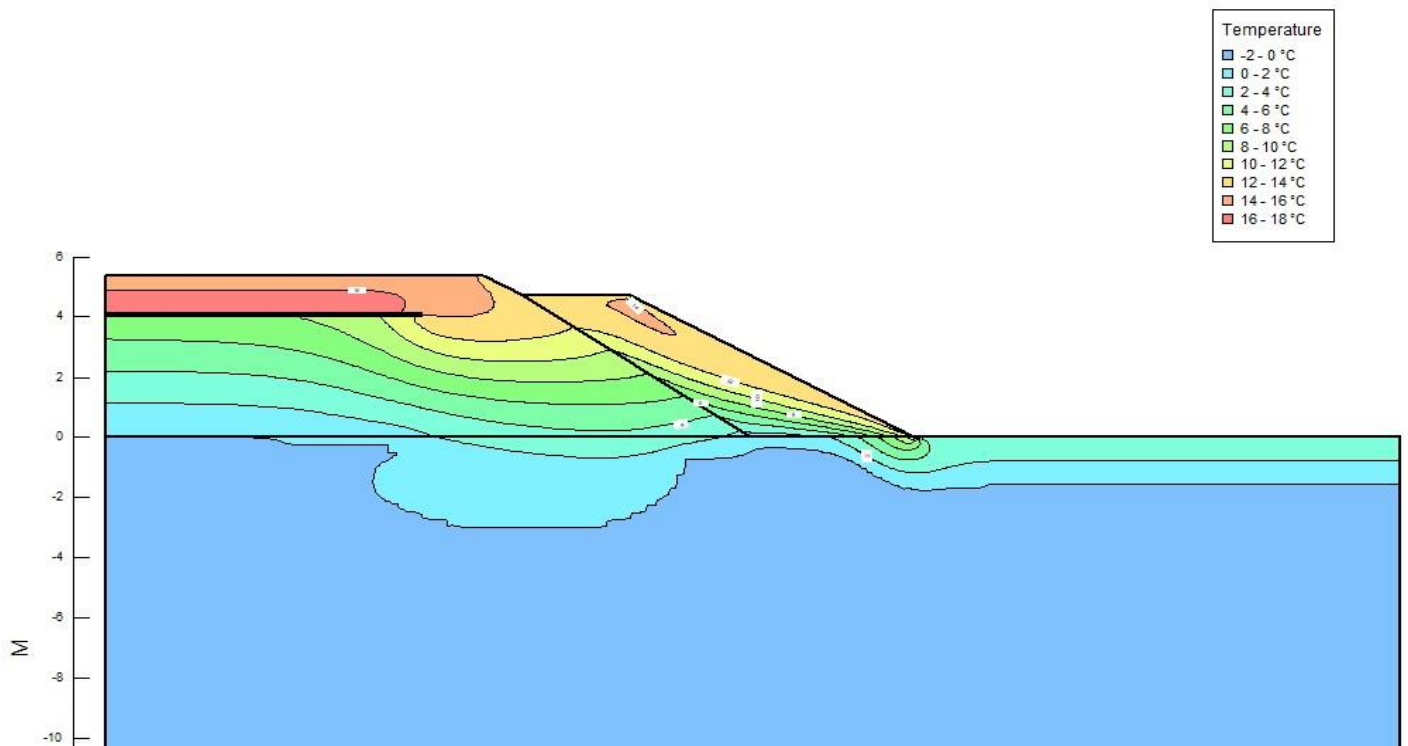
Figure 4-18 Simulation Results for Case 3 for September 15 of Year 12
