# **ACCELERATED CONSTRUCTION OF URBAN INTERSECTIONS WITH PORTLAND CEMENT CONCRETE PAVEMENT (PCCP)**

**KAMRAN M. NEMATI, PI**  
UNIVERSITY OF WASHINGTON

U.S. DEPARTMENT OF TRANSPORTATION  
FEDERAL HIGHWAY ADMINISTRATION

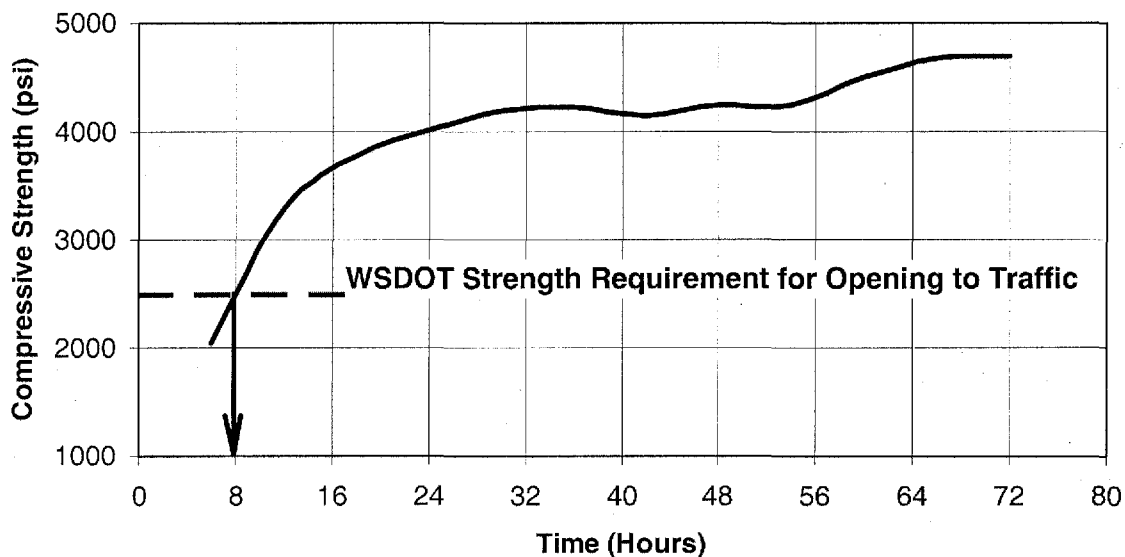
**Figure 12** – Compressive strength gain vs. time

As can be seen from the table above, this mix is capable of reaching the opening strength requirements shortly after placing ( $\approx 8$  hours). The strength gain data shown in Table 3 is plotted in Figure 12.

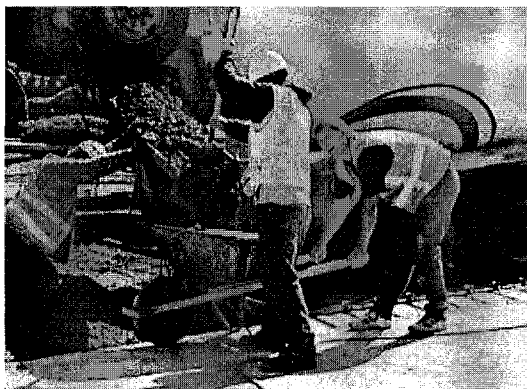
**Figure 13** – Concrete sampling from **Figure 14** – Air content measurement  
mixer truck

Figures 13 and 14 show concrete sampling from the concrete mix truck and air content measurement. Tests were conducted on each concrete truck delivery. These tests included unit weight measurement, slump test (to measure flowability and consistency), and air content measurements.

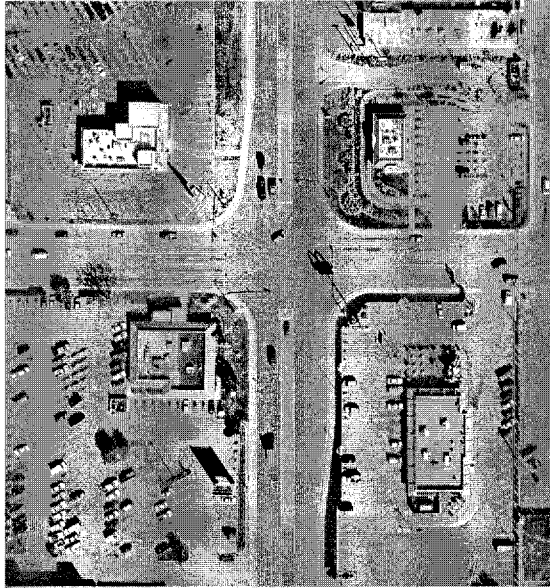
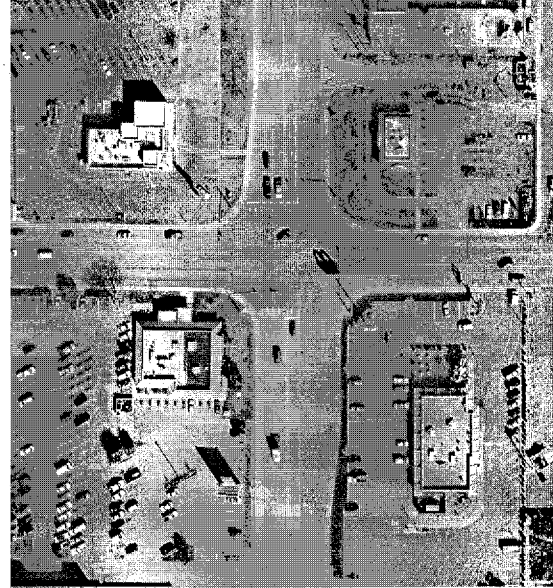
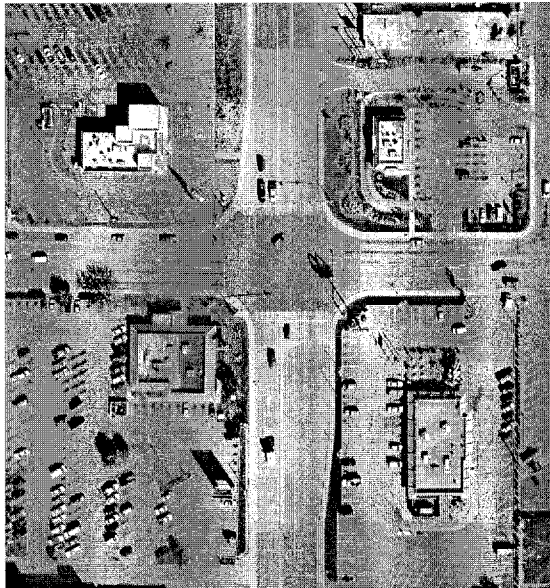
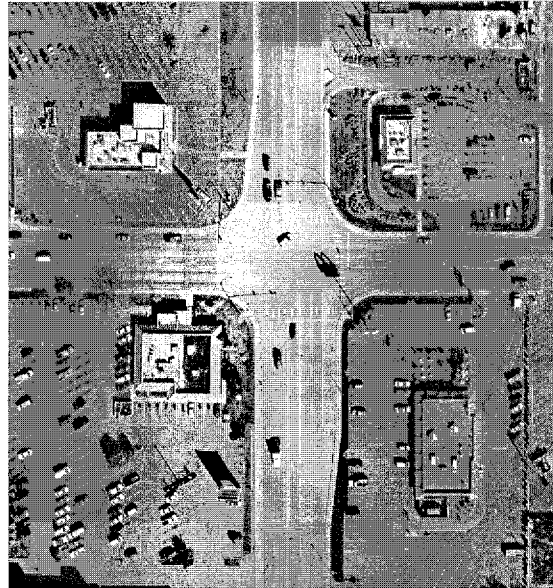
**Figure 16** – Construction sequence of the approach legs in SR 395

**Stage 1:** Construction of the left hand turn lane

**Stage 2:** Construction of the northern approach with traffic pushed to the south

**Stage 3:** Construction of the southern approach with traffic pushed to the north

**Stage 4:** Construction of the intersection square (radius return to radius return)

The 3-day closure rebuilt the intersection square (radius return to radius return). The approach legs were rebuilt in the days prior to the complete intersection closure. The reconstruction of the approach legs for Kennewick Avenue intersection were staged as follows and depicted in Figure 16:

- Stage 4: Construction of the intersection square (radius return to radius return).

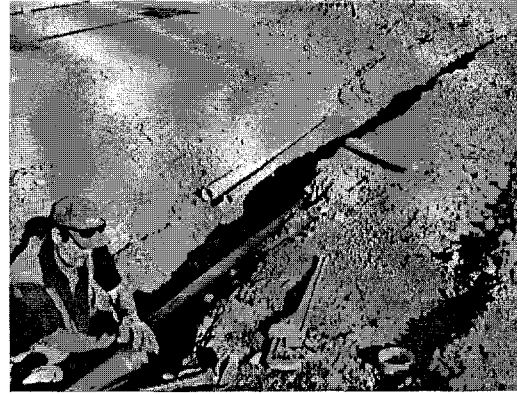
**Figure 21** – Replacing broken electric conduit

During removal of the existing pavement, electrical conduit was encountered in two locations (Figure 21). This required a change order to relocate these conduits and replace the wiring. This emphasizes the necessity to have decision makers onsite to address unexpected problems. The WSDOT and contractor immediately agreed to relocate the utility and address the change order at a later date.

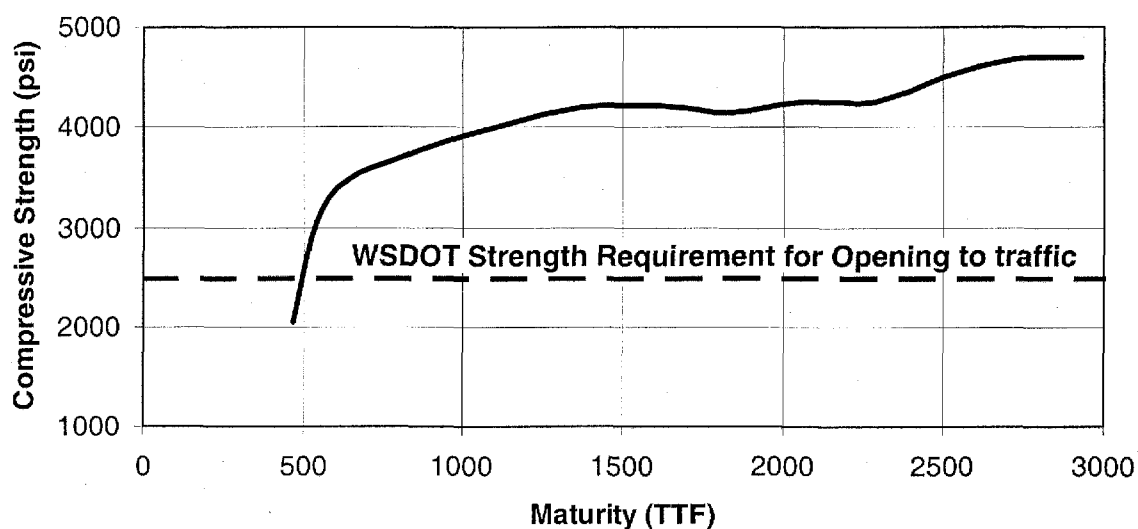
**Figure 39** – Maturity vs. concrete compressive strength

Figures 39 and 40 show the maturity (time temperature factor) versus compressive and flexural strengths for a mix used by the contractor.

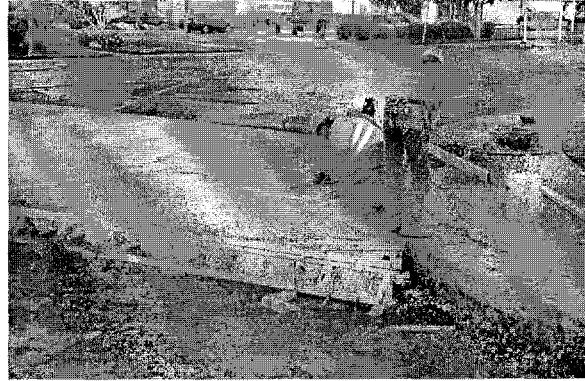
**Figure 43 – Finishing concrete**

Hand finishing was kept to a minimum through proper operation of the Whiteman and roller screeds. Where hand finishing was necessary, it was accomplished with standard hand tools. Figures 42 and 43 show finishing, and Figures 44 and 45 show floating operations.

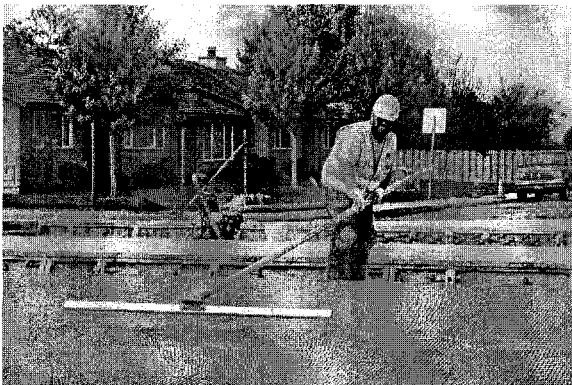
**Figure 46 – Manual texturing of the pavement**

Tines were used to texture the surface of freshly placed PCCP. Figures 46 and 47 show the texturing operation and a textured concrete surface.

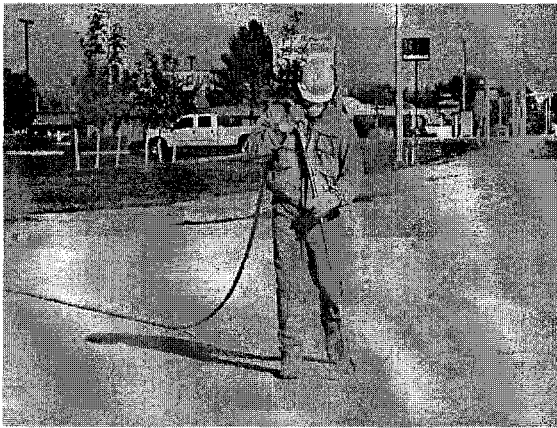
**Figure 52** – *Cleaning the joint reservoir*

The joint sealing in this intersection was in accordance with standard WSDOT specifications which require that sawed contraction joints be from 3/16" to 5/16" in width and 1/3 the depth of placement. The joints are then cleaned, dried, and sealed with a hot-poured asphaltic joint filler. Figures 52 through 54 show Joint cleaning and sealing operations.

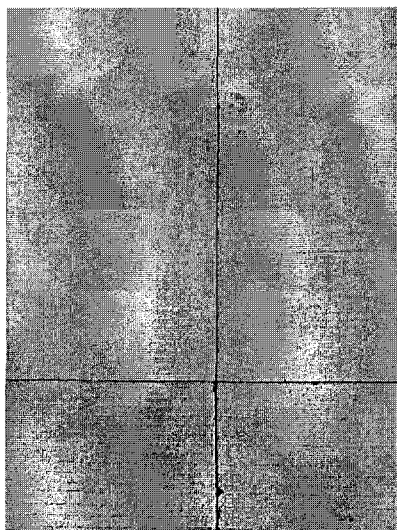
**Figure 55** – *Example of Proper sawcut and sealing*

Figures 55 and 56 show examples of proper and poor sawcutting and sealing.

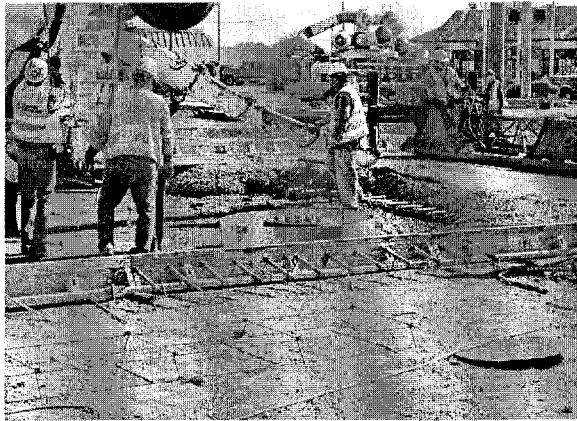
**Figure 58** – Encasing existing utility

Manholes and other utilities should be isolated in order to prevent uncontrolled cracking around these utilities. The utilities were encased in a box out, effectively isolating them from the main concrete slab to minimize the impact of differential movement. The box out was left imbedded in the concrete slab. As the result of this operation, no visible cracks were observed around these utilities after concrete was cured and hardened. Figures 58 through 61 show details of this operation.

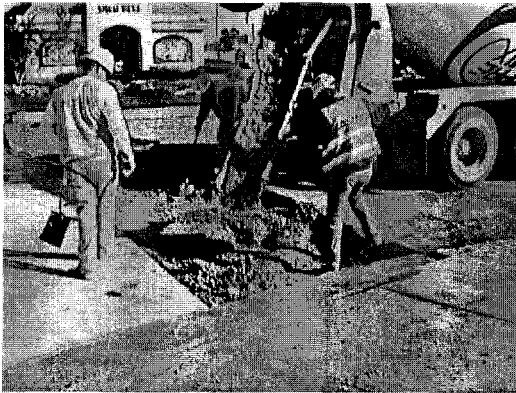
**Figure 62** – Placing concrete for backfill

excavated 2 to 3 feet and the excavated area was replaced with concrete to the level of the inlay that abuts the PCCP. ACP is then placed above the new concrete to the level of the PCCP.

Figures 62 through 64 show placement of concrete for backfill and Figure 65 shows paving with ACP over concrete backfill.

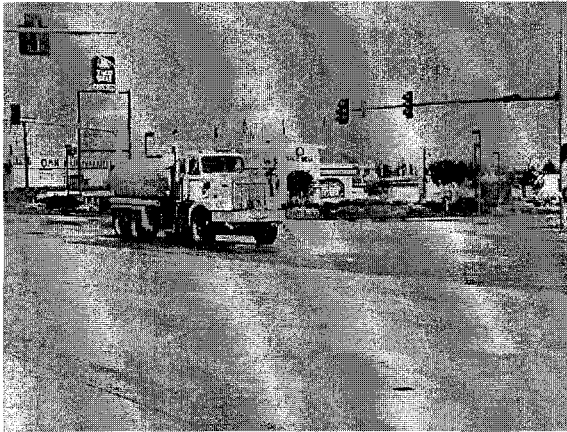
**Figure 66** – Cleaning the roadway with water truck

Before opening to traffic, the intersection was thoroughly cleaned using a water truck, as shown in Figure 66. Figure 67 shows the cleaned intersection.

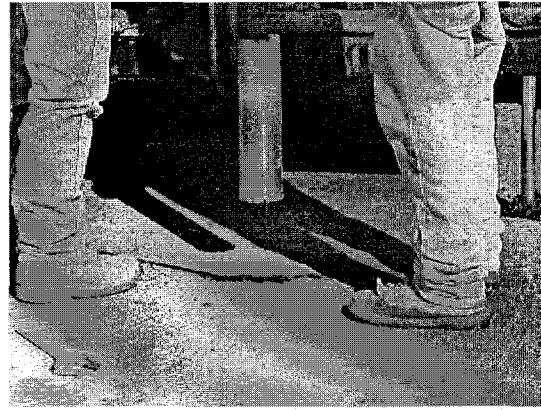
**Figure 68** – Coring concrete

Cores were taken from the newly paved intersection for depth measurement (Figure 68).

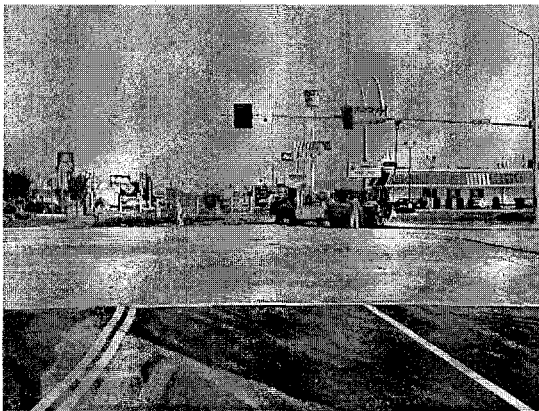
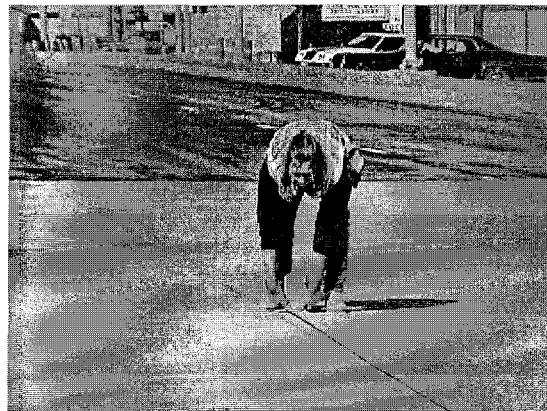
**Figure 69** – Placing striping

The next step was to place striping prior to opening to traffic. Figures 69 and 70 shows this operation.
