# BEST PRACTICES FOR PAVEMENT EDGE MAINTENANCE

Texas Department of Transportation

**Report No. 0-4396-1**

**May 2004**

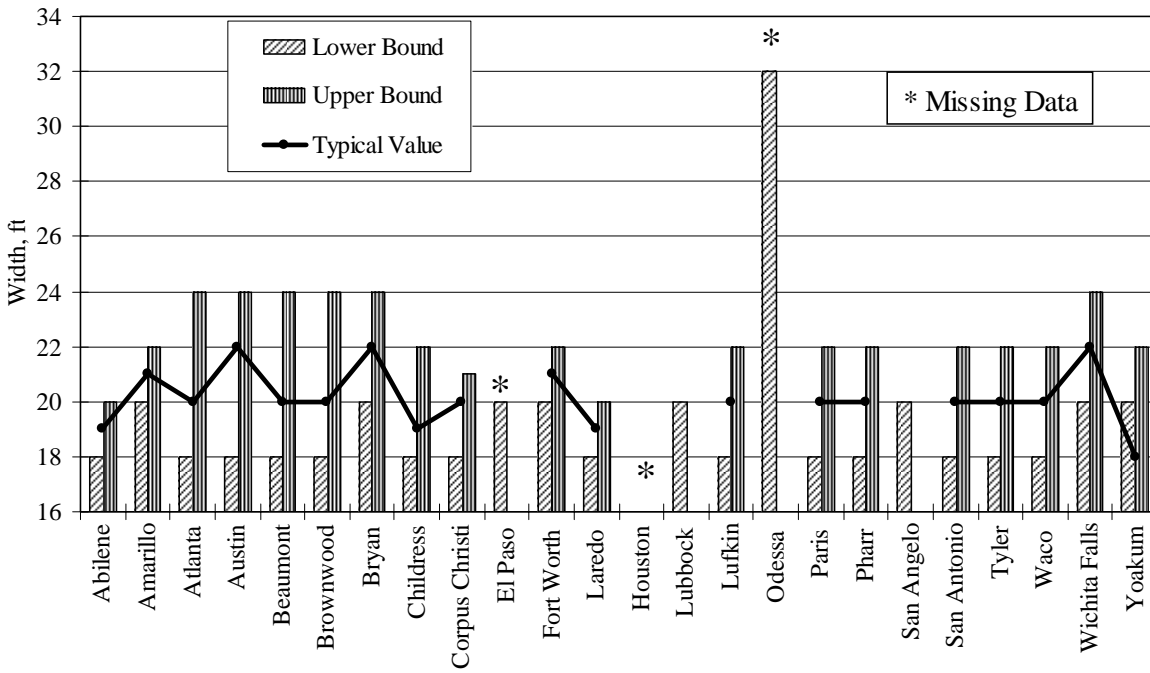
**FIG. 4.5.** Maintenance Supervisor Subjective Estimate of Typical FM Road Width, by District

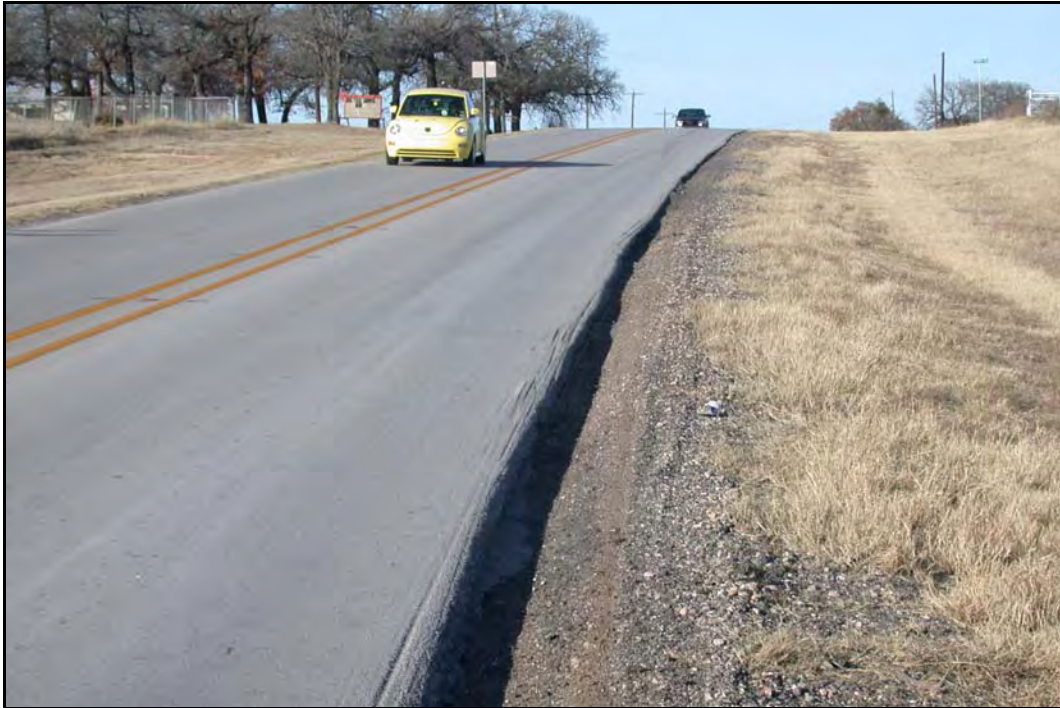
**FIG. 4.8.** Edge Drop-off at Relatively High-Volume, Narrow FM Road (21-foot width, ADT 4,400 vehicles/day).

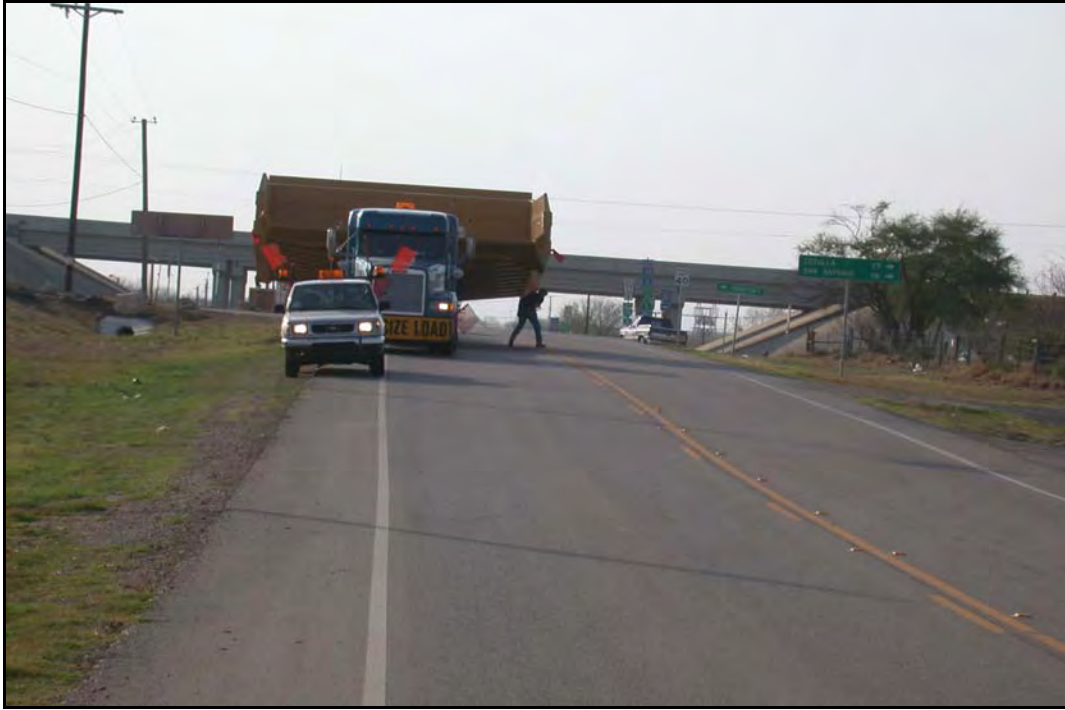
**FIG. 4.9.** Edge Damage due to Unconventional Traffic.

“unconventional traffic”, as explained in the low volume roads section (see Figure 4.9). On the other hand, roads in densely-populated urban areas frequently experience edge damage associated with the abusive or unauthorized use of the roadway such as left turn bypass maneuvers, cutting corners, or vehicle pull-offs. These unauthorized or abusive uses of the roadway actually can produce significant edge damage in a short period of time.

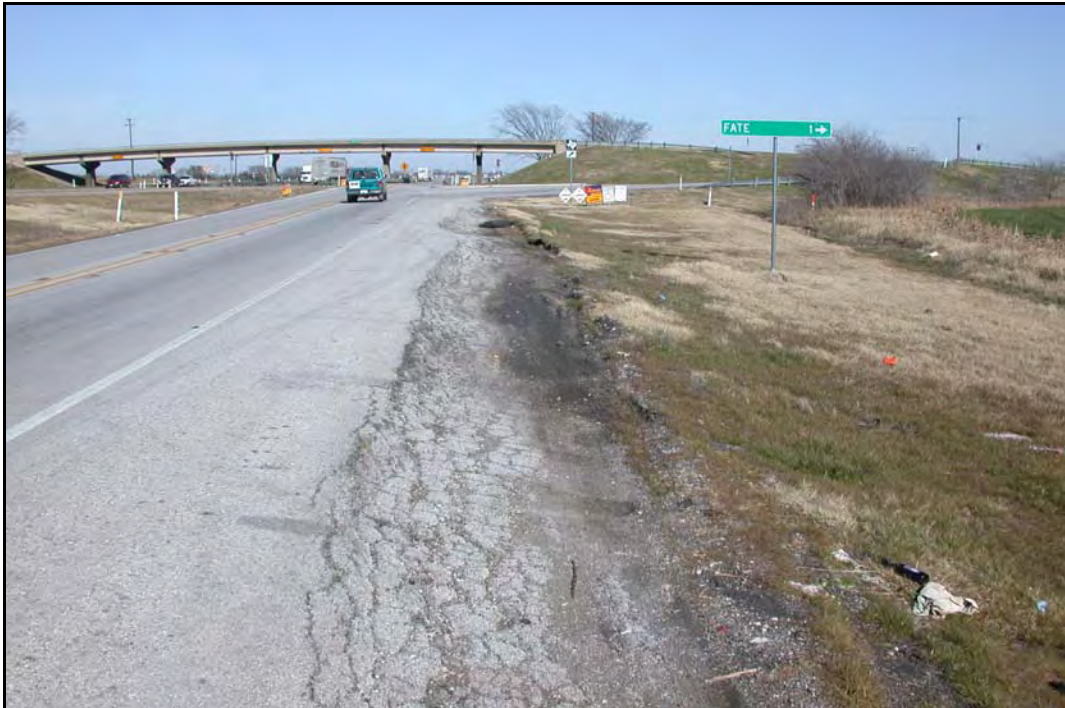
**FIG. 4.10.** Edge Damage Along Interstate Highway Access Road.

Interstate highways and similar controlled-access highways are designed to meet the needs of modern day traffic. Therefore, these highways are usually structurally and geometrically sound. Despite these facts, several districts have experienced edge damage or drop-offs on their interstate highways. Unlike edge drop-offs on narrow, low-volume roads, here the edge damage is mainly due to unauthorized uses such as truck pull-overs, illegal access or exit, and cutting corners, both intentional (illegal) and unintentional (run off the road). Some of these abusive uses occur on the frontage road instead of the main highway (see Figure 4.10). Also, edge damage may result from failure to pull edges after an overlay, or from inadequate backfill due to the limitations in the specification.

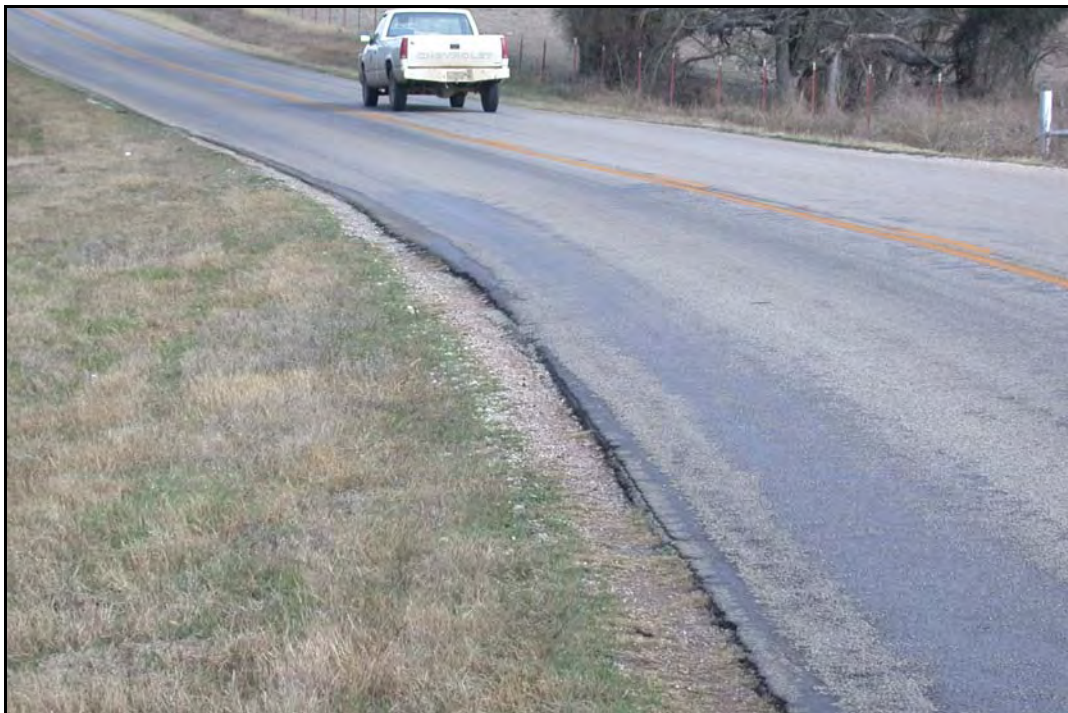
**FIG. 4.11.** Typical Edge Drop-off at Inside Horizontal Curve on a Low Volume FM Road.

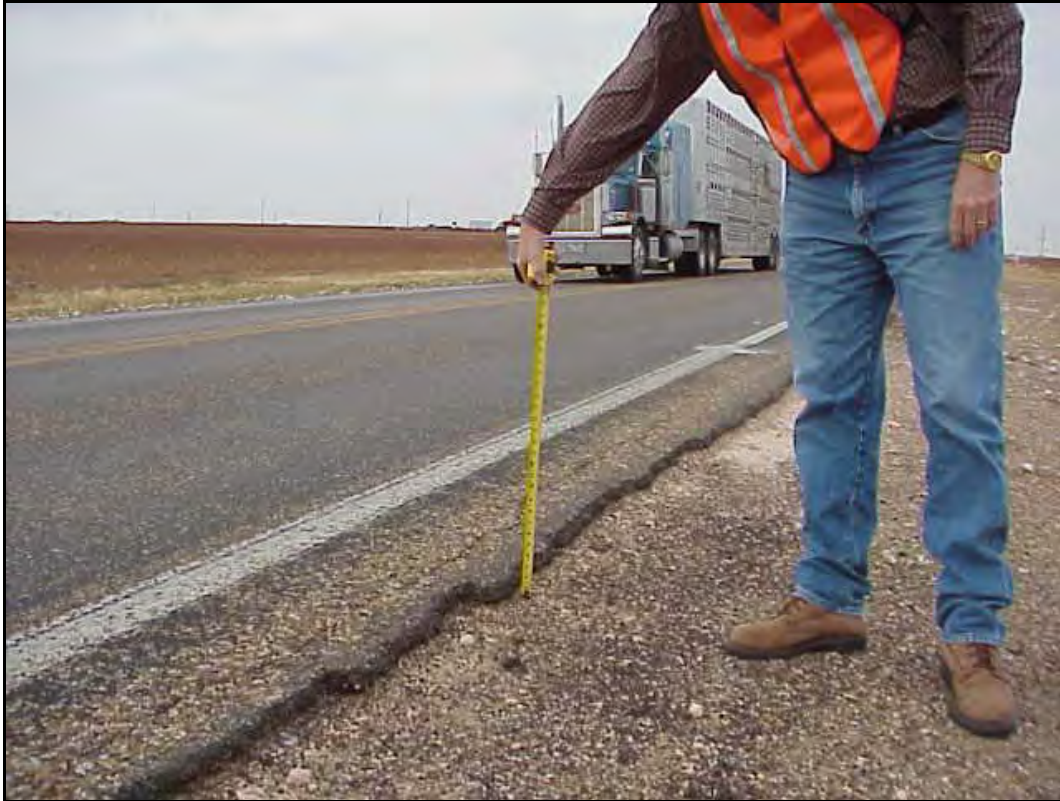
**FIG. 4.15.** Typical Pavement Edge Damage Associated with Cotton Production in West Texas.

continuous once the harvest begins. When processing plants start their operation, it is costly to shut down even during adverse weather; therefore, the operations keep running despite weather conditions and this aggravates edge damage significantly. In the case of the oilfield or logging industry, oftentimes trucks create access to these sites by simply driving across the ditch line, creating significant edge damage.

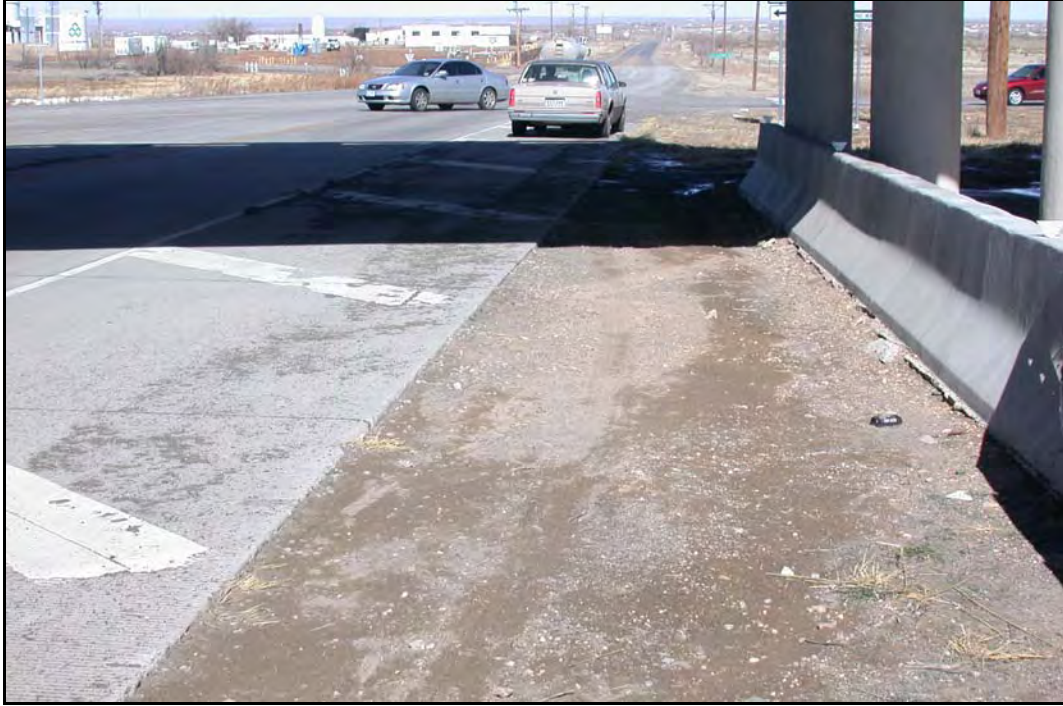
**FIG. 4.16.** Pavement Edge Damage Associated with Vehicle Pull-offs Beneath an Overpass.

One of the most common abusive uses of the roadside edges consists of trucks pulling over on the side of the road. This is a very common scenario on Interstate highway systems but also happens on other State, US, or FM roads with high traffic volume. The truck drivers often pull over on the shoulder to rest or sleep, check their load, or whatever, especially near an intersection or interchange, and oftentimes underneath an overpass (see Figure 4.16). Sometimes these pullovers are not intentional. For example, in certain stretches of highway and at certain times of the day, trucks are not permitted on the Interstate which forces them to pull over and in a few cases it is due to the fact that the rest areas are completely occupied. This may cause deep edge drop-offs, sometimes as high as 8 to 10 inches.

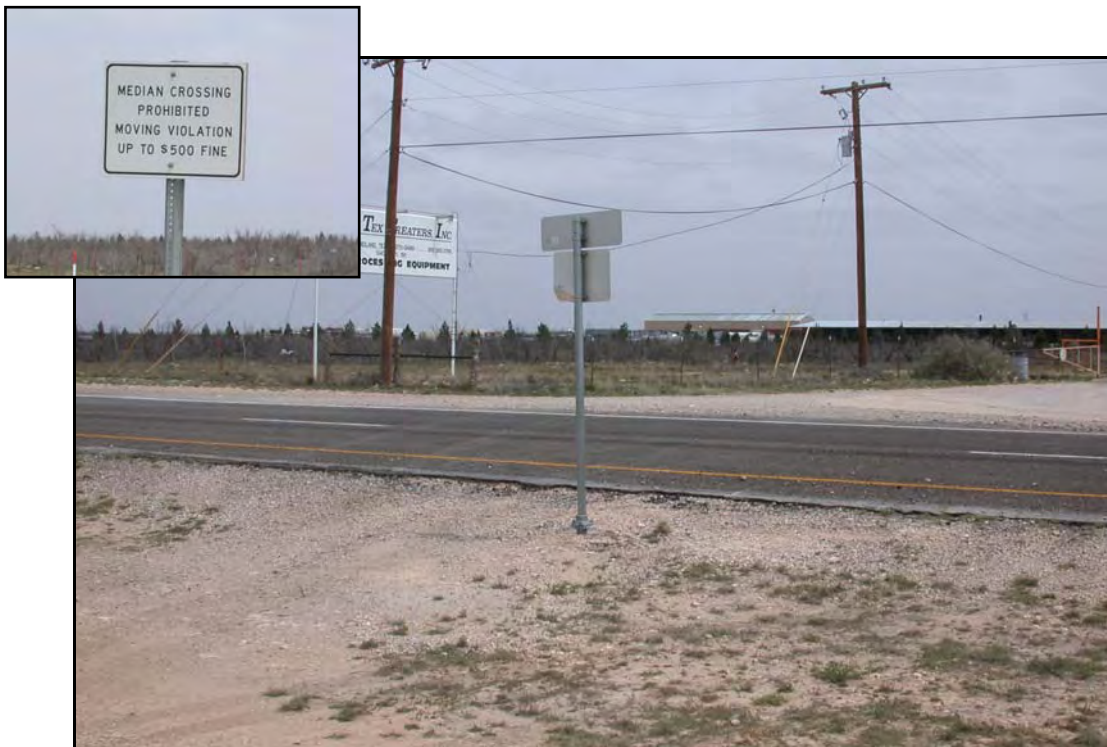
**FIG. 4.17.** Pavement Edge Damage Associated with Illegal Median Crossing. The Inset Shows the Regulation Sign Posted Where the Crossing Continues to Occur

For many reasons, motorists often find it convenient to cross the median of highways at locations other than a designated intersection. These illegal maneuvers commonly occur on divided or controlled access highways in both rural and metropolitan areas (see Figure 4.17) and this can cause significant pavement edge damage. Similarly, impatient motorists on freeways in congested urban areas frequently create their own exit ramps by cutting off the pavement across the median to access the service road, and this activity also damages the pavement edge. They may even drive on the shoulder, considering it a part of the lane. These abusive maneuvers create edge drop-offs on both the Interstates and frontage roads. Some vehicles may cut across the ramps or exit the highway if they miss a designated exit or turn. In a few districts where the general terrain is flat (e.g. Odessa), drivers cut across the median or drive over the right-of-way to gain illegal access to the Interstate without hesitation. Garbage trucks and mail carriers often drive on the edge to go from one house to the next, all of which creates substantial edge damage.

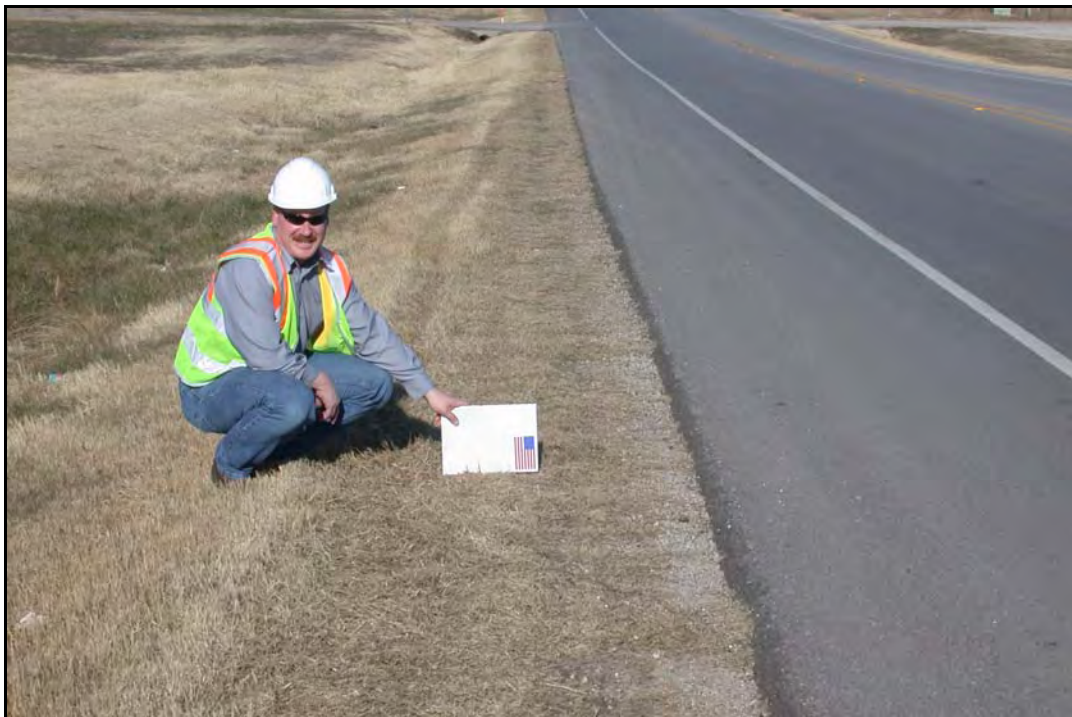
**FIG. 4.19.** Typical Edge Damage Associated with Illegal Left-Turn Bypass Maneuver.

Although left turning is not an unauthorized use, passing off the shoulder area is an illegal maneuver. The road condition and traffic associated with such a maneuver typically involves a two-lane, relatively high-volume road with narrow shoulders. Here, as a vehicle slows to make a left turn to access a housing area or an industrial driveway, due to the high volume of traffic the left-turning vehicle often has to wait a while before it can make a safe turn. Other vehicles behind the left-turning vehicle, rather than waiting, pull around to pass the left-turning vehicle on the right, perhaps leaving one tire on the edge of pavement when a narrow shoulder exists. These maneuvers cause significant damage to the pavement edge (see Figure 4.19). The medium-width shoulder, in this instance, becomes as much an attractive nuisance as a benefit to drivers. Unlike typical low-volume edge damage, here the edge drop-off occurs at the edge of the shoulder.

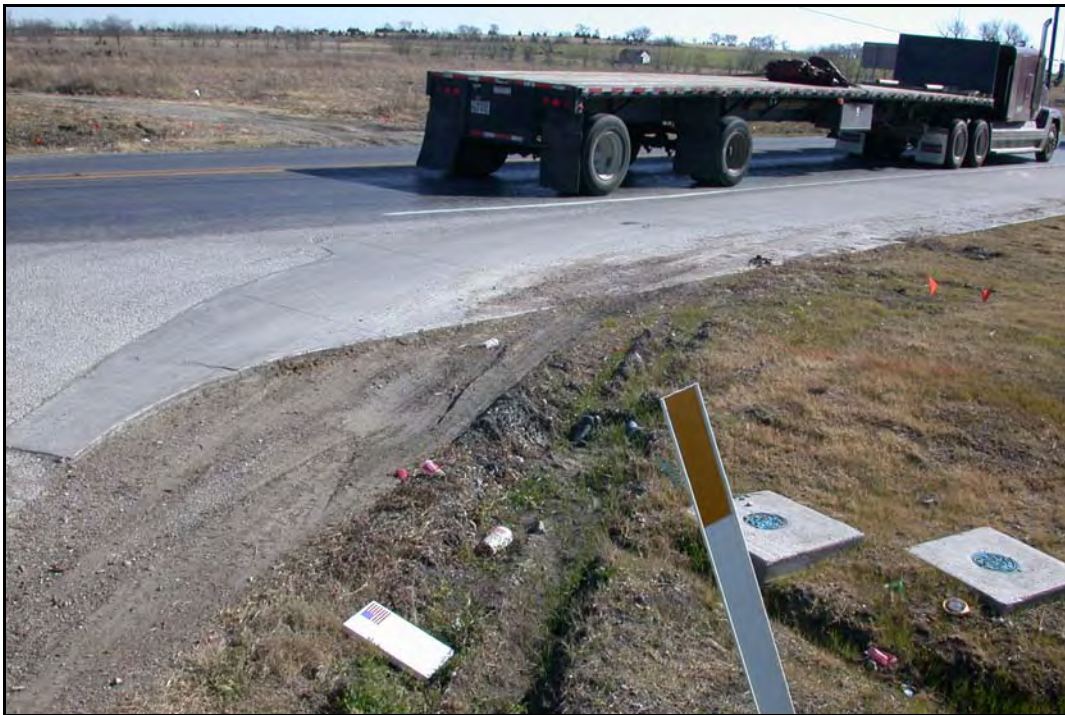
**FIG. 4.20.** Edge Damage Caused by Cutting Corners at a Convenience Store Access Drive.

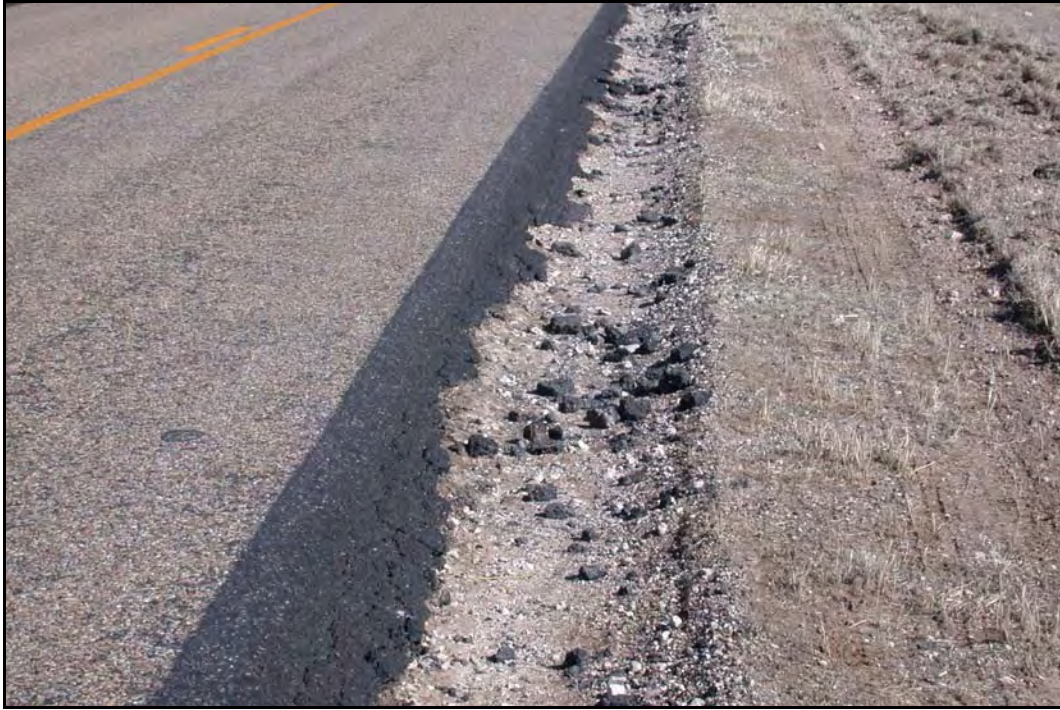
**FIG. 4.22.** Typical Edge Damage on a Low Volume Road Caused by Snow Plow Operations.

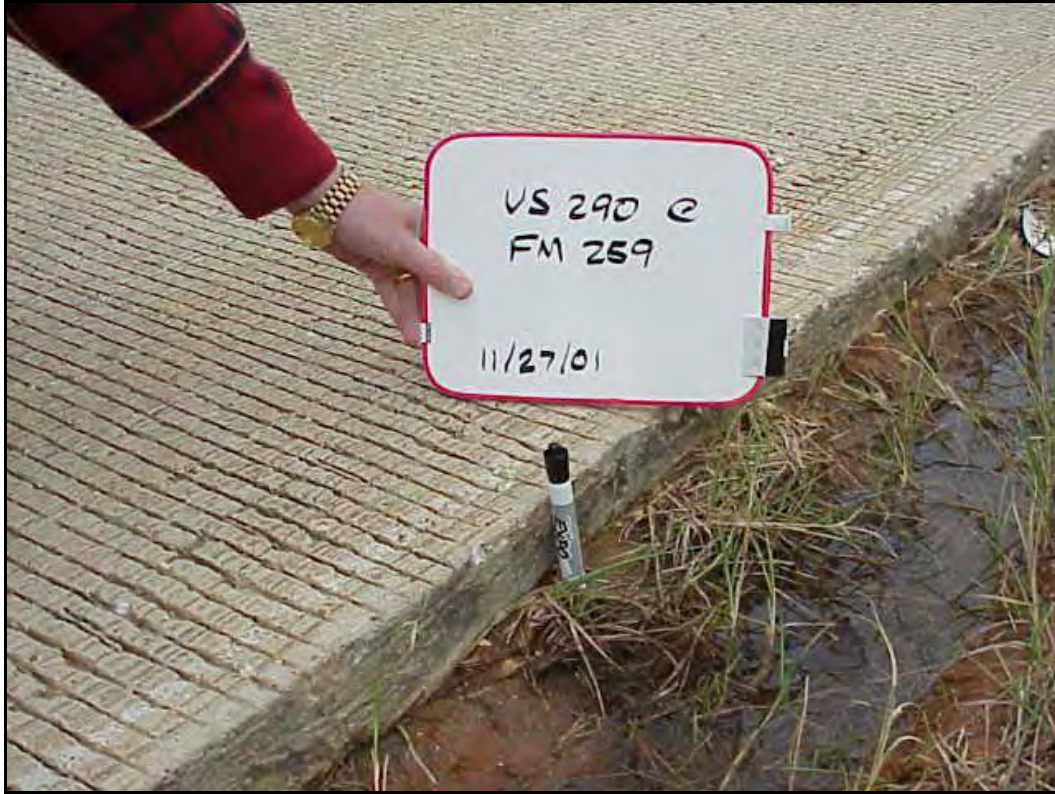
**FIG. 4.26.** Edge Drop-off Associated with Wet Subgrade Along the Edge of Pavement

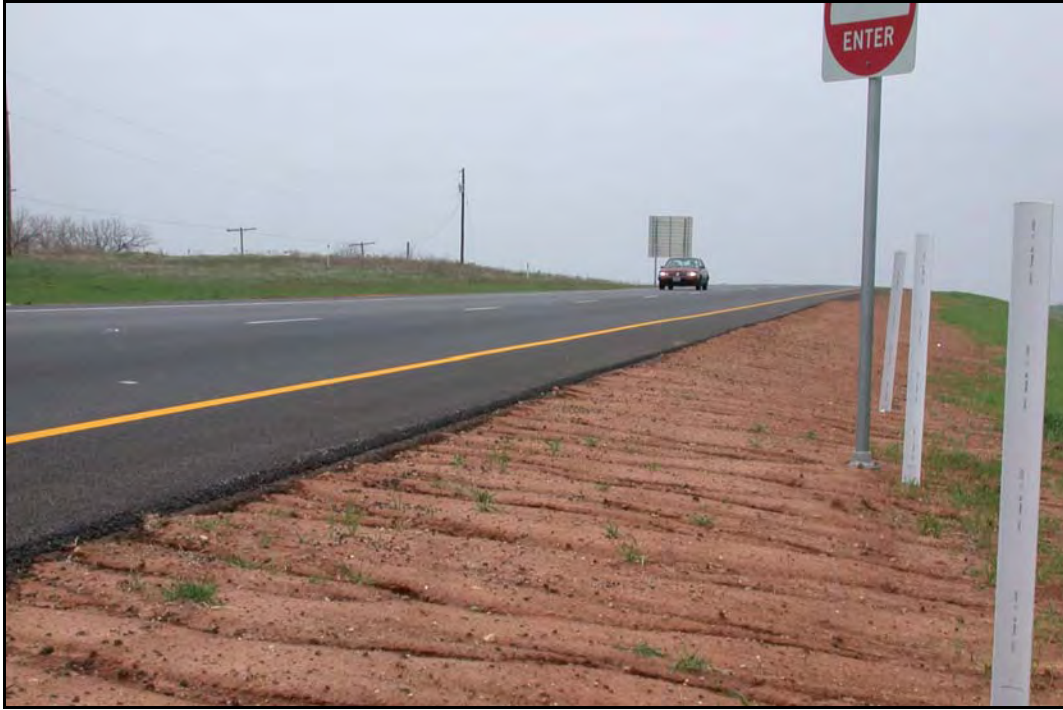
**FIG 5.6** Soil Erosion of Pavement Edge Backfill due to Improper Specification, Wichita Falls District (see Wichita Falls District Profile, Photo 7)

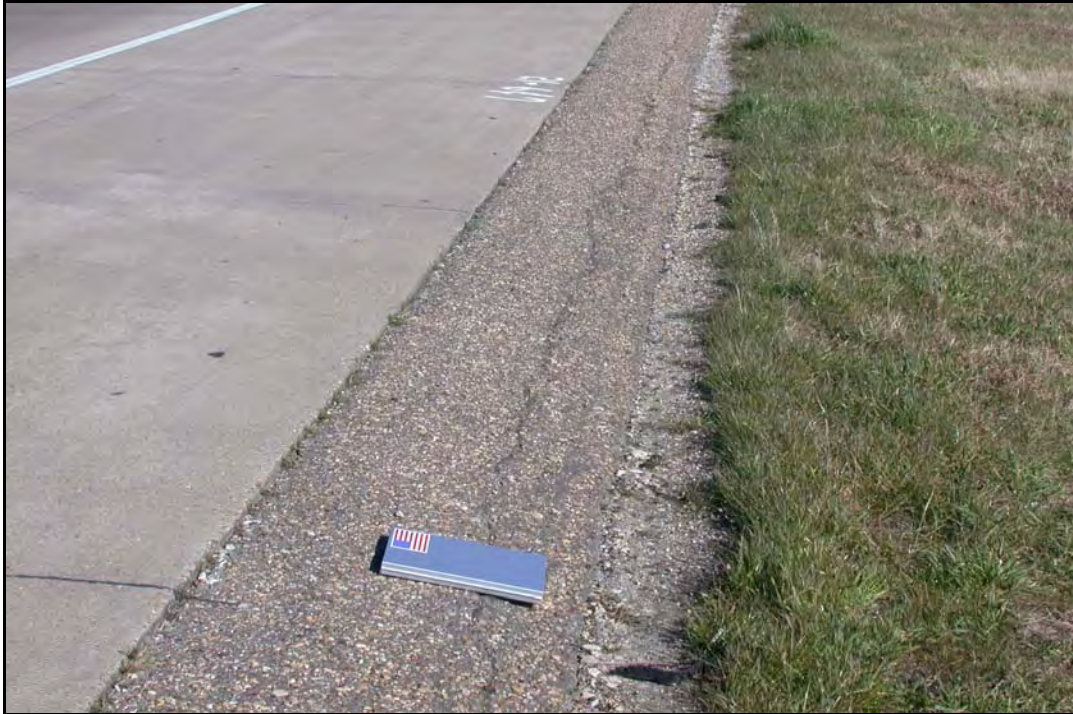
**FIG 5.7** Tapered Edge Detail, Dallas District (see Dallas District Profile, Photo 6)

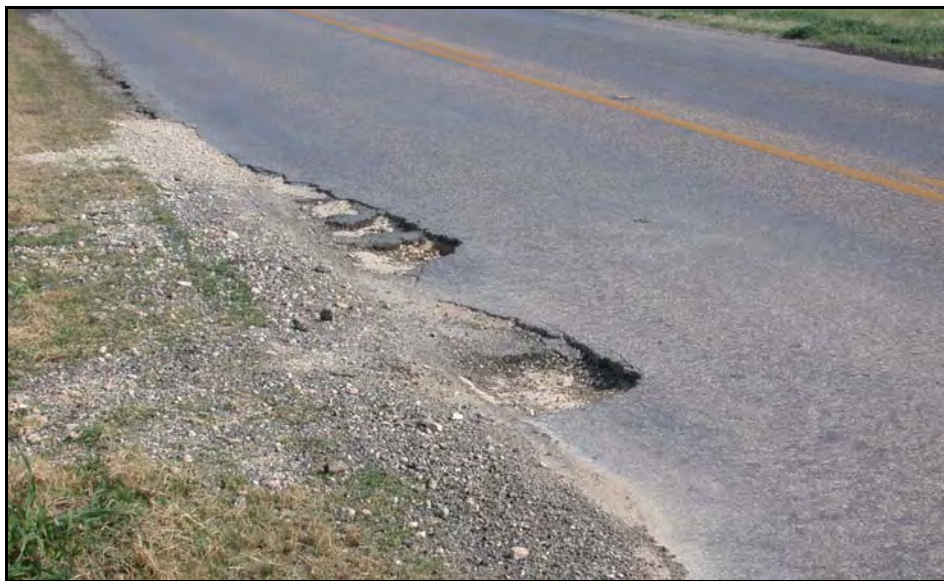
**FIG 5.22** Fishmouth-type Edge Failure, San Antonio District (see San Antonio District Profile, Photo 12)

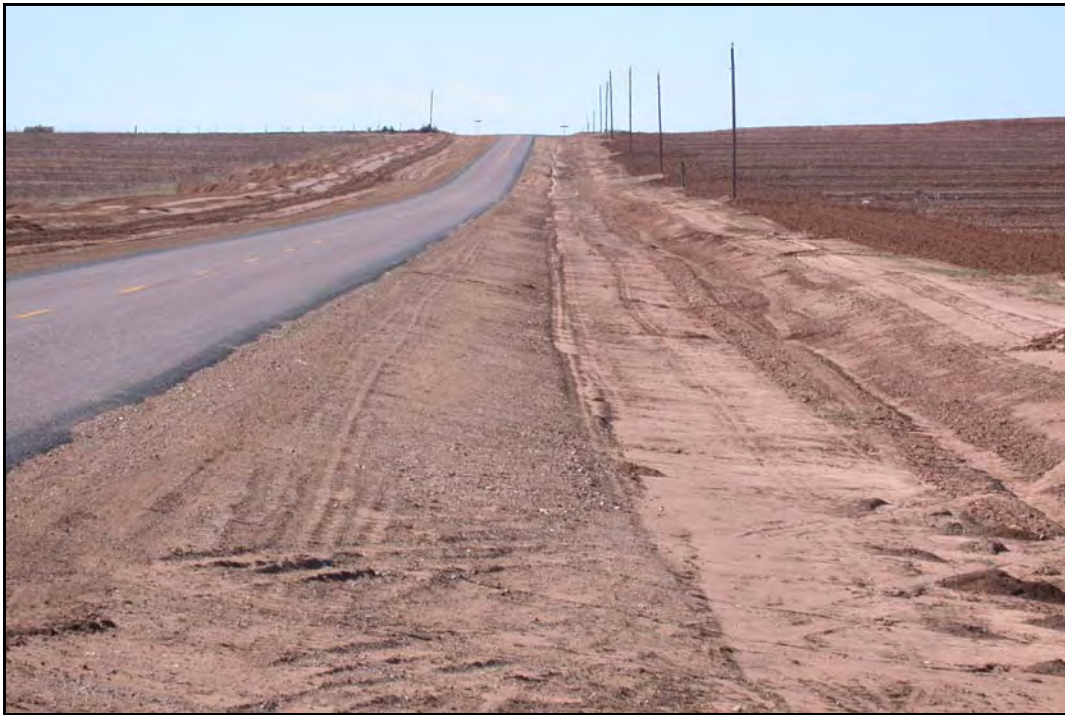
**FIG 5.23** Reshaping (Pulling) Shoulders, Childress District (see Childress District Profile, Photo 15)

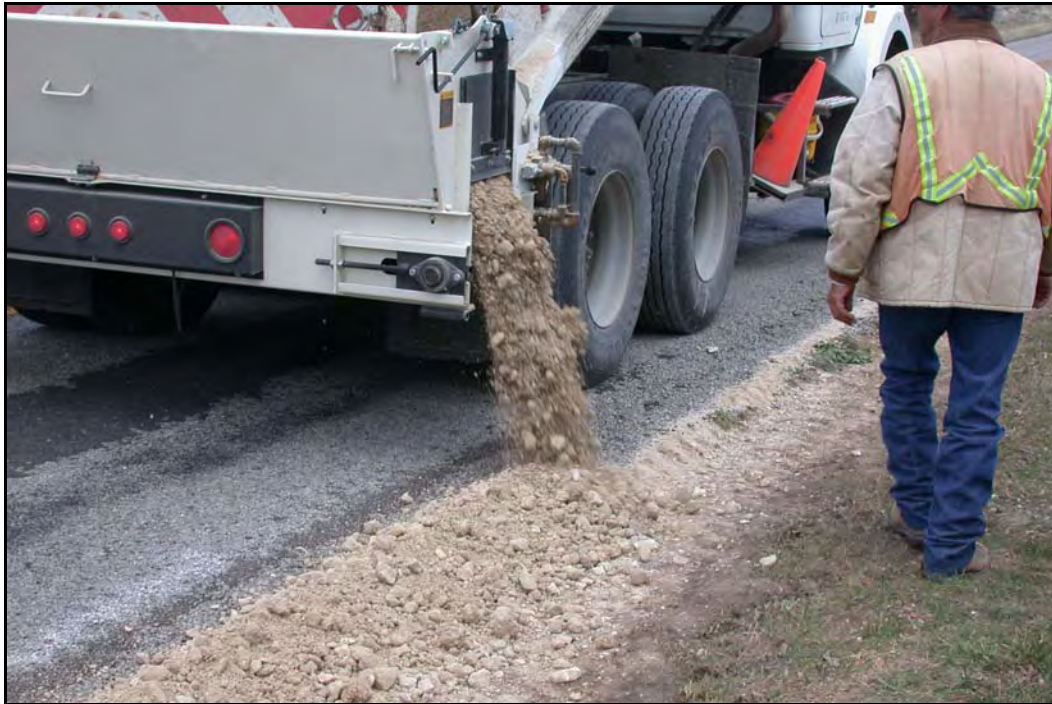
**FIG. 5.27** Delivering Flex Base to the Pavement Edge Using a Swenson Tailgate Cross Conveyor (a.k.a. “Swenson Spreader”), Brownwood District (see Brownwood District Profile, Photo 13)

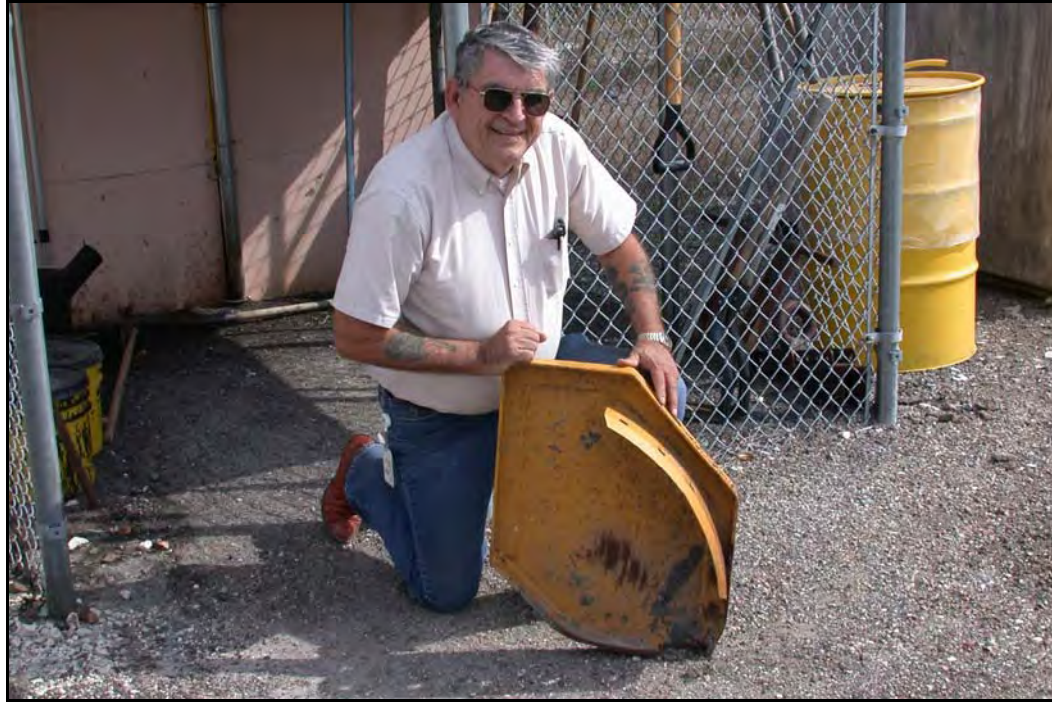
**FIG. 7.3** Motor Grader Blade Shoe for Pulling Shoulders, Corpus Christi District (see Corpus Christi District Profile, Photo 9)

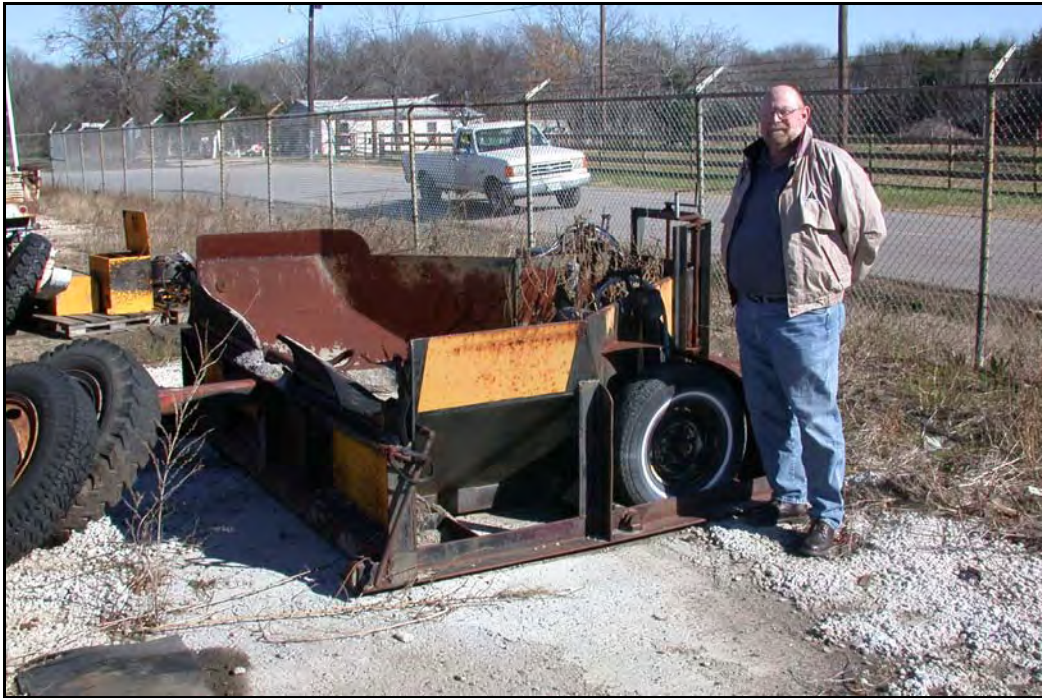
**FIG. 7.8** Drag Box; Tow-Behind, Used for Delivering Material to the Left, Center, or Right Side of Pavement, Waco District (see Waco District Profile, Photo 8)

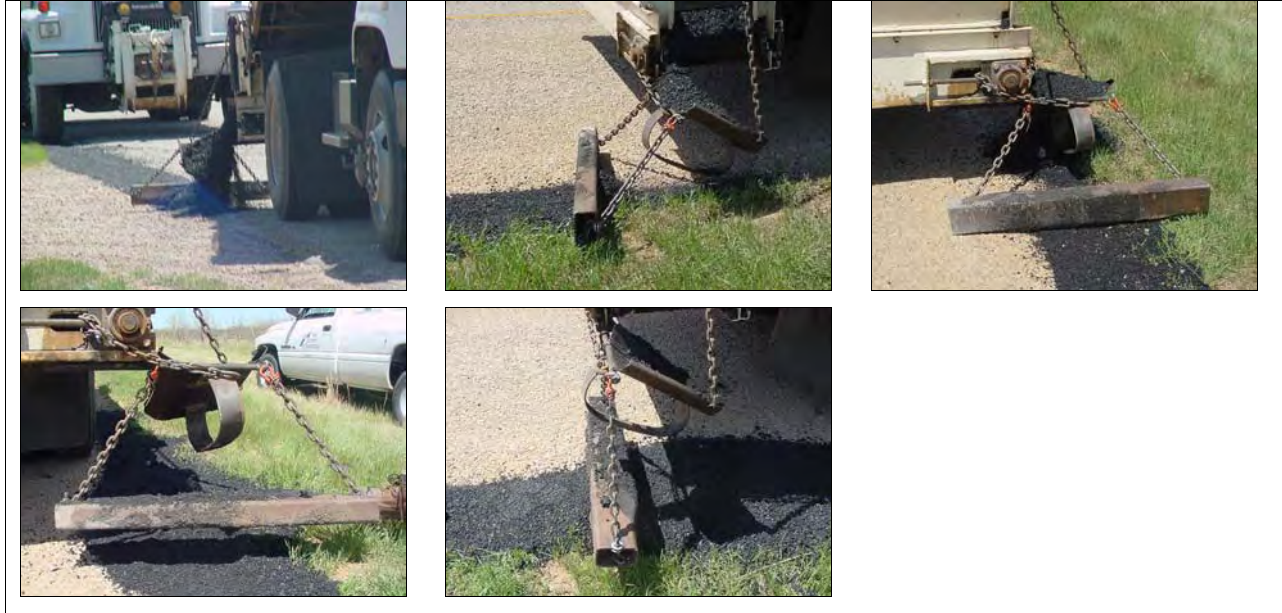
**FIG. 7.15** Photo Series: Side Discharge Chute and Tow-Behind Drag Bar for Edge Repair, Wichita Falls District

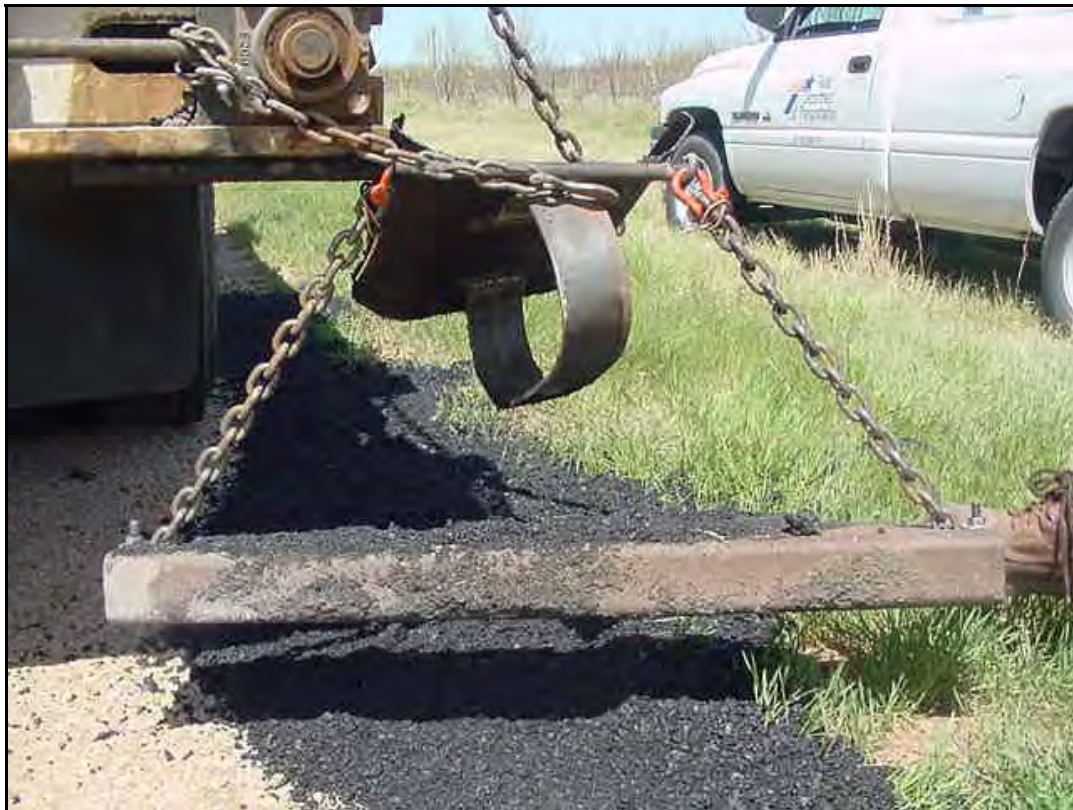
**FIG. 7.16** Close-up View, Side Discharge Chute and Tow-Behind Drag Bar for Edge Repair, Wichita Falls District

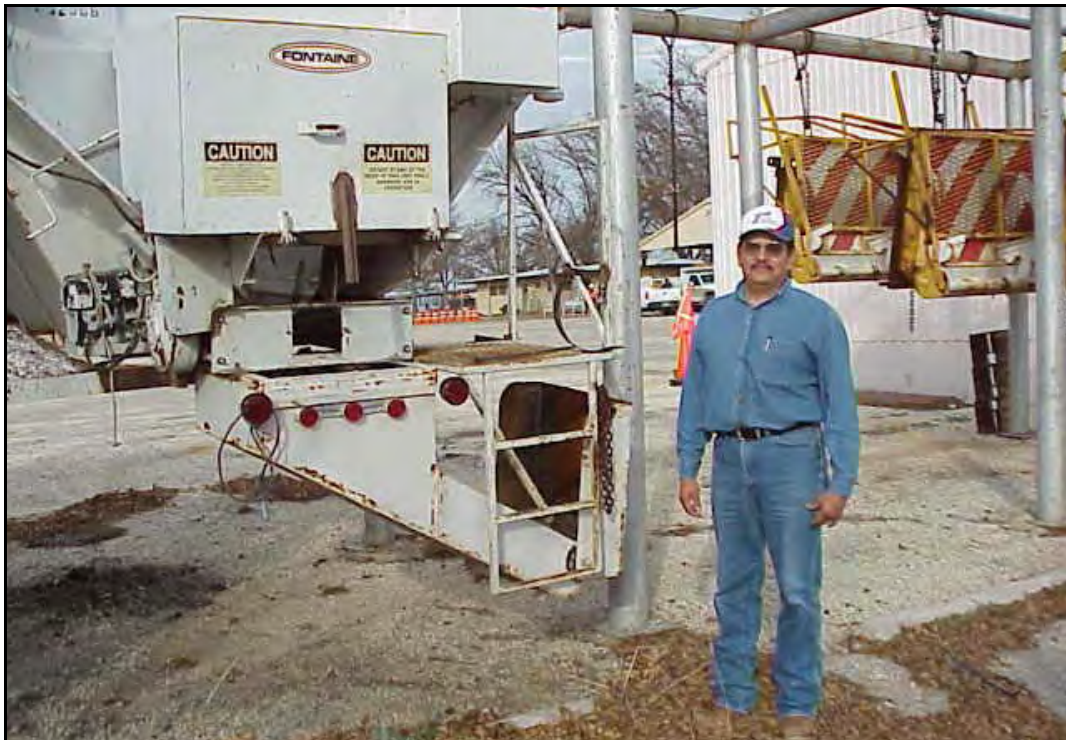
**FIG. 7.17** Modified V-Box Side Discharge Spreader: End View, San Angelo District (see San Angelo District Profile, Photo 16)
