Publication No. FHWA-RD-88-072
July 1989

Rehabilitation of Concrete Pavements

Volume II: Overlay Rehabilitation Techniques

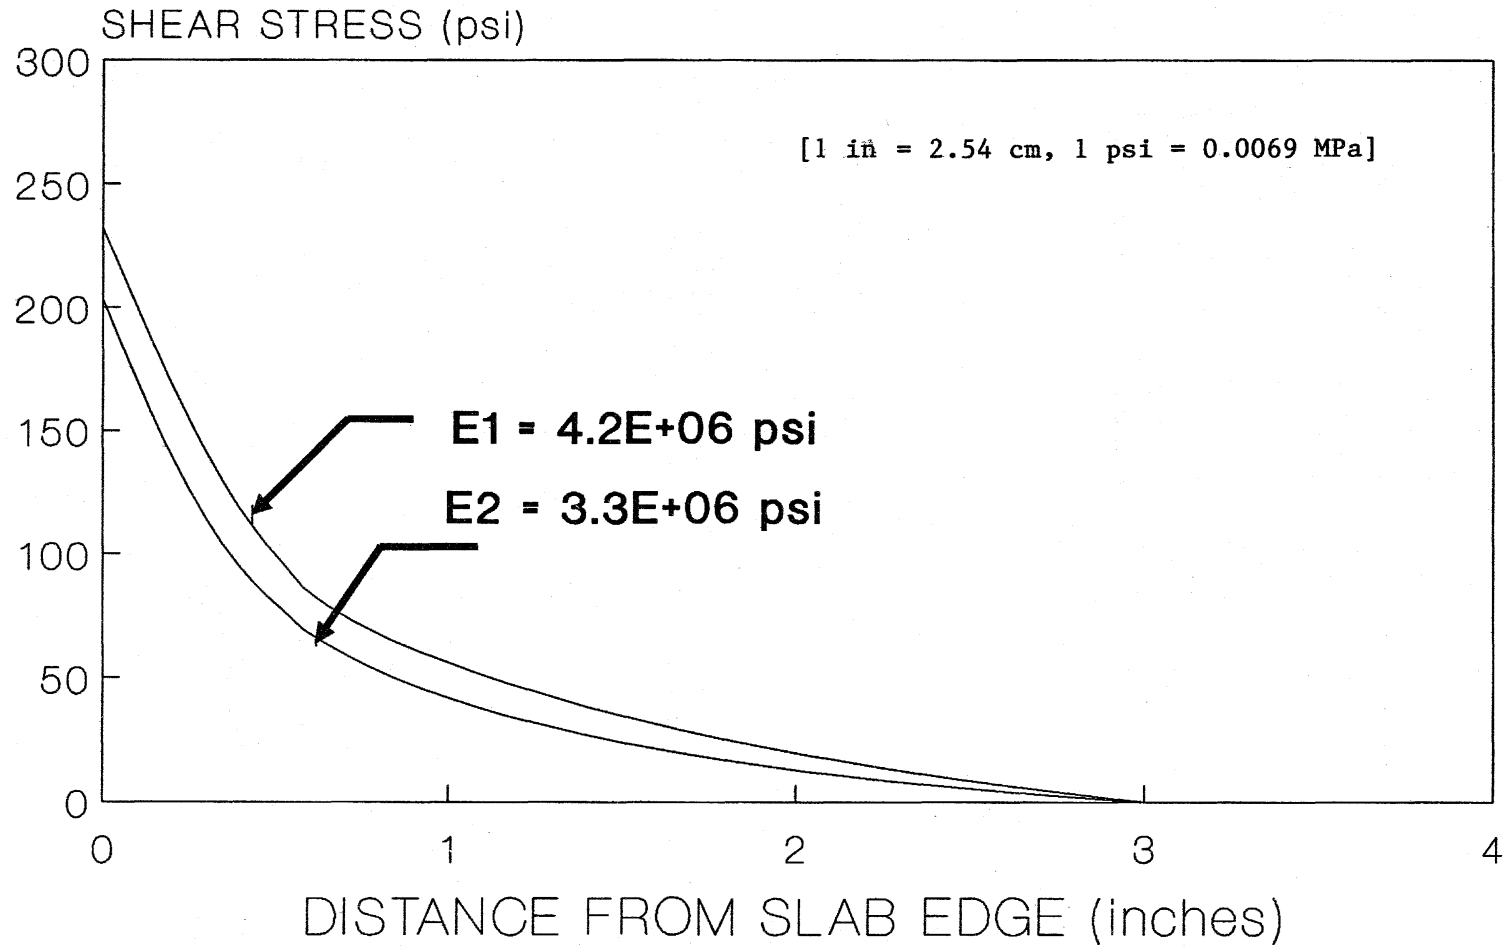
Figure 12. Shear stress distribution for a 1-in bonded concrete overlay from drying shrinkage effects. (30)

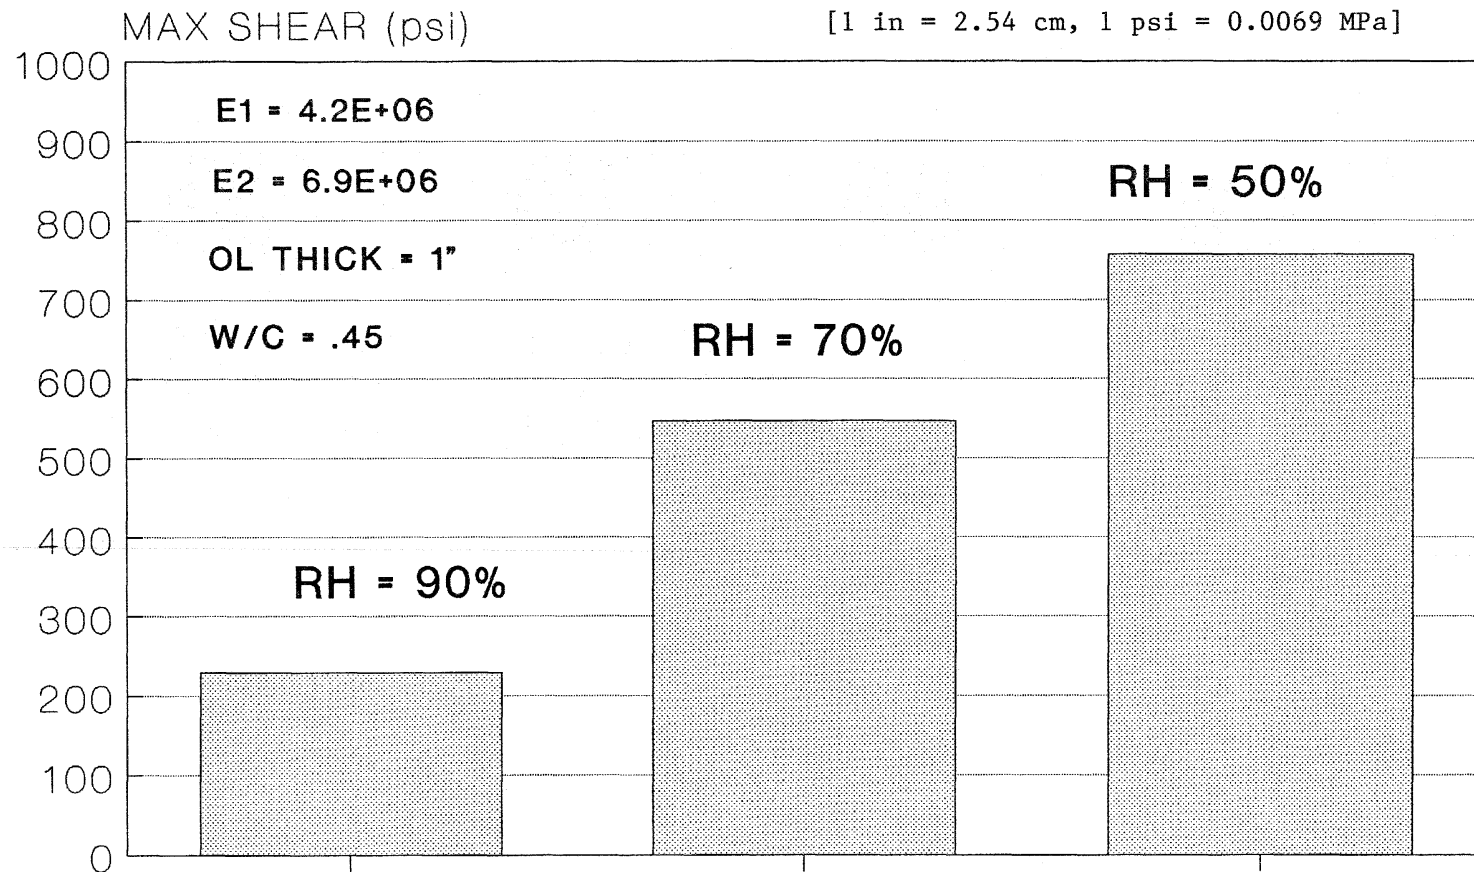
Figure 13. Shear stress induced by drying shrinkage of the bonded overlay at various ambient relative humidity levels. (30)

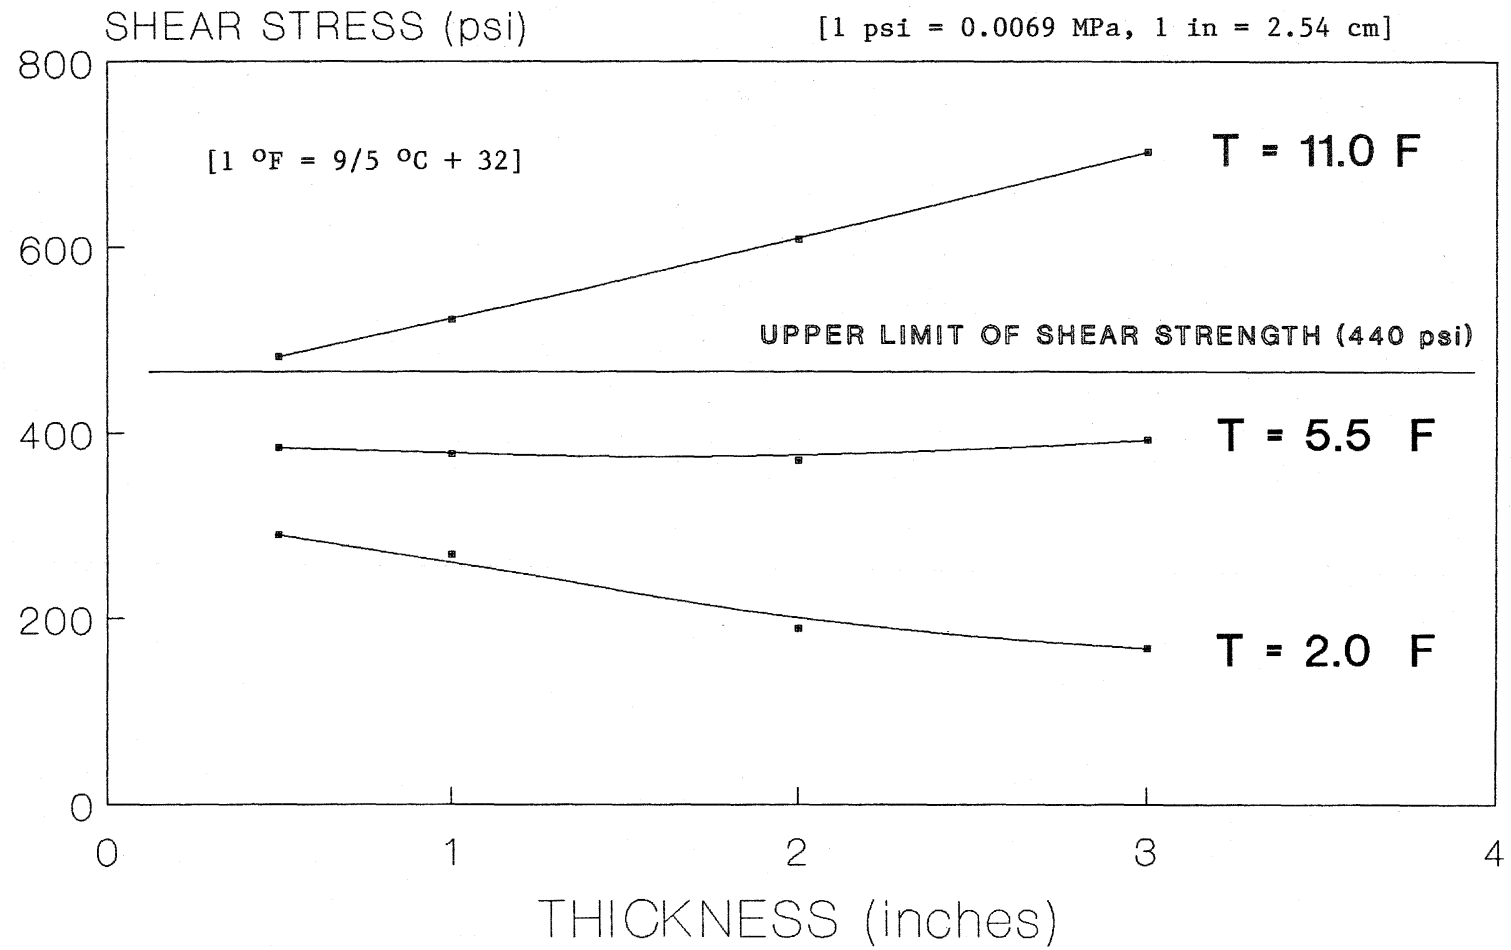
Figure 16. Maximum shear stresses due to shrinkage and differential temperature effects. (30)

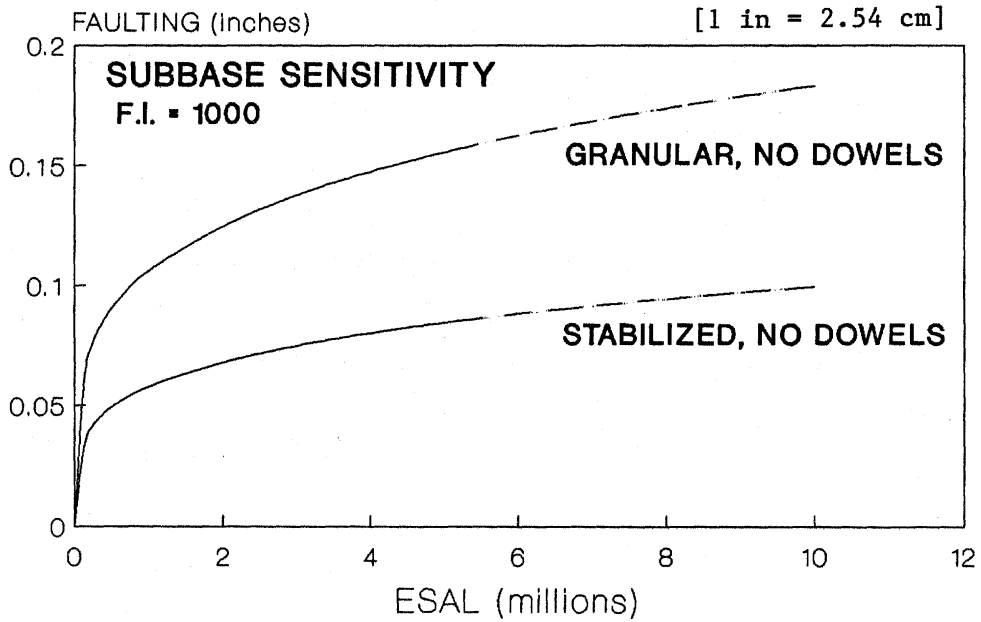
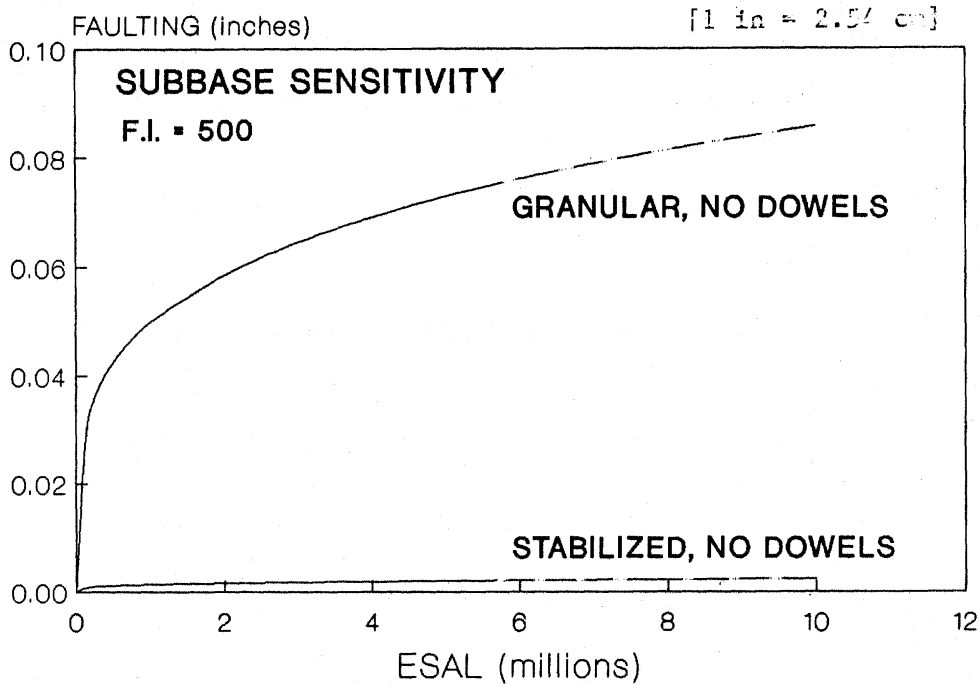
Figure 17. Sensitivity of bonded overlay faulting model to subbase type and freezing index.

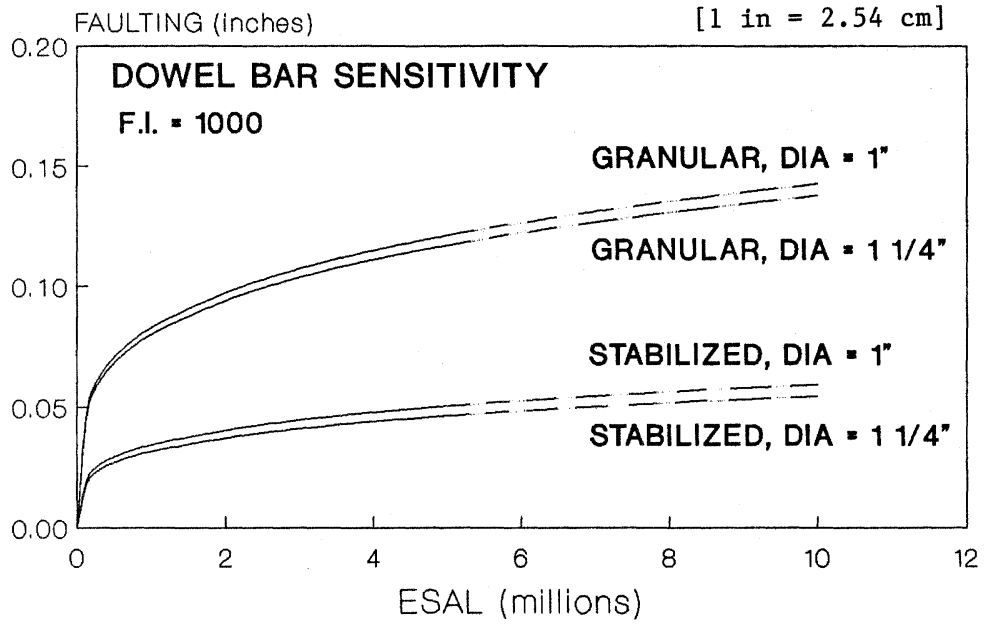
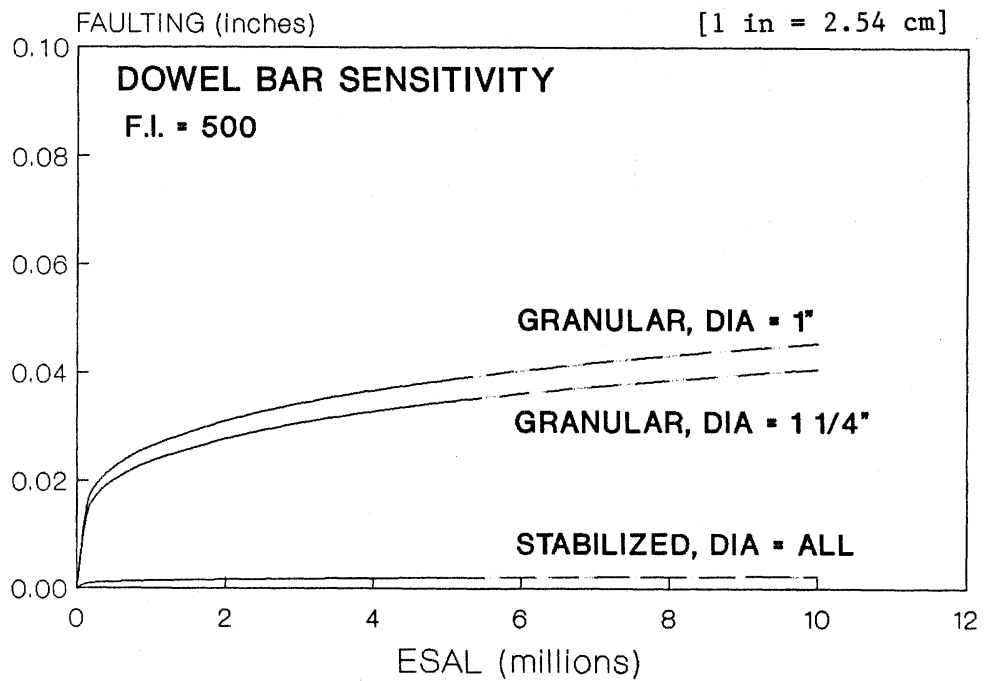
Figure 18. Sensitivity of bonded overlay faulting model to dowel diameter and freezing index.

indicates very little potential for faulting on overlay pavements in the south where Freezing Index is low. In practical terms, the Freezing index is a parameter that relates to the seasonal joint opening at the contraction joints.(1) Where joint openings are wider (Freezing Index is higher) there is both less aggregate interlock and if dowels are present, greater bearing stresses induced on the dowel bars in the existing pavement. Both of these phenomena lead to increased faulting.

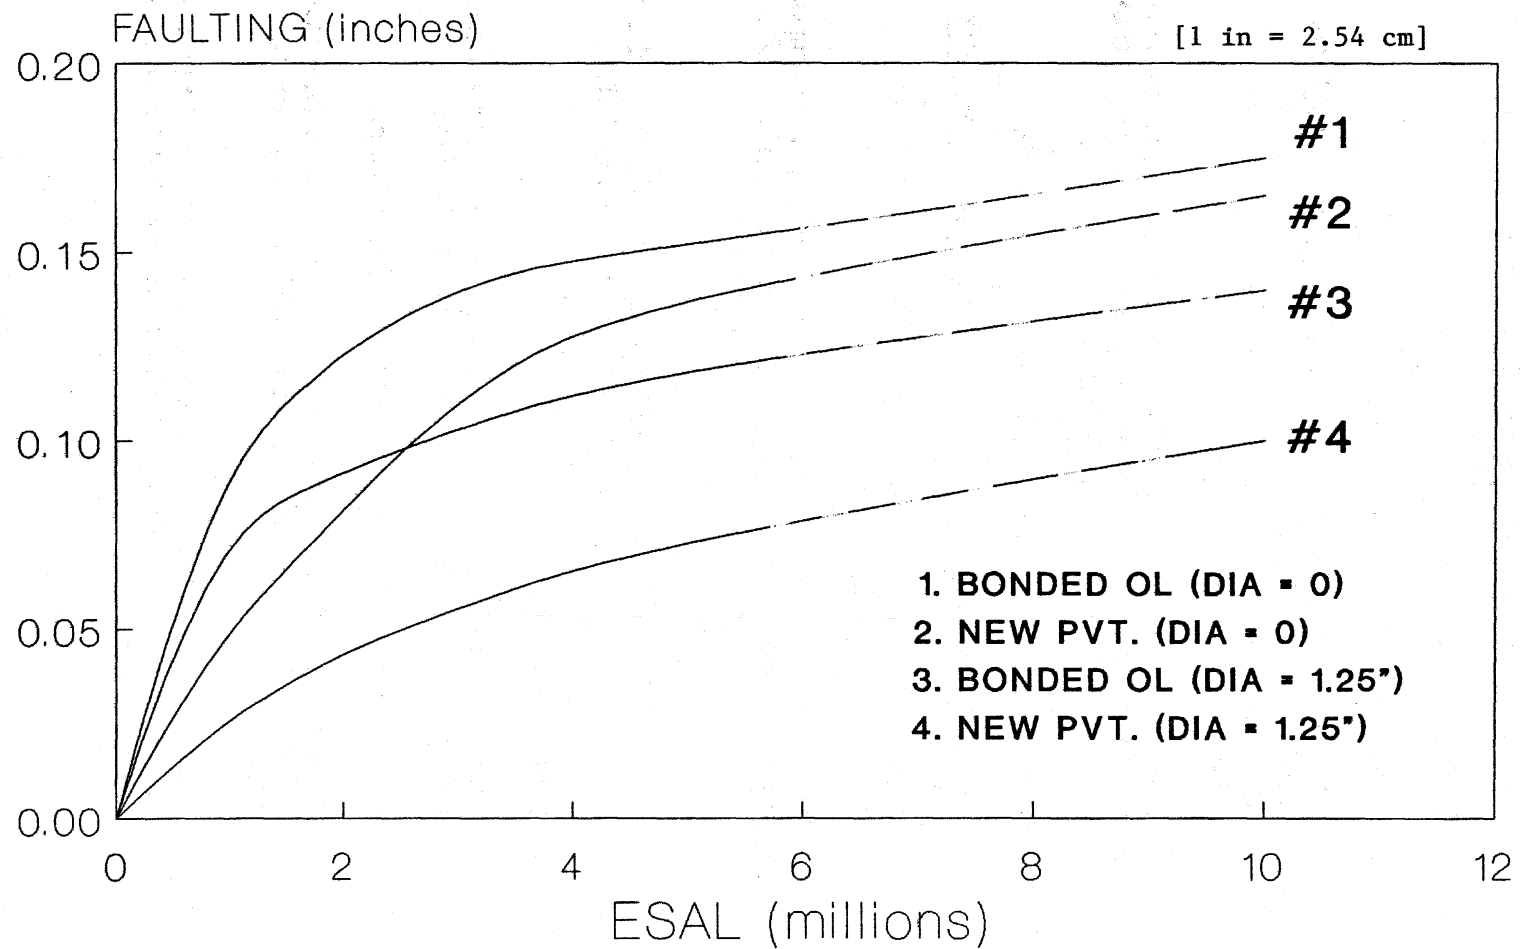
Figure 19. Comparison of predicted faulting on bonded overlays to predicted new pavement faulting.

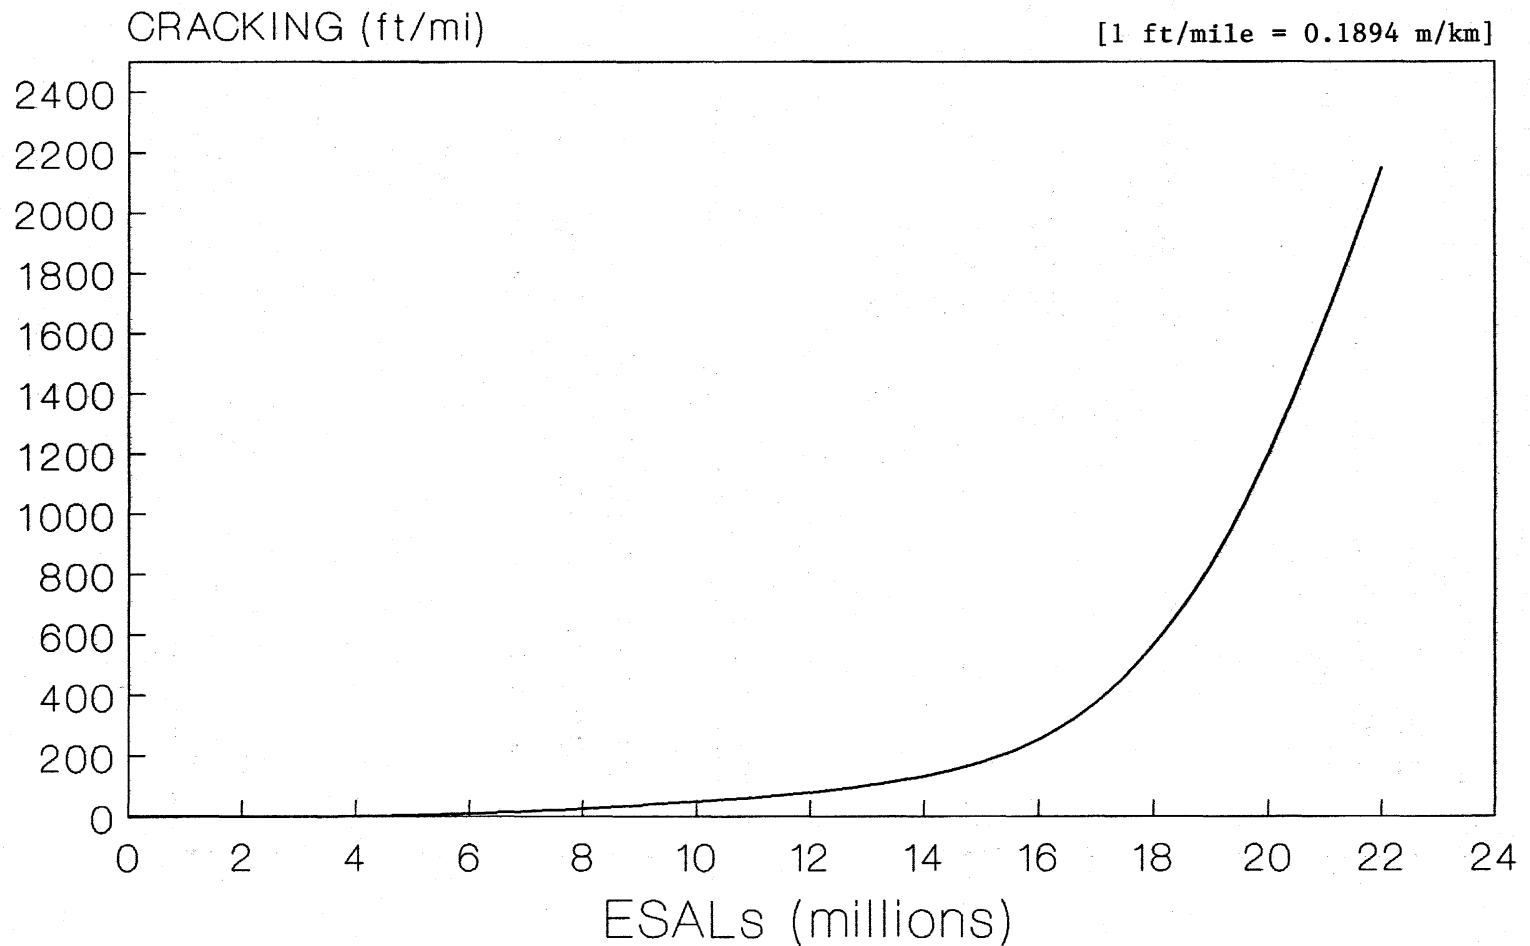
Figure 22. Typical fatigue cracking development curve.

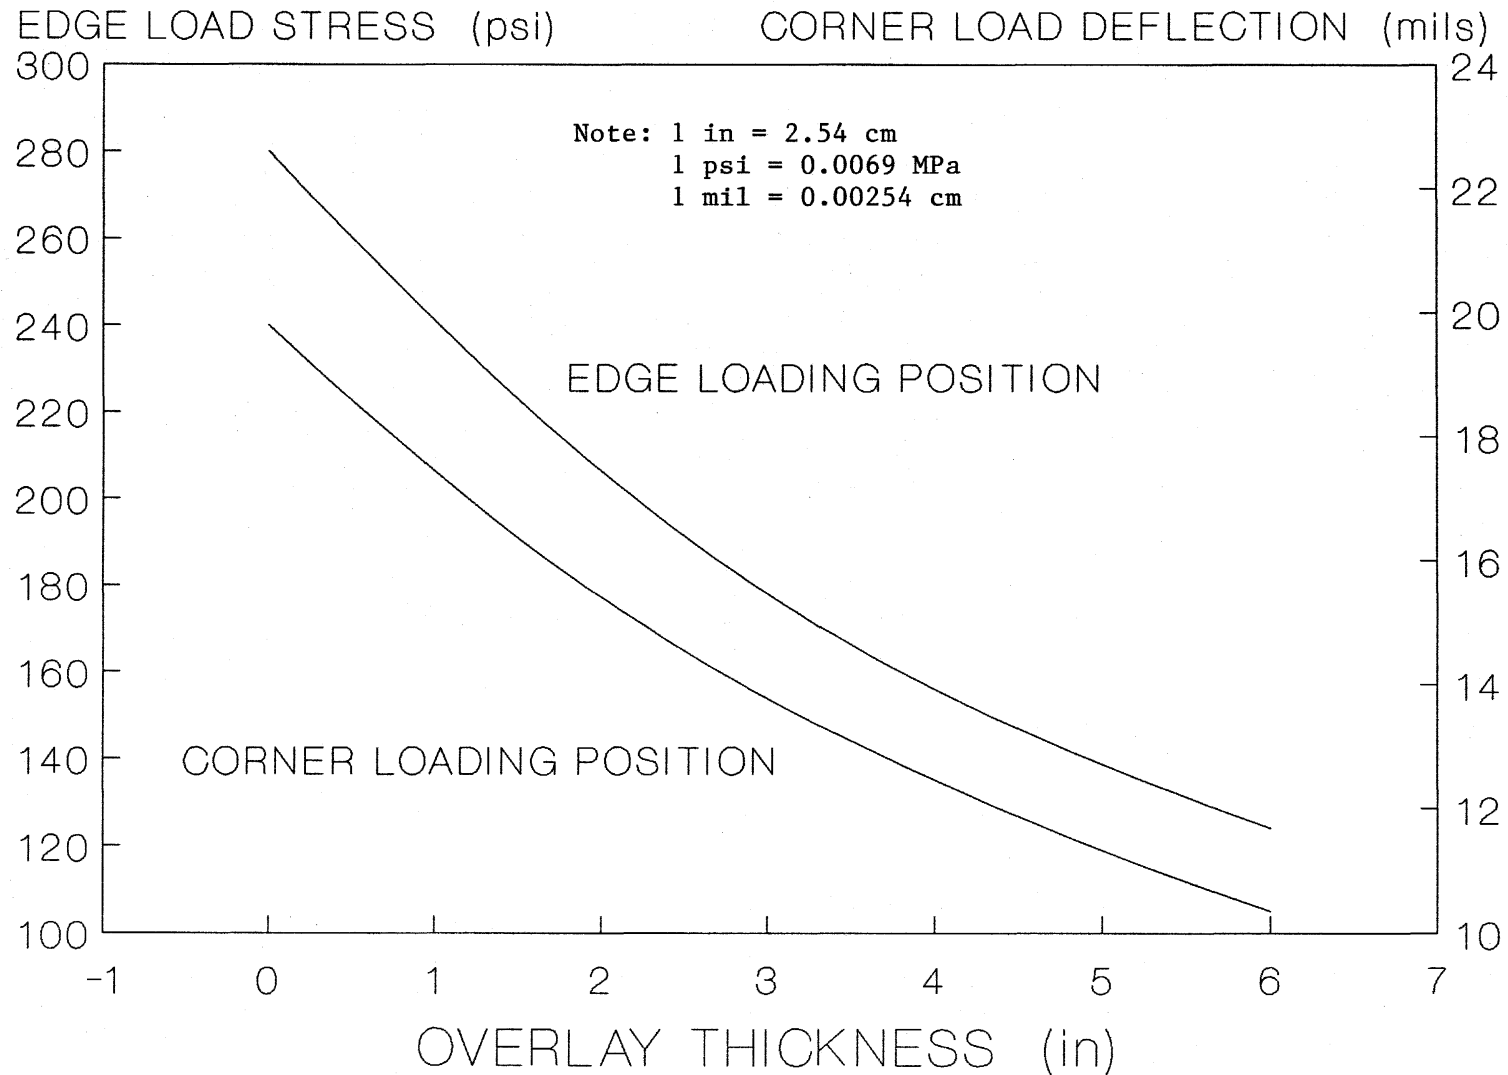
Figure 23. Edge load stress and corner deflection versus overlay thickness on a standard 9-in concrete pavement. (Developed by ILLI-SLAB modelling of a 9 kip wheel load [tire pressure = 75 psi] positioned at free edge and corner.)

The addition of a few inches of portland cement concrete bonded to the existing slab thickness results in reduced critical stresses and deflections in the slab system. Typically, the critical tensile stress is located along the outside edge at the bottom of the existing slab under an edge wheel load. It is highly advantageous when both the old and new overlay concrete act together as one monolithic
