Validation Study for Detection and Quantification of Corrosion in Bridge Barrier Rails

Final Report | December 2018

Sponsored by
Federal Highway Administration
Iowa Department of Transportation
(InTrans Project 15-538)

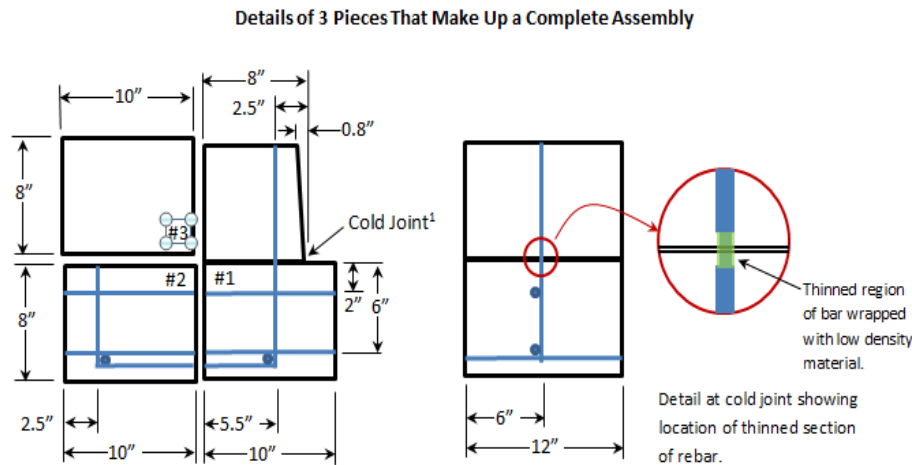
In the initial phase, there were three technologies evaluated: x-ray radiation, GPR, and a magnetic flux leakage (MFL) approach using a giant magnetoresistance (GMR) sensor. A set of controlled samples (Figure 1) containing pristine reinforcing steel with and without epoxy, and reinforcing steel with 25% and 50% section reduction, were embedded in concrete at a depth of 2.5 in. from the sample surface.

- Notes: 1 – Cold joint could be simulated using a thin piece of plastic to separate the two pieces.
2 – Embed bent rebar for handles for lifting on sides of specimens.

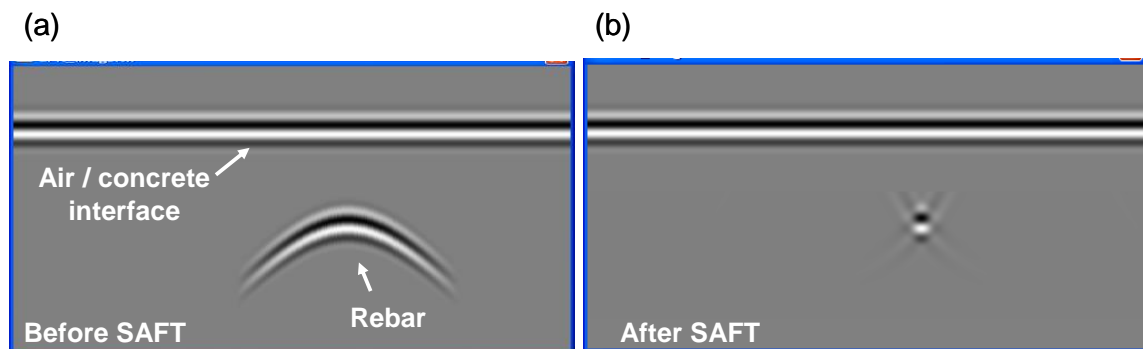
Figure 3. Model-generated GPR B-scans containing responses from an air/solid interface (front-wall) and a small embedded reflector simulating reinforcing steel

Figure 3 demonstrates the results of applying SAFT to a model-generated B-scan image. Figure 3a shows the raw B-scan, and Figure 3b shows the B-scan after the SAFT processing.

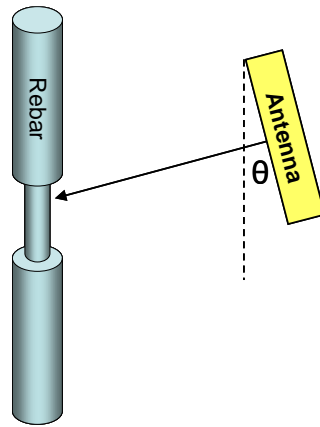
Figure 4. Assumed simplified geometry for thinned reinforcing steel

It was proposed to develop a laboratory simulation model capable of predicting the GPR response from a straight reinforcing steel segment having a thinned region (Figure 4). The dependence of the GPR reinforcing steel response was studied for various combinations of the degree of thinning, the position of the antenna relative to the thinned region, and the antenna tilt angle (θ) as shown in Figure 4.

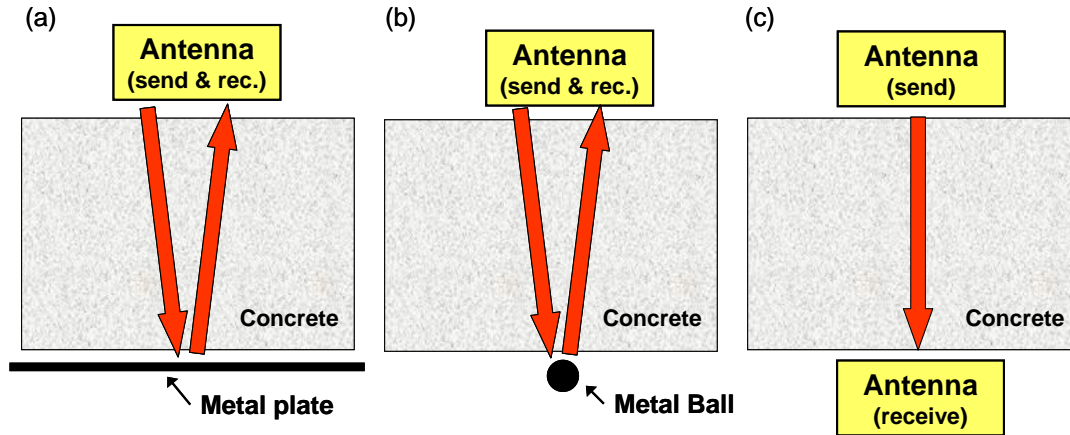
Figure 5. Measurement setups investigated for assessing concrete property variations within structures: (a) and (b) pulse/echo setups requiring only one GPR antenna and (c) pitch/catch setup requiring two antennas

In accounting for concrete properties, measurement schemes to determine EM wave speed and attenuation in concrete structures were developed. Both single antenna and double antenna approaches were explored, as illustrated in Figure 5.

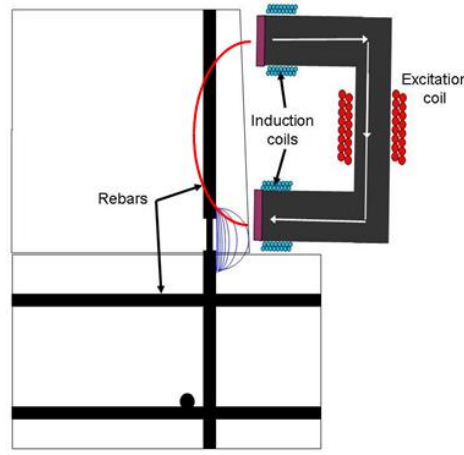
Figure 6. Probe design that combined magnetic reluctance and MFL measurements for inspecting reinforcing steel in concrete structures

The probe design is shown in Figure 6.

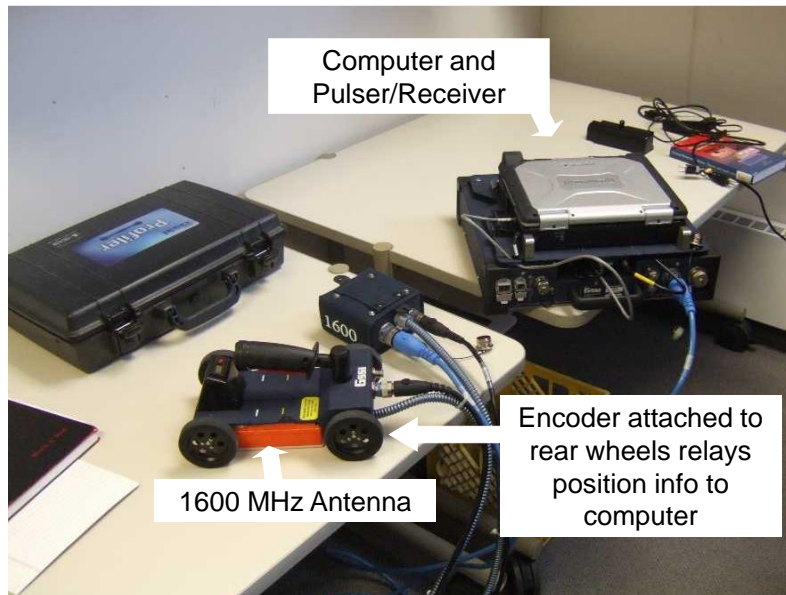
Figure 7. Portable GSSI ground penetrating radar equipment employing a single 1600 MHz antenna

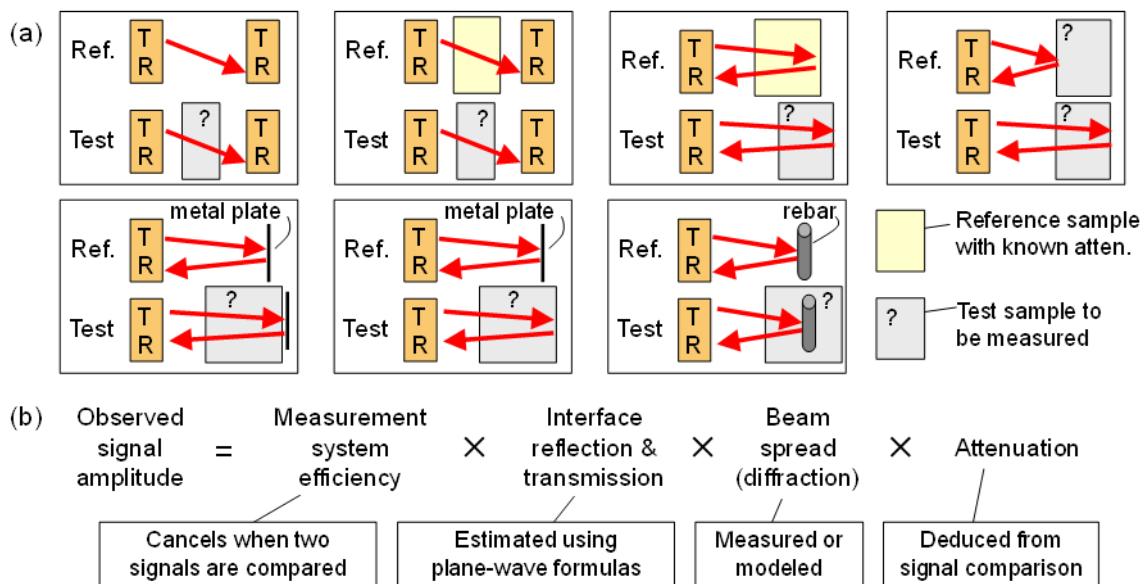
Figure 10. (a) Some of the many possible setups for normal-incidence attenuation measurements and (b) general form of the model expression used in attenuation deduction

Many setups can be used to measure the EM attenuation of a test specimen, and some of these are pictured in Figure 10a.

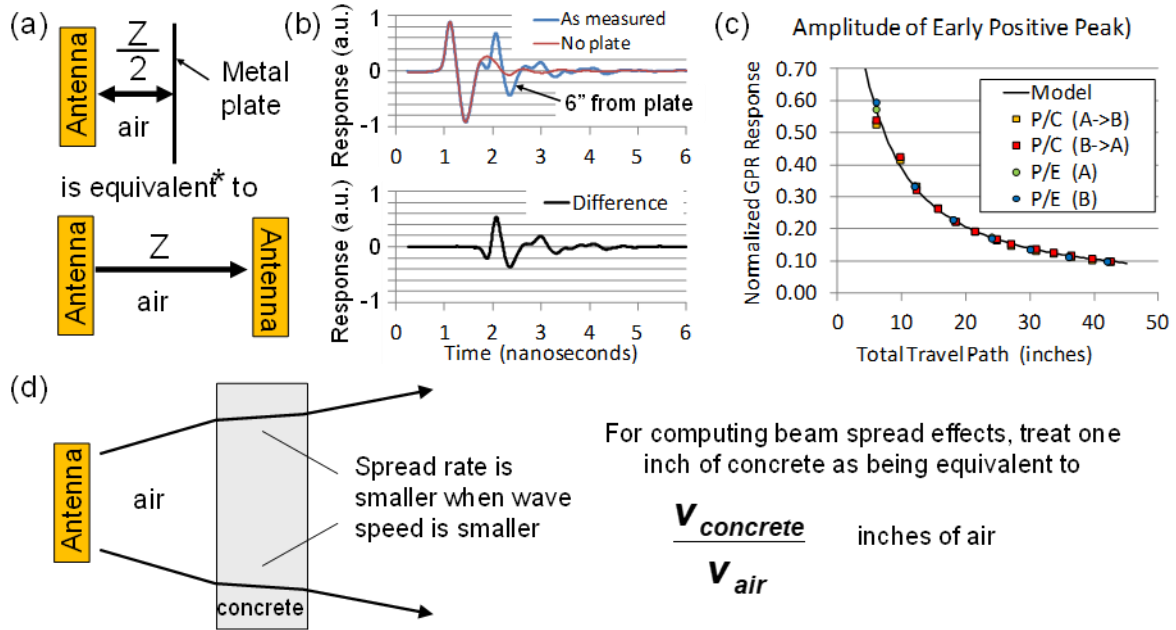
Figure 12. (a) Equivalence (under paraxial approximations) between pulse/echo and pitch/catch beam-spread measurement setups for two identical antennas, (b) pulse/echo signal reflected from a metal plate in air before and after subtraction of the direct-coupled signal, (c) comparison of (broadband) beam-spread effects for pulse/echo and pitch/catch measurements, and (d) handling of beam-spread corrections in concrete

Of course, Equation 3 and the associated Δ power law only apply directly to GPR beam spread in air. To compute beam-spread factors for layered structures (such as the antenna/air/concrete/air/antenna), researchers used a paraxial approximation based on Snell's Law of Refraction as illustrated in Figure 12d.

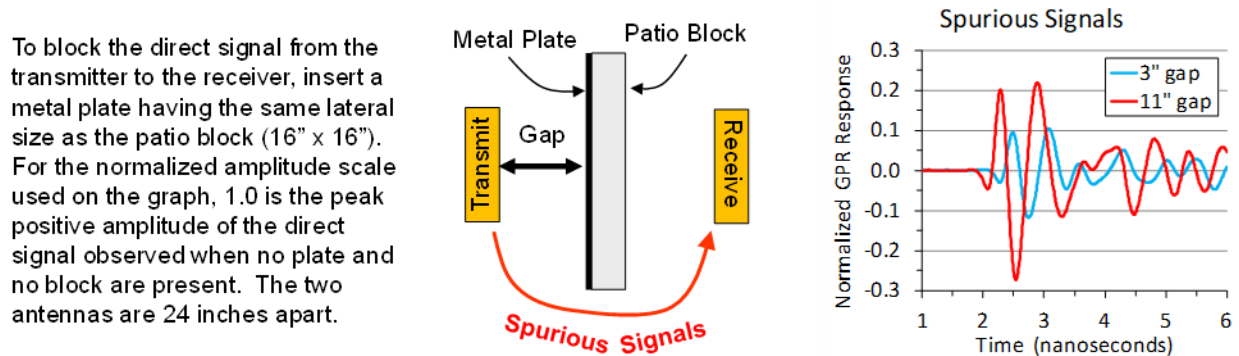
Figure 14. Simple measurement setup used to quantify strengths of spurious GPR signals associated with travel paths that bypass blocks under study

GPR signals arising from other travel paths that interfered (constructively or destructively) with the primary signal of interest here (direct transmission from transmitter to receiver through any blocks present). This is illustrated in Figure 14.

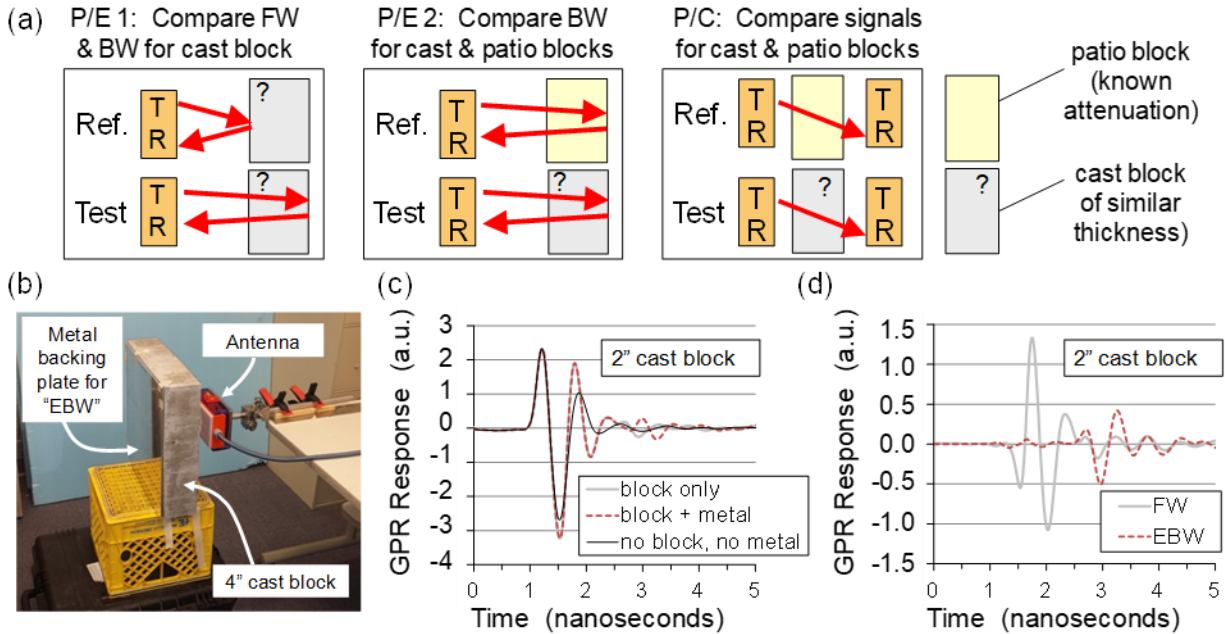
Figure 15. (a) Setups for attenuation measurements on cast concrete blocks (24-in. antenna separation for P/C), (b) cast block with metal plate in place for enhanced back-wall (EBW) echo acquisition, (c) raw GPR signals for setup P/E-1 using 2-in. cast block, and (d) resulting front wall (FW) and EBW echoes (prior to windowing) deduced by signal subtraction

The attenuation measurement setups used to examine the cast blocks are indicated in Figure 15a.

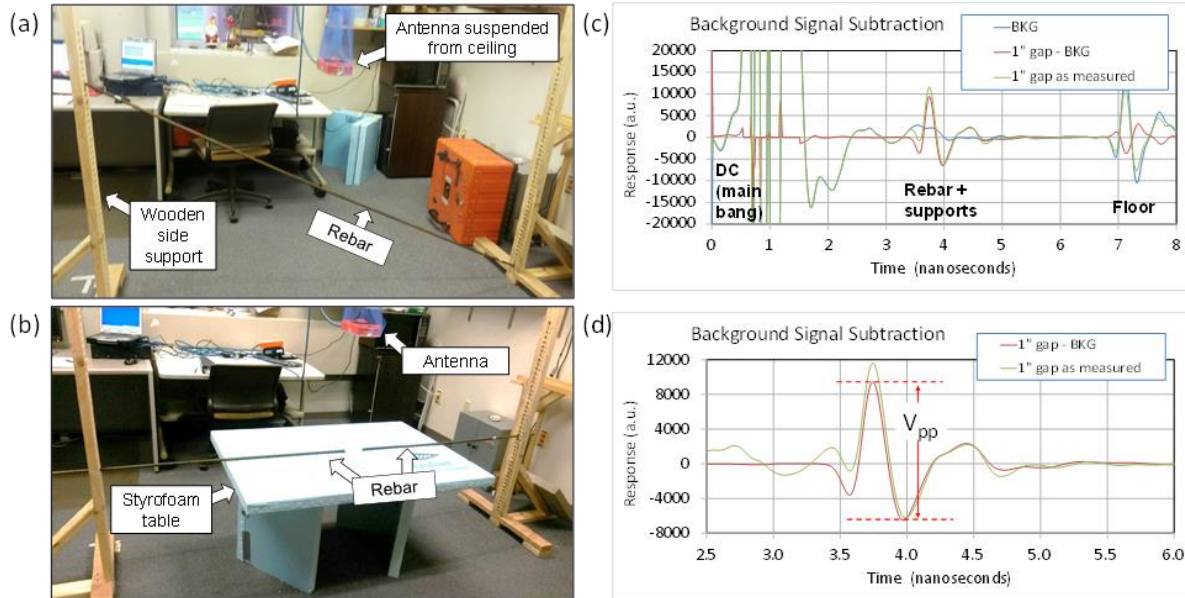
Figure 18. Examples of lab setups and of background signal subtraction for a long reinforcing steel bar containing a 1-in. gap

As illustrated in Figure 18a and Figure 18b, the antenna housing was placed in a plastic mesh bag and suspended from the ceiling. Reinforcing steel bars were placed either on a Styrofoam table or supported by wooden side structures. For most measurements, there was ample distance between the antenna, the reinforcing steel, and the floor, to allow for relatively clean separation of the direct-coupled (DC) signal and the reinforcing steel and floor echoes. In none of these measurements was the antenna moving with respect to the reinforcing steel. Rather, with the geometry fixed, the researchers operated the equipment in “free running mode” to repeatedly fire GPR pulses and capture returning signals. Each captured signal was a 1024-point waveform spanning 8 or 10 nanoseconds of time and digitized using a 16-bit analog-to-digital (A-to-D) converter. For a given measurement setup, several hundred signals were averaged to remove electronic noise, after making small time adjustments to correct for equipment drift during the course of the measurements. In all cases, the researchers: (1) measured the GPR signal from the reinforcing steel target + support structure, (2) measured the GPR signal from the support structure alone (referred to here as the background signal), and (3) subtracted the two signals to estimate the GPR signal from the reinforcing steel target without supports. An example of background subtraction is illustrated in Figure 18c and Figure 18d for the case of a long reinforcing steel bar containing a 1-in. long gap. After background subtraction, the peak-to-peak voltage (V_{pp}) was used to quantify the strength of the reinforcing steel response (Eisenmann et al. 2016).

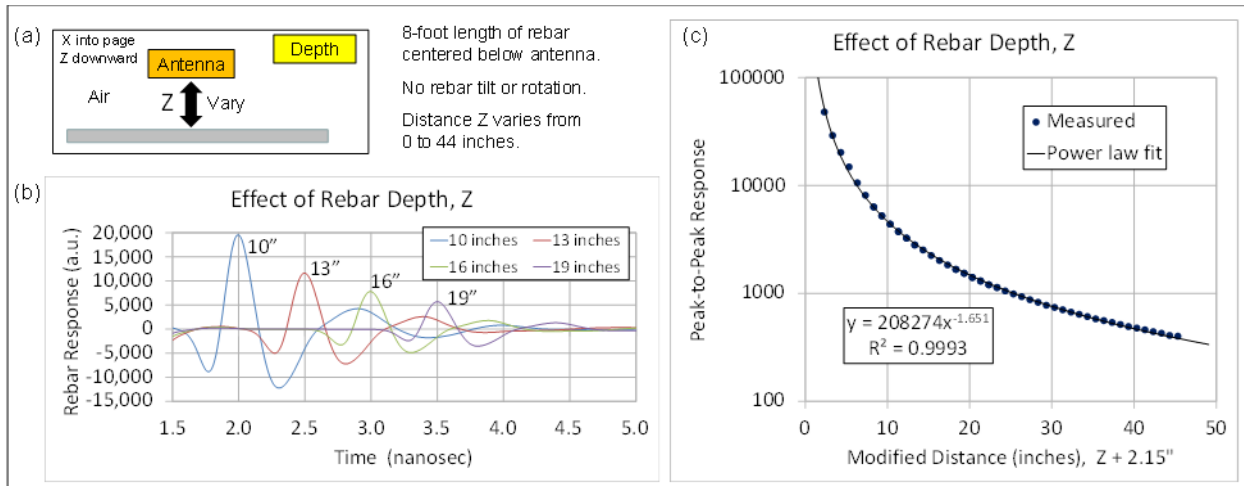
Figure 19. Effect of varying the reinforcing steel depth, Z

1. When the reinforcing steel depth Z was increased (Figure 19), the reinforcing steel response dropped steadily in amplitude and shifted later in time. The peak-to-peak response could be approximately summarized by the power $V_{pp} = C(Z+2.15)^{-1.65}$, where Z is the separation between the bottom of the antenna housing and the top of the reinforcing steel, and C is a constant depending on the gain setting used. In the power law, the researchers have modified the separation distance by adding an extra 2.15 in. They posited that $Z+2.15$ in. represented the distance of the reinforcing steel from an effective source location within the antenna housing. Without this modification, a power law representation (i.e., $C(Z)^p$) provides a much less accurate summary of the measured data.

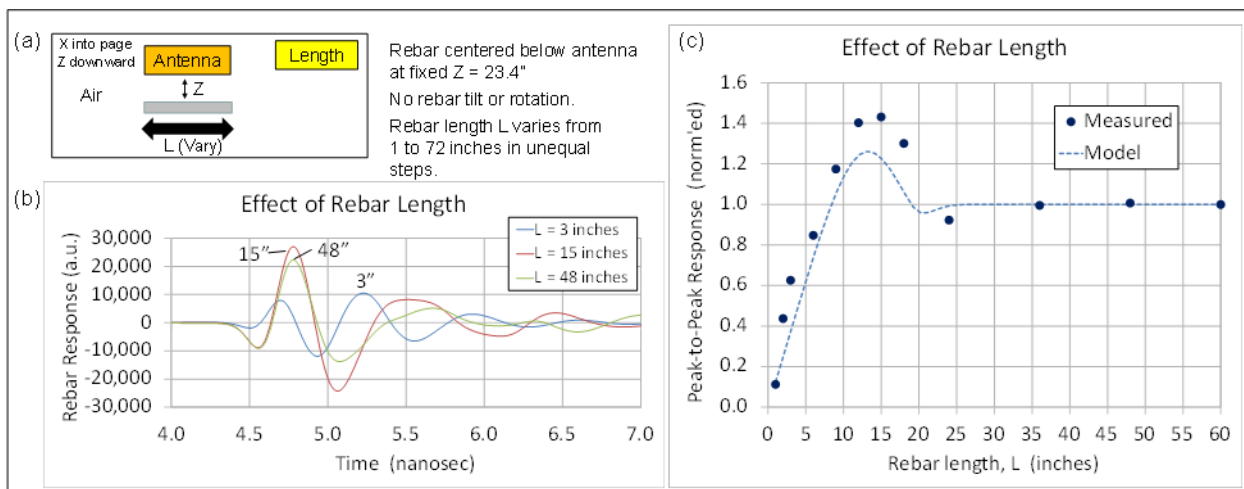
Figure 20. Effect of varying the reinforcing steel length, L

- When the reinforcing steel length L was varied (Figure 20), the arrival time of the GPR signal was relatively stable, but its amplitude and detailed appearance changed. The peak-to-peak response initially rose as L increased, peaking near $L = 15$ in. The response then fell, but beyond $L = 36$ in. little change was seen. The peak in the response was believed to be a consequence of net constructive interference from the sum of the reflected signals from metal surface elements distributed along the length of the reinforcing steel. A similar peak was predicted by a simple model. At the nominal center frequency (1.6 GHz), wavelength in air is $\lambda = 7.4$ in. Thus, the peak seen in Figure 20 occurs near $L = 2\lambda$, but that is coincidental since the peak length is also dependent on the standoff distance between the antenna and reinforcing steel (23.4 in. in Figure 20).

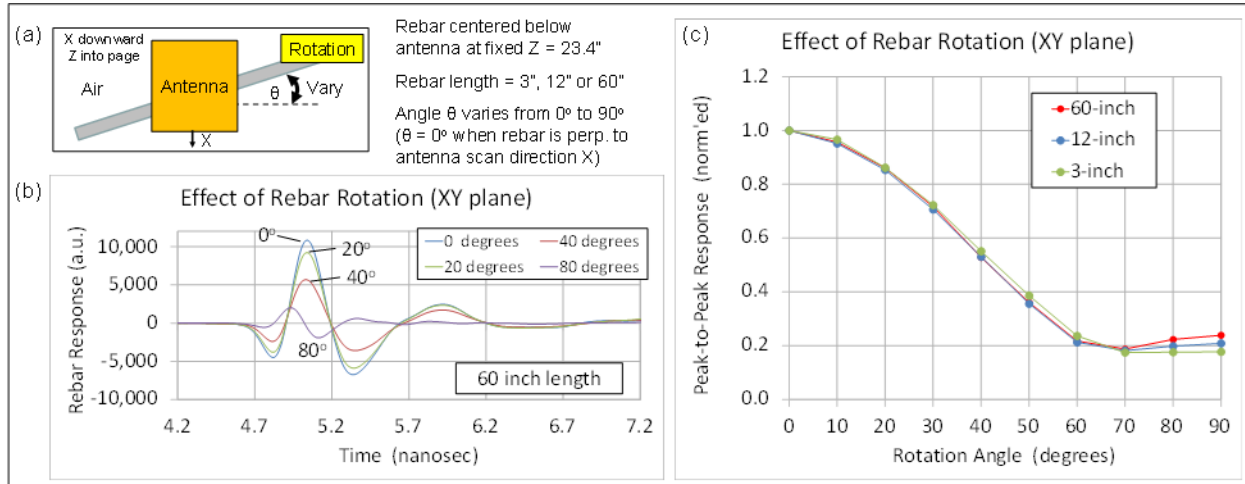
Figure 21. Effect of varying the reinforcing steel rotation angle θ

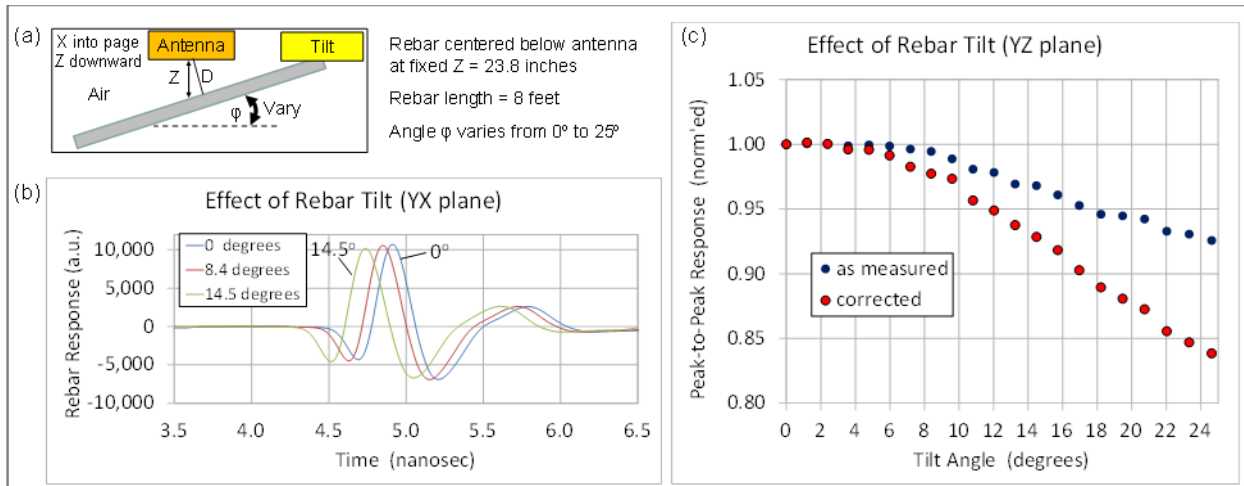
Figure 22. Effect of varying the reinforcing steel tilt angle ϕ

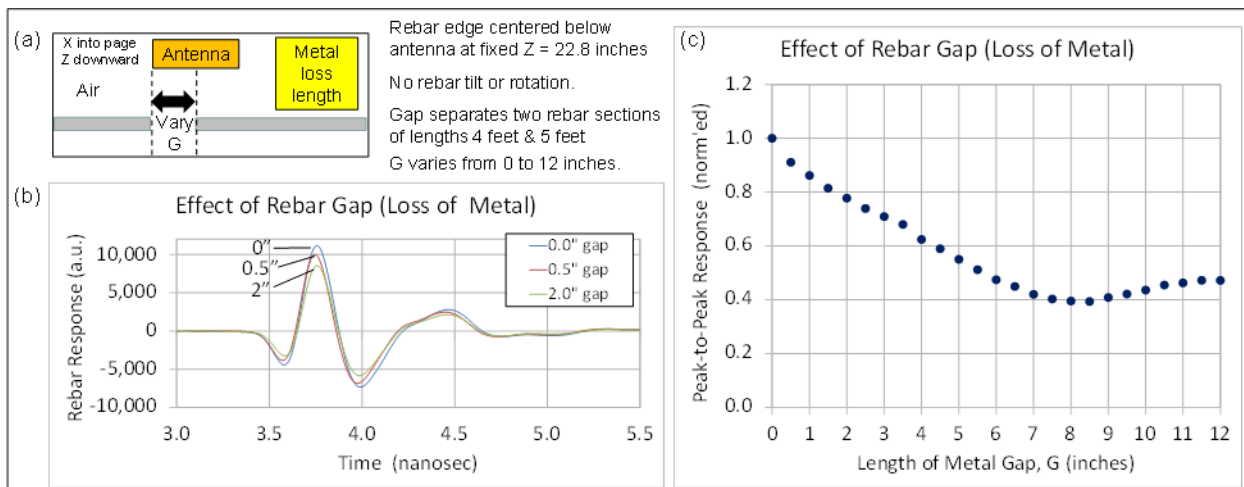
Figure 23. Effect of varying the reinforcing steel gap length G

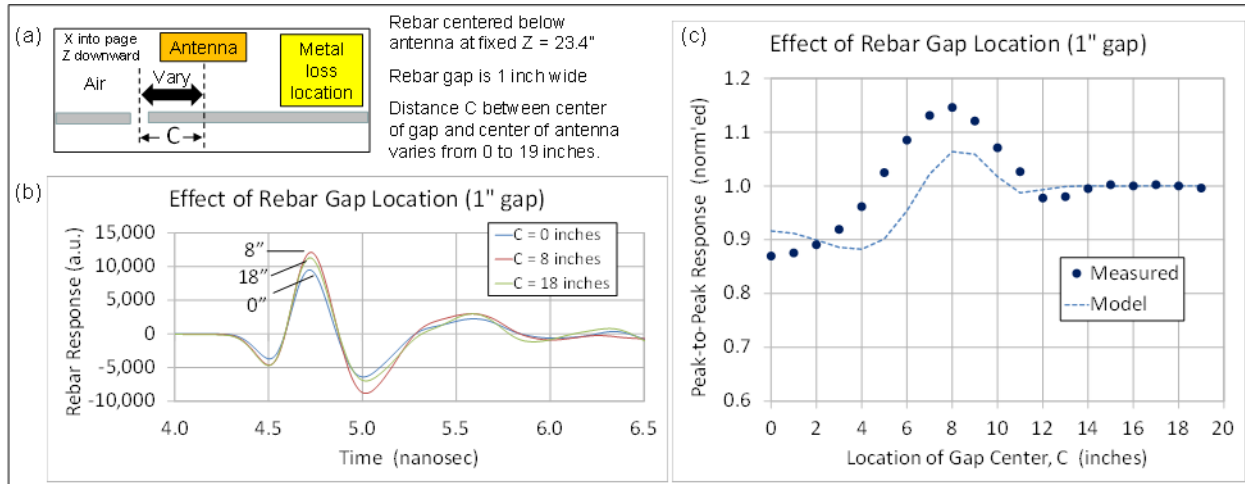
Figure 24. For a 1-in. reinforcing steel gap, effect of varying the gap location C

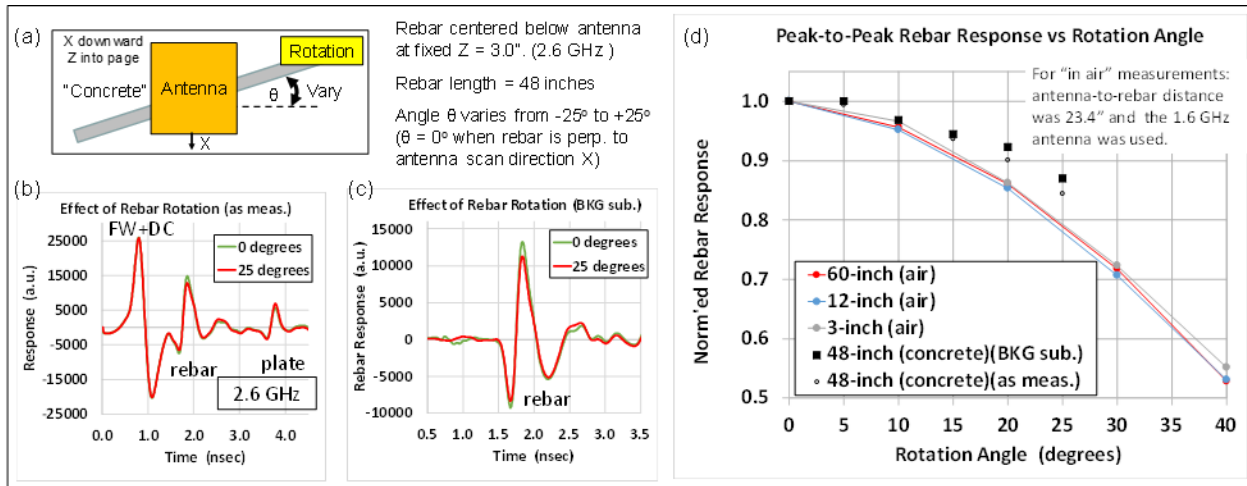
Figure 26. Effect of reinforcing steel rotation: (a) measurement setup, (b) representative GPR signals as measured, (c) reinforcing steel signals after background subtraction, and (d) dependence of peak-to-peak reinforcing steel amplitude on rotation angle, normalized to be unity at zero angle

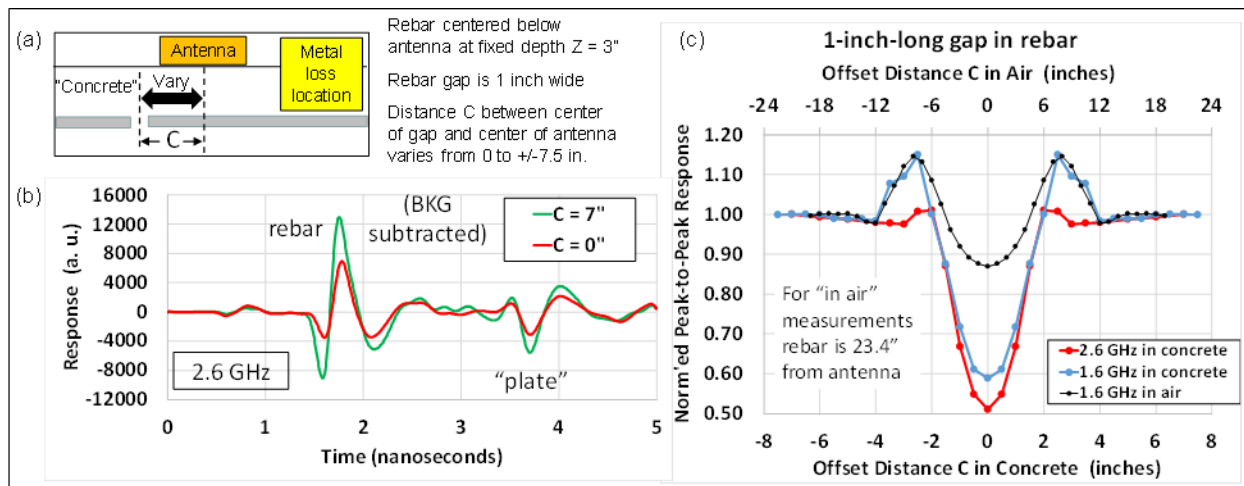
Figure 27. Effect of varying the gap location C for a 1-in. reinforcing steel gap

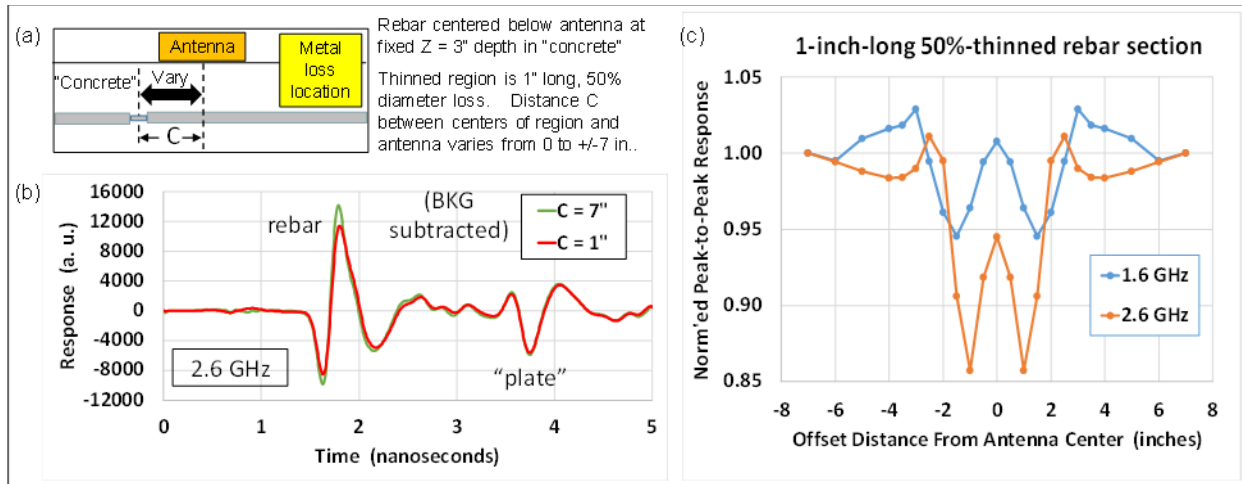
Figure 28. Effect of varying the offset distance C for a 1-in. long, 50%-thinned region

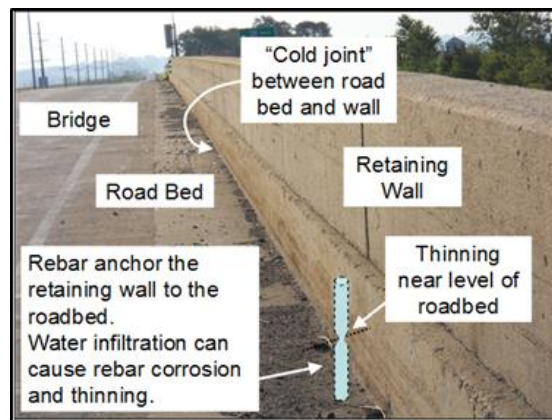
Figure 29. Identification of regions of interest on the bridge deck

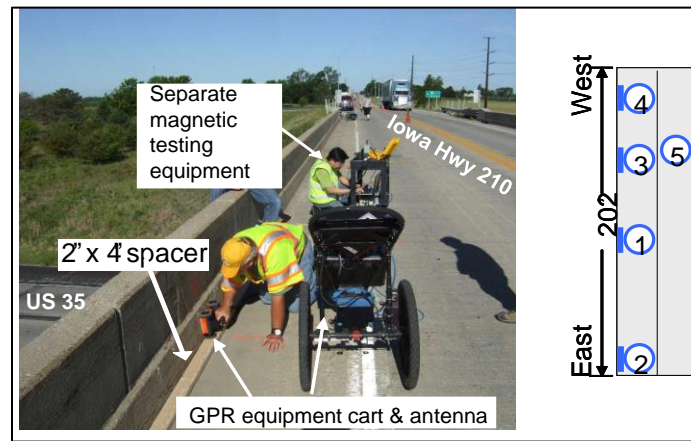
Figure 30. Data collection illustrating the spacer used in collection of the reference data

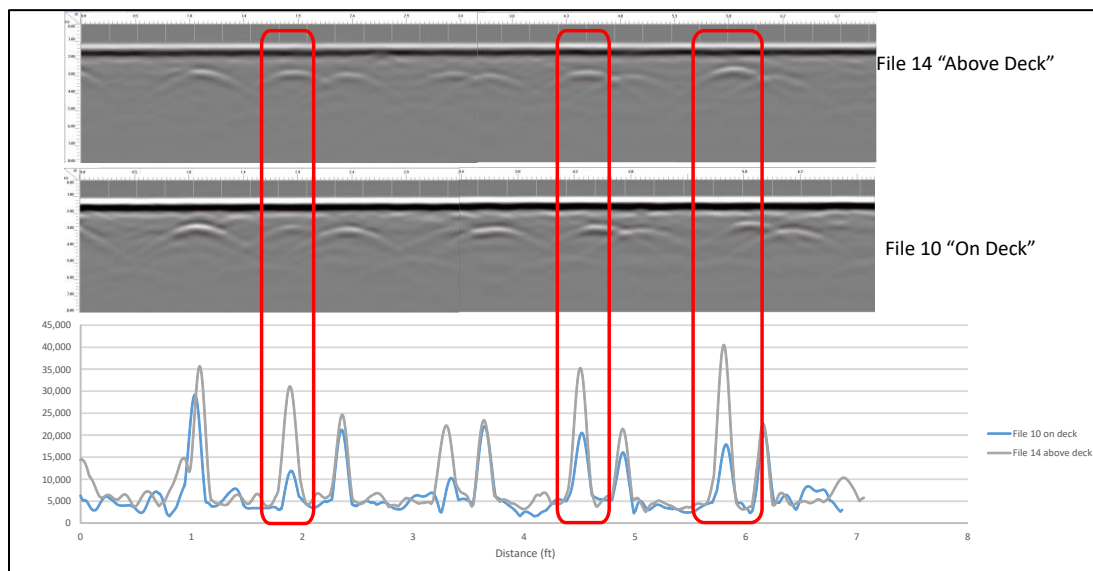
Figure 31. Example of B-scans and amplitude data take from a section of the bridge

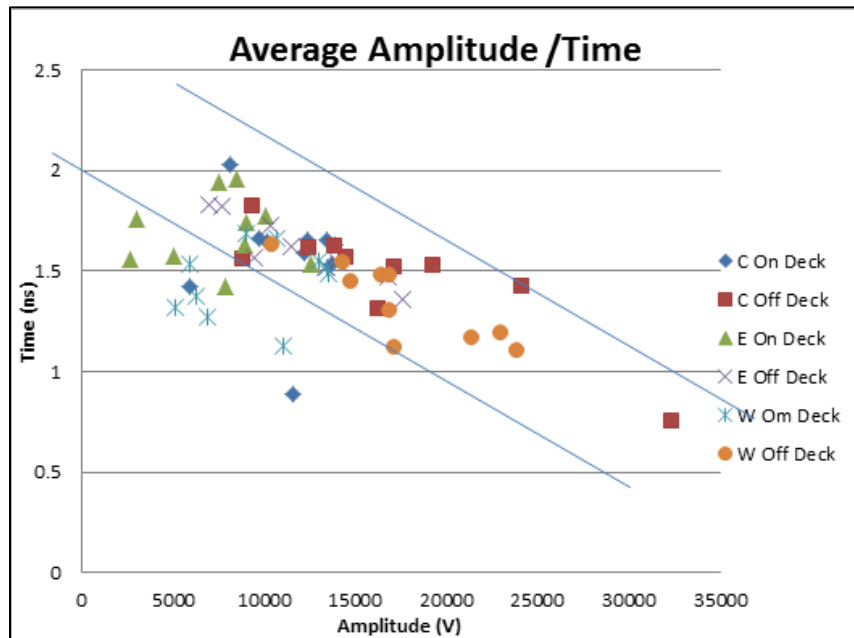
Figure 32. Compilation of data collected in 2012 from all inspected sections

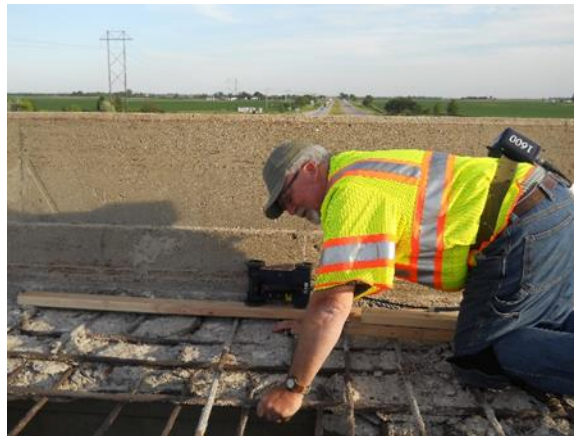
Figure 34. Gap shown in the bridge deck near an inspection site

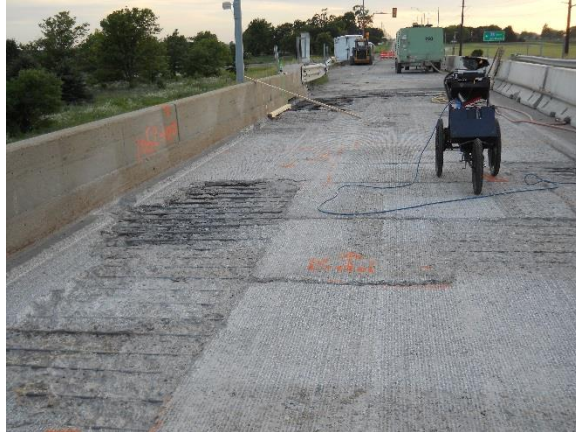
Figure 35. Amount of concrete removed during initial repair efforts

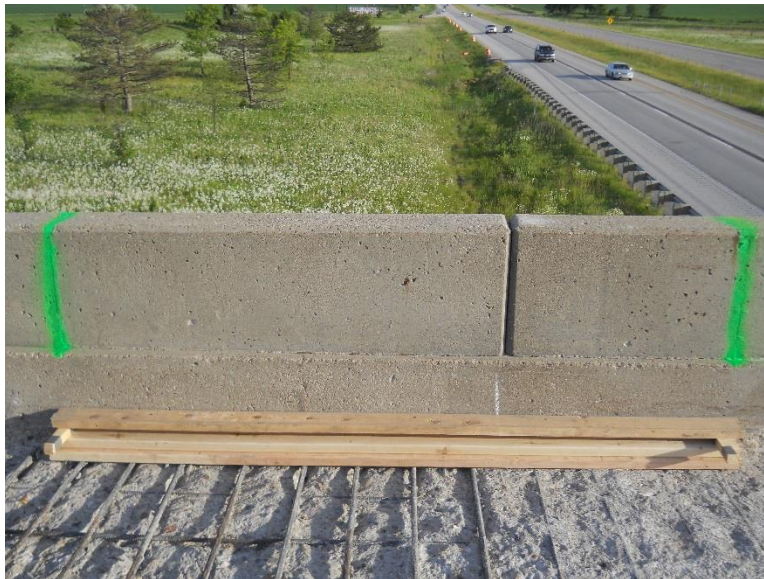
Figure 36. Configuration of material used to elevate the antenna to mimic the 2012 inspection location

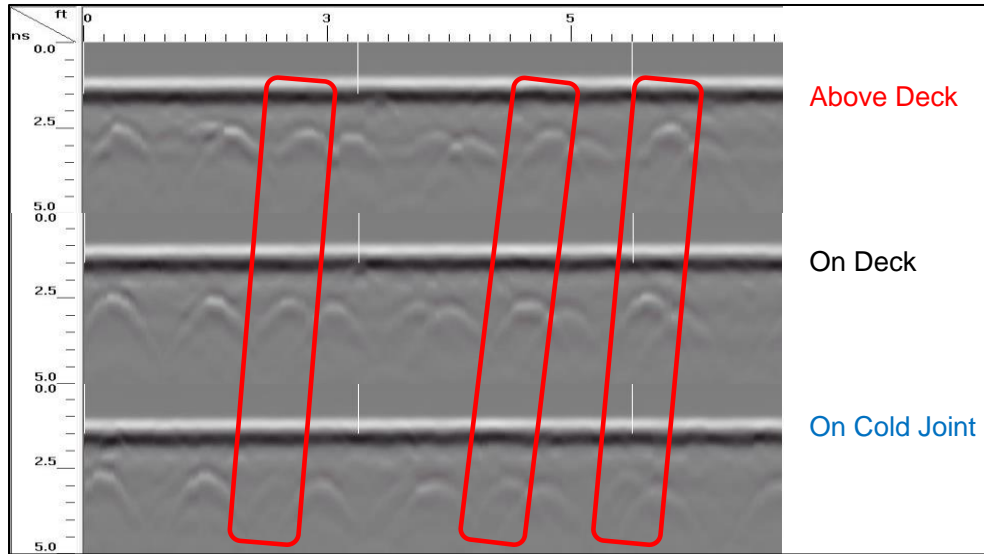
Figure 37. Example of data collected on three different levels

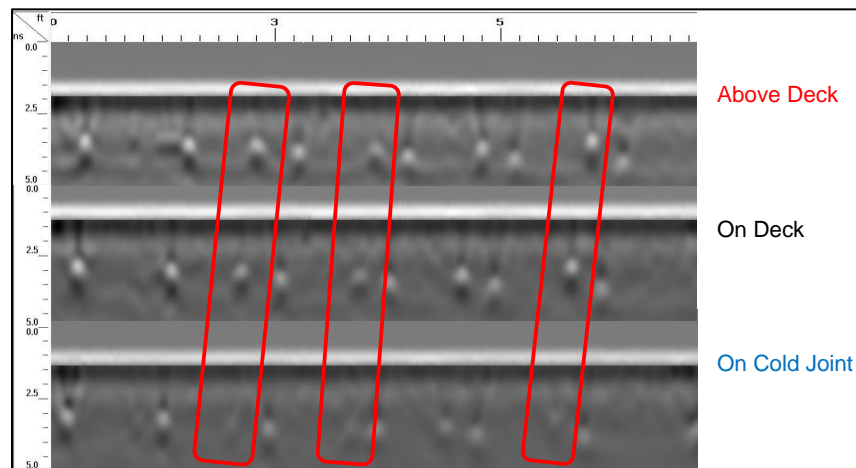
Figure 38. Same data with SAFT performed

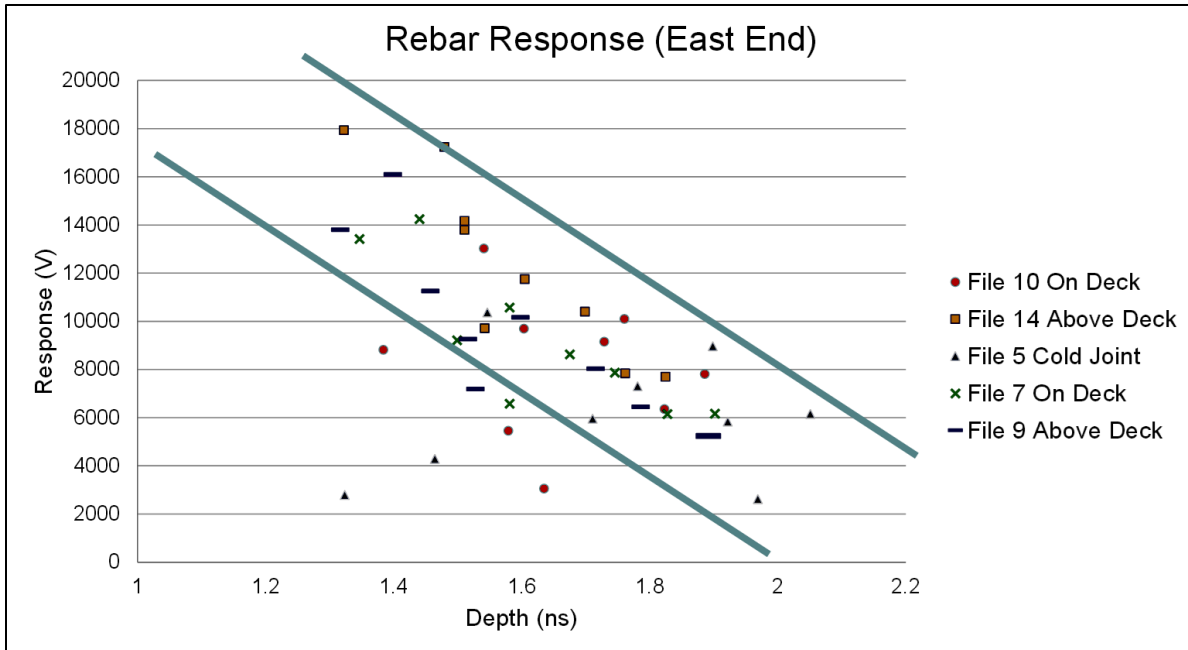
Figure 39. Combined data from one section showing both field dates

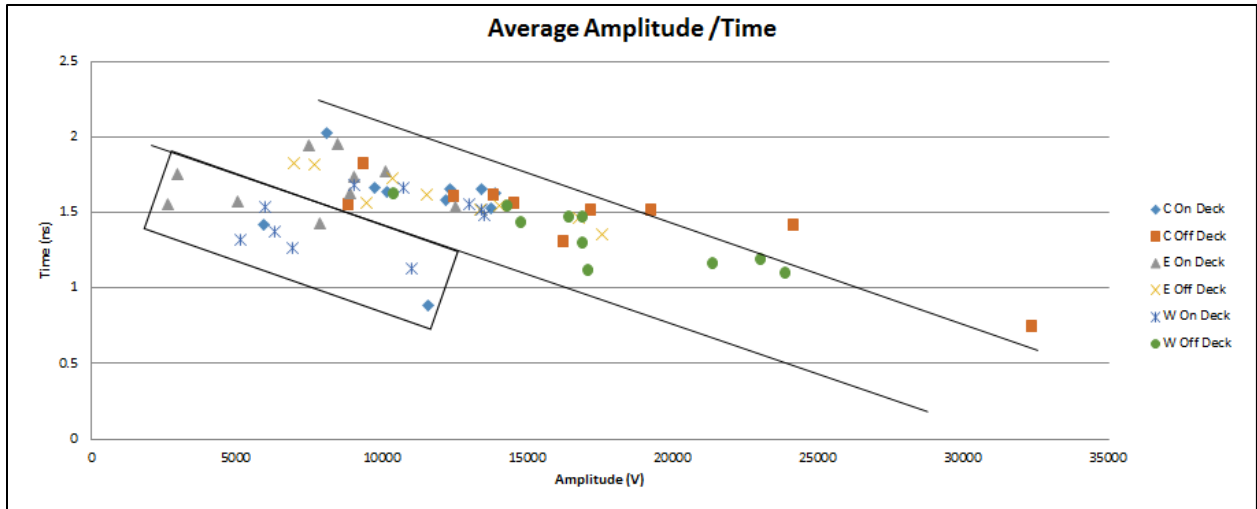
Figure 40. Data collection from June 2012

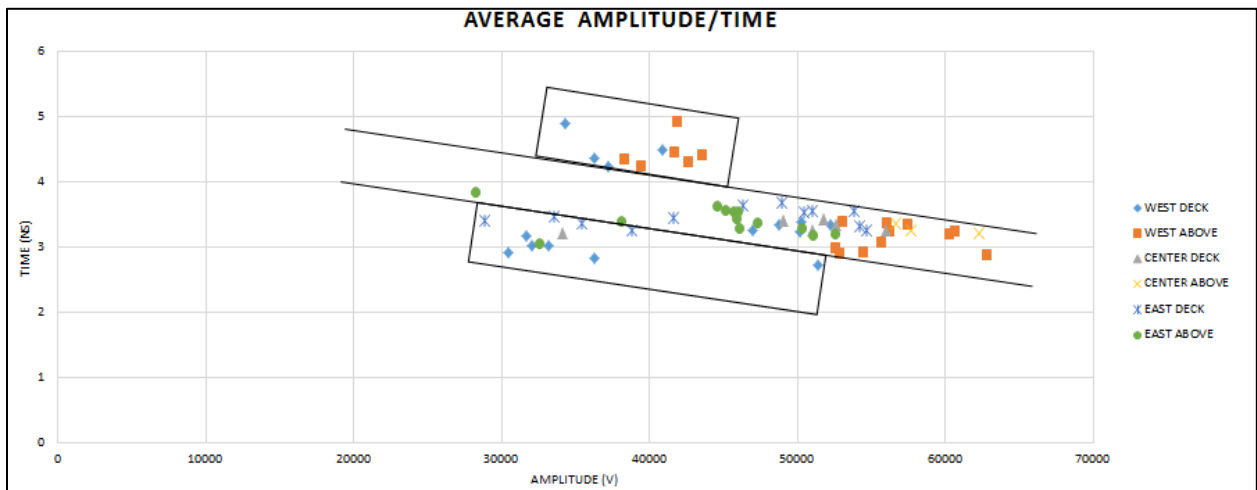
Figure 41. Data collection from December 2016

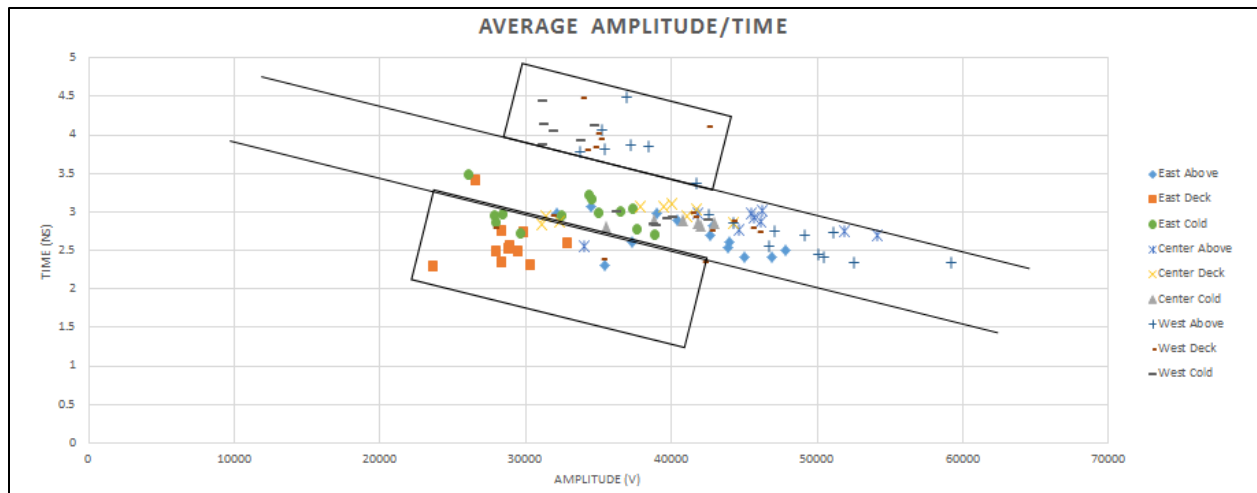
Figure 42. Data collection from June 2017

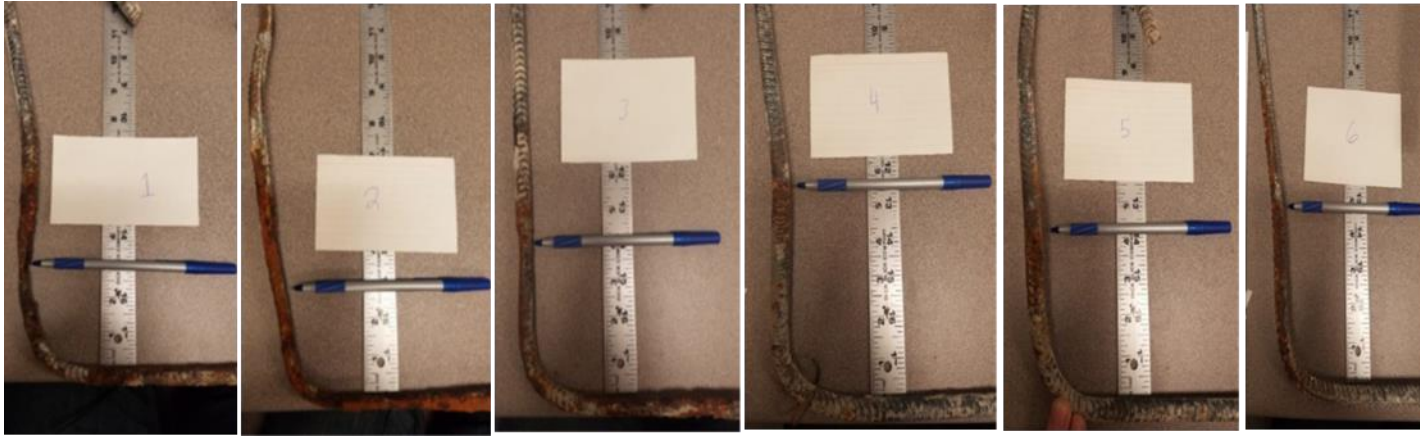
Figure 43. Reinforcing steel taken from IA 210 bridge after demolition of part of the bridge

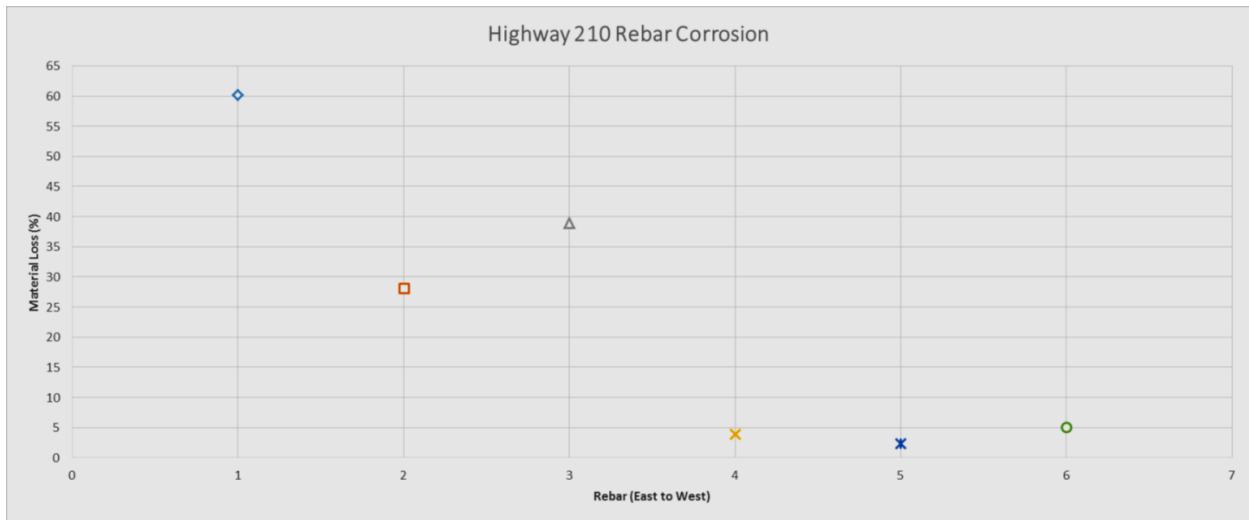
Figure 44. Material loss due to corrosion from reinforcing steel in Figure 43

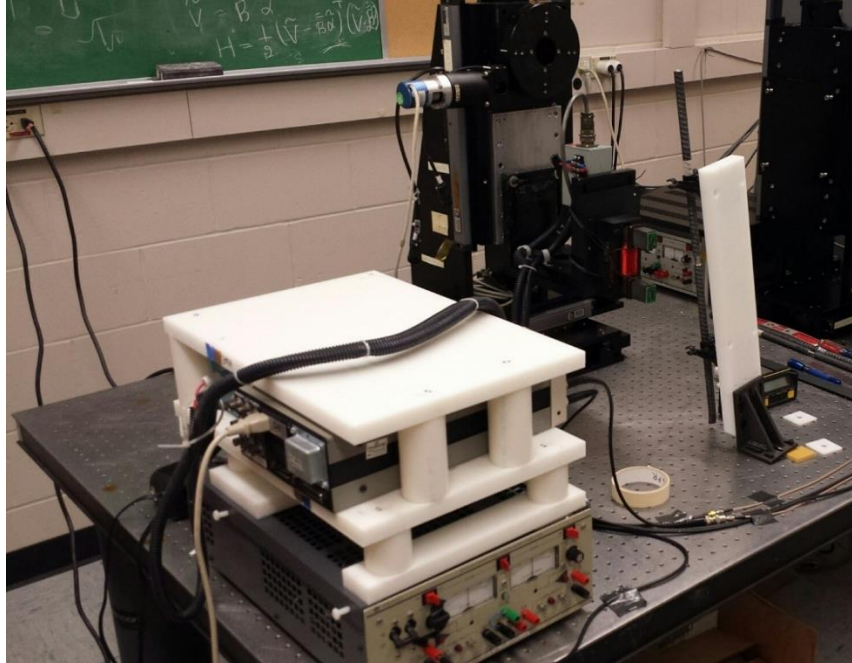
Figure 45. Reconstructed MFL system

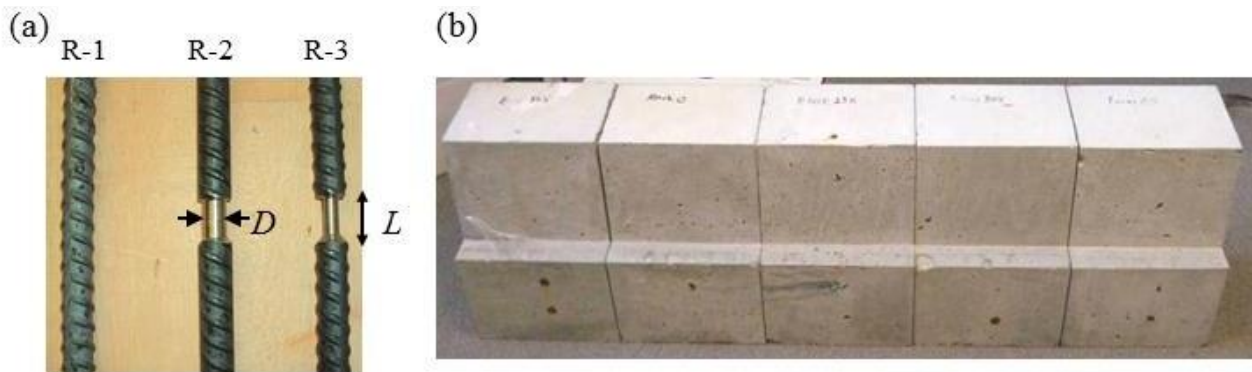
Figure 46. (a) Bare #4 reinforcing steel samples and (b) mockup samples consisting of either #4 or epoxy-coated #6 reinforcing steel bars

The diameter and length of the defects are shown in Table 2.

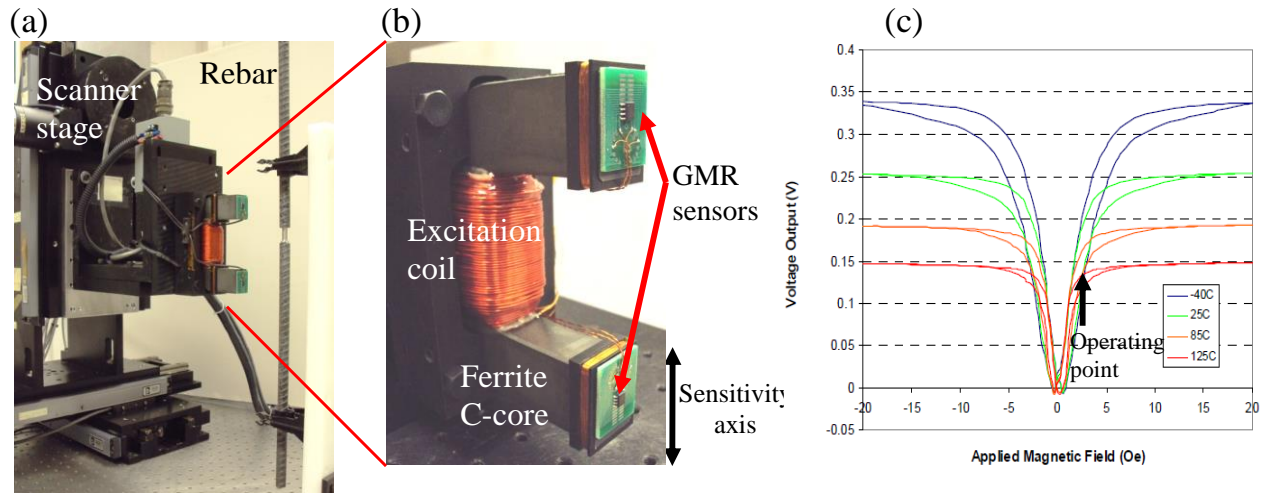
Figure 47. (a) Experimental setup for performing MFL scans on bare reinforcing steels and mockup samples, (b) close-up of MFL sensor probe consisting of an electromagnet to apply magnetizing field and two GMR sensors to detect the vertical component of leakage field at the pole-piece of the electromagnet, and (c) nominal output of the GMR sensors versus magnetic field
