Validation Study for Detection and Quantification of Corrosion in Bridge Barrier Rails

Final Report | December 2018

Sponsored by
Federal Highway Administration
Iowa Department of Transportation
(InTrans Project 15-538)

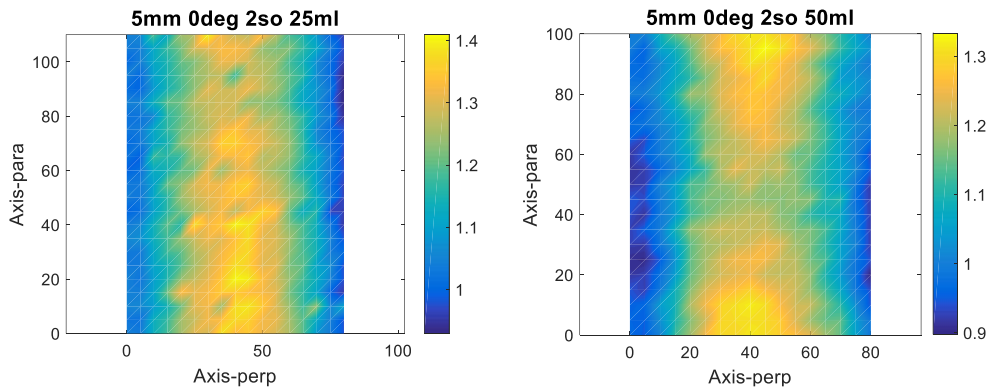
Figure 48. Difference in material loss between 25% (left) and 50% (right) material removal with a 2-in. standoff distance

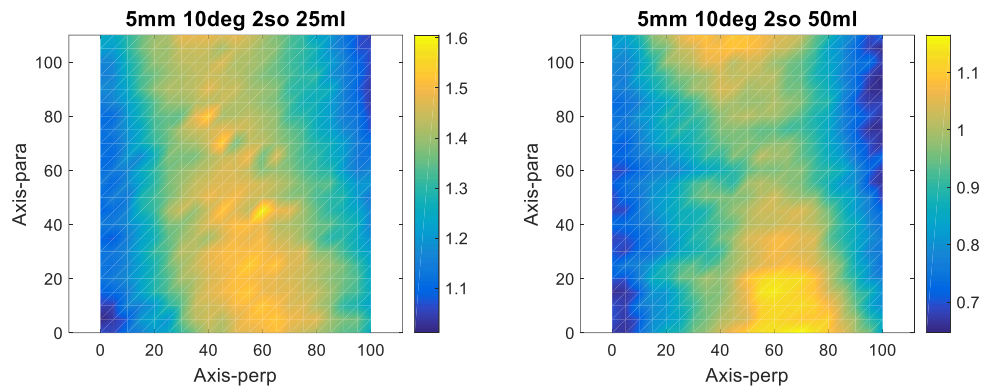
Figure 50. A 10° tilt combined with a standoff of 2 in., and material removal of 25% (left) and 50% (right)

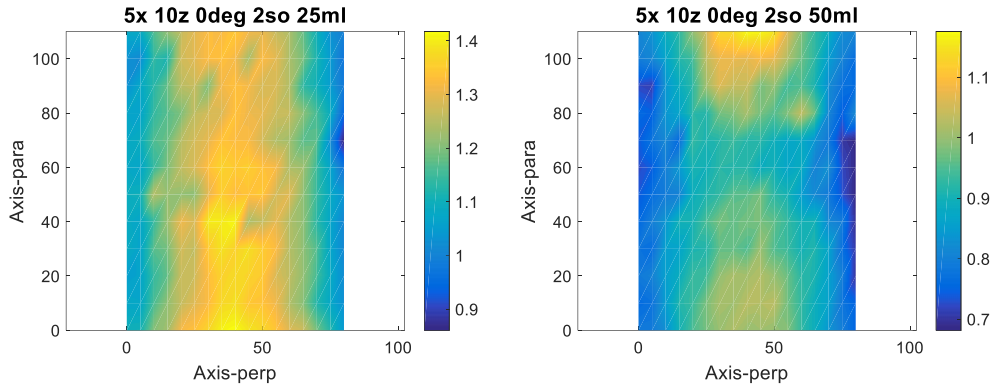
Figure 52. An increase of 5 mm in the Z direction during scanning, and material removal of 25% (left) and 50% (right)

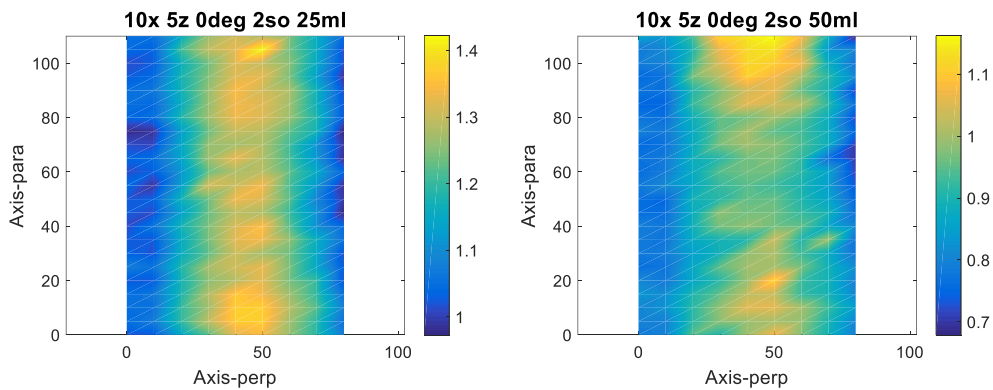
Figure 53. An increase of 5 mm in step in the X direction during scanning, and material removal of 25% (left) and 50% (right)

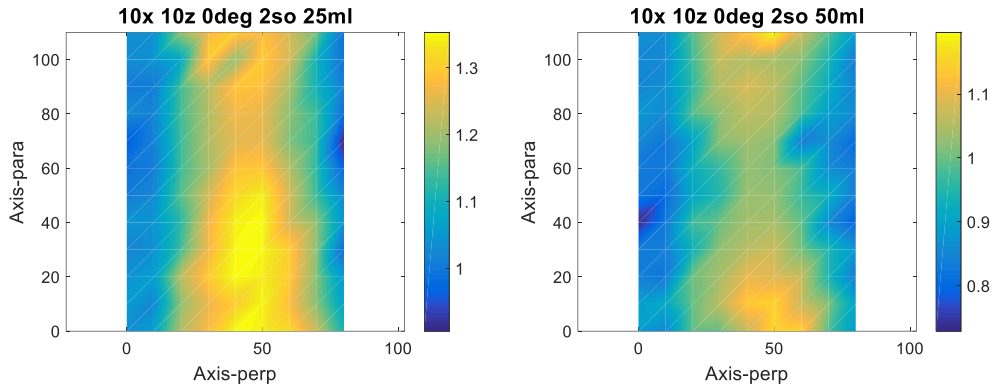
Figure 54. An increased step with 25% material loss (left) and an increased step with 50% material loss (right)

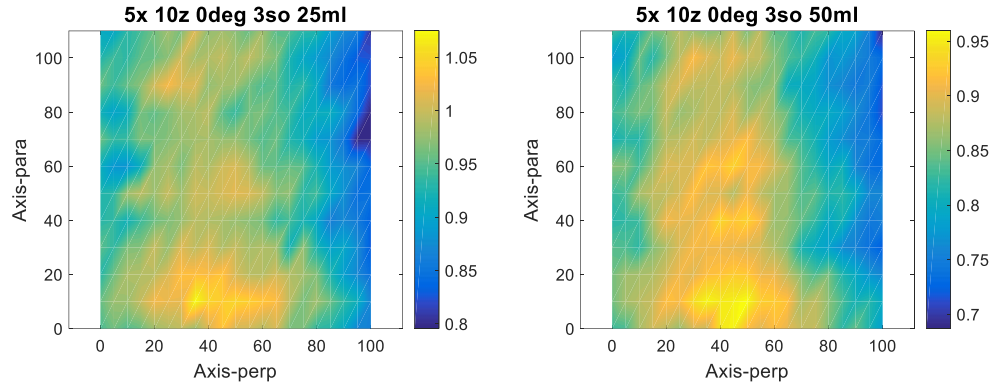
Figure 56. Concrete sample with a step increase in the Z direction with 0° tilt, and material removal of 25% (left) and 50% (right)

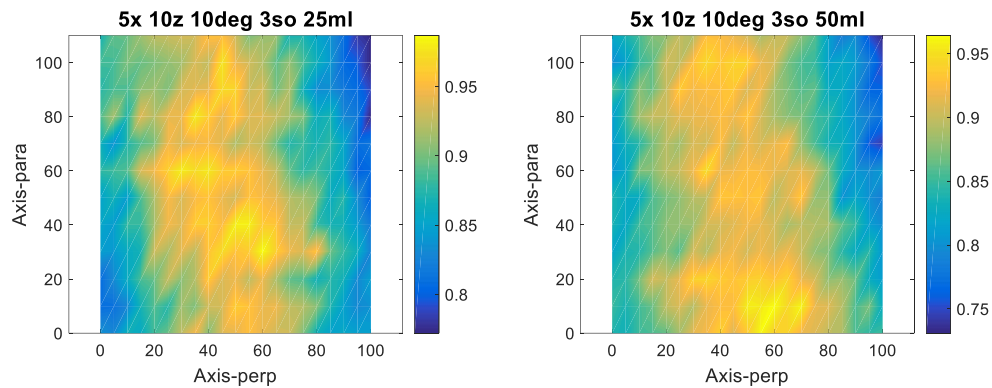
Figure 57. Concrete sample with a step increase in the Z direction with 10° tilt, and material removal of 25% (left) and 50% (right)

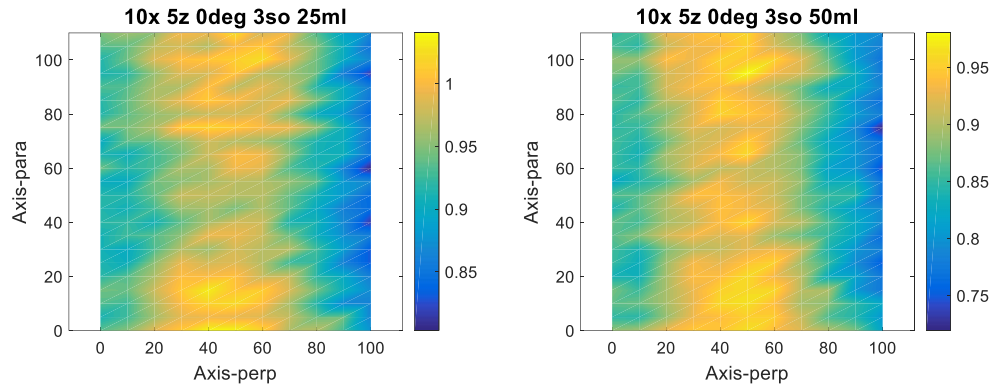
Figure 58. Concrete sample with a step increase in the X direction with 0° tilt, and material removal of 25% (left) and 50% (right)

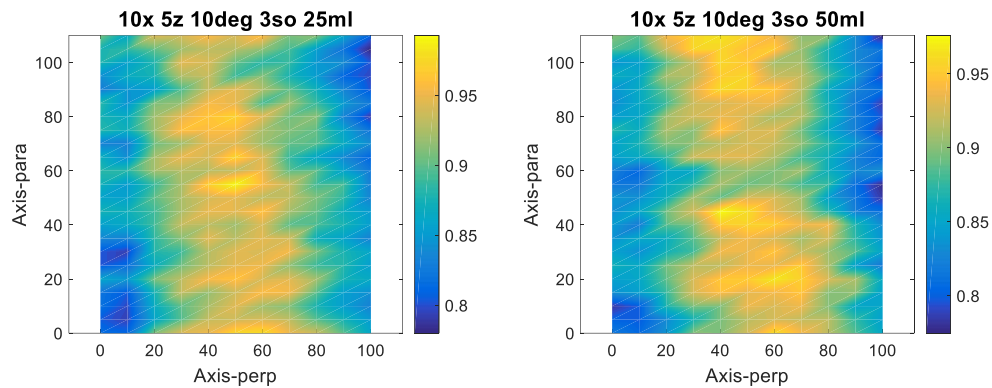
Figure 59. Concrete sample with a step increase in the Z direction with 10° tilt, and material removal of 25% (left) and 50% (right)

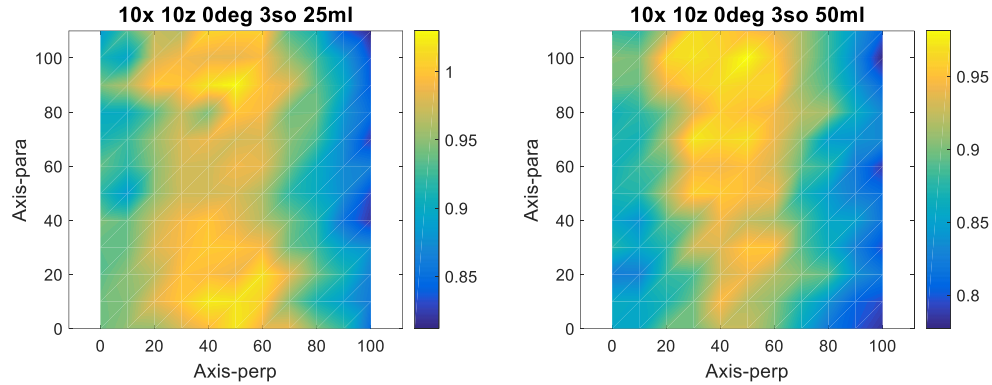
Figure 60. A 10 mm step for the X and Z directions with 0° tilt for material removal of 25% (left) and 50% (right)
